Archaeological building and desk-based
assessment of an animal shelter at Culworth
County Heritage Site, Northamptonshire

Report 10/195

December 2010

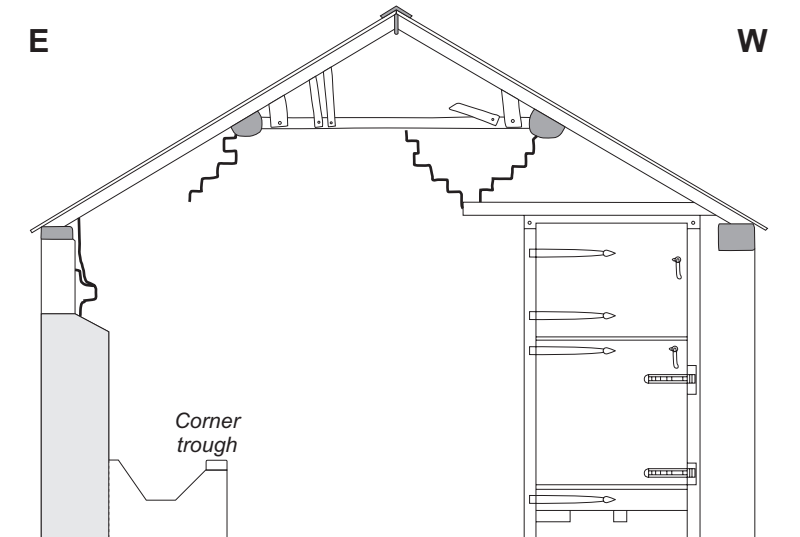
Elevation 2- central dividing wall, north side

The brickwork of this central gable does not fill the entire wall-plane but rather it stops at the same level as the purlins (Fig 6, elevation 2, Plate 6). Above this remains of vertical wooden slats are present; this would have provided additional ventilation to the southern stalls. Two cracks are present above the timber tie-beam set into the wall on which the western wall plate/beam sits; one is angled by way of the edges of bricks both vertically and horizontally until it reaches the underside of the western purlin, the other peters out when it reaches the top of the wall below the line of the ridge under the slotted section. There is another crack between the east wall above the stone boundary wall, and the central cross wall, whilst here the two sections of wall are bonded above the boundary wall level there has clearly been movement. Another crack runs down from the eastern purlin for a short length before petering out.

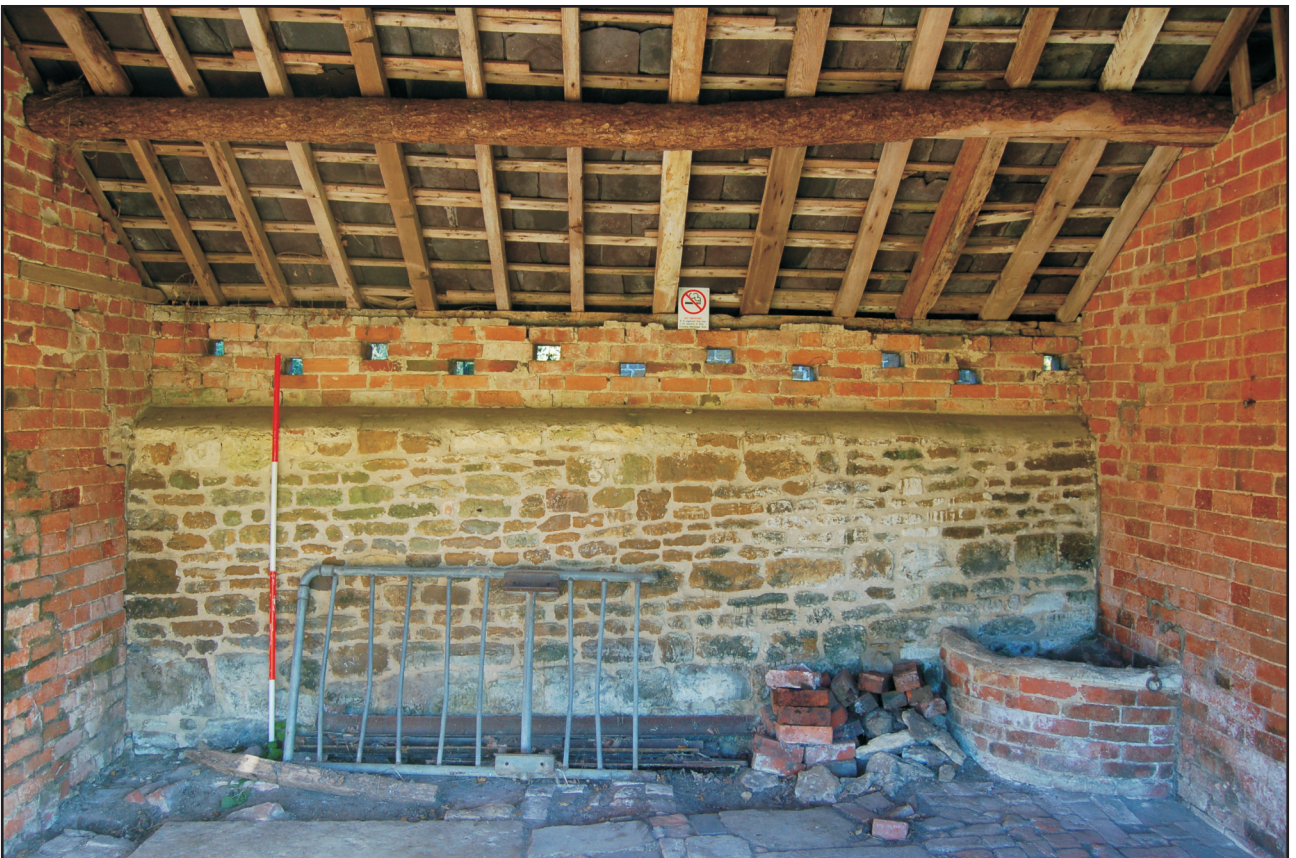
The original east boundary wall is constructed of roughly dressed and un-dressed ironstone blocks laid in lime mortar; it is approximately twice the thickness of the brick wall which is built on top of it (Plate 2). This section of wall has headers missing from each course to provide a through draught for ventilation, though given that the entire west side is open, this seems superfluous. Neither the north or south walls are bonded into the stone boundary wall, but are simply butted up against it. The north brick gable wall is severely cracked, due largely to the fact that the wall was not bonded into the earlier stone wall (Plates 3 and 4). The crack extends from the floor up the side of the stone wall and then spreads westwards and vertically before bifurcating, one branch petering out, the other stopping only when it reaches the oak beam set into the wall (Fig 6, elevation 1). Two further, but narrower, cracks are present above the oak tie beam. There has clearly been re-pointing or attempted repairs to cracking in the past using Portland cement which is of very poor quality being smeared not only into the joints but over the surface of the bricks.

The east internal wall of the hovel, looking east Plate 2

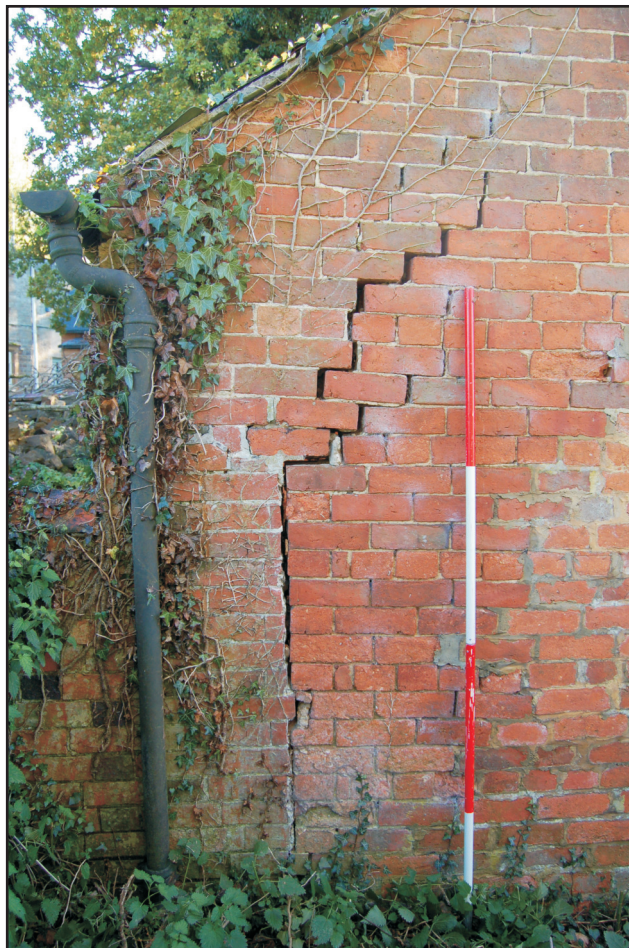
- 5.5 The cracking present in the walls is most likely simply a result of relatively poor foundations, though these have not been investigated so their depth/width/condition is unknown. Movement is also probably partly a result of being poorly, or not-at-all, tied into the earlier stone boundary wall with the result that any settling shows most readily at the junction between the two different materials. The majority of the repairs have been undertaken using un-sympathetic materials such as Portland cement which is visually unattractive and does not (unlike lime mortar) allow for minor movement within the walls; this may not in itself exacerbate further cracking but it should not be used in the future.

The north wall of the hovel, looking south, showing structural failure Plate 4

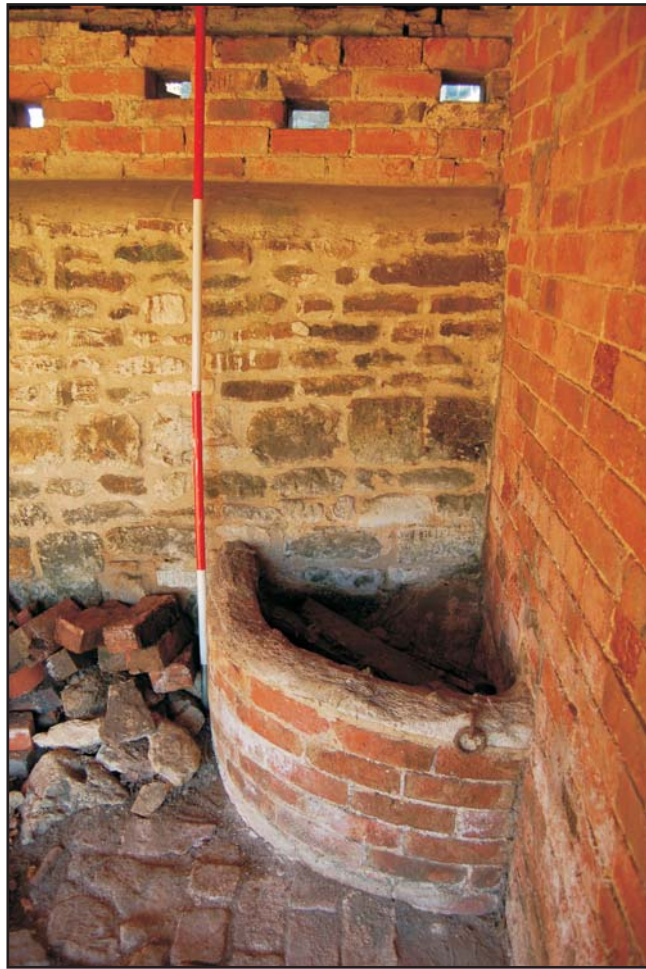
In the south-east corner is a brick trough constructed of curved red brick laid in lime mortar with an oak sill fitted with an iron staple and tethering ring attached (Plate 5). The trough is also lined with brick which retains sections of lime mortar render, although much of this is missing. The bricks of the trough are of the same overall size as those in the side walls of the building.

The trough in the south-east corner Plate 5
of the hovel, looking east

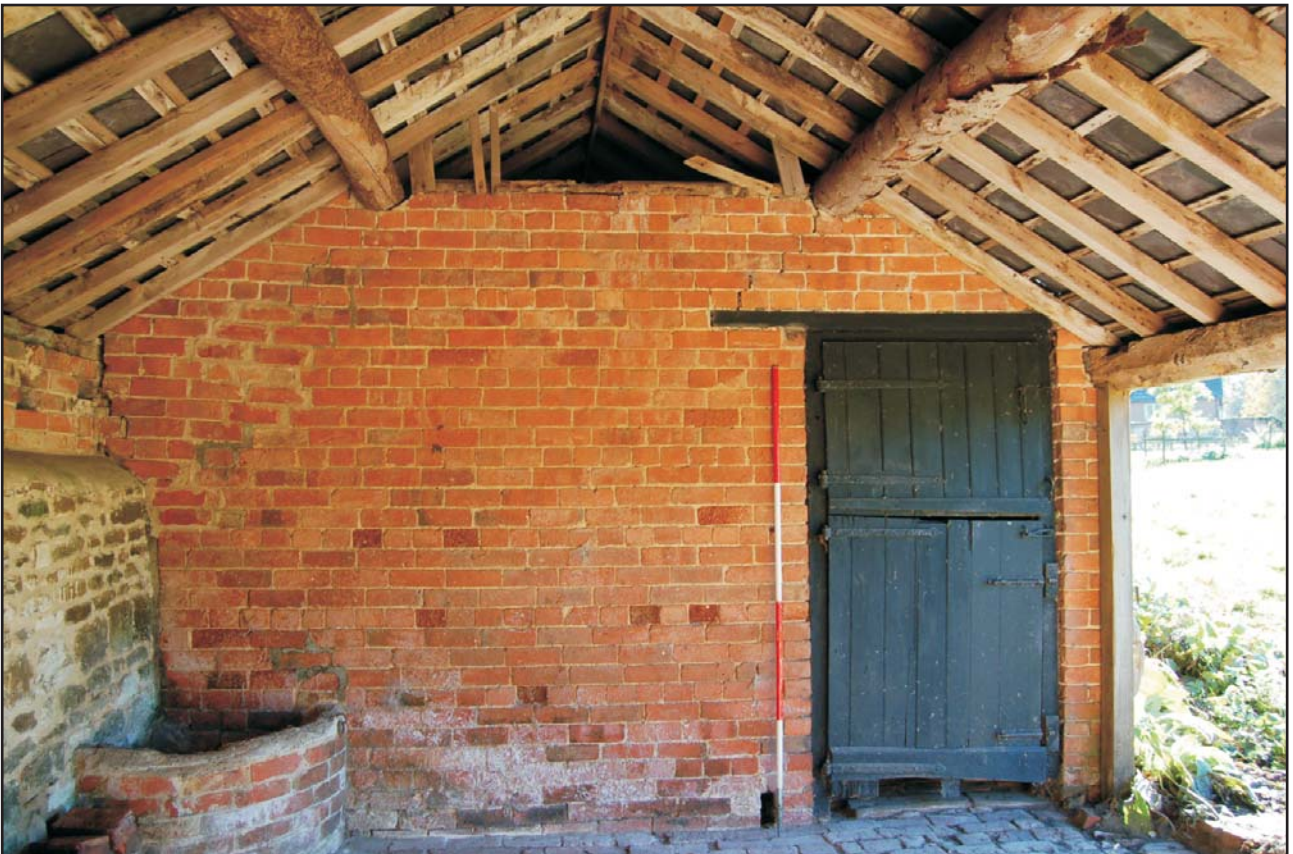
The south wall of the hovel (the central east-west wall) forms the north wall of the room at the southern end of the building (Fig 6, elevation 2, Plate 6). It is constructed entirely of red brick in the same way, and contemporary with, the north gable wall. It contains a two-part stable door hung on an oak frame. The upper leaf is a modern replacement, the lower leaf is earlier, though potentially not original; both are made of vertical planks, ledged, but not braced (CHS notes record a new stable door in September 1996). The lower leaf has had an additional horizontal plank added to the outer (north) side below which only stubs of the planks remains, presumably where they have rotted off. Both doors are hung on spearhead strap hinges which are probably original, and on the upper leaf, clearly re-used. They hang on simple pintle hinges set in the door frame. The upper leaf has a staple and loop of iron, re-set and on the door frame is the catch for a drop latch, though the latch is no longer present on the upper door leaf. The lower leaf has a similar staple and loop but also two modern draw bolts of thin, modern pressed steel; their catch plates have been fixed to blocks of wood on the door frame in order for them to engage.

The south internal wall of the hovel and stable door to the southern room, looking south Plate 6

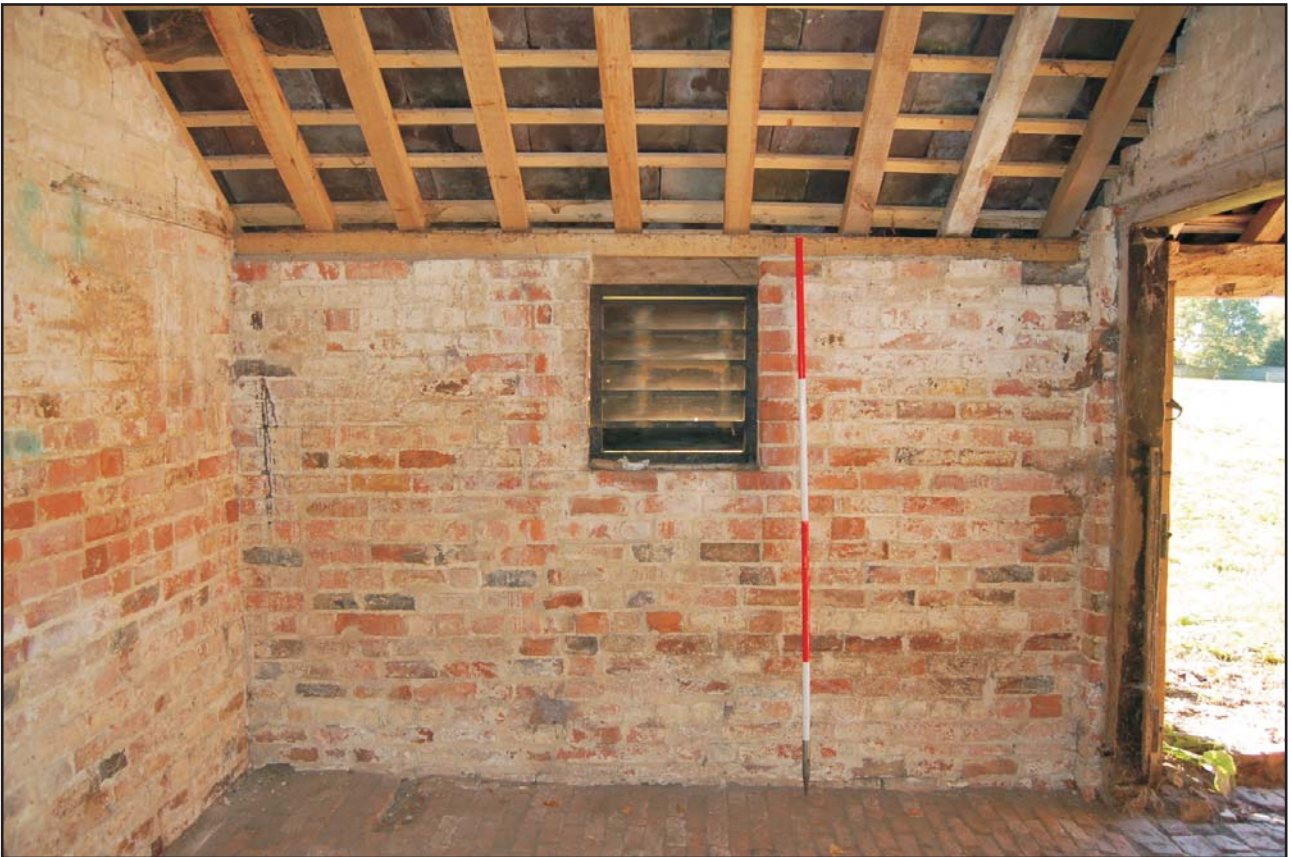
There is a window opening in the west wall fitted with (modern) timber louvres (Plate 7). It is assumed that these replace an earlier version of the same as no evidence survives for another configuration, and it seems unlikely that it would ever have been glazed, particularly at this height where it would be liable to breakage by livestock. The window opening has no sill and its lintel, of timber, is formed by the underside of the western wall plate, a modern softwood replacement.

The west side of this section of the roof is almost entirely a modern replacement with both the wall plate and rafters being made of machine-sawn pine (only one rafter appears to be original), although the purlin does appear to be original being white-washed squared pine (Plates 7 and 9). The eastern half of the roof appears to be largely original; it sits on a wall plate which is contiguous with that of the hovel section. The purlin here is of squared timber and is joined to the rounded timber of the purlin over the hovel section by a simple lapped scarf joint. The rafters and laths are the same as the northern part, though, as previously noted, modern on the west side. The ridge

The west internal wall of the southern room with louvred window, looking west Plate 7

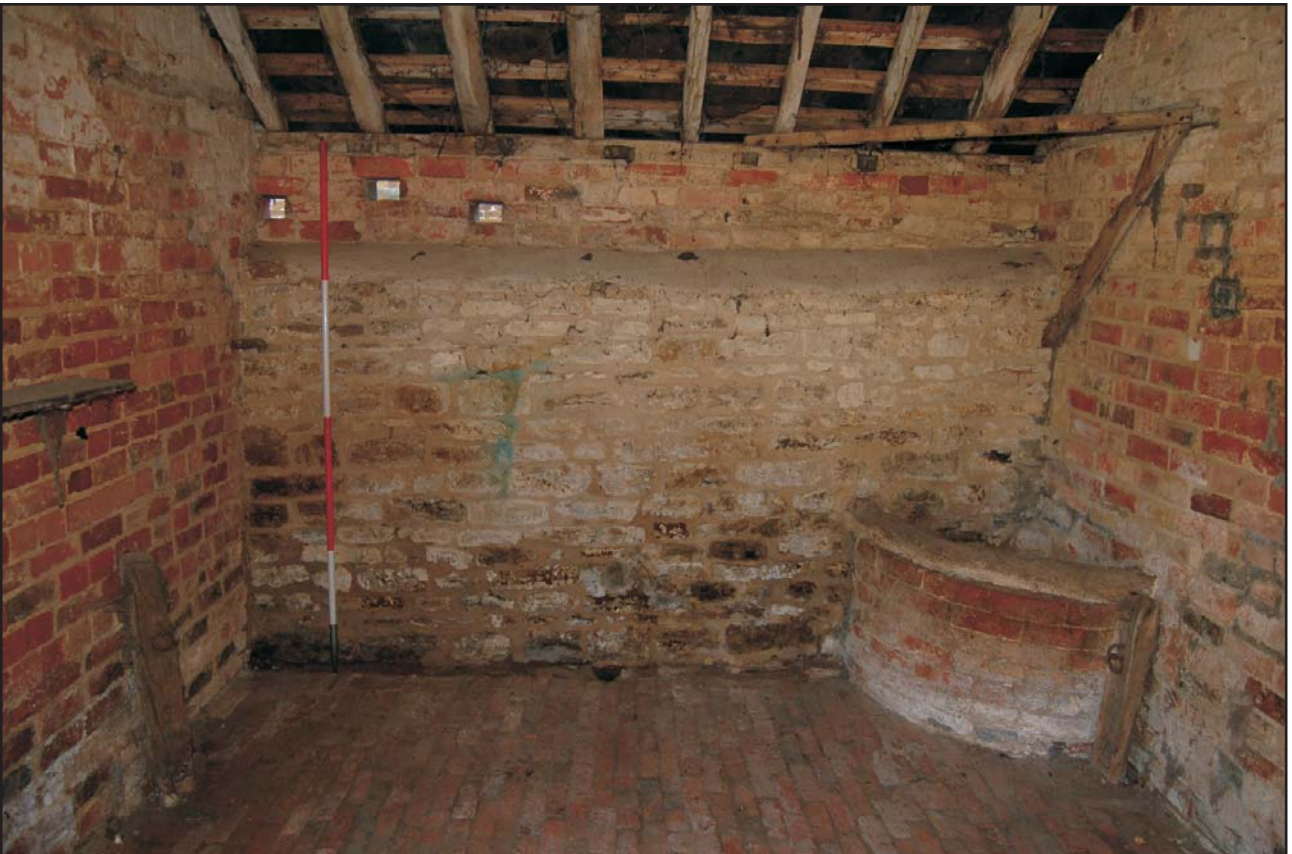
plank and ridge covering is the same as over the hovel. The east wall is constructed in the same way as in the northern section, of brick upon the earlier stone boundary wall, but only features three ventilation holes in this room (Plate 8).

In the south-east corner of the room is a trough made in exactly the same way as the one in the hovel, and of the same materials and dimensions (see Plate 8). The only difference is that the tethering ring is fitted to an oak post set in the floor against the south wall and not in the oak sill of the trough. Another tethering post, with ring, is positioned against the north dividing wall; these indicate that the room provided space for two beasts (perhaps to be tethered for milking?). Though it no longer exists, there is evidence for a hay rack along the length of the east wall, an angled timber remains against the south wall and the slight scar of its former partner can be seen against the south side of the central dividing wall. No structure remains in between, but it can be reasonably assumed that the rack comprised an upper and lower timber rail with slats fitted between which formed a triangular receptacle against the wall to hold hay. A modern, galvanised iron, ring fixed to a square plate has been screwed onto a block of wood set in the south wall. It is assumed that this is a modern replacement of an earlier, higher, tethering hook.

The east internal wall of the southern room, looking east Plate 8

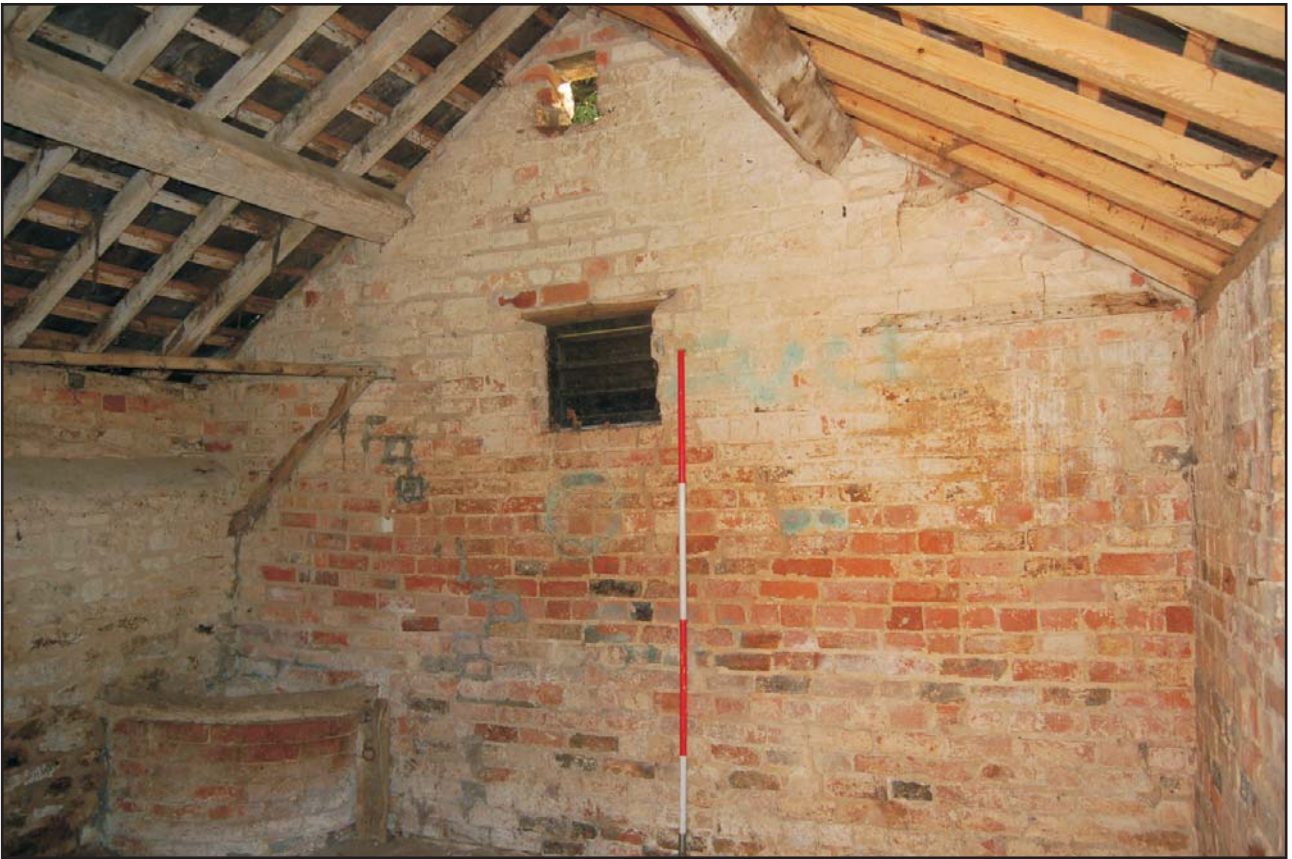
The south gable wall is constructed of red brick in the same way as the other brick walls, and contains two openings; one just below the ridge which is un-lined, another below it fitted with louvres (Fig 6, elevation 3, Plate 9). These are set in a simple frame beneath a timber lintel which extends into the brickwork on either side. Two tie beams extend into the southern gable wall internally on which the wall plates are set; they are not visible externally.

The south internal wall of the southern room, looking south Plate 9

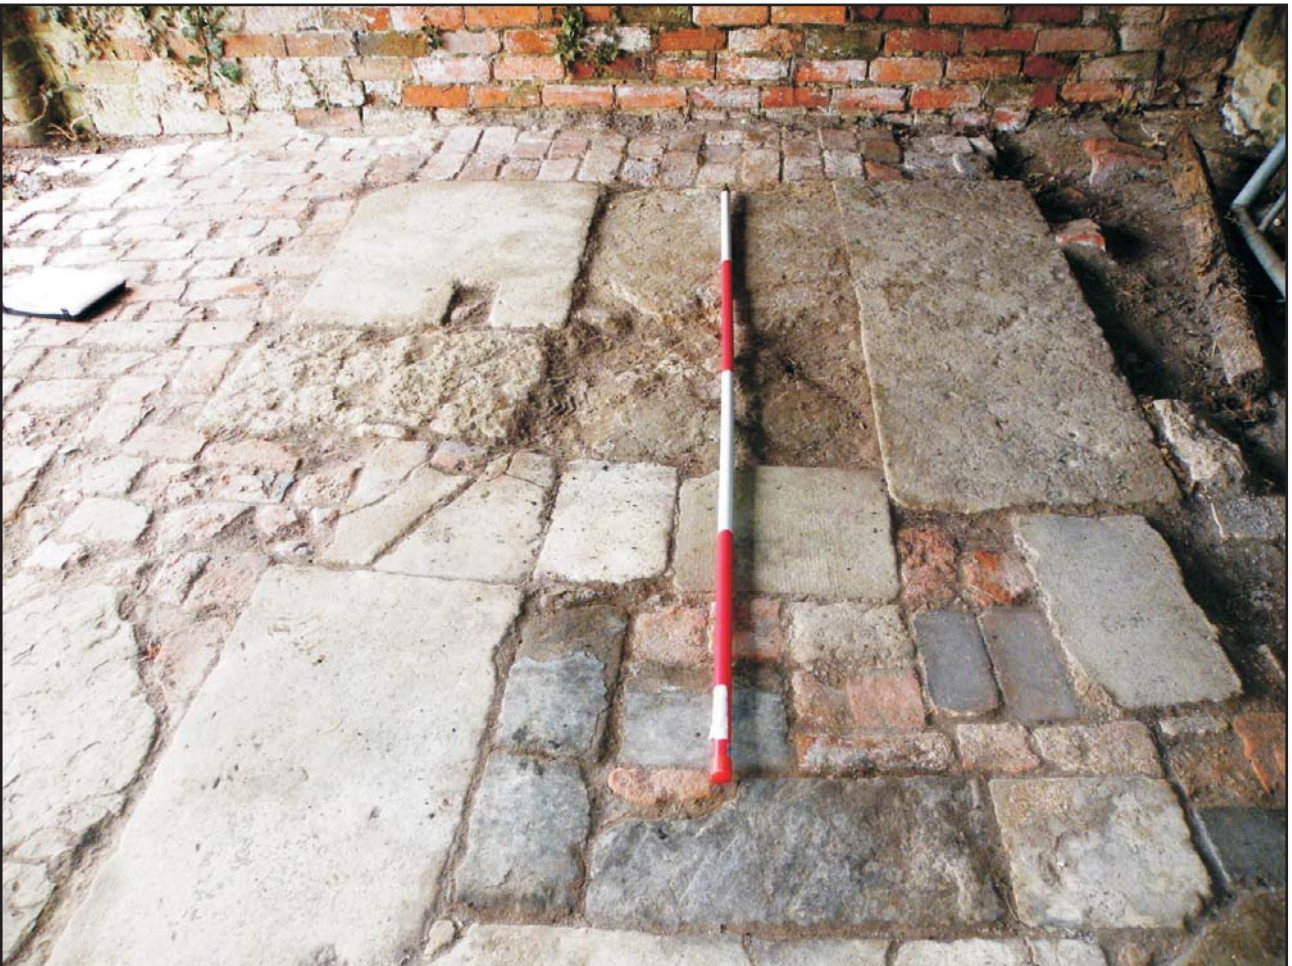
The floor of the hovel is a mixture of red brick, flagstones and the occasional Staffordshire blue engineering brick. The outer line of brick on the open side is laid edge-wise at right angles to the walls line, within the hovel they are laid flat. The stone flags and blue bricks suggest periodic patching and are generally poorly laid (Plates 2 and 10).

- 5.8 The floor within the southern enclosed room is original and un-repaired, the hovel section has undergone extensive repair using alternative materials and in places is entirely missing.

Detail of the floor of the hovel, looking north Plate 10
