Northamptonshire Archaeology

Archaeological Building Recording at Living Stones The Avenue, Flore, Northamptonshire March 2012

Amir Bassir
Report 12/47
March 2012

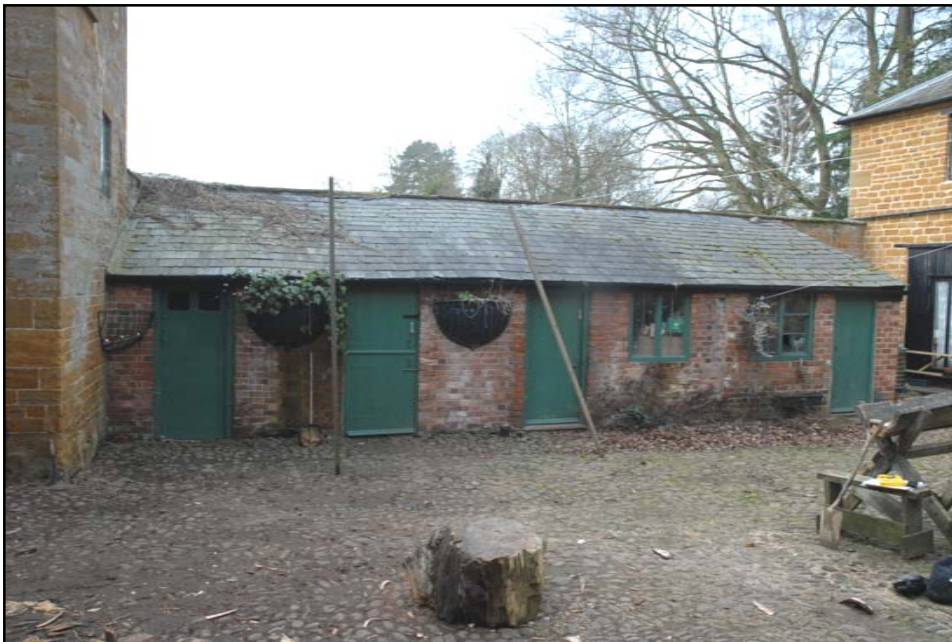
East facing (front) elevation Fig 3

The building is divided into four rooms of varying size each with its own doorway (Figs 3 &5). The building forms the western extent of a central cobbled courtyard as a lean-to built against the pre-existing western enclosure wall, constructed from Northampton sand and ironstone (Fig 2).

There are four east facing doorways with green-painted, wood doors in wooden frames. The date of the doors is unclear as they are of differing styles, but they all appear to be relatively recent and are unlikely to be original. The doors to Rooms 2 and 3 feature modern locks. The casement windows to Rooms 3 and 4 are also unlikely to be original.

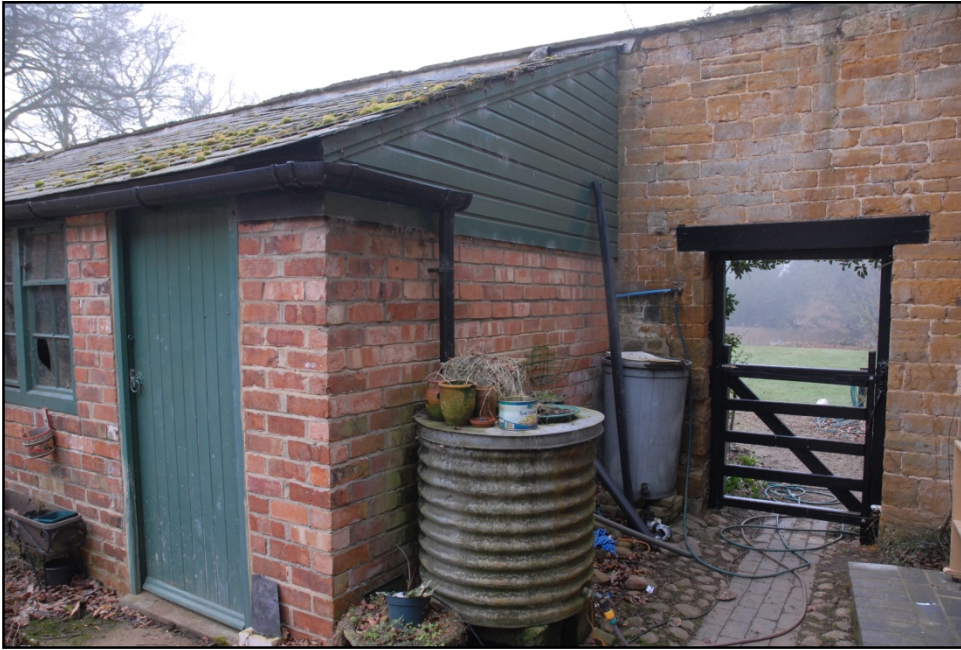
North elevation showing weather boarding (Fig 4)

The roof of the building is of slate tiles with weather boarding on the north elevation and lead flashing where the roof abuts the wall of the south wing of the house and the western enclosure wall. The floor in the rooms is concrete with an earlier brick floor visible beneath the concrete in Room 1 (Fig 7).

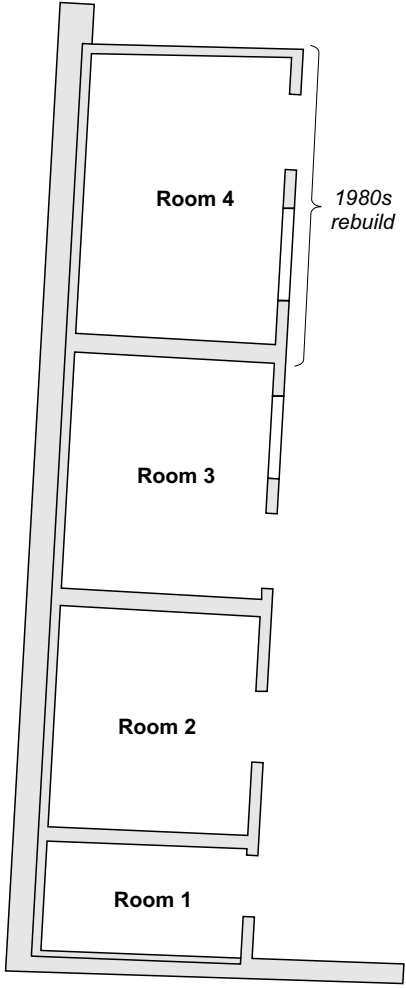
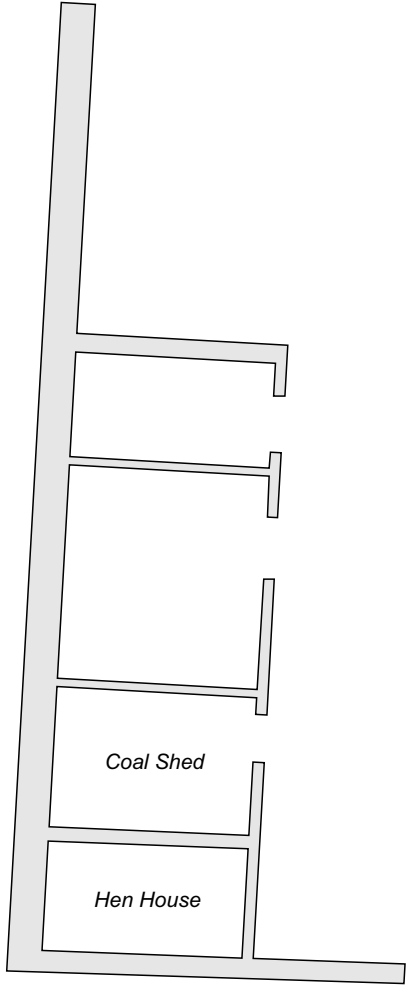
The most northerly bay of the outbuildings was demolished during the mid 20th century to allow vehicular access into a garage which had been constructed in the old stable block. This bay was then rebuilt in the 1980s and fitted with water tanks and access to a drain. (Fig 5)

Present layout of the outbuildings

Approximate pre 19th century arrangement of the outbuildings as shown on the map of 1816 by Daniel Harris

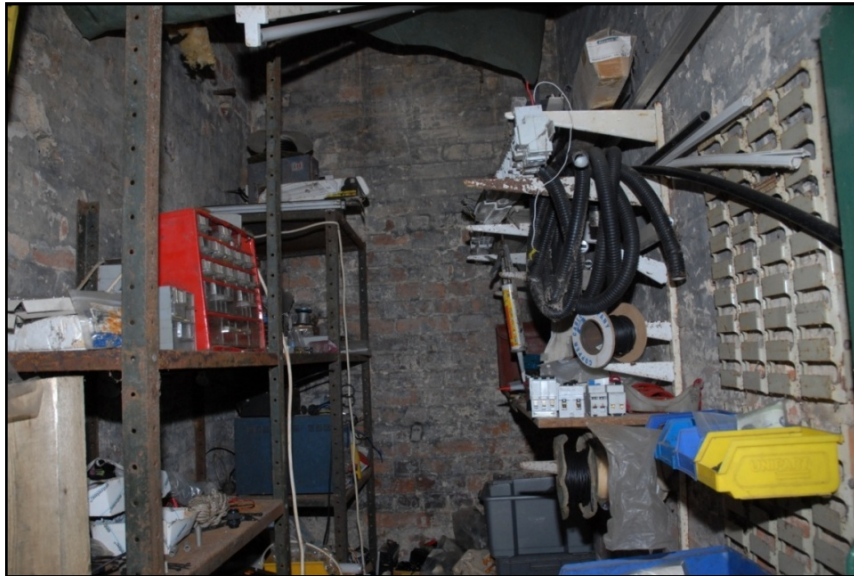
Room 1, looking west Fig 6

This is the smallest room with an approximate internal measurement of 1.6m x 2.8m (Figs 5&6). It is constructed from bricks which have been plastered or painted. These have been laid in stretcher-bond with occasional courses of headers on the western/back wall. Three ascending beam slots on the southern wall and courses of newer bricks higher up the walls indicate that the roof has been raised as part of later alterations. The roof frame is mostly obscured by insulation but, where visible, it appears to be of recent construction.

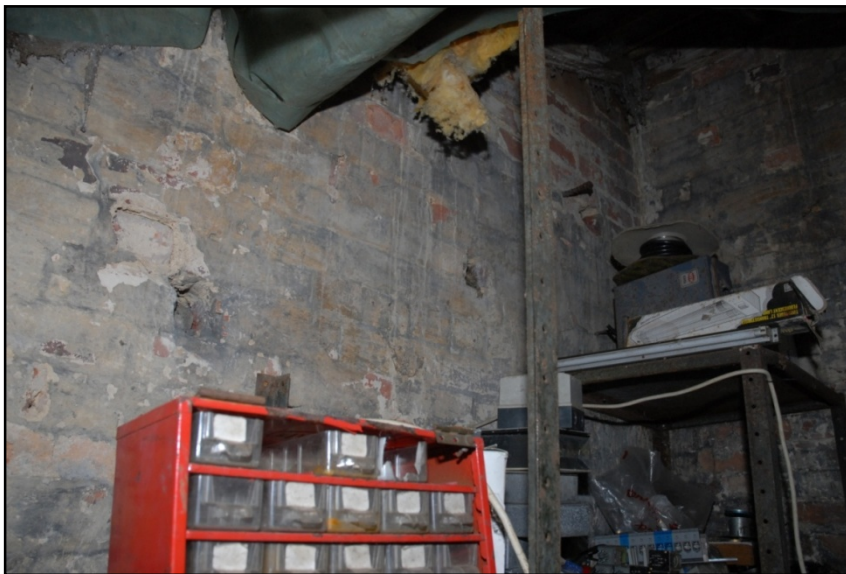
Beam slots in the southern wall of Room 1 Fig 7

The survey has shown that the outbuildings in this location have their origins in the 18th century but have been subject to rebuilding, alteration, renovation in the years since. The most significant phase of works was in 1816 under Daniel Harris when the earlier buildings were probably demolished and replaced by a new and extended range in brick. It is unlikely that any fabric dating prior to the 1816 alterations survives in the structure. It is quite probable that the buildings were re-roofed and the roof level raised at some point in the later 19th century, and the Welsh slate tiles may have been introduced at this time. It is likely that Rooms 1 and 2 are the least disturbed and retain more of their original fabric than Rooms 3 and 4. The beam slots in the southern wall of Room 1 suggest that the wall at least remains relatively unaltered.

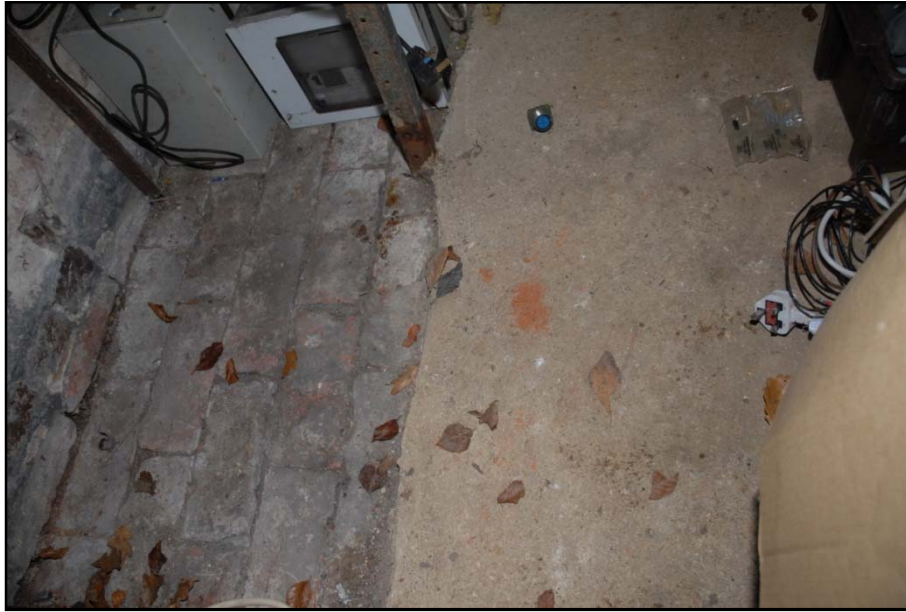
An original floor of flat laid bricks is visible against the southern wall. This is covered by an inch of concrete throughout the rest of the structures (Fig 8).

The original brick floor, overlain by concrete, Room 1 Fig 8

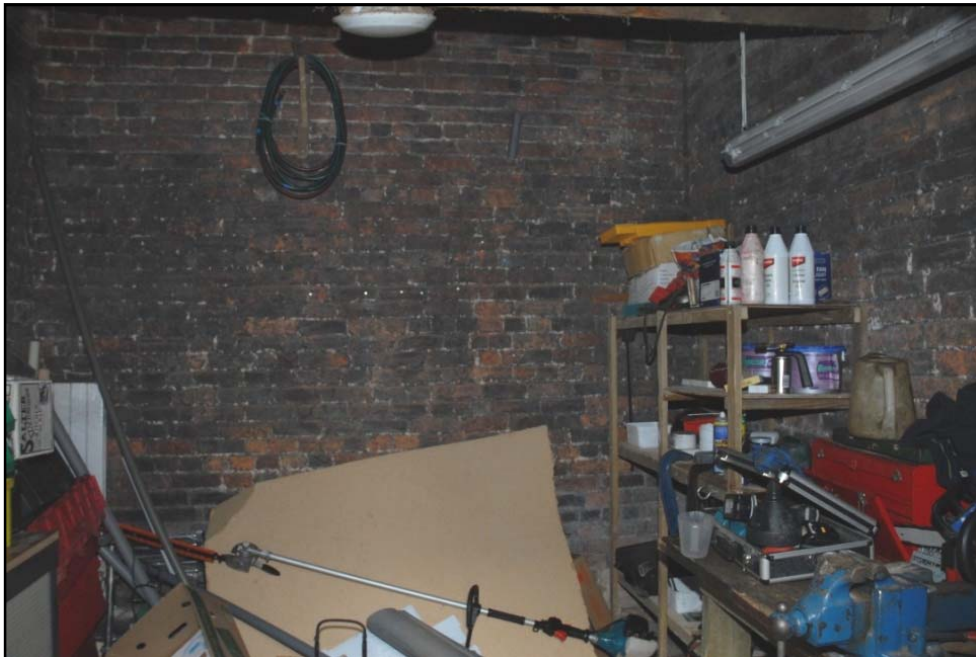
Constructed from unplastered red brick, the walls of this room are still blackened from their former use as a coal cellar (Fig 9). The room has an internal measurement of 3.0m x 2.7m (Fig 5). The roof frame in this room appears to be contemporary with the construction of the room.

General view of Room 2, looking west Fig 9

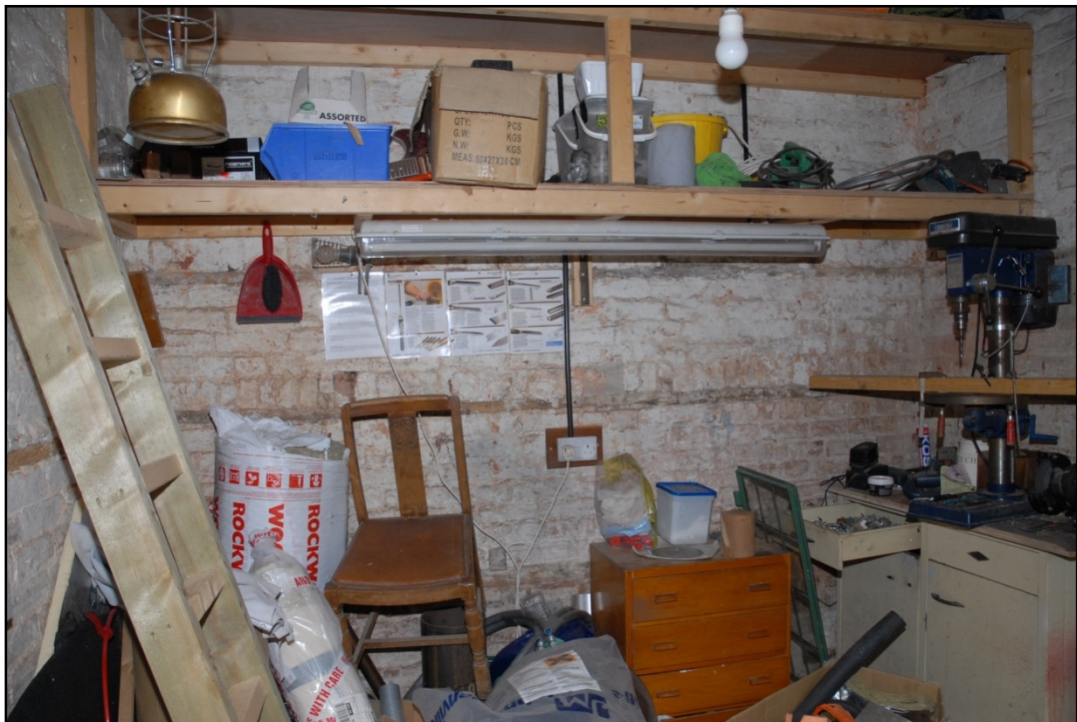
General view of Room 3 Fig 10

Constructed from white painted brick in stretcher-bond with occasional courses of stretchers and headers, the room has an internal measurement of approximately 3.4m x 2.7m (Fig 5&10). Three courses of timber are present at regular intervals in between the brickwork of the south, north and western walls (Fig 12). The timber planks feature both lap and butt joints. The remnants of many nails and screws are present in the wood, presumably as aids to storage. The second timber course in the back (west) wall is overlain by a course of headers on edge. Traces of grey plaster are present on the back wall.

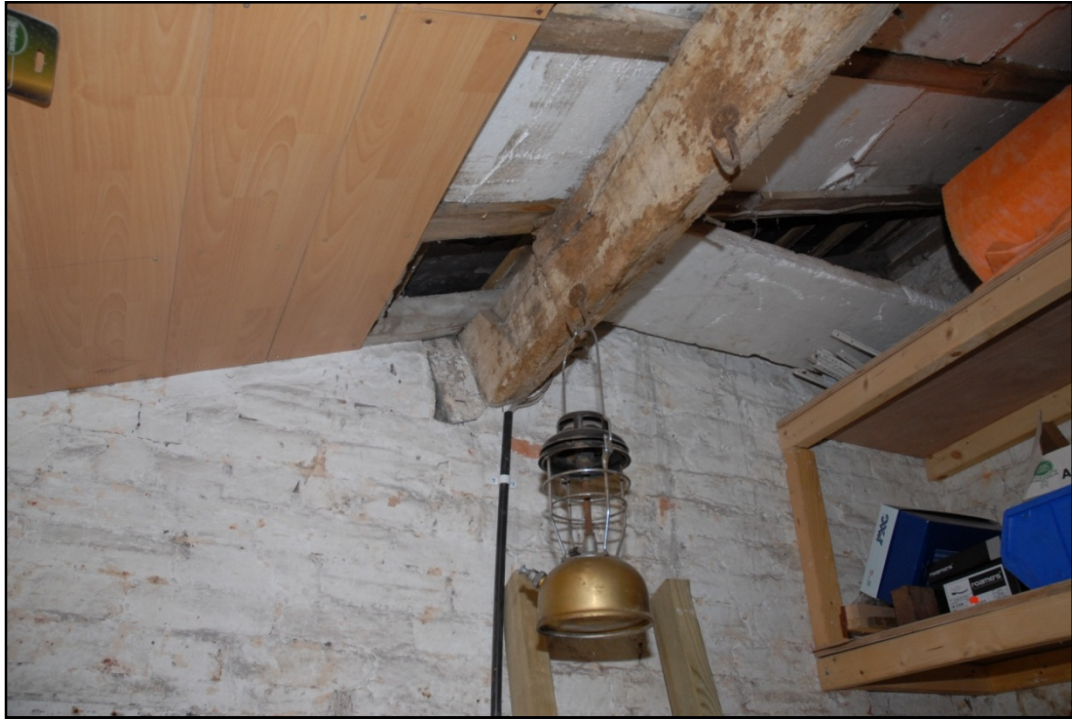
The purlin shows evidence of reuse in the form of a defunct mortice slot in the southern end (Fig 11). Iron hooks are present at intervals along the length of the purlin. The rafters supported by the purlin are recent. The brickwork has been knocked through and expanded to receive the purlin and associated brick and timber packing, though there is no obvious evidence of a scar for an earlier roof configuration (Fig 13).

Purlin in Room 3, showing timber re-use and iron hooks Fig 11

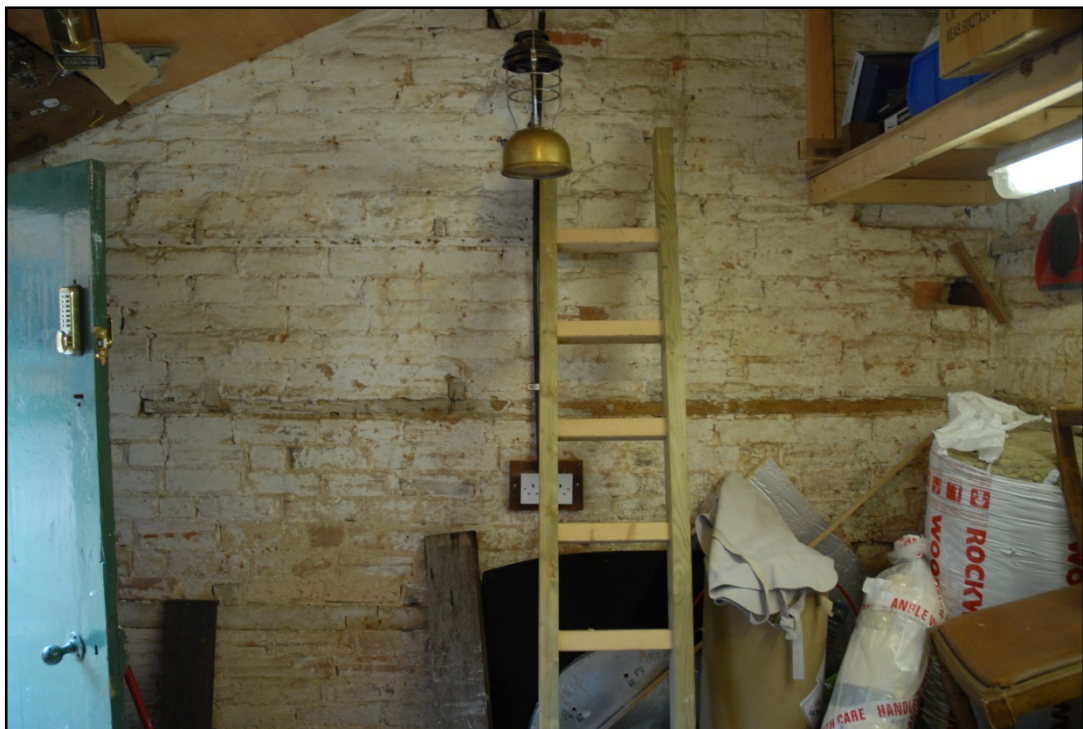
The timber courses in the brickwork of Room 3, looking south Fig 12

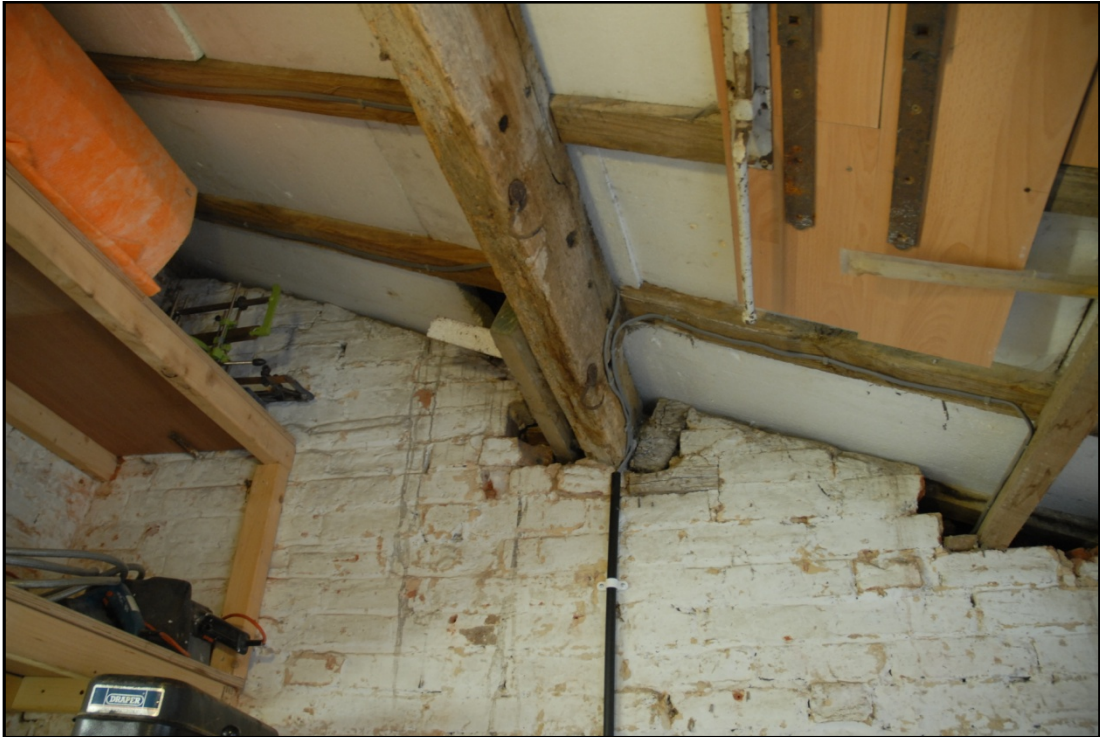
The alteration of brickwork to accommodate the purlin, Room 3 Fig 13

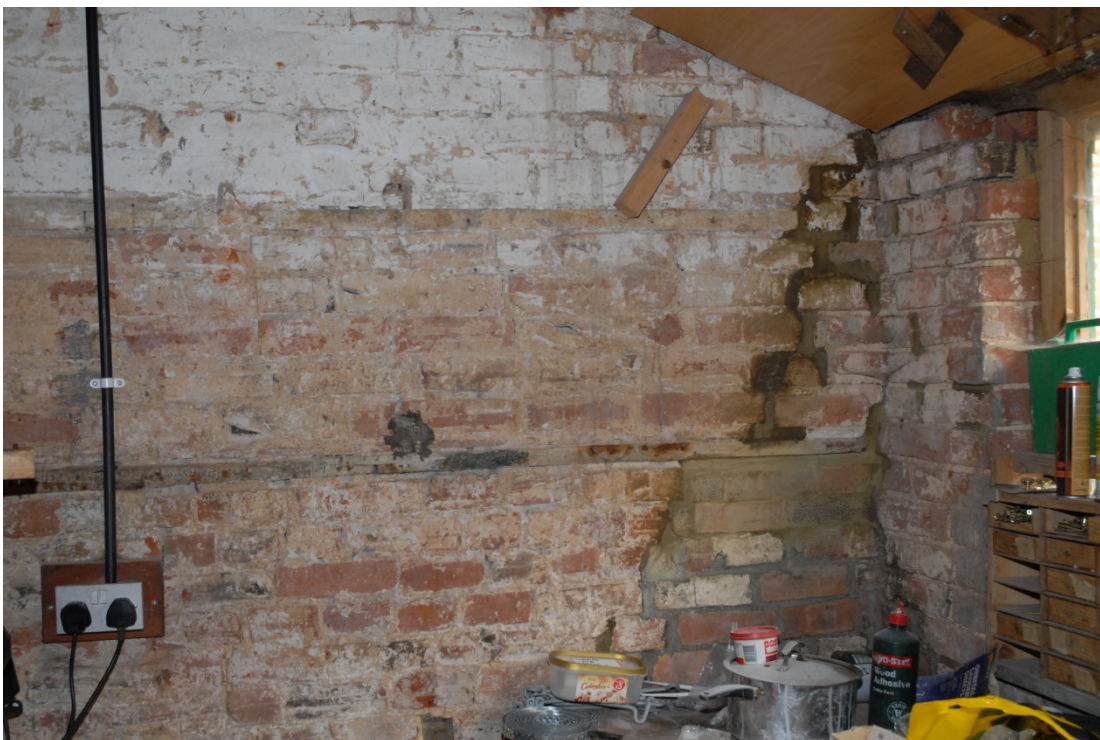
An area of modern brickwork in the north-eastern corner of the room dates to the demolition of the northern room in the mid 20th century and is also visible on the external eastern elevation (Figs 14&19). As in Room 2, Daniel Harris' map of 1816 shows a different position and layout of this room with the doorway further north on the east wall and no window present (Fig 5).

Area of modern brickwork in the north eastern corner of Room 3 Fig 14

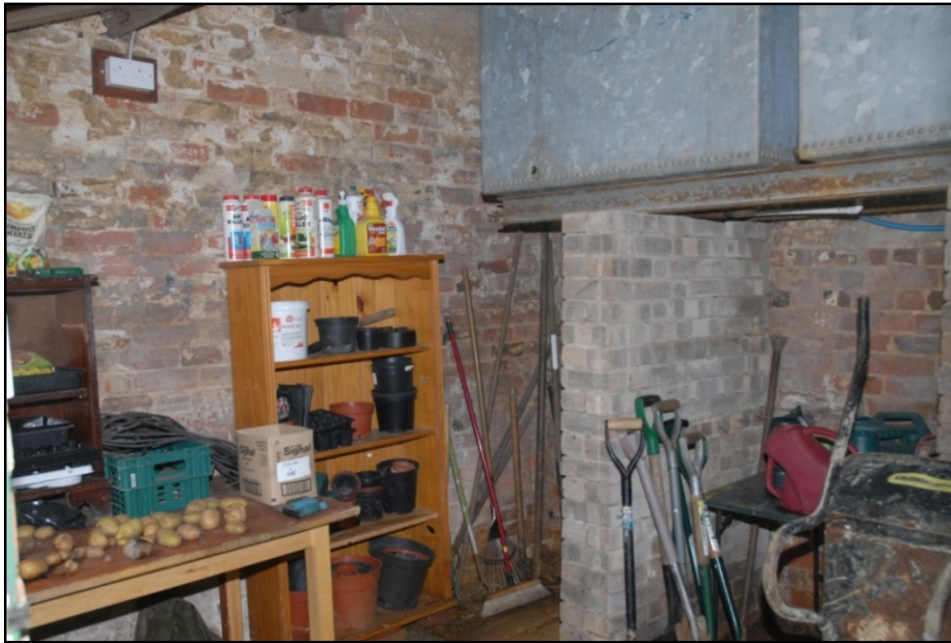
The room houses two metal water tanks which are supported on brick plinths (Figs 15&17). There is access to a drain in the floor via a metal cover with concrete surround (Fig 16). The floor is of concrete and the room is fitted with electrical sockets and lighting.

General view of Room 4 showing the water tanks, looking south-west Fig 15

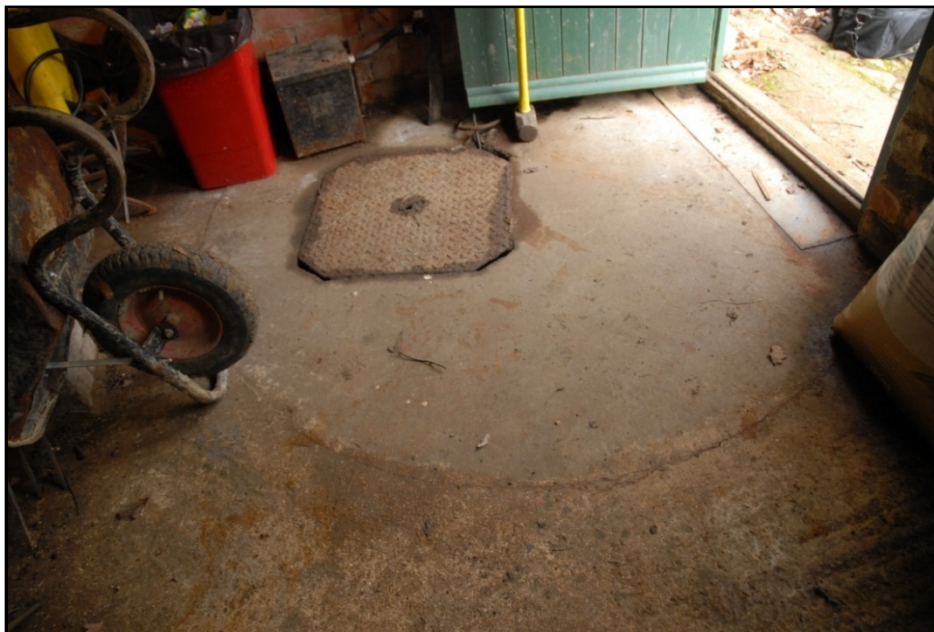
The drain access and concrete surround in Room 4, looking north Fig 16

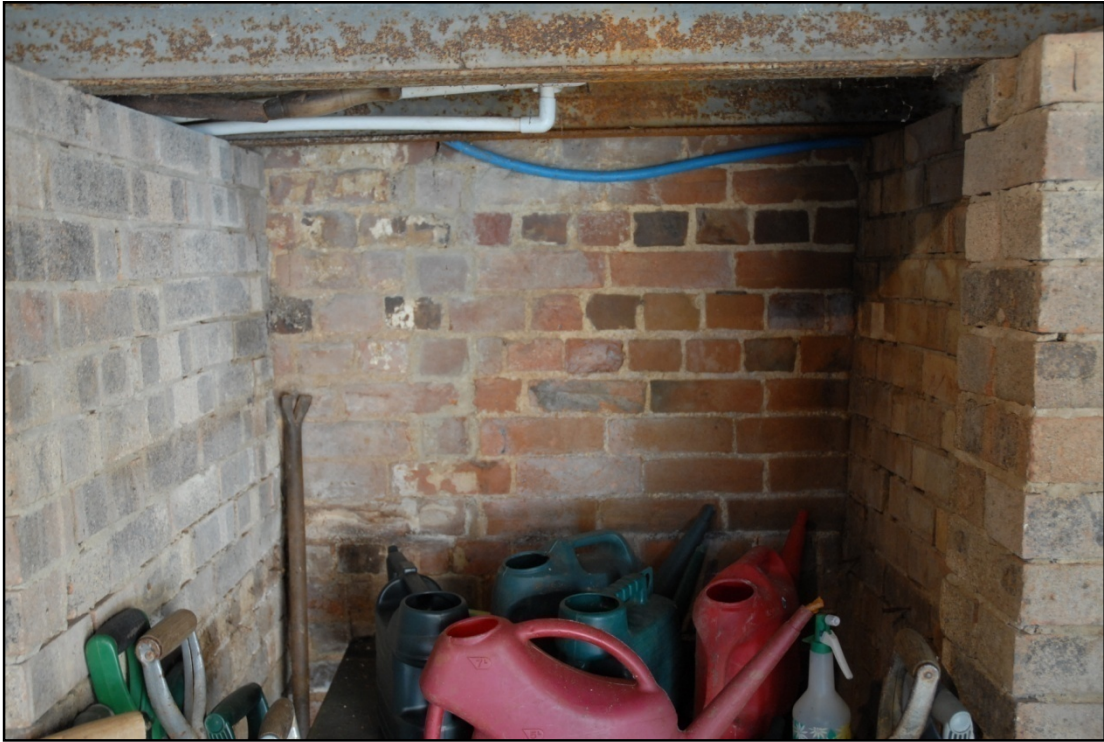
This room was largely constructed in the 1980s following its demolition in the mid 20th century. A straight join is clearly visible on the eastern elevation where the modern rebuild begins (Fig 19). The 19th century fabric partially survives in the west (back) and southern walls (Figs 15&17). The newer build is constructed from courses of red brick stretchers while the older fabric is of painted brick in stretcher-bond with occasional courses of headers and stretchers. The roof frame is of an entirely modern construction.

The merging of the older fabric and later rebuild, beneath the water tanks, west wall of Room 1, also showing brick plinths Fig 17

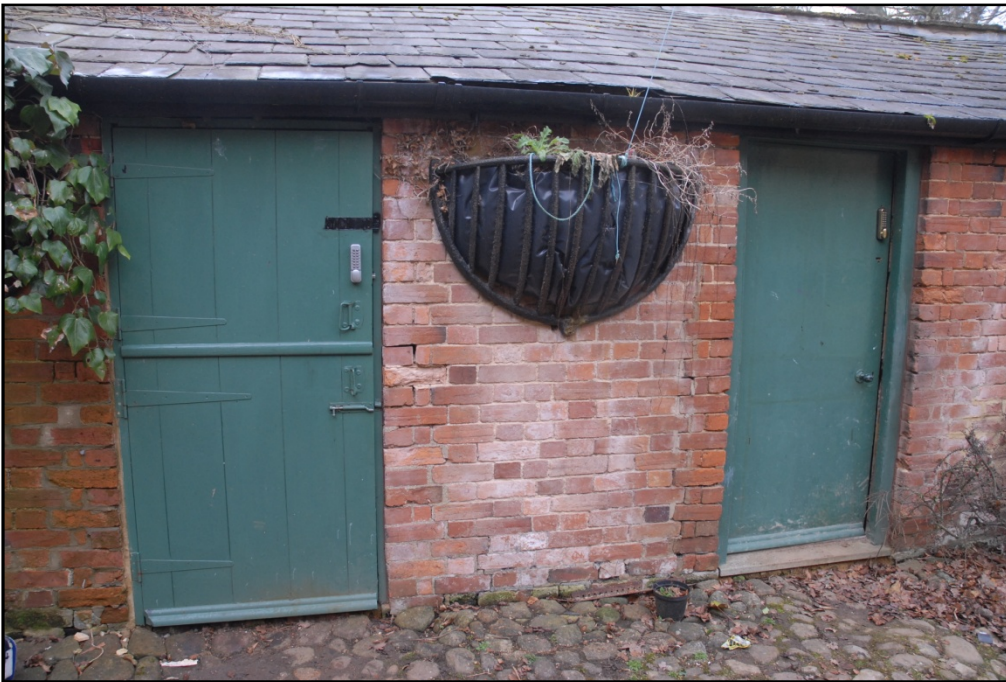
The doorways to Rooms 2 and 3, and later iron manger Fig 18

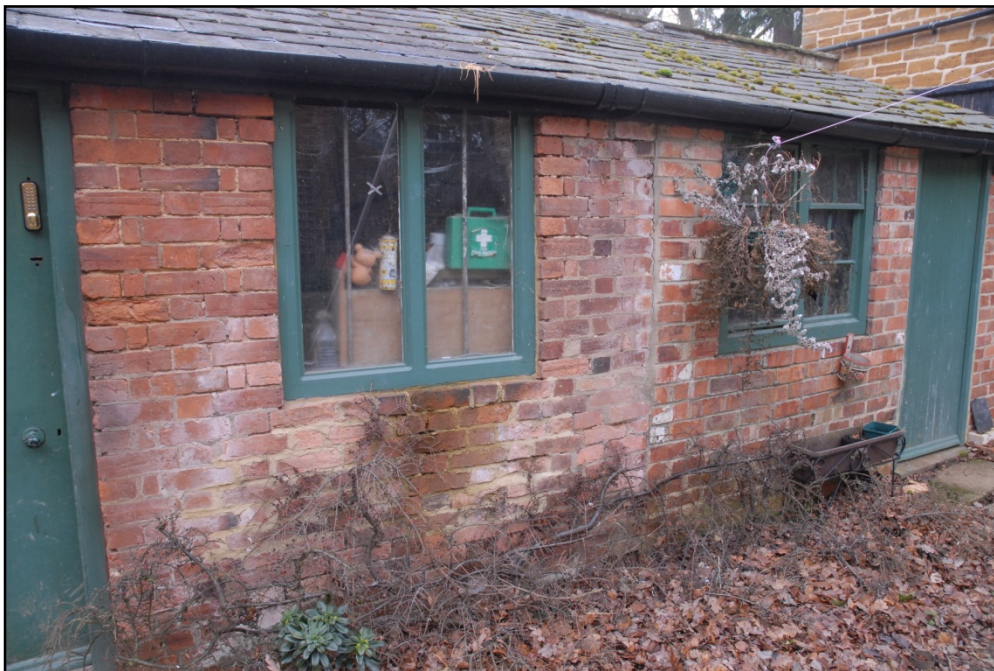
The northern end of the range was demolished in the mid 20th century to accommodate vehicular access in the courtyard. This demolition can be seen in the brickwork in Room 3 and in the older fabric visible in parts of Room 4 which was rebuilt in the 1980s (Figs 4,18&19). The north-eastern corner of Room 3 was damaged during this demolition and rebuilt with modern bricks. The current Room 4 abuts this area (Fig 19).

Demolition scar and vertical joint between Rooms 3 and 4 Fig 19
