Archaeological building recording at Boston Manor, Brentford London

Report 11/91

April 2011

**ARCHAEOLOGICAL BUILDING RECORDING AT
BOSTON MANOR, BRENTFORD
LONDON
FEBRUARY 2011**

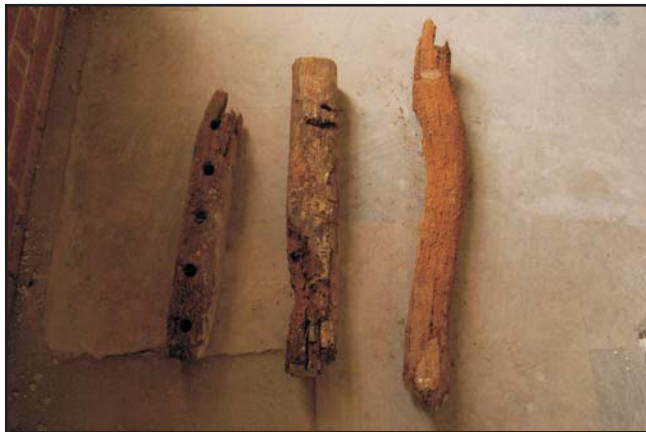
During the extensive opening-up of the Library west wall brickwork, three unrelated and badly rotting timbers were discovered, which had contributed to the separation of the leaves of brickwork. Timbers have often been used to bond walls along their length during (particularly) the 18th century and so-called bonding timbers can be found in many such buildings of every status and function, from stately homes to stables. They often top individual brick-lifts and are sometimes felt to be a belt-and-braces approach to bricklayers who did not otherwise achieve a very good line. Where such timbers are well-chosen and cut to match the brickwork they take the place of a long section of coursing, perhaps every fifth or seventh course. Where not well-chosen, they interrupt brickwork and cause weaknesses. The rarely tie different leaves together across the width of a wall. This is felt to have been part of the problem here. They were probably put in as a contemporary repair (rather than a more measured, bricklaying approach)

The three worm-eaten and degraded oak timbers found horizontally within the west wall were as follows (Fig 4): [Left to Right]

1. 600x100x80mm, of sub-rectangular section and having five holes drilled with a brace and bit in one surface, part way through. These either relate to former dowels or bars, such as are often found between stalls in stables, or are the vestiges or guide bit-holes of an unfinished mortice or groove relating to the timber's former intended use.
2. 730x90x110mm, a plain baulk of timber with edges roughly shaved or chamfered off. Such a timber might serve as a post, pile or pole if used vertically.
3. 950x100x100, a plain baulk of waney-edged timber, little more than a branch. Not straight

Timbers found within west wall of Library Fig 4

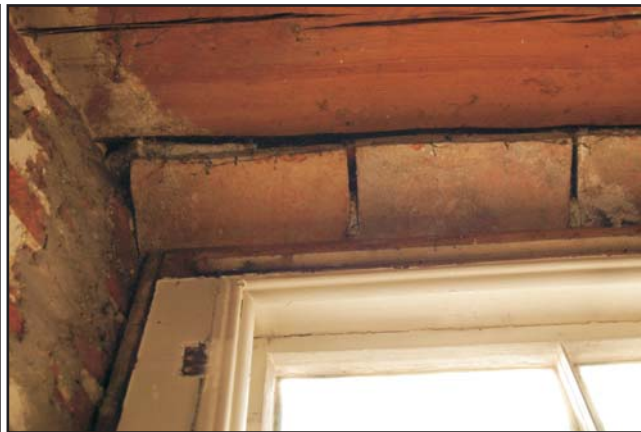
Victorian quarry tiles wedging Library west sash window Fig 5

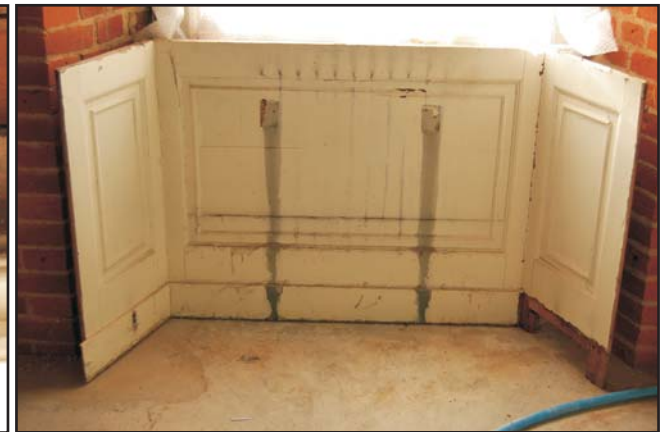
The panelling, also *ex-situ* and stacked up on scaffolding at the time of recording, is part hardwood and part softwood and probably of mid-late 18th-century date, solidly made but restrained, having plain panels within the styles/muntins and rails rebated with a moulding plane producing a *cyma recta* profile. They appear to be mitred rather than scribed, suggesting that some saving was made where possible. The muntins are tenoned into the styles. The panels were fielded by the addition of a decorative bead (Fig 6).

Panelling removed from beneath Library windows Fig 6

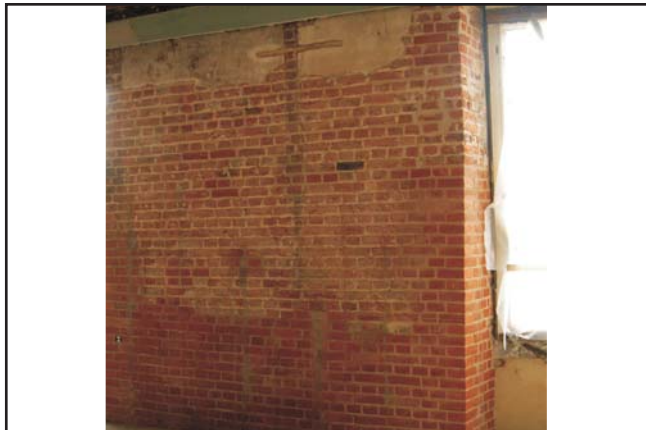
Mark left by removal of former panelling style Fig 7

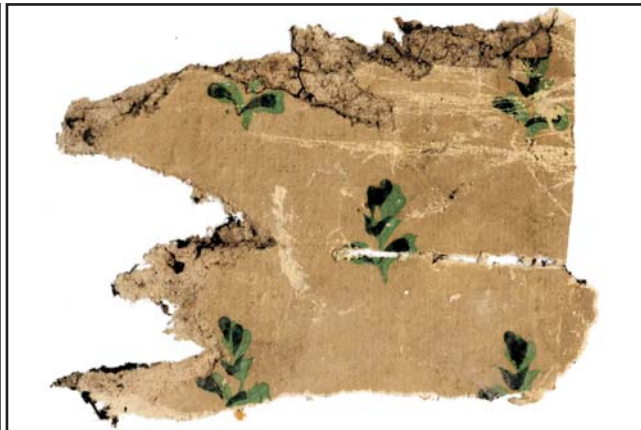
On the brick of the walls lie the vestiges of early plaster, high up, where it has survived subsequent wall treatments. No analysis of these vestiges has been possible but in places it has been damaged by the introduction of almost full-height timber uprights, also now gone (Fig 7). These would probably have been the stays of a frame over which hessian was stretched and then over which wallpaper was pasted. A small piece of a (probably) 1900s-30s wallpaper was salvaged from high on the wall where it was trapped by the dry lining of the most recent wall treatment (Fig 8).

Wallpaper fragment retrieved from high on Library west wall Fig 8

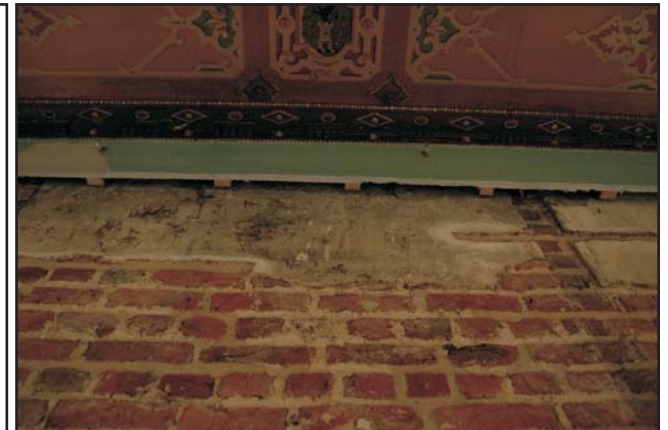
The most recent wall finish comprised plasterboard on dry-lining, which had impinged upon the patterns of the 19th-century ceiling finish and which bore the current cornice (Fig 9).

Most recent decorative scheme on Library west wall Fig 9

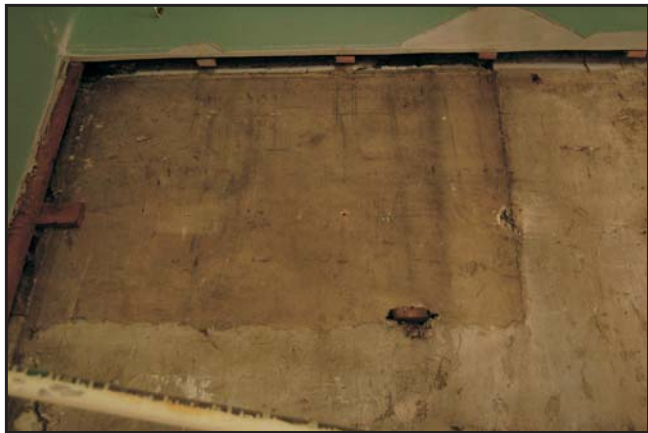
High in the south wall is a plaster-blocked, possibly splayed opening of unknown former use (Fig 10). Its location puts it at the uppermost third of the rear of the ground floor *trompe l'oeil* window on the south elevation. Such a former reveal here might suggest a former difference in south-facing fenestration, but this cannot be proven at present. In its base height it is very similar to the lowest window which today lights the back of the stairs on the west facade (Fig 11). Since the surviving fenestration layout seems to have been in position since the late 17th century, it remains a possibility that this feature is a remnant of the original 1623 layout and may denote an earlier stair location, although this is a tentative suggestion. A blocked *oeil-de-bouef* window adjacent may also be connected to this.

Blocked embrasure in Library south wall Fig 10

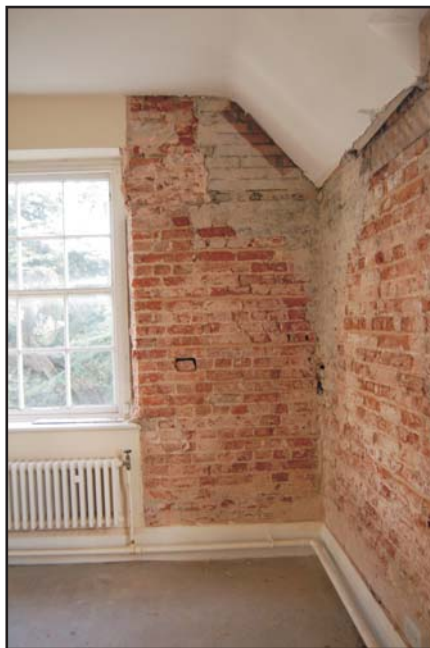
Fig 19

The brickwork exposed here in the west wall has been extensively stitched and tied in mortar. A portion of brickwork in the top south-west corner has been replaced in modern times (Fig 19). Slight differences in mortaring colours and consistency at this height probably relate to the different loads of mix carried up from the ground, rather than being real changes in build. At anything above ground floor level, mortar-mixers were limited by how much they could carry up to the wall tops at any one time, so apparent 'lifts' or separate 'builds' become difficult to assess on the basis of mortar alone.

Brickwork repair in south-west corner of 2nd Floor Living Room

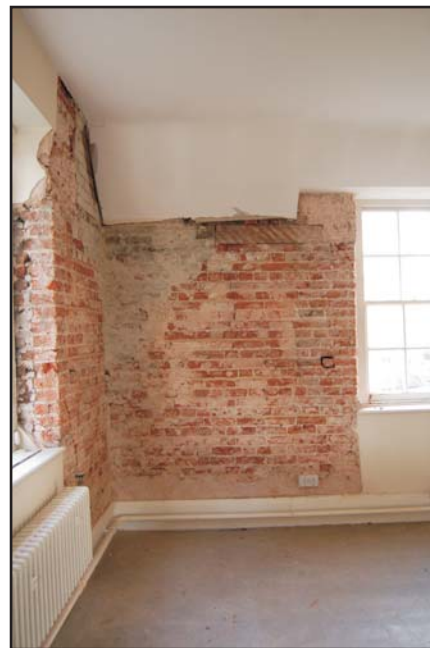
Fig 20

This short section of timber may be the last vestige of the wall-plate mentioned. If so it has already been cut by the window in addition to the works mentioned in 1951. Observation for the present report suggests that, although specified, concrete may not have been universally used, perhaps due to the financial constraints of the immediate post-war period. Certainly the timber simply ends in the major brickwork repair which is carried right around the corner. It may be in yellow stock brick although this is not clear-cut. In other areas of the house the 1960 report notes that War Damage repairs were not always sympathetic.

It is probably not coincidental that the problems of the second floor in the south-west corner related in 1951 lie in close proximity to the problematic area of 2010-11. Unsympathetic alterations in one place may often store up related problems nearby. Not all the problems may ever have been directly related to 'War Damage'.
