# Archaeological building assessment at Lodge Farm Cottage, Water Lane, Bradden, Northamptonshire

Joe Prentice Report 11/182 August 2011 NORTHAMPTONSHIRE COUNTY COUNCIL NORTHAMPTONSHIRE ARCHAEOLOGY SEPTEMBER 2011

ARCHAEOLOGICAL BUILDING ASSESSMENT AT LODGE FARM COTTAGE, WATER LANE, BRADDEN, NORTHAMPTONSHIRE AUGUST 2011

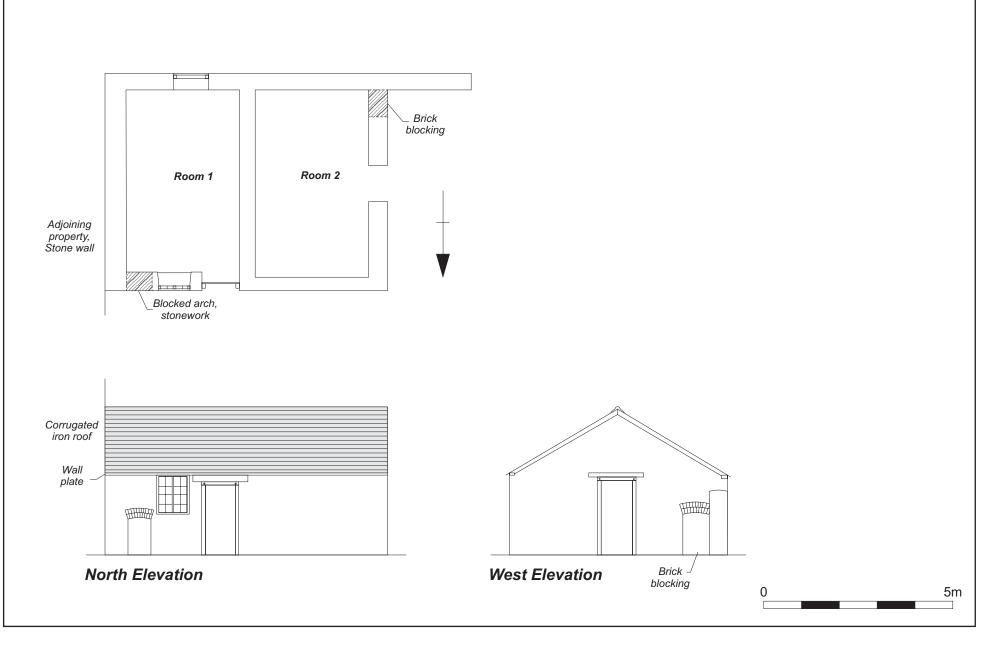
Plan and elevations of the former pigsties Fig 3

4.1 The building lies to the south of Lodge Farm Cottage on the south side of the village of Bradden (Figs 1 and 3). The building is of rectangular plan and contains two equal sized rooms, one accessed via a door in the north wall, the other through a door centrally placed in the west wall (Fig 3). The external walls are constructed primarily of local limestone with occasional use of ironstone throughout. Only threes sides (the north, west and south) were visible as the east side adjoins and is built against the wall of an adjoining property. The jambs to both doorways and the external wall corners retain larger and well dressed quoins, the walls themselves are built mainly of roughly dressed coursed rubble. The roof comprises corrugated iron sheeting; rainwater goods are plastic. Each elevation is separately described and for ease of reference the two rooms have been simply referred to as Room 1 and Room 2.

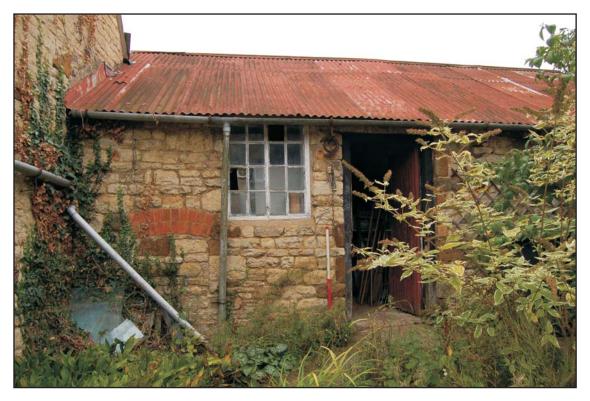
At the eastern end of this elevation is a low arched opening through the wall, now infilled with limestone, but formerly affording access in and out of Room 1. The shallow segmental arch is constructed of two rows of edge-laid red brick (230mm x 110mm x 65mm, Plate 1). This opening is of a size that suggests that the building served originally as a pigsty. There is no scar on this wall to indicate the presence of the small square structure shown on the 1883 Ordnance Survey map, nor is there any indication of any wall visible in the ground surface.

The north elevation showing current and blocked openings, looking south Plate 1

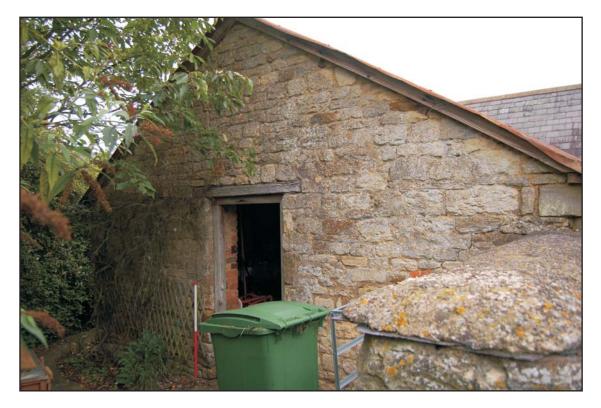
The west gable of the building is constructed in the same way and of the same materials as the north wall (Fig 3, Plate 2). It contains a single, central pedestrian doorway of the same configuration as that in the north wall, fitted with a similarly-constructed door. To the south of the central door at the south-west corner of the main building is a short section of limestone wall which presumably formed the south side of the small square structure shown on the 1883 Ordnance Survey map, although there is no corresponding scar or indication that this structure was bonded to the wall to the north or a return at the west end of the surviving section. In the angle formed by the south side of the former structure and the west gable wall of the main building is a second arched pig opening which formerly allowed access to and from the interior of the west end of the building (Plate 3). Constructed in exactly the same way as that in the north wall, the only difference is that, when infilled, the opening was blocked with red brick rather than stone.

The west elevation, looking north-east Plate 2

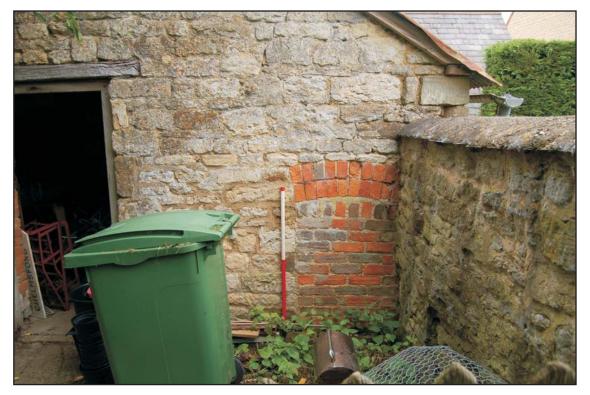
Arched pigsty opening in the west gable end, looking east Plate 3

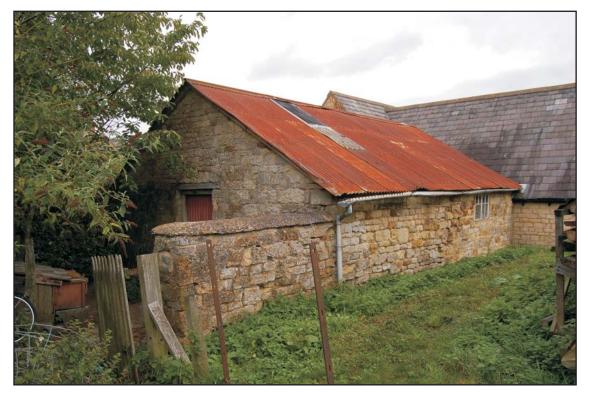
The south side of the building contains no original openings, and at present retains a single, later window inserted into the south wall of Room 1, presumably at the same time as that in the north wall was created (Fig 3, Plate 4). The window in this elevation is located immediately beneath the wall plate and is again formed of a re-used pine frame, this time apparently half of the size of that used in the north elevation and originally containing eight lights, though now retaining only seven (Plate 5). As in the north wall the insertion of this opening has been crudely finished and there is no external sill.

The south elevation, looking north-east Plate 4

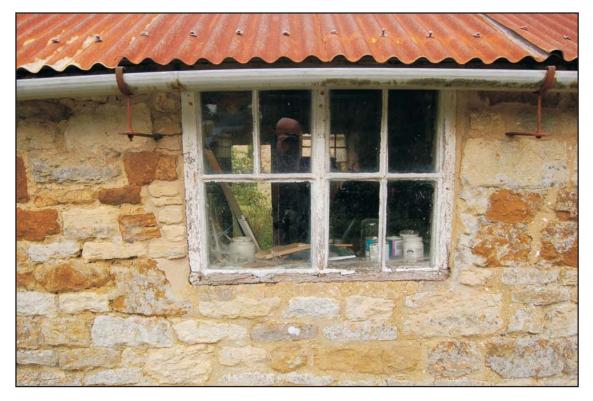
The window in the south wall, looking north Plate 5

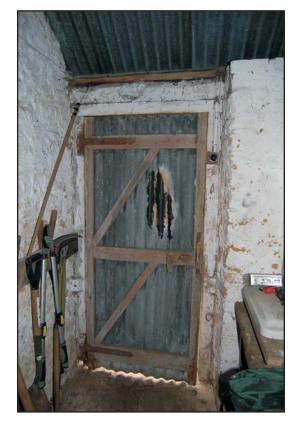
Located at the east end of the building and accessed via the doorway in the north wall. Lit by later windows in both the north and south walls, this room must originally have been lit only by daylight through the door and the lower pig opening unless there was some form of roof light which seems unlikely, and for which no evidence remains. The internal walls are simply limewashed and the floor is of concrete. There are no visible fixtures or fittings which indicate former usage, though it is possible that there were no fixed troughs for either fodder or water, both of which may have been located outside for ease of filling and cleaning. The pedestrian door is a modern replacement and comprises a simple ledged and braced frame with a sheet of corrugated iron sheeting nailed to the exterior, painted red (Plate 6).

The door to Room 1, looking north Plate 6

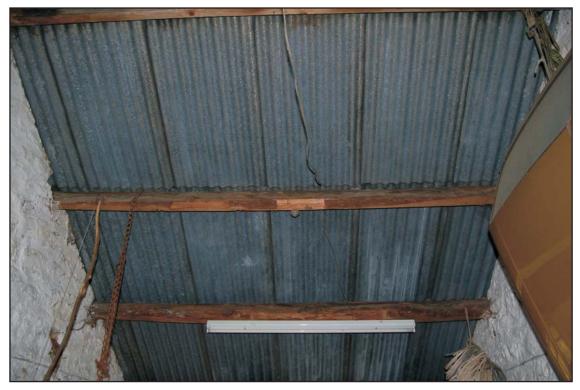
The roof is simply constructed of pine purlins which are set into the east and west gable walls; there are no rafters (Plate 7). The purlins are a mixture of fully sawn and partly sawn timbers, some of which retain their bark. There is no visible indication that the roof has been repaired, especially since the ends of the purlins are set into the east and west, as well as the dividing, gable walls. This might indicate that the roof was always covered with corrugated iron sheeting, a material widely used on farm and other low-cost buildings and commonly used since its invention in 1829 by Henry Palmer. However, the extremely good (internal) condition of the present corrugated sheeting suggests that the roof covering has been replaced and is not original.

The roof structure in Room 1, looking north Plate 7
