Archaeological building and desk-based
assessment of the Courthouse, Long Crendon,
Buckinghamshire

Joe Prentice and
Charlotte Walker
Report 11/101
April 2011

**ARCHAEOLOGICAL BUILDING AND DESK-BASED ASSESSMENT
OF THE COURTHOUSE, LONG CRENDON,
BUCKINGHAMSHIRE
APRIL 2011**

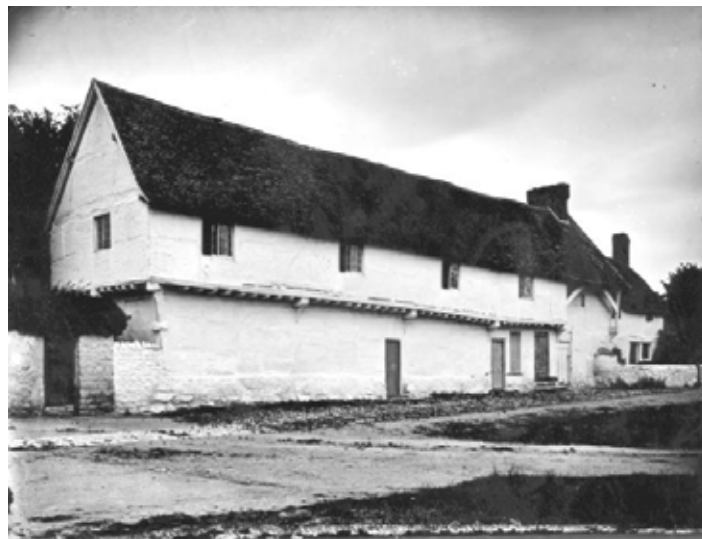
The Courthouse, undated, probably late 19th century. Fig 2

One photograph appears to show an attached building with a chimney stack at the eastern end (Fig 2), though by 1898 this had gone, being present on the 1880 Ordnance Survey map but not indicated on the 1898 Edition.

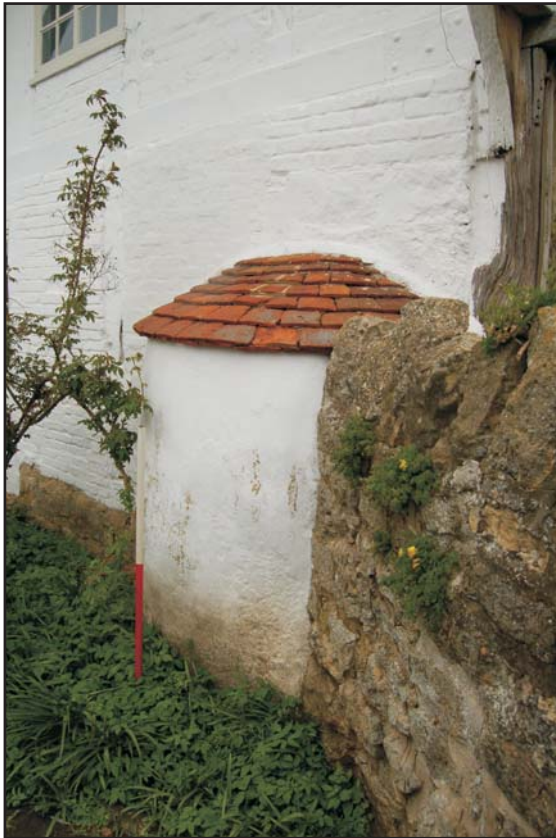
The bread oven, looking north-west Plate 4

At the very eastern end of the wall at ground floor level is a semi-circular projection which is the external manifestation of a bread oven set within the inglenook fireplace of the eastern room (see below, section 4.13). The external surface is rendered so it is not certain if it is made of stone or brick; it is capped by red clay roof tiles (Plate 4).

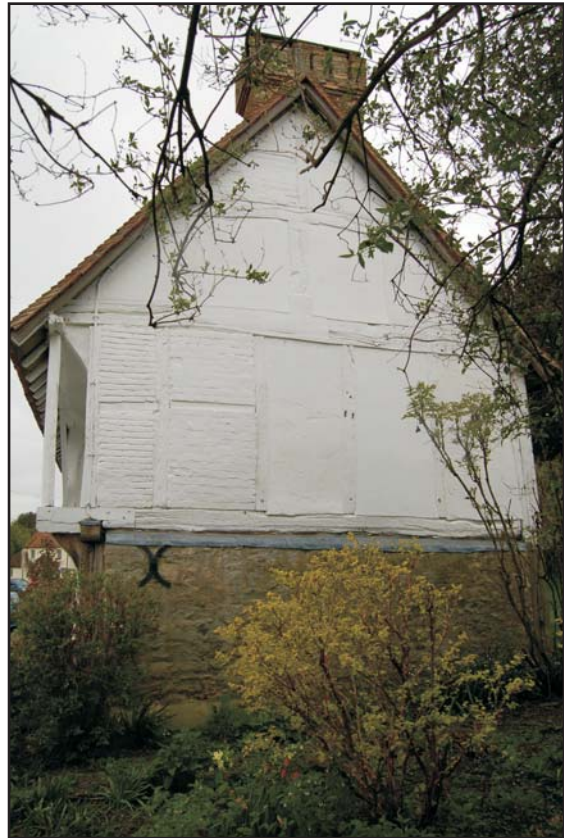
The East gable, looking west Plate 5

- 4.3 The east elevation. The east gable end comprises an entirely stone lower part with no timber framing (Plate 5). A principal beam lies above this stone wall, set back slightly from the stone wall plane, the top of which is capped by lead to throw rainwater off. Above this the remainder of the gable end is timber framed infilled by either brick, wattle and daub or perhaps modern woodwool replacement, though where rendered it cannot be determined. The whole of the timber framed upper section is painted white but it is clear that much of the timber frame has been replaced, the new wood having flat surfaces and sharp edges. A double brick chimney stack rises above this gable, but is set inside the wall plane since it is a later insertion and is essentially free-standing, set away (to the west) from the timber frame of the gable. The whole of the stack above the ridge appears to have been re-built, or at least, heavily repaired.

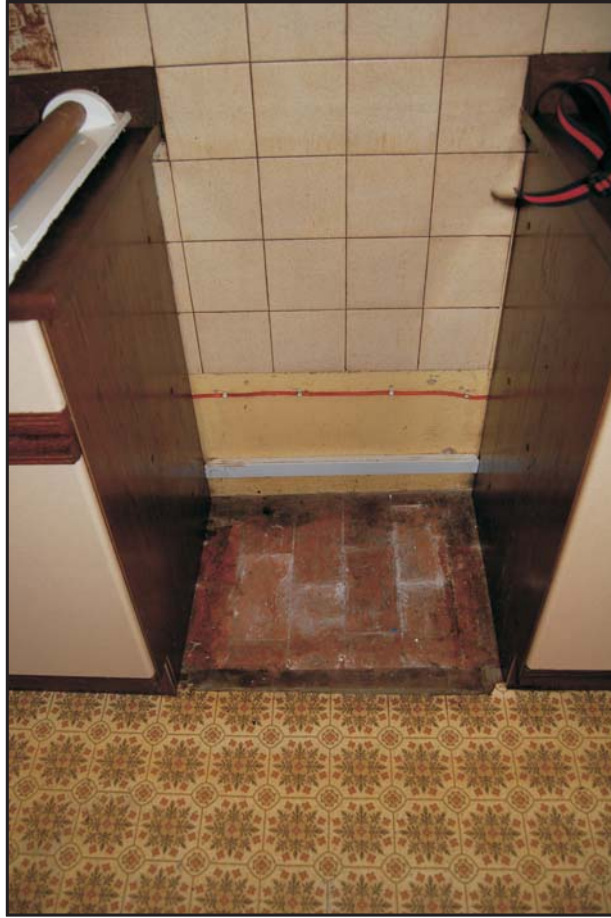
Brick floor of Room 5 extending beneath the south wall Plate 13

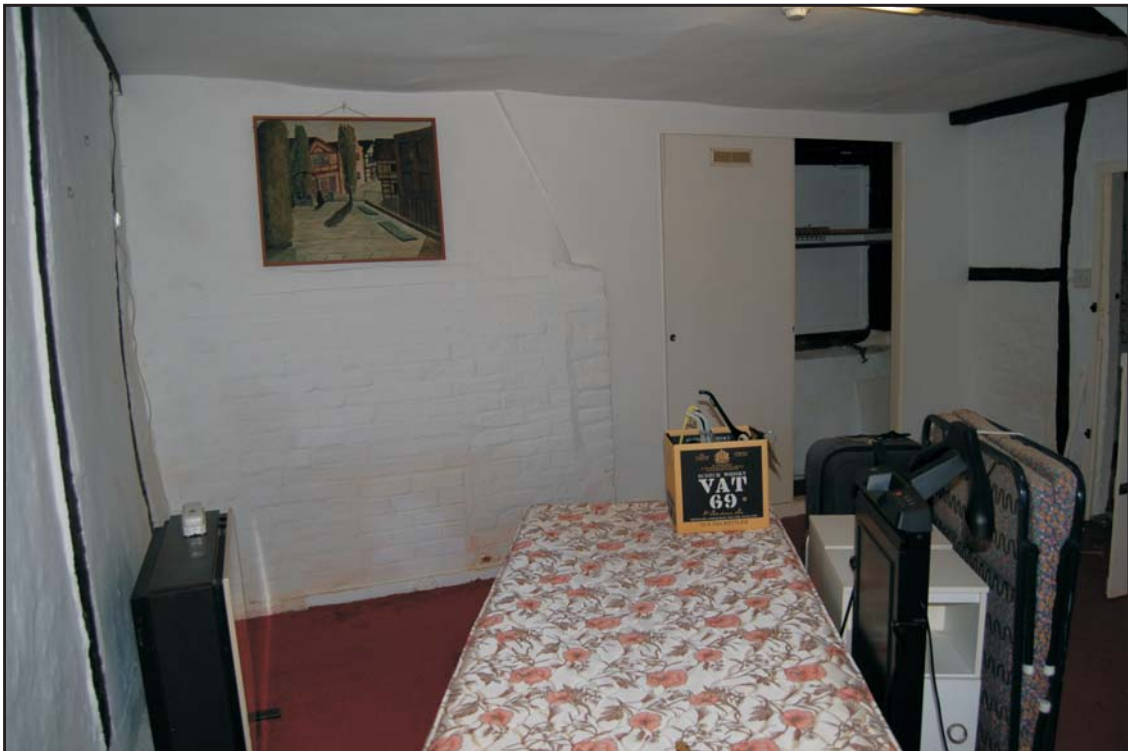
Room 6, looking north, showing the reduced, then blocked fireplaces Plate 14

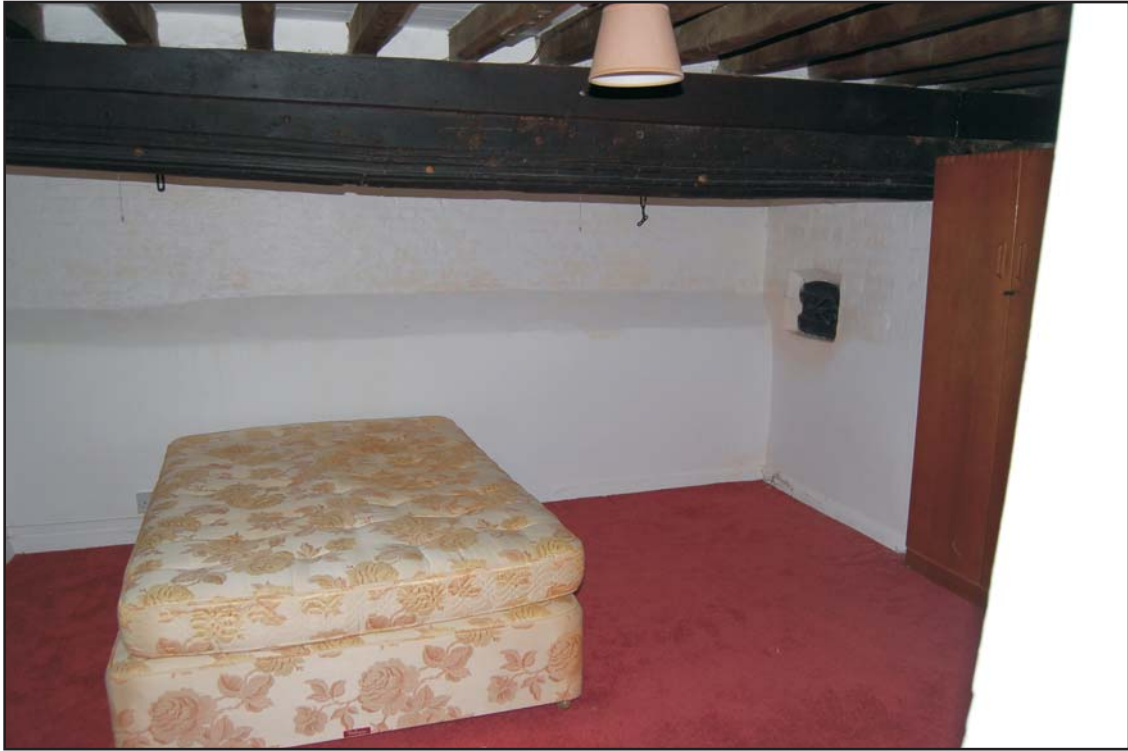
Room 7, the inglenook and bread oven, looking south east Plate 15

On the east side of the room is a large inglenook fireplace which extends the full width of the building, the chimney breast being supported on a deep oak beam with a deeply moulded west face (Plate 15). It is understood that this fireplace is of sixteenth-century date and therefore a later insertion into the building. The beam is painted black and has suffered structural failure at some stage with an iron plate being fixed to the back (east) face to support the split in the beam. It is supported at the north end by a brick buttress built, presumably, against the wall. The south end is supported by a thickened south wall which also incorporates the inner face of a bread oven which extends beyond the south side of this wall manifesting itself externally as a semi-circular projection capped by a conical tile roof. The whole of the fireplace and chimney breast comprises painted brickwork, the back wall retains an iron bar supported on three iron pins set into the wall which presumably was used to support cooking equipment. The bread oven is fitted with a hinged cast iron door with a drop latch decorated with wrought iron scrolls above and below the latch. It was not possible to open the door (perhaps it was rusted shut) so the interior was not inspected. The fire within this inglenook was clearly located at the northern end of the opening since the flue only occupies the northern half of the fireplace, the southern part supports a quarter vault in brick springing from the bressumer which supports the fireplace in the room above (Plate 16).
