Archaeological building assessment of the stable
block at 2 Kings Lane, Flore, Northamptonshire
March-May 2011

Report 11/116

May 2011

**ARCHAEOLOGICAL BUILDING ASSESSMENT OF
THE STABLE BLOCK AT 2 KINGS LANE, FLORE,
NORTHAMPTONSHIRE
MARCH-MAY 2011**

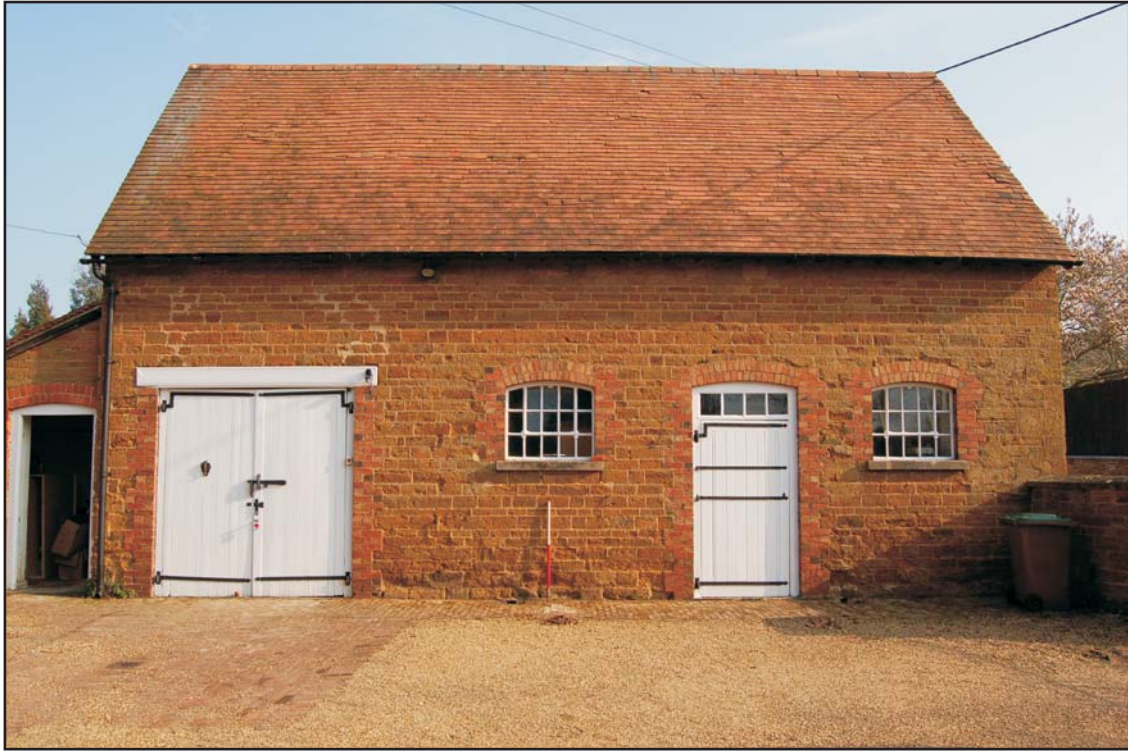
Built of dressed and coursed ironstone bonded in lime mortar this elevation contains two doors and two windows facing southwards onto a small stable yard to the north side of the Manor House (Figs 5 and 6, Plate 1). The doorway to the west contains a double-door of painted vertical planks, the left-hand leaf of the door appears to be a modern replacement, the right-hand leaf appears to be original, both with original hinges. They are hung on a painted frame (probably pine) set beneath a timber lintel, also probably pine. The jambs of the opening are constructed of red brick laid in the fashion of quoins, although here as much to tie the brickwork into the stonework as for decorative effect. The bricks are 230mm x 70mm x 105-110mm in size. It appears that this double-door originally served a separate room, most likely a carriage house, but the internal wall has been removed (see below, section 4.3).

The south elevation of the stable block, looking north Plate 1

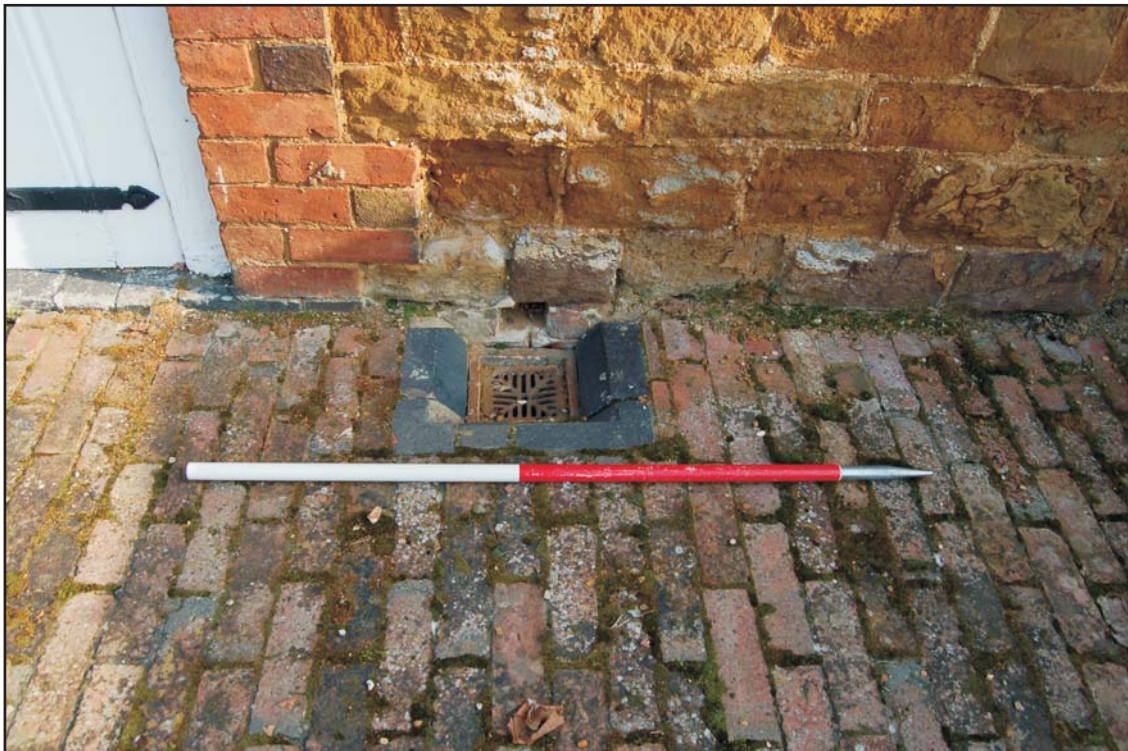
There are two Staffordshire blue plinth stretcher lined drains on either side of the door (Fig 5, Plate 2). These drains did not serve downpipes but rather served drainage channels built into the south wall indicating that these drains were used to drain liquids

from inside the stable block. The drains are set in a contemporary apron of edge-laid red brick forming a paved path along the south side of the building.

External drain originally serving the interior of the stable, looking north Plate 2

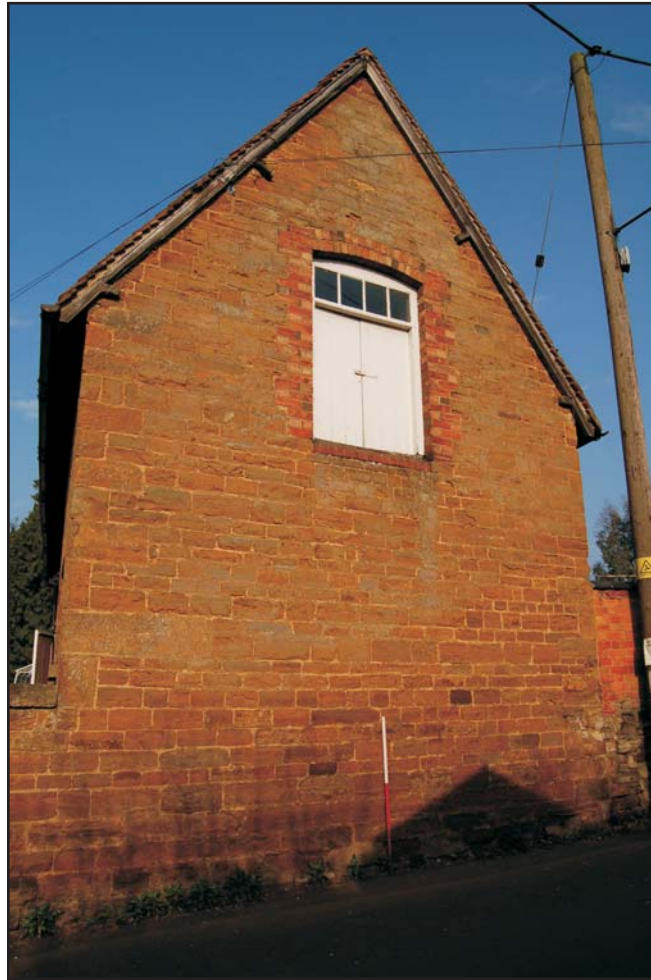
Facing onto Kings Lane this elevation is constructed in the same materials as the south side and contains a single hayloft door at first floor level (Fig 6, Plate 3). The hayloft door is finished in the same way as the door and windows on the south elevation with red brick dressings to the jambs and a segmental arch constructed of two courses of edge laid brick, the only difference is that the sill is made of red bullnose header singles. The loft door is fitted with a timber frame painted white with a fixed four light glazed panel at the top. Beneath are two timber vertically planked doors hinged on either side, fastened by an iron hasp and staple lock.

The east elevation, looking west Plate 3

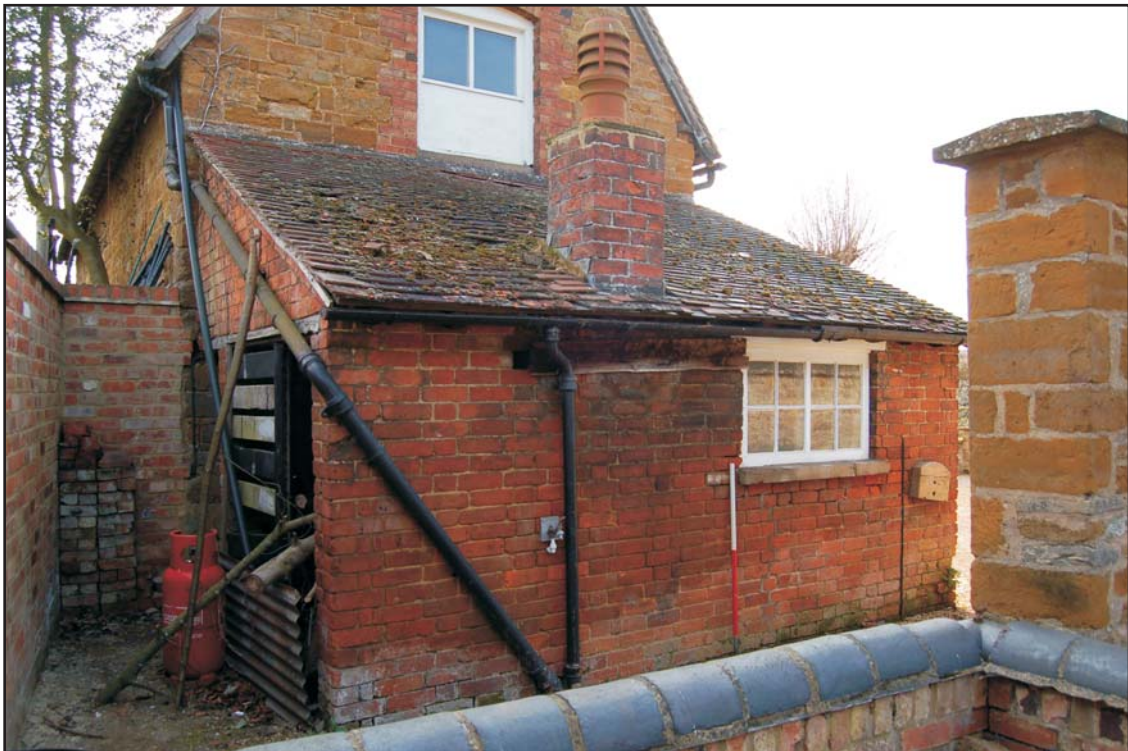
Now only the upper part of this elevation is visible externally since the single storey section was added against it (Fig 6, Plate 4). At first floor level there is a second hayloft door of the same configuration as that in the eastern elevation, though the sill is slightly higher. It retains its original frame but not the original glazing or doors, being fitted now with two fixed square panes of glass in the upper half and a sheet of what appears to be painted plywood in the lower half. The external sill is not now visible due to the addition of the single storey tack room.

The west elevation with later tack room, looking south-east Plate 4

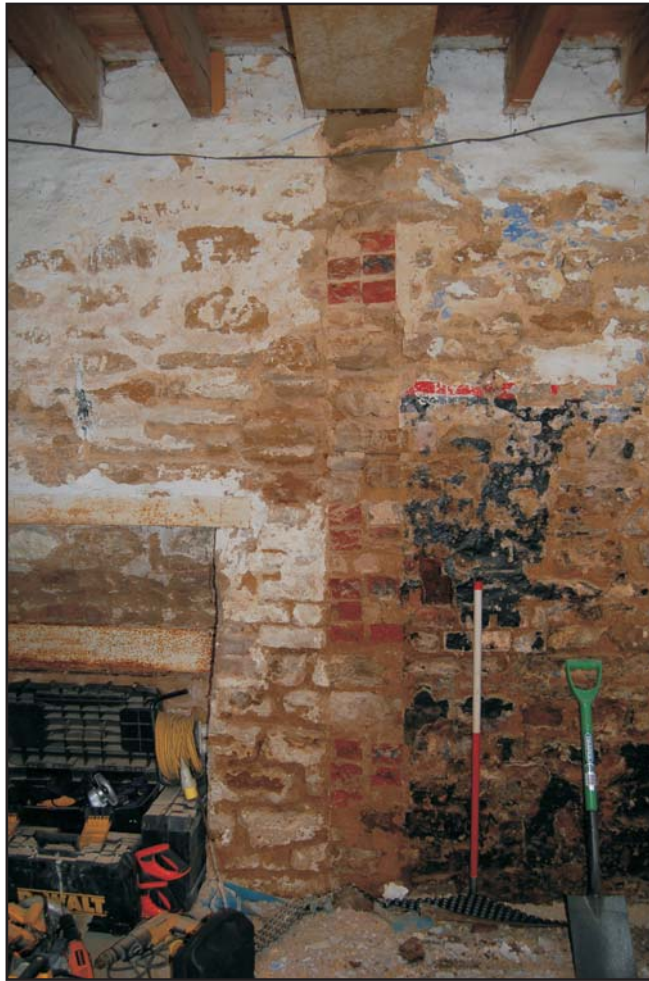
Scar of the former wall dividing the carriage house and stables, looking north Plate 5

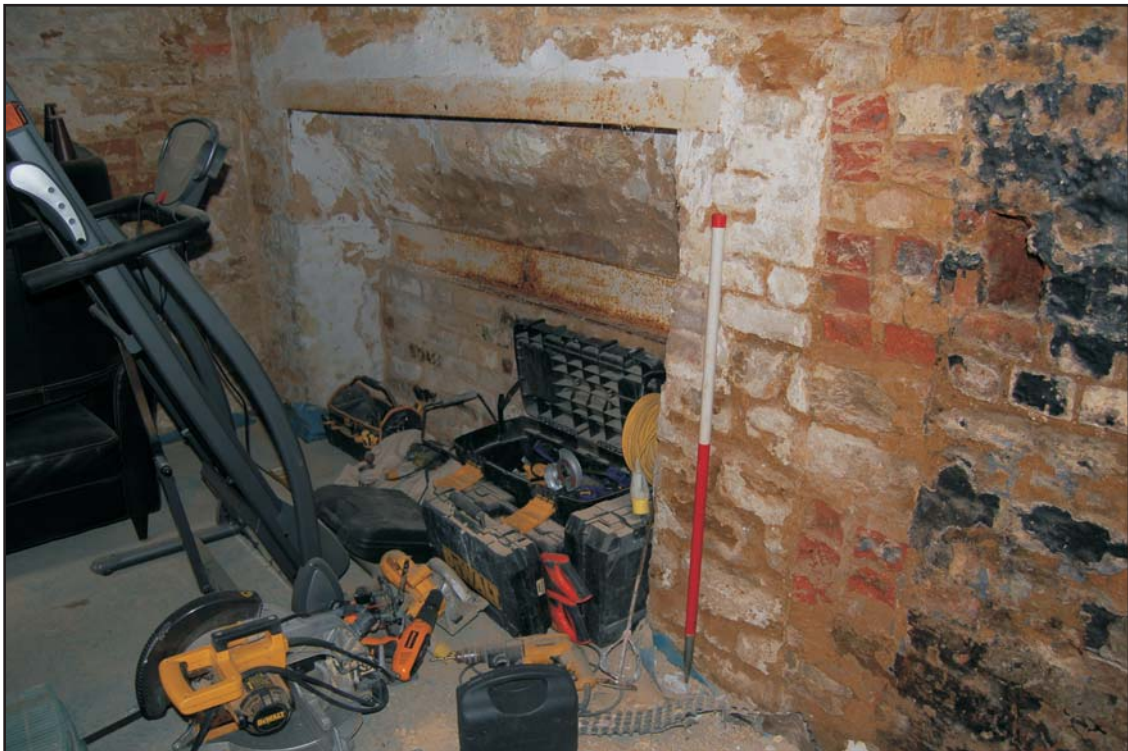
Recess in the north wall of carriage house, looking north-west Plate 6

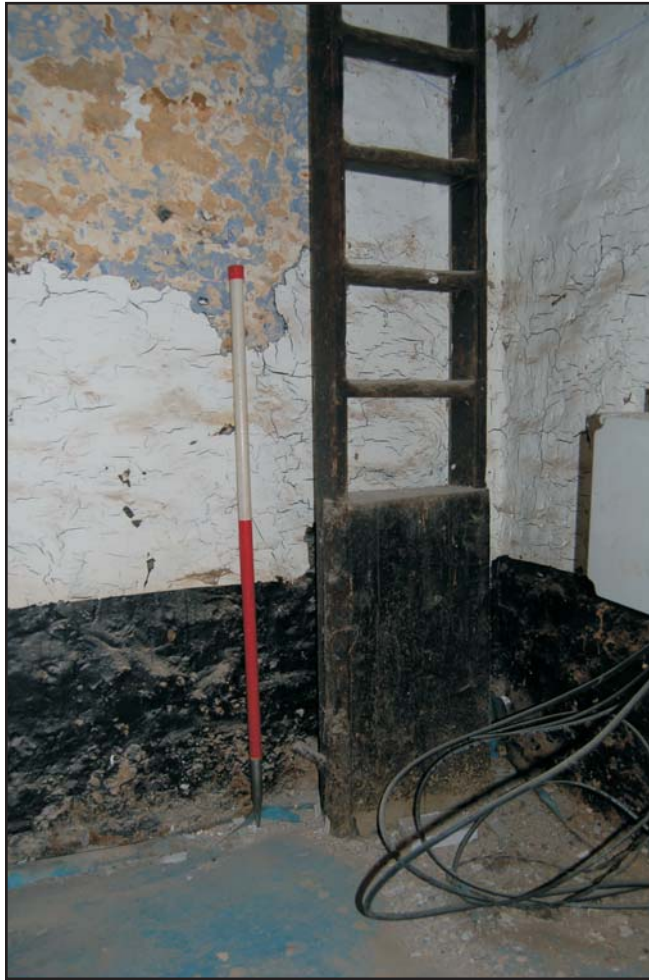
Loft ladder to the first floor, looking south-east Plate 7

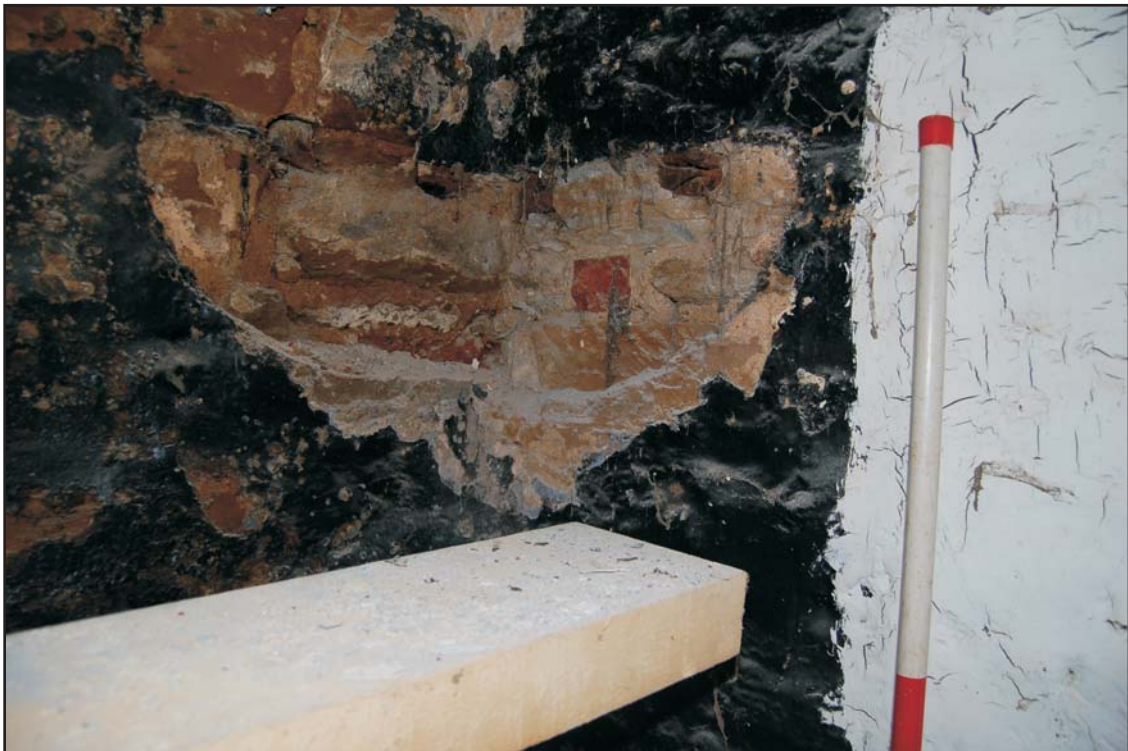
Plate 8

In the north-east corner of the room a scar in the corner indicates where a former trough, presumably for water, was fixed (Fig 5, Plates 8 and 9). During the last site visit, during a conversation with Mrs Broster, a cast iron corner trough was seen fixed to the exterior of the main house, and when measured, this trough was found to match exactly the scar within the building. It is almost certain, therefore, that this was originally fitted within the building but had been removed by a previous owner and re-used as a garden planter (Plate 9).

Scar showing the former location of the cast-iron corner trough in the north-east corner of the stables

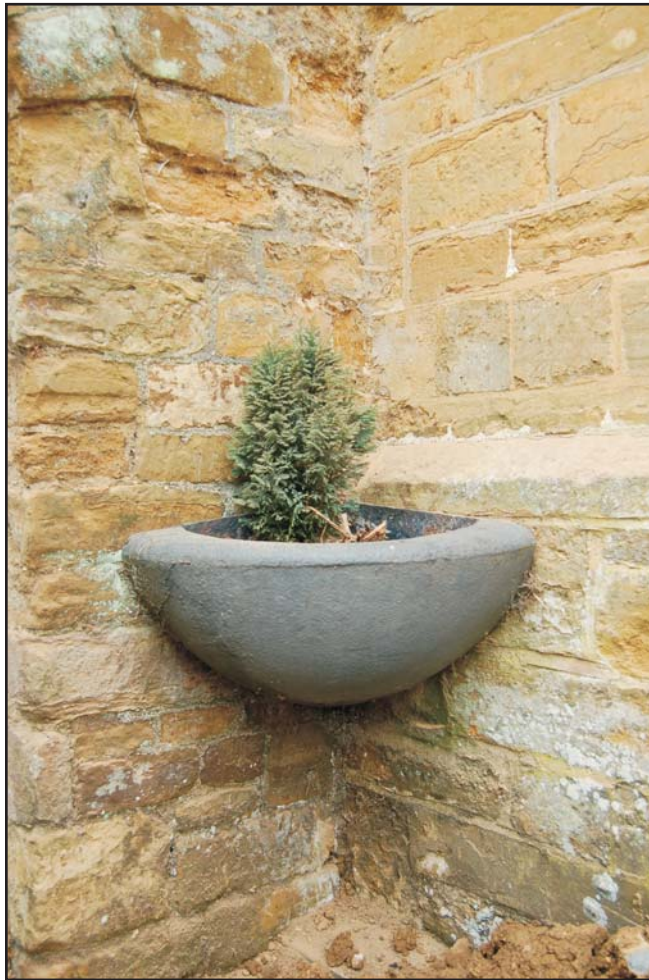
The corner trough re-used as a garden planter Plate 9

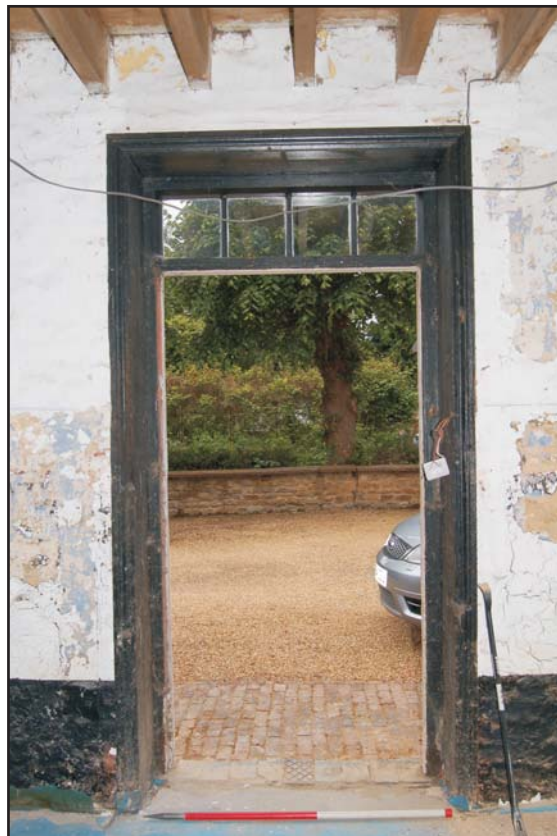
The south wall contains the central doorway and two windows, one to each side (Fig 5). Following the removal of the dry-lining it was observed that the internal jambs of the doorway were covered by black painted vertical matchboard with a simple architrave on the internal surface (Plate 10). The door, originally a two part stable door, has previously been described (see above, section 4.3). This timber lining of the door jambs would have the double effect of not only protecting the brickwork from damage by horse, but also protect the horse from damage by the hard corners of the brickwork. There is a glazed four light overdoor panel for additional light.

The stable door showing the boarded jambs and glazed overdoor panel, Plate 10 looking south

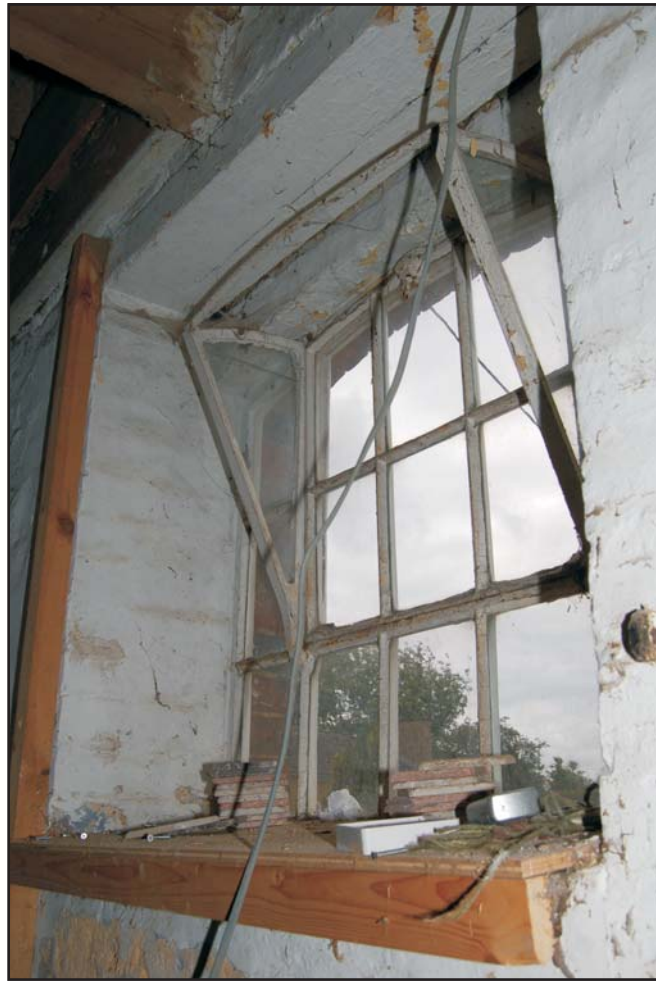
Both windows are of the same size and shape, each is fitted with an original cast iron fifteen light frame, the upper central six of which are hinged on the lower edge and could be opened, resting on an internal integral frame (Plate 11). The sides of the internal restraint bars against which the hinged section rested when opened contain glazed panels to reduce draughts whilst allowing the movement of air through the top of the opened section (Plate 11). The internal sills slope downwards slightly and appear to comprise painted mortar or cement. The level of the windows is higher than would be expected in either domestic buildings or cattle barns in order that the horses would not be spooked by activities outside or liable to damage if panicked by being able to put their heads through the glazing.

The eastern cast iron stable window, looking south-east Plate 11

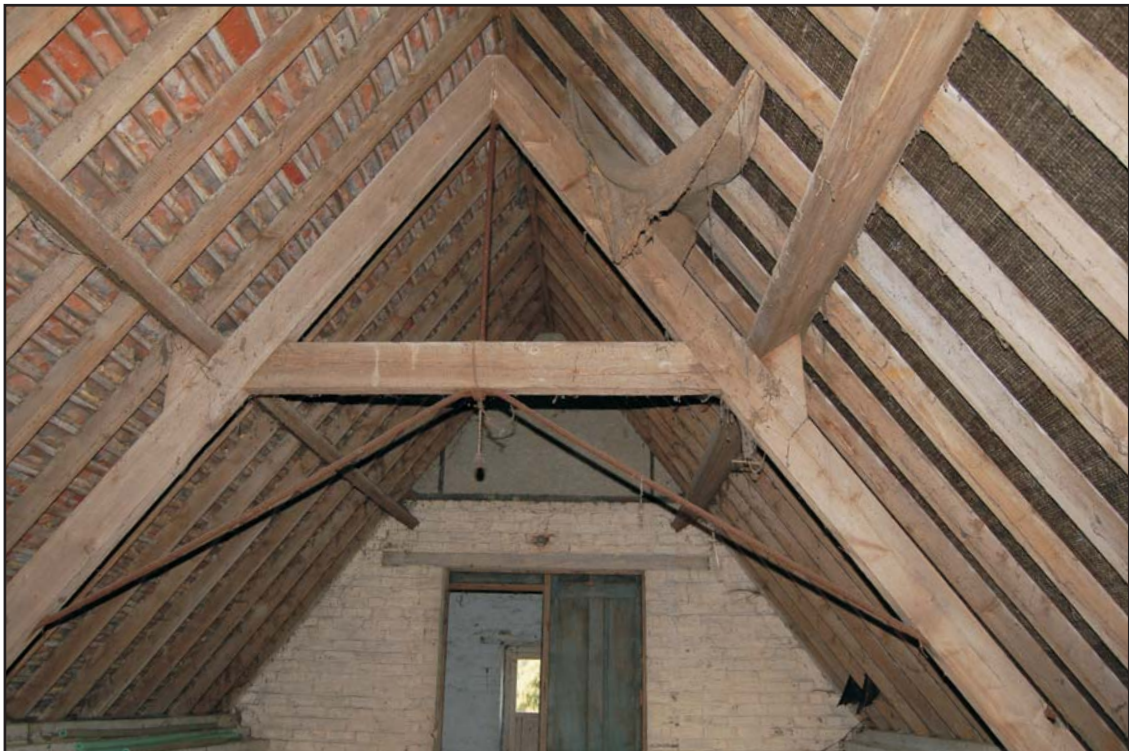
The first floor, looking west Plate 12

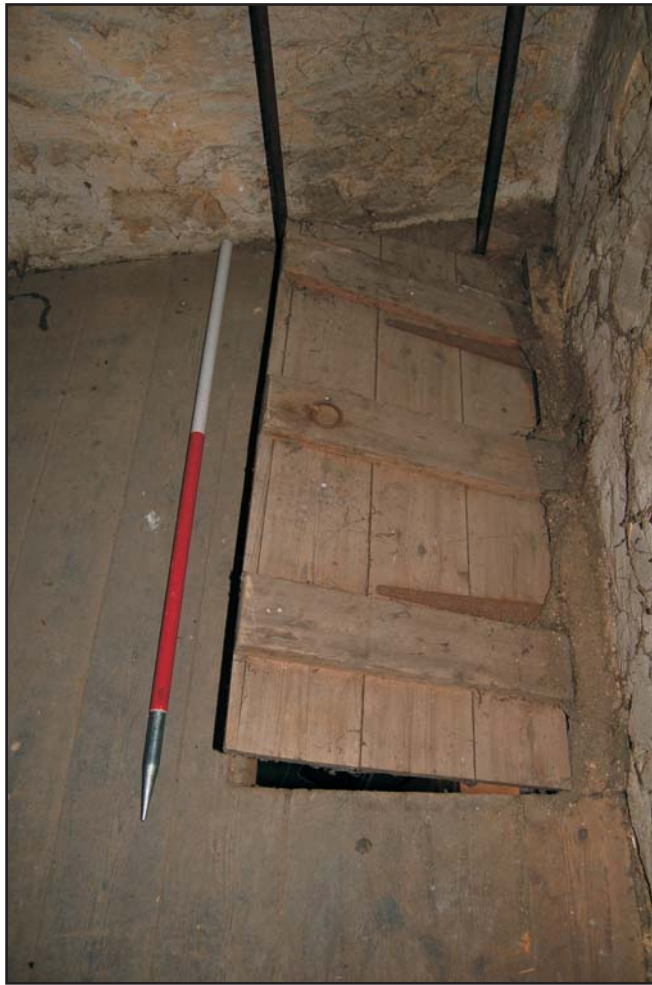
The loft ladder trap door, looking east Plate 13

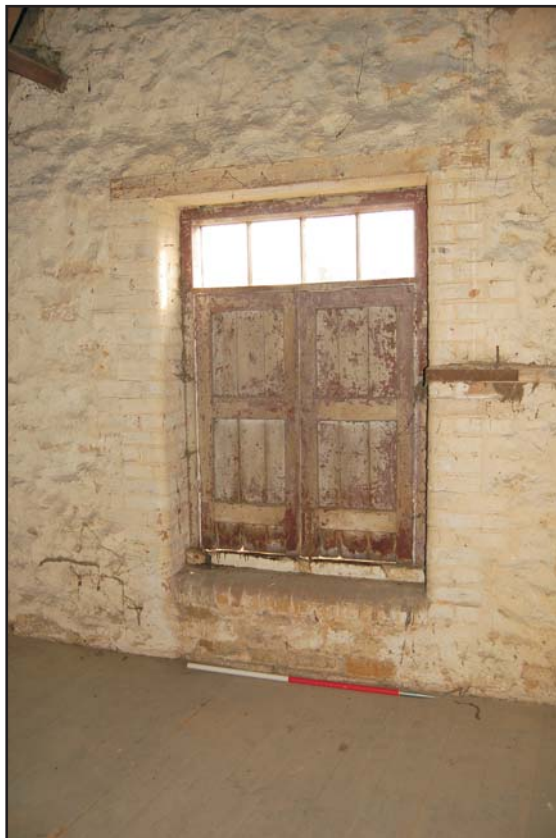
In the eastern gable wall is the hayloft door set beneath a pine lintel with a pine frame (Plates 3 and 14). The upper part has a fixed four light glazed panel, the lower part has two hinged doors of vertical planks set within a pine frame with ledging but no bracing. It is painted a maroon colour, most likely the original paintwork. There is no internal lock although the right hand (south) door has a bolt on the lower edge. The internal sill and the jambs are made of red bullnose bricks, all painted white.

The hayloft door in the first floor east gable, looking east Plate 14

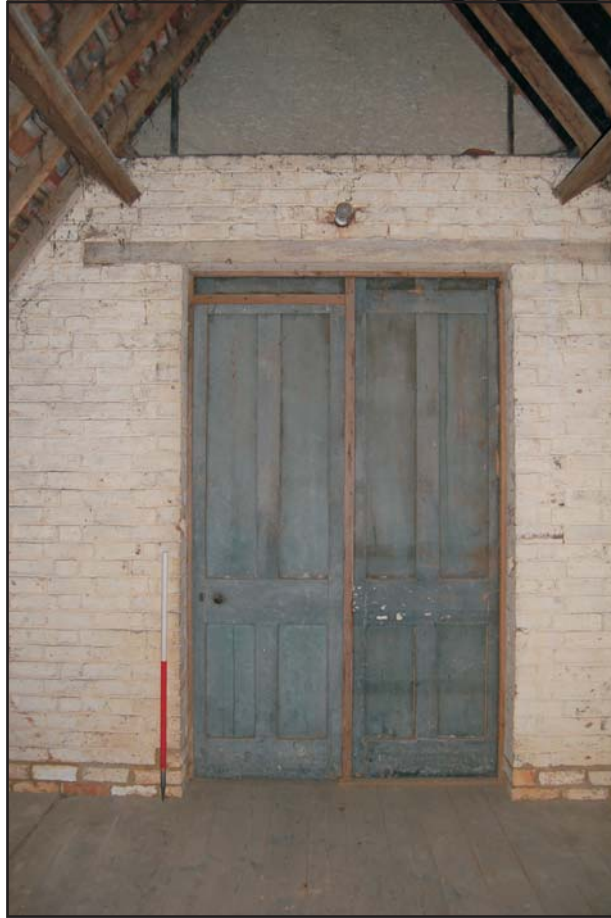
The dividing wall at first floor level, looking west Plate 15

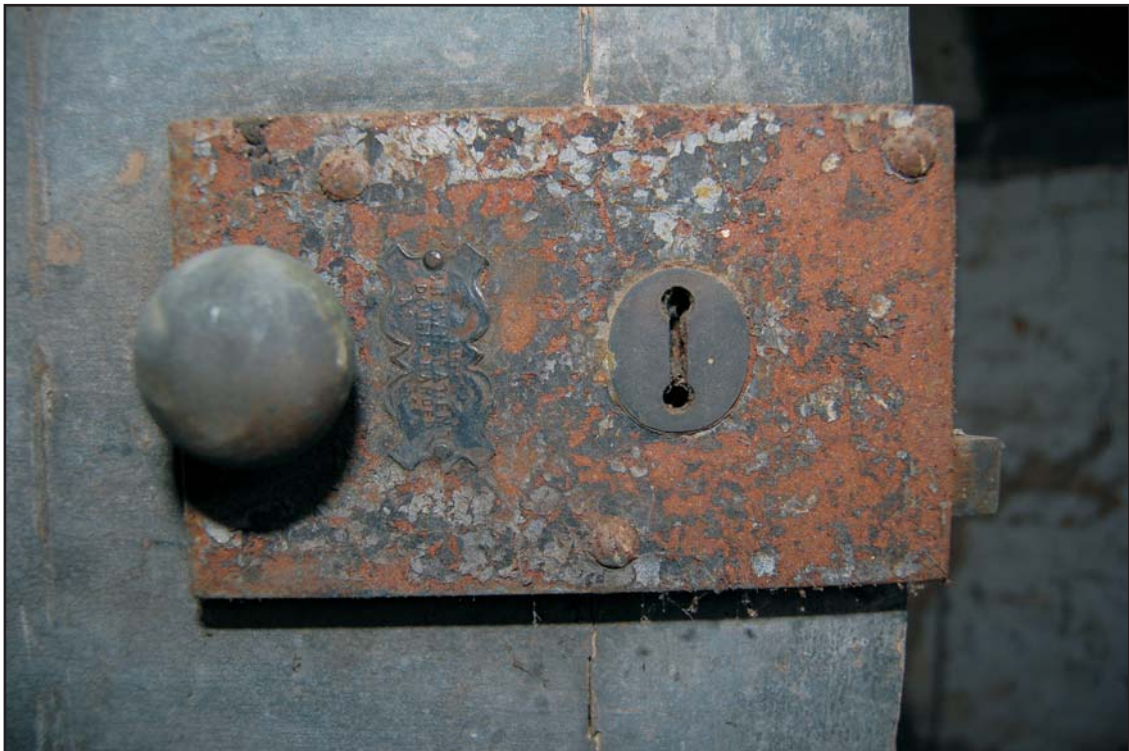
Plate 16

Rim lock on the west side of the door between the two rooms at first floor level, looking east

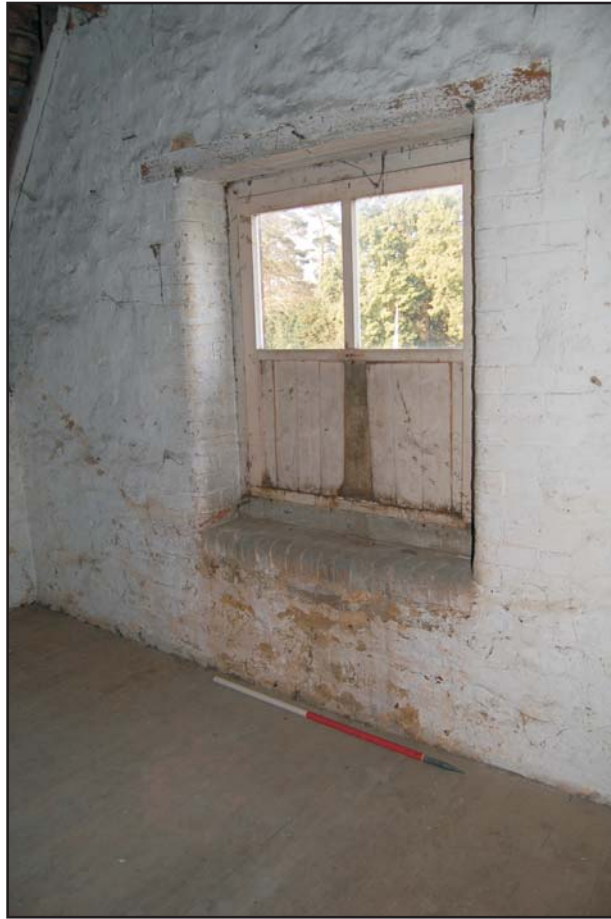
In the west gable wall is a hayloft door with a pine lintel (Plate 17). The original frame remains but the opening is now fitted with a partly glazed and partly boarded infill, all fixed. Originally it was fitted with two hinged doors, the scars of the two sets of two hinges can be seen cut into the frame on each side. This, along with the fact that the jambs and sill are of bullnose bricks, indicate that it was used as a hayloft door and not a window.

The hayloft door in the west gable, looking south-west Plate 17

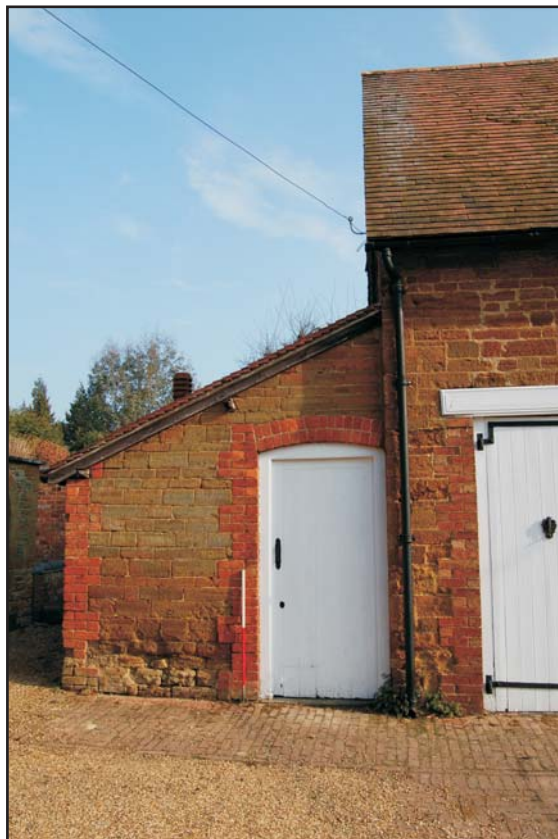
The tack room, looking north Plate 18

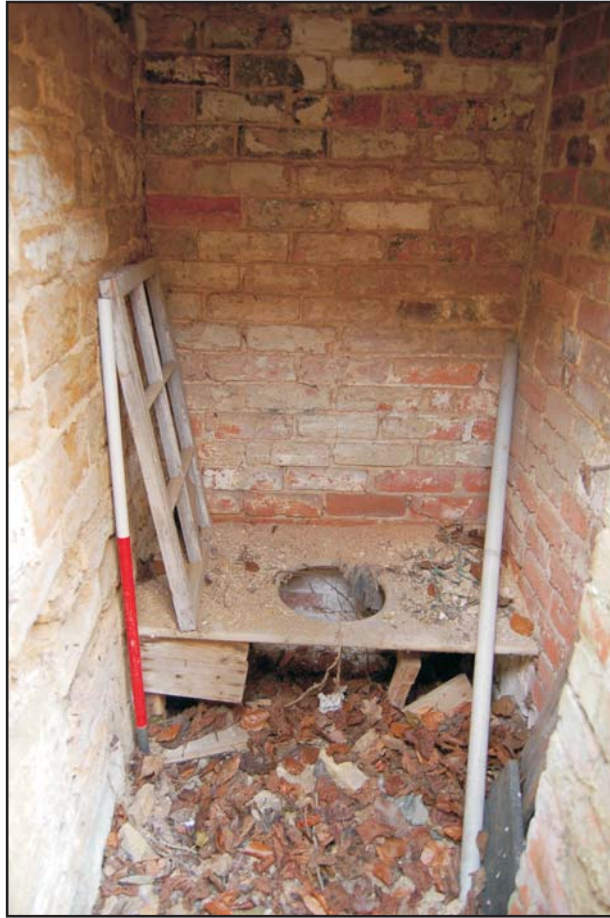
The privy, looking south Plate 19

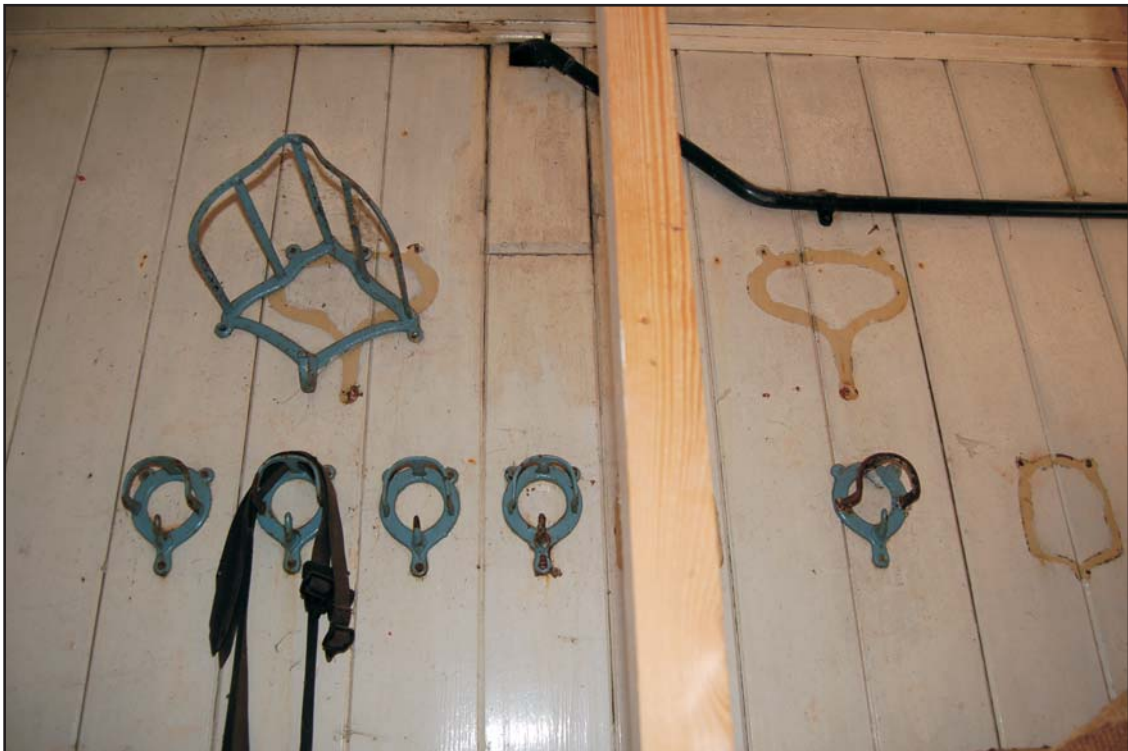
Harness fittings in the tack room on the east wall, looking east Plate 20
