Northamptonshire Archaeology

Archaeological assessment of buildings at
86 High Street, Wollaston, Northamptonshire
July 2011

Report 11/167

August 2011

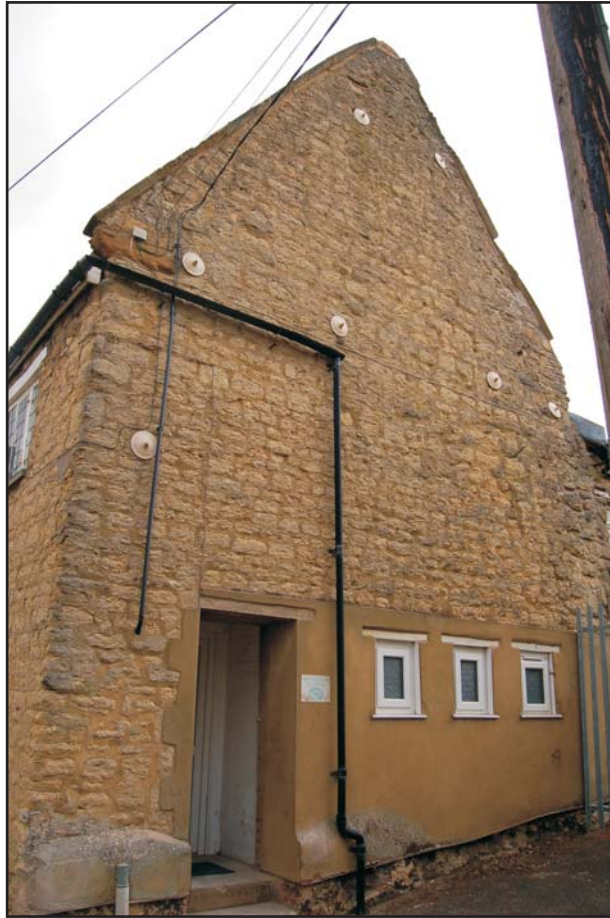
The south elevation faces onto the narrow alley located at the south side of the group giving access to the rear yard (Fig 8, Plate 1). The elevation was originally entirely built of coursed limestone bonded in lime mortar, now heavily pointed and re-pointed with hard cement. There are no original doors or windows, the current ground floor doorway is a modern insertion and to the east a row of three small windows light the modern toilets located on that side. The wall surface is cement rendered to a level just above the door and windows and relates to the chopping out of those openings and may also relate to an incident when it is thought the gable partially collapsed and had to be re-built both internally and externally. Although not easily discernible there is an area of patchy stonework which may relate to this incident above the rendering. There is a badly eroded ironstone kneeler on the west side but none on the east side where a later stone wind has been added. Above the eaves level the parapet of the gable is finished with eroded and partly re-set coping to ridge height where the upper section is missing

South elevation, looking north-east Plate 1

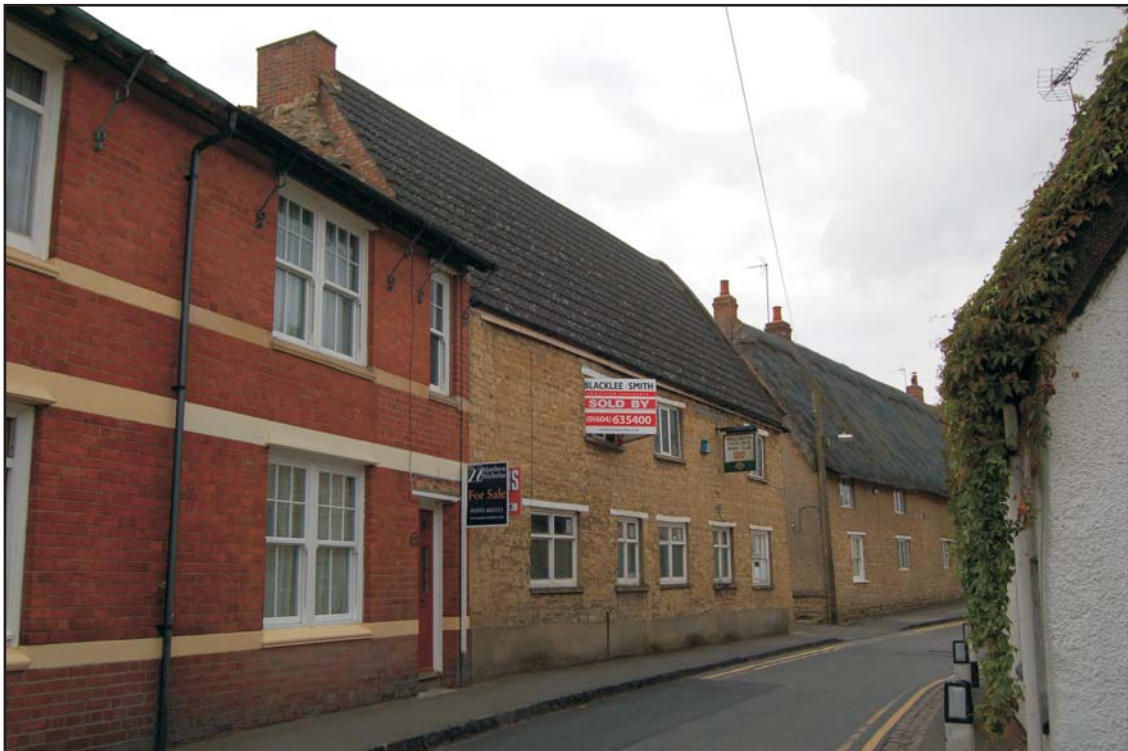
The west elevation is the principal street frontage and contains windows on both floors with two blocked doorways at ground level (Fig 8, Plate 2). There appear to have originally been four windows to both the ground and first floors, the three windows lying directly one above the other starting from the south end, each set beneath a timber lintel. There then appears to have been a single doorway on the ground floor with a fourth window to the north, whilst on the first floor the fourth window lies roughly equidistant beneath the third window and the north gable end (Fig 9). At a later date a second doorway was created by blocking the north side of the ground floor second window from the south and removing the wall beneath. This is the window shown on the c1902 photograph (Fig 6, Plate 2). The window above has been entirely infilled with stone although the lintel remains *in situ*.

The roof is currently covered with interlocking concrete tiles which replace the earlier, and potentially original, thatched roof.

West elevation, looking south-east Plate 2

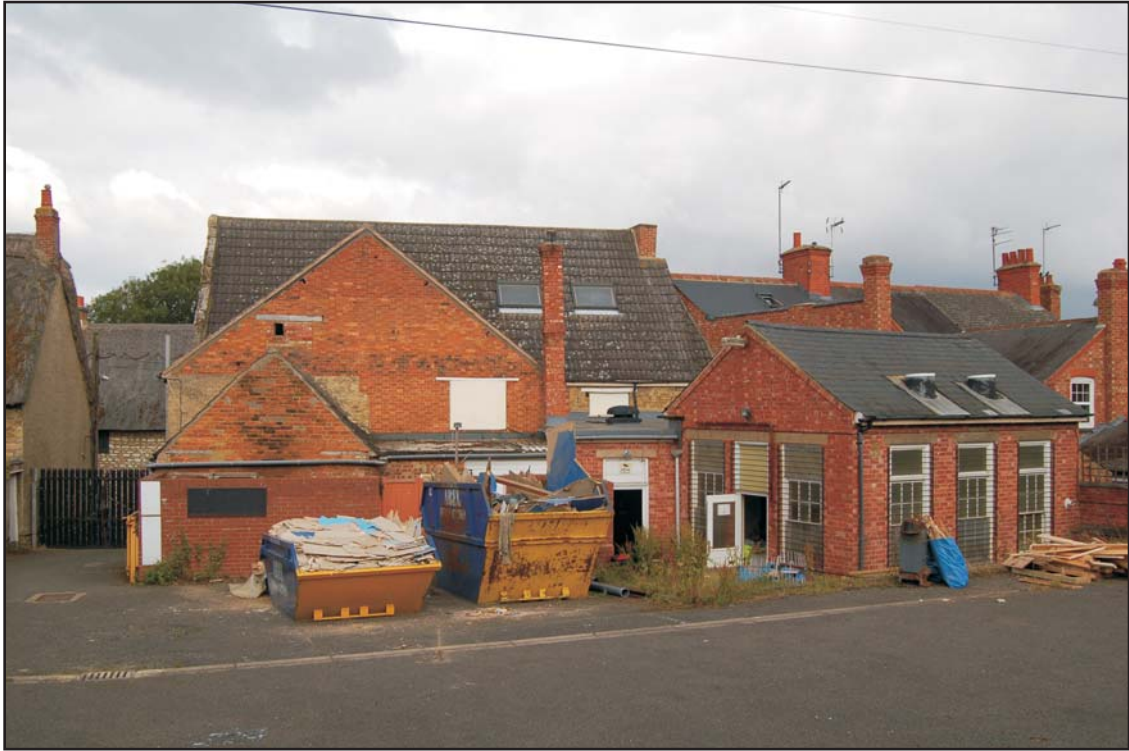
This elevation is now almost entirely obscured by later additions, although a section of the first floor wall can be seen (Fig 8, Plate 3). The upper part of a single window can be seen which retains its lintel, the exterior of the window opening is boarded over so it is not known if the glazing remains. No other section of this elevation is now visible.

East elevation, looking west Plate 3

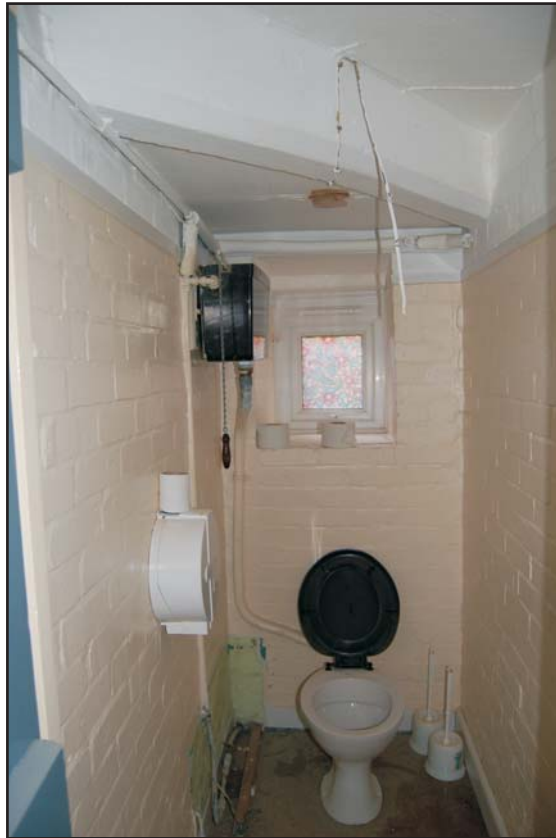
A single toilet with common brick walls and a concrete floor (Fig 8). The ceiling is fibreboard set against joists, possibly original, set into the oak beam which runs along the south side of G2. A further, diagonally placed slightly larger beam also appears to be an early feature but too little could be observed to comment further upon (Plate 4). Its purpose here is uncertain as it has the positioning of a dragon beam, but there appears to be no reason for such a structural element to exist in this location or in this period of building. It may be related to the now removed original staircase, but this seems unlikely and it may, in fact, be no more than a later re-positioned beam connected with the partial collapse and re-building of the south gable wall. The modern brick south wall appears to also be related to the partial collapse and re-build; it contains a single UPVC window with fake stained glass pattern for privacy.

Room G3 showing diagonal beam in ceiling, looking south Plate 4

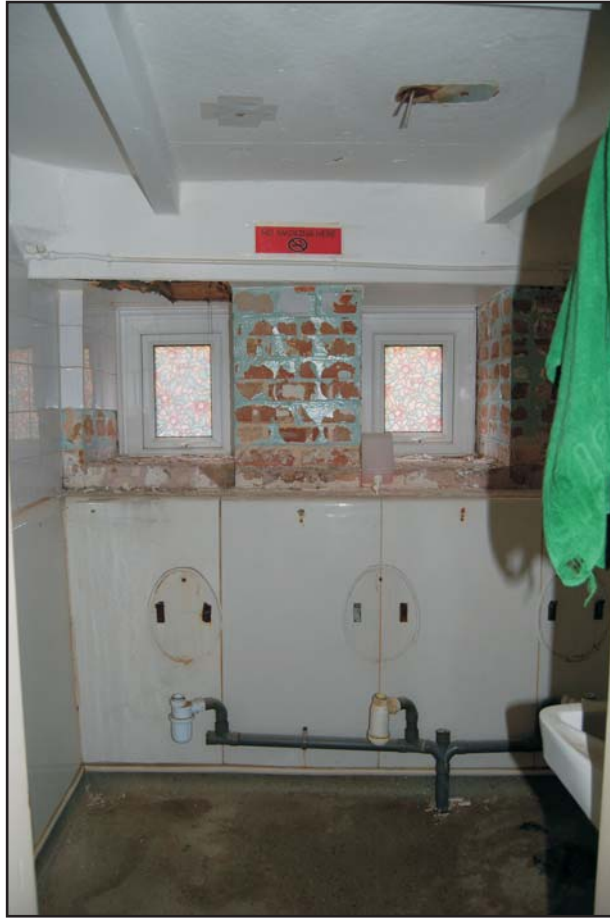
Located immediately to the west of the toilet, this is part of the same suite of alteration made for the use of the building as a club (Fig 8). There are two UPVC windows in the south wall covered with false stained glass. All of the walls are of modern brick, painted. On the east, south and west walls are large porcelain panels which appear to originally have been fitted above a perimeter trough urinal, later replaced by three wall-mounted single urinals, now removed (Plate 5). On the north wall is a single modern sink. The ceiling is fibreboard over joists and the floor is linoleum over concrete.

Room G4, showing urinals, looking south Plate 5

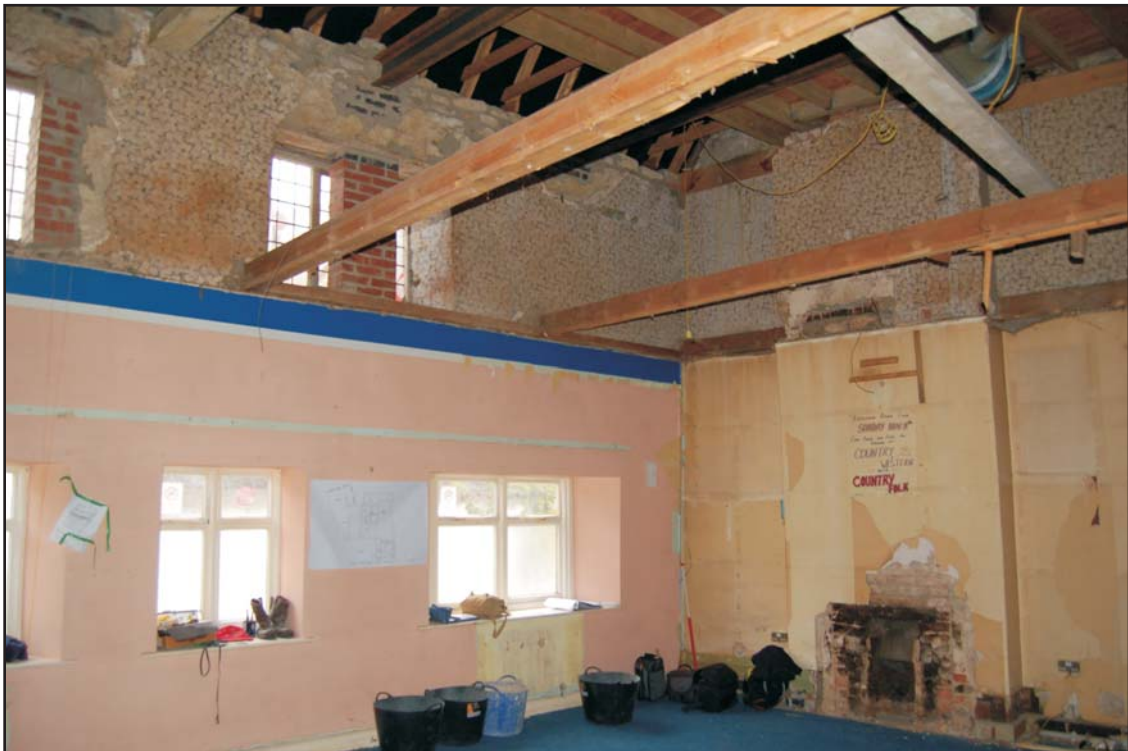
There is no scar of the remaining ground floor ceiling since when it was removed and the higher inserted ceiling inserted, it appears that the walls were plastered to the level of the new ceiling (indicated in Plate 6 by the horizontal pine joists and blue band on the left hand [west] wall). The space above appears to have been utilised for air conditioning units and light storage.

Room G5, looking north-west Plate 6

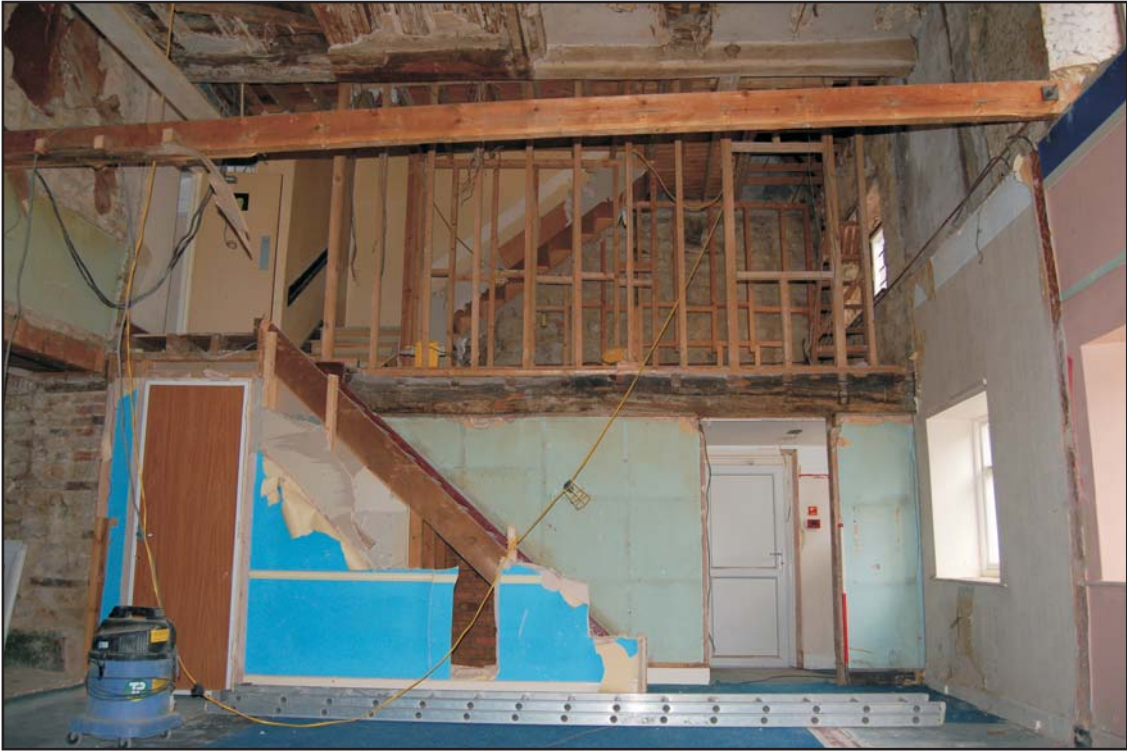
remainder of the space by the *in situ* oak transverse beam previously described (Plate 7). This beam, which retains a series of empty mortices for joists along its north side, indicates the height of the former ground floor ceiling of the house, and currently supports the only section of first floor at the original height within the building. A modern set of pine stairs has been built against the north side of the beam and the wall to the toilets. This staircase appears to have been inserted in the late 1940s; two pencil inscriptions were observed on the underside of two of the risers. They record:

Room G5, looking south Plate 7

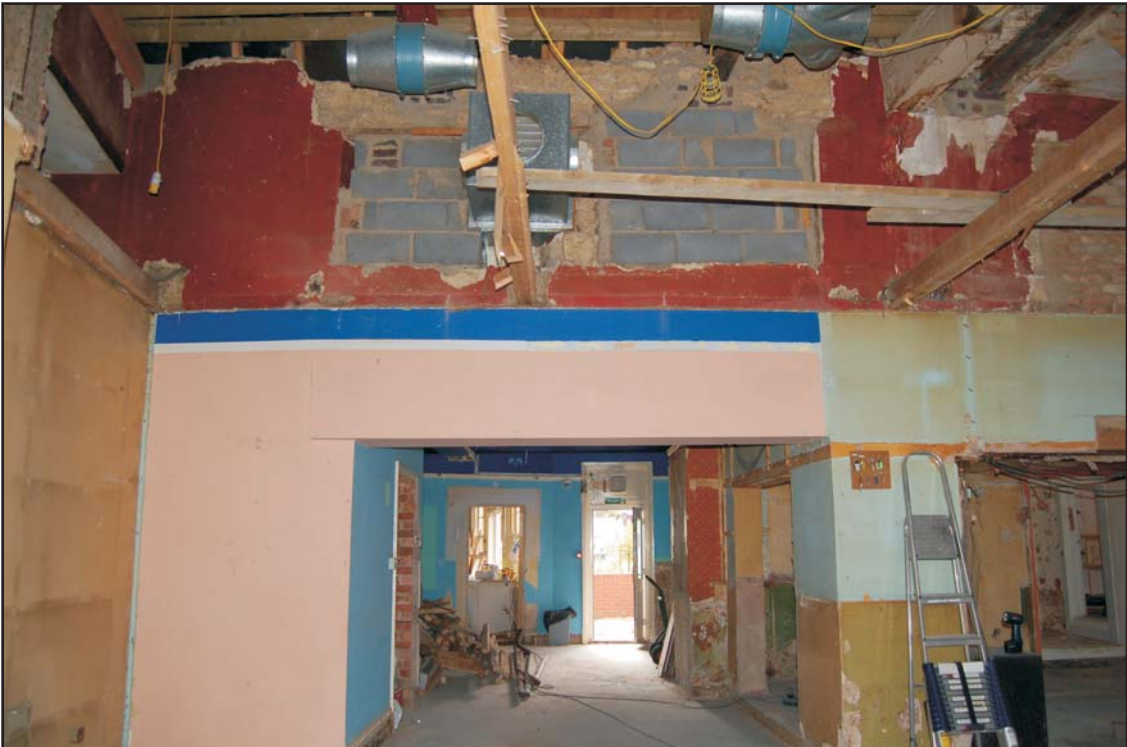
The east wall retains a blocked window, visible from the exterior east side (Fig 9). It is filled with breeze blocks and the vent for an air conditioning unit (Plate 8). To the immediate south is a further area of blocking which suggests a second window, although nothing can be seen on the eastern exterior. Further south is what appears to be the blocked opening for a doorway which formerly would have connected to the first floor of a later extension to the east (Fig 9).

Room G5, looking east Plate 8

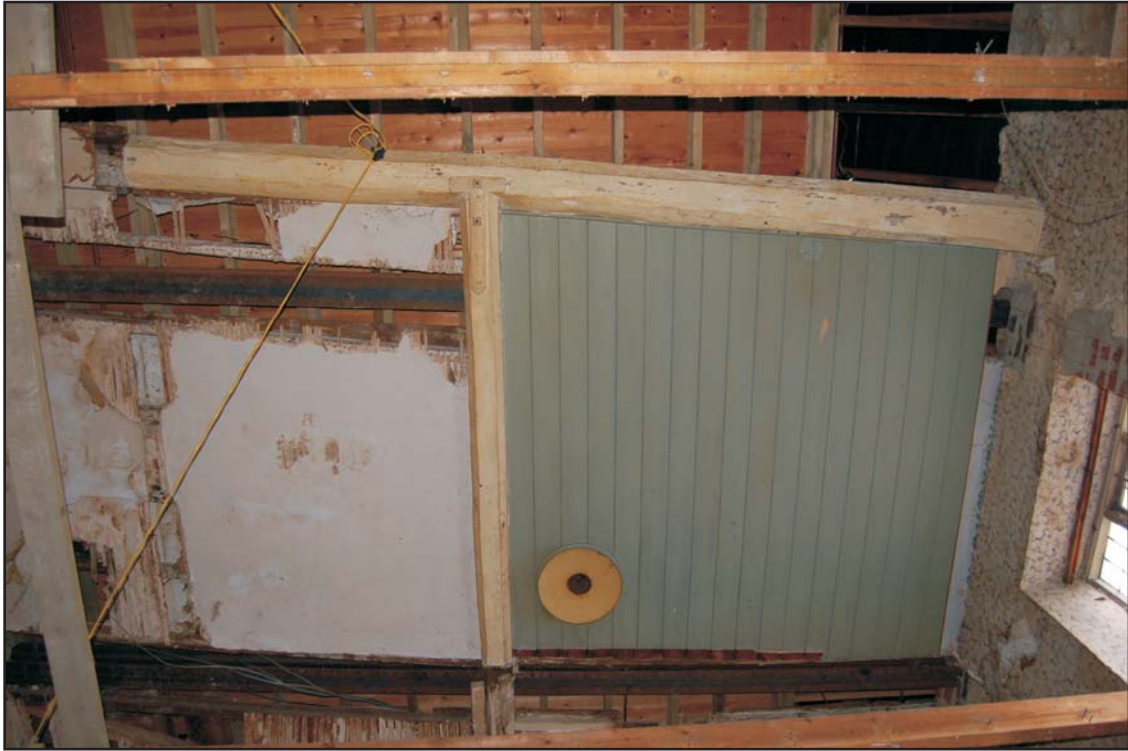
Plate 9

As part of the same exercise the second (or attic) floor was strengthened by the insertion of H-section steel joists below a new attic floor. This insertion was coupled with the building of brick piers across the first floor window openings (see Plate 6). The only saving grace of this crude scheme is that the upper windows have been left intact and all three retain their original frames, ferramenta and leaded panels. Just below the inserted girders some sections of the original oak transverse and axial beams survive (Plate 9). These comprise (presumably) oak beams, painted and chamfered with simple run-out stops. At one junction of the transverse and axial beams the two are strengthened with iron straps bolted to the timber. Above this structural timber fragments of ceiling remains, some showing indications of reed covered with plaster, others split laths and plaster, with one section of matchboard on the underside of the ceiling, perhaps over plaster. All of this ceiling material is fixed to oak joists set into the main transverse beams. In a few places small sections of oak floor boards (formerly flooring the attic level) can be observed from below.

Room G5, looking up, showing ceiling to second floor with original oak beams and modern steels above

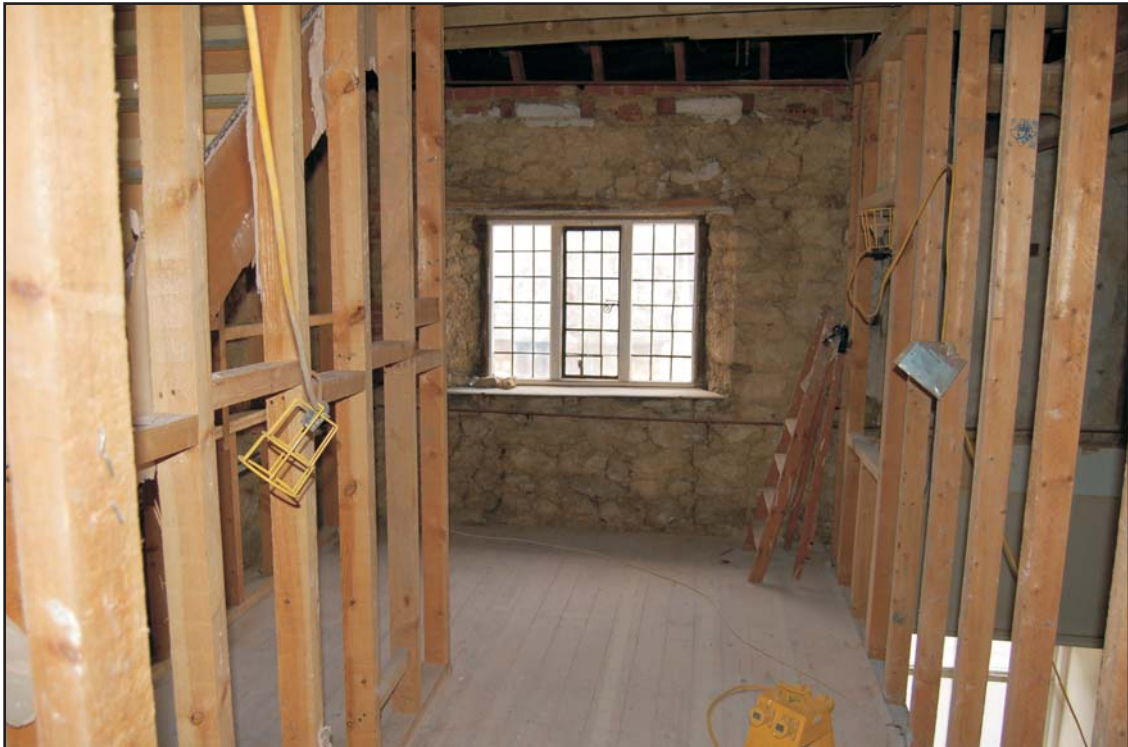
Located at the south end of the stone house, above the male toilets this single remaining section at the original first floor level has been utilised as a landing (Fig 9, Plate 10). The south and west walls are the original external walls of the house, both stripped of plaster and until recently covered in studwork, the north wall is a modern stud (formerly covered in plasterboard) wall, and the east wall is plaster over breeze block laid inside the remains of the original east stone wall. The floor is of modern pine and the two south

Room F1, looking west Plate 10

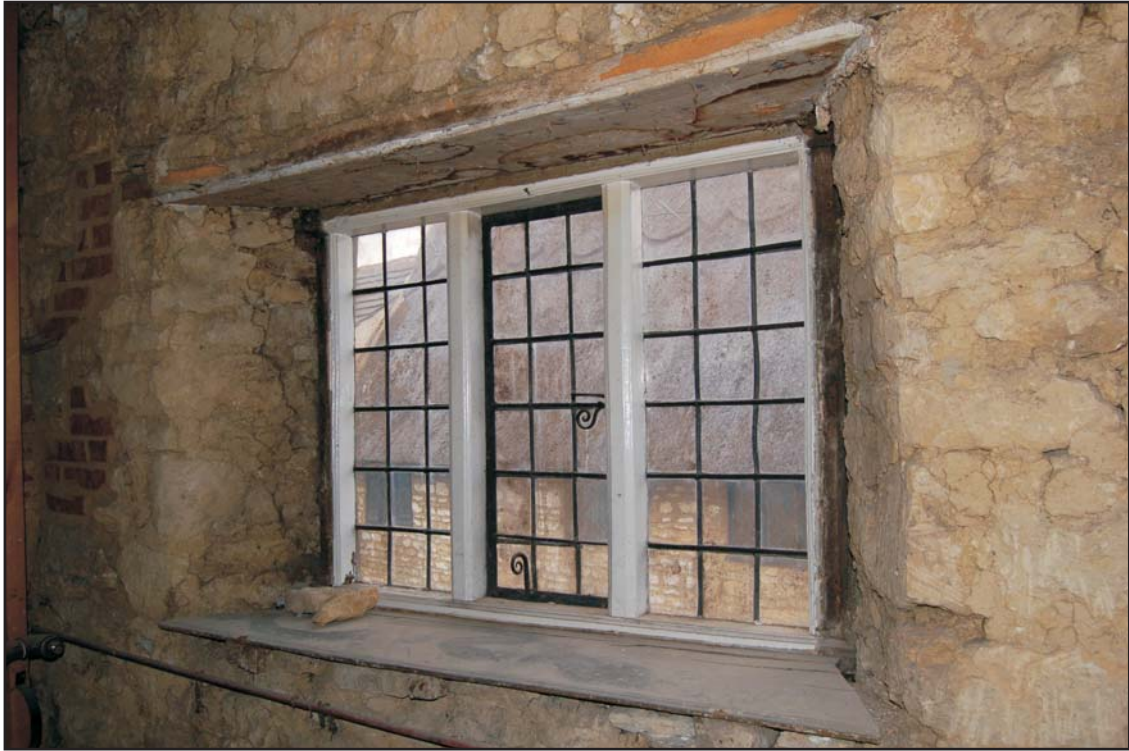
Room F,1 showing window in the west wall, looking west Plate 11

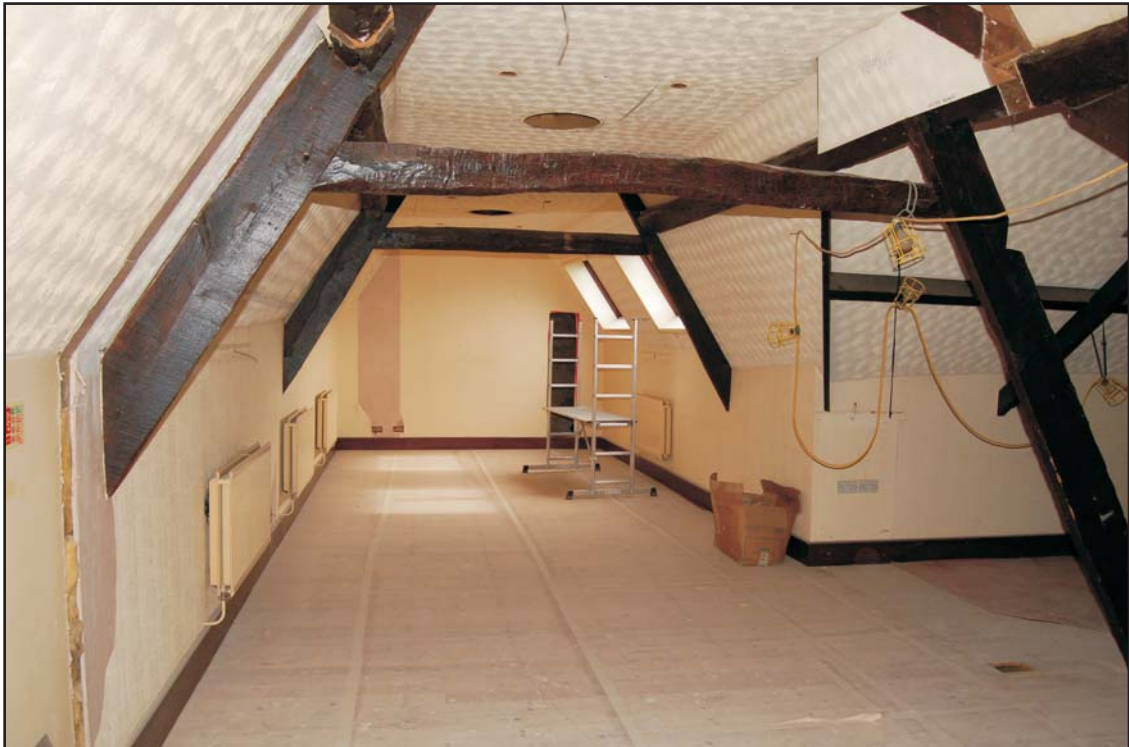
Accessed via the modern timber stairs from F1, the attic of the former stone house is a single rectangular room stretching the entire length of that floor (Fig 9, Plate 12). The present floor is the modern floor supported on steel girders set above the remains of the original second floor (see above, section 4.12), it comprises modern pine floor boards over pine joists which rest on the steels. The underside of the roof has at the same time been covered with plywood sheeting although the main trusses have been left exposed. These are of oak and are of simple A-frame construction, the original tie beams resting on the east and west walls now covered by the inserted floor, the collars visible in the attic room. On the east side are two modern skylights. Originally there would have been some dormers since it is clear that this space would have been used since oak floor boards can be observed from below.

Room S1, looking north showing original roof trusses Plate 12

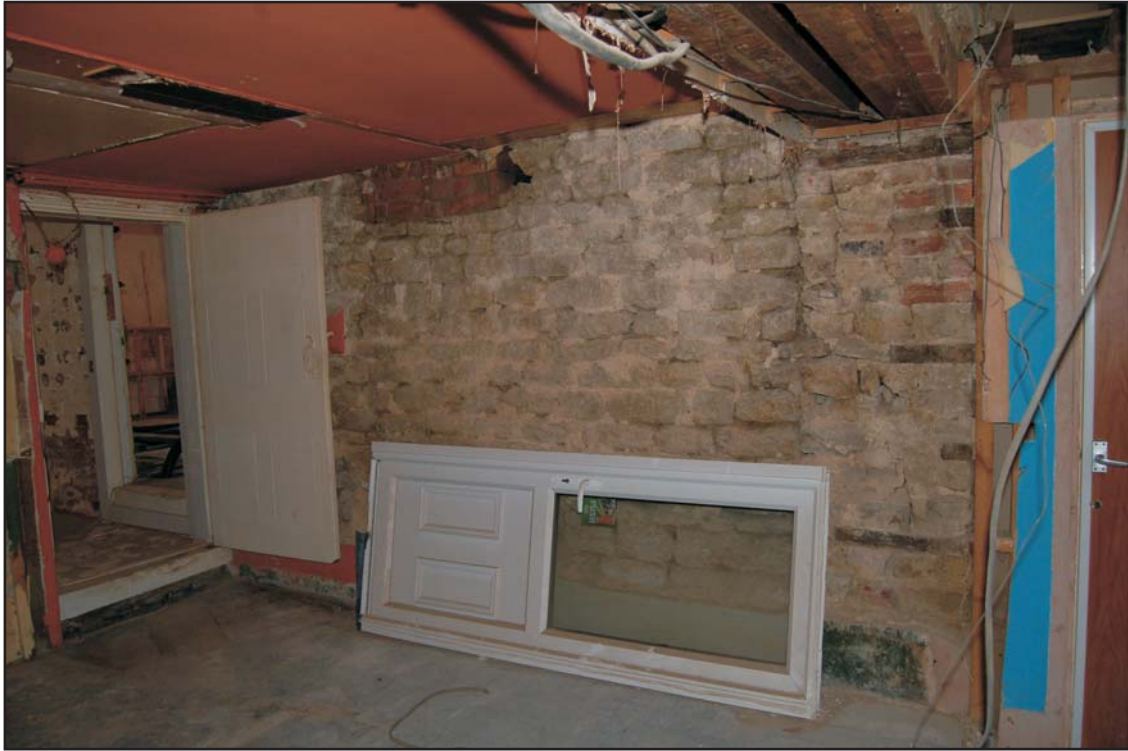
Plate 13

A roughly square space on the ground floor, currently entirely inaccessible from all sides as well as above (Fig 8). It is clear from the evidence of the stonework visible on the south and north sides of the building that this addition is later even though at ground floor level the entire south wall is currently cement rendered, the first floor where visible indicates slightly less well laid stonework which includes pieces of ironstone, a type not seen in the original building. Other reasons to indicate that it is not part of the original building are taken from the two eighteenth-century maps, and a clear butt joint visible on the north side (Plate 13).

Room G12, north (original external) elevation of stone addition, looking south, showing butt joint with east face of the stone house

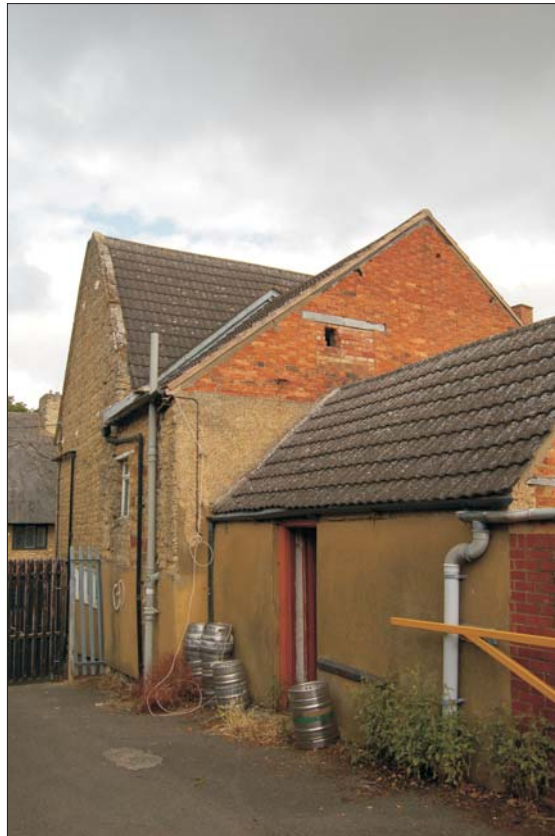
Plate 14

A single first floor room, now subdivided (Fig 9). The south elevation shows that the south wall is built of limestone and ironstone beneath a concrete tile roof. The east elevation is built of stone to eaves height with a later brick gable (Plate 14). The first floor room was recently the ladies toilets but has been stripped of the cubicle partitions revealing a concrete floor and plastered walls. There is a single window in the south wall fitted with a modern timber casement and fixed light with small horizontally opening casement above; all are filled with crinkled wire glass. This window appears to occupy the upper part of a former hayloft window (see Plate 14).

Room F4, east elevation, looking north-west

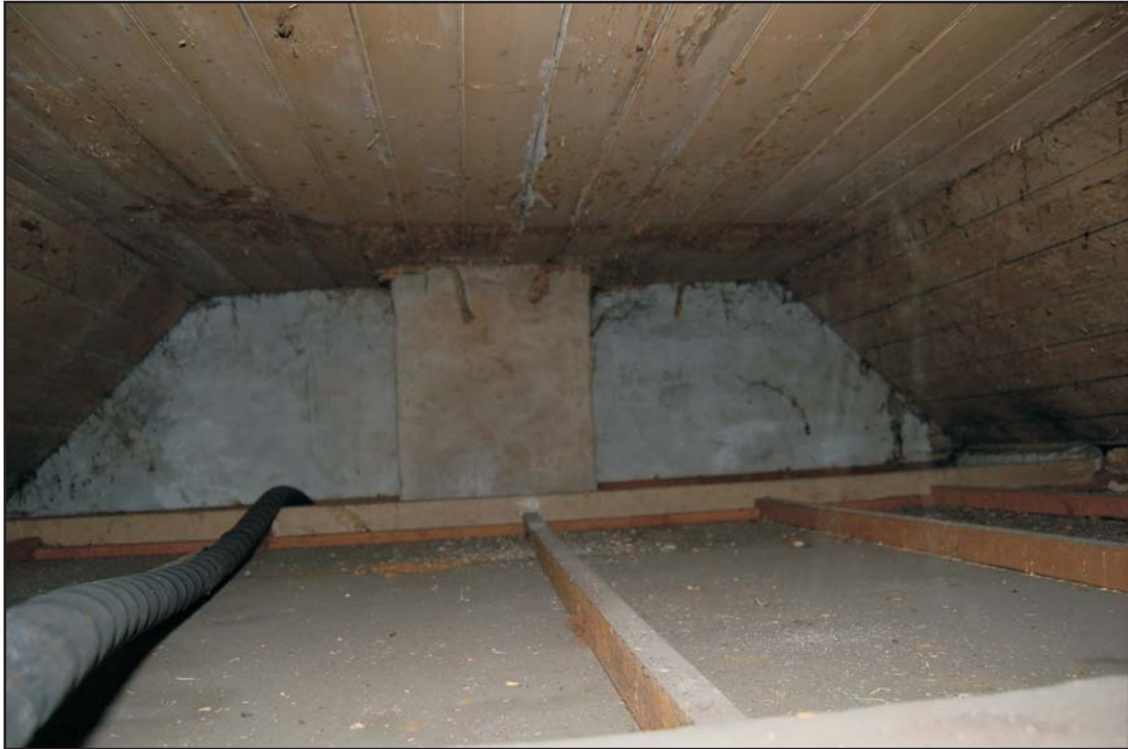
Plate 15

Room G11, roof space showing original matchboard ceiling and inserted modern ceiling, looking east

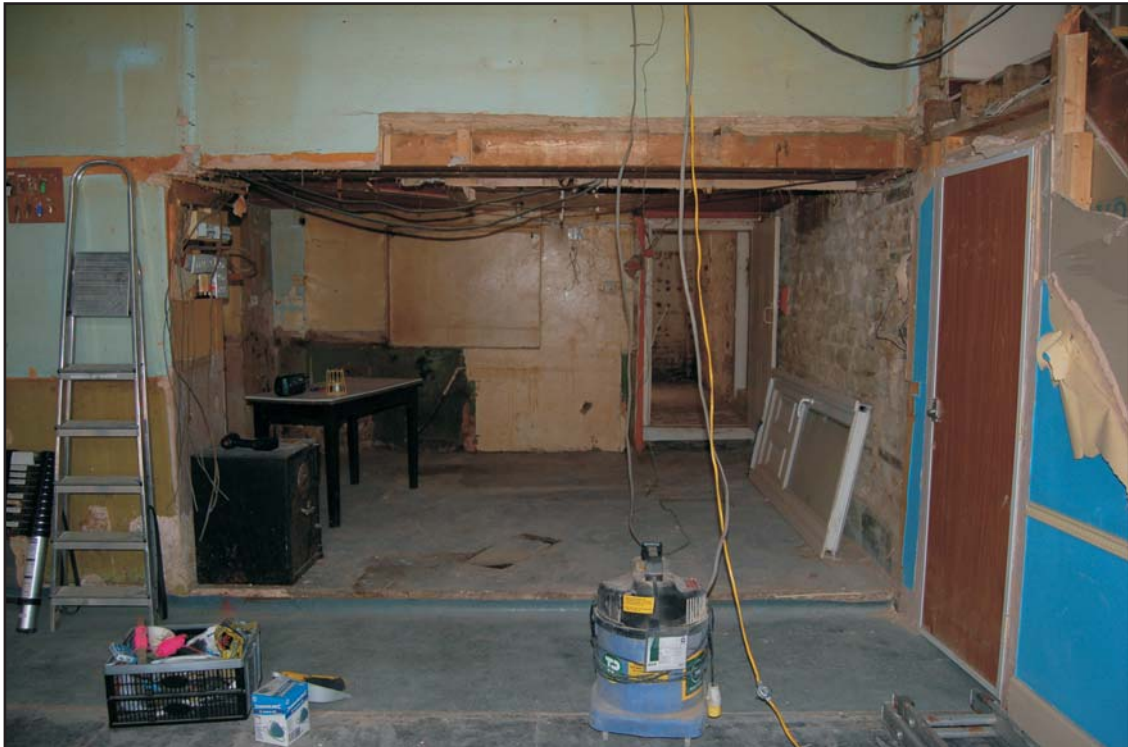
Plate 16

Room G6, former club bar, looking east

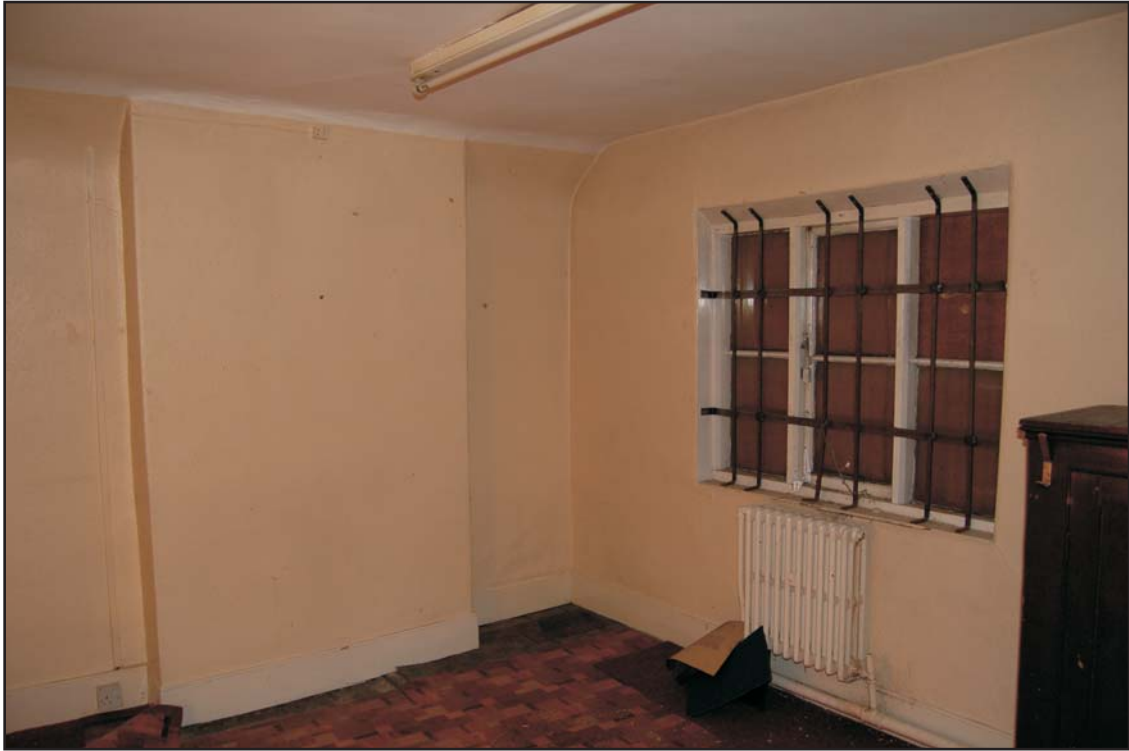
Room F5, former office, looking north-east Plate 17

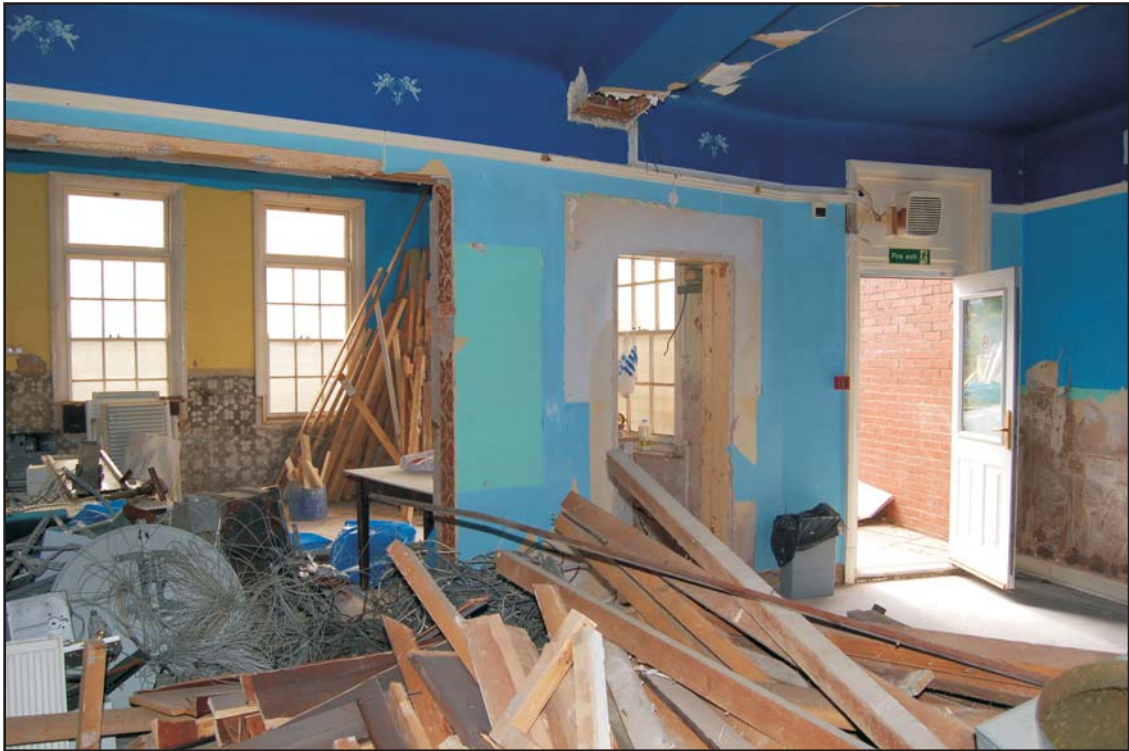
Room G7 (foreground) and Room G8 (left of photo), looking east Plate 18

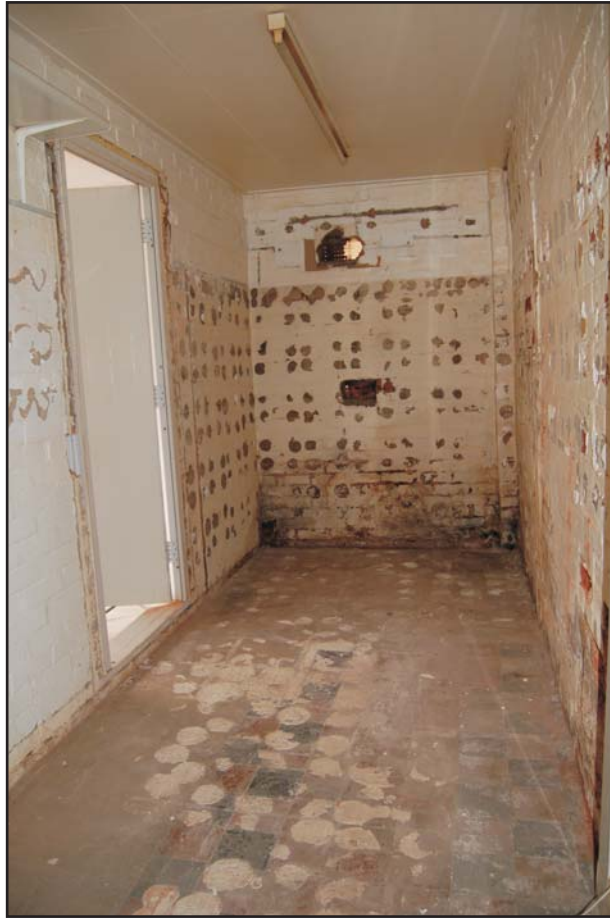
A small rectangular room to the east of the bar and apparently purpose built to serve as a small kitchen linked to it (Fig 8, Plate 19). The south wall is the former external north wall of the beer cellar, G11, whilst the west wall is the former external wall of what was recently the bar, G6. Thus only the north and east walls were needed to create this room, and they are built of Fletton, or common bricks. It has a flat roof. The date of construction is not known but appears likely to be of the second half of the twentieth-century. The floor comprises part concrete and part red and black quarry tiles. There are no internal fixtures or fittings, the majority of the walls had been covered in modern white glazed tiles such as are found in food preparation areas.

Room G10, looking east Plate 19

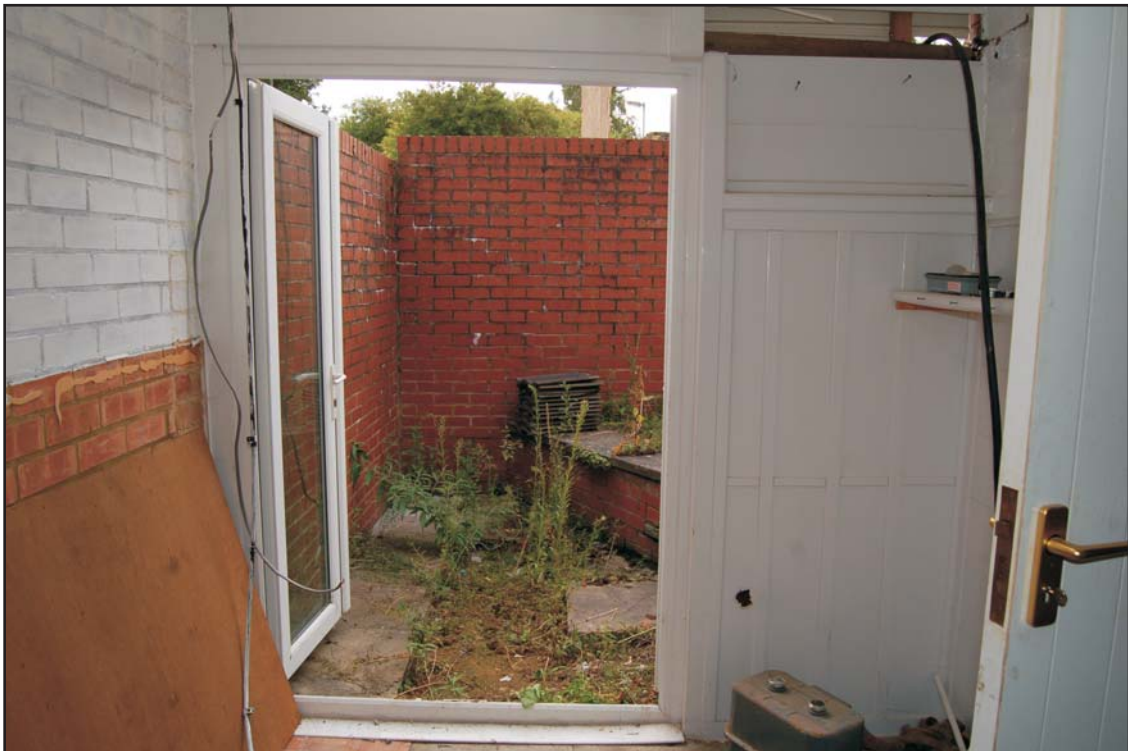
Room G9, looking east Plate 20
