Building recording of a coach house at Mortimers
33 Rectory Lane, Milton Malsor, Northamptonshire
September 2011

Report 11/204

October 2011

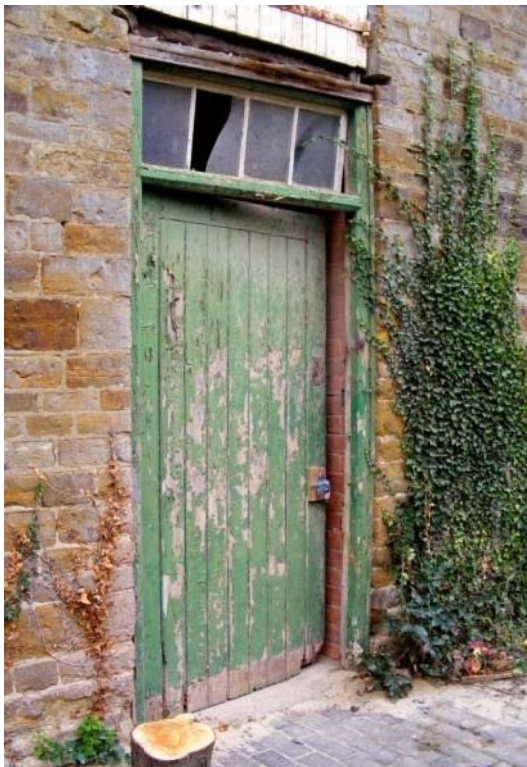
The door opening into Stable 1 Fig 9

timber frame by plain strap hinges top and bottom on the inside (see Fig 35). The bottom of the door is plain wood and slightly damaged having lost a ledge from the bottom. On the east side of the door there is a decorative latch-lifter plate, probably original (Fig 10). Underneath there is an oval metal keyhole escutcheon set into the door, and below that there is a lock on a wooden block that has been added recently.

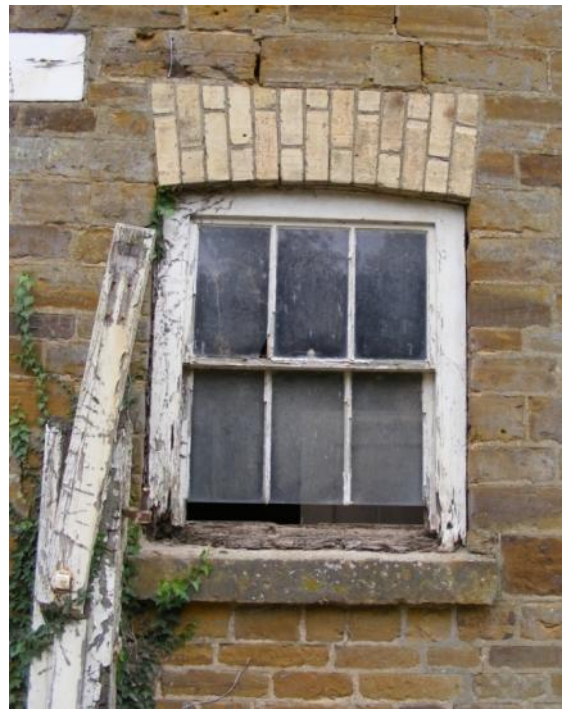
The hayloft door, with strap hinges Fig 11 The carriage house window Fig 12

The windows for the carriage house and Stable 2 are identical six-light, three over three sashes in wooden white-painted frames with ironstone sills beneath flat-topped segmental arches of edge-laid buff coloured bricks. The frame at the bottom of the carriage house window is not in good condition and the bottom rail of the sash is missing (Fig 12).

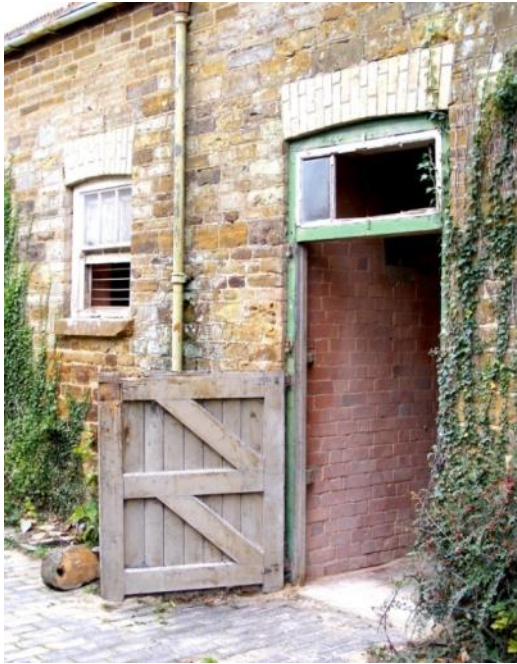
The entrance to Stable 3 is a two-leaf stable door, with the upper leaf missing (Fig 13). The lower leaf is vertically-planked, ledged and braced; painted green on the outside and hung on the outside with plain strap hinges, extending the width of the door, on a green-painted wooden frame (Fig 14). The four-light overdoor panel, which appears to

Doorway to Stable 3,
and window to Stable 2 Fig 13

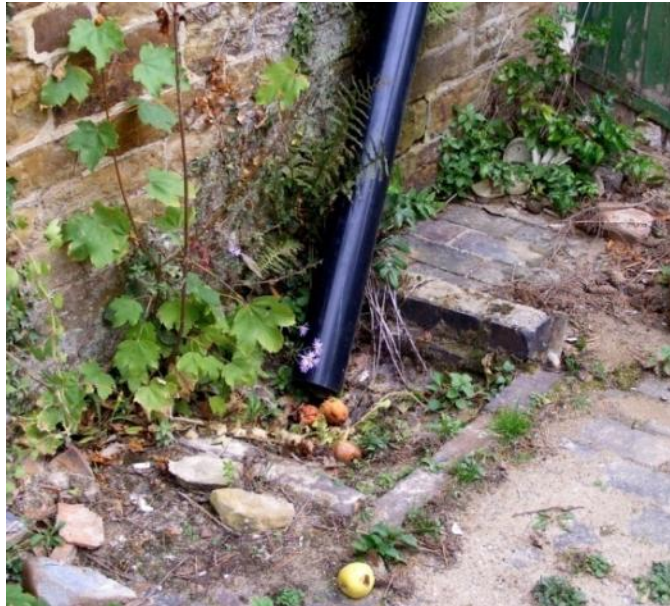
The downpipe would have angled into a brick-lined drain, but the bottom section has been lost and replaced by a freestanding plastic pipe propped against the wall (Fig 17).

Plastic downpipe emptying into brick-lined drain outside Stable 2 Fig 17

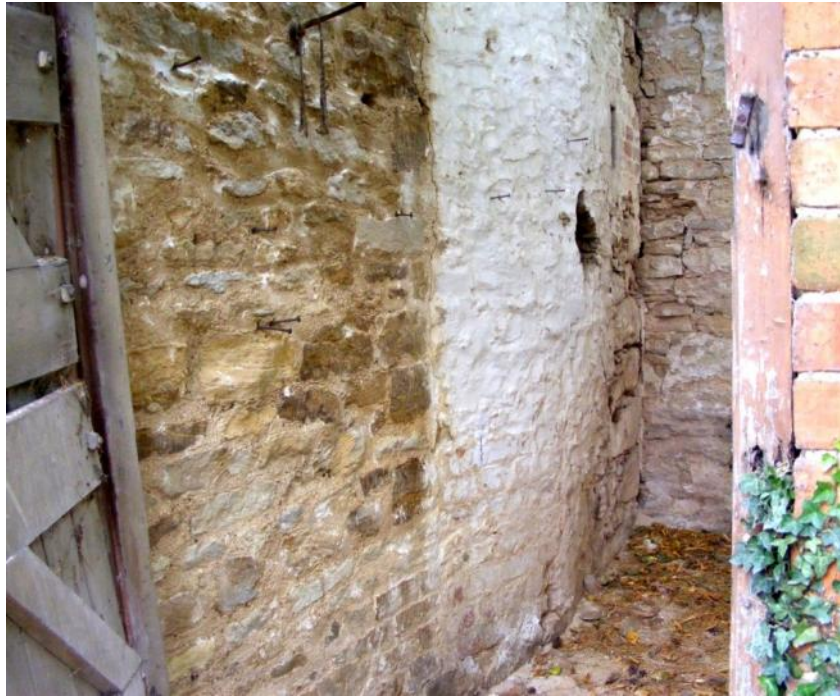
The east wall inside the tool shed; showing the whitewashed bulging rebuild Fig 23

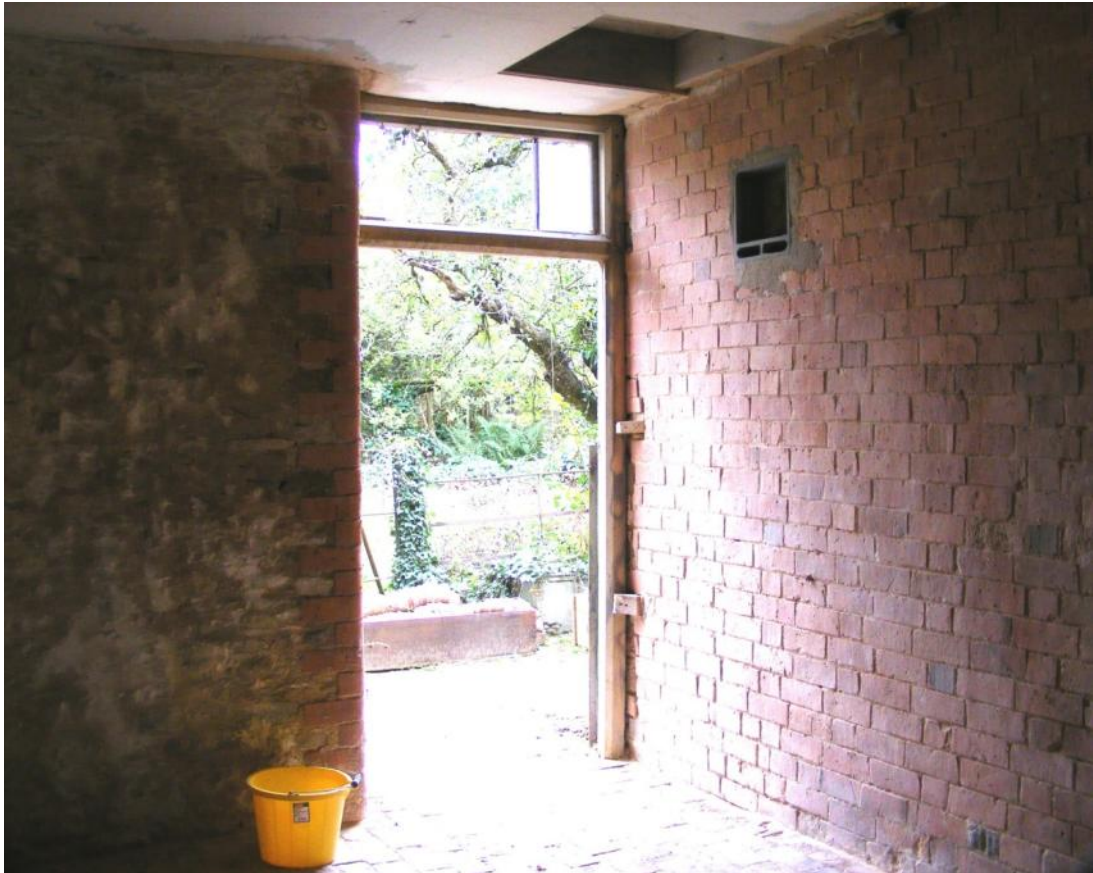
Two modern metal settings, 300mm square, have been inserted high in the east and west walls, with modern brick patching around the one in the east wall (Figs 47 and 48).

Stable 3, door, hayloft hatch and modern fitting Fig 47

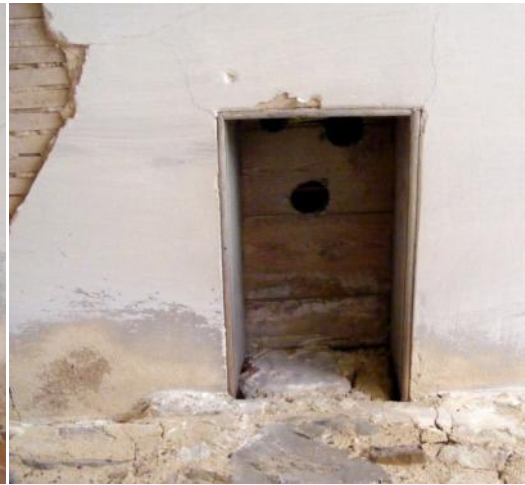
east wall there is a small rectangular aperture in the ceiling that is lined with boards, but is covered by the plank floor of the hayloft, although three holes have been drilled through the floor (Fig 51).

Stable 3, ceiling aperture Fig 51

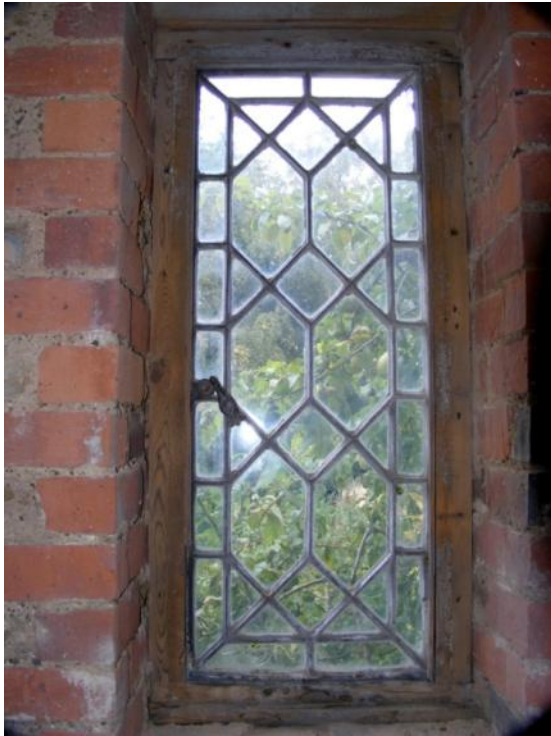
The west window is set within a pine frame, with a brick jamb and a timber lintel. The cement sill is nearly worn away. The framing of the lights are cast iron designed to look like leaded lights, and it is fastened with a decorative handle (Figs 60 and 61).

The hayloft, west window Fig 60

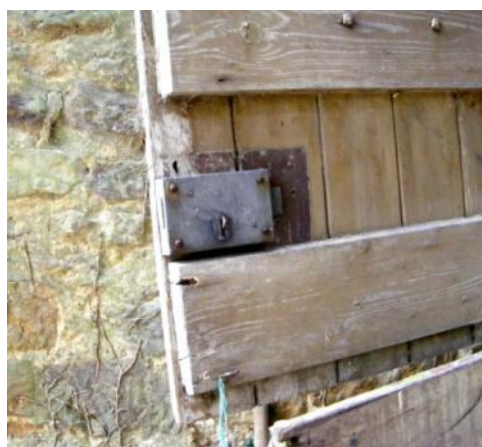
The stable door comprises a lower leaf with three ledges and two braces and an upper leaf of two ledges and one brace, with strap hinges on the outside. It is set in a timber frame under a narrow lintel, all painted red on the outside. The upper leaf is fitted with an iron lock box on the interior, which has replaced an earlier larger lock (Fig 65).

The tool shed, door lock Fig 65

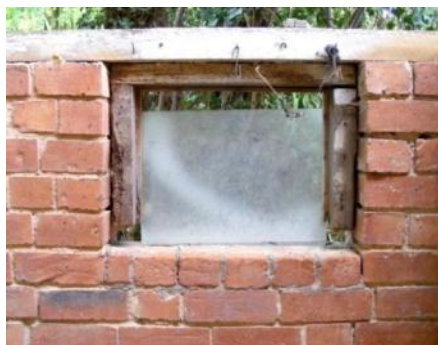
The only window is towards the southern end of the east wall, just below the roof, and comprises a single fixed light set in a wooden frame now decayed, with a brick header sill (Fig 66).

The tool shed window Fig 66
