Archaeological building assessment at Greenhill Farmhouse, 7 Drayson Lane, Crick, Northamptonshire

Report 11/228

November 2011

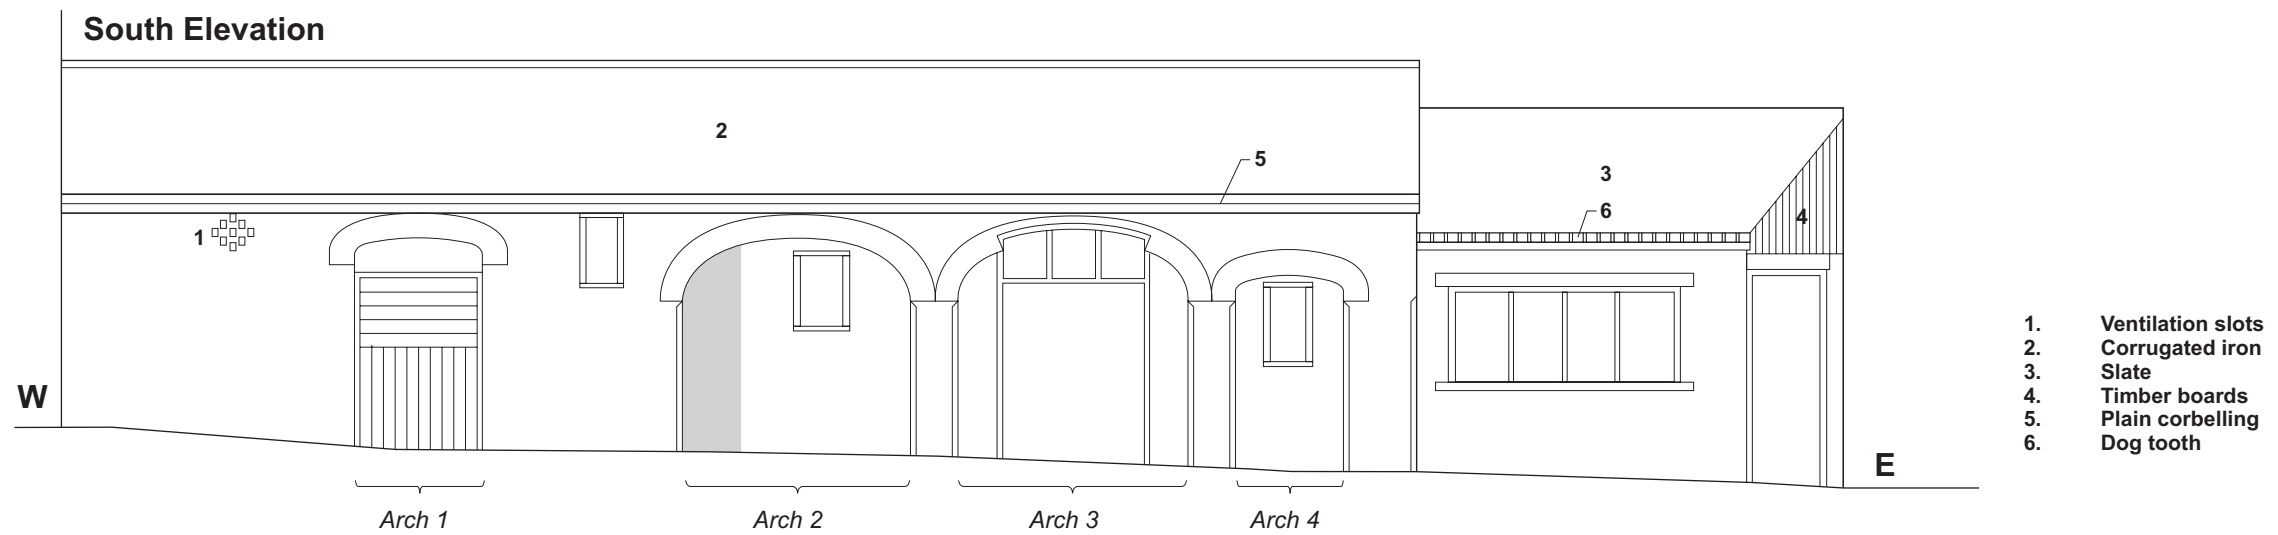
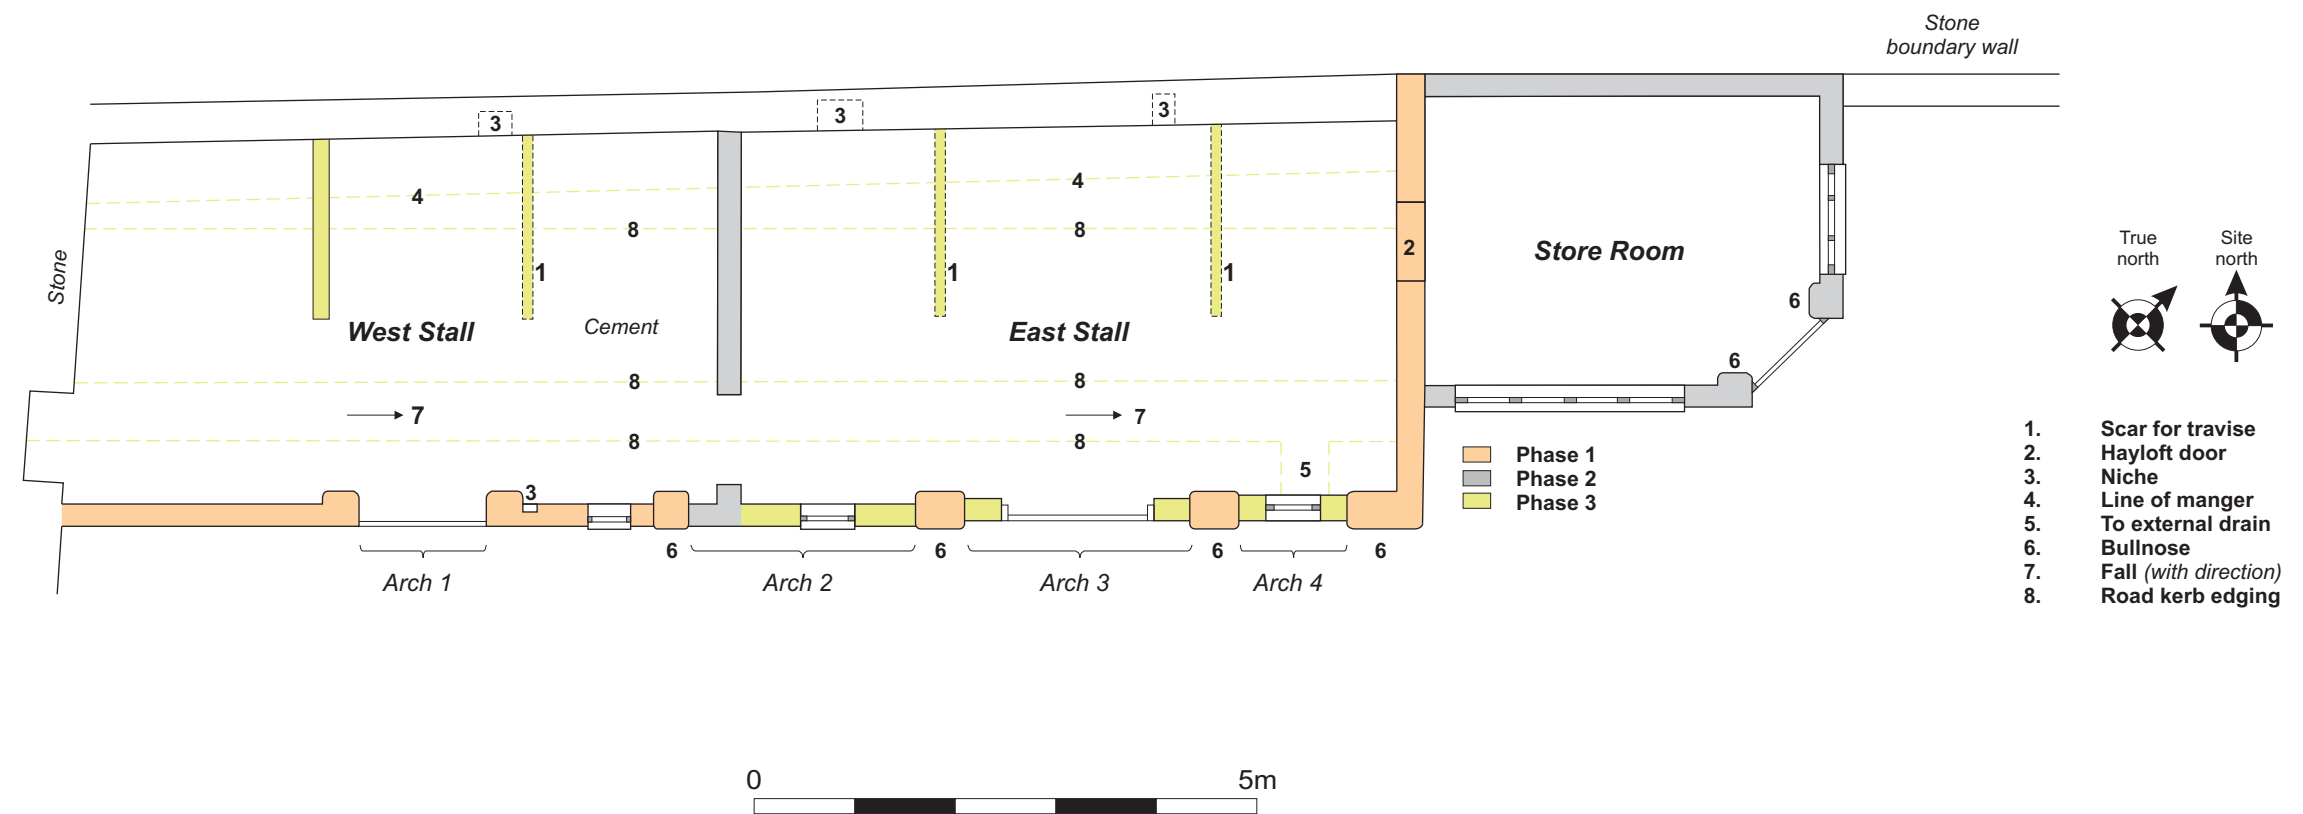
To the east of this was a pedestrian doorway built beneath an elliptical arch formed of (probably) rubbed bricks, although they were too heavily painted for this to be certain (Fig 4, Arch 1). Within the door opening is set a timber door frame fitted with a two-part stable door, although the upper leaf has been replaced and is now connected to the lower by vertical timber slats on the interior; the upper leaf hangs on a single hinge only although the two upper hinge pins remain in the frame. The lower leaf may be original and comprises vertical planks with quarter moulded edges and hung on strap hinges. There is a modern hasp and padlock on the lower leaf along with a simple hook and staple; the upper leaf appears to have been originally fitted with a drop latch although since the upper leaf has been replaced on the latch remains on the frame. All timberwork is painted black.

The next opening was originally one of an adjacent set of two large and one small arched openings each with elliptical arches (Fig 4, Arches 2, 3 and 4). The westernmost two are of the same size, the eastern was smaller and they are constructed in the same way with (probably) rubbed bricks to the arches. The jambs to each opening are all formed of bullnose bricks indicating that these arches were intended for use by livestock, as this type of brick, introduced c1840, was used on doorjambs and other openings so that livestock were less likely to damage themselves on sharp corners. The impost for each arch is formed by a bullnose stop single.

The westernmost arch (Arch 2) has been infilled in two stages, the first comprising the southern end of the dividing wall inserted to divide the building into two parts (Fig 4, Phase 2). This inserted wall, which divided the arch unequally, was apparently located here since it separates the interior into two halves, each of equal size when measured along the southern elevation. It is not clear if this reduced opening was subsequently fitted with a door since the sides of the jambs are now obscured by the second phase of blocking (Fig 4, Arch 2 phase 3). This arch contains a small rectangular window with a single pane, hinged at the centre of each side which swivels open like that previously described.

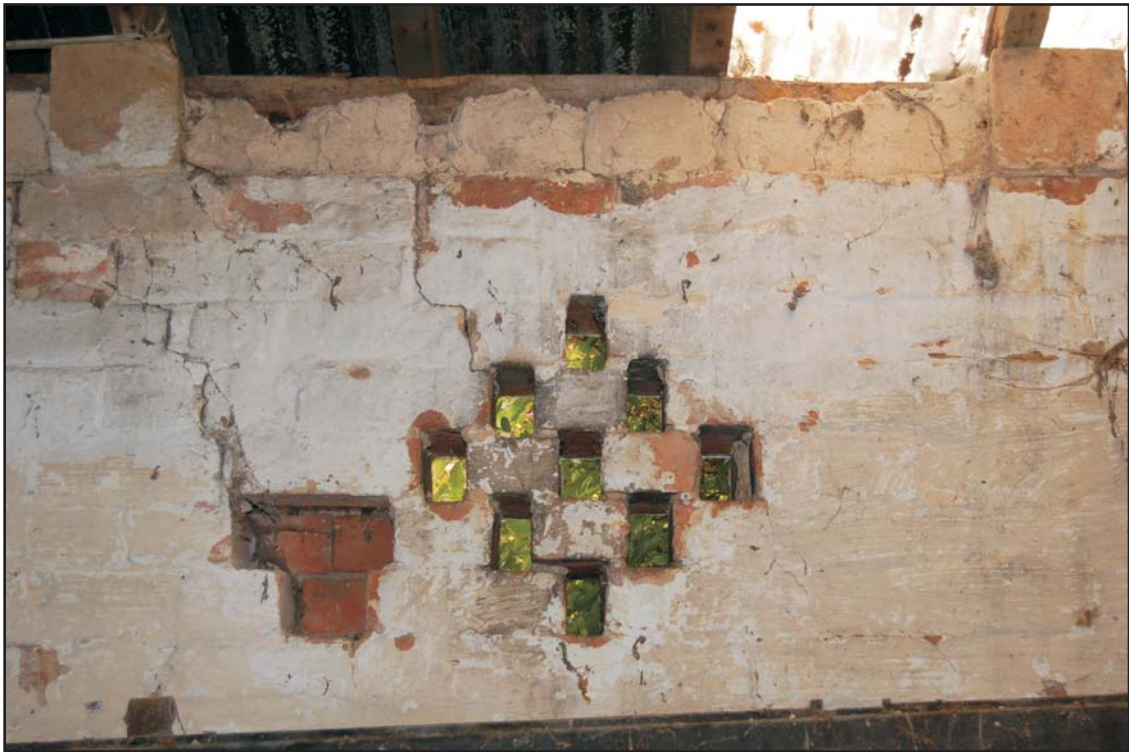
Plate 1

Starting at the west end of the elevation the brick wall comprise standard nineteenth-century bricks laid in (probably) English wall bond, although thick internal and external painting made this difficult to determine. The brickwork appears not to be well bonded to the stone wall of the adjoining stone barn to the west, but this joint was not clearly visible due to vegetational growth in the angle of the two walls. The bricks are 240mm x 110-115mm x 75mm in size and are bonded in a creamy-white lime mortar (9½ x 4½ x 3 inches). Between the angle of the two walls and the westernmost doorway the only visible feature was a ventilation opening comprising a diaper pattern of holes formed simply by leaving space in the brickwork (Plate 1).

Ventilation grid in south elevation, interior, looking south

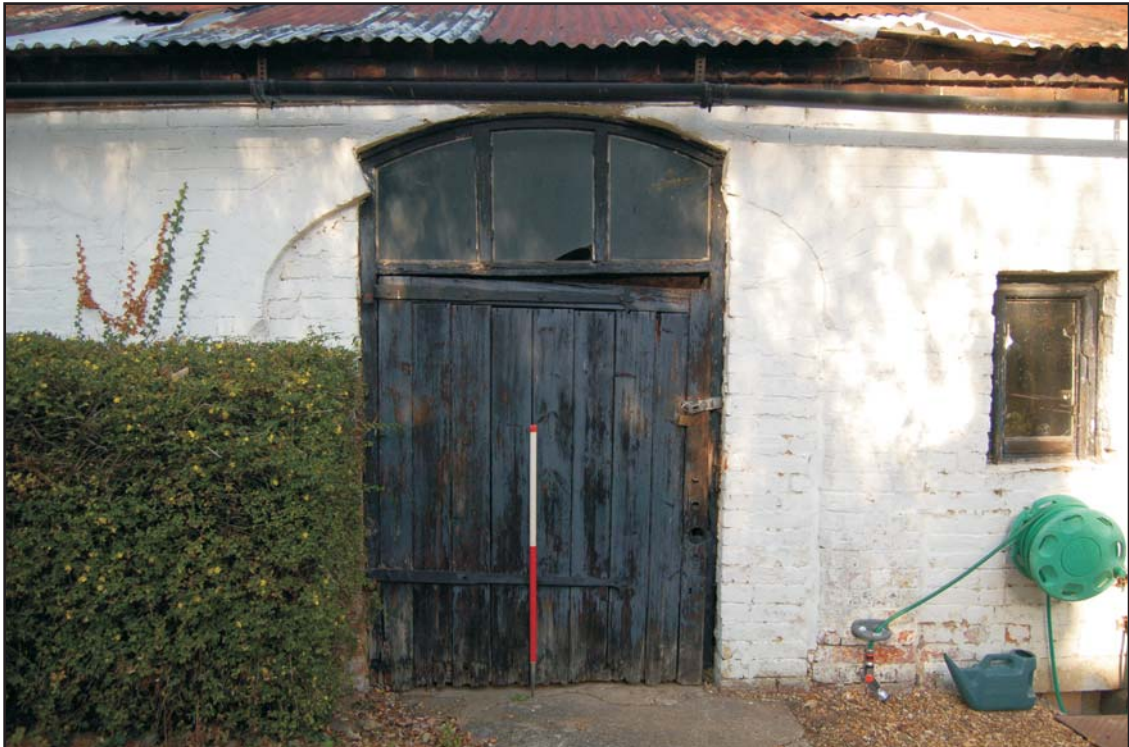
Plate 2

The remainder of this arch and the two located to the immediate east were apparently infilled at the same time (Fig 4, Arches 3 and 4, Phase 3). Arch 3 has a wide single leaf door made of vertical planks with a three-light over door all set within a single frame crudely set within, and chopped through, the elliptical arch (Plate 2). This frame may be a re-used frame since there appears to be no obvious reason why an inserted frame would chop through what is a structural feature, and the height gained from this option is minimal. The door is suspended on simple strap hinges and closed with a modern hasp.

- 5.5 Apart from the two-leaf stable door in Arch 1 all of the remaining doors and windows are clearly secondary insertions since they are fitted within the blocking of the infilled arches, and none appear to have been removed from elsewhere in the same building. The doorway in Arch 3 has clearly been re-used from elsewhere and the brickwork of the arch crudely chopped out to allow it to be fitted.

Arch 3 exterior and inserted timber door- note the chopped-out brickwork of the upper arch

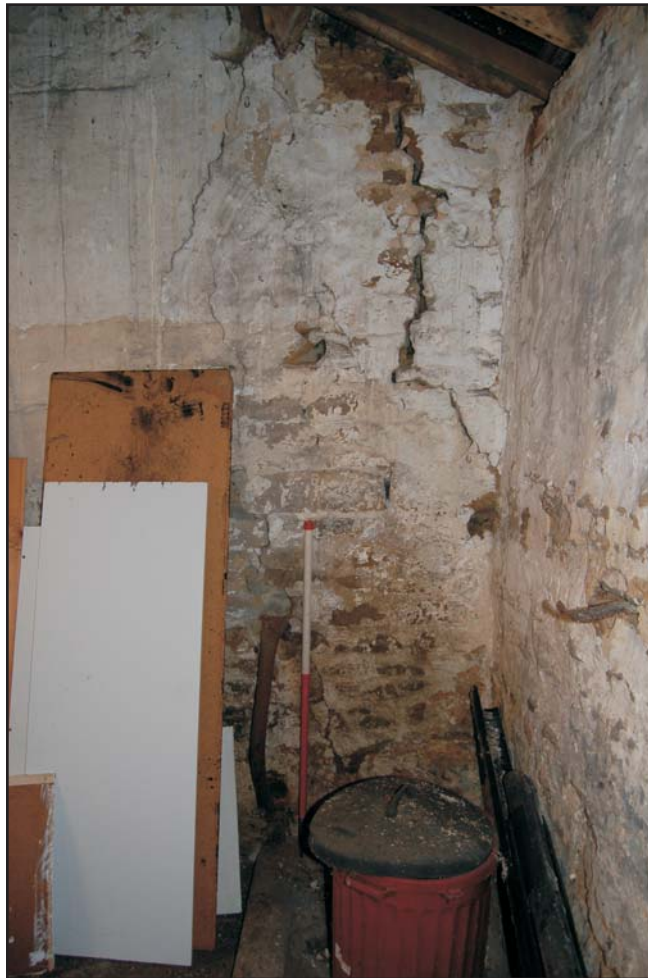
Plate 3

West wall interior elevation with empty sockets of former manger, east side of the dividing wall

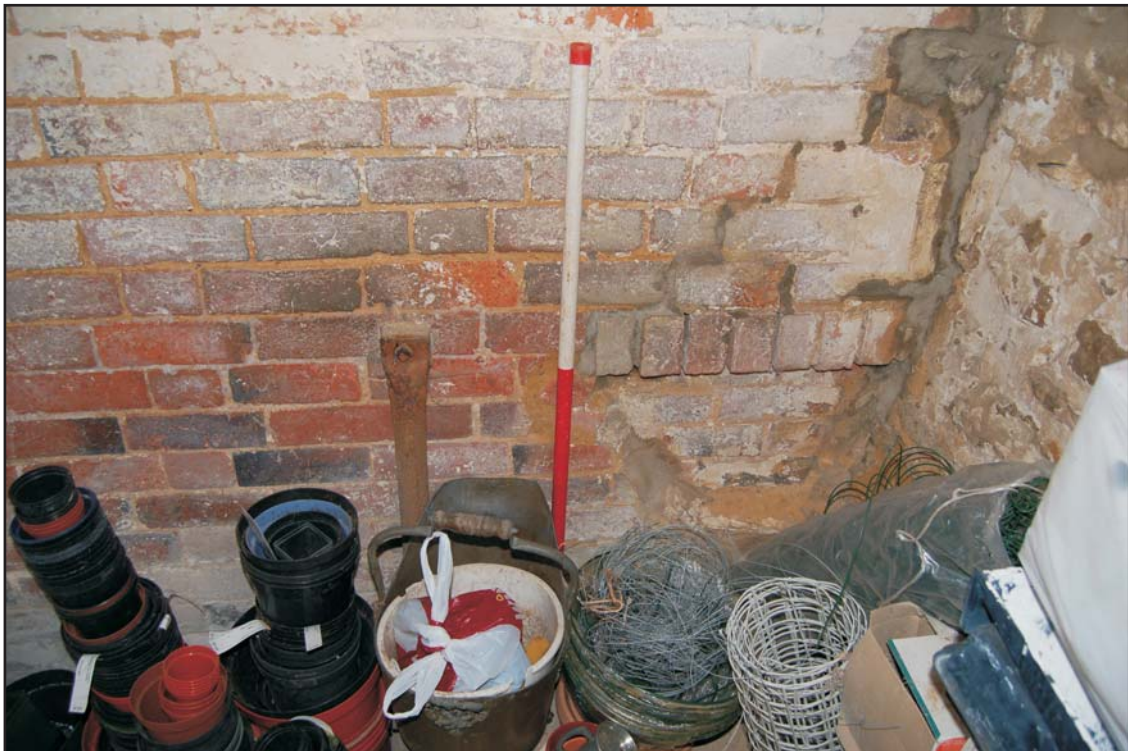
Plate 4

Recess indicating size and profile of former manger, east side of the dividing wall

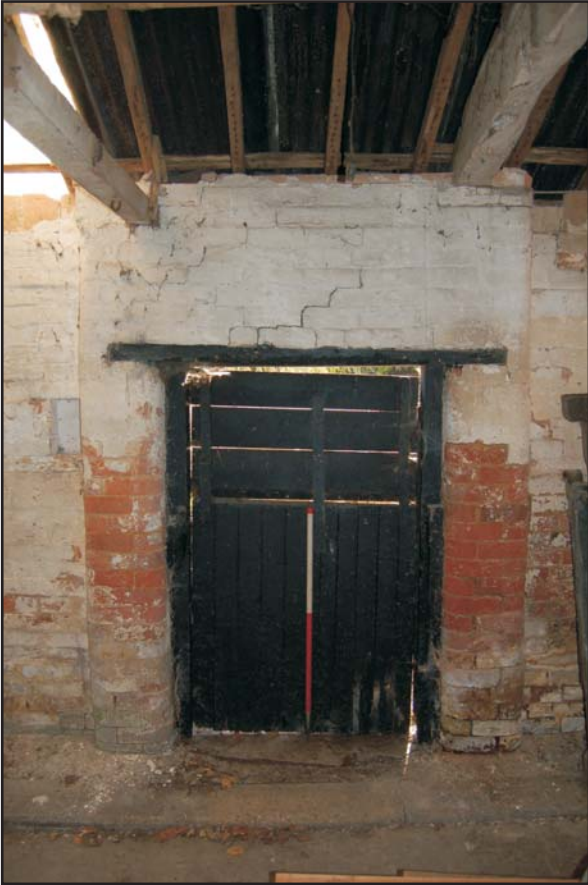
Arch 1, interior, with stable door, looking south
Plate 5

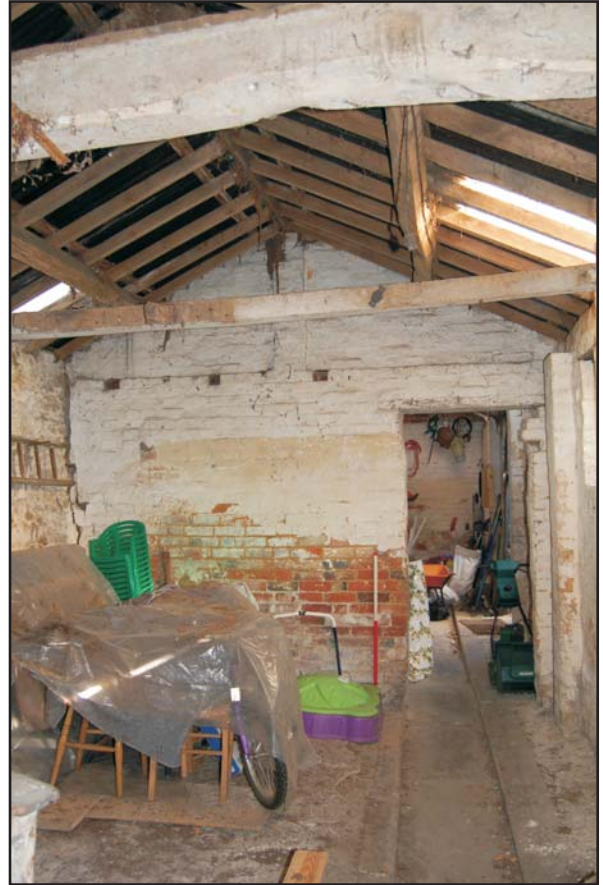
Apart from the evidence of the hayrack and manger, the east wall is essentially plain (Plate 6). The wall is of standard 9 inch construction below eaves level, above that it reduces to a single skin with a central buttress or pier which rises to the ridge. A crudely chopped through doorway at the southern end of the wall now connects this room with that to the east; the jambs are crudely chopped off and the edges smeared with cement. There is a thin timber lintel.

The east wall of the west stalls, looking east
Plate 6

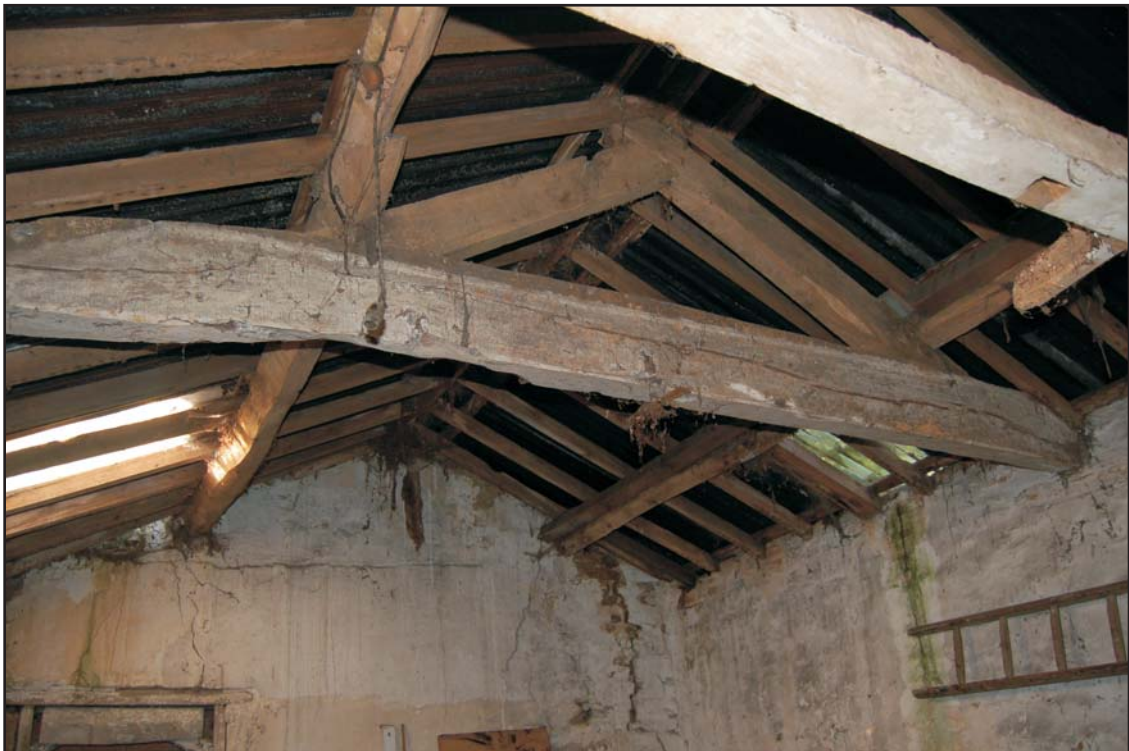
The roof is constructed of the most simple of truss forms, a simple A-frame made of oak (Plate 7). The principal rafters are simply tenoned into the upper surface of the tie beam, the tops are half lapped; all are pegged with a single peg. The south end of the tie beam rests on top of the pier on the west side of the door, the northern end is set into the north wall and rests on a short horizontal length of timber. The purlins, also oak are trenched

Roof truss in the west stalls, looking west Plate 7

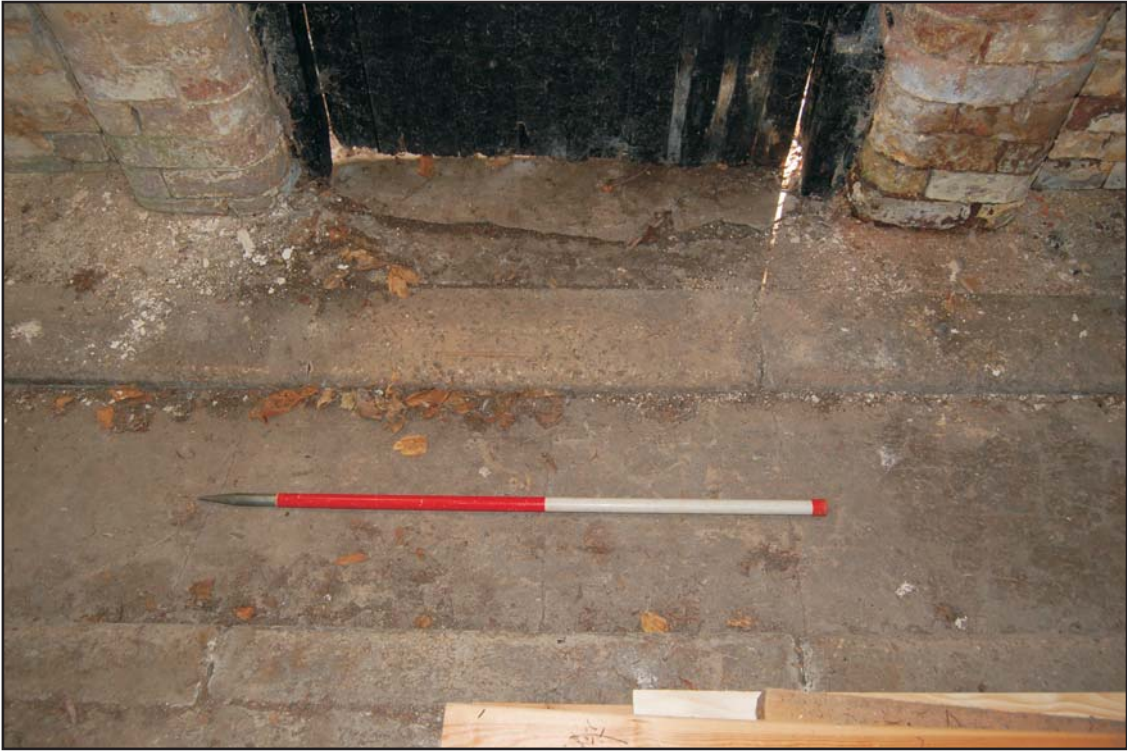
The floor is of modern concrete throughout with a drainage channel along the southern side of the room edged with pre-cast concrete road kerbs edging blocks (Plate 8). This indicates that the floor was replaced during the second half of the twentieth-century when the widespread use of concrete became much more common as a building material. The floor falls gently from west to east and the drainage channel continues through the inserted doorway into the East Stalls. The single timber travise is clearly set into this concrete floor, it is made of a simple frame with a sloping top and is covered on both sides by vertical matchboard. Like all travises it is higher at the head end and lower towards the rear (heel-post) end, although here it is much lower than would have been made if the stalls were designed for horses (Plate 9). A modern iron bar is fixed to the east side to attach a halter to. When these divisions were in place it appears that the manger had been removed and fodder appears to have been placed in shallowly dished concrete troughs formed with pre-cast concrete blocks against the north wall (Plate 9). It is not known if the hayrack was retained at this stage.

Pre-cast concrete road kerbs used to edge the drainage gully, looking south Plate 8

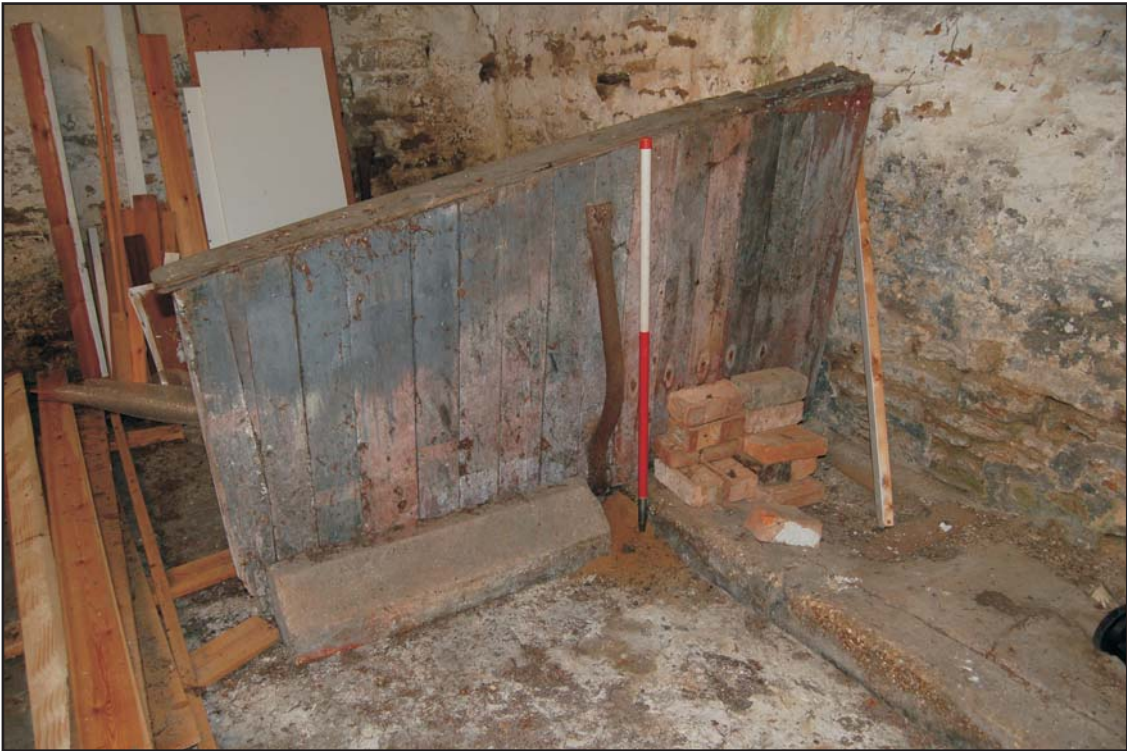
Timber travise in the west stalls, looking west Plate 9

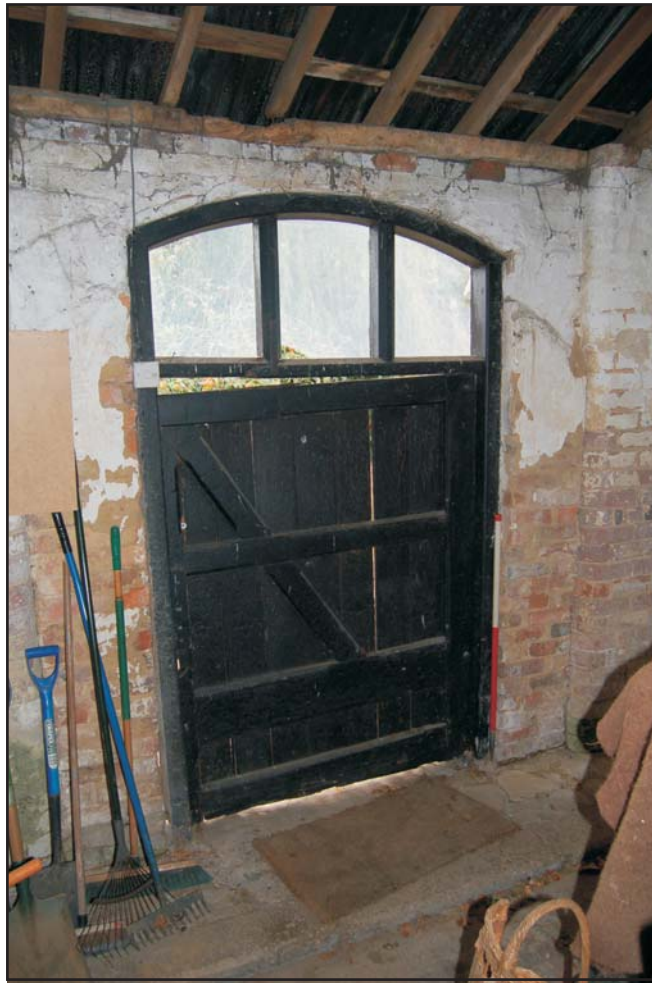
The main door in the south wall (Fig 4, Arch 3), previously described on the exterior is formed of a simple frame with two ledges and a single brace (Plate 10). The south wall is as described before, on each side of the arches the wall has been thickened to create integral piers.

Door in Arch 3, interior, looking south Plate 10

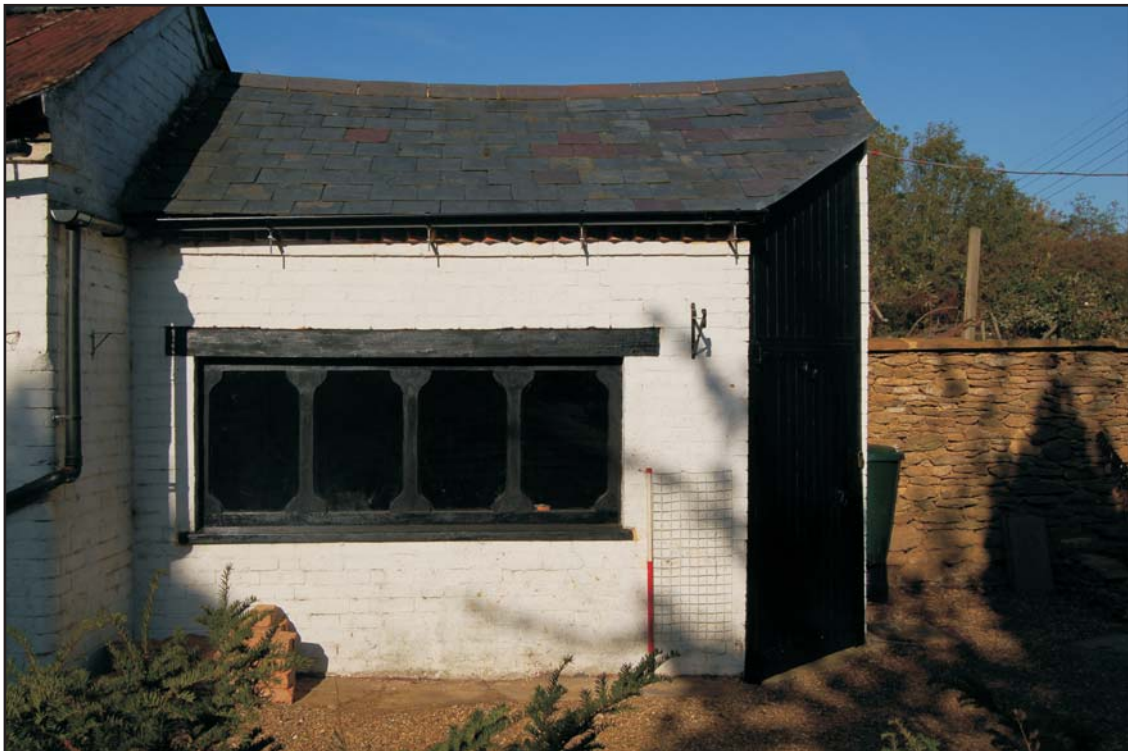
Store room, south elevation, looking north Plate 11

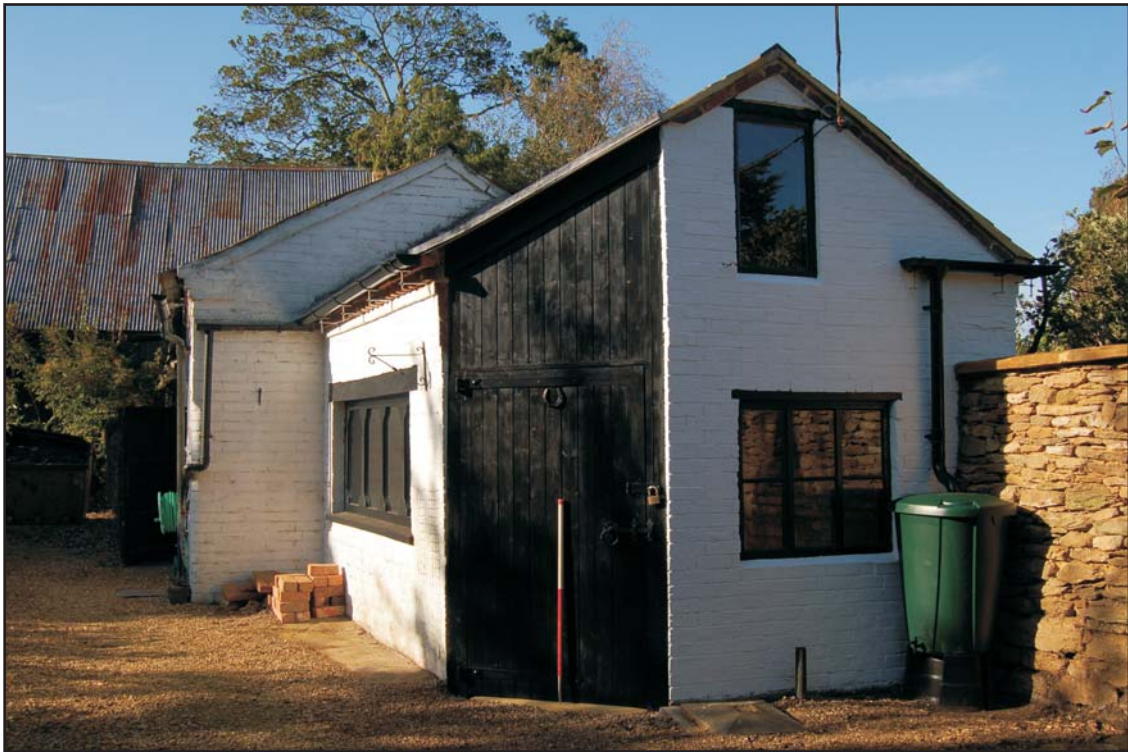
The east wall is similarly constructed to the south wall and contains two windows, one at ground level, the other in the gable (Plate 12). Both appear to be modern replacements, that on the ground floor has six panes, the upper has a single large pane; both are set in wooden frames.

Store room, east elevation, looking west Plate 12

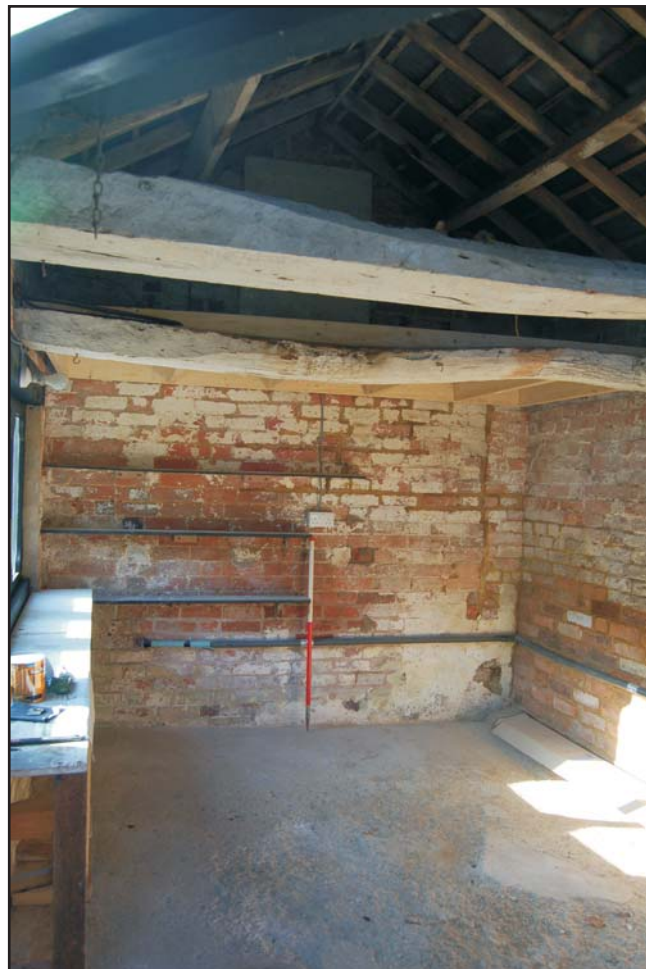
At eaves level there are two lateral beams (aligned north-south) which suggest that there had been a simple loft at some stage (Plate 13). Neither beam retains empty sockets indicating that any joists were simply laid on the upper surface and were not socketed into them. No indication of this upper level now remains, although a modern part-floor has been inserted above the level of the westernmost beam against the west wall; it comprises modern sawn pine with narrow joists and fibreboard sheets.

Store room, interior, looking west showing transverse beams for former hayloft floor Plate 13
