Archaeological assessment of buildings on the
Eydon Hall Estate, Eydon, Northamptonshire;
The detached stable and stock buildings

Report 11/154

July 2011

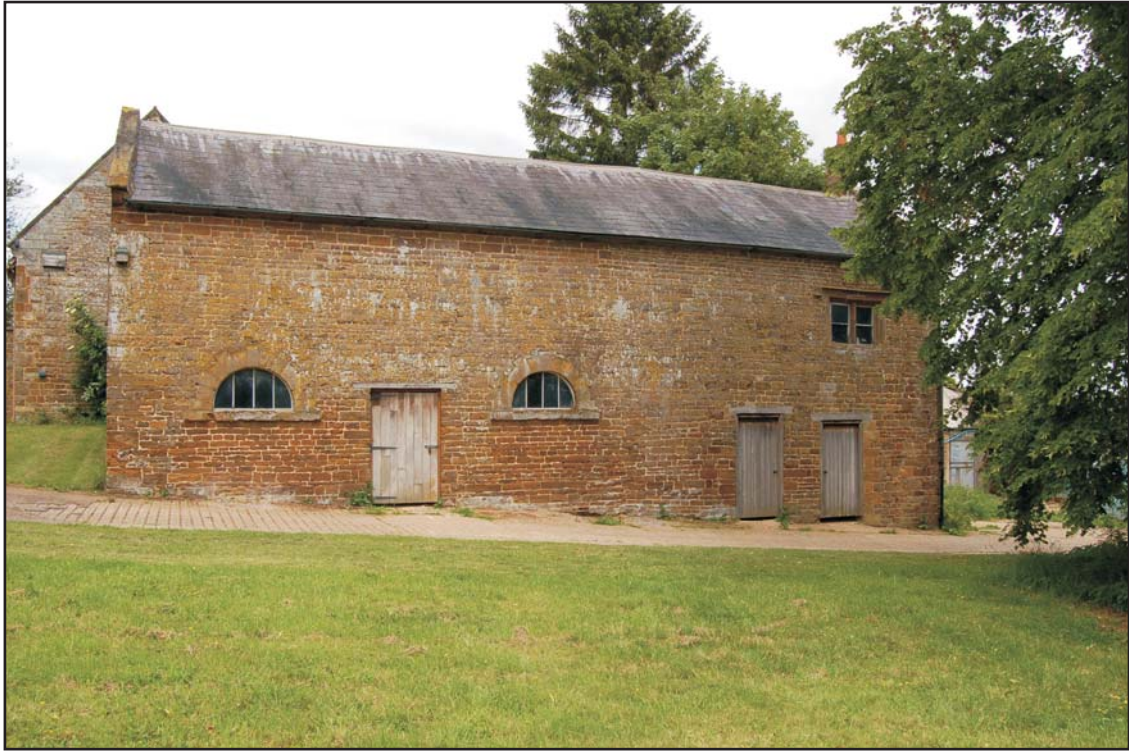
The detached stable south elevation, looking north Plate 1

The stable block is built on a slope which falls from west to east and thus the levels of the doorways at the west end are higher than those at the eastern end, both corresponding to different internal floor levels. Built of dressed and coursed ironstone bonded in lime mortar with no plinth but with large quoins at the corners, this elevation contains three doorways, all secondary, and two arched windows facing southwards at ground floor level with a single, two-light mullioned window at first floor level (Fig 3, Plate 1). The two arched windows are clearly later additions as is the doorway which they symmetrically flank. The form of the windows is identical, each comprising un-moulded sills with the arches formed of alternating larger and smaller voussoirs proud of the wall but in an un-rusticated row. Each is filled by four fixed panes of glass set within timber glazing bars and frame, all painted white. The westernmost arch retains a number of engraved graffiti on the sill and voussoirs comprising capital letters W, H and I (probably representing J) but no dates.

The central door is a modern replacement, set within a modern door frame beneath an oak lintel. The door fittings are all modern. This doorway, between the arched windows serves the main, western stable but was originally entered via a now blocked doorway located close to the internal cross wall which divides the western, upper, room from the lower, eastern room (Fig 3). The jambs of the former doorway can be traced on both sides, and the original lintel height is thought to be close to the level of the doorway to the east, and the sill level of the window of the arched window to the west.

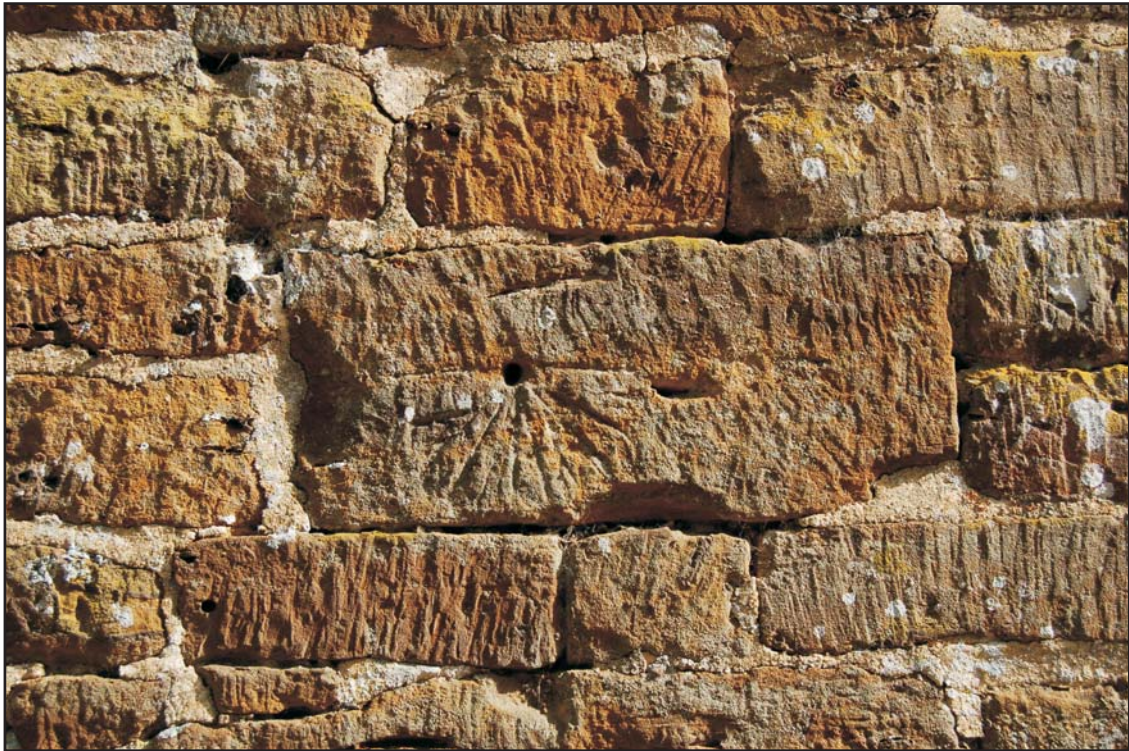
The detached stable, scratch dial Plate 2

There is no indication that the stones of the jambs were moulded or chamfered. To the west of the former doorway is a scratch, or Mass, dial (Plate 2). Generally identified as dating to the medieval period (c1100-1600) they are often re-set even appearing on north or internal walls where they could not have functioned, but are almost exclusively originally built into churches. Displaying wide variations, they are difficult to date and vary from very simple dials with a central hole for the gnomon and a semi-circle of dots representing the times to elaborate radiating lines with Roman or Arab numerals inscribed. The location of the dial here is problematic since there is clearly no suggestion that this building was a church, or even related to it in the manner of a rectory, so it seems more likely that the block of stone on which the dial is incised has simply been re-used.

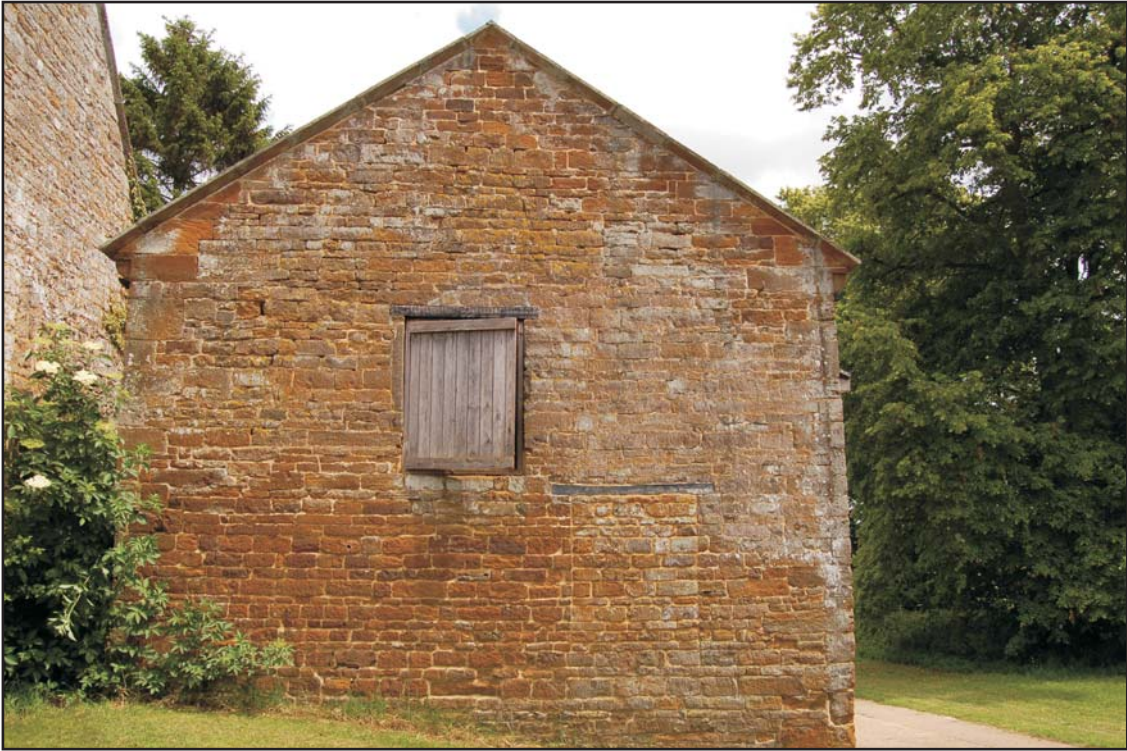
The detached stable west elevation, looking east Plate 3

The west gable end is constructed of the same materials as the south elevation, and it too lacks a plinth (Fig 3, Plate 3). It currently contains a single opening at first floor level although this has been reduced in size from a wider window. As it currently remains, this opening has been made to function as a hay loft door and is fitted with a modern vertically planked door set in an oak frame beneath an oak lintel. The form of the earlier window is uncertain but was probably mullioned like those on the south side of the building. Below, and to the south, is evidence of a window at ground floor level, the sill of which is at approximately the same level as that of the arched windows on the south side, and probably contemporary with them. It was set beneath an oak lintel and has been filled externally with coursed ironstone laid in lime mortar.

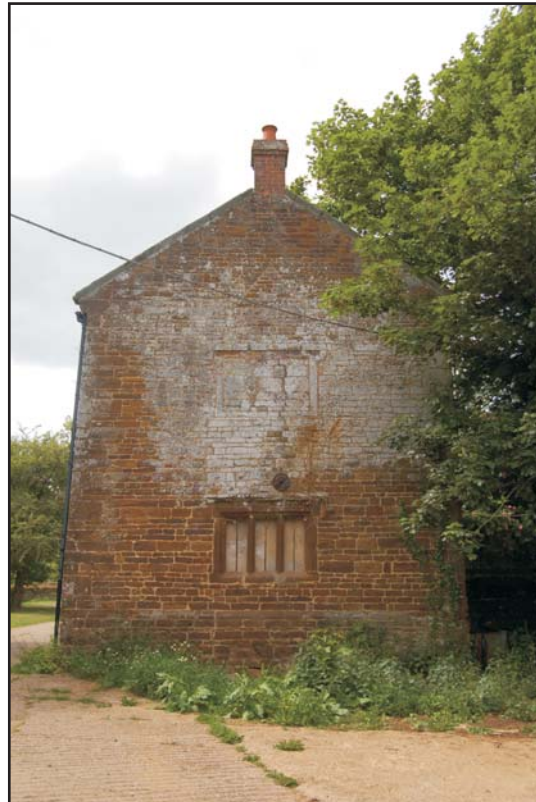
The detached stable east elevation, looking west Plate 4

The east gable end of the building is constructed in the same way as the other elevation but with a plinth (Fig 3, Plate 4). The elevation contains a single window at both ground and first floor levels with a blocked triangular opening at attic level; there is a simple brick stack projecting above the ridge.

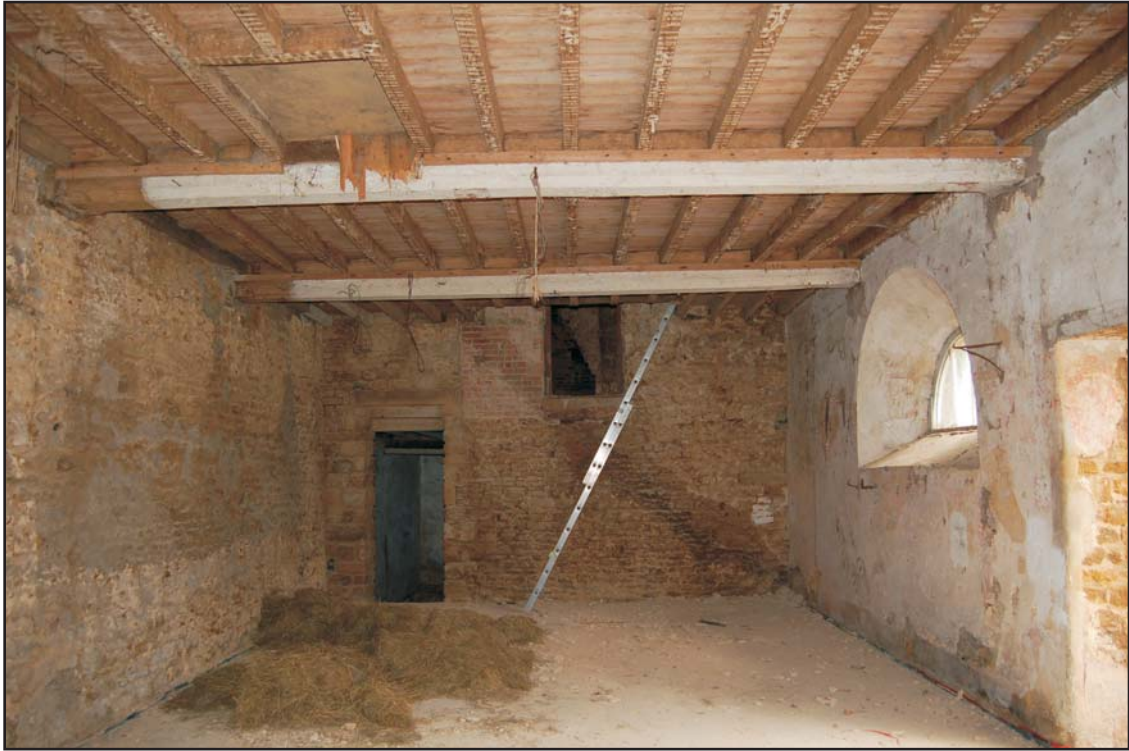
The detached stable, Room G1, looking east Plate 5

A large, rectangular room located at the west end of the building (Fig 3, Plate 5). The floor is of modern concrete laid over a polythene membrane. The interior south wall retains lime plaster across almost its entire surface, including the jambs and soffits of the door and windows, and which is limewashed. The west, north and east walls are of exposed stone and brickwork. The arched windows in the south wall have deeply splayed sills and soffits which allow more daylight into the room.

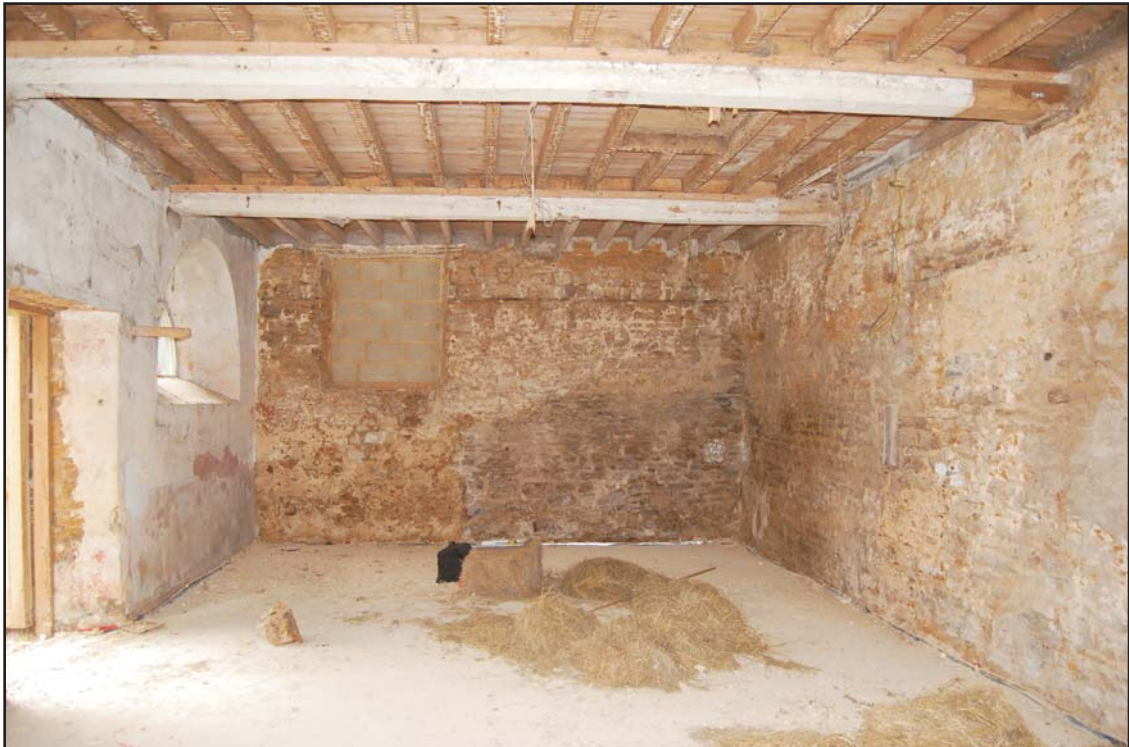
The detached stable, Room G1, looking west Plate 6

In the west wall the recess of the partly filled former window can be seen, the inner surface filled with modern, grey, breeze blocks set beneath an oak lintel (Plate 6). To the north the faint outline of the stall end, or travise, can be seen as a dark stain on the wall. This suggests that the heel post was situated just to the north of the northern jamb of the blocked window and the travise appears to have had a traditional swept top rail, rising towards the headpost, located close to or against the north wall. There are no indications of either a hayrack or manger.

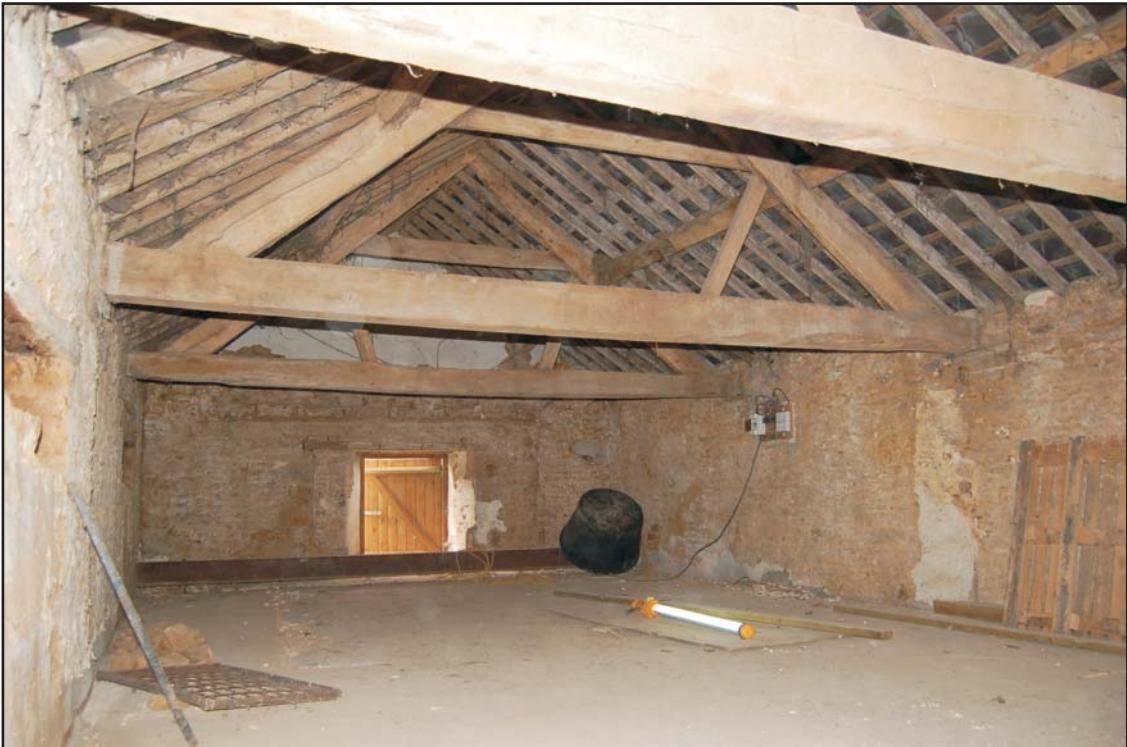
The detached stable, Room F1, looking west Plate 8

Accessed by a modern ladder in the location of the former staircase at the southern end of G1, the upper floor is a single, unlit, space (Fig 3, Plate 8). There is a hayloft door in the west wall, although when closed this allows no natural light into the room since it has no glazing, likewise a hayloft door in the north wall which is also unglazed.

The roof is supported on three oak trusses of vaguely queen post construction (Plates 8 and 9). The struts which give the appearance of queen posts are in fact later attachments fixed with iron nails and rise from the upper surface of the tie beams to the level of the collars. The principal rafters support the purlins which appear to be trenched, although this is not certain. All of the joints are pegged. The secondary rafters do not align with the principals and it appears that the roof has been altered, perhaps being completely replaced with some timbers showing evidence of re-use, not least the trusses themselves which retain empty, redundant, mortices. This evidence, along with the possible reduced gable angles observed in the west gable, suggest considerable re-configuration. The underside of the roof is not felted.

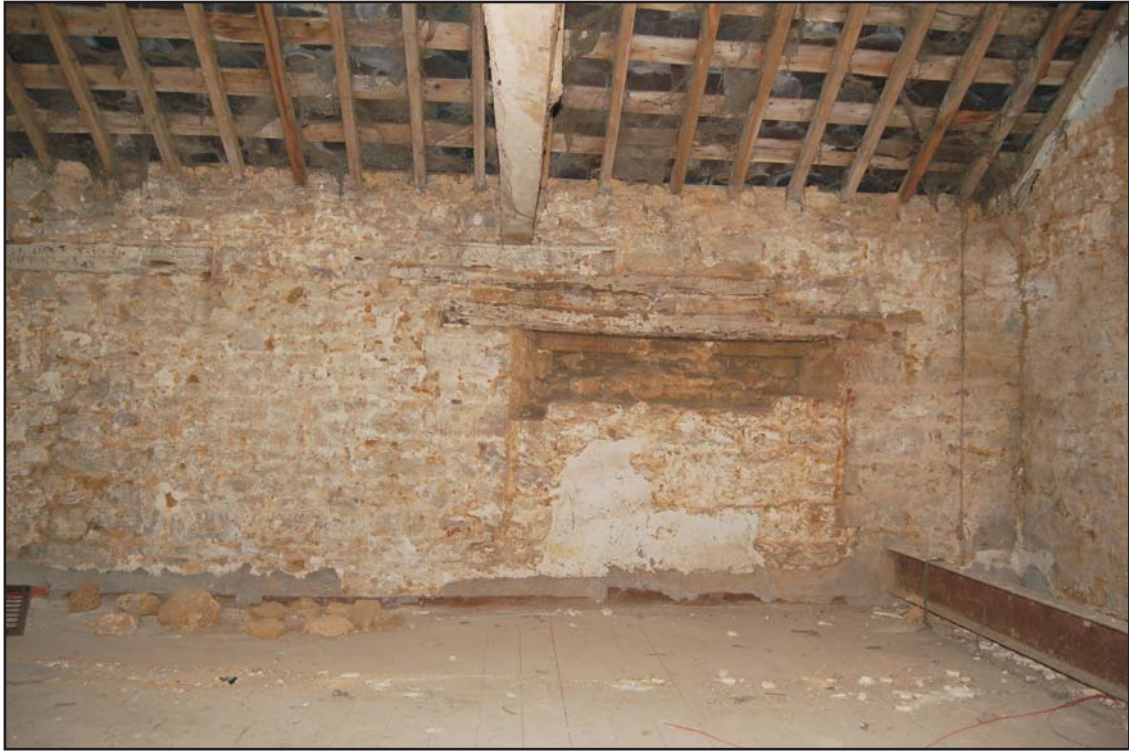
The detached stable, Room F1, blocked window in south wall, looking south Plate 9

The south wall retains the scars of the inner jambs and lintels of the blocked windows at this level (Plate 9). Whilst only partially exposed, the upper edges of the side jambs and moulded lintels of the mullioned outer openings can be observed. Each is set beneath an oak lintel which has the internal edge carefully chamfered and decorated at each end with scroll moulded stops (there were originally three lights with two mullions to each opening like the one extant in F2, see Fig 3). The wall, including those areas of window blocking, retain roughly finished and limewashed plaster.

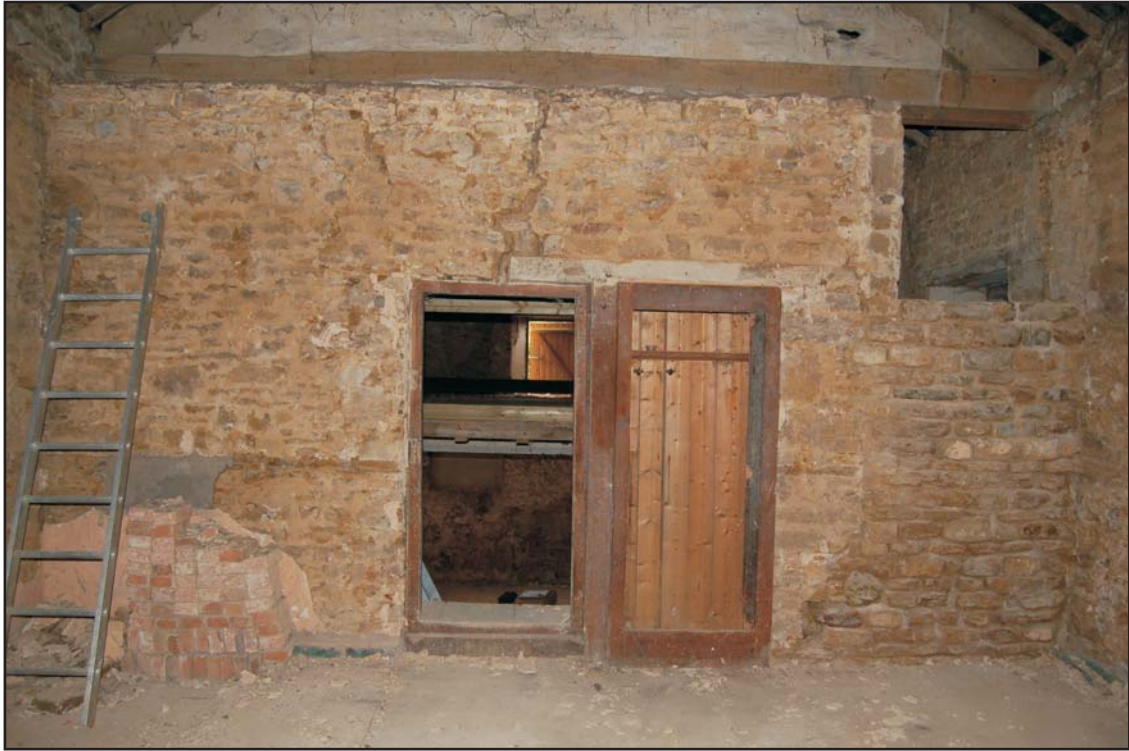
The detached stable, Room F2, west wall, looking west Plate 11

The west wall contains the doorway, formerly from the now missing staircase, currently from a modern ladder (Plate 11). The opening retains no door and is a secondary insertion, the previous doorway was situated to the north, now filled on the west side by brickwork with the east side being utilised as a cupboard. The original doorway was situated beneath a thick oak lintel, when it was moved to the south no lintel was inserted so that the southern side of the doorway is supported simply by the doorframe. The interior of the cupboard is lined with matchboard, some of which is painted maroon. To the north of the cupboard is an internal window or hatch opening set beneath the tie beam, although this does not appear to be an original feature since the stonework beneath it is clearly re-set as is the south jamb. It may simply have been an attempt to allow some natural daylight into the (at present) unlit western first floor room.

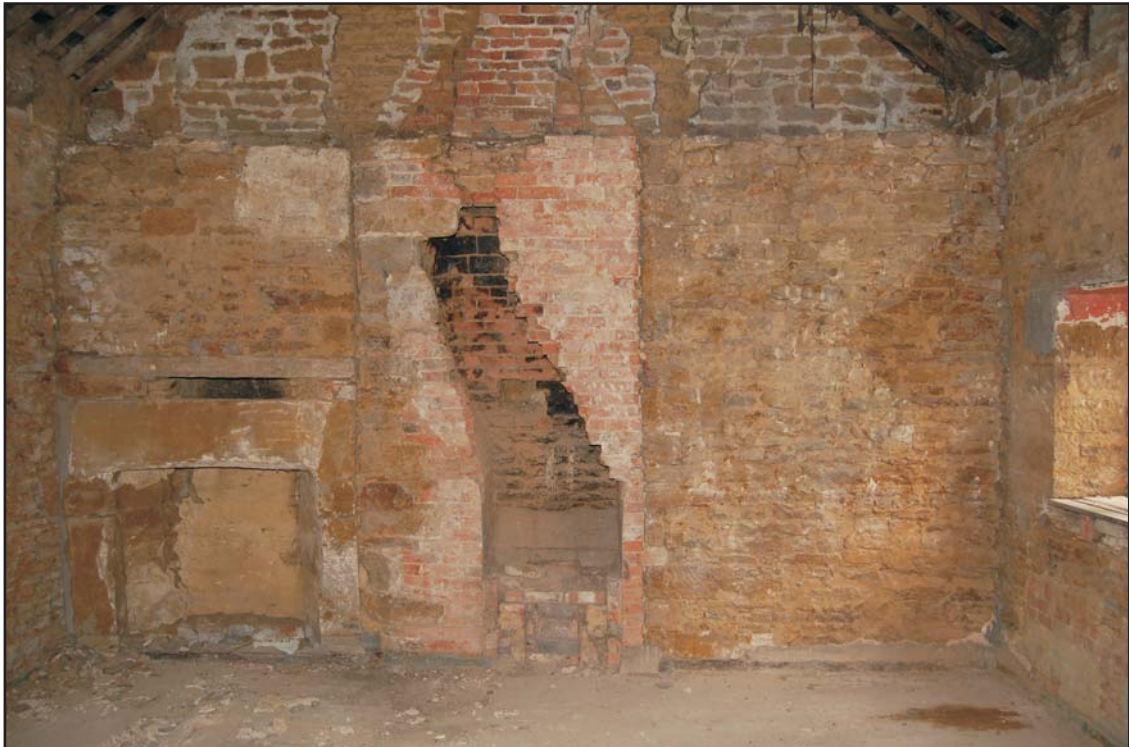
The detached stable, Room F2, east wall, looking east Plate 12

The east wall retains the most evidence of former intervention (Fig 3, Plate 12). It can be roughly divided into three sections, a stone fireplace and associated chimney stack on the north side, a brick fireplace and stack in the centre and the stack, or flue, to the fireplace situated in the room beneath on the south side. All are secondary features, but the two stone stacks pre-date the central brick feature. Both stacks are built against, but not bonded to, the external walls indicating that they were not integral to the first phase of the building. The fireplace at first floor level is better preserved than that on the ground floor, and retains moulded jambs as well as the lintel which is cut from a single block and has chamfered edges. These terminate in moulded stops at their lower ends on either side but are too badly eroded to determine the exact form. The fireplace has lost its hearth and hearth slab. Currently there is a void through to the floor below. The

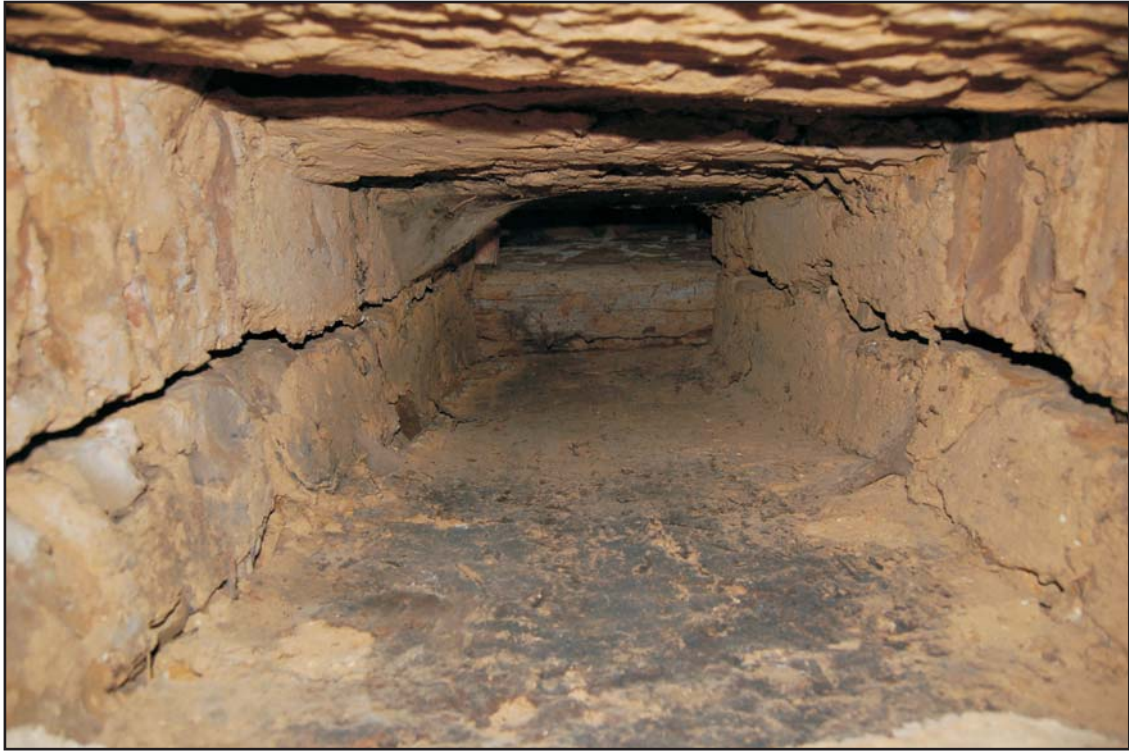
back of the fireplace has been re-plastered and shows no sign of having been used, but inspection up the flue reveals sooting showing that at some stage the fireplace was utilised (Plate 13). This view also shows how the stack has moved away from the external wall due to the lack of bonding. In the angle of the south and east walls is located the stack to the fireplace below. Here it presents a simple stone face with no other features apart from a tiny fragment of facing plaster at floor level. Both the northern fireplace stack and the southern stack have been cut off at eaves level and it is unclear if they originally joined to connect at ridge height and formed one external stack or projected through the roof line individually. Between these two stone stacks the recess has been infilled with a predominantly brick fireplace and associated flue, although with some ironstone down the north side (Plate 12). This is clearly the last phase of addition in this room and by the size of the bricks probably dates to the second half of the nineteenth-century. The front of the flue has, for some reason, been largely removed, taking with it the arch which formed the lintel of the fireplace opening although evidence for the height of the springing remains on the north side. The fireplace appears to have undergone some changes, and seems to have been reduced, or narrowed, though currently retains no grate. The brick stack appears to have been visible only to eaves level which suggests that at this stage the room had a ceiling at this level, above that height the flue narrows and rises to the ridge where it emerges and is visible externally decorated with a simple projecting collar fitted with a clay pot. Internally, behind the brick flue of the central stack, the triangular opening observed on the eastern external elevation can be partly seen, although too little to add to its previous description, and apart from confirming that this opening passed through the full thickness of the wall little more can be said of it.

The detached stable fireplace flue, looking up, showing sooting Plate 13

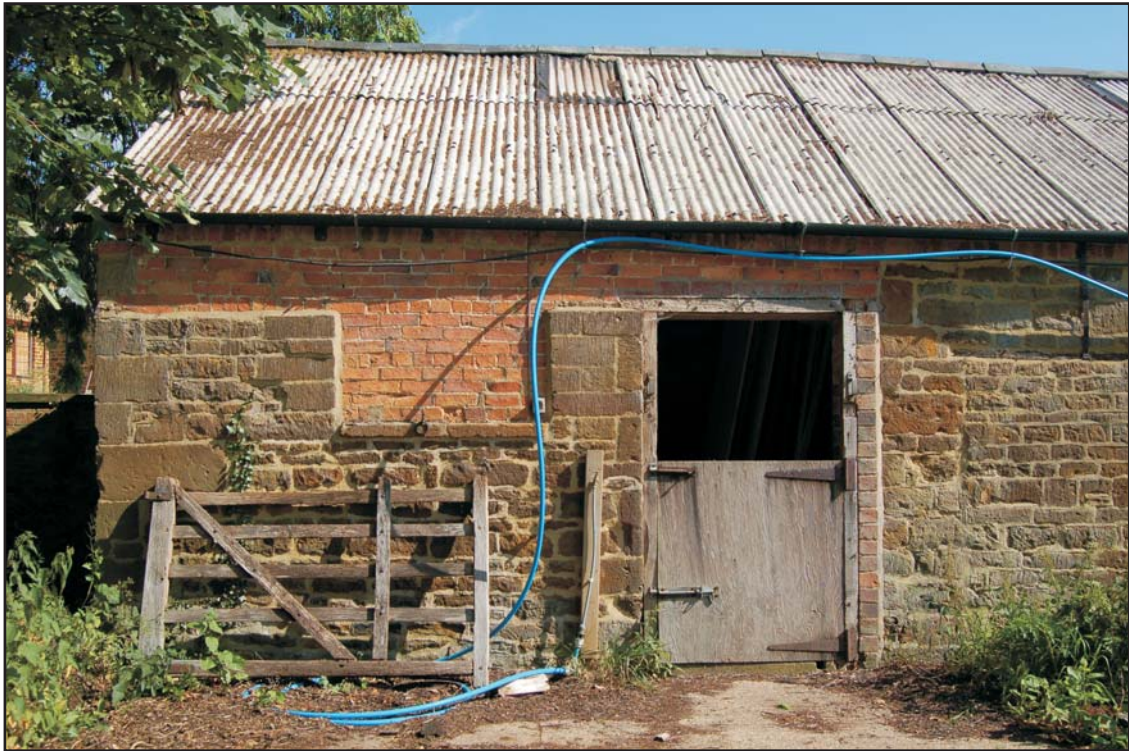
Stock building SB1, looking north Plate 14

An ironstone stable situated at the western end of the range (Fig 4, Plate 14). The walls comprise dressed and un-dressed ironstone with larger dressed quoins at corners and openings. The roof is corrugated asbestos with blue clay ridge tiles.

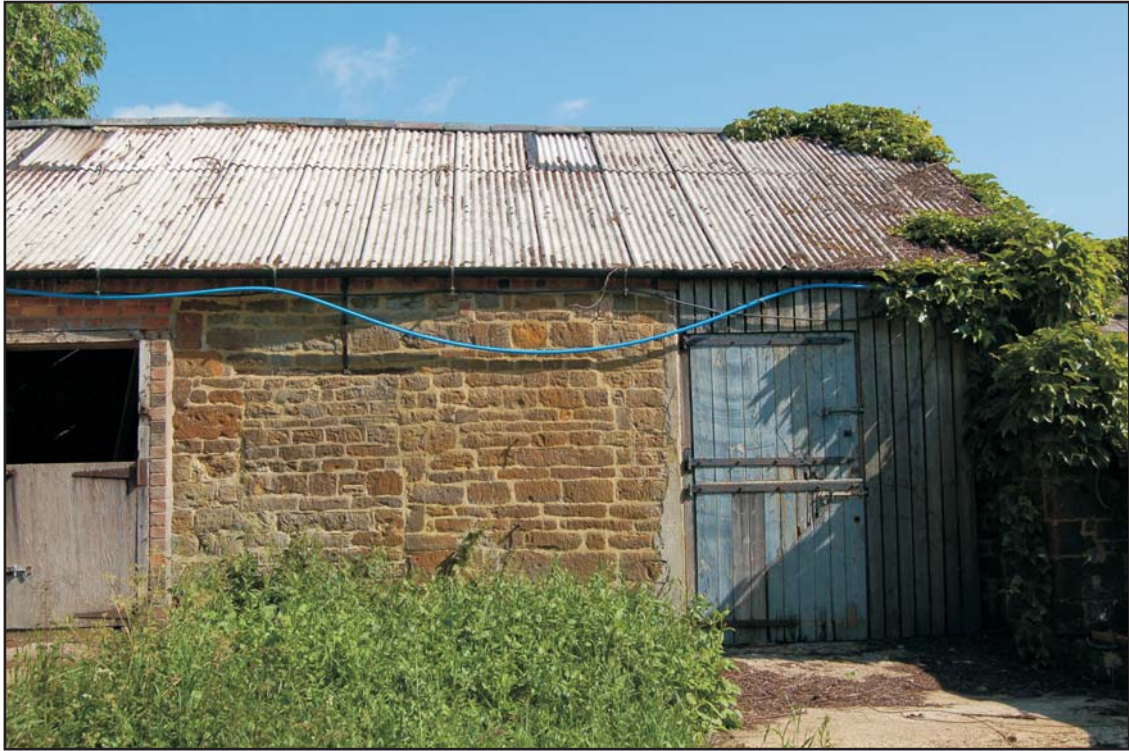
Stock building SB2, looking north Plate 15

Located to the immediate east of SB1, and constructed at the same time, this building is constructed of the same materials and roofed in the same way although this section contains two panels of translucent polythene for additional light (Fig 4, Plate 15).

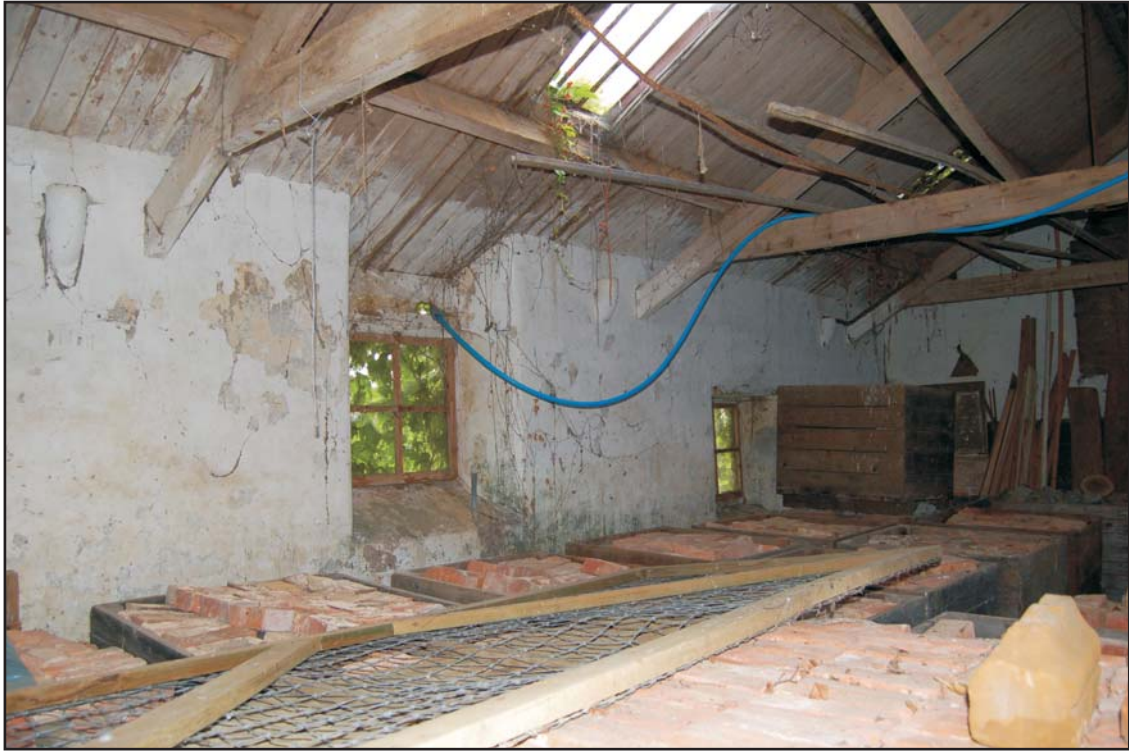
Stock building SB3, interior, looking north-east Plate 17

Internally the room is a single space but was mostly filled with stored materials (Plate 17). The north wall contains five, four light timber framed windows, the upper half of which hinge and open inwards resting originally on curved stays, now all missing (but present in SB4). All of the wall surfaces, reveals, sills and soffits are plastered and limewashed apart from where the matchboarded underside of the roof lies directly above the window opening (Plate 17). The easternmost window is, in fact, half a window since the dividing wall which separates this room from SB4 cuts across it. Between each window and set into the wall are curved, probably salt-glazed drain, pipes, their open ends pointing upwards (Plate 17). These would have been either built into the wall during construction or added later for ventilation, a typical late nineteenth-century feature.
