## Archaeological building recording at Easton Neston House, Northamptonshire

Report 11/261

**ARCHAEOLOGICAL BUILDING RECORDING  
AT EASTON NESTON HOUSE, TOWCESTER,  
NORTHAMPTONSHIRE  
2007- 2009**

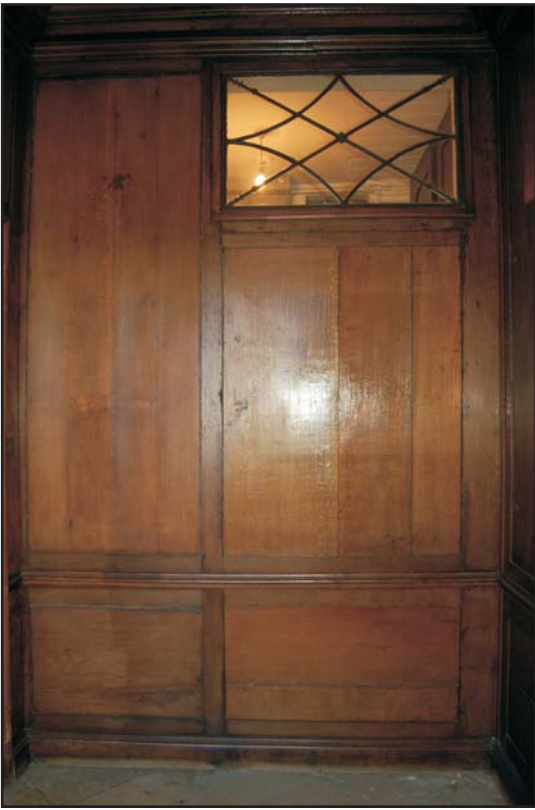
Wren Wing corridor, panelling on the east side, looking east Plate 1

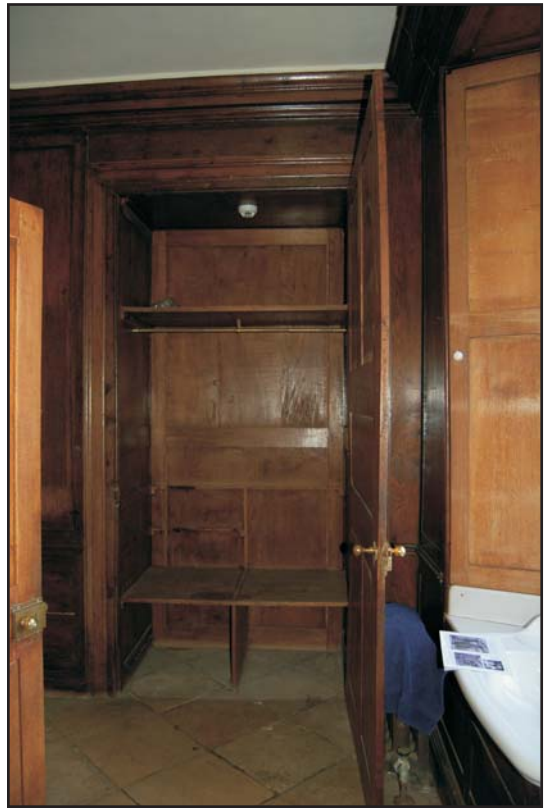
Wren Wing corridor, former doorway to the entrance hall in the south wall, looking south Plate 2

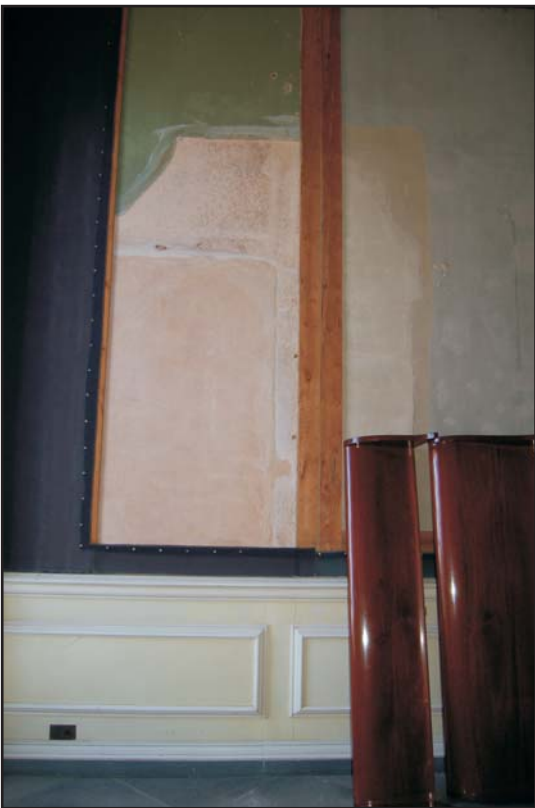
In the north wall of the entrance hall the former doorway which connected to the Wren Wing corridor can be seen as a scar in the wall (Plate 3). The plaster which covers the former opening is modern pink plaster rather than pale creamy-white lime plaster which further suggests that this blocking is modern and dates to the twentieth century. Above and to the east of the former opening is a further scar, this time in paintwork only, which perhaps suggests the former presence of either a large doorcase, overdoor painting or decorative panel laid onto the surface. This second scar does not appear to have related to the former doorway unless it was of a large doorcase and the door which sat within it was placed asymmetrically. The panelling, which survives at and below dado height, appears to all be modern as it passes seamlessly over the former doorway and the blocked fireplace opening to the east.

Entrance Hall showing location of the former doorway to the Wren Wing corridor in the north wall, looking north Plate 3

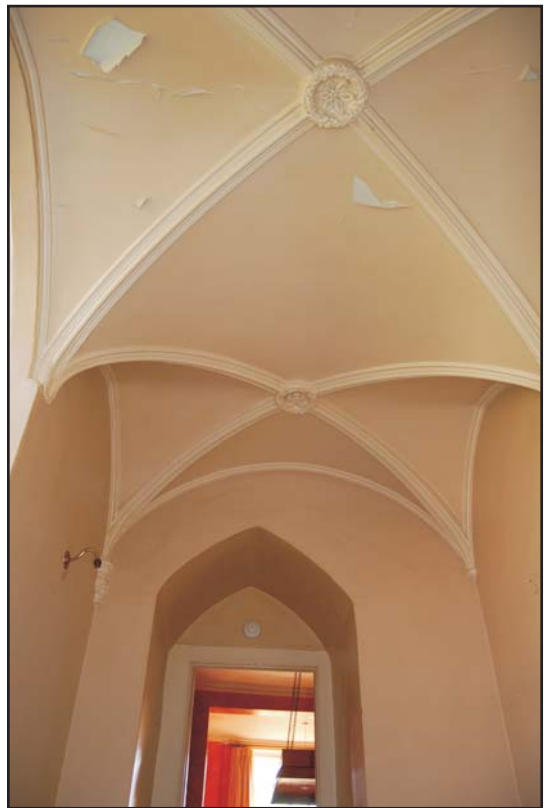
Ground floor WC below stair half landing showing vaulted ceiling, looking east Plate 4

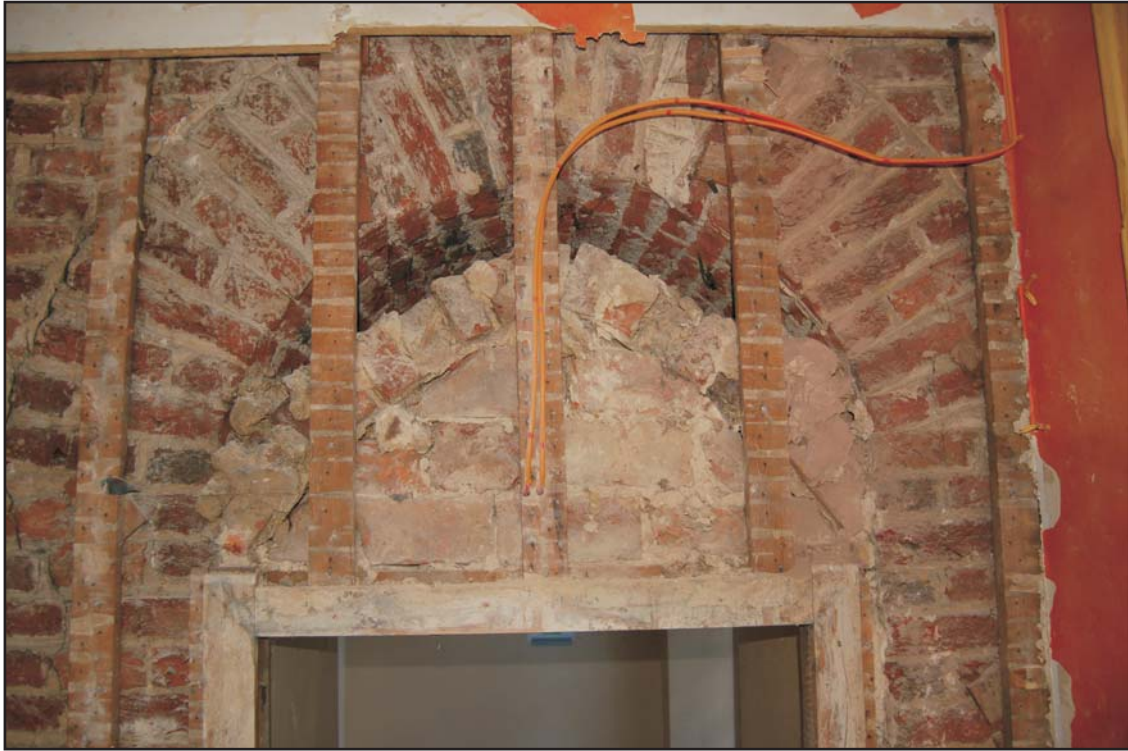
Plate 5

Pointed arch of the vaulted ceiling below the semi-circular structural arch in the west wall of the kitchen, looking west

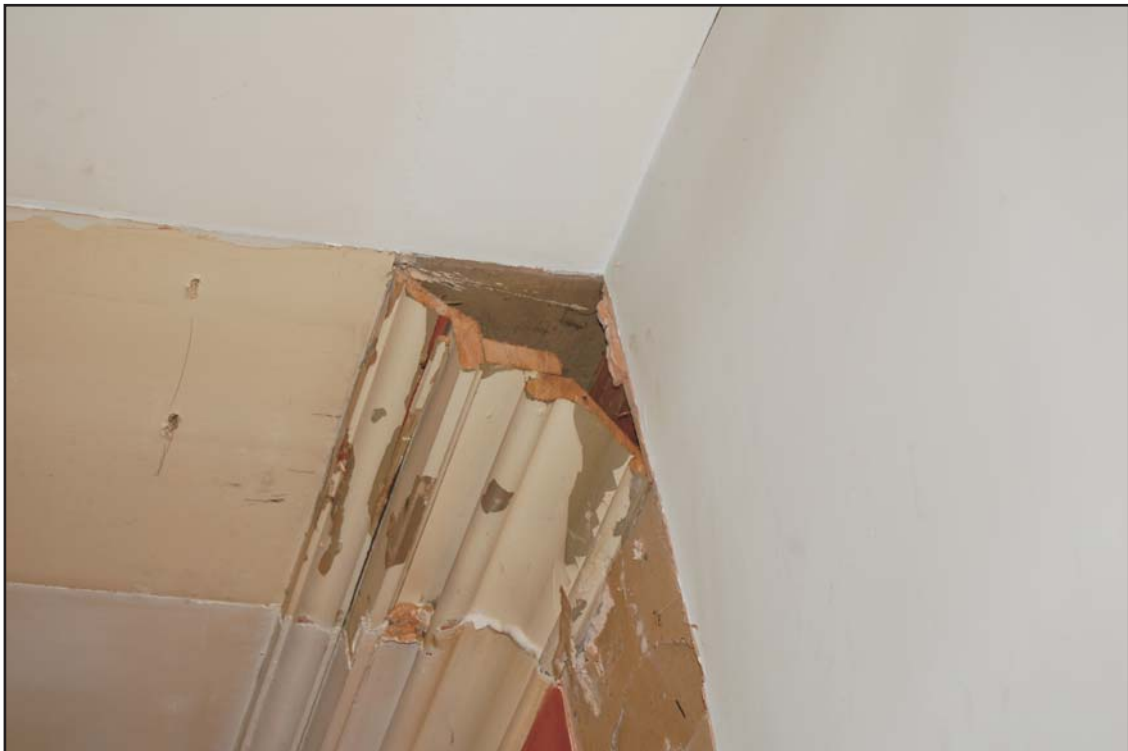
Plate 6

Detail of the timber box-cornice on the south side of the southern room of the kitchen, looking west

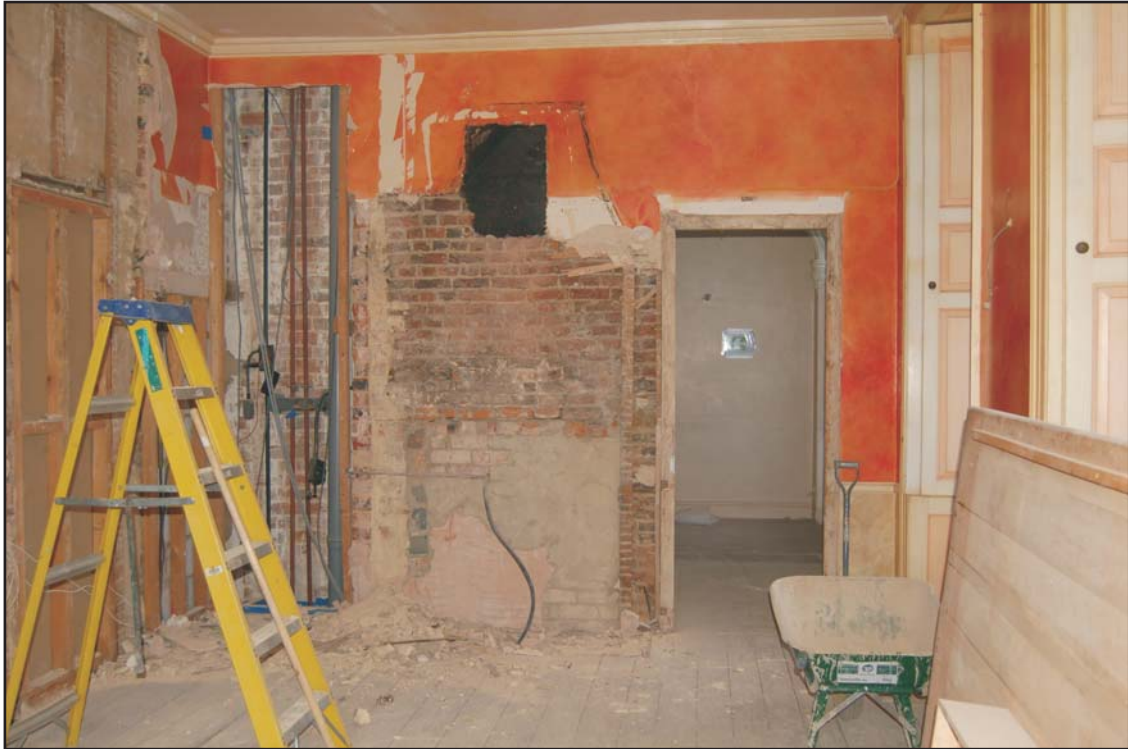
Plate 7

West wall of the northern room of the kitchen showing the blocked fireplace, looking west

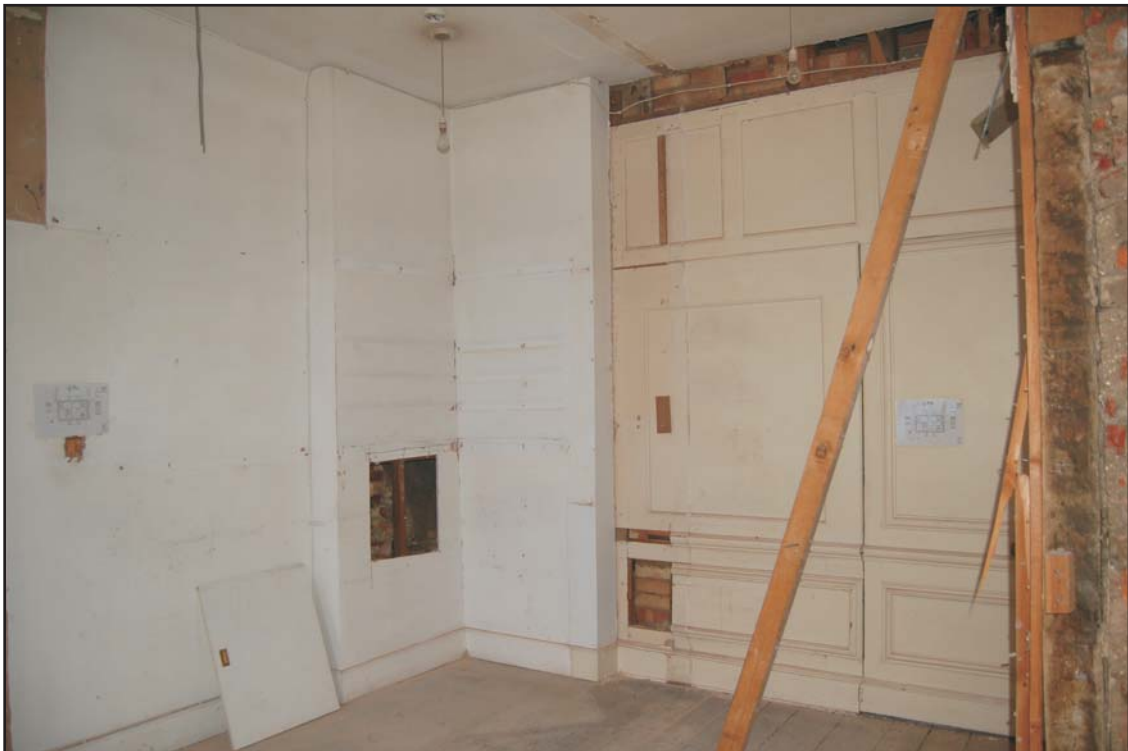
Plate 8

West wall of the southern room of the kitchen showing panelling and jib door, looking south-west

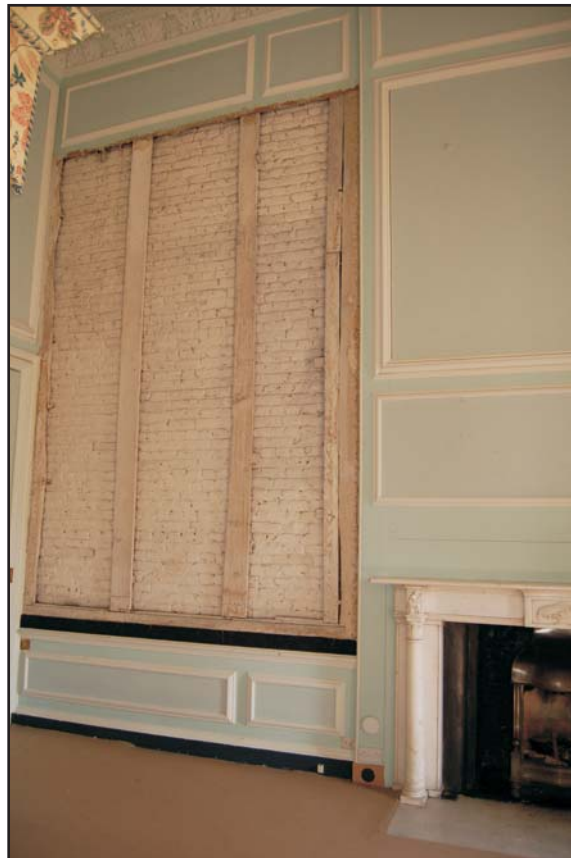
Plate 10

The former tapestry on the north side of the room occupied the space to the west of the fireplace and lay above the dado panelling but below two shallow panels set beneath the cornice (Plate 10). The frame here comprised a perimeter of boards which also served to support the adjoining panelling with two vertical planks between. The tapestry was only attached to the perimeter boards, the two internal ones appear to have been included to support the panelling above and below. The planks/boards were fixed to the wall by either being nailed to wooden blocks set within the brickwork (suggesting they were part of an original scheme) or by metal spikes driven into the wall. These spikes had flattened heads, each with two holes through which nails were fixed to the sides of the frame. The spikes appear to be secondary features and may have been added later for additional strength. The brickwork of the wall was all painted white and contained no features. The bricks measured 230mm x 110mm x 65mm and were laid in English bond.

North wall of the Master Bedroom on the first floor showing the location of the former tapestry to the west of the fireplace, looking north

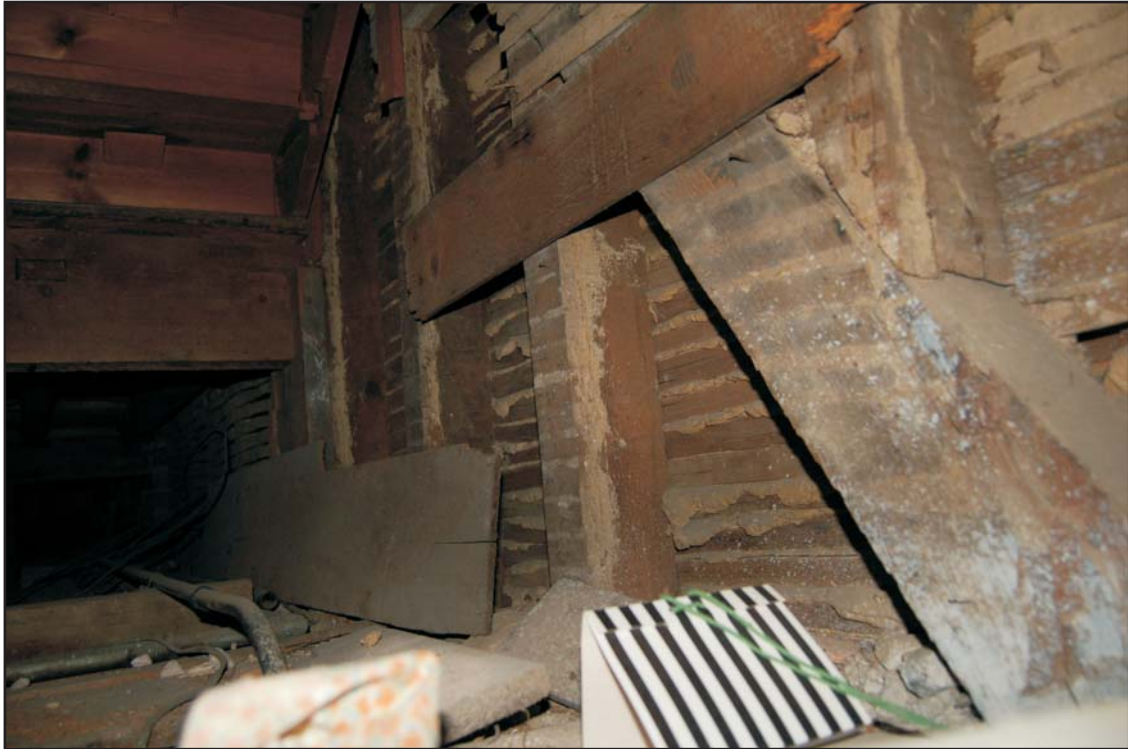
Plate 11

Void beneath raised floor of the corridor to the second bathroom showing back of plaster wall located to the north, looking west

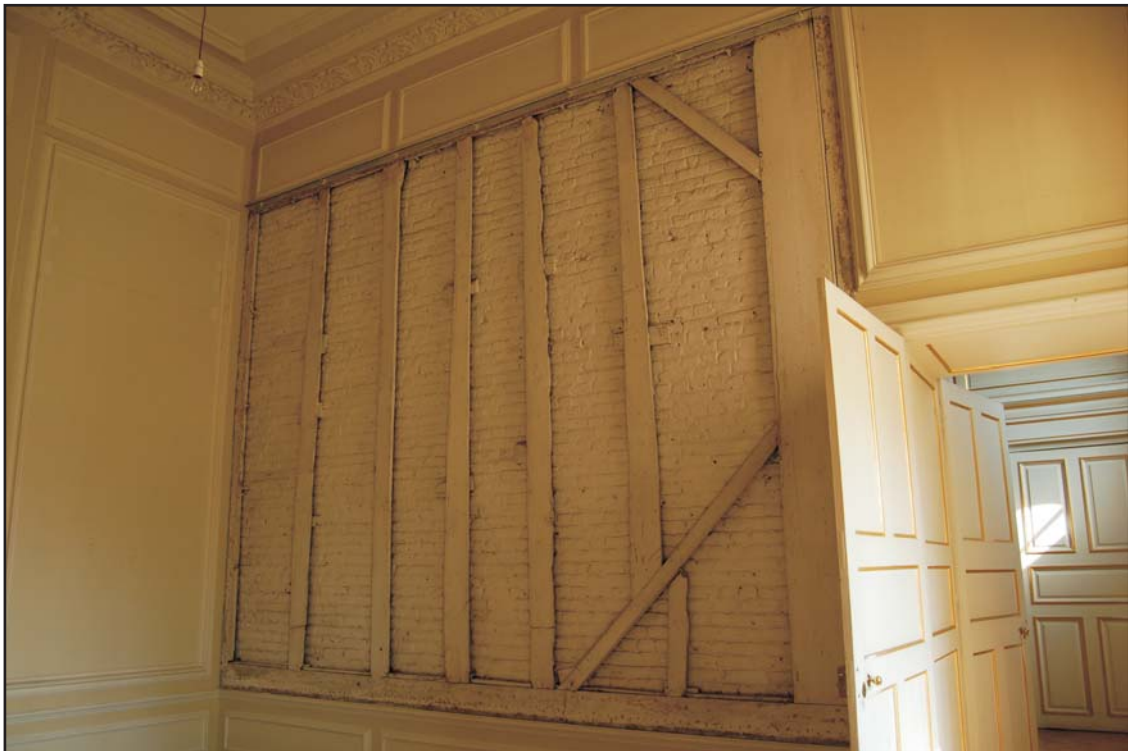
Plate 12

North wall of the first floor Bedroom One showing the location of the former tapestry, looking north

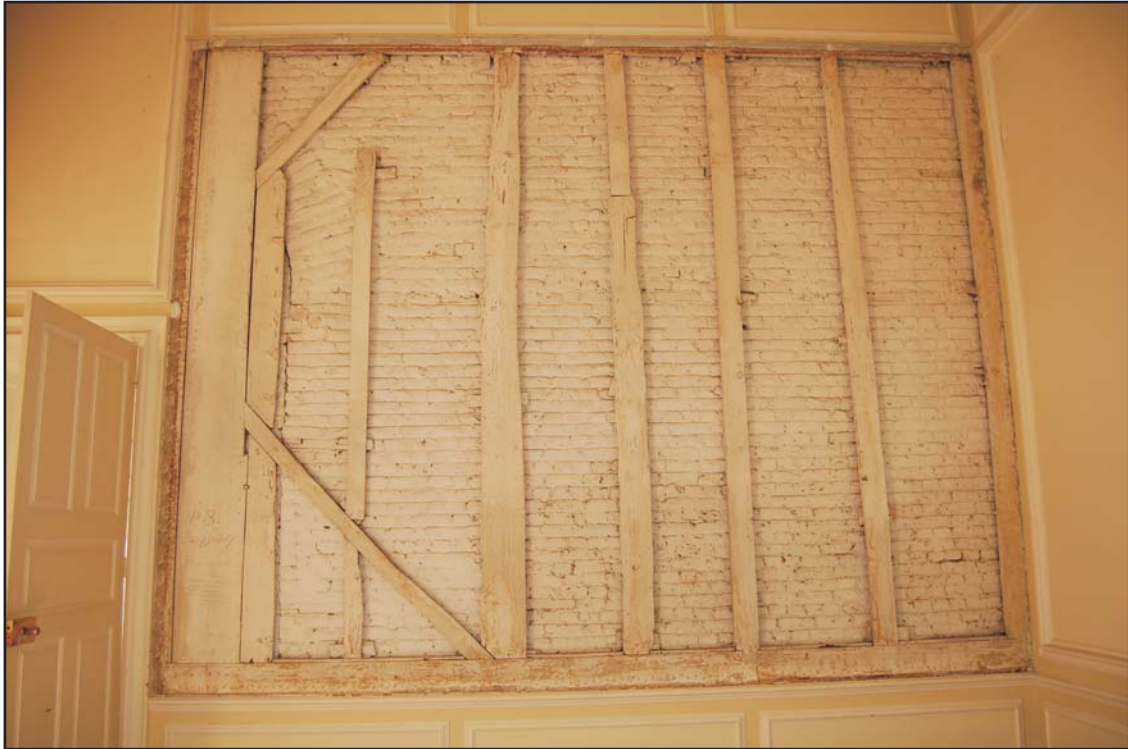
Plate 13

South wall of the first floor Bedroom One showing brick arch to the right (west) of the door and frame for former tapestry, looking south. Note graffiti on the wide vertical plank to the immediate right side of the door

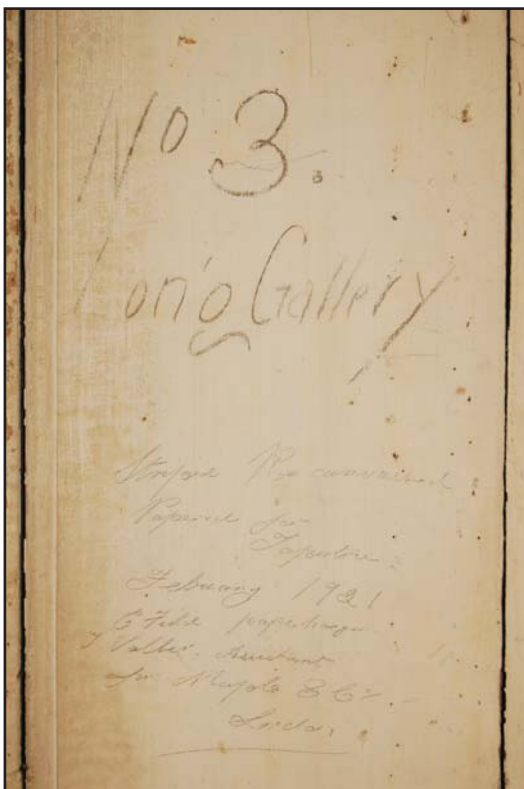
The south wall of the same room was similarly configured with no covering from the south-west corner to the west side of the doorway leading into the Master Bedroom to the south (Fig \*, Plate 13). Again panelled above and below, the bare section contained five vertical planks with a bordering frame but with two additional three-quarter height vertical planks towards the east side close to the doorway. This side has in addition diagonal bracing at the top and bottom on the same side. The wide plank on the east side of the wall, fitted just inside the outer frame (which contains numerous nail holes where the fabric had been fitted) retained pencil graffiti (Plate 14). The graffiti reads:

Detail of the graffiti written on the vertical plank on the south wall of Bedroom One  
Plate 14

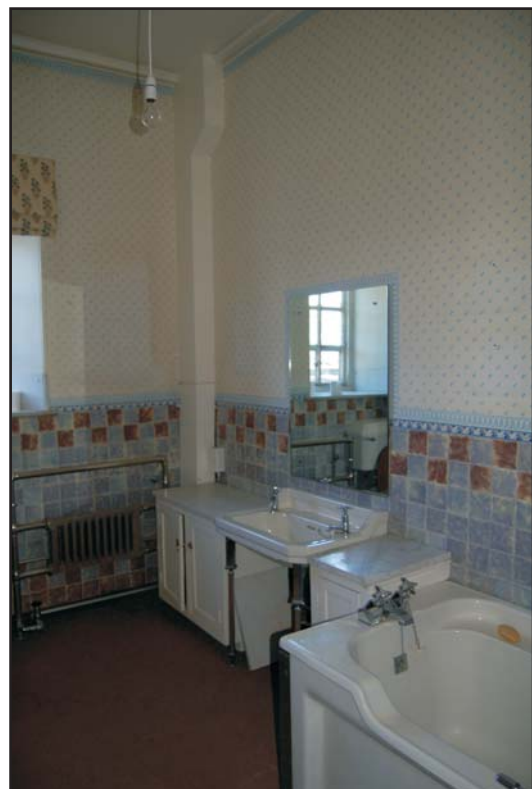
Second Master Bedroom en suite looking north-east  
Plate 15

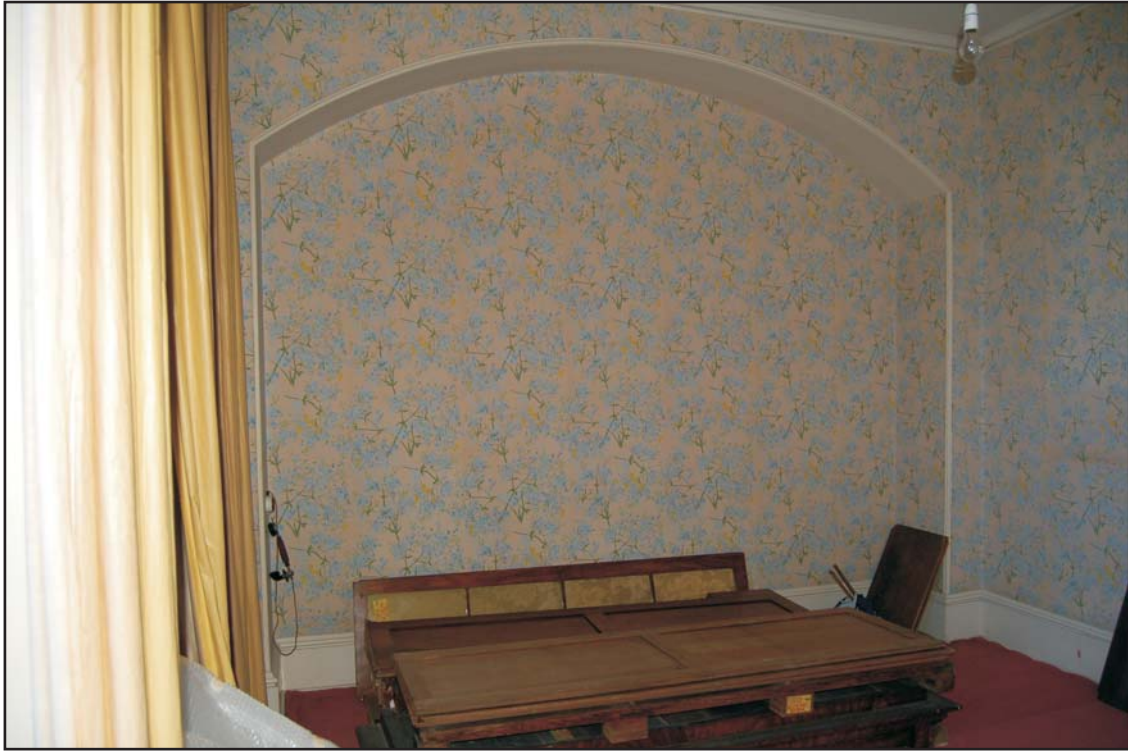
Plate 16

Alcove in the east wall of Bedroom Four, looking east

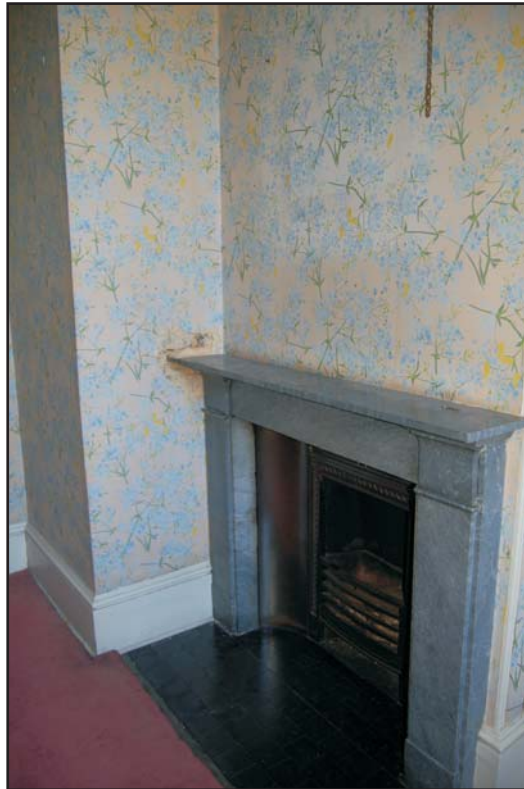
Plate 17

Shaft of dumb waiter built over mantel shelf of fireplace in the west wall of Bedroom Four, looking west

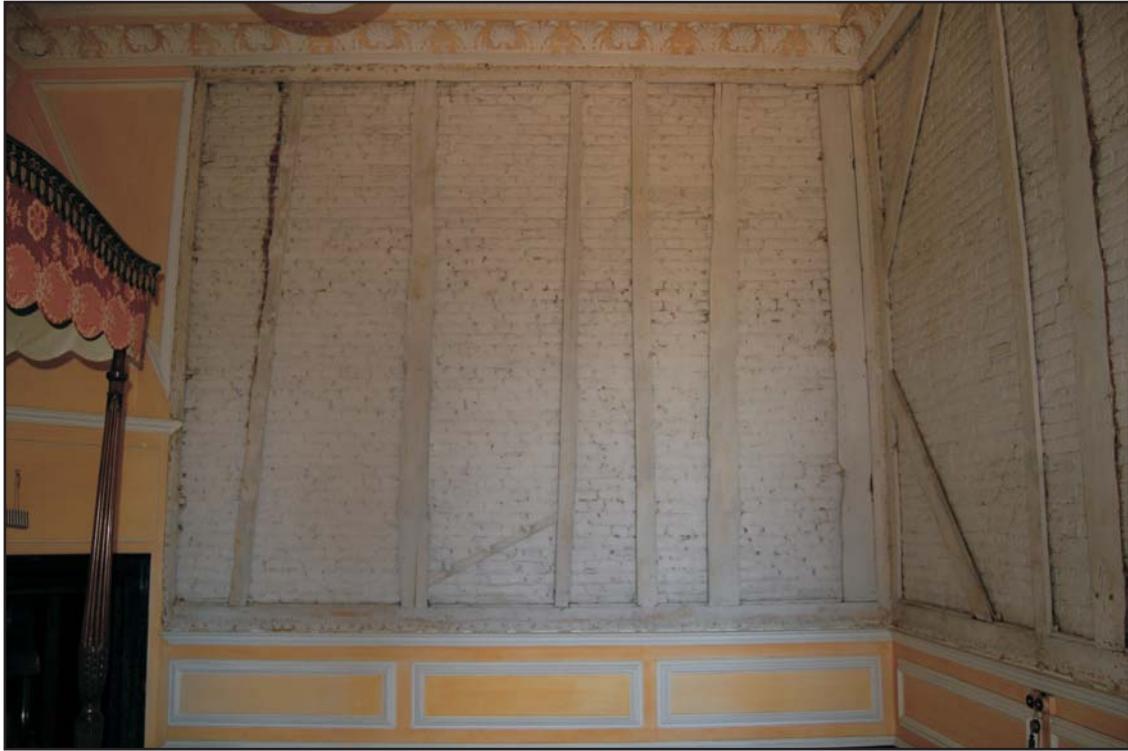
Plate 18

East wall of Master Bedroom Three showing the location of the former tapestry, looking east

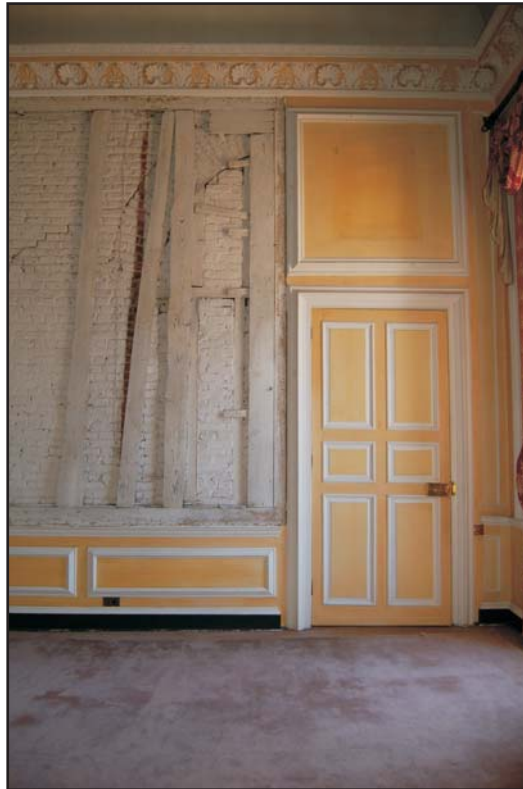
Plate 19

South wall of Master Bedroom Three showing the location of the arch to the left (east) of the door and the frame of the former tapestry, looking south

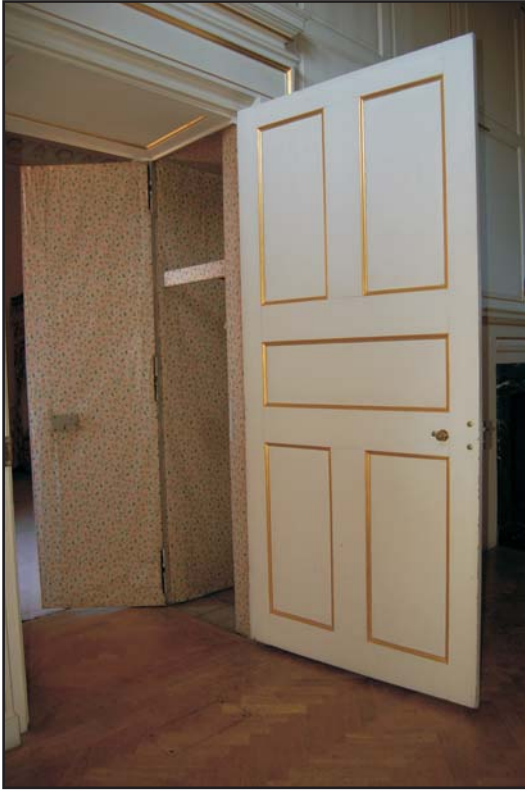
Cupboard located between the door of the cross corridor (foreground) and Master Bedroom Three in the space created by the structural arch on the south side of that room, looking north-east  
Plate 20

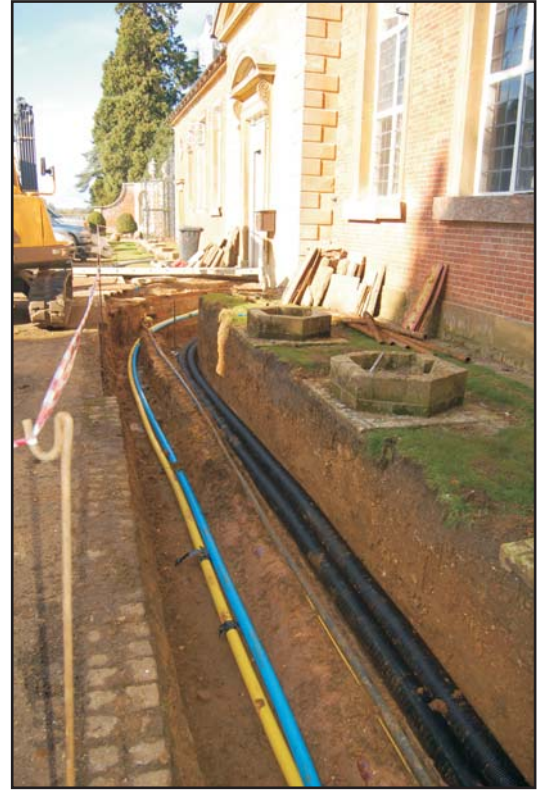
Service trench in the main forecourt of the house, looking west along the south side of the Wren Wing  
Plate 22

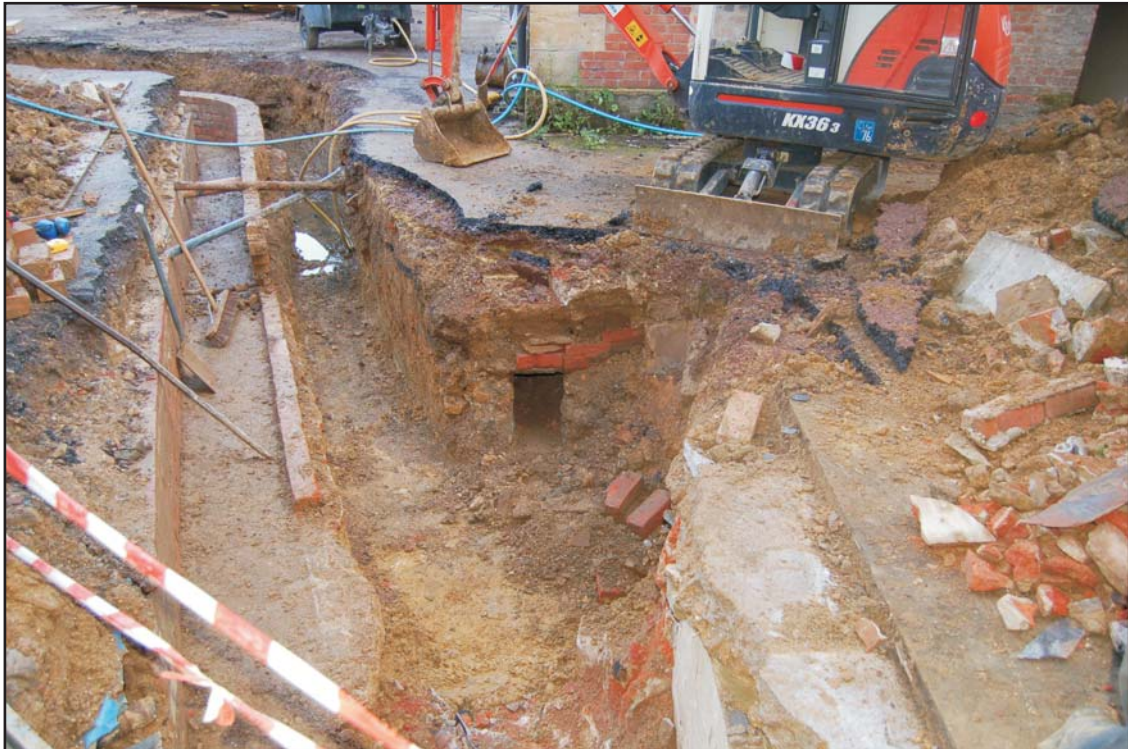
Plate 21

Stone culvert on the north side of the Wren Wing, looking north

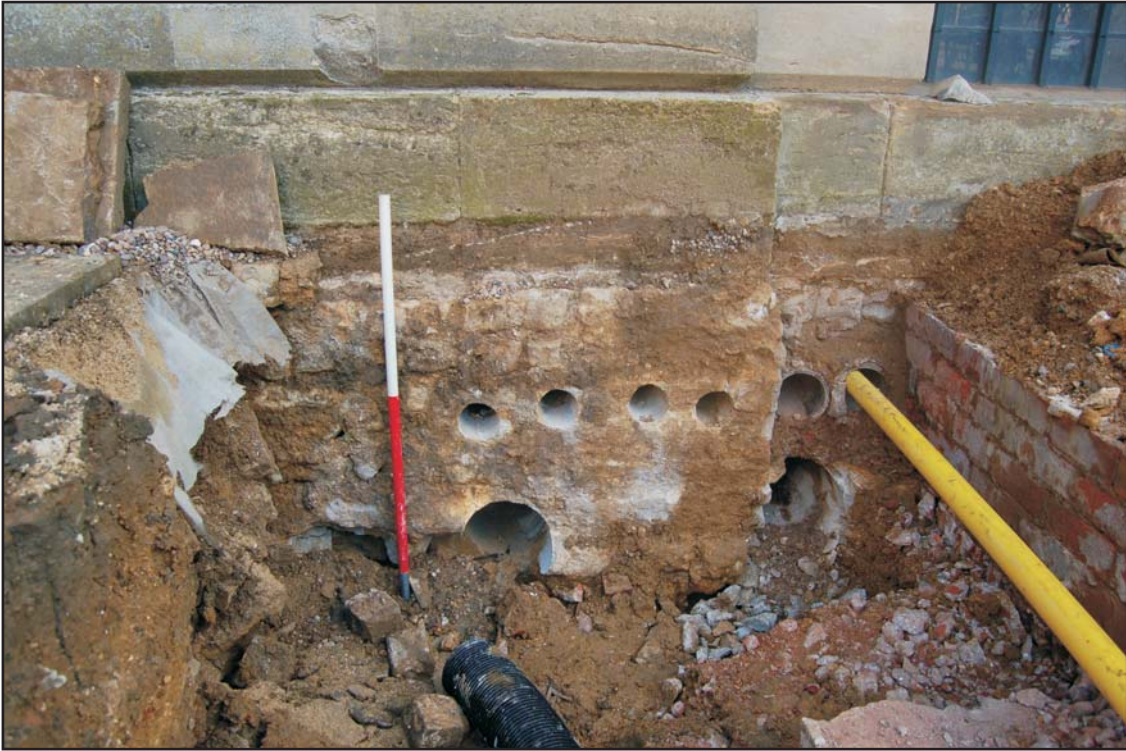
Plate 23

The drilling of holes in the west wall of the house foundation only confirmed what was already known, that the interior walls were of red brick faced with stone of the exterior (Plate 23). Below ground level they were of undressed or roughly dressed limestone, not fine ashlar which faces the remainder of the house.

West side of the main house foundation showing drilled holes for new services, looking east

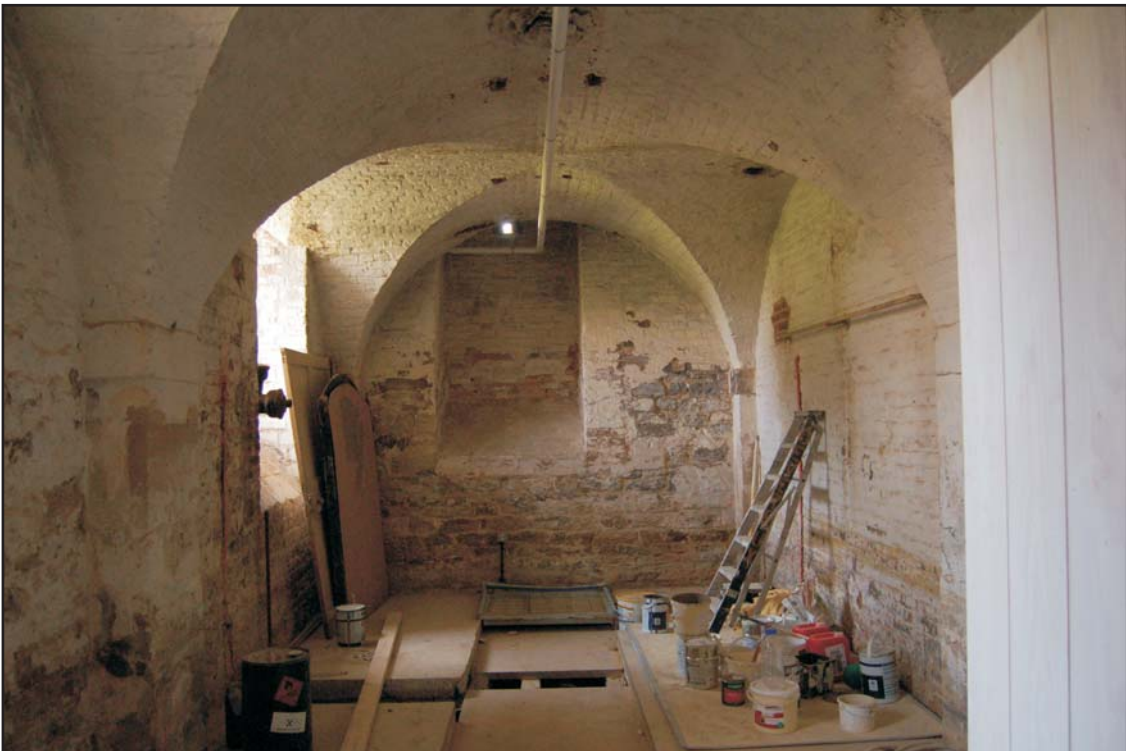
Plate 24

Floor ducting (temporarily covered) in the basement room at the north-east corner of the house, looking east

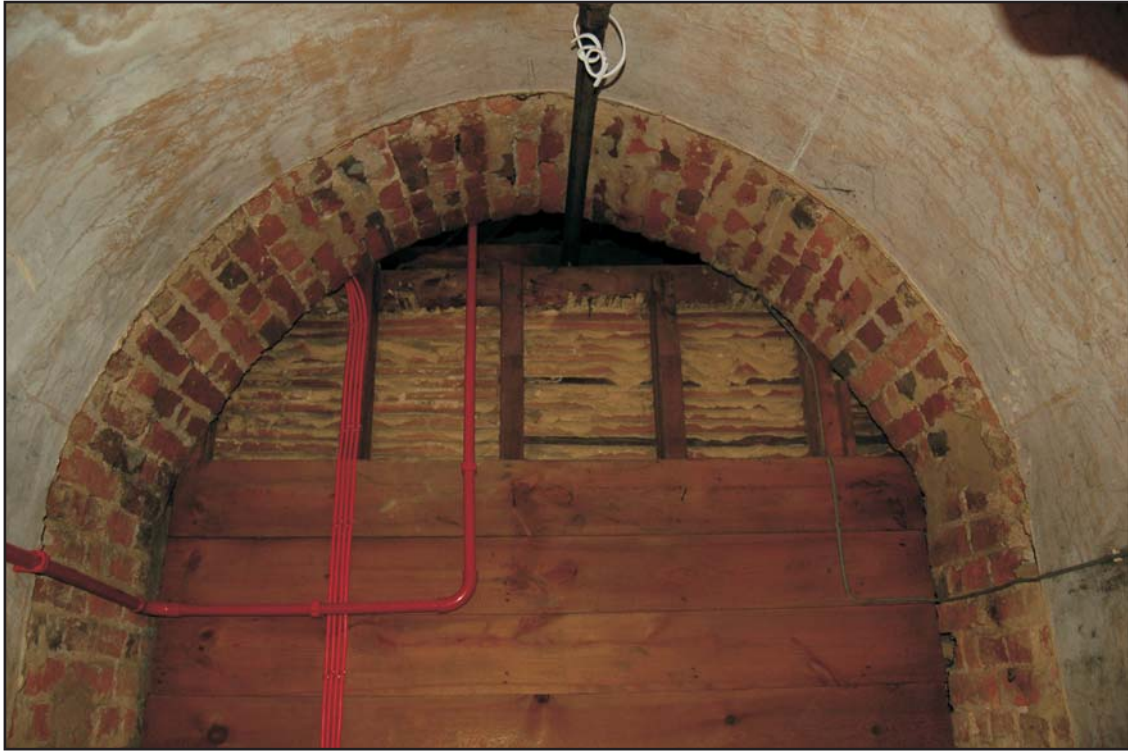
Plate 25

Archway blocked by the back of nineteenth century lath and plaster wall on the east side of the first floor Bedroom Two inserted above the former full height hall, looking west

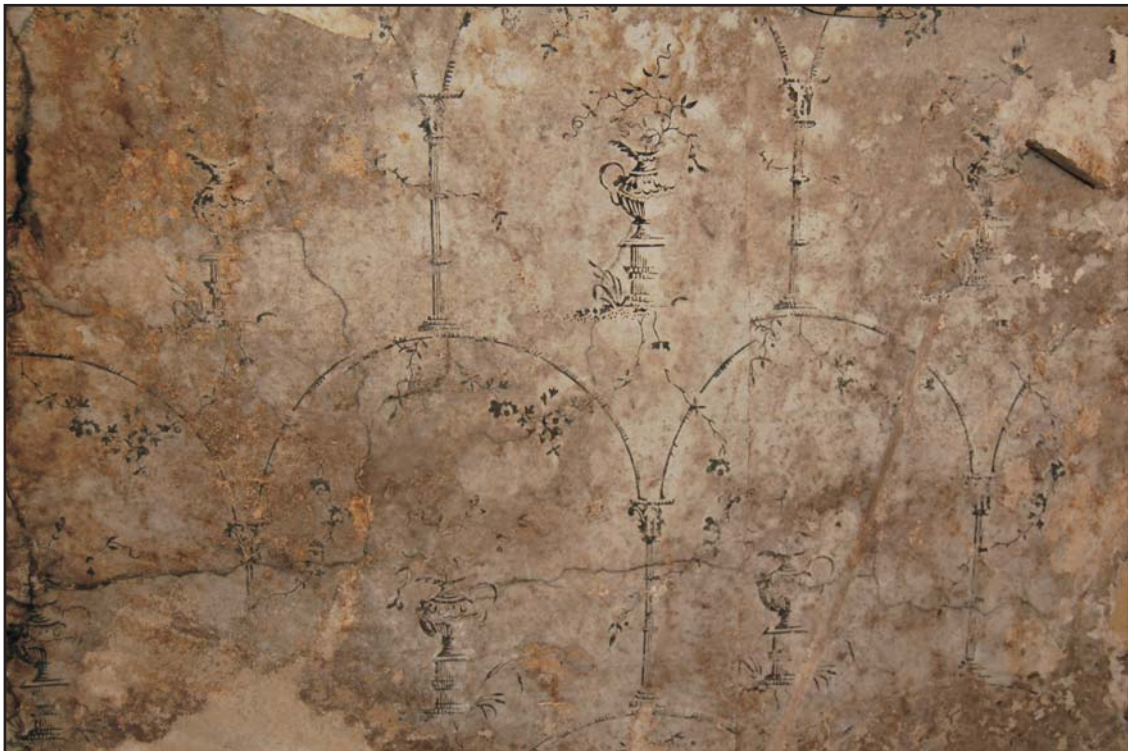
Plate 26

"Pillar and arch" pattern wallpaper of c1775-1780 lining archway formerly overlooking the full height hall

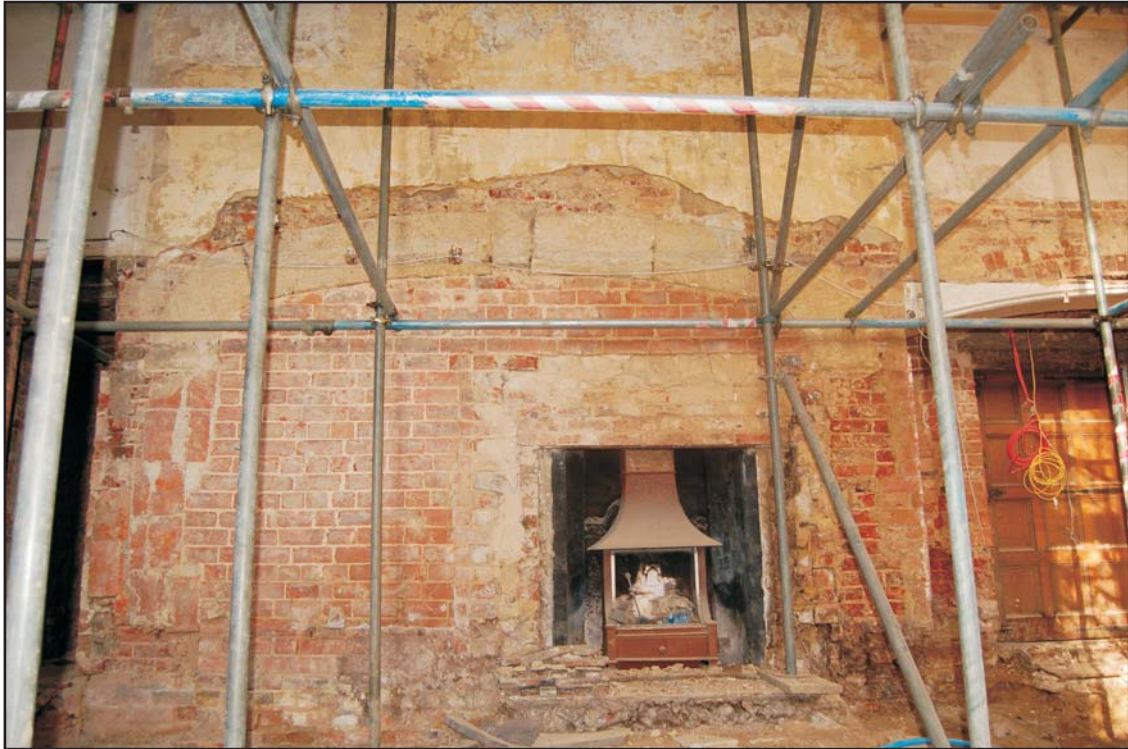
Plate 27

Large fireplace opening with stone voussoirs, subsequently infilled and reduced in the west wall of the service room at the east end of the Wren Wing, looking west

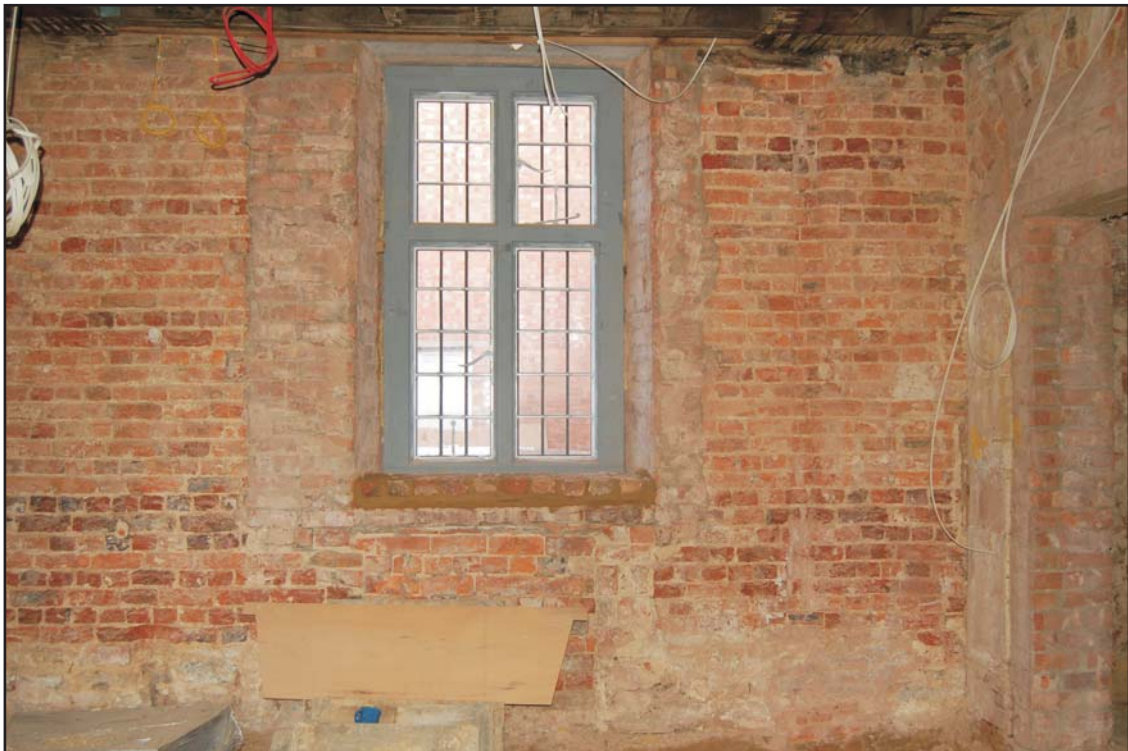
Plate 28

Narrowed window in the north wall of the room to the east of the central doorway of the Wren Wing, looking north

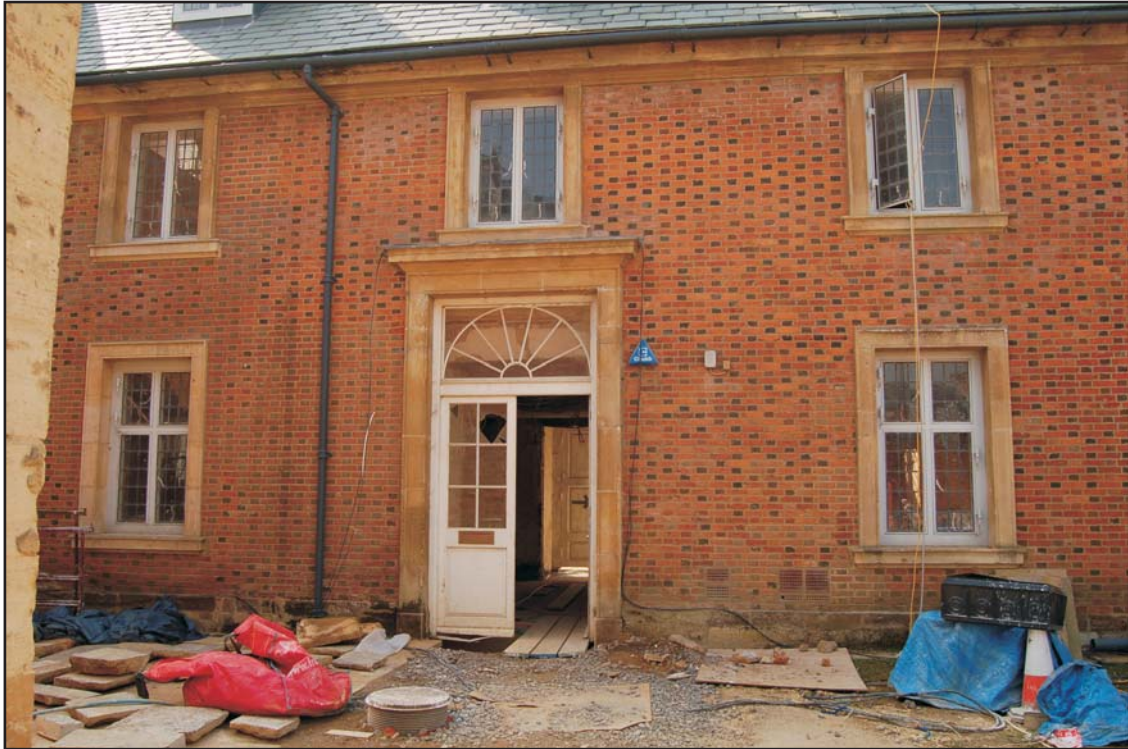
Plate 29

The ground floor room on the east side of the central doorway of the Wren Wing had previously been sub-divided by the previous owner, and these modern divisions were removed, partly to re-instate the layout of the space but also because they had been damaged in the fire and were of no historic value. Again the damaged plaster on the walls was stripped which revealed that the two windows in the north wall had been narrowed, and a further window close to the present central north door had been entirely infilled (Fig \*, Plate 28). It is thought that this was carried out during the early years of the twentieth century. Externally there is no indication of any infilling, and it appears that the entire external wall was re-faced and the door and windows given new stone surrounds (Plate 29).

Exterior of the north wall of the Wren Wing showing evidence of the re-facing with new brick and stone surrounds to windows and doorway, looking south

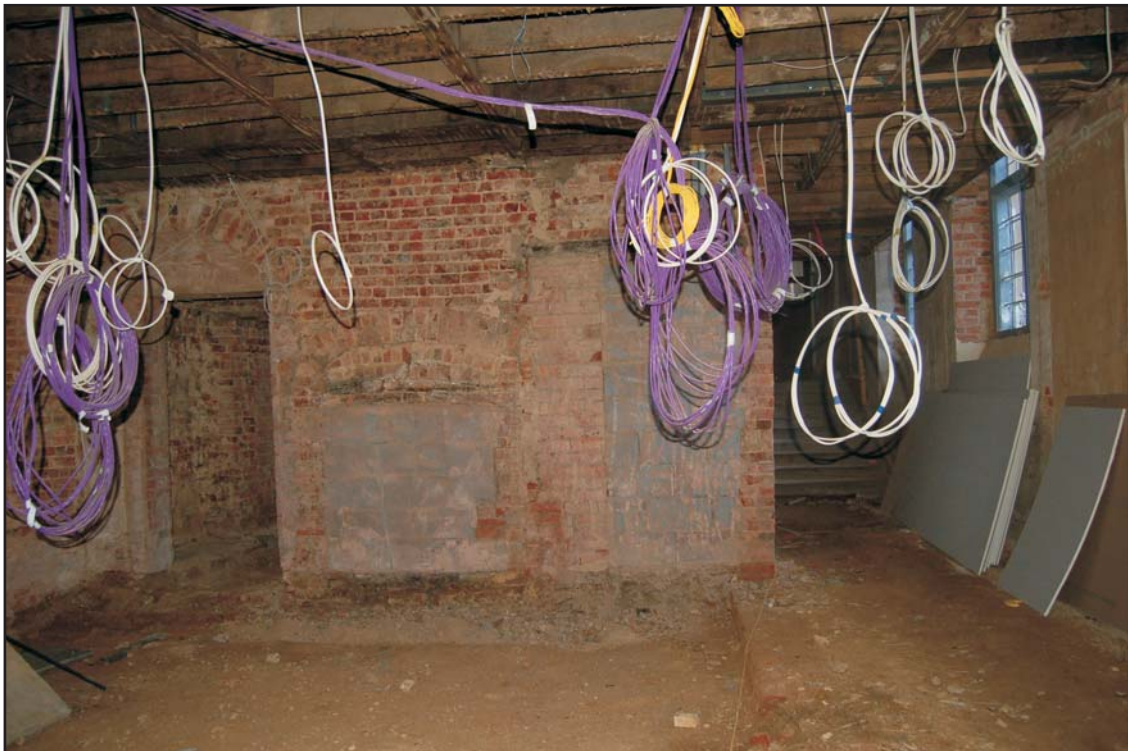
Plate 30

Blocked fireplace (left) and doorway (right) in the east wall of the room to the east of the central doorway in the Wren Wing, looking east
