## Archaeological building recording at Easton Neston House, Northamptonshire

Report 11/261

**ARCHAEOLOGICAL BUILDING RECORDING  
AT EASTON NESTON HOUSE, TOWCESTER,  
NORTHAMPTONSHIRE  
2007- 2009**

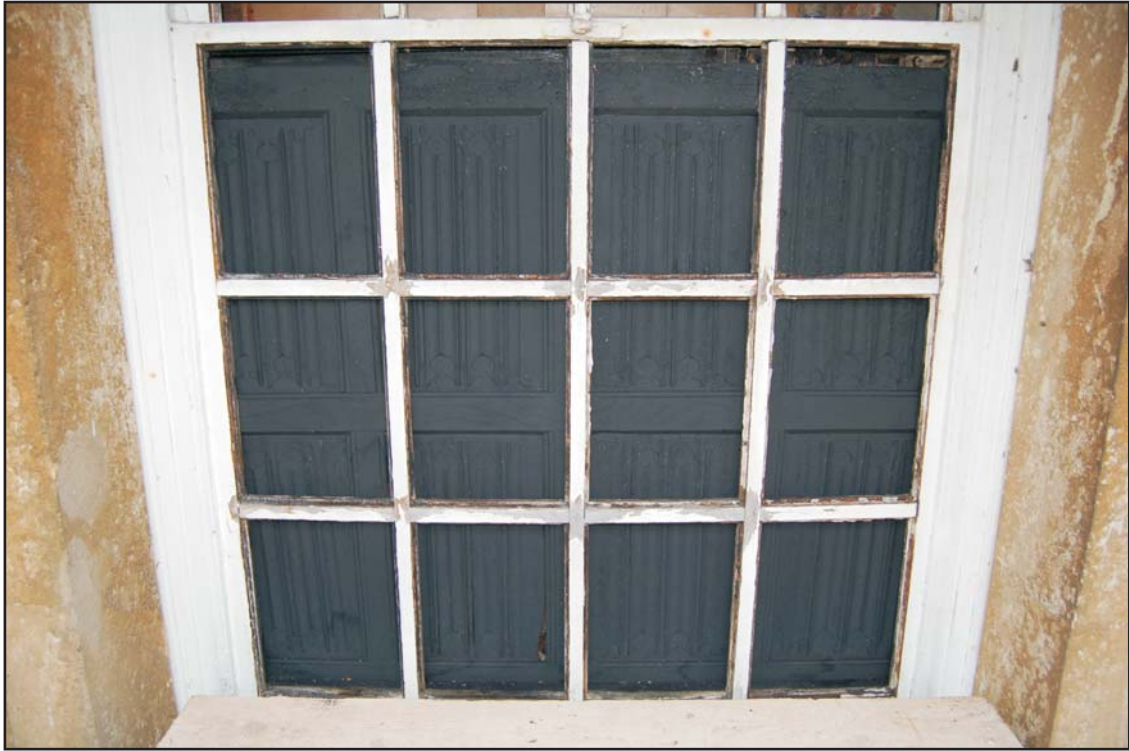
Plate 31

A partly blind window, built as such, in the centre of the north elevation revealed that the upper part of this tall sash window concealed re-used oak panelling of probable late sixteenth- or early seventeenth-century date (Fig \*, Plate 31). It is located in the upper half of the window located above the vaulted lobby at the north end of the building at the level of the half-landing on the main staircase. The panelling had been painted or stained black and comprised two separate designs, one a classic linenfold pattern, the other of angular interlocking diapers infilled with stylised leaves of quatrefoil and trefoil configuration (Plate \*). The panelling had been cut to fit in various places, most obviously where the decorated ends of the linenfold had been cut off so that a horizontal rail could be inserted. It is not known where the panelling came from originally, or even if it is of the date to which it belongs although stylistically it can be dated to c1640-1680 (Alcock and Hall 1999). There is a possibility that it is nineteenth-century 'Jacobethan', though this does not seem likely since the carving is rather good and charmingly uneven, characteristics often missing from later reproductions. If original it would most likely have been part of room decoration though it is too early to have been incorporated in the current house as by the time the existing building was completed plain panelling was being used as is evident from surviving interiors. It is also not clear at what date it was inserted here, the space behind it could not be seen clearly and it is not known how it was fixed, or what it was fixed to. After the present glass had been removed and the glazing bars repaired the panelling was re-painted and the glass replaced. The panelling remains *in situ*.

- 5.8 Re-used oak panelling of probable seventeenth-century date was observed set behind glazing in a blind window in the north facade. Stylistically the panelling pre-dates the present house and is unlikely to have come from within the building. Most likely it was simply a section of timberwork that was available and was used to provide a background to cover the brickwork of the blocking. The dates of its insertion here is unknown but the panelling, which may date to the mid seventeenth-century, has been retained *in situ*.

Black painted oak panelling behind glazing bars in the blind window in the north elevation of the main house, looking south
