Heritage asset assessment of Coombs Farm Barns
Thornborough, Buckinghamshire
May 2012

Report 12/124

Northamptonshire Archaeology carried out a heritage asset assessment of Coombs Farm Barns, Thornborough, Buckinghamshire. The assessment demonstrated that the 19th-century buildings are in poor to very bad condition and are of overall low significance.

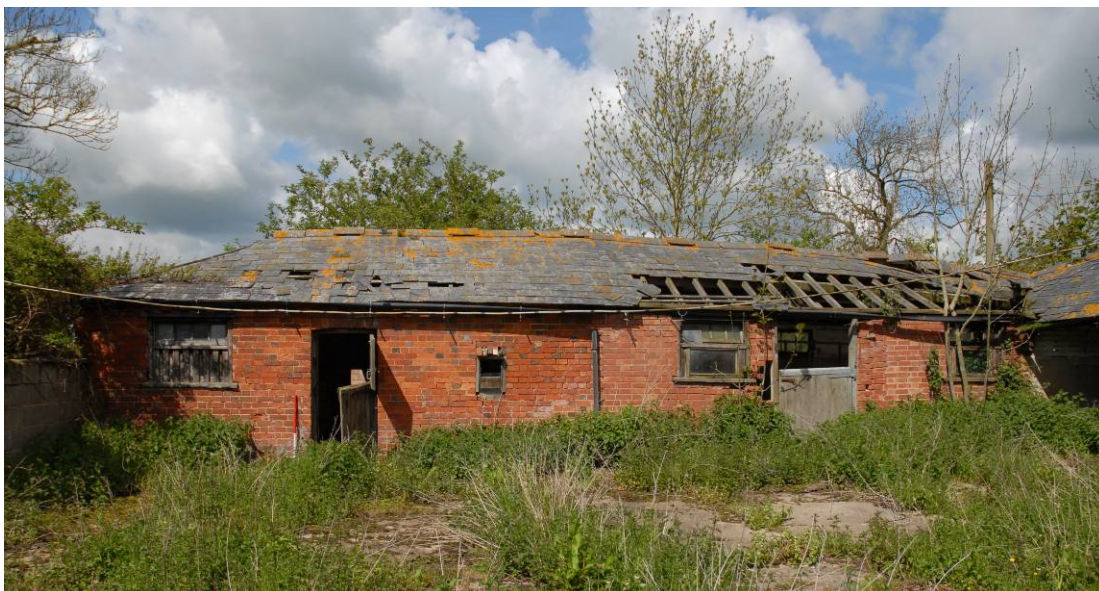
Fig 3

Building 1 is a cattle shed on the western side of the main courtyard (Figs 2 and 3). The building has two rooms, the southern of which was likely to have been a stable. The northern room had been modernised with a concrete floor and metal cattle feeding trough. There are doors into the two rooms consisting of split stable style ledged and braced doors.

Building 1, looking west

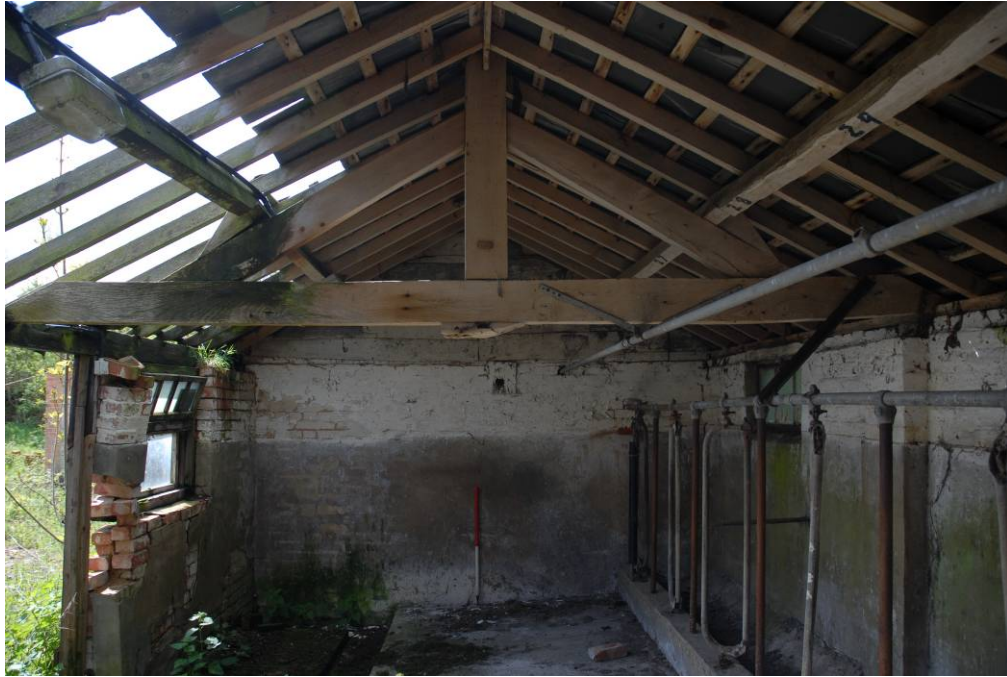
Fig 4

The roof is a kingpost truss and is covered with Welsh slate. The timber work of the kingpost truss is machine-sawn pine with an iron bolt joining the kingpost to the tie beam (Fig 4).

Interior of Building 1 showing the kingpost truss

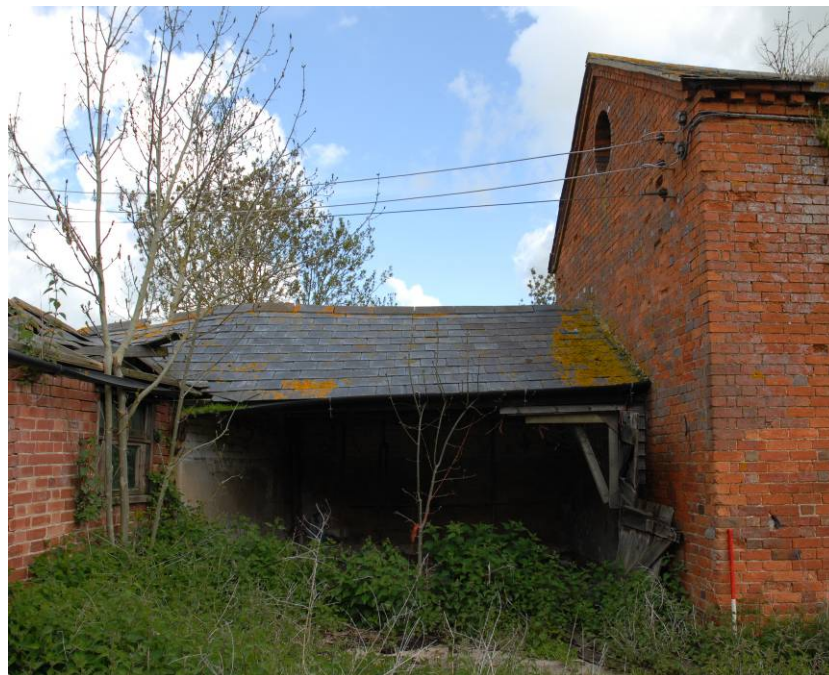
Fig 5

Building 2 is an infill between Buildings 1 and 3 and consists of a small open fronted shelter shed (Figs 2 and 5). The shed has a later concrete floor and metal and concrete feeding trough on the back wall. There is the remains of a ledged and braced split stable door, which may suggest the building was not always an open shelter shed.

Building 2, open cattle shelter shed, looking north

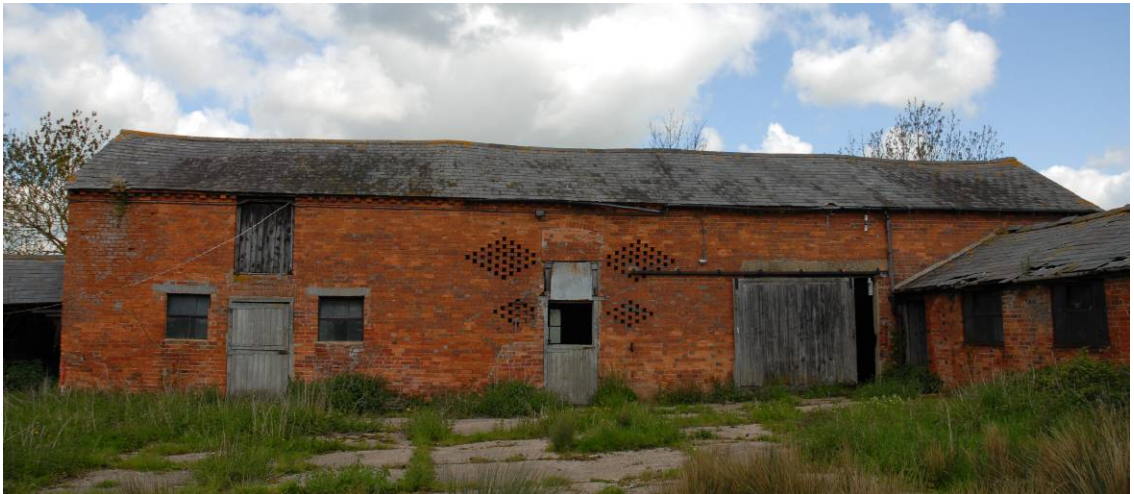
Fig 6

Under the eaves there is a course of dentil enrichment consisting of alternate projecting bricks. There are also four diamond shaped panels of ventilation holes in the brickwork on the courtyard facade of the building. These, however, have been cut by the insertion of a later doorway. The windows in this building are metal framed with concrete lintels and are later insertions, as is the large opening on the eastern side of the yard facade. There is an original round window in the apex of the west gable.

Building 3, looking north

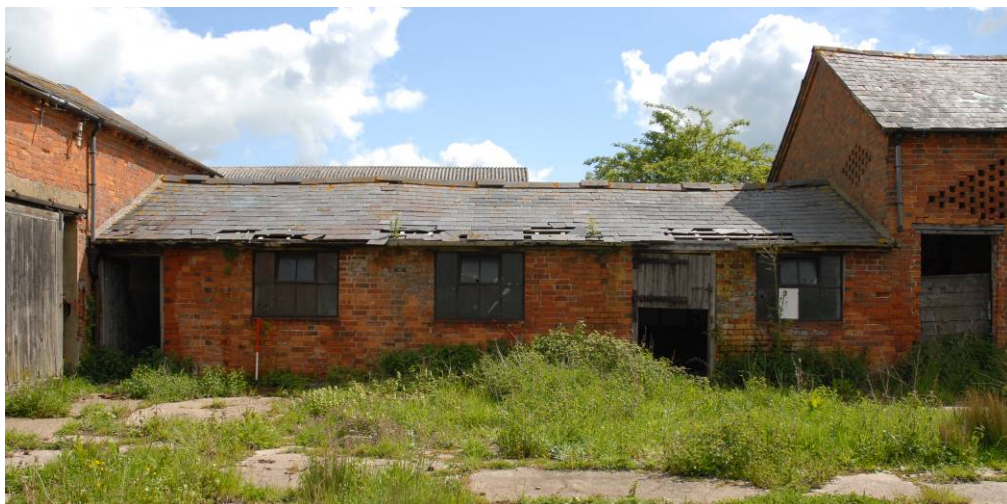
Fig 7

Building 4, looking east

This building has three metal framed windows replacing the originals and two doors, the northern of which is a ledged and braced door, the other is a split stable style door.

Internally, the building has the remains of a milking parlour, consisting of a concrete floor and metal fittings. The east wall of the building has been moved out and the roof line altered on this side to accommodate the milking parlour machinery which is no longer extant.

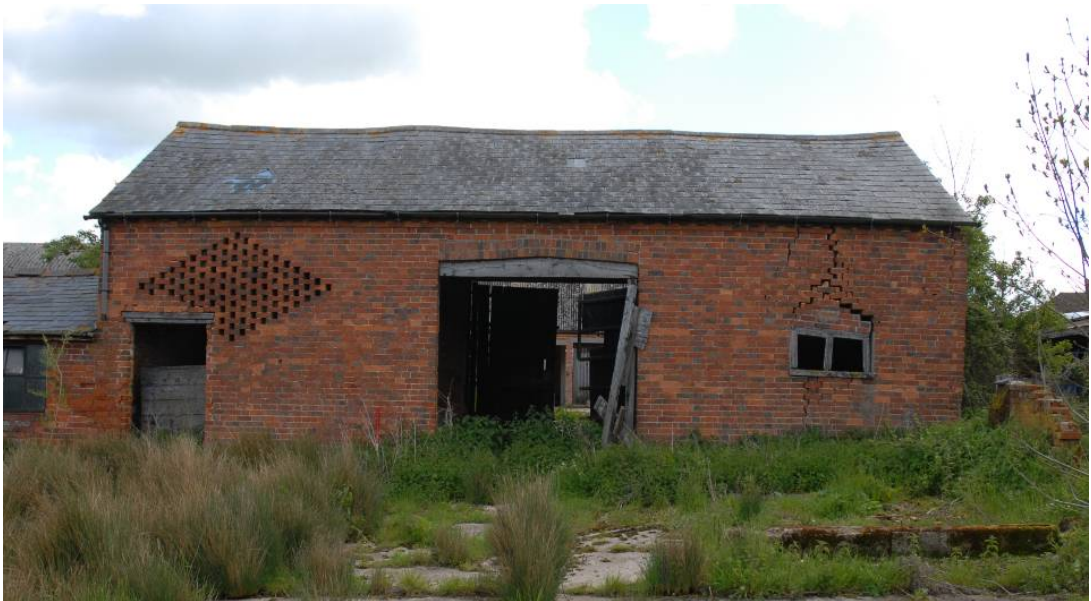
Fig 8

Building 5, looking east

There is an inserted door at the northern end of the main yard facade which cuts the bottom of the diamond shaped panel of ventilation holes in the brickwork. As Building 3, there is under the eaves a course of dentil enrichment consisting of alternate projecting bricks. This would suggest that this building and Building 3 are contemporary with the other buildings being slightly later.

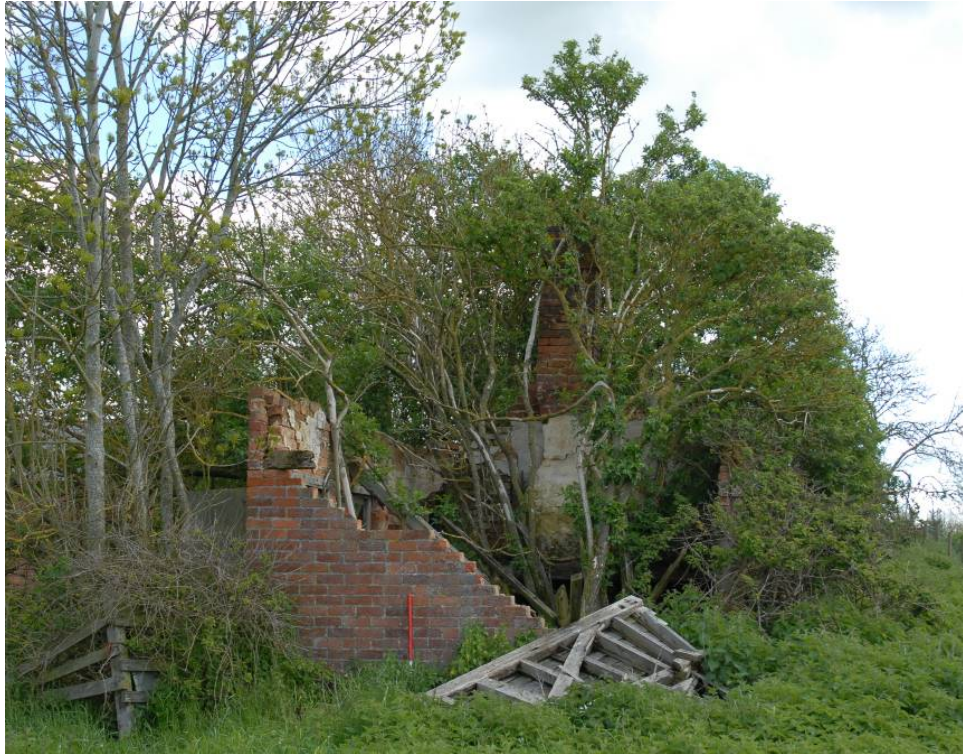
Fig 9

This building is to the south of the main courtyard and consists of a roofless ruin with several of its walls also partially collapsed (Figs 2, 9 and 10). Young trees and shrubs are growing within the building making access difficult.

Building 6, looking north-east

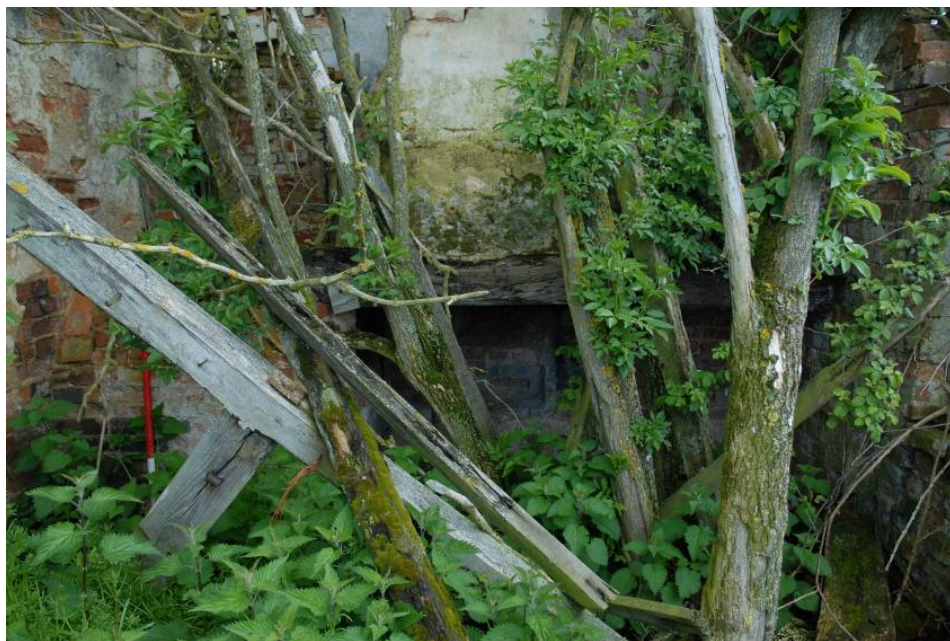
Fig 10

The building in the east wall of the western room has an inglenook fireplace, with a small cast iron oven set into it (Fig 10).

Building 6, inglenook fireplace, looking east

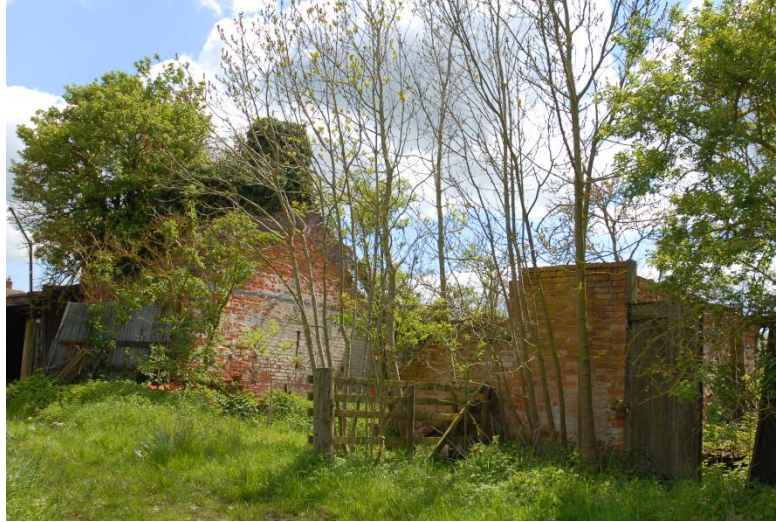
Fig 11

Building 7 is on the same alignment as 6 and like 6 it is without its roof and is overgrown with young trees and shrubs (Figs 2 and 11). Much of the north wall of the building is no longer standing. The eastern end of the building is two storey although the floor is no longer extant and there is a chimney in the western gable of the east end (Fig 12).

Building 7, looking south-east

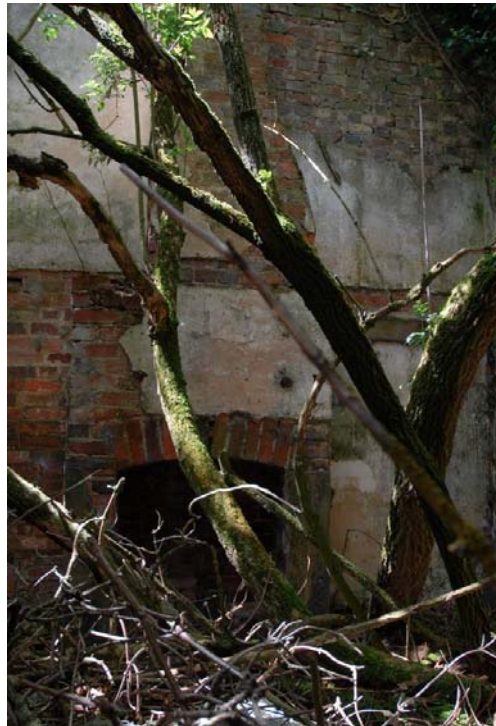
Fig 12

Fireplace and chimney breast, Building 7, looking west

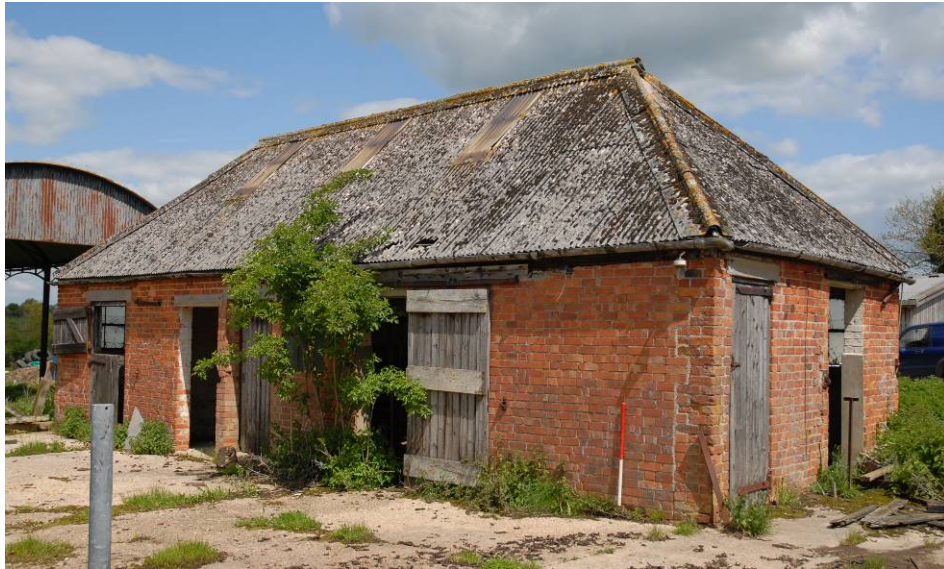
Fig 13

This building is free standing and forms the eastern side of the smaller secondary yard (Figs 2 and 13). It is in red brick with a hipped corrugated asbestos roof, the windows are metal framed with concrete lintels and are later insertions. The doors also have concrete lintels.

Building 9, looking north-east

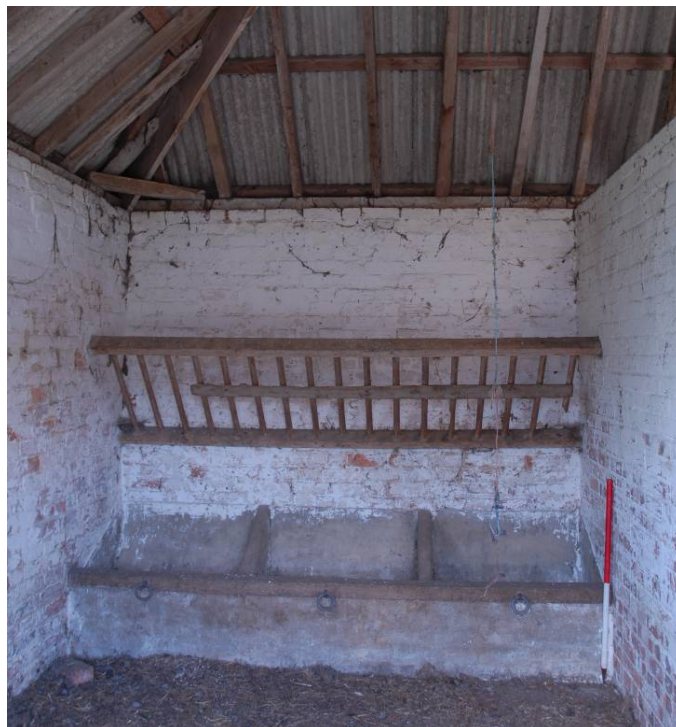
Fig 14

The room at the northern end of the buildings retains its brick feeding trough with wooden feeding rack over. There are tether rings for three animals (Fig 14).

Building 9, feeding trough and rack

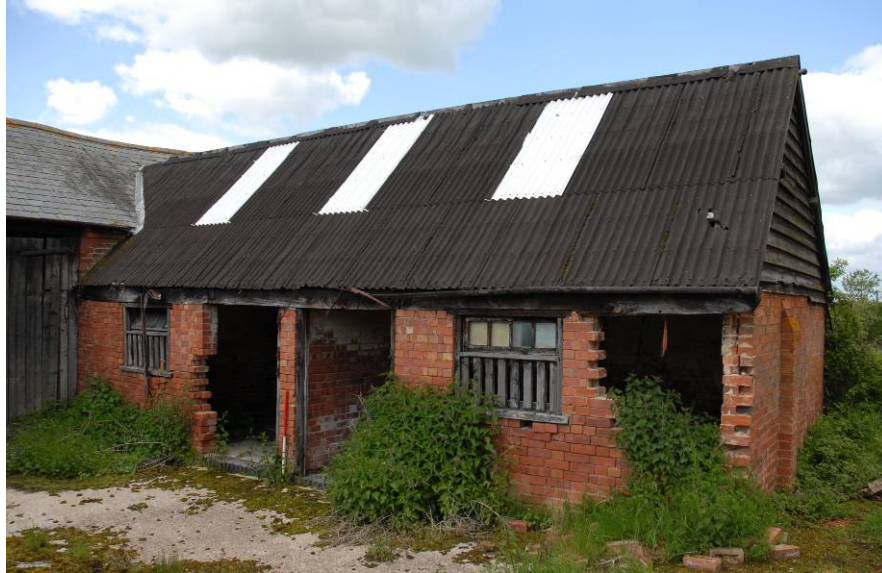
Fig 15

Building 10 is built onto the eastern side of Building 5 and forms the northern side of the smaller courtyard (Figs 2 and 15). This building retains its wood topped brick feeding trough and original wooden horizontal sliding hit-and-miss ventilator windows. The doors however, have been removed and the brickwork around the openings has partially been taken down.

Building 10, looking north-west

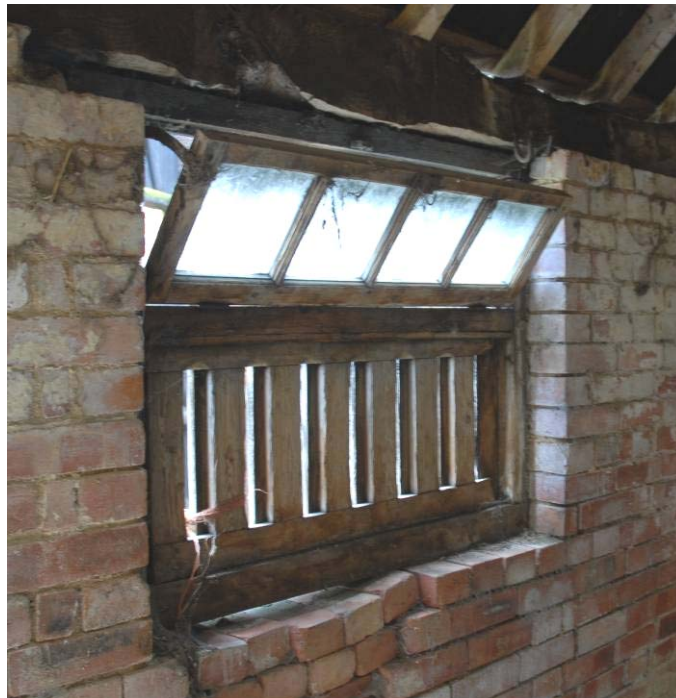
Fig 16

Building 10, horizontal sliding hit-and-miss ventilator window

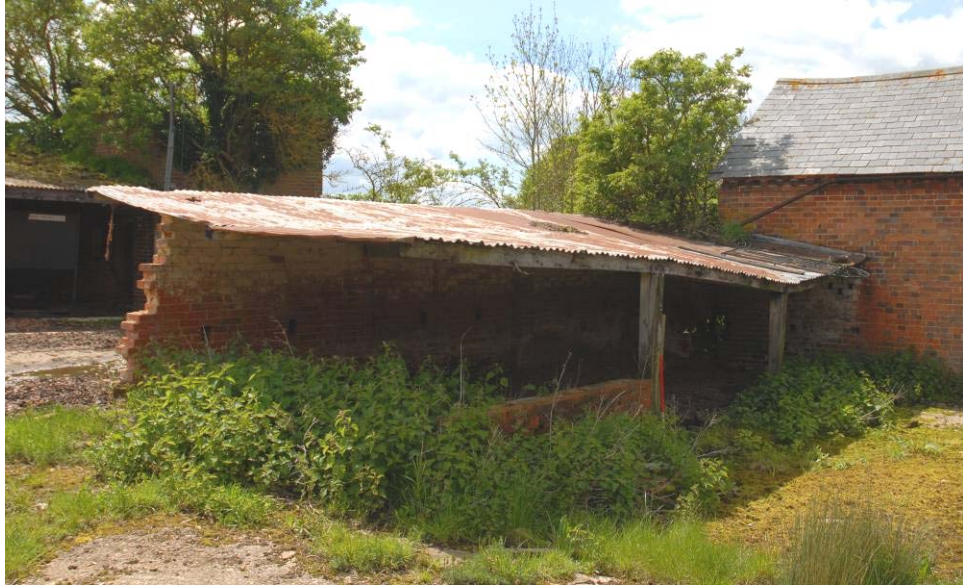
Fig 17

Building 11 comprises a post and corrugated iron roofed lean to structure built against the south wall of the smaller yard (Figs 2 and 17).

Building 11, looking south-west
