Archaeological Building Recording at The Bakehouse, 1 Wales Street, Kings Sutton Northamptonshire, March 2012

Report 12/68

April 2012

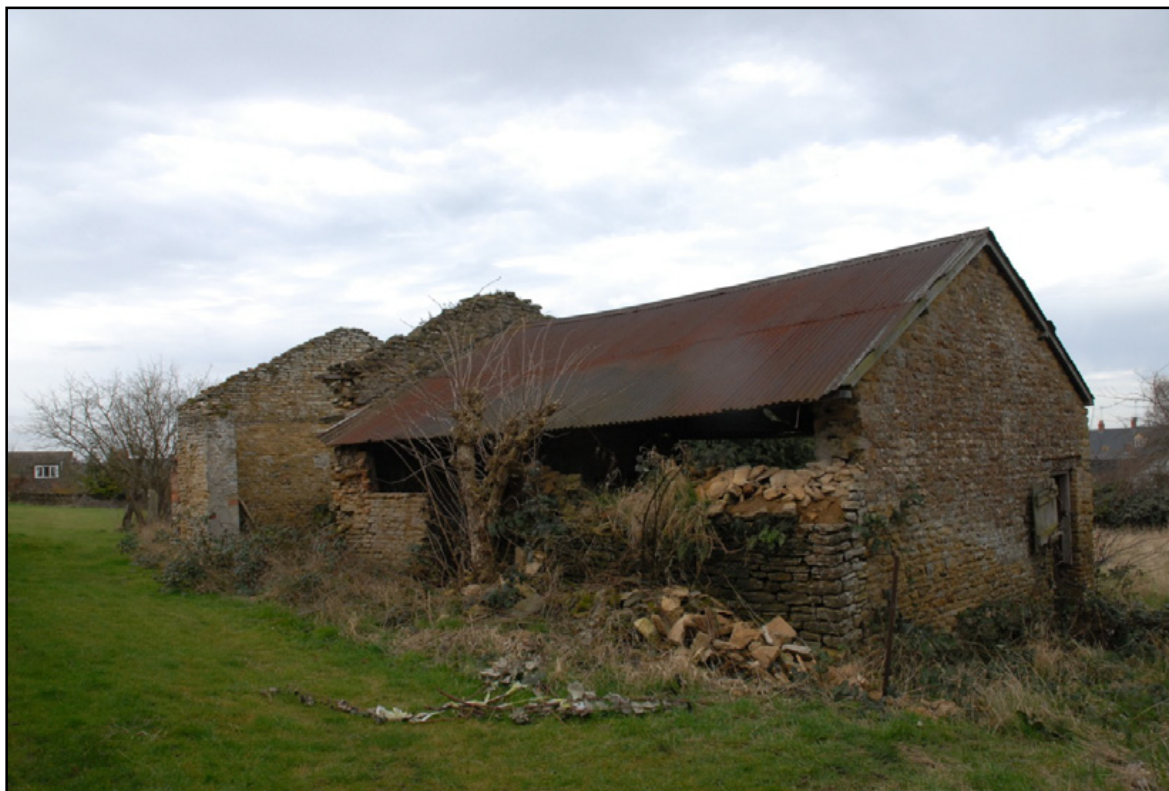
The southern elevation, looking west Fig 3

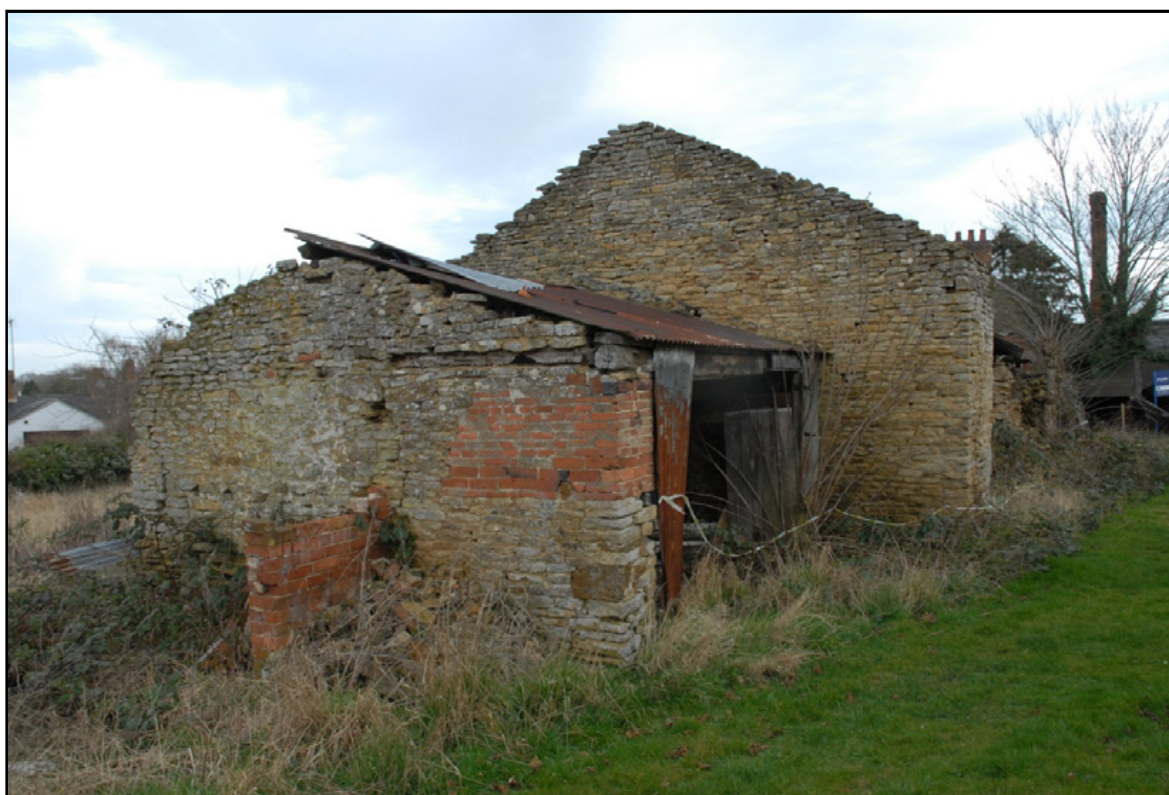
General view of the buildings, looking north-east Fig 4

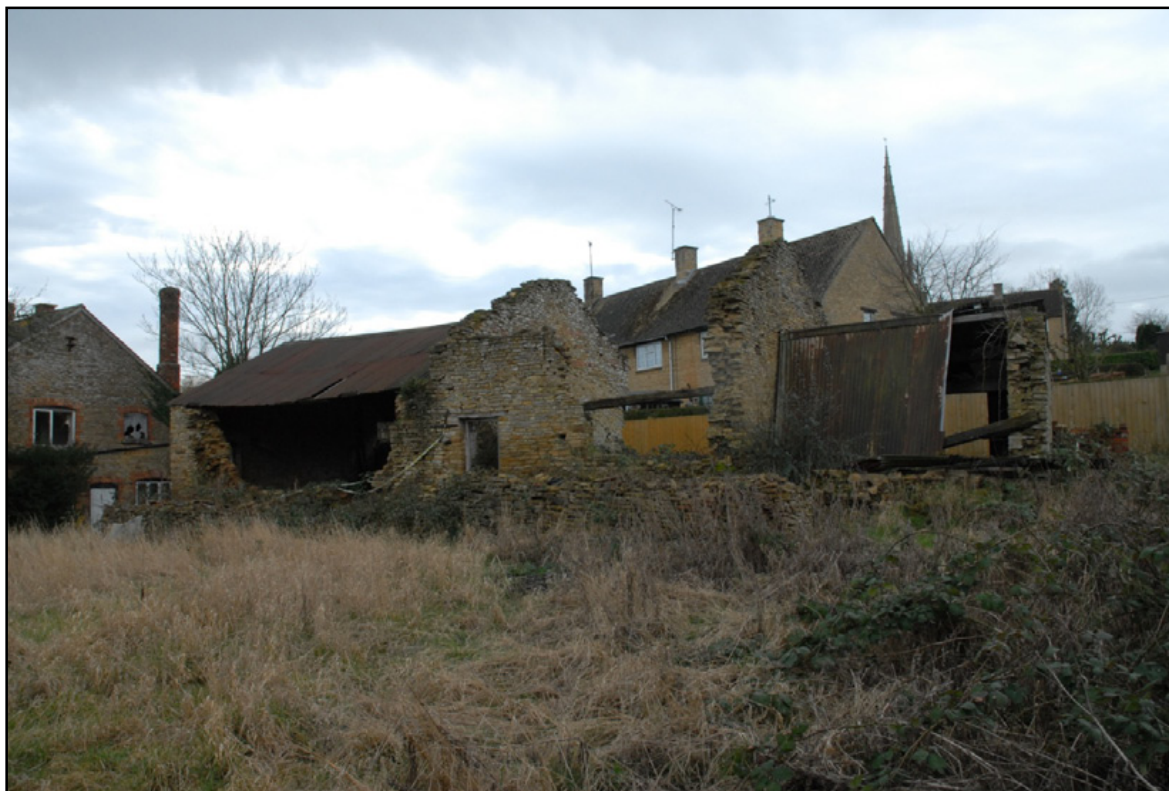
The outbuildings are in a very poor condition and partly overgrown with vegetation. Several of the walls have partially collapsed and the remaining are in a state of disrepair (Figs 3-6). The roof of Room 2 is entirely missing and the roof of Room 3 has partially collapsed into the building (Fig 5). The roof of Room 1 is in a better state of preservation though the walls on which its wall plates rest are collapsing. The remnants of a later, brick-built fourth room are partially visible, abutting the western wall of Room 3 (Figs 4).

The northern elevation, looking south-east Fig 5

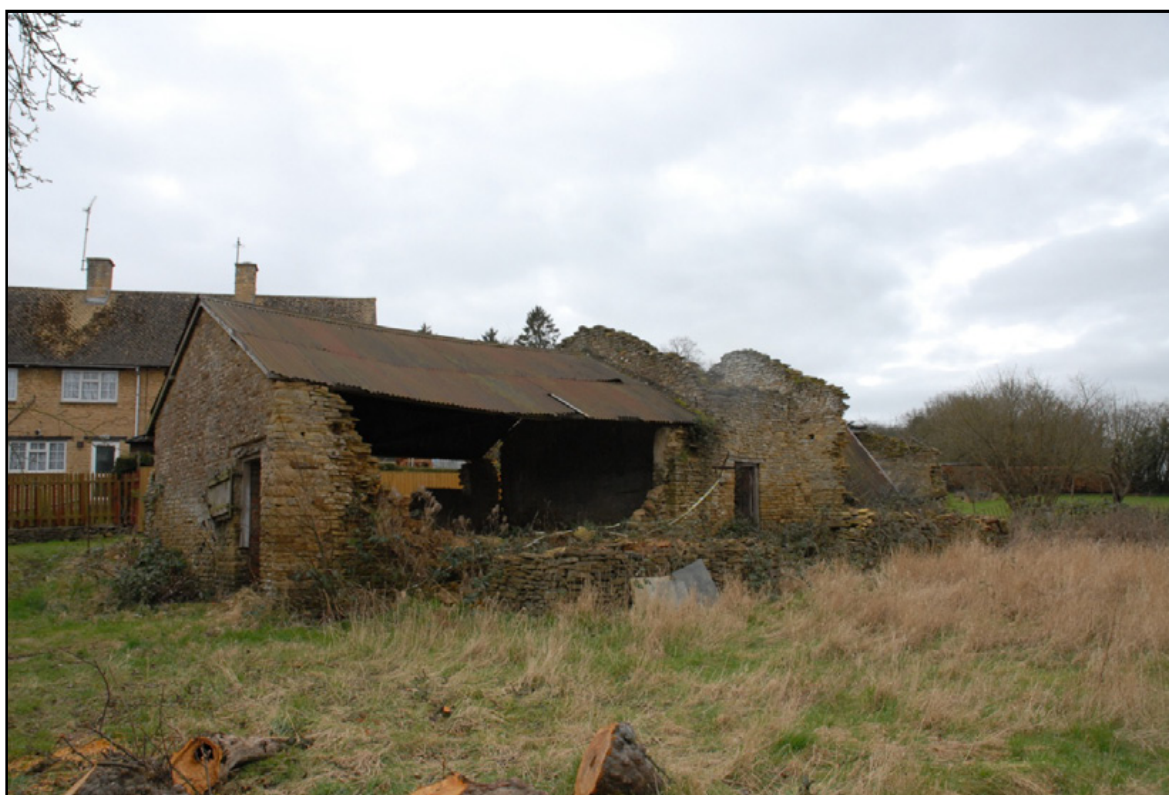
The northern elevation, looking south-west Fig 6

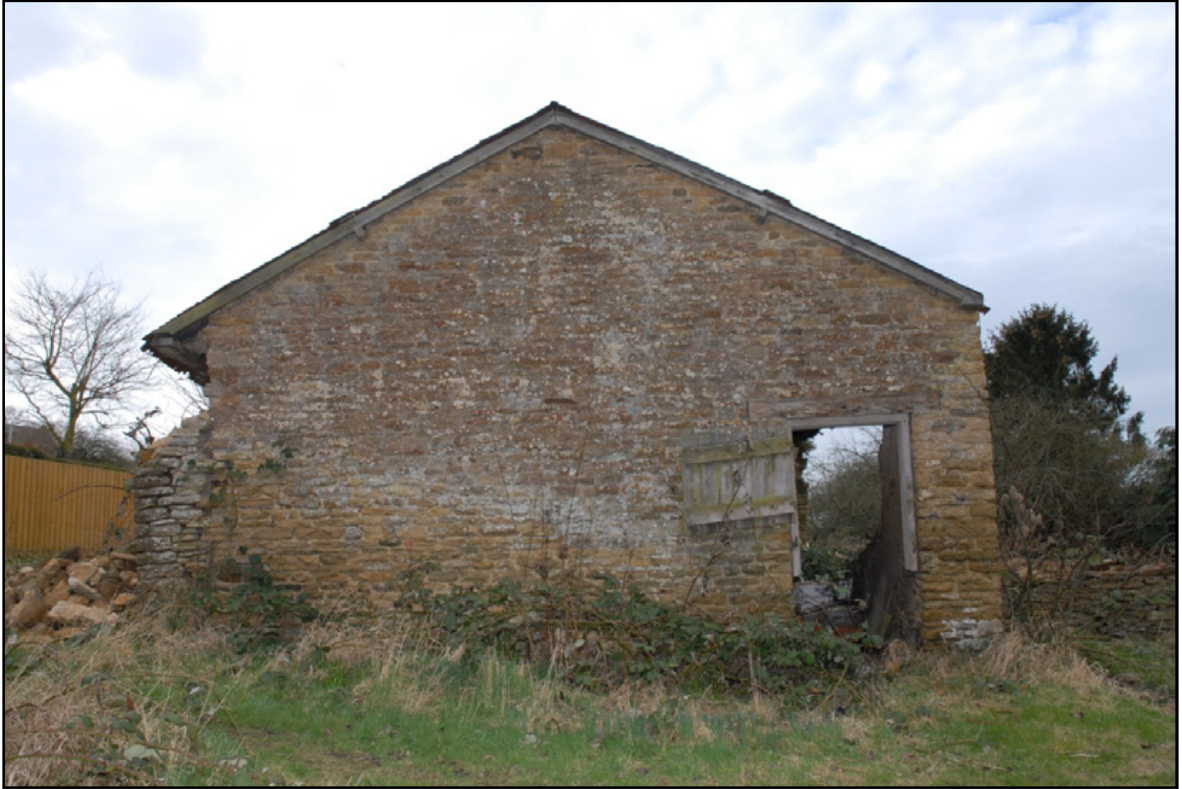
The eastern elevation, showing differential weathering, looking south-west Fig 7

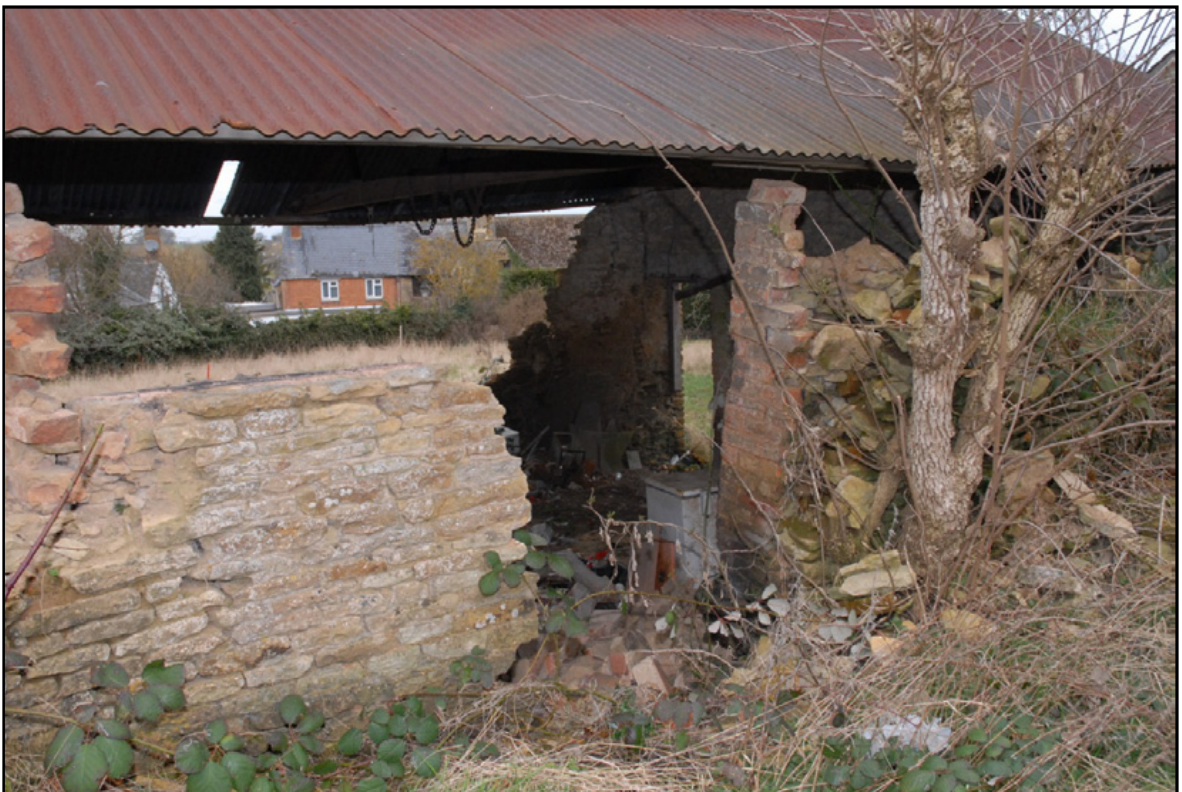
This is constructed mainly from ironstone and limestone with some brick patching around the doorway and openings. The north and south walls are in a very poor condition and have partially collapsed. The remains of a door and an opening are present in the southern wall (Fig 8). A doorway with the remains of a wooden door and frame is built into the eastern wall (Fig 9). A timber lintel supports the stonework above. The stonework on the left door jamb has been replaced with red brick on the interior. The remains of the doorway on the southern elevation also have red brick replacing the stone work on the jambs. Though the southern and northern elevations have largely collapsed, the remains of window openings are evident in the brickwork, opposite one another (Fig 10). Due to the collapse of the walls, it is unclear if these openings are later insertions or are contemporary with the building and then patched with brick. A straight, vertical joint is present on the internal northern elevation, indicating that the building was perhaps open fronted on the north and later blocked (Fig 14).

The south elevation, showing the remains of a doorway and window Fig 8

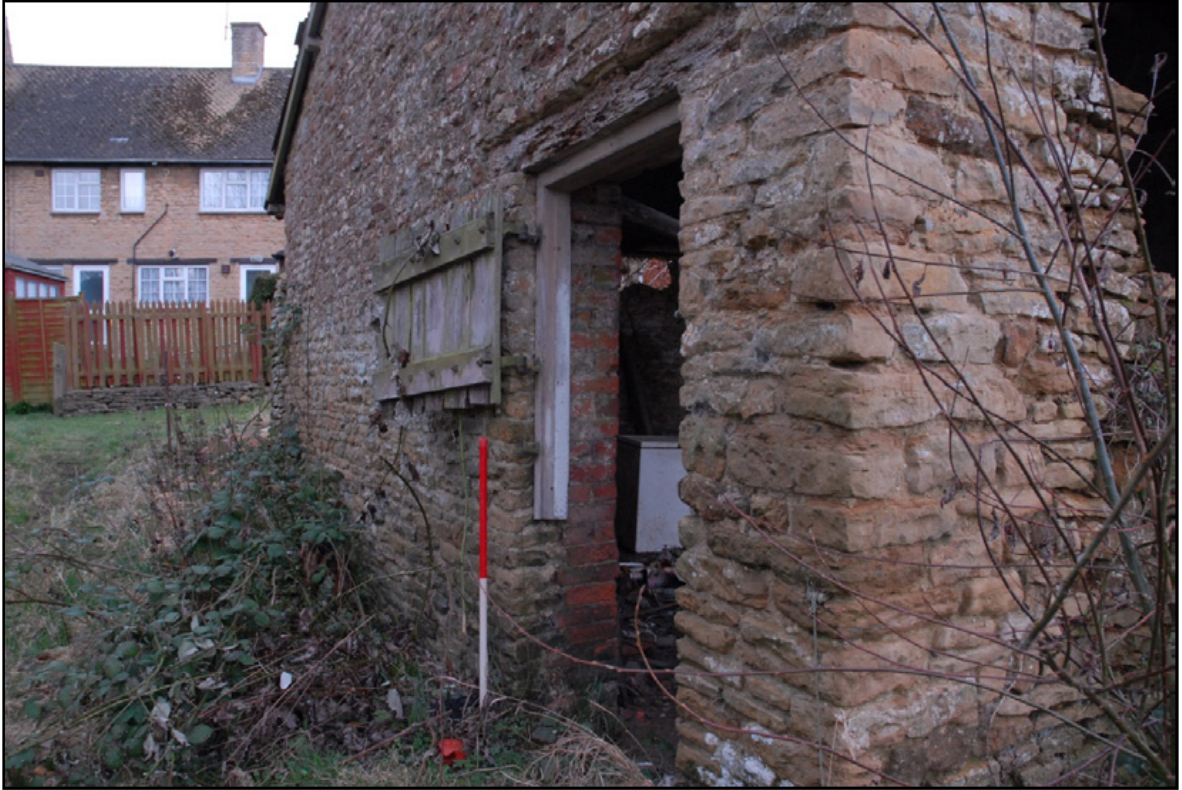
The doorway to Room 1, showing the internal brick jamb, looking south Fig 9

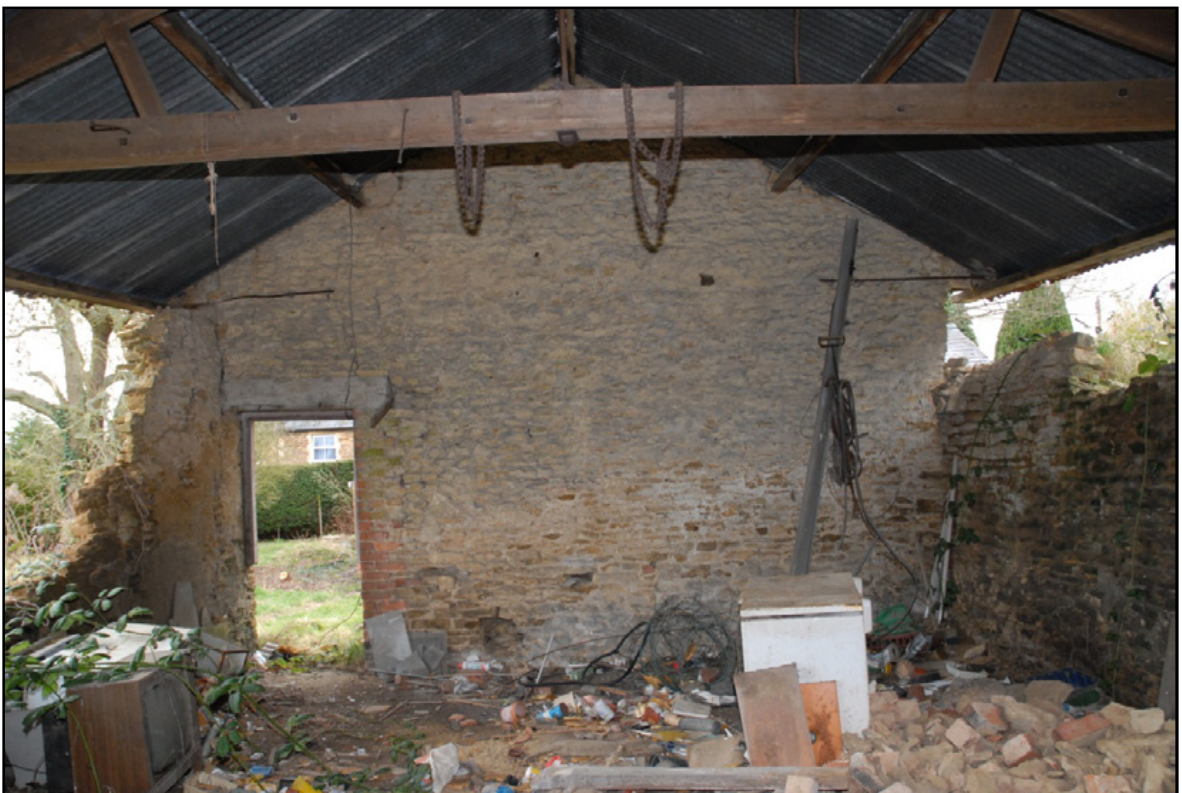
The eastern wall of Room 1 Fig 10

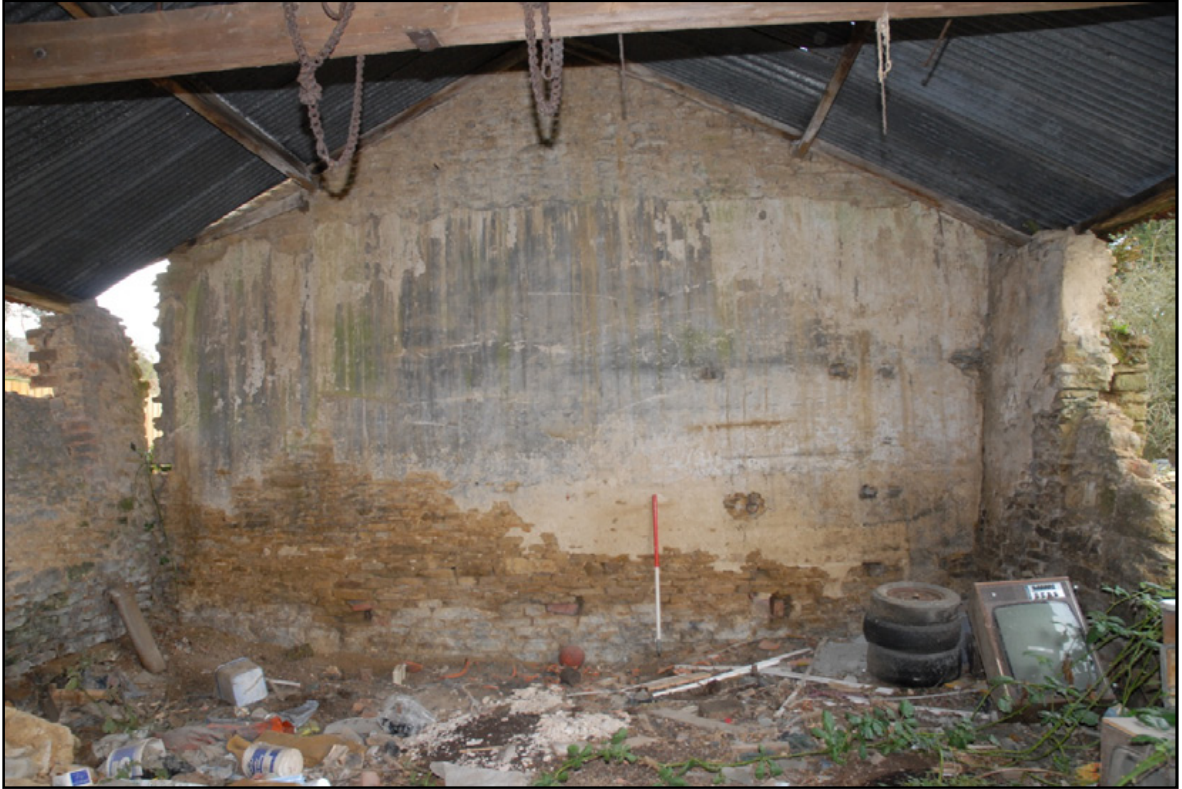
The brickwork of the internal western wall bears the remains of a creamy, yellow-grey plaster which is also present on the internal northern wall of the same room (Figs 11 & 12). The eastern and southern walls are unplastered. An iron ring is embedded in the western wall of the room, approximately 1.0m from the ground and 1.5-2.0m from the northern wall.

The western wall showing plasterwork and window openings to the right and left Fig 11

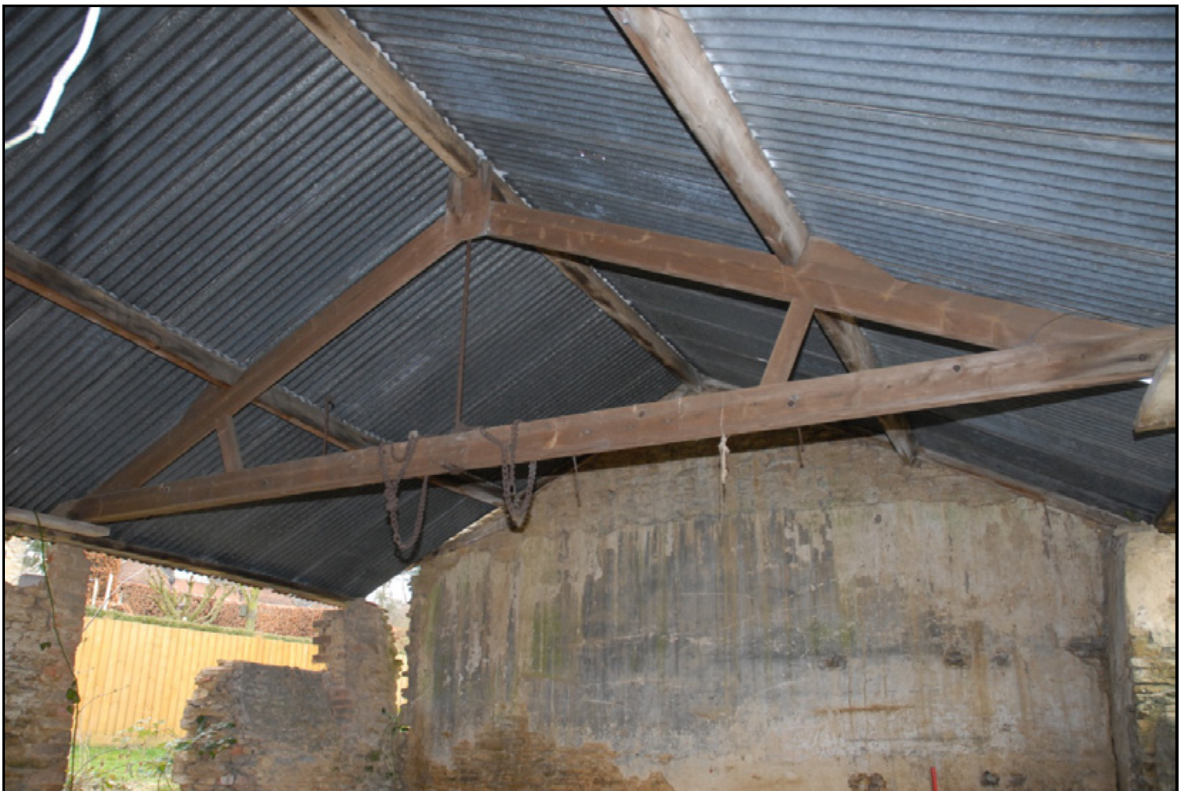
The room has a corrugated iron roof on a simple wooden frame of machine-cut timbers with timber wall plates and a central truss with iron supporting rods (Fig 12).

The corrugated iron roof with wooden frame, truss and supporting rod Fig 12

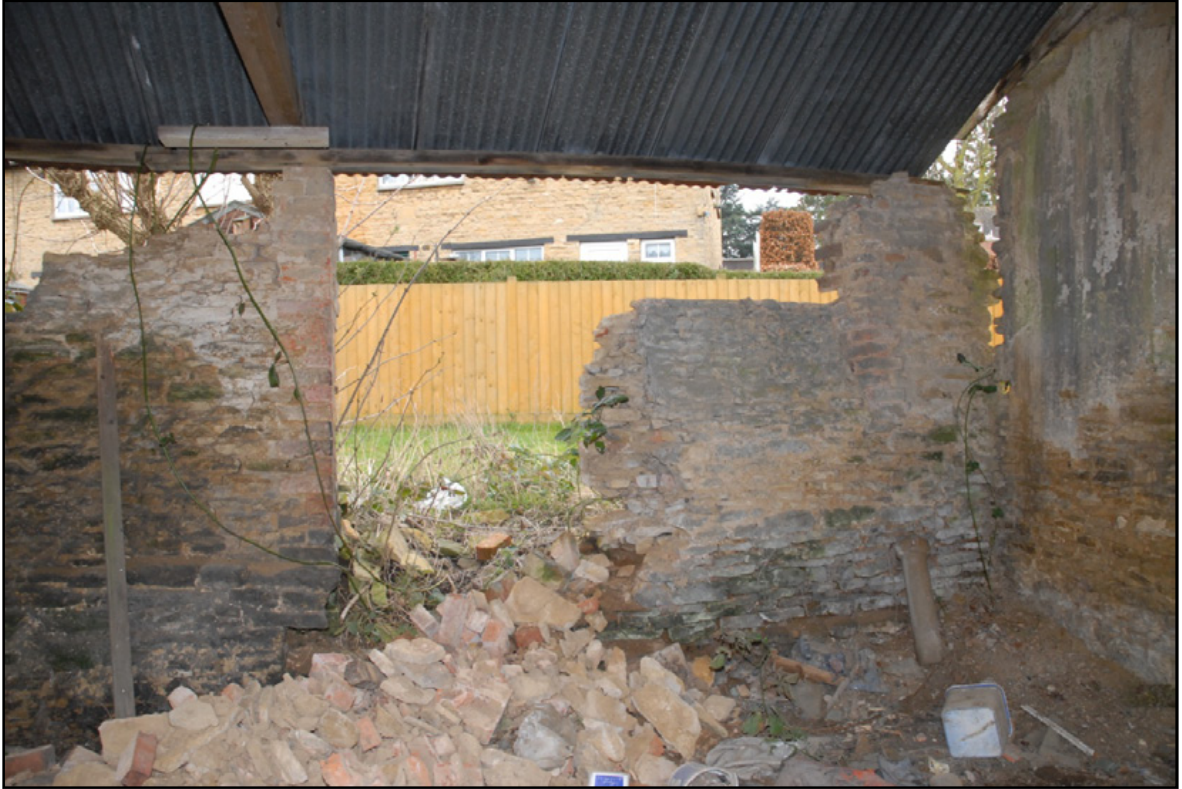
The doorway and window opening on the southern elevation of Room 1, looking south Fig 13

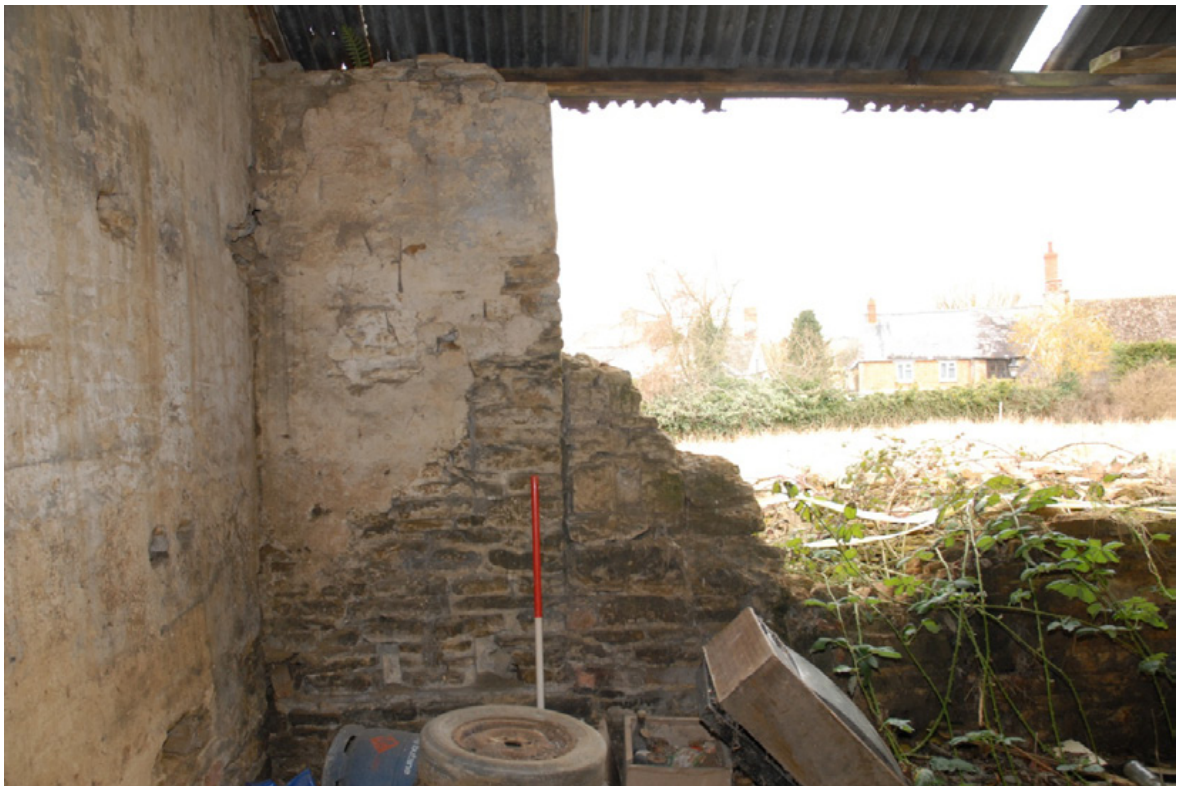
The vertical joint beneath the window opening on the northern wall, looking north-west Fig 14

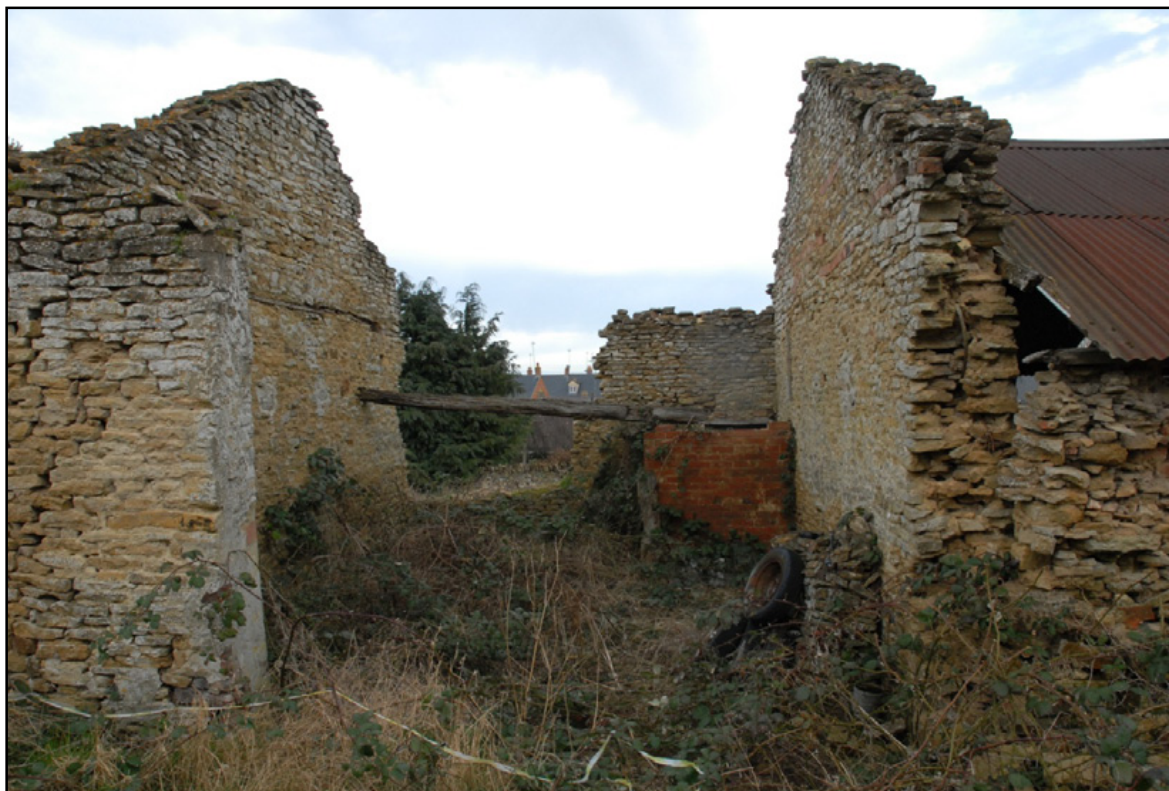
General view of Room 2, with the brick partition in the background, looking north Fig 15

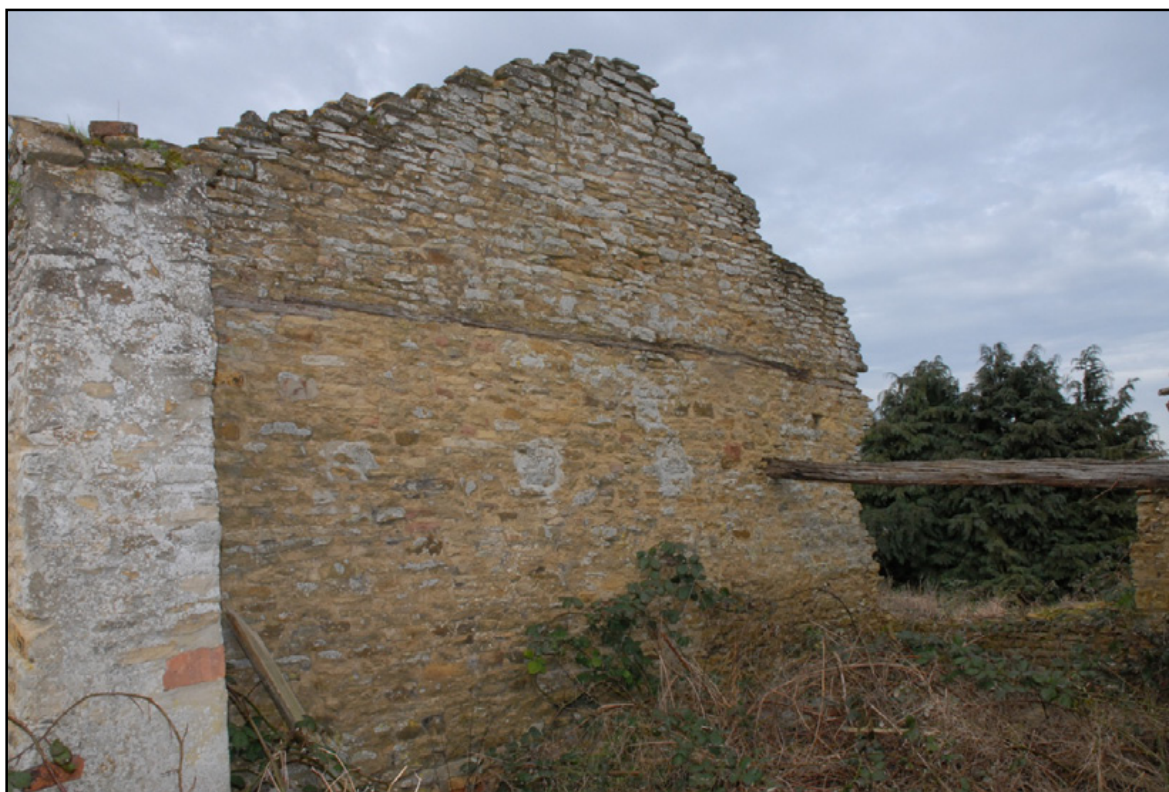
The western elevation, showing the timber course and extraneous timber Fig 16

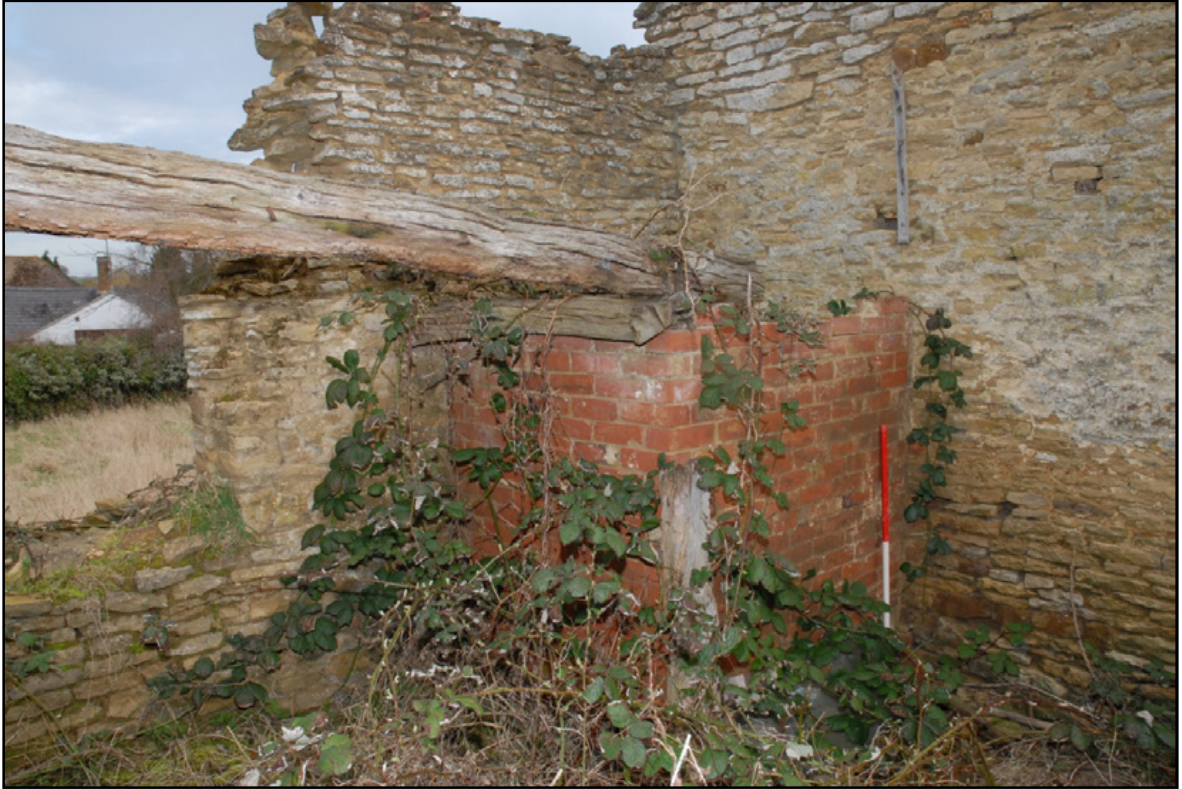
The north-eastern corner has been subdivided into a smaller room by a red brick partition wall which is mortared onto and abuts the earlier stone walls (Figs 17 & 18). It survives to a height of approximately 1.5m and encloses a space of c1.5 x 1.25m. This room is accessed by a narrow doorway in the northern elevation of Room 2 (Fig 20). Due to overgrown vegetation, this room could not be entered during the site visit. This doorway pre-dates the brick partition wall. A vertical wooden tethering post with an iron ring was present at the exterior corner of the partition wall (Fig 17). A substantial extraneous timber protrudes from the western wall and rests atop the brick partition wall. The purpose of this timber is uncertain (Figs 15-18). However, blocked sockets in adjacent stonework suggest it may be the last vestige of a lost upper floor.

The brick partition with extraneous timber and the tether post obscured by vegetation, looking north Fig 17

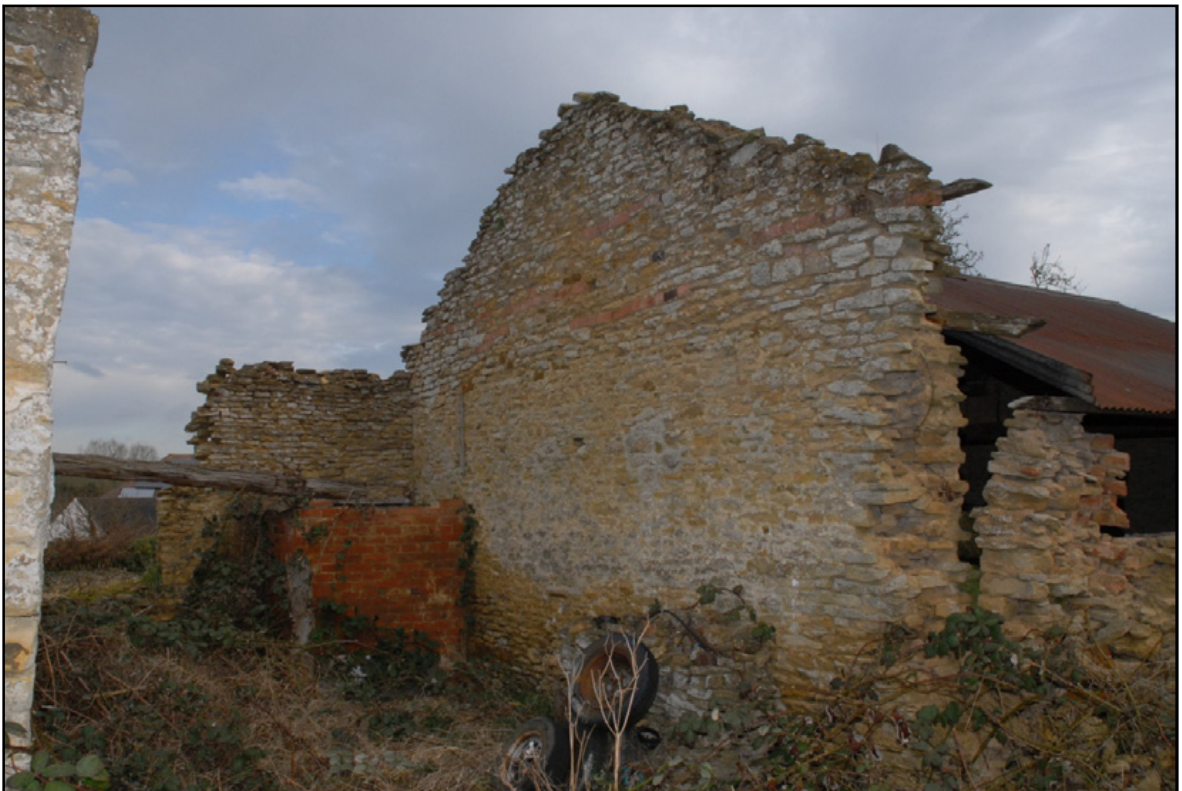
The eastern gable showing patches of red brick Fig 18

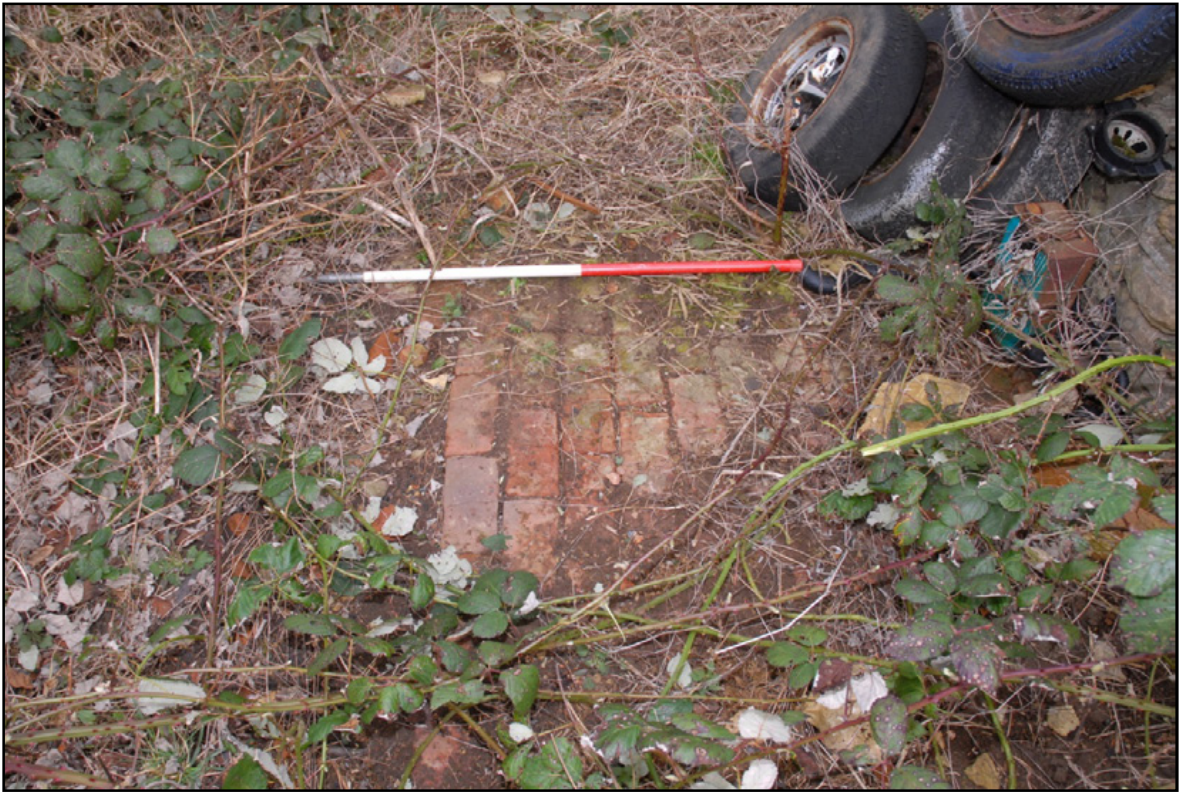
The floor of the room is largely hidden by vegetation but patches of a red brick floor surface were visible in places (Fig 19)

The brick floor in Room 2 Fig 19

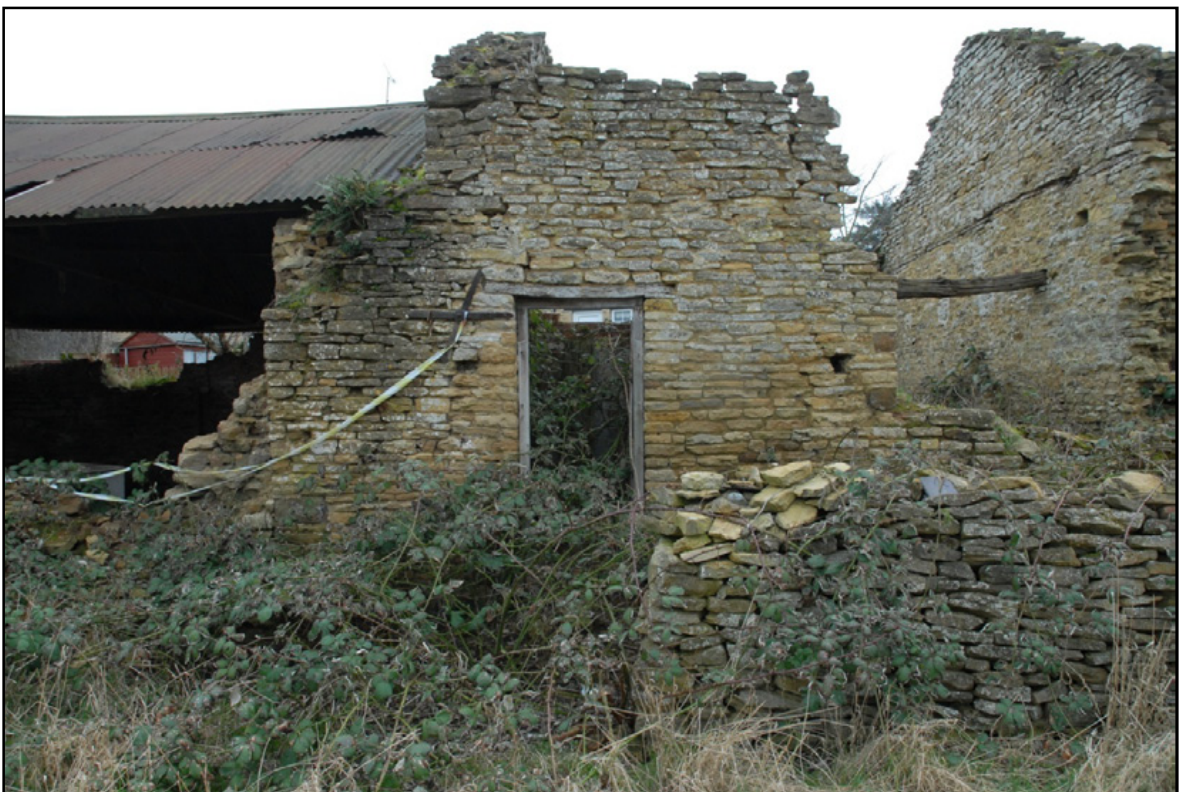
The north elevation of Room 2, showing the doorway and iron tie, looking south-east Fig 20

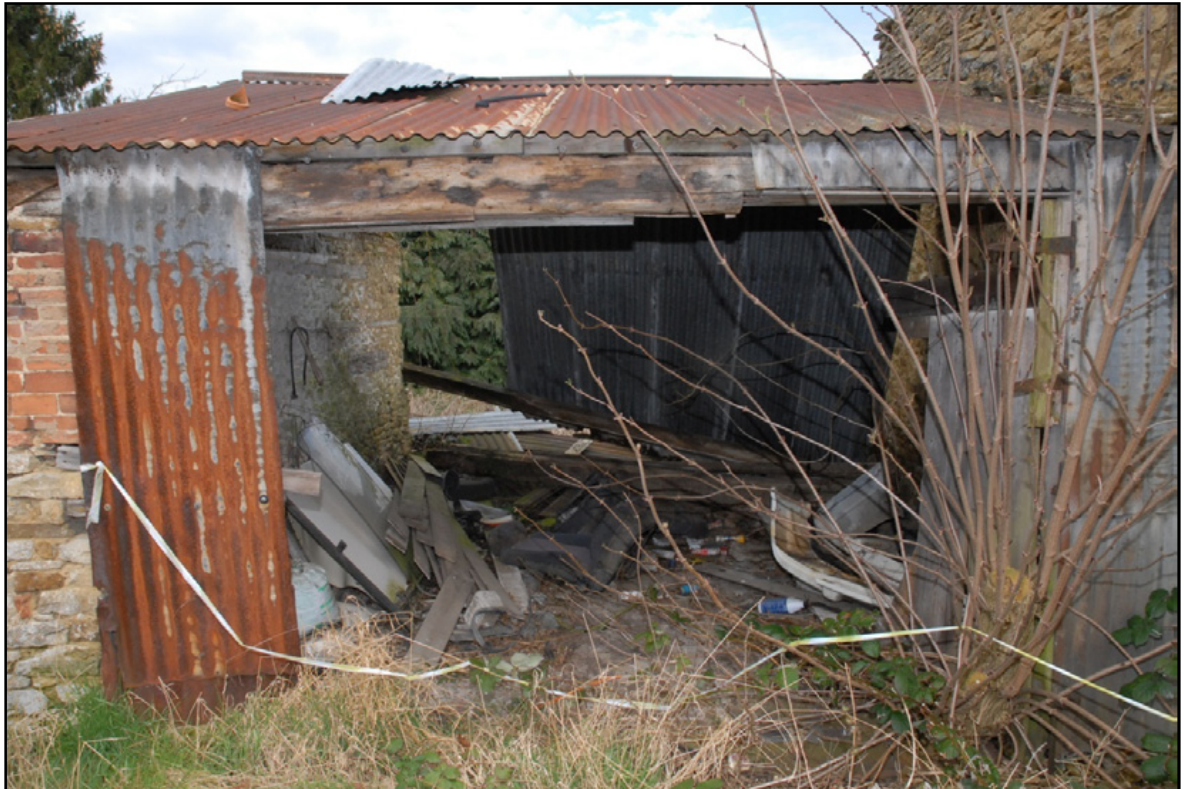
The southern elevation appears to be open fronted with corrugated iron sheets flanking the remains of a hinged wooden door. A timber lintel runs the length of the elevation, supporting the roof (Fig 21)

The south elevation of Room 3, looking north-west Fig 21

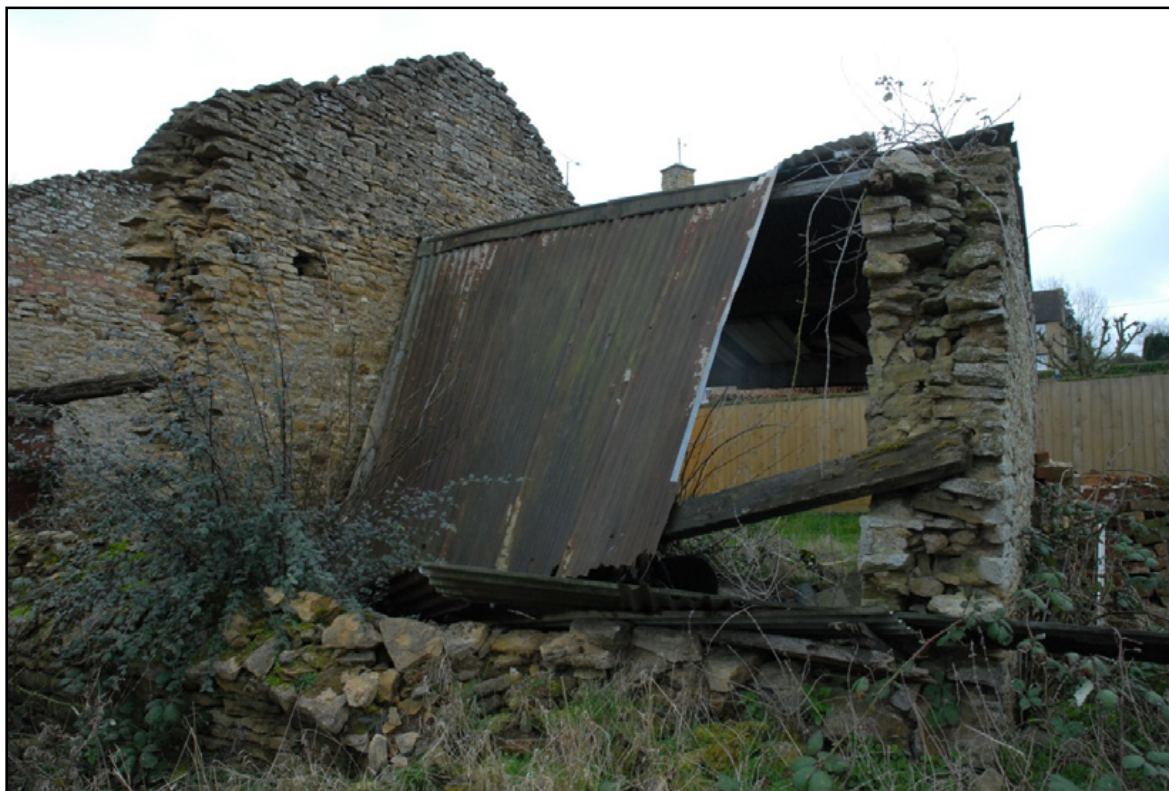
This room is built onto the western elevation of Room 2. The northern wall has collapsed outward and survives to a height of less than 1.0m (Fig 22). The corrugated iron roof has partly collapsed into the room. The room is mostly inaccessible due to vegetation and debris.

The north elevation of Room 3, showing the collapse of the north wall and roof Fig 22

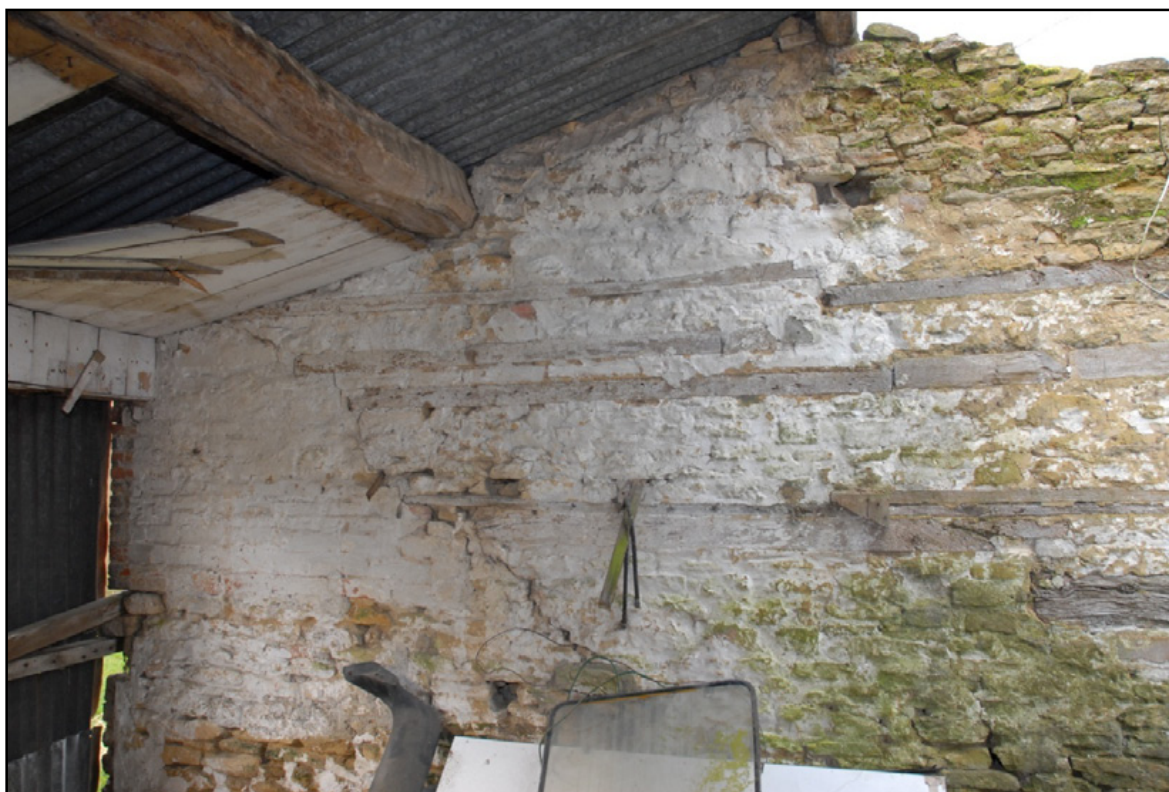
The western wall of Room 3 Fig 23

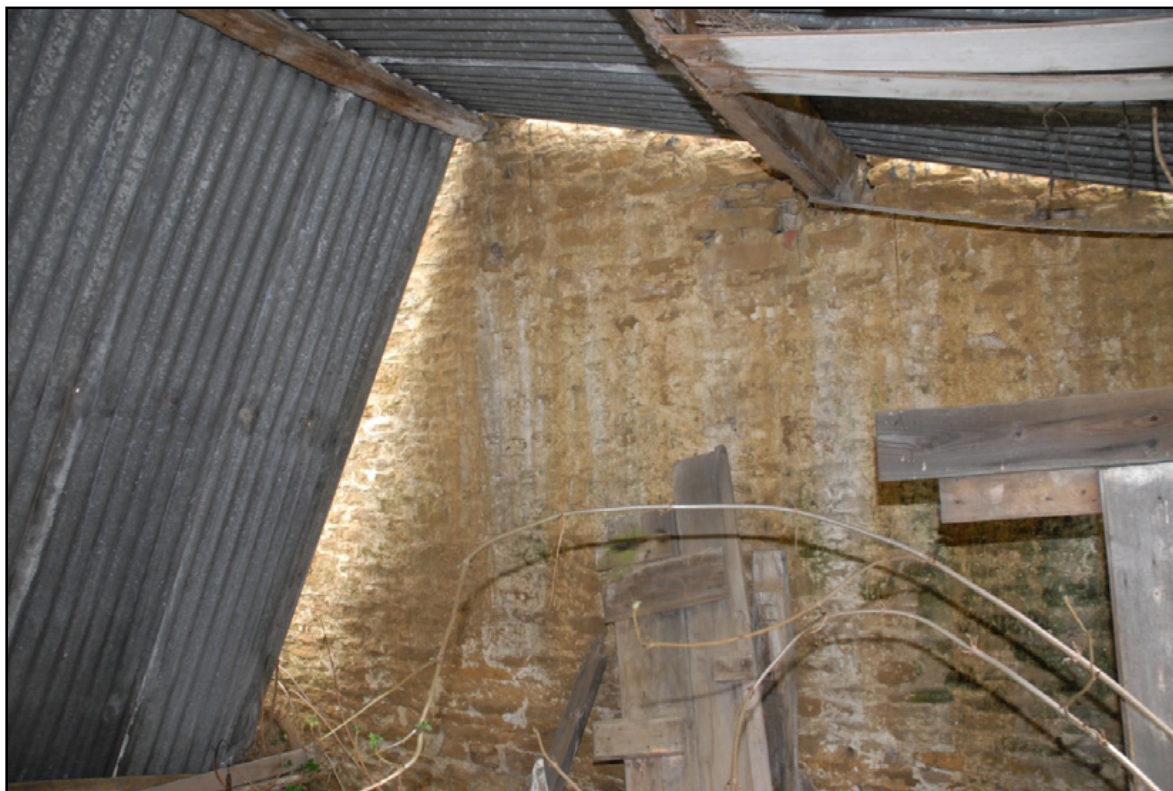
The eastern wall of Room 3 Fig 24

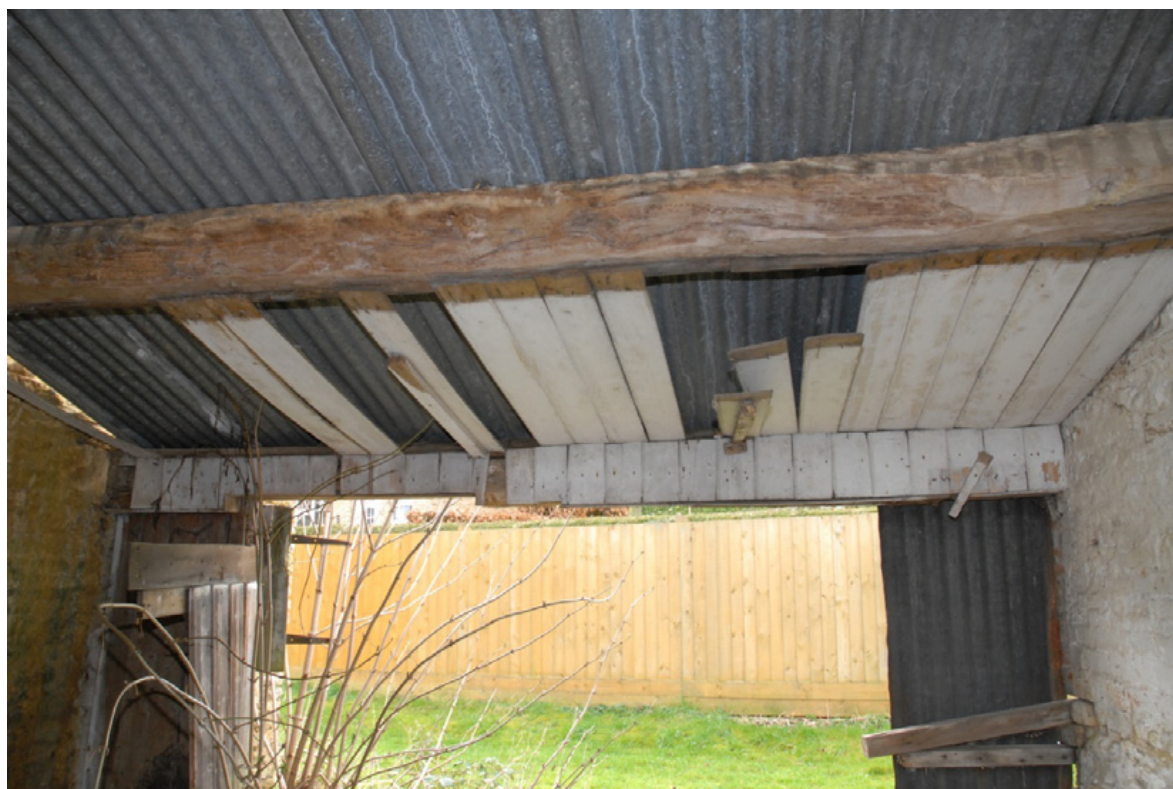
The remains of white painted, timber cladding are present on the underside of the corrugated iron roof (Fig 25). A red brick floor survives within the room.

The white painted, wood cladding below the roof of Room 3 Fig 25
