Archaeological Building Recording at The Bakehouse, 1 Wales Street, Kings Sutton Northamptonshire, March 2012

Report 12/68

April 2012

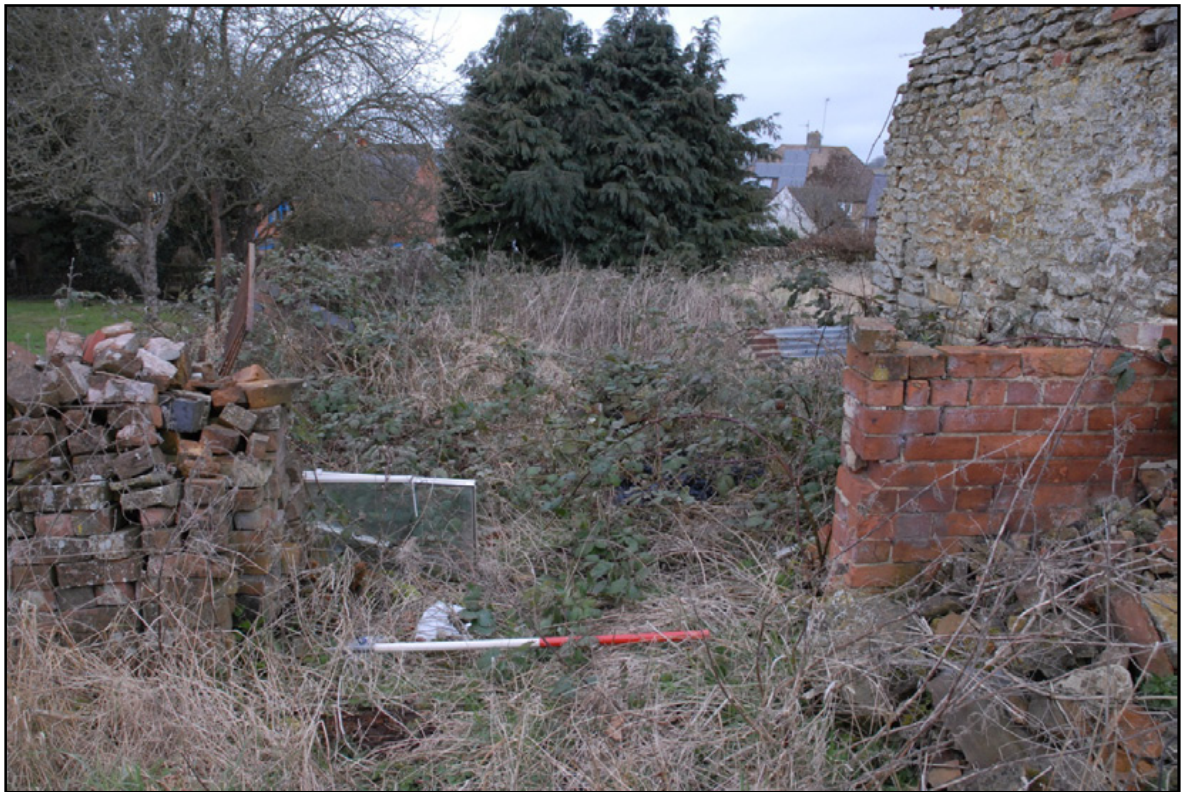
General view of Room 4 with the surviving brick wall to the right Fig 26

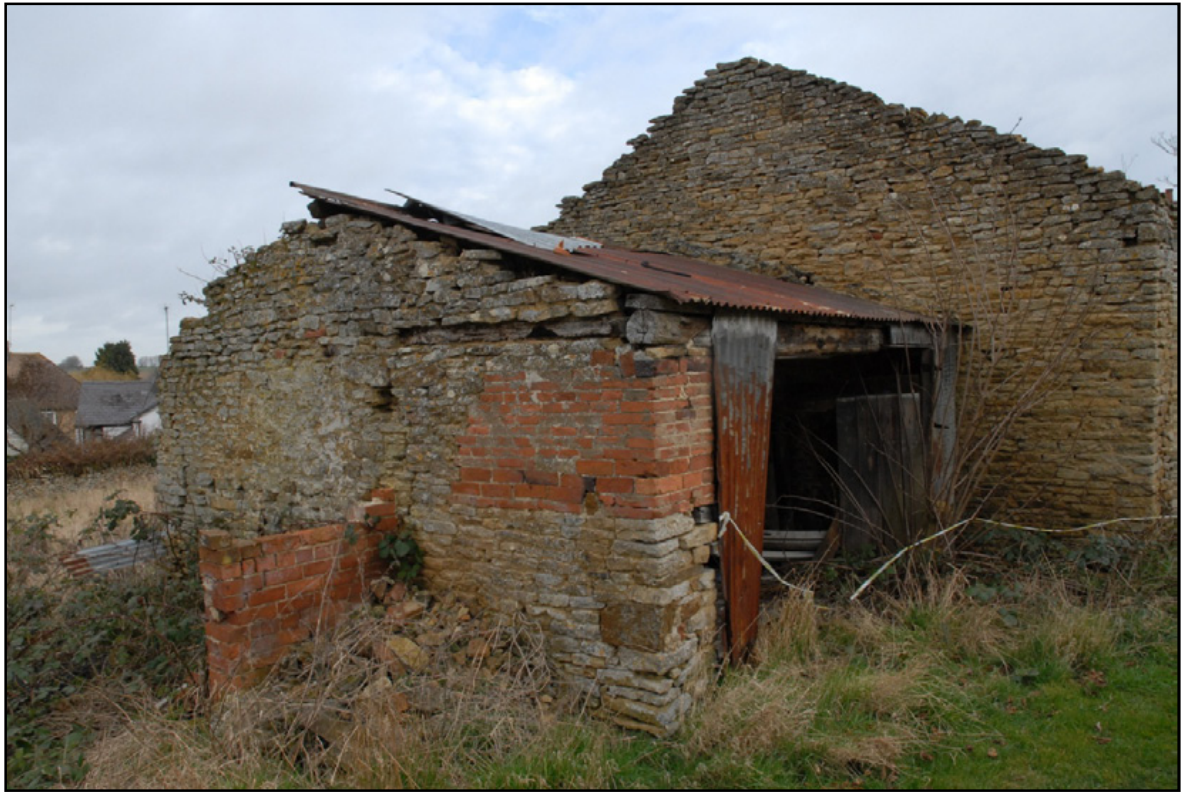
The eastern wall is a mix of construction materials, largely built from ironstone, limestone and sandstone with patches of red brick and tile. Several timbers are also present in the fabric. An area of red brick repair can be seen on the western face of the western elevation (Fig 27). The interior elevation of the western wall has been painted white. (Fig 23)

The west elevation of Room 3 with the wall of Room 4 to the left Fig 27

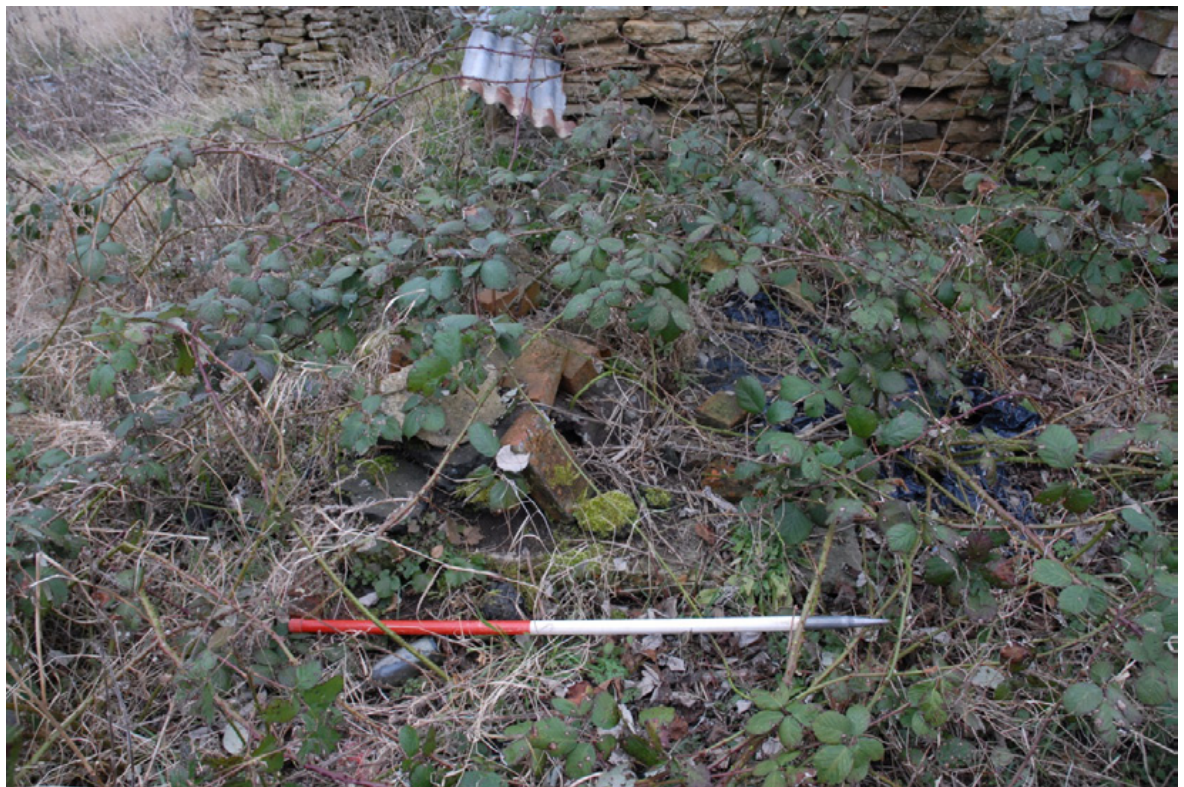
The extent of this room can only be speculated upon as it survives in scattered fragments and a small length of wall abutting the western wall of Room 4 (Figs 26 & 27). The area this room once occupied is heavily overgrown, though traces of the former brick floor are visible in the vegetation (Fig 28). This survey estimates the size of the room to be approximately 3.5 x 3.5m.

Fragments of the brick floor of Room 4, largely hidden by vegetation Fig 28
