## Archaeological building recording at Walltree House Farm, Steane, Northamptonshire

Report 13/80

May 2013

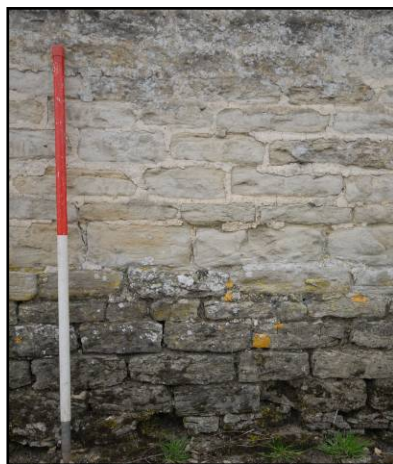
The barn was constructed with coursed pale grey limestone bonded in a lime mortar (Fig 14), small patches were repaired with concrete mortar. Internally the walls are lined with bricks bonded in a lime mortar. They are laid alternatively with two rows of shiners and rowlocks (also known as rat-trap bond) with a row of stretchers (Fig 15), this pattern is not repeated in the brick pilasters. The bricks (240mm x 110mm x 70mm) are red in colour and have small to medium-sized inclusions (including flint) and voids. This was possibly to give the wall a smoother, cleaner surface.

External limestone wall, Fig 14  
looking north-west

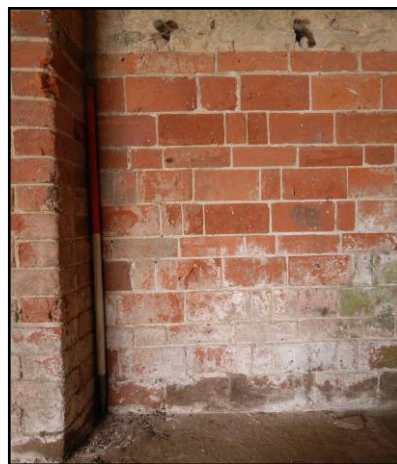
Internal brick wall, Fig 15  
looking south-west

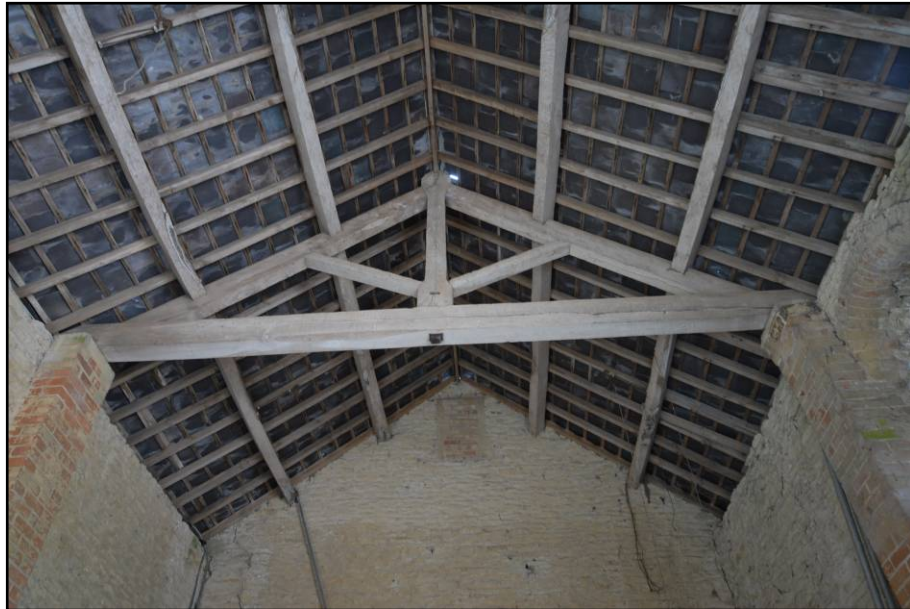
The roof of the gabled building was constructed of timber and laid with grey Welsh slate tiles. There are three wooden machine sawn king post trusses, supporting a frame of machine sawn purlins, rafters and battens (Fig 16). The north-eastern bay was also supported with iron ties, and externally the western bay was supported on the south-western corner by a stone buttress (Fig 17).

Machine sawn king post trusses, purlins, rafters and battens Fig 16

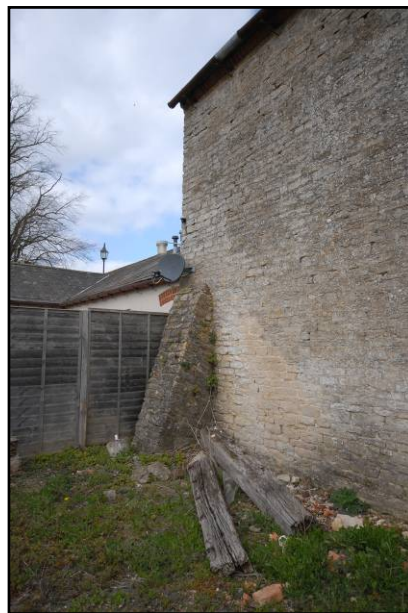
Buttress, looking north-west Fig 17

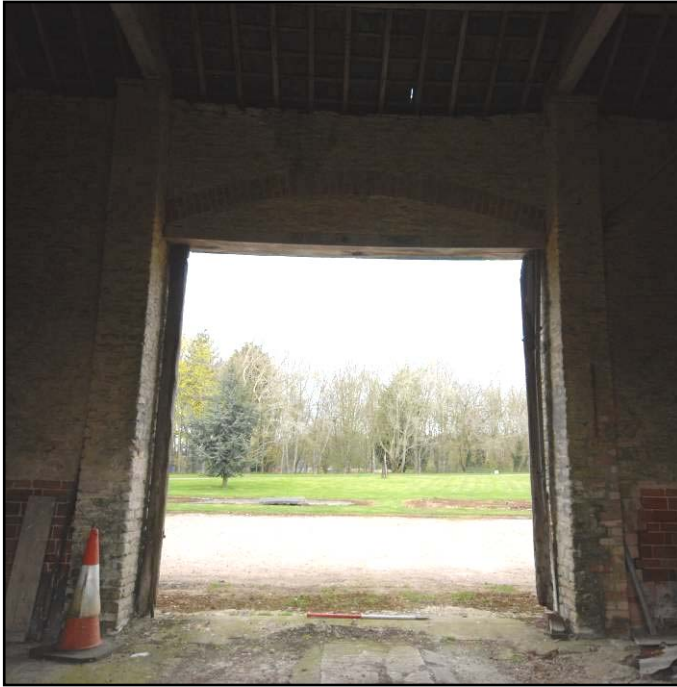
There were three pairs of pilasters supporting the trusses. All were brick except for the two flanking the north-western door, which were stone-built (Fig 18). The north-eastern stone pilaster was repaired with brick (Fig 19). There are other areas of the internal stone wall that have been repaired with brick, this brick (220mm x 100mm x 70mm) is a variegated red and yellow colour; possibly used by the Ministry of Defence (MoD). The top of the wall was finished off externally with a header course of bull-nosed bricks and a rounded stone at each corner.

Stone pilasters, looking north-west Fig 18

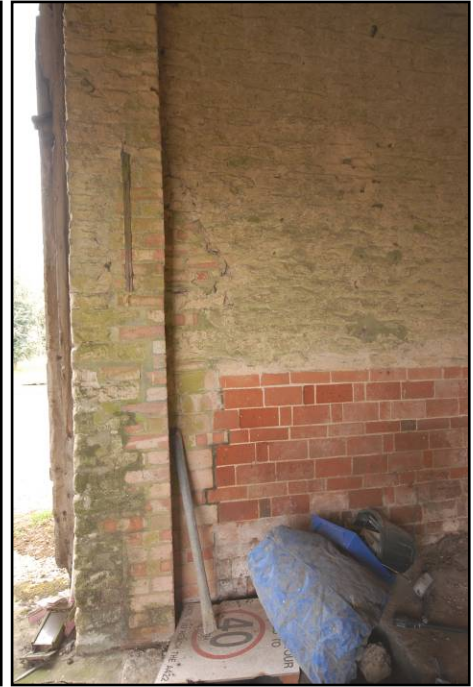
Brick repairs to pilaster, looking north-west Fig 19

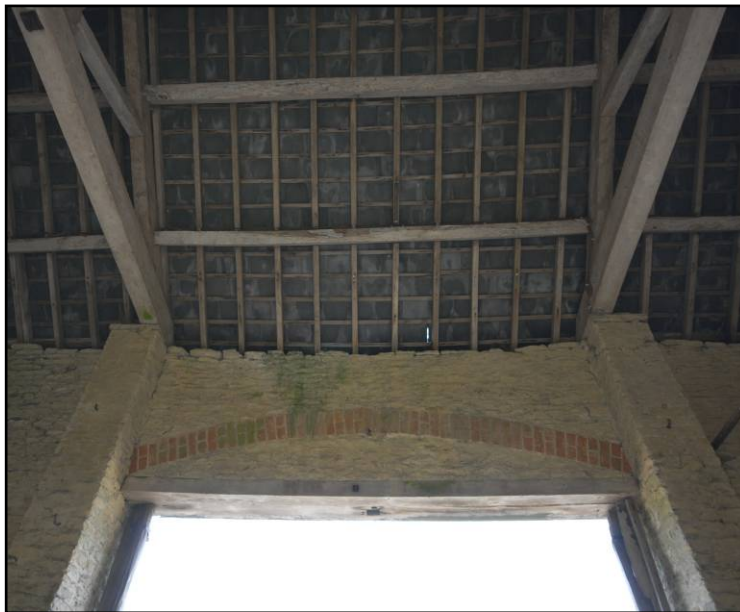
The building has two large opposing entrances on the north-west and south-east sides. The lintel of the north-west door are two wooden beams, internally a segmental relieving arch is visible above the door (Fig 20). Two wooden door jambs with iron hinges remain, however, the left one was bent out of position (Fig 21).

Brick segmental relieving arch, looking north-west Fig 20

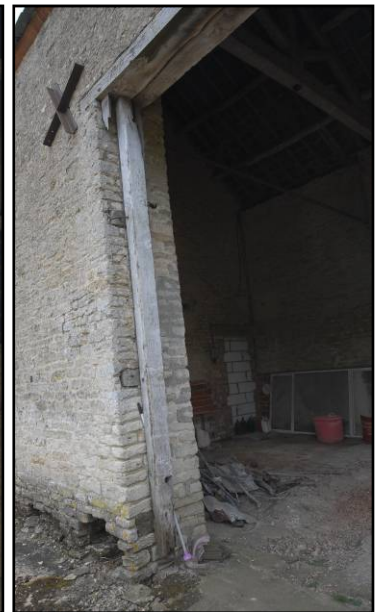
Door jamb, looking east Fig 21

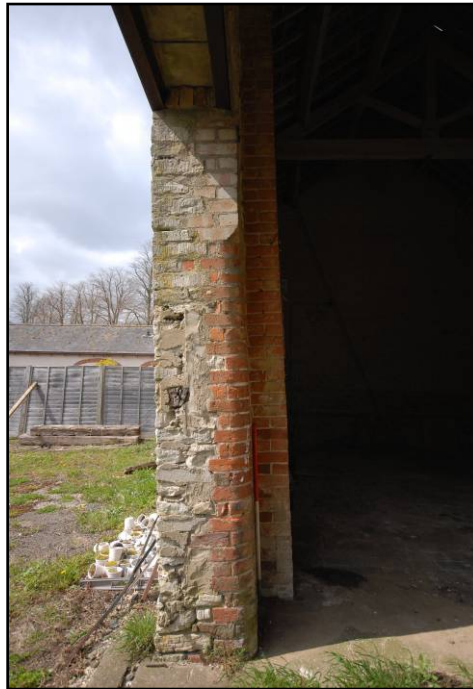
The south-east door was originally much lower than the other; the original bull-nosed brick used on the inside of the doorway remain. During the Second World War the MoD raised this door, this can be seen through the use of the red and yellow variegated brick, the in-between brick was chamfered to give a neat transition (Fig 22). Bull-nosed bricks

are typically used to avoid damage to the arris over time. Also a steel girder was used as a lintel, and only one of the wooden door jambs remain.

Original features and changes to door,  
looking south-west Fig 22

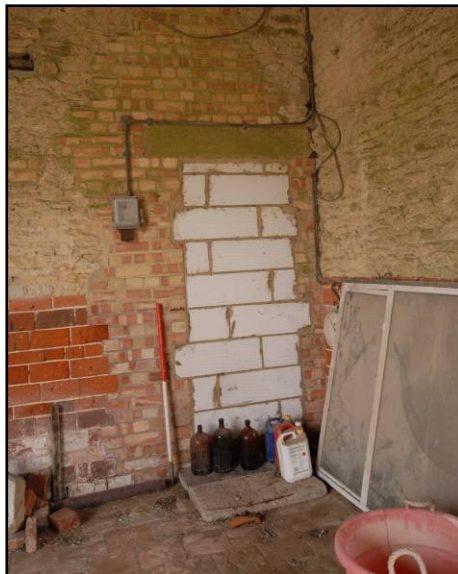
At the south-western and north-eastern corners of the barns are openings bricked-up with breeze blocks. These doors were later inserted to connect the barn with the buildings to either side, but closed off when the neighbouring buildings were converted. Both openings have concrete lintels and extensive brickwork repairs surrounding the openings. The brick utilised is the variegated yellow and red variety. The south-western opening has a wooden plywood box as steps whereas the other opening has a concrete step (Figs 23 and 24).

North-eastern door, Fig 23  
looking north-east

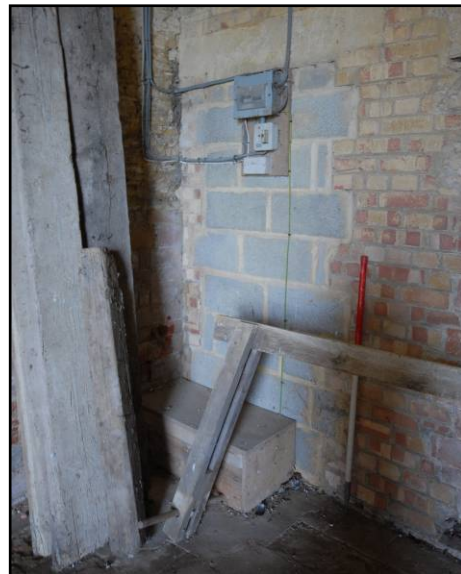
North-western door, Fig 24  
looking north-west

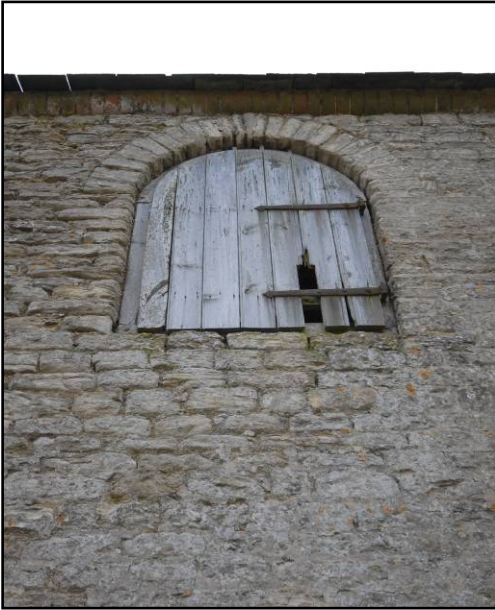
An arched opening was located in the north-western bay at a high level, just under the eaves next to one of the pilasters. Externally the opening is constructed entirely of stone (Fig 25). Internally the arch and right side is lined with bull-nosed bricks, the left hand side is keyed into the pilaster to give a flush surface. The lintel is probably tiled (Fig 26).

External view of window, Fig 25  
looking south-east

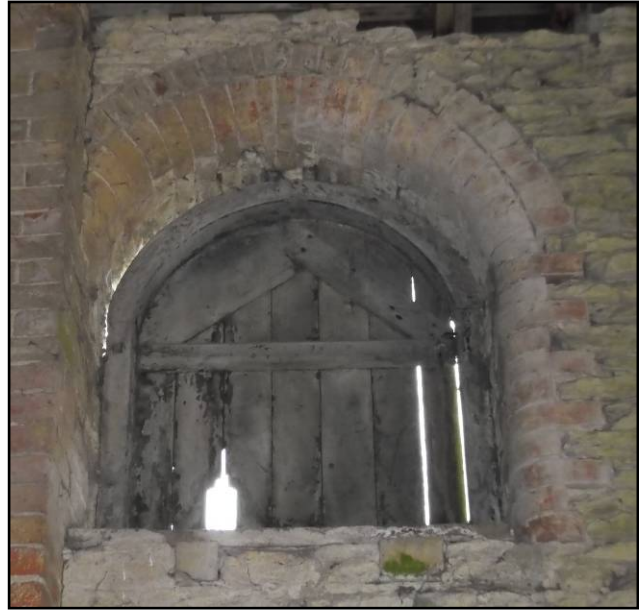
Internal view of window, Fig 26  
looking north-west

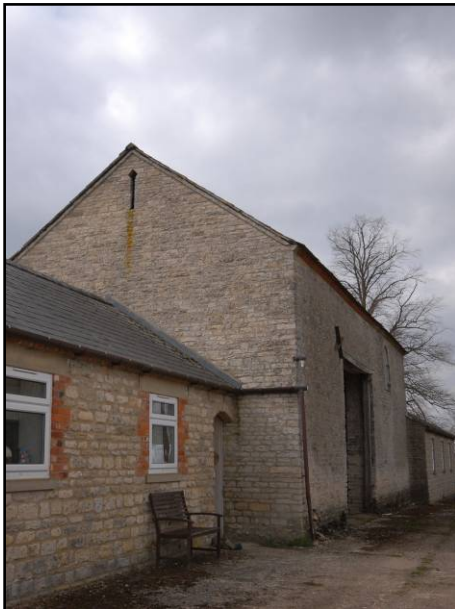
At the top of each gable are externally narrow slit windows (Fig 27), internally it can be noted that they have been bricked up. It is likely that they were splayed as the bricked-up area is a much larger rectangle (Fig 28).

External view of window, Fig 27  
looking south-west

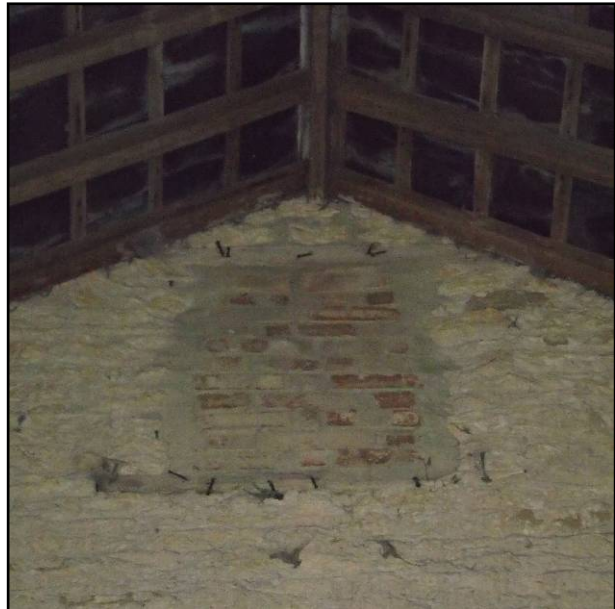
Internal view of window, Fig 28  
looking south-west

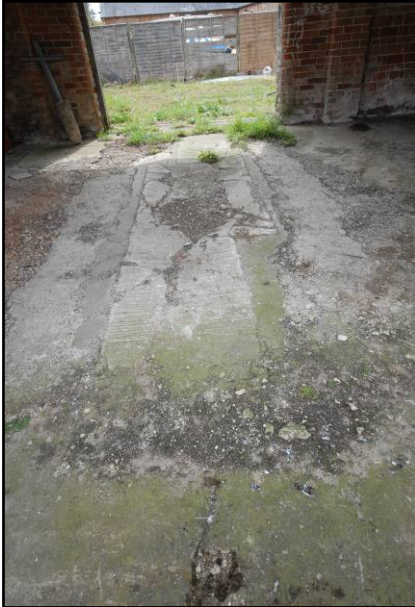
The flooring can be divided into three distinct areas. The central area between the two barn doors has been replaced by concrete with an asymmetrical level surface in the centre (Fig 29). To either side the original brick and tile floor remains, albeit in a poor

Central concrete area, Fig 29  
looking south-east

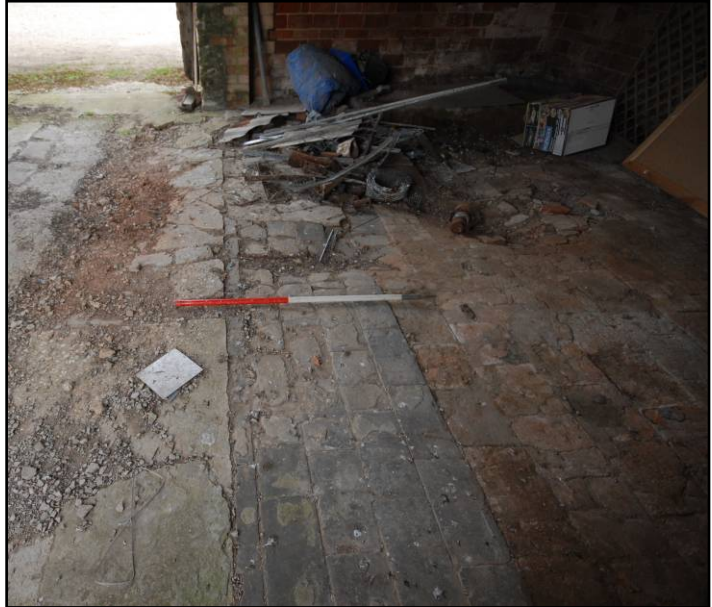
condition. The areas are lined with blue bricks with a wider central part (Fig 30), the remainder of the floor was laid with red square tiles (240mm x 240mm) (Fig 31). A possible repair was made near the north-western door where the floor was laid with red brick. There are areas that have been infilled with concrete or dirt. In the south-western corner is a raised concrete platform, measuring 2.10m by 0.85m.

Blue brick border, looking north-west Fig 30

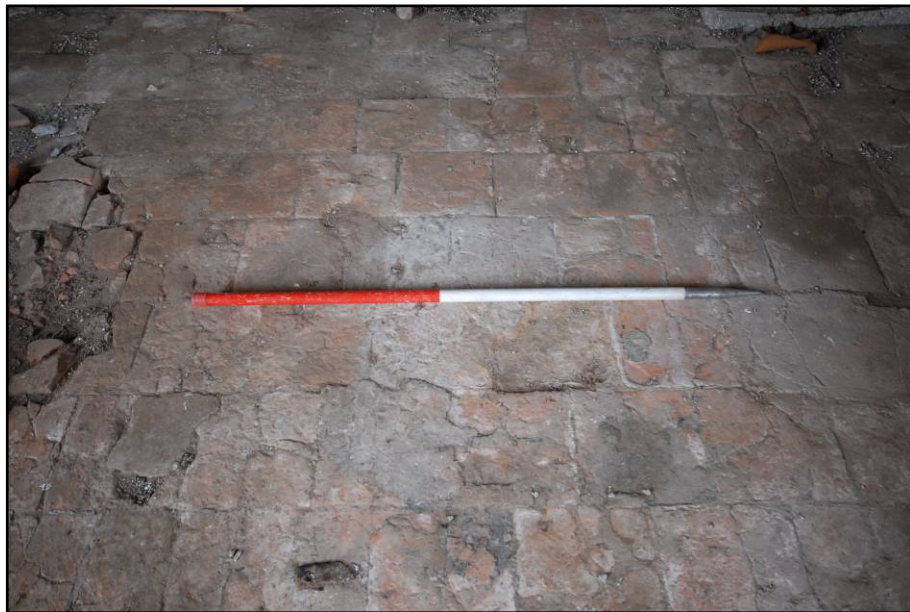
Red tile detail, looking north-east Fig 31

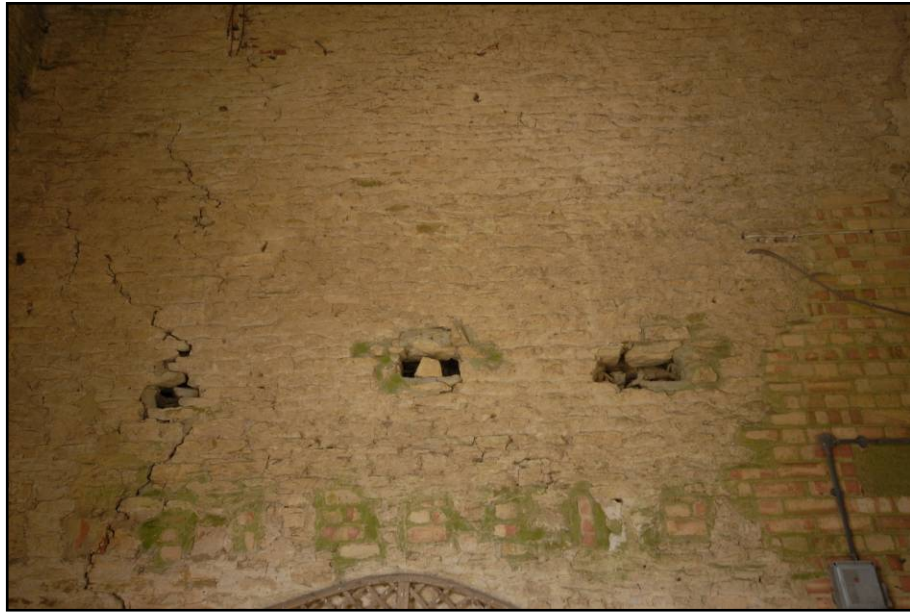
There is very little evidence of original fixtures or fittings. There is electricity in the barn. On the wall, approximately at a height of 2.62m, are three hollows. These are large enough for beam slots, but there is no evidence on the side walls of slots. Therefore it is difficult to conclude if there ever was a platform in this part of the barn. Below these is a row of infilled holes (Fig 32). On the right, inside the south-western door, are three wooden stumps (Fig 33).

Holes in the wall, looking south-east Fig 32

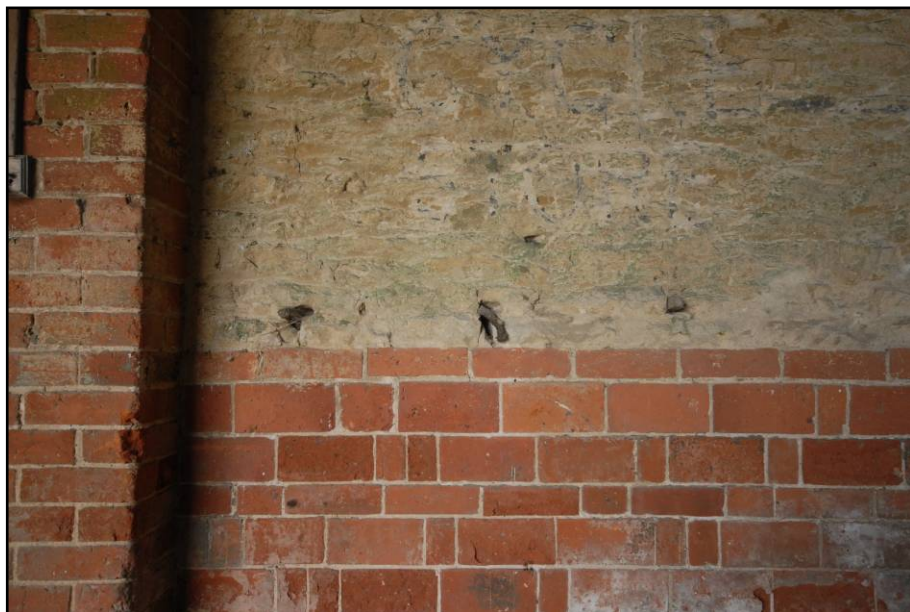
Wooden pegs in wall, looking south-west Fig 33
