Archaeological building recording at 23 Regent  
Street, Northampton  
June 2013

Report 13/113

July 2013

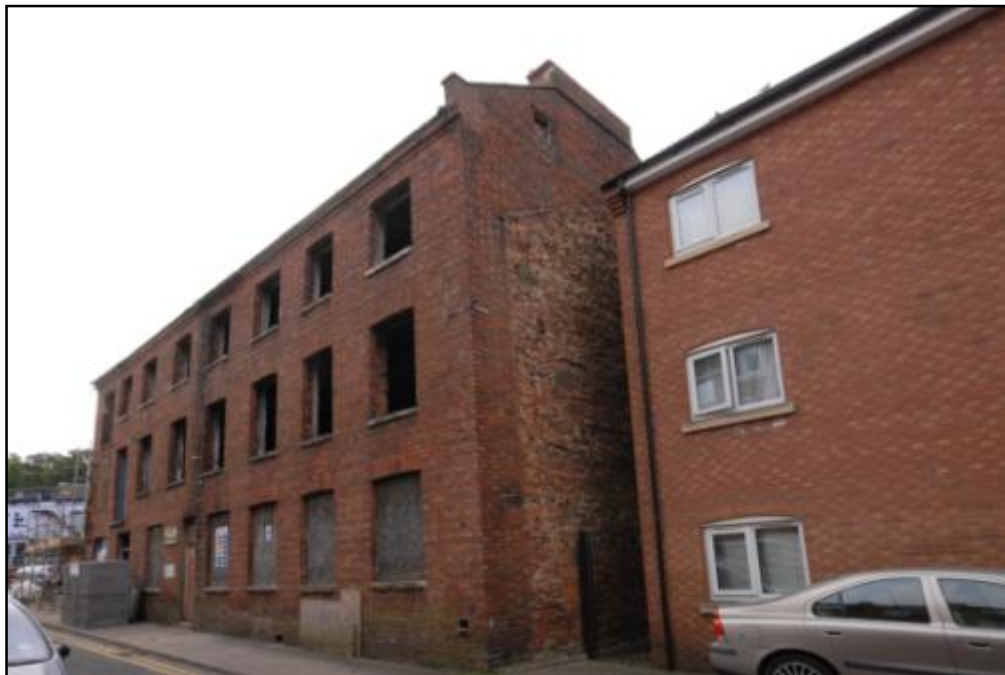
Historic maps show several smaller structures present in the current courtyard area, abutting the south wall of Building 2. A scar seen on the south wall of Building 2 likely relates to one of these structures. Evidence for a former, gabled building, demolished to make way for housing, could be seen on the western elevation of Building 2 (Fig 9).

The north and western elevations of Building 2, showing scar of demolished structure Fig 9

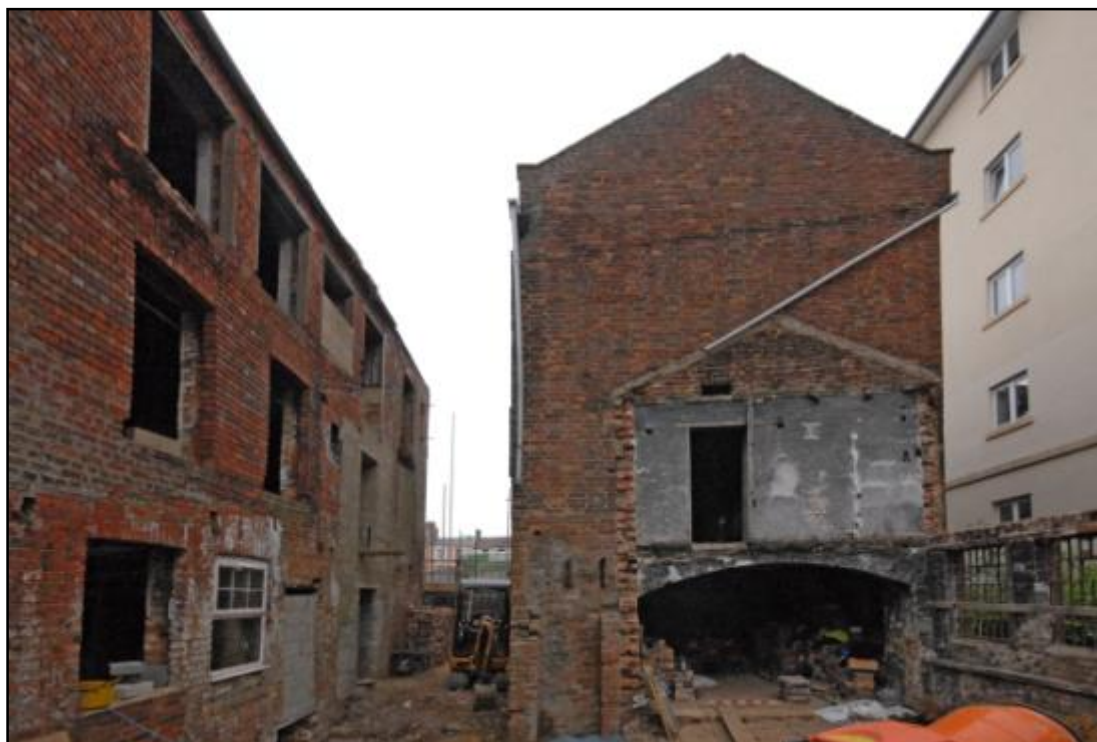
The west elevation of Building 1, showing scars of demolished annex, looking east  
Fig 16

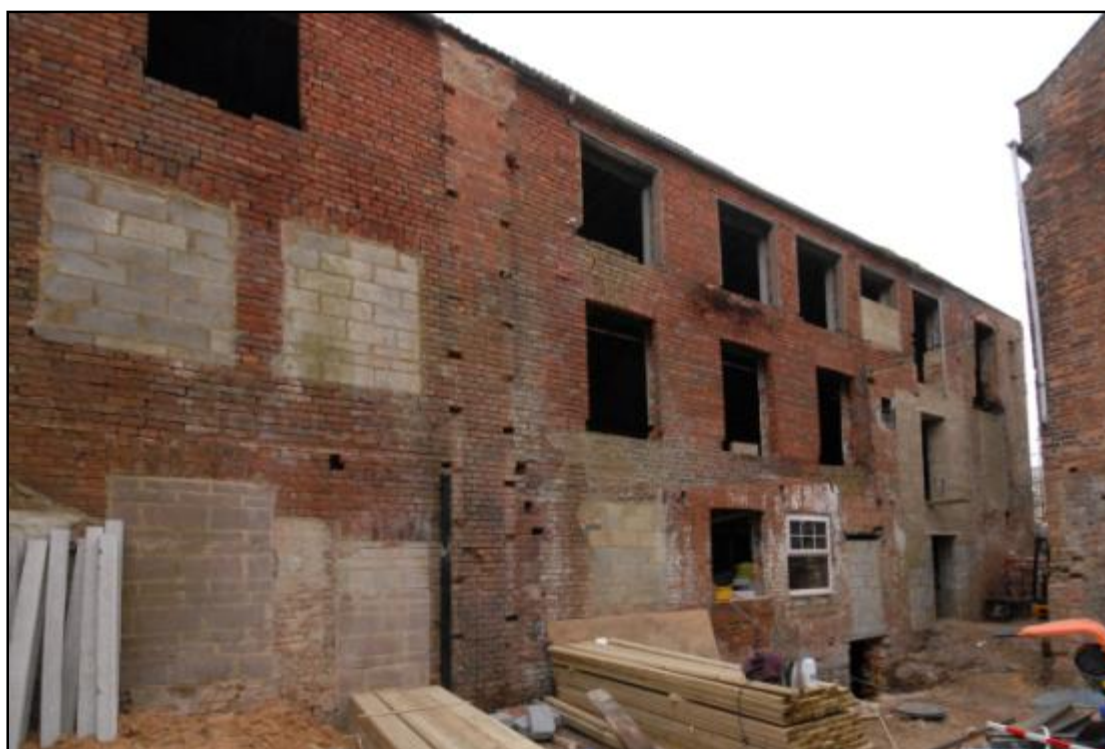
The uniformity in window and door configuration seen on the north elevation of Building 2 is partially disrupted on the south elevation (Fig 17). The regularity of the windows is disrupted at ground floor level for reasons which are unclear due to lack of remaining evidence. Built at a lower level than the windows to either side, a doorway in this elevation provides access from the courtyard to the ground floor of Building 2. A blocked doorway in the basement suggests a former stair leading up to the courtyard in this area (Fig 60).

South elevation of Building 2 with staggered beam slots and scar visible, looking north-  
east Fig 17

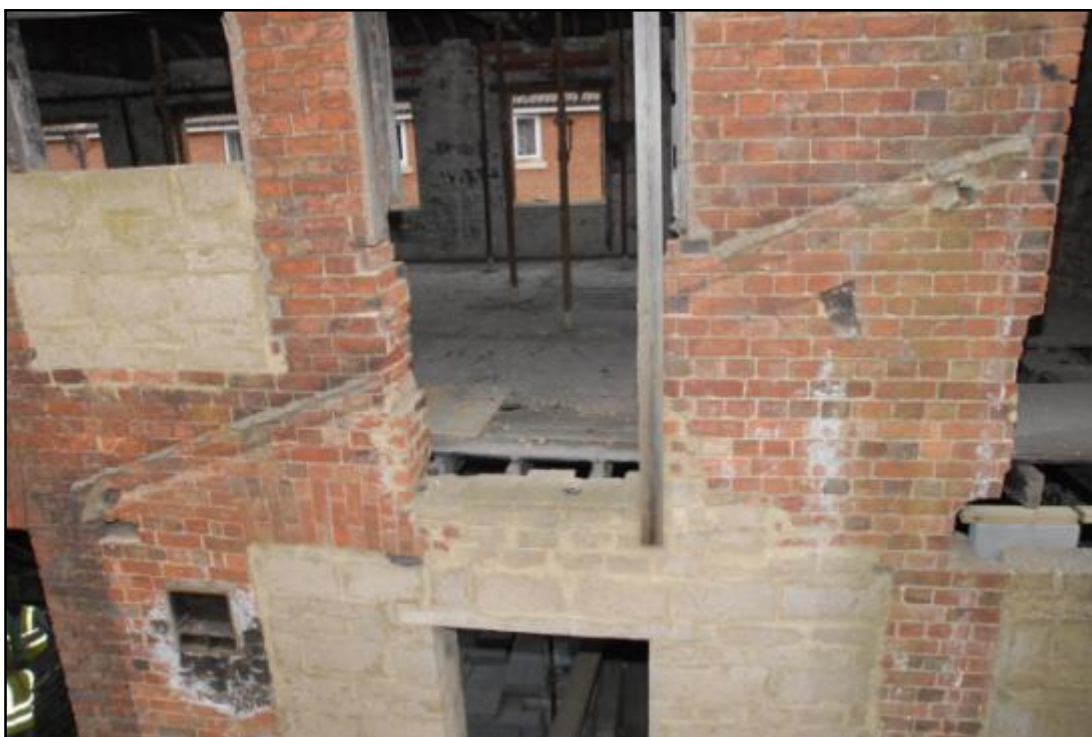
Building 2, scar of former link structure (note square opening at bottom left) Fig 19

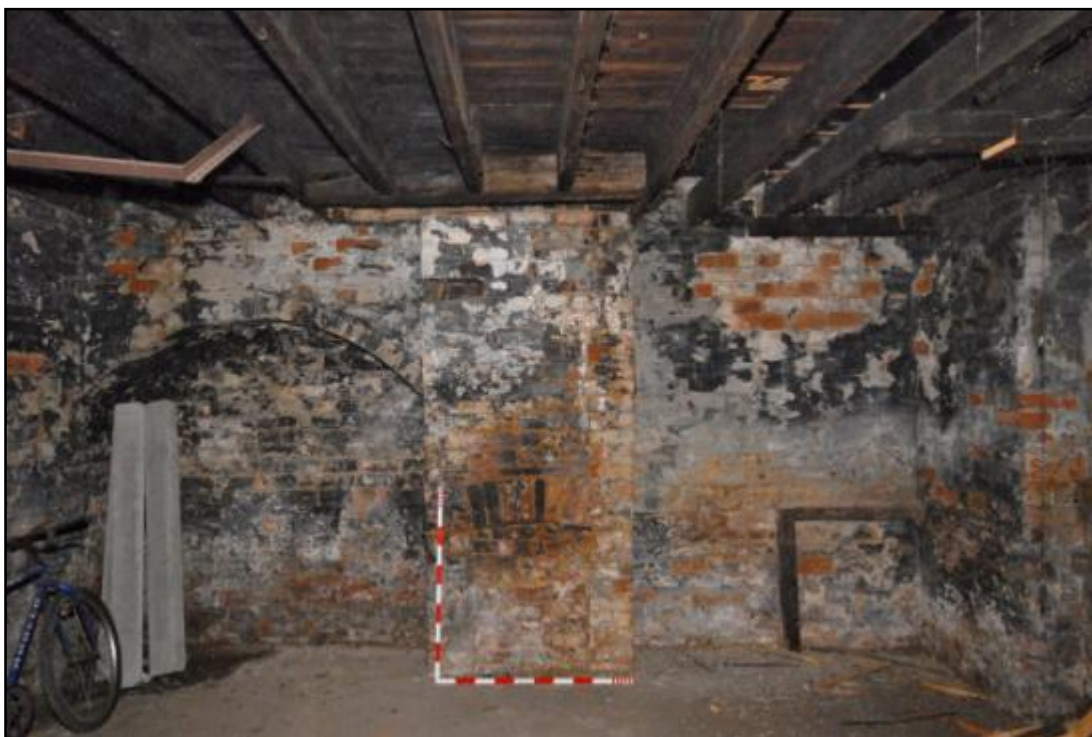
Building 1, ground floor, east wall with blocked fireplace flanked by arch Fig 26

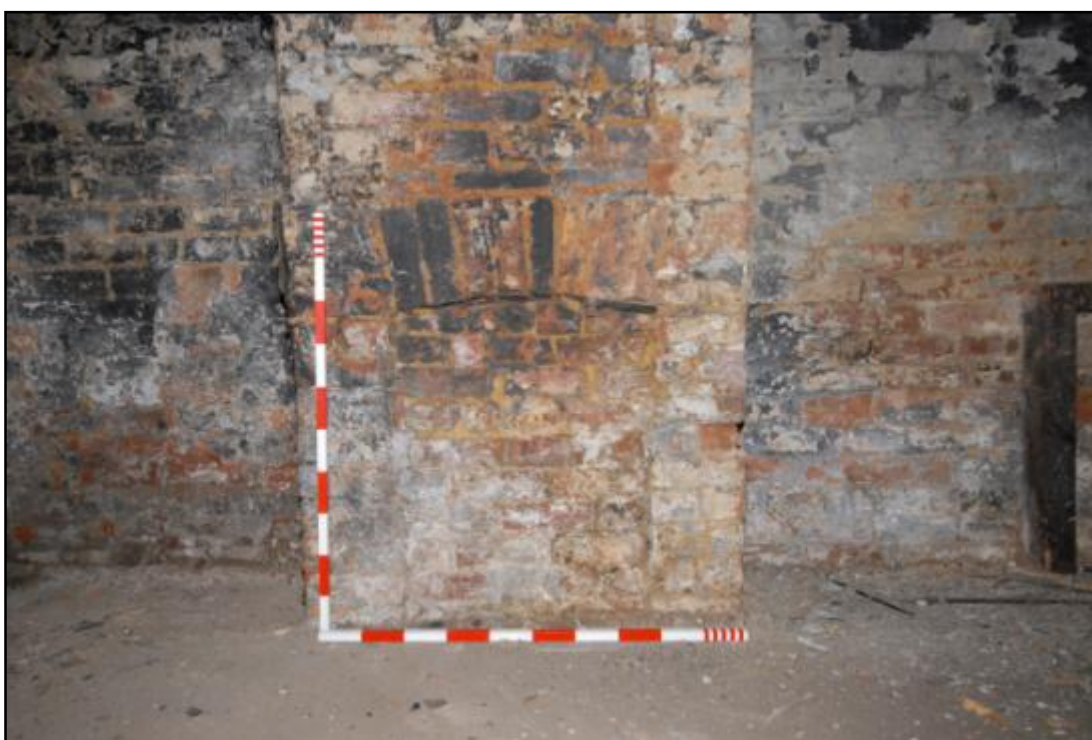
The fireplace, in keeping the style of windows throughout this building, has an arched, brick mantle over an opening 0.6m wide x 0.8m high (Fig 27). The date of the blocking is uncertain.

Building 1, detail of the east fireplace Fig 27

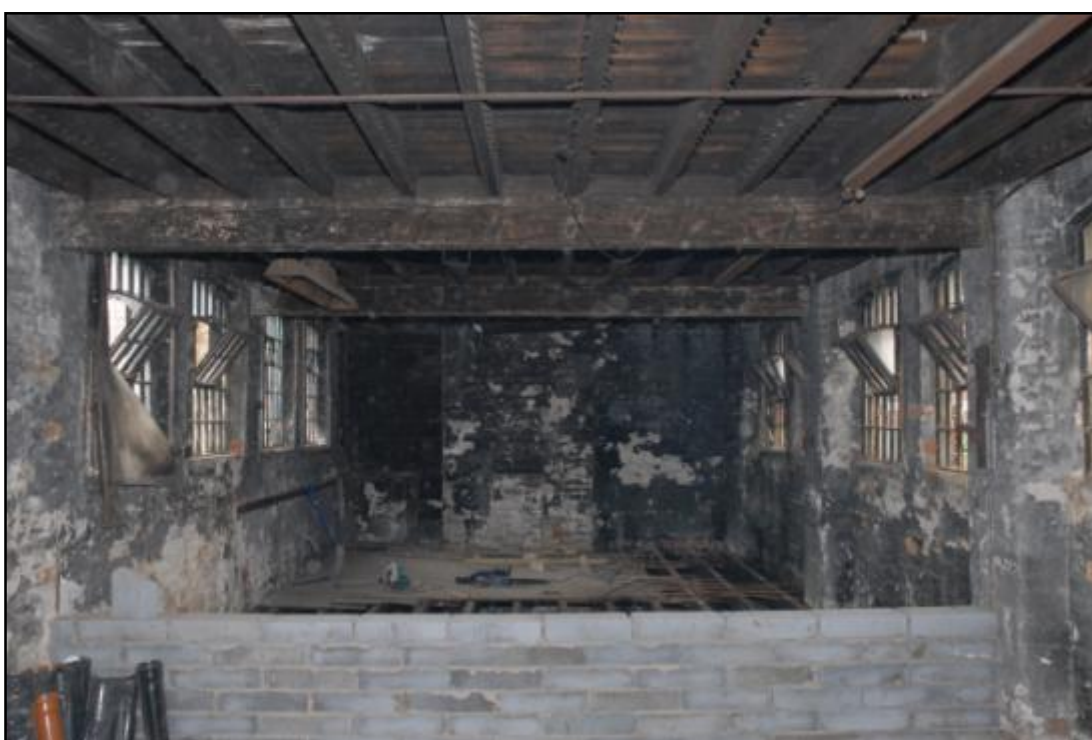
Building 1, first floor, looking east, showing chimney flue with blocked fireplace Fig 33

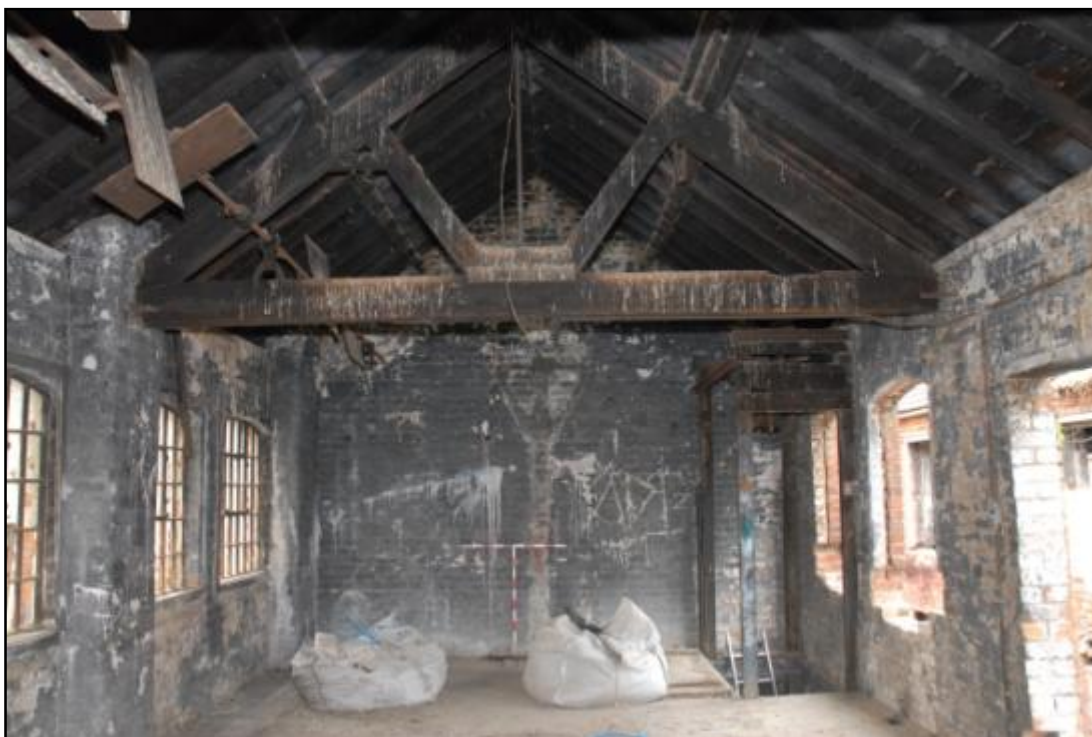
Building 1, second floor, looking east, showing lift shaft and scar of former machine support with drive shaft carried over the truss Fig 34

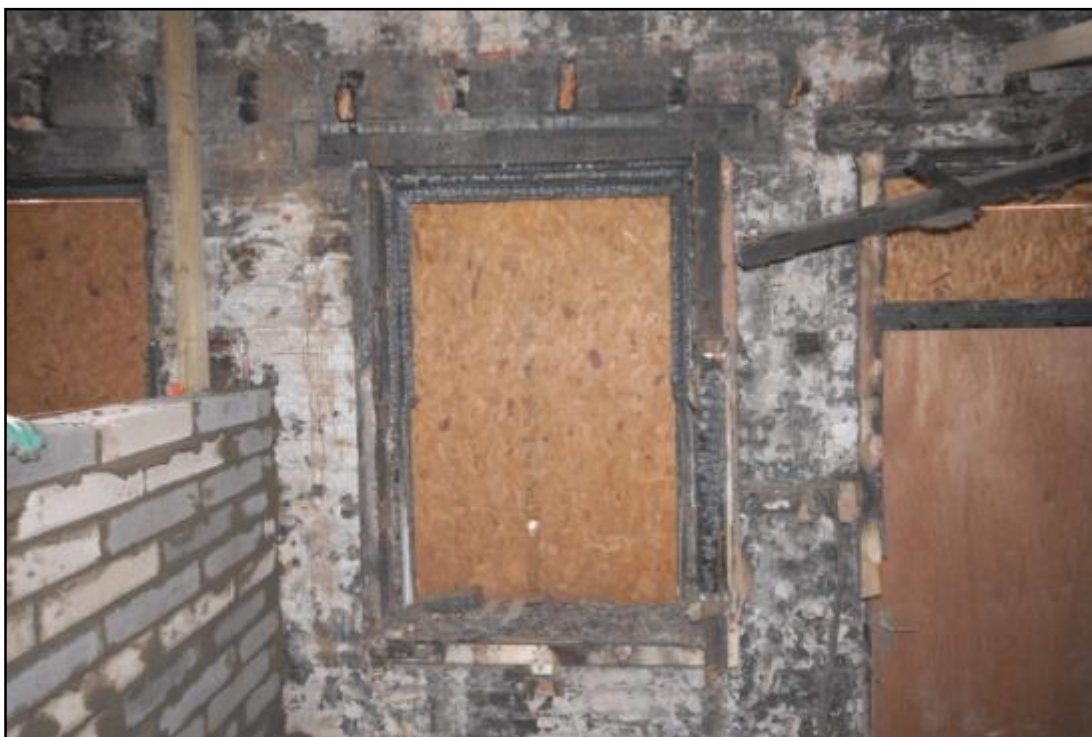
Due to fire damage, no windows survived in Building 2 with the exception of a badly fire damaged sash frame at ground floor level on the north elevation (Fig 48). This window type suggests that this area of the building functioned as office space rather than workshops or factory floor. Except for those at top floor level on the south wall, the windows are set within slightly arched, tapered, segmented lintels and stone sills. Building 1 has a much greater survival of windows. These are 29 lights set in cast iron frames with inward opening, central hoppers, with decorative, cast iron stays internally (Figs 28 & 29). Forty-five light, cast iron framed windows were present at the eastern end of the north elevation (Fig 23). All windows in Building 1 were set between segmental arched lintels and stone sills.

The room was formerly lit by the north and south facing windows. No window glass or cast iron frames survive in this building but the fire damaged remains of a sash window frame could be seen to the right of the secondary door (Figs 48). The presence of a sash window in this part of the building suggests that this area functioned as offices rather than as a factory floor. All windows in the building had tapered, slightly arched lintels and stone sills. No evidence for electrical lights survived in the room but it can be assumed that these were fitted (Fig 47).

Building 2, ground floor, fire damaged sash window Fig 48

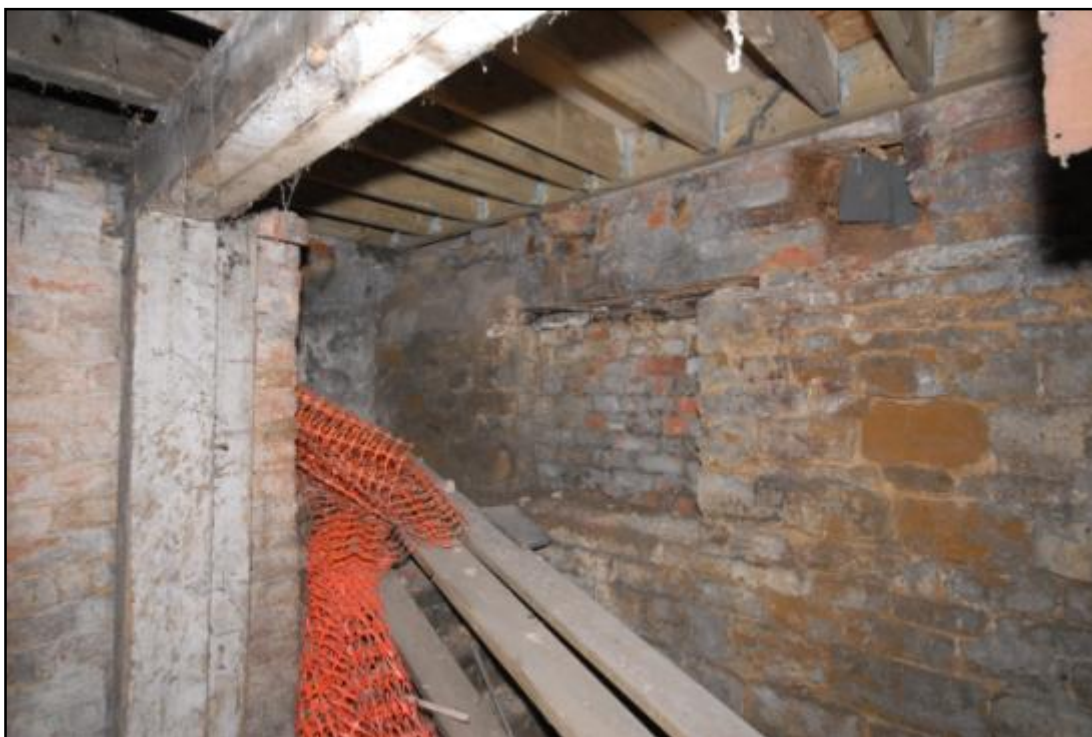
The blocked light well adjacent to the basement stair Fig 50

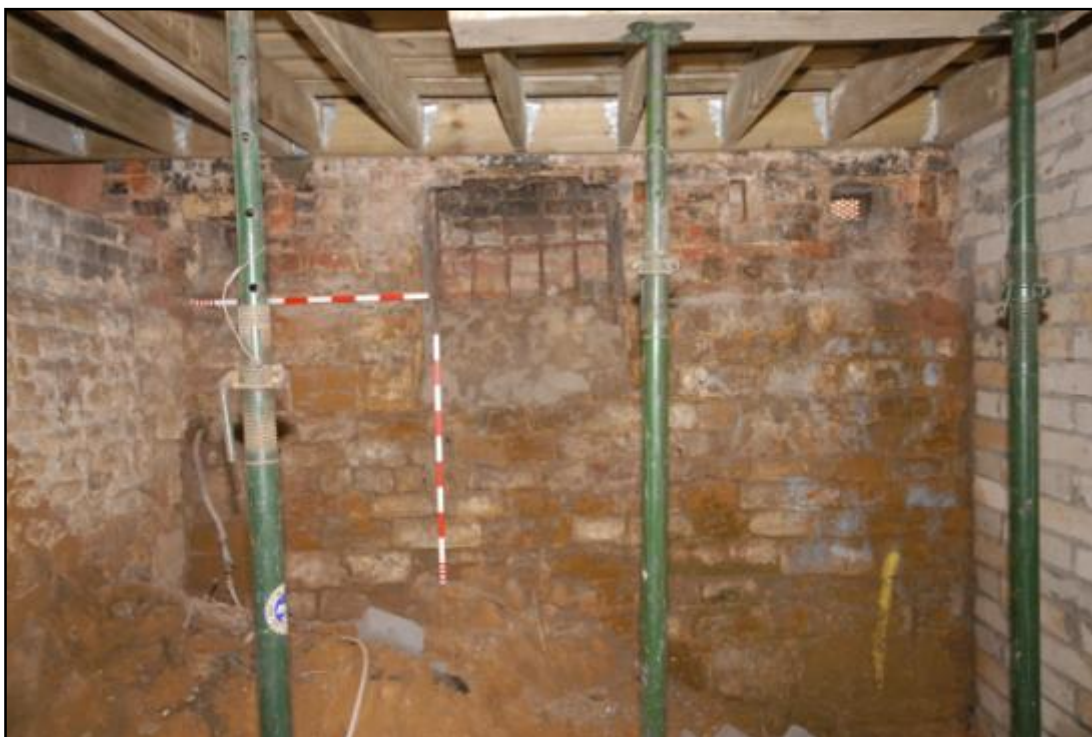
Room B1, blocked light well with vent to the right, looking north Fig 54

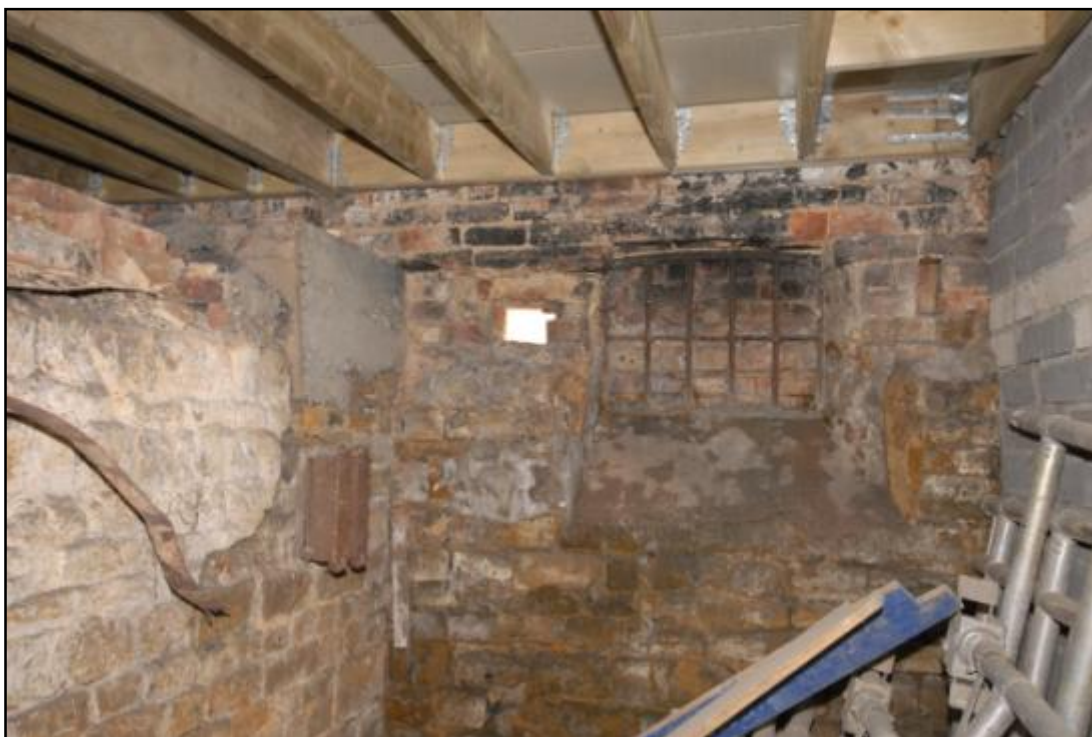
Room B2, blocked light well with electric box to the left Fig 56

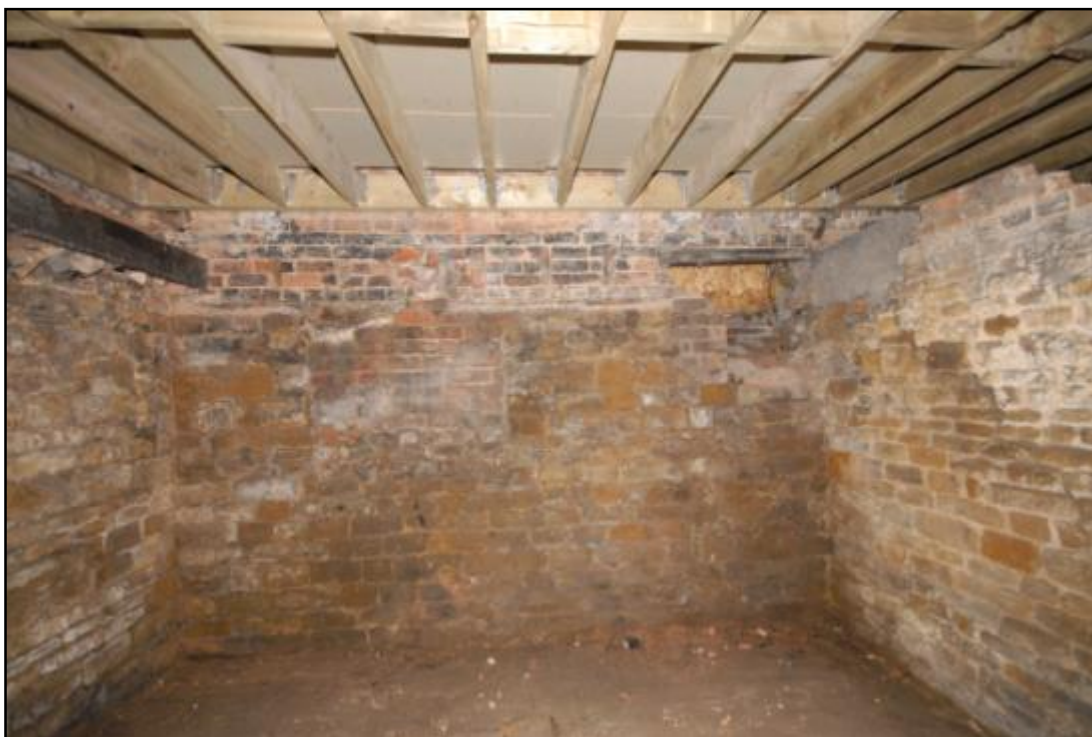
Room B3, blocked light wells, looking north Fig 58

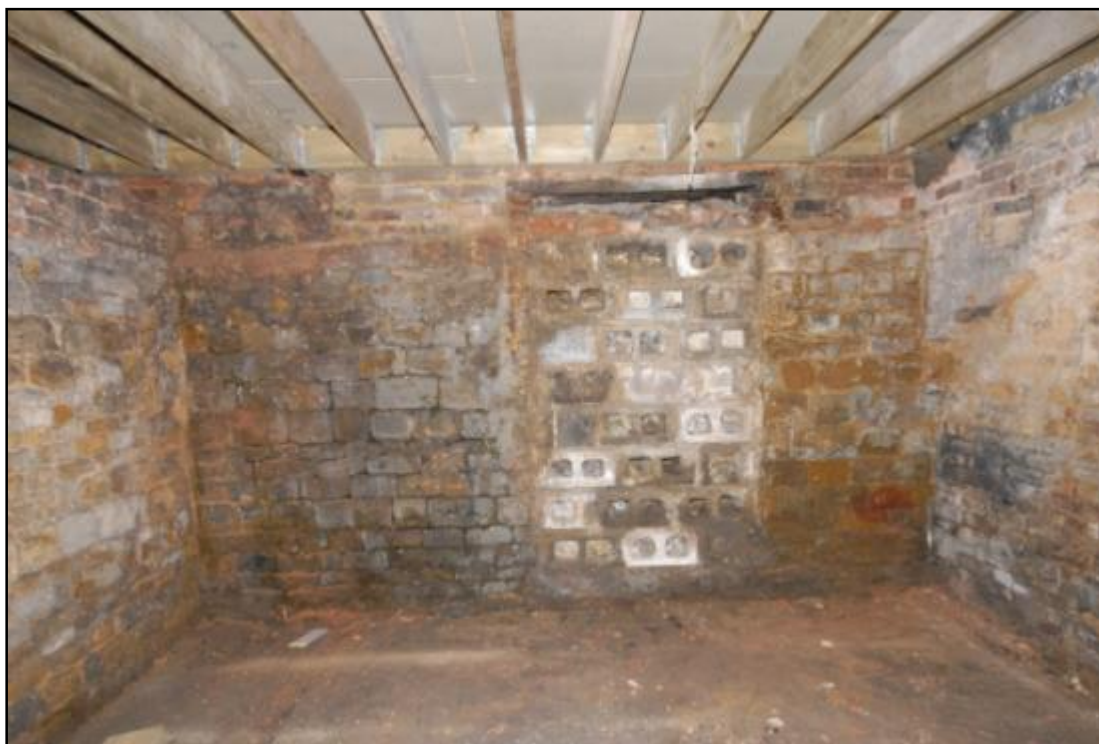
Light wells and vents were built into the north wall of the basement. These were blocked by the time of this survey, most likely for security. A light well, now blocked could also be seen facing westwards in Room 4. A door formerly provided access between Room 4 and the courtyard to the south (Fig 60).

Room B4, showing blocked door, looking south Fig 60

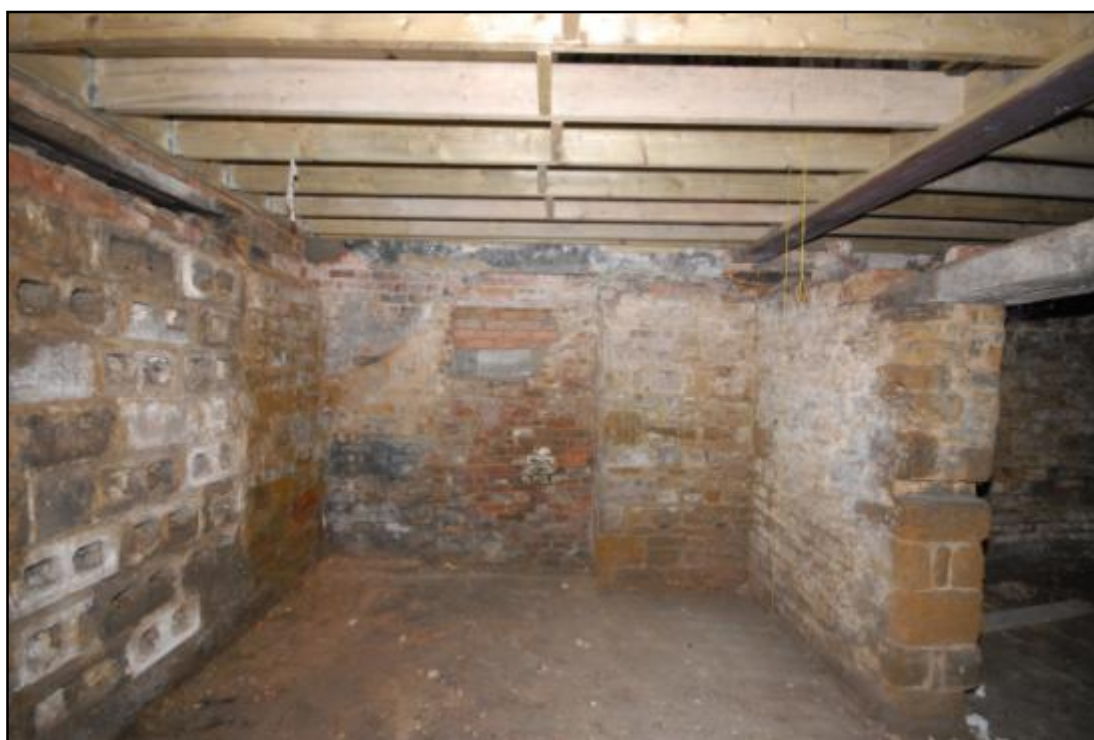
Room B4, showing blocked door, looking west Fig 61

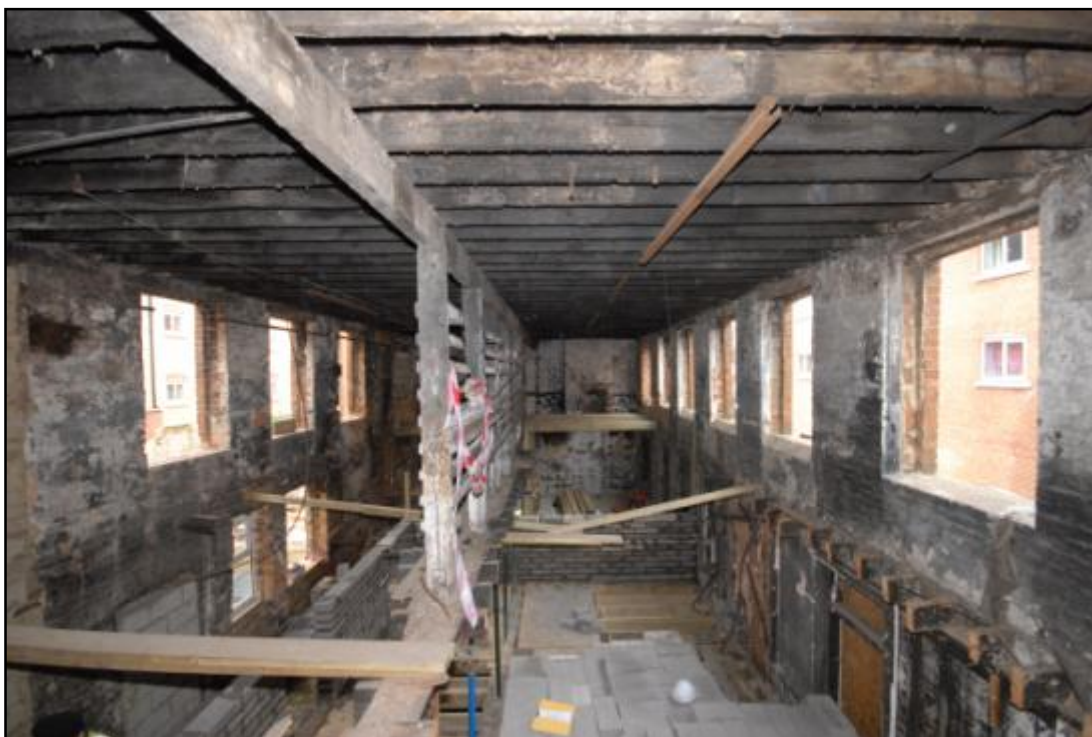
Accessed via a stairwell in the north-east corner of the room, this floor was largely inaccessible due to severe fire damage to the floor joists. The remains of a central lath and stud partition runs east-west down the room, with the ends of the former joists visible beneath, carried on a spine beam (Fig 63).

Building 2, first floor, looking west, showing the remains of the central partition and joists  
Fig 63

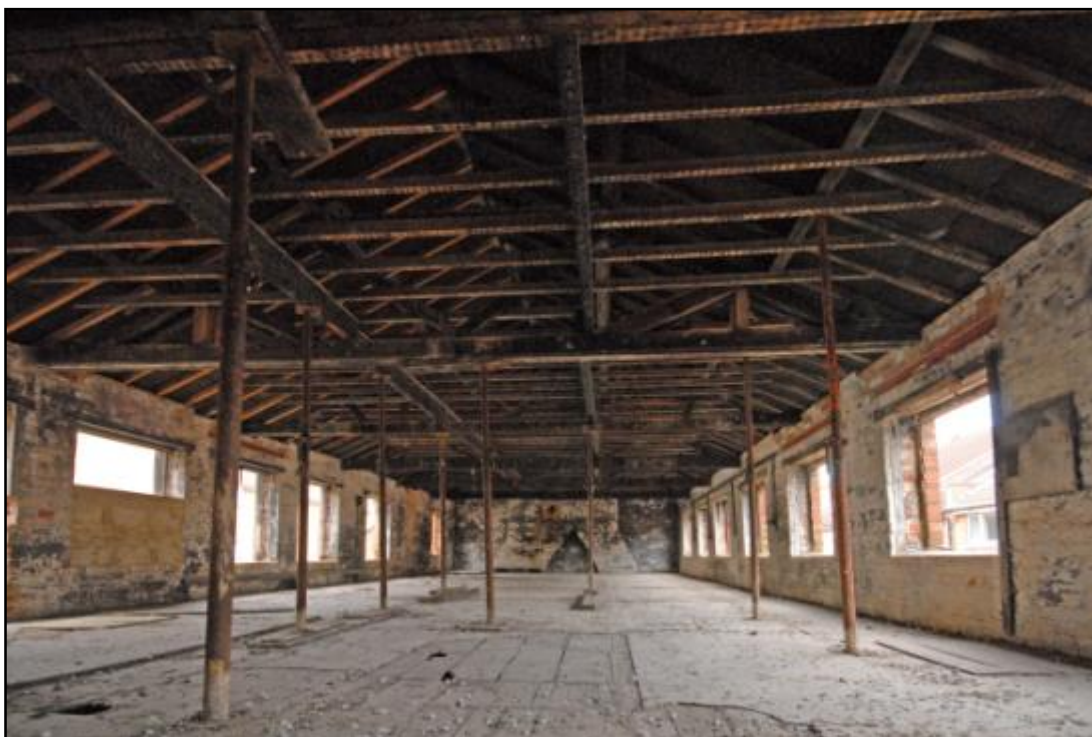
This room was a large, open plan space with no evidence of partitions surviving. The two chimney flues merge together into a single flue and rise through the roof at the west end of the room (Fig 65). Due to the fire damage sustained by the floor joists, the room was deemed unsafe to enter.

The second floor, looking west with chimney flues in the background Fig 65
