## Archaeological building assessment of the barns at Rectory Farm, Islip, Northamptonshire

Report 10/105

August 2010

**ARCHAEOLOGICAL BUILDING RECORDING AT  
RECTORY FARM BARNs, ISLIP, NORTHAMPTONSHIRE,  
JUNE 2010**

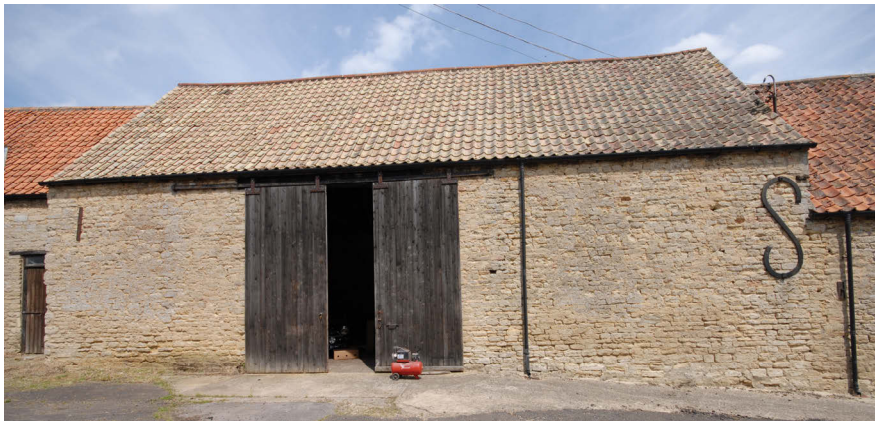
Fig 8

The walls are of roughly squared, coursed limestone bonded with lime mortar (Fig 8). Quoins have been used intermittently in the north and west corners (Figs 8 and 9). Internally there are bricks to a height of 1.14m to the north-west and south-west walls and brick piers under each tie beam. An internal brick buttress to a height of 2.1m is present on the south-west wall, 1.8m from the north-west wall (Fig 10). The corners of the brick piers and buttress are all bull-nose profile bricks. The internal walls have been whitewashed. An iron tie rod has been fitted to the south-east wall of the barn; the anchor plate consists of a large S-shaped iron rod to both elevations.

Barn 1, south-west elevation

The cart door is a two-leaf 20th-century timber plank door, hung on a rail rather than hinged (Fig 8). The boarded doorway opposite in the north-east wall does not contain any earlier door or frame.

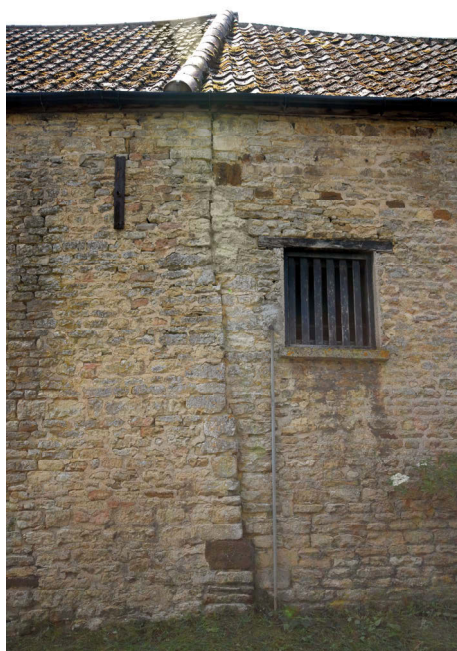
Fig 9

The building has four bays open to the apex of the roof (Fig 6). A single-leaf blocked door is in the north-east wall, opposite to the existing cart door. A blocked ventilation slit is visible near the apex of the north-west wall, the only sign of any fenestration in this barn (Fig 9).

The join of Barns 1 and 2, north-east elevation

The building comprising Barn 2, the store and hayloft is clearly built up against the north-west wall of Barn 1 (Fig 9), and therefore later. It is also of note that the replacement of the roof did not respect the original, indicated by the ridge tiles on a different alignment to the join.

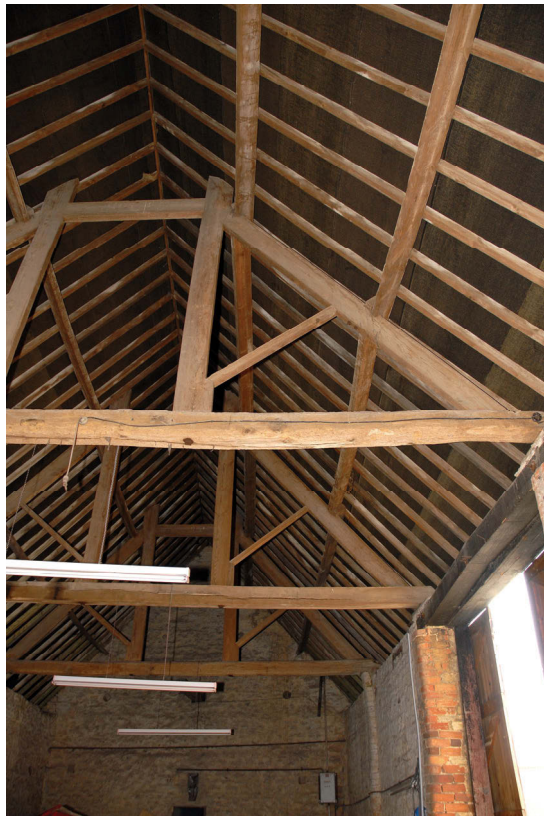
Two original tie beams survive; the central tie beam and all other roof timbers are modern, the trusses are now of a simple Queen post construction with splayed struts. (Fig 11). However, the roof configuration probably replicates the original. The roof has been felted and covered with pantiles.

The roof timbers and felting to Barn 1 Fig 11

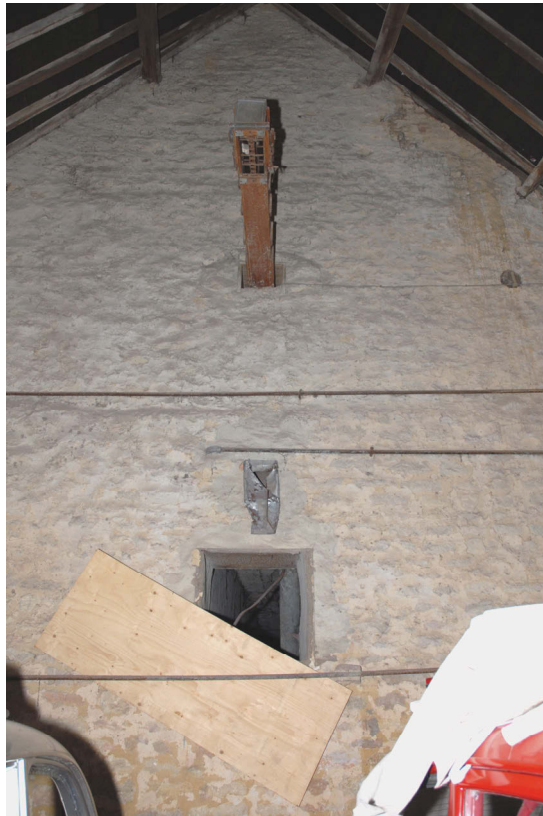
Fig 12

Some machinery survives in the south-east wall above two openings which would have originally led to Barn 3 (Fig 12). It appears that the engine for this machine would have been housed in Barn 3 to drive the chains contained in the surviving component.

The tie rod and surviving machinery and openings in the south-west wall of Barn 1

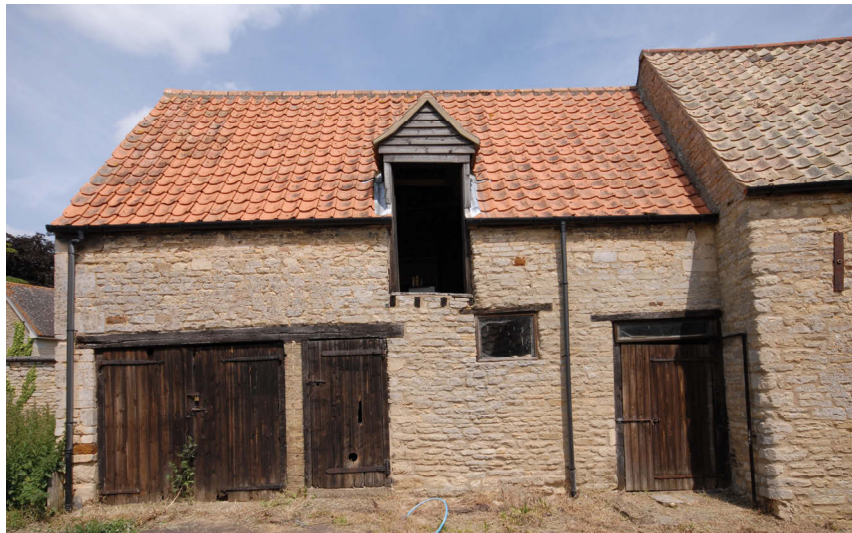
The door is in the south-west wall; the door and frame are of modern timber with a small glazed light above. The window in the north-west wall is slatted and the window in the south-west wall has been glazed using modern timber and glass (Figs 6, 7 and 13).

Barn 2 and Store with the Hayloft above Fig 13

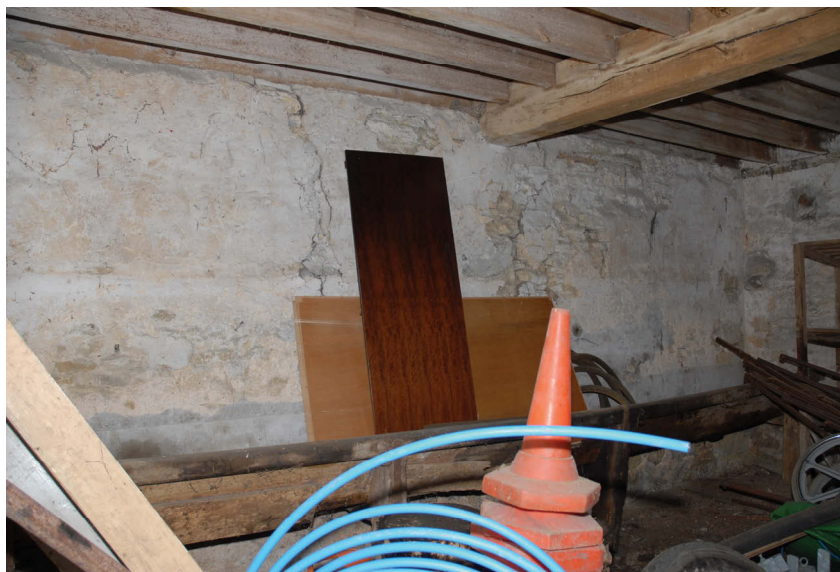
The floor is heavily obscured by stored items but areas of cobbles and concrete are apparent. The cobbles are concentrated towards the north-east wall where a simple trough type timber manger runs along the full length of the wall (Fig 14).

Barn 2, north-west wall, including the manger Fig 14

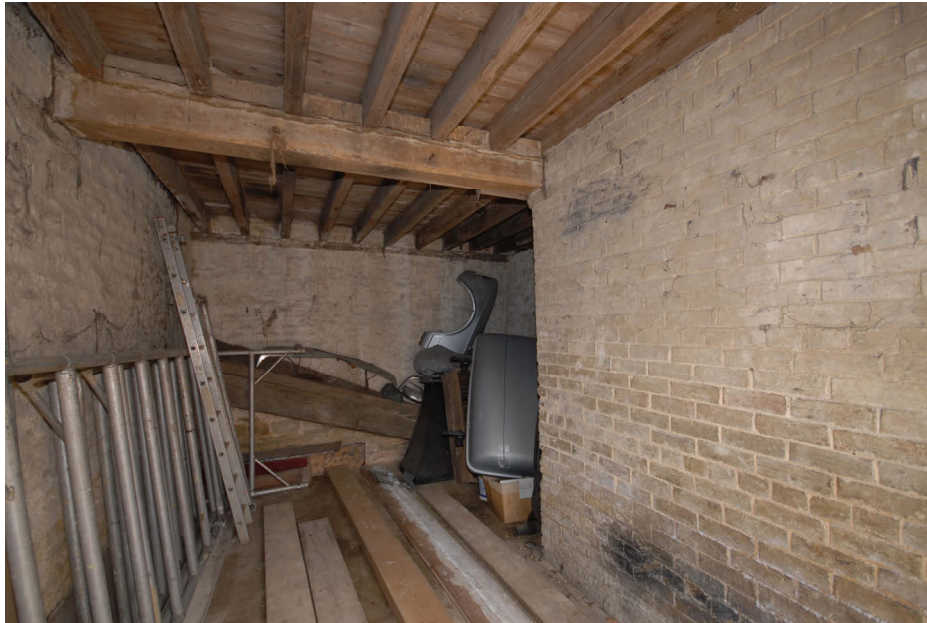
Fig 15

This area was created by dividing Barn 2 in half. The external walls are as Barn 2, with the remains of whitewash on the internal elevations. The wall enclosing the stairwell in the south corner of the area is of painted brickwork in stretcher bond (Figs 6, 7 and 15).

The Store with the brick dividing wall

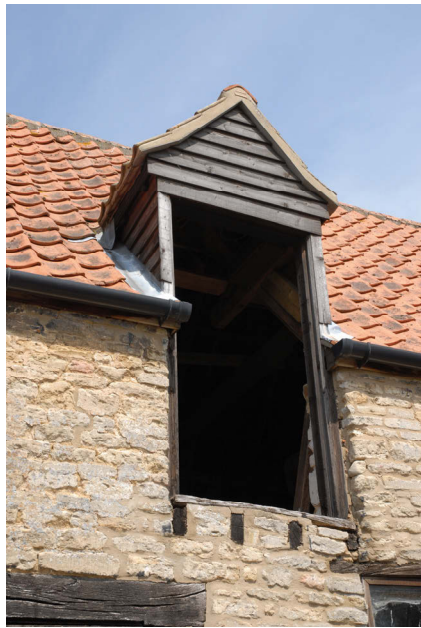
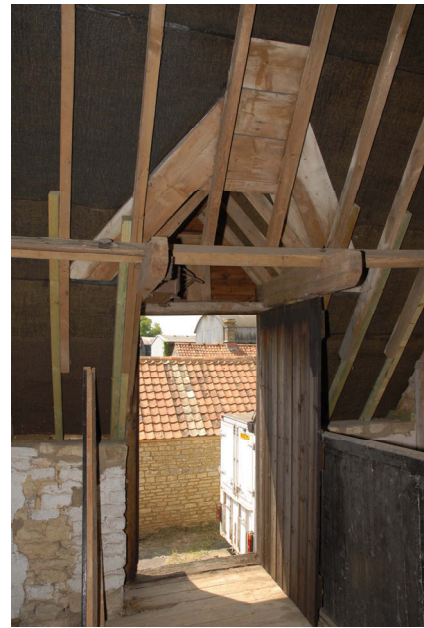
Figs 16 and 17

The pitching door and the associated frame are both of modern timber. A gablet is above the pitching door and the roof is pantiled. Exposed joist ends below the pitching door may indicate that a small jettied platform may have once been present (Figs 16 and 17).

The pitching door and gablet in the hayloft roof

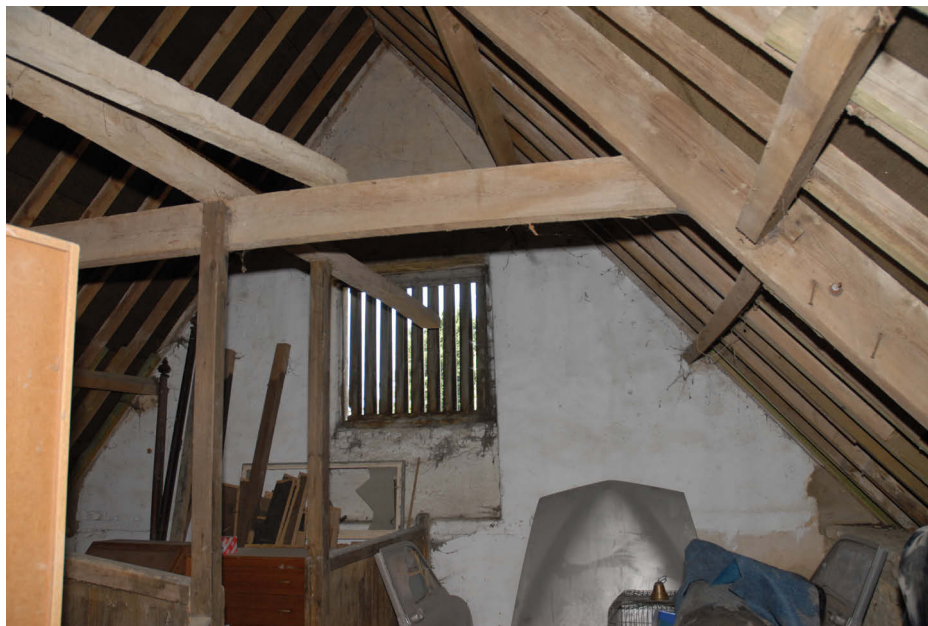
The single slatted window is located in the gable wall and has had the lower half blocked, seemingly when the cattle byres were built as demonstrated in the scarring to the gable wall (Figs 18 and 19).

The partially blocked window in the north-west wall of the hayloft Fig 18

Scarring on the north-west gable indicates the roof pitch of the later cattle byres now demolished, shown on the undated aerial photograph in Figure 23. The window in the same gable has clearly been blocked up in the lower half (Figs 18 and 19) to accommodate the byre roof.

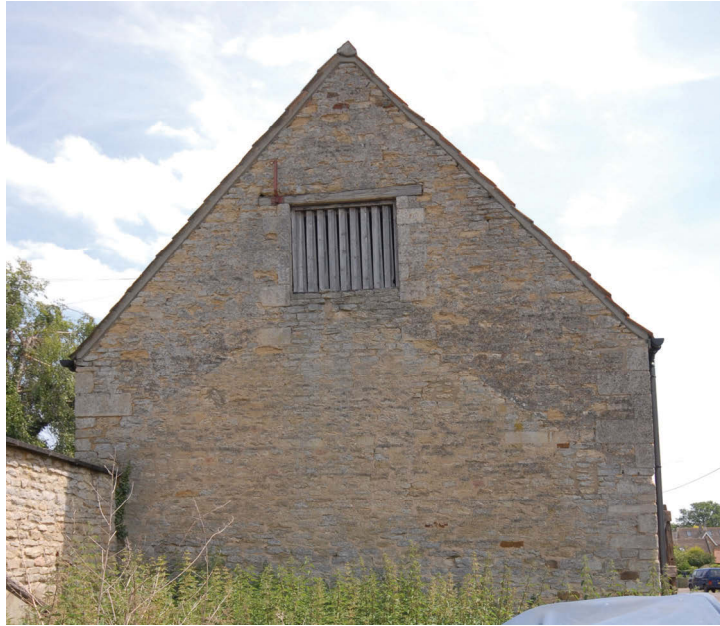
Scarring from the cattle byres on the north-west wall of the Store and Hayloft above Fig 19

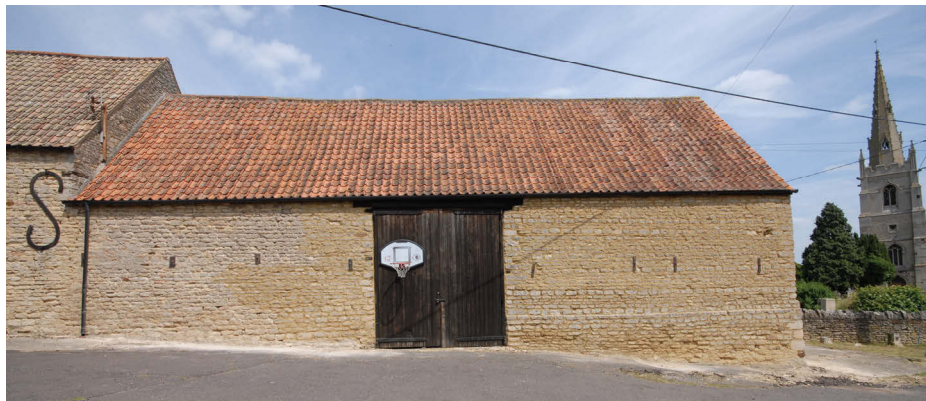
Fig 20

The walls are of roughly squared, coursed limestone with extensive recent repointing in lime mortar (Fig 20). The wall to the north-west of the entrance door is of a similar sized stone and coursing to that of Barn 1; the wall to the south-east of the door features a chamfered plinth and occasional courses of larger, more finely dressed stones (Fig 21). This is reflected in the gable end and in the entire north-east wall of the barn. Quoins are used in the corners of the gable wall, but are not present in the join to Barn 2.

Barn 3, south-west elevation

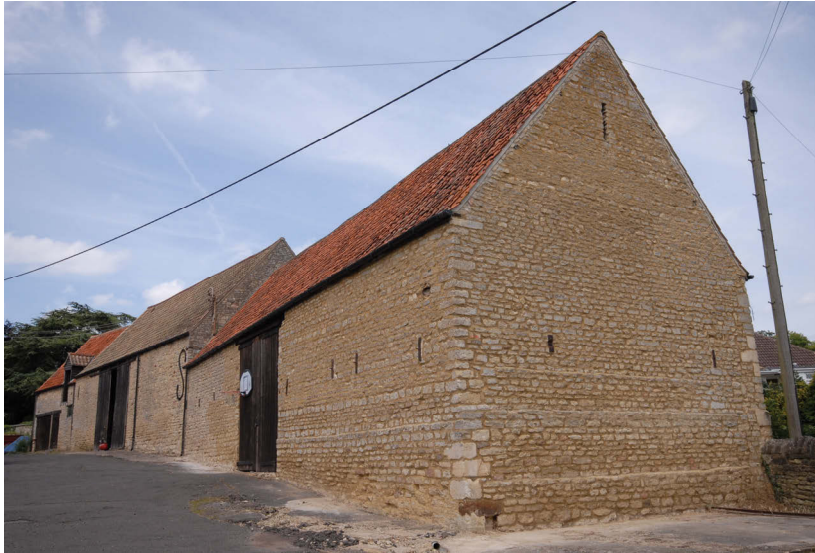
The southern corner of Barn 3      Fig 21

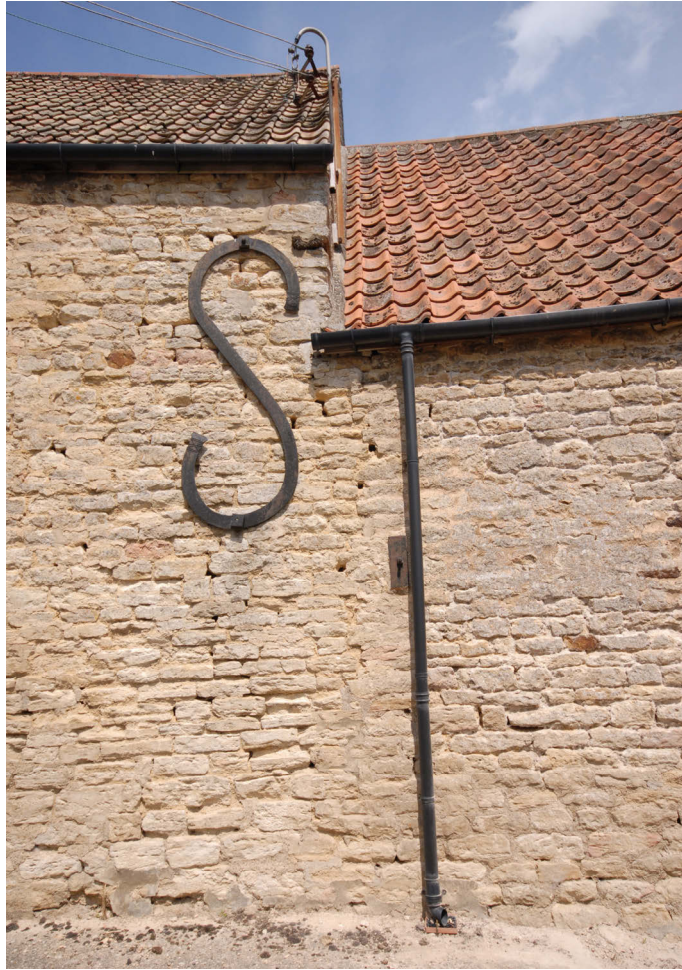
The join between Barns 1 and 3, south-west elevation Fig 22

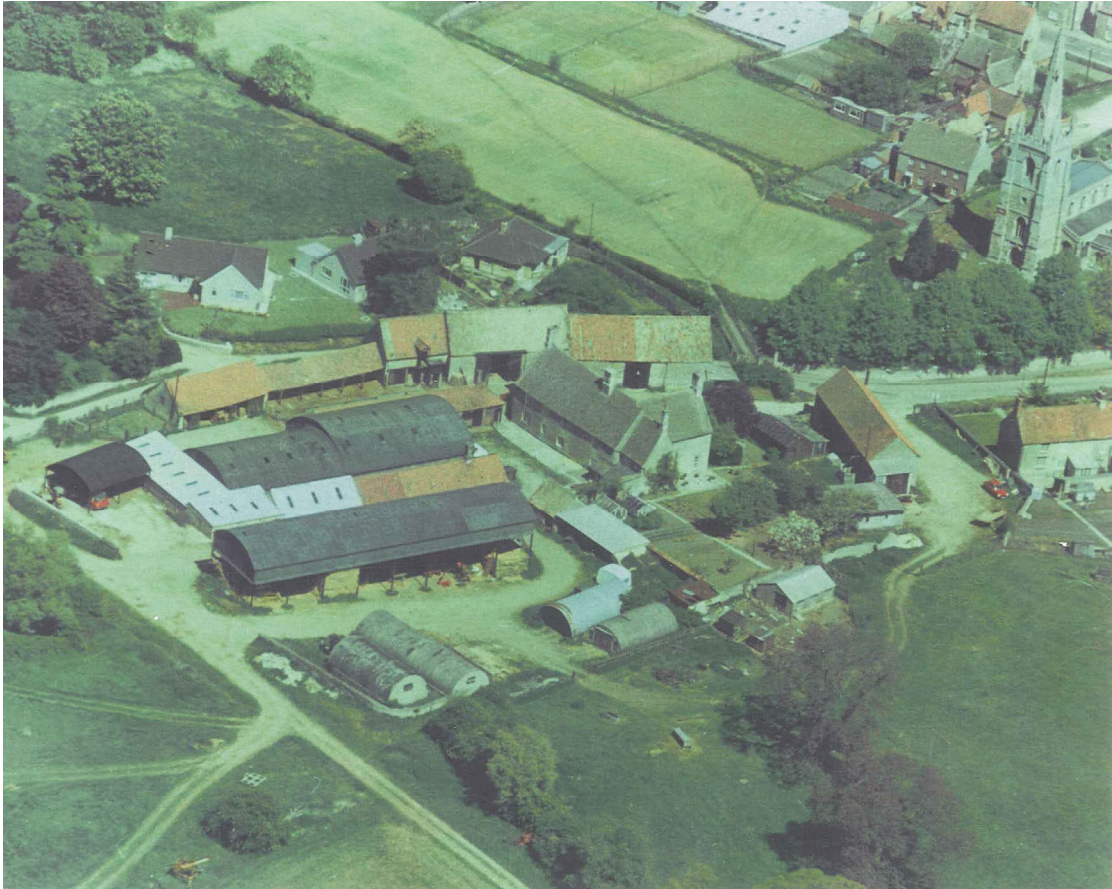
Undated aerial photograph showing the former cattle byres to the left of the barns.  
Photograph provided by Mr. Arnold Fig 23
