ARCHAEOLOGICAL WATCHING BRIEF

AT EASTBURY MANOR

BARKING, ESSEX

JULY 2003

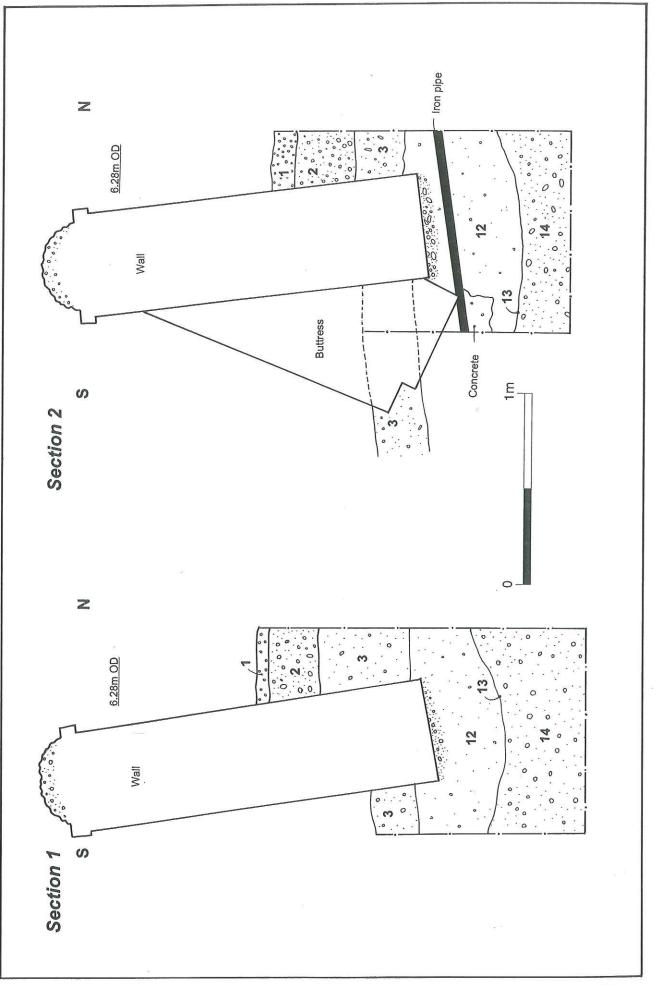
Fig.5

Prior to it being dismantled, the wall was 19.6m long (excluding the gateway), 2.1m high (from the base of the foundation course to the top of the concrete coping) and approximately 0.55m thick (Plate 1). It was supported on its south side by four brick buttresses, which had been built to counter a significant lean to the south, probably caused by weak foundations and the pressure exerted against the base of the wall by the higher ground level on the northern side (Plate 2). The south and north elevations of the wall are shown in Figures 3 and 4 respectively, and show the types and combinations of brick and mortar/cement used in its construction and repair. Representative sections through the wall are shown in Figure 5.

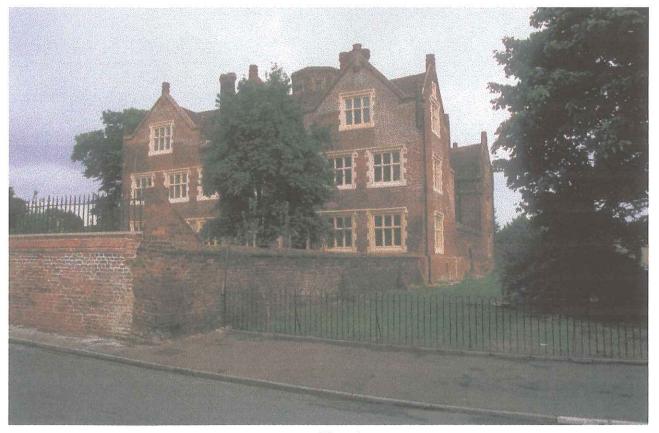
Plate 1

- **Plate 1** General view of south face of garden wall, looking north-east
- Plate 2 End-on view of wall looking east, showing inclination of wall from vertical

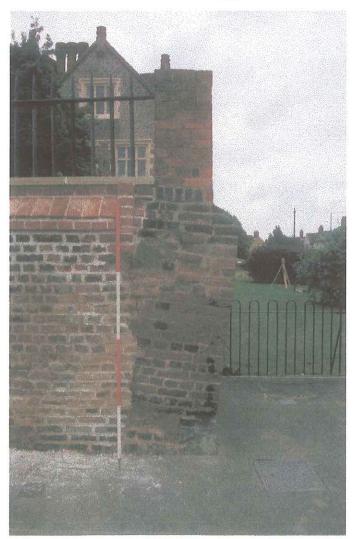
Plate 2

Despite the best efforts of the original builders to provide a stable footing for the wall, it eventually began to develop a lean to the south, probably due to weak foundations and the pressure exerted by the build-up of soil to the base of the wall in the garden. Pictorial evidence, from a number of engravings dating to the late 18th and 19th century (Figs 7 and 8), suggests that the wall had began to lean by the late 18th century, if not sooner, and a large buttress is clearly depicted at the east end of the wall. At this time the wall is shown to be standing to its full height, the top of the wall level with the transom of the adjacent, southfacing ground floor window. A doorway is shown leading through the wall in the position of

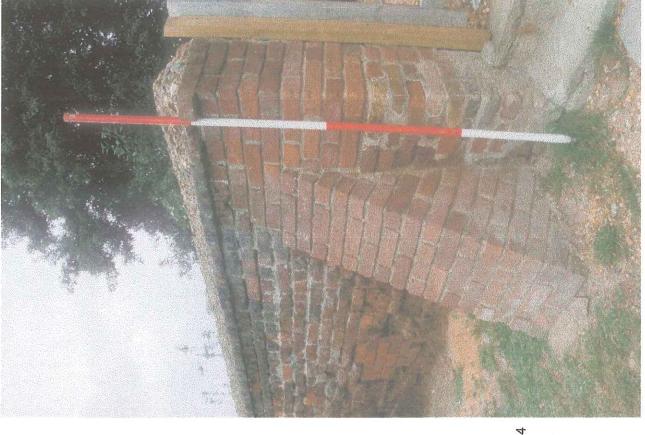
Plate 4 View of rebuilt buttress and east end of wall by house

The four brick buttresses on the south face were bedded on concrete foundation pads and were weakly keyed into the brickwork of the wall (Plate 3). As noted above, the buttress nearest the house was rebuilt at a later date, probably in the late 19^{th} or early 20^{th} century (Plate 4).

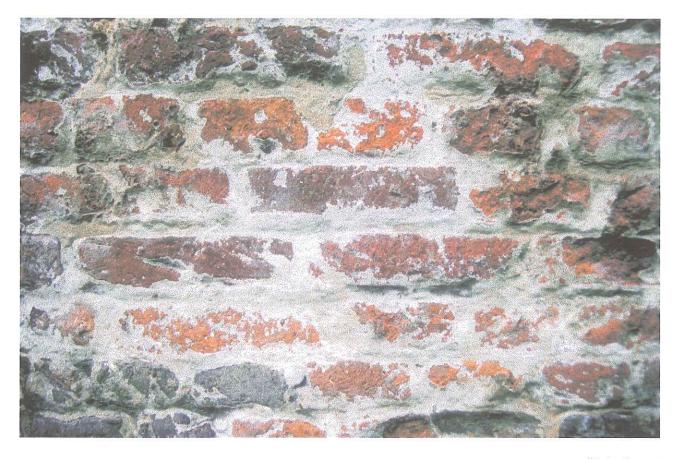
Plate 5 Detail of brickwork

On the south elevation, near the centre of the wall, there were traces of limewash (Plate 5). One small patch covered an area of roughly $0.3m^2$, a larger patch covered an area of approximately $3.1m^2$. From the thickness of the flakes, this part of the wall appears to have been limewashed a number of times.

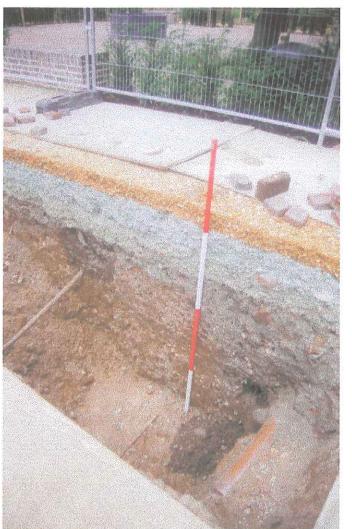
Plate 6 General shot of new foundation trench showing old foundation trench in section and modern services

Cutting the fill of the foundation trench and post-dating the construction of the wall were a number of service trenches for water and sewage pipes and electricity cables. These were largely confined to the eastern end of the new foundation trench, close to the house, and had caused significant disturbance and truncation to earlier remains. The service trenches had presumably been burrowed underneath the wall and the pipes and cables fed through, although close to the house by the gate it is likely that gateway steps were taken up when the sewers were put in.
