Archaeological Buildings Assessment at

Eastbury Manor, Barking

November 2009

Report 09/156

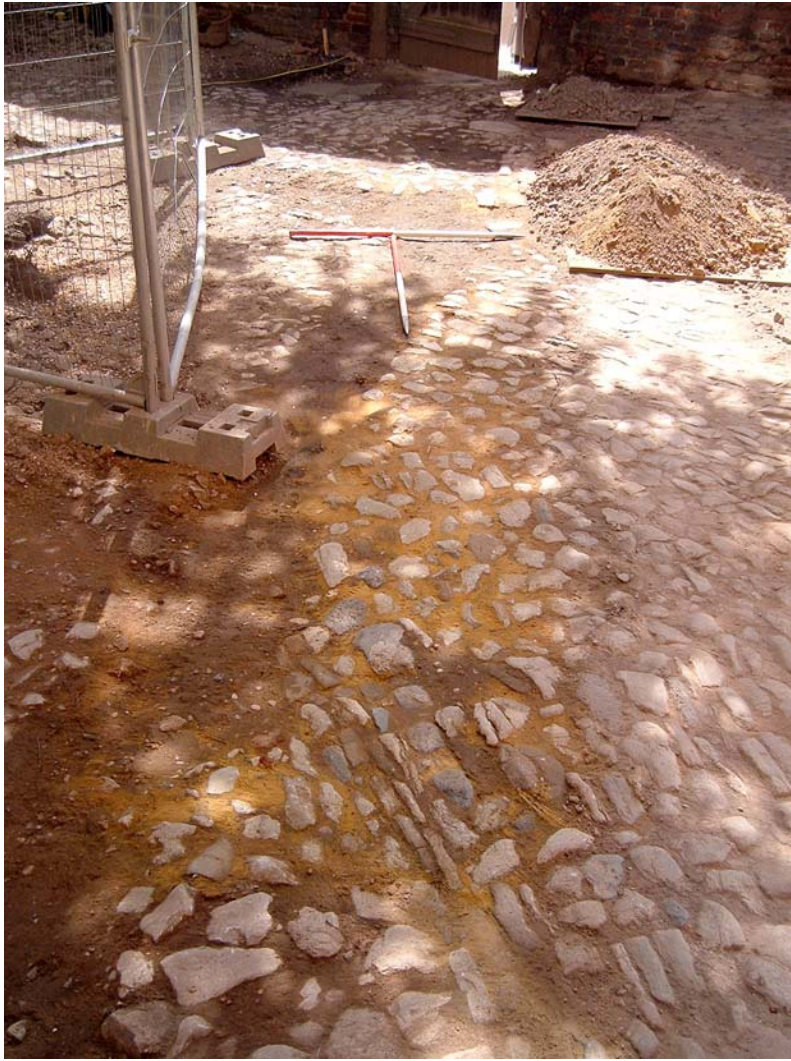
Fig 5: Western side of the courtyard looking south

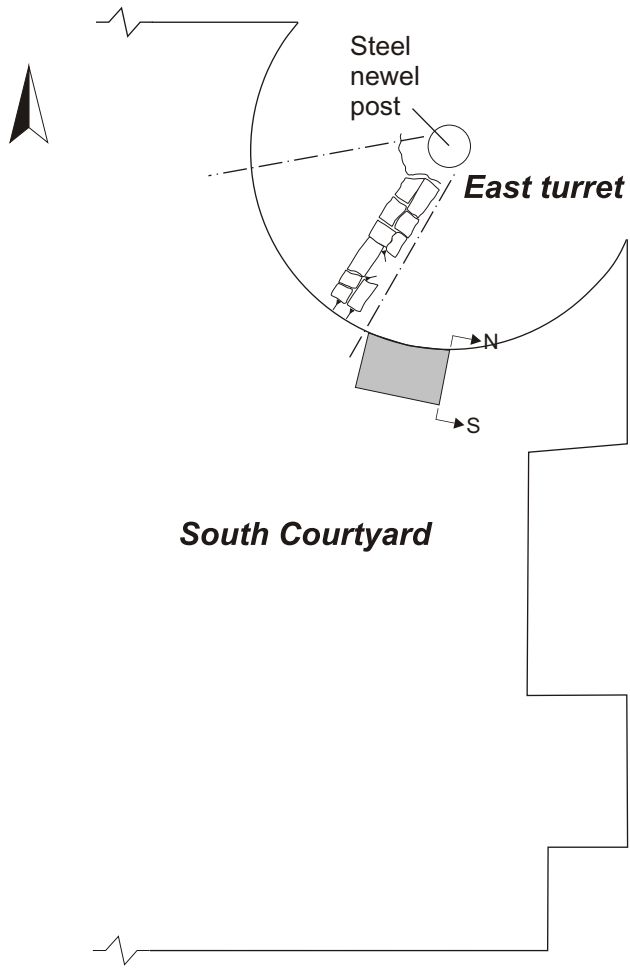
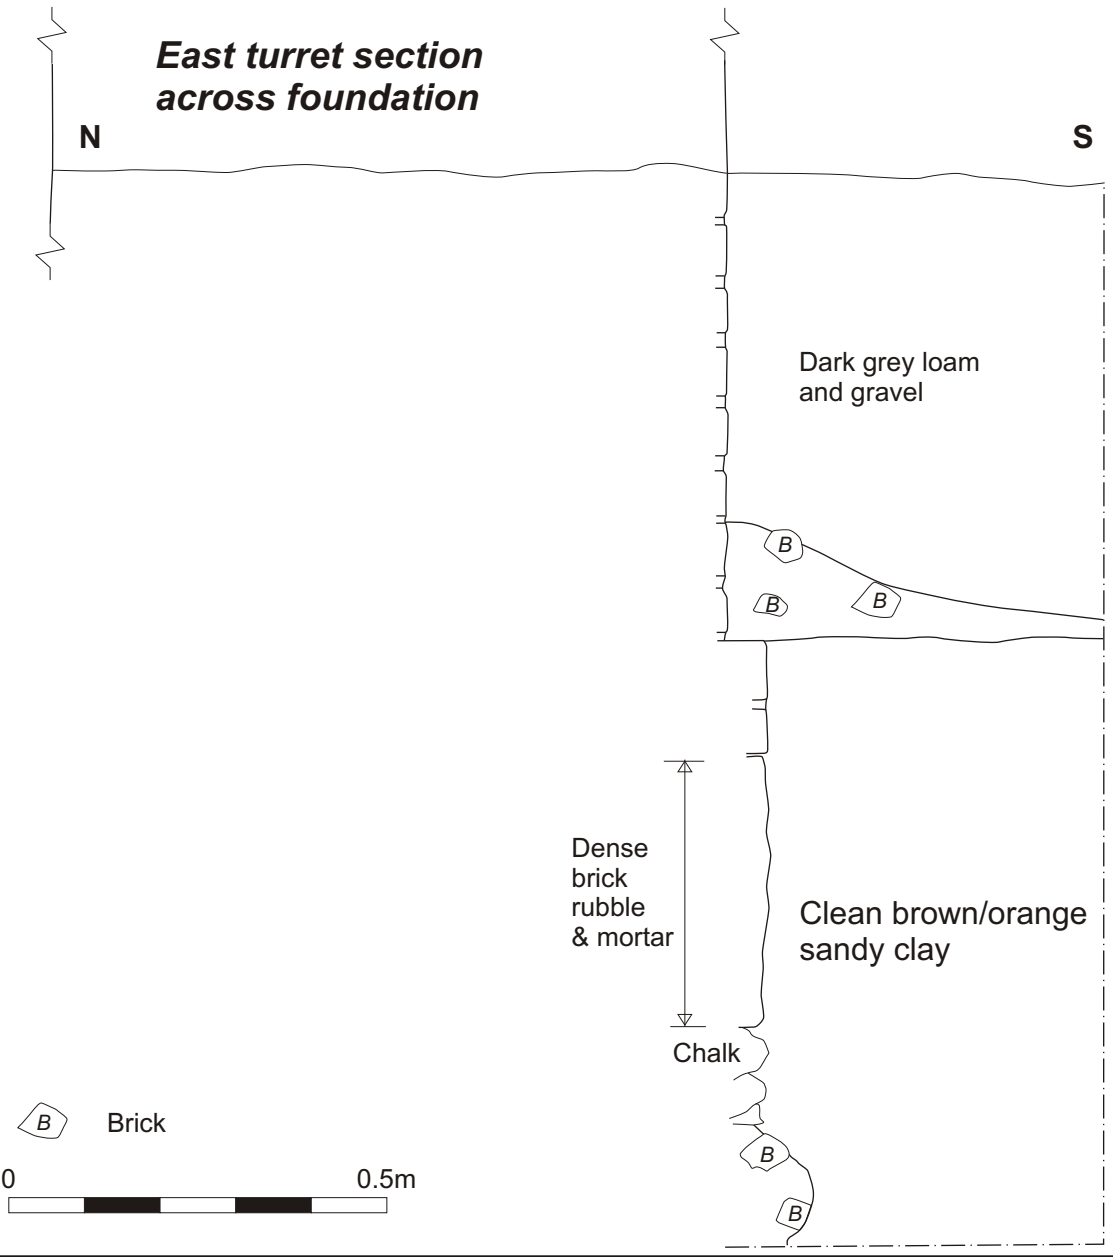
East stair turret, plan and section Fig 6

The new works involved two things: Firstly the depth and nature of the former turret foundations needed to be explored; this involved hand-digging a test-pit down the outer face of the former turret wall. The test pit measured 1m long x 0.7m wide and extended to a depth of 1.4m (Fig 6).

No cut for a construction trench for the turret wall was observed. Therefore it is likely that the wall either fully filled its construction trench on this outer side (highly likely to minimise tendencies toward outward movement) or that the test pit fell entirely within the fill of any construction trench preventing fuller observation.

The soils encountered outside the wall from a depth below the crushed brick deposit, to the base of the test pit, a total of 800mm, comprised clean brownish-orange sandy clay, believed to be either natural geology or the same possibly redeposited.

At this level, some 600mm below the modern ground surface, the seven observed courses of former turret wall stepped out to form an offset foundation. This comprised two brick courses (150mm) over a packed mass of dense brick rubble and mortar, forming a sort of concrete (350mm thick). Beneath the packed foundation lay rubble, again slightly offset (but less so) this time formed of chalk rubble and occasional brick set in mortar.

The inner side of the test pit showed that the cobbles of the courtyard at this point had been laid on a layer of compacted dark grey loam mixed with gravel 500-600mm thick. This abutted the wall of the former turret over a depth of 6 courses of brick. At its base, and also abutting the wall, against the face of which it accumulated more thickly was a thin layer of crushed brick and soil, up to 150mm thick. This is considered to be the builders' trample which accumulated when the turret, and the whole house was constructed in the 16th century. No evidence was noted of the rubble spread from the tower collapse observed by Cox and Turnbull 1994. The cobbles were also absent from this part of the courtyard.

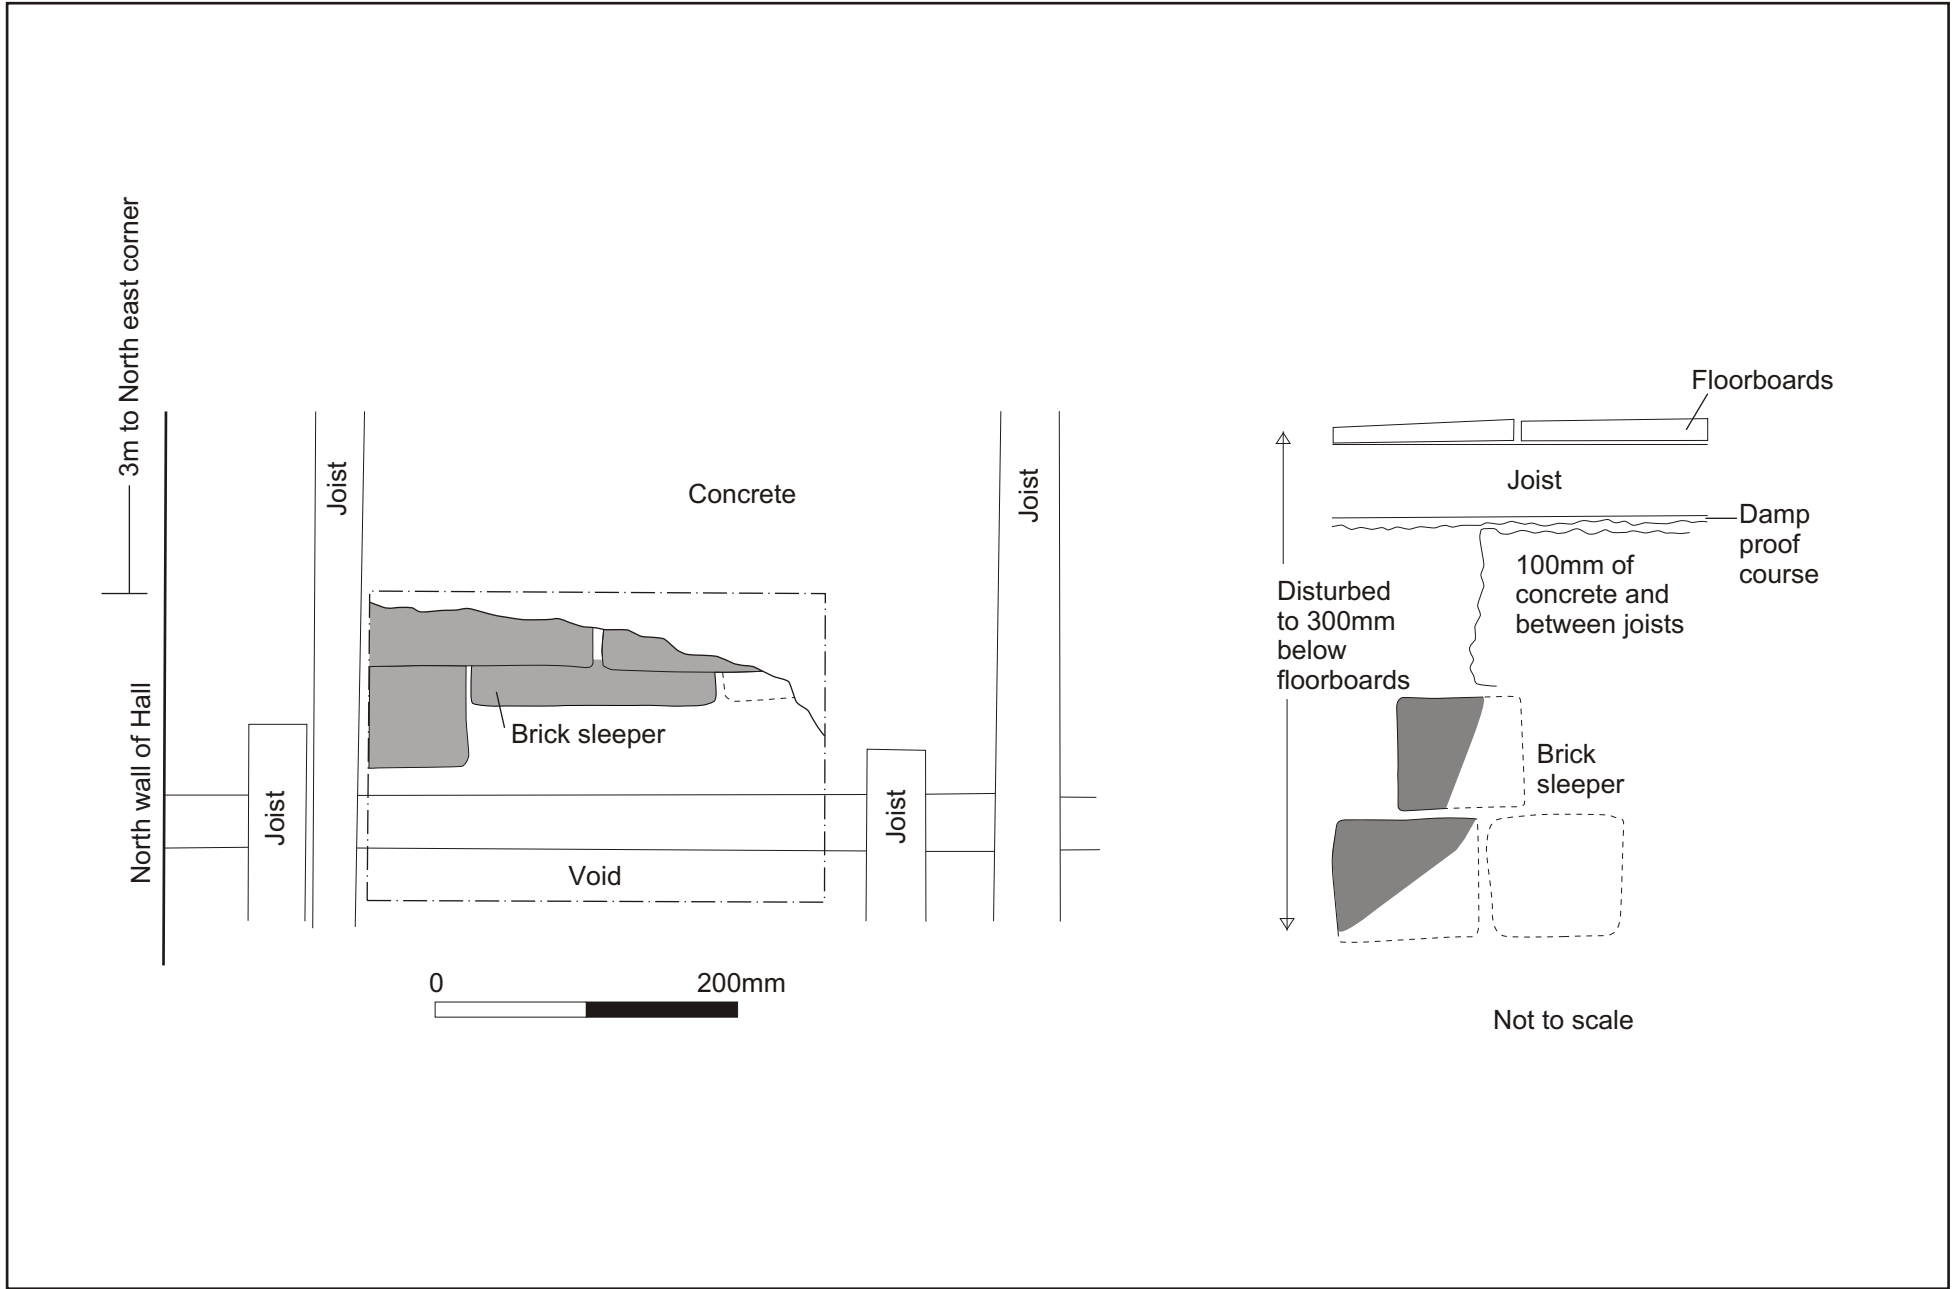
Old Hall plan and section showing the under floor makeup Fig 7

In order to better appreciate the impact the concrete and the formation of the modern floor had made on the sub-floor space in the room, a small test-pit was hand-broken (through the concrete) close to the north (outer) wall and 3m from its junction with the east wall. The test-pit measured approximately 300mm x 200mm and utilised observed weaknesses in the material which were exploited as the pit was widened to give access to the void beneath.

Between the modern joists and the concrete was a mastic damp-proof membrane. The concrete here was 100mm thick and underneath it lay partly a brick sleeper or dwarf wall formed of 19th-century bricks, aligned north-south and comprising two offset courses. These were cleaned up and recorded within the test pit before a lack of space at depth prevented deeper exploration, other than to probe down the outside of the exposed bricks.

The material outside and over the bricks comprised a gritty sand, mortar, brick and wood shavings, compacted but very dry and having no cohesion. This was clearly disturbed ground, and comprised builder's debris which accumulated rapidly when the last floor was removed and the current one laid. It showed that the sub-floor beneath the current floorboards has been disturbed in modern times over a wide area to a depth of 300mm. There was no indication of the original 16th-century Hall floor, reputed to have been of sixteen-inch black slate and other red tiles (Clarke and Black 1834, 12 and plate 1). Similarly the brick sleeper observed seems to have been of 19th-century brick (so far as the limited space allowed observation), so appear not to be remains of any 16th-century dais which Clarke and Black observed. It is likely that what they were observing was removed soon after and replaced with a new timber floor resting on brick sleepers, very much like such floors were constructed in hundreds of churches in the mid 19th-century.

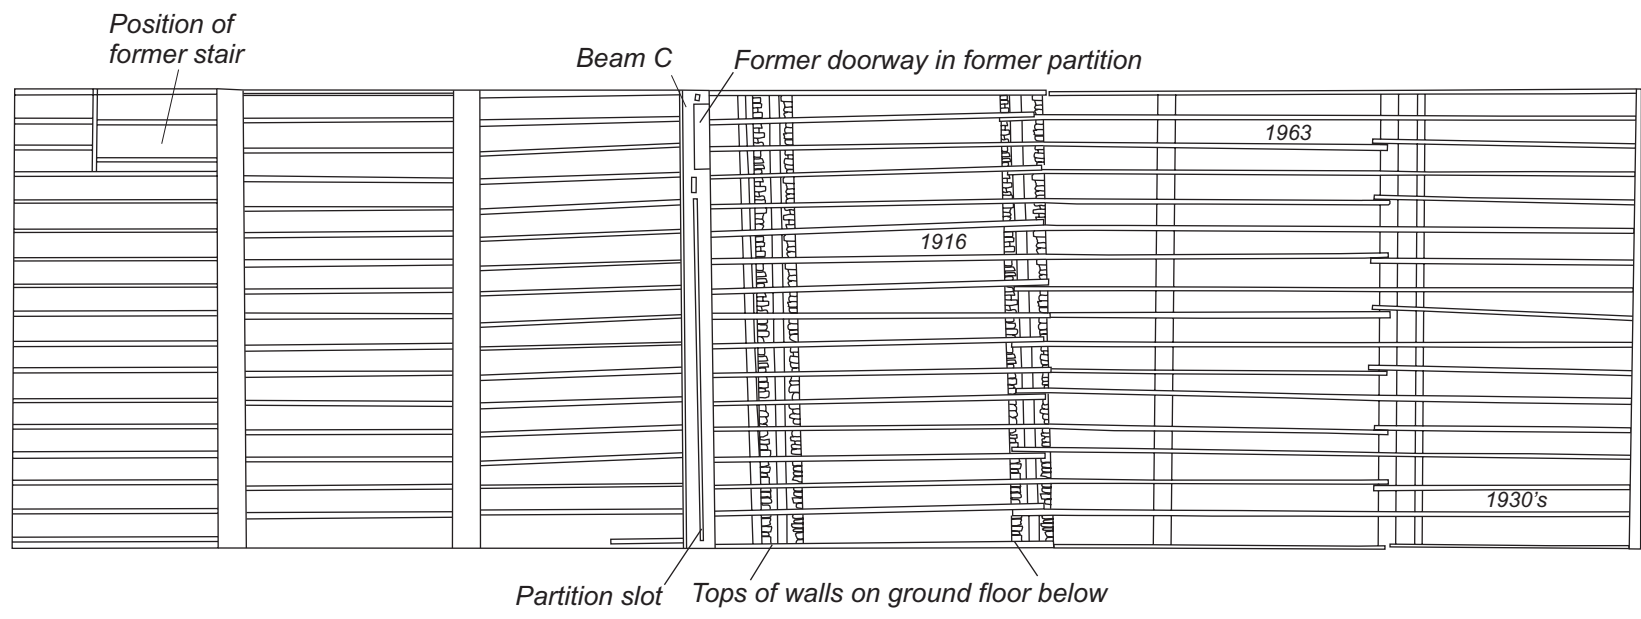
East wing, first floor plan, showing beams and joists Fig 8

The floorboards of the first floor of the east wing (Fig 3) were lifted as part of the ongoing renovation. A drawn record was therefore made of the beams and joists. This revealed that the beams and joists at the southern end of the room were the originals (Fig 8). The joists were joined to the beams with double soffit tenons with diminished shoulders, these joints were also pegged (Fig 8, insert). This is the type of joint observed by AOC Archaeology on the first floor during their 2004 survey of the building. The oak beams had rebates along their edges for floorboards (Figs 8, insert and 9), which meant that the beams would have been exposed between the floorboards. The beams measured 0.4m wide by 0.37m deep (15 ¾ inches by 14 ½ inches); the original joists were c0.05-0.07m wide by 0.37m deep (2-2 ¾ inches wide by 14 ½ inches). Battens had been laid over the original joists and beams to raise and level the modern floorboards. The third beam (from south to north), had a slot in it for a stud partition (Figs 8 and 9). At its western end there were two empty mortices for a door frame through the partition (Figs 8 and 10). A corresponding slot and mortices were noted in the beam above (Fig 11). To fashion the partition the tenons of the studs were located in the mortices in the soffit above (Fig 11) and the lower tenon then worked, not necessarily gently, along the slot (Figs 8 and 9) in the lower beam until each stud was vertical. Horizontals would then brace them if the fit

In the south-western corner of the room there was evidence of a possible former stairway or hatch through into the first floor from the ground floor (Figs 8 and 14). This may date from the turn of the 19th-century when the ground floor was being used as a stable and the first floor as a hay loft.

In the middle of the room the joists were supported on the tops of two walls from the floor below instead of beams (Figs 8 and 15). The beams and joists from these walls to the northern end of the room had been replaced in pine (Figs 8 and 16).

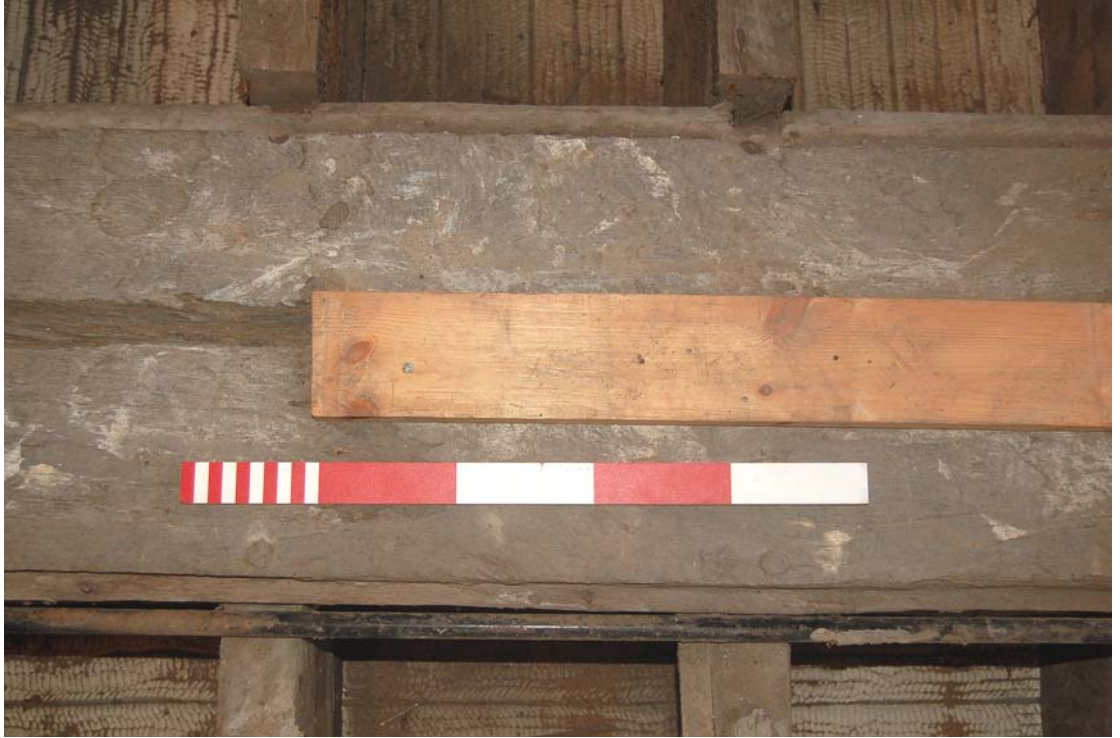
Fig 9: First floor partition slot in beam C

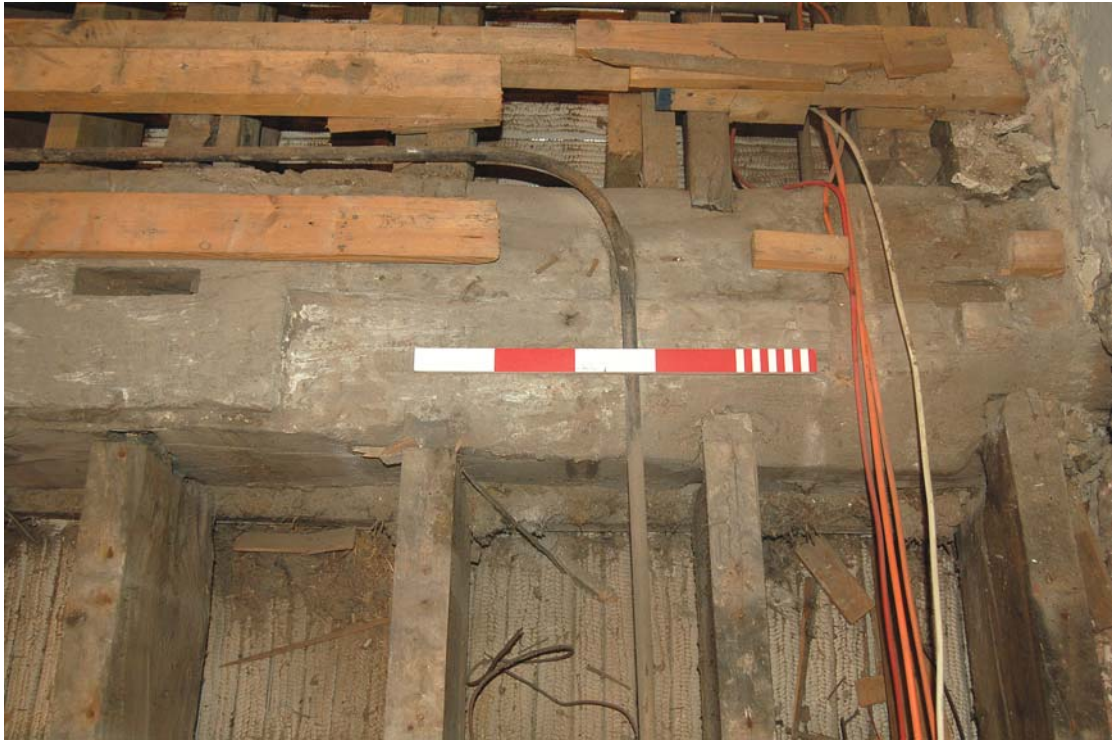
Fig 10: First floor mortice for doorway in partition on beam C

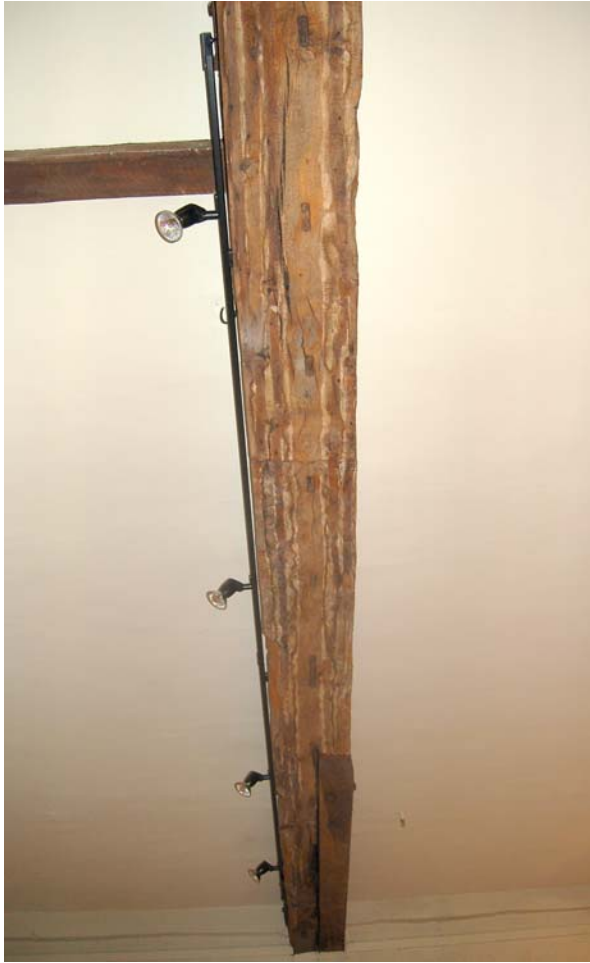
Fig 11: First floor beam above beam C showing corresponding slots for partition

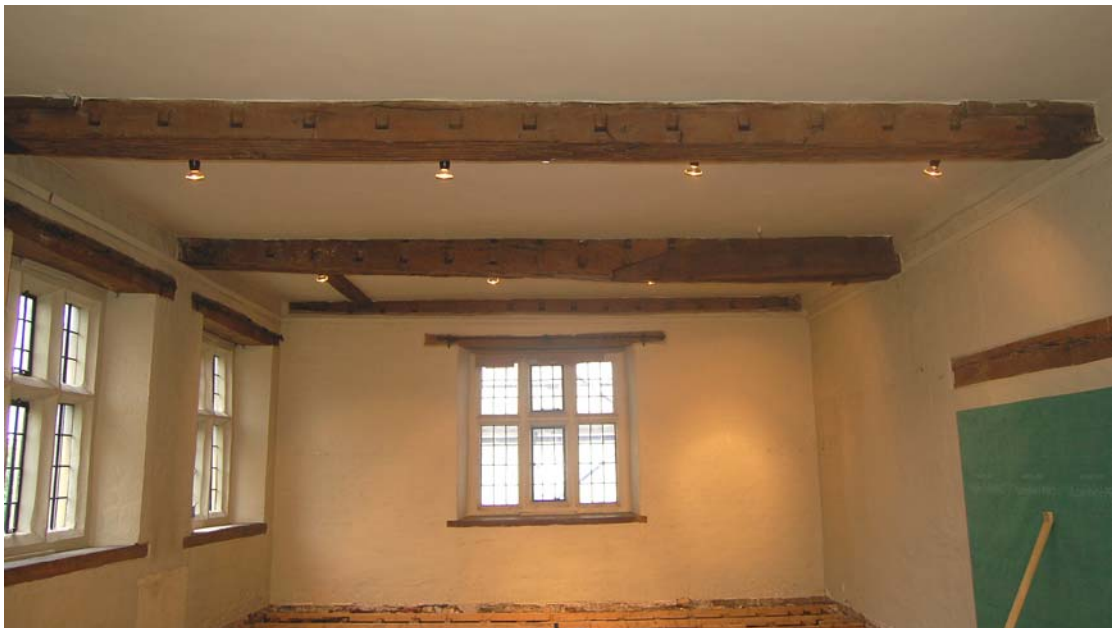
The original beams retained evidence for the same double soffit tenons with diminished shoulders joints for the joists as observed on the first floor. Only one mortice for each was visible however, below the current ceiling level of the first floor (Fig 12). The upper holes were masked by the lath and plaster ceiling.

Fig 12: First floor general view of beams

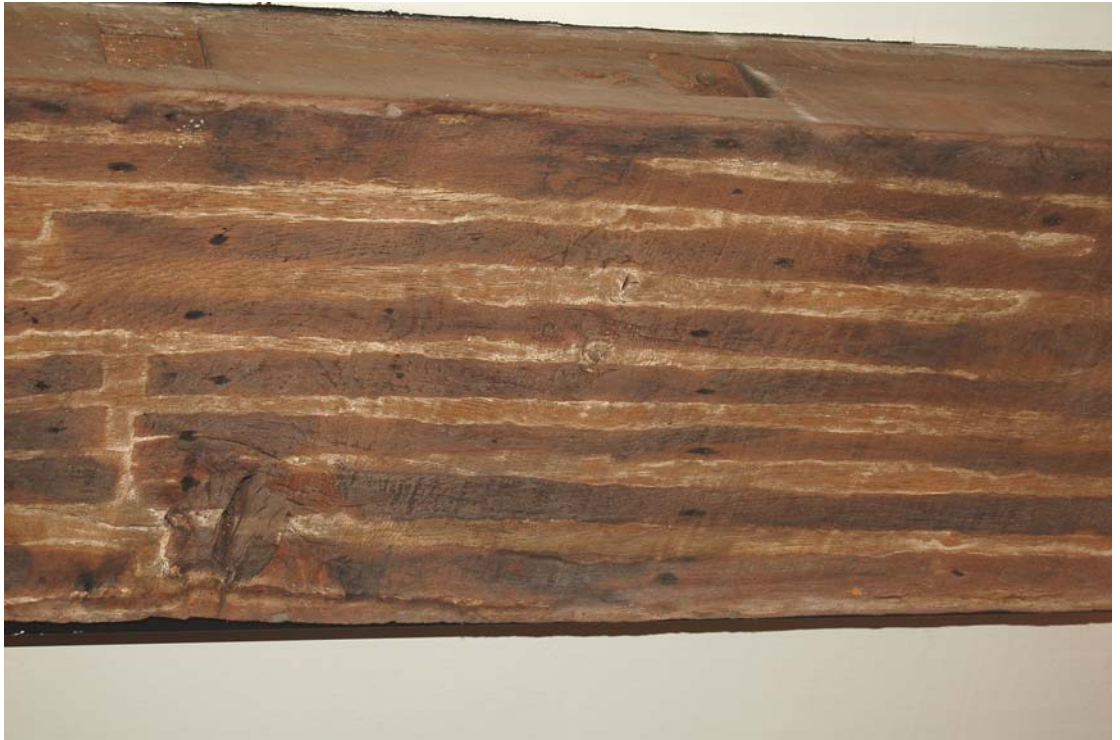
Fig 13: First floor, close up of underside of beam showing scar of lath and plaster ceiling

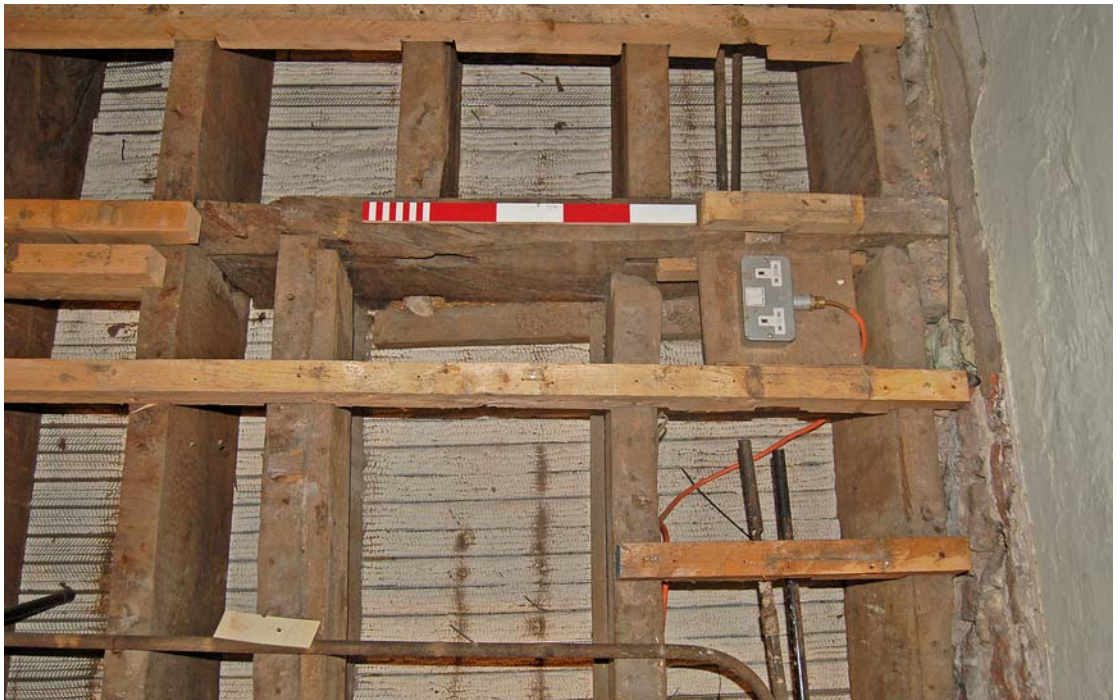
Fig 14: First floor south-west corner position of former stair or hatch

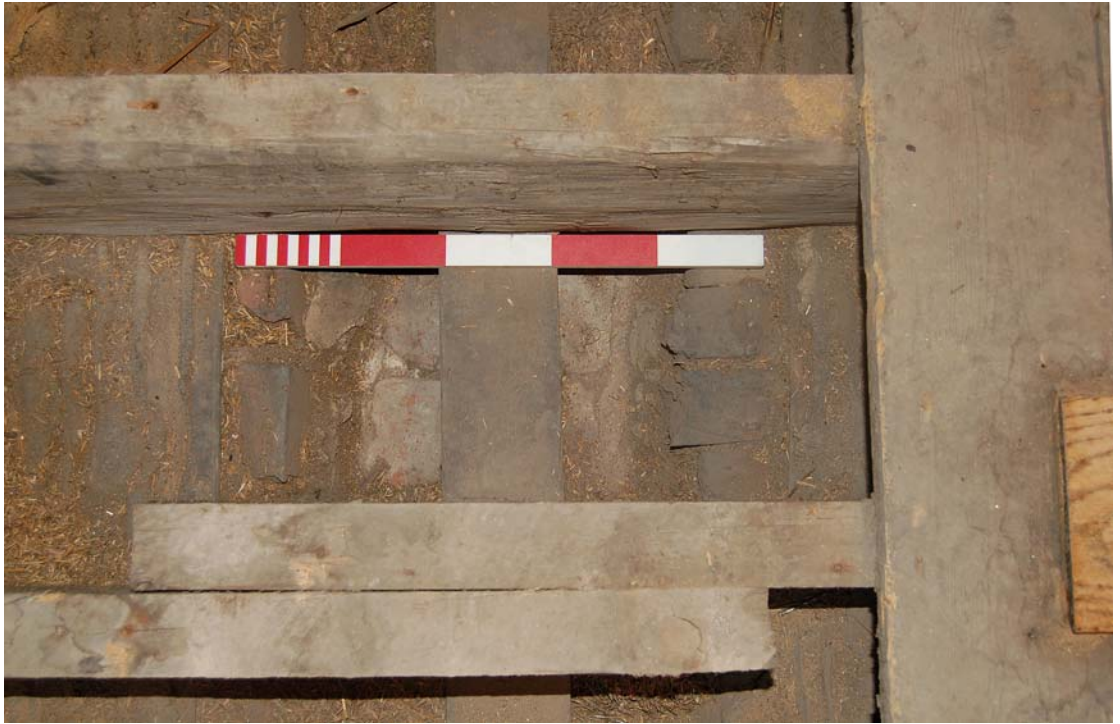
Fig 15: First floor top of wall below joists

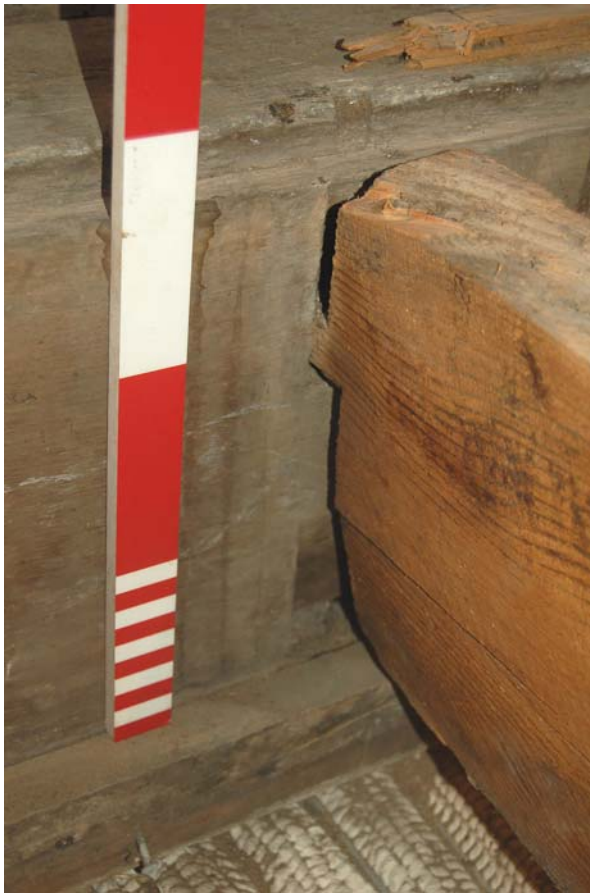
Fig 16: First floor Pine joist set into oak beam

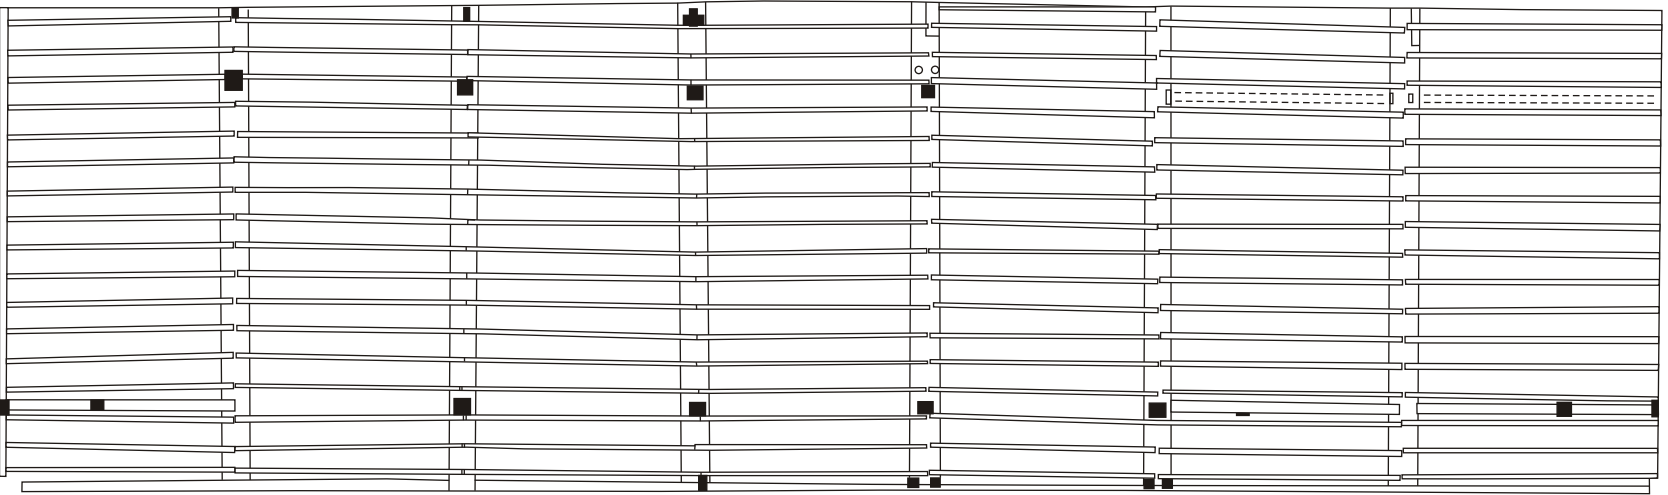
East wing, attic plan, showing beams and joists Fig 19

The floorboards in the attic (Fig 3a) were removed in two stages. Just as on the first floor a drawn record of the joist layout was made (Fig 19). The survey demonstrated that the joists were modern machine sawn pine 50mm wide by 180mm deep. The joists had been cut to hang on the original oak beams, thus raising the floor level slightly (Figs 20 and 21).

The original oak beams were variable in their condition, two of the beams had had new wood spliced into their western ends and a third had suffered badly from woodworm at its western end. Some of the beams retained partial remains of a rebate for the original floorboards, a feature in common with the first floor. David Williams (pers comm.) noted that it is unclear why the rebate was truncated here. Perhaps the floor was being re-laid after some warping or twisting of elements of the structure which were making the floor uneven, or perhaps a 'shake' in the oak broke the surface, rendering the floor sharp and dangerous. Given an extended period when the principal floor beams were exposed to the elements, some deformity of the wood over time might be understandable.

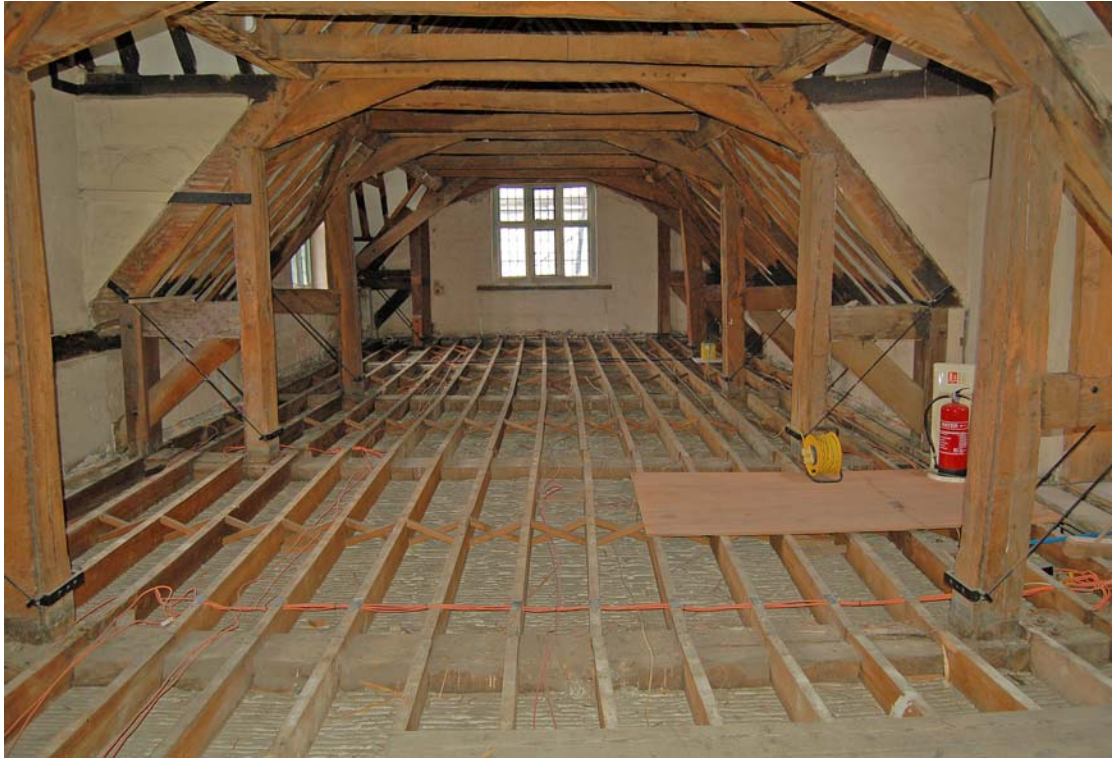
Fig 20: General view of the attic floorboards removed, showing the modern joists and original beams

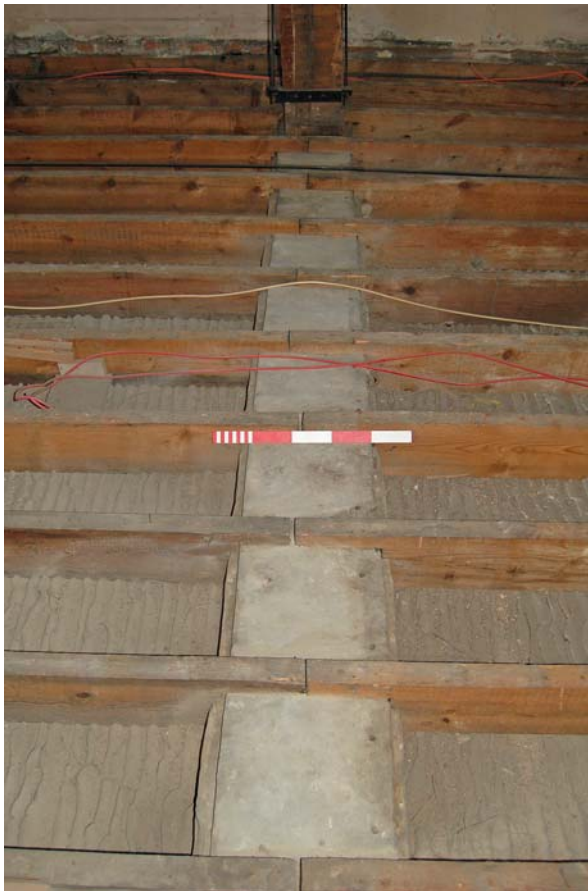
Fig 21: Attic, detail of replacement joists over original beam

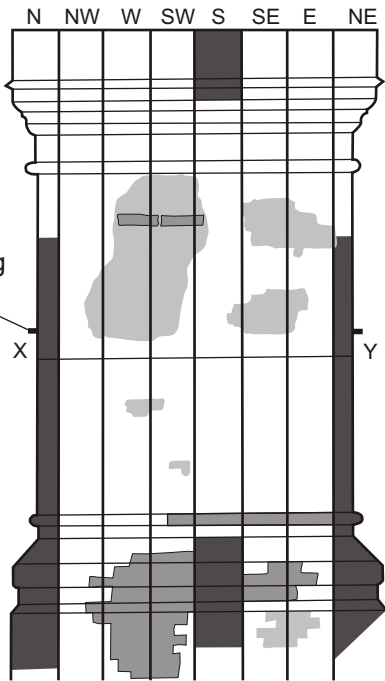
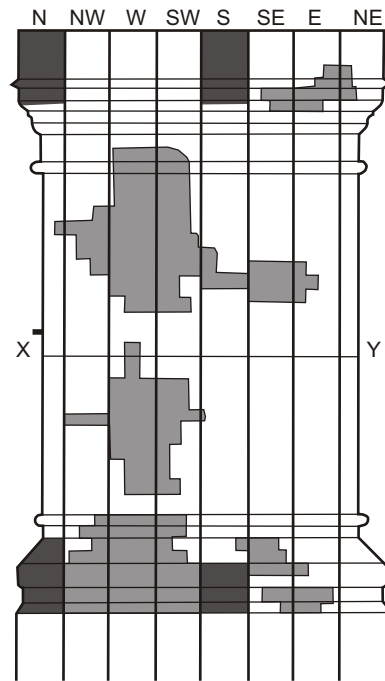
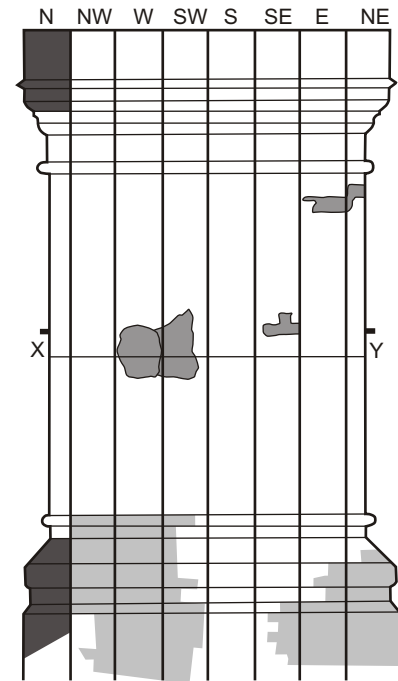
South west chimneys, details of the stacks (opened out) Fig 22

A further phase of rebuilding appears to have taken place from just below the iron tie rod which had been built into the three stacks for support (x-y Fig 22).

The very top five courses appeared to have also been replaced. The mortar used in these phases of rebuilding was a cement mortar with frequent gravel inclusions.

The latest work prior to the rebuilding of the chimneys involved localised re-pointing and brick replacement. The three stacks had also been capped with concrete and a lightning conductor fitted. Where re-pointing had taken place this consisted of a finer sandy grit cement mortar, which had been applied over the earlier pointing.

The size of brick varied within the chimneys, partly due to the use of moulded bricks and various replacements, also many of the bricks were very worn. The difference in the phases of rebuilding was mainly observed by the change in colour of the bricks and the amount of inclusion. The bricks in the lower part of the chimney had an orange fabric with crushed brick inclusions, (grog), many of the bricks varied in colour to an almost purple shade where they had been overfired. The bricks in the upper part of the chimney were a similar orange fabric with crushed brick and small rounded stone inclusions, but less of them exhibited evidence of overfiring. The later replacement bricks had an orange fabric, with fewer inclusions. The surface of the later bricks was also smoother as they had not been weathered as much as the surrounding bricks.

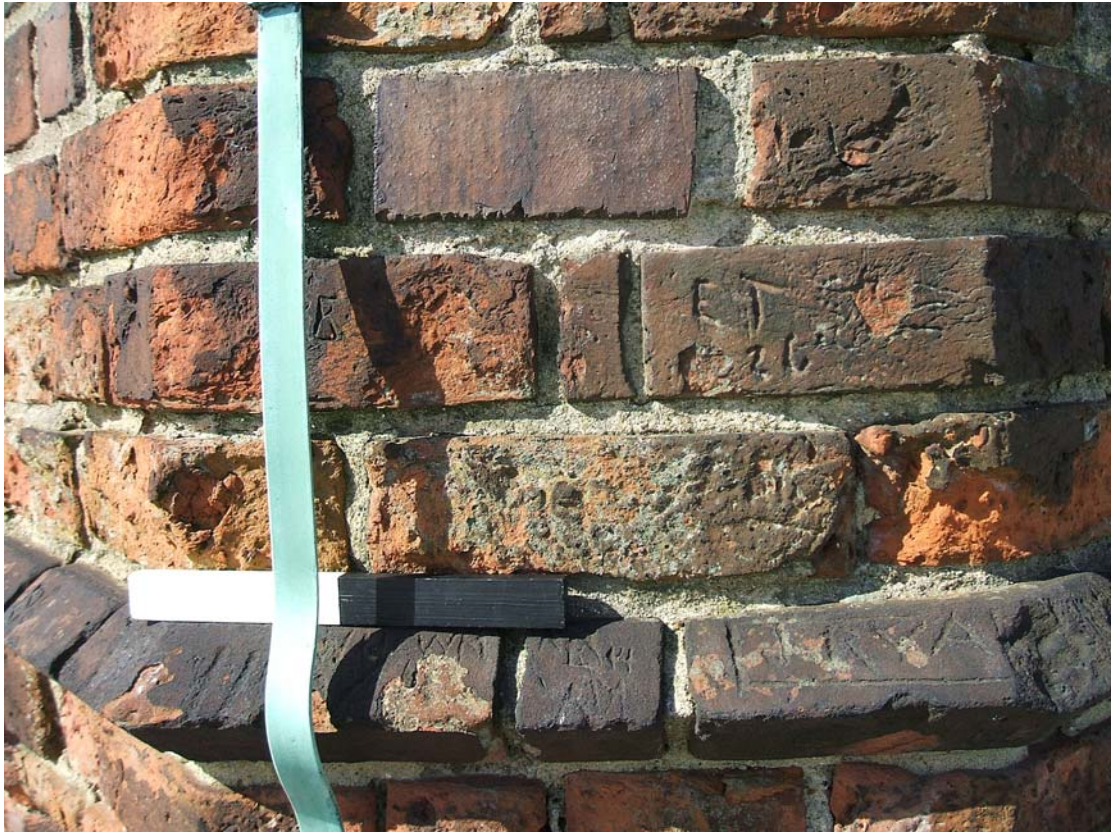
As part of the renovation works the south-west chimney (Fig 3a), (consisting of three individual stacks), was to be dismantled and rebuilt with replacement bricks where necessary. Prior to this commencing a drawn and photographic record of the chimneys was undertaken to demonstrate areas of replacement brick and re-pointing (Fig 22). The recording of the chimneys demonstrated that there had been at least four phases of rebuild and repair to the chimneys. No dates are known for the rebuilding of the individual stacks but it must have taken place prior to 1900 as there was graffiti of this date on the top part of the northern most stack (Fig 23).

Fig 23: Graffiti on north chimney stack

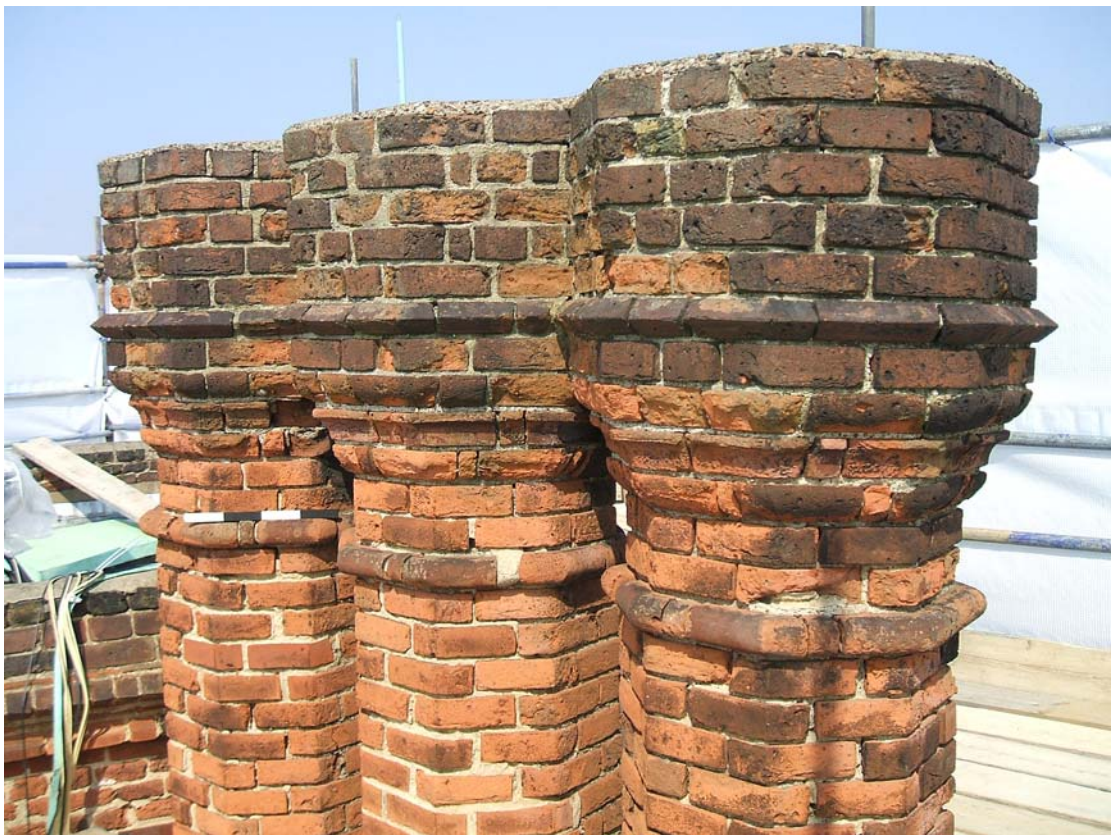
The chimneys, although not the originals, were rebuilt in a mock Elizabethan style with moulded brickwork forming decorative courses (Figs 24-26).

Fig 24: General view of chimney looking north-east

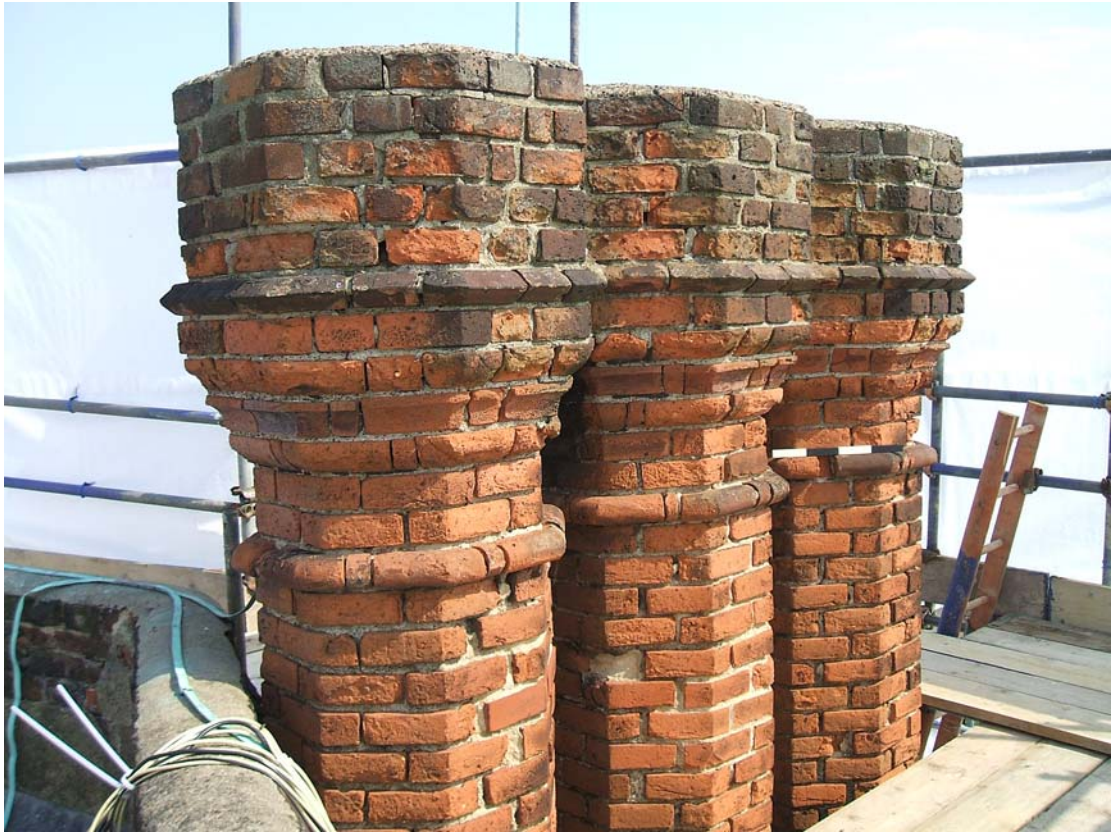
Fig 25: General view of chimney looking south-east

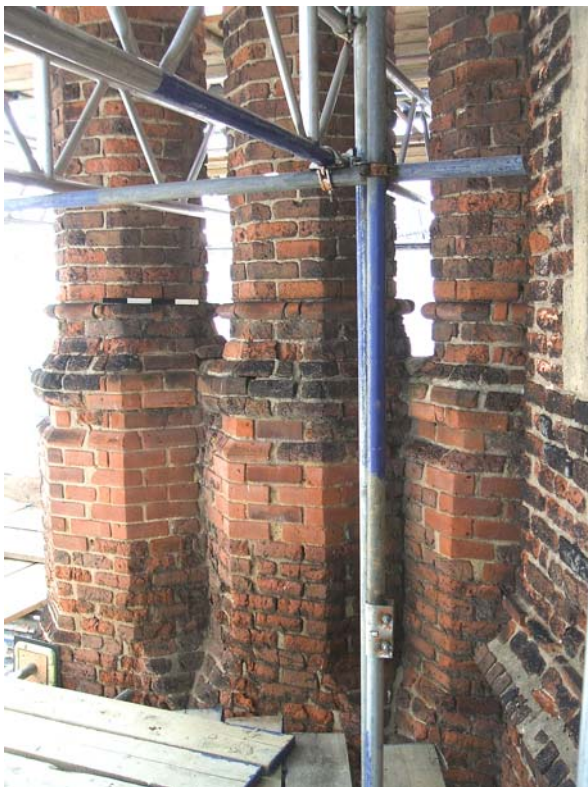
Fig 26: General view of lower part of chimney looking west
