An archaeological watching brief during the excavation of a French drain around the perimeter of the church of St John the Baptist, Flitton,

Bedfordshire

March 2006

Report 06/48

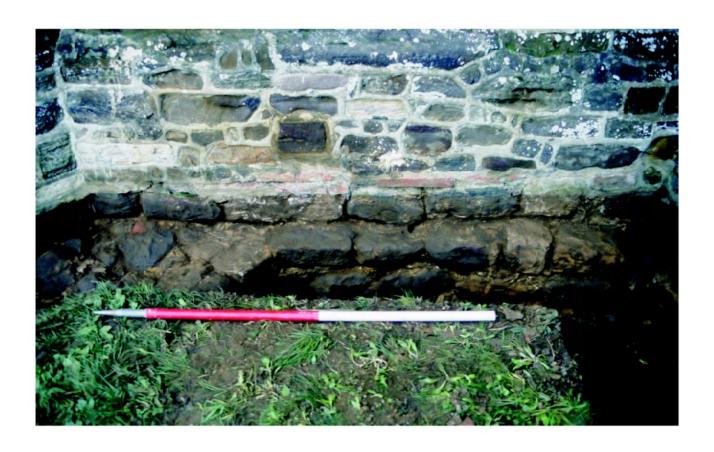
Plate 1

- 3.3 West end of the south aisle (Fig 2). The foundation to this section of wall is essentially flush with the masonry above and has no off set. The stonework is of fairly small undressed ironstone blocks bonded in a creamy white lime mortar for three to four courses. However, the bottom of the French drain trench revealed a solid mass of masonry that extended from the diagonal buttress along this section and the full width of the trench. It has the appearance of a wider foundation though the western limit was not established.

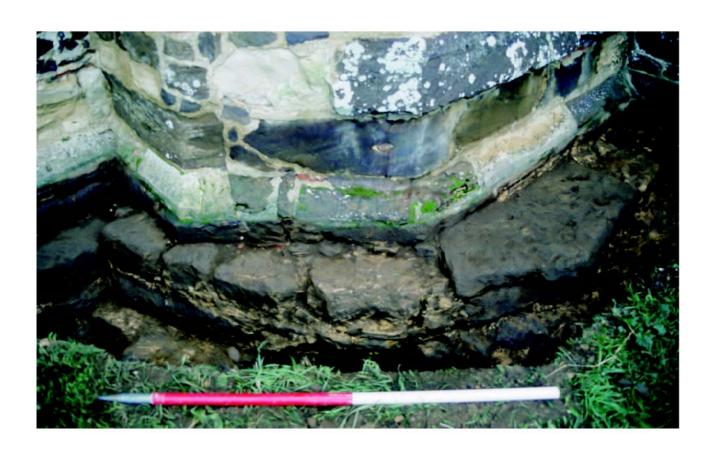
Plate 2

- 3.4 The stair turret and south side of the tower (Fig 2, Fig 3 sections 3 and 4, Plate 2). The stair turret comprises three straight faces though the foundation is constructed with an irregular curve. The stonework is mixed and comprises some very large stones with smaller fragments roughly coursed. The footing is off set from the wall above and continues neatly along the south side of the tower. The south side of the stair turret sits on the same mass of masonry identified on the west end of the south aisle, though again its southern limit was not established due to the narrowness of the trench.

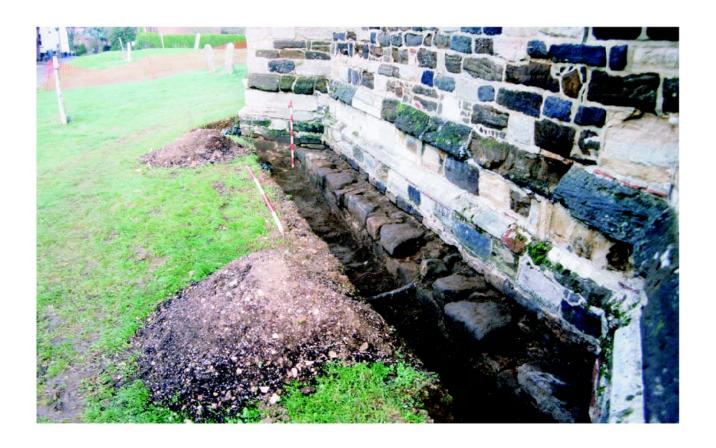
Plate 3

- 3.5 The west side of the tower and the north and south diagonal buttresses (Fig 2, Fig 3 section 5, Plate 3). The foundations of both of the diagonal buttresses were built flush to the walls above, and retain no off set. The section of wall between, the west face of the tower, has an off set foundation built of coursed iron stone bonded in a creamy white lime mortar.

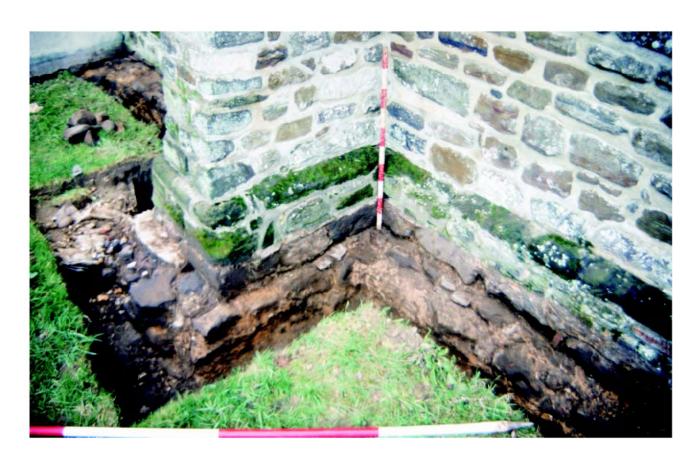
Plate 4

- 3.8 From the east side of the north door to the western side of the De Grey mausoleum the foundation comprised a simple off set stone foundation (Fig 2, Fig 3 sections 7 and 8, Plate 4). In the east angle of the westernmost of the two buttresses the contractor found a Jetton in the topsoil (Fig 2, see below, section 4.2). At the far eastern end of this section of wall the remains of an angled corner buttress could be seen which indicate that this corner of the north aisle was free standing and there was no contemporary chapel on the north side of the chancel where the western arm of the mausoleum now stands (Plate 5). The corresponding south-east corner of the south aisle retains a similar *in situ* corner buttress.

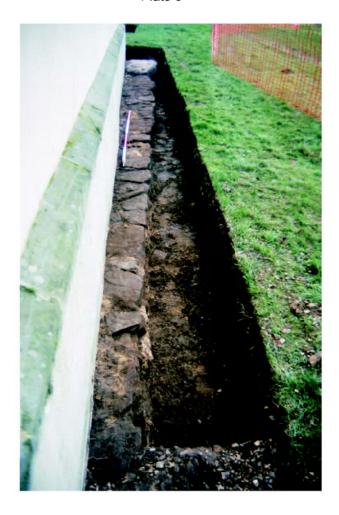
Plate 6

- 3.9 Where the mausoleum juts northwards from the north aisle wall the foundation is wider and constructed of larger pieces of stone (Fig 2, Fig 3 section 9, Plate 6). Along the north side of the mausoleum the foundation continues in the same fashion, but does not run exactly parallel to the upstanding wall, rather it is wider at the western end and narrows slightly towards the east. This is probably no more than a reflection of the fact that foundations are often roughly made and when the upstanding wall is constructed any correction in alignment is effected at this stage. The stone foundation stops short of the current length of the north wall of the mausoleum, and as this part of the building is earlier than the rest it might indicate that this early part was slightly shorter than the chancel. If this is the case, however, the two windows in this side of the mausoleum must have been altered as they are central to the present length of this wall. However, since the external walls are covered in cement render no indications of alterations can be seen. The remainder of the mausoleum drain trench on the north side revealed that the foundation was generally of brick in line with the upstanding wall (Fig 2, Plate 7). A single

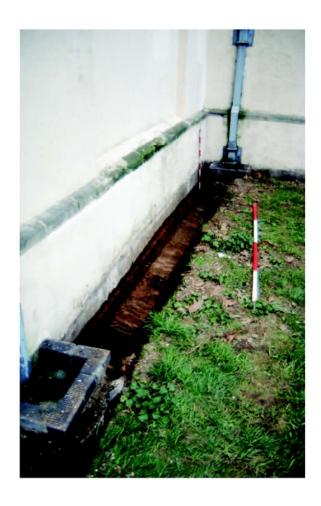
Plate 8

- 3.10 The south side of the mausoleum comprised the same vertical brick foundation as on the north. Two brick drains were revealed, both comprising narrow channels formed by parallel brick sides capped by the same type of red bricks laid cross ways over the top (Plate 8). At the west end of the southern wall of the mausoleum the stone footings of an angled corner buttress were revealed (Fig 2, Plate 9). The brick wall of the mausoleum and the parallel brick drain both overlay this stonework. The presence of the buttress footing indicates that this corner of the church was originally the eastern limit of the chancel.

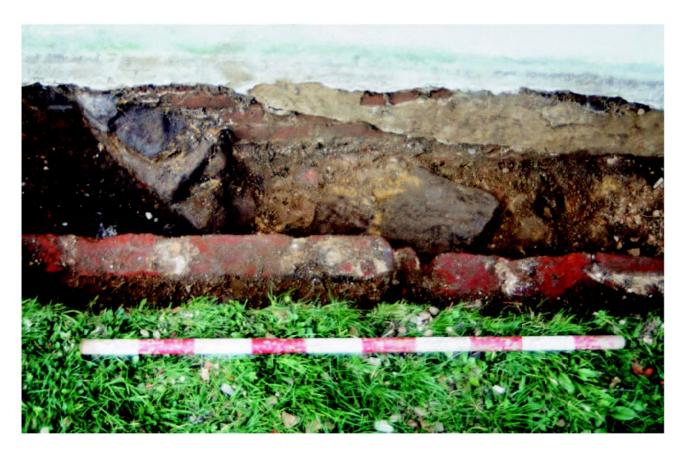
Plate 9

- 5.2 The south wall of the 1705 phase of the mausoleum sits over a stone angled corner buttress foundation which formerly supported the south-east corner of the chancel. A similar angled buttress on the north-east corner of the north aisle indicates that there was no chapel on the north side of the church where the western arm of the first phase of the mausoleum now stands. It therefore appears that the church was built in a single phase and has had no additions other than the mausoleum. The short section of stone foundation which lies beneath the north wall of the eastern arm of the mausoleum cannot easily be reconciled with the church and may not be related to it.

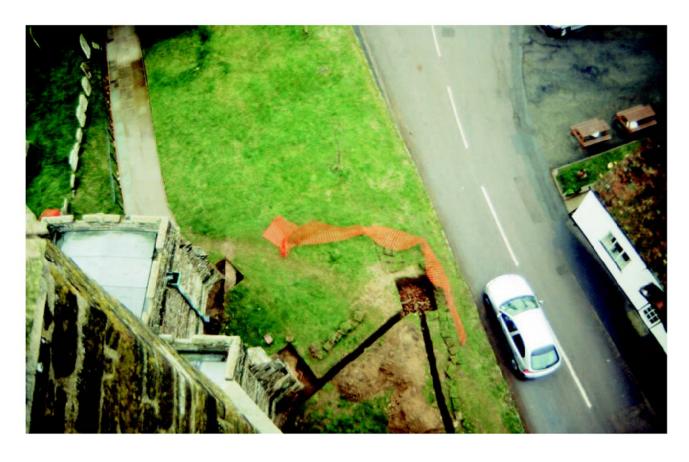
Plate 10

- 3.12 Five soakaway pits were dug in which the rainwater from the drains could dissipate (Fig 2). Two of these soakaways already existed and the new drain runs were simply connected to them (soakwaways 1 and 5). No articulated burials were uncovered in soakaways 2 and 3, though some disarticulated bone was recovered (Fig 2, Plate 10). This was left at the church for re-burial. In soakaway 4 one undisturbed grave was partially uncovered in the northern side of the drain run; this was left *in situ* (Fig 2). In the soakaway pit at the southern end of the drain run the side of a stone coffin was revealed. Only the very edge was uncovered and is was not possible to determine if the coffin was complete or fragmentary or whether it contained a burial. The soakaway pit was completed to one side and the coffin left *in situ*.
