Archaeological building assessment
and desk-based research on
Pump Cottage, Coombe Abbey,
Warwickshire.

Revised November 2007

Report 07/179

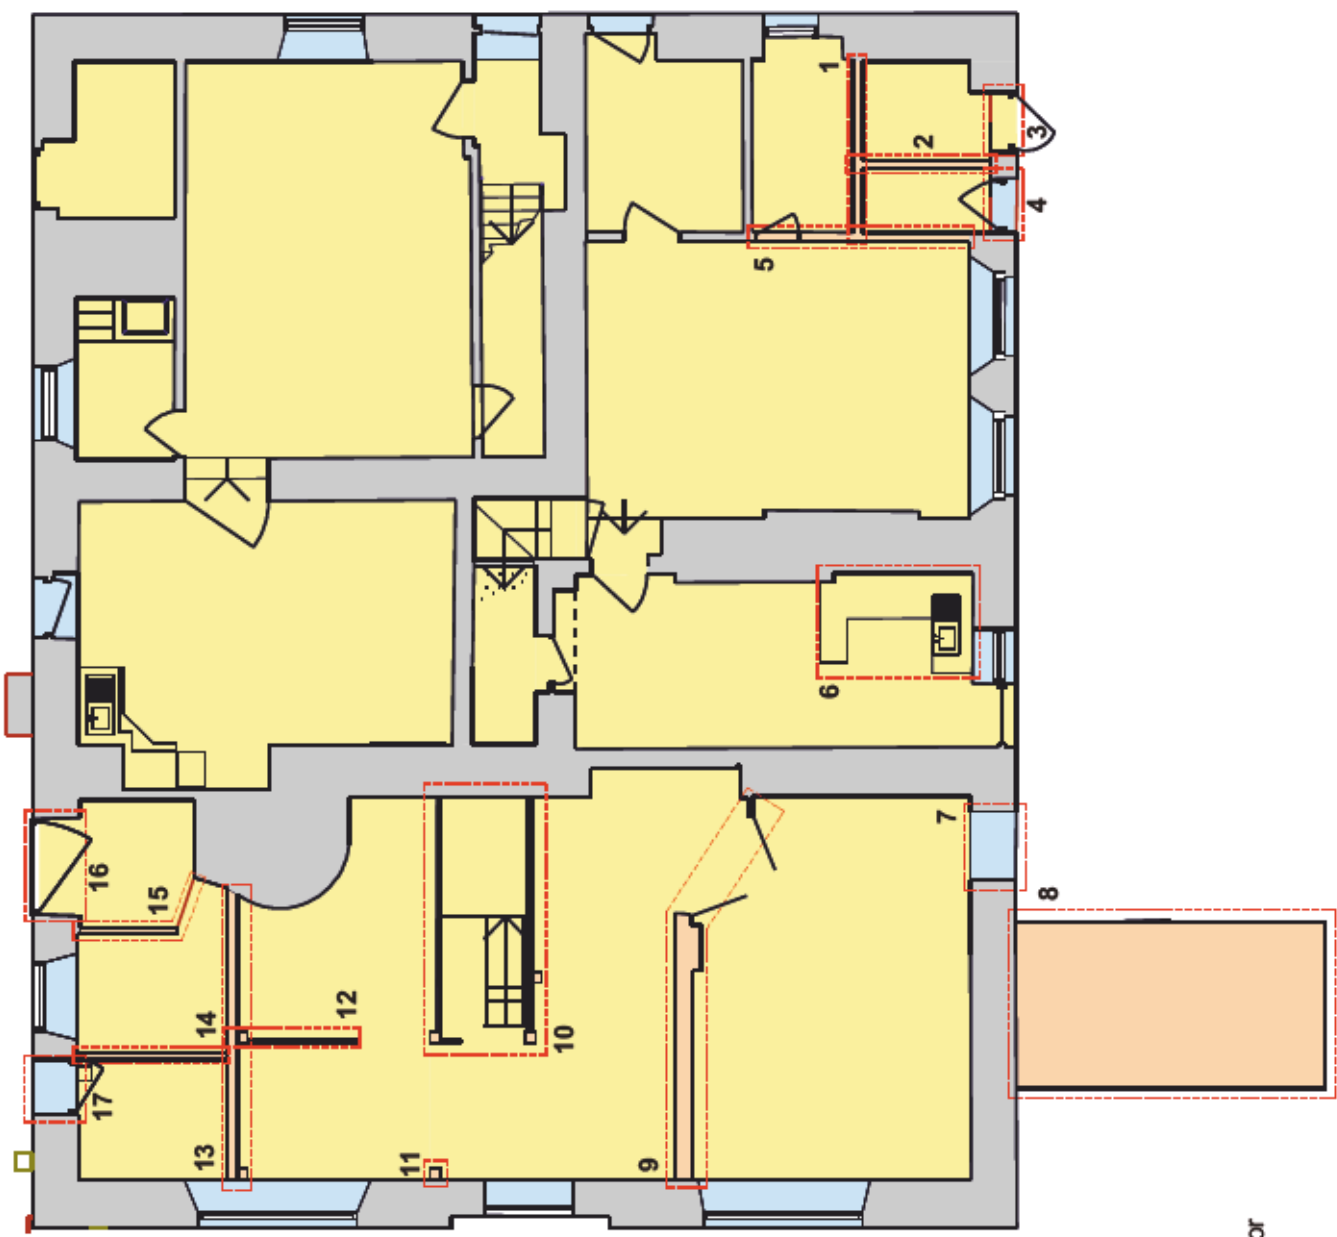
Proposed alterations: Ground floor Fig 8

1, 2 and 5. *Removal of internal wall.* These walls are of brick and probably twentieth century in date, most likely being inserted after the demolition of the adjoining service range in the 1930's after which time the cottage was converted for domestic use.

3 and 4. *Replacement of existing doors with new French doors.* These doors are probably of the same date as the walls 1 and 2 as they relate to the spaces created by those walls.

6. *Existing kitchen removed-new units to be installed.* This comprises standard modern kitchen units which are probably no more than 10-20 years old.

7. *Block up existing opening.* This is a modern door and frame. The opening is also modern with a concrete lintel and most likely was created post 1930's demolition of the adjoining service range, probably much later in the twentieth century.

8. *Demolition of existing out building.* A home made garden shed/greenhouse constructed from odd pieces of wood and plastic sheeting with glass windows on the east side. It is probably no more than 20 years old at the most, and may be much newer.

9. *Removal of internal wall with door.* A brick wall of probably nineteenth century date, but not original to the building as it sits awkwardly in front of one of the blocked arches to the east. This wall continues up through this floor and the first floor to the roof. Probably inserted when the west end of the building was altered to accommodate the first floor timberwork related possibly to brewing, and to create a room above on the south side of the building.

10. *Removal of existing staircase with timber post.* Whilst almost certainly in the position of an earlier staircase, the present narrow one appears to be twentieth century in date and appears to be carpenter made. The timber post is probably of late nineteenth century in date and forms part of the support frame for the floor above.

11. *Removal of timber post.* The post is probably of late nineteenth century in date and forms part of the support frame for the floor above.

12 and 13. *Removal of internal wall with timber post.* The wall is probably twentieth century in date and was inserted when toilets were added in the small rooms created to the north of this partition wall. It cuts clumsily across the window in the west façade of the building. The toilet was accessed through a doorway of similar date in the north wall (see

below, 17). The timber post is probably of late nineteenth century in date and forms part of the support frame for the floor above.

14. *Removal of internal wall.* The wall is probably twentieth century in date and was inserted when toilets were added in the room to the west and in the space to the east of this wall. It was accessed from the east via another small space which in turn was accessed via a doorway created in the position of a former window in the north exterior wall (see below, 16).

15. *Removal of internal wall with door.* Part of the same scheme outlined in 12, 13 and 14. Brick twentieth century wall and door added when this area was sub-divided for the creation of store room and toilets.

16. *Block up existing opening.* At present a doorway, this was originally a window; the voussoirs of the window survive above it although the jambs to the current door are wider than the window which was clearly part of the original building. The doorway was created during the twentieth century to allow access to the rooms created by the addition of the walls 13, 14 and 15.

17. *Block up existing opening.* A modern doorway relating to the creation of toilets. Twentieth century in date.

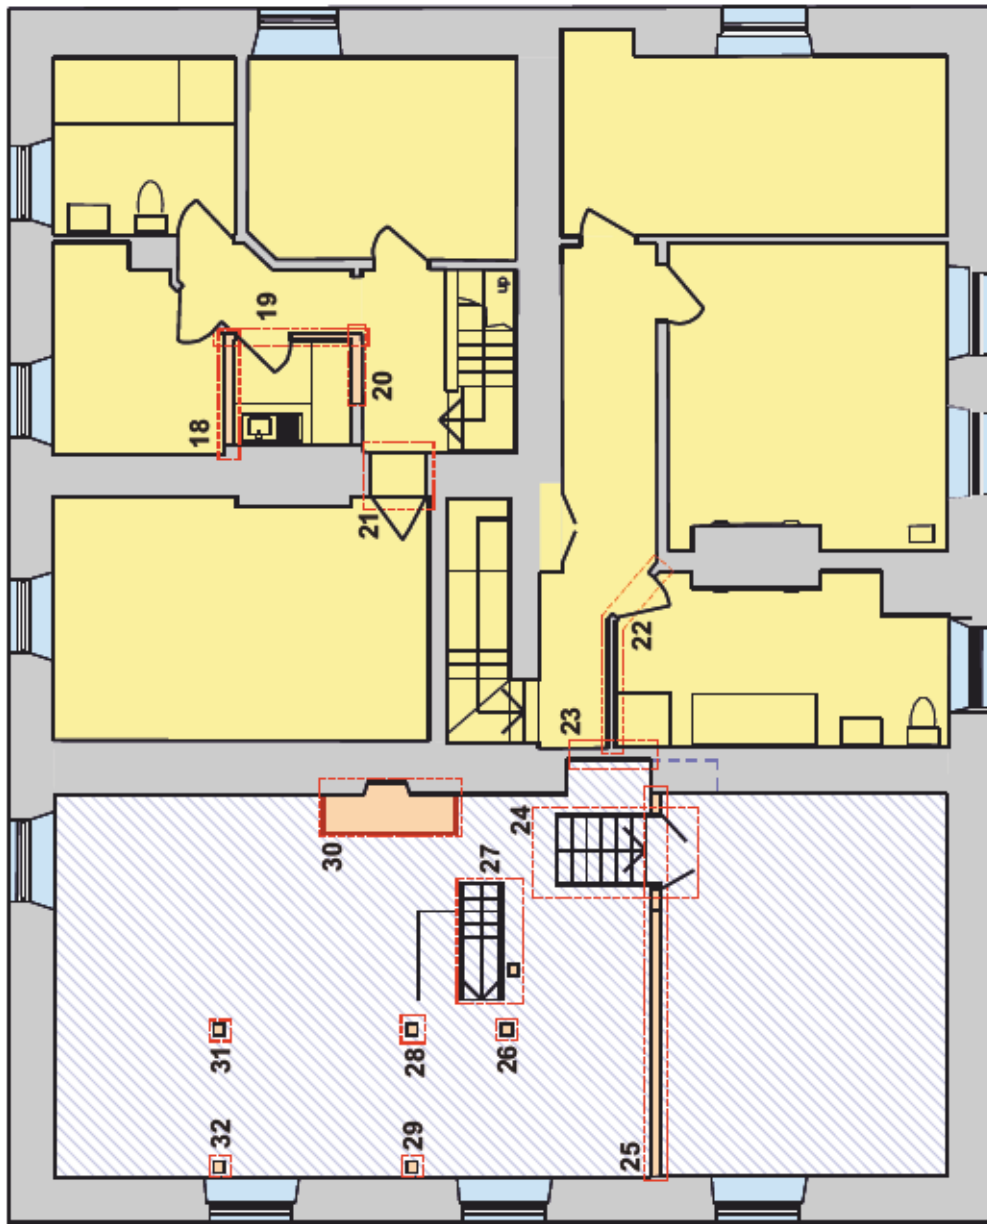
Proposed alterations: First floor Fig 9

18 and 19. *Removal of internal wall.* Stud and plasterboard walls of late twentieth century date inserted to create an internal kitchen space for the flat.

20. *Partial removal of internal wall.* Stud and plasterboard wall of late twentieth century date inserted to create an internal kitchen space for the flat.

21. *Removal of existing door.* Timber door and frame of nineteenth century date, not original to the building and almost certainly inserted when the upper floor was converted for domestic use during the nineteenth century when the building was attached to the now demolished north service range. The door has been stripped (it would have been painted originally) and is a standard mass-produced door of the period.

22. *Removal of internal wall with door.* Probably of late nineteenth century date, inserted to create a bathroom and toilet when the building was converted for domestic use during the nineteenth century when it was attached to the now demolished north service range.

23. *Partial removal of wall-new opening.* This wall is part of the original building constructed of coursed rubble stone set in lime mortar and forms the main north-south internal wall separating the two unequal parts of the building's internal space.

24. *Removal of staircase.* A timber staircase of carpenter work inserted when the brick wall on the ground floor (9) and upper floor (25) was inserted during the nineteenth century. The staircase was necessary due to the unequal levels of the floors in the two parts of this end of the building.

25. *Removal of internal wall.* Of nineteenth century date it appears to have been added to create an extra room at the south end of the building on both floors.

26, 28, 29, 31 and 32. *Removal of timber posts.* All part of the framework for the timber shallow troughs and associated floor and of nineteenth century date.

27. *Removal of staircase with timber post.* Whilst almost certainly in the position of an earlier staircase, the present one appears to be twentieth century in date and appears to be carpenter made. The timber post is of late nineteenth century in date and forms part of the support frame for the floor.

30. *Removal of existing fireplace.* This fireplace is a secondary addition as it relates to the present floor which is supported on the posts of nineteenth century date. It is also clearly

cut into the stone wall as the facing of the flue and the fireplace surround is all of nineteenth century brick.

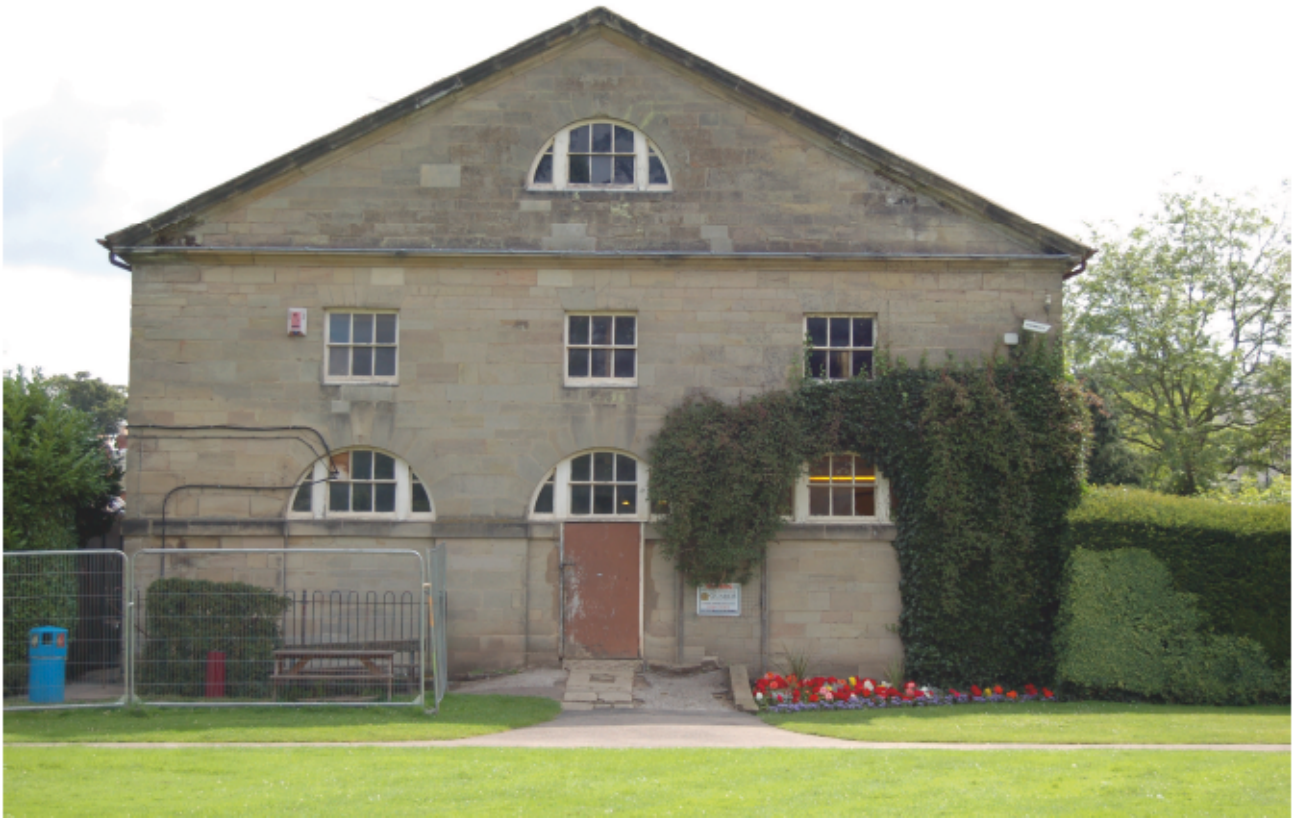
The west façade is the most architecturally accomplished comprising a symmetrical arrangement of three arches at ground floor level, each glazed in their upper parts, and with a simple flat string course at the height from which the arches spring. Three square windows are arranged above at first floor level and sit below a simple stone cornice which is also used to define the gable ends forming a pediment at the centre of which lies a semi-circular window (Plate 1). The whole façade is built of finely dressed buff coloured sandstone.

Plate 1: West façade of the building.

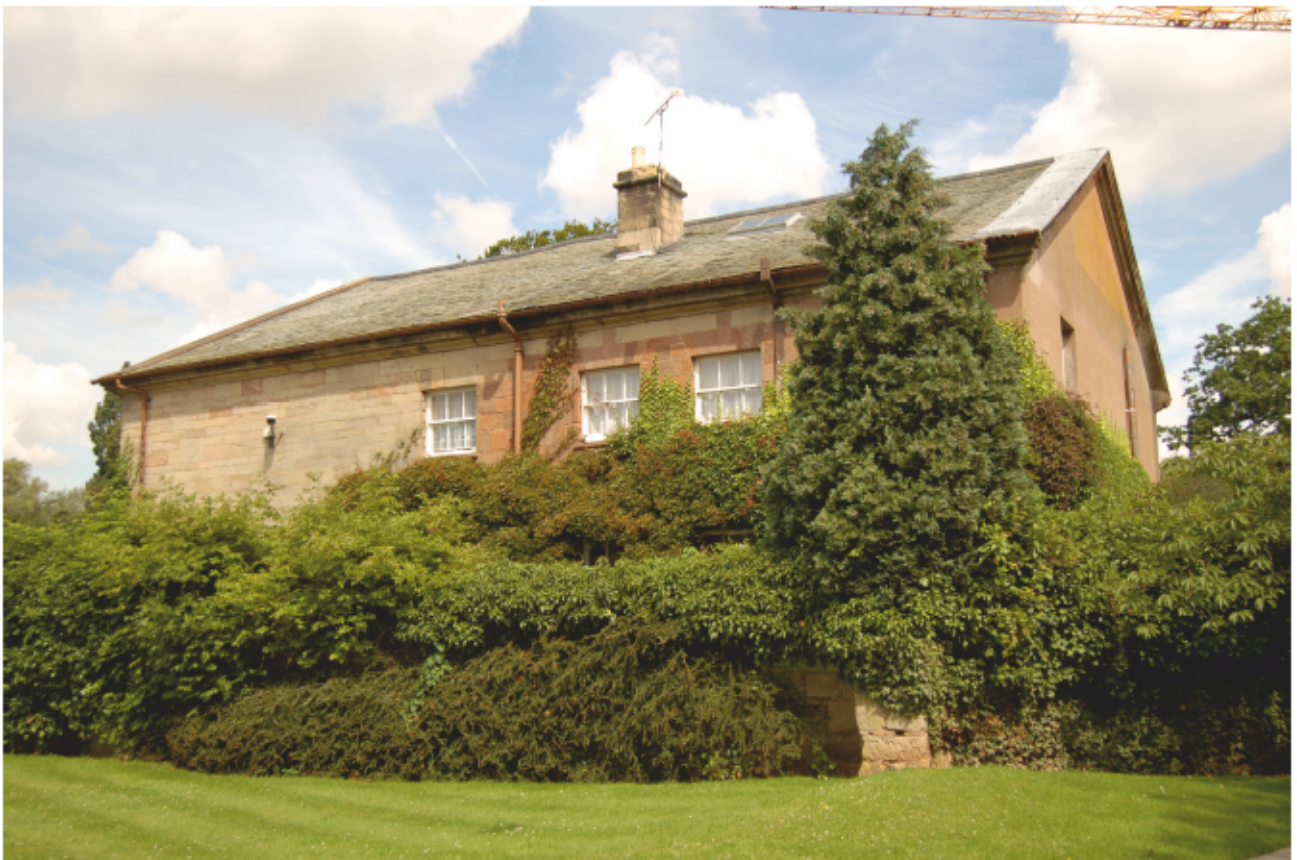
The south façade contains further windows and doors (three on the first floor), again partly original, partly later and is built of both red and buff sandstone (Plate 2). It is not clear if the distinction between the two colours of stone indicates the presence of former structures,

phases or alterations or is simply a reflection of the stone available at the time of construction. They may also simply represent different beds of stone from the same quarry.

Plate 2: South façade of the building.

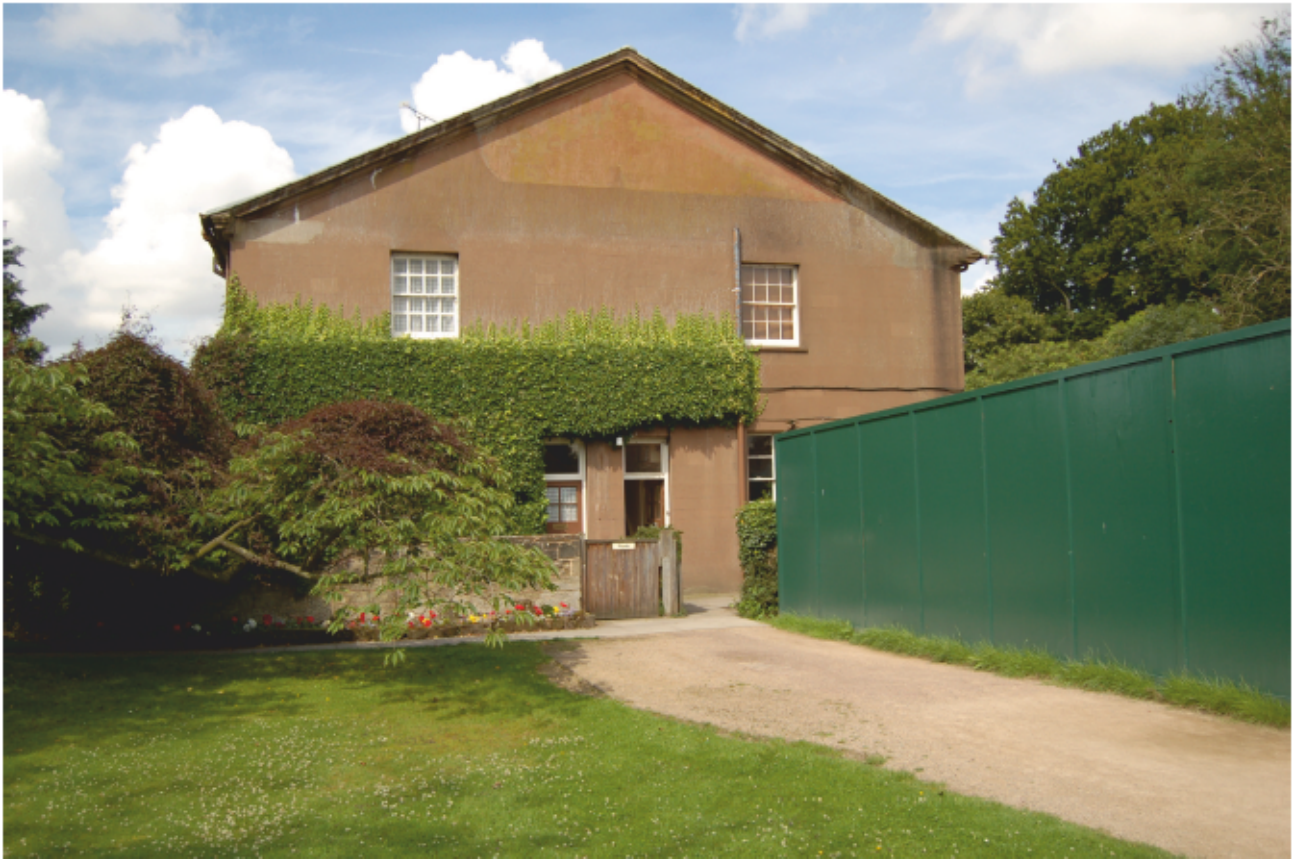
The east façade similarly contains windows and doors and is cement-rendered (Plate 3). This is a result of it being incorporated into the north kitchen range at which time this once exterior face would have become interior wall surfaces. If, as elsewhere on the building, this façade was of ashlar masonry it is likely to have been keyed to receive plaster. After the kitchen range was demolished this façade would have had a rough appearance and it seems that it was rendered and given false bedding lines to try to blend it with the other façades. A cornice has also been re-created at eaves and gable level though this did not originally exist (see below, attic).

Plate 3: East façade of the building.

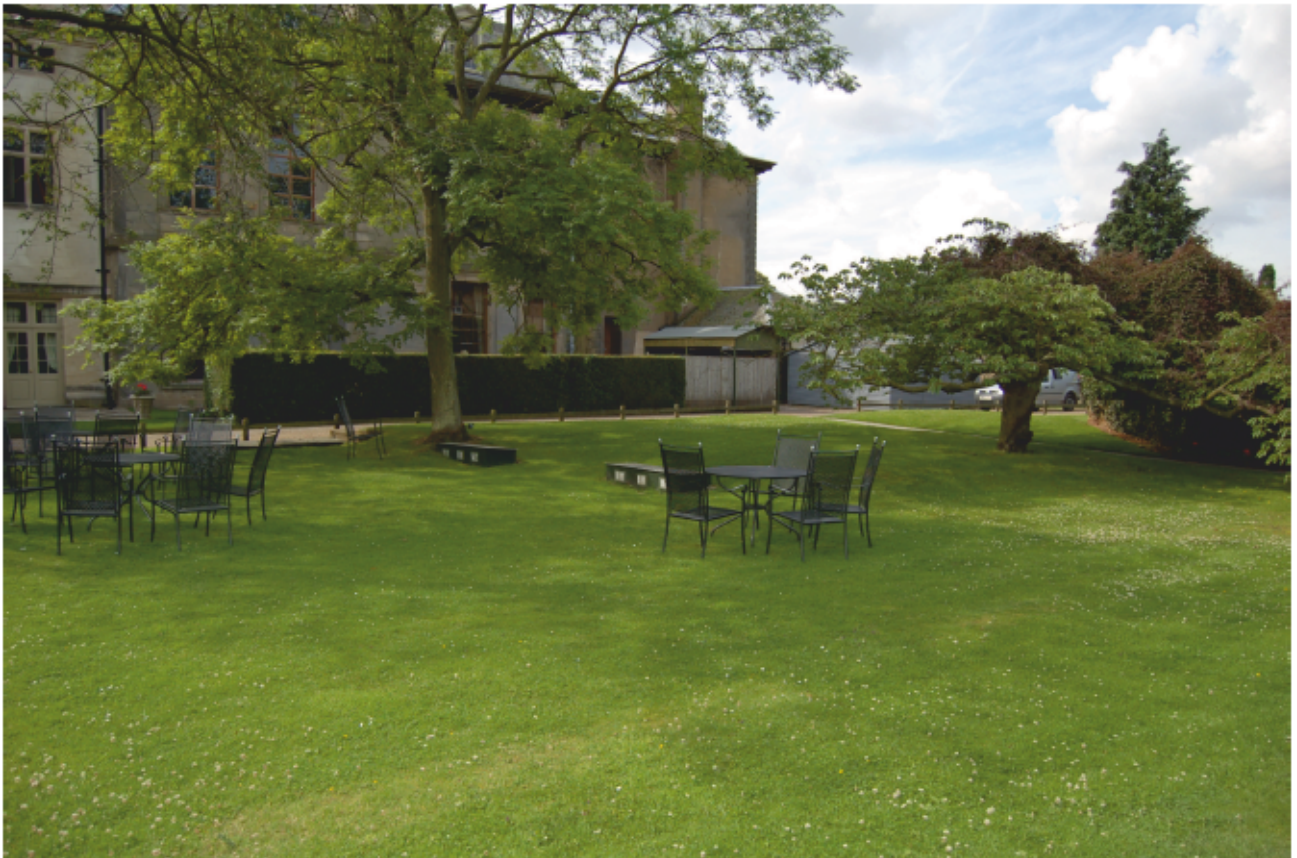
The cottage is partly enclosed by a stone wall which must post-date the demolition of the kitchen range in the 1920s (Fig 3). It is constructed of sandstone, both red and buff and contains mostly dressed stone fragments presumably from parts of the abbey which were being demolished. To the east and south of this wall is lawn containing trees (Plate 4).

Plate 4: Lawn area to the south-east of the building looking south-west.

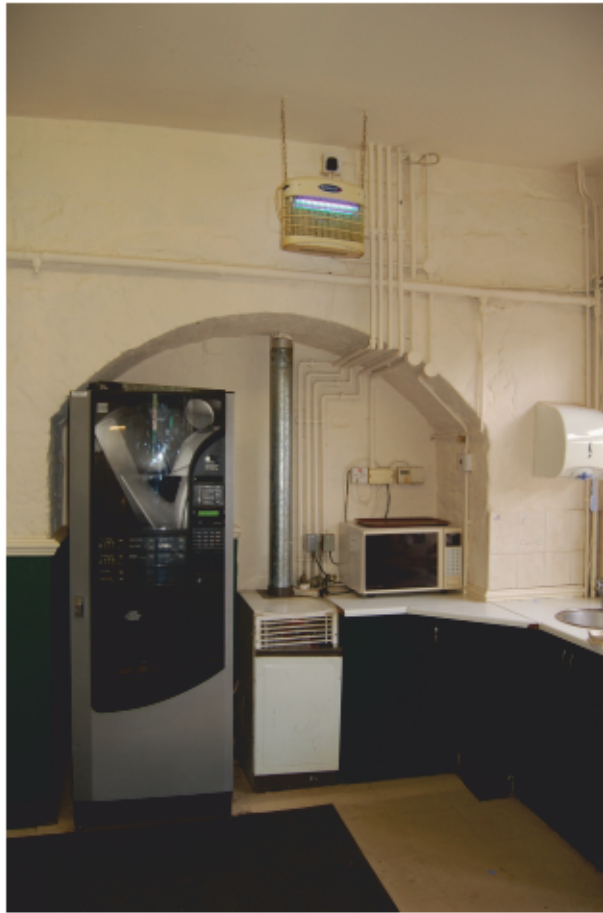
Plate 5: Arch in west wall of Room 6.

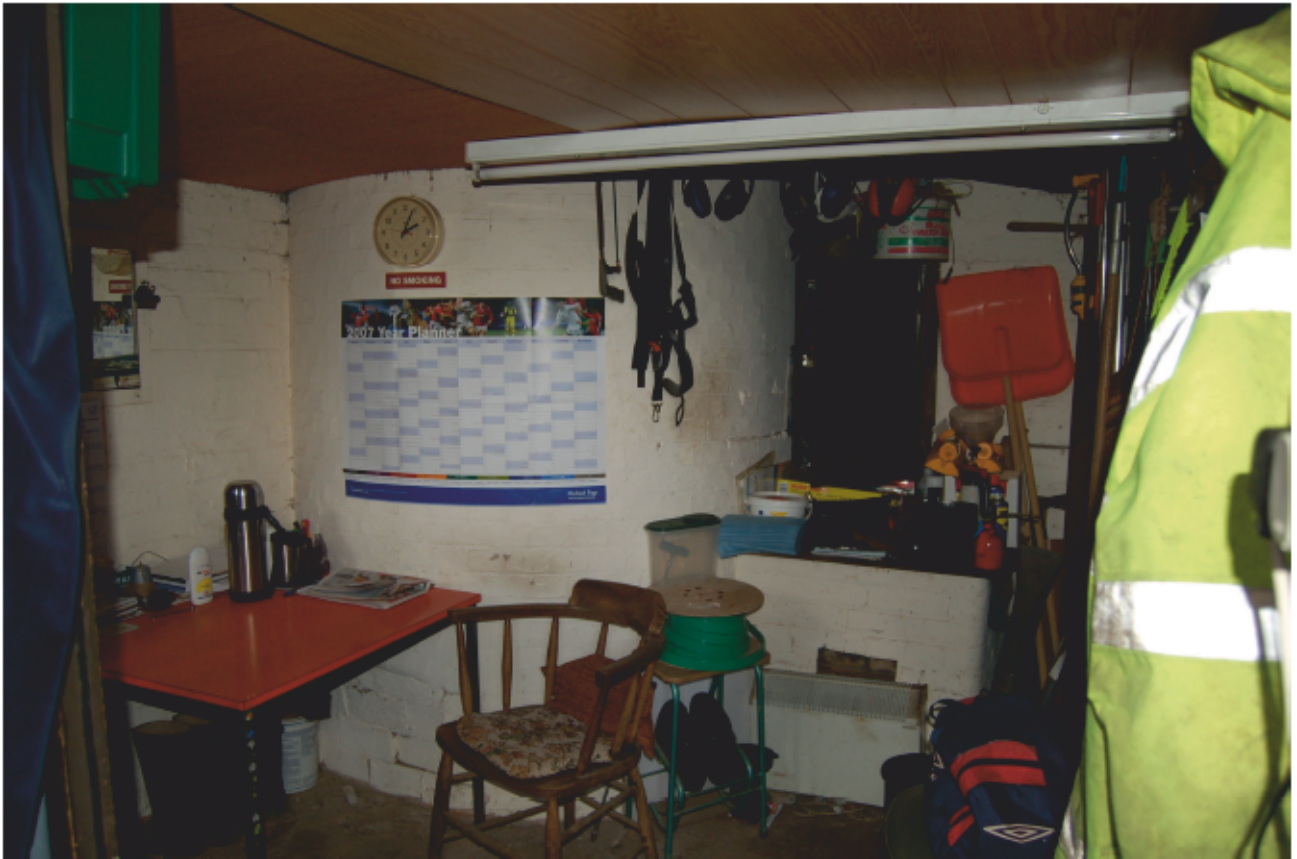
Plate 7: Brick structures at north end of Room 4.

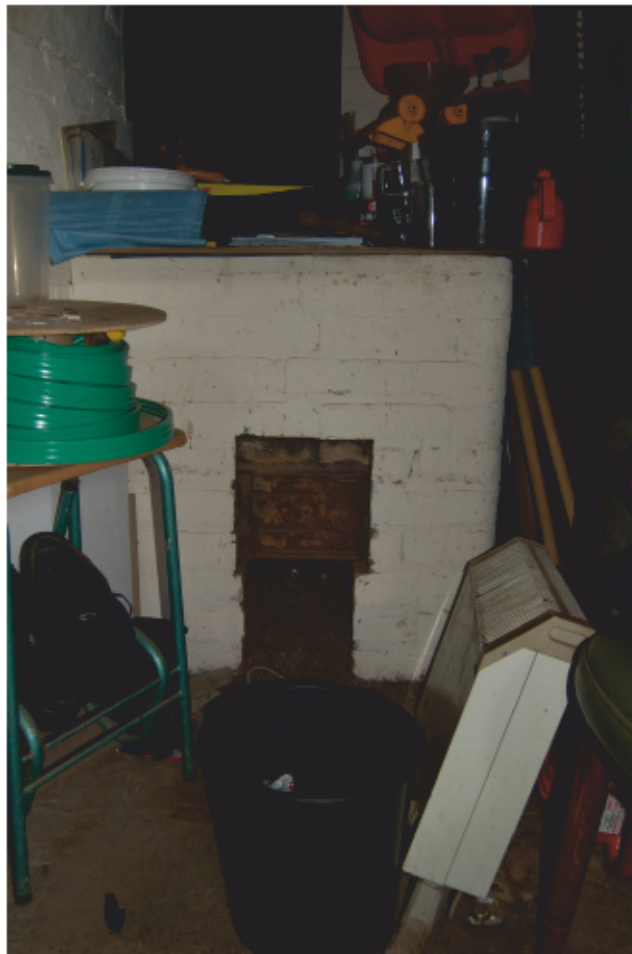
Plate 8: "Copper" water heater looking east.

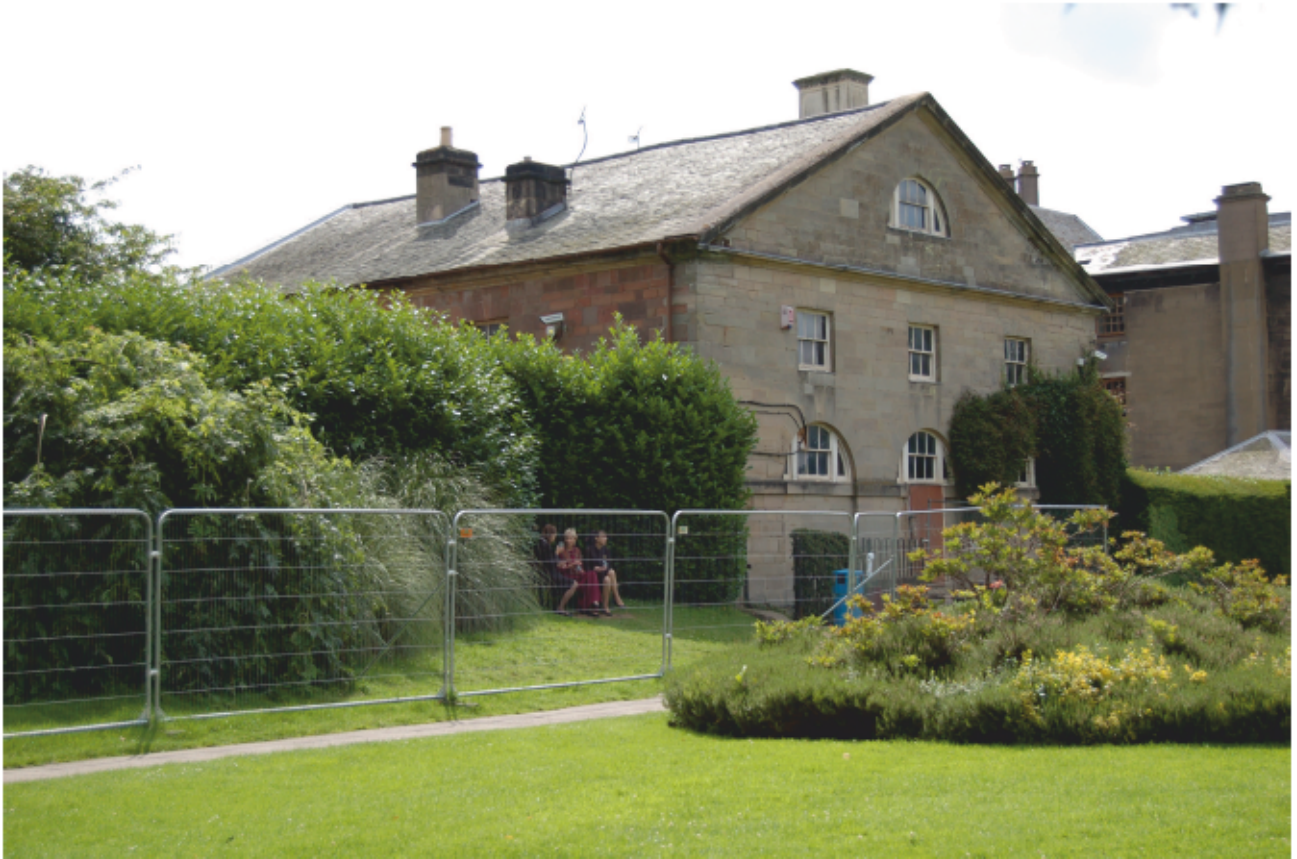
- 4.4 The Gardeners' Store, ground floor. Accessed from the western side of the building through the central archway via a tarmac ramp, the store comprises the whole western side of the building (Figs 3 and 6). The present entrance is a later modification as all of the three arches were originally decorative only; the lower portions are slightly recessed and the semi-circular "therm" windows appear to be original (Plate 1). Divided into three parts by two vertical broad timber mullions the central section is fitted with sash windows. The external wall is finished in finely cut ashlar blocks of buff coloured sandstone. Internally the wall is constructed of roughly dressed blocks, presumably sandstone but now painted. The central doorway is roughly cut through and has been poorly finished externally with cement and internally with brick. It contains a modern wooden door frame and door into Room 4. Each window internally has a steeply sloping sill of brick, maximising light onto the floor-space of the room. The ground floor interior has been sub-divided by a brick wall towards the southern end (Room 5) and by another brick wall towards the northern end (Rooms 1, 2, 3 and 4, Fig 4). These three rooms are accessed only by exterior doors, neither of which is original. That into Room 3 has been made in the position of a former window, though it is wider than the original opening but the same height as the voussoirs remain in situ. The room itself simply leads into Room 2 which was formerly used as a toilet. The south wall of Room 3 is the north side of the curved structure mainly seen in Room 4, but there is no access into it from Room 3. Room 1 is also accessed via a modern opening, this time a narrow, tall door with a light over (Fig 7). The room was formerly used as a toilet and retains a cast iron cistern bearing the name ST NICHOLAS in embossed letters. The south and east walls are inserted and are of modern brick, the southern wall cuts across the northernmost of the three arched windows in the west face of the building. The room to the south (Room 5) contains no features indicating former use. The east wall contains the recessed remains of an arch formerly leading into Room 16. To the north a further arch also formerly lead into Room 16 and this arch must still have been open and in use when the brick dividing wall was inserted as the brick wall is angled to the south so that the arch remained its full original width (Fig 3). Hinges remain indicating that it formerly was hung with two doors. A recent doorway has been knocked through the south wall, which has a concrete lintel. In the main room (Room 4) there are timber posts and boarded walls which further sub-divide the room, and create a frame which supports the first floor (see below). These timbers are principally of oak, bolted together at the joints, and are of nineteenth-century date. In the north-east corner of Room 4 is a brick structure with a curved west end. It appears to have been an oven/furnace which must have been accessed from Room 6 as the only opening is a small (now blocked) stoke-hole or ash pit at floor level on the west side (Plate 7). It may be related to the heating of water during the brewing process. Next to it, and possibly contemporary with it, on the south side is a "copper" water heater, the west side of which contains the stoke hole (Plate 8). Neither structures have visible flues which lie within the thickness of the eastern wall and exit the roof via a chimney stack which rises from the roof above this wall line (Plate 9).

Plate 9: Building looking south-east showing chimneys on north side.

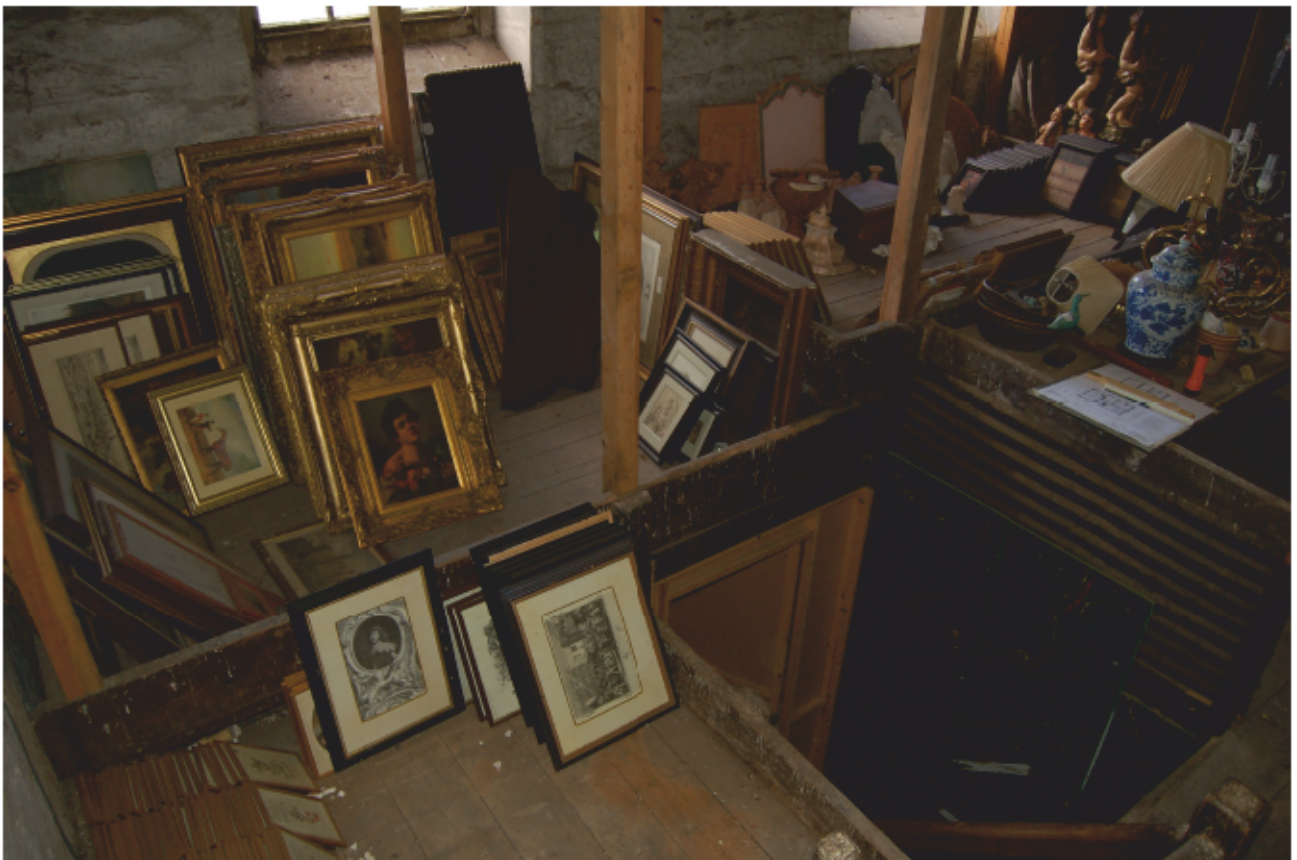
- 4.5 The Gardeners' Store, first floor. Reached via a short set of ladder steps this room comprises part timber flooring, timber troughs and part concrete slab (Room 18, Fig 4). It is currently used for storage. Timber flooring forms a relatively small area at the top of the steps and is of oak or elm (if cleaned it will be possible to determine which). If it comes from the building it is not in its original position as it is supported by the nineteenth-century oak frame. In the east wall a small fireplace must be an addition as it relates to the floor level supported by the oak frame. A concrete slab lies at the northern end and is

supported by the brick wall at the northern end of Room 4 below. It forms the ceiling of rooms 1, 2 and 3 on the ground floor. The remainder of this level comprises three troughs formed of thick pine boards laid flat with similar edge-set boards to create shallow troughs or trays approximately 150mm deep (Plate 10). The troughs are constructed in such a way that each overlaps the other allowing liquid in the highest one to be drained first into the middle one then into the lowest one via drilled holes at the overlap in the bottom boarding. The highest trough is at the northern end of the room, the lowest at the southern end and must originally have been lined with copper, lead or some other waterproof material as none of the timber retains any sign of liquid staining or damage. The southernmost trough still retains a section of lead pipe on its underside where a 30mm diameter hole has been drilled through its base. The pipe is now cut off approximately 400mm below the underside of this trough but indicates that liquid drained from it was being conducted to the ground floor either for processing, storage or use. What the liquid was is unclear but almost certainly relates to brewing, an essential aspect of country house self-sufficiency. This part of the building is open to the roof which comprises a large oak tie beam with queen posts forming a massive truss (Plate 11). Two rows of purlins support rafters, the lower row being pegged, and the roof is covered with slate. None of the timber is painted and shows no sign of ever being covered. The west wall contains five windows. These comprise the upper parts of two of the arched windows of the ground floor, cut across by the wooden troughs. At a very high first-floor level are two complete square sash windows and at gable height a single semi-circular window. The north wall contains a single window which is a later addition and may have been added after the insertion of the concrete floor. At the south-east corner of Room 18 a short flight of timber stairs leads to another room at a mezzanine level (Room 19: Fig 4; Plate 12). This lies above Room 5 on the ground floor and is divided from the remainder of this section of the building by a brick wall. The inner surfaces of this room are plastered, as is the ceiling. The southern end of the large truss runs across the room at eaves level and rests on a short wall plate. The room is lit by a single window in the west wall fitted with a sash, above a wooden sill. The floor is of modern machine-sawn narrow pine boards. The door is a substantial and well made six panel example with fielded panels which appears to be of fairly high quality and may have originally come from the main house.

Plate 10: Timber troughs in Room 18.

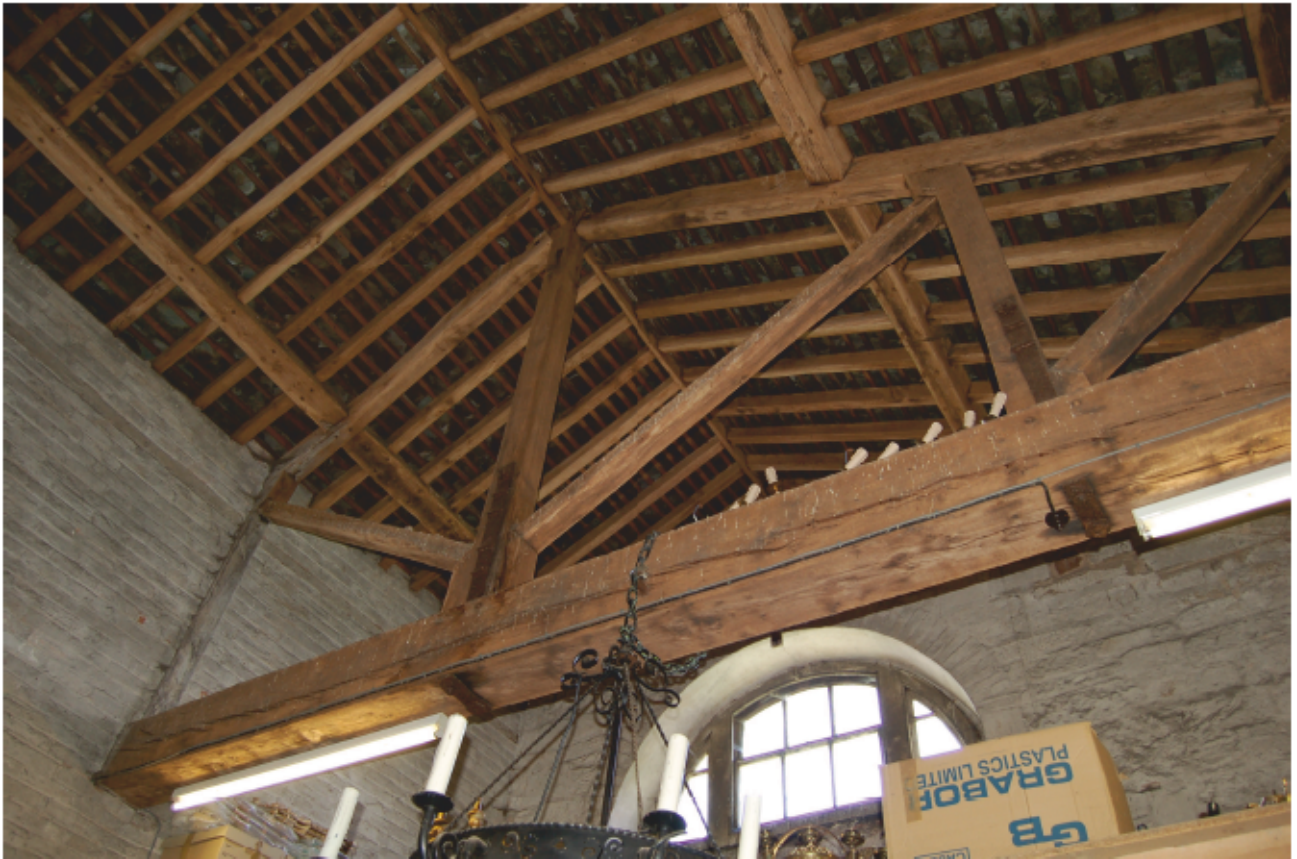
Plate 11: Truss of Room 18.

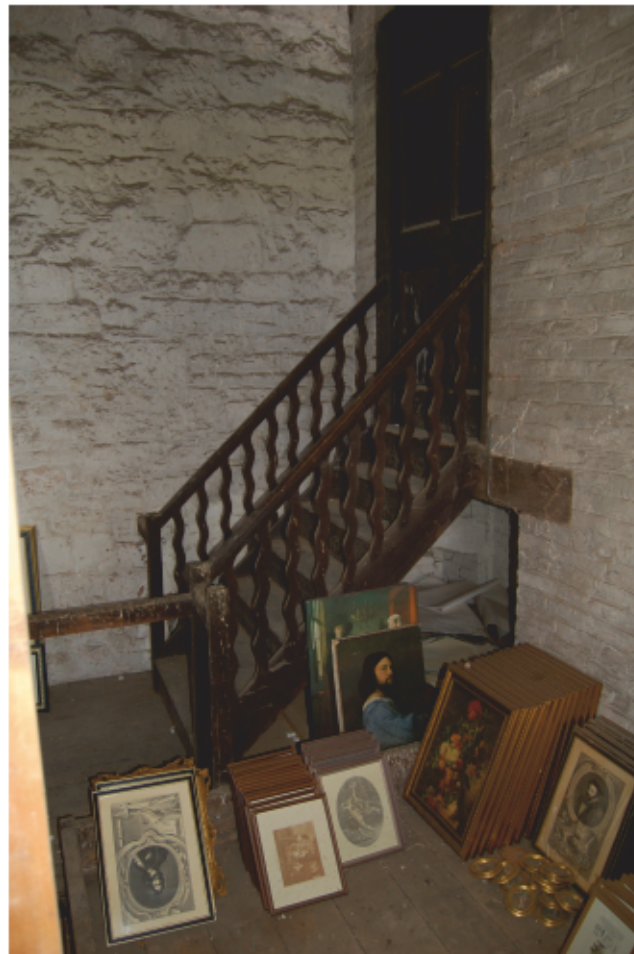
Plate 12: Steps leading into Room 19.

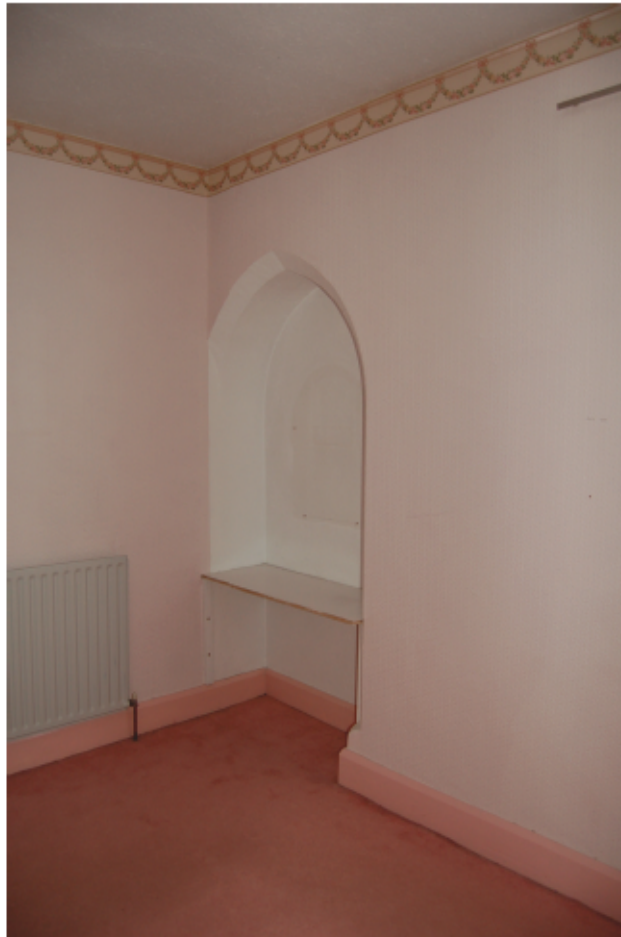
- 4.7 Dove Cottage, first floor. Accessed from the north side of Room 15 on the ground floor the rooms of this part of the building are partly modern divisions and part earlier alterations, but none appear to be part of the original building plan (Fig 4). A landing gives access to each room which consist of a bathroom and two bedrooms. Room 27 is the bathroom and apart from the simple nineteenth century fireplace surround contains no pre-modern features. A window in the south wall is an original opening with a later sash. Room 28 contains an identical fireplace which lies back-to-back with that in Room 27 and two sash windows. Room 29 is created by a studwork wall dividing it from the landing and Room 28 and contains no fireplace. It has a single window in the east wall, an original opening with a later sash. In the angle of the north-east corner of the room in the east wall a pointed arched opening indicates a former first floor link into the now demolished north

kitchen range (Plate 13). This range was part of Nesfield's additions to the house in the 1860's and was demolished in the 1920's.

Plate 13: Pointed arch formerly connecting into now demolished kitchen range from Room 29.

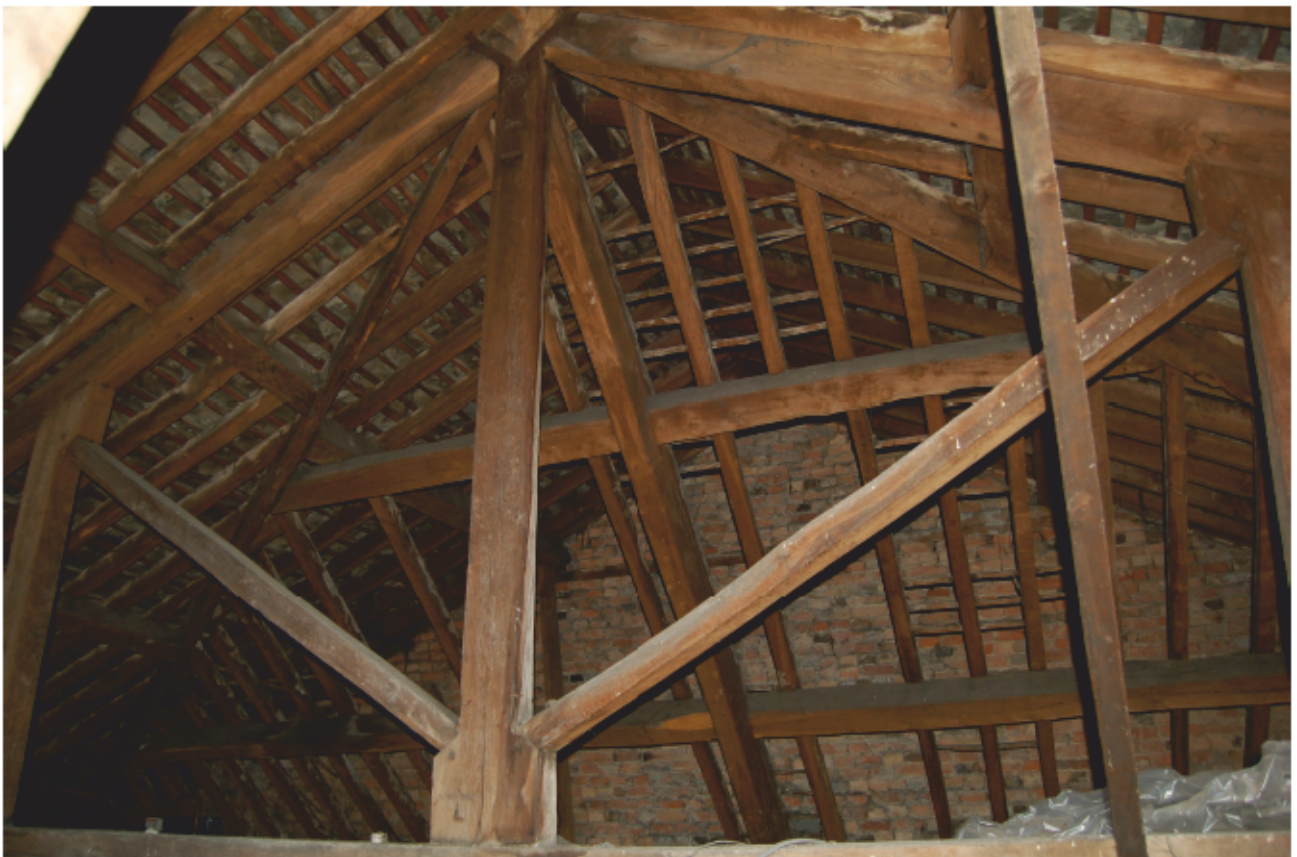
Plate 14: Timbers of original hipped roof looking east.

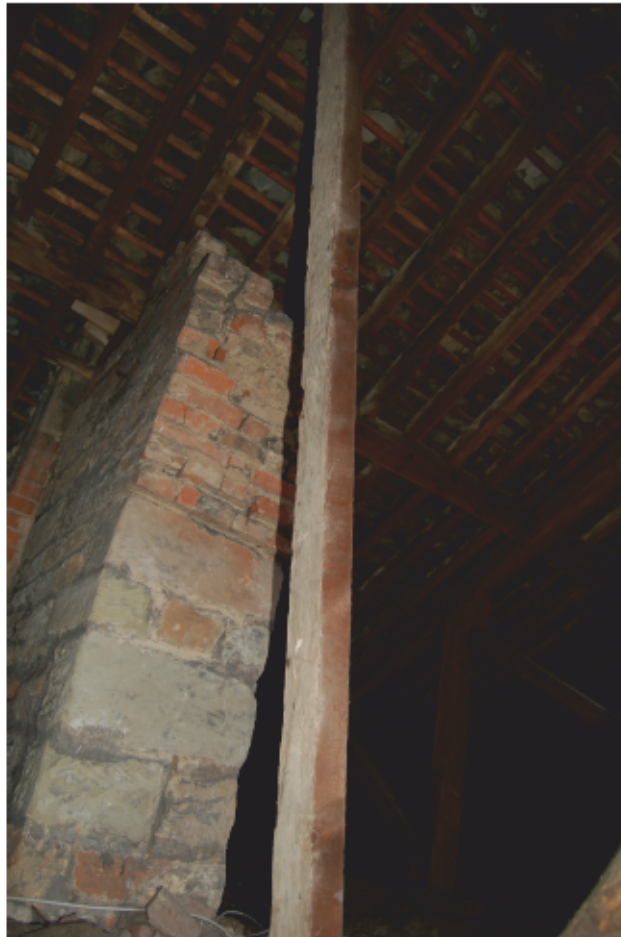
Plate 15: South side of chimney stack, note the stub of brick linking arch.

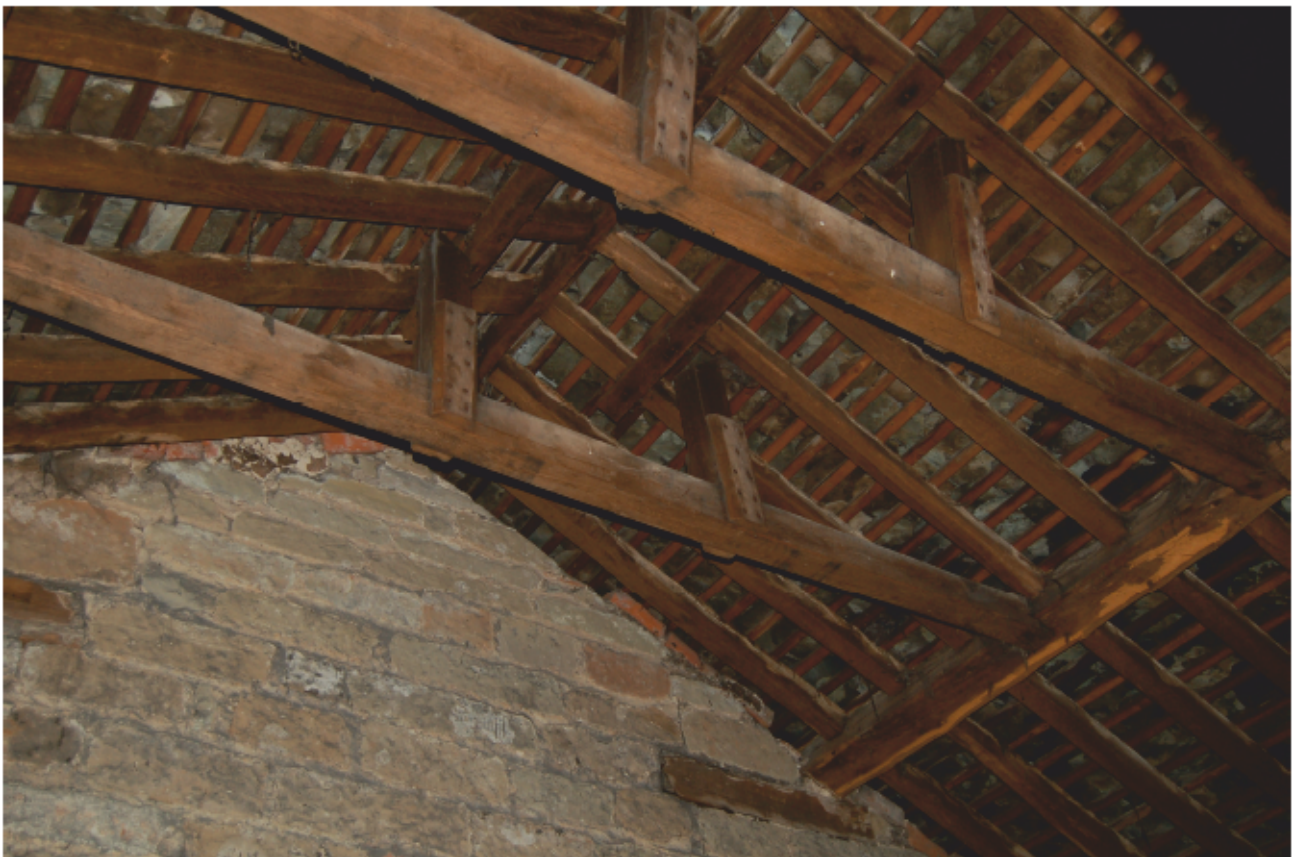
Plate 16: Stubs of possible cupola structure.

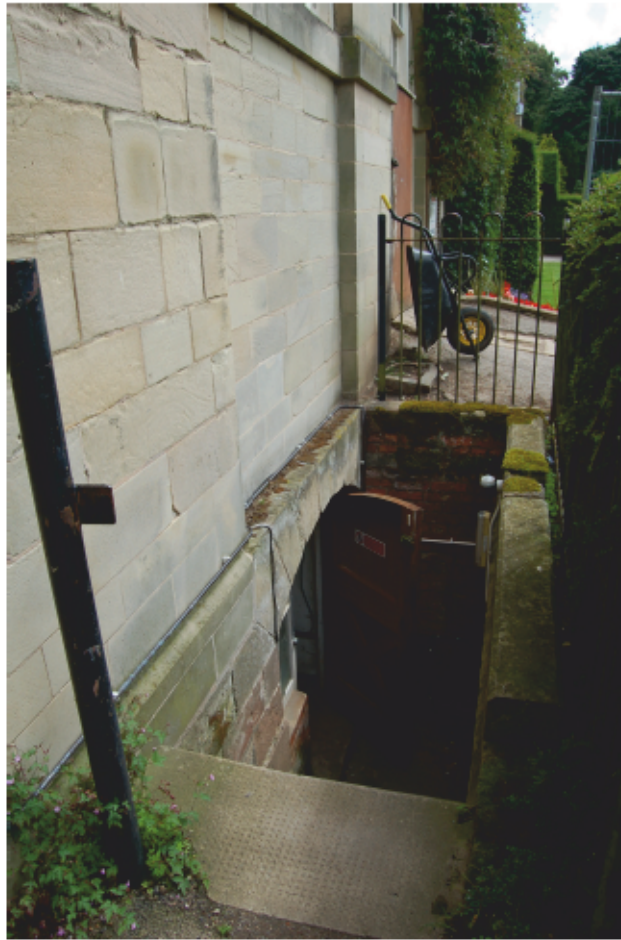
- 4.9 The cellars, beneath Pump Cottage. The cellars are currently accessed via a flight of steps on the western façade of the building (Room 30: Fig 5). This entrance is not original, but has been created by extending a light-well and building steps within the space, then knocking a doorway through the light-well window (Plate 17). This window and light-well lie directly beneath the arched window at ground floor level, indeed, originally all of the ground floor windows had corresponding light-wells beneath. The cellar contemporary with the building lies directly beneath the footprint of the gardeners' store; it has the same dimensions east-west and north-south, though it is not rectangular, rather the top north-east corner is missing. This might relate to what was originally in that part of the building on the ground floor, or be the position of an original internal stair (though this appears unlikely). The remainder of the cellar is groin-vaulted, the vaults resting on the perimeter walls and a central pier, probably all of stone although they are rendered and painted. On the west side of the cellar there are three recessed niches which appear to have all been light wells but are now blocked apart from the northernmost (the current door). The floor is of modern concrete which covers the location of a well located towards the north-east corner (maintenance staff pers.comm). In the south-east corner is a doorway which may have been knocked through at a later date when further cellars were added to the south. However, since the present entrance does not appear to be original there must have been an

entrance elsewhere and this might have been it with a flight of steps on the south side of the building, removed when the other cellars were incorporated.

Plate 17: Steps to cellar on west front.
