Archaeological building assessment
and desk-based research on
Pump Cottage, Coombe Abbey,
Warwickshire.

Revised November 2007

Report 07/179

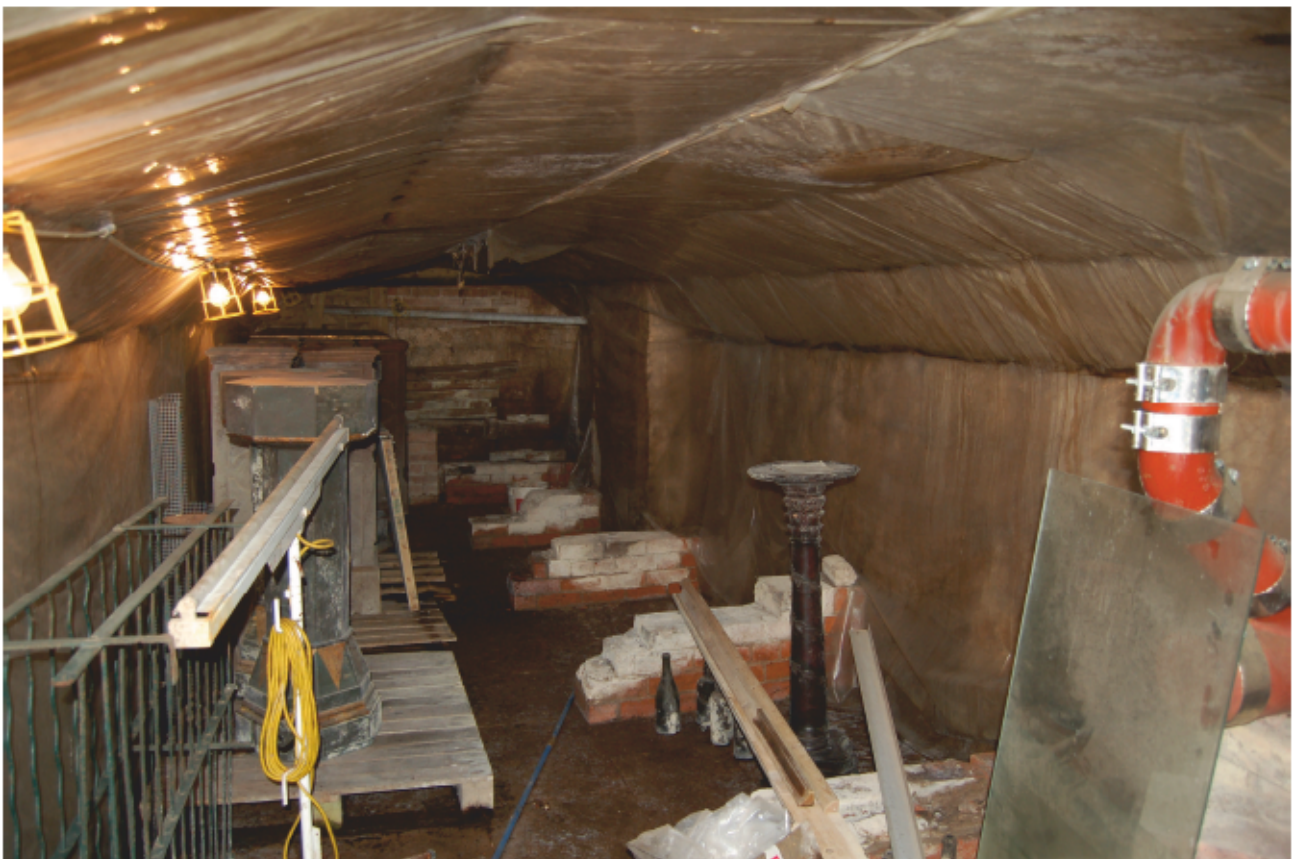
Plate 18: Cellar Room 32 looking south.

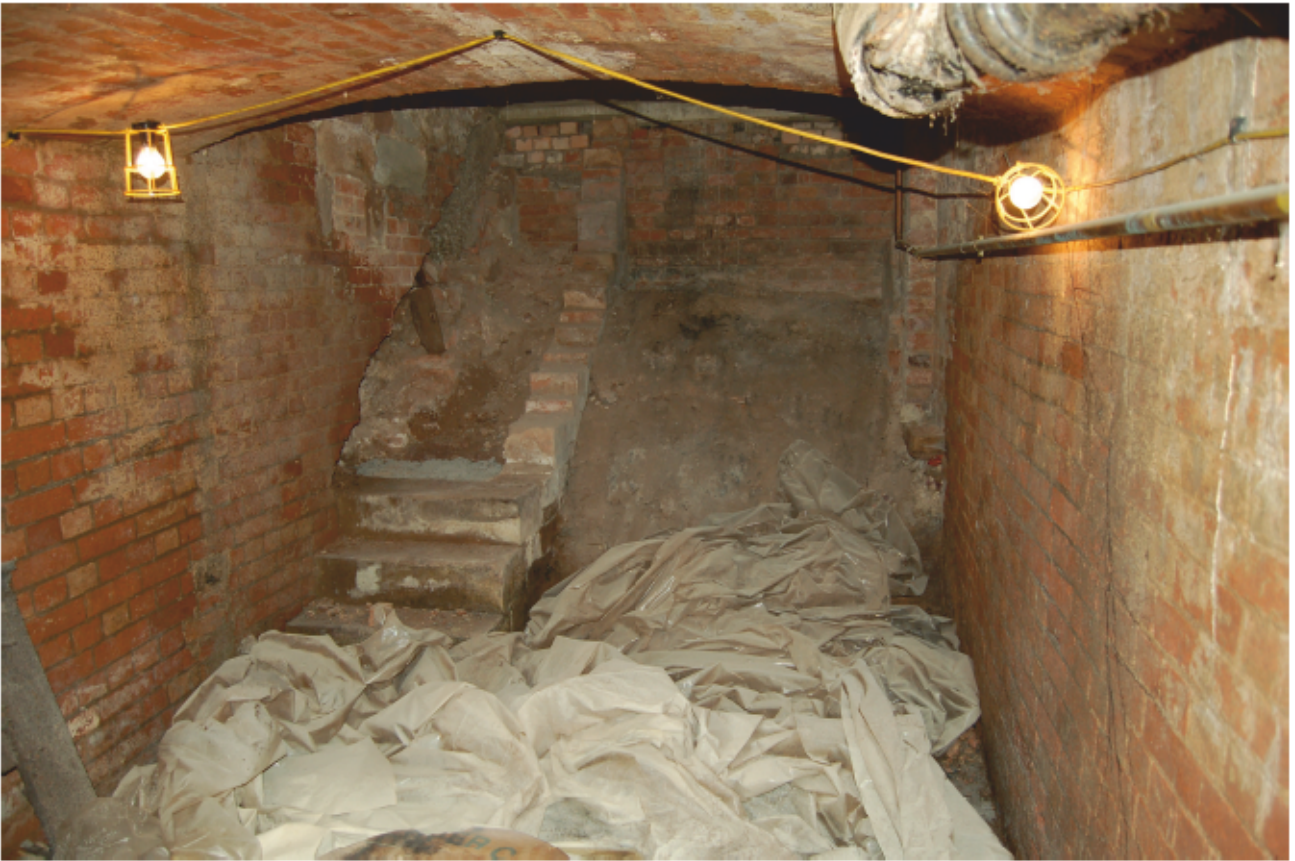
Plate 19: Former flight of steps in Room 35.

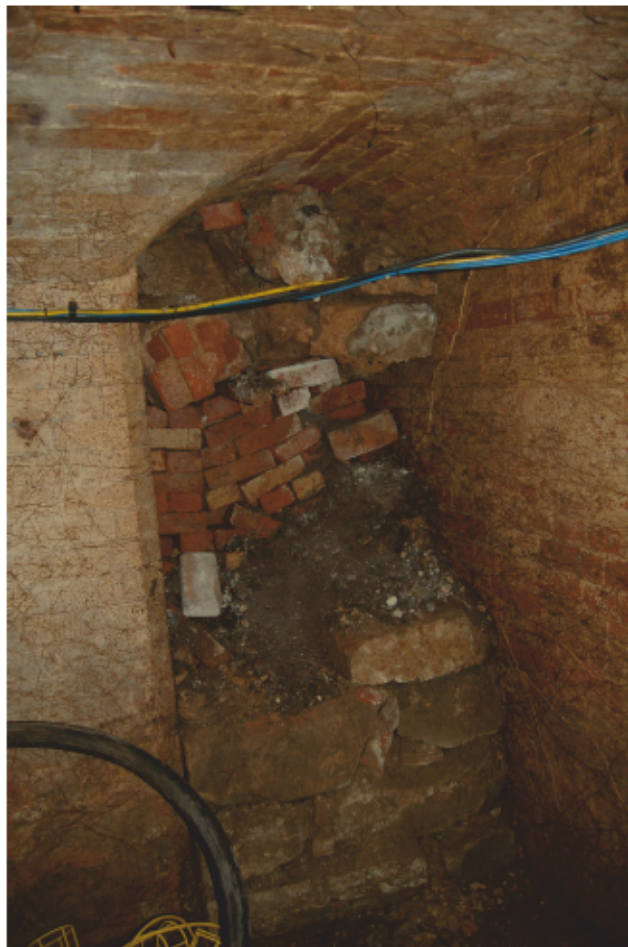
Plate 20: Blocked cellar corridor at east end of Room 34.

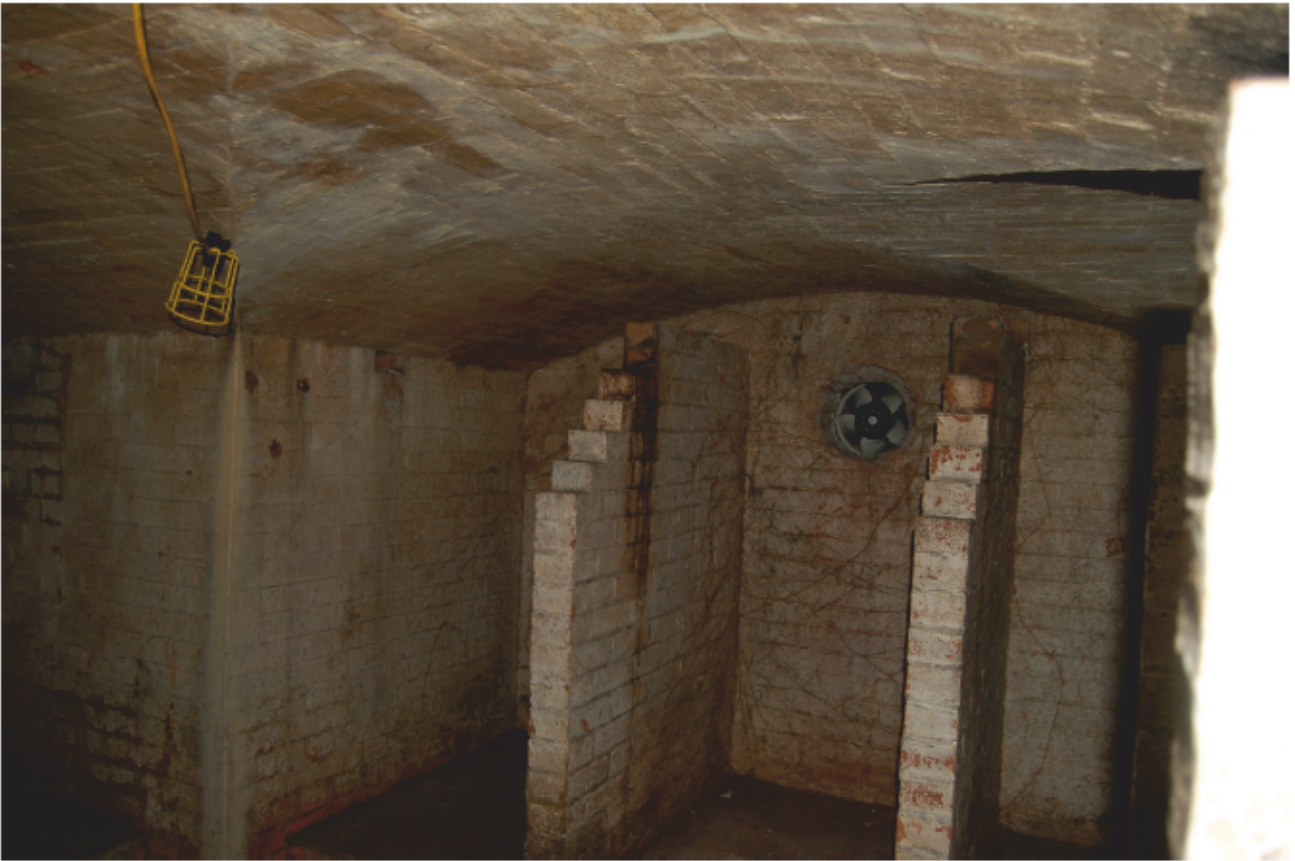
Plate 21: Brick wine-bin divisions in Room 37.

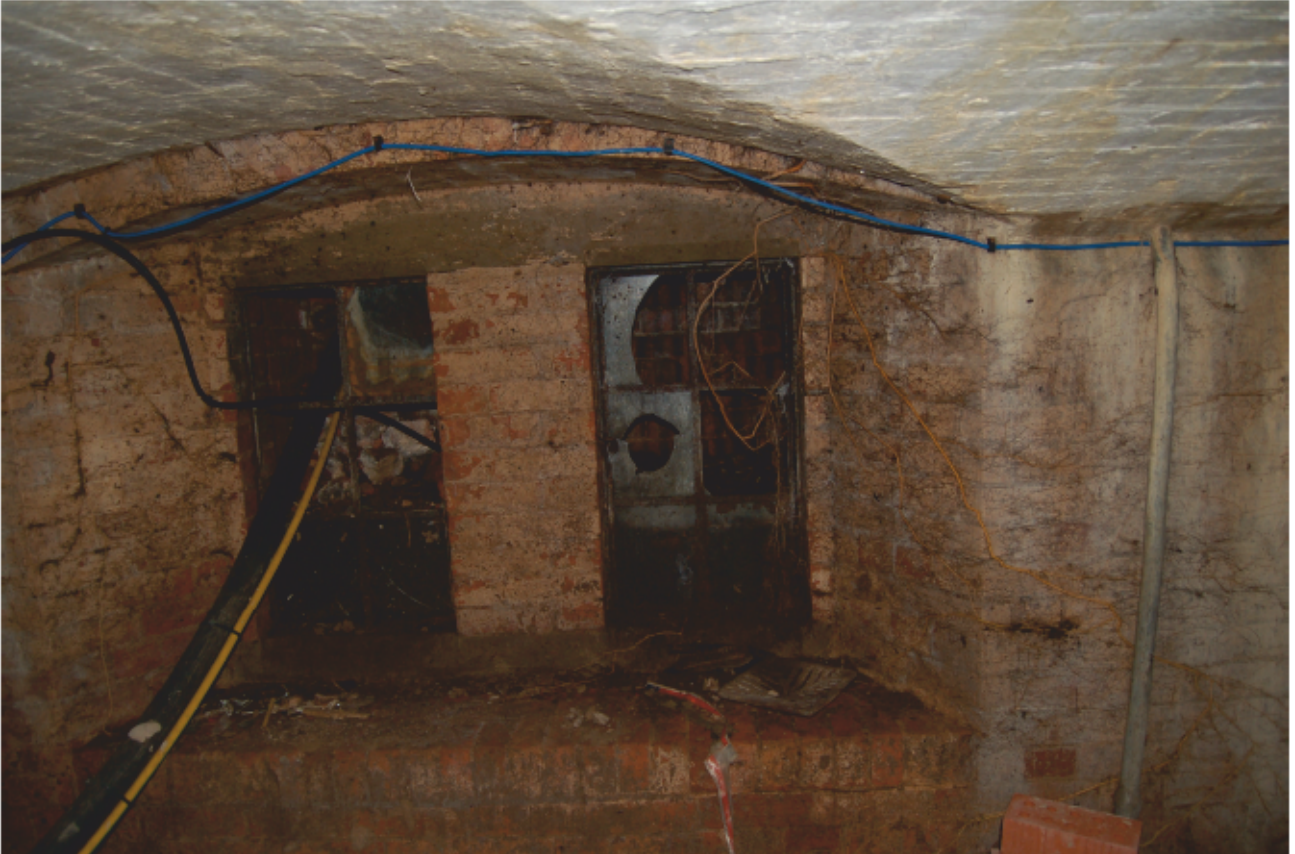
Plate 22: Windows of light-well in east wall of cellar, Room 38.

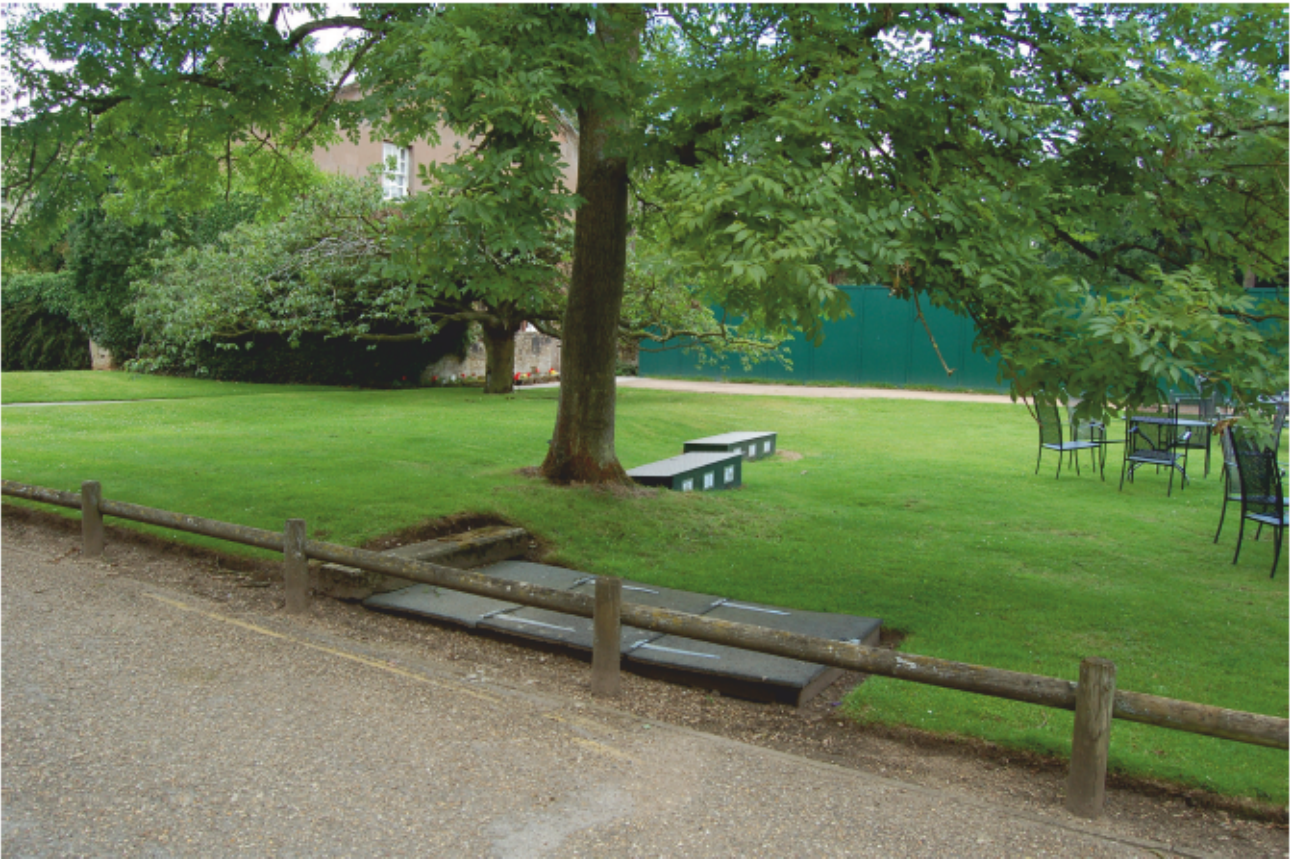
Plate 23: Modern coverings for cellar steps from Room 39 (foreground) and two light-wells (background).
