A Building Assessment of the attic space at  
111 High Street Burton Latimer  
Northamptonshire

Tim Upson-Smith

September 2008

Report 08/144

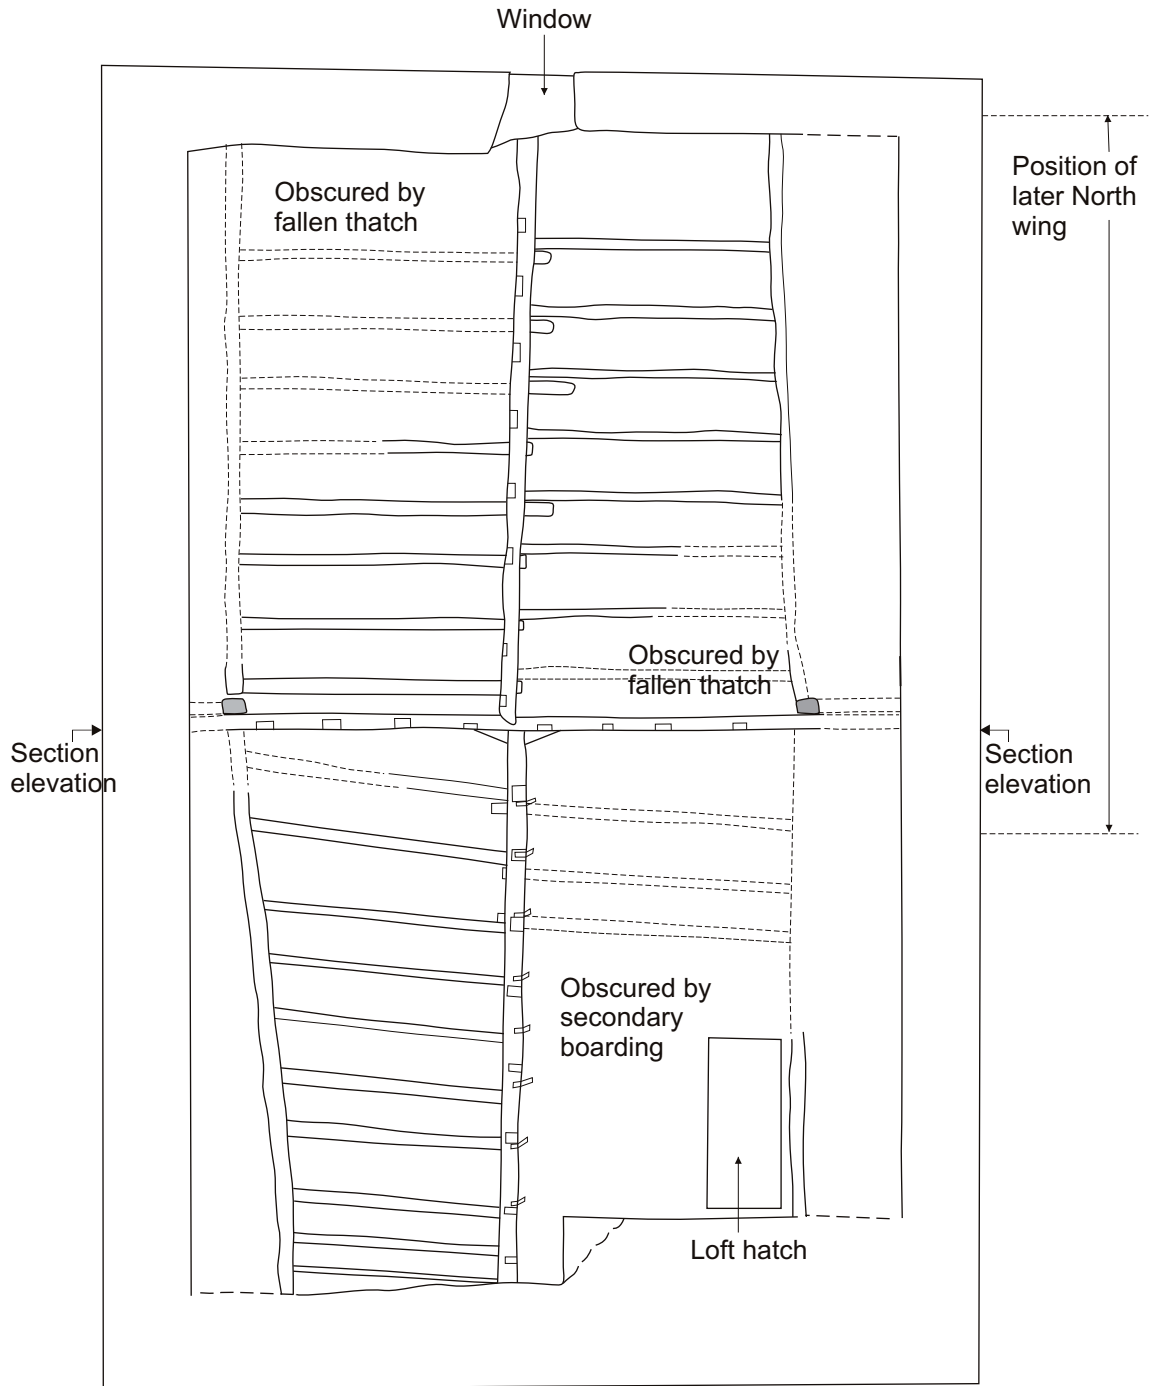
Plan of attic Fig 4

blocks pegged to it (Fig 4). The secondary rafters consist of either small roughly straight branches, some still wayney edged, or roughly squared off branches. Many have broken and are worm ridden. The ridge piece has broken through adjacent to the principal truss and is supported by a wooden strut (Plate 2).

The principal beams forming the floor of the attic have empty mortices in a pattern which makes no sense to the building; this would suggest that these beams have been reused (Fig 4). The longitudinal beam is in two parts; the opposite edge of each length had been sawn therefore it may have originally been one short beam which has been sawn in half longitudinally to span the building (Plate 5).

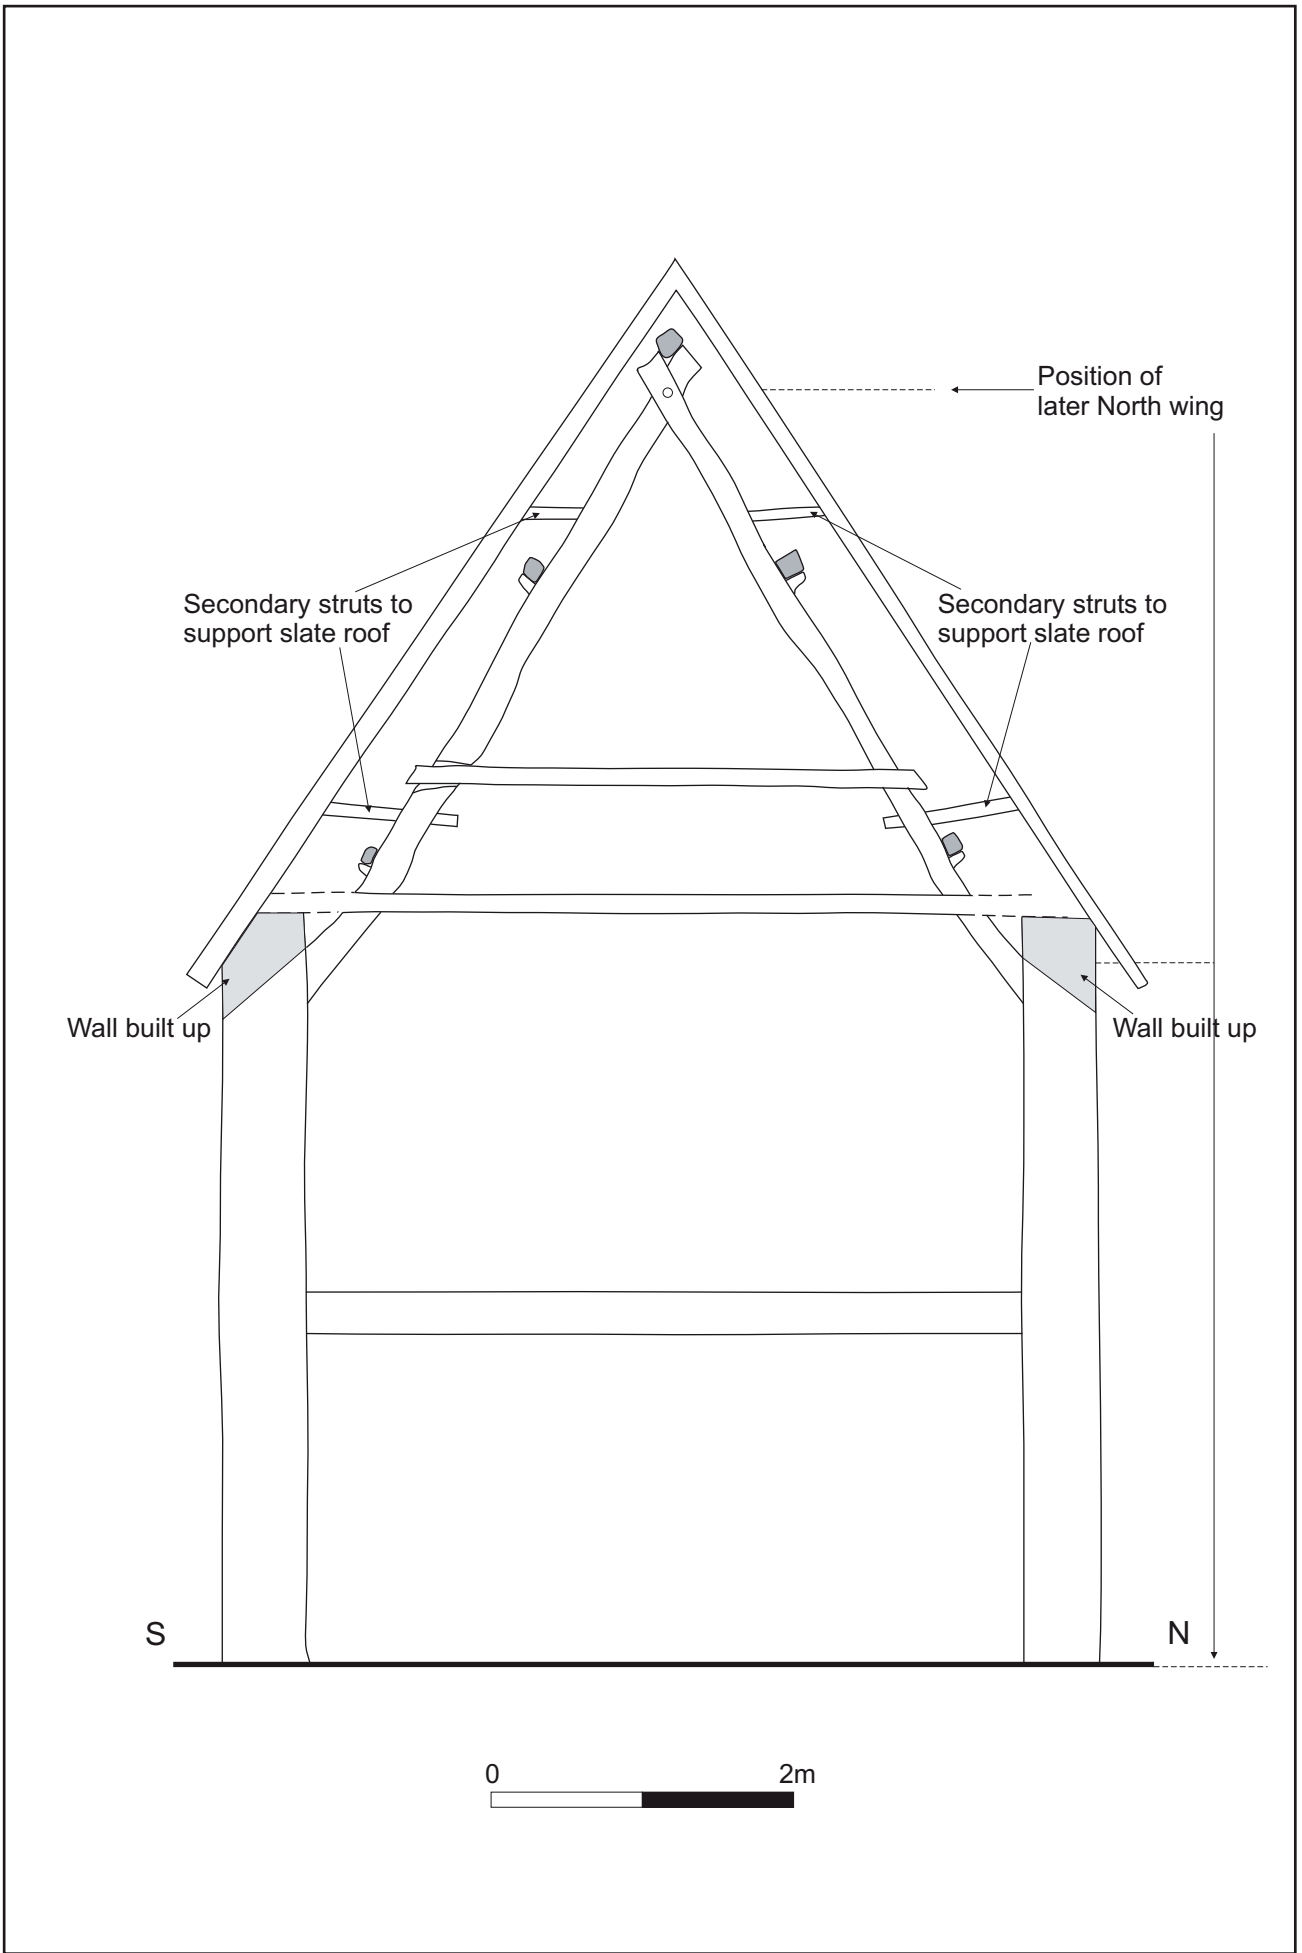
Sectional elevation Fig 5

Subsequently a welsh slate roof has been added, which necessitated the raising of the walls as the original thatched roof was retained (Fig 5). Evidence of this raising can be seen on the street facing gable end where there is a visible join in the stonework, which has been partially obscured by paint. The ends of the purlins of the slate roof are visible within this later work.

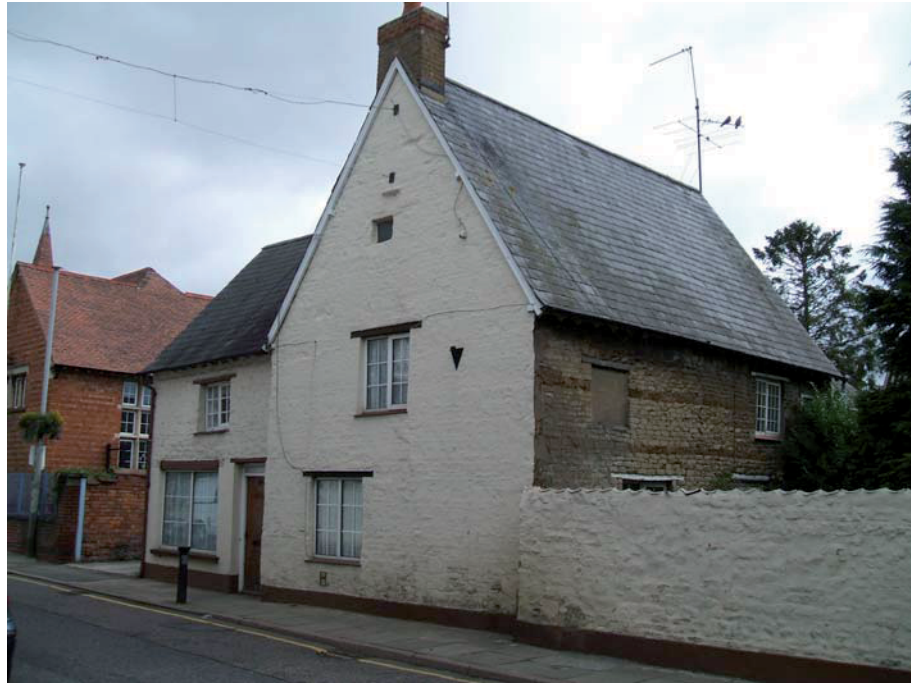
Plate 1: The exterior showing the ironstone banding on the southern elevation

The south elevation of the main block shows the ironstone banding and has irregular fenestration (Plate 1). There is a modern single storey extension to the rear of the property.

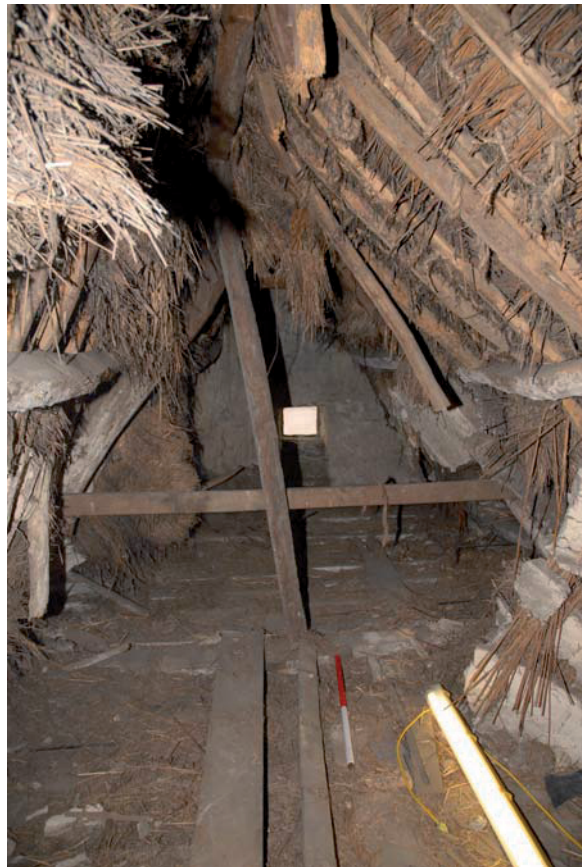
Plate 2: The attic interior

The roof consists of a central collared principal truss, with a ridge piece along the full length of the roof (Plate 2). The principal truss is roughly squared, and pegged at the apex (Plate 3). A collar within the truss appears to be a replacement as this was squared off sawn timber. The purlins are not themselves jointed to the principal truss but rest on small

The recording of the attic space has demonstrated that the original thatched roof is in very poor condition with many of the secondary rafters having rotted through and the thatch fallen onto the floor of the attic room.

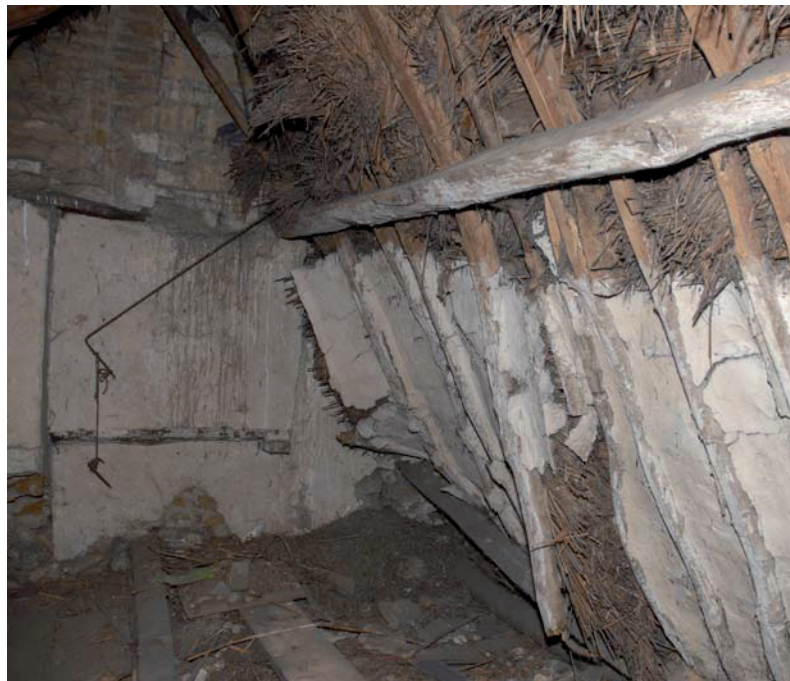
Plate 4: The attic interior showing the whitewashed plastered thatch

The thatch from the roof where the rafters are broken has fallen through into the loft space. Where this had not occurred the thatch has been plastered and lime washed (Plate 4). This with the presence of a small window in the street facing gable suggests that the space has at some stage been used as a room. Both gable ends have chimney breasts but there was no evidence of a fireplace in the loft room.

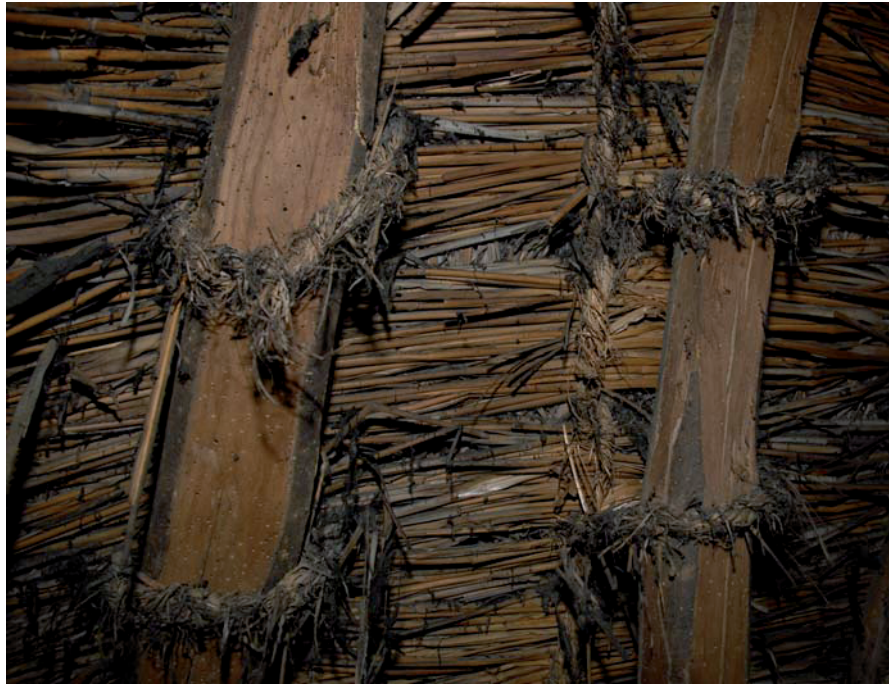
Plate 6: Detail of the thatch ties

The thatch consisted of traditional long straw which had been tied into bundles with twisted straw ties. The first layer was laid horizontally with subsequent layers placed vertically (Plate 6).
