Archaeological Watching Brief and Building
Recording at Corner Farm House
Main Street, Ashby St Ledgers
Northamptonshire
November 2008

January 2009

Report 08/214

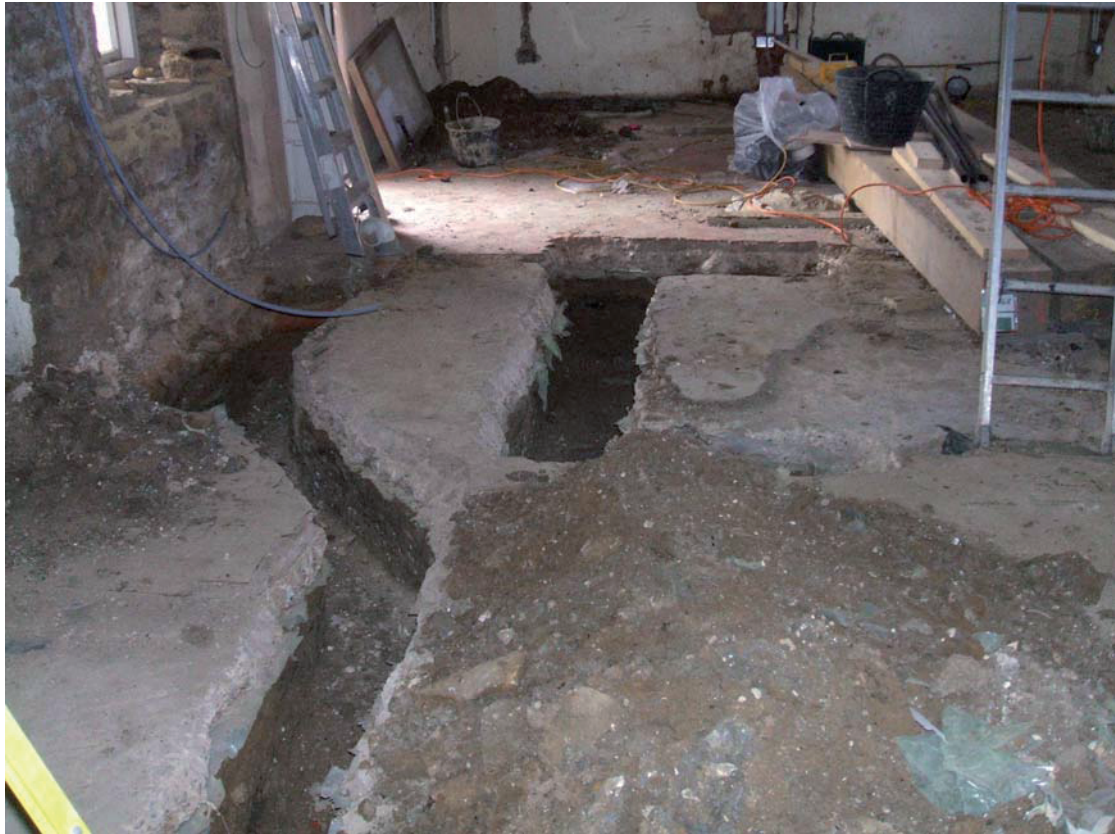
The front room was the original house built in the early 18th century and measured 11.90m by 5.70m. No clear internal structural elements were visible due to fire damage and the stripping out of the building. The floor was a modern concrete, layer (101), which was cut through for new services trenches (Plate 1).

Plate 1: Room 1 with services trenches open looking west

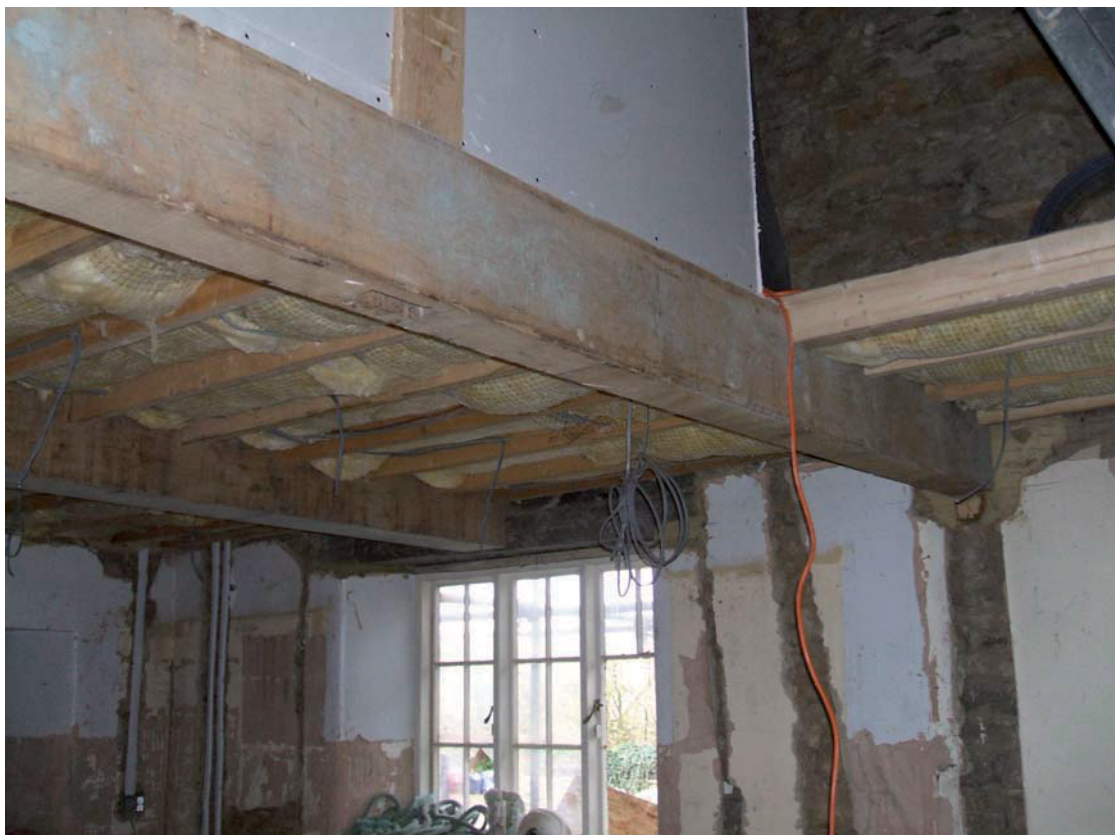
Some of the joists for the ground floor ceiling were exposed during works but are not thought to be of great age (Plate 2).

Plate 2: Room 1, new replacement beams, looking north-west

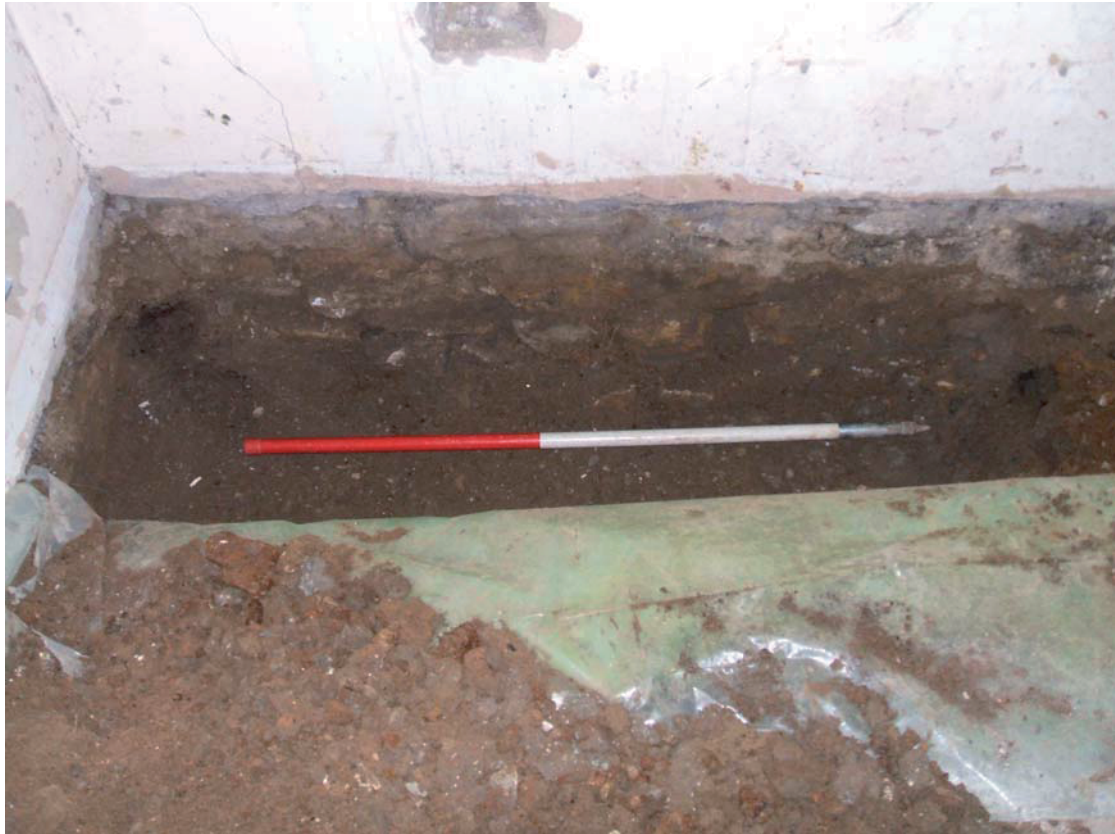
The walls of the room were of coursed ironstone with an interior plaster covering. Very little of the stone was exposed during assessment but parts seen appeared to be in good condition (Plate 3).

Plate 3: Room 1 services trench, showing plaster-covered wall and ironstone wall below ground level, looking west.

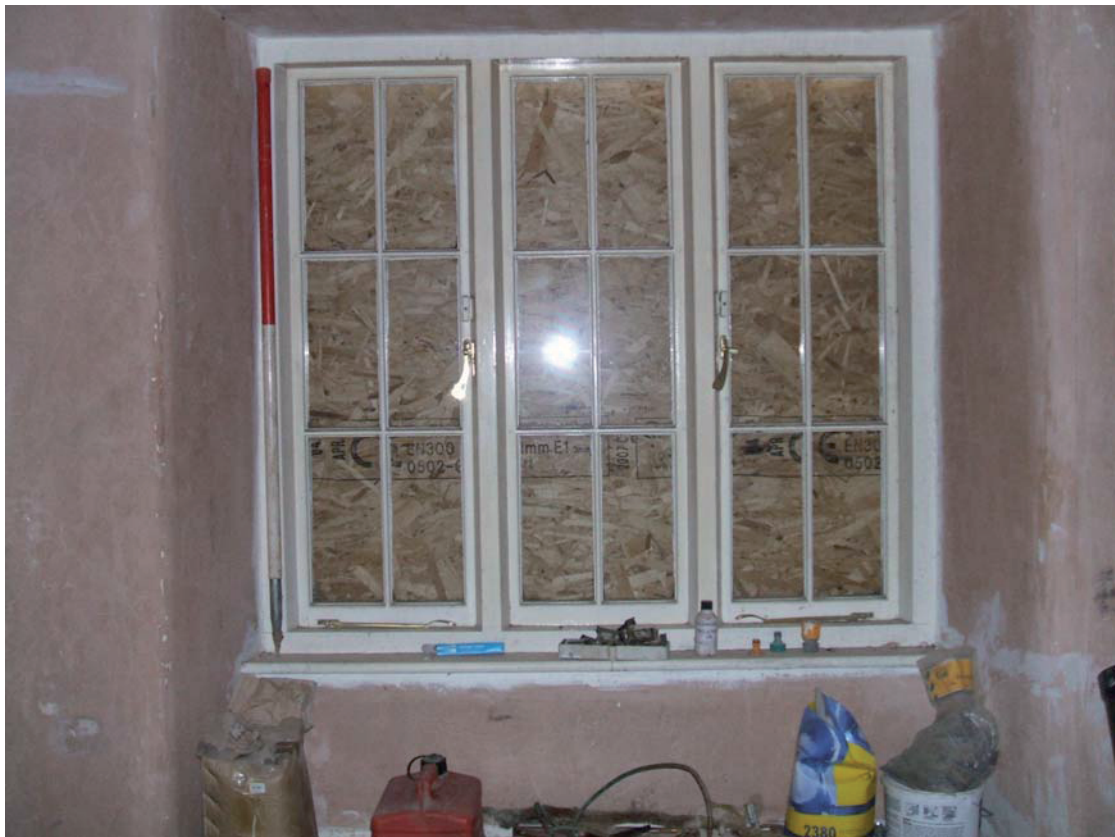
The room contained two casement windows set into splays in the eastern wall with modern fastenings casements (Plate 4). These windows were set directly opposite the two doors set in the western wall for entrance to the back garden. One of the doors had evidence of fire damage (Plate 5), and it is likely these doors are a modern development of the house.

Plate 4: Room 2, window, looking east

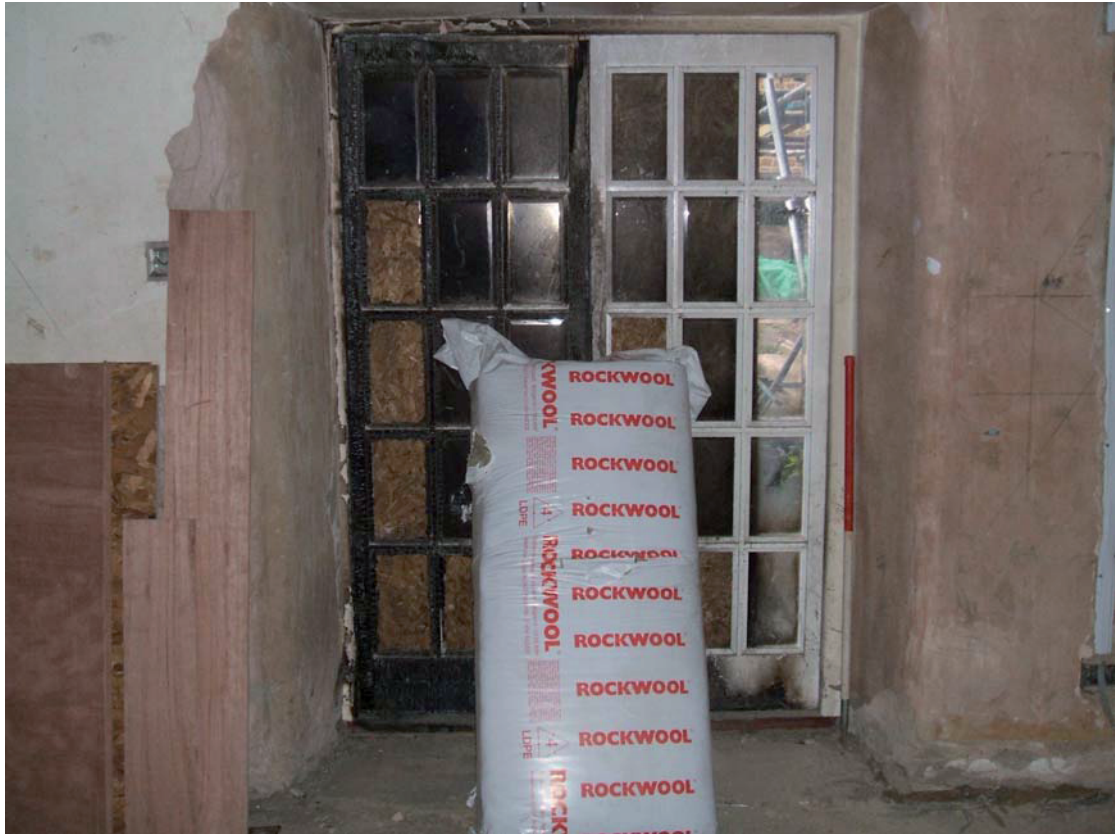
Plate 5: Room 2 door with fire damage, looking west

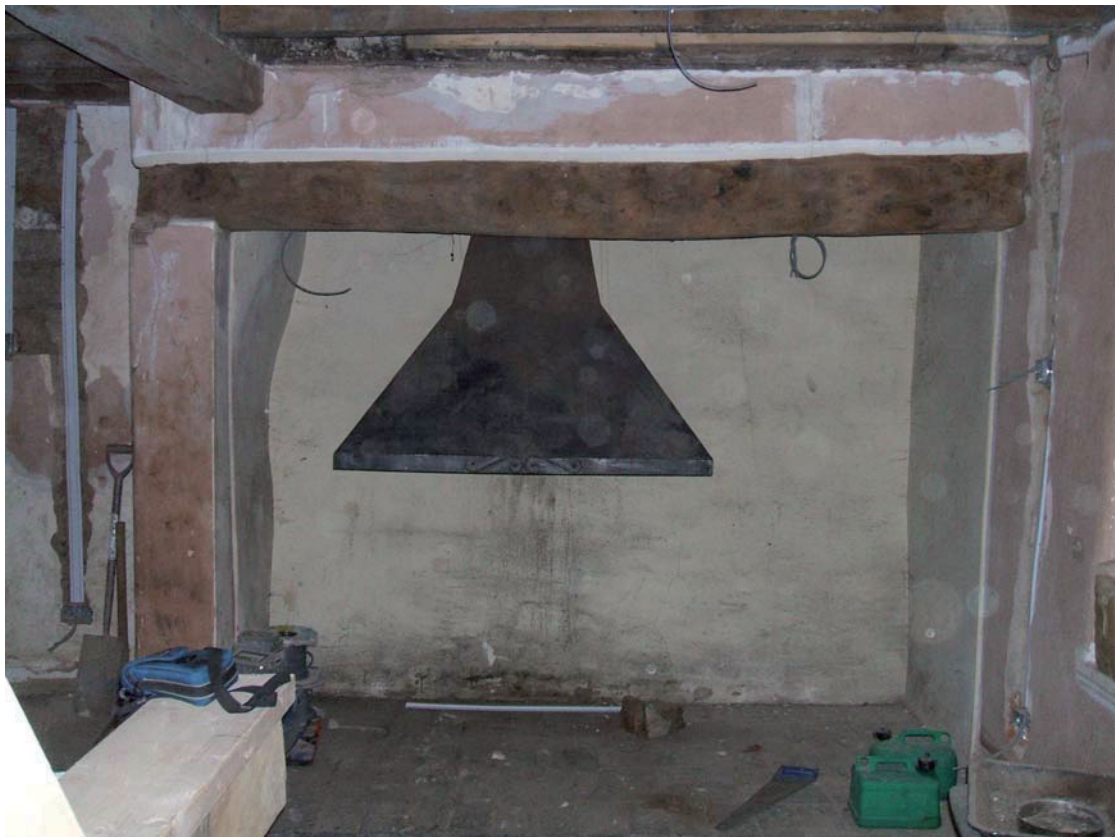
A large inglenook fireplace, 2.20m wide, was located on the north-east side of the room. It was made out of similar plastered stone walls to the rest of the room with a decorated timber bressumer across its top (Plate 6). A cast iron chimney liner was still in place during the ongoing building works.

Plate 6: Room 2, fireplace, looking north

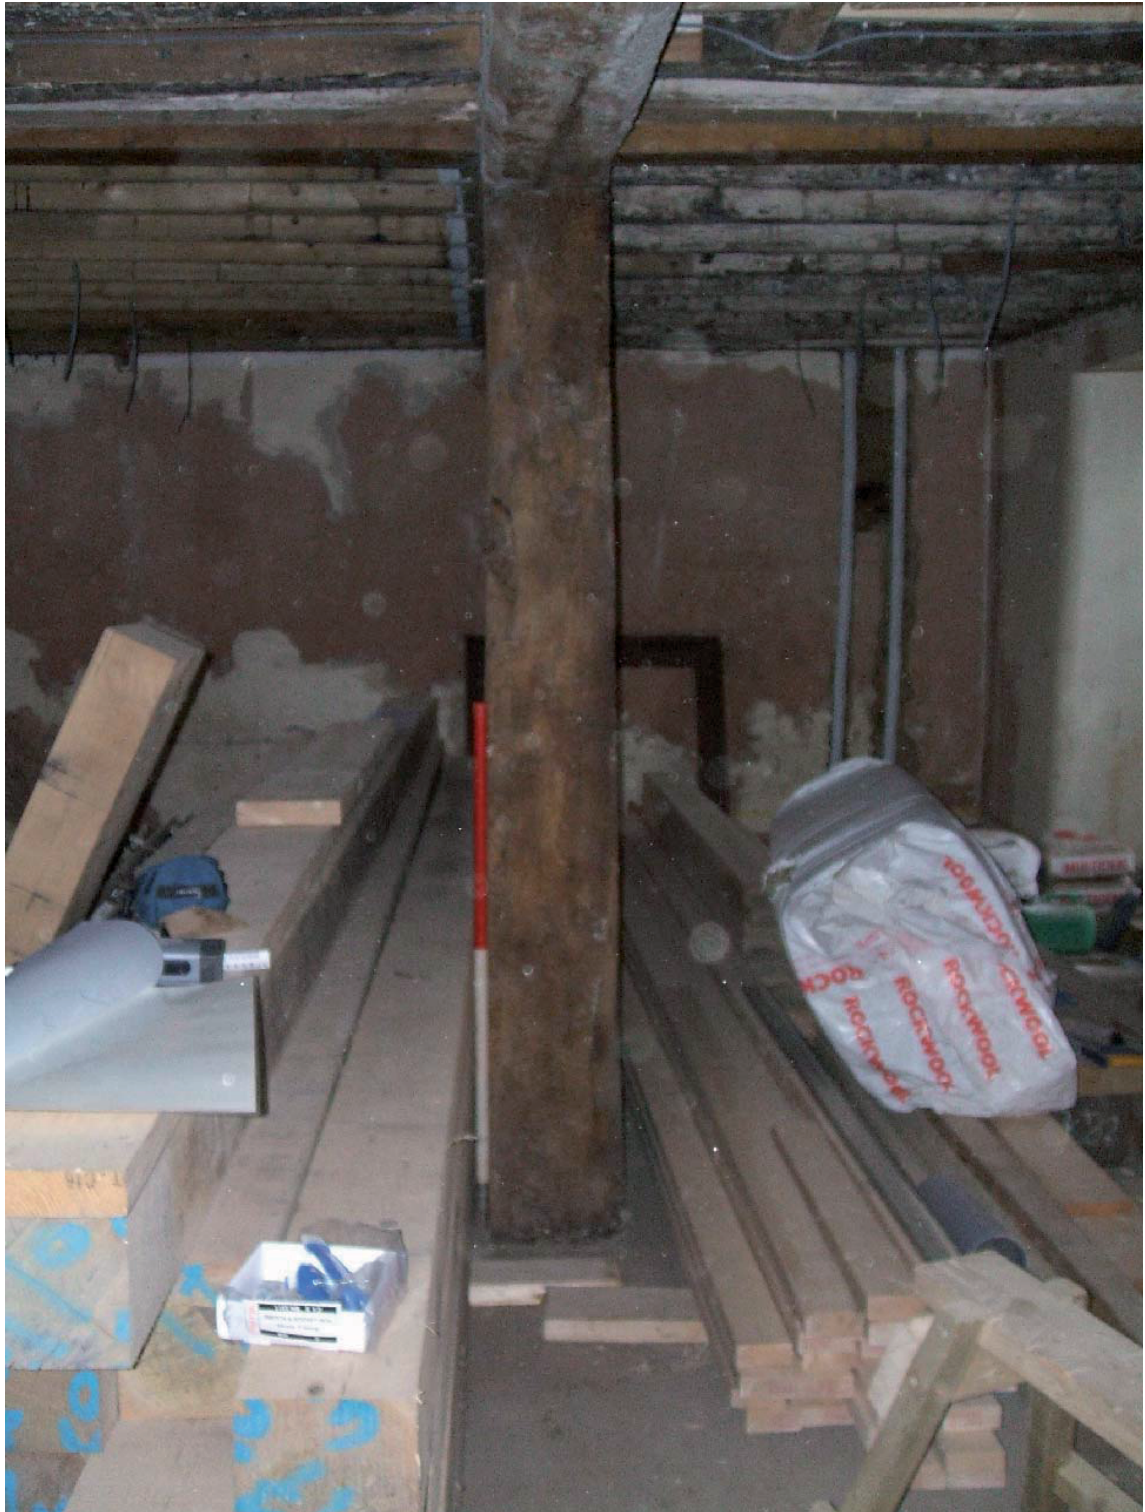
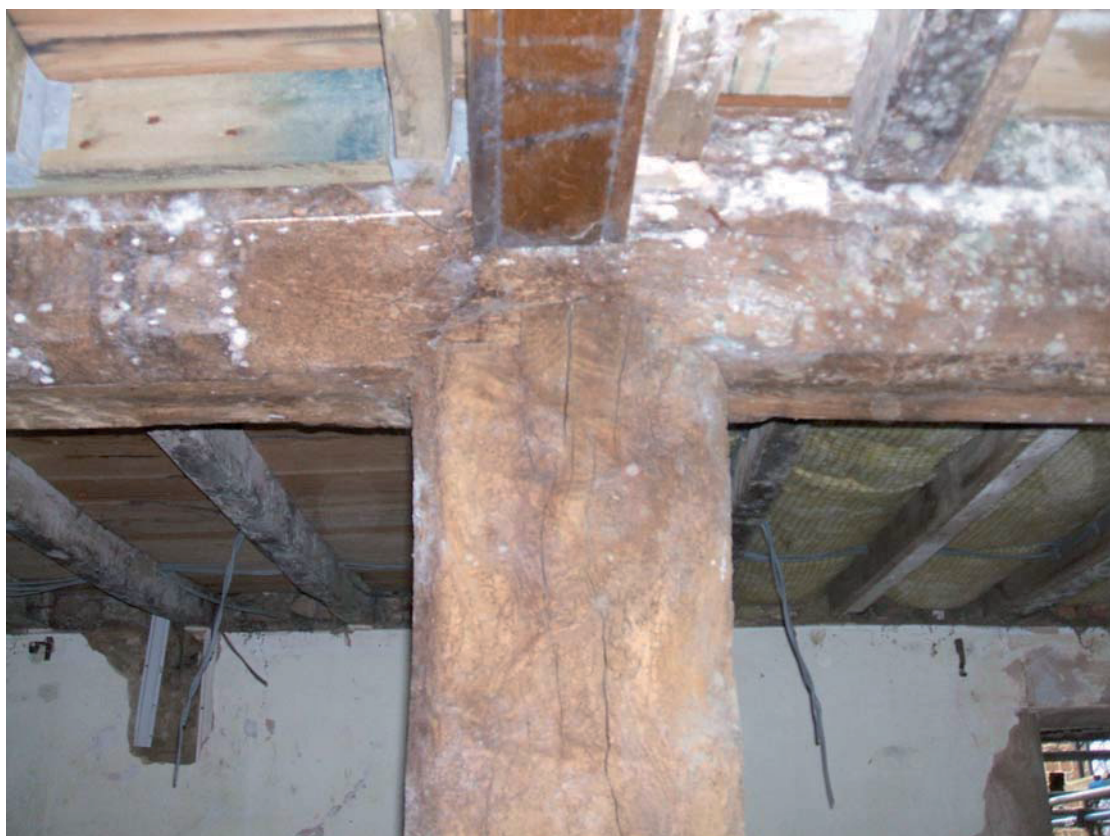
The room's ceiling was carried on a jointed axial beam which was itself supported by a wooden upright post in the centre of the room (Plates 7 and 8). The beam and post were

broken in places and decayed but showed little to no evidence of any fire damage that was evident on the doors to the west.

Plate 7: Room 2, axial beam and central post, looking south

Plate 8: Room 2, axial beam and central post, looking west

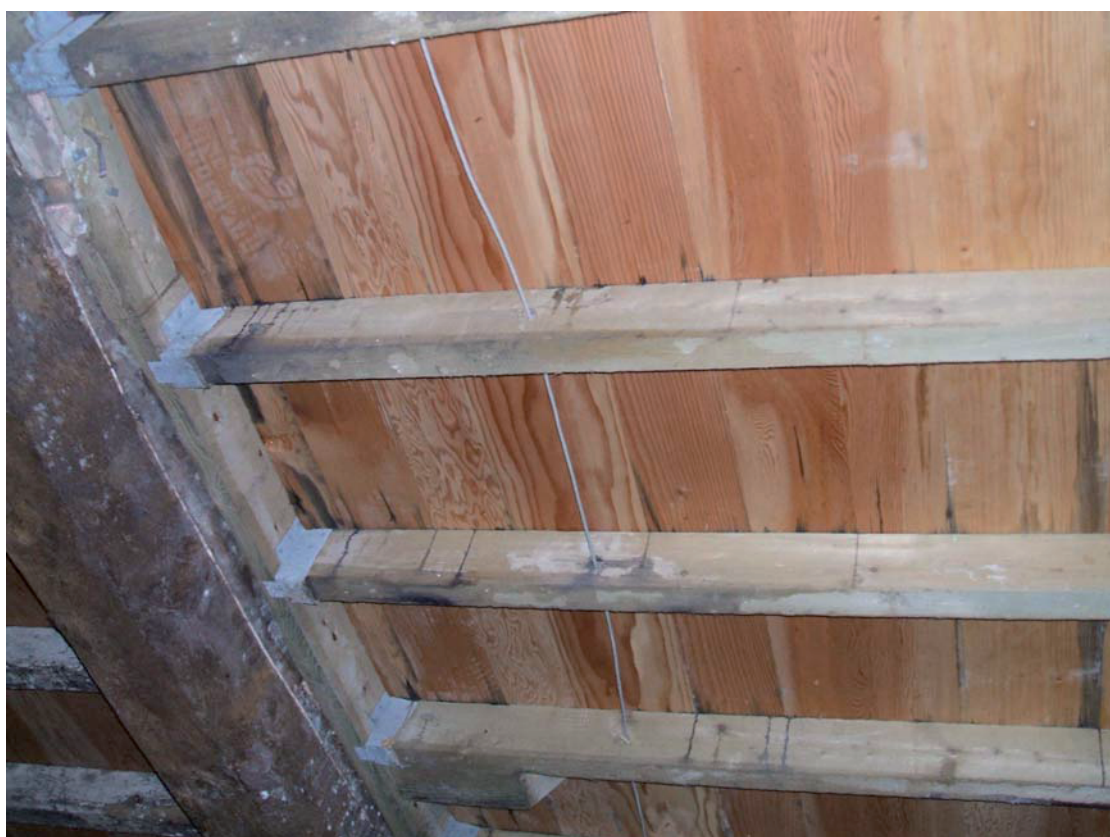
Attached to the beam were 19 separate joists in varying states of decay supporting the floor above. The majority of the joists seemed to have been completely replaced (Plate 9) with some supported by later renovations (Plate 10) and with some earlier timbers adjacent. Many of these earlier joists were seen warped and decayed (Plate 11).

Plate 9: Room 2, replaced joists, looking north-west

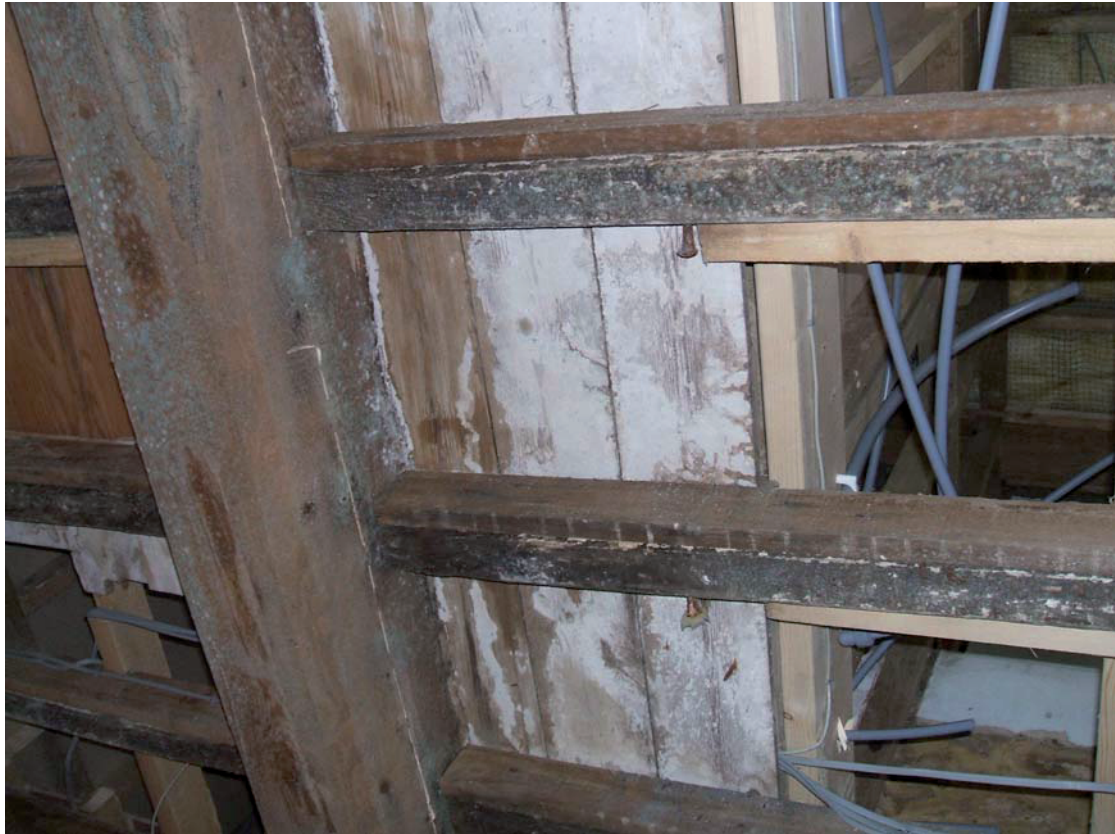
Plate 10: Room 2, remodelled and supported joists, looking north-west

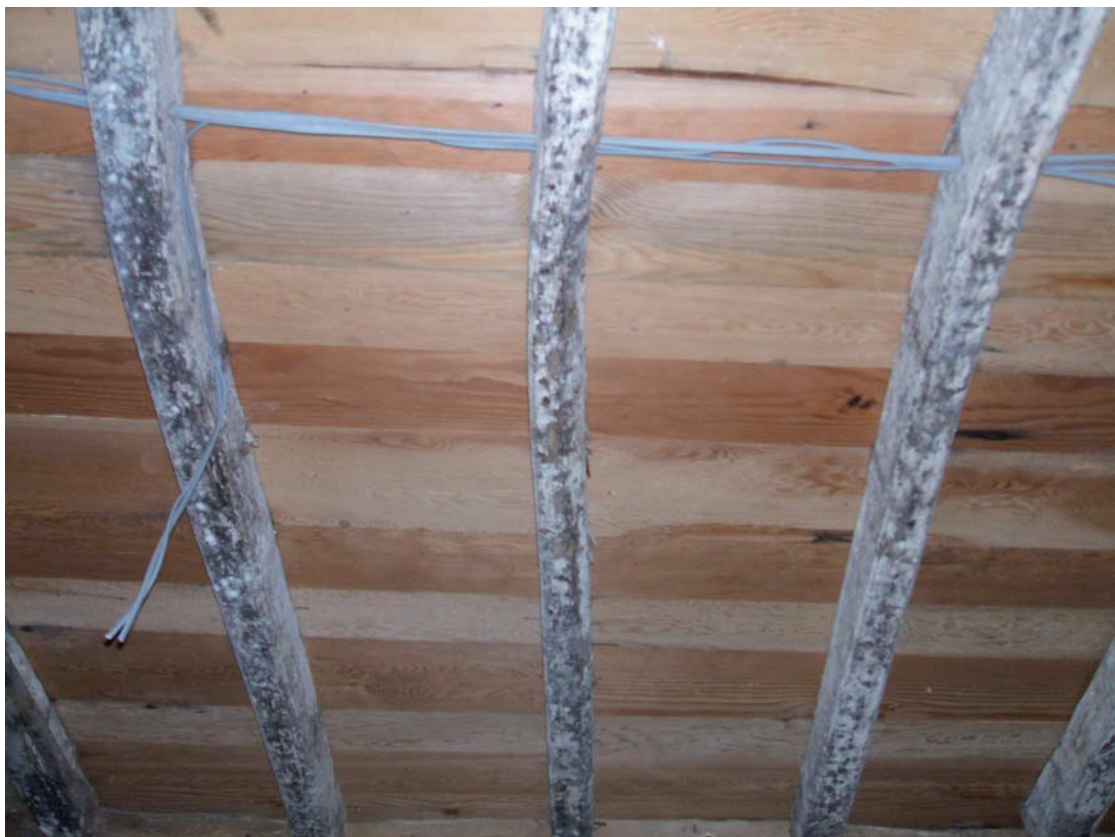
Plate 11: Room 2, early joists still *in situ*, looking east
