Archaeological building assessment at
Blatherwycke Hall stables

Northamptonshire

Report 09/18

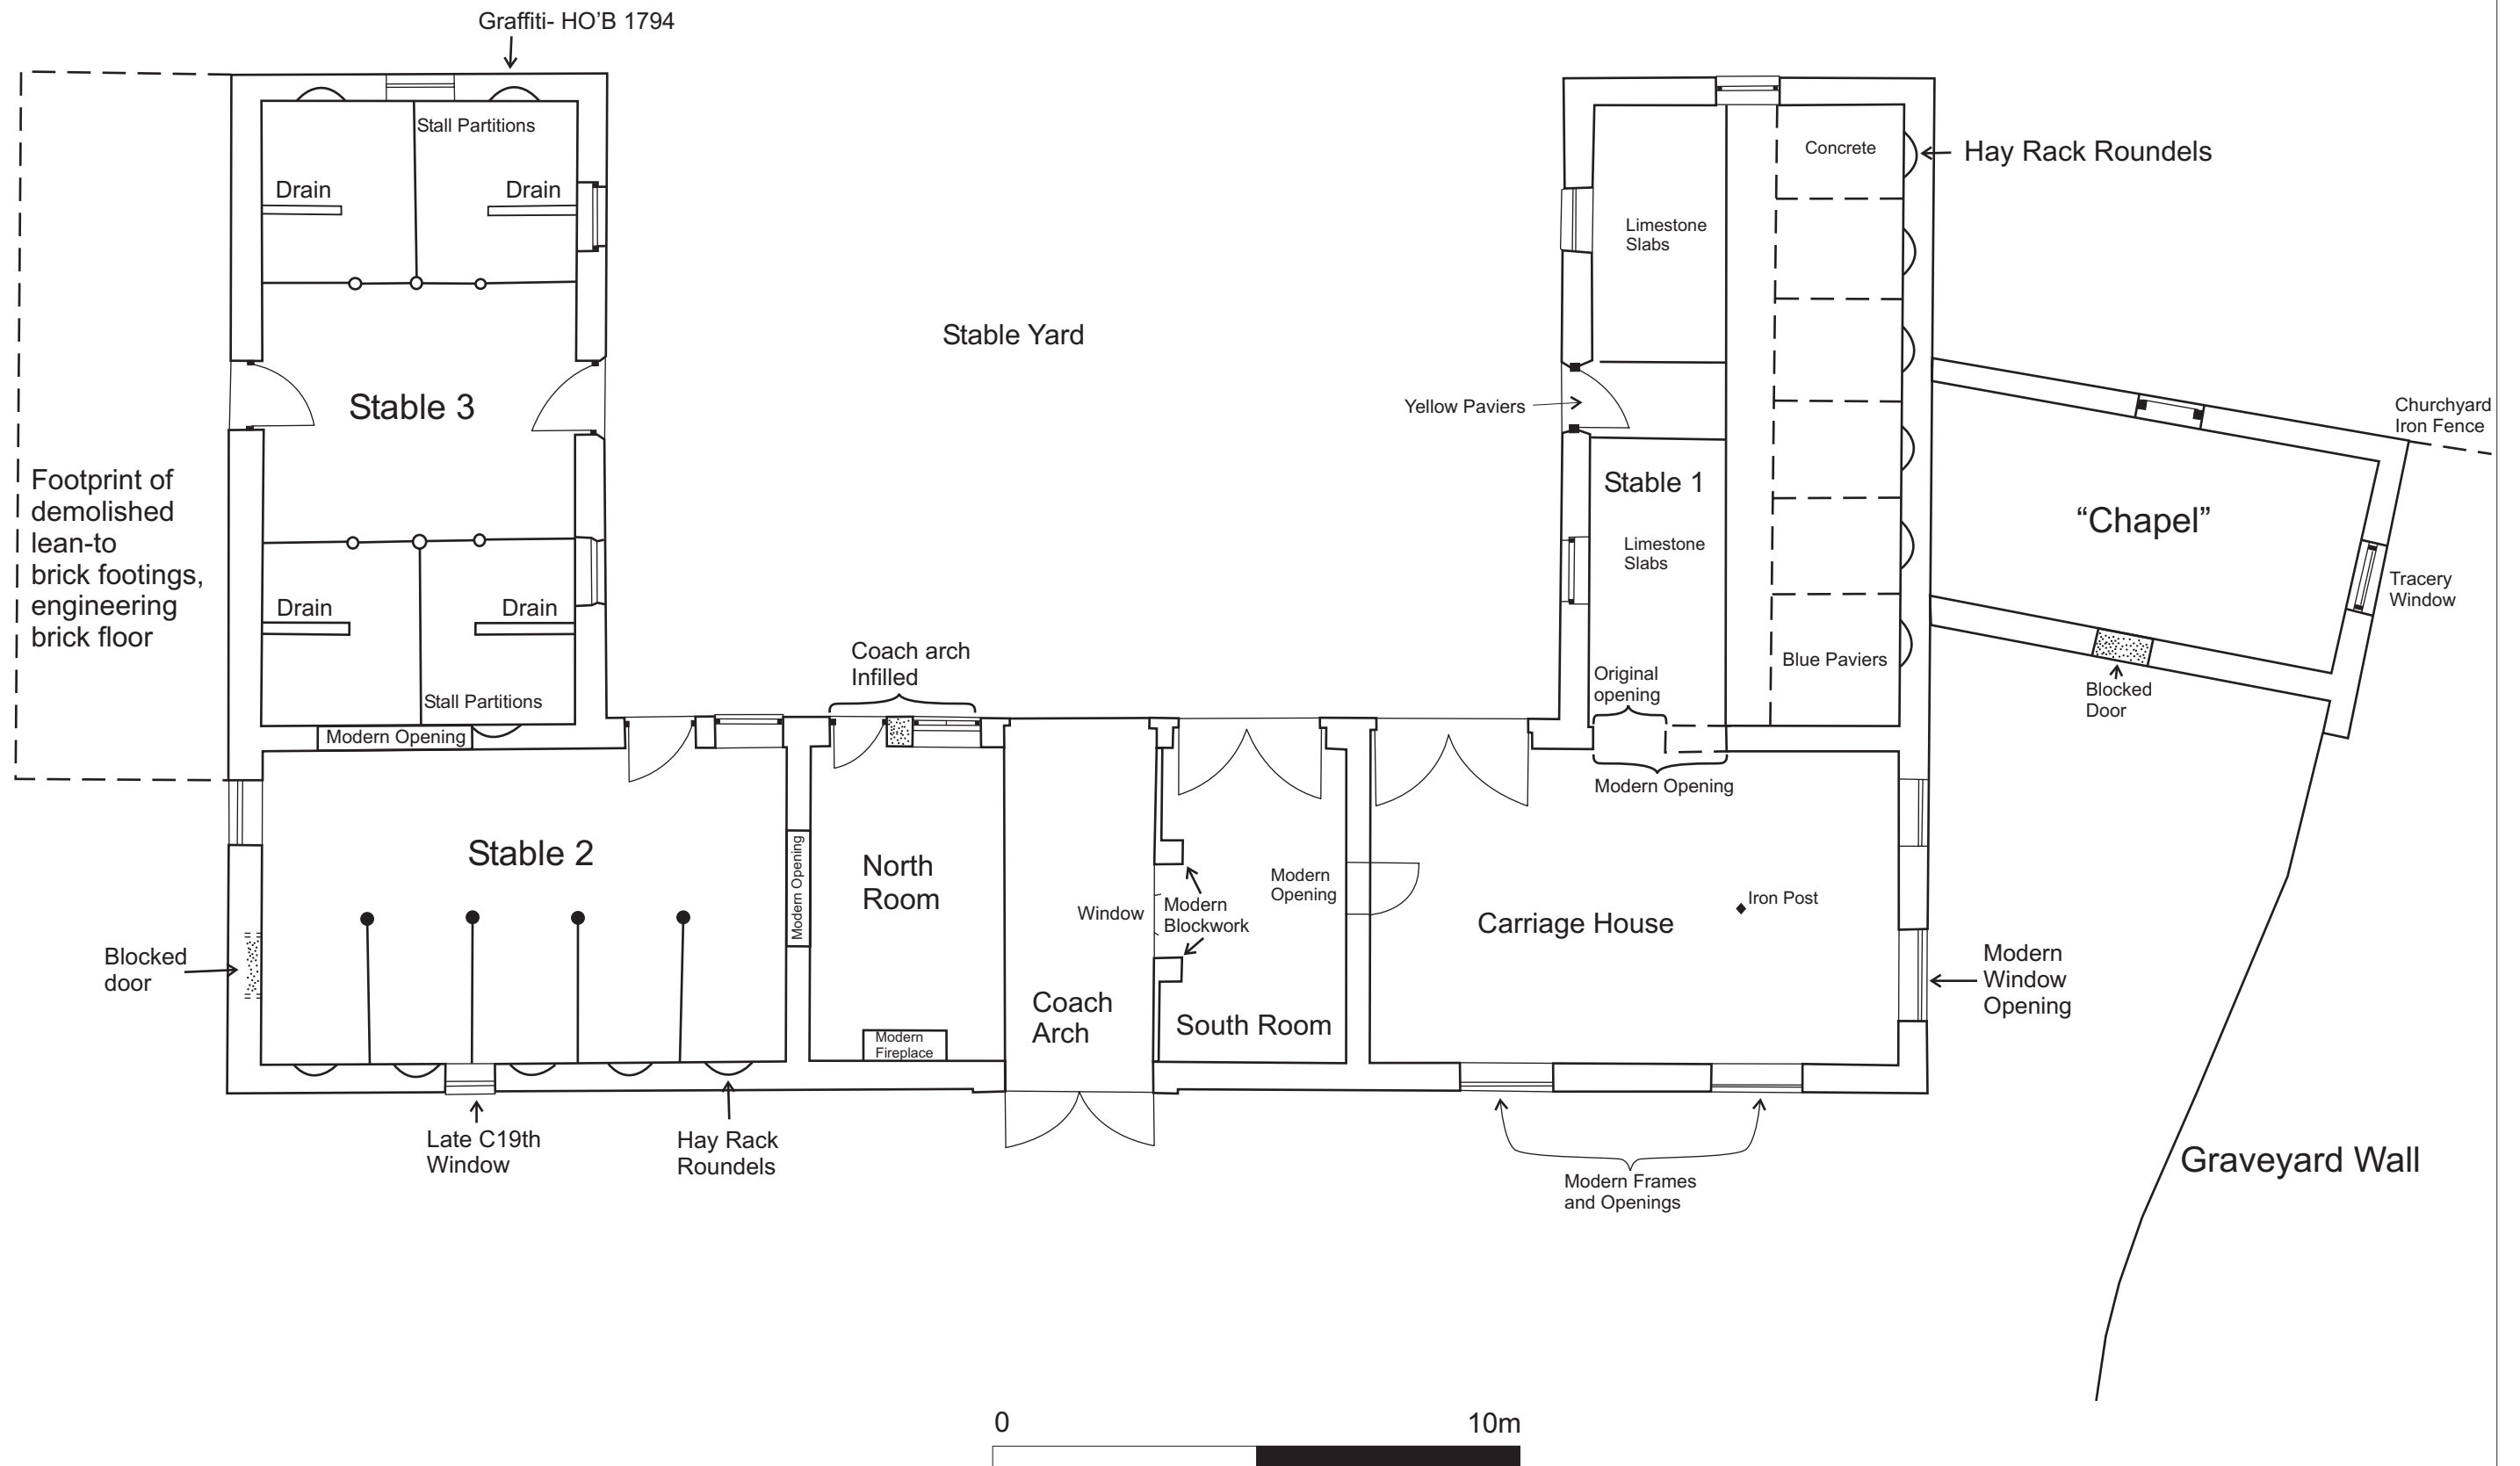
Blatherwycke Hall Stables - Ground Floor Fig 5

Ground floor; Stable 1. Situated in the southern wing this room was formerly a stable with stalls for six horses (Fig 5). The walls are primarily of undressed limestone with occasional use of red brick, and are bonded in lime mortar. Originally accessed from the stable courtyard to the north via a tall doorway with an arched top the room (at the first visit) was filled with debris due to the collapse of both the roof and the first floor, though subsequent clearance has enabled a full examination of the floor and lower parts of the walls to be made (Plate 15). The collapsed timbers were examined during removal, and though many were seen to retain carpenters marks (all Roman numerals formed by flat chisels) the majority of the timber was so badly rotted that no meaningful sense could be made of their former use. Since the roof and floors of the west and north ranges remain *in situ* comment will be made of their constructional detail and layout. The internal jambs of the door are finished in plaster within which is set the doorframe, probably of oak. Above the door is a semi-circular overdoor light, now empty but originally probably fitted with glass; originally it was divided into segments, as can be faintly seen on the sepia photograph showing a horse (see front cover). There are three windows, one in the east end wall and two in the north wall to either side of the central door. The windows are all square and are set high in the wall, a typical arrangement for stables to prevent horses from being able to reach the opening and potentially breaking the window glass. All openings are currently boarded from the outside and only one, in the eastern end wall, retains any glazing bars which indicate a nine pane sash arrangement, the upper portion containing three panes, the lower six. The windows are constructed below oak lintels set beneath a brick relieving arch and the internal jambs were lined with wood. The sills at ground floor level were sloping and either lined with wood (the east elevation) or plastered (north elevation). At first floor level there do not appear to have been any sills, the wall here was thinned to the thickness of the window frames below sill level (Plate 16).

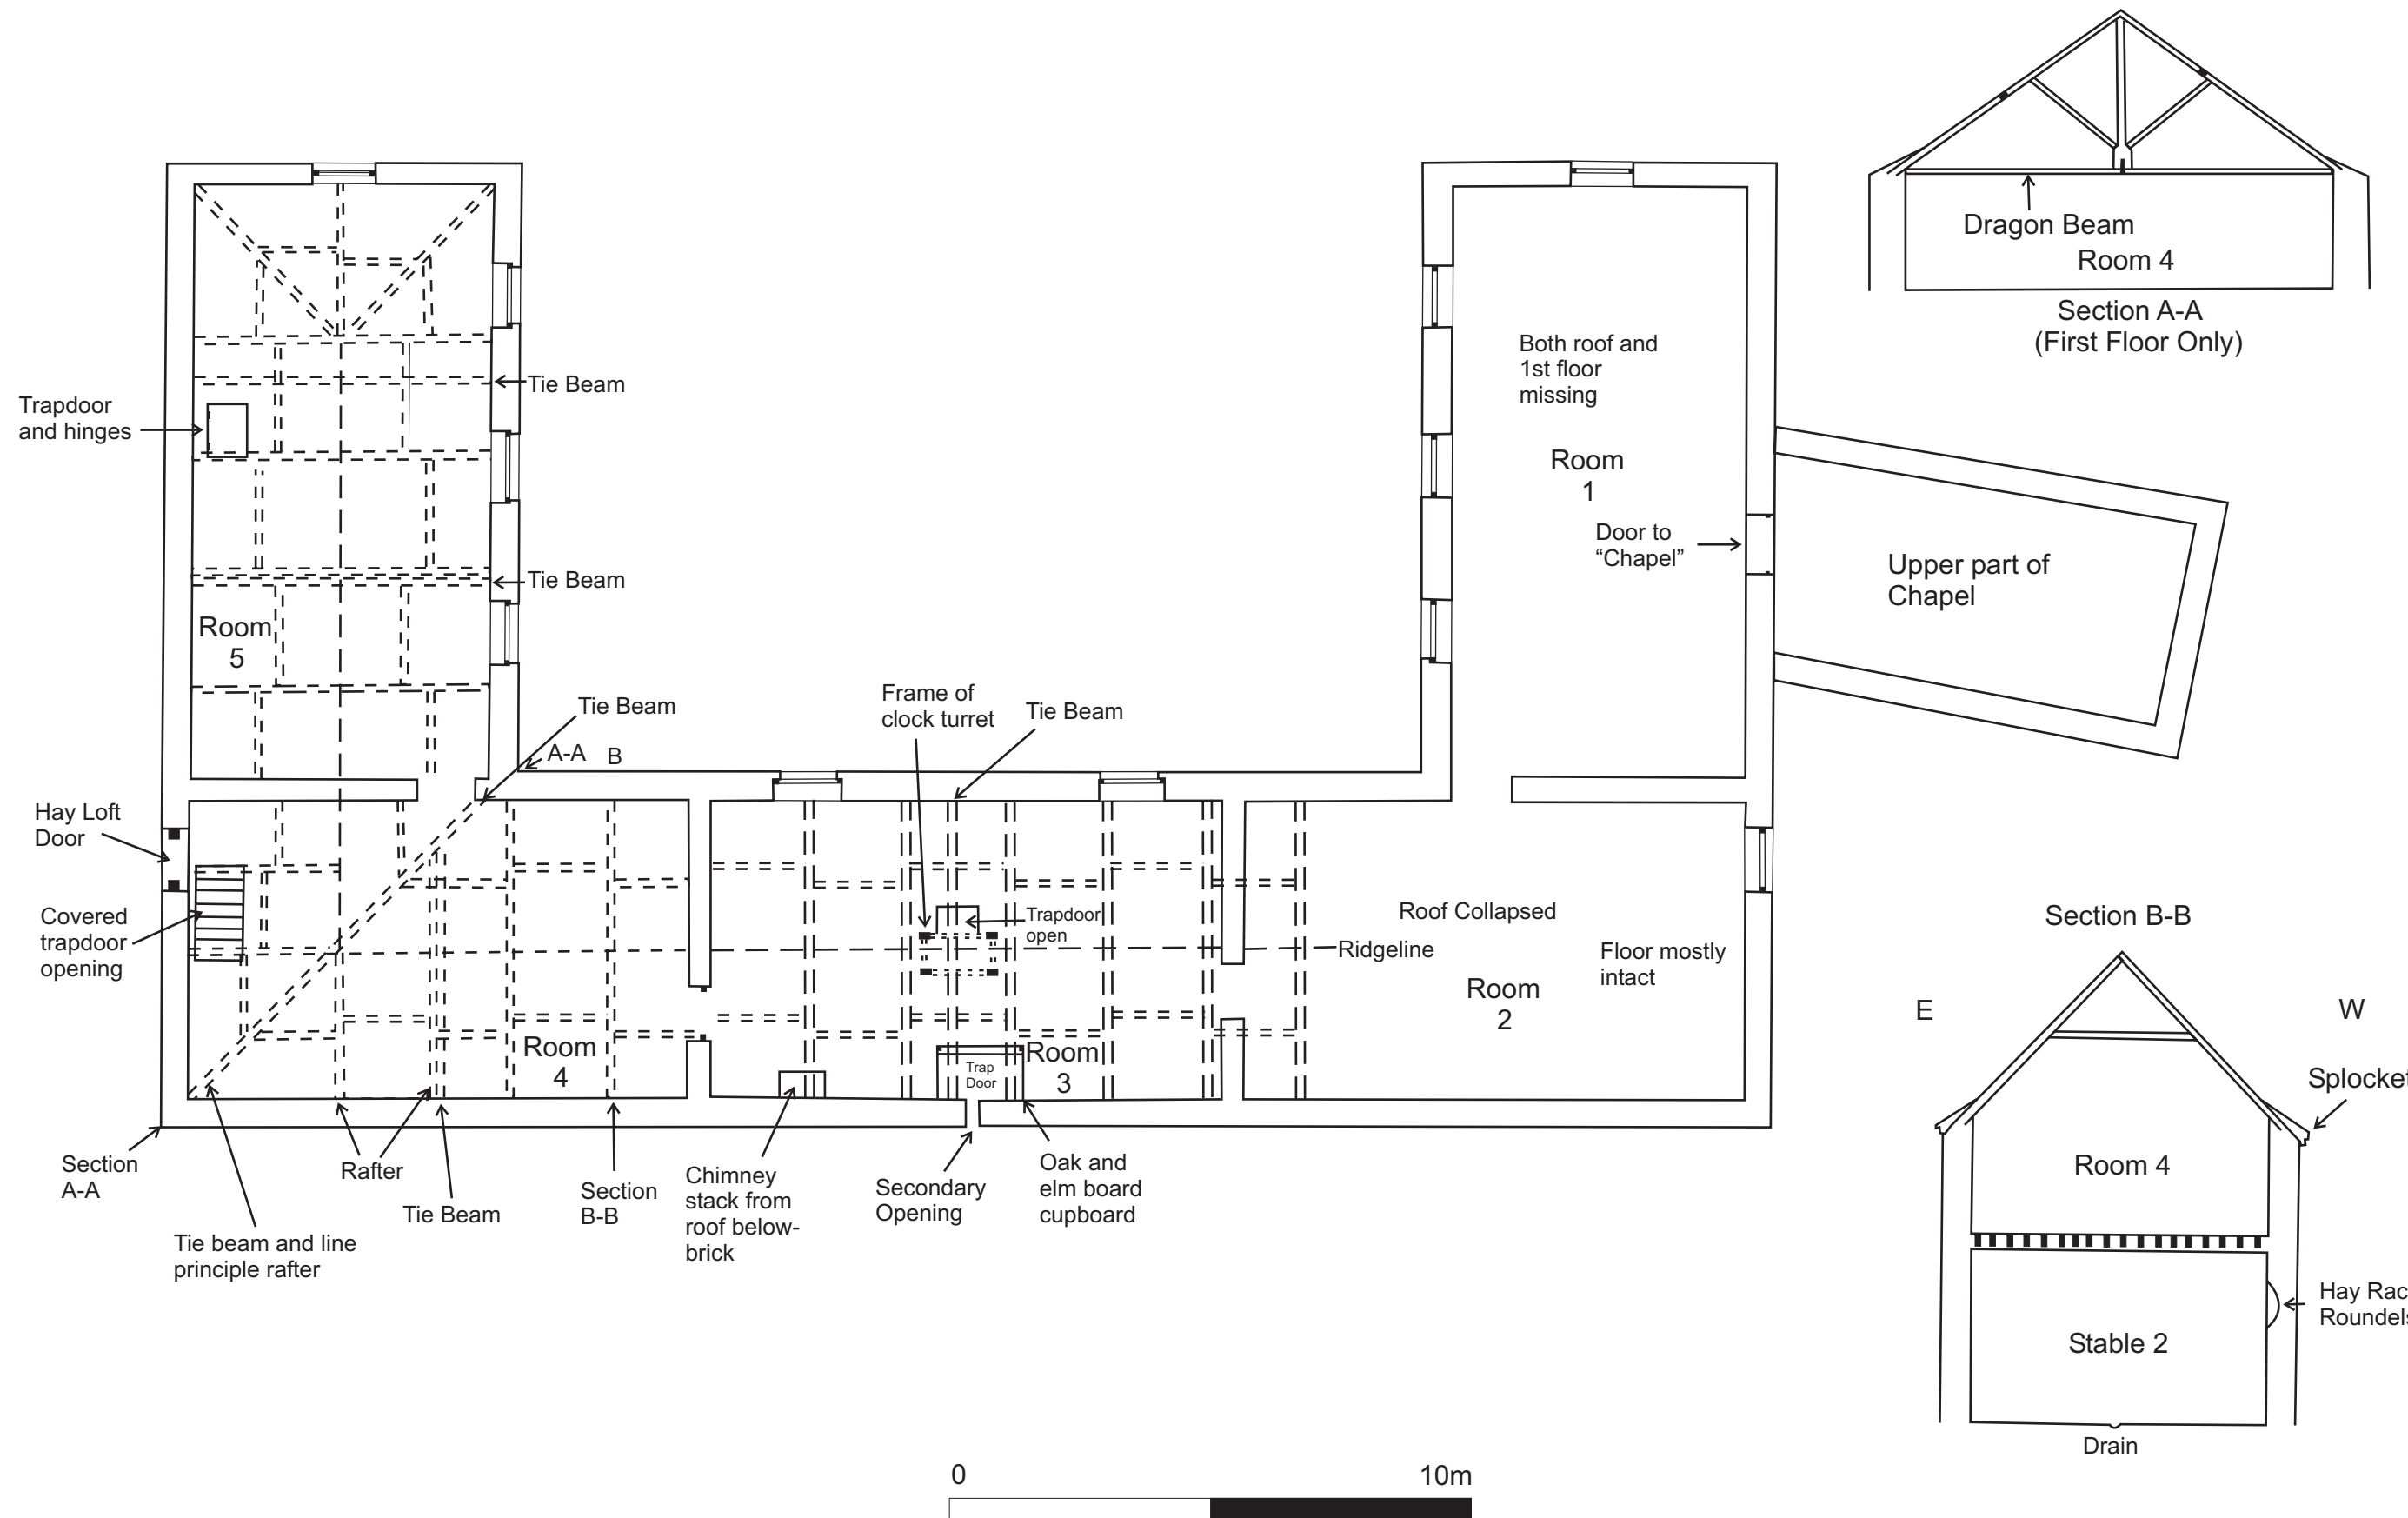
Blatherwycke Hall Stables - First Floor Fig 6

- 4.14 **First Floor; Room 2.** Also partially collapsed, this room retains much of its floor, albeit in poor condition, but almost none of the roof (Fig 6). This did survive in very poor condition when the site was first visited in early 2008 but was largely removed for Health and Safety reasons during July of the same year to allow the safe removal of the remaining Collyweston roof slates and safe access to the remainder of the ground and first floors (Plate 29). The room retains a window opening in the south wall and a doorway into Room 3. This doorway retains the only surviving door on the first floor, of simple vertically boarded and ledged (but not braced) pine construction; it may be original. It has two iron strap hinges and a wooden lock box (not original and positioned upside down) but the former drop-latch has been removed at some stage. The door is hung on a pine frame with simple quarter mouldings beneath an oak lintel. The walls of Room 2 are plastered and retain traces of a white or pale cream coloured limewash. There are very faint traces of graffiti which were too faint to decipher since these walls have been exposed to the elements for a number of years. The floor is of pine boards over joists and principal beams of the same material, the roof timbers too are all of pine. This use of pine is unusual in a building of this period, normally such structural timberwork is oak. Why it should have been used is uncertain, but there is no doubt that it is original since to have replaced the entire structure of the roof and all the timbers of the floors would have meant significant intervention to the walls and there is no indication that this happened. All around the perimeter of the floor, at the junction with the wall, is a red brick fillet. It is present in all of the rooms and is clearly a later addition as it is placed over the wall plaster. Although its purpose is not absolutely certain it was probably added at a stage when there had been some movement in the building and a small gap had appeared between the edge of the floor boards and the walls. It might then have been added to try to make the upper floor rodent-proof by filling the gap where they could climb the internal walls, although in reality it probably proved worthless as the exterior of the walls was far rougher and would allow any rodent easy access.

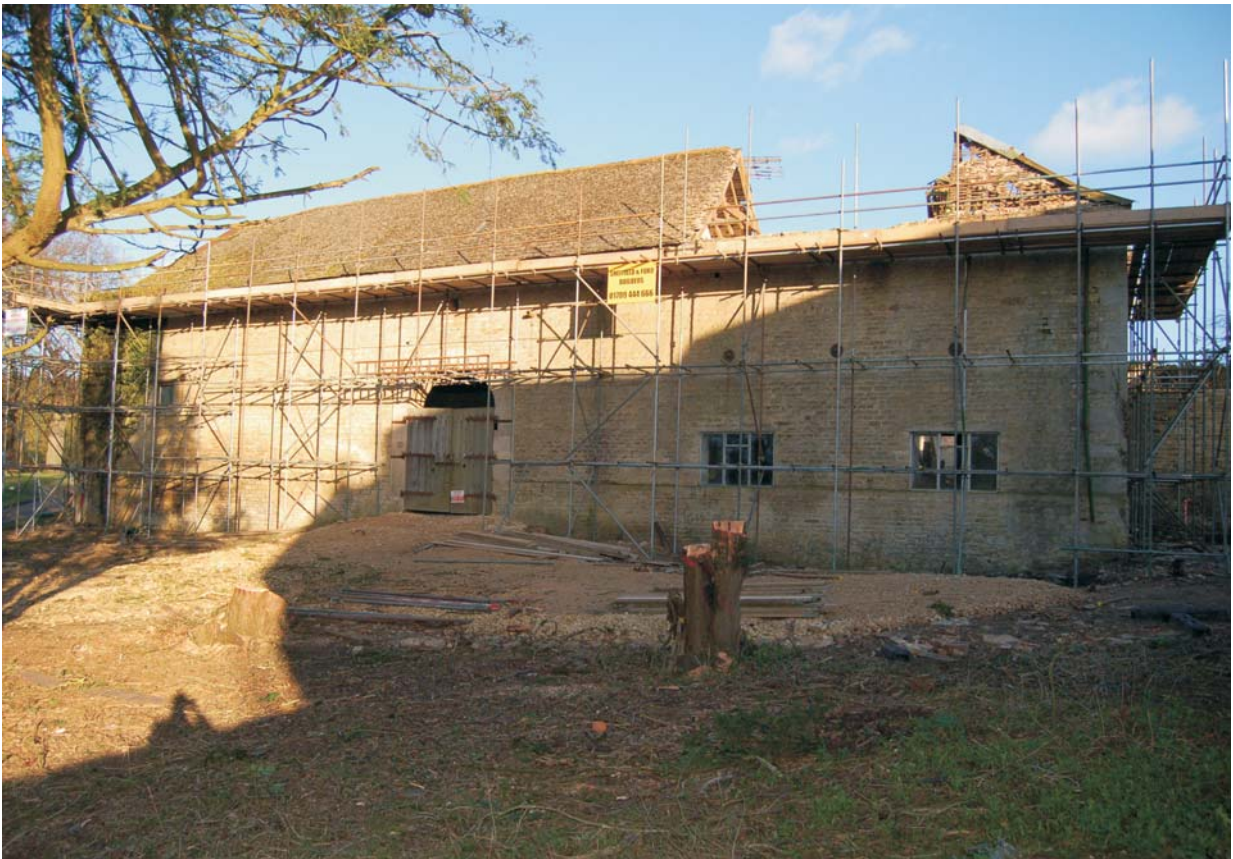
- 4.4 **West façade.** The long, western façade was originally punctuated by a single, central carriage arch (Fig 5, Plate 3). The archway is constructed of large ashlar blocks and voussoirs, the outer surface and soffits of which have been pock-marked to create a rusticated effect within a plain border (Plate 9). The present timber doors are modern and fitted to unsightly iron straps fitted over the stonework of the western external face. Originally there is no evidence that there were doors here as there is no trace of hinges or any rebate into which doors would have fitted. Though this initially appears unlikely it would have allowed carriages and coaches to drive straight under cover without having to wait for the stable block doors to be opened. The area into which they entered was not originally connected to the remainder of the building and the opposite archway was fitted with doors, so it did not compromise the security of the building.

The remainder of the western façade, originally plain, is now pierced by three windows, one in the northern half, the other two in the southern (Fig 5, Plate 3). That in the northern half appears to be nineteenth century in date and is fitted high in the wall of the ground floor, close to the ceiling (see below, section 4.11). It is a simple rectangular opening with an oak lintel and sill painted with maroon paint, and while it retains the outer part of the frame the fenestration is now missing. The two windows in the southern half are identical to that on the south façade (see Plate 5), both Crittall-style iron frames, and all three of the same size, though on the western side they are set low, with their sills being formed by the upper surface of the plinth. They sit beneath concrete lintels and it must be reasonably assumed that all three were fitted at the same time. A small opening placed high in the wall above the central arch is also secondary but appears never to have had a frame or glazing. Its use is uncertain but it does seem most closely to resemble an owl hole, a deliberate opening created to allow owls access for the purpose of vermin control, useful if the first floor was used for the storage of hay, oats and straw.

Plate 3: The west side of the stables

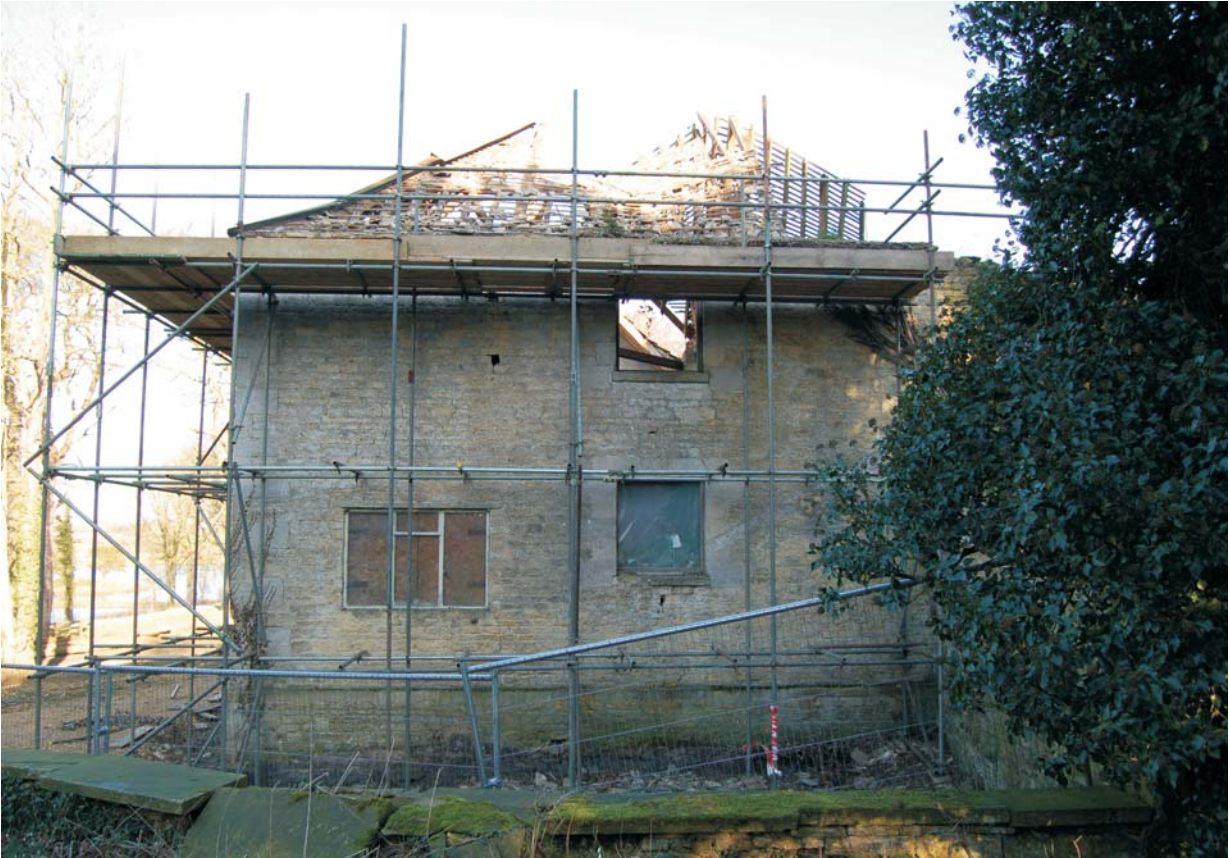
4.2 *South façade.* The walls of the south side of the building are built of roughly dressed coursed limestone with fine ashlar quoins and a simple square plinth, also finished in ashlar. It had no doors and only one window on each of the ground and first floors at the western end of the façade (Figs 5 and 6). Each window is square and has flush ashlar jambs and a flat stone lintel (Plate 5). The sill, which projects slightly from the wall plane, is also limestone. Neither window on this façade retains its original frame. A modern window has been inserted towards the western end of the ground floor during the twentieth century. The opening is at a slightly lower level than the original and is wider and fitted with a Crittall style iron frame with both side windows opening casement fashion, and the small central upper section also opening. The lintel is of concrete and there is no sill, the jambs have been well repaired but do not have the ashlar blocks present on the original openings. The roof above this section of the building has collapsed, causing some loss to the stonework of the walls towards eaves level.

Plate 5: South facade showing original and later window openings

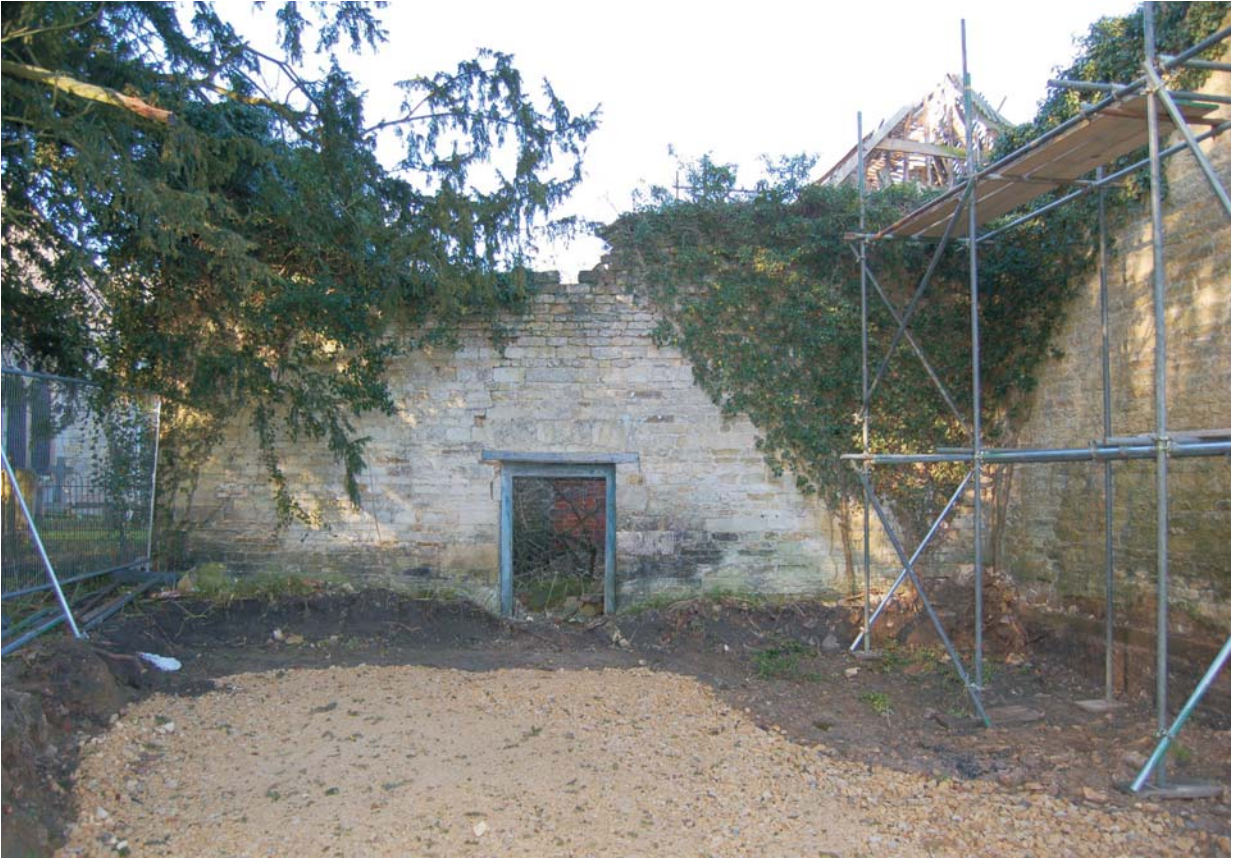
4.3 *“Chapel”.* Approximately halfway along this side of the stables a small two storey building has been added at a curiously oblique angle (Fig 5). This building is not depicted on the map of 1826 (amended 1846) and stylistically it has the appearance of a mid-nineteenth century building, most particularly the southern gable end which has two pointed arched windows fitted with timber tracery (Plate 6). It is clearly built against the stables, the walls are butt jointed, not bonded and it has no plinth. At the south-west corner is an integral buttress though there is not a corresponding one on the south-east corner. The roof and floor have collapsed into the interior and there is no visible floor; it is not clear if a stone or ceramic tile floor has been removed or whether it was of timber, now rotted, although there are no empty wall sockets for joists. There is a doorway on the east side fitted with an oak frame and a simple pine plank door *in situ* beneath an oak lintel

(Plate 7). Another doorway in the west wall appears once to have been open, but is now blocked with stone externally and brick internally. The window in the east end is of a 'Gothic' pointed arch on the exterior but on the interior sits beneath an oak lintel (Plate 8). The opening is divided by timber glazing bars into three vertically with further divisions of simple Y-tracery above and was glazed, traces of clear glass and putty remain. The window appears to be set rather high in the wall when viewed from the interior; this is due to the higher ground level within the churchyard. The window at first floor level appears to have been a smaller version of that on the ground floor, but divided into two rather than three sections, again with Y-tracery; the upper portion of the stone arch and gable apex has been lost through collapse. The upper floor was not accessed from the stables on the ground floor but only from the first floor where a doorway has been knocked through the south wall. Collapsed joists, as well as empty sockets in the walls inside this extension indicate that they were aligned east-west across the short axis.

Plate 7: Door in the east facade of the "Chapel" looking west

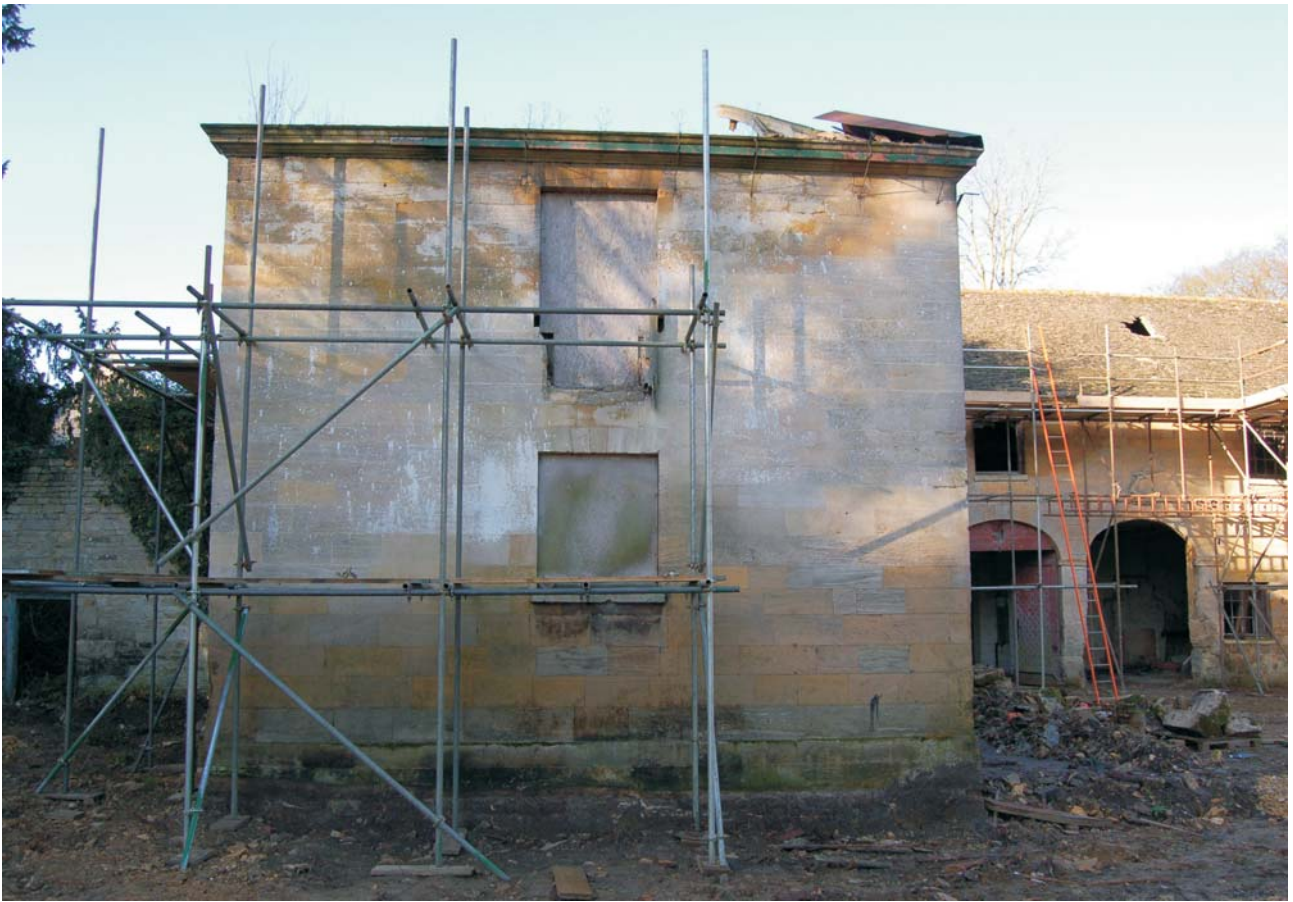
Plate 11: East facade of the south wing looking west, altered window at first floor

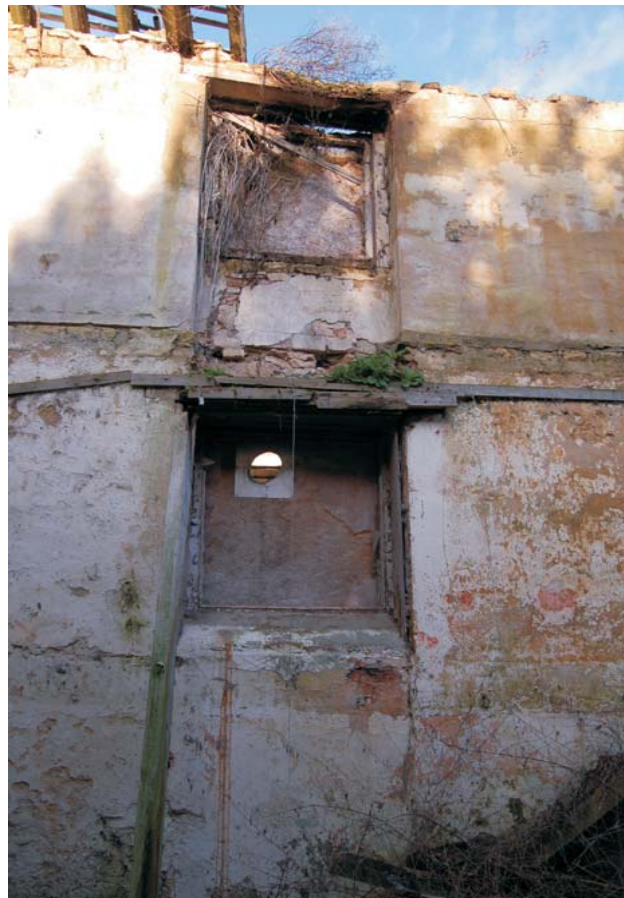
Plate 16: Window details at ground and first floor- south wing, looking north

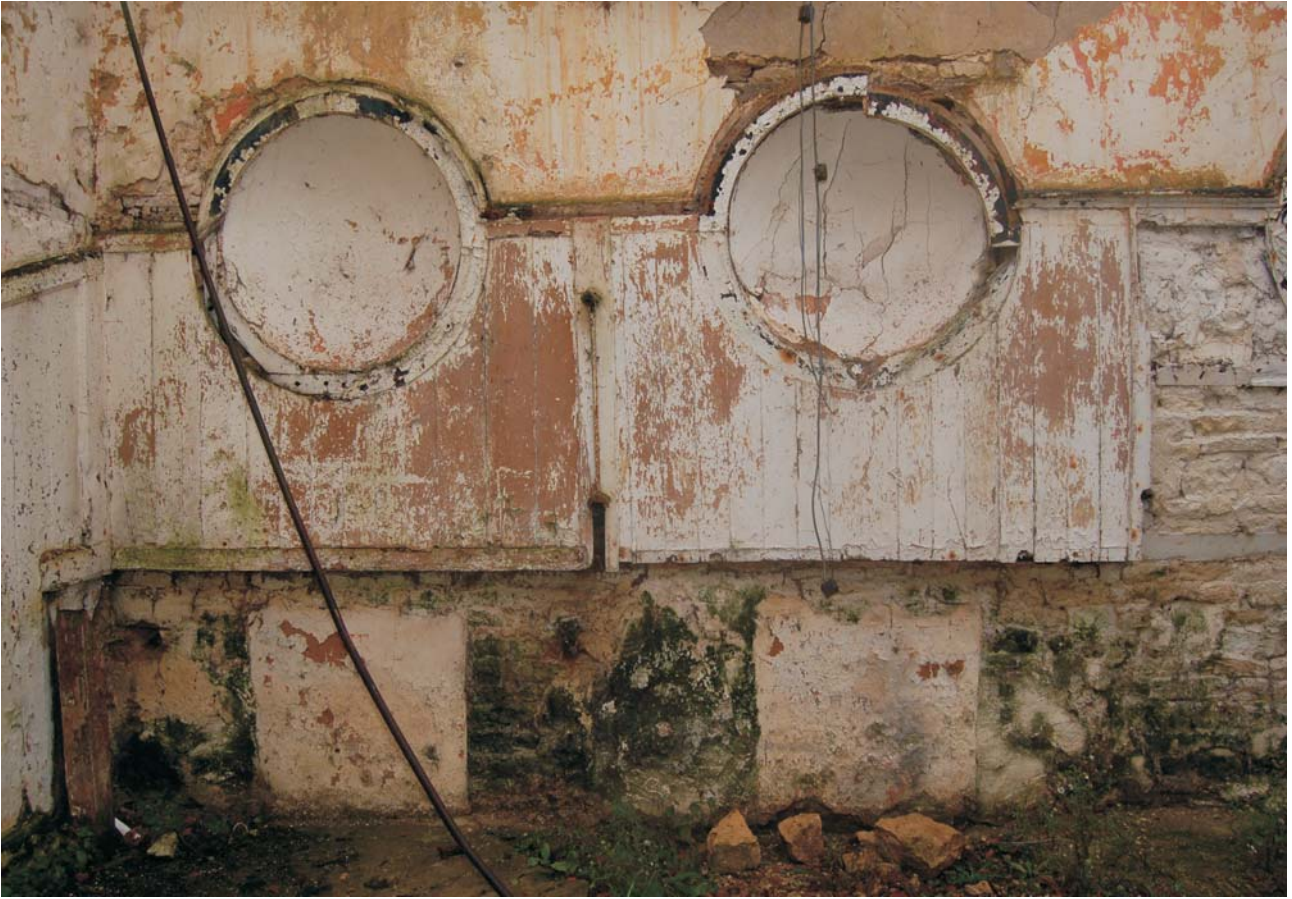
The walls of the stable are plastered and painted white (with lime wash) though there is evidence that there was a decorative scheme which comprised blue borders to panels with each corner finished with an inset quarter circle cut-back (quadrant), most evident now in this wing at first floor level (Plate 17). The stalls faced the south wall and all stall divisions are now missing, however, at the west end the profile of the sloping top edge can be seen against the west wall of the room (Plate 18). It is constructed of oak with vertical boards capped by a broader top rail. At the west end a post set into the wall was originally topped by an acorn shaped finial, now missing, but the outline of which can be seen in the wall plaster. This finial was found during the clearance of the room and has been retained. It appears to be of oak and is lathe turned, cut in half and covered in many layers of paint including yellow ochre, black, white and maroon. The lower surface has the remains of a tenon by which it was fixed into the top of the upright of the stall end against the wall. Though the remainder of the stall divisions are now removed there is enough evidence in the south wall to determine that the divisions comprised timber on the lower part with vertical iron bars on the upper portion, and probably iron posts at the north end of each stall (Fig 5). It is assumed that each stall division followed the same pattern. In the south wall at the centre of each stall are the remains of distinctive hay racks which comprise a large circular dished recess set into the wall, 3 feet in diameter, which were originally fronted by an iron grille over the lower half which would have held the hay (Plate 19). Each circle is

Plate 19: Hay rack roundels in the south wall of stable 1, looking south

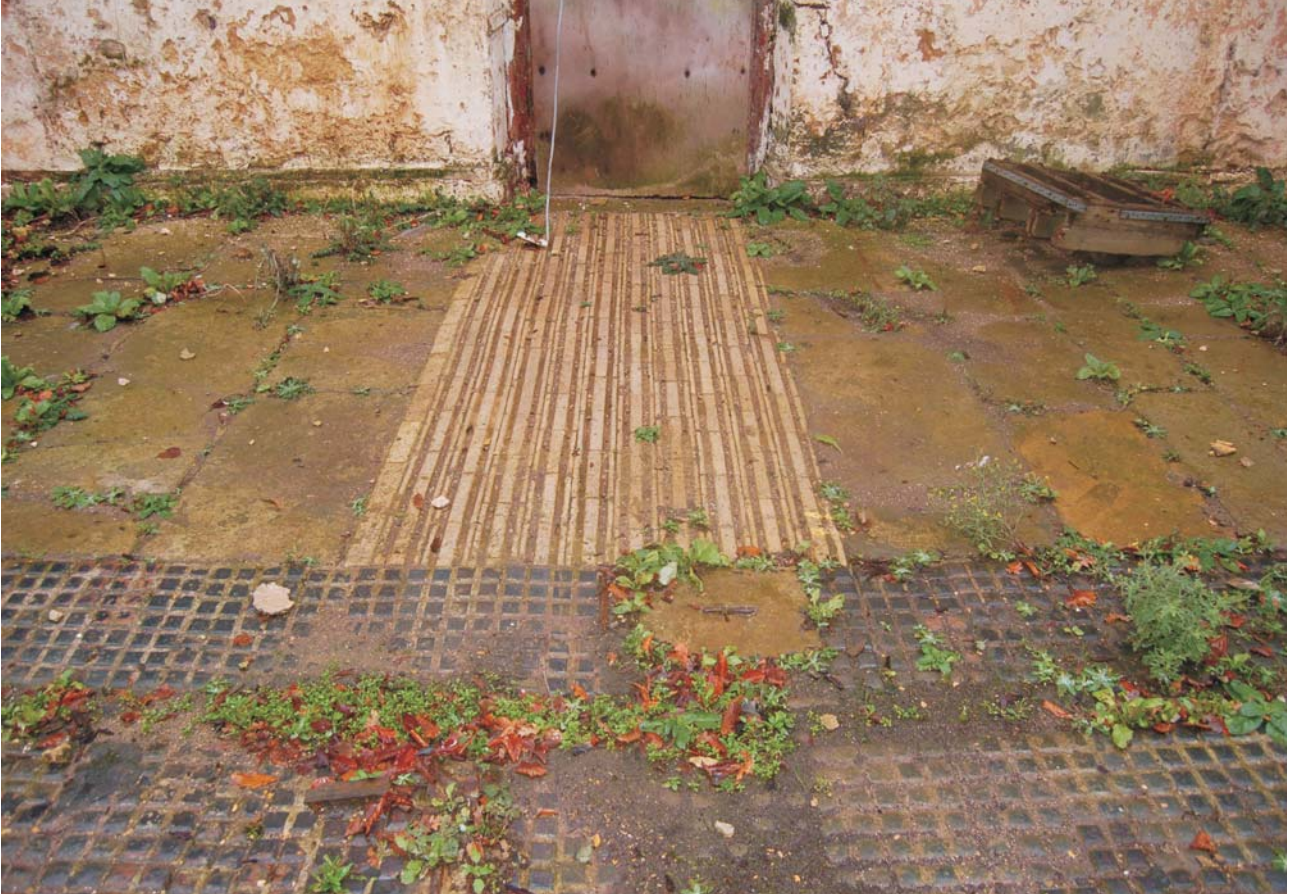
The floor of the room is roughly half limestone slabs (north of the centre-line) and half blue engineering brick pavers with an embossed grid pattern (rather like a bar of chocolate, Plate 20). These blue pavers run to a central drain aligned east-west along the long axis of the room. The floor of the easternmost bay of the stalls has been replaced with concrete. A narrow strip, the width of the doorway, lies north-south from the entrance across the room until it joins with the blue pavers.

Plate 20: Paviers in stable 1, looking north

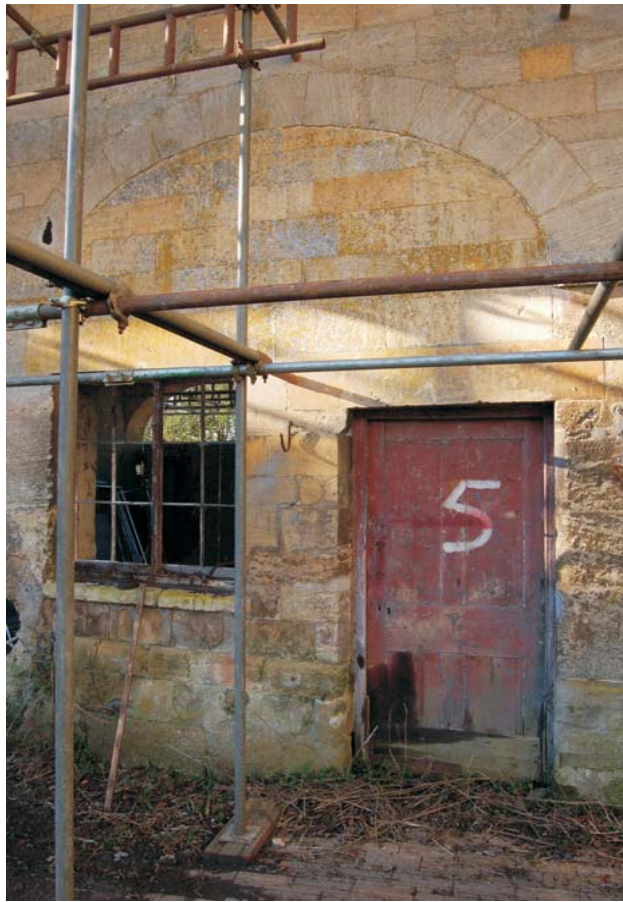
Plate 23: Infilled coach arch in east facade of west range, looking west

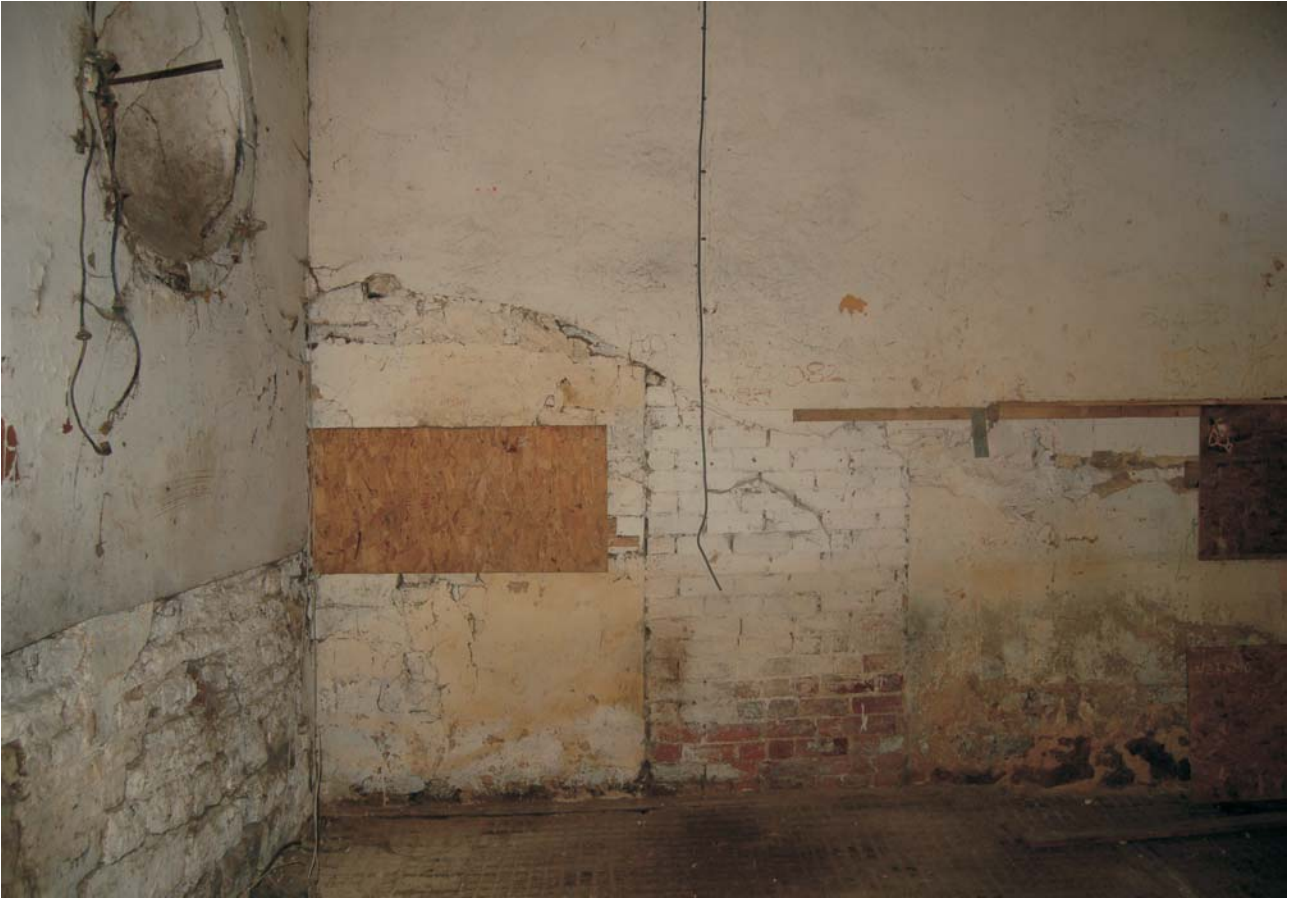
Plate 25: Blocked doorway and scar of stall, north wall of stable 2, looking north

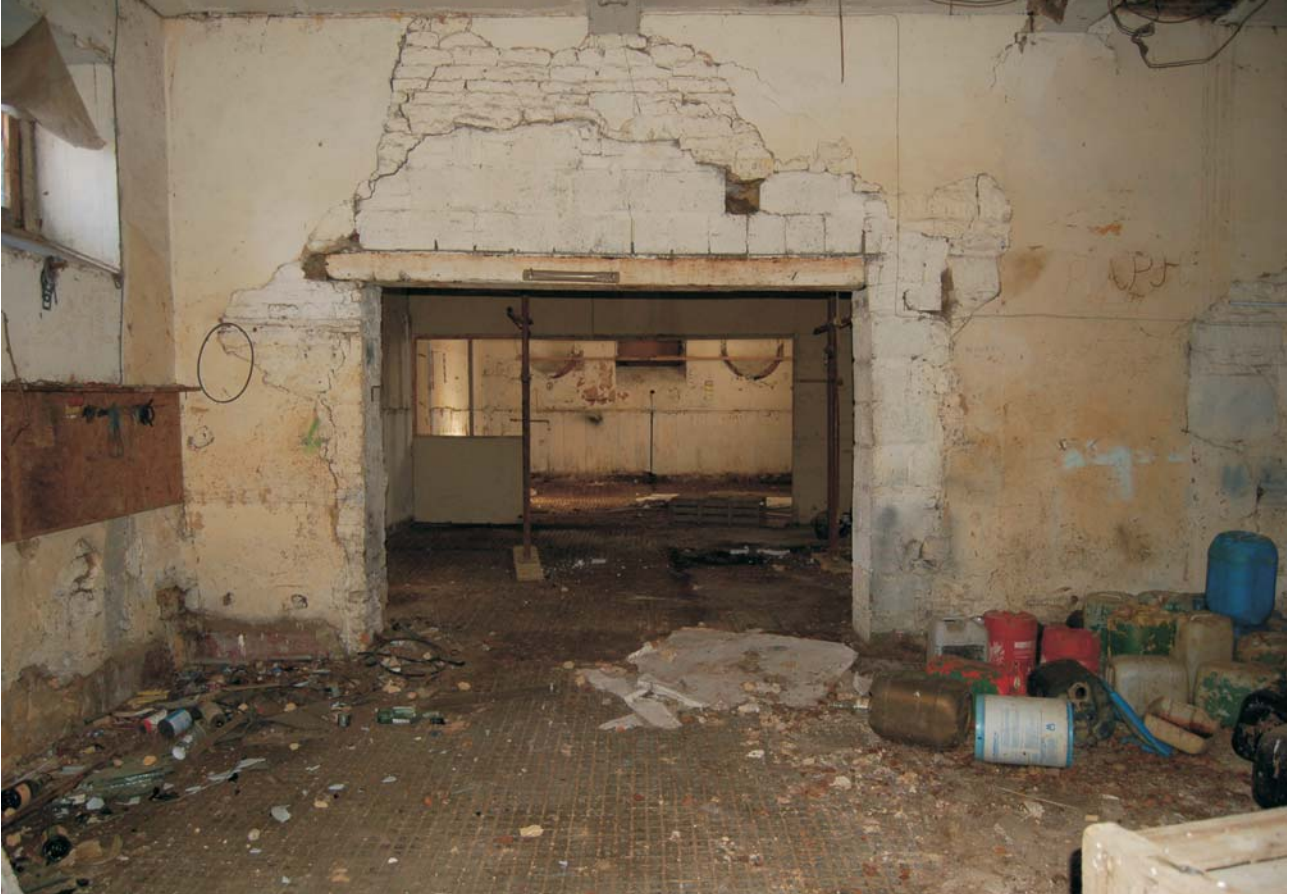
- 4.11 **Ground floor; Stable 2.** Situated at the north end of the west range this room was formerly another suite of stables, now connected to the room north of the coach arch via a wide modern opening knocked through the dividing wall (Fig 5). The room was originally accessed via a square headed door set in an arched opening in the east wall, flanked by a square window also set beneath an arched top opening (Plate 24). The door is vertically planked and is ledged but not braced; it is almost certainly a later replacement. The window contains no original frame and the semi-circular section above is boarded in. In the north wall is another window, almost certainly original as it mirrors the window position in the south wall. Here, however, it has been altered; the lintel is a simple oak

Plate 26: Modern opening between stable 2 and stable 3, looking east
