Archaeological building assessment at
Blatherwycke Hall stables

Northamptonshire

Report 09/18

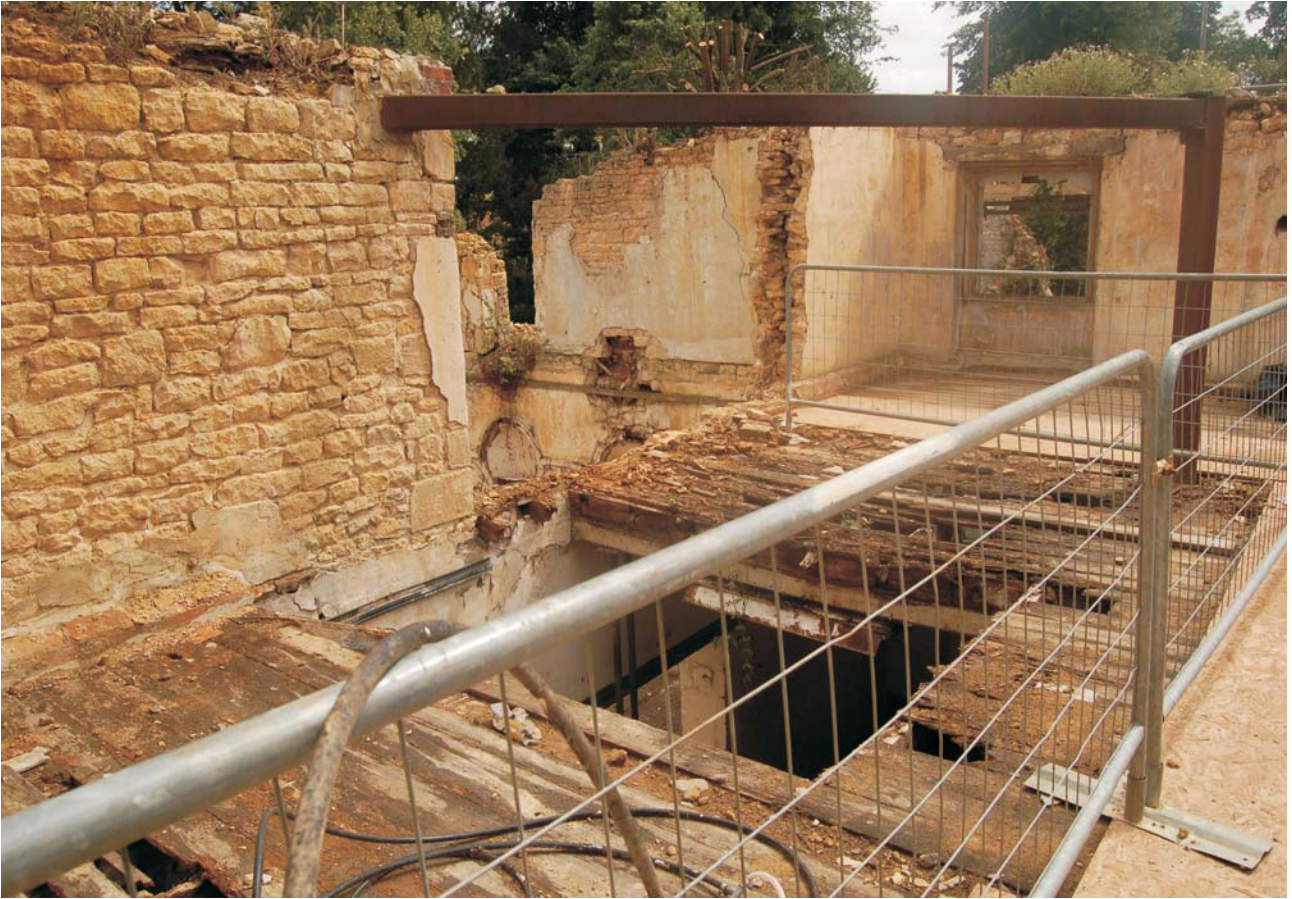
- 4.14 **First Floor; Room 2.** Also partially collapsed, this room retains much of its floor, albeit in poor condition, but almost none of the roof (Fig 6). This did survive in very poor condition when the site was first visited in early 2008 but was largely removed for Health and Safety reasons during July of the same year to allow the safe removal of the remaining Collyweston roof slates and safe access to the remainder of the ground and first floors (Plate 29). The room retains a window opening in the south wall and a doorway into Room 3. This doorway retains the only surviving door on the first floor, of simple vertically boarded and ledged (but not braced) pine construction; it may be original. It has two iron strap hinges and a wooden lock box (not original and positioned upside down) but the former drop-latch has been removed at some stage. The door is hung on a pine frame with simple quarter mouldings beneath an oak lintel. The walls of Room 2 are plastered and retain traces of a white or pale cream coloured limewash. There are very faint traces of graffiti which were too faint to decipher since these walls have been exposed to the elements for a number of years. The floor is of pine boards over joists and principal beams of the same material, the roof timbers too are all of pine. This use of pine is unusual in a building of this period, normally such structural timberwork is oak. Why it should have been used is uncertain, but there is no doubt that it is original since to have replaced the entire structure of the roof and all the timbers of the floors would have meant significant intervention to the walls and there is no indication that this happened. All around the perimeter of the floor, at the junction with the wall, is a red brick fillet. It is present in all of the rooms and is clearly a later addition as it is placed over the wall plaster. Although its purpose is not absolutely certain it was probably added at a stage when there had been some movement in the building and a small gap had appeared between the edge of the floor boards and the walls. It might then have been added to try to make the upper floor rodent-proof by filling the gap where they could climb the internal walls, although in reality it probably proved worthless as the exterior of the walls was far rougher and would allow any rodent easy access.

Plate 29: Room 2, first floor, looking south

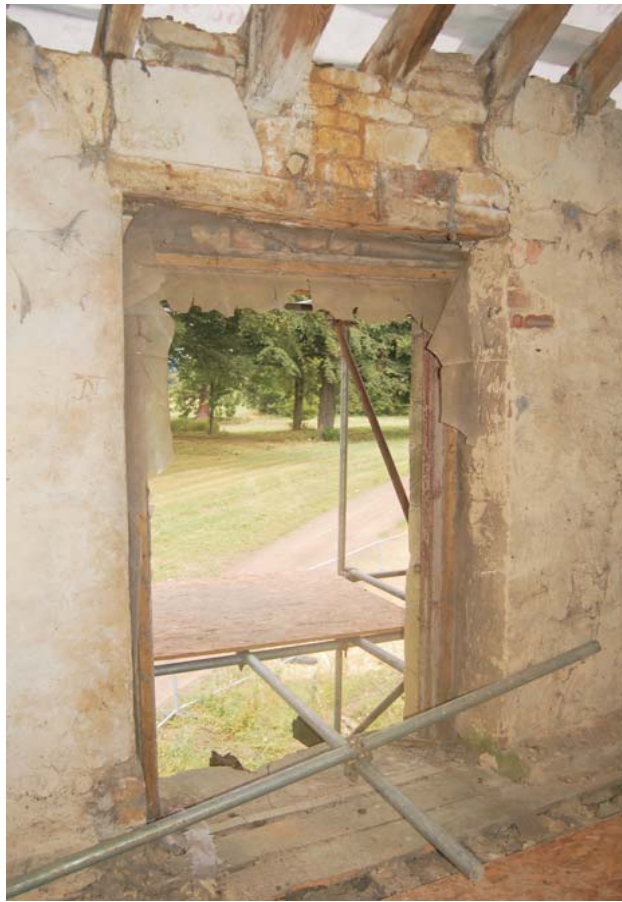
Plate 35: Former window converted to hay-loft door in north wall of Room 4

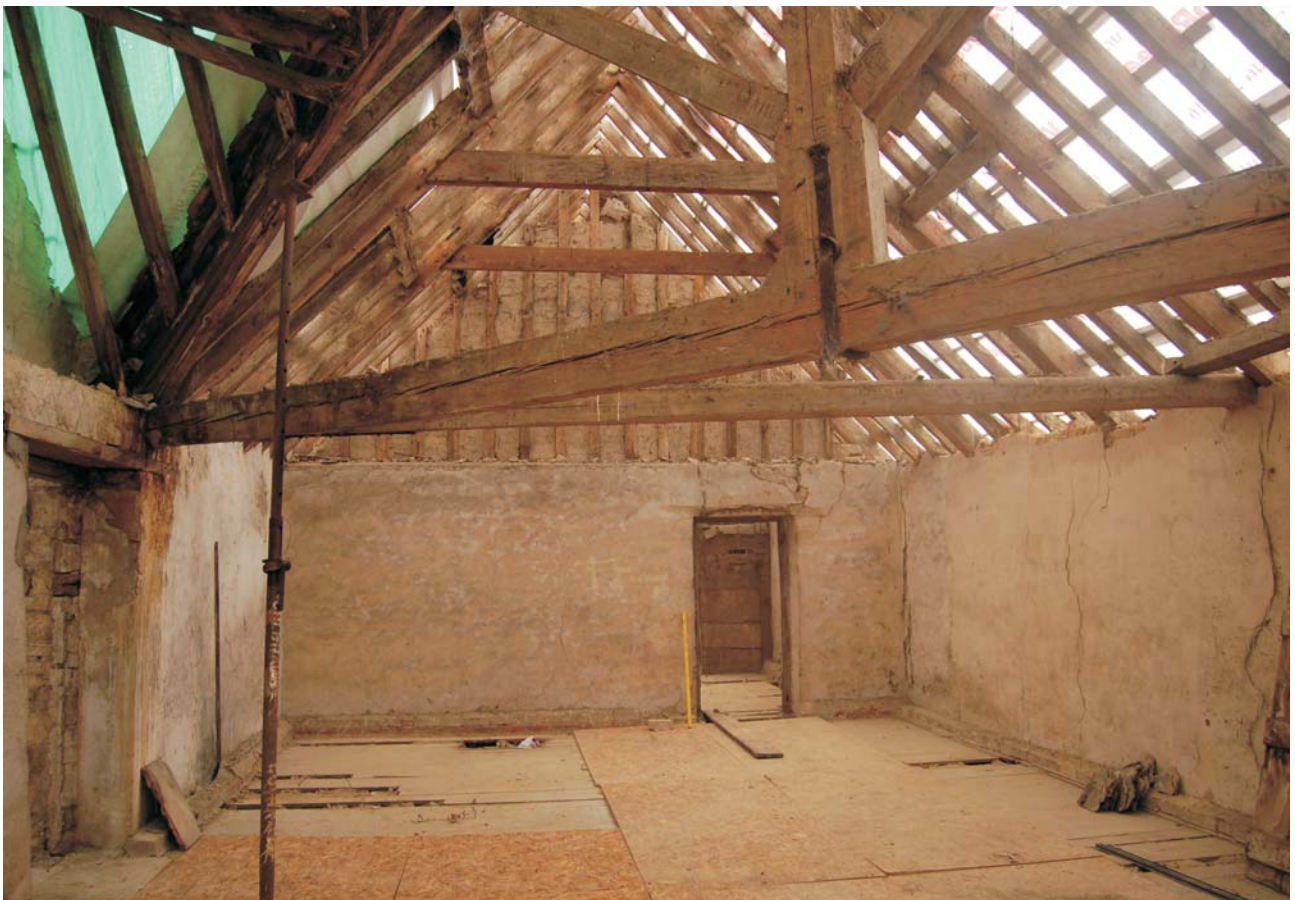
Plate 36: Dragon beam at junction of beam and post showing iron strap, Room 4

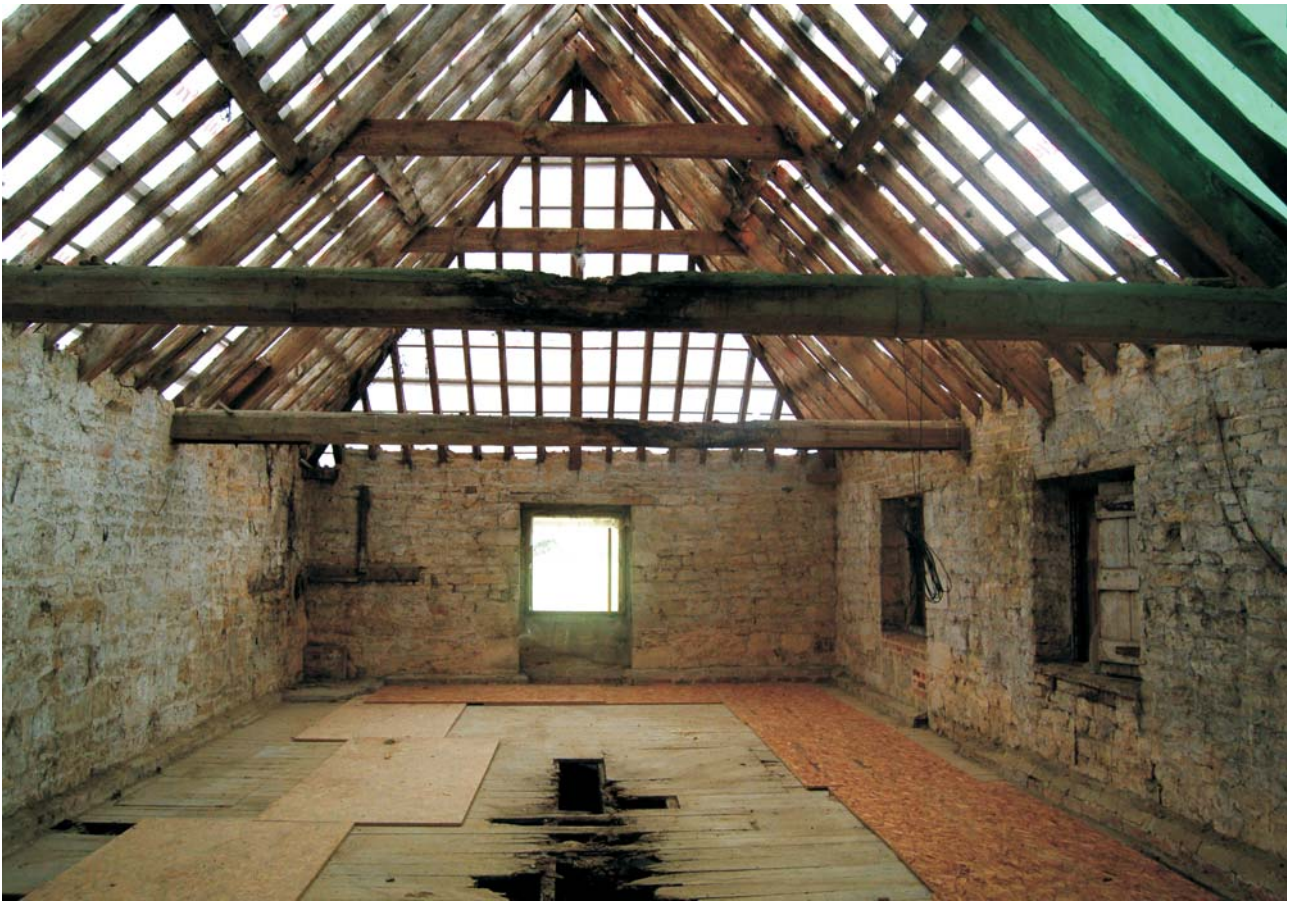
Plate 37 Room 5 looking east showing un-plastered walls and roof structure

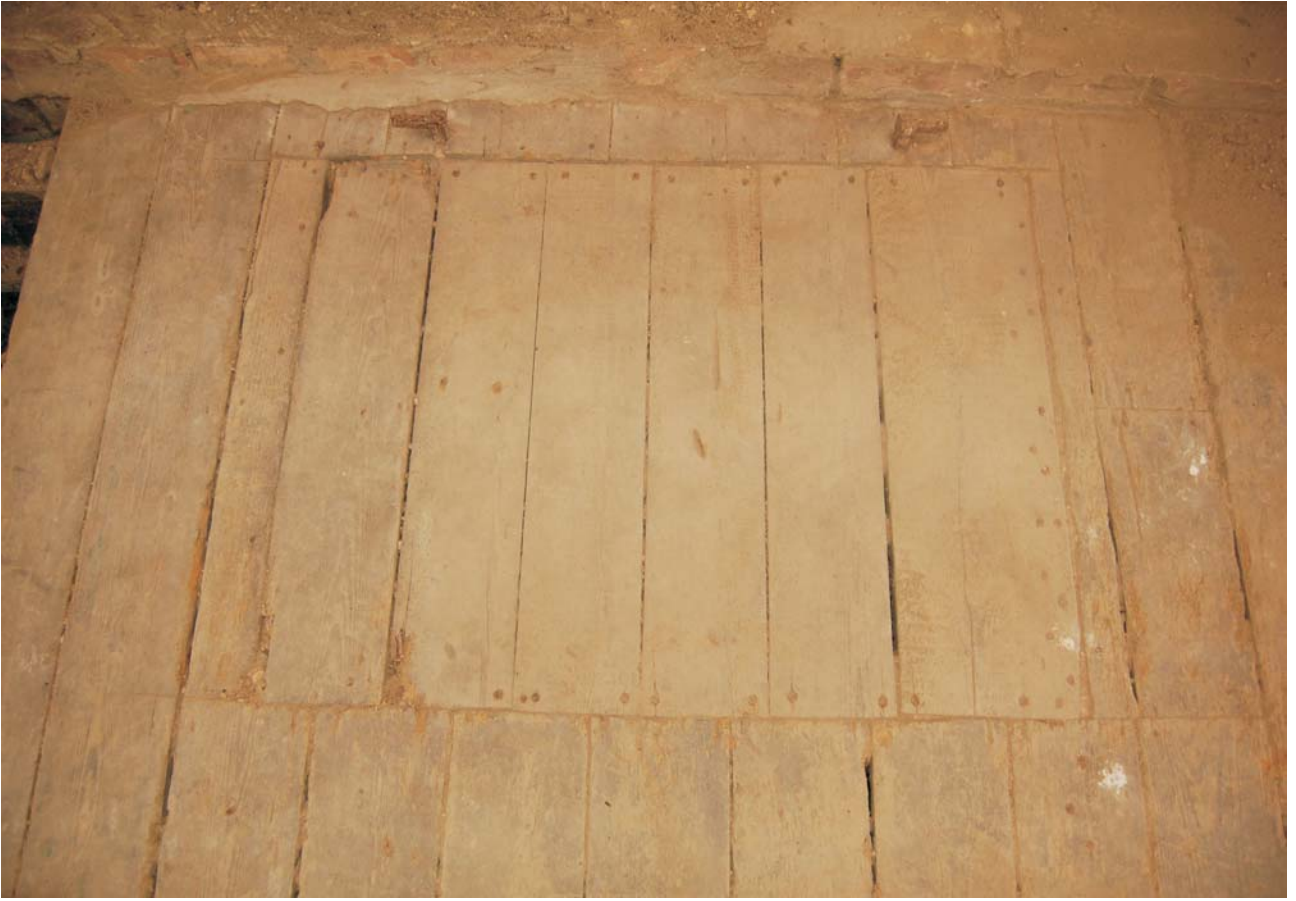
There are few features in the room, one of which is a boarded-over trapdoor against the north wall which was formerly fitted with a hinged door; two hinge pins remain *in situ* on the north side of the opening (Plate 39). This trapdoor is not an original feature but has been cut though, saw marks in line with the north and south edges continue into the floorboards on either end where the board-saw has slightly bitten into them. Further west along the north wall the rusted iron pipe flue from what might have been a stove (although no hearth slab remains) has been fitted through the wall. This is a secondary feature. The red brick fillet seen in other rooms continues around the walls at floor level.

Plate 39: Trapdoor against north wall of Room 4 with hinges on north side
