Archaeological building recording of Dinton Castle Aylesbury, Buckinghamshire

March – October 2009

Report 09/174

ARCHAEOLOGICAL BUILDING RECORDING OF DINTON CASTLE AYLESBURY, BUCKINGHAMSHIRE

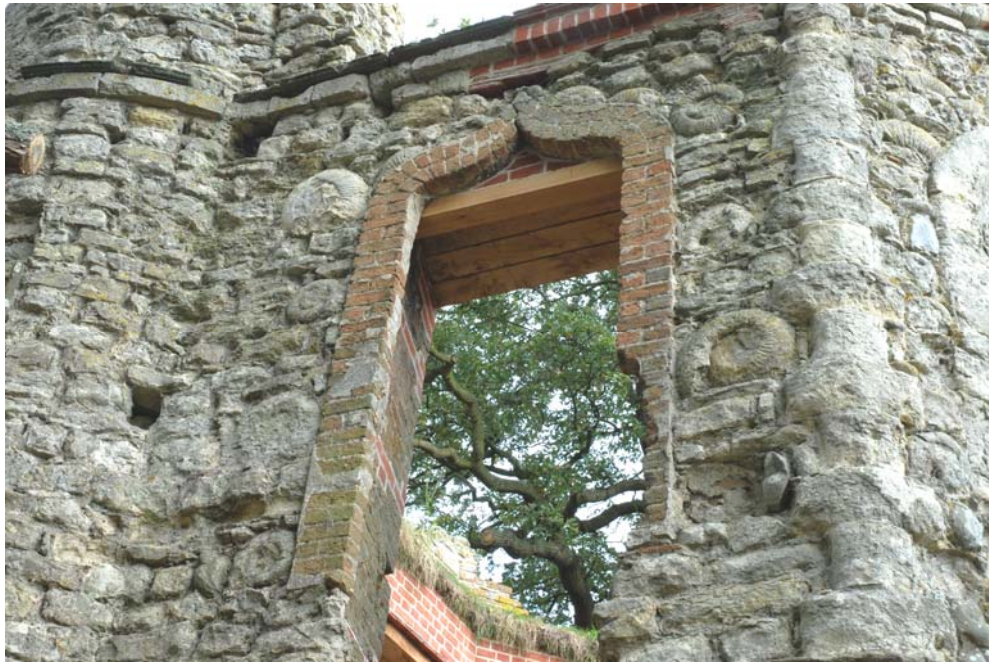
Ammonites in external wall Fig 8

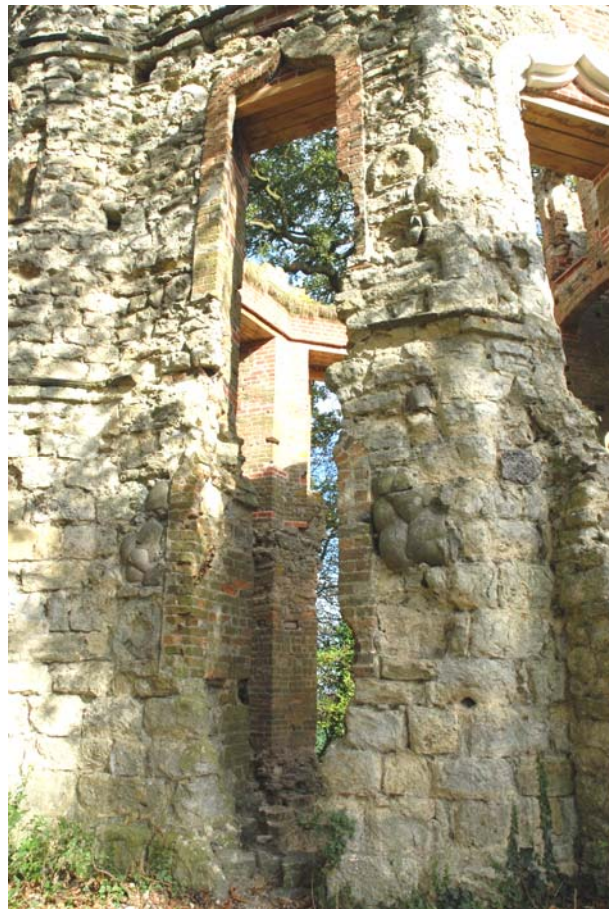
Brick detailing around window on south-west wall Fig 9

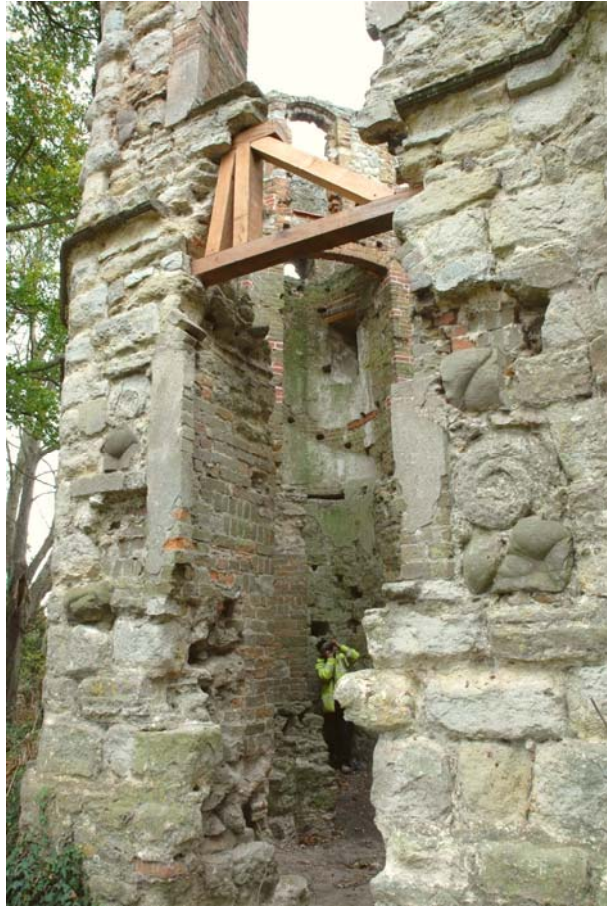
Stucco covering of brick detailing on windows in northern Bay Fig 10

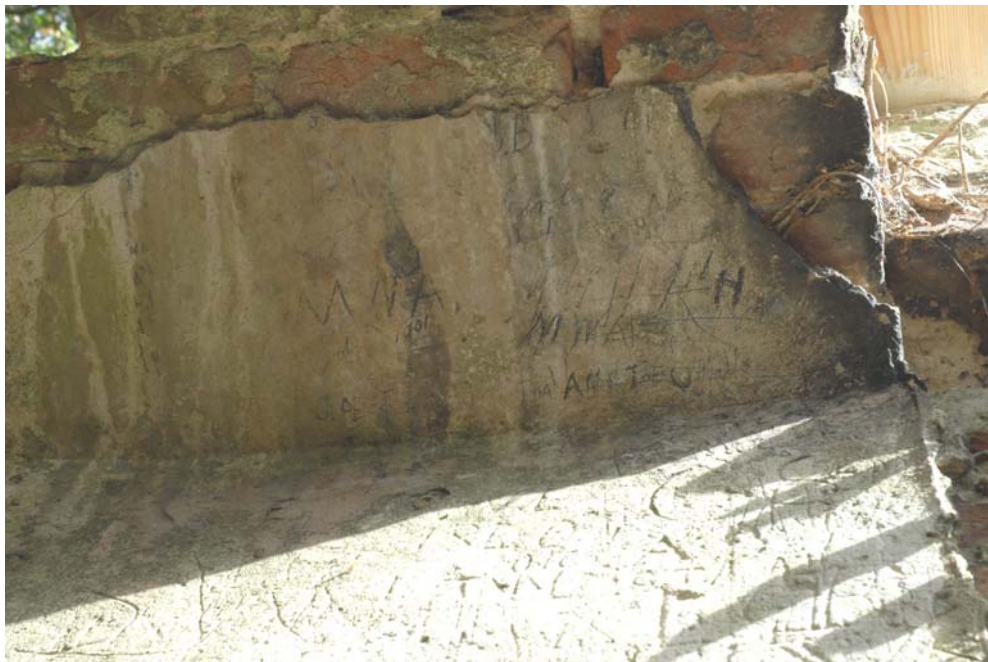
Dinton Castle was constructed of both limestone and red brick laid in a creamy white lime mortar. The half-basement was constructed of limestone. The external walls were constructed of roughly coursed limestone rubble and dressed quoins. The limestone utilised was of the Portland Stone Member with occasional sandstone blocks (www.bgs.ac.uk). The structure includes many large locally-found ammonites incorporated in its external walls, they are now in poor condition due to exposure to the elements and several are missing (Fig 8). Brick was utilised on much of the internal walls and as external detailing around the windows and doors (Fig 9). Externally the brick detailing was covered in stucco, which had largely fallen off (Fig 10). Internally some small patches of light greyish-white lime plaster survived on the lower and upper floors (Fig 11).

Surviving plaster with graffiti on window in southern Bay Fig 11

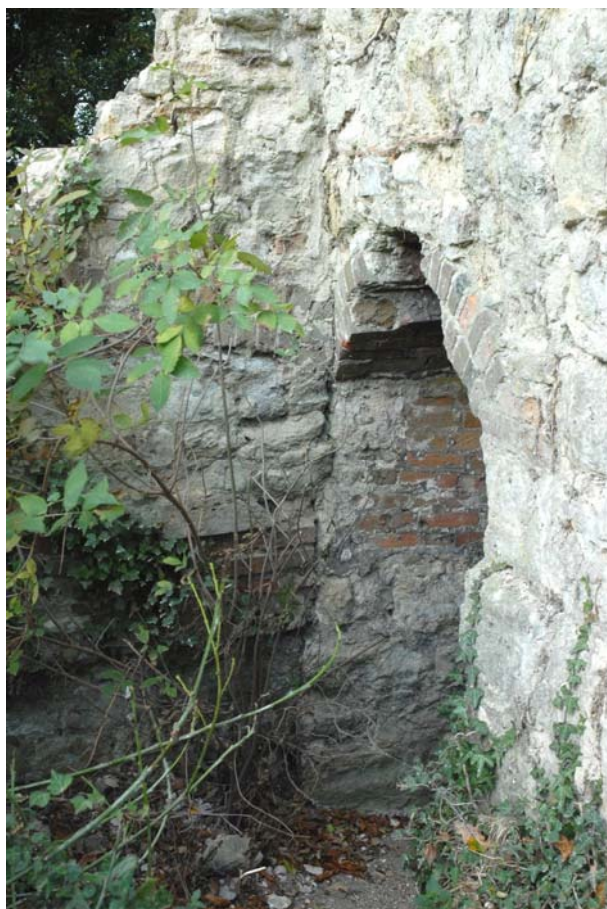
This floor is accessed via the doorway on the south side through a now fragmentary porch which appears to have had an entrance in the east side of that structure, which survives today as an L-shaped projection (Figs 4 and 12). The west wall of the porch is butted onto the south face of the hexagon, suggesting that it may be a later feature. There is no corresponding wall on the east side which indicates the presence of a doorway. The entrance into the octagon is beneath a segmental brick arch and it is assumed that there was an internal short flight of stairs to rise from the external ground level up to the level of the lower floor above the half-basement (Fig 20). No clear evidence remains, though occasional empty sockets in the interior wall face indicate the location of principal beams.

Door and porch on the southern Bay Fig 12

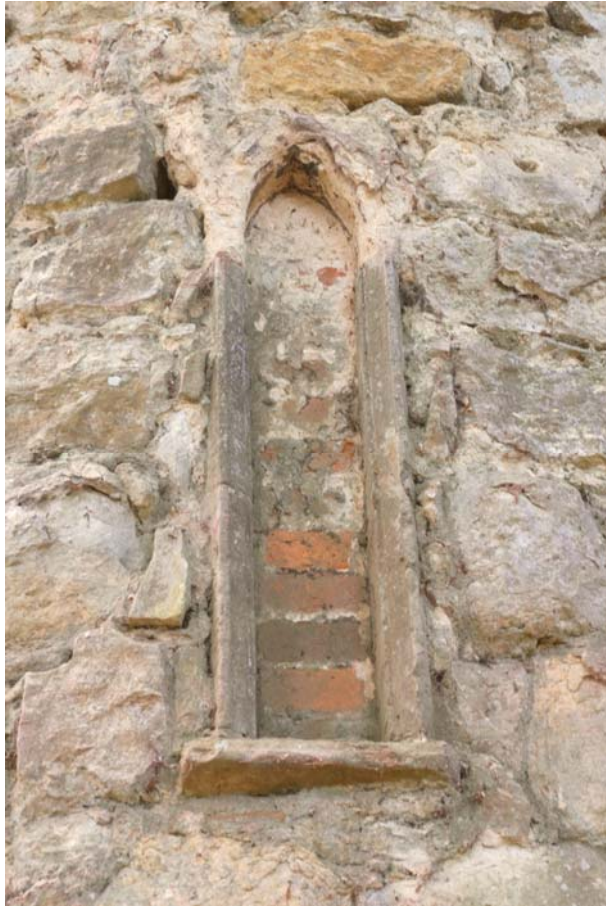
One of the blind windows in the turrets Fig 14

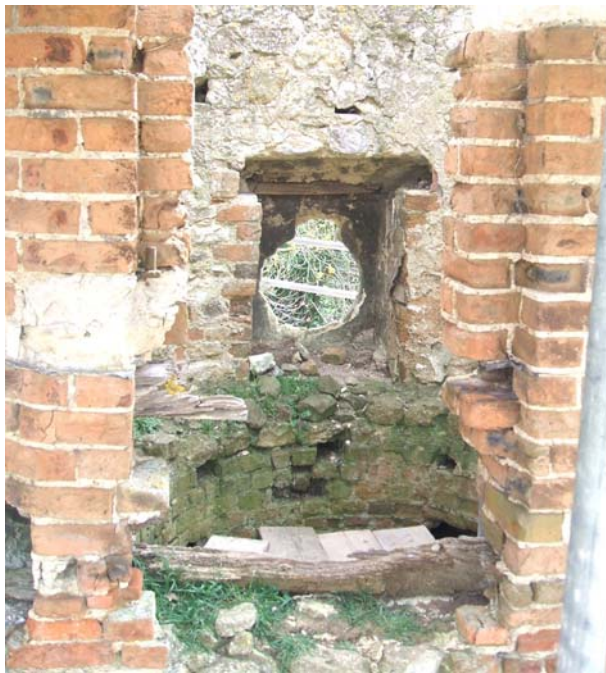
these windows is of stone not stuccoed brick. All are blind in the fireplace turret, the blocking comprising brick covered with stucco, in the staircase turret the ground floor windows are also blind. The two second floor windows were apparently functional but their method of glazing is uncertain. At the top of each turret there is also a bull's eye window. The one within the flue turret is blind, that in the staircase turret appears to have been open. Each is bordered with stone and not stuccoed brick (Figs 15 and 16).

Functional bull's eye window at top of the stair turret Fig 15

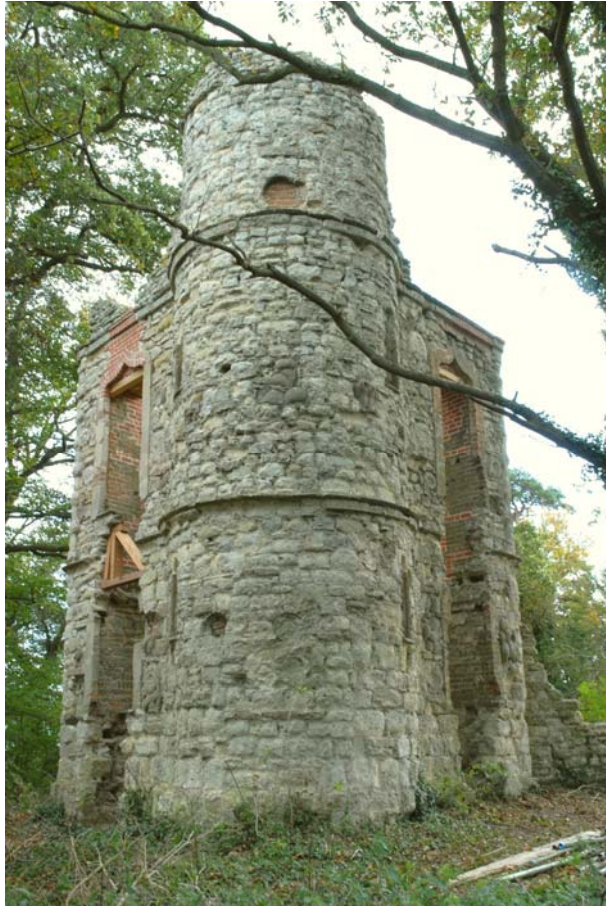
Blind bull's eye window at top of western fireplace turret Fig 16

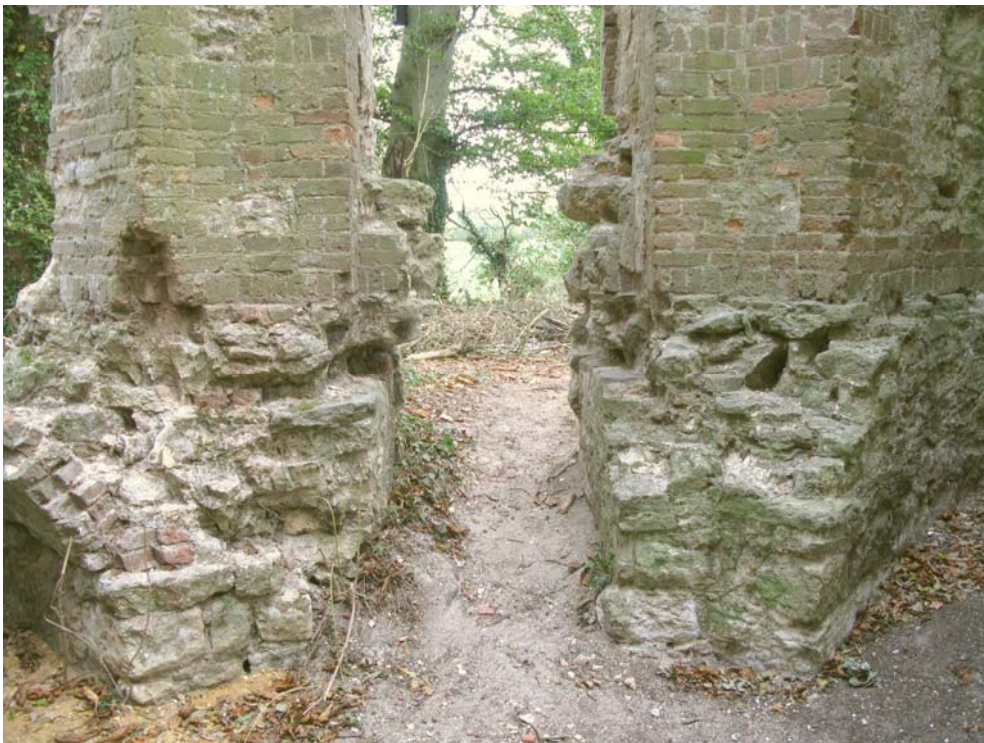
It is not quite clear how the half-basement was accessed; a break in the north-east cant of the north bay appears to be a constructed rather than broken through opening which may have been a doorway (Figs 5 and 17). There is no indication at present of steps. In the central north facet of the octagon there is a round arched recess, the arch constructed of brick (Fig 18). There is a brick-built fireplace at the base of the west turret, the segmental arch of which is now missing, though the springers are still present on either side (Fig 19). It is not known at what level the half-basement floor was situated, but it is believed to be much deeper than the 200mm suggested previously from inspection of the test-pits dug by the owner, since at that level there would not be enough head room to make this a usable space. The half-basement appears to be filled with rubble from the collapse of the upper sections of the building.

Opening to the half-basement in the northern Bay Fig 17

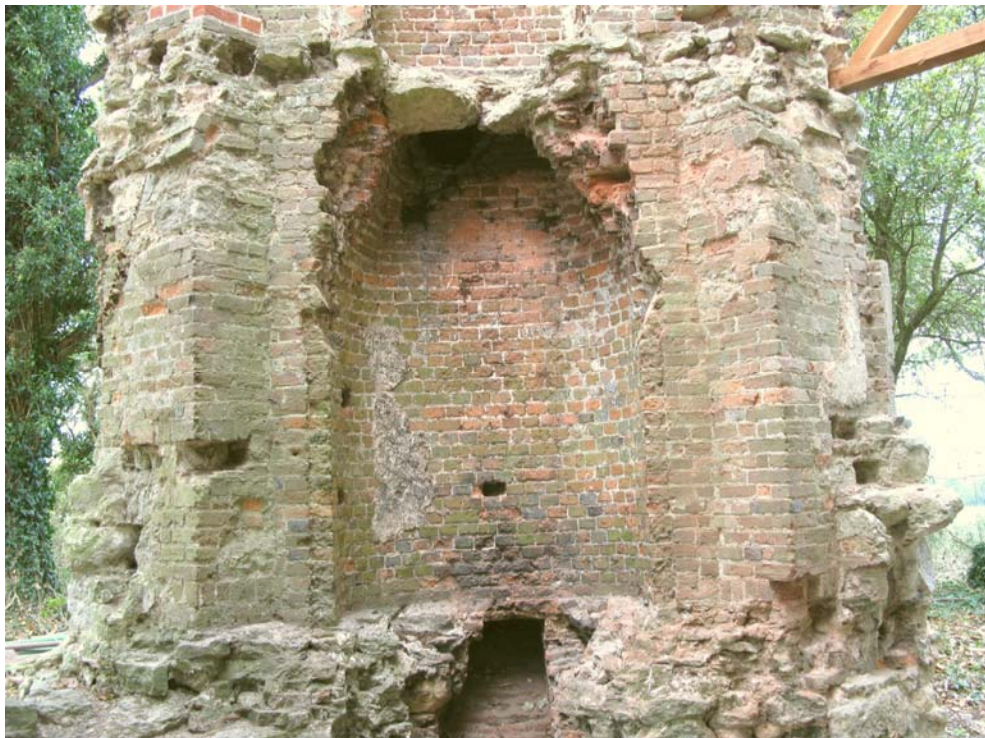
Internally the walls are constructed entirely of red brick and traces of wall plaster remains indicating the finish of the internal surfaces. There are unusually also traces of plaster within the fireplace recess, on either side of which a chopped-back rebate indicates the location of the fire surround. The arch of this fireplace has either collapsed or has been broken out (Fig 21).

Lower floor fireplace Fig 21

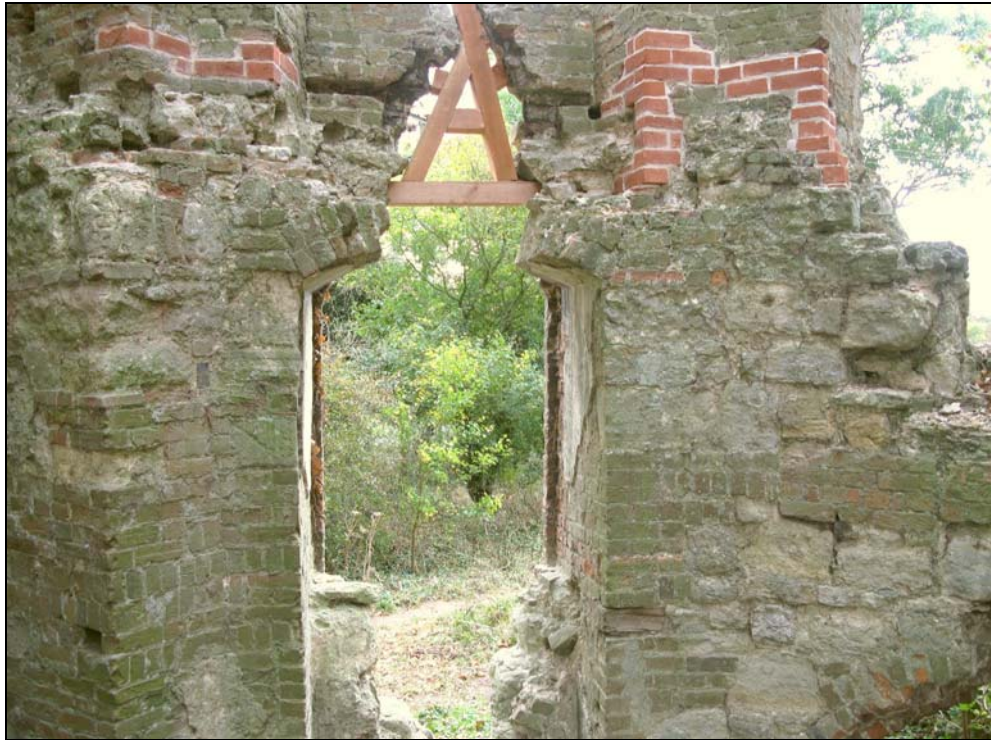
The window reveals are all splayed from floor to ceiling rather than just above sill level; this could be for a number of reasons. It could be simply that they allowed the visitor to approach the window, would have allowed the option of a window seat, or more likely could have housed cabinets for the fossil and mineral collection since there is such limited wall space around the outside of the room. It would also have afforded good lighting to view any collection. Empty square sockets on either side of the window jamb at sill level indicate the presence of timber sills (Fig 23). No indications remain of the type of window fixtures or arrangements which must have been made of wood. The internal soffits of the windows were finished with a flat timber lintel (most now missing) and do not follow the ogee shape visible externally. The window adjacent to the staircase turret on the south side of the octagon still retains a small section of lime plaster on both the jamb and soffit (Figs 22).

Lower floor window with plaster in southern Bay Fig 22

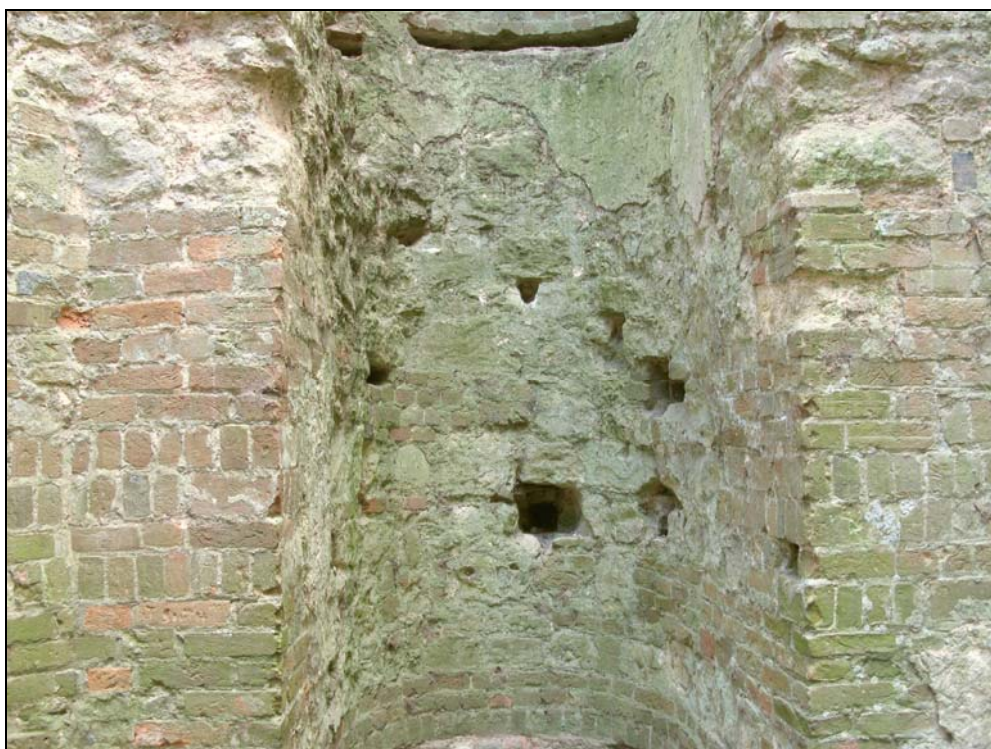
From this level, the upper floor was accessed via a spiral staircase in the east turret (Fig 24). A series of empty sockets show the line of timbers which supported the timber stairs, and a scar within the surviving plaster shows the angle of the rise of the string.

Internal view of stair turret Fig 24

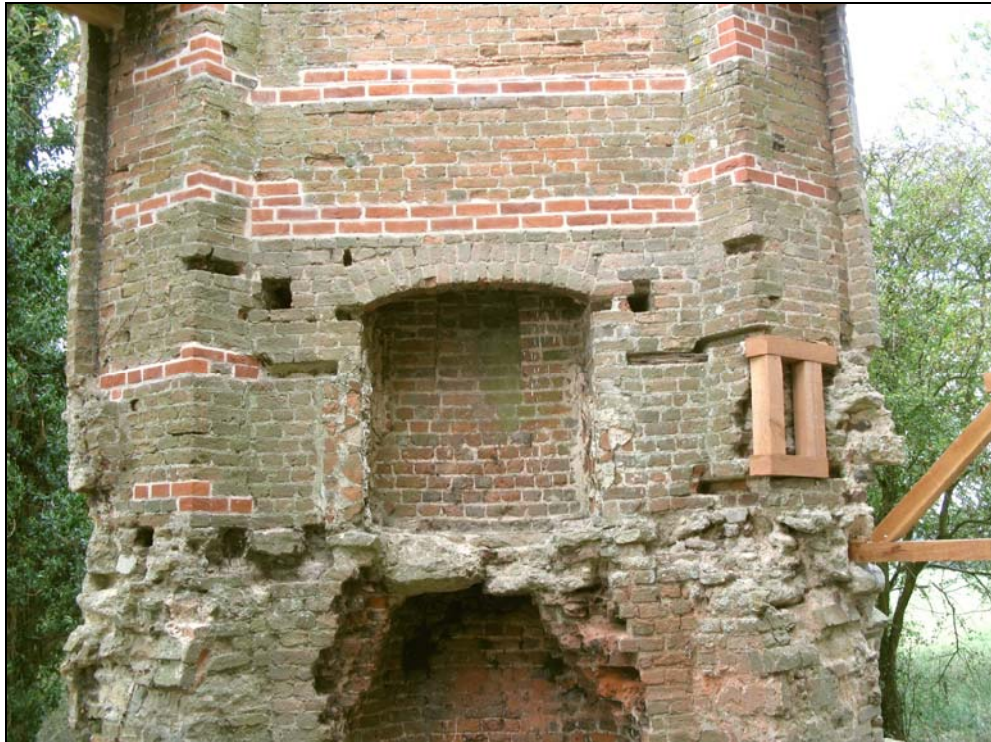
The west turret contains the only fireplace to retain its segmental arch, which is constructed of brick, and is smaller and narrower than that on the lower floor (Fig 28). The purpose of two empty square sockets on either side of the opening are unclear, though chopped-back rebates on either jamb indicate the presence of a decorative surround with mantel shelf (Figs 27 and 28).

Upper floor fireplace Fig 28

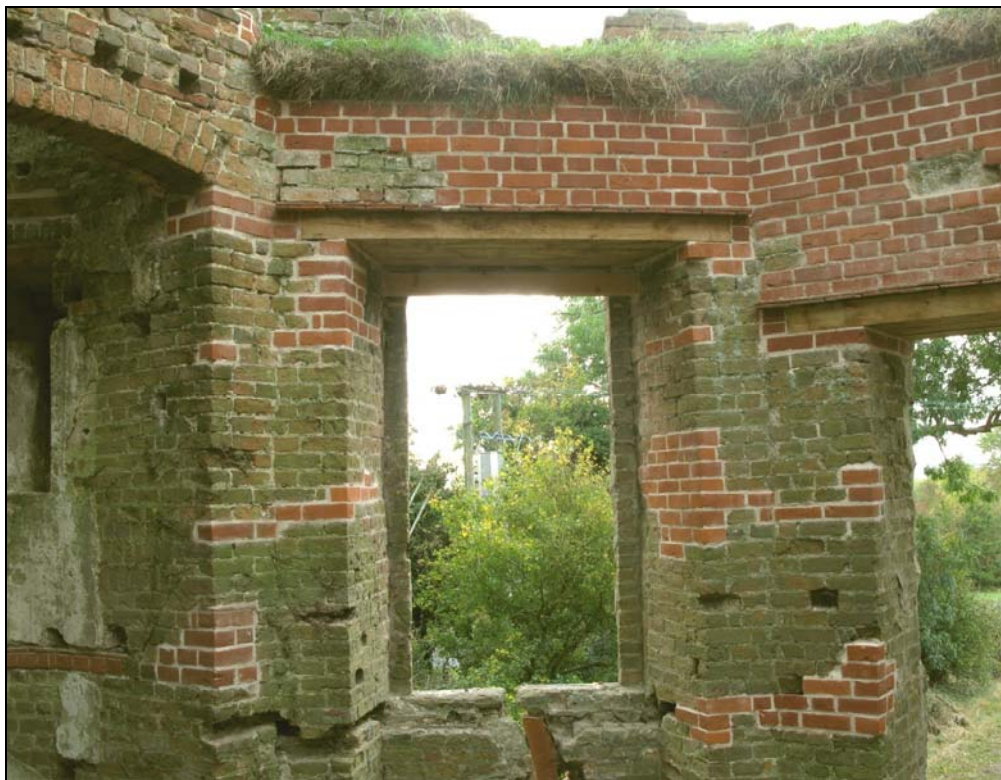
Surviving timber set into the brickwork, or empty sockets around the internal wall plane in a horizontal band, suggest the presence of either a timber dado panel, or perhaps even full-height panelling since other horizontal bands survive above (Fig 5). Smaller, square sockets in the splays of the window reveals suggest that these too could have been either panelled or more likely fitted with internal shutters. Many of these horizontal sockets have been in-filled during the recent stabilisation works with new brick. The fact that there are no traces of plaster on the internal wall surfaces at this level further support the theory that it was panelled (Fig 29).

Upper floor window in southern Bay after consolidation work Fig 29

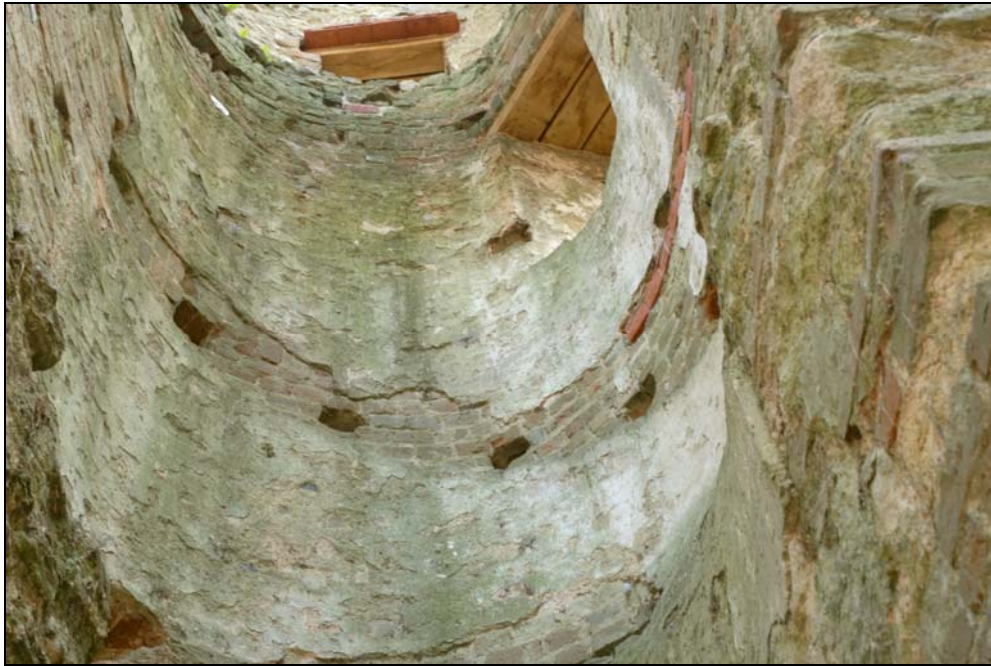
The eastern tower housed the stairwell with the beam slots supporting the spiral staircase visible in the walls (Fig 30). Graffiti found at the top of the stairwell indicates that it was still possible to gain access to this level until the mid 20th century (Fig 31). This section was plastered as it would have been difficult to panel the internal curved surface.

View of stair turret into the upper floor Fig 30

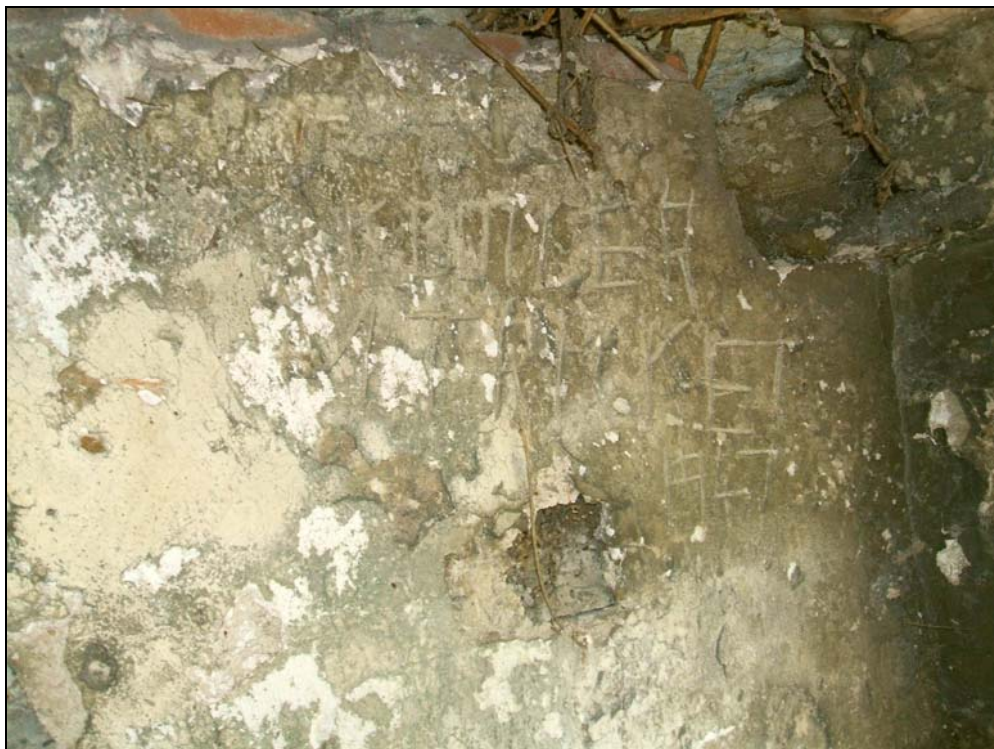
Graffiti on top of stair turret Fig 31

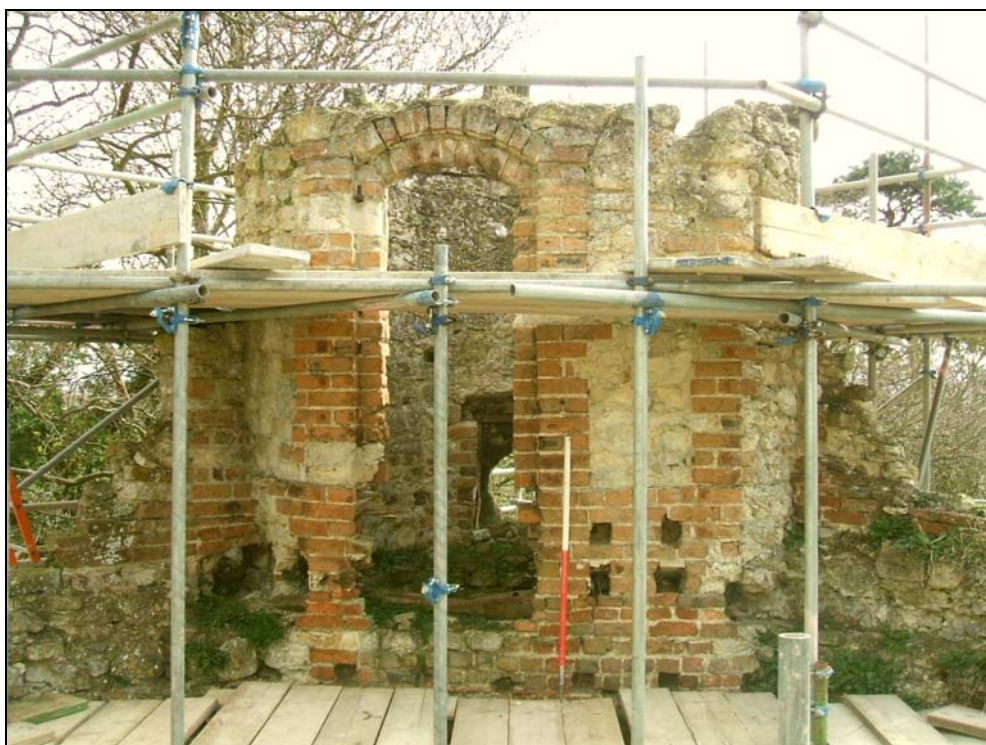
Door leading onto the roof Fig 32

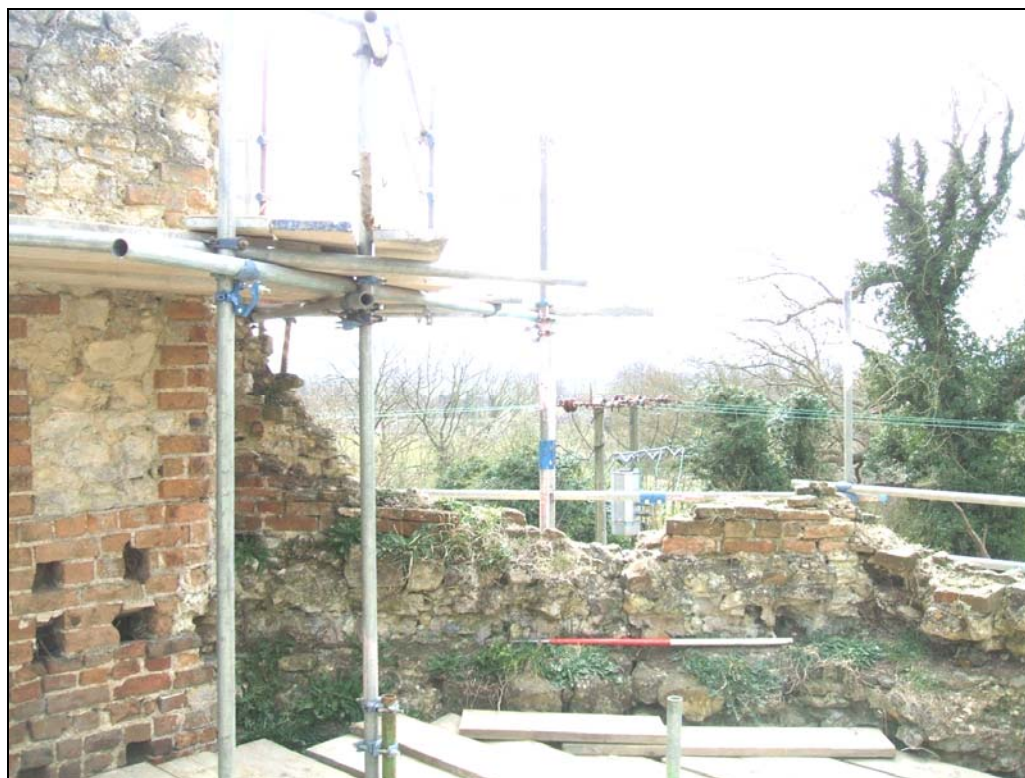
Remaining parapet of the southern Bay Fig 33
