Project Designs and Client Reports No. CP/451/07

REPORT ON AN ARCHAEOLOGICAL BUILDING RECORDING PROJECT AT THE HAGG ALLENDALE NORTHUMBERLAND

NY 8306 5360 Planning Application Ref: 20060898

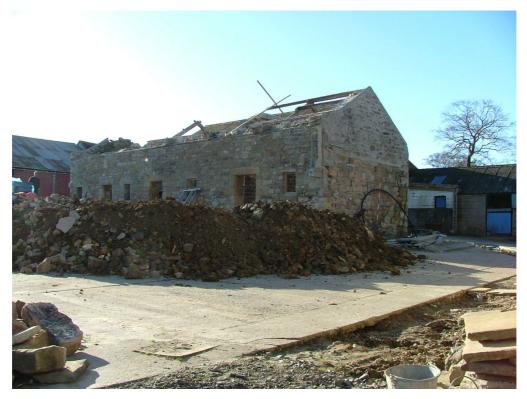
Plate 2 – East and north elevations of the former byre

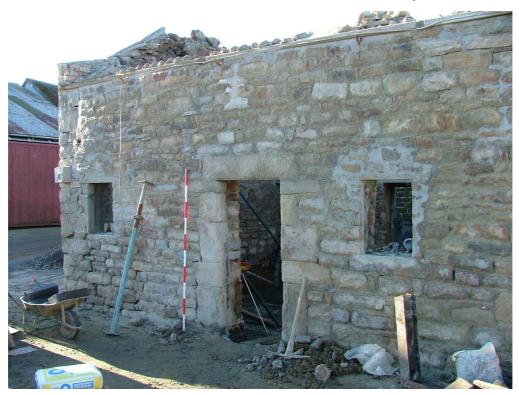
- 5.1.2 The building measures approximately 16.50 metres long and 5.85 metres wide externally and is constructed of roughly coursed, what appears to be, yellow sandstone. In the eastern elevation there are three doorways each measuring approximately one metre in width, and four small windows (Plate 2 and Figure 7). The jambs of these doorways generally consist of alternating long and short blocks of squared masonry, and the lintels are of rectangular blocks of dressed masonry (Plate 3).

Plate 3 – The southern doorway and two windows on the east elevation

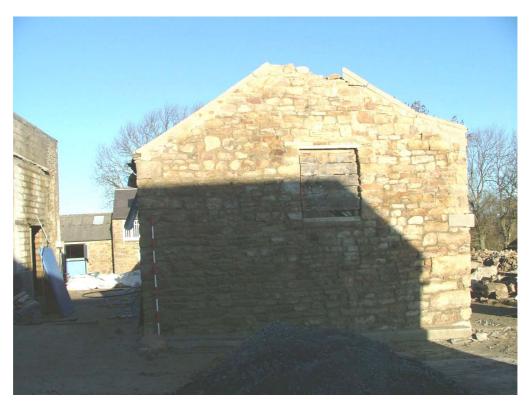
- 5.1.3 The southern gable end has a pitching hole at first floor level (Plate 4), used to transfer hay to and from a cart a ground level to the loft above the animal stalls. The hay would have provided insulation for the animals during the winter months. In his assessment, Ryder notes that there were indistinct traces of a possible blocked opening below the pitching hole⁵, this was not obvious at the time of this survey either externally of internally.

Plate 4 – South elevation

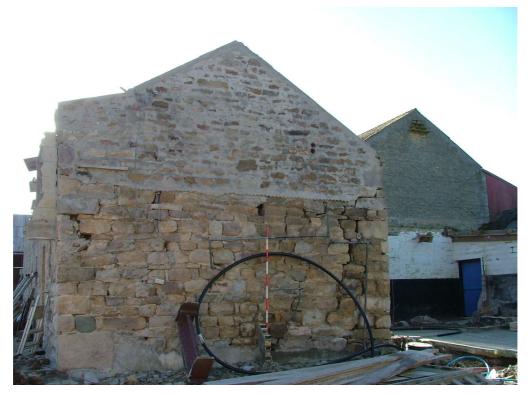
- 5.1.4 The northern gable end shows the scarring from a former lean-to with corrugated sheet roof (Plate 5). It was also apparent that the eastern side of the gable had been slightly heightened, and was no longer symmetrical with the western side; this appears to have been related to the roof of a later block-work byre or milking parlour which was situated against the eastern elevation. The pitch of the roof of the later building obviously rose to a level slightly higher than that of the eaves of the byre; therefore an increase in height at this side was required to allow rainwater to run off. At the west side of this elevation, a crack in the masonry may be an indication of an earlier structure being incorporated into the fabric of the byre, as the masonry appears to be larger, although the bottom half of this elevation has not been recently mortared compared to the other walls. Another possible indication of an earlier building is the thickness of the north and part of the west elevation, compared to the rest of the structure, i.e. approximately 0.80 metres wide and 0.60 metres wide respectively (Figure 7).

Plate 5 – North elevation

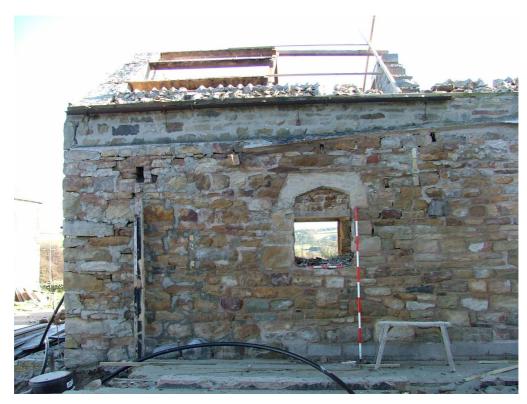
- 5.1.5 The western elevation, until recently also hidden behind later structures, also displays evidence of an earlier building. At the north end is a window with a four-centred arch head (Plate 6). This is certainly not characteristic of an agricultural building and its presence may suggest that it has either been reused from an earlier building, or that the byre incorporates part of a structure built for human habitation. It has been suggested by Ryder that this feature is possibly part of a bastle-period doorway, as ground floor windows in defensible buildings, common in this locality, were not as large as this⁶. There was no evidence on the exterior that this was formerly a doorway, however in the recent past this side of the building has been underpinned (as shown by the concrete blocks at the base of the wall on Plate 6), therefore some of the original masonry may have been replaced. Also at the north end of this elevation were two block-up ventilation slits, both at different heights, and the large boulders of the foundations were also observed.

Plate 6 – North end of west elevation (Large scale = 2 metres, small scale = 0.50 metres)

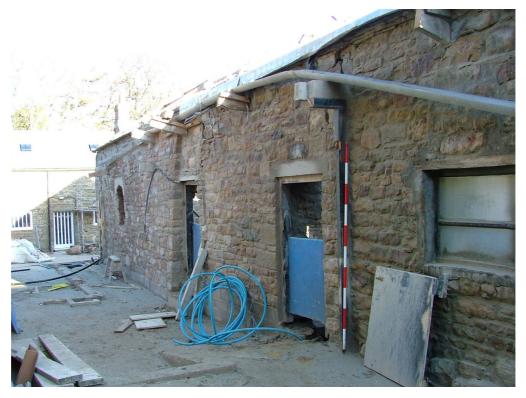
- 5.1.6 Mid-way along the west elevation there was possibly further evidence for an earlier structure, although recent remedial works to the fabric of the building may account for some of these features. Beside one of the two doorways in this elevation, the wall project out from the south end of the elevation, and is not completely vertical (Plate 7).

Plate 7 – West elevation

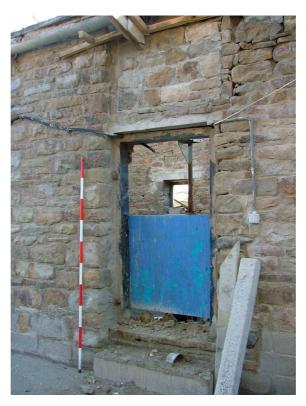
- 5.1.7 Above one of the two doorways on this elevation is what may have been a former pitching hole (Plates 8 and 9). The lintels of these two doorways have been replaced with concrete versions. At the south end of this elevation is a window (Plate 7).

Plate 8 – Doorway, west elevation

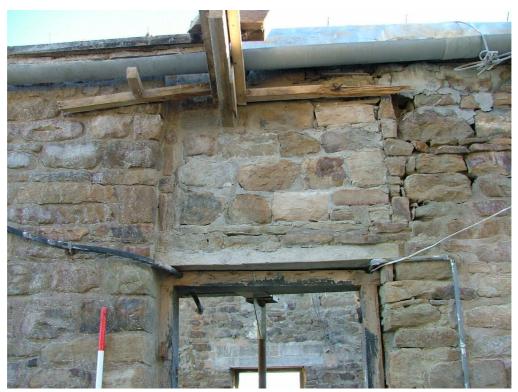
Plate 9 – Possible former pitching hole? West elevation

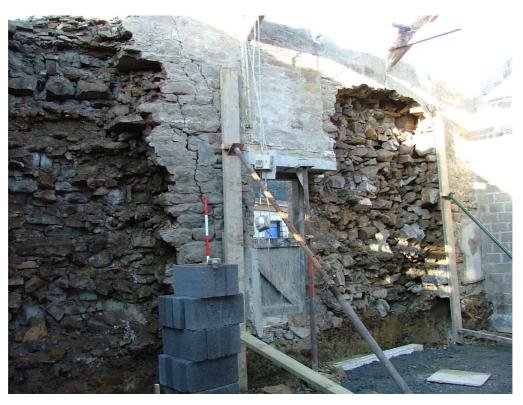
- 5.2.1 The floor of the interior of the byre had been removed by approximately 0.50 metres at the time of survey revealing the clay sub-soil. Parts of the west wall had collapsed due to previous remedial works not including through stones, which would have tied the wall together (Plate 10). A cross-wall, which divided the southern end of the byre from the rest of the building, had been removed by the time of survey (Plate 11 and Figure 7). A block work wall, which forms part of the conversion of the building into a dwelling, had been inserted at the north end of the structure. Figure 7 shows the location of former cattle stalls.

Plate 10 – Sections of the collapsed west wall

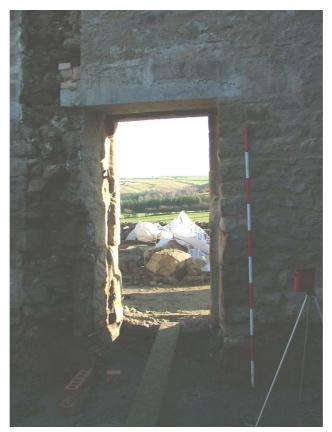
Plate 11 – View looking east showing scarring of former cross-wall (left of photograph)

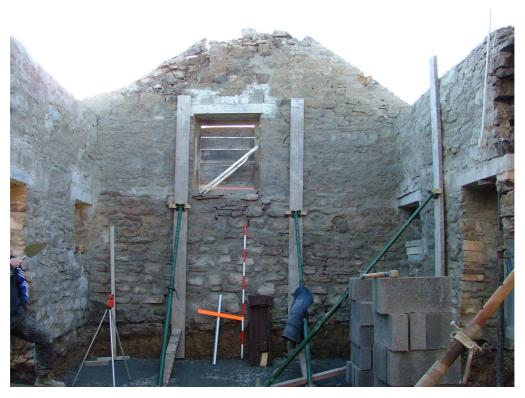
- 5.2.2 Although there has clearly been a first floor loft at one time, due to the presence of the pitching hole in the south elevation, there was no evidence for the joist holes which supported the floor at the time of survey; this appears to be due to the recent insertion of mortar (the loft may have originally only extended over the southern end of the byre) (Plate 12).

Plate 12 – South elevation, interior

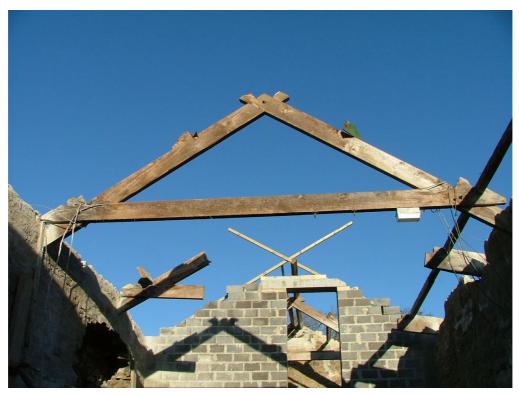
- 5.2.3 Some of the collar roof trusses remained (Plate 13) which, according to Ryder, supported modern asbestos corrugated sheeting⁷.
- 5.2.4 Internally, the unusual window noted on the western elevation (Plate 6) was observed to be wider than it was externally. It was also possible to note that there were straight construction breaks below the window which hints at this originally having been a doorway despite the lack of vertical joints on the exterior wall (Plate 14). When Peter Ryder visited the site this window was blocked-up, it has since been revealed and in the sides there are holes which are reminiscent of drawbar holes used to house wooden or metal bars for security (Plate 15). The concrete lintel replaces a timber version.

Plate 13 – View looking north of remaining roof trusses

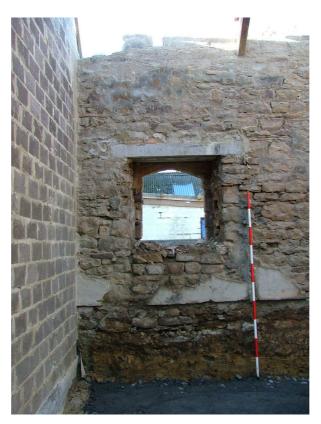
Plate 14 – West elevation, interior of window

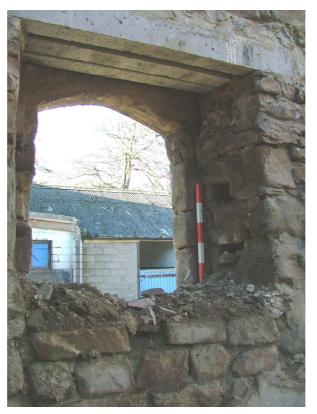
Plate 15 – Interior of window, west elevation, showing possible holes for metal or wooden bars? (Scale = 0.50 metres)

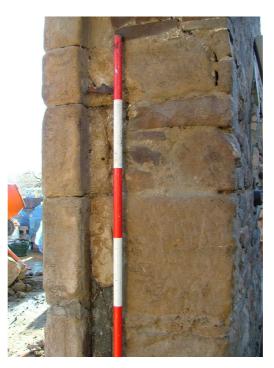
- 5.2.5 The jambs of all the doorways on the eastern elevation are rebated internally, indicating that all these doors opened inwards (Plate 16).

Plate 16 – Detail of doorjamb, east elevation
