# NORTH PENNINES ARCHAEOLOGY LTD

**Client Report No. 248/05**

**REPORT ON AN  
ARCHAEOLOGICAL  
EVALUATION AT  
THE SALMON COOPS,  
CORBY CASTLE,  
CARLISLE,  
CUMBRIA**

**For  
BINGHAM YATES AND  
PARTNERS**

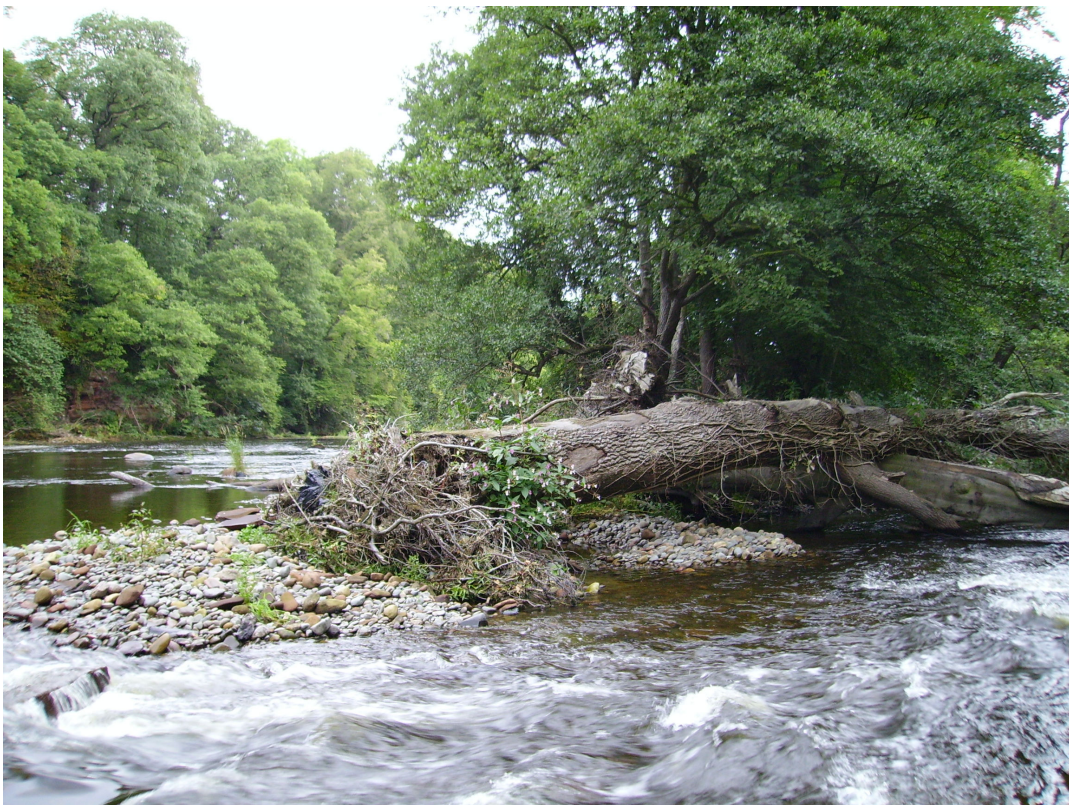
- 5.2.1 *Plate 6:* on the request of the Corby Castle Estate, the extreme south western tip of the southern eyot was inspected to see if the storm damage of January 2005 had exposed any man-made structure. A visual inspection observed a large accumulation of storm gravel and an uprooted tree, but no deliberately revetted edges could be ascertained due to the dense vegetation. At the south eastern extent of the eyot an area of shallowly submerged sandstone bedrock was observed. It appears that the eyot if a man-made construction at this point was built directly onto a natural sandstone island. A similar phenomenon was also observed was at the northern tip of the northern eyot (see discussion of Plate 17).

PLATE 6: SOUTHERN TIP OF THE SOUTHERN EYOT, LOOKING WEST

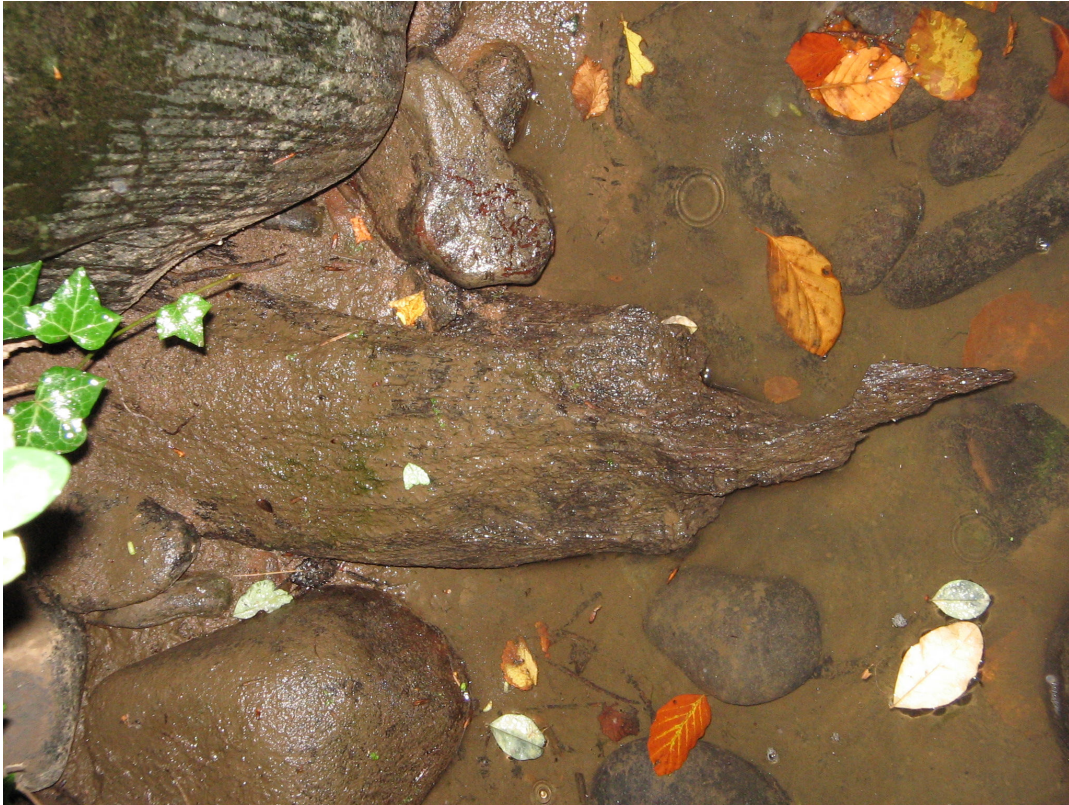
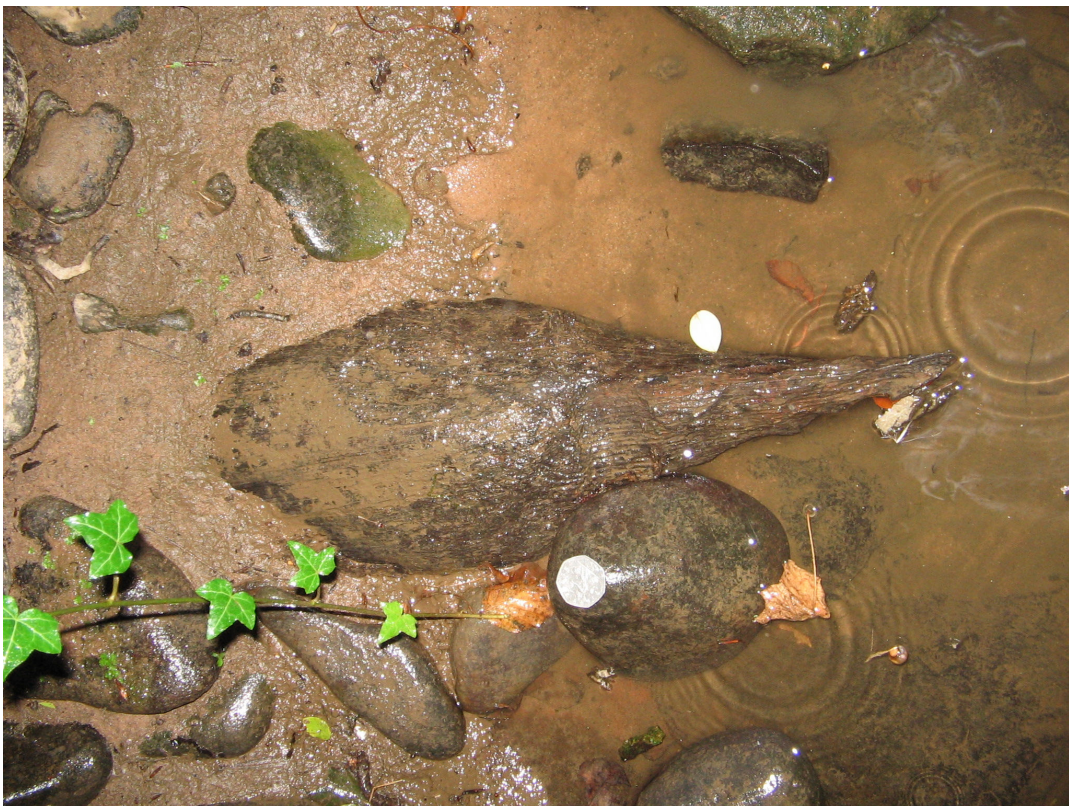
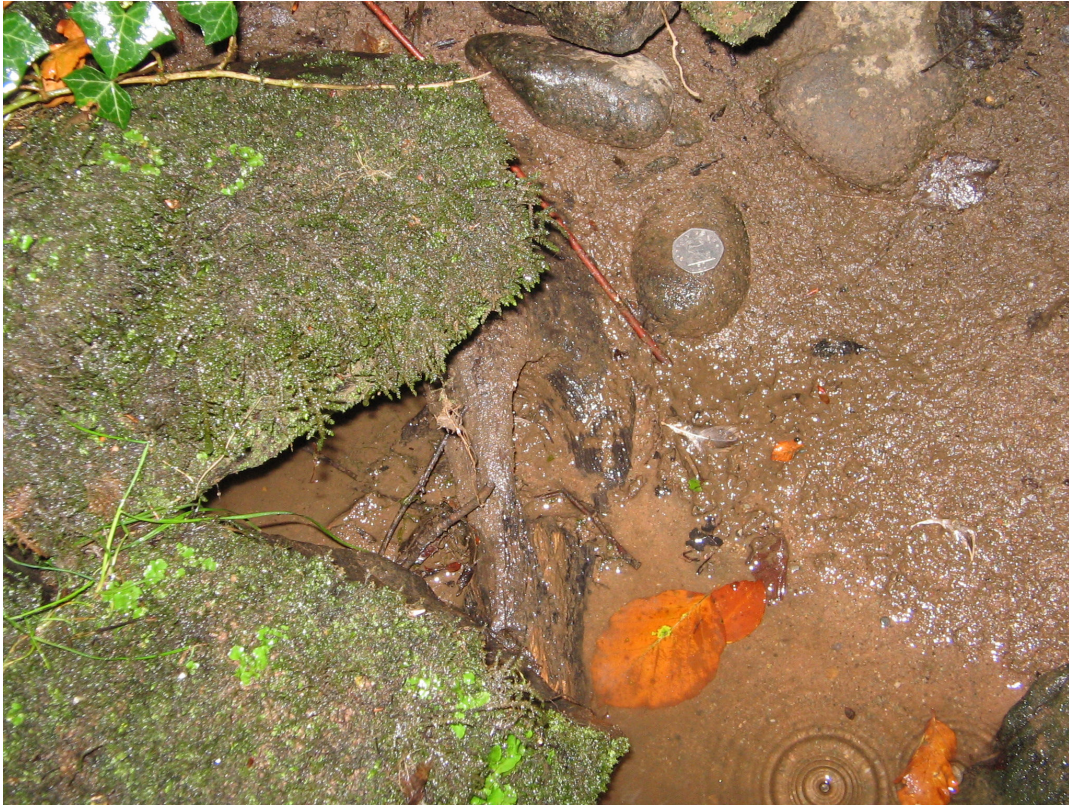
- 5.2.3 At the base of the sandstone rubble, 17 apparently *in situ* horizontally laid timbers were observed; a further timber, 1.3m in length, was observed on the bed of the eastern river channel, possibly eroded from the southern eyot (Fig 4). The cross section of the timbers were generally sub-circular and they had a diameter of up to 0.3m. On a number of examples bark could be observed, suggesting that whole trees had been used. Many of the timbers were hafted into a point, and as this had no obvious function it is possible that the timbers had been re-used from elsewhere. As shown in Plate 9, a number of the timbers had apparent joints cut into them, sometimes at the hafted end, which again suggests re-use. It is not clear whether the observed joints on some of the timbers relate to the eyot construction.

- 5.2.4 The discovery of the east-west laid timbers suggests that the southern eyot was constructed on a timber 'platform' of sorts. As the timbers are right at the base of the eyot it seems likely that the whole of the eyot is a man made construction. The timbers may be some of the earliest elements to be observed during this fieldwork, and may even be earlier than timbers observed in the causeway area (see Area 2 in evaluation results section).

- 5.2.5 The condition of the timbers appeared stable, but this may be because they had only recently been exposed from beneath storm gravel, and were therefore still waterlogged. On the advice of Sue Stallibrass (English Heritage Science Advisor, North West region) a sample will be taken from one of these already exposed timbers to see if a dendrochronological (tree ring) date can be obtained. This would not damage the structure of the southern eyot further. Unfortunately, due to the high water level in the winter period, this has been impossible, and will have to be carried out in the summer of 2006. The results will then be added to this report.

PLATE 7: TIMBER AT EASTERN EXTENT OF SOUTHERN EYOT

PLATE 8: TIMBER AT EASTERN EXTENT OF SOUTHERN EYOT (COIN FOR SCALE)

PLATE 9: TIMBER AT EASTERN EXTENT OF SOUTHERN EYOT (COIN FOR SCALE)

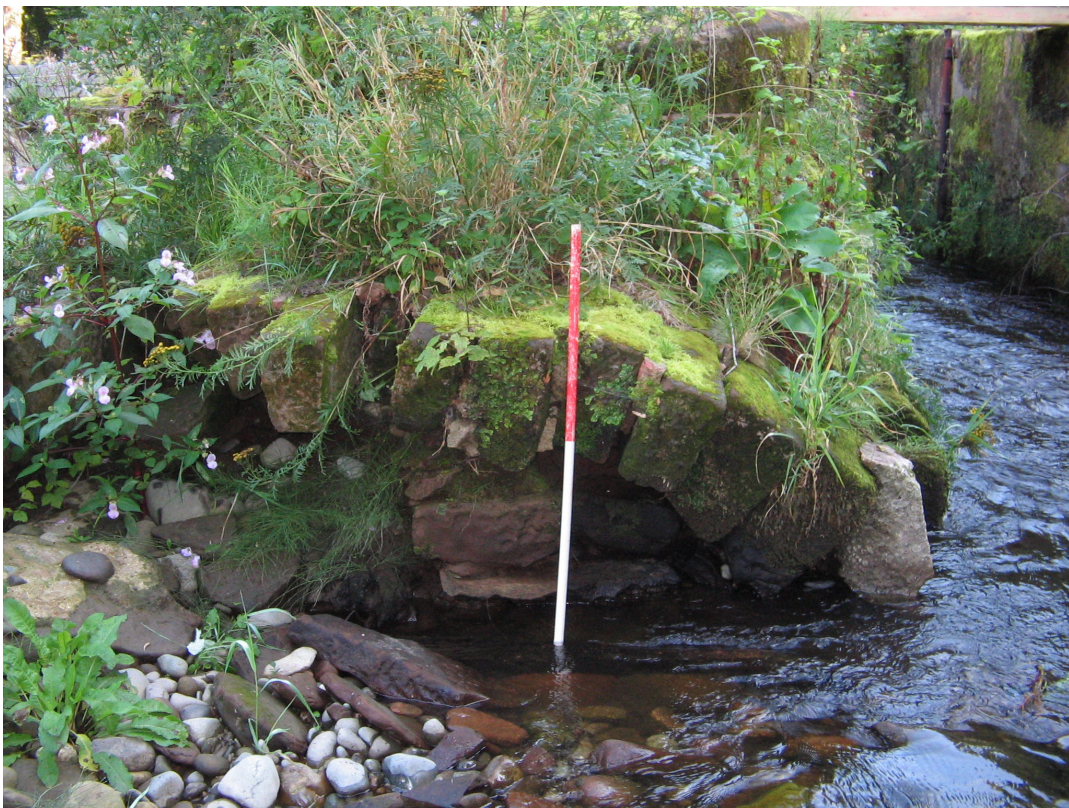
- 5.2.6 *Plate 10:* Moving north of the southern eyot, into the causeway (Area 2) and Salmon Coops area the condition of some of the stonework was examined. Immediately north of the causeway an intriguing feature was noted. This took the form of a stone arch, which may represent a late addition to the causeway/coop area. The construction of stone arches, perhaps as a revetment of sorts, was also noted on the northern eyot (see Plate 16 and Area 5 test pit, evaluation results below). Some of the stone used in the construction of this possibly late strengthening arch may have been re-used from elsewhere. Indeed, some of the sandstone blocks are not dissimilar to the early 19th century stonework on the façade of Corby Castle. Heavy tool marks were observed on some of the sandstone blocks.

- 5.2.7 The condition of the stone arch north of the causeway is of some concern as it appears to have been made unstable by recent storm and flood activity.

PLATE 10: ARCHED STONWORK AT NORTHERN EXTENT OF CAUSEWAY (AREA 2)

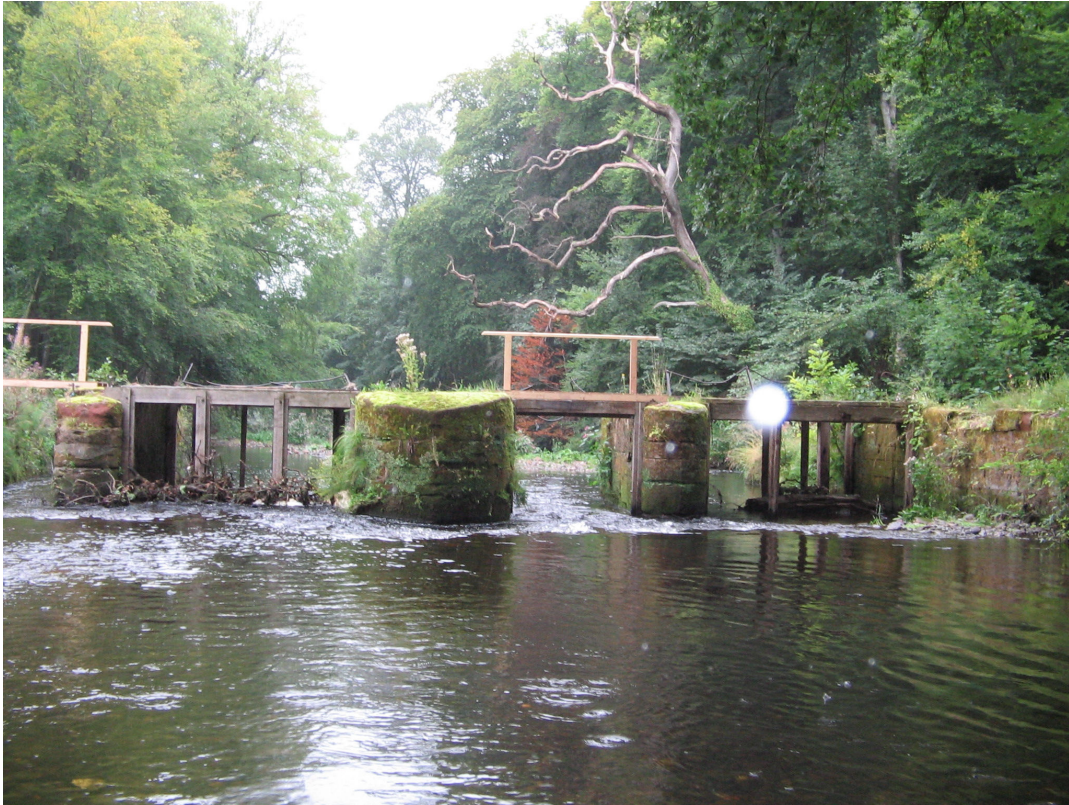
- 5.2.8 *Plates 11 and 12* show the present condition of the causeway, weir and salmon coops themselves. The stone piers of the salmon coops (Plate 11) and the revetted area to their east can easily be matched to some of the early depictions such as the 1832 engraving (Plate 1) or the 1843 tithe map (Fig 6).

- 5.2.9 Due to the 2005 flooding, the timber superstructure of the coops is currently in some need of repair. Traditionally the timber superstructure has consisted of two pairs of parallel wooden gates between each gap created by the sandstone pillars. A floor of stone slabs in between each of the gaps is angled to provide a strong rush of water over it. The fish are caught by opening the lower gates slightly, and closing the upper pair (RCHME 1994, 5).

PLATE 11: THE SALMON COOPS, LOOKING NORTH

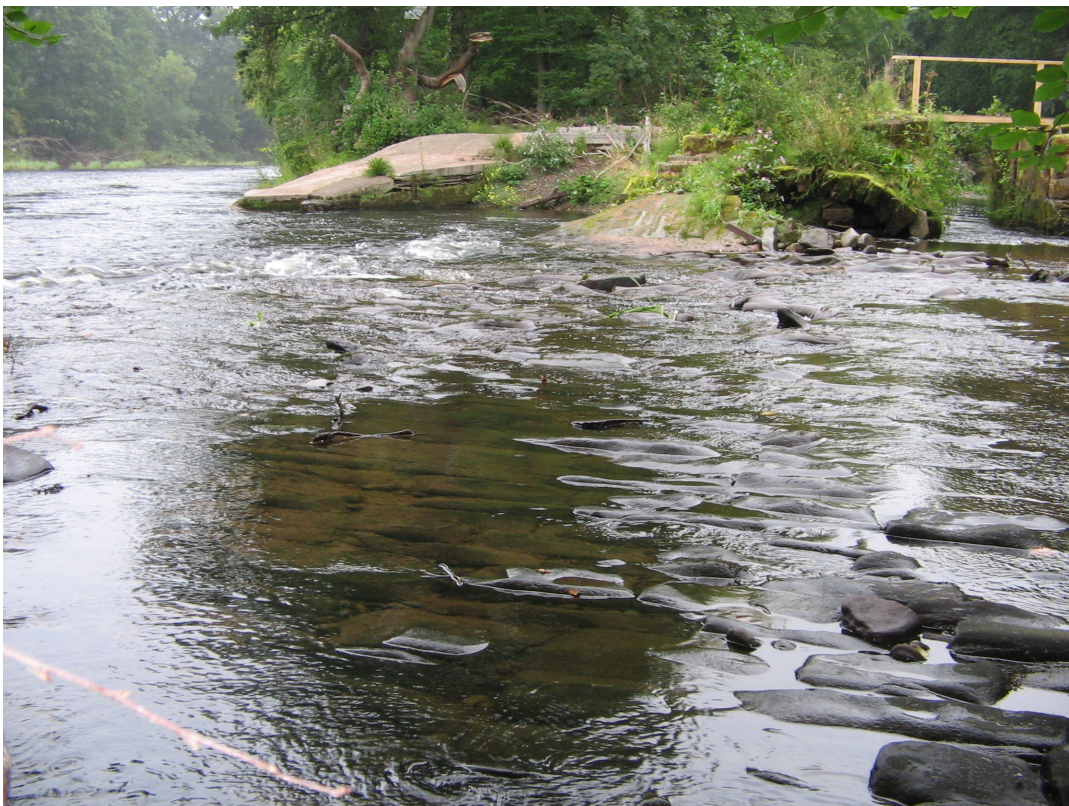
PLATE 12: WEIR AND CAUSEWAY (AREA 2), LOOKING NORTH

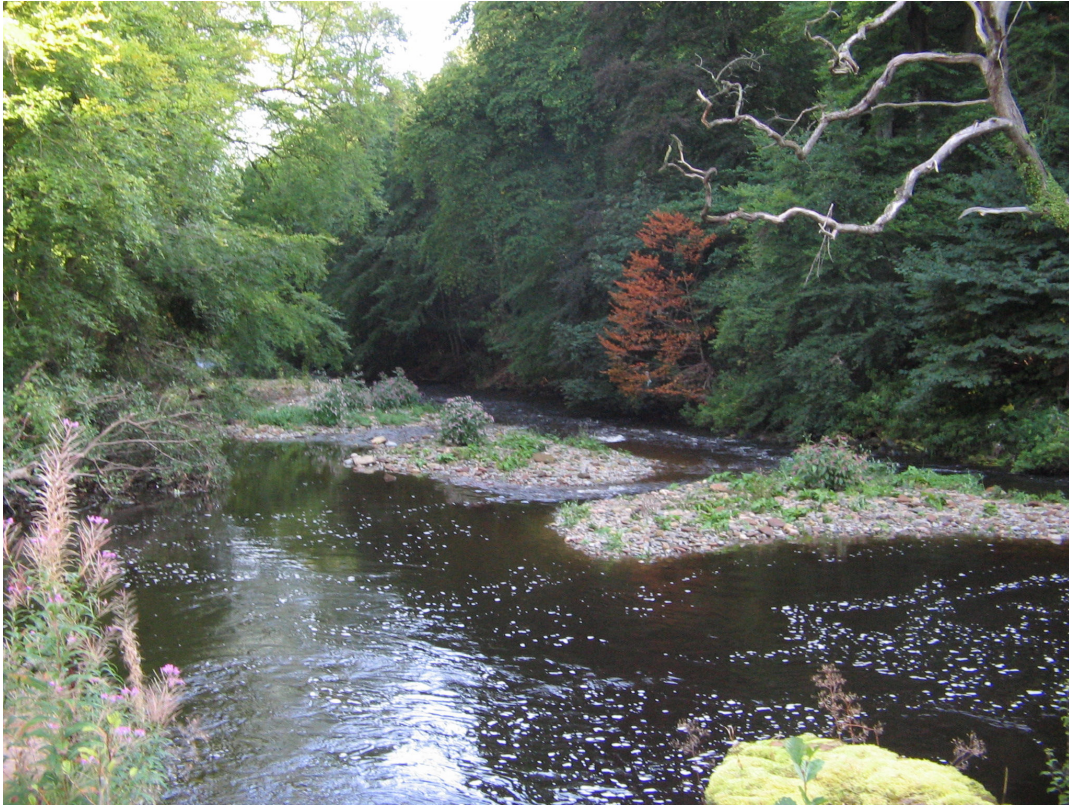
- 5.2.11 *Plate 13:* Moving north, to the southern part of the northern eyot, the storm gravel accumulations from January 2005 were observed. Due to the flood and storm activity much of the eastern side of the northern eyot was exposed and a number of areas had, along its entire length, apparently suffered from recent damage. Figure 4 notes at least two areas of storm breach where the eyot had been entirely overrun by flood water, and

- at least six places where stretches of revetment (timber and stonework) had been exposed.
- 5.2.12 *Plate 14*: on the top of the southern half of the northern eyot a number of areas of laid sandstone surface were observed. Figure 4 shows the extent of the pitched stone as observed by the Bingham and Yates survey and the North Pennines Archaeology survey. As Plate 14 shows, the construction of these laid stones is perhaps not as fine as the pitched stones observed in Areas 2 and 4 (see evaluation results below), although it is less clear whether this represents a chronological or a functional distinction. The sandstone surface is certainly well worn, and is not dissimilar to some of the coops stonework itself. It seems likely that this sandstone surface to the northern eyot extends at least as far as Area 4 (see Fig 4), as a small portion of surface was observed north of the test pit in that area. The presence of the sandstone surface demonstrates that much of the northern eyot was certainly man-enhanced.

PLATE 13: GRAVEL DEPOSITS EAST OF N EYOT, LOOKING NORTH

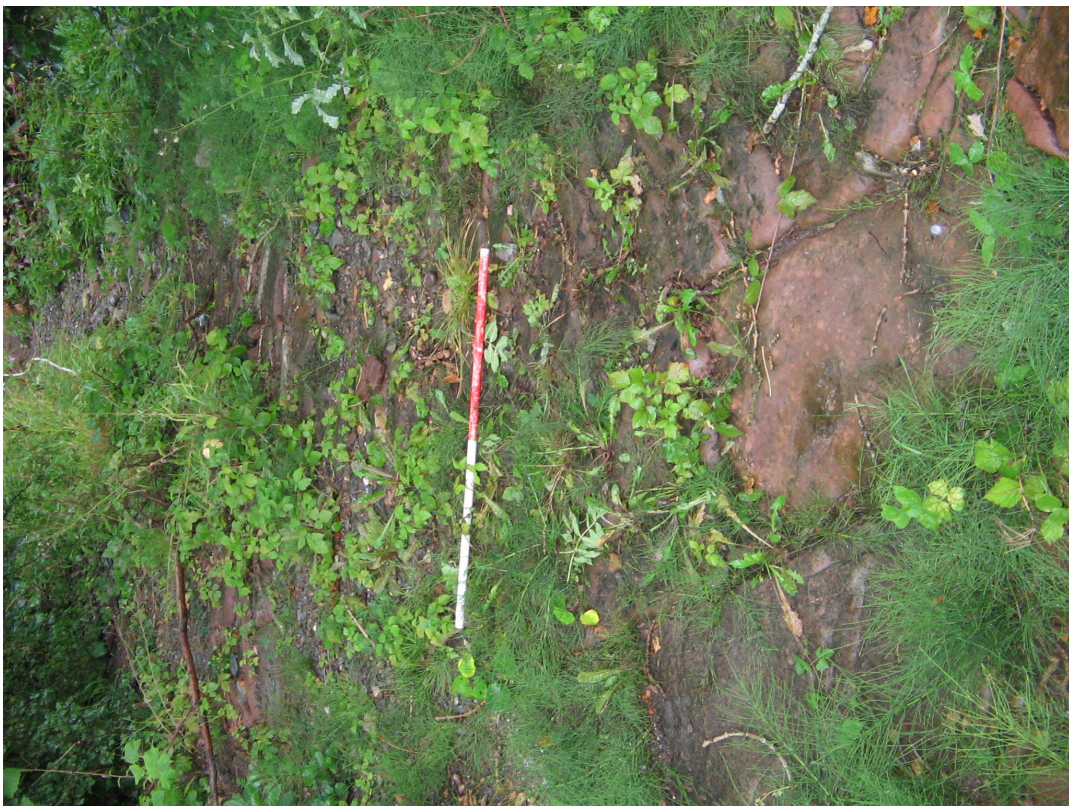
PLATE 14: EXPOSED SANDSTONE SURFACE N. EYOT, LOOKING N (PORTRAIT)

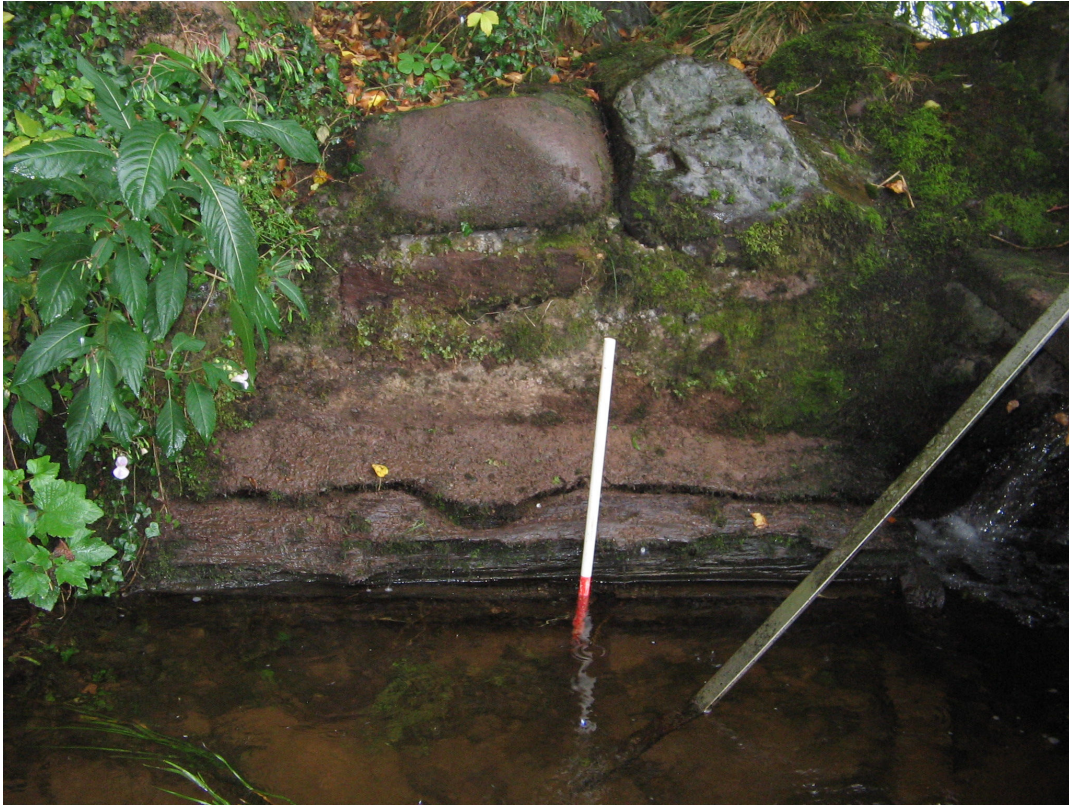
- 5.2.15 In the central area of the northern eyot, two canalised breaches of the eyot were observed (Fig 4). As Plate 15 shows, these breaches incorporate stonework and timber revetting, but are also concreted and reinforced with steel bars. It may be that some of the stone and timber observed here has been re-used from elsewhere on the eyot. The reason for the construction of these canalised breaches is unclear, but Corby Castle Estates suggested that they may have been constructed in the earlier part of the 20th century to regulate water level around this part of the northern eyot (Jim Clarke, *pers comm.*). It may be that the breaches were canalised as the easiest way to carry out repairs after they had been inadvertently created by earlier storm damage.

PLATE 15: CANALISED BREACH OF NORTHERN EYOT, LOOKING SOUTH

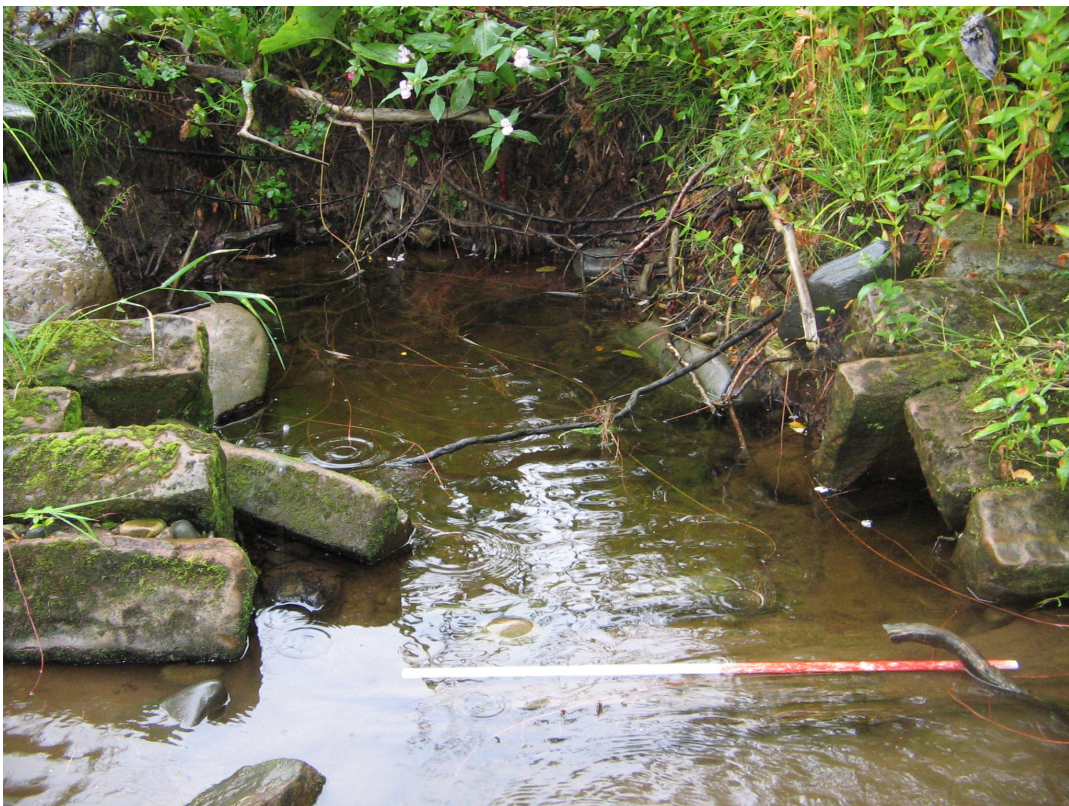
- 5.2.16 Areas of exposed timber-and-stone revetment, and arched stonework (Plate 16) were all observed in the central part of the northern eyot, suggesting that much of the visible eyot is entirely man made. Some of the structure had been severely damaged by storm and flood erosion.

PLATE 16: DAMAGE TO STONWORK OF NORTHERN EYOT, LOOKING WEST

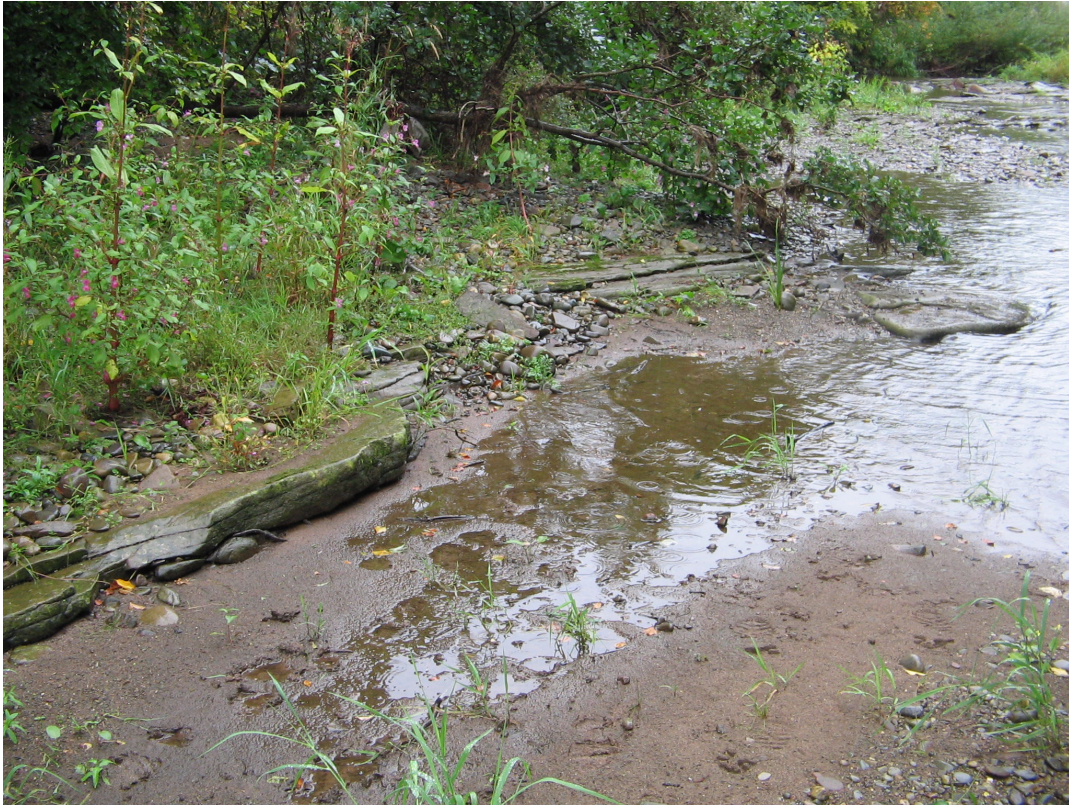
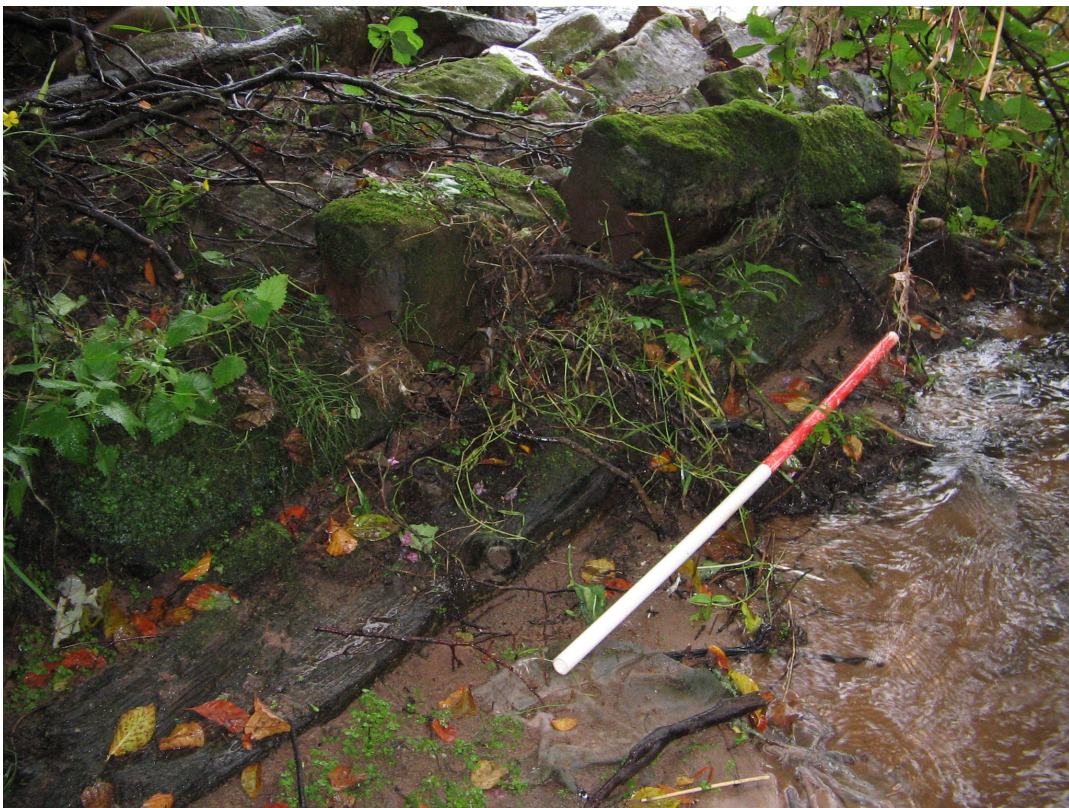
- 5.2.17 *Plates 17 and 18*: towards the northern tip of the northern eyot, exposed sandstone bedrock was observed. As Plate 18 shows, some of the timber and stone revetment of the northern eyot seems to have been built directly onto this sandstone bedrock island. If this is the case, it suggests that the built-up eyot is completely man made. A similar sequence was observed during the excavation of the test pit in Area 5 (see evaluation results below).

PLATE 17: EXPOSED SANDSTONE BEDROCK, N.EXT OF N. EYOT, LOOKING W

PLATE 18: EXPOSED REVETMENT, TIMBER AND BEDROCK, N. EXT OF N. EYOT

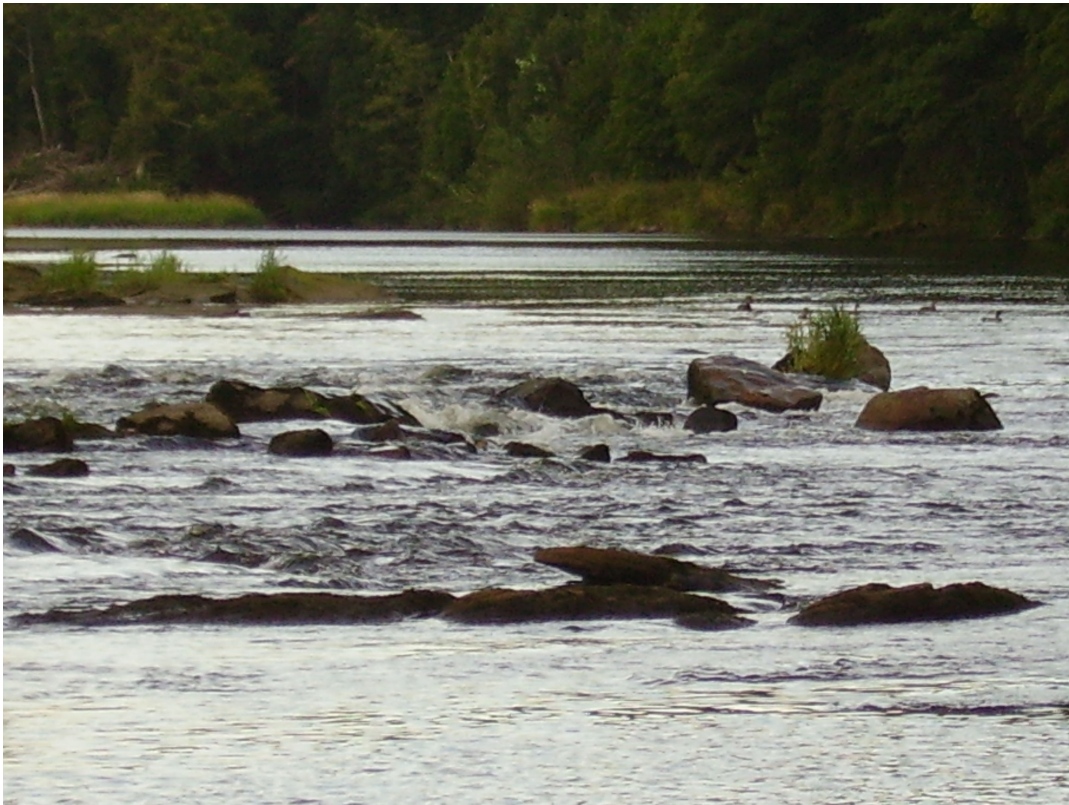
PLATE 19: ERODING REMNANTS OF N. TIP OF N. EYOT, LOOKING N

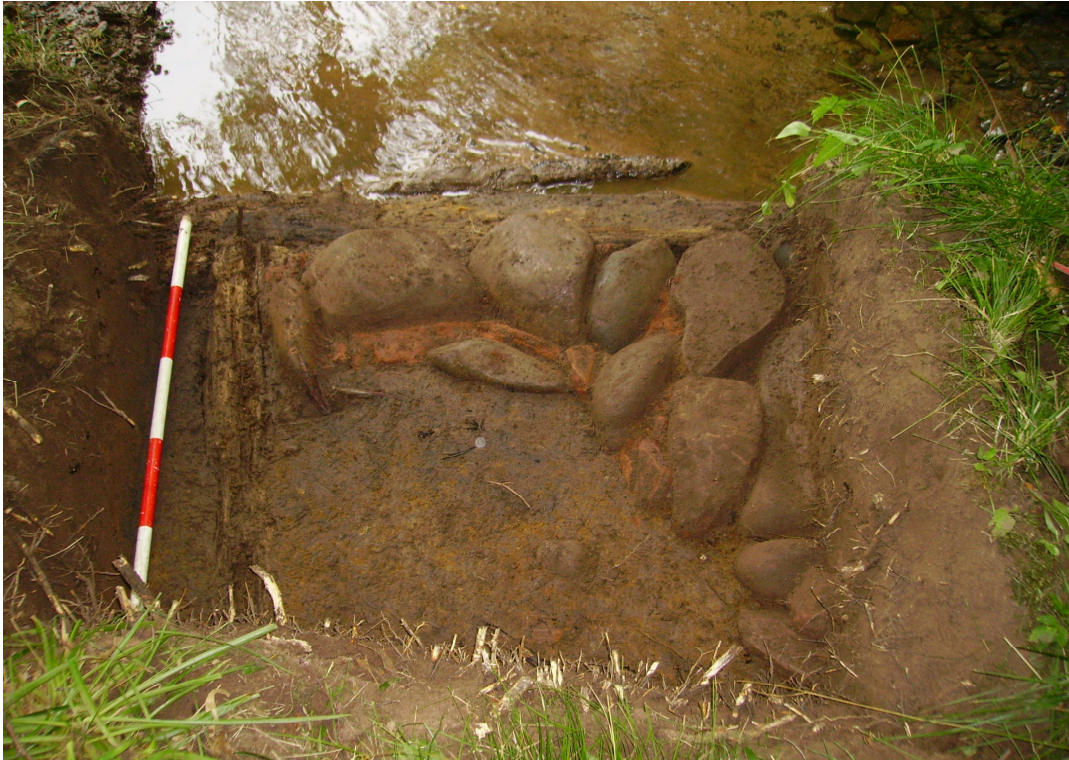
- 6.1.21 The condition of the revetment timbers [103]/[104] is perhaps of the most concern in monument management terms. It appears that repeated periods of waterlogging and then drying have caused severe degrading to the structure of the timbers, to the extent where parts of timber [104] have completely decayed away.

PLATE 21: AREA 1 TEST PIT POST EXCAVATION, LOOKING NORTH EAST

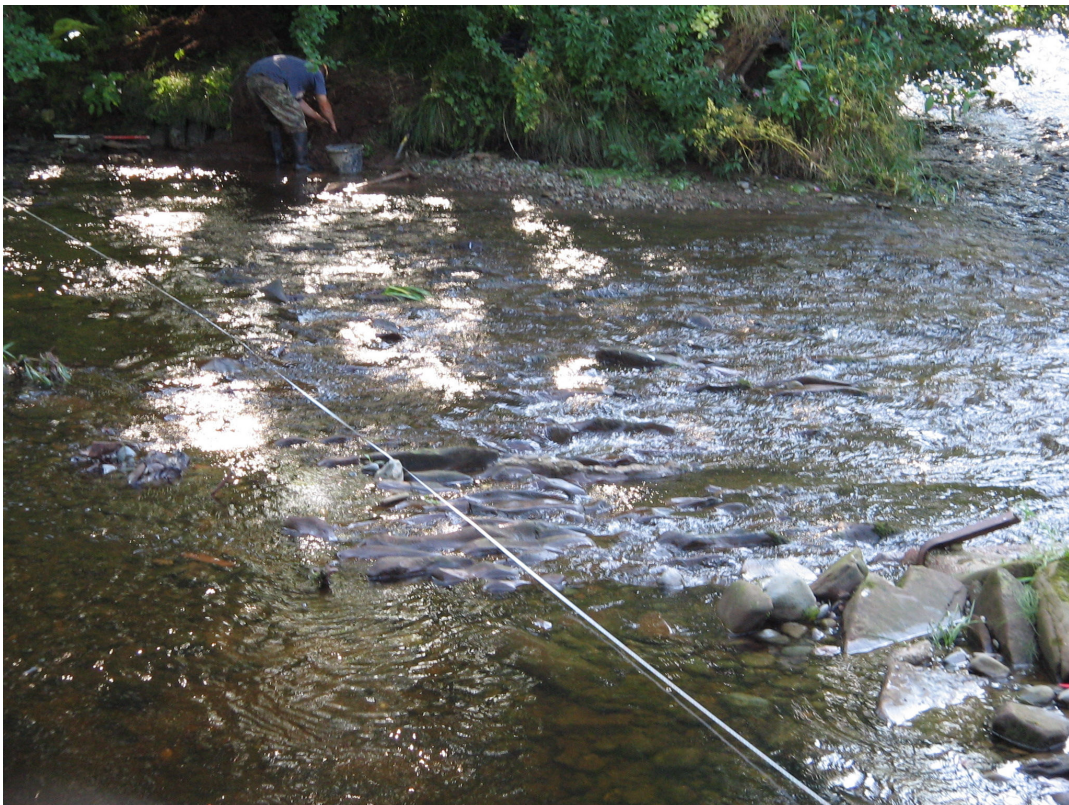
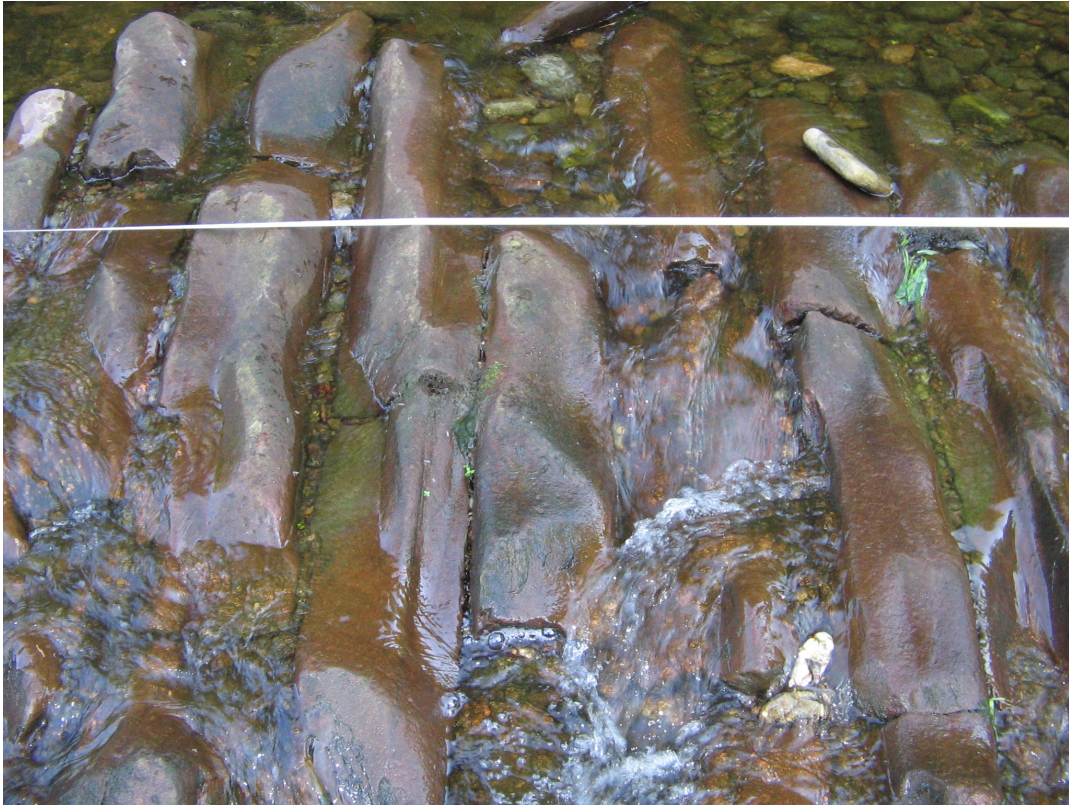
- 6.2.1 A measured sketch of the ford between the eyots was drawn (Area 2, Fig 4). As demonstrated by Plates 22 and 23, a base-line was set out and the pitched stone work was drawn submerged under shallow but rapidly flowing water. The measured sketch is of the 'causeway' between the northern and southern eyots is shown as Fig. 10.

- stonework suggests that they were intended to be visible and were probably not a 'foundation' for a now eroded away eyot.
- 6.2.4 Pitched stone surface [100] was evidently very well constructed, even though many of the stones were now heavily water eroded and in some cases obscured by concretions (see Fig 10). At the southern extent of the causeway, the stone coursing appeared to flow around the northern extent of southern eyot, suggesting that the pitched stone surface [100] was perhaps contemporary with the eyot revetment observed in the Area 1 test pit.

- 6.2.5 Towards the northern extent of the pitched stone surface [100], the angle of the pitched stone work raised up to meet a weir, and other brick vaulting relating to the salmon coop structure itself. At this point the stone work had obviously been repaired a number of times; the latest repair being the laying down of an east-west aligned strip of concrete 0.7m wide (see Fig. 10). It is probable that where the pitched stone work [100] met the weir structure that this was a point of great water pressure and as such was in need of frequent consolidation/repair. At the north-eastern of the pitched stone surface the flooding of January 2005 had evidently destroyed some of the surface and exposed underlying timbers [101] (see below).

PLATE 22: AREA 2 LOOKING SOUTH, AREA 1 TEST PIT UNDER EXCAVATION

PLATE 23: DETAIL OF STONWORK OF AREA 2 'CAUSEWAY', LOOKING EAST
