**Client Report No. CP/418/06**

**REPORT ON AN  
ARCHAEOLOGICAL  
BUILDING RECORDING  
PROJECT AT  
TOWNFOOT FARM  
CASTLE CARROCK  
BRAMPTON  
CUMBRIA**

**NY 5420 5562  
Planning Application Ref:  
1/06/0973**

01 March 2007

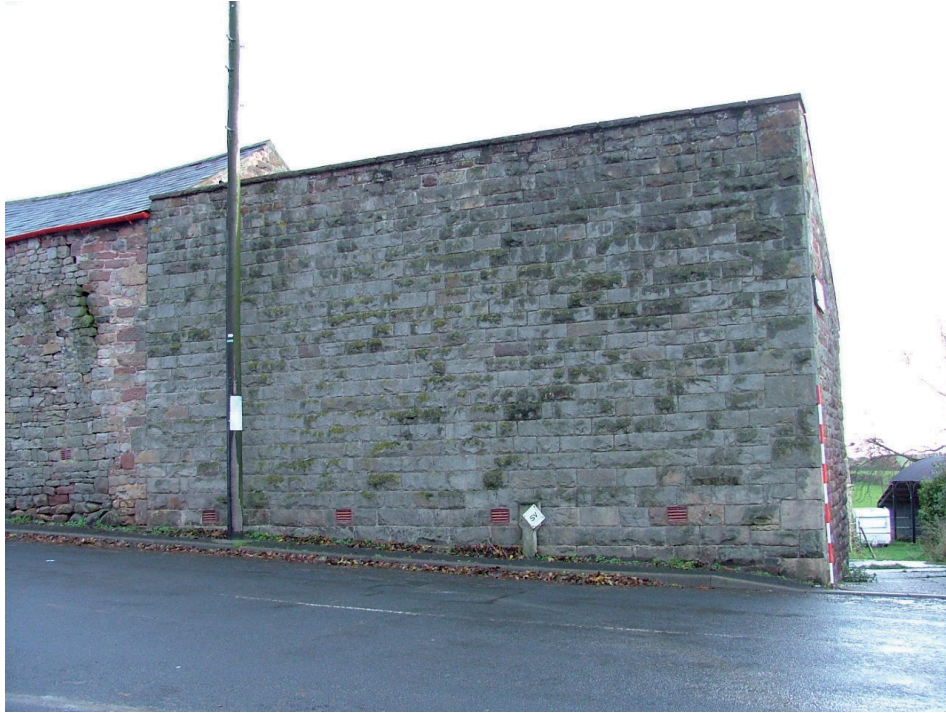
- 5.1.2 Building **2** has been constructed against the northern gable end of Building **1**. This building is constructed of coursed and squared masonry which has a rusticated appearance, and is quite different from the masonry of Building **1** (Plate 4). The roof of this building is pitched and faces the west. The north elevation of Building **2** provides evidence for a former first floor doorway now blocked up, which may have been used as a pitching door for the transference of hay from the cart to a hayloft (Plate 5). The masonry of the north elevation is not as coursed and well dressed as that of the east elevation (compare Plates 4 and 5).

**Plate 4** – East elevation of Building 2, Range A

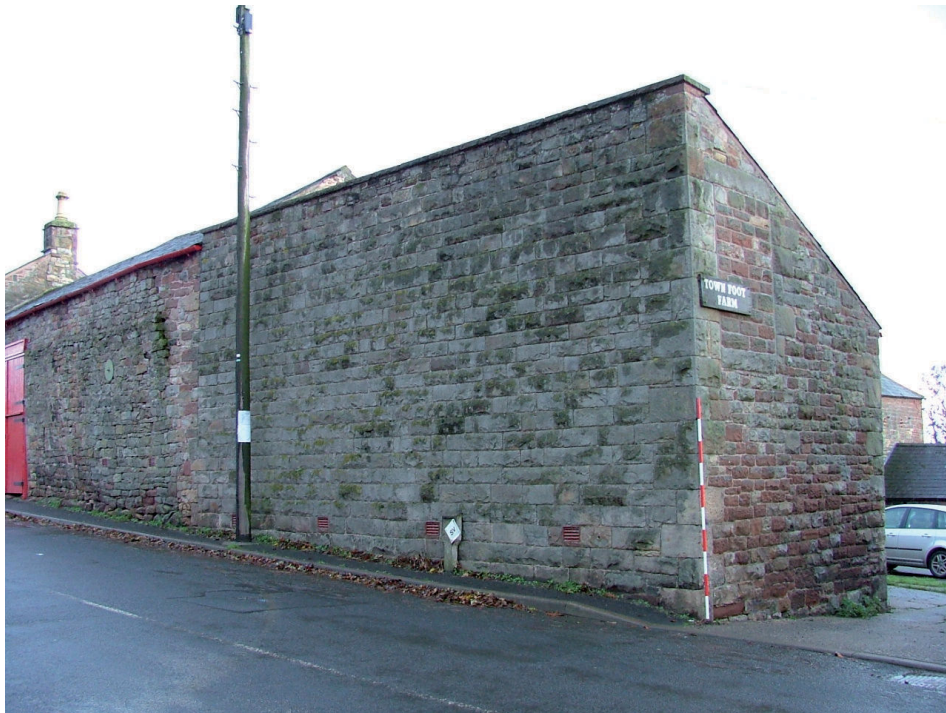
**Plate 5** – North and east elevations of Building 2

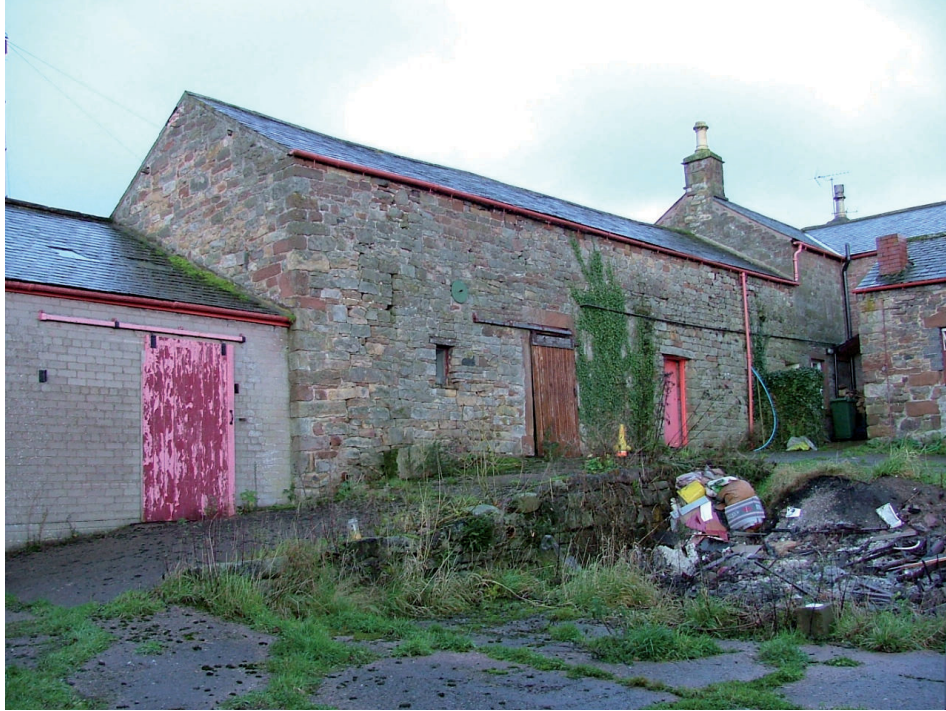
- 5.1.3 The western elevations of Buildings **1** and **2** face into the farmyard (Figure 9). Along this elevation of Building **1** are two standard doorways and a small window. It was possible to observe on this elevation the change in masonry along the top of this wall and at the northern end, which was noted on the eastern elevation (Plate 6). A further circular tie plate also remains *in-situ*.

**Plate 6** – West elevation of Building 1

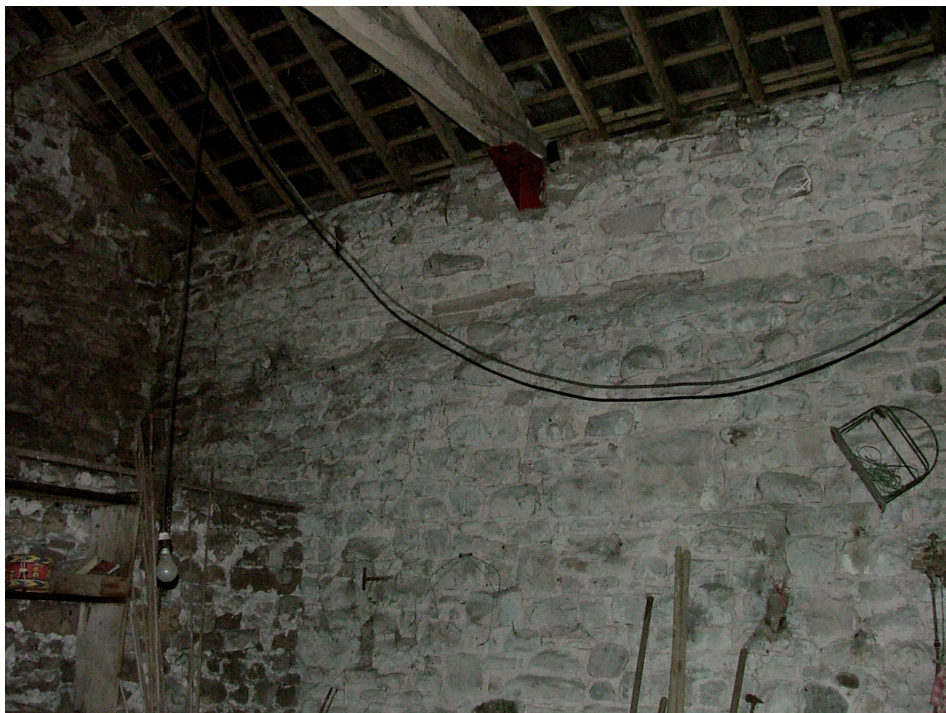
- 5.2.4 It was possible to observe the change in masonry on the upper part of the walls of Building 1, as the addition was not as thick as the older section of the barn (Plate 10).

**Plate 10** – Interior of Building 1 showing change in masonry (west wall)

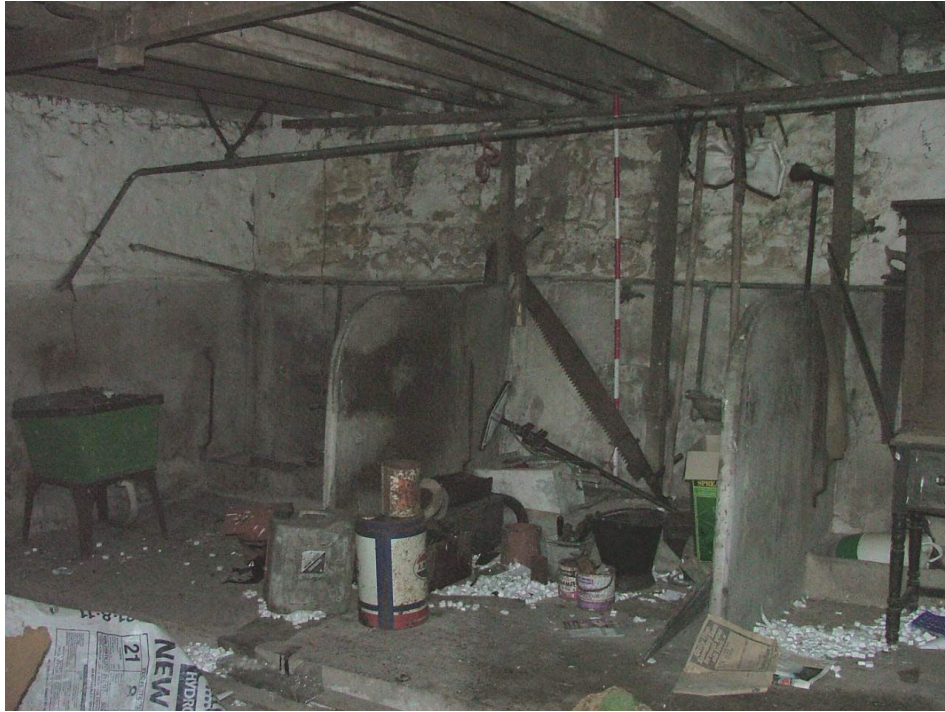
- 5.2.5 The byre which occupies the northern part of Building 1 was accessed via the doorway on the west elevation. This room consists of three concrete double stalls against the eastern wall which would have provided accommodation for a maximum of six cows (Plate 11). The floor is of concrete with a central manure channel, and the walls have been plastered to a height of approximately one metre from ground level. Limewash, a traditional wall covering which acted as a disinfectant and absorbed moisture, is still visible on the remainder of the walls.

**Plate 11** – Interior of byre, Building 1

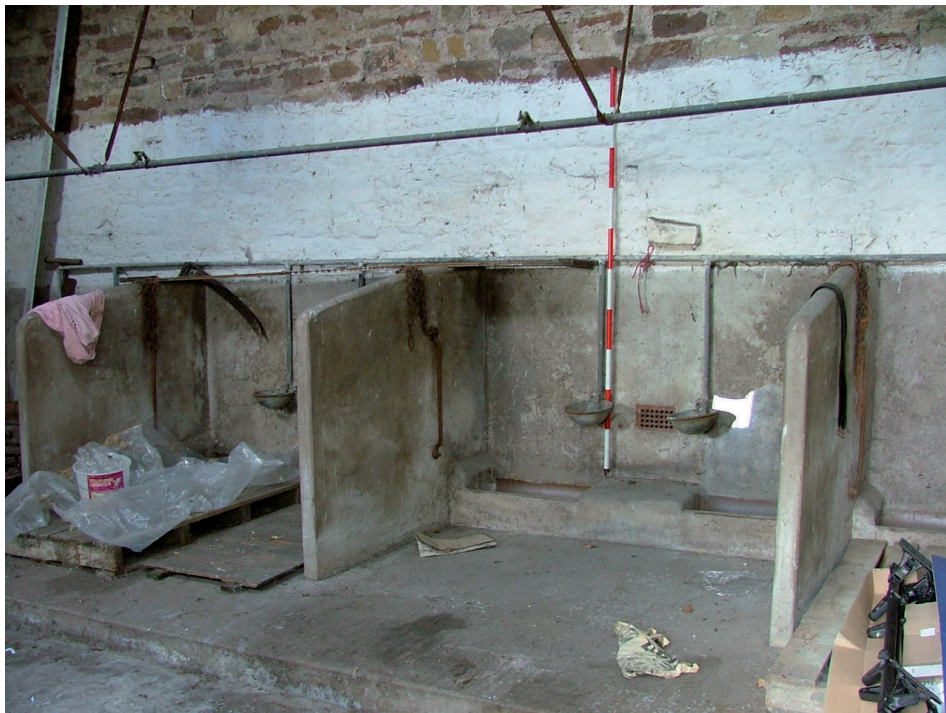
- 5.2.6 The interior of Building 2 was accessed via a sliding doorway on the west elevation (Plate 7). Internally, this building is all one room and had most recently been used as a byre. Three concrete stall divisions against the eastern wall create four double stalls, which would have provided accommodation for a maximum of eight cows. As with the byre in Building 1, the floor is of concrete with a central manure passage, and the walls have been plastered to a height of approximately 1.30 metres from ground level (Plate 12). The blocked-up first floor doorway in the north elevation was observed, however there did not appear to be any evidence for joist holes of a former first floor, and consequently this doorway may originally have been used to transfer hay to and from the upper parts of the roof space. Iron tethering bars and chains used for tying up the cattle remain *in-situ*, as do the ceramic feeding troughs and metal water troughs (Plate 13).

**Plate 13** – Interior of Building 2 showing stall divisions, troughs and tethering bars

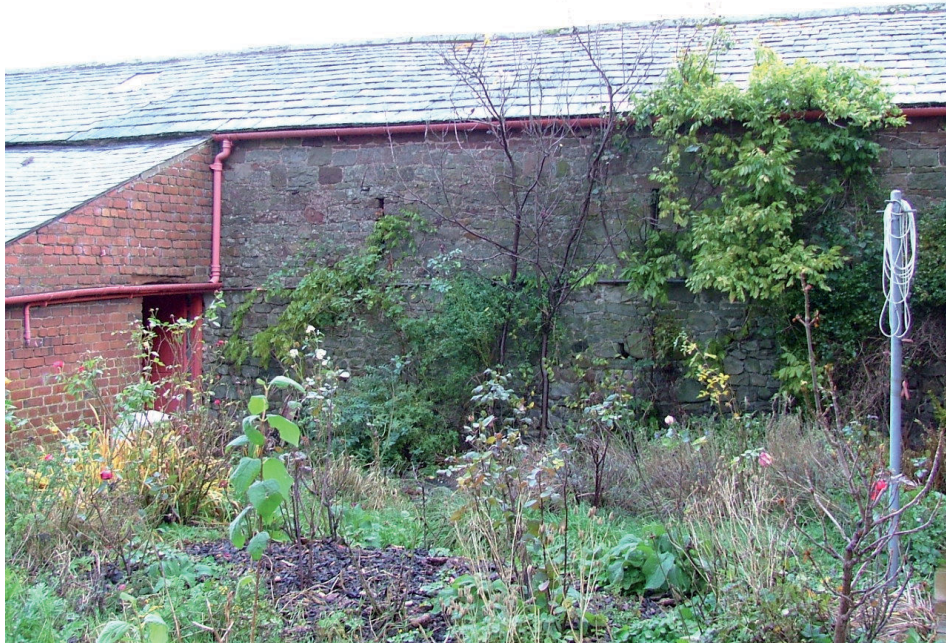
- 5.3.3 The southern elevation of Building 3 is largely obscured by Building 6 and some foliage (Figure 11 and Plate 16). There were, however, two ventilation slits observed along this elevation.

**Plate 16** – Part of the southern elevation of Building 3, with a section of Building 6 visible to the left

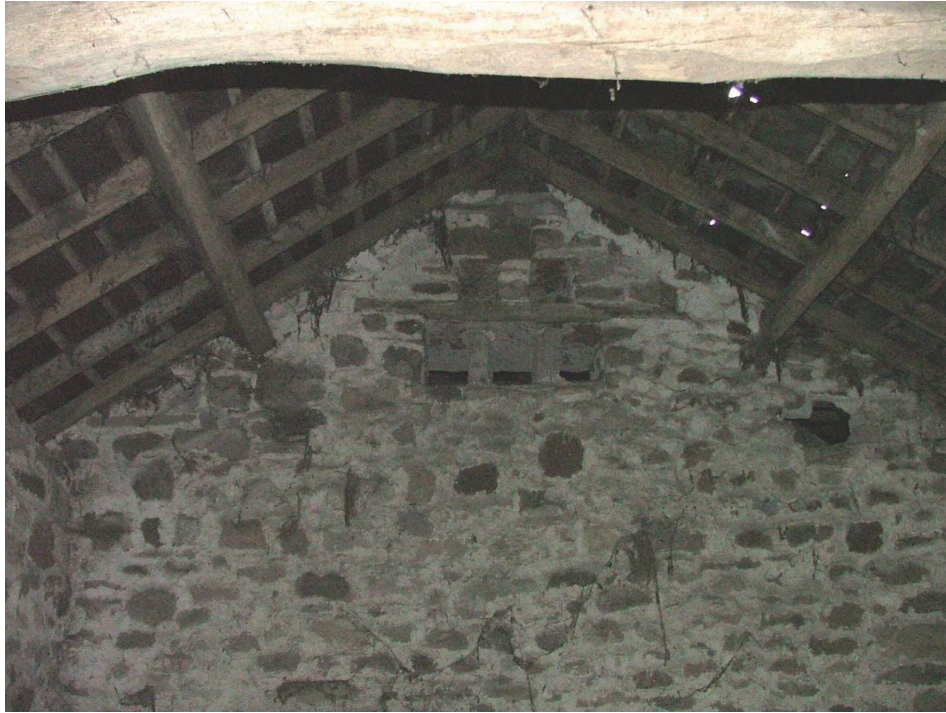
- 5.4.2 Beside one of the pig sties was a further timber partition which had a ladder that gave access to the first floor. This would appear to have been used as a hayloft, and these were often located at first floor level as the hay provided insulation for the animals below. In the western gable end of Building 3, close to the apex of the roof, a bird nesting box could be observed consisting of six holes created by horizontal pieces of sandstone and squared blocks of masonry separating each hole (Plate 18). Nesting

boxes such as these were included in farm buildings in the late 18<sup>th</sup> and the 19<sup>th</sup> centuries to allow pigeons to roost, thus providing eggs<sup>4</sup>.

**Plate 18** – Nesting box, western gable end of Building 3

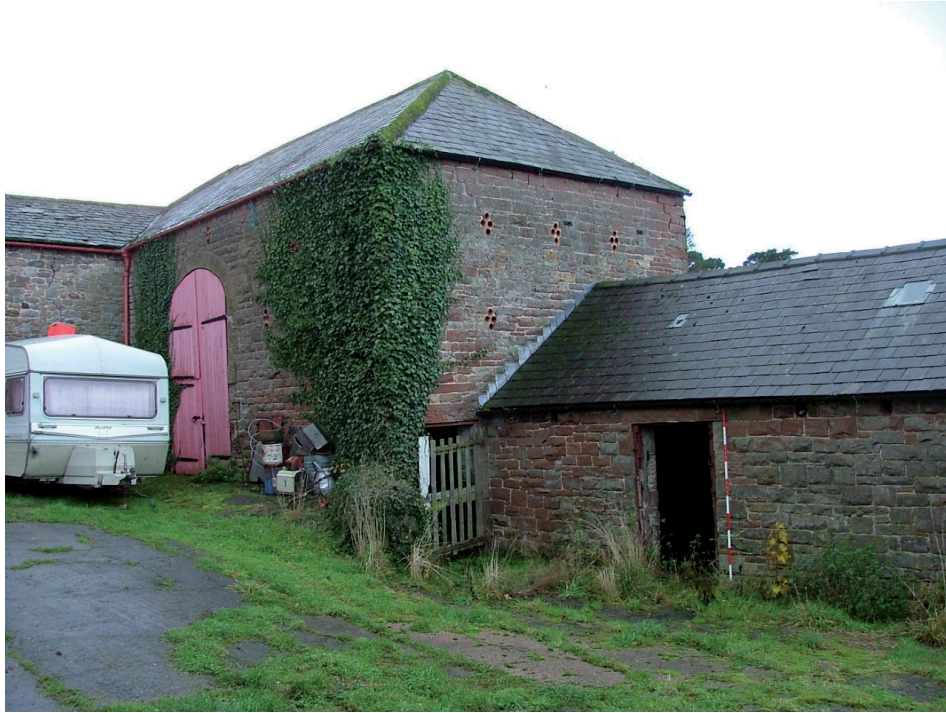
- 5.5.4 Sections of ceramic pipe laid in either a diamond or pyramidal shape have been included within the fabric of the building to provide ventilation (Plates 19 and 20).

**Plate 19** – East and north elevations of Building 4

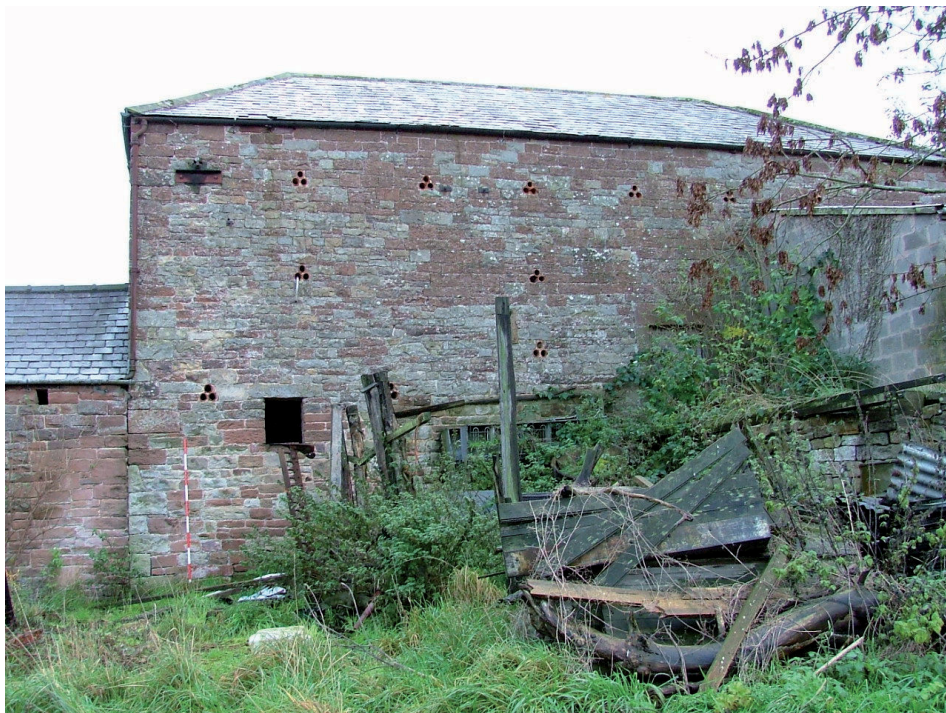
**Plate 20** – West elevation of Building 4, masonry wall to the right of photograph retains a ramp (on which Building 7 has been constructed) which may have allowed for the transference of hay into the building from a cart

- 5.6.4 On the western wall at first floor level there is a window (Plate 27). No evidence for a former first floor was observed at the time of survey, although the building was devoid of any natural light, and it was only possible to note features with the use of a torch. If there had not been a first floor, then this window presumably was used for transferring hay from carts into the building for storage. At this point, on the exterior of the building, there was a man-made ramp below the window which may have been used to bring a cart up to the side of Building 4, although Building 7 now obscures the window (Plate 20).

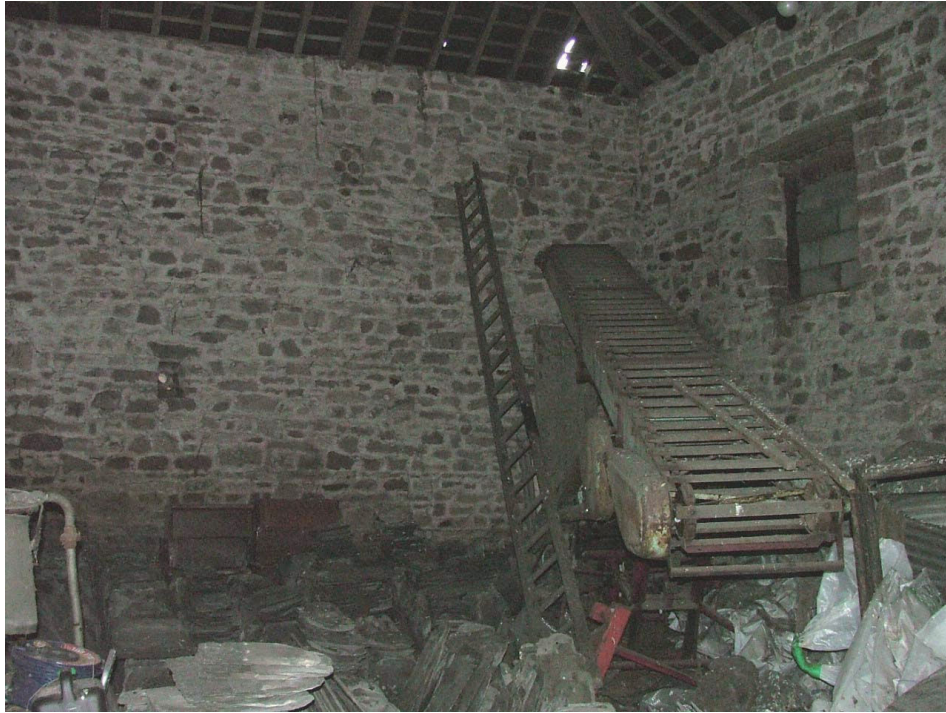
- 5.6.3 At the northern end of this building there is a platform (Plate 24), which has more recently been used for storage, but there remains *in-situ* gearing and wheels with attached belts which appear to relate to machinery for driving the thresher, which also remains *in-situ* within the building (Plate 25). On the side of the threshing machine is the wording 'RICKERBY LTD CARLISLE' (Plate 25). As the firm Rickerby's came into existence in 1880<sup>5</sup>, and combine harvesters were introduced in 1930s, although it took many years for them to replace other forms of power for threshing, then it is possible to suggest that the threshing machine dates from the first half of the twentieth century. An electric motor also remains *in-situ* set into the wall above the threshing machine (Plate 26). The introduction of electricity onto a farmstead to drive machinery occurred around after the Second World War and continued into the 1950s and 60s<sup>6</sup>. Also remaining in Building 4 is a baler for moving hay bales into the hayloft or for stacking in the barn (Plate 27).

**Plate 27** – Baler and pitching window, interior of Building 4

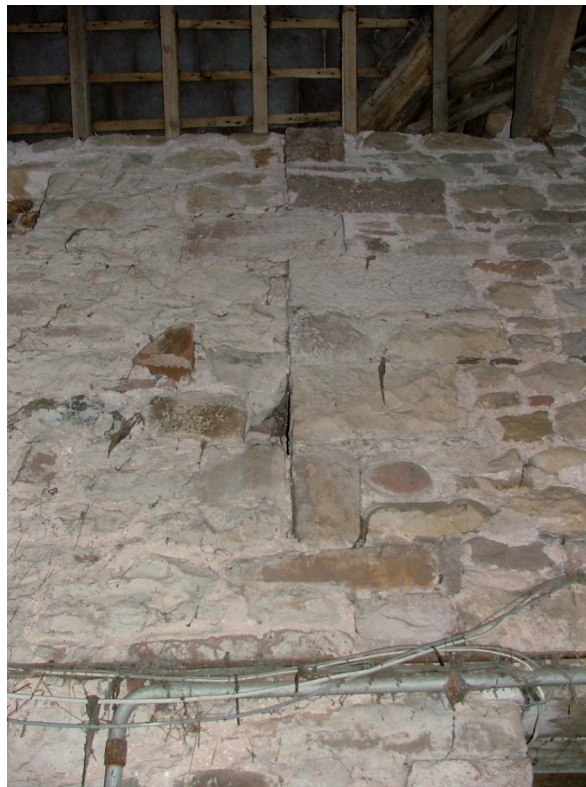
- 5.6.5 The quoins of the western gable end of Building 3 could be observed within Building 4 (Plate 28). This evidence, along with the presence of the nesting boxes in this elevation, suggests that Building 3 was in existence before Building 4.

**Plate 28** – Quoins of western gable end of Building 3 with the east wall of Building 4 to the left

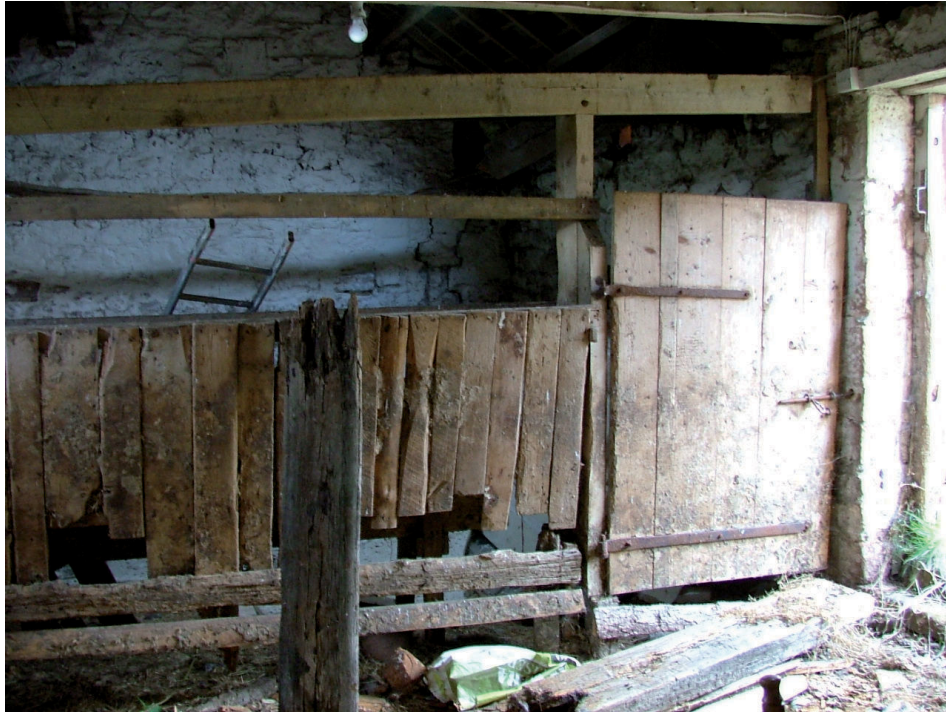
- 5.6.7 The interior of Building 5 is split into two by a timber partition. It would appear that this was also used as a loose box, or stable as the walls have been limewashed and there are hay racks remaining *in-situ* (Plate 29).

**Plate 29** – Timber partition in Building 5 with hay rack and door

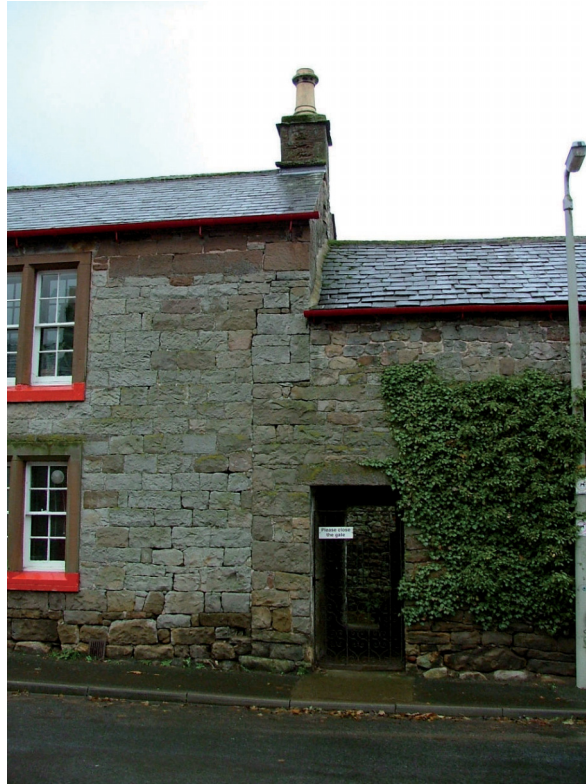
**Plate 35** – Construction break between farmhouse and Building 1

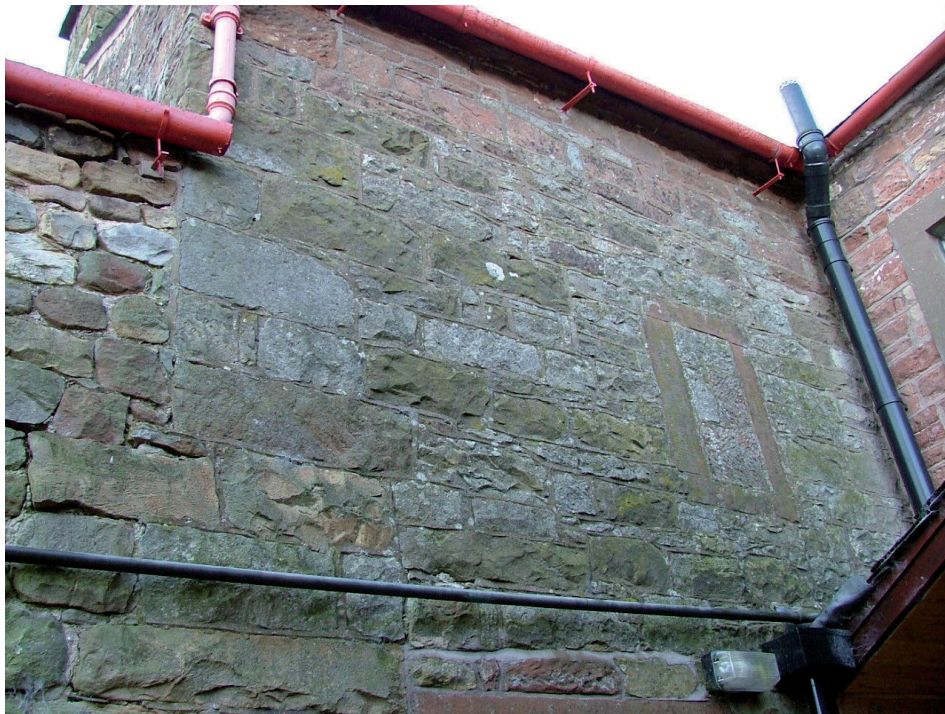
**Plate 36** – West elevation of farmhouse showing different construction phases between the house and Building 1 (to the left), also shows a former window
