THE PARISH CHURCH OF ST MARY, MORPETH
ARCHAEOLOGICAL WATCHING BRIEF
WINTER 2012/2013

St Mary's Church, Morpeth. Archaeological Watching Brief, Winter 2012/2013

NC ref. CM 16/19; 15569. NGR NZ 1971 8509. PFR 877. Oasis ref. peterfry1-144515

An Archaeological Watching Brief, Winter 2012/2013

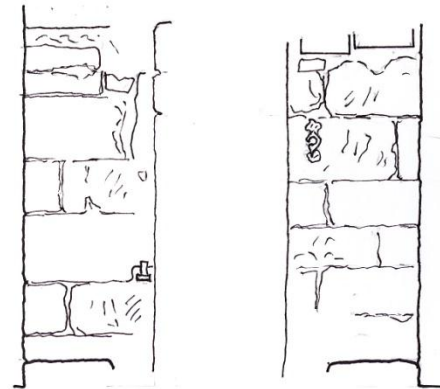
Illus.3 Internal Elevations of North Doorway

3.4 Stripping the plaster from the internal face of the wall revealed the jambs of a splayed opening 1.32 m wide, coursed in with the adjacent walling and apparently coeval with the wall, ie of 14th century date. The opening was blocked with roughly-squared stone laid in irregular courses, with no clue as to its date.

3.5 When the blocking stonework was revealed, the former doorway was revealed to have jambs with an internal rebate and externally a narrow chamfer, which had been mutilated by a small external rebate being cut into it; within the chamfer the doorway had been exactly 1.00 m wide. There was no evidence of any drawbar tunnel (such as the south door has) but the west jamb had one old pintle for the former door (see appendix 1), leaded into position, and the east jamb a mutilated plate with a circular hole for a bolt, which unfortunately was misplaced by the contractors before it could be recorded in detail.

Elevations of Jambs after partial removal of blocking and remains of plaster

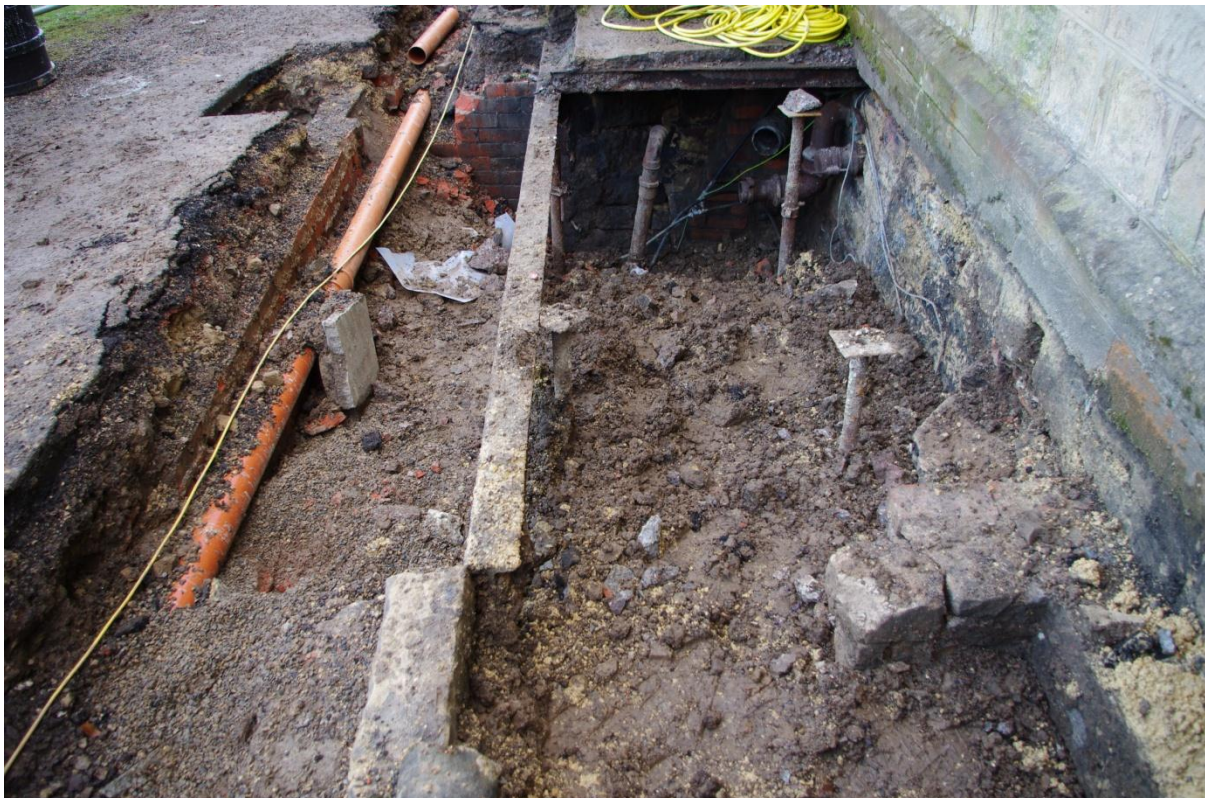
Illus vii. Remains of Boiler Room looking east

Concrete slab over boiler house now largely removed; this is partially infilled with debris, quite a lot of pipework still in position – to be filled in completely. Sketched and photographed. Seemed to be two phases of work, large squared stone and (mid C20?) brick. Two pieces of headstone, with well carved later C18 inscription, retrieved from debris, taken by PFR to be cleaned and photographed.
