Holy Island House, Gilesgate, Hexham

Archaeological Recording during Partial
Reconstruction of North Gable, November/December
2015

Planning Application no. 15/02717/LBC

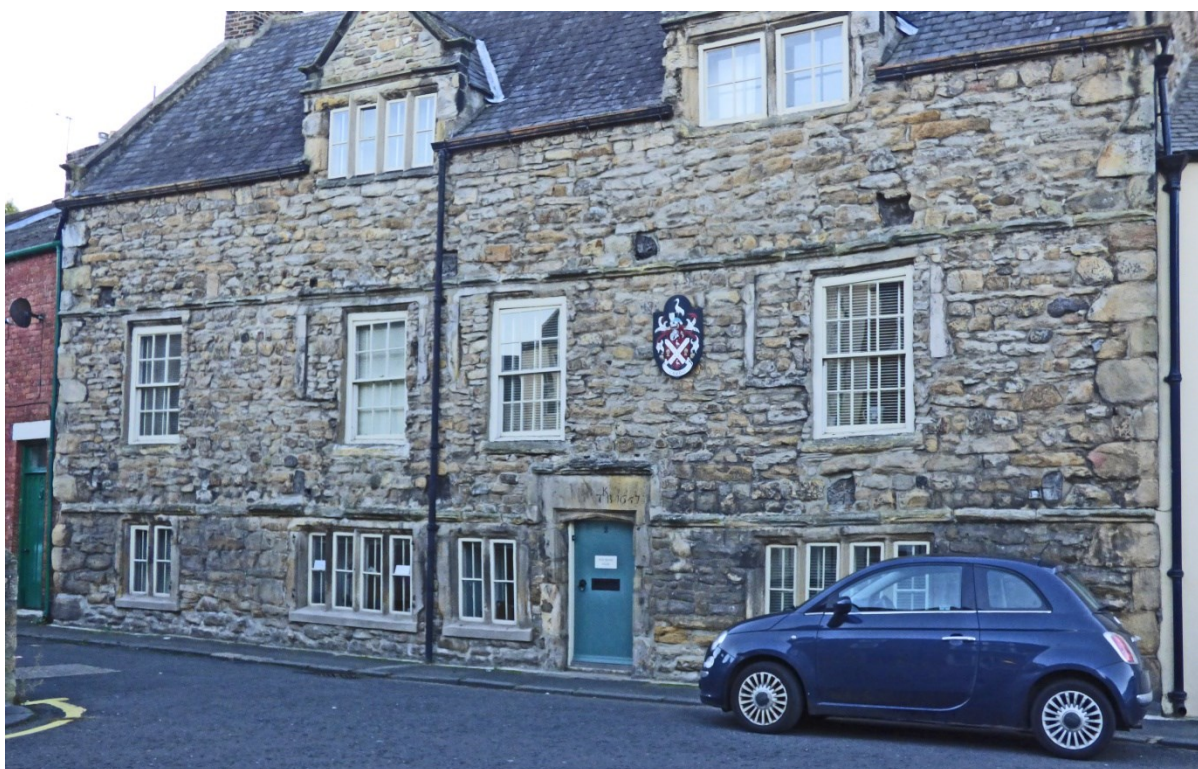
(1) The Front (East) Elevation

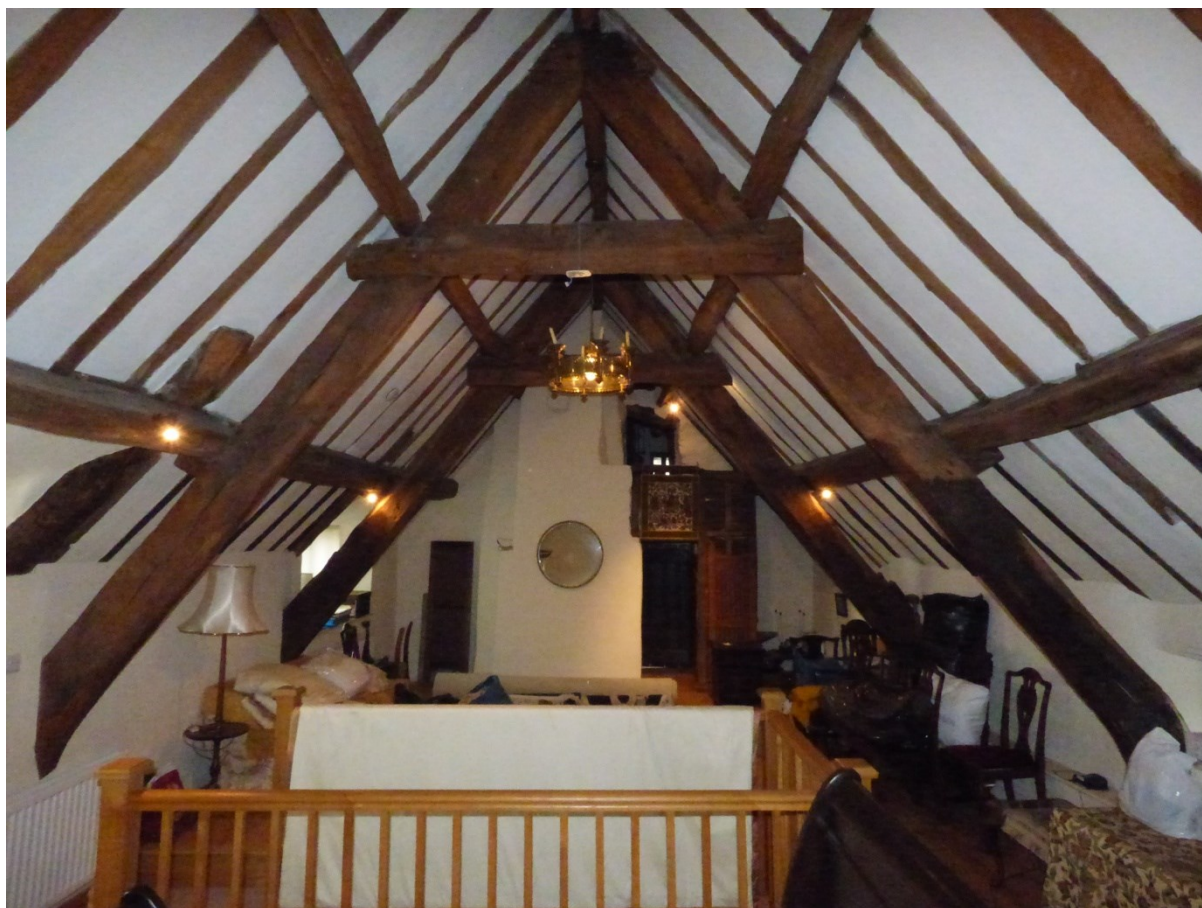
(16) Second (Attic) floor looking north showing upper cruck roof trusses (P16)

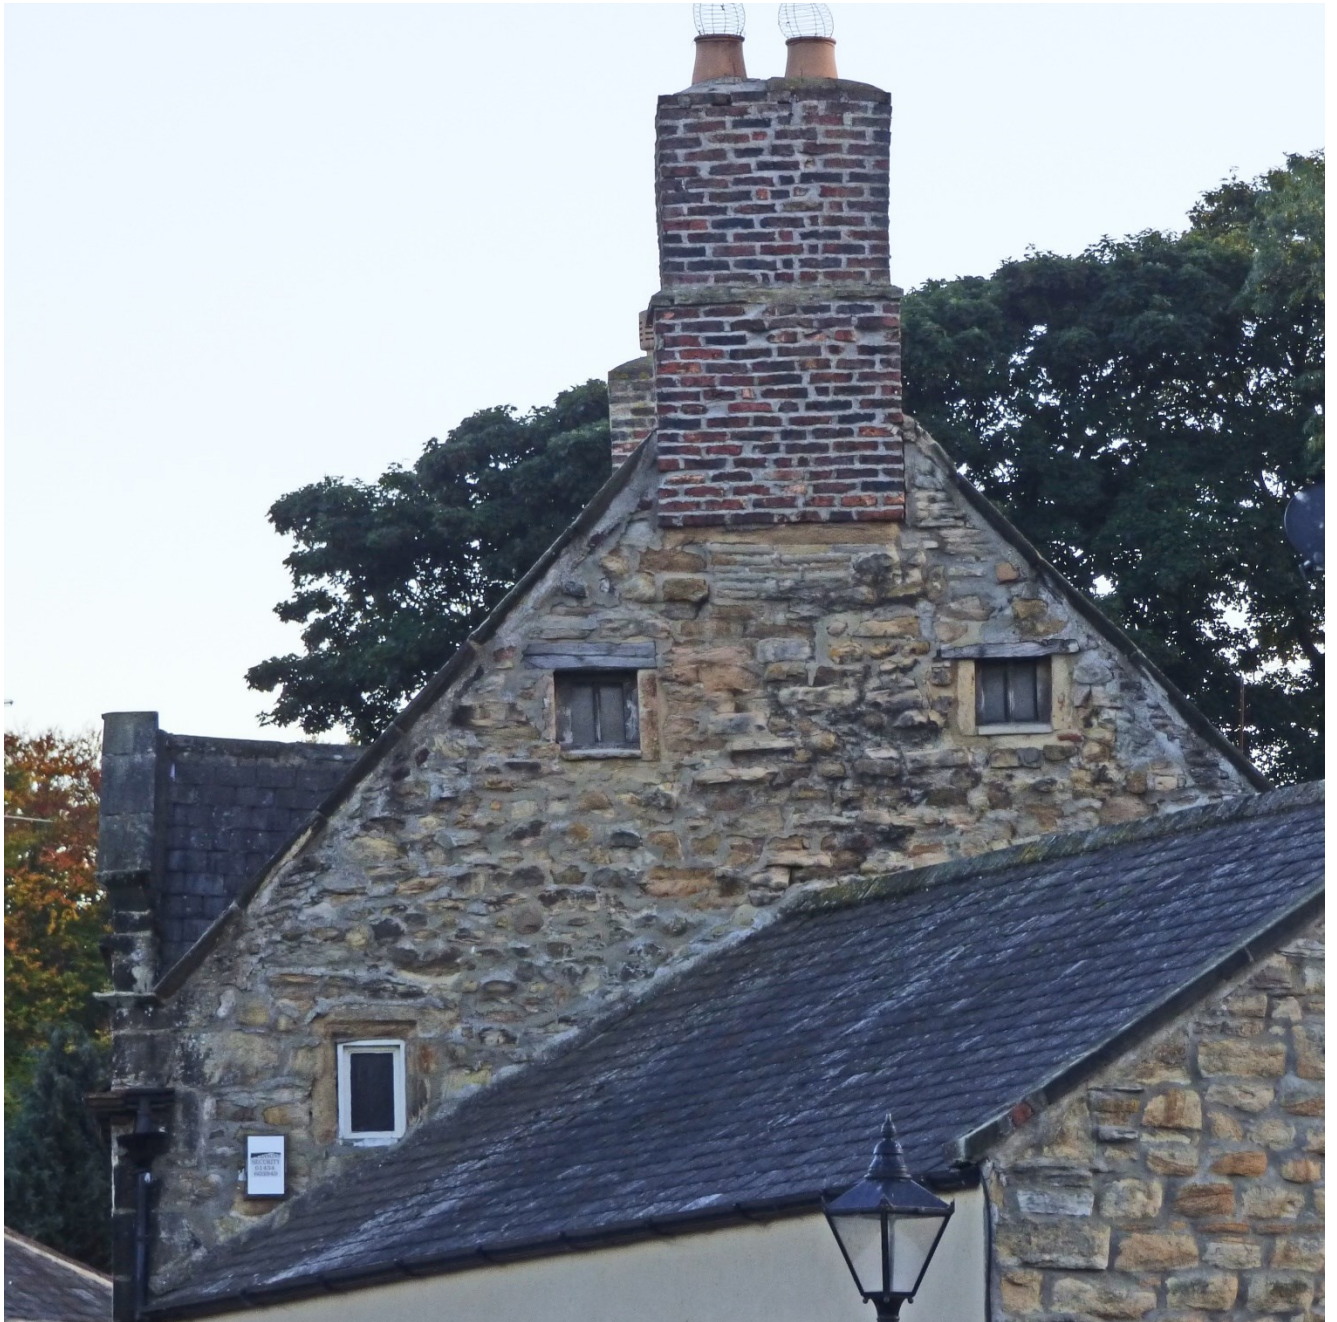
(2) North gable end before works, November 2015 (P2)

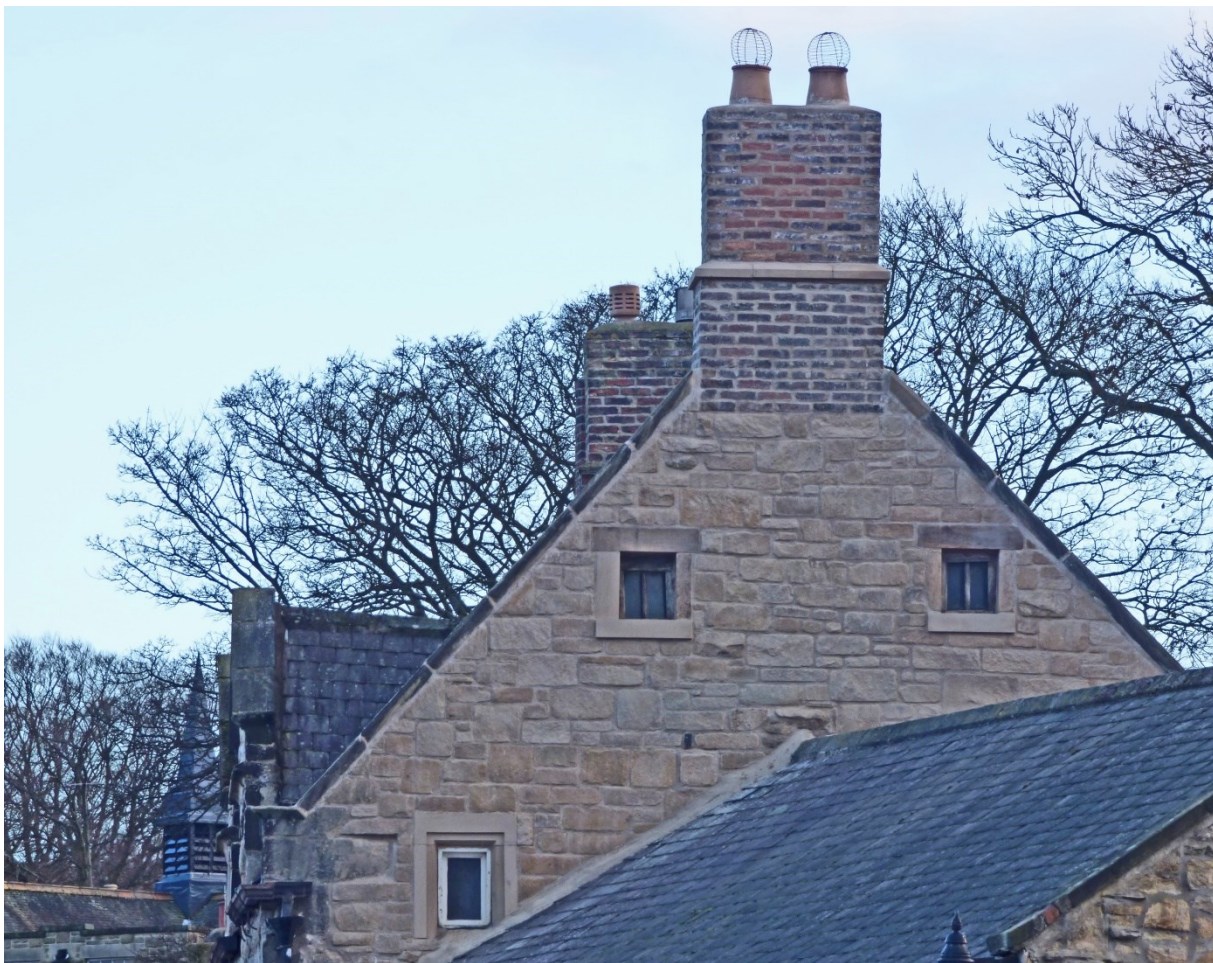
(14) North gable end after works, February 2016

The wall was photographed after works when the scaffolding had been finally removed. The chimney was rebuilt (P14/15) more or less following of its original form (with 12 courses below the stringcourse and 10 above, as against the original 16 and 14, with a new ashlar string-course, chamfered above, and the wall below was refaced in squared sandstone blocks, laid in a slightly snecked manner. New triangular blocks were introduced beneath the gable coping, erasing the evidence of the earlier roof-line. The surrounds of all three windows were renewed, that at attic level with a surround following the original stepped-and-chamfered profile, those at a higher level with new oak lintels.

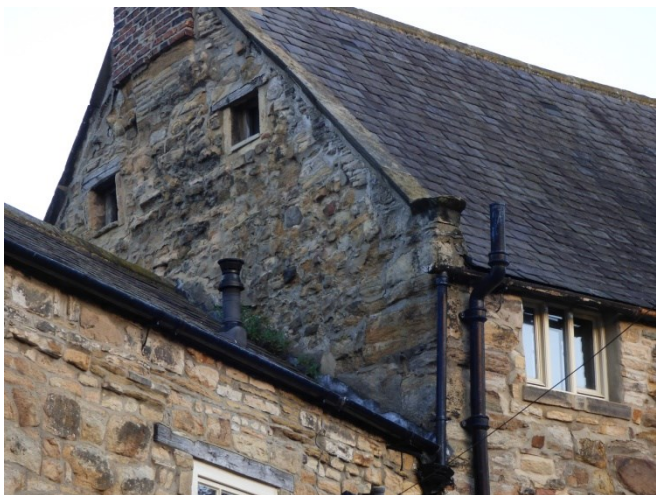
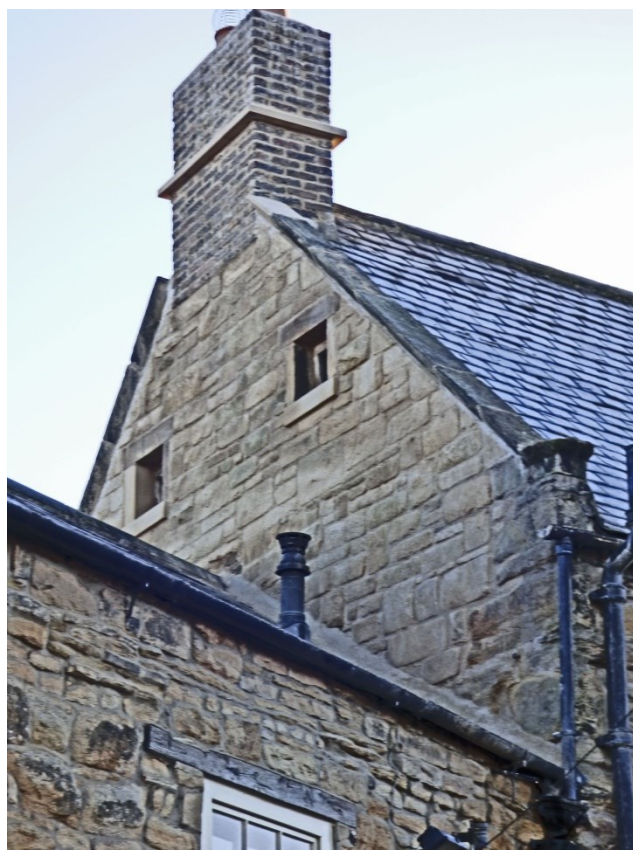
(3) North gable end from north-west, before and (15) after works

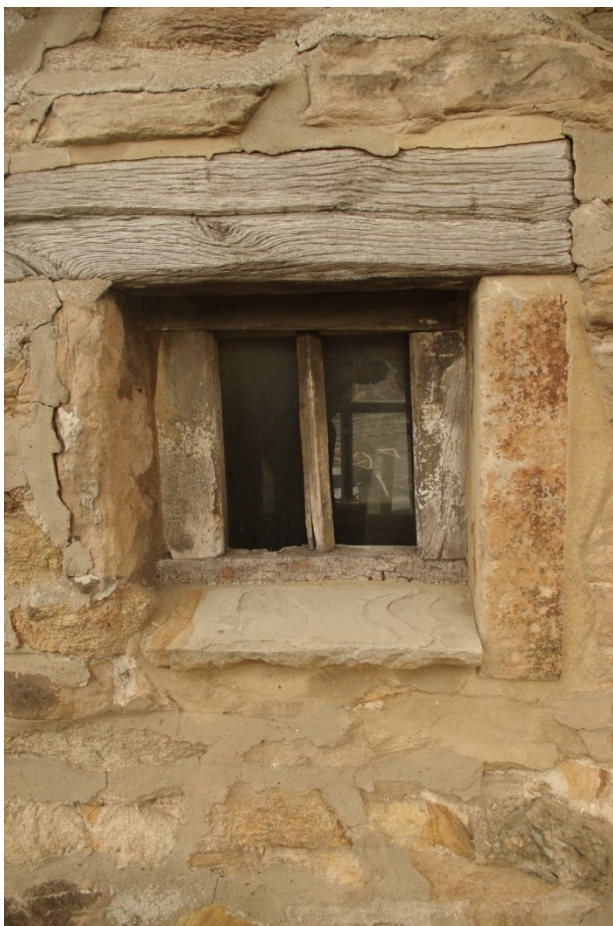
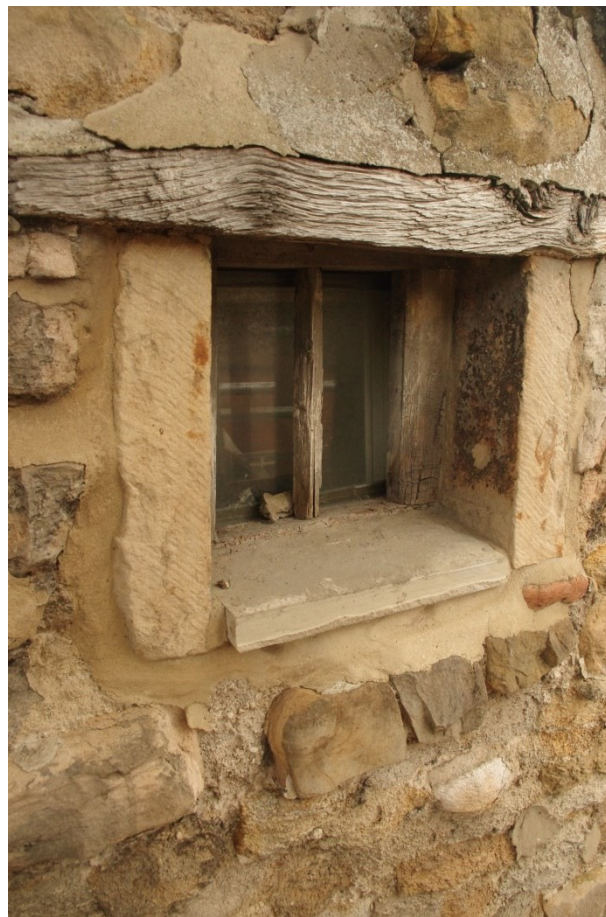
(5) Eastern upper and (6) Western upper windows before works

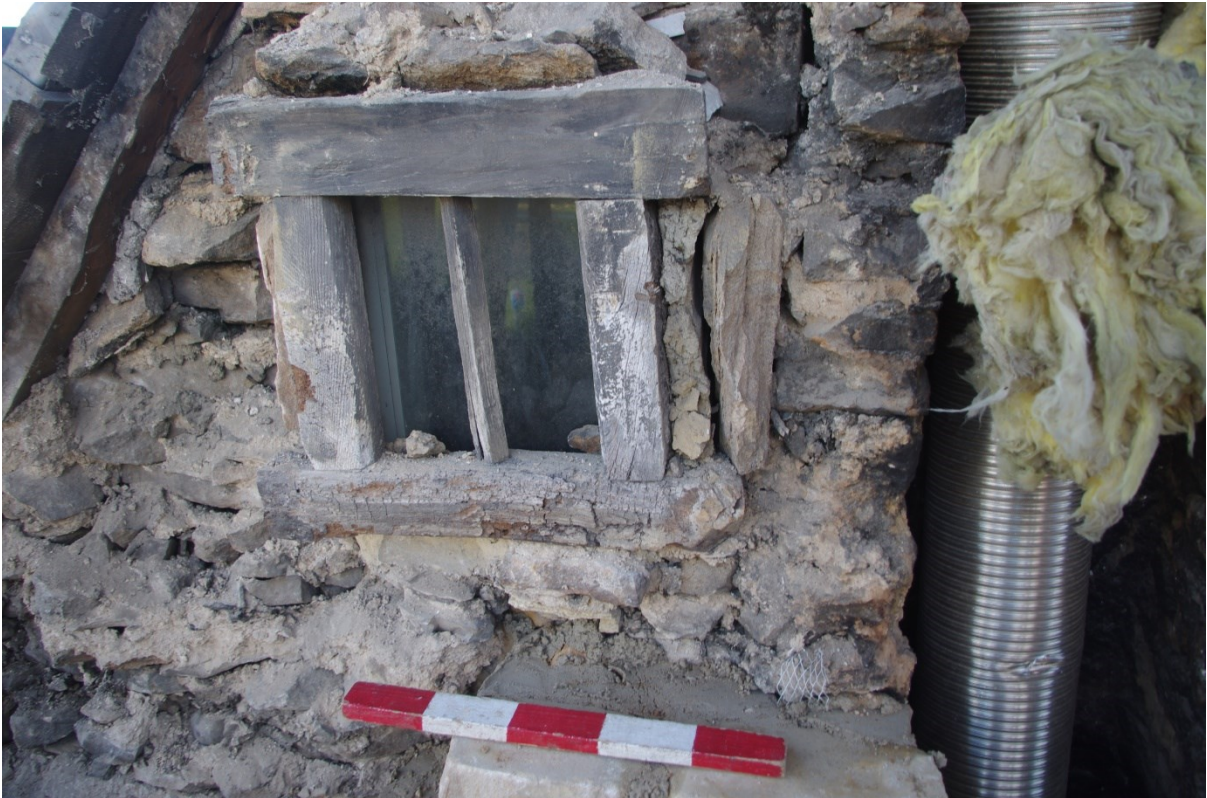
(12) The eastern upper window in the north gable end, with timber frames revealed when the outer face of the wall was removed

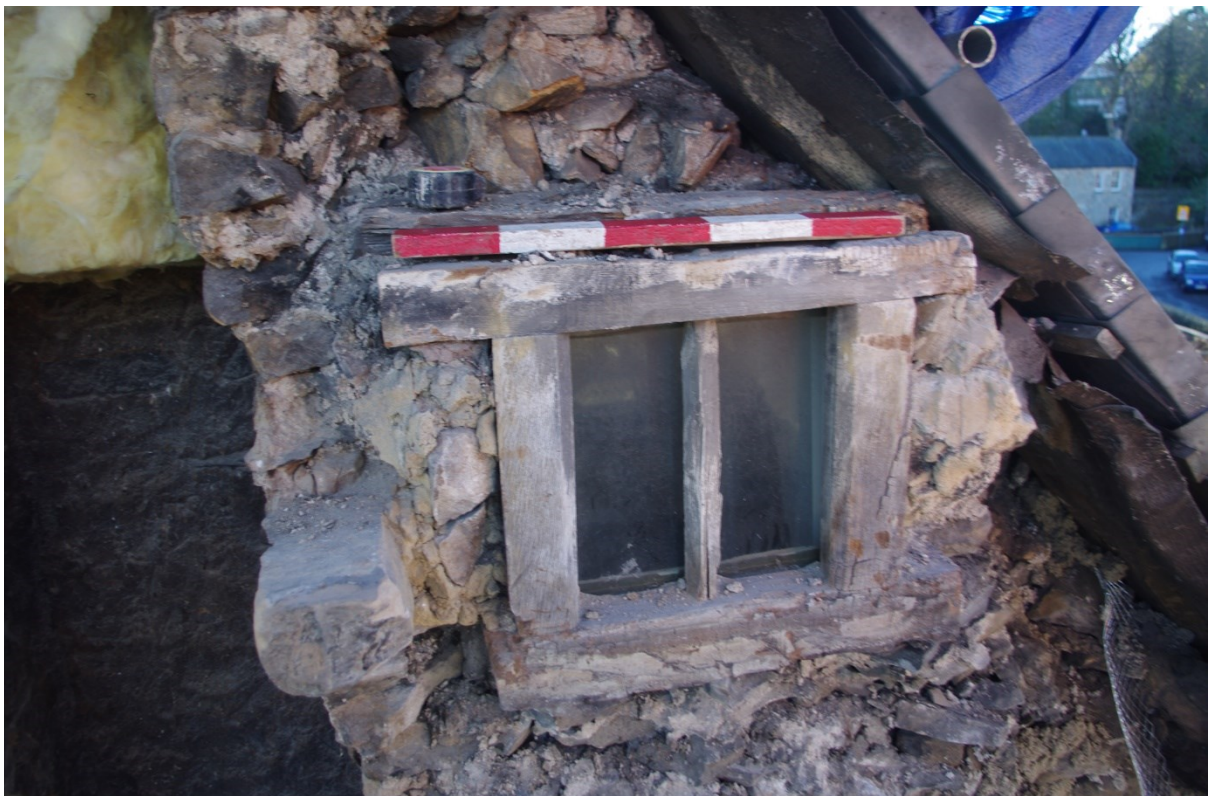
(13) The western upper window

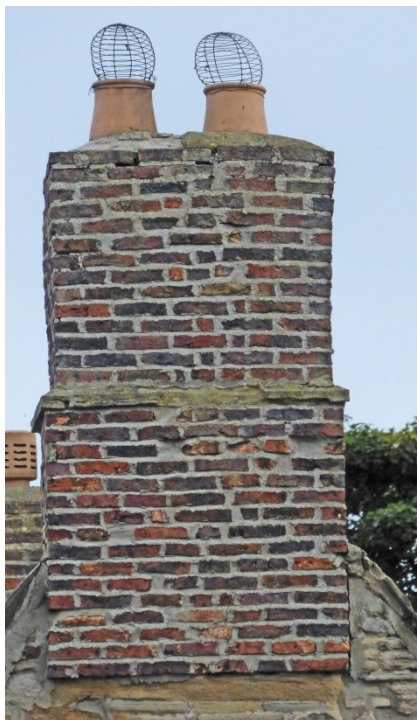
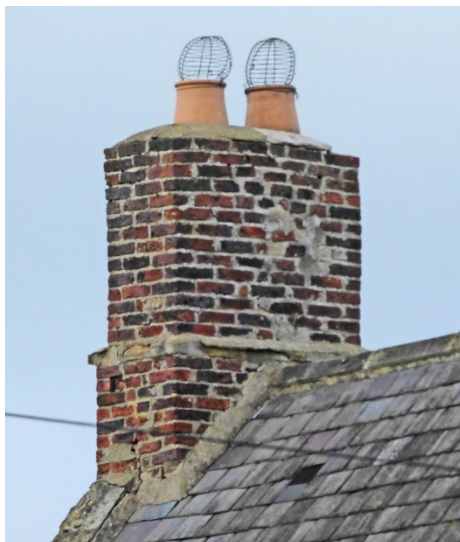
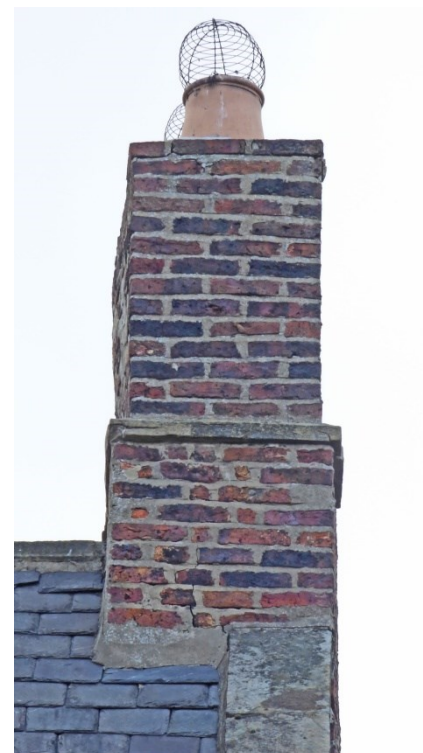
The north gable end of the building, rising above the roof of the adjacent no 1 Holy Island, was in poor condition and the chimney stack thought to be in danger of collapse; an application for listed building consent was made for works involving the rebuilding of the gable-end chimney stack (which is of brick and thought to be secondary to the building) along with partial re-facing of the weathered stone wall surface beneath, which entailed the renewal/reconstruction of the surrounds to three small windows.

The Chimney Stack before rebuilding, from the north (8) , south-west (9) , and east (10)

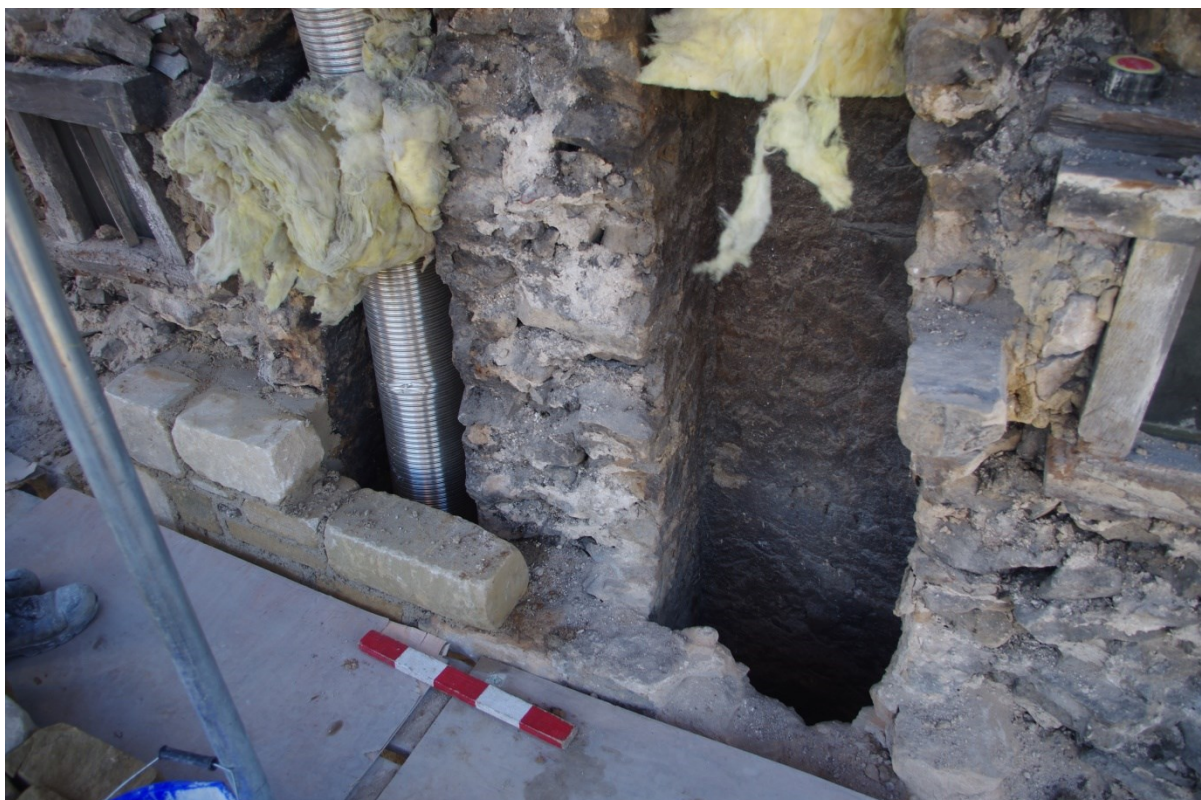
(11) The twin flues of the chimney revealed by the removal of the outer wall face.

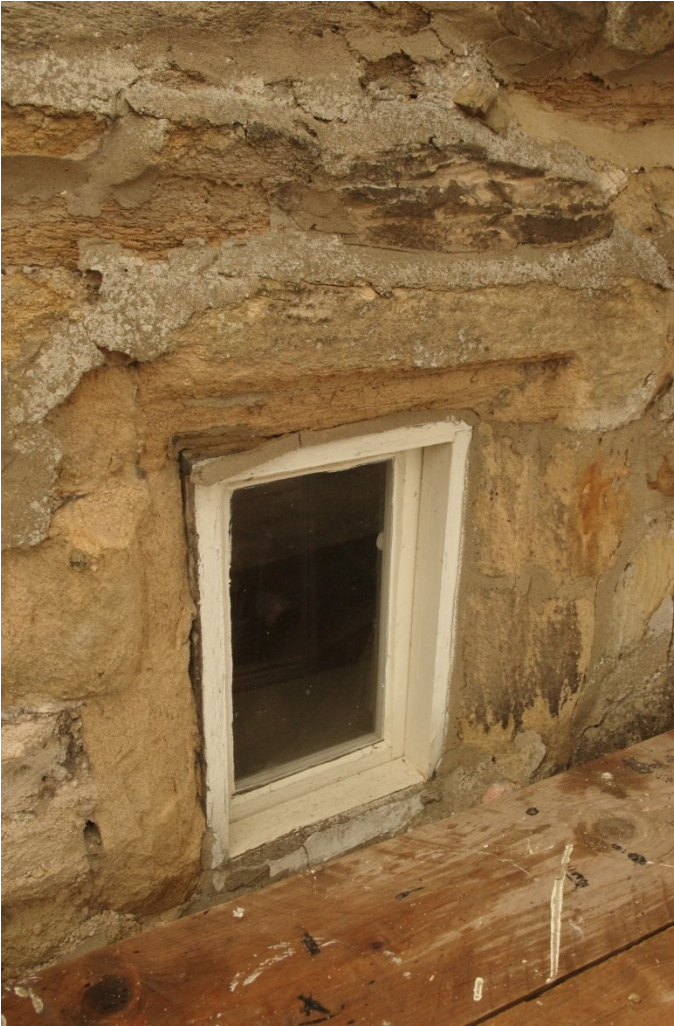
An inspection of the wall from scaffolding, on the 13th November 2015, prior to the commencement of works, allowed the chimney base (P7) and three openings (P4-6) to be photographed from close quarters. A second visit was made on 25th November, when much of the wall face had been removed, including the external surrounds of the openings, and the chimney had been dismantled. There had not been any corbels; the front face of the chimney had been barely supported on the slab beneath; the contractor's opinion was that 'would not have lasted one more winter'. There were only two flues in chimney (P11) showing that the second/attic floor had been unheated. The two upper windows each had two-light timber frames (P12-13), of morticed but not pegged construction, which were set well back from the external wall face; their jambs and mullions were chamfered, lintels and sills left square. The window at attic level, near the east end of the wall, had a modern casement window, and its stone surround was badly decayed (P4).

(4) Attic window in north gable end before works.

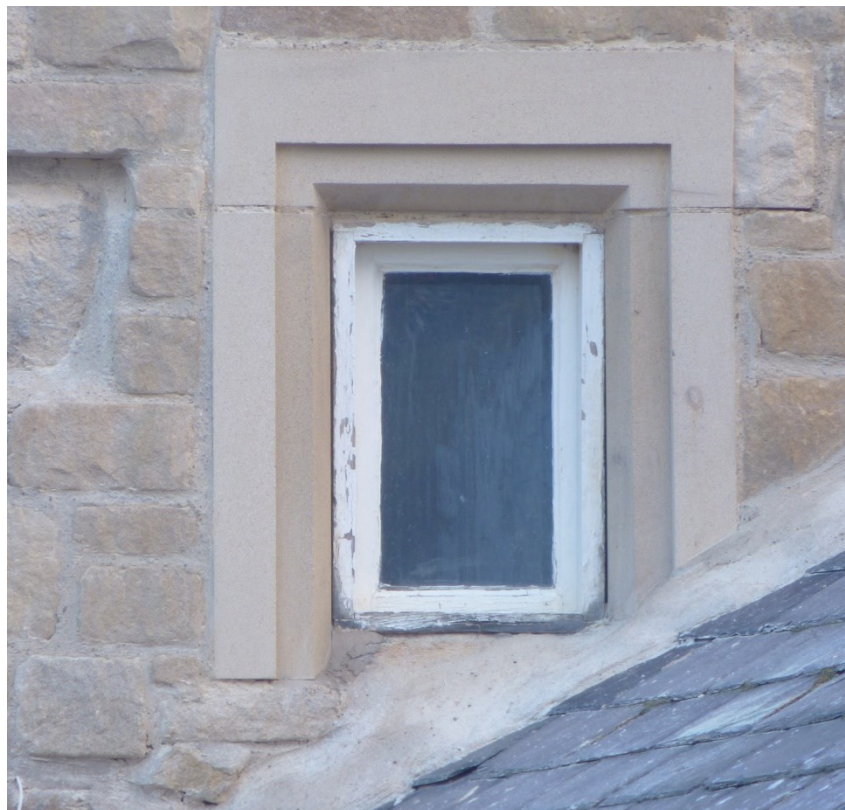
(17) Attic window after works

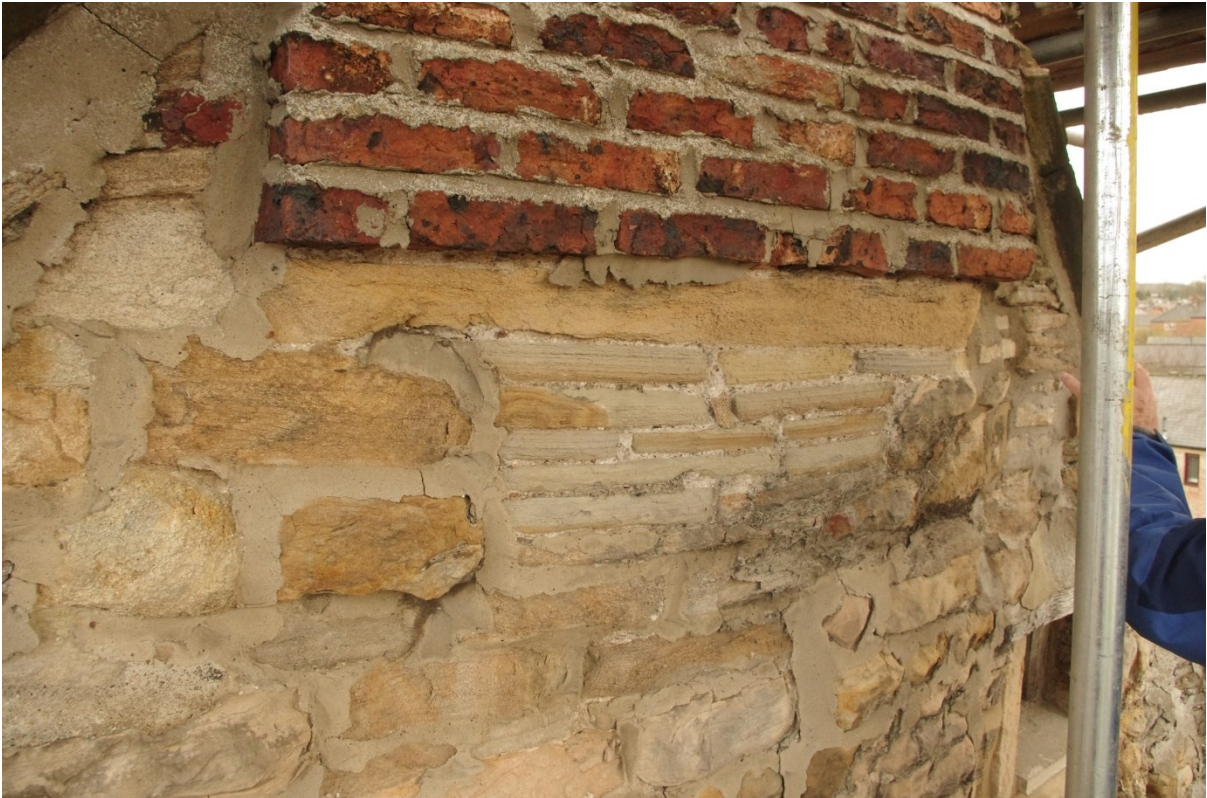
(7) Base of stack before works
