Roman Road Sewer Repairs, Duntocher: Archaeological Monitoring

Data Structure Report

by Diane Gorman

issued 30th August 2012

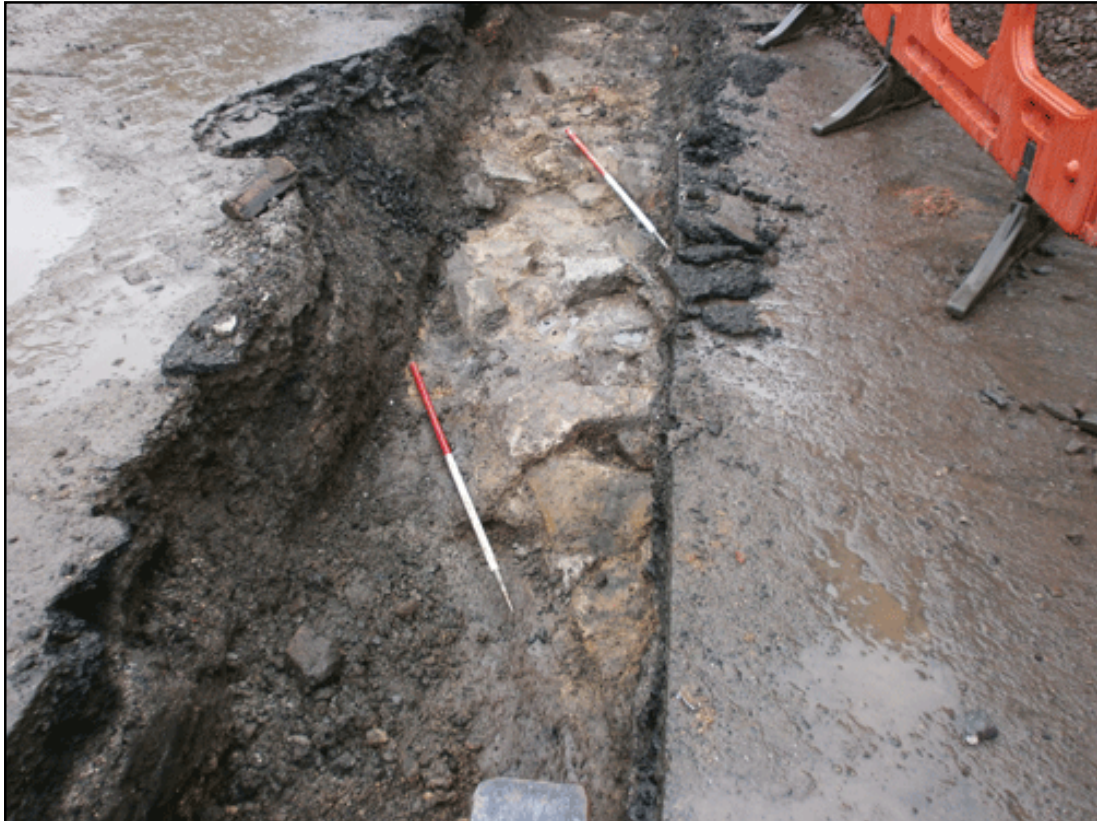
Figure 4b: Structure [023]

21. Approximately 10m north-east of MH5 the remains of a linear structure [023] were exposed (figure 4b). These ran across the trench north-west to south-east, the extremities of which (at the north-west and south-east ends) were obscured by the limits of excavation of the trench, meaning the full extent is unknown. Structure [023] consisted of a double skin of partially worked blonde, mortared sandstone, with fragments of blonde sandstone, stones and slate in the core. At the maximum point this structure was 1.47m wide, with 2.2m of length visible. It is very likely the structural remains run further in both directions. The stonework consisted of both shaped, dressed blocks in rectangular and square form, and irregular sandstone only worked on one side (to provide regular facing). It is possible some of the stonework within this structure had been re-used for a previous building.

22. Structure [023] was one course high indicating the remains represent a foundation course. The thickness ranged from 0.5-0.6m. A demolition deposit (022) was found on the north-eastern side of this wall, which included similar blonde sandstone blocks and fragments in addition to broken glass and partially worked metal detritus. The location and nature of the demolition material can be assumed to be the result of the destruction of the upper courses of structure [023], fallen to the north-eastern side. A number of the sandstone blocks found within demolition material (022) were painted bright colours (red, yellow, white and blue). This would indicate the stonework has been painted in modern times, and re-used for another purpose, most likely within a structure.

36. The blonde sandstone structural remains [023] are most likely to be the foundation courses of the wall of the blacksmiths depicted on the 1865 and 1896 Ordnance Survey mapping. The location and orientation of the wall are correct to depict the outer wall (the westernmost) wall of the blacksmiths. The demolition deposit (022) found on the north-eastern side of the wall may derive from the destruction of the upper courses of this wall. This demolition deposit continued almost to the edge of the south side of the burn, stopping perhaps 2m shy of the edge.

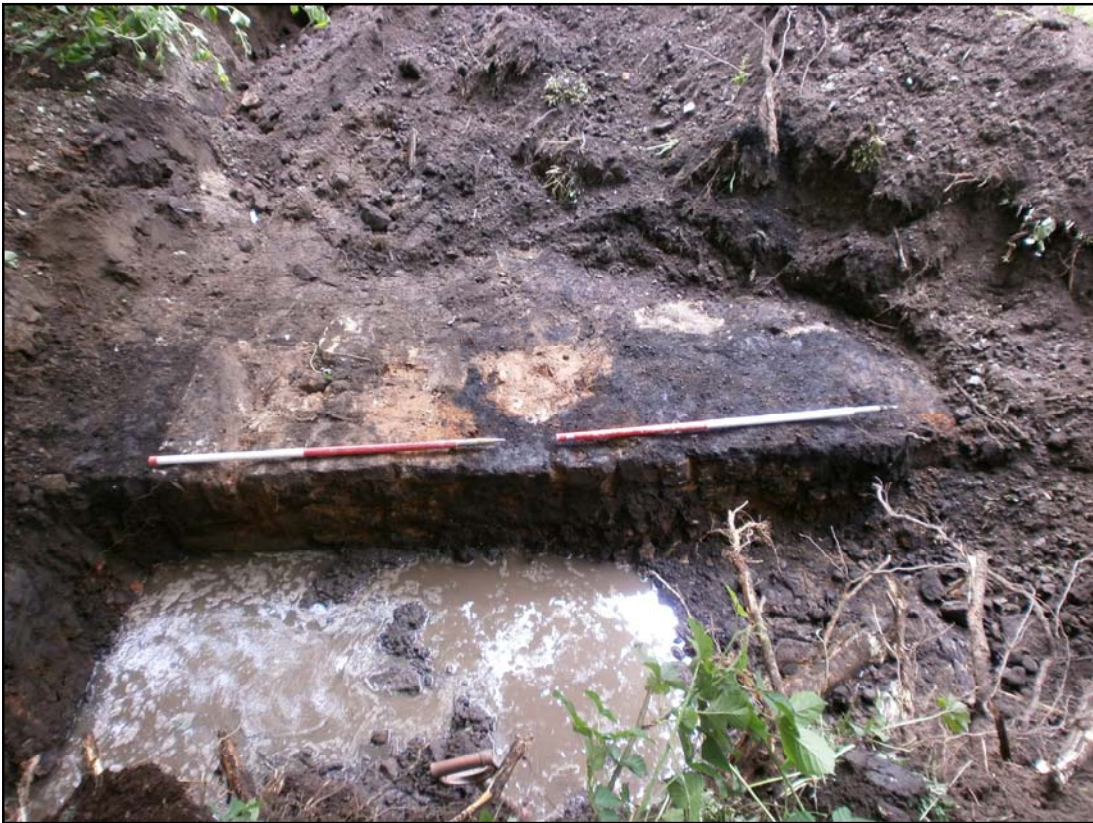
Figure 5a: Structure [015]

29. Immediately to the south of the pipe, structure [015] was exposed (figure 5a). The structure did not seem to have been truncated by the sewer pipe. This consisted of mortared, worked, blonde sandstone blocks; of generally unknown size and form; the upper surface of the structure is mostly obscured by deposit (018). This was a very compacted black material, gritty in texture with the appearance of coal.

30. The structure was three courses high (as visible); the lower part of the structure was obscured by the water from the sewer pipe. On plan, the form of the structure (i.e. the number of skins) is unclear due to (018) and also due to general degradation of the stonework on the upper surface of the structure. The full extent of the structure was not exposed due to limits of excavation; the eastern edge was exposed, but it is possible it continues further west. The structure was left *in situ*. Later works in the area did not expose the southern extent of the structure.

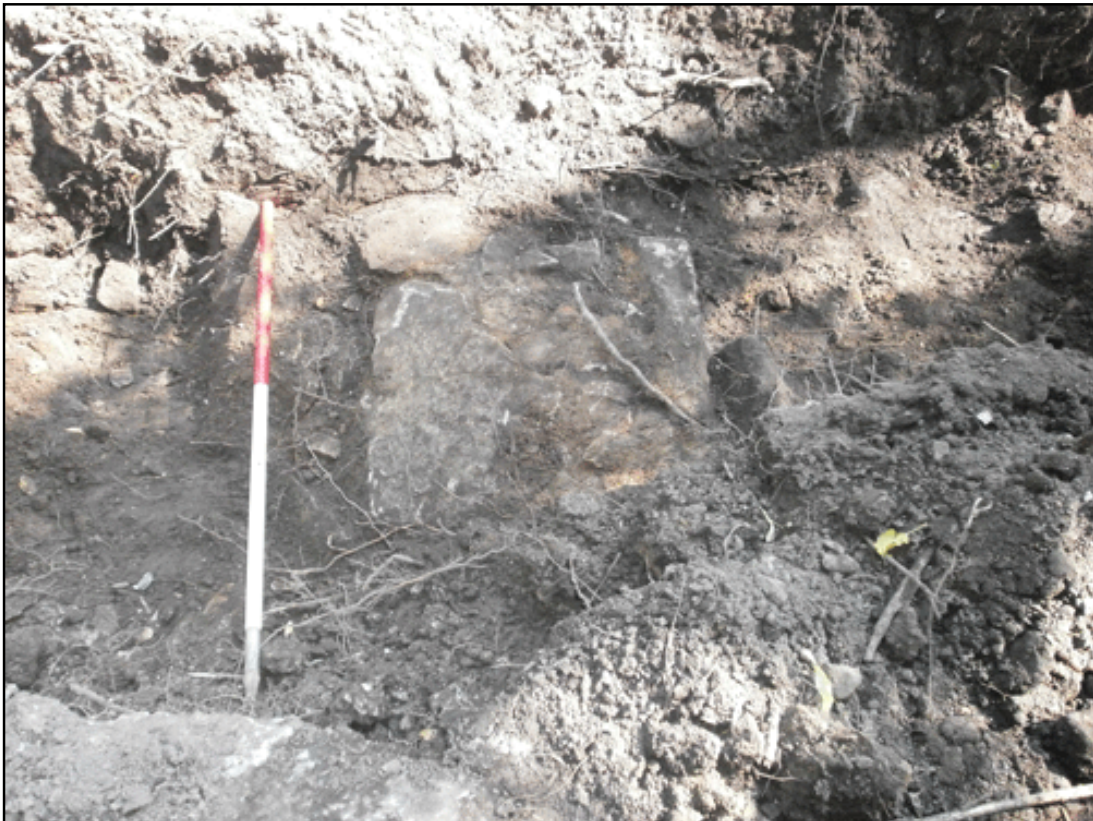
Figure 5b: Structure [041]

32. Two structures were found within this area, [041] and [042]. Structure [041] (figure 5b) was surrounded by deposit (017), and consisted of worked, rectangular, blonde sandstone blocks mortared with (049). The structure was two courses of a double-skinned wall with a rubble core, with straight even faces on both sides and was orientated north-south across the pipe trench. One modern pottery sherd was found below this structure, indicating a recent date of construction. The limits of excavation obscured the northern and southern extremities of the structure; it is possible the structure extended further south but it seems very likely to have been truncated by the modern manhole [043] to the north. It was truncated to the east by the previous line of the sewer pipe running from manhole [043]. Structure [041] was found at 0.5m

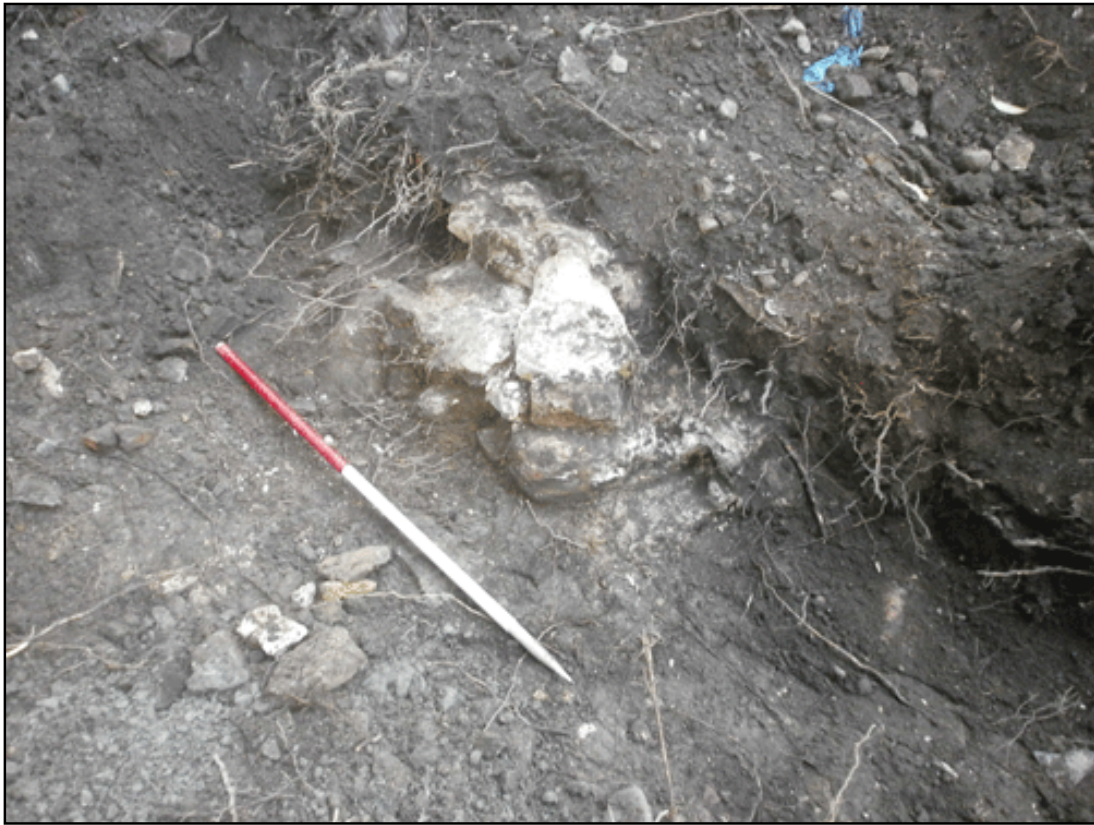
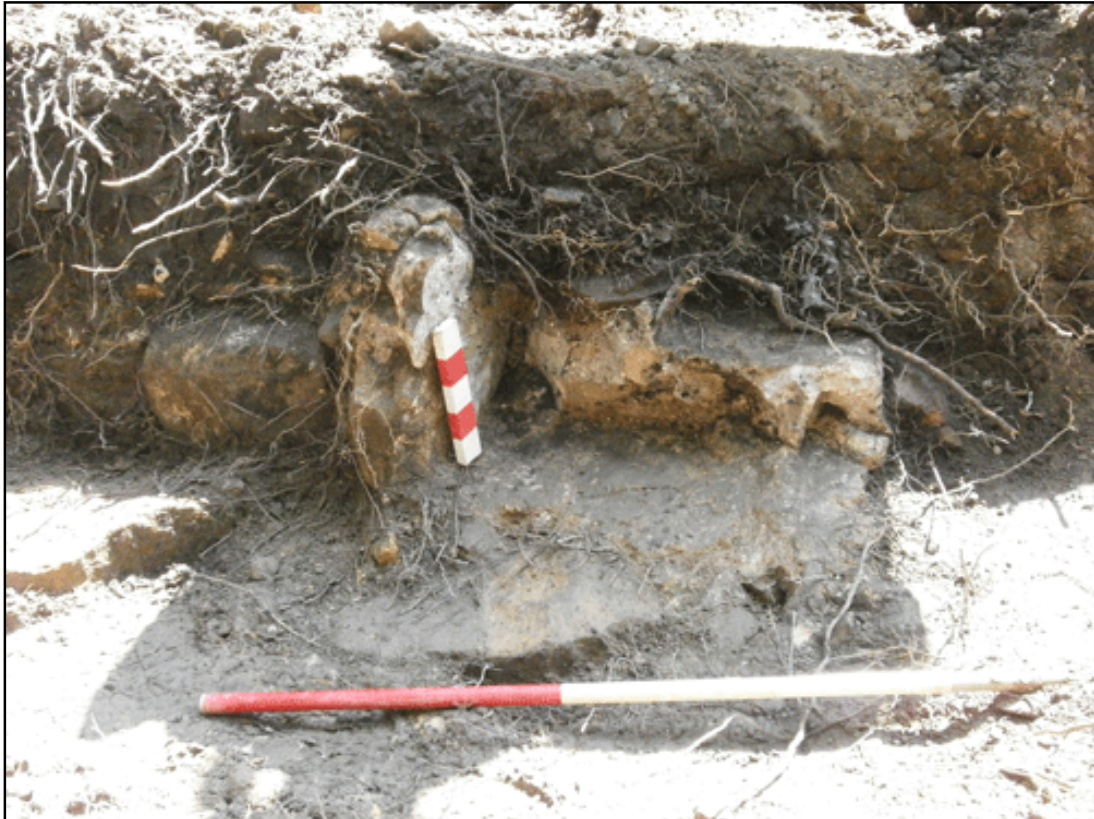
Figure 6a: Structure [042] pre-excavation

Figure 6b: Structure [042] post-excavation

33. Structure [042] was found east of [041], west of the bridge. It ran NNW-SSE across the trench, west of manhole [044]. The full extent is unknown; it is possible it extends further south outside the limits of excavation. The north side had been truncated by the plastic sewer pipe trench running from manhole [043] to manhole [044]. To the west and south-west it was truncated by the trench for the previous older pipe. The full extent of the structure is unknown; it is possible there were further courses below the depth of the limits of these excavations.

34. The structure was approximately 0.5m high as visible by 0.8m wide (figure 6a, 6b). It consisted of what appeared to be a rough conglomerate of unworked, blonde sandstone fragments bonded by mortar (047) and possible concrete (046). The date of the concrete is uncertain, but does not appear to be modern. An area of blonde sandstone was visible at the base of [042]; mostly obscured by a layer of mortar [047]. It is possible this is natural *in situ* bedrock, which has been incorporated into the structure. To the north of this structure, an area of possible bedrock (045) was exposed. This was visible in the south-facing section of the pipe trench. It appeared to be natural *in situ* blonde sandstone bedrock, and did not appear to have been worked. It was necessary to fully excavate the remains of [041] and [042] exposed within the pipe trench.

42. It should be noted at this point that despite the similar orientation of structures [041] and [042], there are differences in construction which are worthy of attention. The unusual character of the conglomerate which forms the basis of wall [042] comprises mortar, concrete and sandstone but no modern detritus. This is entirely different to the composition of structures [041] and [015]. It is therefore possible that these structures formed common elements of group of buildings, but wall [042] either pre-dates or post-dates structures [041] and [015]. Possibly wall [042] already existed, and the other elements were built up around it.
