Valleyfield, Fife: Historic Building Recording

Data Structure Report

RATHMELL  
ARCHAEOLOGY LTD

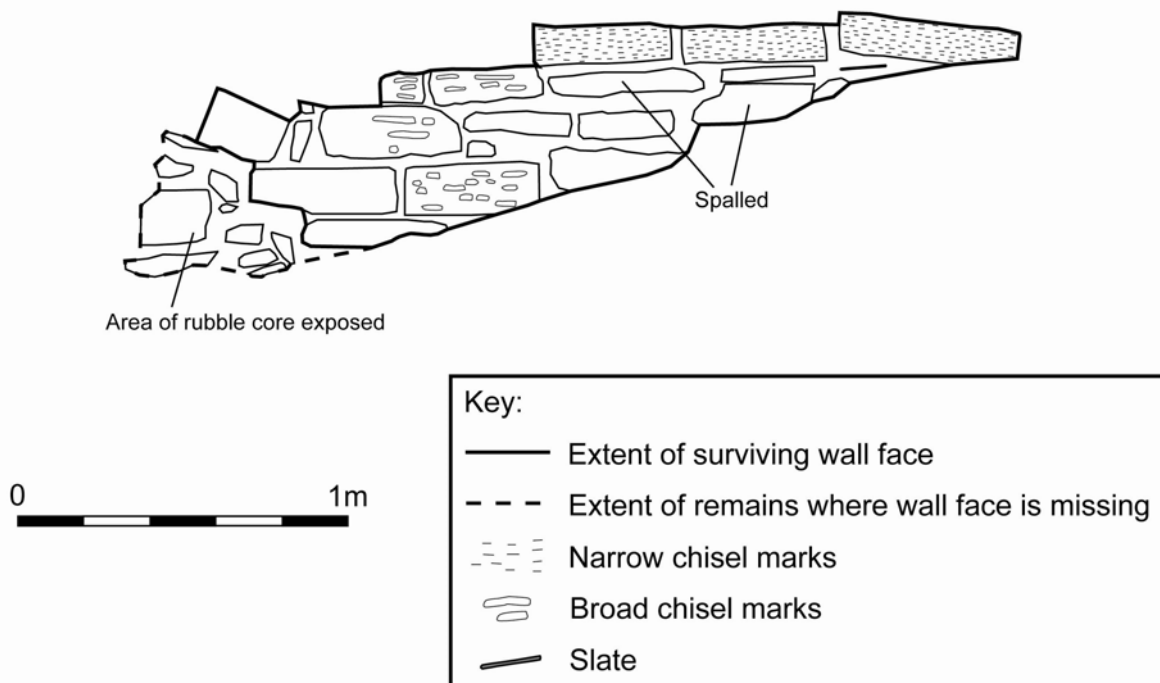
Figure 7b: Structure 1, West Stair: Elevation a (East-facing revetment)

39. The character of the revetment wall, represented by Elevations a, b and e, varied markedly across its extent. The eastern elevation, Elevation a (Figures 7a & b), survived in reasonable condition throughout, though the quoins had been displaced at the south end, and the coping stones were also absent in this location. The masonry comprised 4 courses of coursed rubble, with no mortar present. Each block had been roughly squared, and the faces coarsely finished by way of horizontal broaching. Two sizes of chisel had evidently been used in dressing the stones, a narrow-bladed form and a broad-bladed form, as shown in Figure 7b. In some places, the surface of the rubble blocks had been obscured by moss, while in several examples, the surfaces had entirely spalled due to environmental damage. Fragments of slates were occasionally to be found, bedded within the existing mortar.

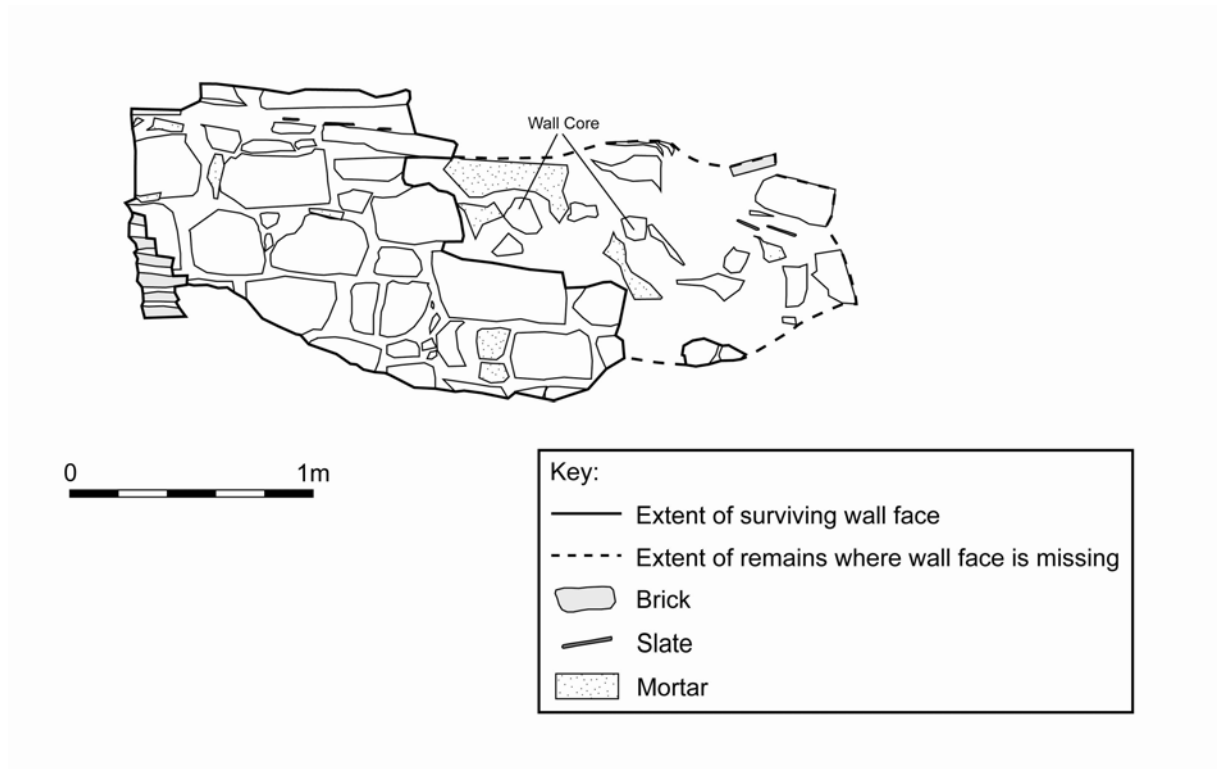
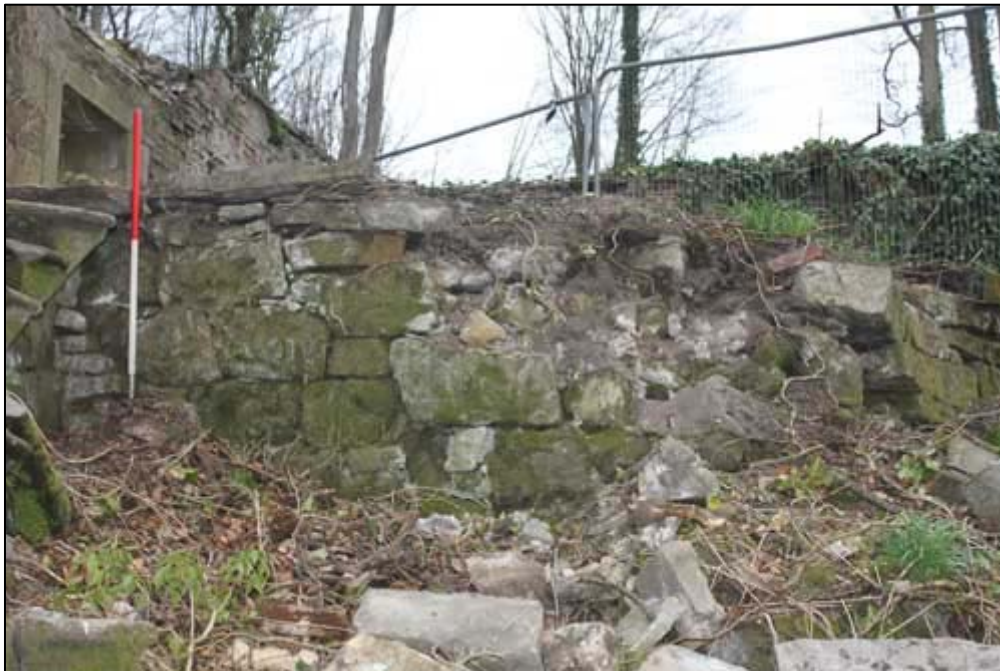
40. Elevation b formed part of the south revetment wall of the feature (Figures 8a and b). It survived in poor condition, with around half of its fabric absent, including the quoins at the east end (abutting Elevation a). In the fabric that survives, it is possible to identify the lines of possible courses, but these appear to be less well-defined than those surviving on Elevation a. Also of interest was a small section of hand-made bricks which abutted the adjacent Elevation c (east staircase) and obscured part of Elevation b to the rear. These bricks did nothing to enhance the structure visually (c.f. Structure 2, Elevation b) but they may have had a functional use in helping to support the adjacent stair,

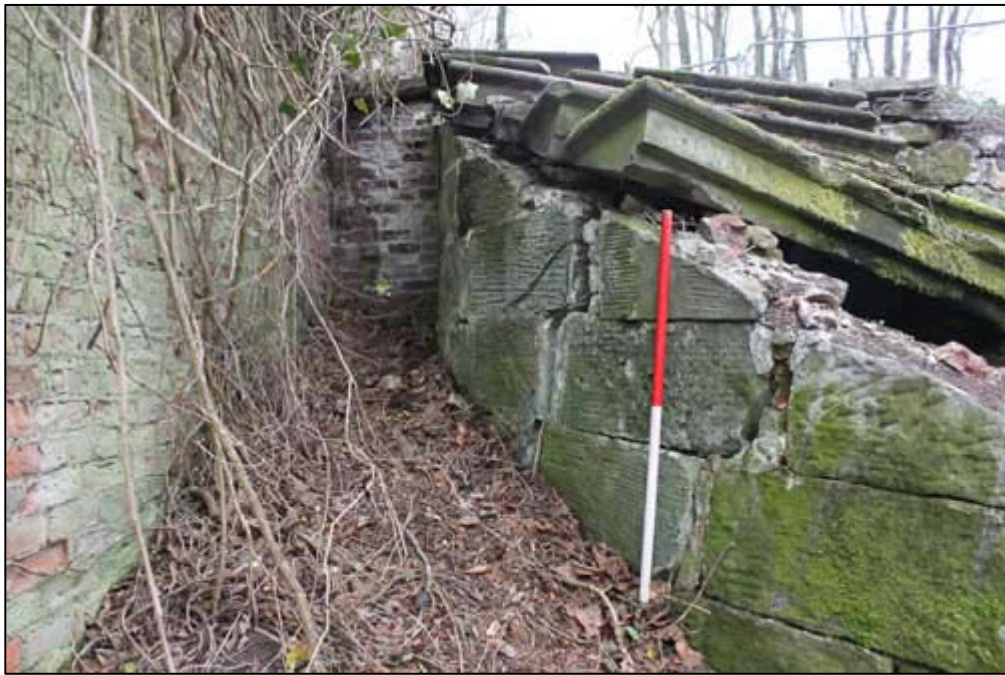
Fig. 9a: Structure 1, West Stair: Elevation e (South-facing revetment)

41. The third elevation of the revetment was Elevation e (Figures 9a and b). This elevation had to be hand-drawn, as access for the machine was limited due to the narrow nature of the gap between the western wall of the stair and the nearby boundary wall of the Flower Garden. This elevation was composed entirely of hand-made bricks, standing to a height of 17 courses. This was considerably lower than its counterpart on Structure 2 (East Stair) which suggested that a significant amount of soil may have built up here, obscuring the lower courses. Some spalling of the outer surfaces of the brick had occurred, and there was evidence of re-pointing in places, concentrated in particular in the lower western corner. This repair work appeared to have been carried out using cement, as opposed to lime mortar, and the modern pointing could be distinguished by its darker greyish hue.

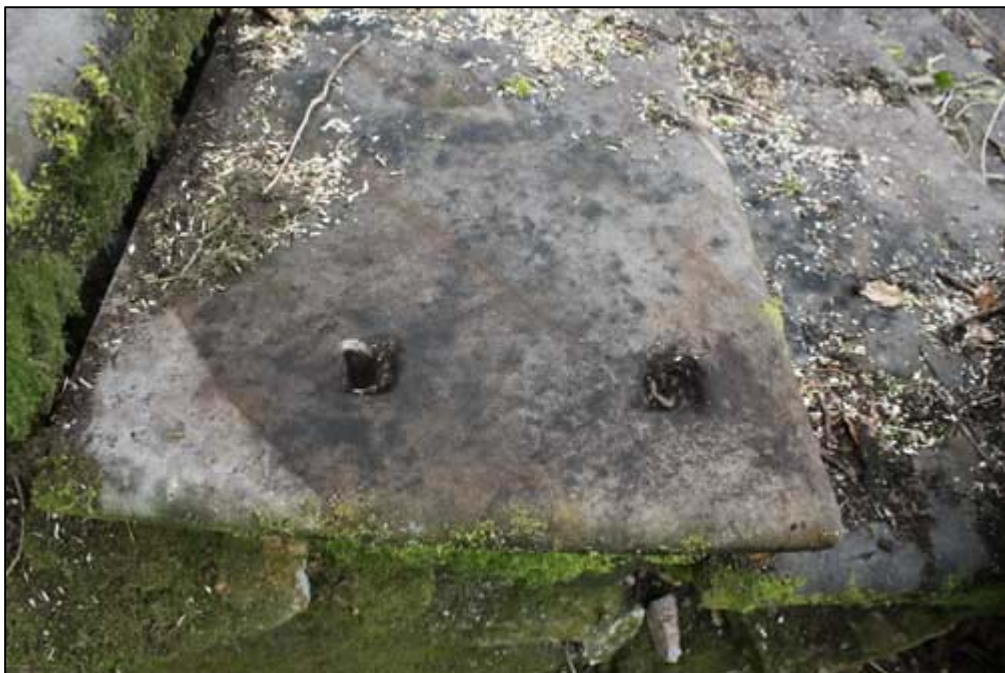
Figure 10b: Structure 1, West Stair: Elevation d – Remains of Iron Bannister Rail

42. The second element of the structure was the stair itself, which abutted the south edge of the revetment wall and then curved smoothly round to the east. The steps were made up of individual wedge-shaped blocks sandstone, of which twelve remained *in situ* with several displaced examples surviving nearby. Each step had been polished to a fine smooth finish with rounded edges to front and sides and two mouldings beneath, the upper beaded, the lower squared (Figure 10a). Originally, iron banister rails ran down either side of the stair – the stumps of these still survived *in situ* (Figure 10b).

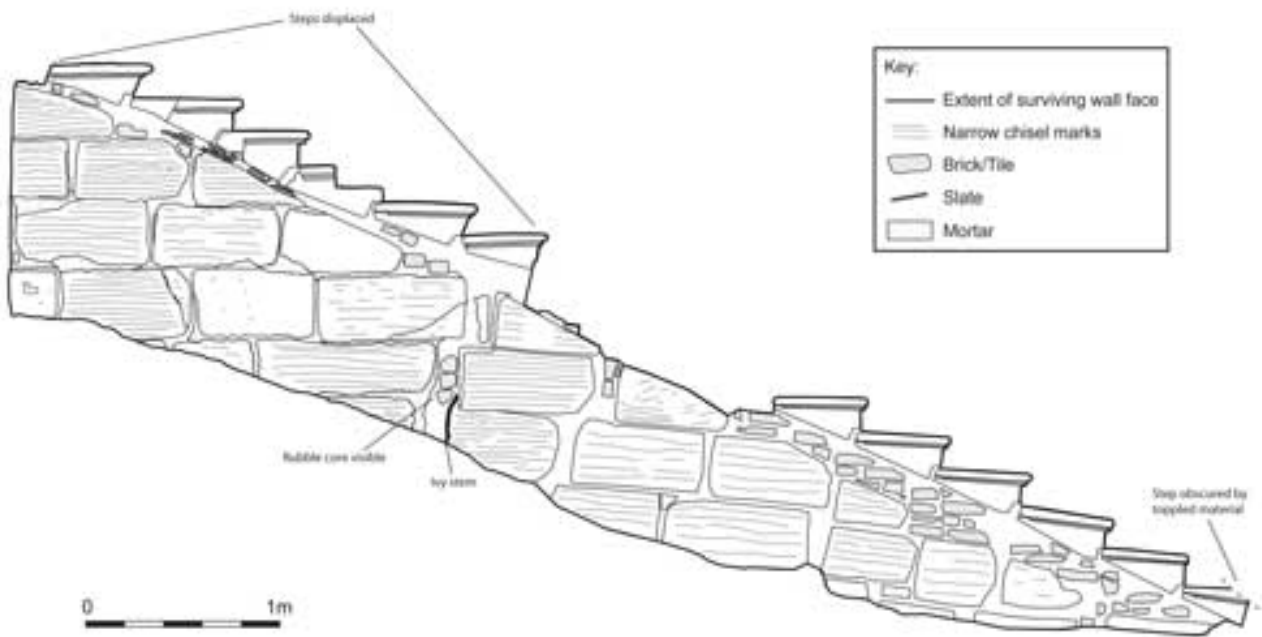
Figure 12a: Structure 1, West Stair: Elevation d (South-facing revetment)

45. Elevation d was much larger in extent than Elevation c, representing the external edge of the curve (for a general view, see Figure 9a, and Figure 12a). Here the north end had to be hand drawn due to the cramped and overgrown conditions which prevailed between this particular elevation and the adjacent enclosure wall. The individual blocks which made up this elevation were all squared and most showed horizontal droving (again undertaken by a narrow-bladed chisel) over their faces. They were also extremely large, measuring up to 0.6 x 0.4m in extent (Figure 10b). This elevation had evidence of substantial cracks in places, probably caused in response to the shifting of the slope on which it sat. The occasional small blocks which were present in the elevation may represent earlier attempts to combat this slumping of the structure, and it may also be the case that the numerous small fragments of brick and slate which are used to raise the level of the steps at the lower, south, end of the structure represent a similar attempt to repair the steps in response to changes in ground level.

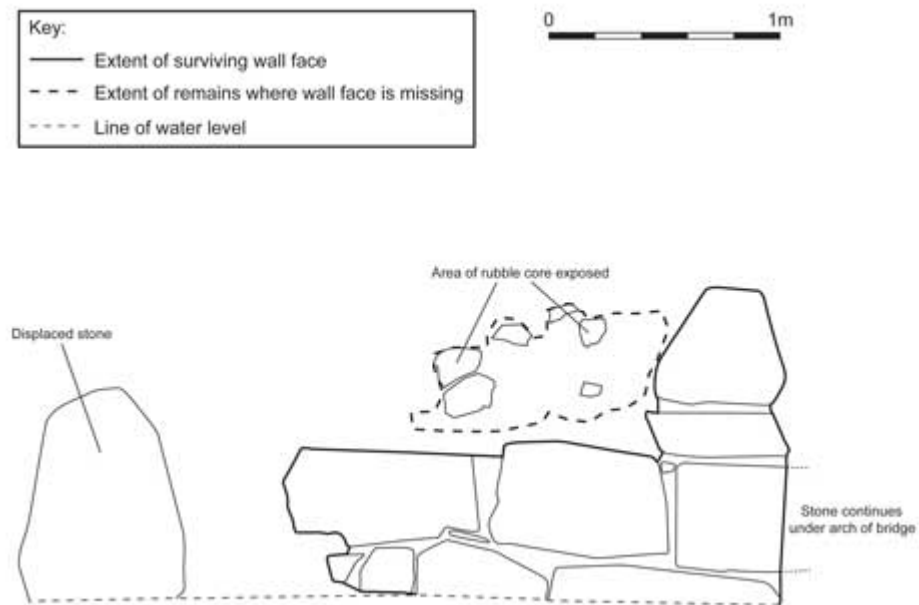
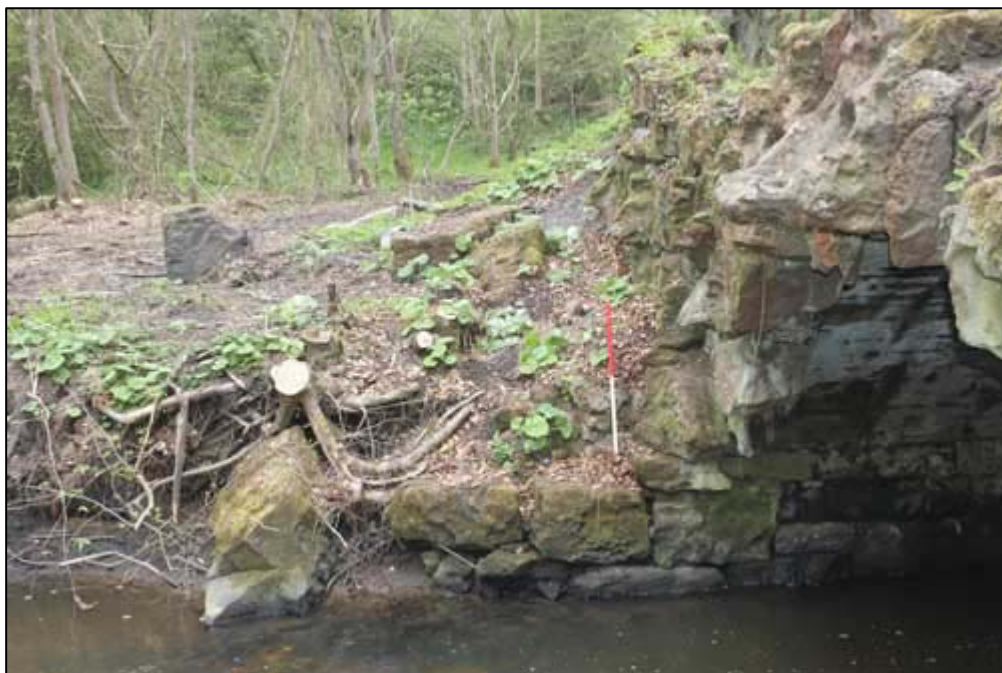
58. The main bridge structure also incorporates four revetment walls, created to help secure the banks on either side of the bridge structure. Their conditions varied throughout. On the south side of the bridge, the east revetment (Elevation b) survived in good condition reaching a height of four courses (Figures 23a & b), while the west revetment (Elevation c) had been subject to substantial collapse and was now only partially complete (Figures 24a & b).

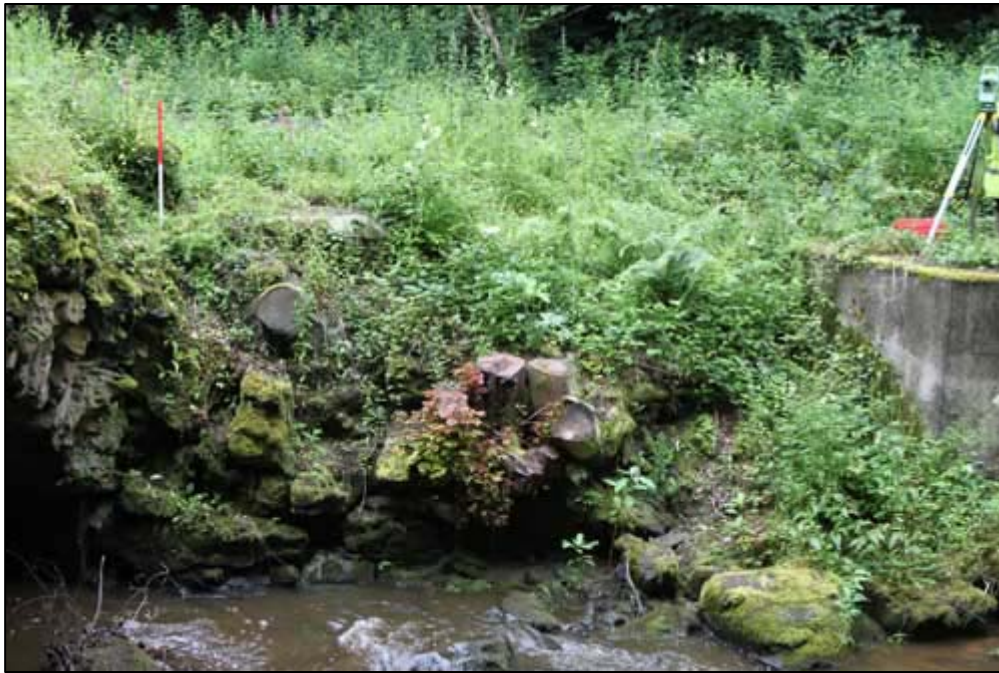
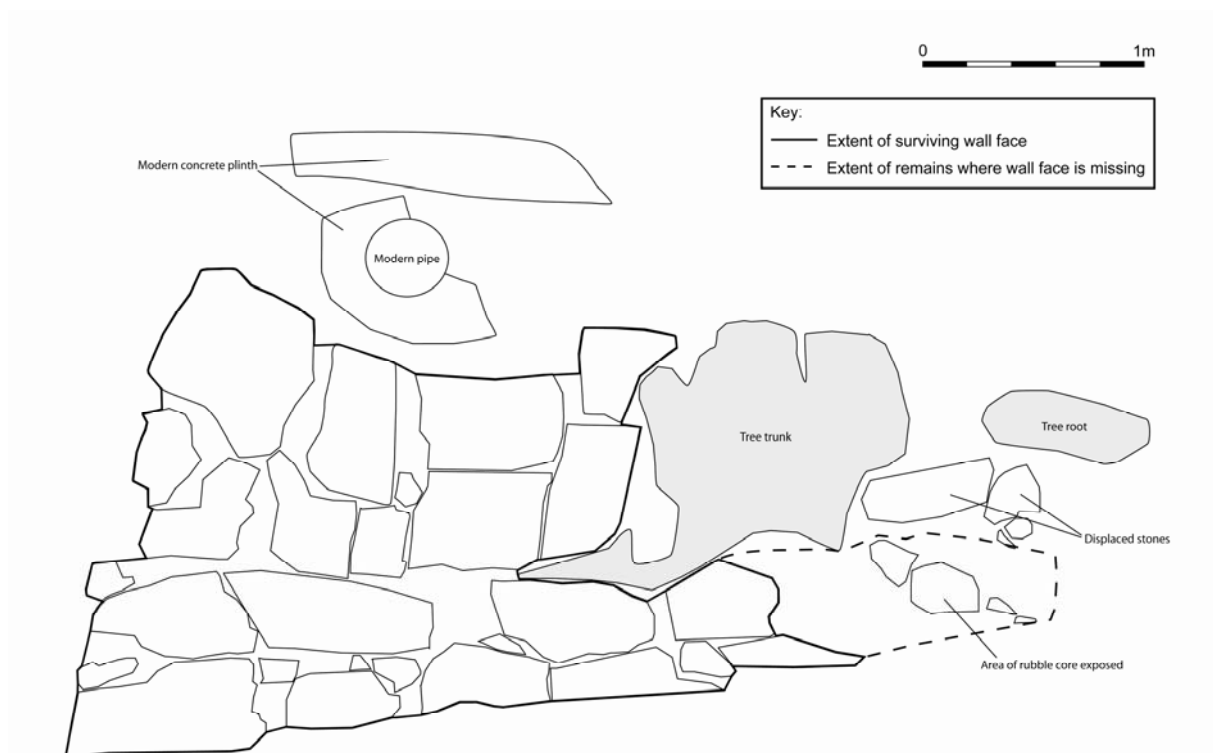
65. Elevation c (Figures 30 a & b) survived in much better condition, comprising a coursed rubble revetment which survived to a height of four courses. The masonry was heavily rusticated, with individual blocks varying in size. The largest measured 0.7m x 0.4m in extent, but the majority were much smaller. Some disruption of the upper courses had been caused by the growth of a tree on the bank in this location, and the wall face was itself much obscured by vegetation.

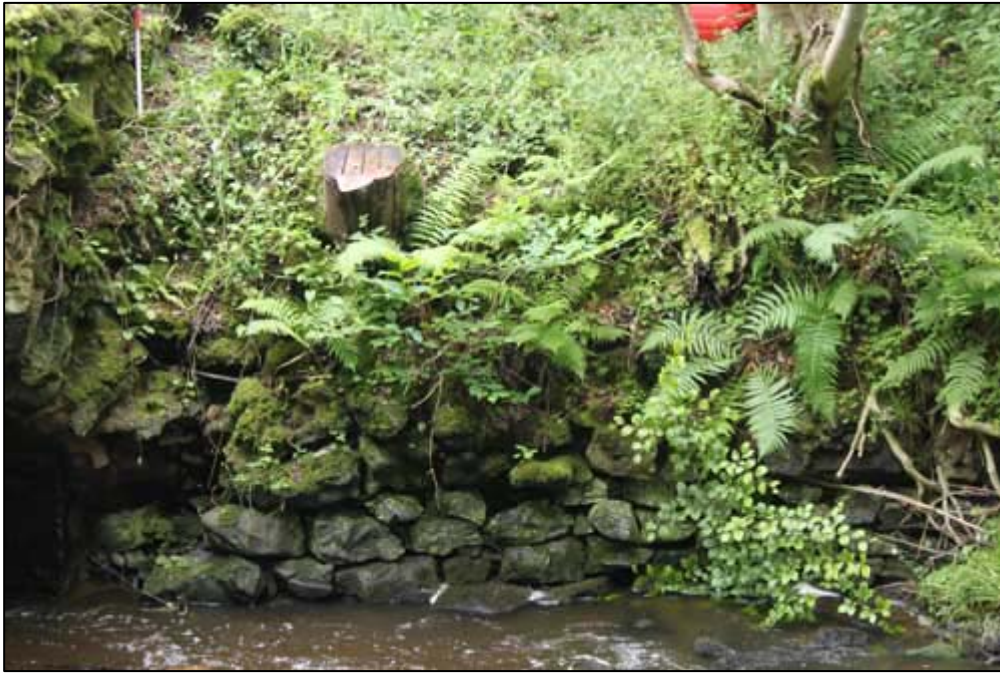
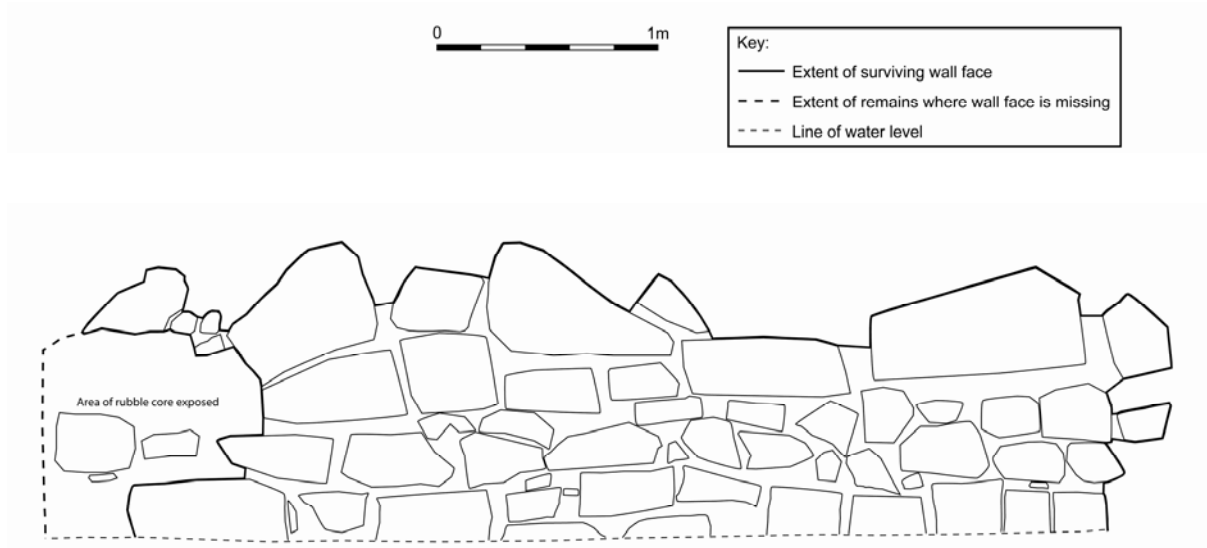
66. On the west side of the bridge, Elevations e and f displayed similar variation in their condition. The south west elevation, Elevation e, survived in excellent condition (Figures 32 a & b), and appeared to merge into a longer stretch of revetment wall which extended further up the west bank of the Bluther Burn. Only the stretch lying closest to the bridge and forming the bridge revetment was recorded, in keeping with the scope of the works. Rusticated blocks of sandstone was used throughout, forming four rough courses, again with sizeable blocks used in places, measuring up to 0.6 x 0.4m in extent. One facing stone was missing: this would have lain immediately adjacent to the main face of the arch (Elevation d).

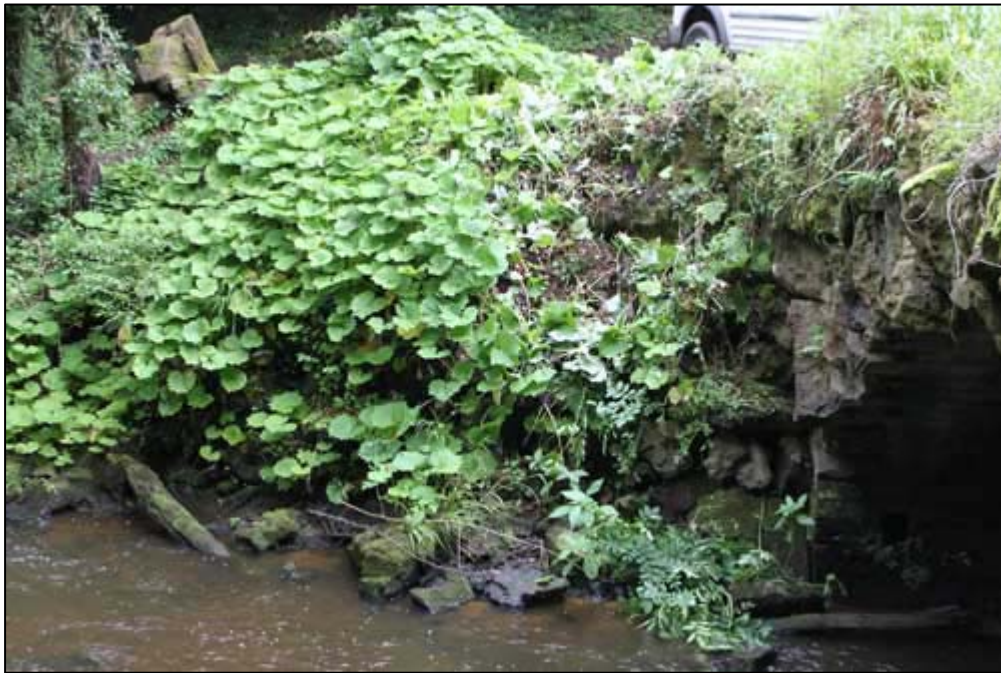
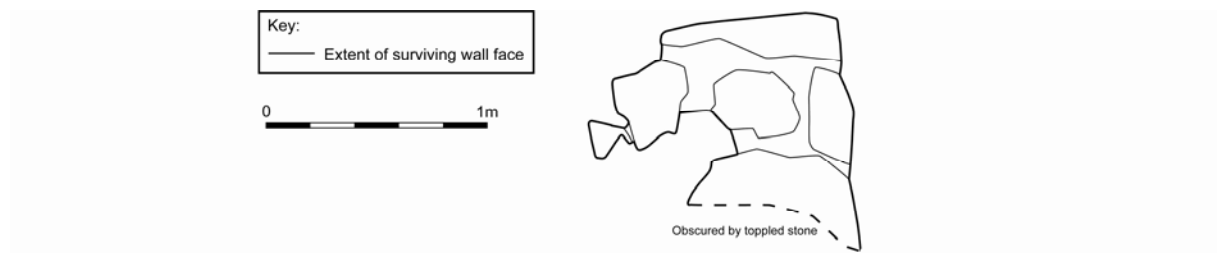
67. The final elevation, Elevation f (NW revetment) was much less well-preserved. While four courses survived in vestigial form, the walling was absent over much of its length, with large voids and tumbled blocks providing evidence of displacement (Figures 33 a & b). Again, there was evidence of rustication, and the larger blocks appear to have been roughly squared off, with the largest measuring 0.7 x 0.3m in extent.

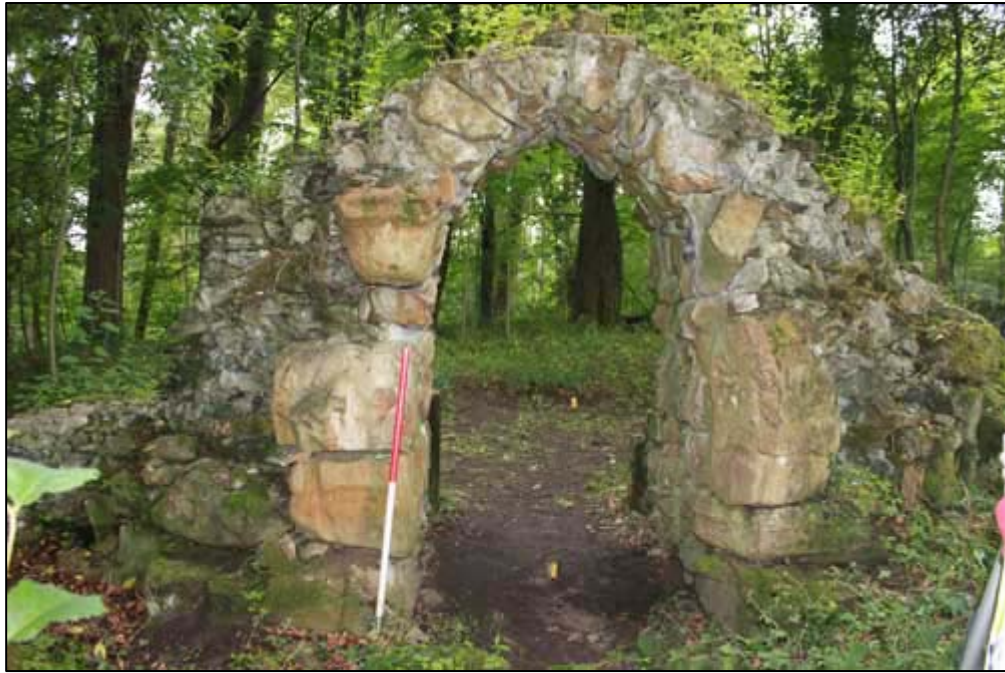
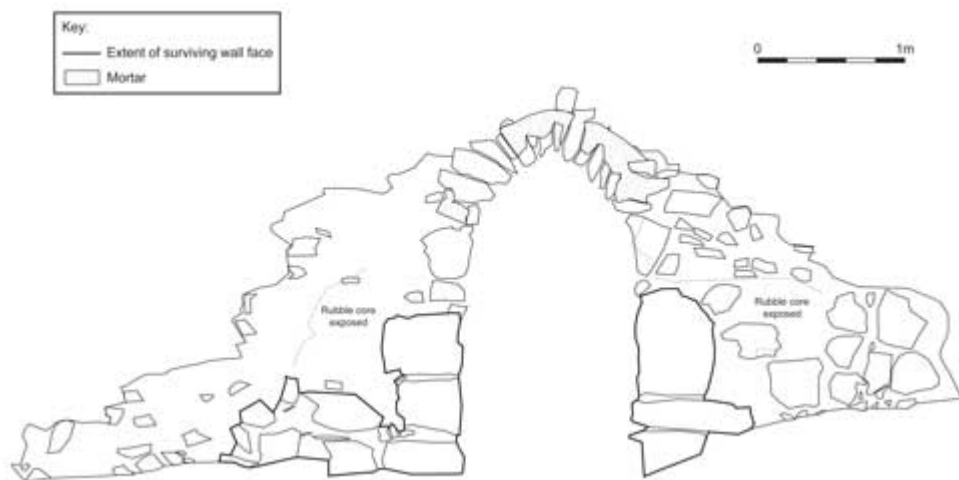
73. Elevation b, the south-west facing wall, is similar in many respects (Figures 36a & b), though the broached masonry is absent here, and the large facing stones instead show signs of rustication, suggesting perhaps a transition from the ordered, 'artificial' world beyond the ha-ha to the natural 'rustic' world beyond.

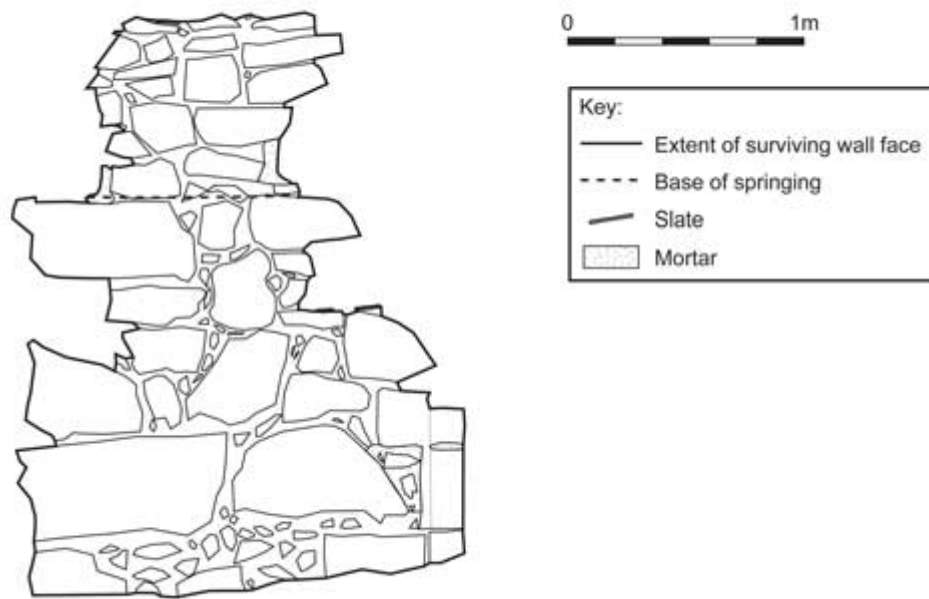
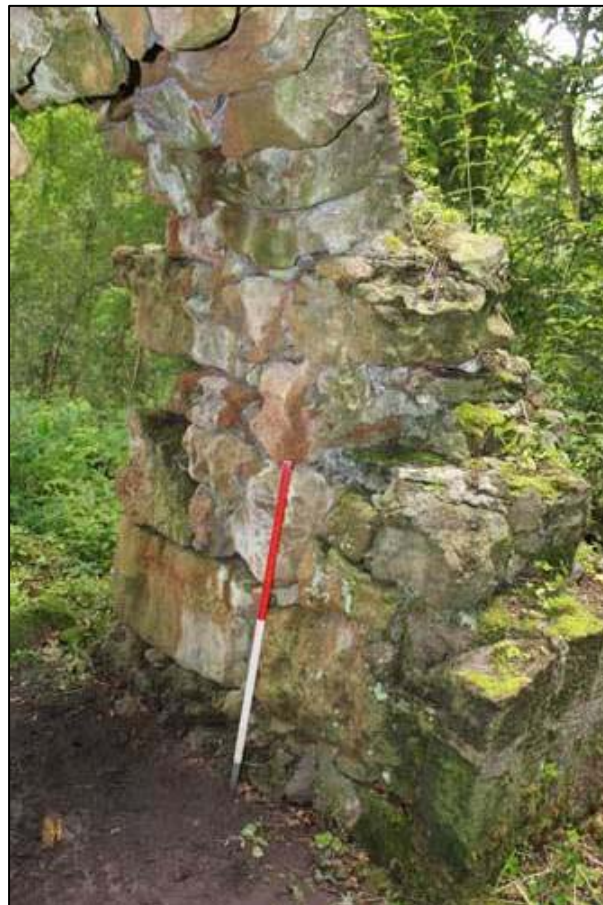
75. In both elevations, the wall faces remained straight for a height of approximately 1.5m before the springing for the arched opening began. On Elevation c, this was at a height of five courses (Figures 37a & B), while on Elevation d, 6 courses were evident. The external faces of the outer voussoirs which defined the arch were again heavily rusticated, the arch itself quite pointed in character. On both elevations, the outer facing stones of the basal courses were broached as opposed to rusticated, in keeping with the general character of the masonry in this particular location.
