**Catrine Weir, Catrine, East Ayrshire:
Archaeological Mitigation**
Data Structure Report

issued 30th April 2012

1. This Data Structure Report is for archaeological works required by Catrine Community Trust, in support of the emergency repair works recently undertaken to the historic fabric of Catrine Weir, a Scheduled Monument (No. 5670) protected under the Ancient Monuments and Archaeological Areas Act 1979. These archaeological works were designed firstly to mitigate any adverse impact on the archaeological remains during the repair works (Turner, 2012), and secondly, to meet the terms of Historic Scotland, who have issued Scheduled Monument Consent as part of Ancient Monument Grant conditions (Ref. No. AMH/5670/1/1.pt. 3.2).

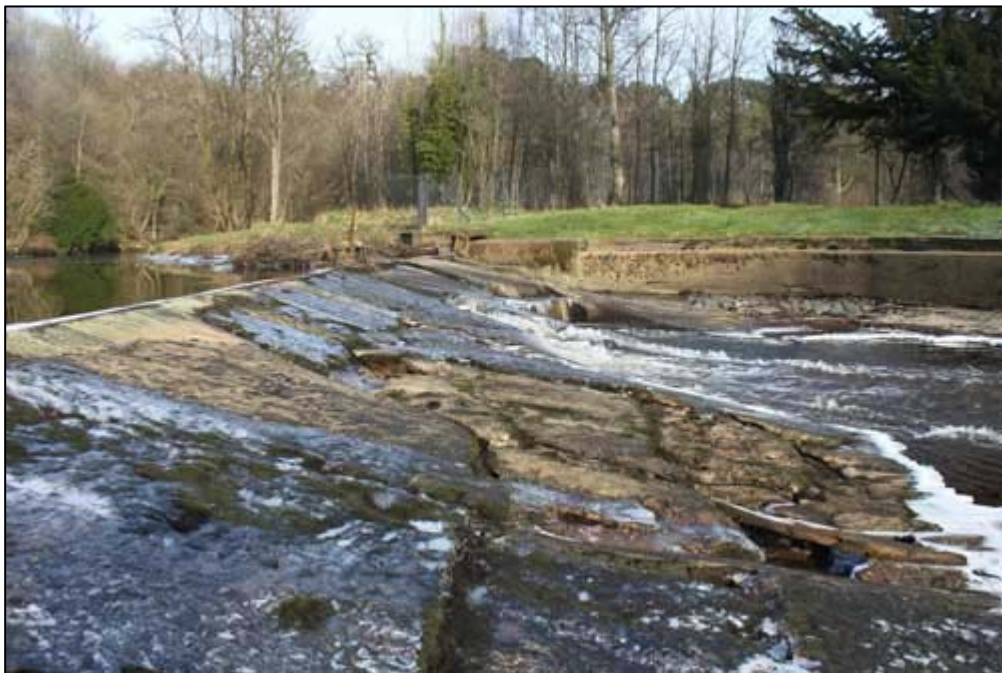
Figure 1b: View across Spillway with Voids visible

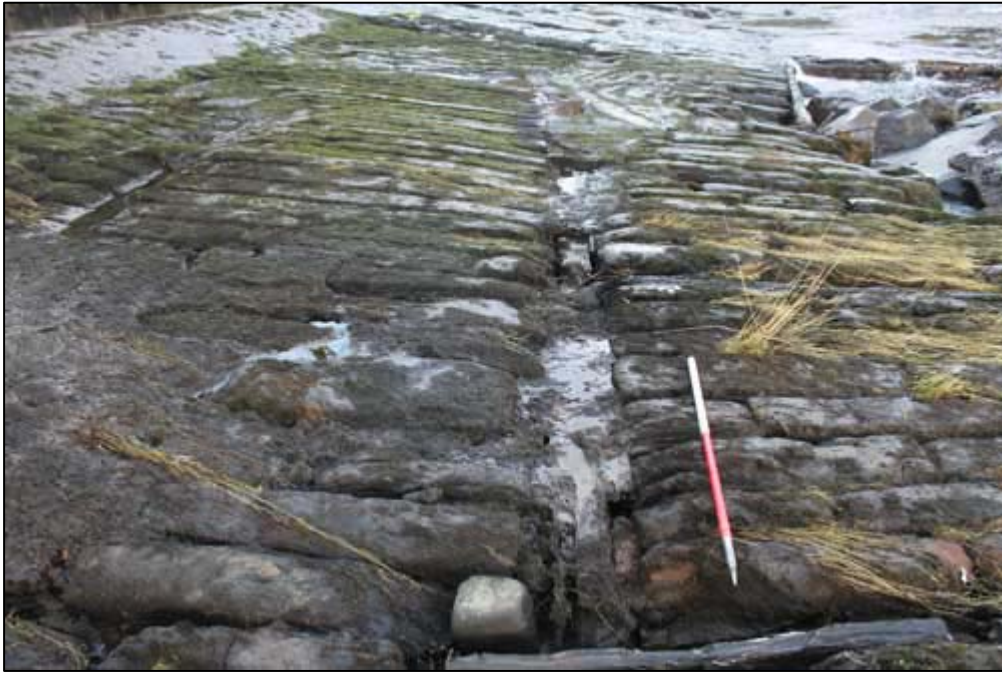
Figure 3a: View of Spillway, showing details of Original Fabric

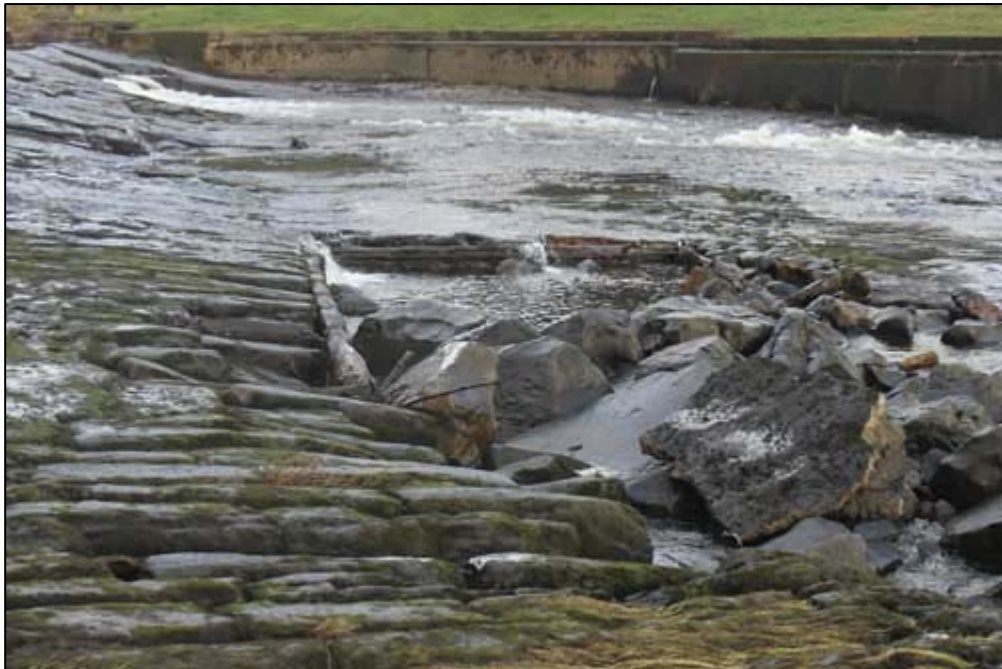
19. This area, located at the western edge of the spillway near the southern limits of the weir, was the first to be excavated on the 16th January, 2012, in bright, clear and very cold conditions. The void was rectangular on plan, measuring approximately 2 x 3m in extent (Figure 3b).

Figure 3b: Trench 1 ('Void 1') – Pre-Excavation, viewed from SSW

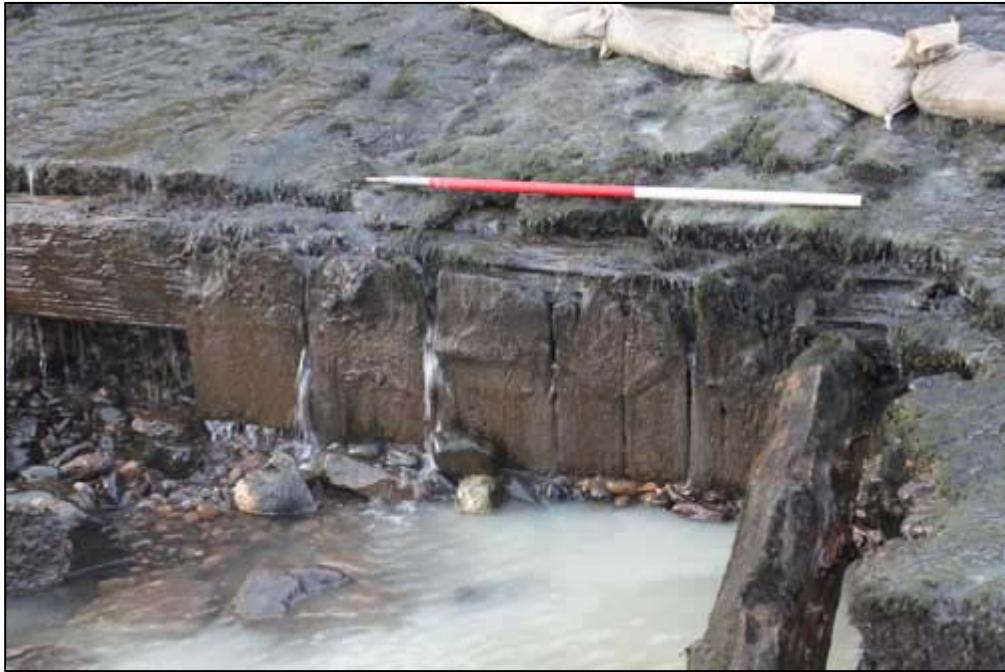
20. Extant timbers survived on the north, east and west sides of the trench, with the original fabric completely absent in the east. The condition of these timbers varied greatly, however, according to their location. Along the western edge (Figure 4a), the rectangular-sectioned timber which defined the N-S edge of the crib was still furnished with timber shuttering on both sides over at least half of its exposed length. This shuttering comprised roughly-shaped lengths of timber planking, measuring 0.3m wide and 0.4m deep, fixed in place by roughly-shaped hand-cut iron nails.

Figure 4a: Trench 1: *In Situ* Timber Shuttering on N side

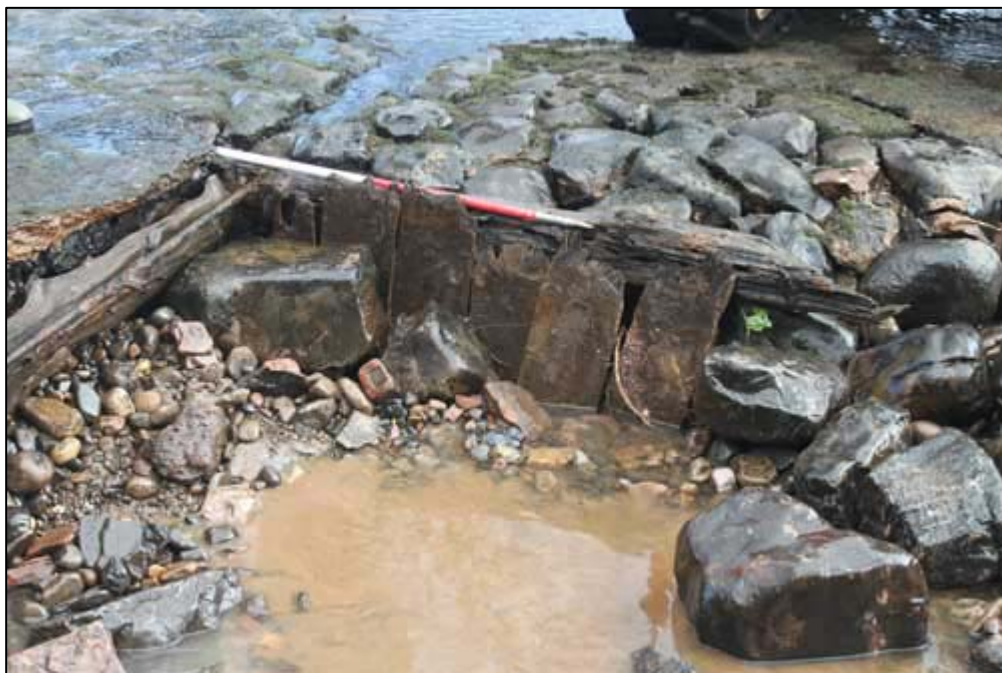
21. Similar shuttering also remained *in situ* along the eastern edge of the trench, though here it was in much less robust condition (Figure 4b). Many of the planks were loose, with the upper edges eroded to such an extent that the nails and nailholes were now absent. All of this intact shuttering occurred on the west side of the timber frame: on the east side no shuttering survived, in an area where the squared sandstone setts of the spillway had also been replaced by unworked whinstone boulders.

Figure 4b: Trench 1: *In Situ* Timber Shuttering on S Side

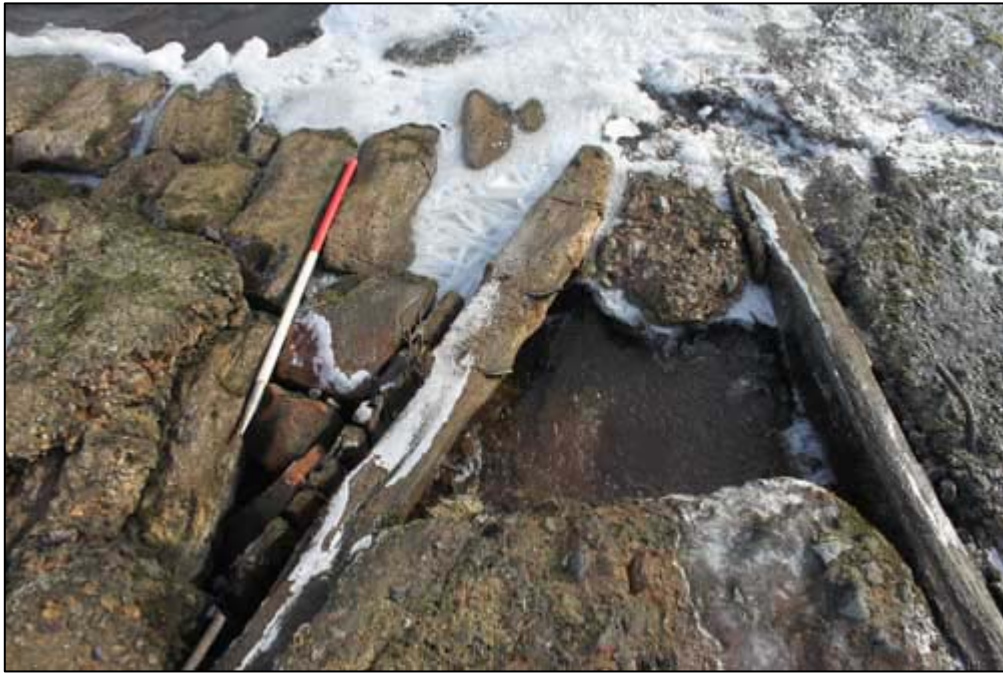
25. Trench 2 was of interest on account of the two converging spars which defined the limits of the trench/void and which formed part of the original weir structure. The reason for this unusual shape is not obviously apparent, though it seems likely that the timbers here may have been constructed in this fashion to create a cross-member which gives added strength to the structure in this location. It is assumed that in its original form, the converging spars would have been adjoining, and pinned together at the E end with hand cut nails. This part of the structure has now been lost.

Figure 6a: Trench 2, Viewed from WNW

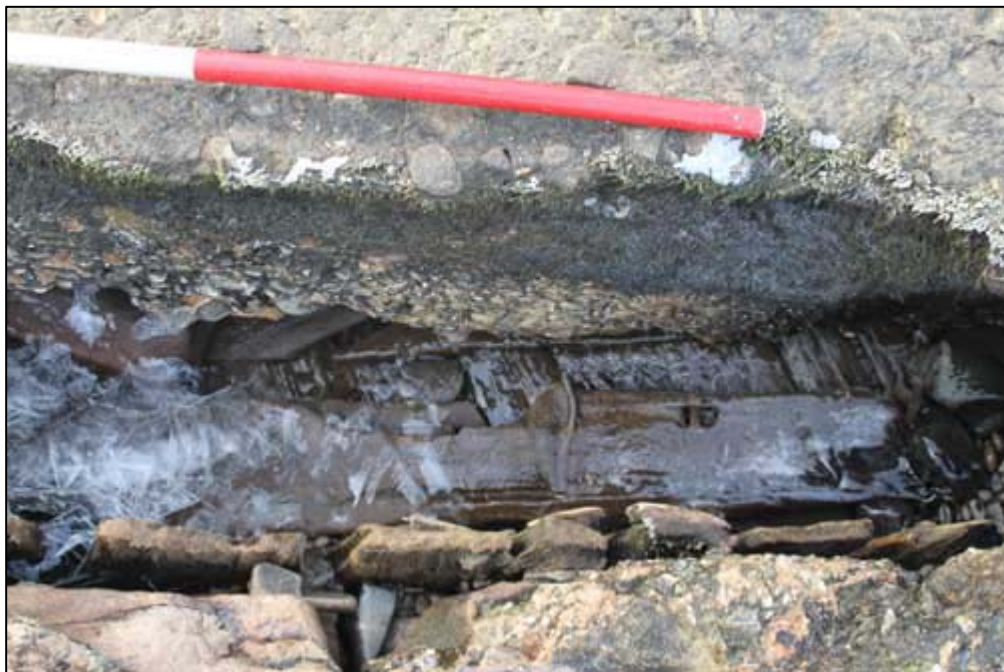
Figure 6b: Unnumbered Void to NW of Trench 2, showing Basal Layer of Timber Planking

37. A departure from the structural norm described by Murdoch was identified in a small void lying to the north-west of Trench 2. Here there was glimpsed a basal layer of flat timber planks, forming a platform beneath what would originally have been the level of the setts. The setts had been removed and replaced by concrete, but the original timber spar was still in place and the timber 'platform' - which had individual planks running parallel to the weir crest - clearly underlay this structural element of the nineteenth century weir.

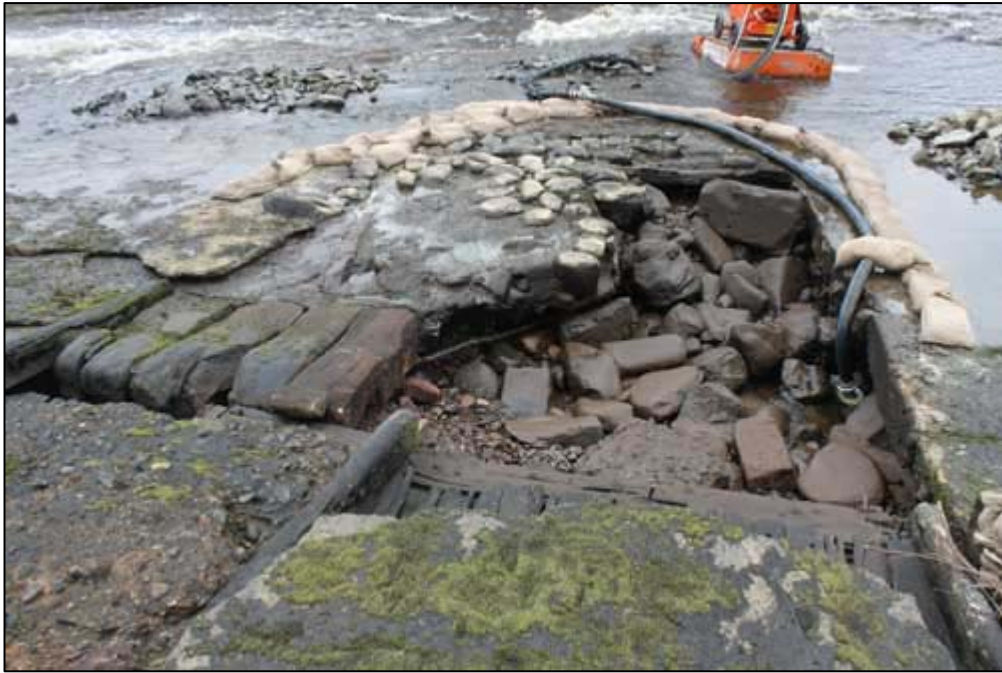
32. Beneath the timber platform, in the area supported by the three perpendicular beams, there was merely a void, with no evidence of gravel infill. However, the structure had been subject to later damage and modification, probably undertaken in association with consolidation works. The sloping spars had been sawn off virtually flush with the surviving structural remains and, given the presence of sandstone setts in the area lying immediately to the NE, it can be surmised that any additional portions of the weir structure occurring here were in such a poor state of repair that they were either deliberately removed at this time or subject to later destruction through erosion. While the underlying void may also have been packed with gravel during the original construction of the weir, thus supporting the overlying timber platform, any such bedding material has now been washed away.

Figure 6a: View of Trench 3 from WNW, post-excavation

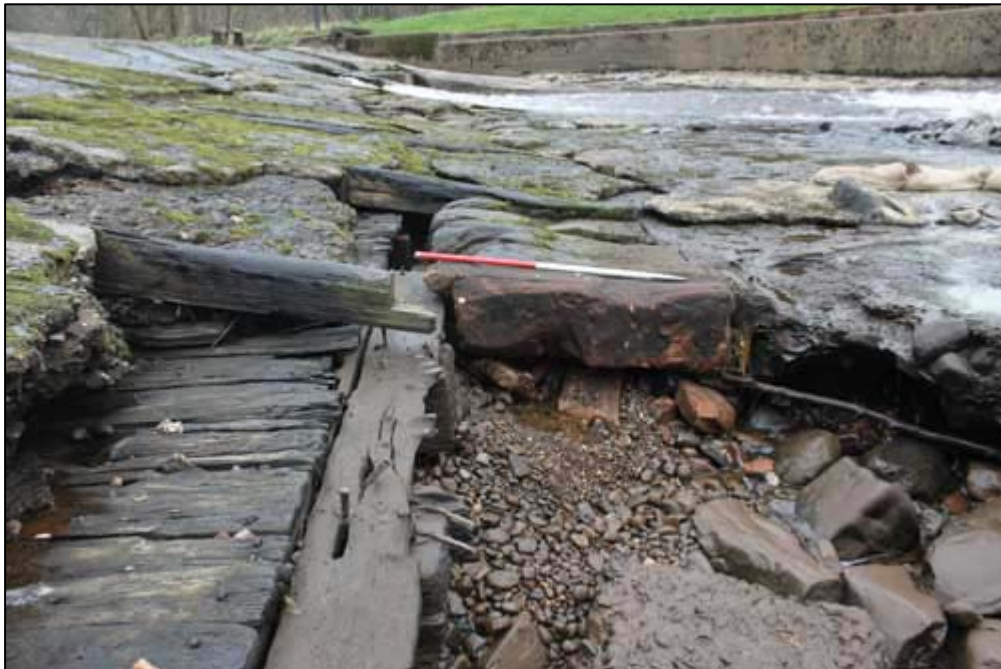
31. Beneath the sloping timber spars which could be identified on the surface of the spillway, there was a level surface formed by a horizontal row of roughly-squared timber planks, each measuring roughly 0.28m in width and running perpendicular to the line of the weir crest. These were affixed to a sleeper beam along the E edge by hand-cut iron nails, with 2 nails used per individual plank (Figures 6b and 7a). This sleeper beam was, in turn, supported by two rectangular-sectioned planks located below the upper sloping spars, and a central square-sectioned beam measuring 0.35 x 0.35m in extent (Figure 7b), again running perpendicular to the weir-crest.

Figure 6b: Trench 3: S-Facing Section showing Level Surface of Horizontal Timber Planks

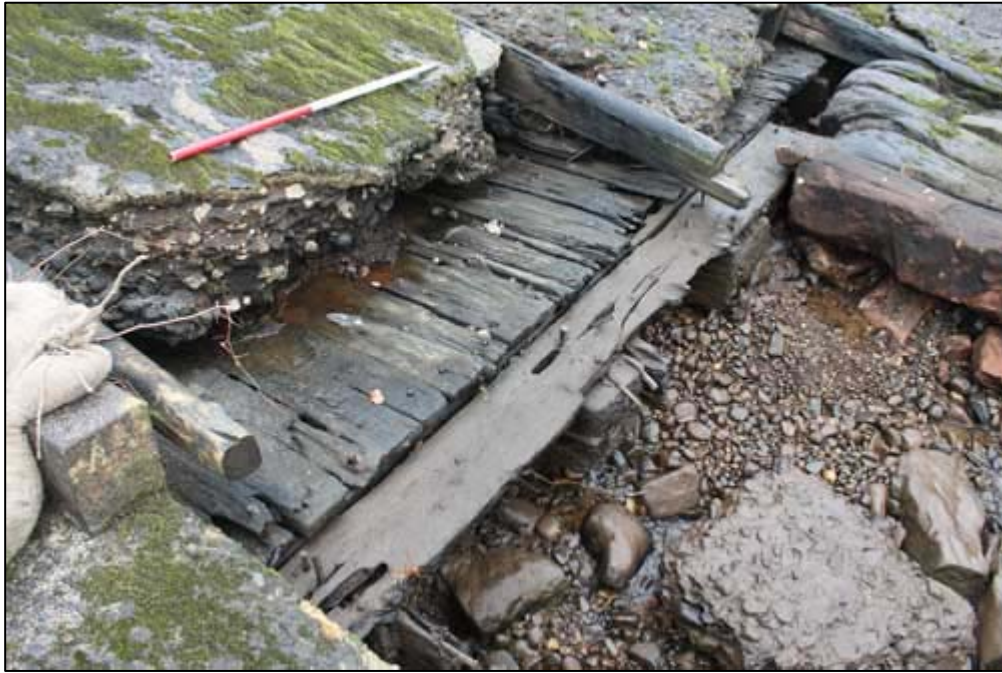
Figure 7a: Trench 3, Horizontal Timbers and Supporting Members, seen from S

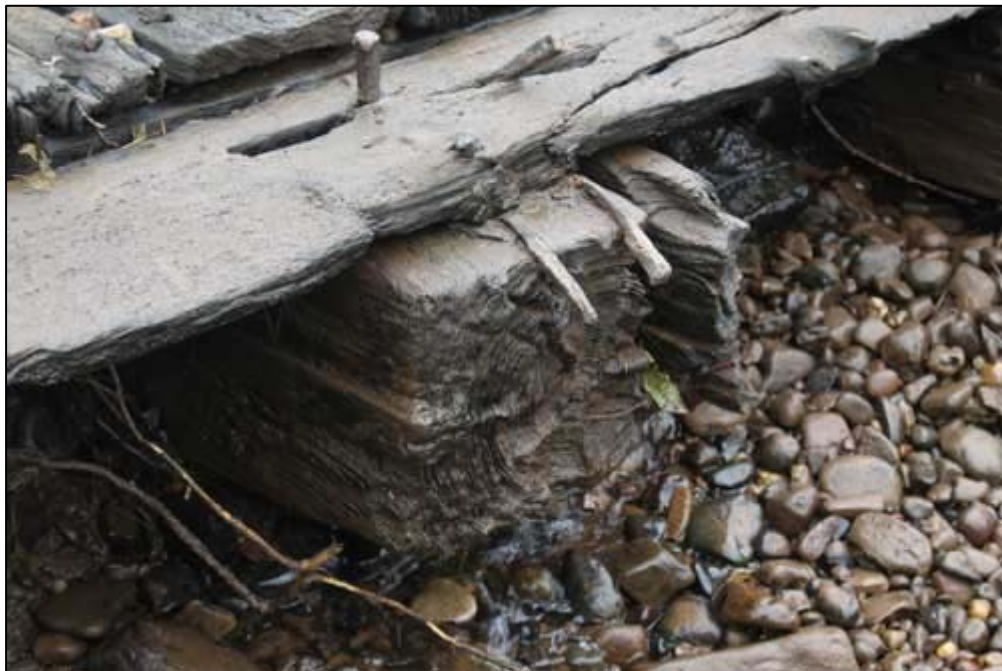
Figure 7b: Square-sectioned Post forming support for Timber Floor
