Brandon Cottage, Tiree: Archaeological Mitigation

Data Structure Report

by Diane Gorman

issued 23rd February 2012

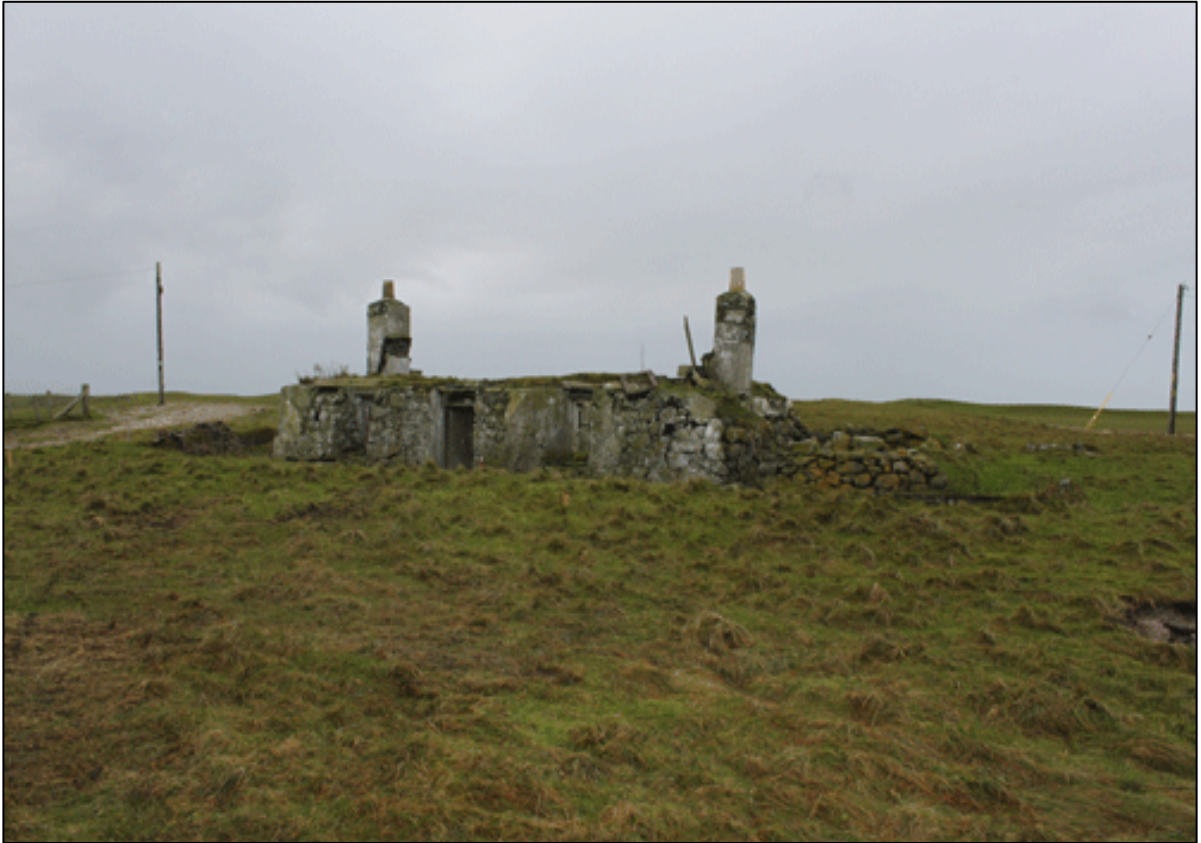
13. Brandon Cottage was rectangular in plan, measuring three by one bays, with an additional unroofed enclosure located at the northwest end (Figures 2 & 3a). The structure was ruinous, with only the ground floor remaining and the roof collapsed; fragments of the roof remained attached to the structure, and amongst the general modern debris within the interior. The quantity of debris was such that recording was limited in areas.

Figure 3a: Brandon Cottage, northeast elevation

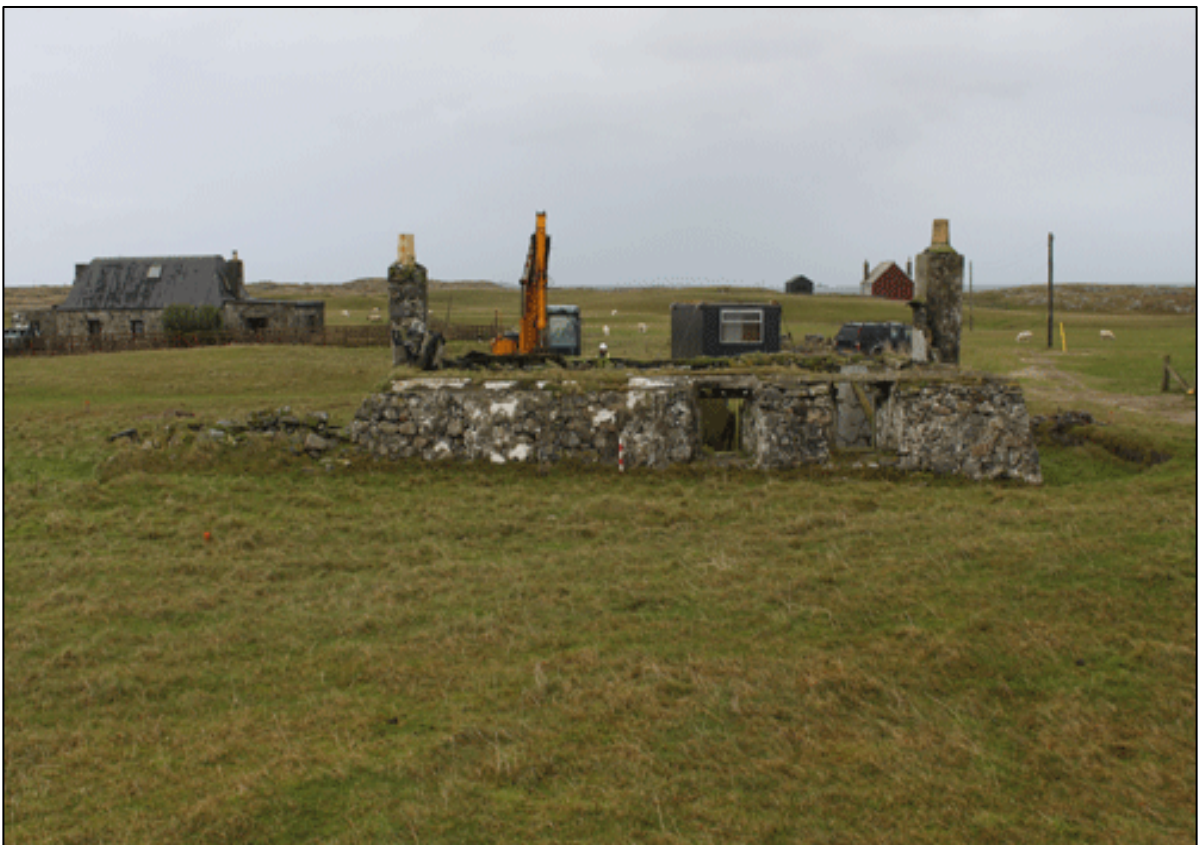
Figure 3b: Brandon Cottage, southwest elevation

22. Due to the structure's proximity to the shore, it was subject to strong winds blowing in from the Atlantic Ocean from a south-westerly direction. This resulted in a build-up of wind-blown sand at the south-western/western side of the cottage, to such a height that the current ground level sat just below the exterior window sills on the southwest elevation (Figure 3b).

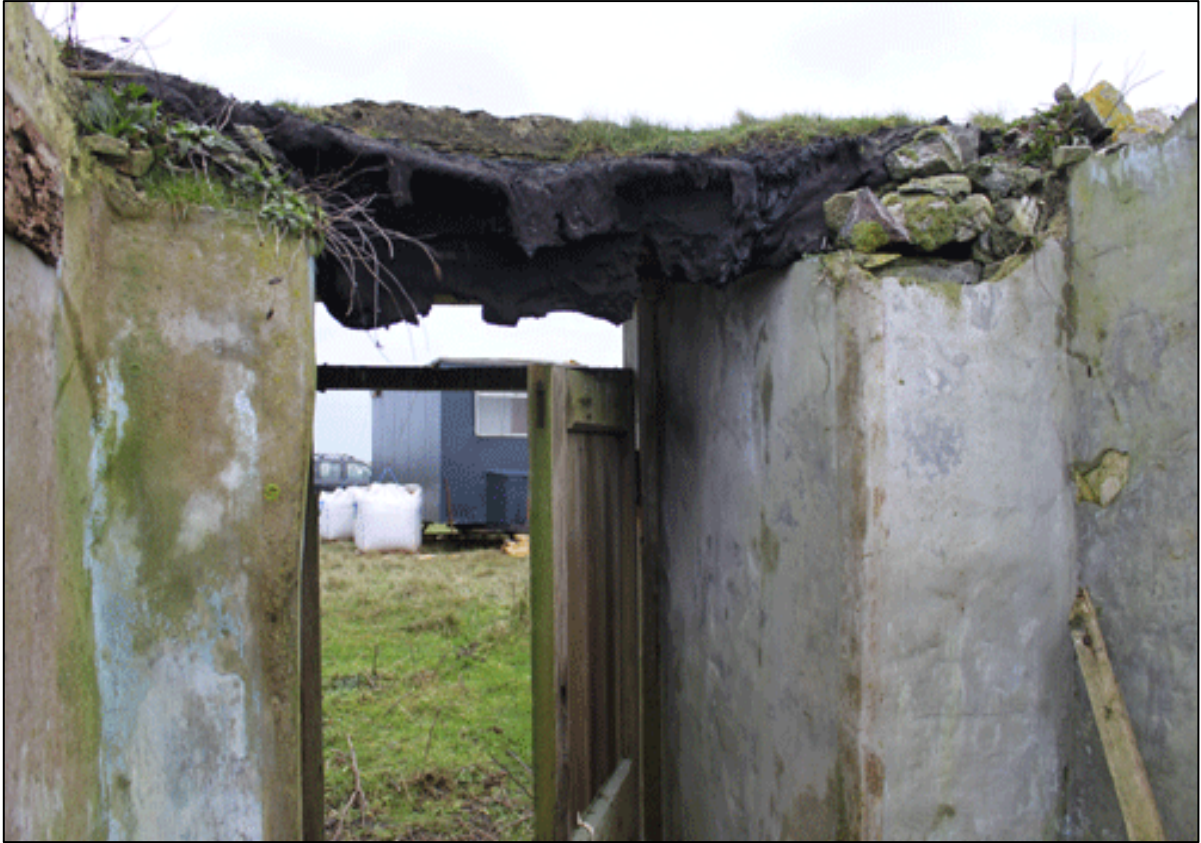
14. Traces of the black felt roof were evident where small areas had remained attached to the wall head (Figure 4a). The walls were double-skinned with an inner sand cavity (Figure 4b), designed to soak up excess water which drained off the roof, with the roof timbers resting upon the inner wall face. The absence of gable walls indicates a hipped roof. The skins of the wall on either side of the sand cavity were made of rubble, consisting of small to large natural unworked stones, and a few stones which look to have been shaped. The rubble was bonded with lime-mortar. The double-skinned construction used throughout resulted in a wall thickness of approximately 1m.

Figure 4a: Remnants of Black Felt Roof

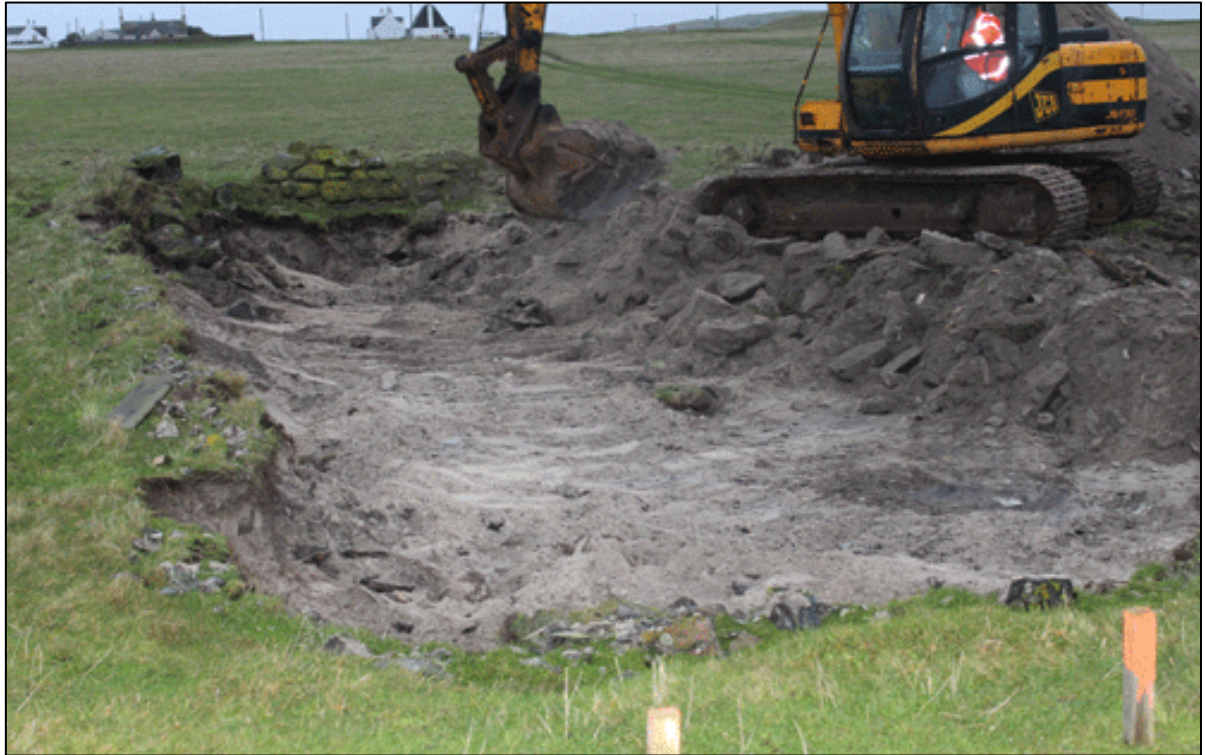
Figure 5a: Remains of northwest wall of Room A

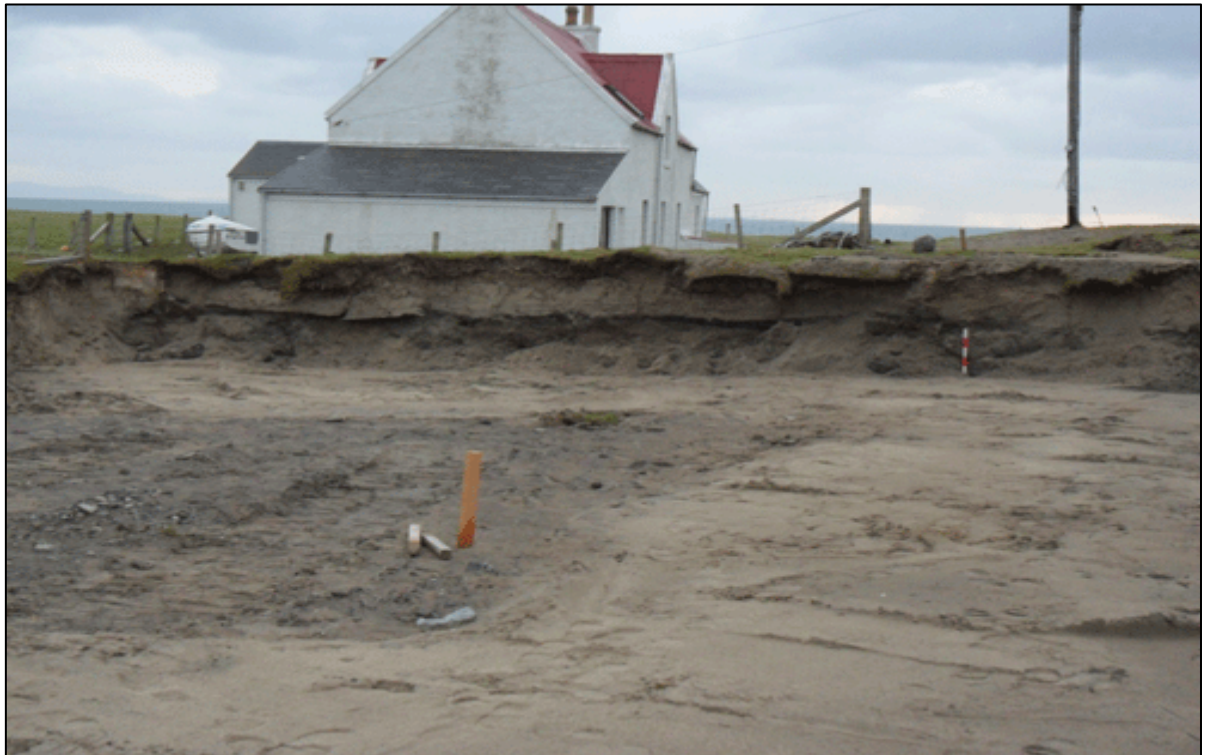
Figure 5b: NNW facing section of reduced area

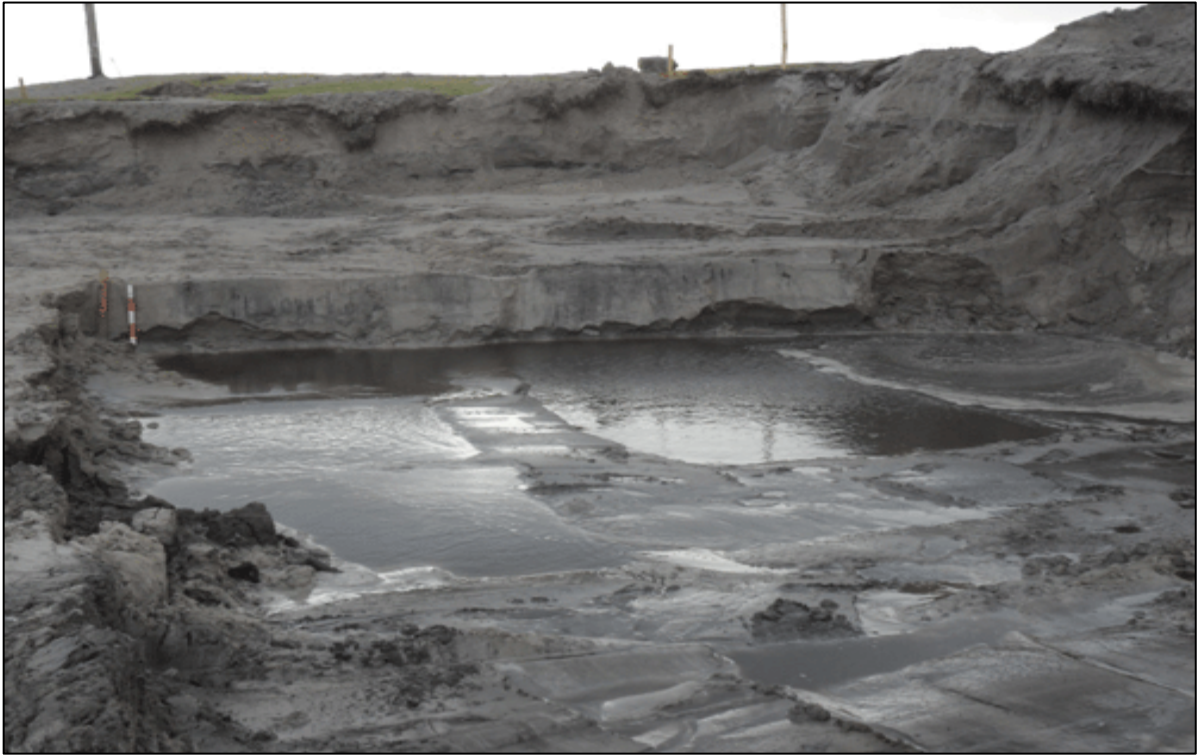
Figure 6a: NNW facing section of basement area

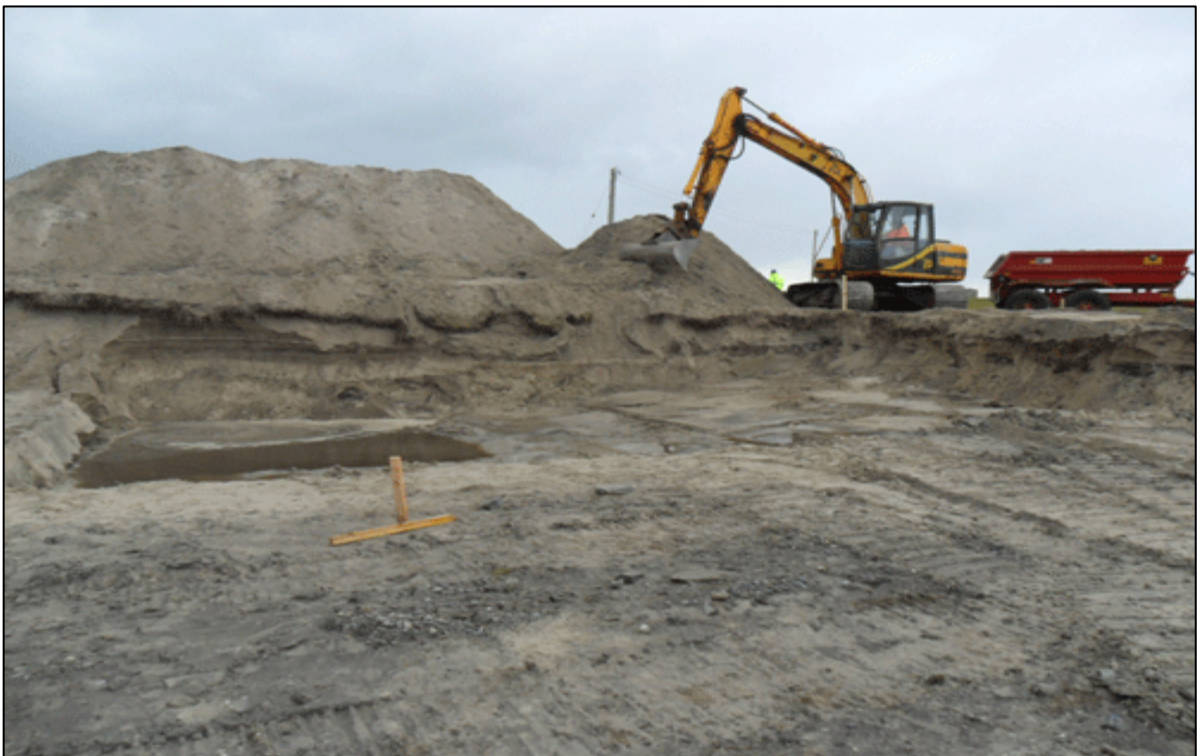
Figure 6b: General, excavated basement area
