# Hatton Farm, Marykirk, Angus: Archaeological Mitigation

Data Structure Report

by Peter Klemen  
issued 02<sup>nd</sup> December 2013  
on behalf of Mr Kevin Mclean

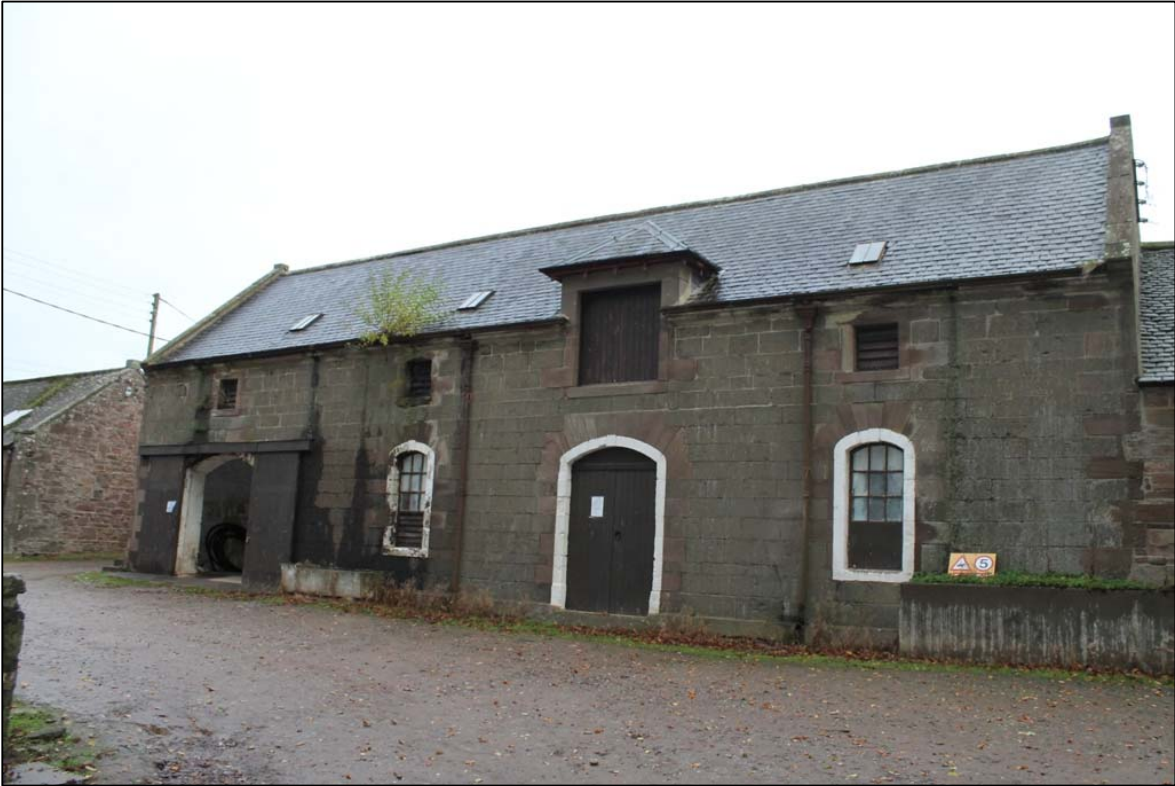
18. Room A forms the southern wing of (001) and is the elevation that forms the front of the building as it is accessed by the farm track (Figure 4 & 5a). The use of well formed worked ashlar blocks throughout would suggest that this was always intended as the front elevation. On the eastern end of the southern wing an extension has been added and the use of coursed rubble with ashlar quoins demonstrates a contrast in the construction of the extension representing nineteenth century activity. Spanning the junction between the two parts of the southern wing is a concrete trough (1) 880mm by 5.65m. Standing at two storeys and a total height of 7.54m, the lower main storey is at a height of 4.47m and there are number of contemporary features still visible.

Figure 5a: Southern wing and elevation

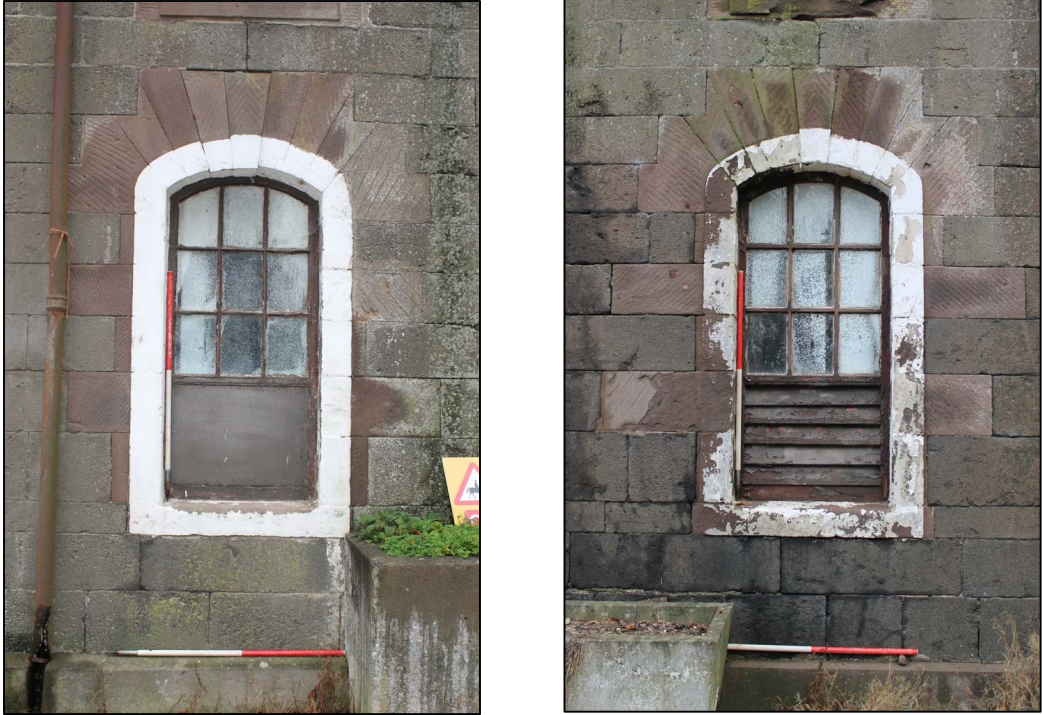
19. There are two segmental arched windows (2i & 2ii) both measuring 1.97m by 1.17m (Figure 6a), two segmental arched doorways (3i & 3ii) with a central doorway measuring 1.60m in width by 2.28m in height and the western doorway measuring 2.50m in width by 2.60m in height. Located on the second storey are three square windows/air vents (4 i-ii) (Figure 7a) that each have wooden slats as protection from the weather. There is also a central hatch (5) (Figure 7b) which would have allowed access for storage in the upper level; for example a hay loft. The second storey features could not be measured as access was not possible. The ashlar blocks used in the construction of windows 2(i & ii), windows 4(i-iii) and doorways 3(i & ii) have a linear carved design used on the stonework and the sandstone used in the construction of these features including doorway 5 are red in colour and in contrast to the rest of the grey coloured sandstone ashlar blocks used in the construction.

Figure 6a: Windows 2 (i) & (ii) in the southern wing/elevation

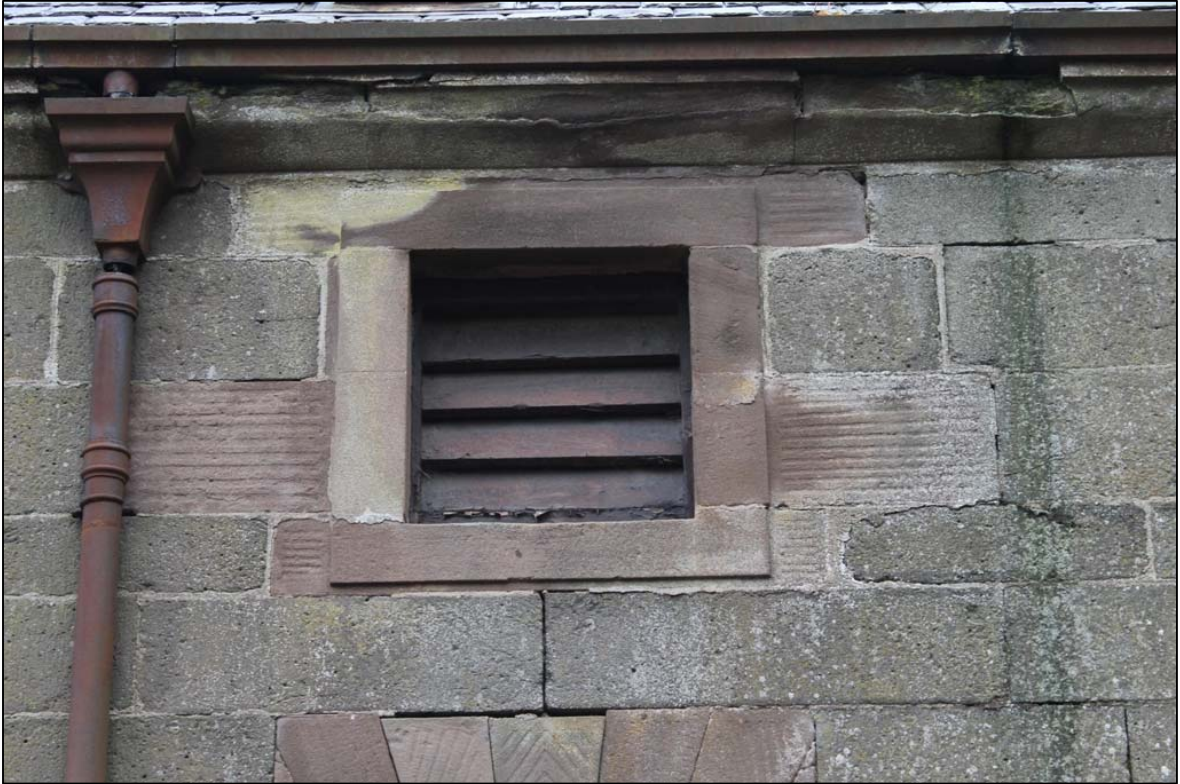
20. The roof is slated across both the two storey and the adjoining extension of the southern wing with four small skylights (6 i-iv) located in the roof and facing south. The guttering and drain pipes are all original features, and are manufactured from cast iron (Figure 7a).

Figure 7a: Second storey window/air vent 4 (i)

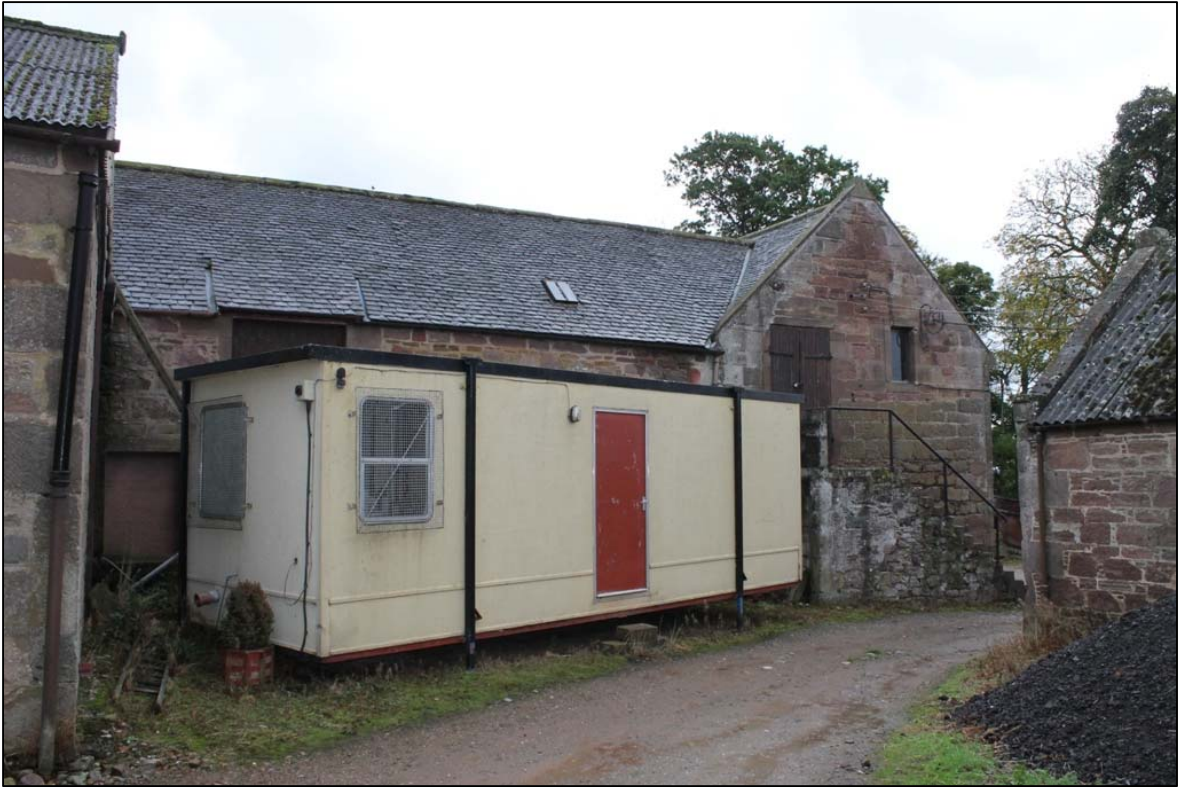
21. The external west elevation (Figure 8) is partially obscured by a welfare unit (Figure 9a). However, the west end of the southern wing is visible (9bi) and access behind the welfare unit is possible. Across the western elevation there are three windows (2i-iii). Window 2(i) measures 700mm by 1.10m and both windows 2(i-ii) measure 1.10 by 1.40m. There are two doorways 1(i-ii) with doorway 1(i) measuring 1.50m by 2.30m and 1(ii) measuring 1.20m by 2.10m. There are a set of stairs (3) located on the west end of the southern wing measuring 2.17m by 5.80m and each step measuring 1.35m wide and 180mm high (9bi). They are constructed in sandstone and capped with concrete (Figure 8bii). There is also access to the second storey through a square entrance with a wooden door (4) similar to that of (5) in the southern elevation.

Figure 9a: West elevation of (001) showing the welfare unit

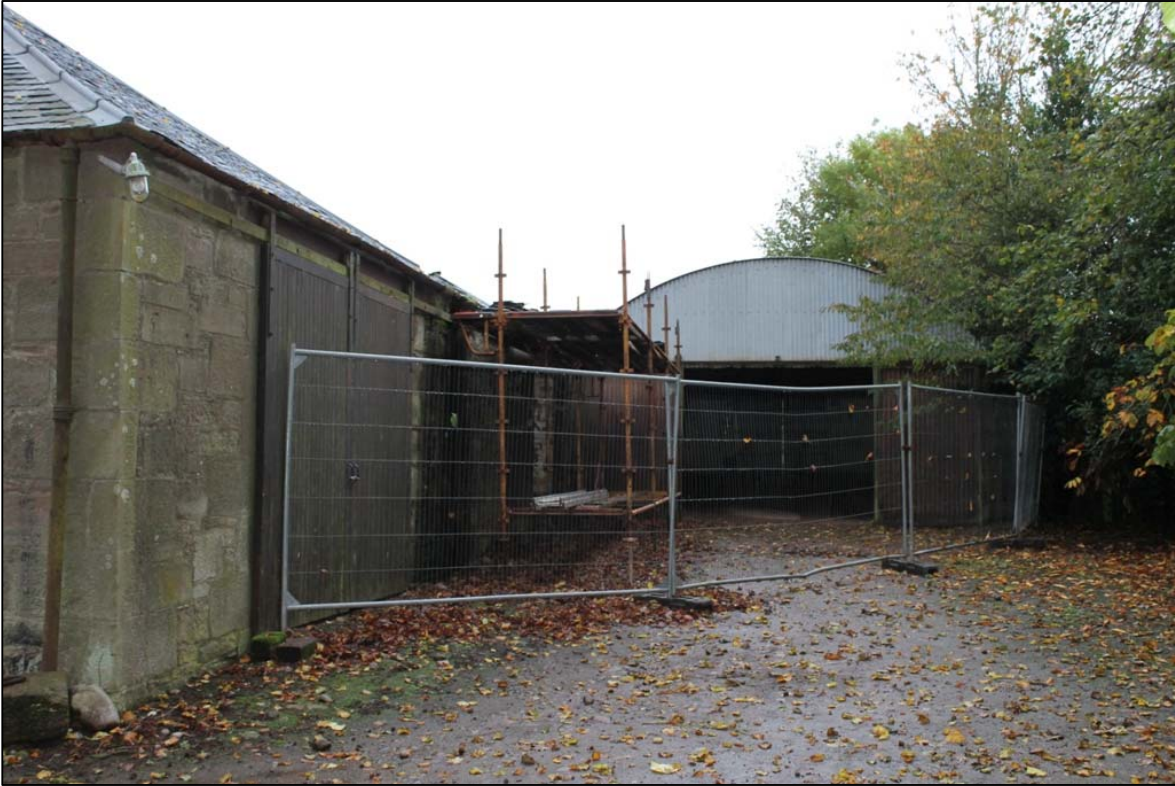
22. The east elevation is largely obscured by scaffolding and Heras fencing (Figure 10a) although two doorways are visible. One forms the access into the interior of the southern wing and Room A and measures 3m by 2.70m, with a second doorway entering Room C which has the same measurements. Constructed along the eastern wing and totally obscuring the east elevation is a modern corrugated iron extension. The north elevation (Figure 11b) has five skylights set into the roof and two metal air vents located on the ridge of the roof.

Figure 10a: East elevation (001)

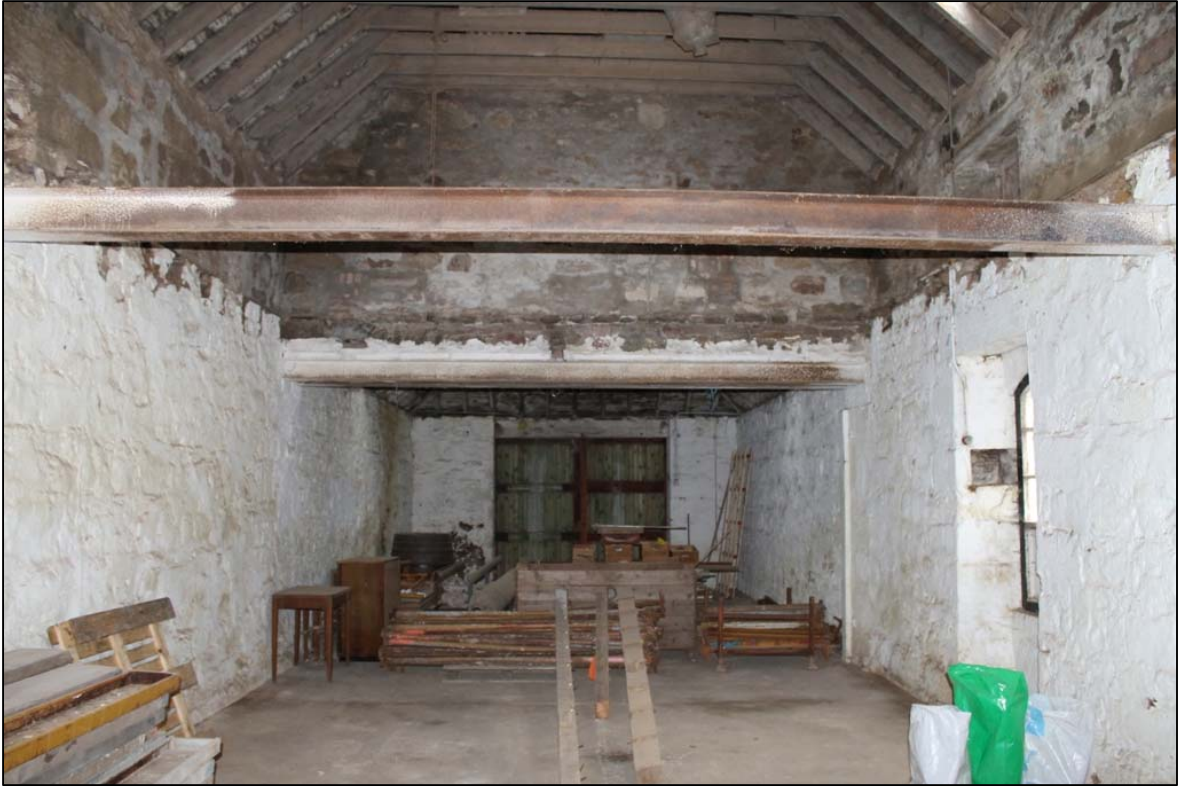
24. Room A occupies the entire southern wing of (001) and is rectangular on plan measuring 26.3m by 5.5m with a total height of 7.5m (Figures 11a & 11b). Formally subdivided into two floors the remains of the upper storey were not accessible due to health and safety issues. The whole ground floor level has been whitewashed internally but the upper storey is not. The measurements already mentioned for the southern exterior elevation are the same for the interior. There are two further internal doorways, one that enters Room B measuring 1.30m by 2m, the other entering Room C measuring 1.20m by 2m. The floor is concrete and the roof rafters, webs, bottom and top chord all constructed from wood. Four steel girders are visible aligned north-south across the width of the room at the height of the first storey, these are later insertions and assumed to have provided support for the southern wing (Figures 11a & 11b). There are no other features within Room A apart from the door visible in the east elevation (Figure 11a).

Figure 11a: Room A looking east showing where the extension has been added

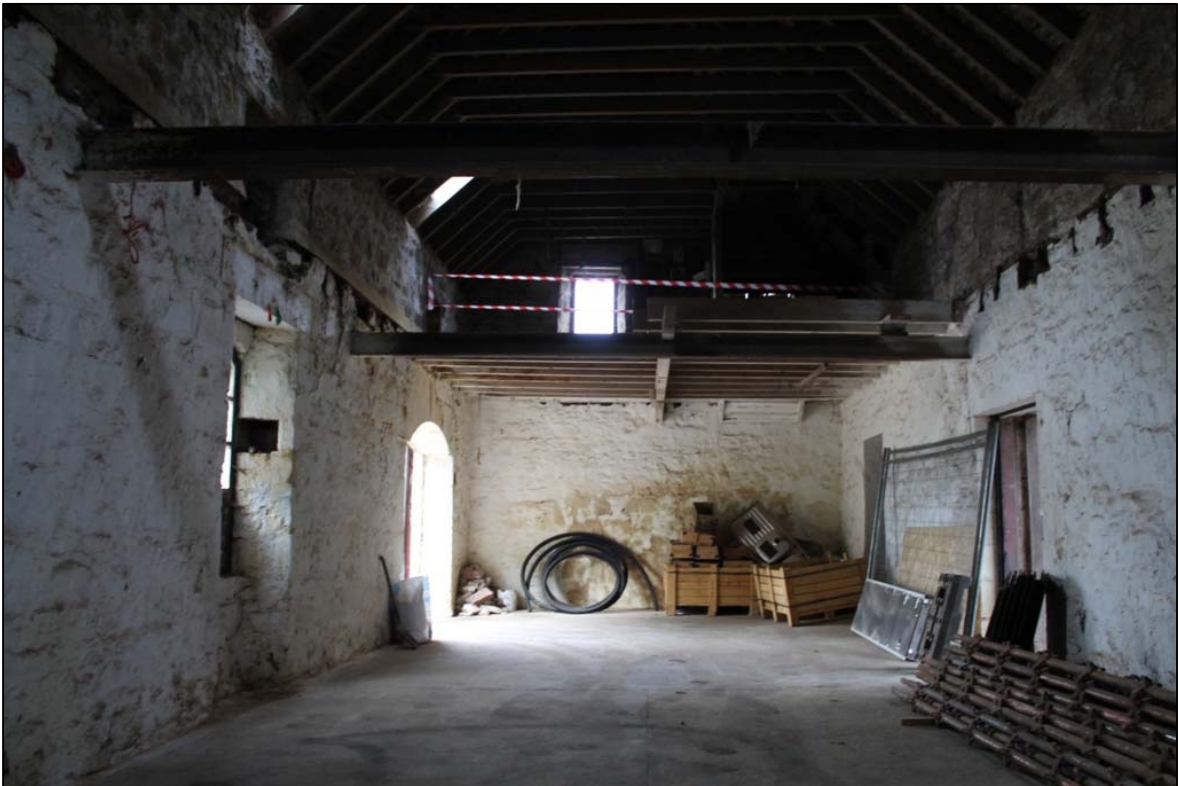
Figure 11b: Room A looking west

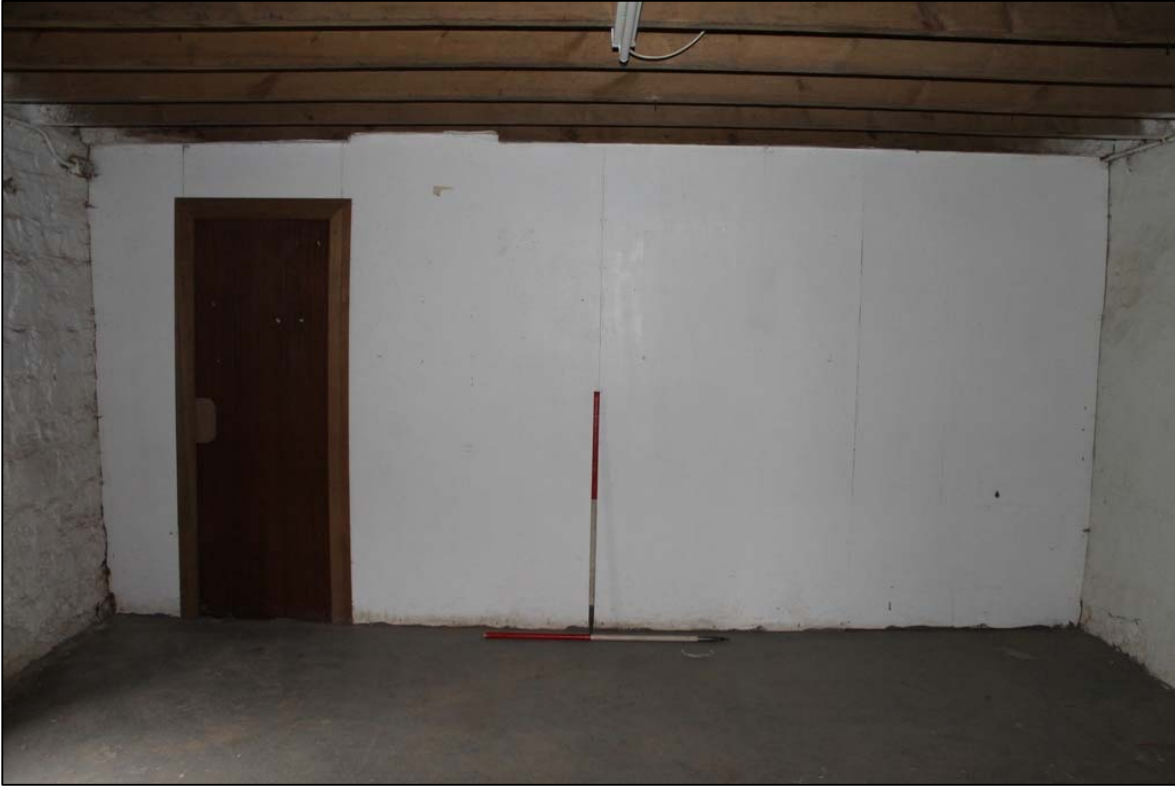
25. Room B is rectangular in shape and measures 7.6m by 3.8m with a concrete floor and wooden ceiling joists and flooring at a height from the ground of 2.5m (Figure 12a). The north end of the room has been separated using chip board and has a modern doorway, 850mm by 2m, leading into the room behind (Room H) (Figure 11a). Prior to this partition both Rooms B & H would have formed the west wing of (001) (Figure 3).
26. On the west wall of Room B there is doorway 1(ii) and window 2(ii) that are visible in the external west elevation. The measurements are the same as those already mentioned. The southern wall has the doorway that provides access into Room A. All walls in Room B are white washed and there are modern electrical cables and pipes visible on the eastern wall (Figure 12b).

Figure 12a: Room B illustrating the partition, floor and ceiling

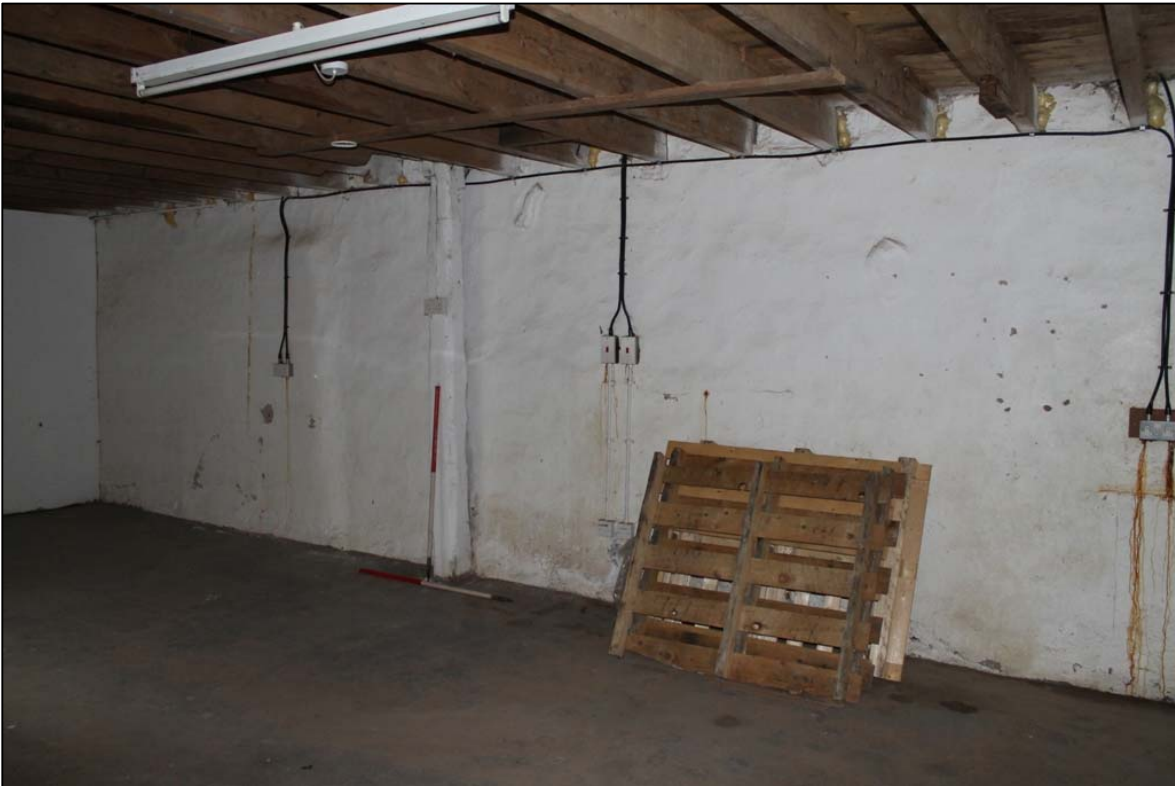
Figure 12b: Room B east wall illustrating the white wash render, floor, ceiling and modern fixtures

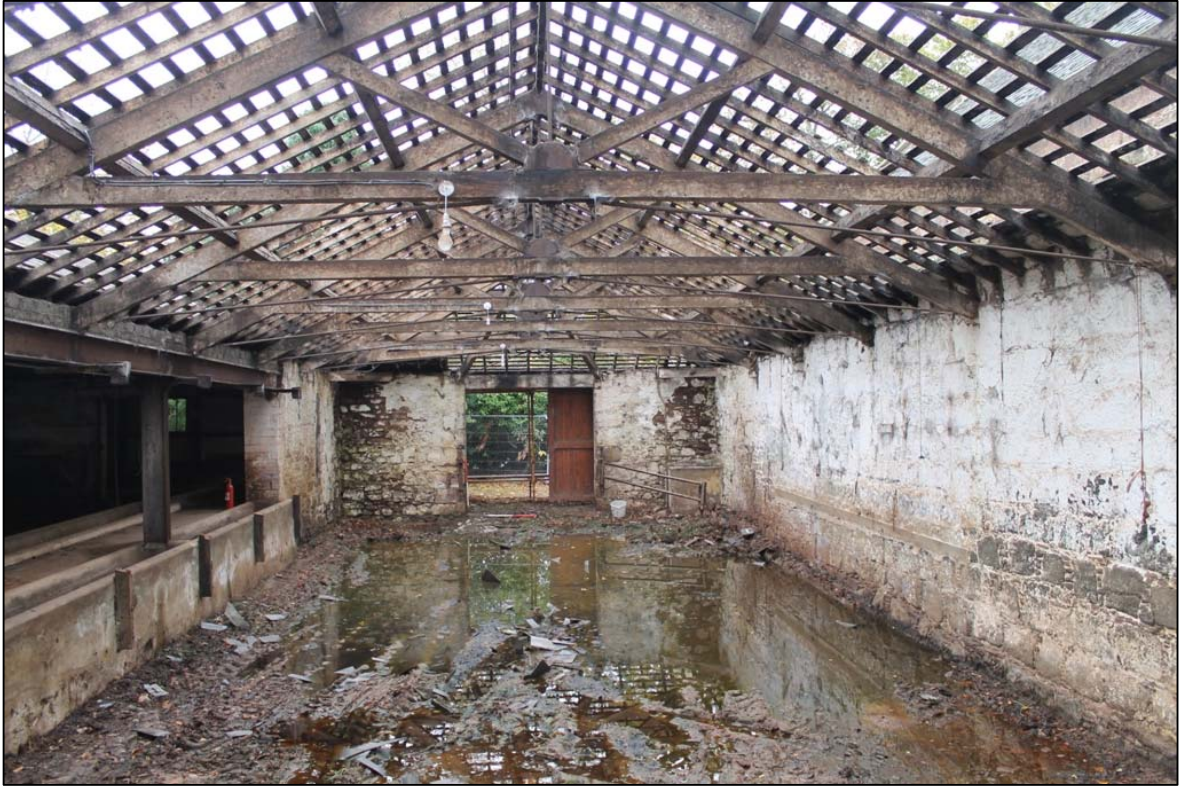
27. Room C is rectangular on plan and aligned east-west, measuring 7.6m by 22m by 6.0m in height and in poor condition with the slated roof gone and the wooden rafters and joists clearly visible (Figure 13a). With roof absent, there is a waterlogged floor with standing water and slurry (Figure 13a). In the east end of Room C is the door visible from the external east elevation. Located at the north end of the room is a concrete water/feed trough (I) aligned north-south, 7m in length with a total height of 900mm and a maximum width of 750mm. The internal dimensions of the trough are 550mm wide and 160mm in depth (Figure 13b). The central area of the north wall is open for 9m east-west which enables both Rooms C and D to be visible from each other (Figure 14a). There is also another concrete water/feed trough (II) (Figure 14a) which is 9m in length and has the same height and internal dimensions as trough (I).

Figure 13a: Room C looking east

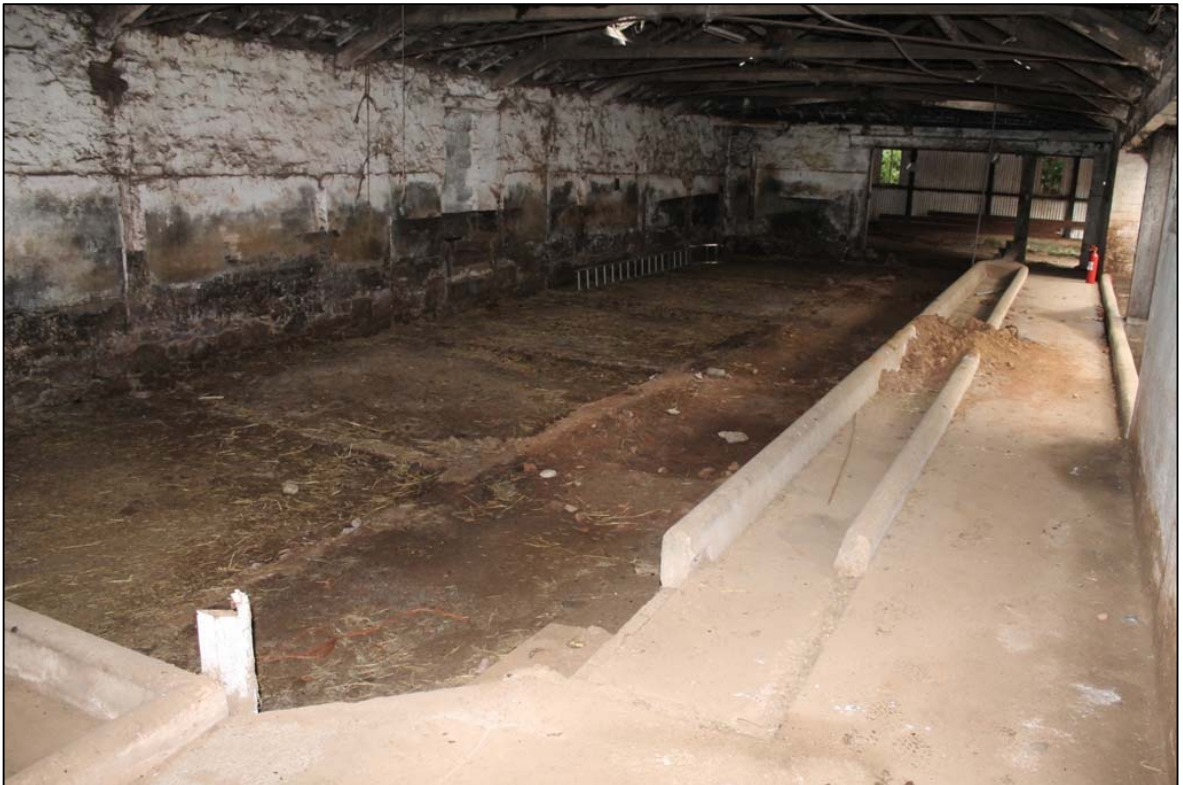
29. Rectangular in shape measuring 7.6m by 22m by 6.0m in the internal area of the room there is evidence where animal pens have been removed to produce a larger open area (Figure 14b). The condition of foundation remains for the animal pen walls would suggest that they have not been removed recently. There are the remains of five animal pens with dimensions approximately 4m by 3.5m. Further features include four skylights in the roof which is constructed by wooden rafters and joists with a slated roof. Within the middle of the north wall there is a cast iron water trough, measuring 900mm by 500mm. Within the eastern wall there is a door that measures 3m by 2.70m.

Figure 14b: Room D demonstrating trough III and the remains of the removed animal pens

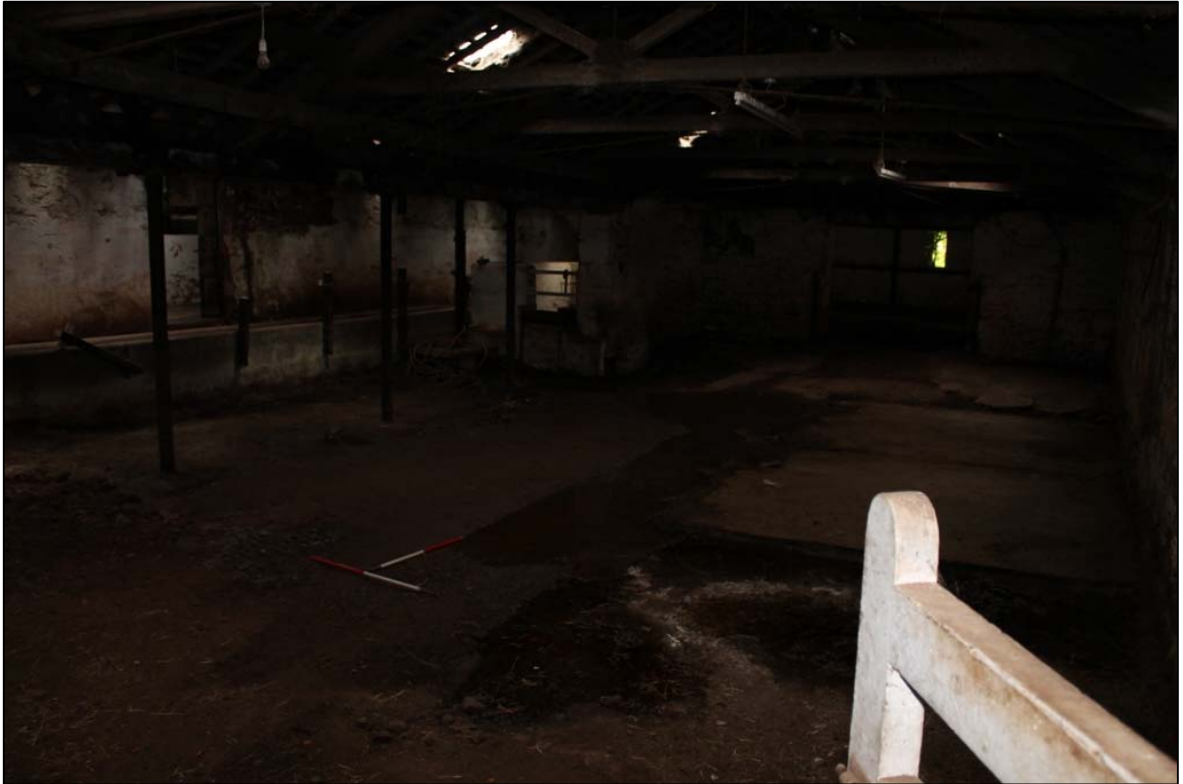
30. Again rectangular on plan, this room measures 12.2m by 22m and 6.0m high with a slated roof and wooden joists and rafters (Figure 15a) and whitewashed walls. Within the western wall there is one window (i) measuring 640mm by 1.10m and a doorway (ii) measuring 1.00m by 2.15m. There are another two water/feed troughs aligned east-west (V) measuring 10m in length and the other north-south trough (IV) measuring 13m in length, the internal dimensions are the same as the rest of the troughs.
31. Located at the north-east end of Room E is a small white washed animal pen (iii) (Figure 15b) with internal dimensions of 2.90m by 1.80m and a wall thickness of 260mm. There are three doorways (iv, v, vi) in the eastern wall with two (v, vi) located to the east of the animal pen and measuring 1.20m by 2.20m and doorway (iv) measuring 2.70m by 2.20m.

Figure 15a: Room E demonstrating the internal open area, concrete floor and roof

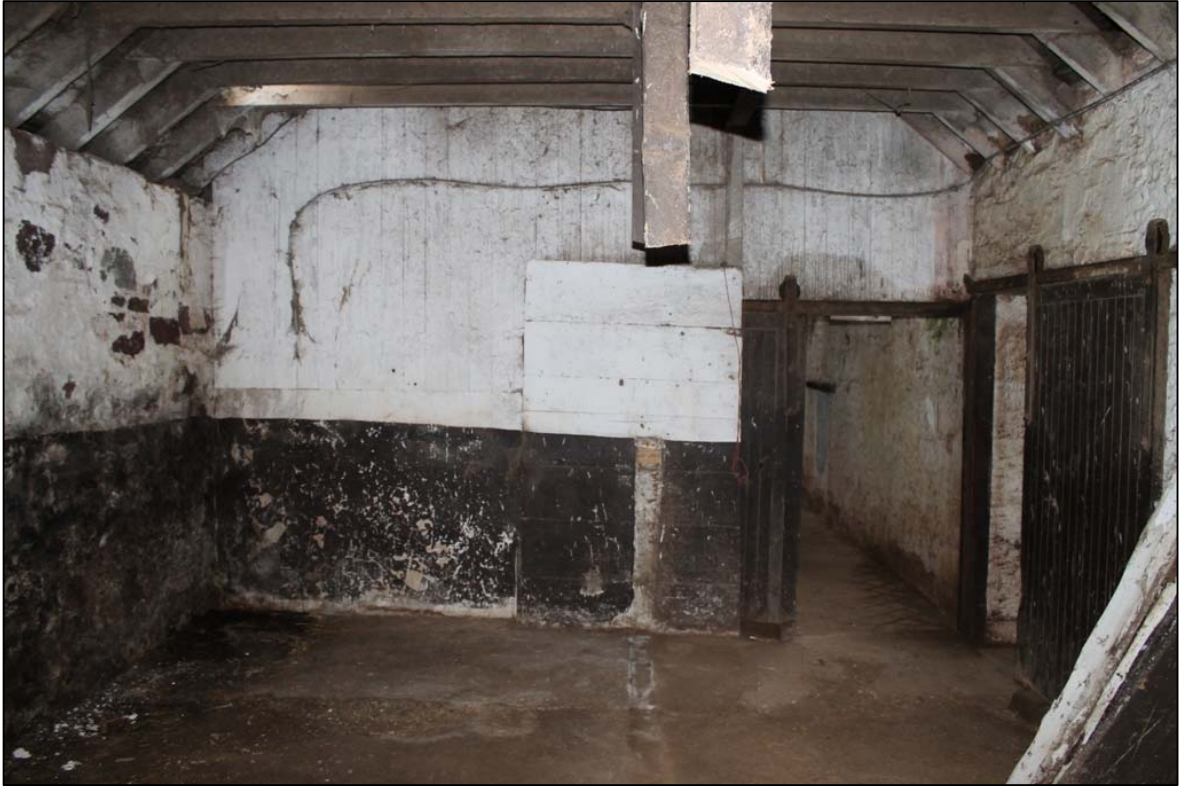
32. A small rectangular room measuring 4.8m by 6m in extent and 5.9m high, with whitewashed walls, concrete floor and a slated roof with wooden joists and rafters. There are three doors (i, ii, iii); doorway one (i) measures 2m by 2.15m and leads to an external building. Doorways (ii & iii) both measure 1.00m by 2.15m, with doorway (ii) leading to Room E and doorway (iii) leading Room G (Figure 16a). There are no other features within Room F.

Figure 16a: Room F showing the east wall and doorway (iii) (front) and doorway (iii) to the right of the image.

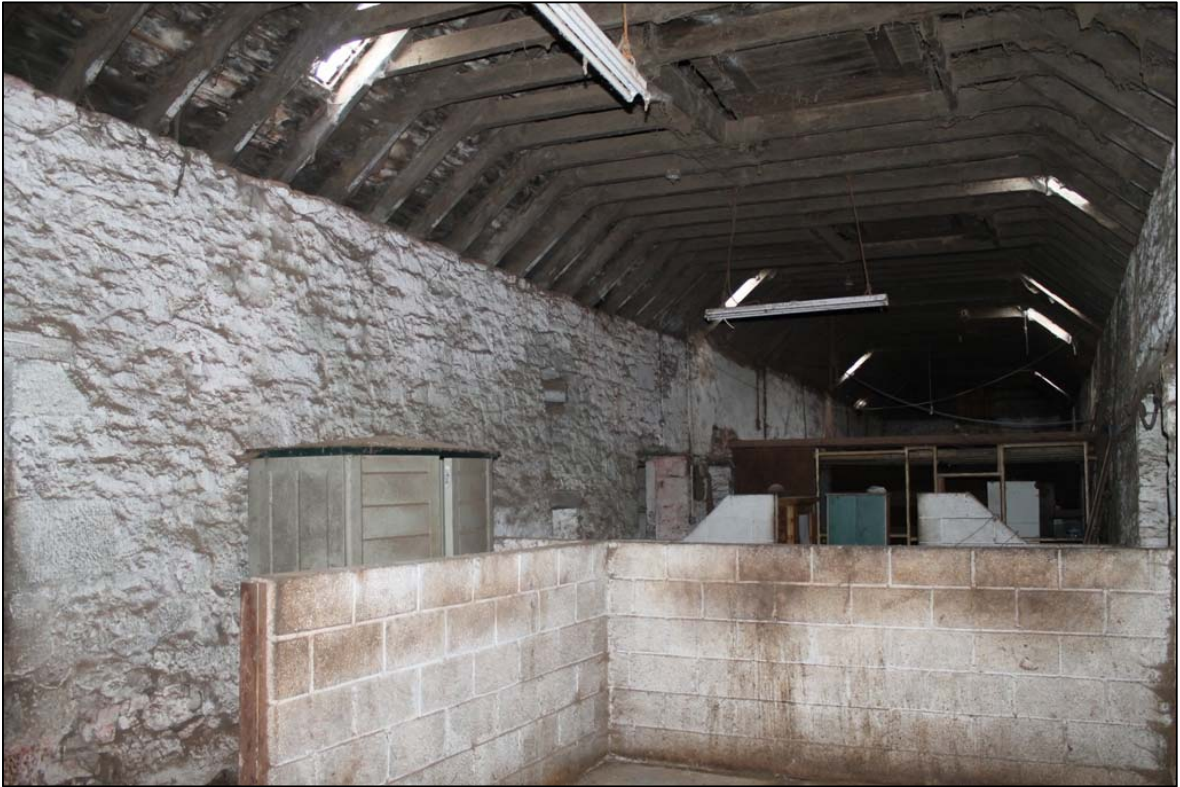
34. Room H forms the northern end of the west wing and is currently used as a tack room and for general storage (Figure 17a) with the room being subdivided from Room B by a wooden partition (Figure 17b). The walls are whitewashed, the floor concrete, with a slated roof and wooden joists and rafters. There are modern breezeblock constructed animal pens located in the northern part of the room (Figure 17a). The dimensions of the room are 3.8m by 20m.

Figure 17a: Room H looking south.
