# Hunterston Converter and Substation, West Kilbride, North Ayrshire: Archaeological Evaluation

Data Structure Report: 2<sup>nd</sup> Addendum

by Douglas Gordon & Louise Turner issued 30<sup>th</sup> June 2014 on behalf of RSK Environment Ltd

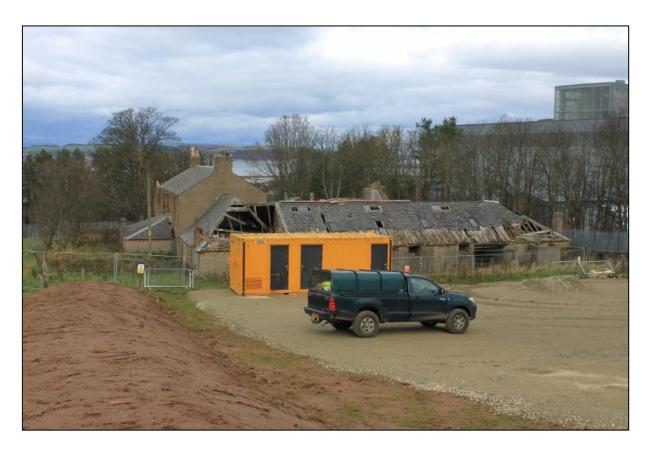
Figure 4a: View of Goldenberry Farm from north, with cowshed/?dairy `d' to right and House `a' to left.

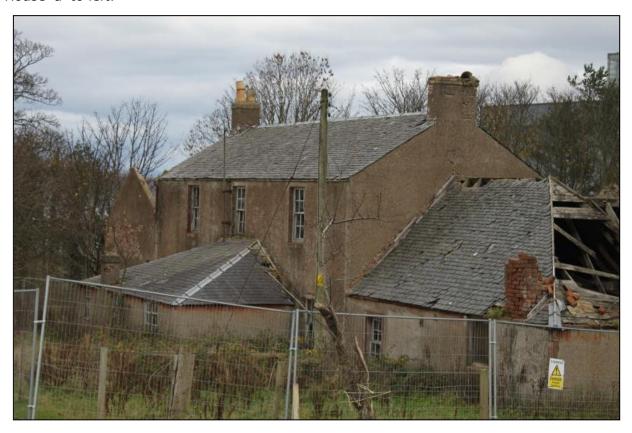
- 34. On the rear (external) north-west elevation of 'a', the flanking ground floor windows have been displaced slightly to accommodate a one storey outshot or extension ('b'). Outshot 'b' is not shown on the Ordnance Survey 1<sup>st</sup> Edition map, which suggests it may be a recent addition. A later date is further strengthened by the presence of a vent in the south west wall which suggests either construction (or potentially, insertion) at a later date when either gas lighting or gas heating was introduced. The windows are also of different design: they are larger windows, not of traditional sash-and-case construction, indicating a 20<sup>th</sup> century construction date. However, this must be balanced against the presence of the displaced ground floor windows of 'a:' while these represent typical sash-and-case windows contemporary with the original build of the farmhouse, it is possible that the windows were themselves moved at the time 'b' was constructed. Unfortunately, with the whole of the exterior surfaces of both 'a' and 'b' concealed beneath a coat of roughcast, any further information which remains inherent in the masonry could not be identified.

Figure 4b: Rear, NW, elevation of Farmhouse `a' with outshot `b' and structure `c' (?scullery or wash-house) to fore

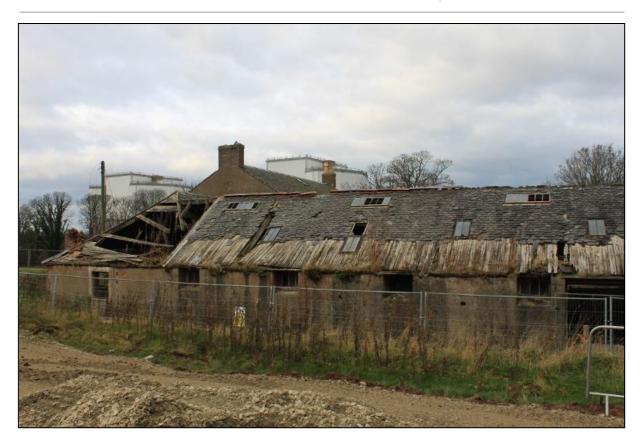
- 38. Structure 'd,' which formed the south-east edge of the courtyard farm layout, was rectangular in plan and measured 4 bays in length (Figure 5a). It had recessed small three-pane windows sitting over a sloping sill. These were located at wallhead height, with salt-glazed ceramic pipes built into the thickness of the wall at the midpoint between the two windows. The roof was slated, merging into the roof of structure 'c' at the southwest end and incorporating the timbers of structure 'l' at the north-east end. Two rows of rooflights were evident, an upper rank of five-pane lights set at irregular distances, and a row of smaller two-pane lights set one per bay above the wall-mounted ceramic pipes. Ventilated ceramic ridge tiles had been laid along the apex of the roof.

Figure 5a: Cowshed/?dairy 'd' with structure 'c' to left and farmhouse 'a' to rear

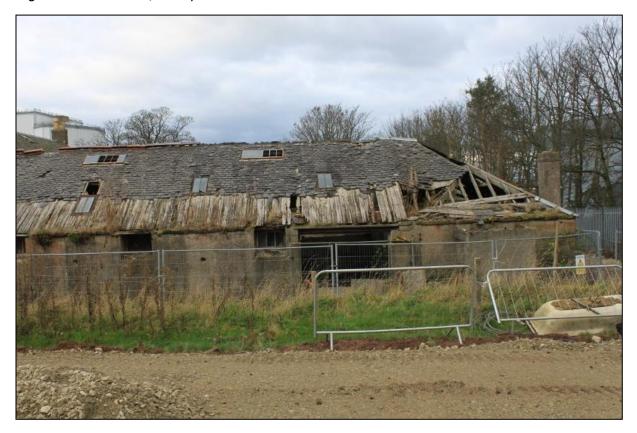
- 40. A broad doorway at the north-east end, once covered by a sliding door, appears to have been a later insertion. Beyond this doorway, a small extension 'k' with a central single door in the south-west elevation also appears to be a later addition (Figure 5b). This abuts the junction between structures 'd' and 'l': the exposed timbers suggest that both would originally have been one storey high, the original timbers of the roof now incorporated into the raised roof structure in a manner similar to that observed previously in structure 'c.'

Figure 5b: NE end of cowshed/?dairy 'd'

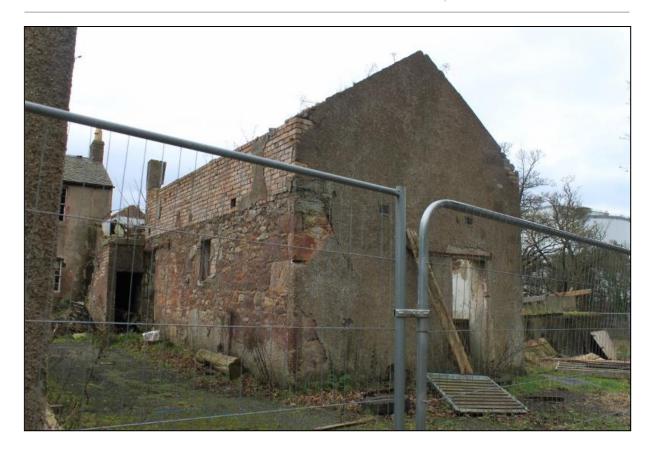
- 41. Structure 'e' was arguably the most interesting of the structural elements, mainly because much of the external render which originally covered its south-east elevation had fallen away, revealing the fabric (Figure 6a). Rectangular on plan, the structure had begun its life as a single storey building, composed of snecked rubble walls with roughly squared quoins. The fabric appeared to be dominated by sandstone. It is unclear whether the roof was originally hipped or pitched, but at some point it was built up using yellow bricks to create an attic level. The presence of small iron grilles within the walling at regular intervals suggested that this work had taken place in a period when gas lighting or heating was in use, perhaps in the early 1900s. Access to the upper level was via an external stair composed of brick, i.e. contemporary with the raising of the wall height.

Figure 6a: Structure 'e:' Detail of quoins on E elevation taken from the W

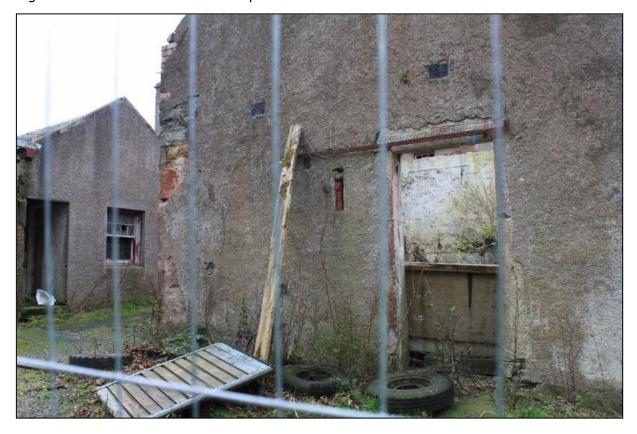
- 42. Access to the interior was via a narrow doorway in the south-west elevation (Figure 6b). Set slightly off-centre, this opening had once been associated with a sliding door, the rail of which survived above. It seems to have been a later insertion: the location of the original doorway is unclear, with no evidence for openings apparent on the south-east elevation. There is an additional narrow doorway at the south-west end of the south-east elevation, located just to the north-east of the brick forestair. The presence of a slot-type window in the north-east elevation might suggest a barn, while the presence of a 'window' in the south-east elevation is more difficult to interpret. Set unusually high, this may be a hatch as opposed to a window, allowing access at attic level for the loading/unloading of hay or straw for animals housed below.

Figure 6b: Structure `e:' detail of NE elevation, showing original slot-type window, later ventilator grilles and sliding door.

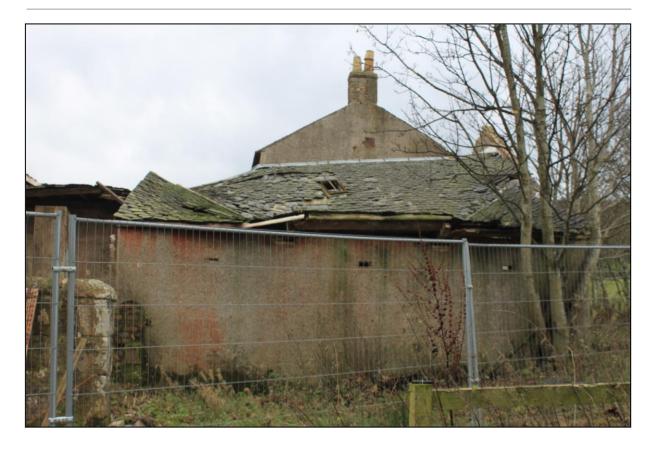
- 44. Structure 'f' was a modern brick structure, constructed adjacent to (and abutting) the external wall of structure 'e.' It had horizontal slot type windows which had once held metal grilles, features consistent with the use of gas heating or lighting (Figure 7a). Its purpose could not be ascertained, but it clearly functioned as some kind of ancillary structure.

Figure 7a: Structure `f', with return of unnamed wall to left.

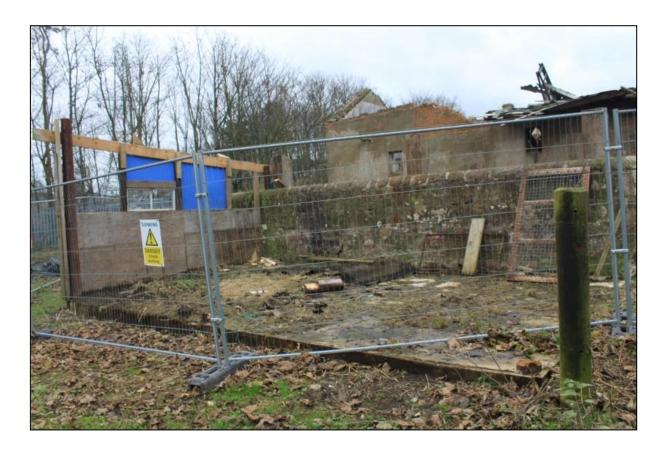
- 45. Structure 'h' was very modern in build (late 20<sup>th</sup> century), surviving only as an area of hard-standing associated with the upstanding remains of timber stud walls. It abutted the exterior of structure 'g', which comprised a low mortared wall which appeared to form a small yard or paddock adjoining the main courtyard farm structure (Figure 7b).

Figure 7b: Remains of structure 'h', comprising concrete apron and one upstanding stud wall (unnamed wall forming external courtyard to rear)

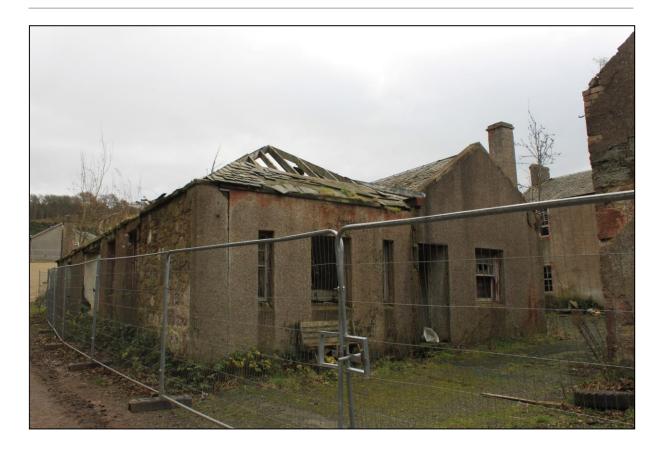
Figure 8a: NW Elevation, structures 'j' and 'l'

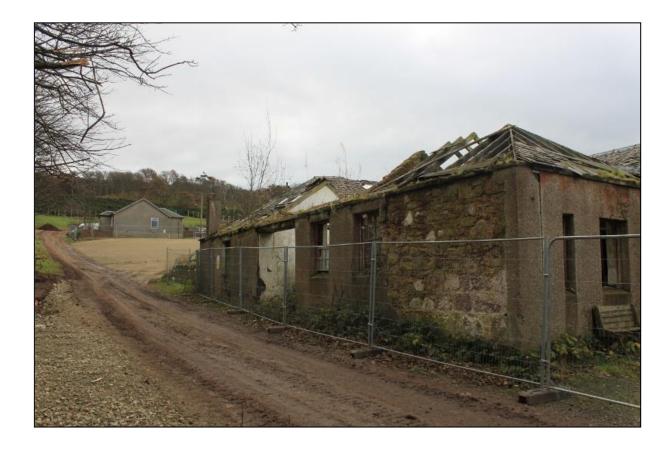
Figure 8b: NE Elevation, structure 'j'
