# Dunlop House, Dunlop, East Ayrshire Historic Building Recording

## Data Structure Report

issued 27<sup>th</sup> November 2015

on behalf of McTaggart Construction Ltd

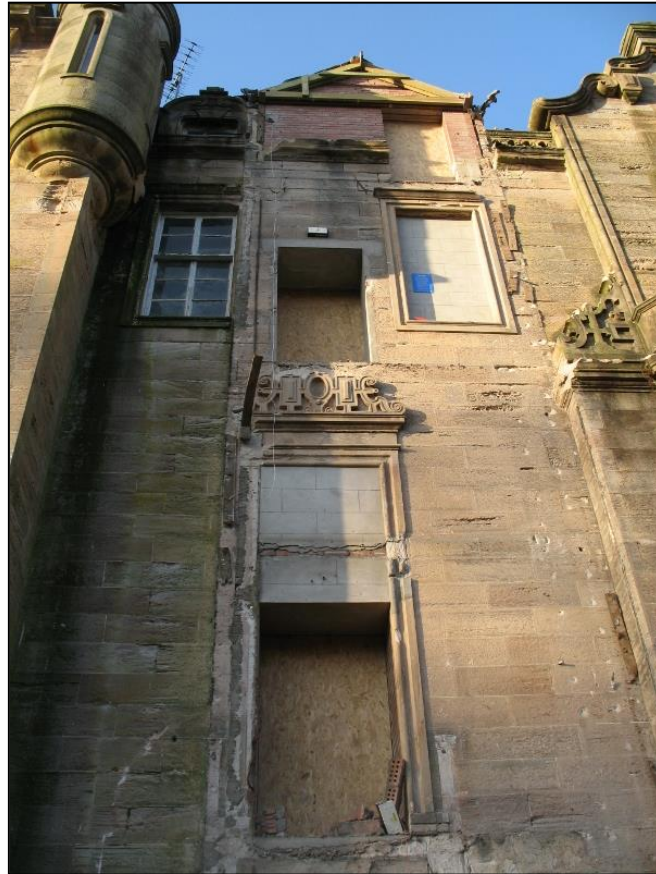
16. At first floor level, a massive window had been partly infilled to create a doorway and its external mouldings slighted over much of their length on the W side to accommodate the external stair. However, the overlying strapwork of this window survived in good condition.

Figure 1a: S Elevation – Central, Recessed Bay – Upper Storeys & Wallhead

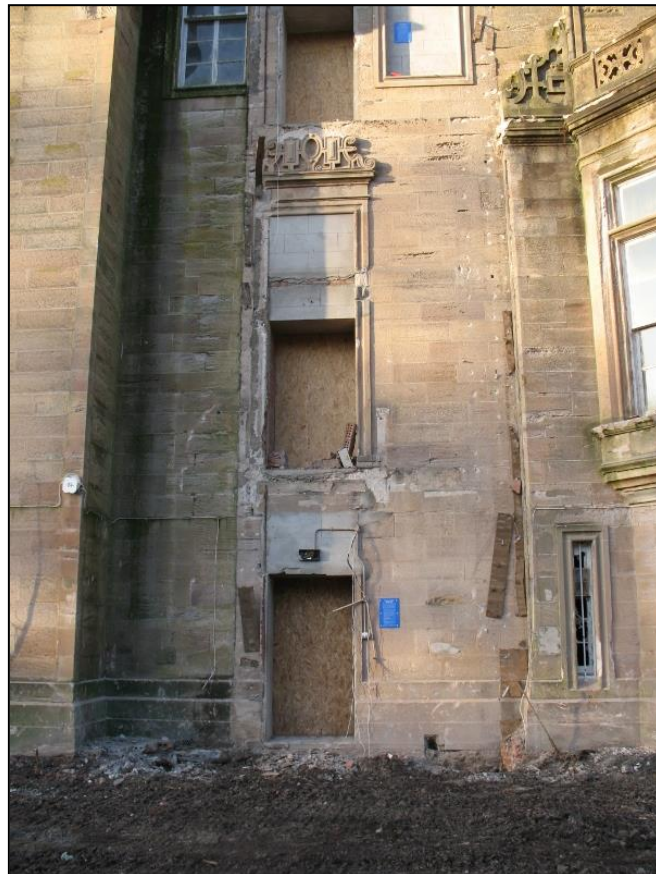
17. The ground floor opening was less easy to interpret (Figure 1b). Internally, the edges of the embrasure had been entirely reworked in brick, which may have been undertaken as a means of making an existing doorway narrower. The external mouldings of this opening remain intact, but in this instance, this does not assist interpretation as the line of the plinth course would be appropriate either for a window or a secondary doorway.

18. However, the presence of a doorway in this location is not logical – although Room 014 allows direct access into a servants' stair, access for servants was also suggested within the E wall of the N end of Room 025, a location which makes more sense as it suggests entrance directly into the servant's dining hall and allows access into a back (service) corridor. That the opening was originally a window is further supported by the fact that a blocked fireplace was identified in the W wall of this room, an unlikely feature for a room designed as an access route for servants. The window hypothesis is also more likely given the fact that the original opening was reduced in size through the use of breeze blocks in the upper section as part of its conversion into a doorway.

Figure 1b: S Elevation - Central, Recessed Bay, Lower Storeys

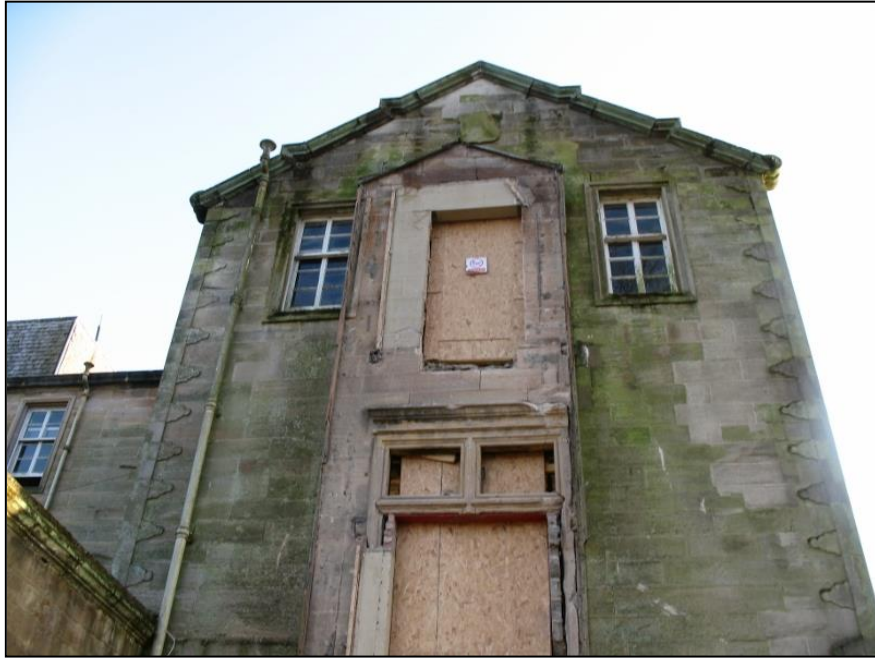
Figure 2a: N Elevation – W Bay following removal of External Stair (Upper)

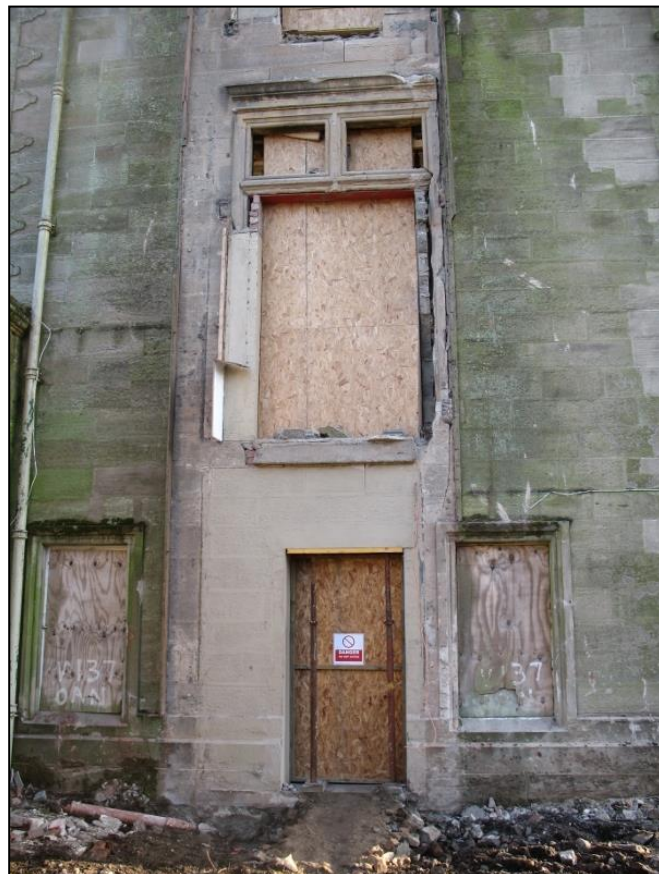
Figure 2b: N Elevation – W Bay following removal of external stair

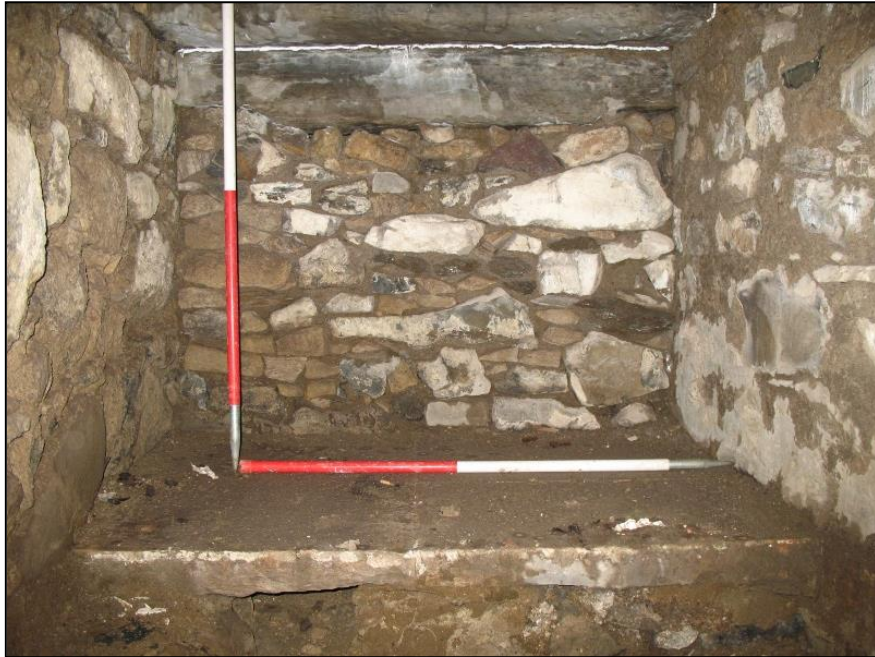
Figure 3a: Interior of Extant External Stair at Ground Floor Level, looking S towards abutment wall

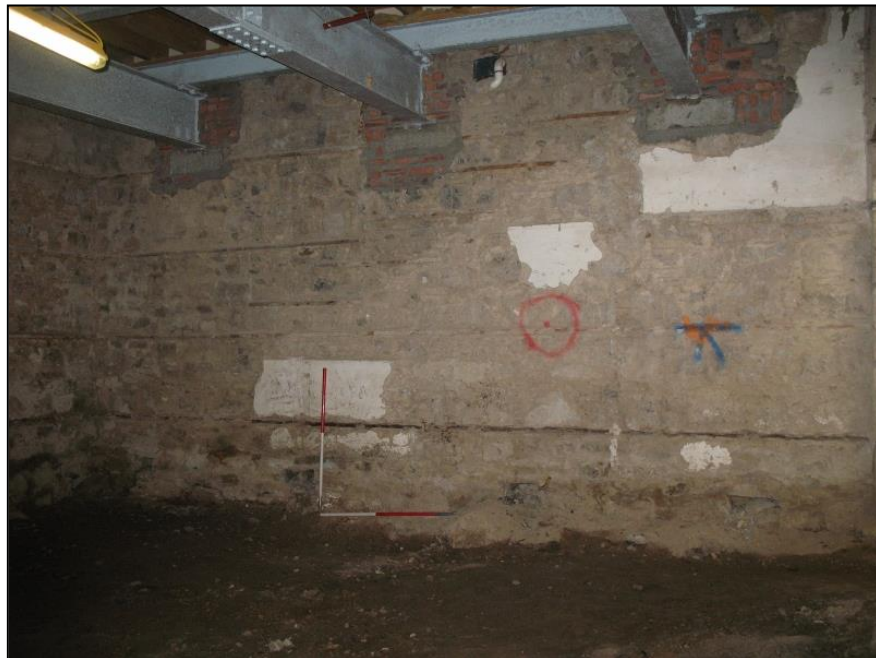
Figure 3b: N Elevation – Line of timber panelling along main stair, S wall, Room 002/003/004

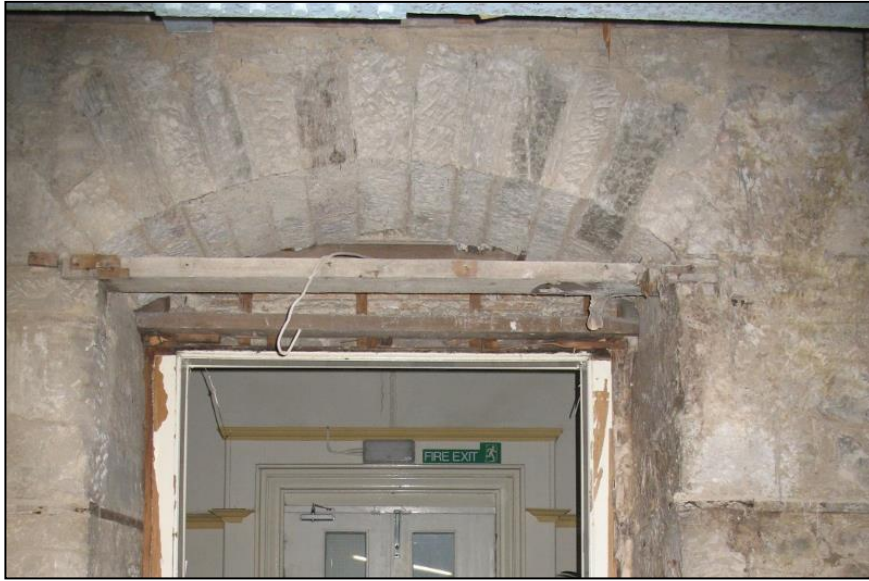
Figure 4a: Relieving Arch and *in situ* timber lintel/lath & plaster over doorway between vestibule 001 and 002/003/004 to rear, looking E

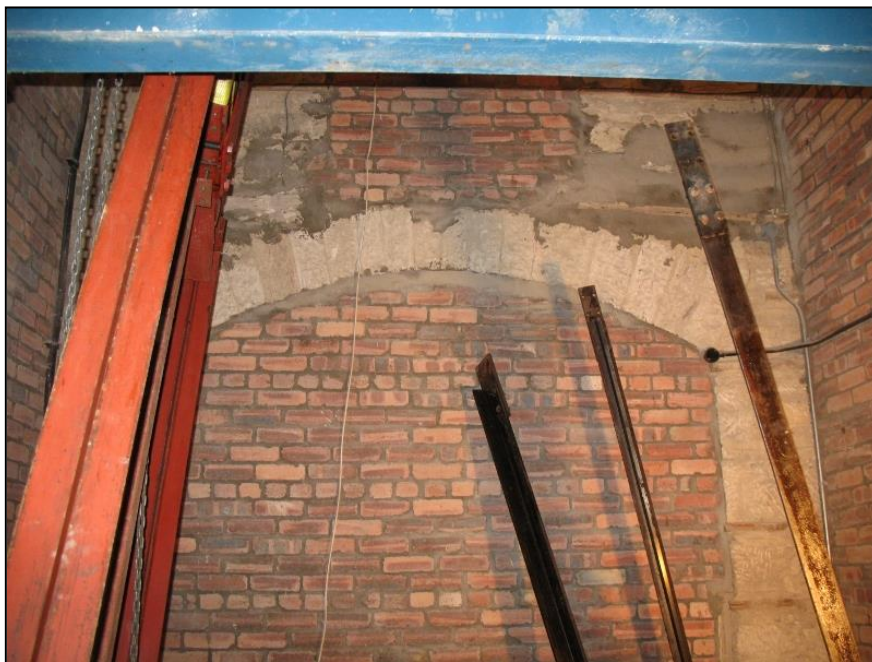
Figure 4b: Former arched opening in N wall of lift shaft, viewed from Room 014

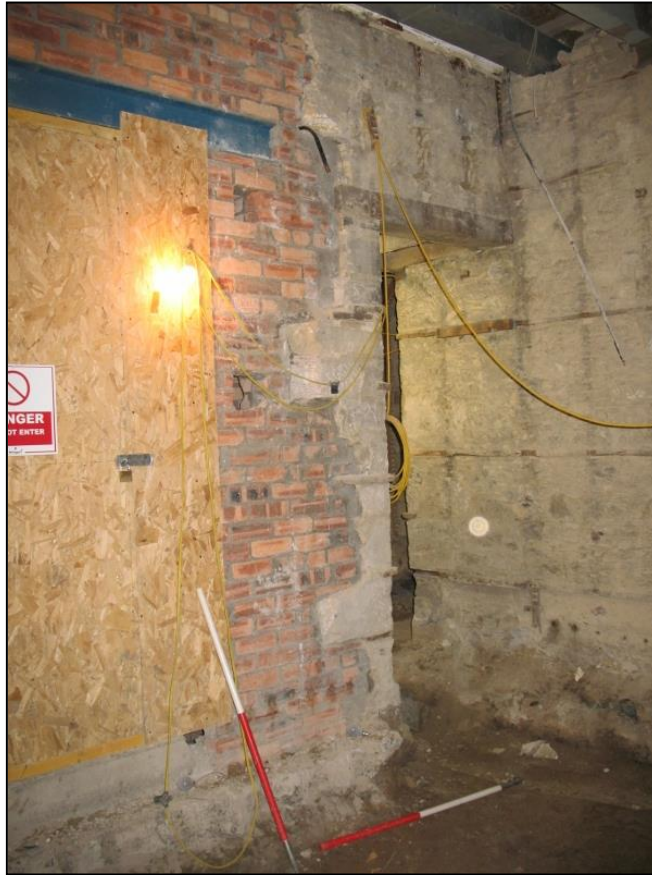
29. The S wall of the lift shaft had been constructed on the line of an earlier internal wall: traces of the earlier feature still survived (Figure 5a), despite the fact that a hole was punched through the masonry to allow the insertion of the lift and its accompanying mechanism.

Figure 5a: External view of lift shaft, viewed from Room 014, showing hole punched through original masonry and then infilled with brick following insertion of lift

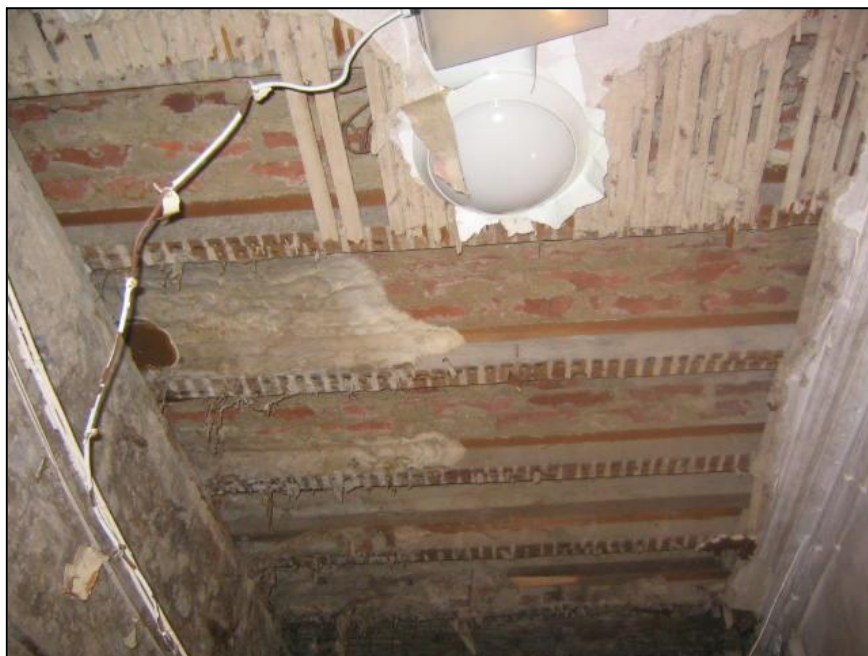
Figure 5b: View of the exposed ceiling fabric in corridor 006, showing fireproof jack-arch construction

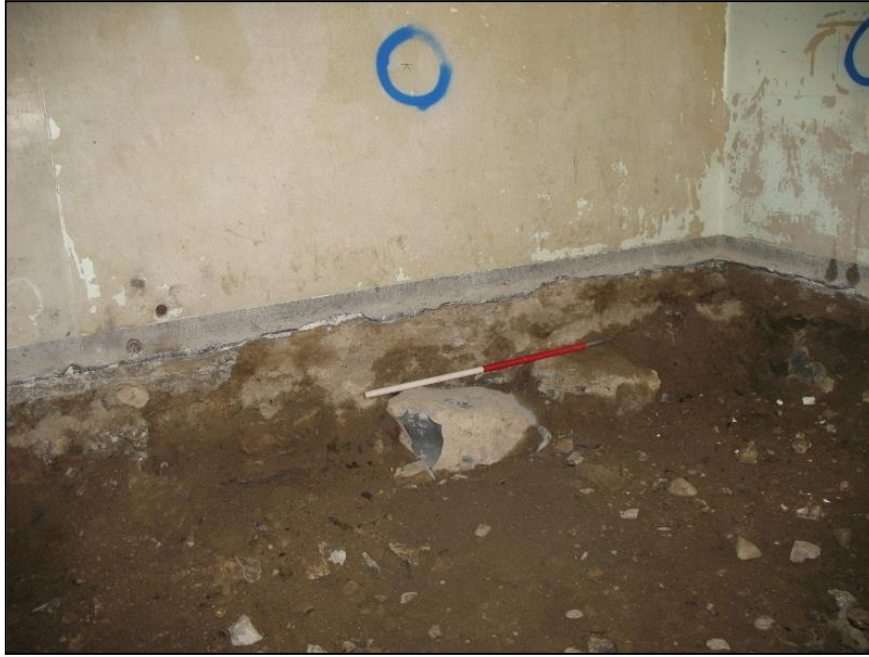
Figure 6a: *In situ* boulder course at base of S wall, Room 023

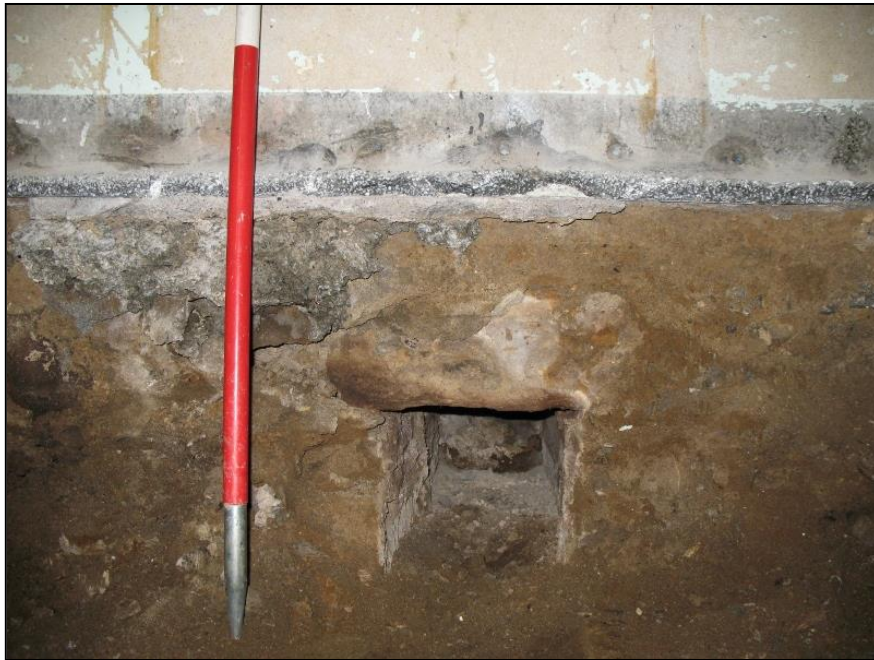
Figure 6b: Stone-built drain or duct running beneath internal wall dividing Rooms 009 and 023

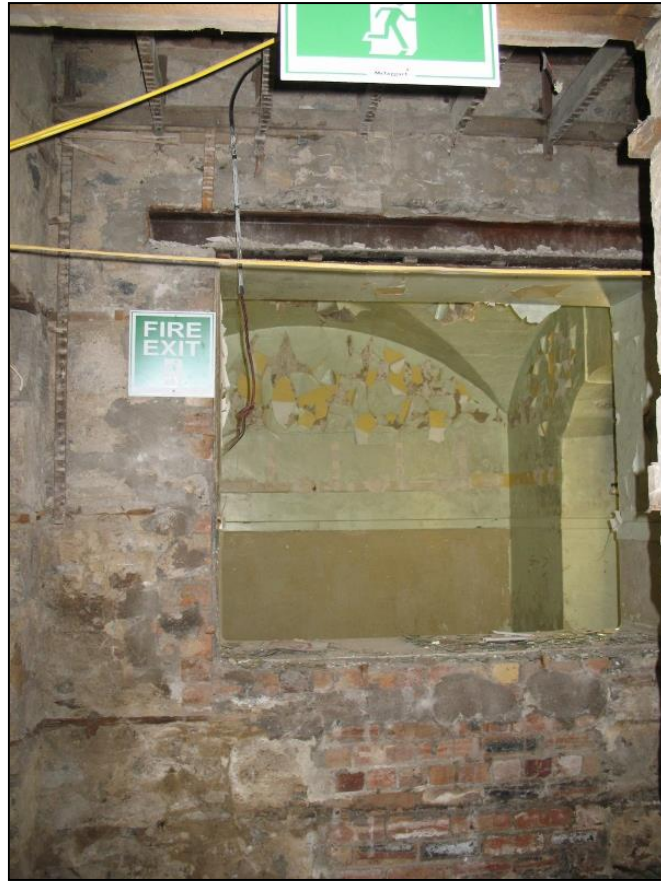
Figure 7a: Site of blocked doorway accessing Room 009 from Corridor 005 (N end)

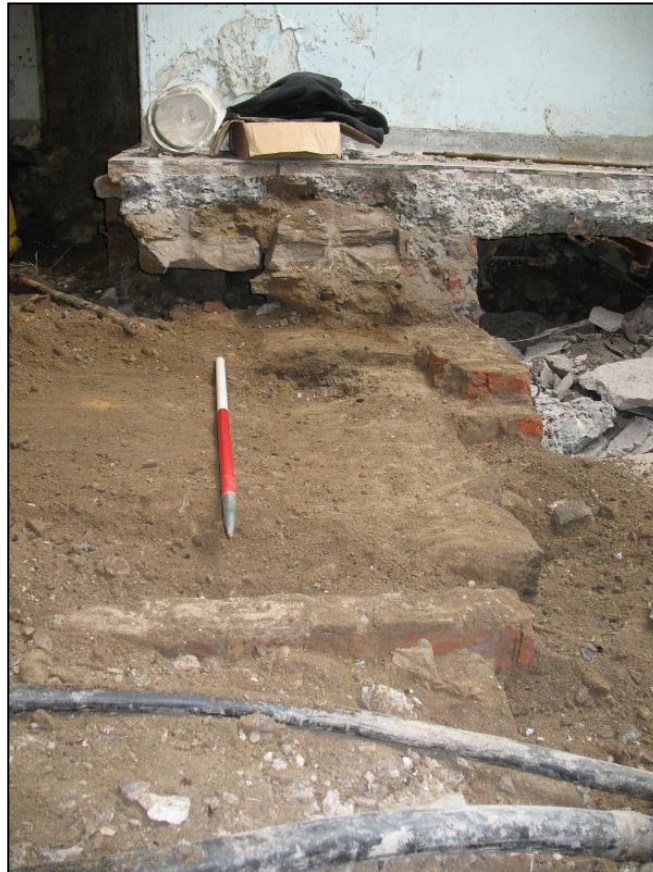
Figure 7b: Line of earlier E-W walling originally forming cross-wall between Room 007 and Corridor 005

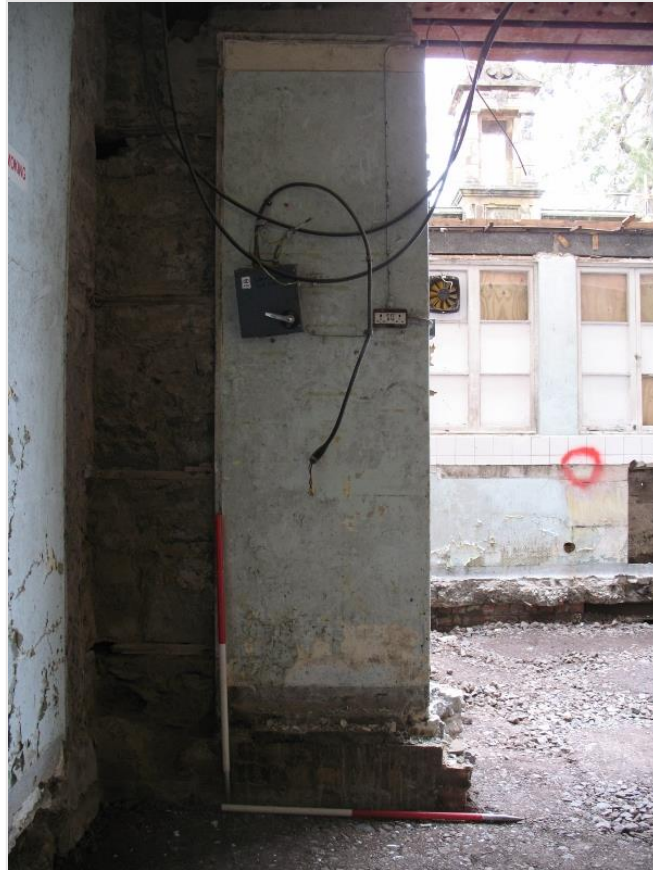
Figure 8a: Line of earlier E-W walling originally forming external N wall of house

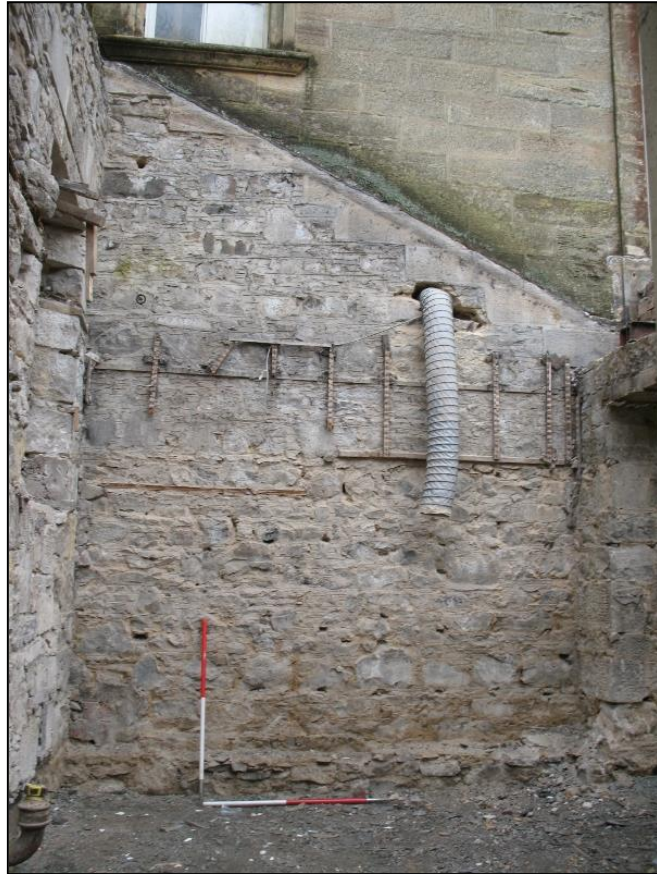
Figure 9a: S Wall of 031, showing shared wall with main house and raggle

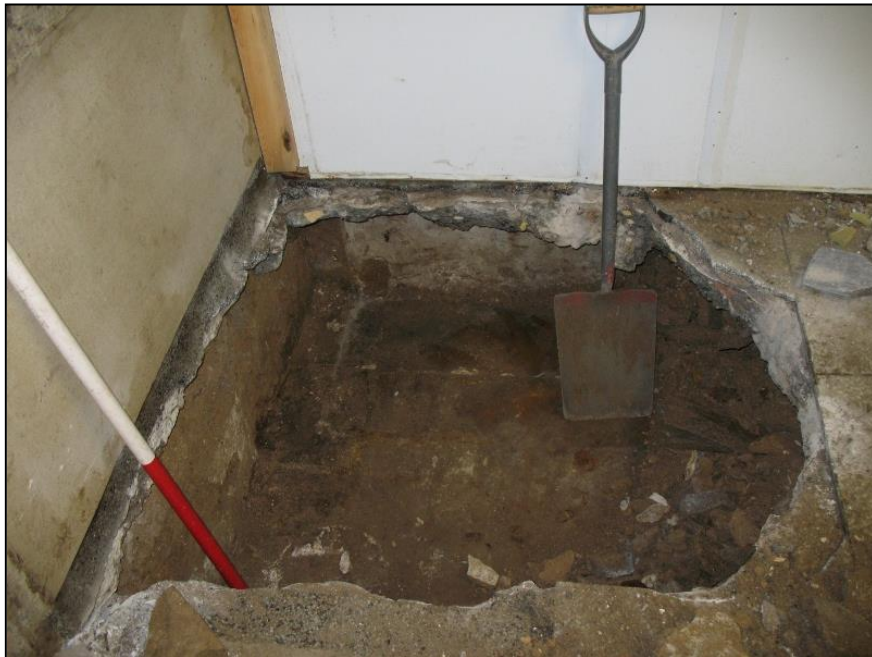
Figure 9b: Sandstone flagged floor revealed beneath modern terrazzo layer, Room 033

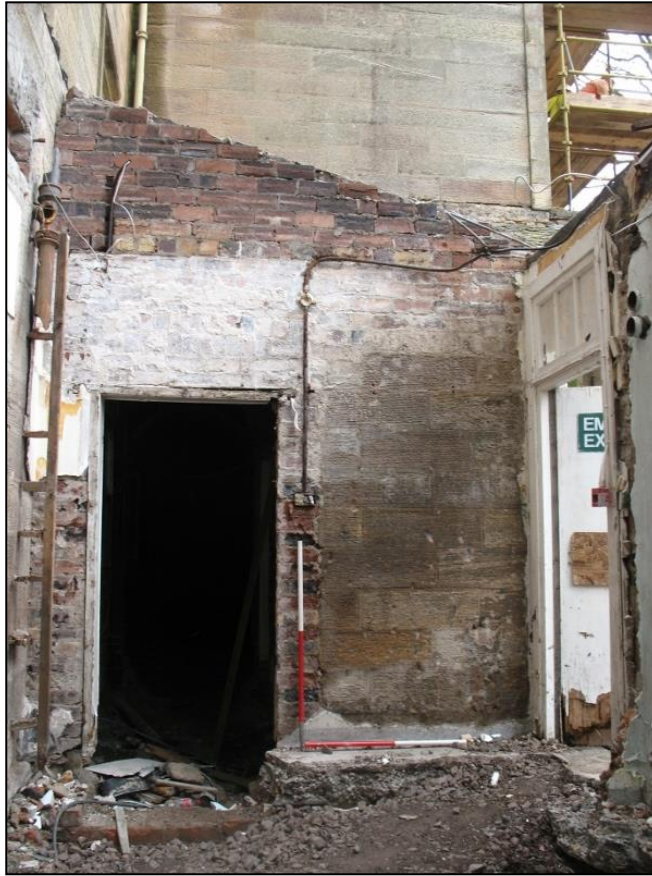
Figure 10a: Entrance to Main House Structure, from demolished remnants of Corridor 029, Looking S

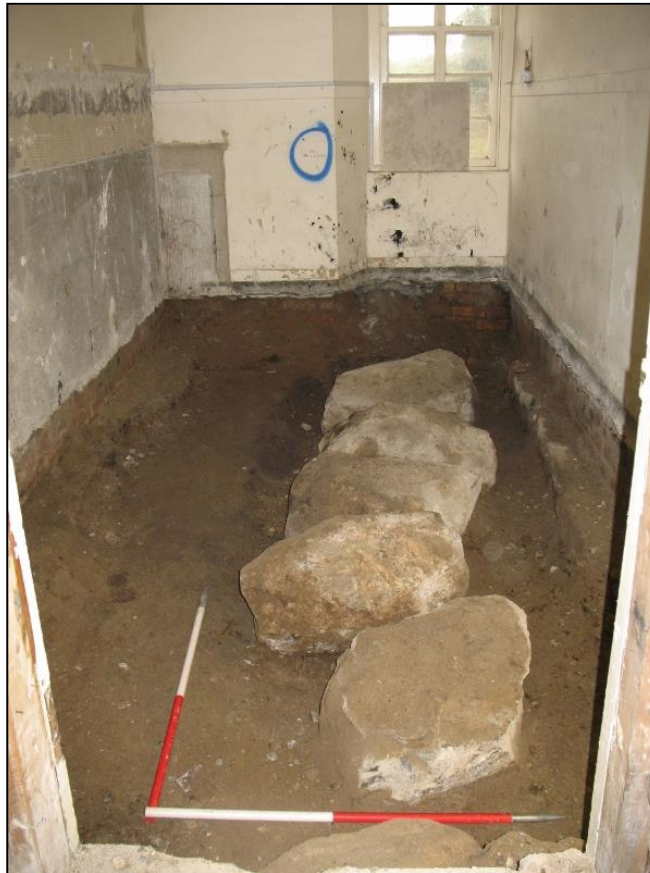
Figure 10b: Basal course of boulders marking original S extent of room 025

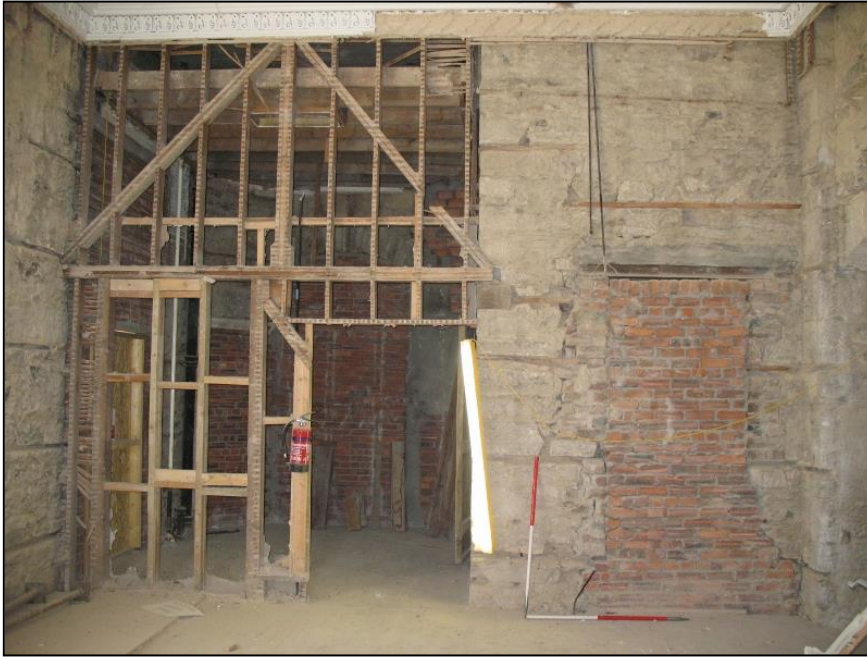
Figure 11a: Room 106 – View from Room 102, showing Masonry Cross-wall (to right) and frame of timber stud wall (to left)

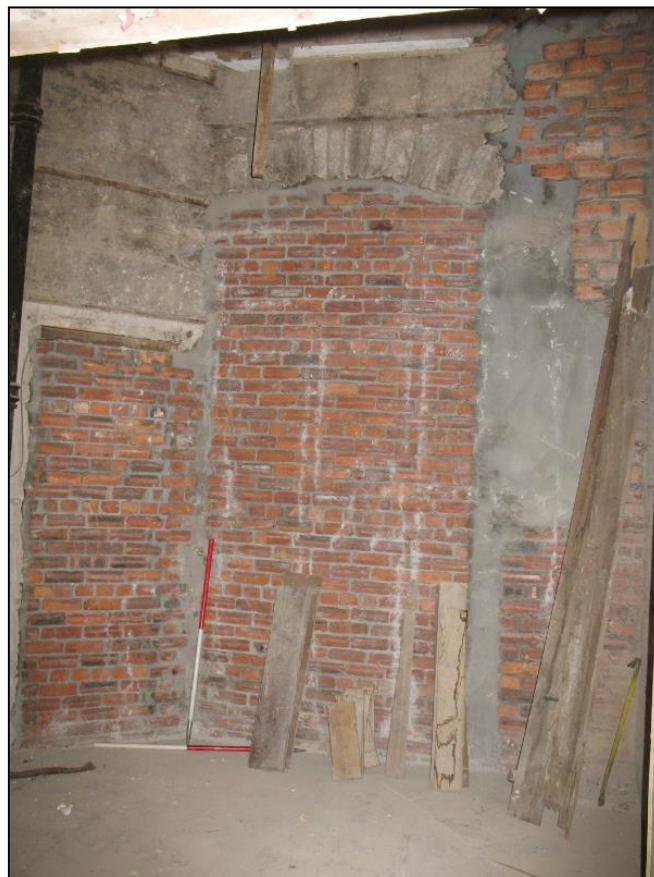
Figure 11b: Room 106 – View of W wall, seen from NE corner

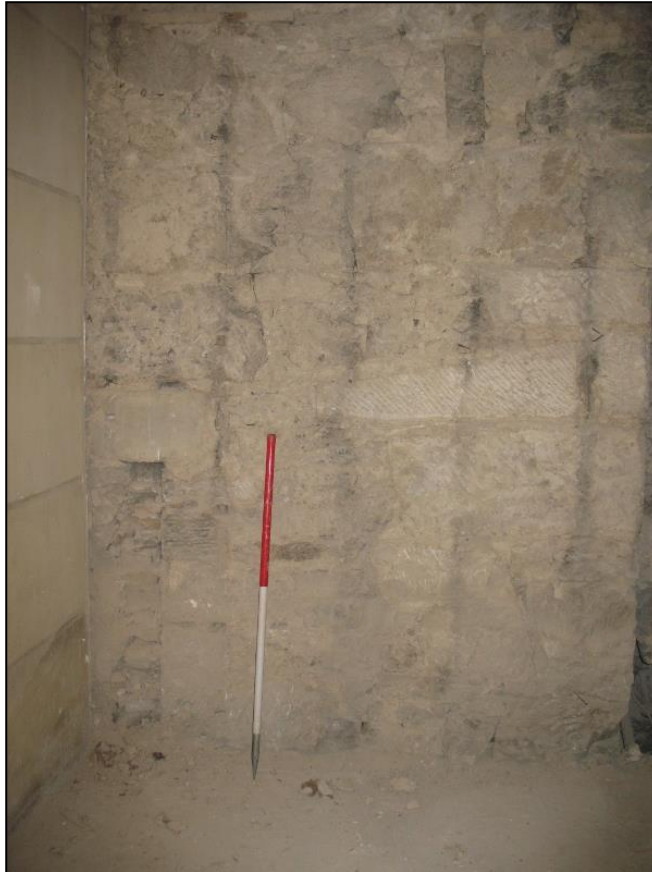
Figure 12a: Relict Fireplace in E wall, Room 114

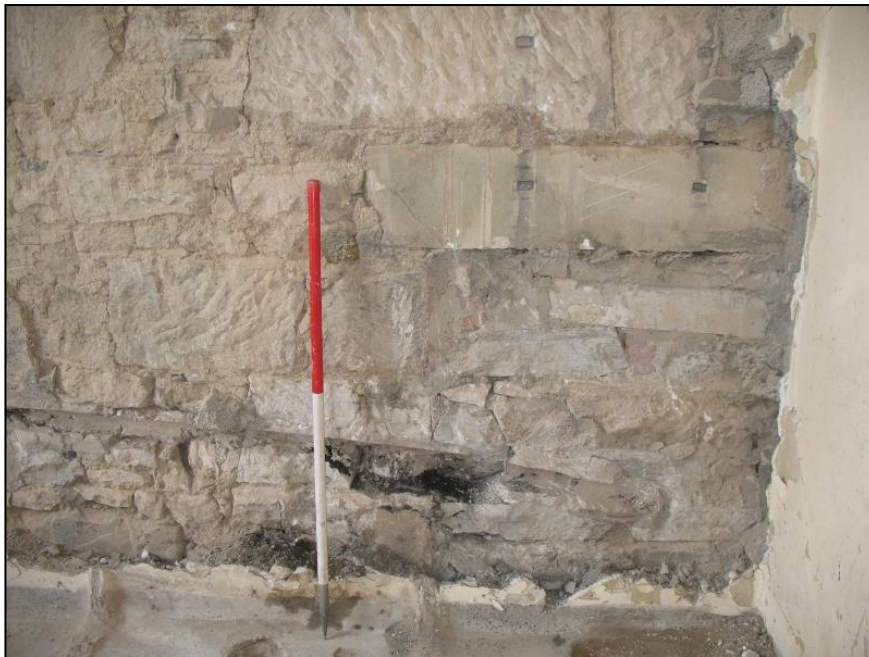
Figure 12b: Relieving arch at low level, S wall of Room 115

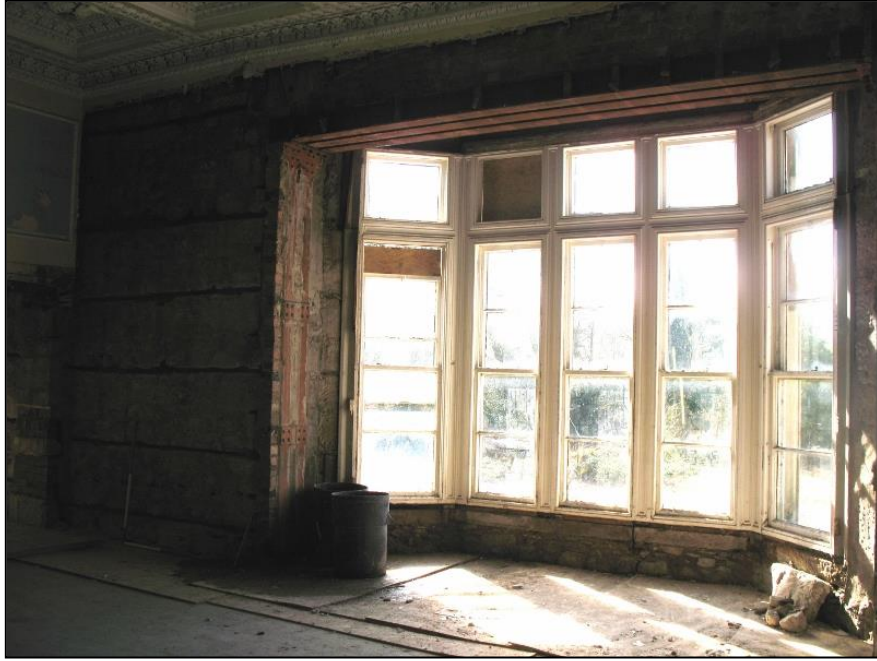
55. While the layout of the significant public rooms – i.e. 103, 104 and 105 – had not changed through the years, it was clear that there had been significant failures of the building's fabric in places. In particular, the large bay window in Room 103 displayed evidence of significant repair and consolidation works.

63. The use of riveted steel beams was also evident in the main bay window of Room 103 (Figures 13a & b). This was the most imposing and monumental window in the entire house, and it had clearly been subject to failure at some point: the original lintel, which is composed of a single segmental arch spanning the entire opening, has been reinforced through the addition of three steel beams, placed parallel along the length of the window, with a brick superstructure filling the void between arch and beams, thus helping to remove the weight borne by the overlying arched lintel onto the beams. The window embrasure was also strengthened through the addition of brick and steel beams.

Figure 13a: 1930s reinforcement of bay window, Room 103

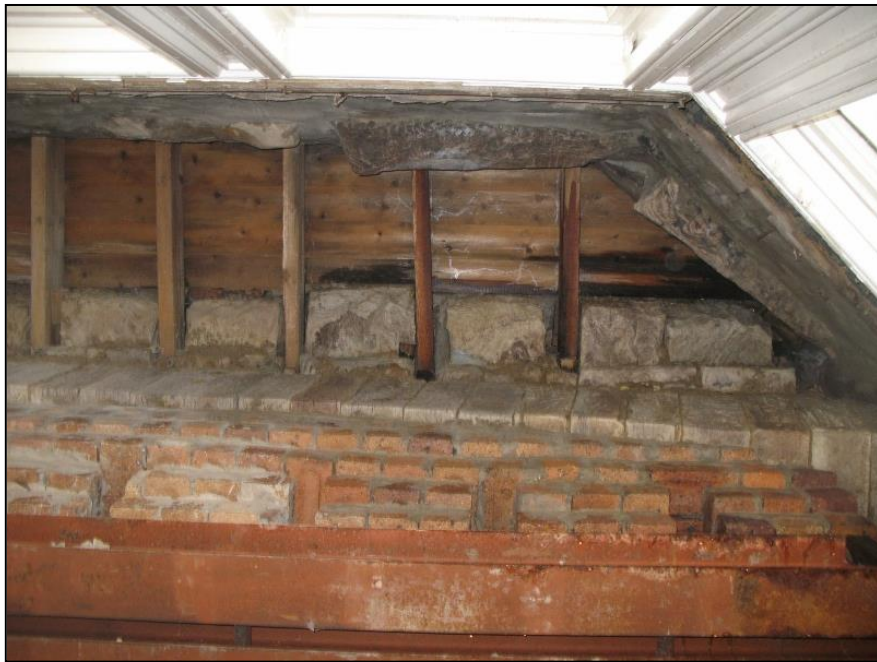
Figure 13b: Reinforcement of main bay window, Room 103, seen from below, showing (bottom to top – steel beams, brick superstructure, original segmental arch lintel, and joists/flooring of 2<sup>nd</sup> floor

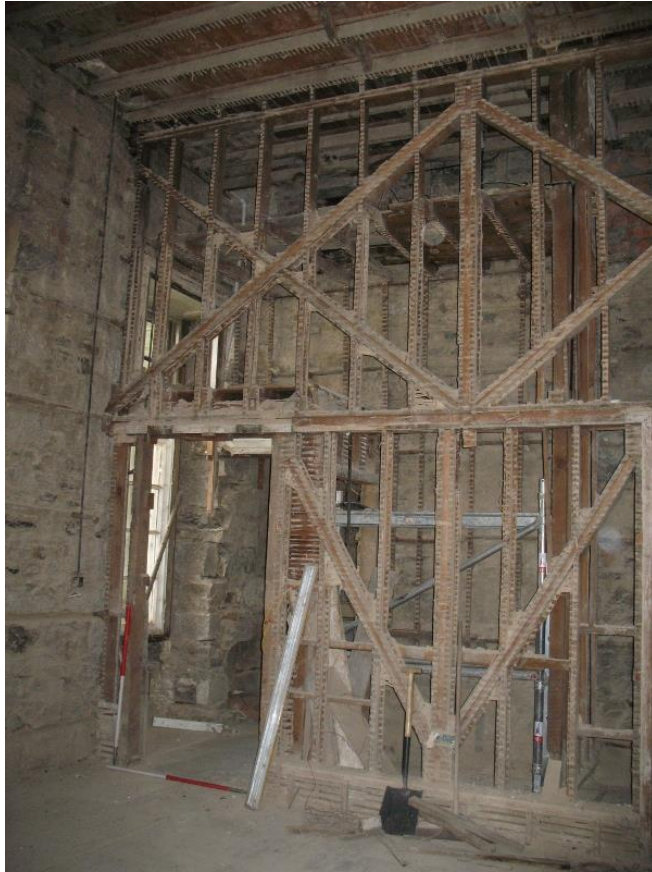
66. The subdivided space at the S end of Room 111 was clearly part of the original build (Figure 14a), and its presence requires explanation. At first, this area was interpreted as wall void and storage: however, as surface finishes were stripped away, it became apparent that Room 119 was floored at mezzanine level (Figure 14b). This flooring was located directly below stair 214, the latter allowing access between 2<sup>nd</sup> and 3<sup>rd</sup> floor levels. The uniform build of the timber partition work - and the surviving presence of intermediate floors - argues that this stair continued downwards, linking 1<sup>st</sup> and 2<sup>nd</sup> floor levels. It accessed the 1<sup>st</sup> floor via 119, with the base of the stair located in 113.

Figure 14a: Room 119 from interior of 111 – site of former stair, with timber flooring still *in situ*

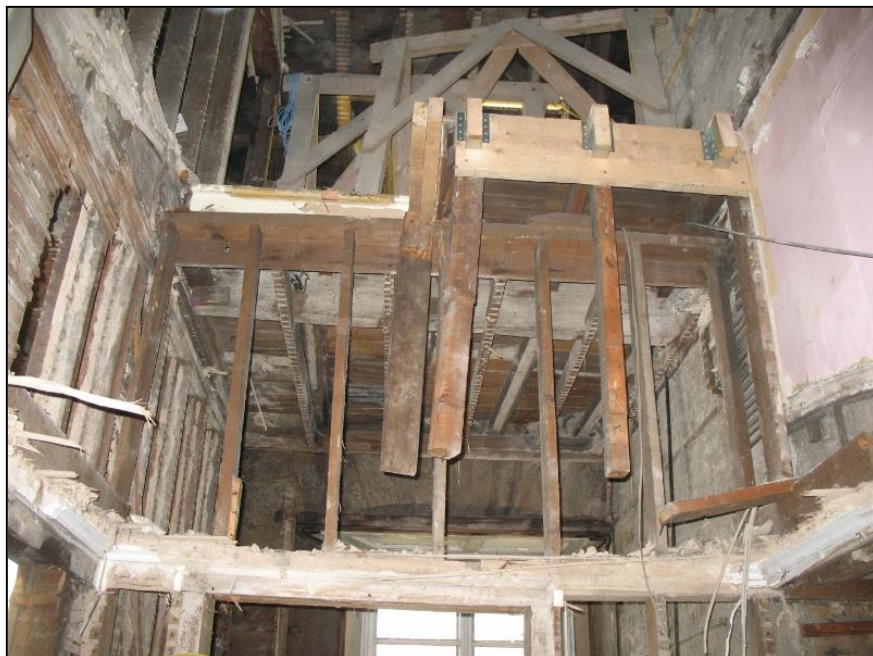
Figure 14b: Room 119 from interior of 113 – site of former stair, with timber flooring still *in situ*

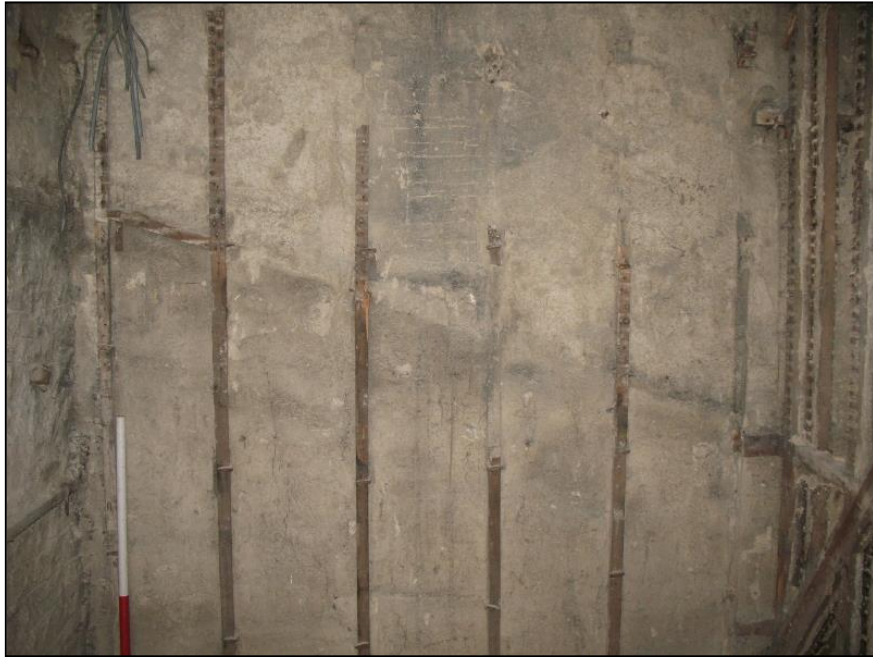
67. A slight colour difference in the masonry of the W wall of 113 suggests the presence of a timber stair and represents the last traces of such a feature (Figure 15a). Since the stair was built entirely of timber, and placed within an area defined on two sides by timber studwork, the absence of associated features such as raggles is not entirely unexpected. The later conversion of stairwell 113 into a cupboard required the cutting of a doorway in the timber stud wall to allow access from Room 111.

Figure 15a: W wall of Room 113, showing line of former stair

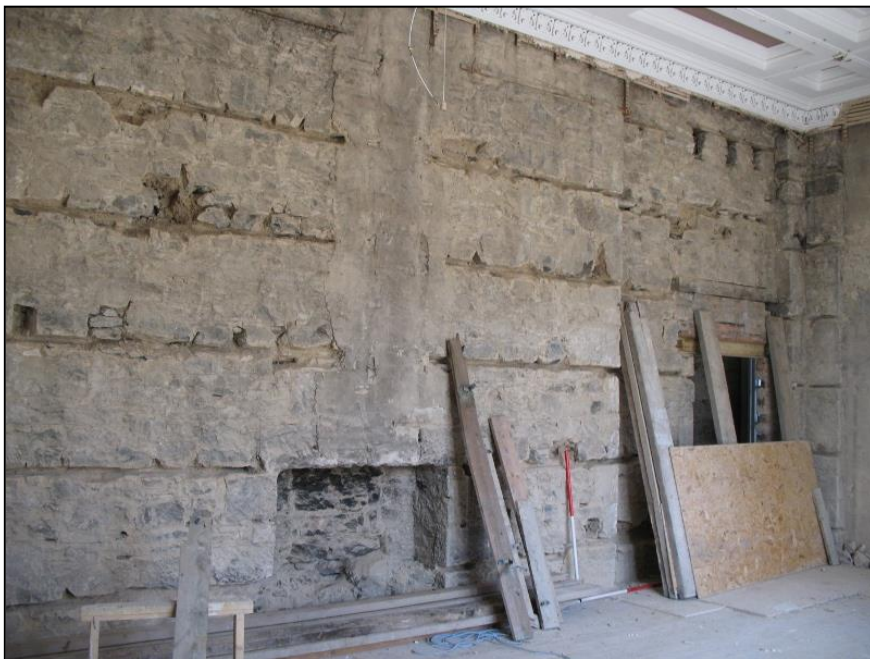
Figure 15b: High Level Joist-holes at S end, E wall, Room 104

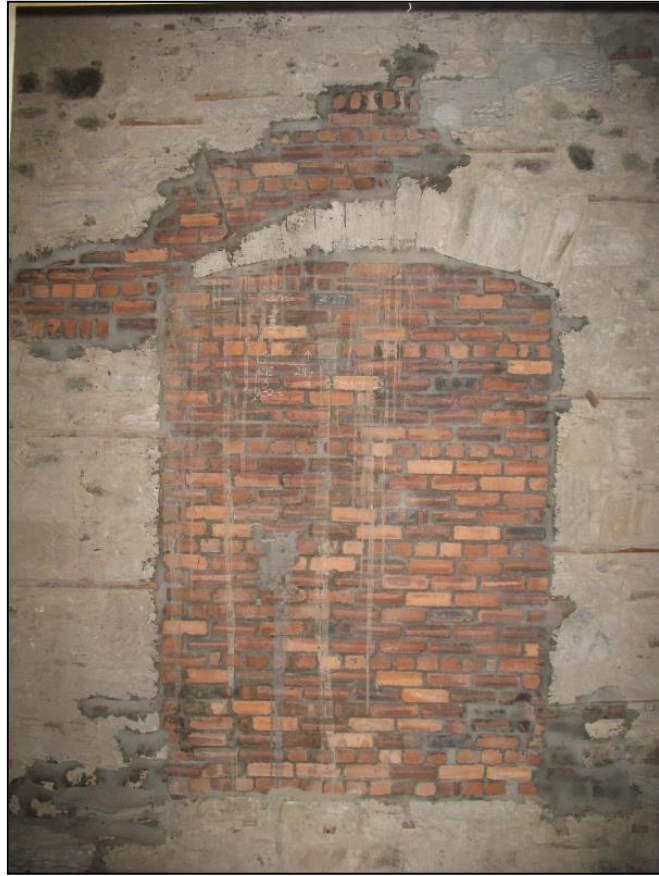
Figure 16a: Bricked up doorway & line of stair, N wall of lift shaft, from Room 221

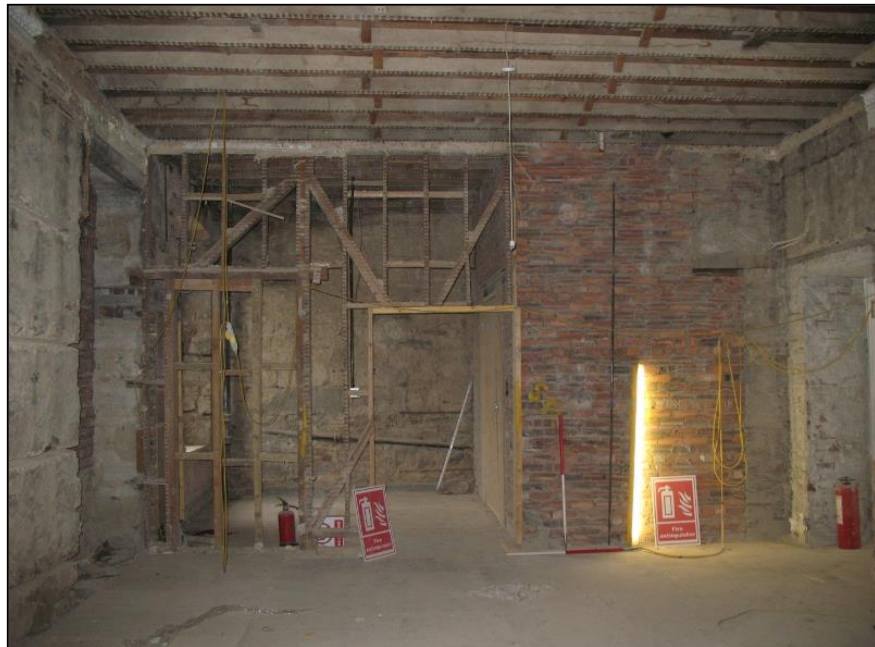
74. Access from Room 219 into the adjacent 221 was originally via a doorway at the S end of the timber element of the cross-wall. This was later blocked using an inserted panel of studwork, and a new doorway cut into the N section of the stud wall (Figure 16b), where it abuts the brick lift shaft.

Figure 16b: W wall of Room 219 (looking into 221), viewed from E

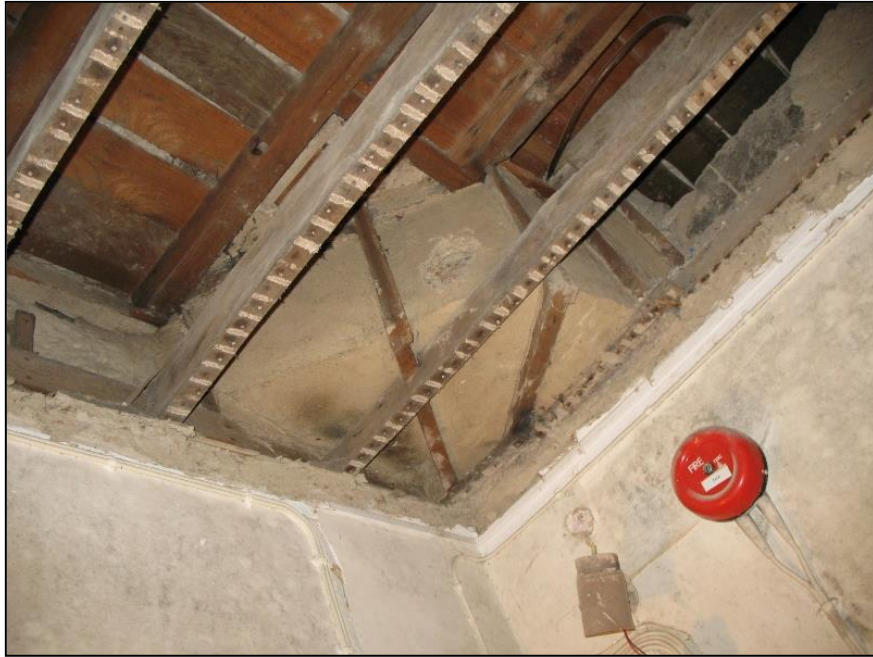
Figure 17a: Stone plinth for fireplace in SW corner of Room 221, viewed from below

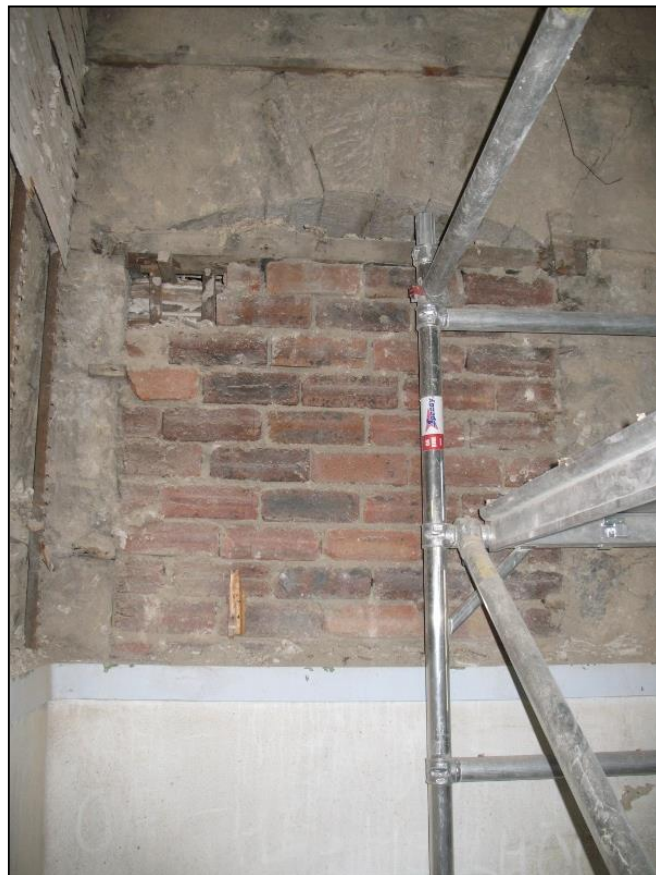
Figure 17b: Blocked doorway, W end of N wall, Room 216

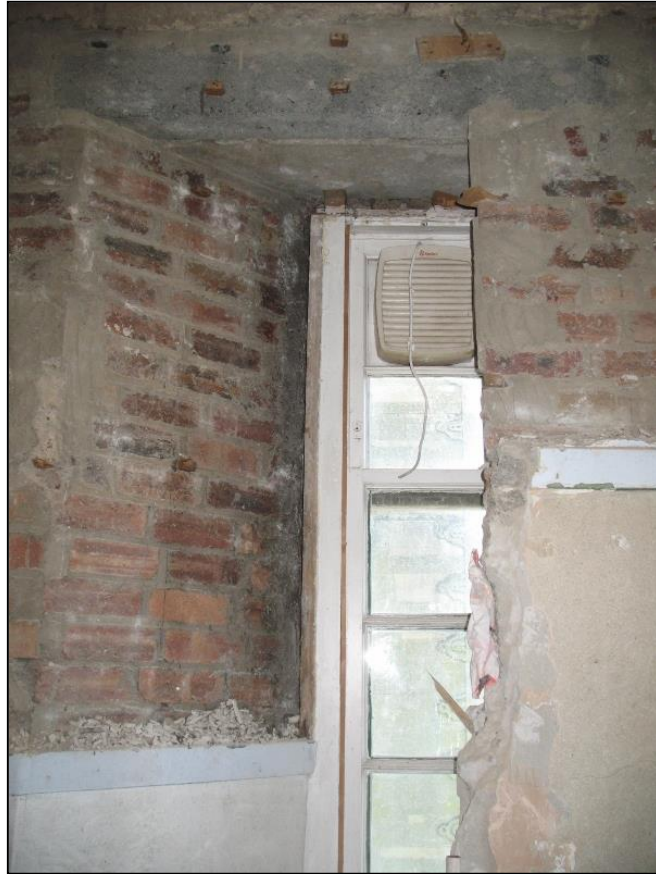
Figure 18a: Splayed window embrasure created through insertion of later brickwork, N wall, Room 216

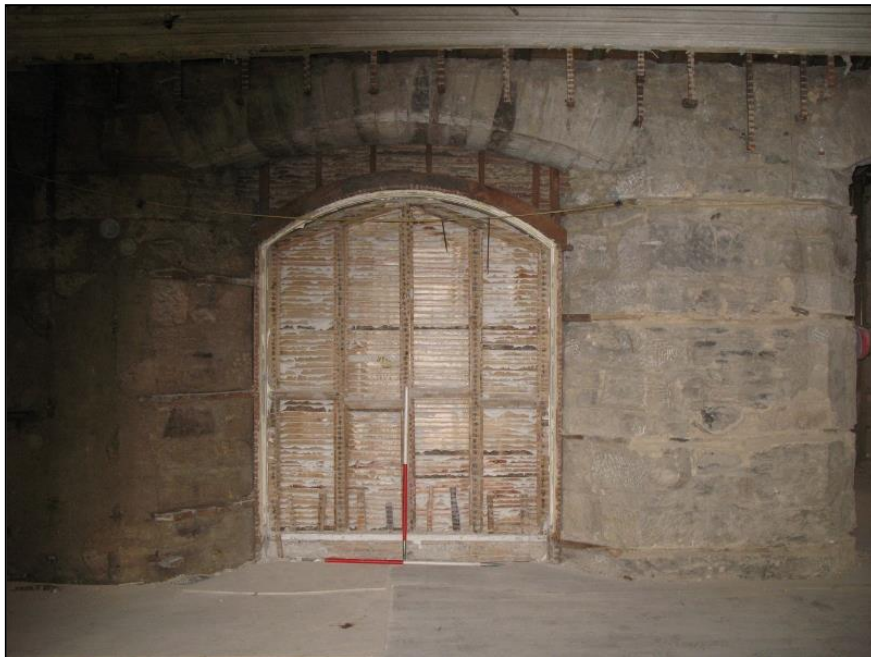
Figure 18b: Central arched recess in E wall, Room 202, showing relict timber studwork

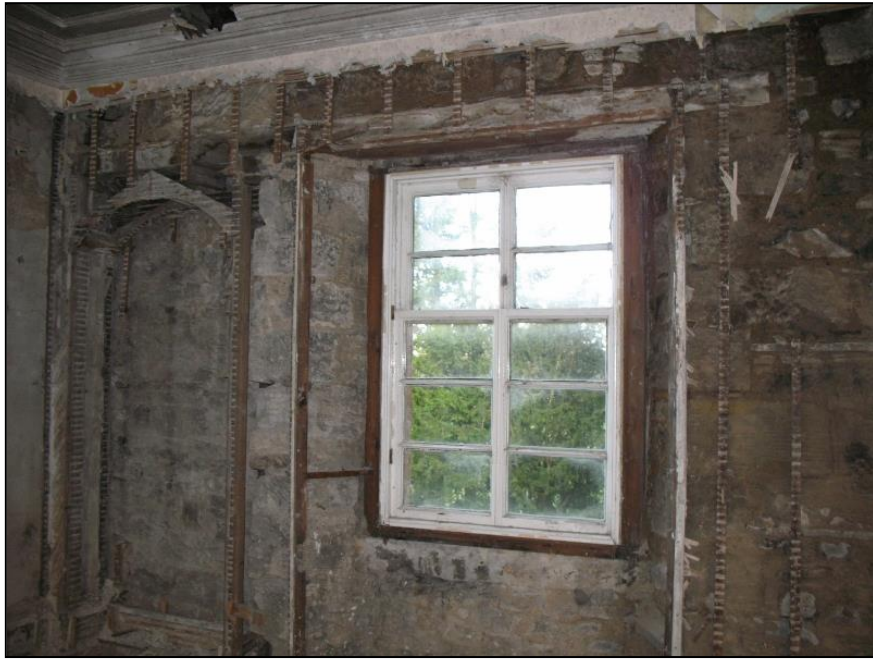
Figure 19a: Arched recess at N end of E wall, Room 202, showing relict timber studwork
