# Dunlop House, Dunlop, East Ayrshire Historic Building Recording

## Data Structure Report

issued 27<sup>th</sup> November 2015

on behalf of McTaggart Construction Ltd

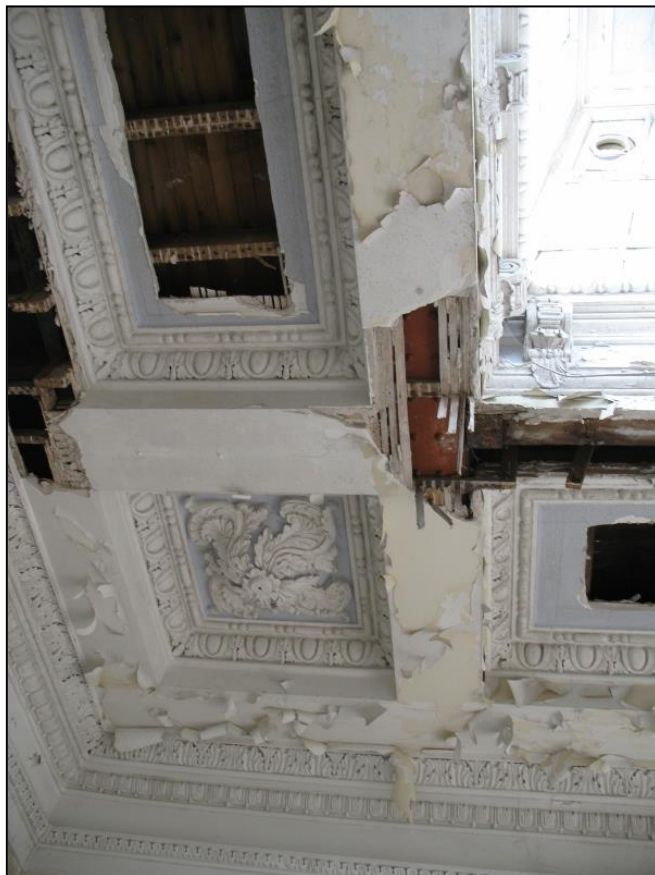
80. Though it had been assumed that the decorative plasterwork was original throughout the building, evidence eventually emerged of earlier consolidation works. During this phase of the on-site works, water ingress at the skylight surmounting the atrium caused the failure of a foliate boss in one of the coffered sections, resulting in further explorations to assess the full extent of the water penetration. This work revealed that the plain wooden perimeter beam which lay between the glazed central section and the coffering comprised a later plywood sheet masking riveted steel beams below (Figure 19b). These beams were identical in character to those noted elsewhere in the building, and must therefore have been introduced during the major renovation and remodelling works undertaken in the 1930s.

Figure 18a: Upper level of Atrium 201 – 1930s consolidation works revealed

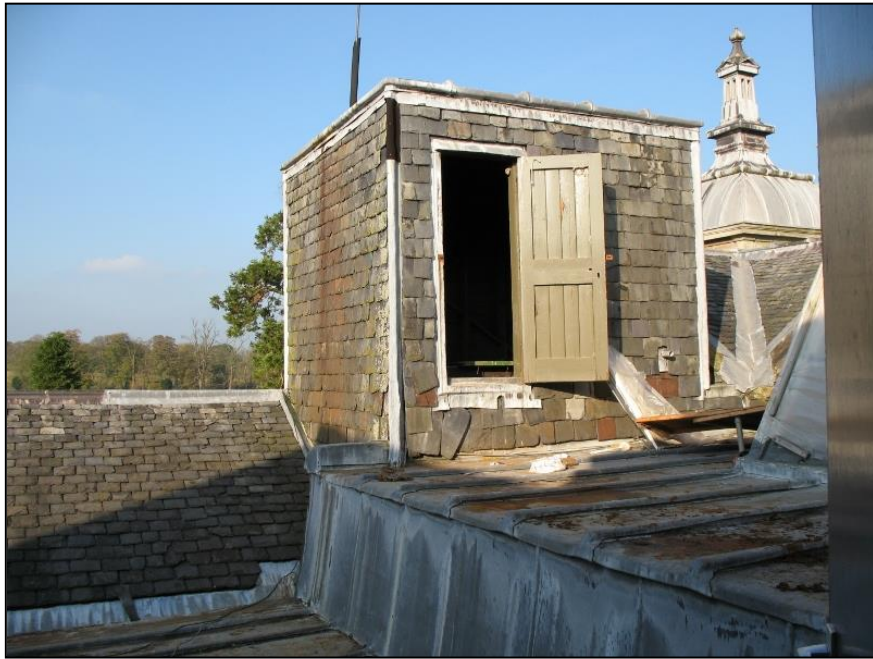
Figure 19a: Inserted caphouse projecting above original roofline

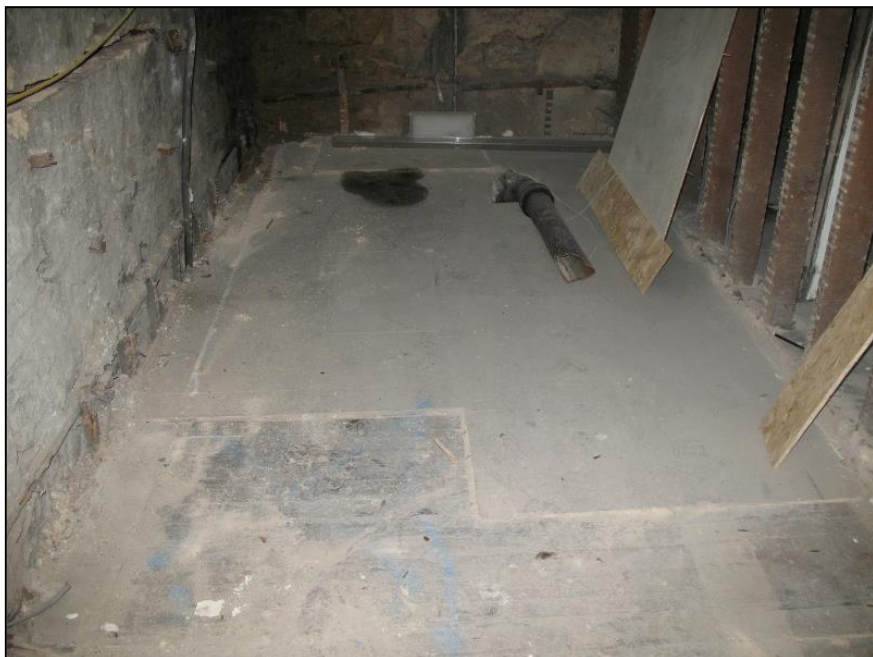
Figure 19b: Inserted floor over site of stair in S end, Room 308

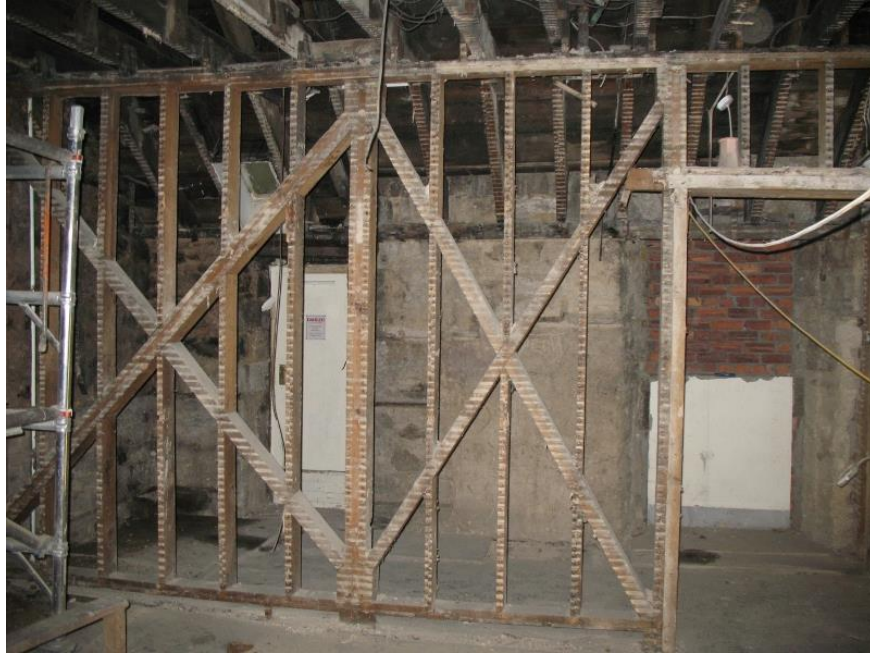
Figure 20a: E wall of Corridor Extension 311 – inserted doorway to left, original doorway to right

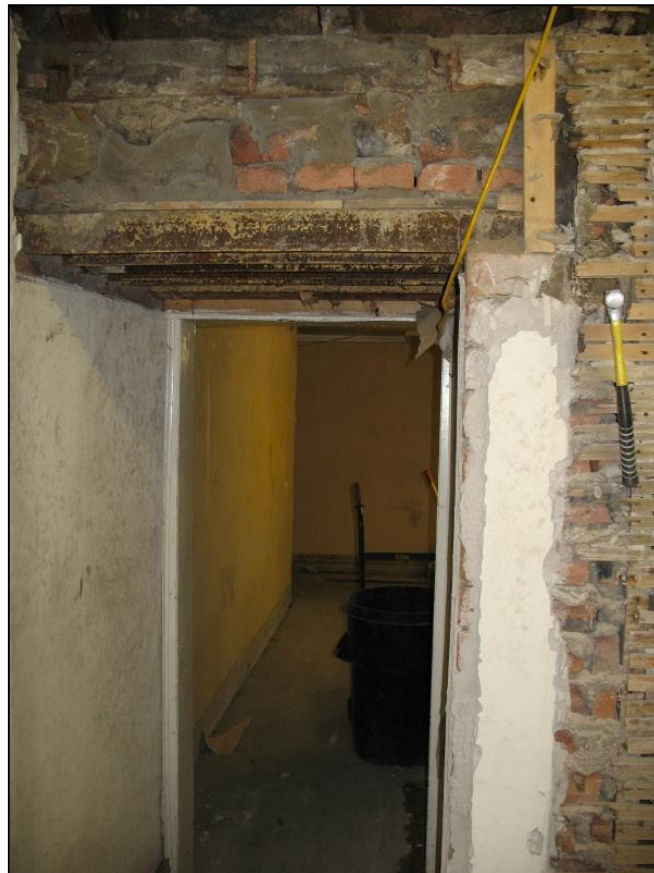
Figure 20b: Inserted doorway between modern Room 303 and Corridor 311

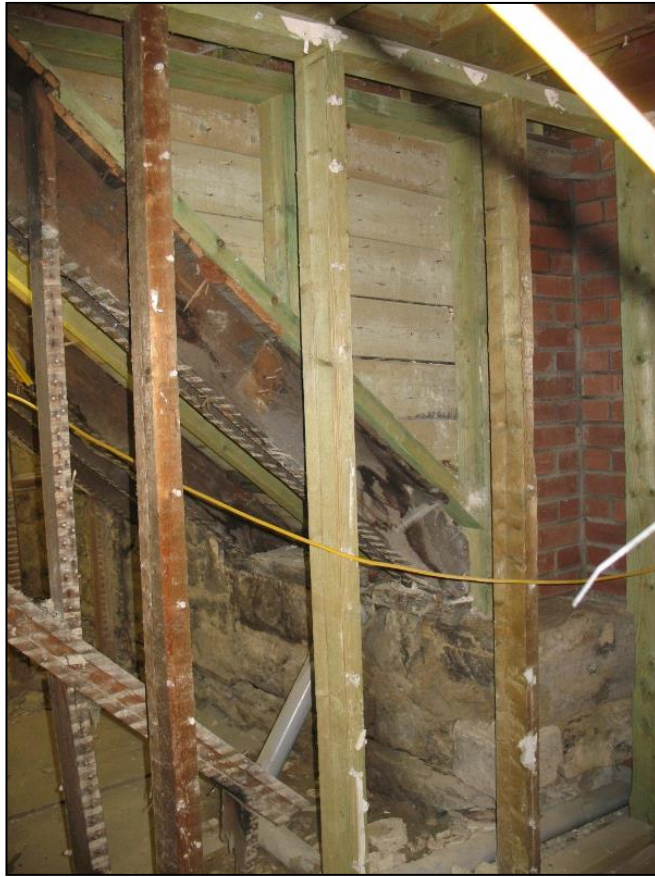
86. The addition of the external fire escape on the S elevation also damaged the original line of the wallhead in this location. Though the height of the wallhead has been raised to allow access onto the stair, it is possible that the doorway utilised the site of a former dormer, now lost. While most of the timber and brick components used in the construction of stair and doorway are clearly modern, occasional original timber studs still appear to be *in situ*. These extend to a height flush with the roof of the stair, as opposed to a height compatible with the wallhead (Figure 21a). Though this suggests that the wallhead was originally higher in this location, it is, however, possible that the timber was reused.

Figure 21a: Looking SW towards junction between original wallhead and modern external access stair, with *in situ* original timber to left of modern examples

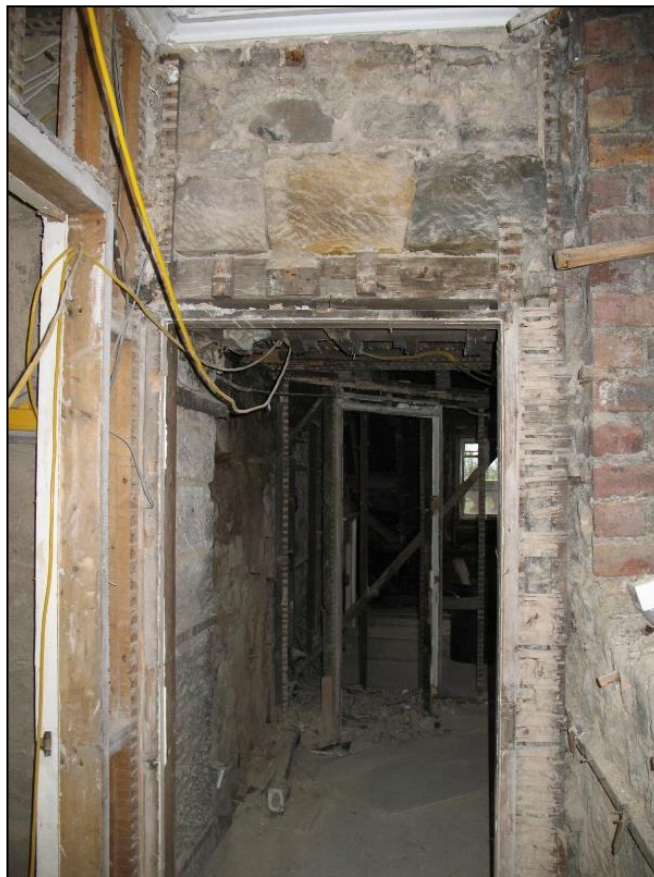
Figure 21b: Flat arch lintel, Corridor 304

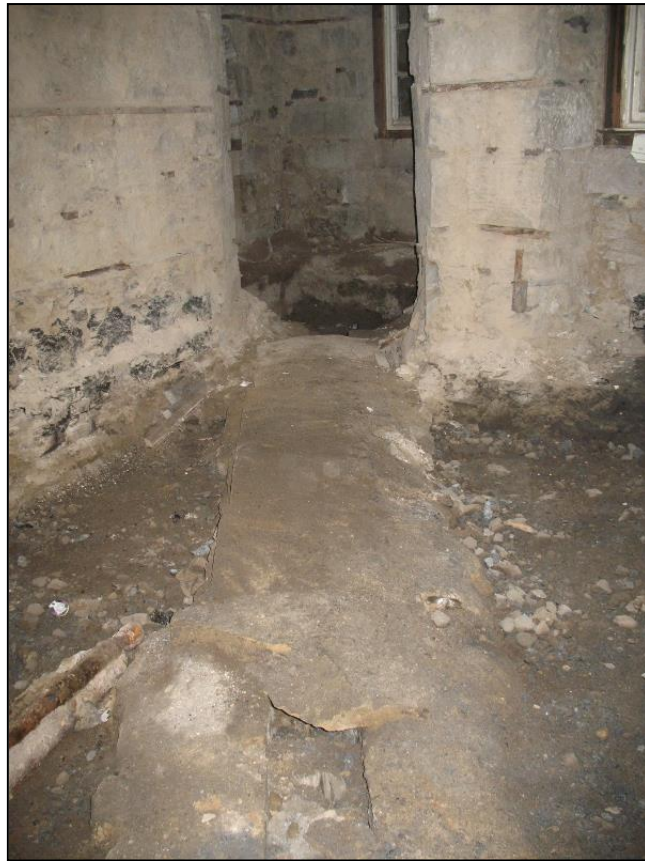
Figure 22a: Extant stretch of original service duct, looking NE across 016 towards 017

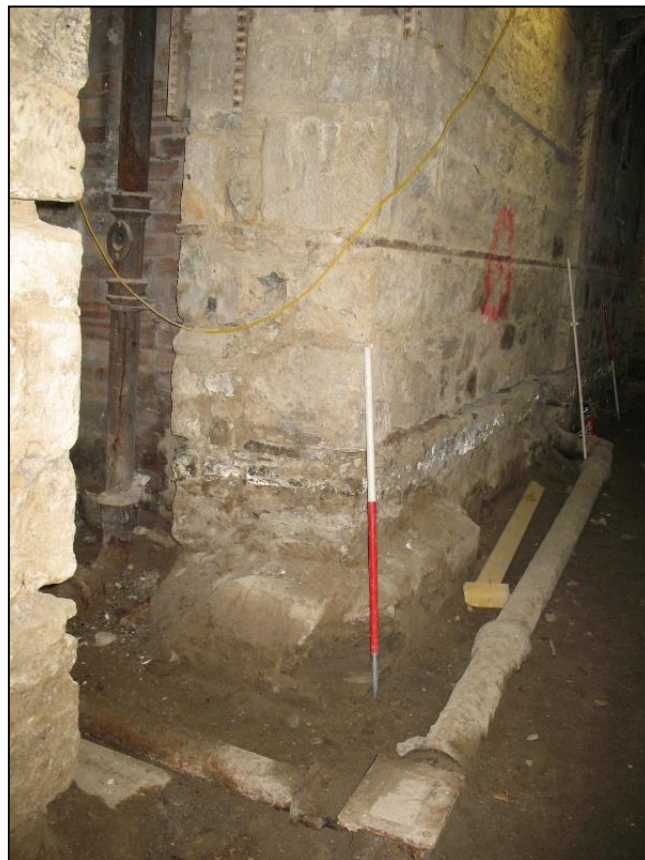
Figure 22b: Cast iron drainage pipe revealed during ground reduction in Corridor 008
