Black Bull Close, Brechin: Archaeological Mitigation

Data Structure Report

by Liam McKinstry
issued 29th November 2016
on behalf of Mr Aaron Souttar

RATHMELL  
ARCHAEOLOGY LTD

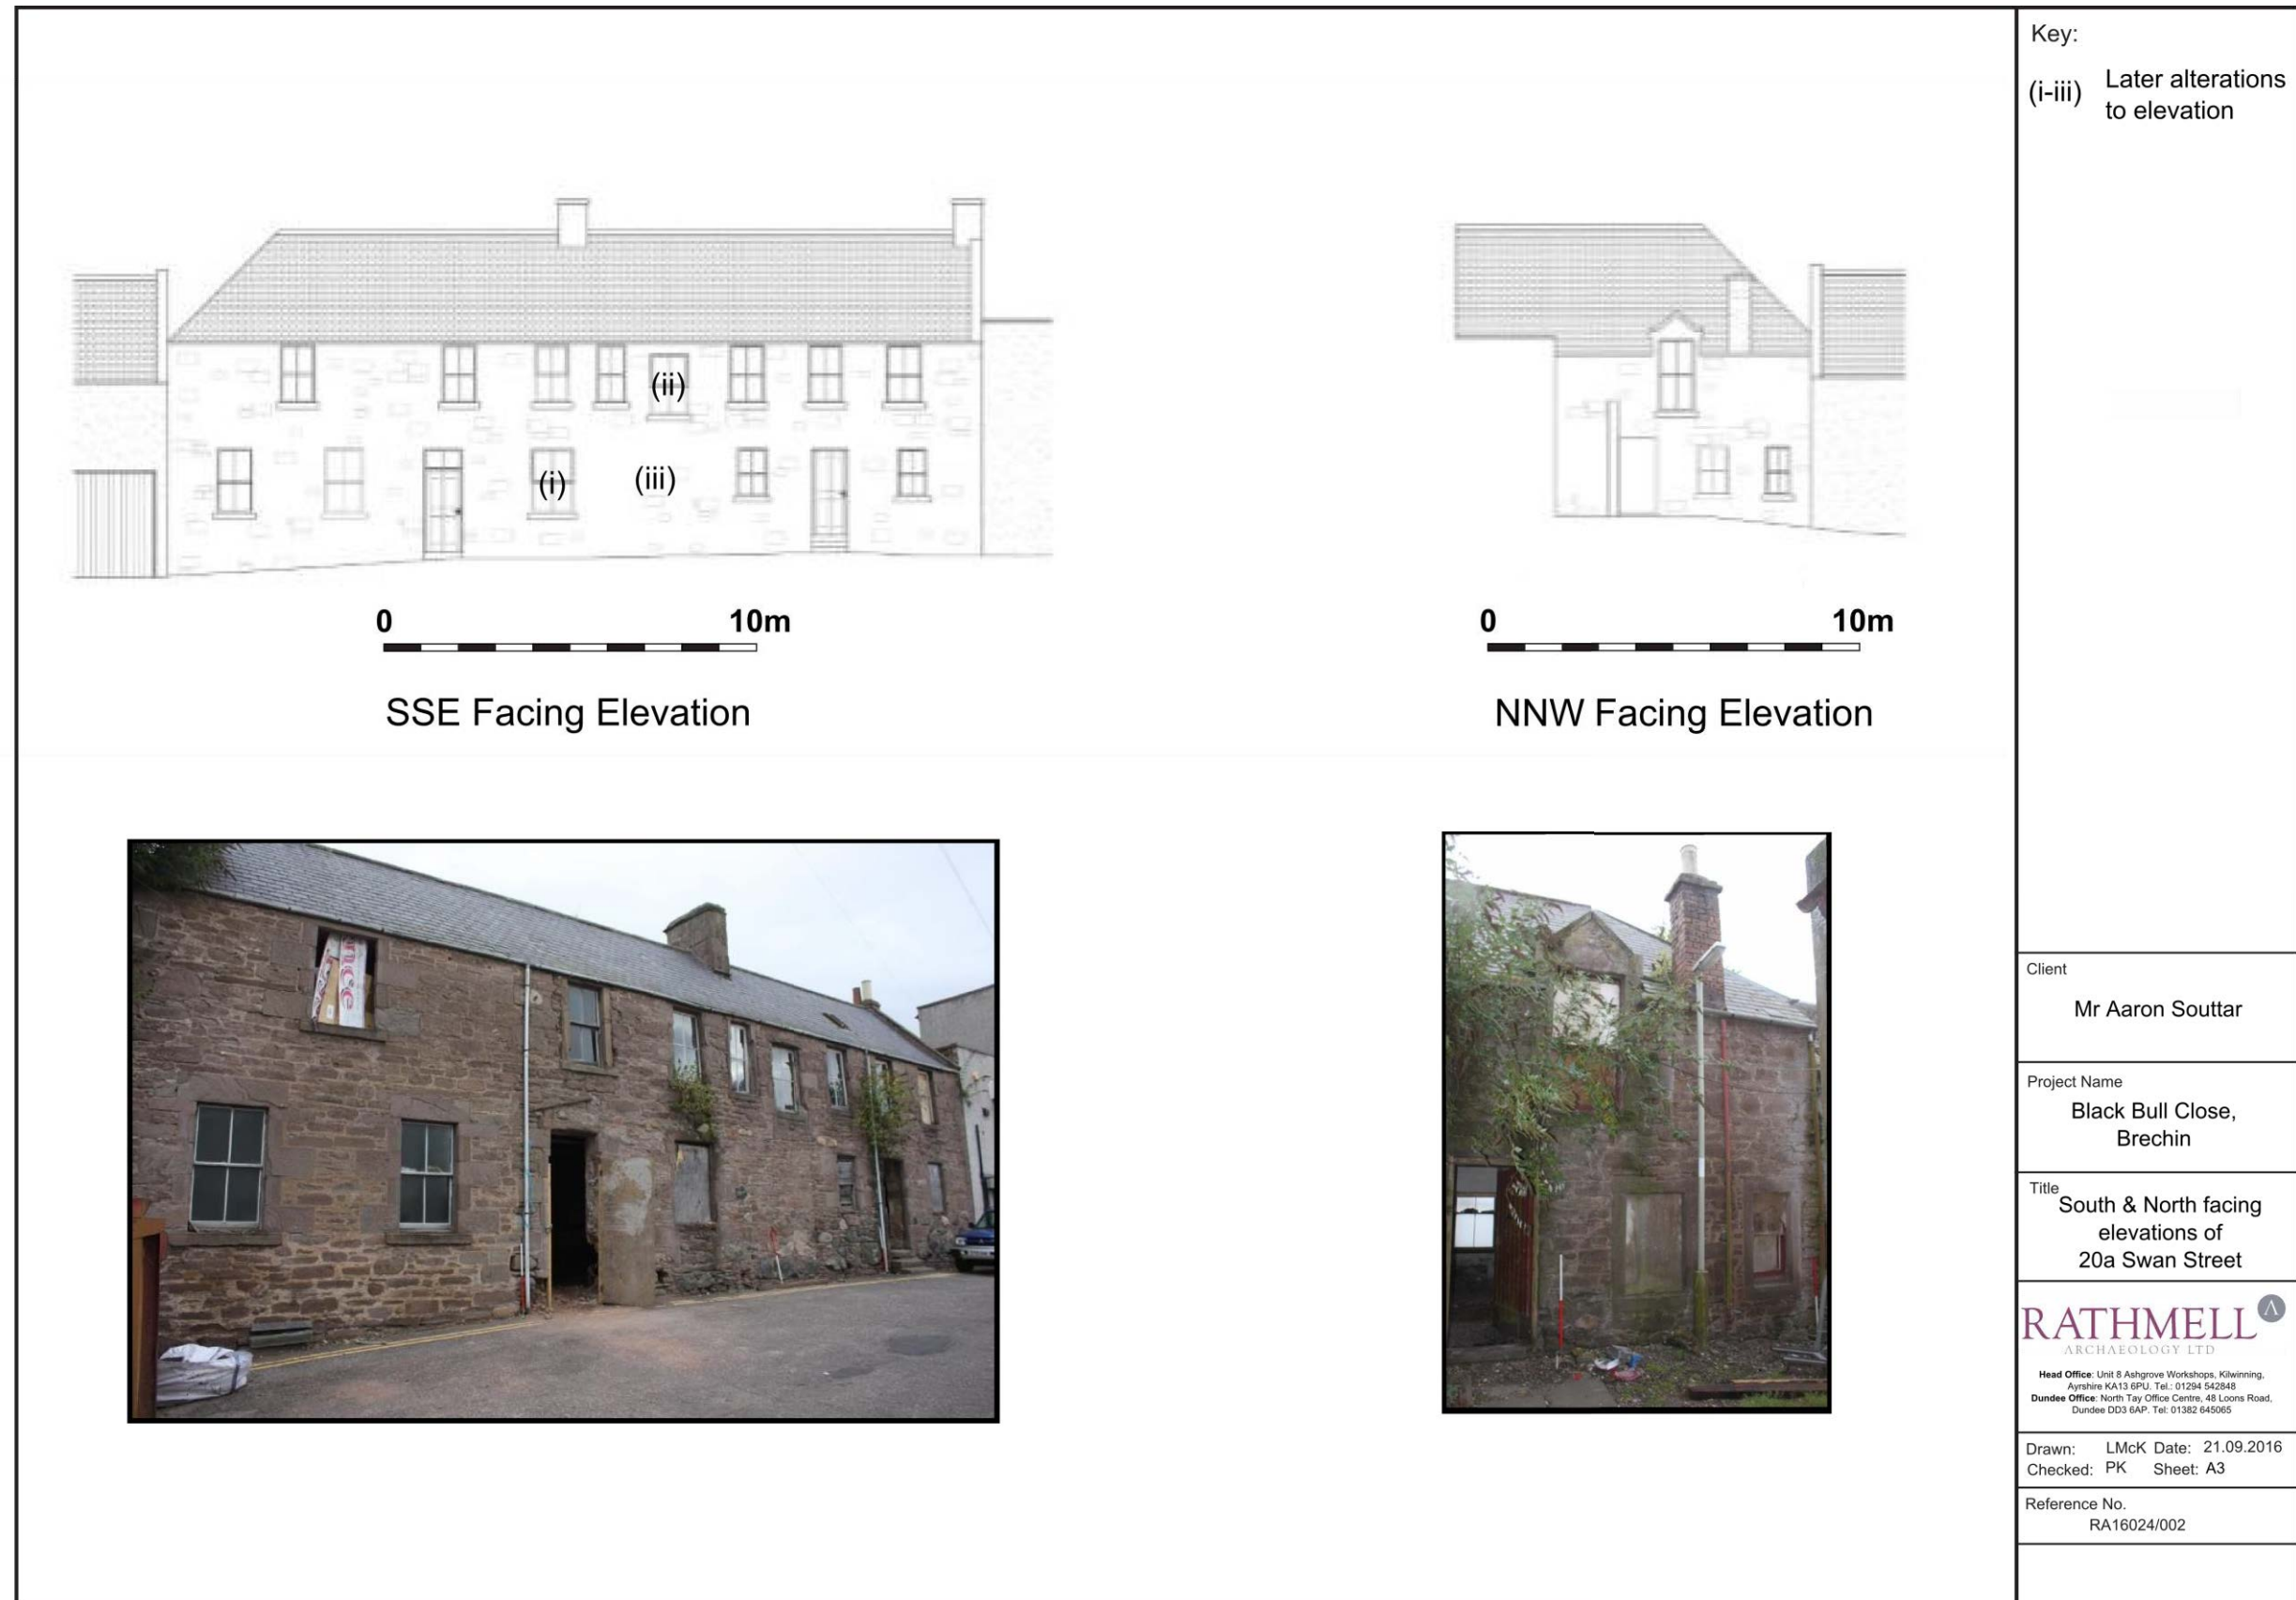
Figure 4: Elevations of 20a Swan Street (Store Room).

13. The building's main, SSE elevation (Figure 4) is for the most part built of squared coursed red sandstone rubble. Some cherry-cocking is evident. The exception to this is at the base of the ENE end where large roughly faced whinstone rubble and boulders have been incorporated into the building fabric, possibly during later alterations.

14. Though in its current state the building is divided into two properties, from the architectural evidence it seems probable that it may once have been three separate properties. The current elevation consists nine bays (which become more asymmetrical towards the WSW end), with 2 doorways and 13 windows arranged in an irregular fashion. The windows are a mixture of original sash and case, though some have been replaced by modern forms and others have been blocked up. The door openings appears to be original but modern temporary (wooden board) doors have been fitted. The door at the ENE end of the elevation is reached via a series of three stone steps at its base. Similar steps may also have existed for the door at the WSW end of the elevation but they had been removed and the door is now surmounted by a rectangular light.

15. Several later alterations could be seen on the SSE elevation which are marked (i-iii) on Figure 4. The first of these alterations (i) was noted on one of the current windows where the wall beneath the window appeared to have been blocked up suggesting that the window had originally been a doorway. The second alteration (ii) was located directly above the second and consisted of a window, which like (i) showed signs that it was a partially blocked up doorway and converted into a window. There is also the possibility that the partially blocked door was also a later addition to the building as a main internal (NNE-SSW running) wall may have once ran into that part of the front elevation (Figures 4 and 5). It is difficult to say what the original purpose of the blocked up opening was, though it may mark the site of a hatch for loading or unloading goods at first floor level via a hoist. The third alteration (iii) was located to the immediate ENE of (i) and consisted of a large square blocked-up area which may possibly have once been a set of double doors. The stone used for the blocking was of a similar sandstone to that used in the rest of the building, but the size and shape of the stones was different.

17. The building's NNW elevation (Figure 4) was constructed using similar material and construction methods as the NNE elevation, although due to the presence of a modern building built up against it, only the WSW end could now be viewed. The elevation consisted of one bay of three windows and one door. The margins of the ground floor windows differed from those in the front, SSE, elevation – comprising machine-cut ashlar as opposed to hand-tooled blocks - which may suggest that both were later additions. The window at the WSW end of the elevation was sash and case and the other was boarded up. The 1st floor window was hinged with the upper part of the window consisting of a dormer projecting out from the roof. The door, like those in the SSE elevation, was a recent temporary insertion made of wooden plaster board.

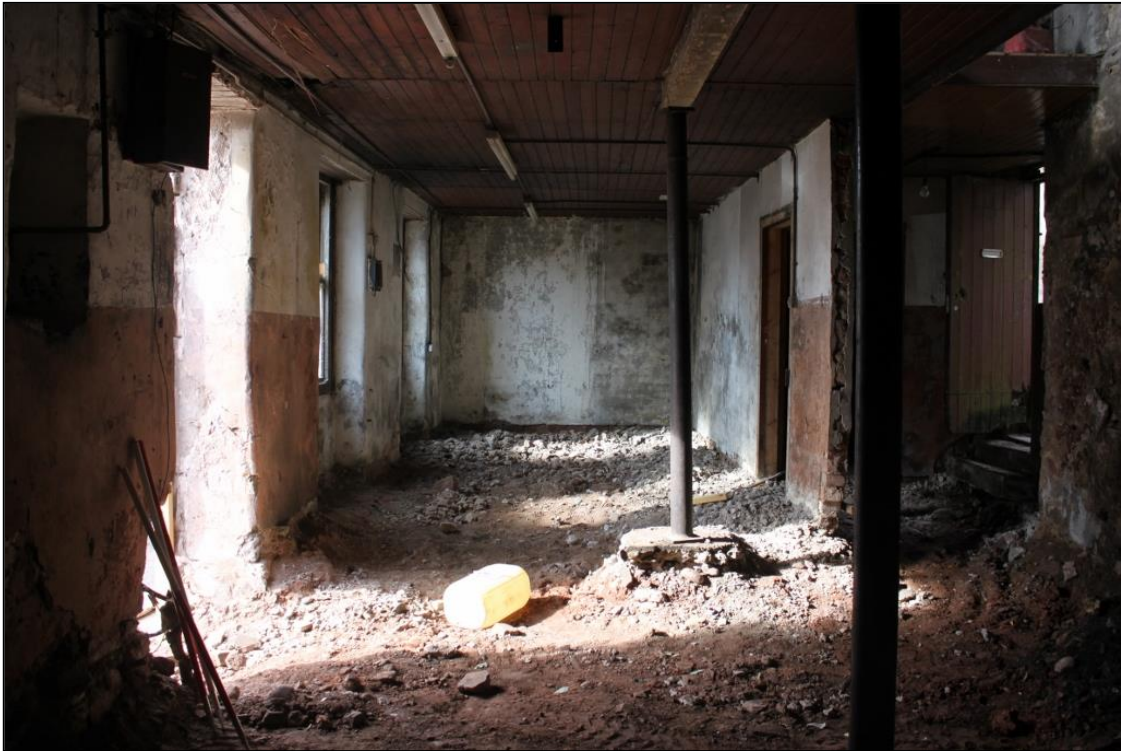
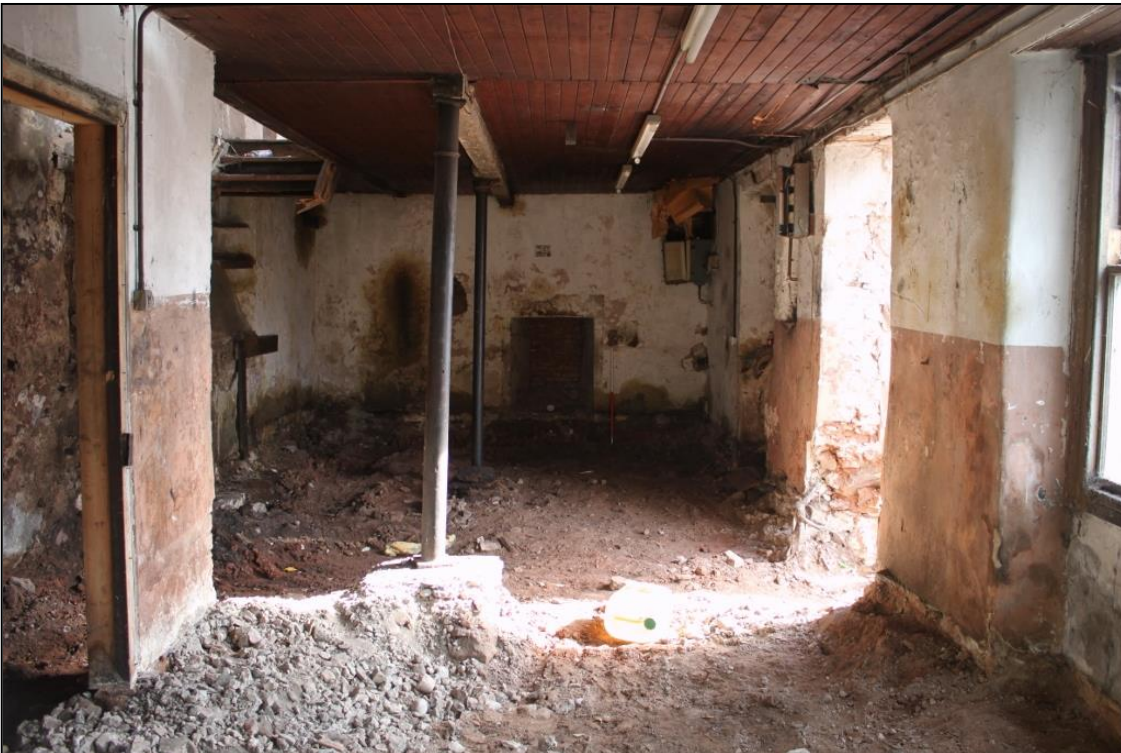
Figure 6a: View of Room 1, Ground Floor, 20a Swan St. From ENE

Figure 6b: View of Room 1, Ground Floor, 20a Swan St. From WSW

20. Room 1 (Figures 6a and 6b) was originally rectangular in plan but the construction of Rooms 2 and 3 within the WNW angle meant that the modern floor plan was 'L'-shaped. The walls which formed Rooms 2 and 3 were brick built with plastered surfaces. The vast majority of the flooring within Room 1 had been removed prior to the building recording with only small sections of a bare poured concrete surface surviving close to the walls and beneath the temporary internal roof supports. The surviving walls of Room 1 were plastered and painted and all of the observable services appeared to date to the twentieth century or later. No original eighteenth or nineteenth century features were present. On the SSE wall there was one doorway (the original door replaced by a temporary one) and three windows, one of which appears to have been a former doorway with the lower half blocked to create a window (See SSE elevation). The NNW wall was staggered on its WSW side due to the presence of rooms 2 and 3 (Figure 5). Two recesses for shelving were noted on the NNW wall directly beneath the current staircase (recently demolished) (Figure 7a). One of these recesses would have been partially covered by the staircase when it was still standing, suggesting that Rooms 2 and 3 and the staircase were later insertions to the building (Figures 7b and 8a). A fireplace was located on the ENE wall (Figure 8b). The WSW wall was plain and had no features of note.

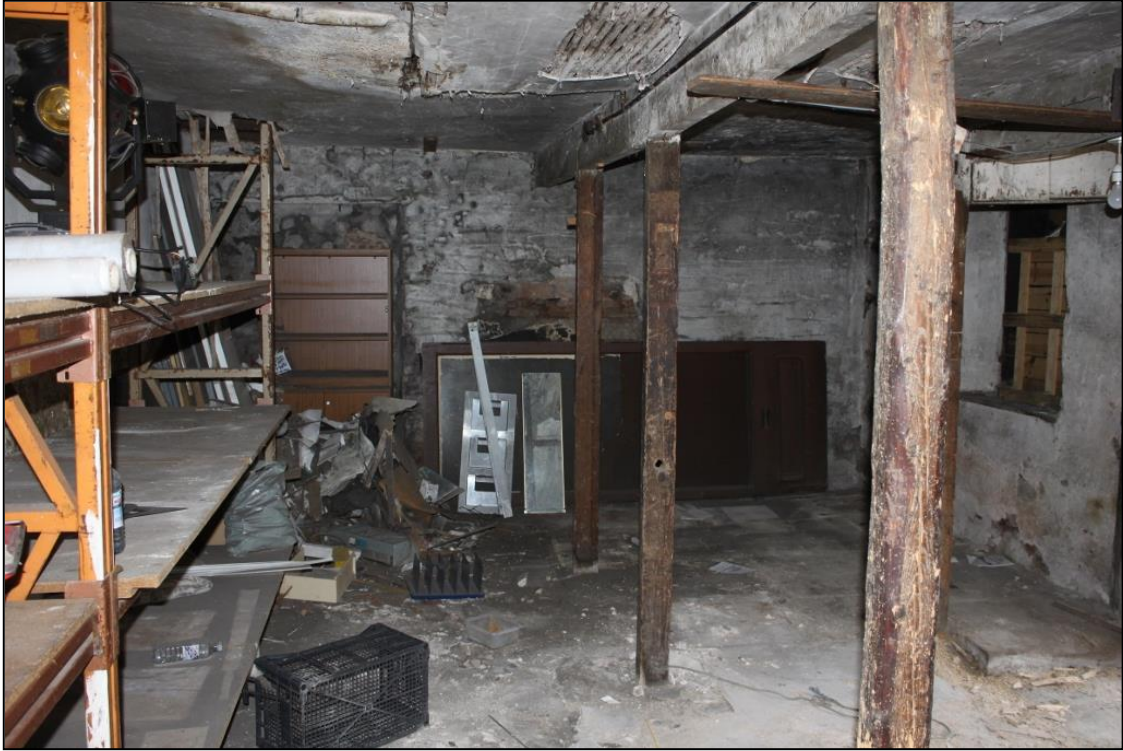
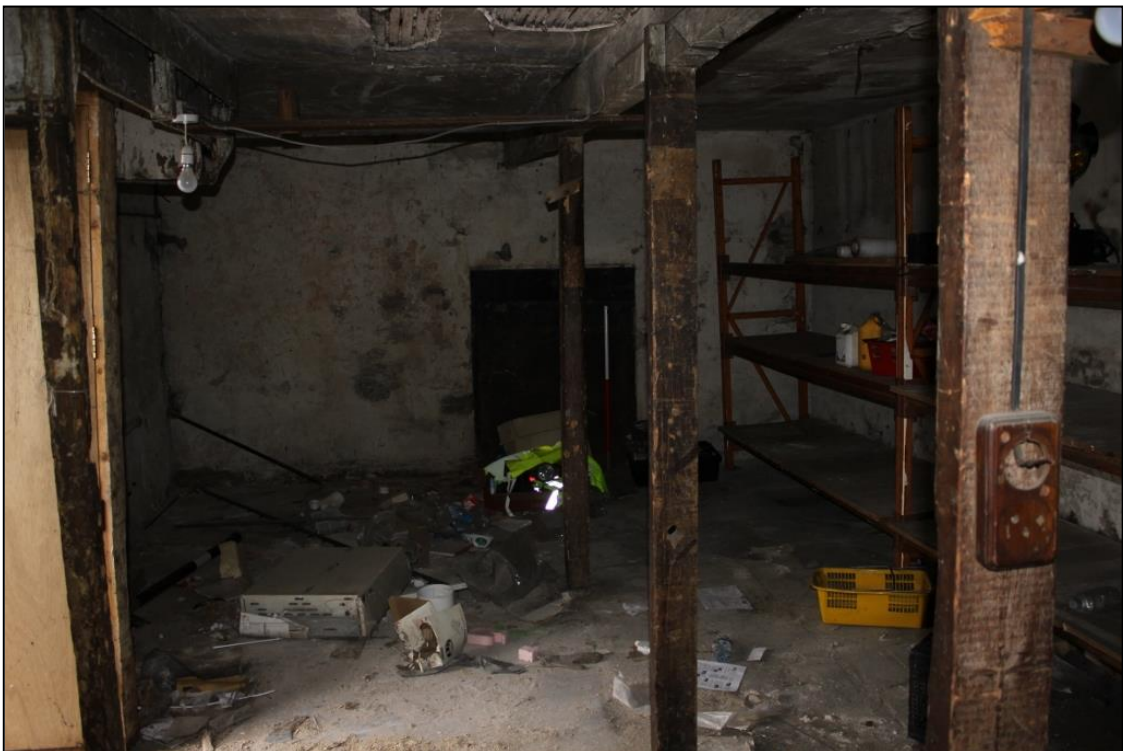
Figure 9a: View of Room 4, Ground Floor, 20a Swan St. From WSW

Figure 9b: View of Room 4, Ground Floor, 20a Swan St. From ENE

22. Access to Room 4 was off Swan Street with no connecting doorway from Room 1. The room was rectangular on plan and its walling consisted of painted plaster similar to that found in Rooms 1-3 (Figures 9a and 9b). The exception to this was the ENE wall which consisted of a painted thin plaster coating under which the walling was still visible. A number of twentieth century or later services were also visible on the walls and ceiling but there were no original features. As well as the doorway there were two windows located on the SSE wall, both of which were blocked. There were two blocked up

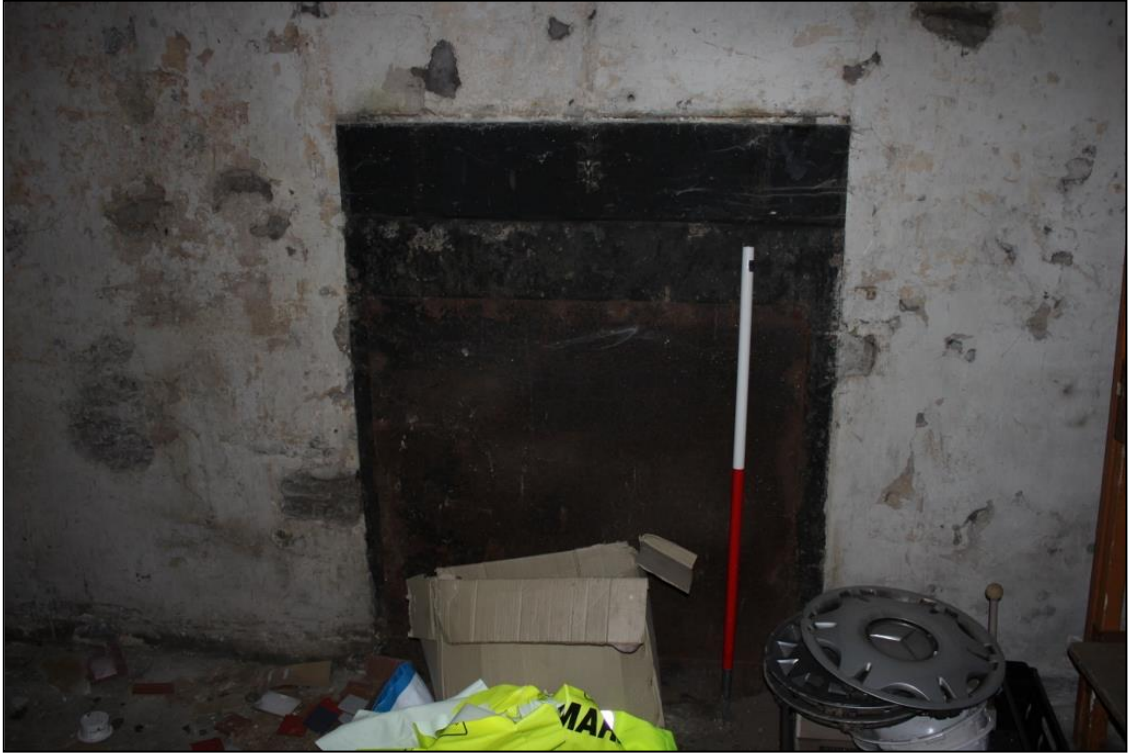
Figure 10a: View of fireplace in ENE facing wall, Room 4, Ground Floor, 20a Swan St

fireplaces, each with no original surviving features or details, on both the WSW and ENE walls (Figure 10a). Also on the ENE wall, to the immediate NNW of the fireplace, was a blocked up doorway: whether this would originally have led out onto the street or into another building is unclear. The remaining NNW wall contained no features or details of note. The ceiling within Room 4 consisted of painted lath and plaster, from which sections had broken or crumbled off (Figure 10b). The floor within Room 4 consisted of a mixture of large square/rectangular shaped, possibly original, paving stones and a bare poured concrete surface. The remains of recent internal divisions could be seen in the form of wooden roof supports, close to the door and running along the centre of the room (Figures 9a and 9b). This evidence of internal division may reflect the room's recent usage as a store room for the print works.

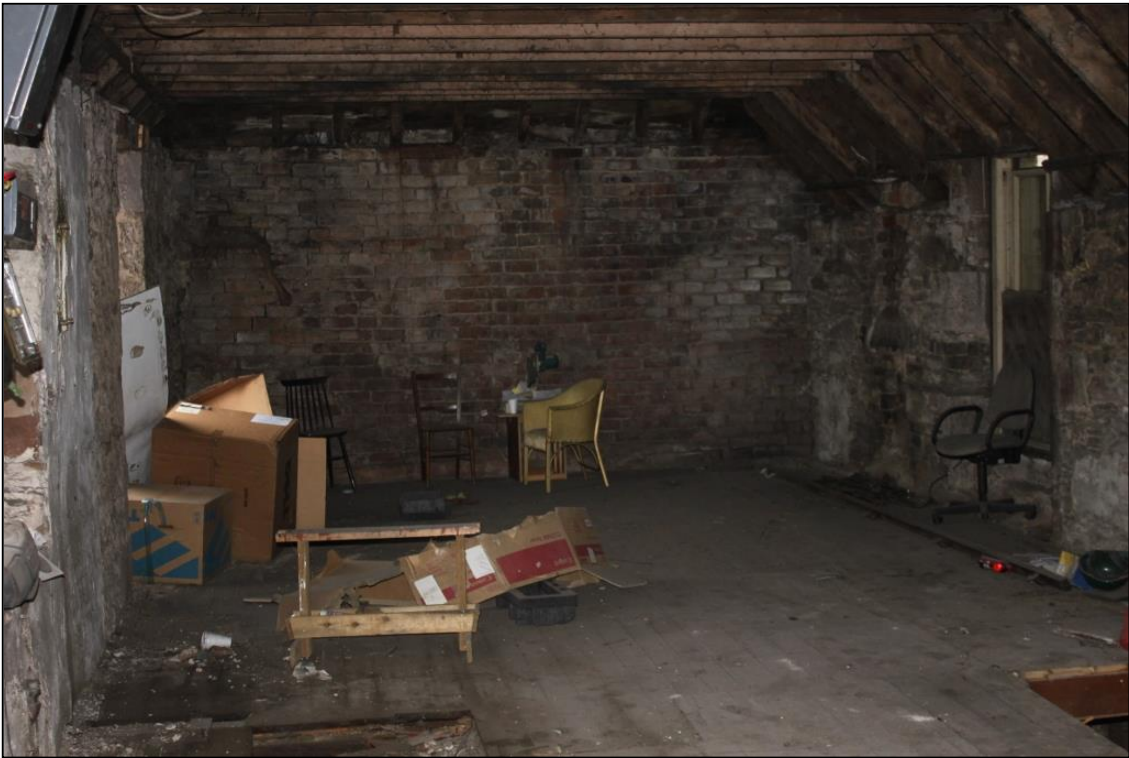
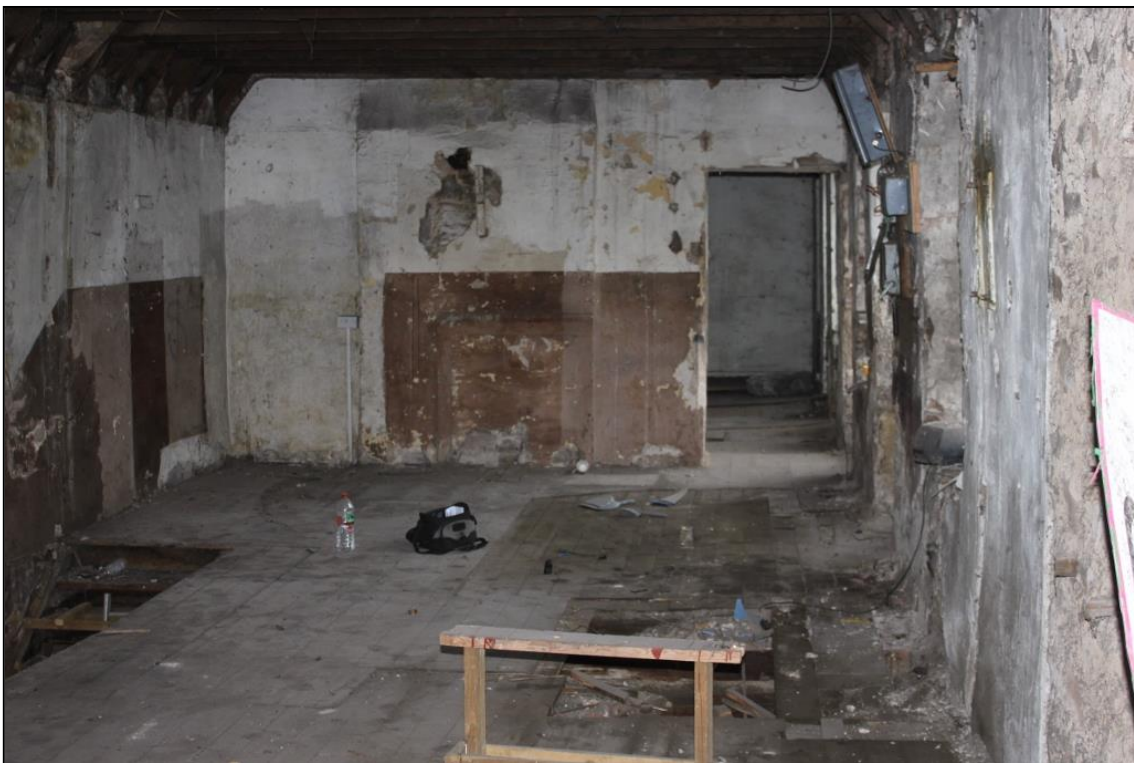
Figure 11a: View of Room 5, 1st Floor, 20a Swan St. From ENE

Figure 11b: View of Room 5, 1st Floor, 20a Swan St. From WSW

23. Room 5 was 'L' shaped in plan with access via a now-demolished staircase from Room 3 located centrally against the NNW wall (Figures 11a and 11b). The walling within the room consisted of painted plaster directly over masonry, excepting only the extreme WSW ends of the NNW and SSE walls where the masonry was left bare and the WSW wall, which comprised an exposed brick surface. The NNW wall was staggered, projecting out slightly to the NNW at its WSW end where a small fireplace (Figure 12a) and a projecting dormer window were located. Above the opening for the demolished staircase was a small skylight set into underside of the exposed pitched roof. On the SSE wall were a row of four windows which were a mix of original sash and case and later hinged or blocked windows. On the ENE wall there was a blocked up (and painted over) central fireplace (Figure 11b) as well as an opening at its SSE end which stopped short of a window located directly opposite. This window seems to be a later addition as the ENE wall appears to have been a main internal division. There was no ceiling within the room and the original roofing timbers were visible. The flooring within the room consisted of bare floorboards in which gaps were noted. Some parts of the floor appeared to have been sealed up openings which may have been either sealed up trap doors or openings for an original staircase.

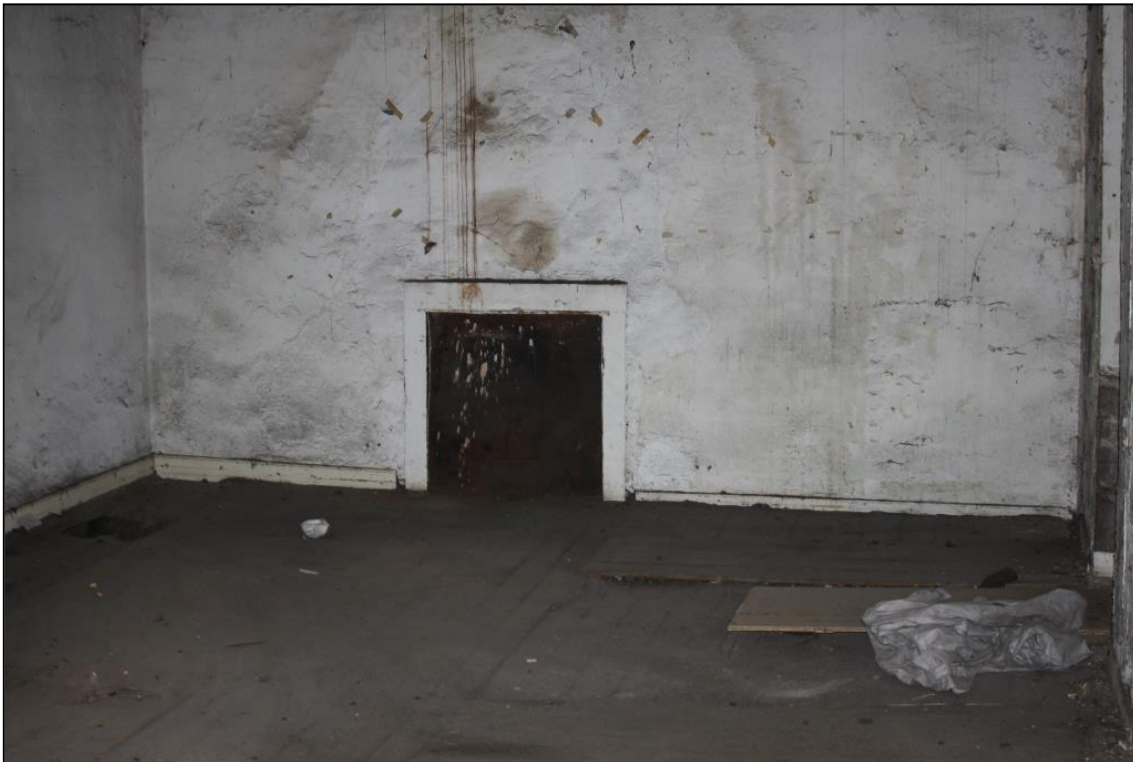
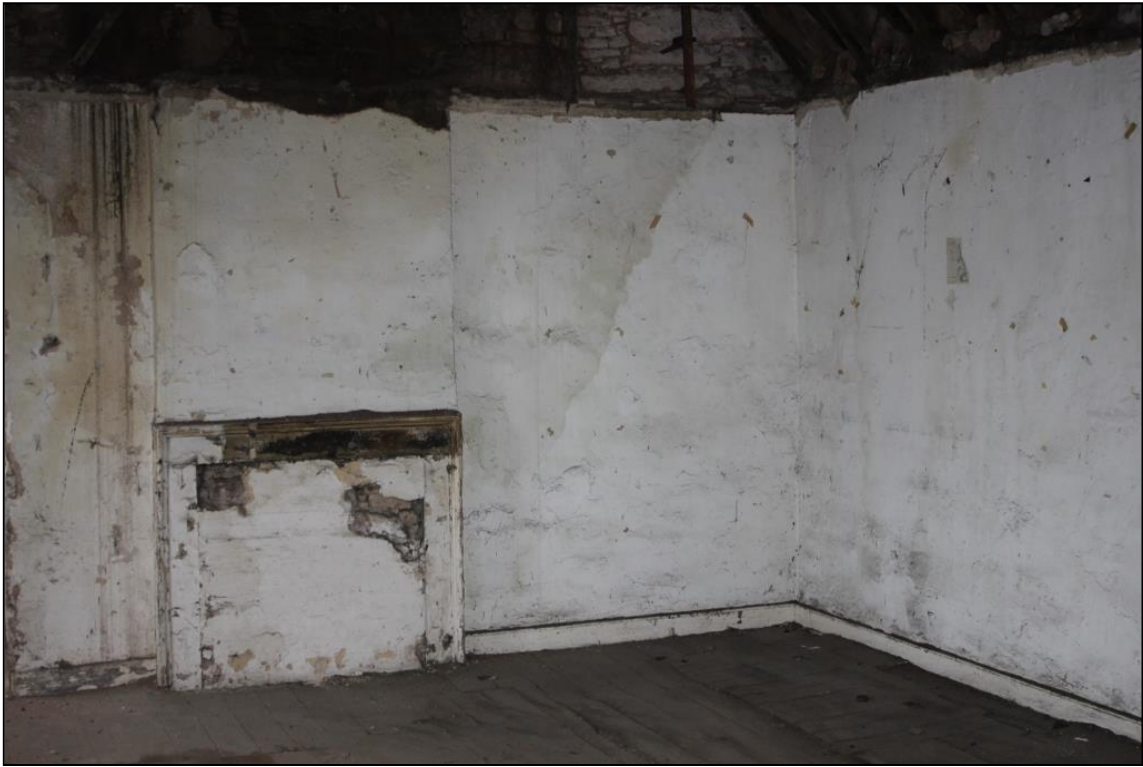
Figure 12b: View of Room 6, 1st Floor, 20a Swan St. From WSW

Figure 13a: View of Room 6, 1st Floor, 20a Swan St. From ESE

24. Room 6 was rectangular in plan (Figures 12b and 13a) with access into the room coming from the doorway in its WSW wall at its SSE end (see above for more details on the WSW wall). The walling within the room consisted of painted plaster with a plain painted wooden skirting at its base. The flooring within the room was similar to that of Room 5 with exposed plain floor boards which also contained two areas next to the SSE wall which may have been sealed up trapdoors or openings for staircases (Figure 13b). Like Room 5 there was no ceiling and a set of large double skylights (Figure 14a) along with a smaller single skylight were set into the exposed underside of the pitched roof. Located centrally on both the WSW (Figure 13a) and ENE (Figures 12b and 14b) walls were blocked up fireplaces. A series of three, later, hinged windows was set into the SSE wall none of which contained any original details.

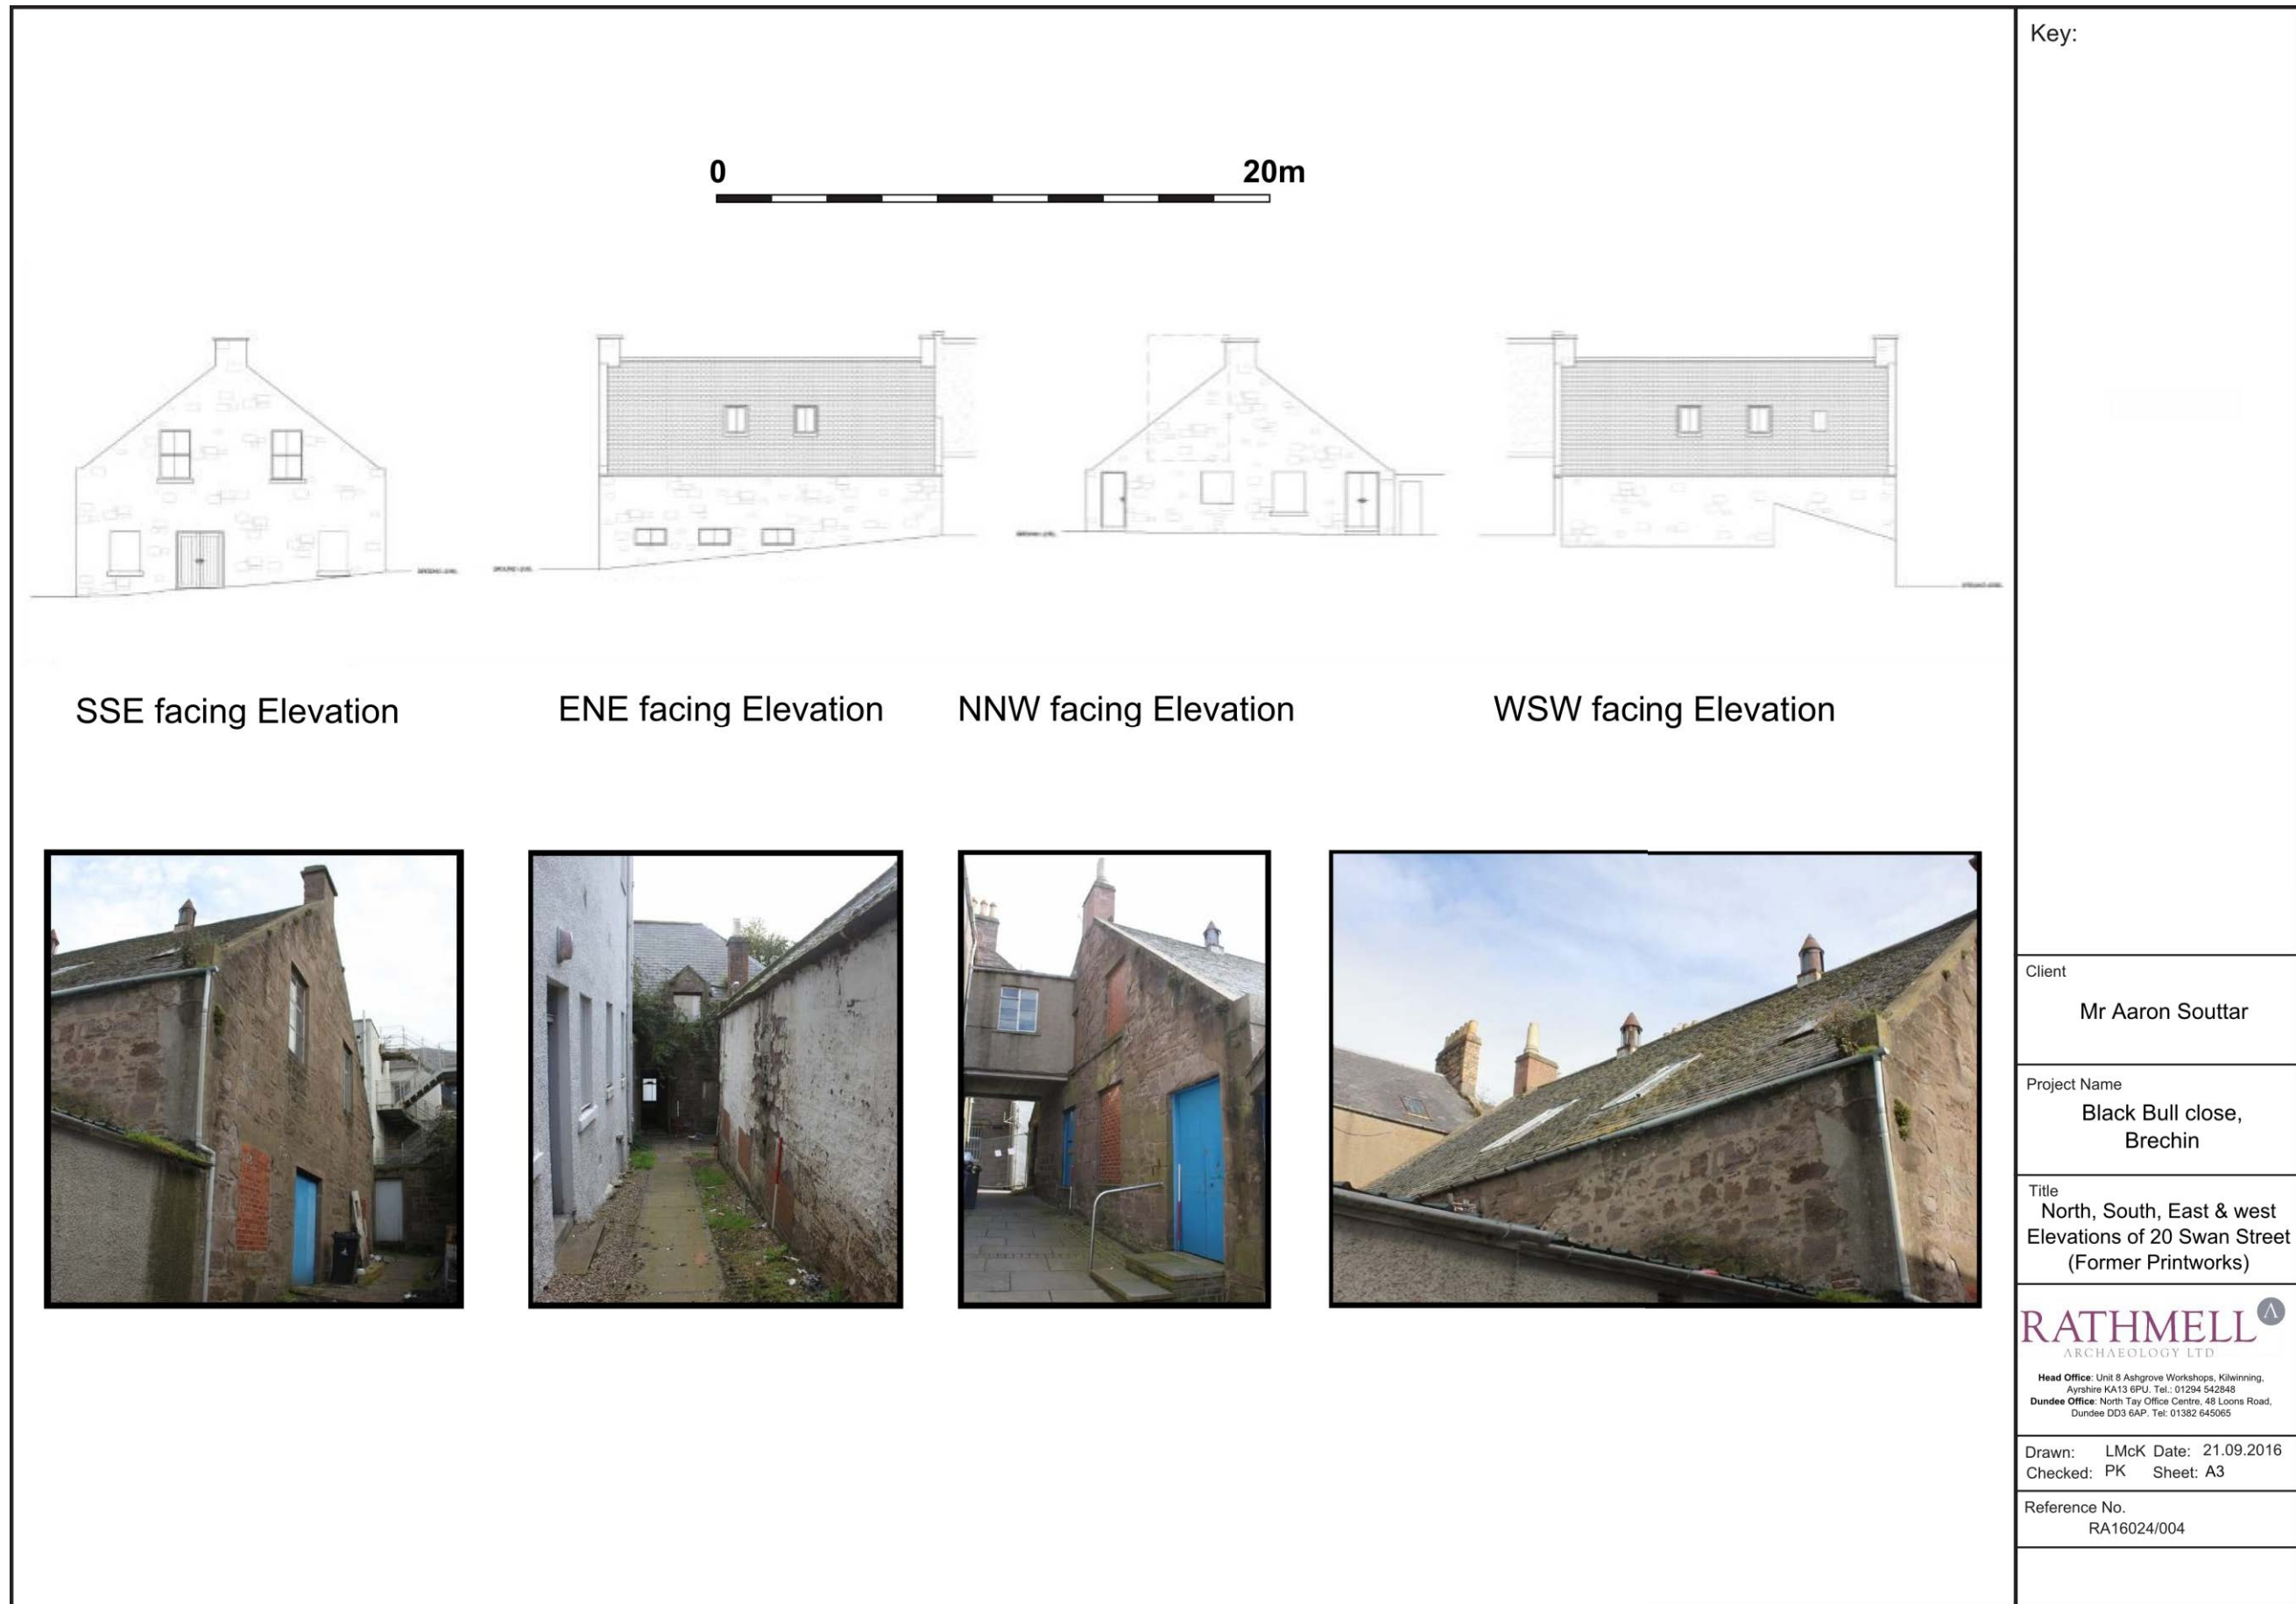
Figure 15: N and S Elevations of 20 Swan Street (Former Print Works).

26. Where visible, the building's NNW elevation (Figure 15) is built of squared coursed sandstone rubble, though parts have now been concealed beneath a layer of concrete with possible traces of paint close to the edges of the building. The elevation was divided into three bays of three windows and two doors. The doors were placed towards the outer edges of the bays, with two windows, of differing dimensions, located within the central portion. Both doors and the ENE window had painted wooden shutters, while the remaining window had been blocked with modern bricks. Another window, located above the WSW window had also been blocked with modern bricks. The NNW elevation was a gable end and there was an original chimney located at the end of the roof ridge.

27. The SSE elevation (Figure 15) is for the most part built of squared coarse sandstone rubble. Parts of the elevation had been obscured beneath a layer of concrete with possible traces of paint noticeable close to the edges of the building. The elevation was divided into two, slightly asymmetrical, bays of four windows and a set of double doors. The building has been built into steep slope, with the basement exiting out through central, modern, double doors onto Liddles Close, flanked by large rectangular windows now blocked with modern bricks. The Ground (upper) floor has two large hinged windows which seemed to be later additions. The SSE elevation was a gable end and there was an original chimney located at the end of the roof ridge.

28. The building's ENE elevation (Figure 15) is for the most part built of squared coursed sandstone rubble. Much of the elevation was rendered and then painted. The elevation comprised three equal bays with three equally spaced windows or ventilators at basement level in the SSE end. These latter features had now been blocked with modern bricks. At ground floor level, part of the ENE end was obscured by a modern 'gantry or link corridor' like structure which had been built up against it. The pitched roof was slated, with two cast iron rooftop ventilators remaining in situ on the roof ridge. There were also three skylights set into the roof.

29. The WSW elevation (Figure 15) was only partially visible due to the construction of a modern structure immediately adjacent. Only the upper part of the elevation was observable, with fabric similar to that seen in the other elevations. Traces of an earlier roofline at the SSE end showed where a previous structure had once abutted the building. Much of the elevation had been concealed beneath a thin layer of cement render, which had subsequently been painted.

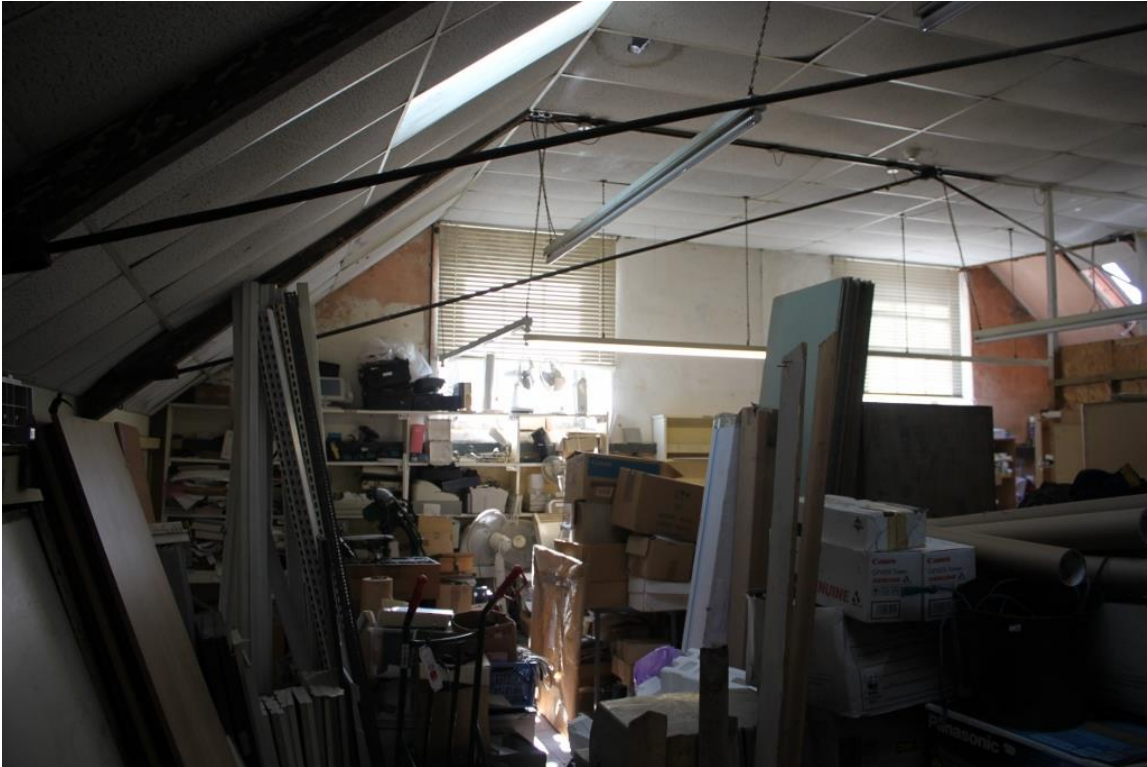
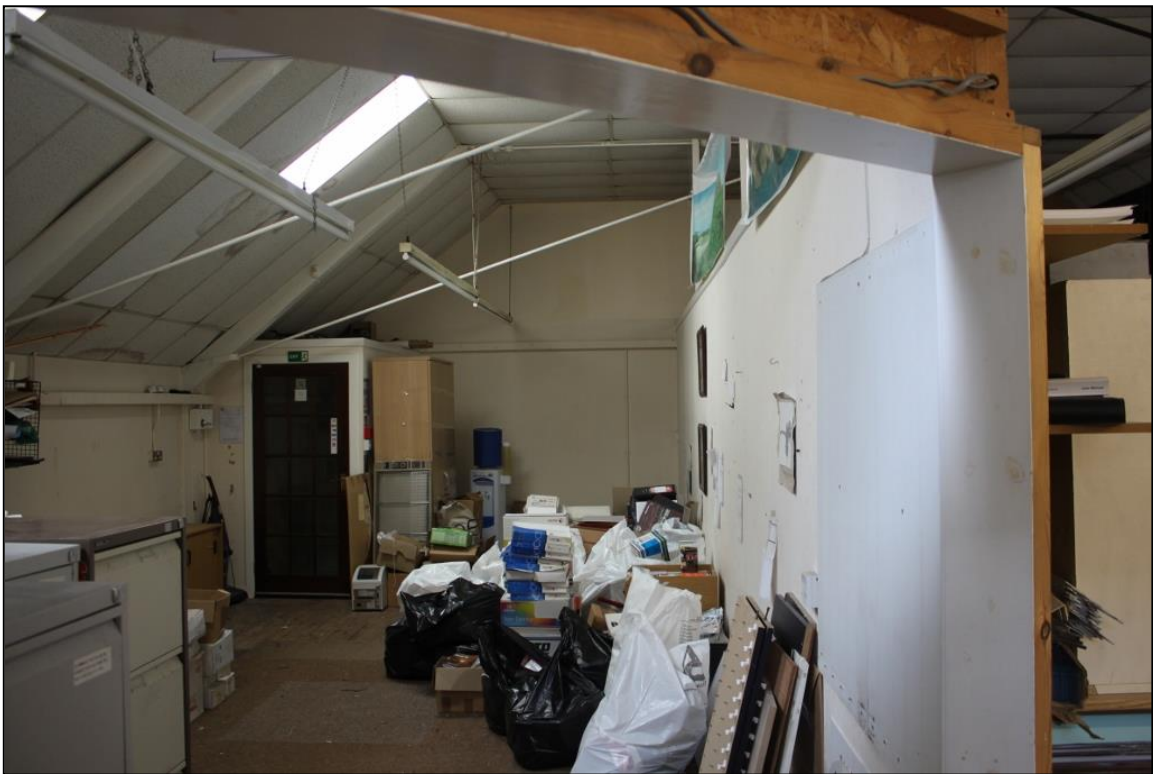
Figure 17a: View of Room 1, Ground Floor, 20 Swan St. From SSW

Figure 18b: View of Room 1, Ground Floor, 20 Swan St. From S

31. Room 1 (Figures 17a & 18b) could be accessed from Liddles Close through the two doors situated at the WSW and ENE ends of the NNW elevation. The interior walls were plastered and painted, with some sections of modern synthetic panelling observed. The suspended ceiling consisted of modern synthetic tiles, placed roughly halfway up the height of the pitched roof (Figure 17b). Beneath this suspended ceiling metal roof supports could be observed along with sets of strip lighting (Figure 17b). The natural lighting for the room came through a number of skylights set into the roof (Figure 18a). The flooring within the room consisted of linoleum tiles and small areas of carpeting which overlay wooden floorboards.

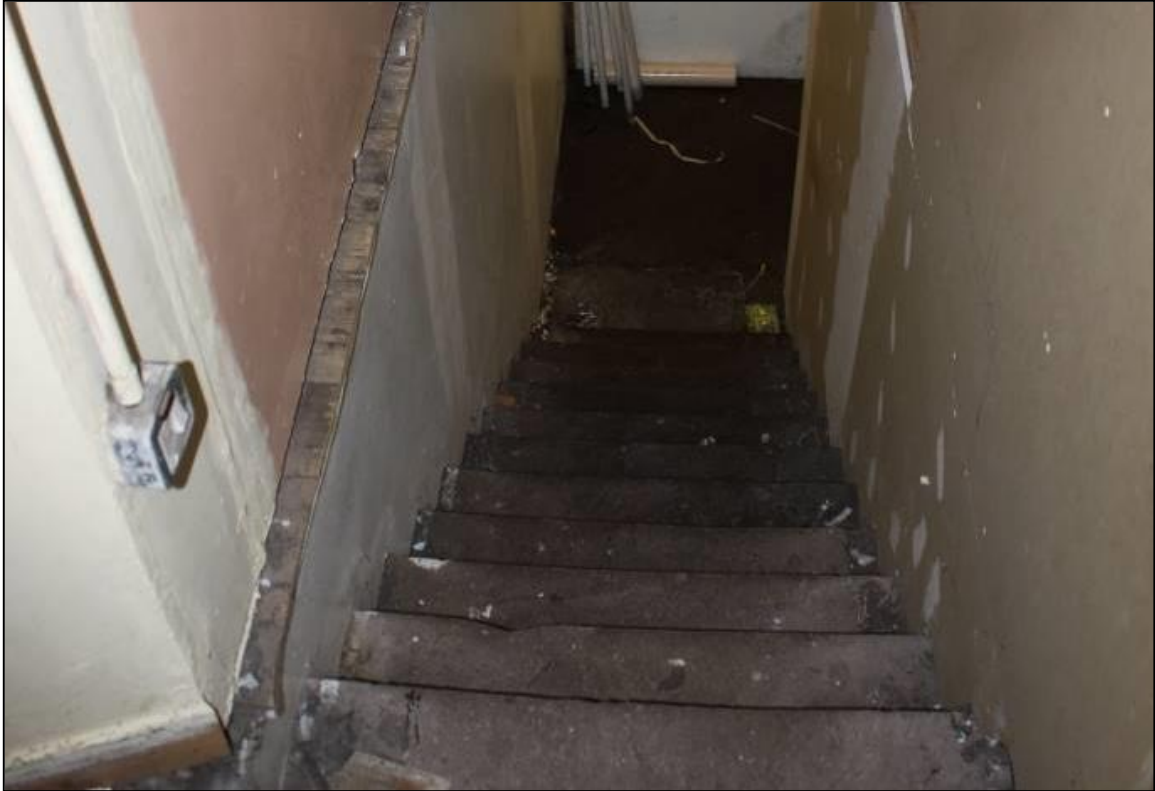
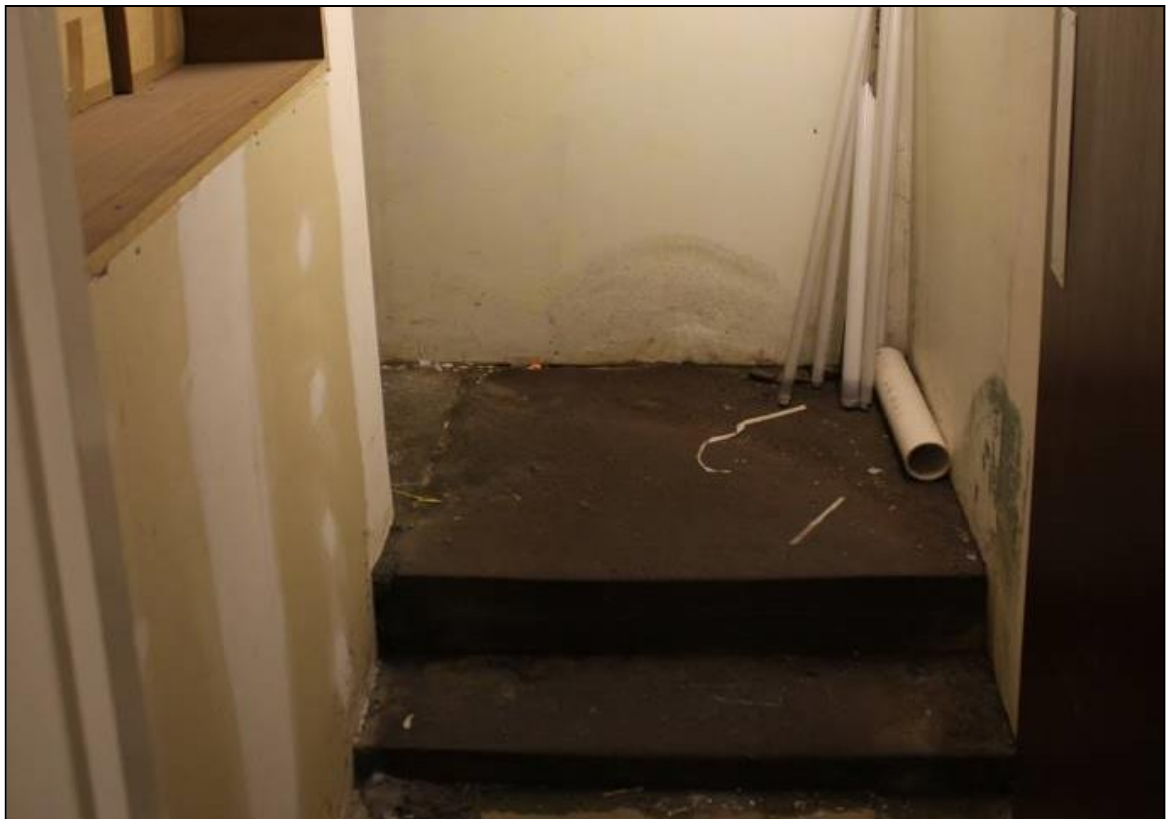
Figure 19a: View of stairs to Basement, Room 1, Swan St. From W

Figure 23b: View of stairs to Ground Floor, 20 Swan St. From E

32. Access into Room 2 (Figure 19a & 23b) was via a narrow set of stairs located close to the WSW door where it accessed Room 1 through the NNW wall. Room 2 was rectangular on plan and subdivided by a modern timber stud wall lined with plasterboard. This ran virtually the entire length of the building, creating two narrow rooms: 2a (Figure 19b) and 2c (Figure 20b), with an opening at the NNW end separating Room 2 from Room 3 (Figure 23a). A further subdivision at the end of 2a created a small store room, 2b (Figure 20a). The ceiling and walls within Room 2 consisted of modern plastered and painted surfaces with a mixture of strip lighting and suspended lights set into the ceiling. The flooring consisted of wooden floorboards, with some use of linoleum, some carpeted and bare areas.
