Black Bull Close, Brechin: Archaeological Mitigation

Data Structure Report

by Liam McKinstry
issued 29th November 2016
on behalf of Mr Aaron Souttar

RATHMELL  
ARCHAEOLOGY LTD

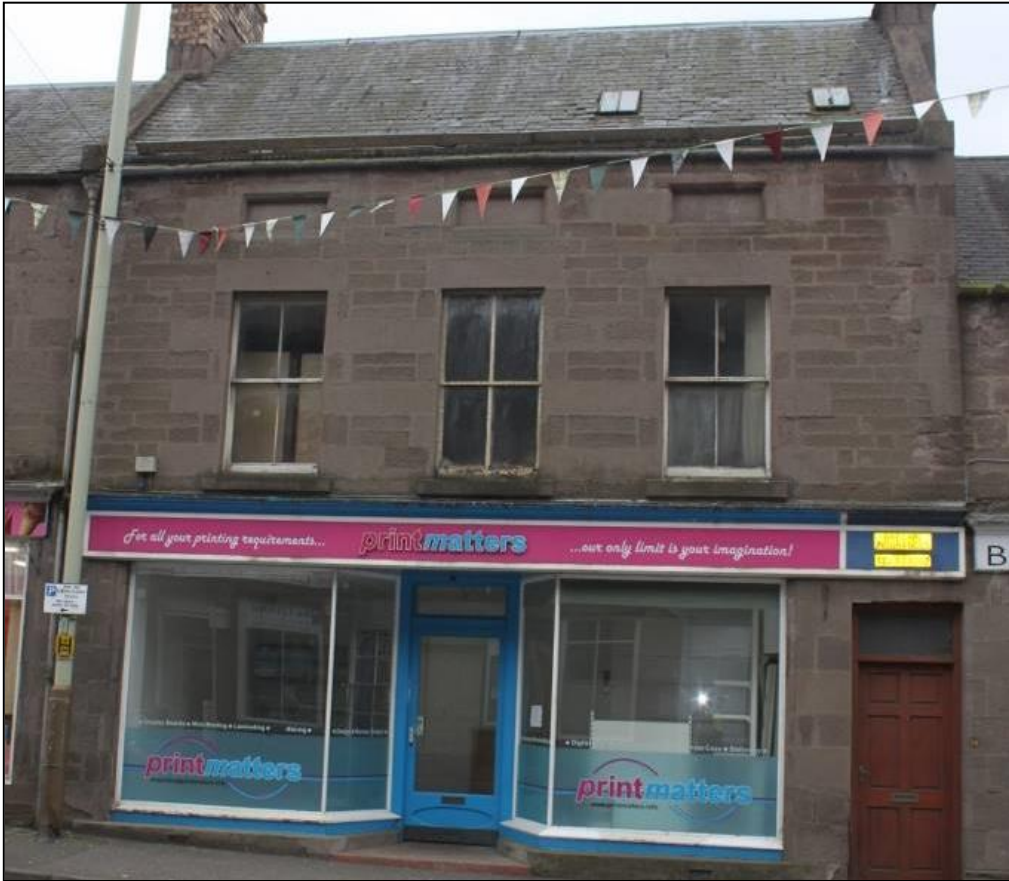
Figure 25a: Front elevation of 14-18 Swan St. From the N

35. The building's front, NNW, elevation (Figure 25a) is built of squared coursed sandstone rubble, although in this case the courses were laid out in a much more regular fashion and the individual blocks of stone more regular in size. The elevation was two storeys high and three bays in length, with a central door allowing access into the ground floor shop premises and a second doorway at the WSW end enabling access to first floor level above. The 1st floor had three equally spaced sash and case windows with the central window clearly blocked behind the glass. The 2nd floor consisted of three narrow, blocked-up windows each of which lay directly above one of the windows in the 1st floor. It is possible that these would originally have been ventilators, although alterations to the wallhead cannot also be ruled out, either at the time of construction or at a later date. The roof is pitched and slated, with two small skylights at the WSW end.

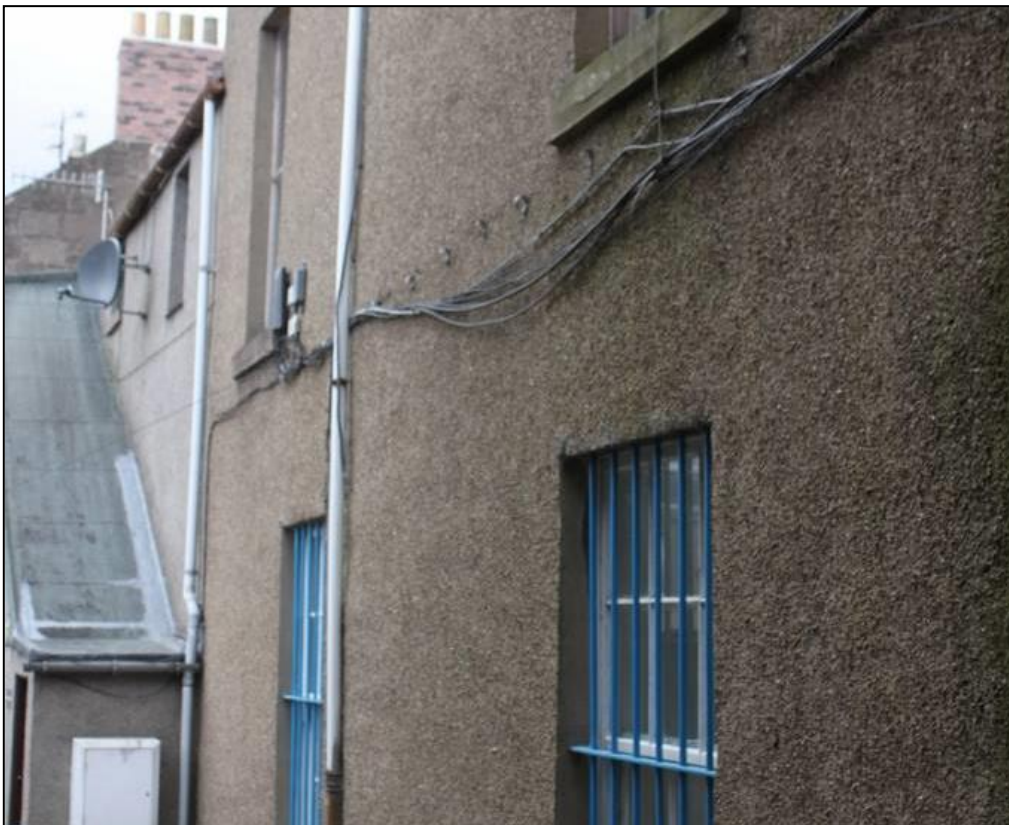
Figure 25b: Rear elevation of 14-18 Swan St. From the E

36. The rear SSE elevation (Figure 25b) was rendered with a modern pebble dash layer, concealing the masonry below. The elevation had two regularly spaced windows at ground floor level, each of which had steel security bars fitted over them. The 1st floor had two regularly spaced windows slightly offset from the line of the ground floor windows below. No evidence for 2nd floor windows could be discerned through the pebble dashed surface of the SSE elevation. Two large skylights were set centrally within the pitched slated roof.

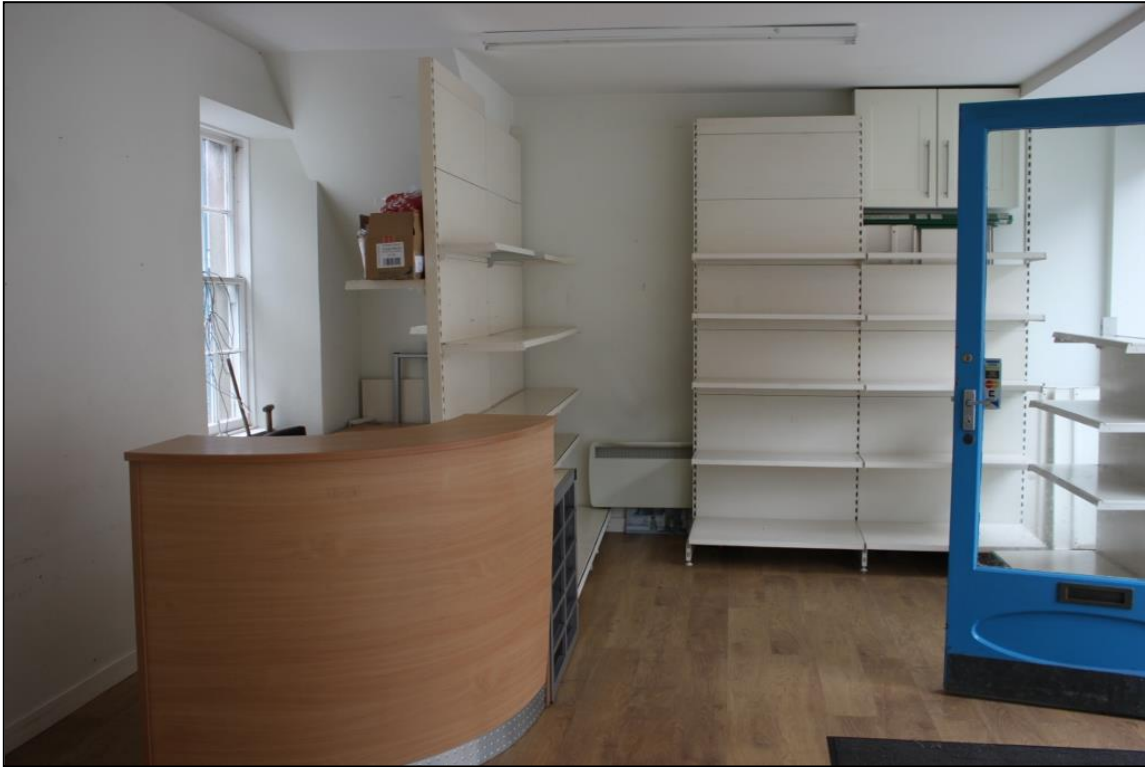
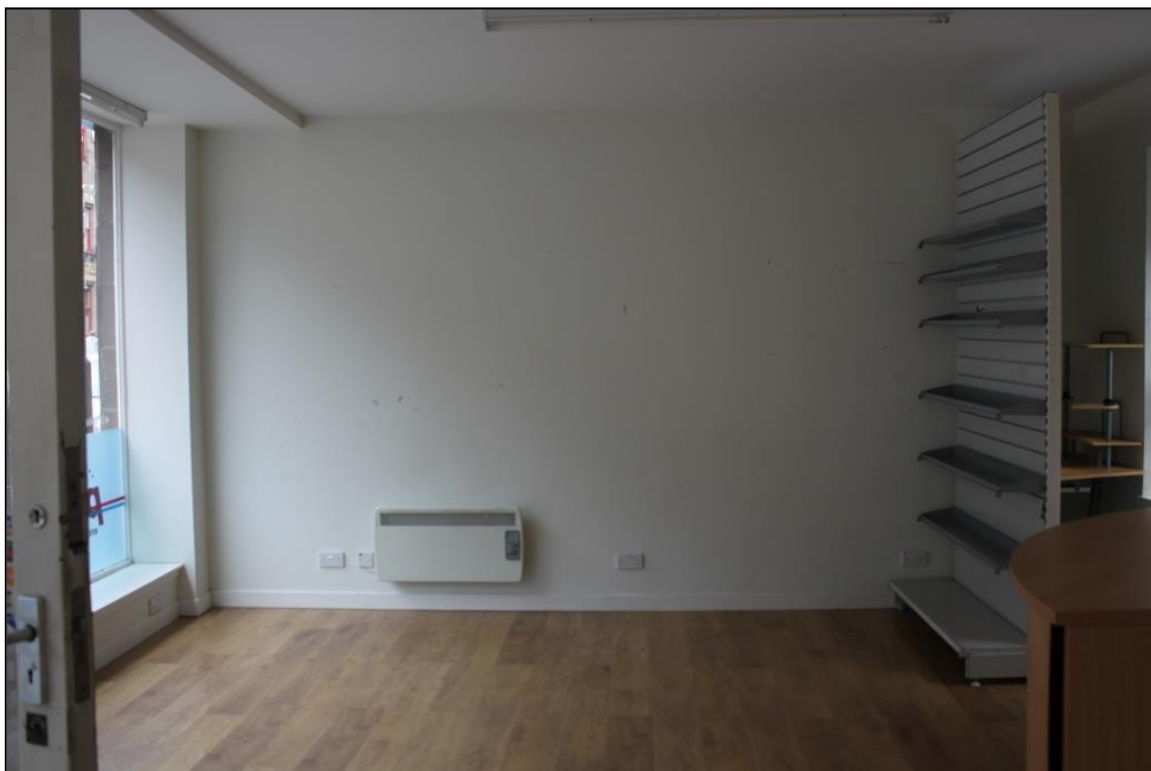
Figure 26a: View of Room 1, Ground Floor, 14-18 Swan St. From the E

Figure 26b: View of Room 1, Ground Floor, 14-18 Swan St. From the W

38. Room 1 (Figures 26a & 26b) was accessed via Swan Street through a central glass and timber door within a larger glazed shop front (Figure 27b). Two windows were set into the SSE wall: neither had any original features associated (Figure 27a). The walls and ceiling within Room 1 were covered in modern plaster and painted with strip lighting fitted to the ceiling. The suspended ceiling consisted of plain painted plaster which appeared to be modern. The room was empty with the exception of free standing shop displays and counters stacked close to the SSE wall. The flooring consisted of a modern wood effect laminated surface.

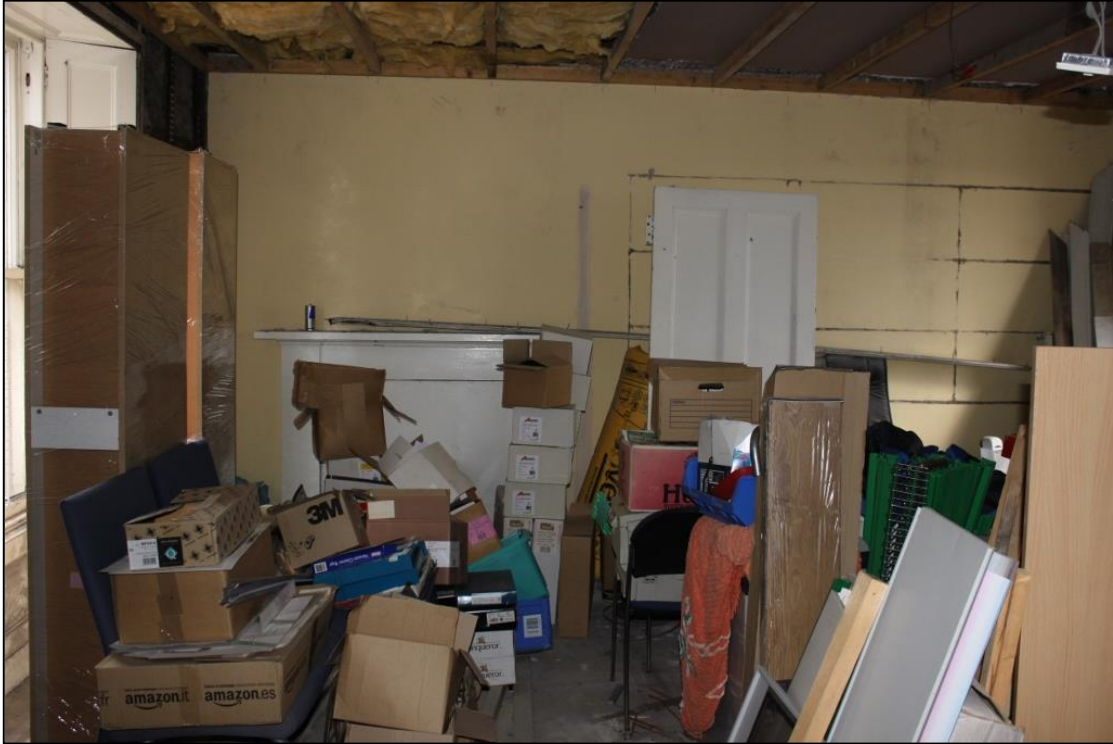
Figure 29a: View of Room 2, 1st Floor, 14-18 Swan St. From the W

41. Room 2 (Figure 29a) was square in plan and was accessed from the stairwell through an opening in the WSW wall (the door having been removed). The walls consisted of painted lath and plaster, of which small sections had broken or crumbled off. The exception to this was, as in Room 3, the NNW wall where the lath and plaster surface had been completely removed exposing the wall material underneath and the 2nd floor rafters and insulation material at the ceiling. On the NNW wall was a large sash and case window with original window frame and internal shutters. A similar frame and internal shutters were noted on a large window on the SSE wall. There was a fireplace set into the ENE wall of the room which was blocked but still retained a plain painted wooden mantelpiece which again may have been original. The rest of the room was filled by modern detritus and refuse presumably left over from the print shop on the ground floor.

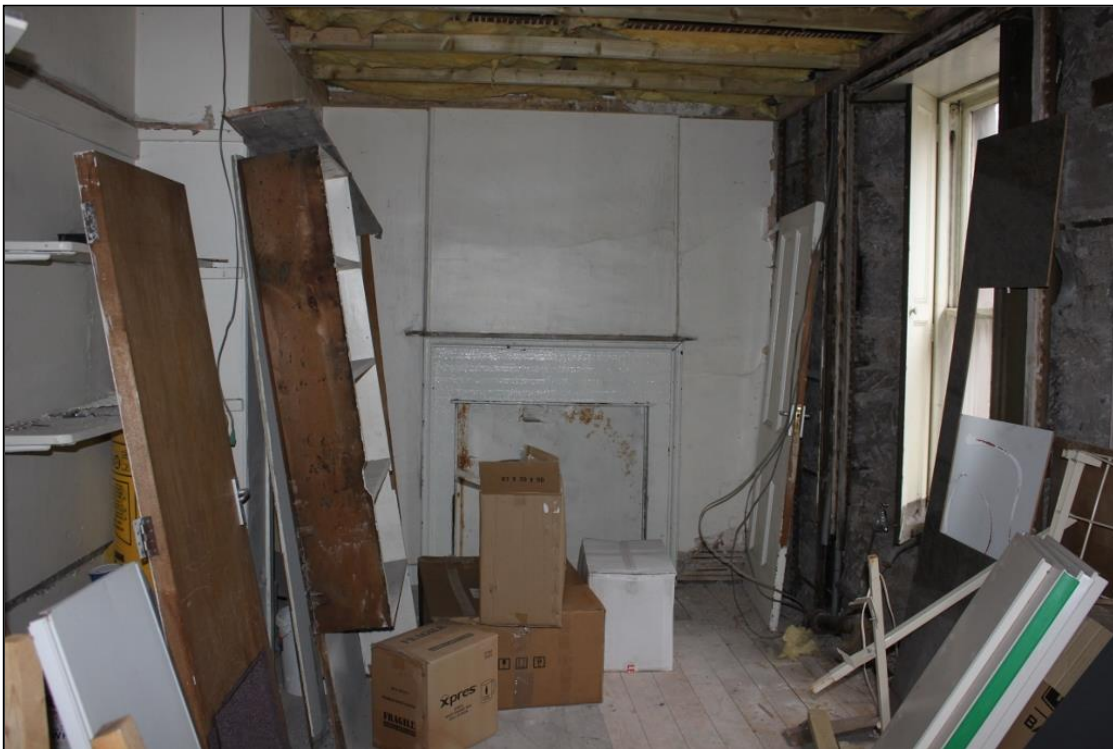
Figure 29b: View of Room 3, 1st Floor, 14-18 Swan St. From the W

40. Room 3 (Figure 29b) was rectangular in plan and was accessed from the stair through an opening in the SSE wall (the door having been removed). The walls consisted of painted lath and plaster, from which small sections had broken or crumbled off. The exception to this was the NNW wall and the ceiling where the lath and plaster surface had been completely removed exposing the squared rubble building fabric of the wall and the 2nd floor rafters and modern insulation material at ceiling level. In the NNW wall, there was a large sash and case window with original frame and internal shutters. There was a blocked fireplace set into the WSW wall (Figure 30a) which retained a plain painted wooden mantelpiece which may also have been original. The rest of the room was filled by modern detritus and refuse presumably left over from the print shop on the ground floor.

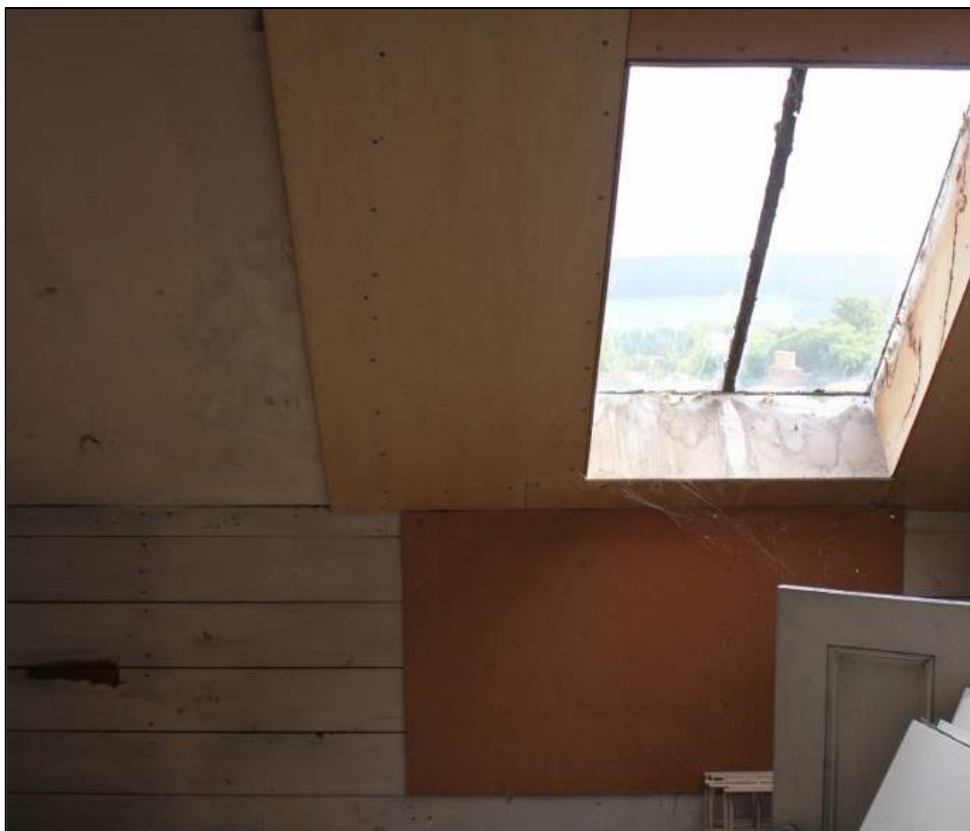
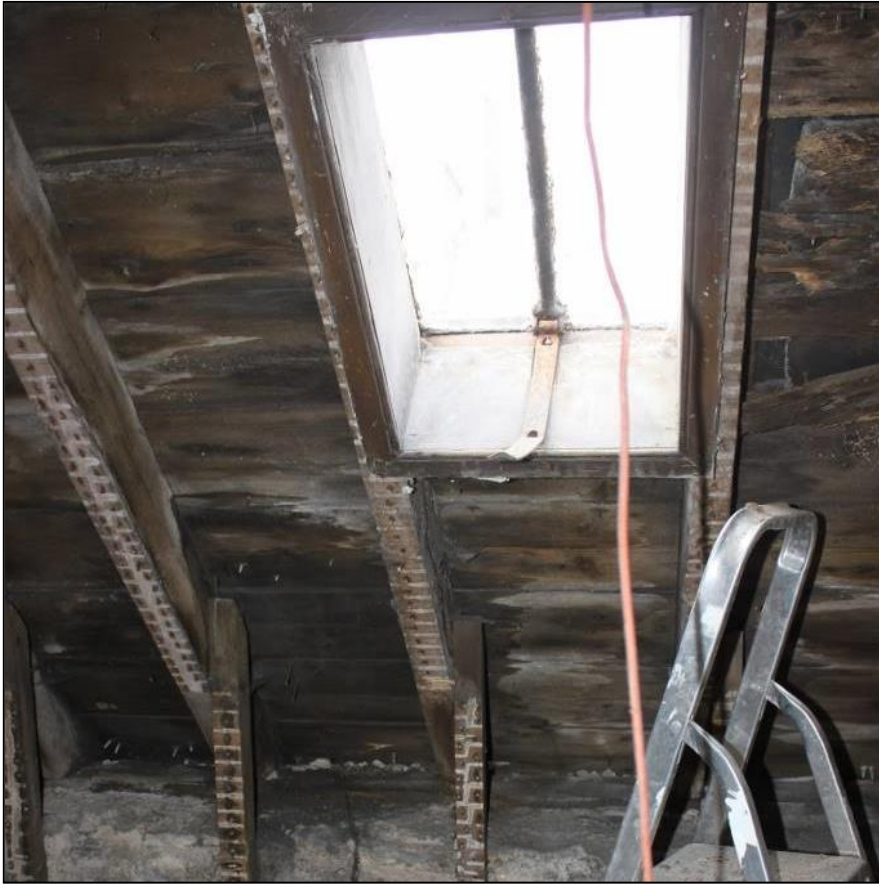
Figure 31b: View of Room 4a, 2nd Floor, 14-18 Swan St. From the NNW

Figure 32a: View of Room 4a, 2nd Floor, 14-18 Swan St. From the SSE

42. Room 4 (Figures 31b & 32a) was L-shaped in plan and accessed through an opening in its WSW wall, the door having been removed. The room appeared to be a converted loft space, judging by the partially pitched nature of the ceiling. The ceiling and the upper portion of the walls consisted of painted lath and plaster. The lower part of the wall was covered with wooden panelling, some sections of which had been varnished while others appeared to have been sanded down. The flooring within the room comprised timber floorboards, some of which had been lifted. A small and a large skylight were set into the pitched NNW and SSE portions of the ceiling respectively. Close to where the stairwell was accessed, an early 20th century light switch survives *in situ* on the WSW wall. At the western end of the room a subdivision, 4b, had been created to form a small toilet. Much of the lath and plaster surfacing had been removed in this room, particularly on the NNW side, as well as most of the toilet fittings. A small skylight was also noted, set into the pitched roof within the room.

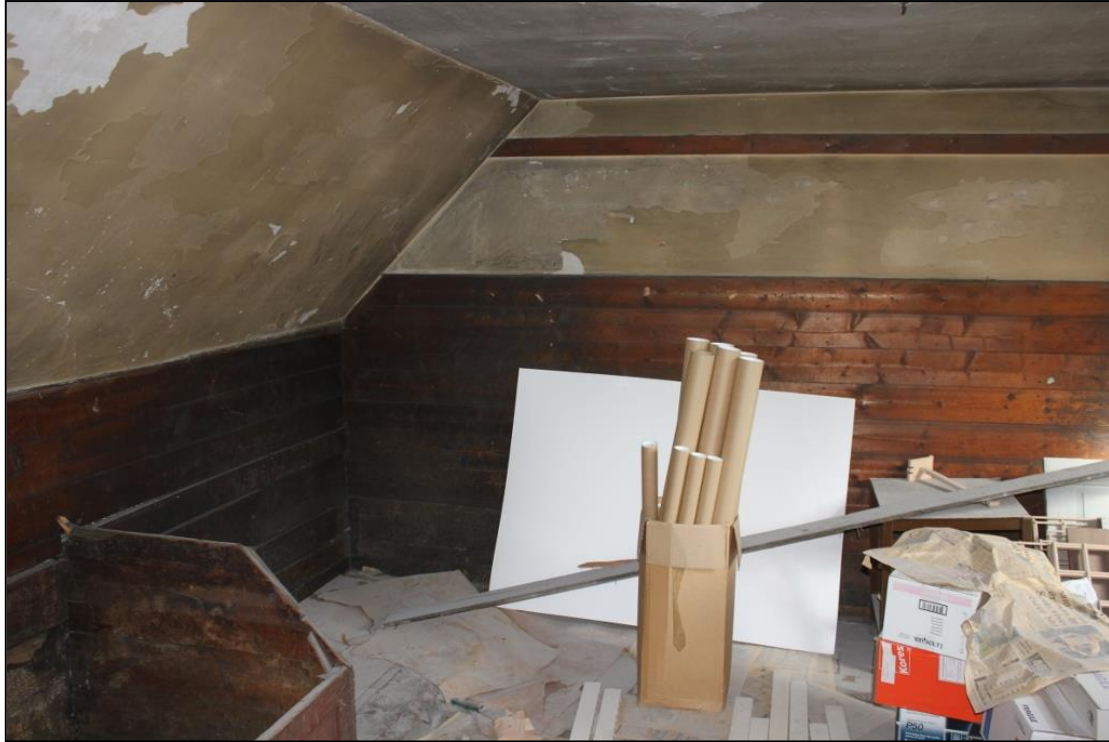
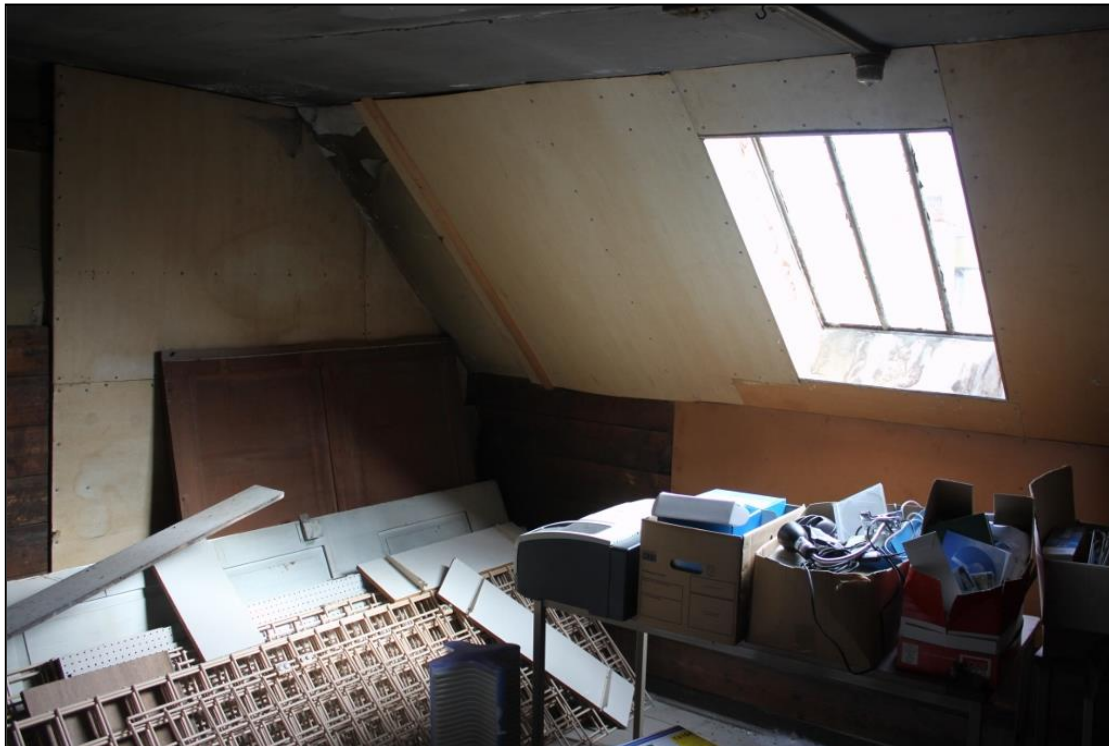
Figure 33a: View of Room 5, 2nd Floor, 14-18 Swan St. From the WSW

Figure 33b: View of Room 5, 2nd Floor, 14-18 Swan St. From the WNW

43. Room 5 (Figures 33a & 33b) was square in plan and accessed through an opening in the WSW wall. As with Room 4, the room appeared to be a converted loft space which was clear from the partially pitched nature of the ceiling. The ceiling and the upper part of the walls consisted of painted lath and plaster. Again, the lower part of the wall was covered with wooden panelling, some sections of which had been varnished while others appeared to have been sanded down. The flooring within the room comprised exposed timber floorboards some of which had been lifted. A large skylight was set into the SSE pitched part of the ceiling. The room contained what appeared to be early 20th century wooden fittings: a shelf (Figure 34a), a set of coat hooks fitted either side of the opening in the WSW wall and a wooden box set against the NNW wall (Figure 32b). Also close to the opening was a possibly early 20th century light switch (Figure 34b).
