**Brodick Castle Fire Pond, North Ayrshire:
Archaeological Watching Brief**
Data Structure Report

by Joss Durnan

issued 16th January 2017

on behalf of Armitage Groundworks Ltd

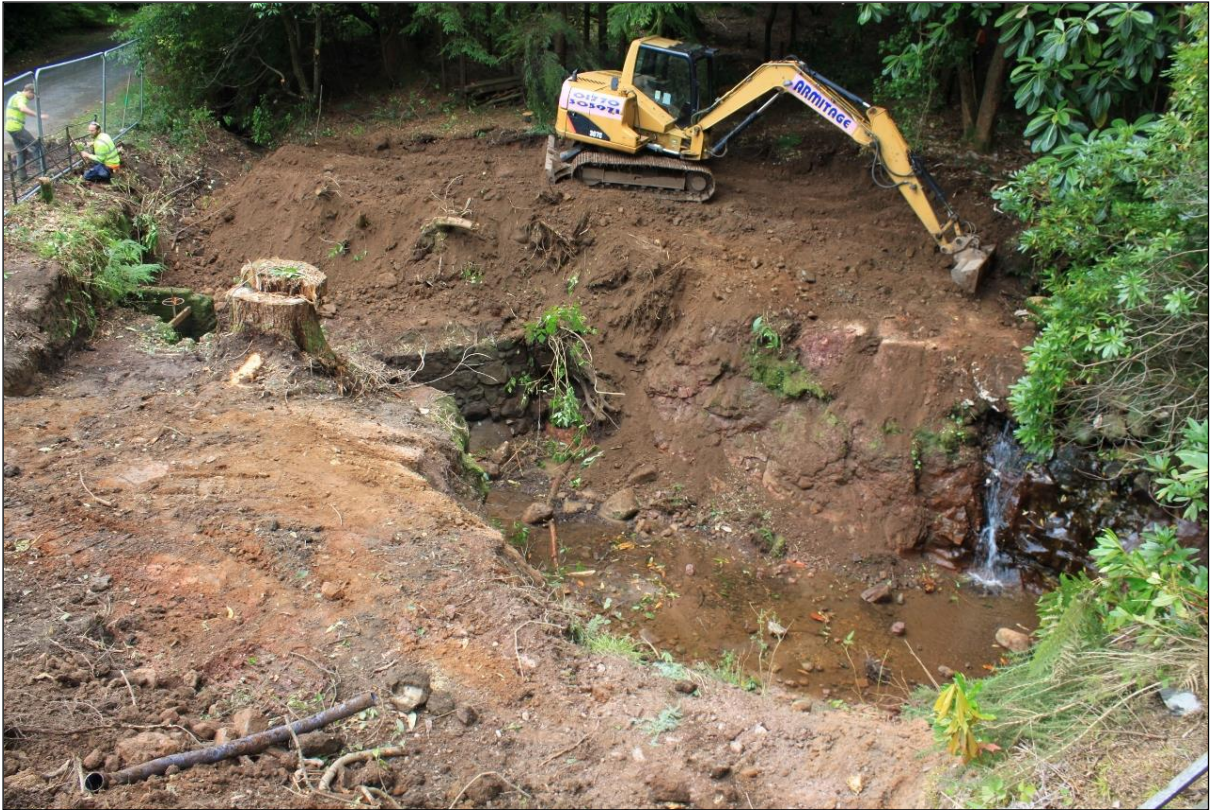
5. At the time of the works, the fire pond was not functional and largely drained. It was roughly square in plan, measuring approximately 10m wide with sides rising to between 3m and 8m in height with a flat base (Figure 2). The north, west, and east sides of the pond were almost vertical, formed by natural bedrock into which the pond had been cut. The southern side was formed of bedrock and two retaining walls which channel the discharging water from the pond through the sluice gate. These retaining walls were composed of a foundation course of large undressed boulders with smaller roughly dressed boulders above. The walls were bonded together with mortar, and rose to approximately 3m in height (Figure 3).

Figure 2: The fire pond viewed from the east during excavation.

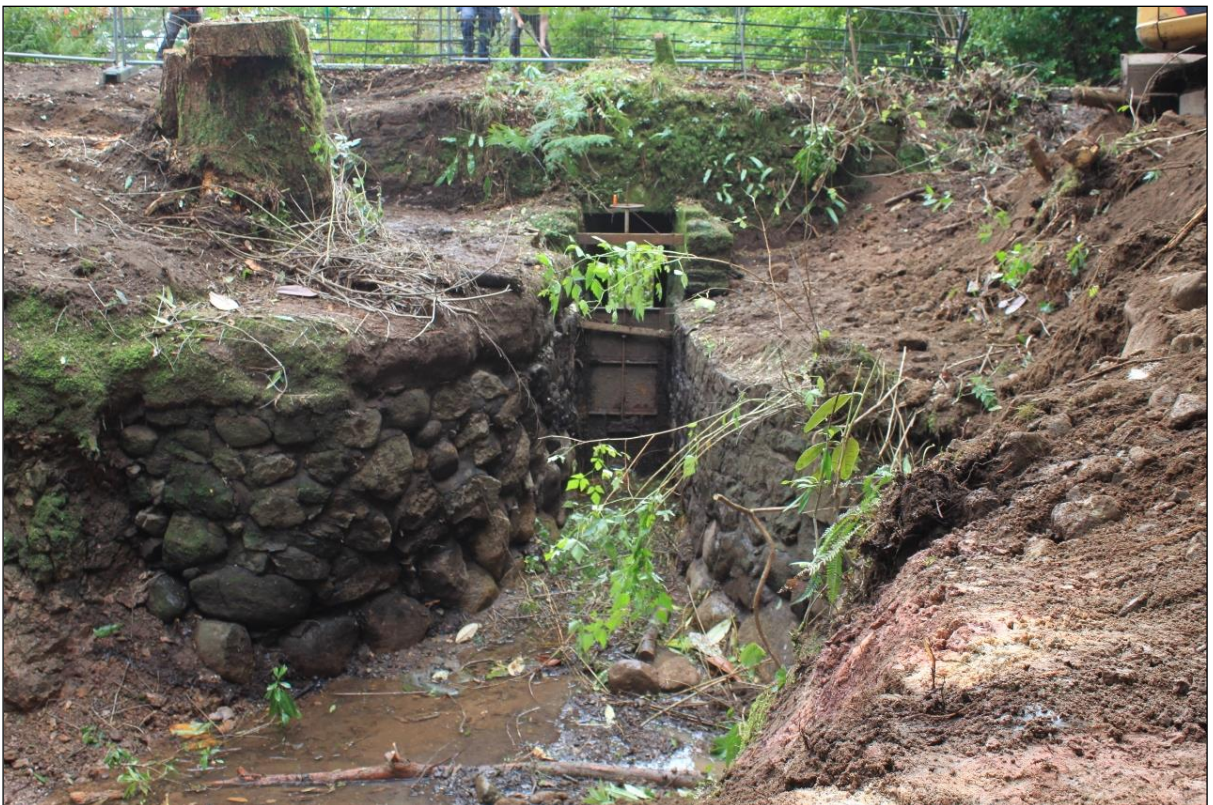
Figure 3: Sluice gate and retaining walls viewed from the north.

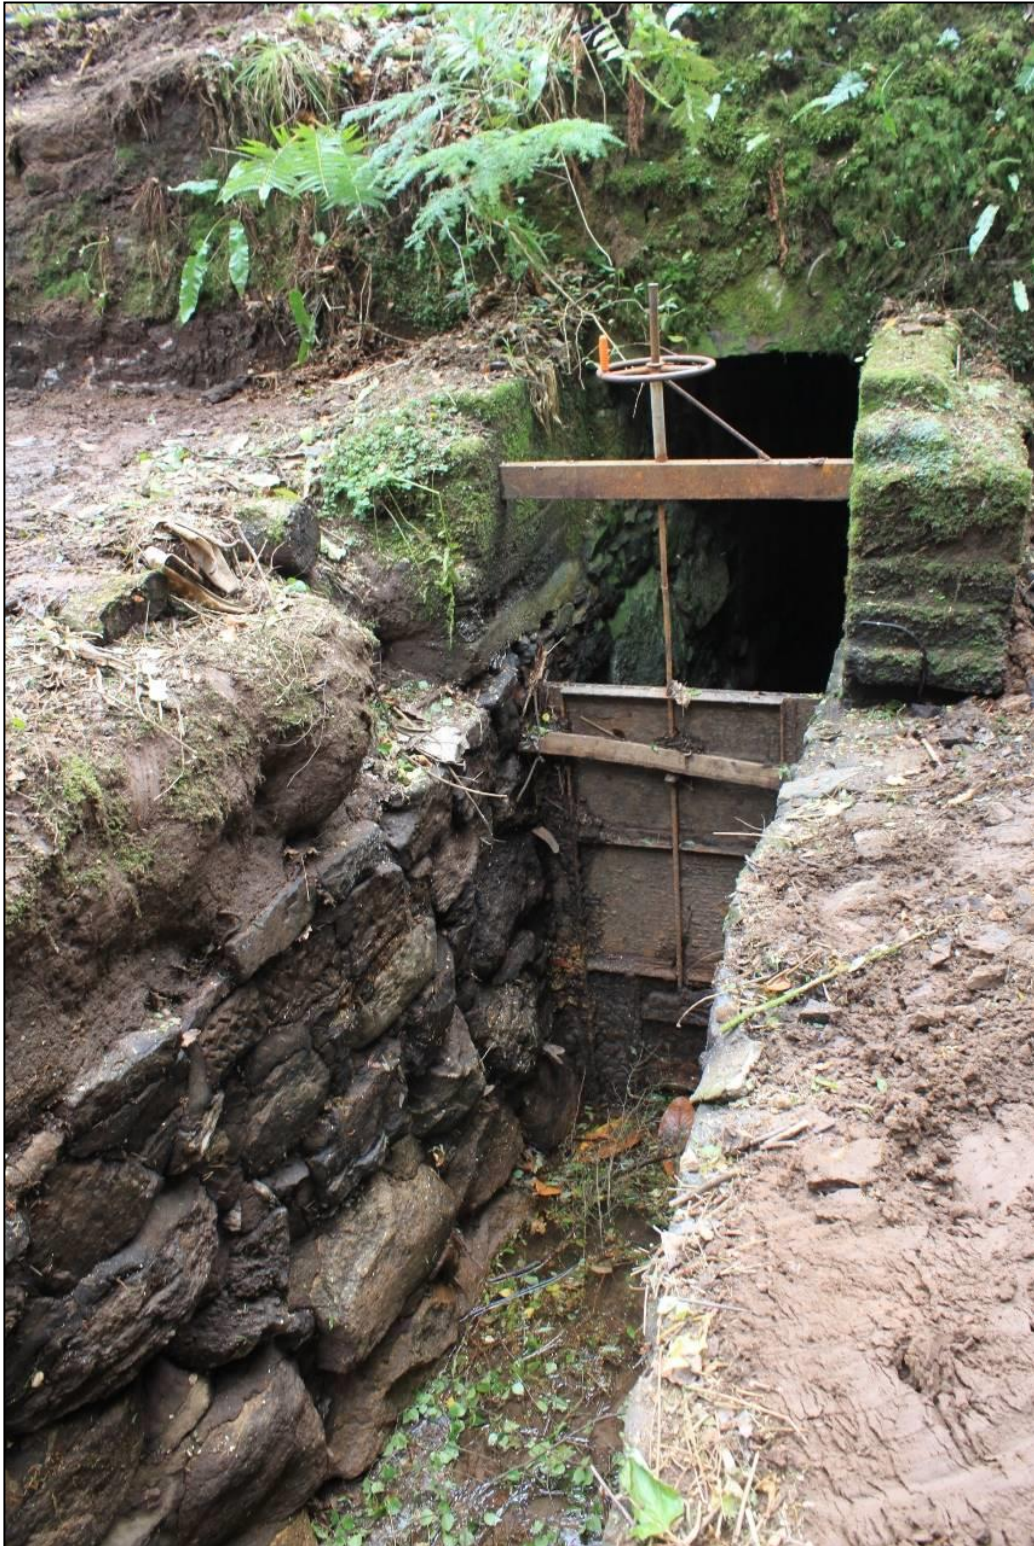
6. The Mill burn entered the fire pond in its northwest corner at a height of approximately 4m and discharged through the sluice in the south, level with the pond's base, before continuing underneath the bridge carrying the estate road. The sluice gate was held in place by a cast iron crossbeam, itself bonded on either side to two brick buttresses built on top of the retaining walls (Figure 4).

Figure 4: Sluice gate location in relation to the retaining walls.

29. The retaining walls of the sluice appeared to be of considerable age and may date from the original construction phase of the fire pond. The gate, constructed of brick and concrete elements, was likely a later addition. The sluice gate was non-functional at the time of inspection, but the retaining walls appeared substantial enough to still effectively channel the Mill Burn.

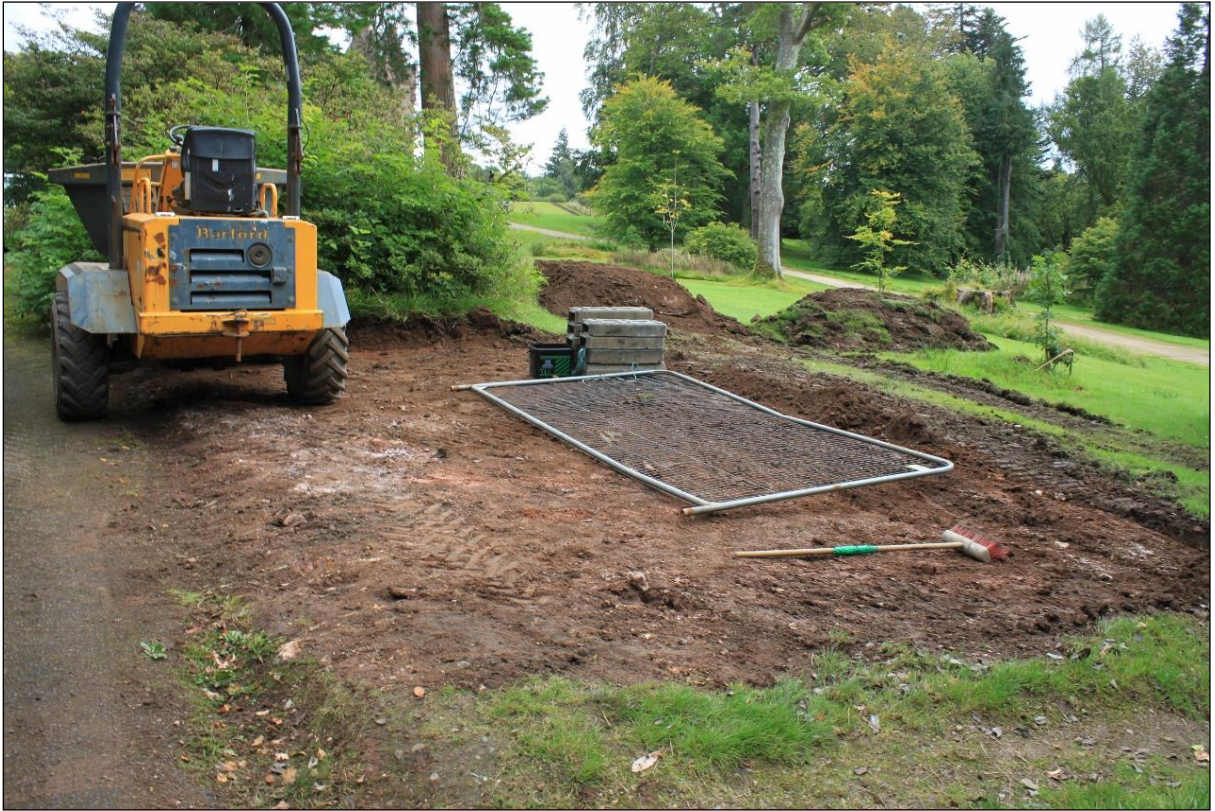
10. Area 1 was located immediately south of the estate road and measured 10m from east to west and 4.5m from north to south. This area was used as a lay-by for plant and materials used during the works. Area 1 was excavated to a depth of 200mm (Figure 5).

Figure 5: Post-excitation view of Area 1 from the northwest.

15. Area 1 was covered by particularly shallow topsoil, a friable mid greyish-brown clayey silt with occasional small sub-angular stone inclusions **(001)** reaching a depth no greater than 150mm. Beneath this was a layer of made ground composed of a friable mid reddish-orange slightly clayey silt with infrequent charcoal inclusions **(002)**. There was also a small outcrop of bedrock within the excavated area immediately adjacent to the road, suggesting that the soil deposits in Area 1 were quite shallow.

23. Area 1 was noted as being in close proximity to the location of a gardener's cottage that formed part of a former walled garden west of Brodick Castle. However, no archaeological remains relating to the cottage were uncovered, and the shallow deposits in this area were not formed of demolition material. Instead the deposit **(005)** likely represents made ground relating to the construction of the estate road.

30. The excavations in Area 1 showed no impact on an archaeological features and, given that this area served as a temporary lay-by to be used only for the duration of the works relating to the fire pond, no recommendations are made.
31. Areas 2 and 3 showed evidence of having been disturbed both frequently and considerably during the 20th century. No archaeological features of significance were discovered, therefore no further archaeological works are recommended.
32. The sluice was found to be a much more substantial feature of the fire pond than initially

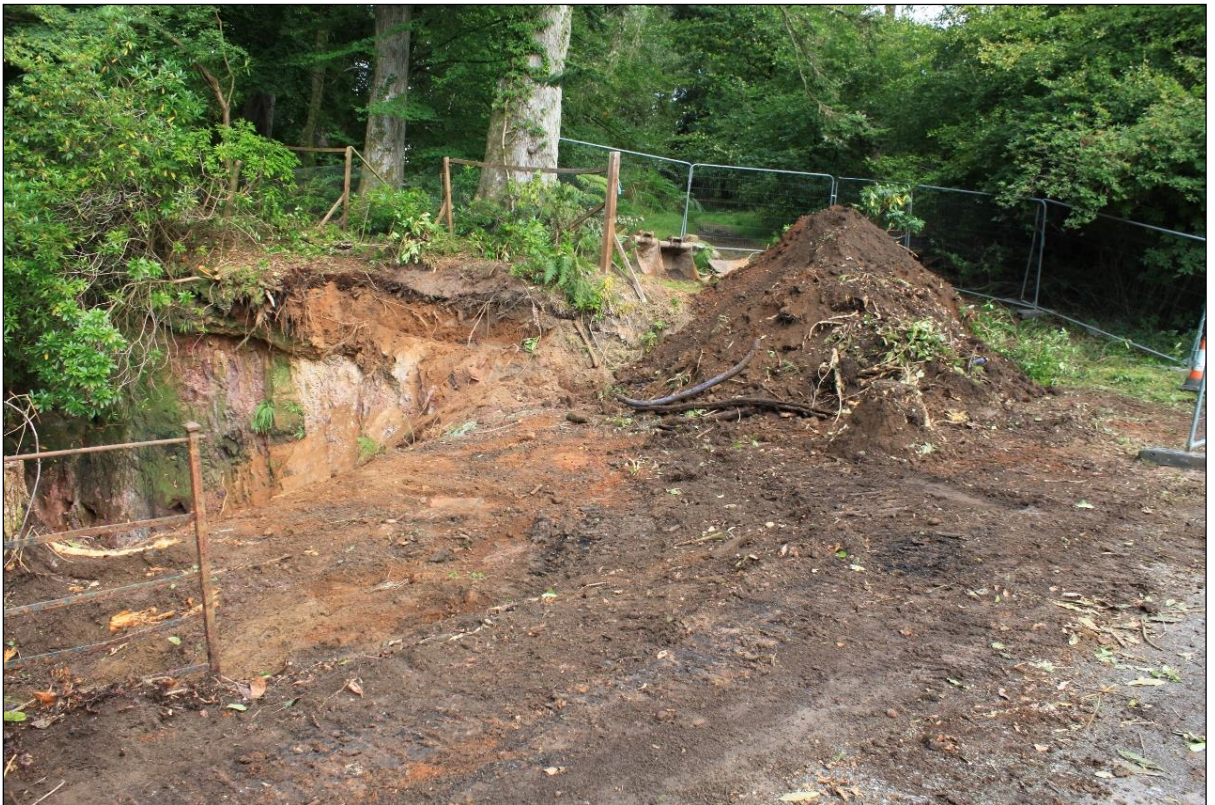
11. Area 2 was located immediately to the east of the fire pond and measured approximately 15m from east to west and 12.5m from north to south. This area varied in excavated depths to a maximum of approximately 500mm (Figure 6).

Figure 6: Post-excitation view of Area 2 (19th September 2016) from the south.

16. The topsoil **(001)** in Area 2 was approximately 300mm deep. Beneath this was a friable mid orangish-brown mottled red/grey clayey silt **(004)**. This deposit was very mixed and appeared to have been disturbed at various stages. As a result it was interpreted as a mixed dump of different deposits and made ground, probably relating to the former hardstanding **(007)** access to the fire pond.

24. The deposits in Area 2 were very mixed, suggesting this area has been disturbed frequently over time. It is likely that these deposits represent made ground being built up to facilitate construction of the disused hardstanding area, and the repeated dumping of material from a position on the hardstanding. The excavated area to the east of the hardstanding was comprised entirely of natural subsoil **(006)**, suggesting that only the area of ground to the west, between the hardstanding and the fire pond, was used as a dump.

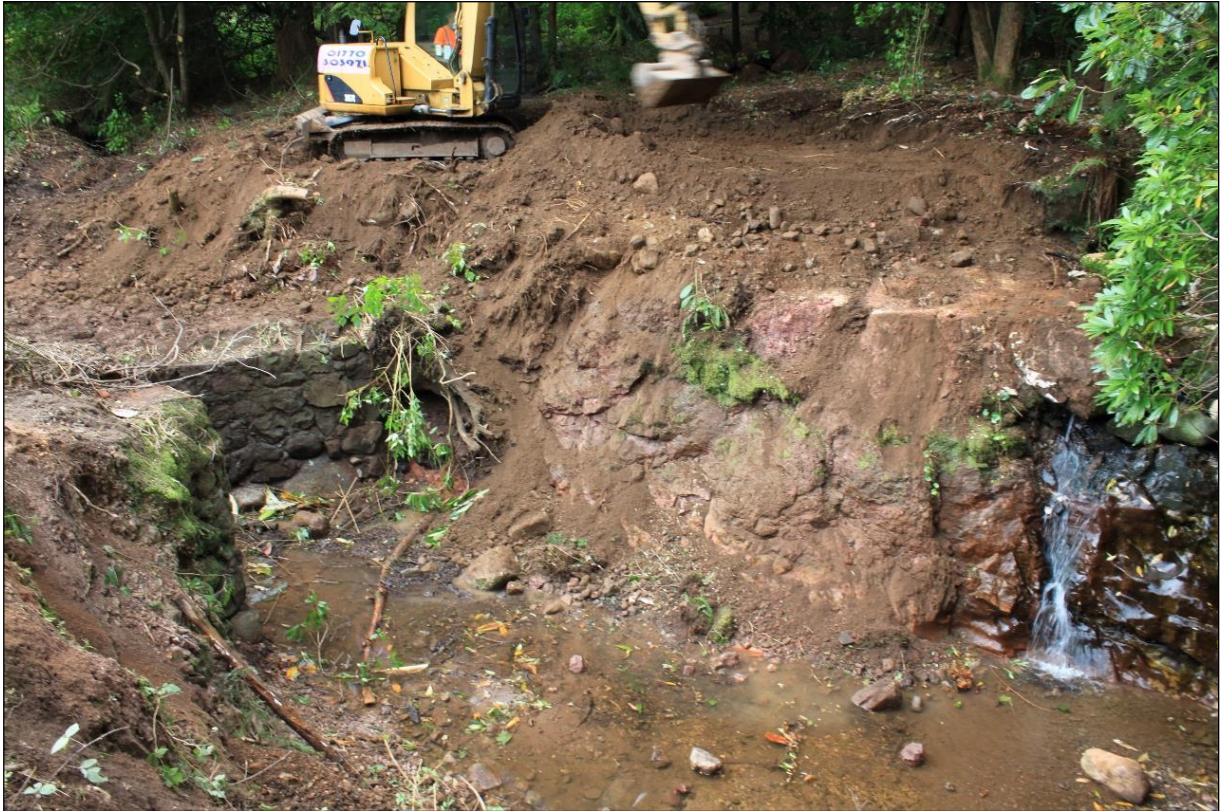
Figure 7: Area 3 during excavation.

12. Area 3 was located immediately to the west of the fire pond and measured approximately 15m from north to south and 5m from east to west. This area varied in excavated depths to a maximum of approximately 2m (Figure 7).
13. An additional area to the northeast of the fire pond was partially stripped of topsoil and a loose sandy deposit **(003)**, likely a deposit of hillwash. Due to this area's proximity to the fire pond, however, the reach of the mechanical excavator was severely limited. Furthermore this narrow area could not be safely accessed on foot and so was visibly inspected from a safe distance in the adjacent Area 2. It was clear that considerable root action from surrounding trees and other vegetation had taken place; therefore this area will not be discussed further (Figure 8).

26. Very little activity was evident in this area, the topsoil lying directly on top of natural subsoil. The original function of the disused 2" water main could not be discerned. Lying within the topsoil **(001)** and being detached at both ends, it may have been discarded from elsewhere on the estate.
27. The loose rubble **(005)** comprised a significant organic component of decomposing plant matter. As a result this deposit was interpreted as a late-20th century dump of rubble and midden material.
28. The machine-cut pit was unexcavated during these works but likely served as a rudimentary sump to aid drainage from the estate road.

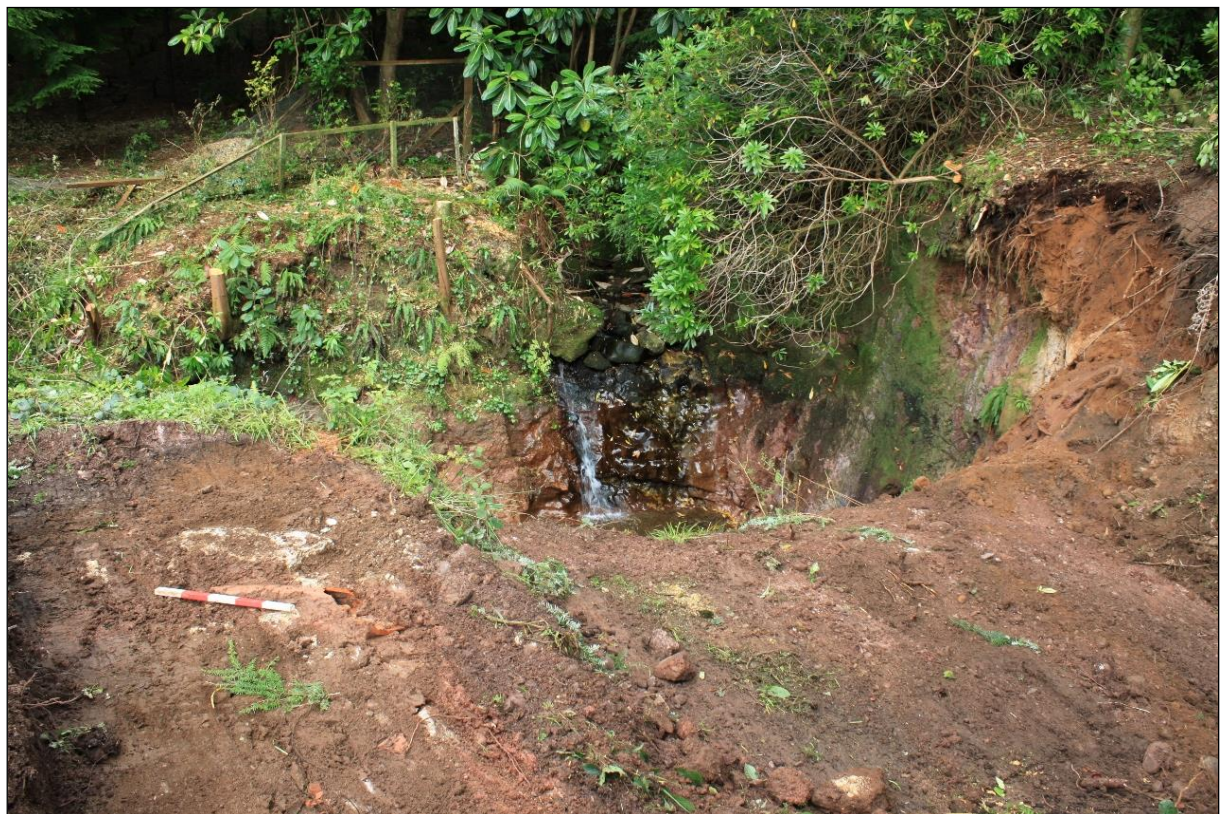
Figure 8: Inaccessible area (far right, **(003)**) to the north of Area 2.

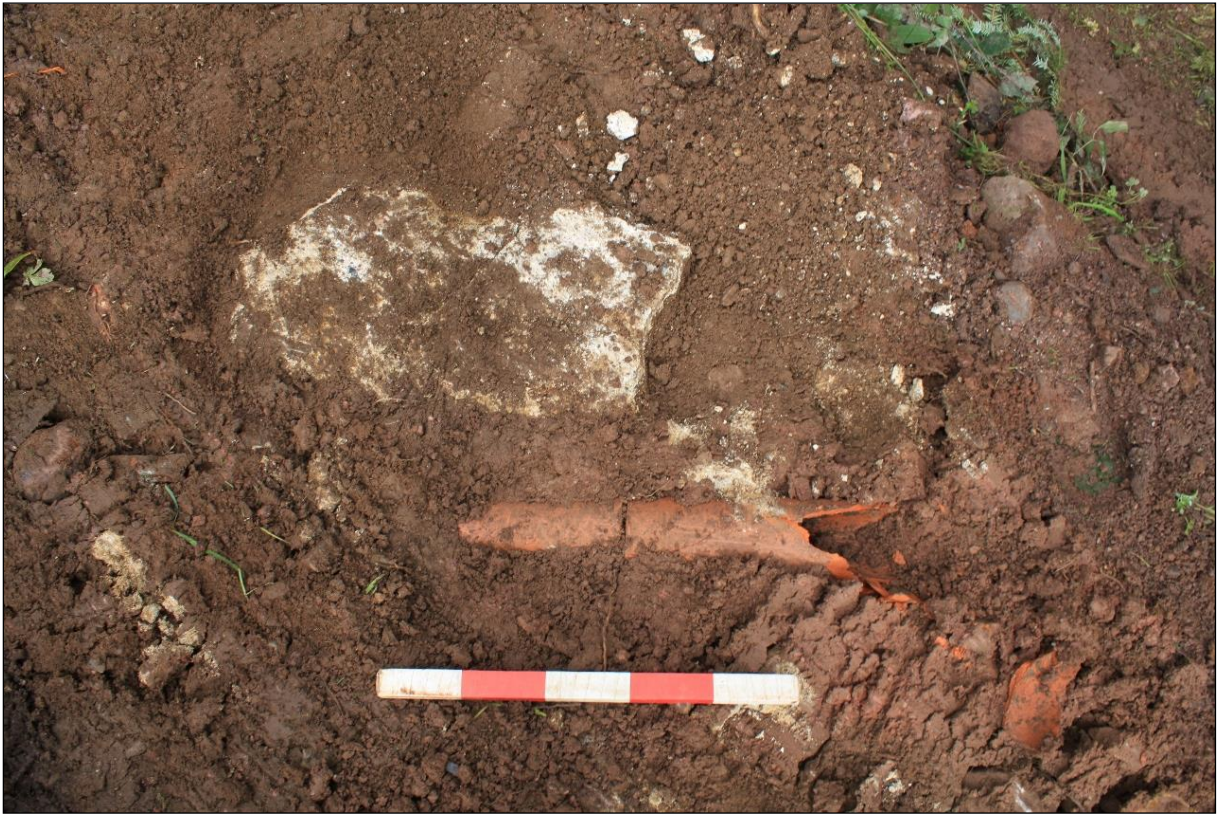
17. Two features were exposed within this area. These were: a circular ceramic drain (Figure 9) running from east to west, probably of late 19th or early 20th century date, and a modern 80mm plastic drain running from east-southeast to west-northwest. Both of these appear to run towards the eastern sluice wall, where they likely once discharged into the Mill Burn. Despite the apparent age of the ceramic drain, its location and route suggest that it probably postdates the construction of the fire pond, but predates the hardstanding area, which truncates the drain. These drainage features were not given context numbers due to their age and ubiquity on archaeological sites.

Figure 9: Circular section ceramic field drain in Area 2.

25. It was evident that the ceramic field drain in this area had not been functional for some time, having been truncated by the hardstanding. The later plastic drainage pipe revealed during the initial works on 19th September 2016 was exposed further on 15th December 2016, showing that it ran parallel to the estate road (Figure 13). This feature may have served as a drain to carry water away from the road to be discharged into the Mill Burn.

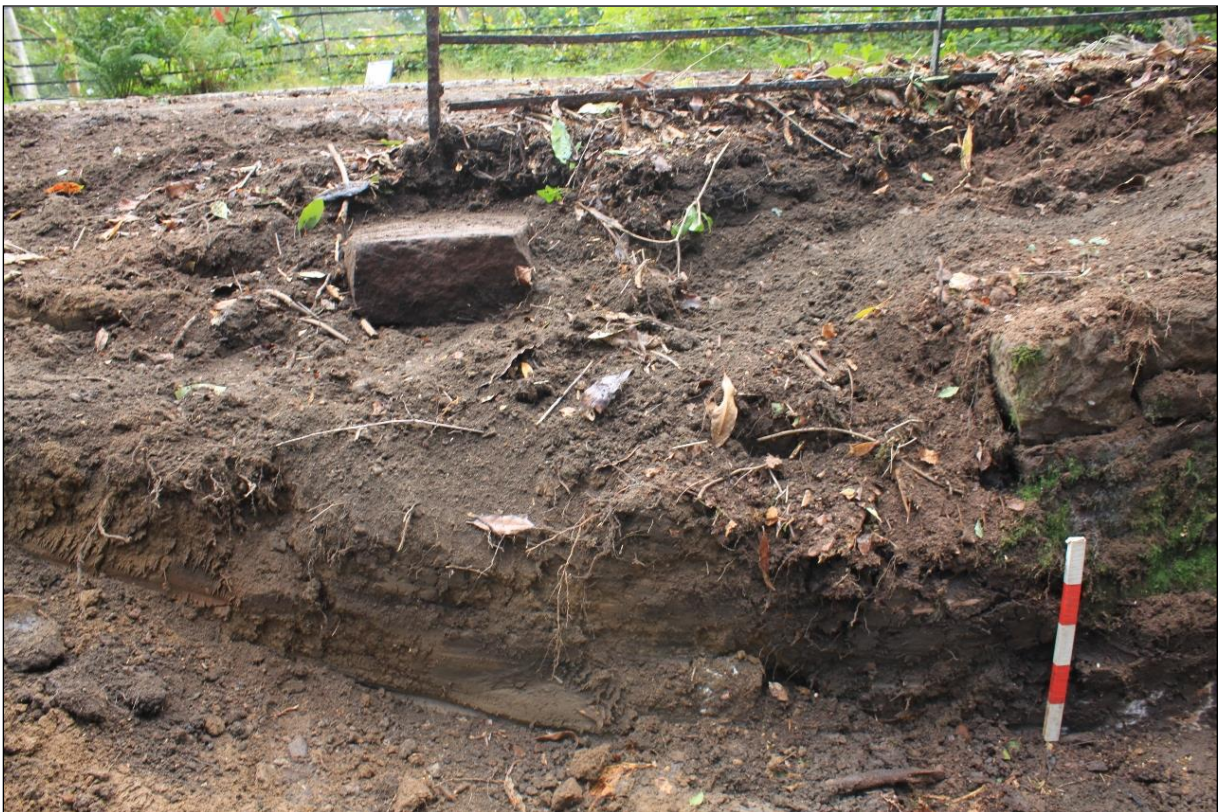
7. A wrought iron estate fence, likely contemporaneous with the construction of the bridge, was in place on either side of that structure. The foundation stone of one of the fence posts was partly excavated on the north stretch of fence, facing the fire pond (Figure 10).

19. A large slab (400mm x 600mm x 200mm) anchoring the easternmost post of the stretch of wrought iron estate fence immediately south of the fire pond was also partly exposed by the removal of vegetation. The surrounding topsoil was removed by hand excavation and the slab left *in situ* (Figure 10).

Figure 10: Iron fence foundation stone and bridge retaining wall (right).

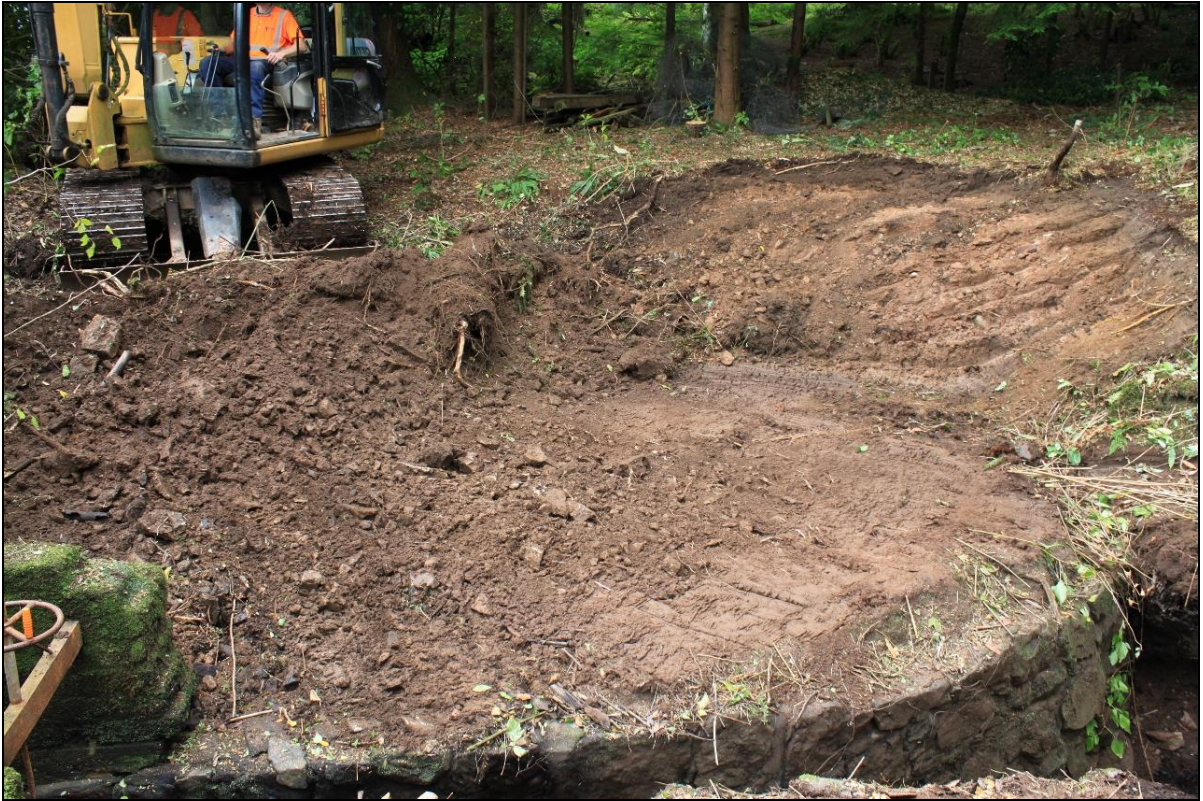
Figure 11: Context **(005)** during excavation.

(005). The northern half of Area 3 was characterised by an underlying layer of subsoil **(006)**: a firm brownish-pink silty clay with occasional stone inclusions (Figure 11).

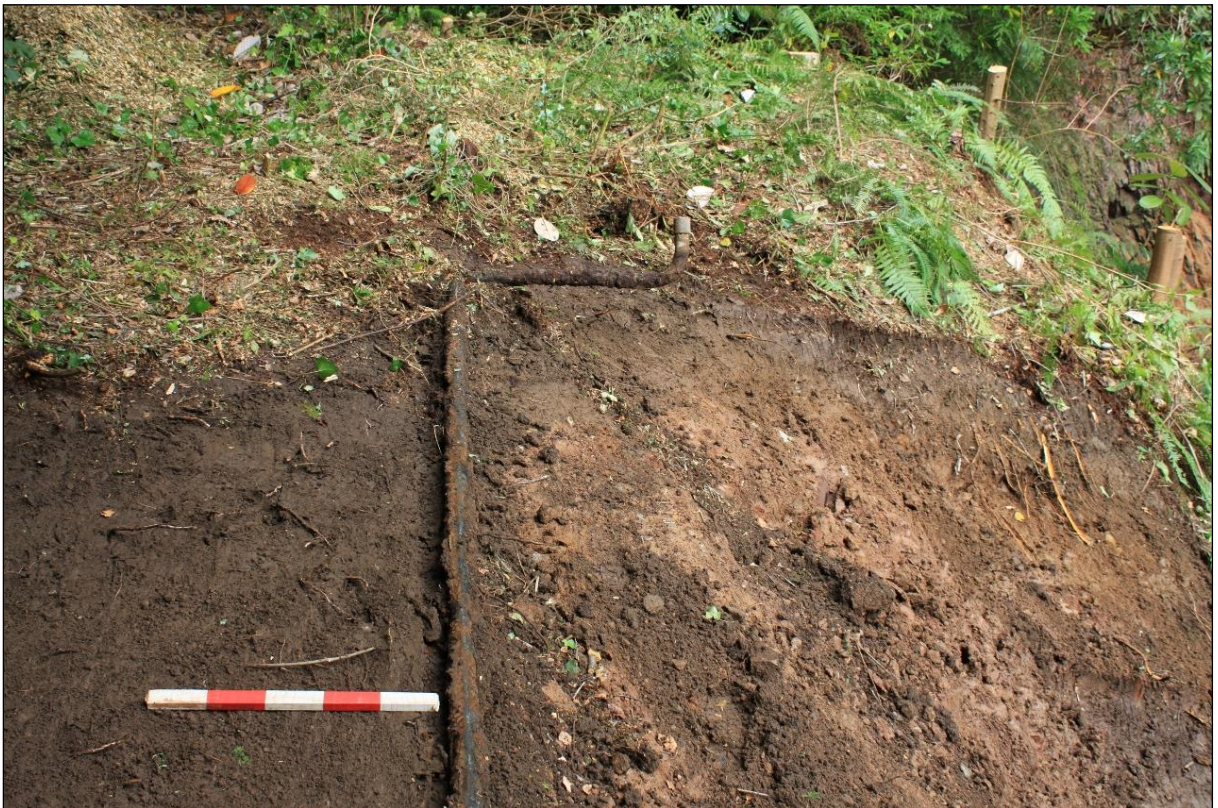
Figure 12: Defunct 2" water main in Area 3.

22. Two features were present in Area 3. These were: a disused 2" cast iron water main, and a machine-cut pit measuring approximately 1m x 2m x 0.5m. The water main ran in a north-northeast to south-southwest direction, terminating in the north-northeast where it had been folded over (Figure 12).

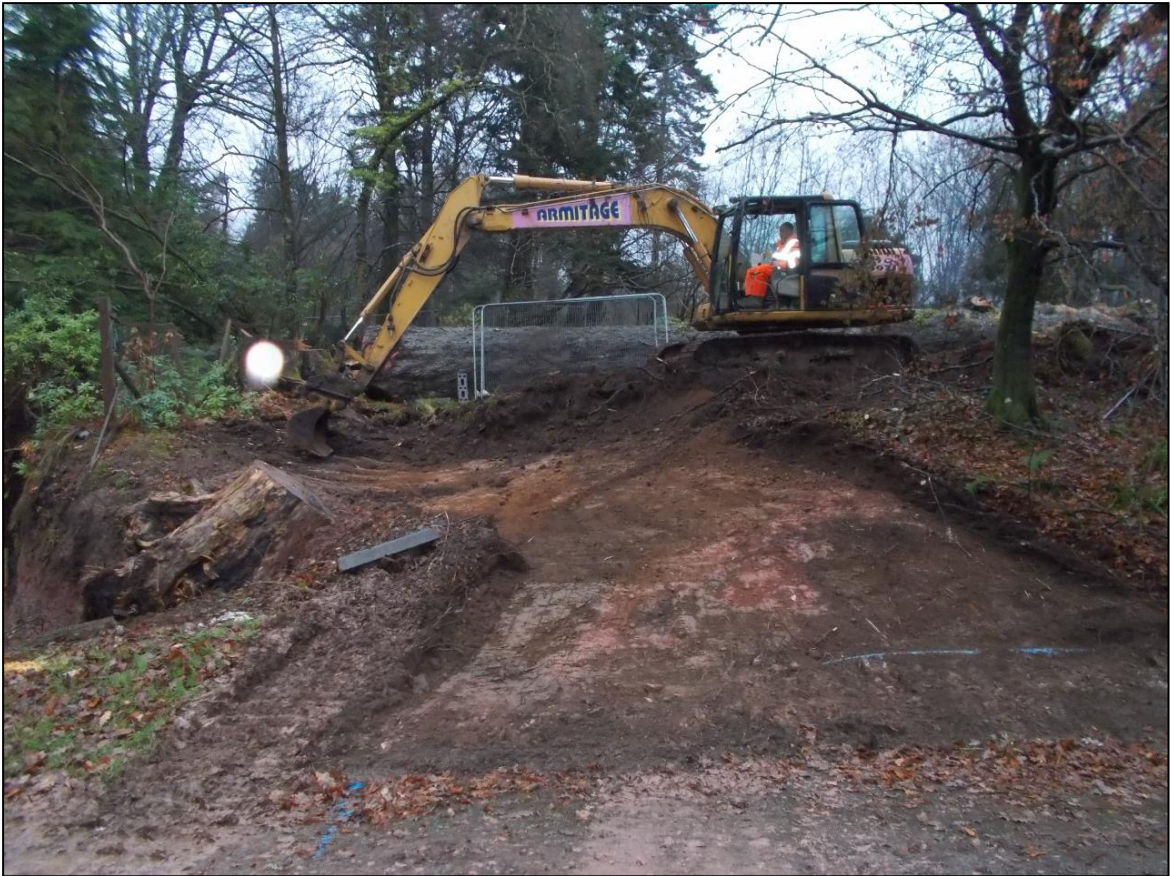
Figure 13: Extension of Area 2 excavated on 15th December 2016 showing plastic pipe running parallel to the estate road.

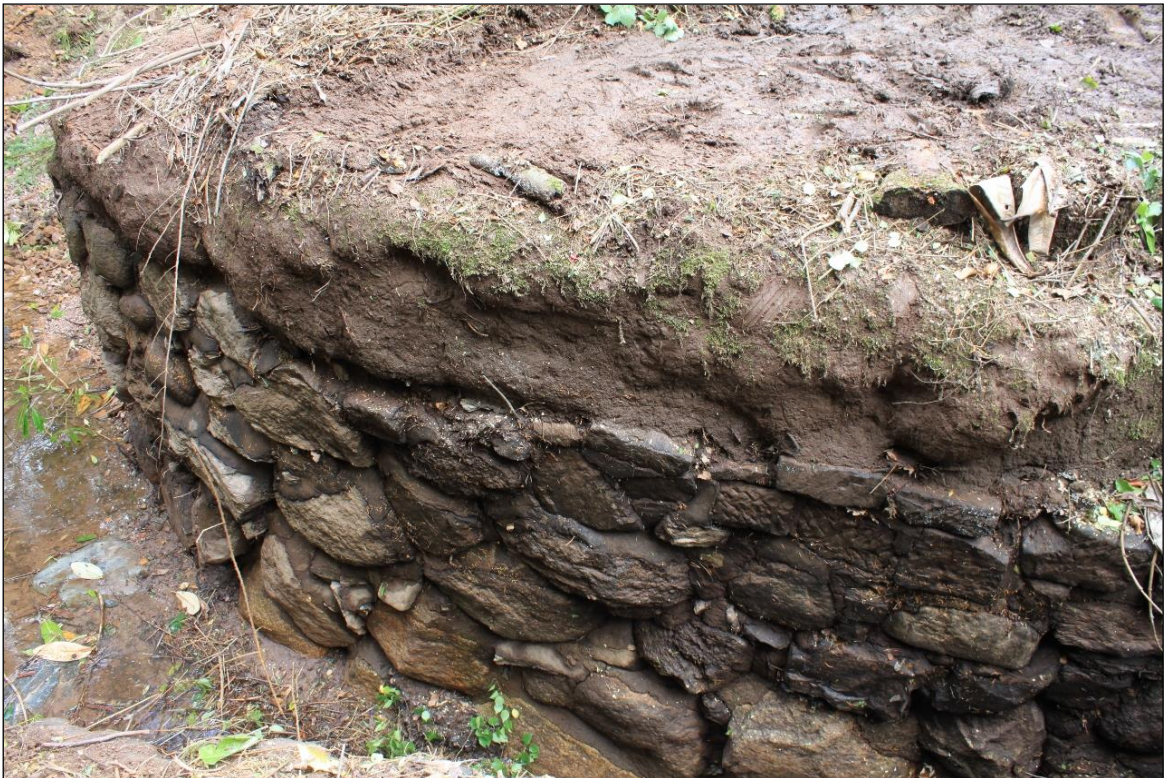
Figure 14: West-facing retaining wall of the sluice structure showing much-worn bonding material.

thought. The retaining walls are particularly noteworthy as they may relate to the original construction of the fire pond. Despite the apparent robustness of these walls, they were in a poor state of repair with very little bonding material remaining (Figure 14). It is suggested that any ongoing works should take measures to safeguard the historic fabric of the retaining walls.
