Culzean Castle Spine Wall Consolidation: Archaeological Mitigation

Data Structure Report

issued 31st March 2017

on behalf of National Trust for Scotland

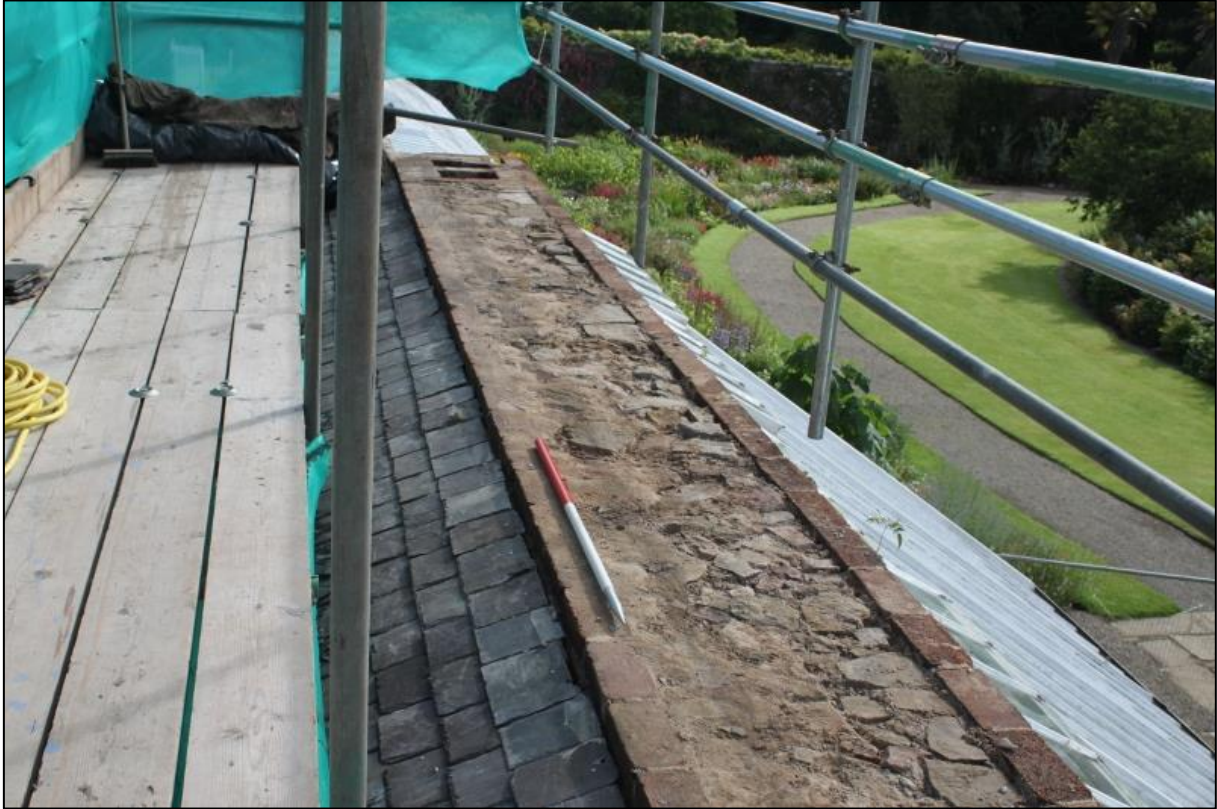
18. The first archaeological monitoring visit (July 2016) took place following the removal of the concrete coping blocks over a distance of approximately 30m along the length of the spine wall as it ran between the potting shed range and the glasshouses starting at their NE end. The wallhead was already in the process of being consolidated at the NE end, over a distance of 10.5m, making inspection impossible. The roof of the potting shed had also been replaced in this area, and one of the original flue outlets rebuilt using handmade bricks [003]. The wallhead was then consolidated with an external face of bricks set out in stretcher bond and bonded with lime mortar, with the area between this and the original wall structure infilled with crushed sandstone rubble set in a matrix of lime mortar [002] (Figure 4a).

Figure 4a: Consolidated area at NE end of Spine Wall (0-10m SW of NE end)

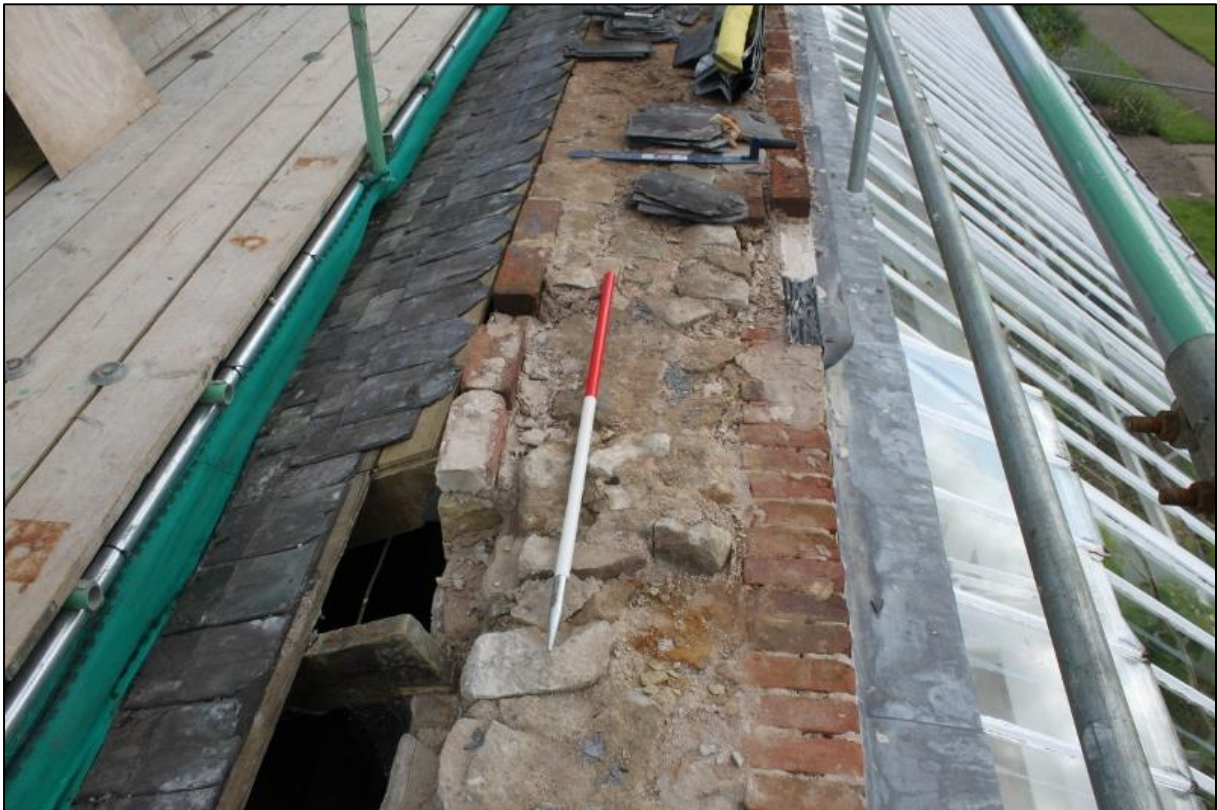
19. Beyond this point, the original masonry remained exposed, allowing unimpeded inspection of its character (Figure 4b). The locations of flues were noted, and sample lengths of the wallhead drawn on plan to provide more detailed records of the structure (see Figure 2).

Figure 4b: Transition between Consolidated Fabric [001] & [002] and Original Wall Fabric [006] and Scarcement Ledge [008], with Relaid Bricks [004] and Modern Lead Flashing [005] at SE edge (Looking NE)

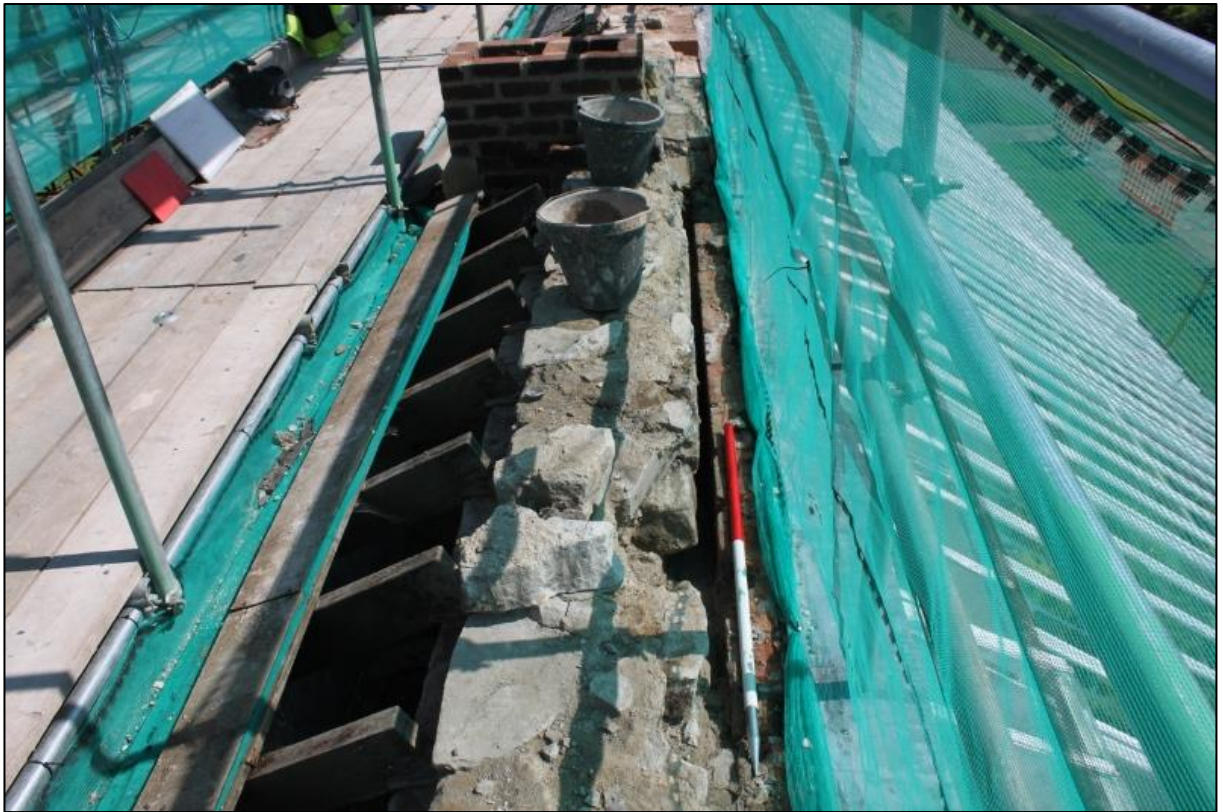
22. The presence of void (010) suggests that – rather than representing a later attempt at consolidation of a pre-existing wall face (i.e. the handmade brick lining noted at a lower level on the SE-facing side of the wall) - the modern brick face [007] represents instead a raising of this brick lining to create a change in the roofline of the glasshouses. As [007] is only one skin in width, the void can be envisaged as the space above the inner skins of the earlier brick lining: this latter feature would have been more than one skin in width as it needed to accommodate the full width of the flue, which, where exposed, measured 0.2m. We can therefore envisage that the NE side of the spine wall included a similar scarcement ledge to that still extant on the NW side, though at a much lower level. This would have allowed the siting of a wallplate, upon which rested the cast-iron frame forming the rear edge of the roof of the glasshouse/vinery.

Figure 5a: Rubble Wall [006], with Scarcement Ledge [008] to left and Modern Brick Lining [007] to Right, with Void (010) to rear

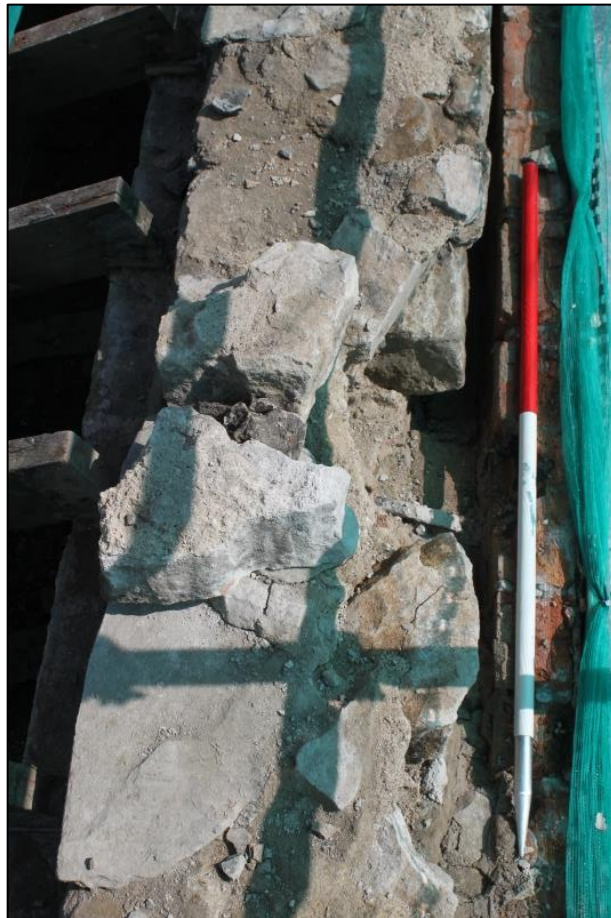
23. The case for a change in roofline was further supported by the regular presence of iron straps or ties [011], bedded deep within the rubble core of [006], from which they projected by a short length (Figure 5b). Four of these items were identified in total, occurring at semi-regular intervals running between 15 and 28m SW of the NE end of the consolidation works. The spacing of these ties varied between 1.25 and 1.7m: either this distance varied at the time of construction or – more likely - the original intended distance between the individual ties can no longer be determined due to later remodelling or consolidation works.

Figure 5b: Wall [006], with Iron Strap [011] to left of Void [010] and modern brick lining [007]

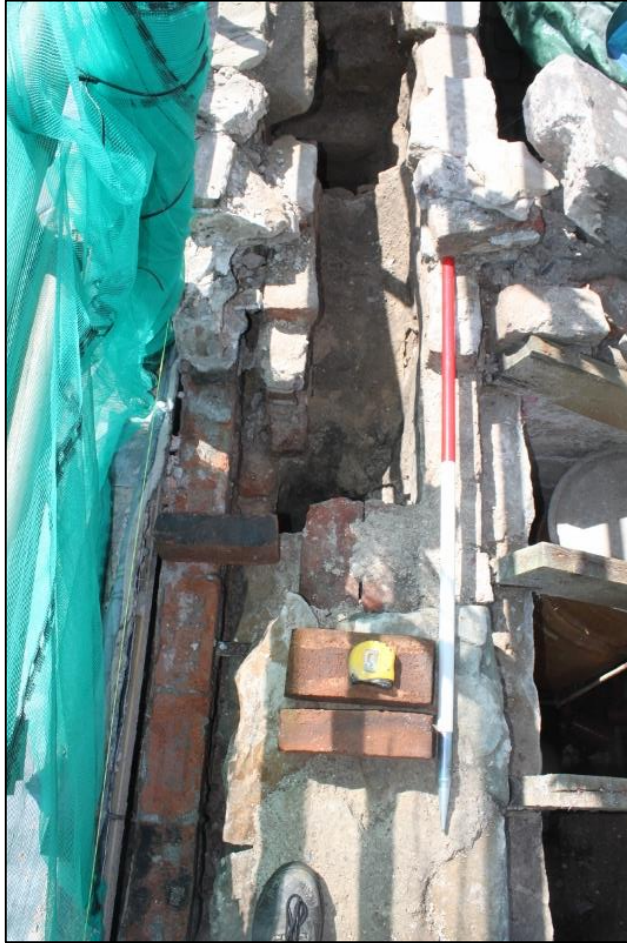
Figure 6a: Flues [013] (front) and [017] (rear), with change in wall configuration evident

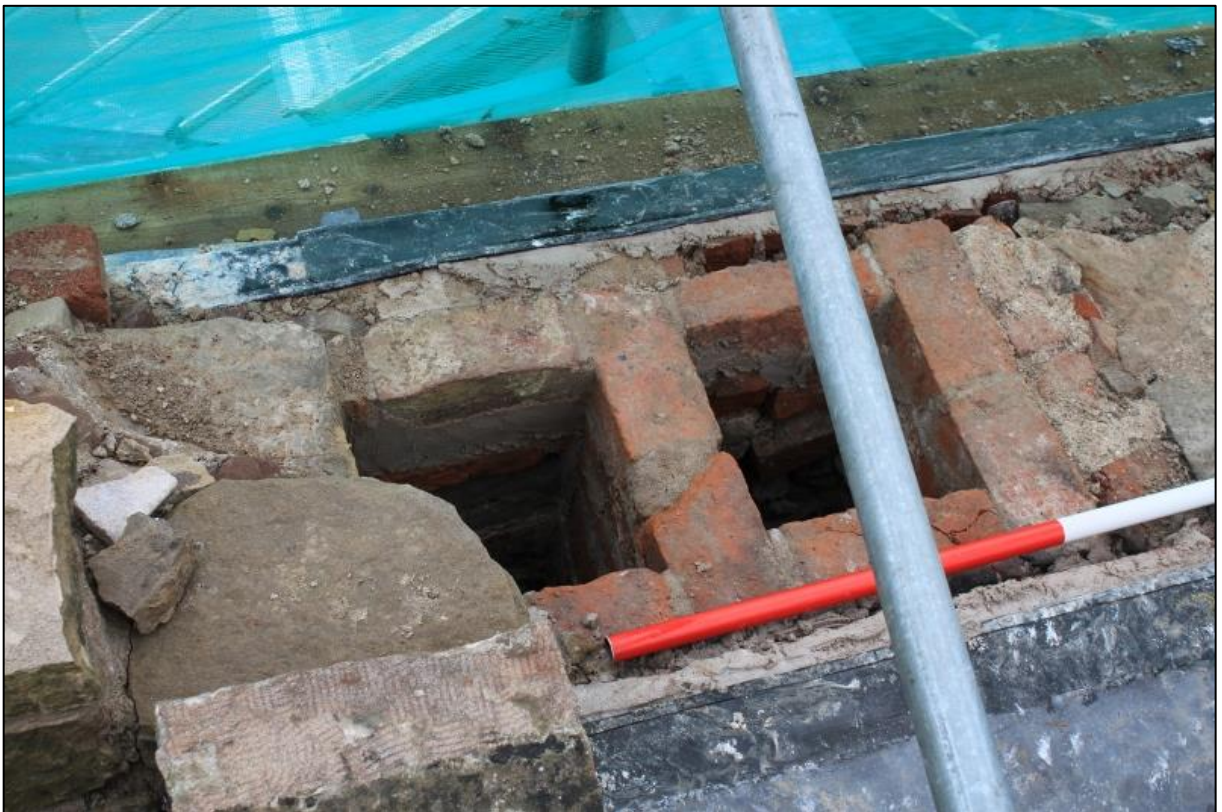
Figure 6b: Flues [022] and [024], handmade brick lining in upper courses

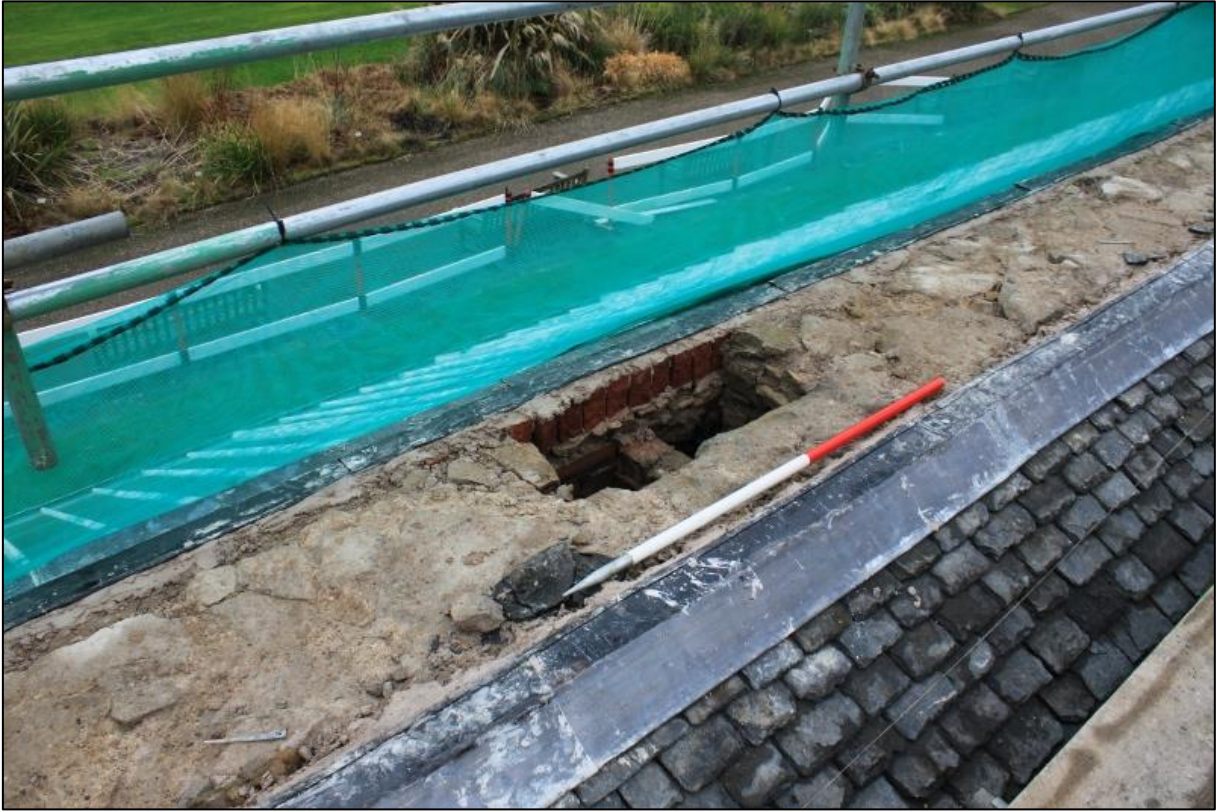
Figure 7a: Flues [027] and [028], partly dismantled at upper levels

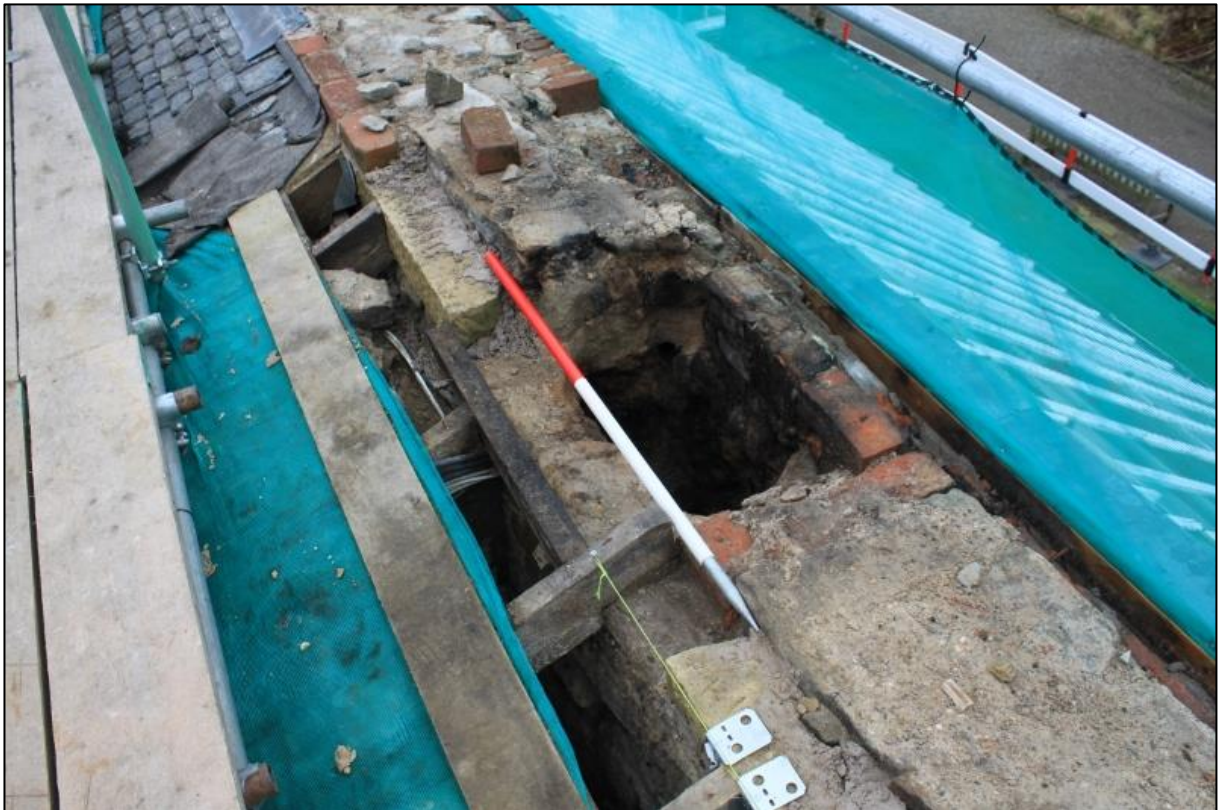
Figure 7b: Flue [029] showing heavy sooting of interior

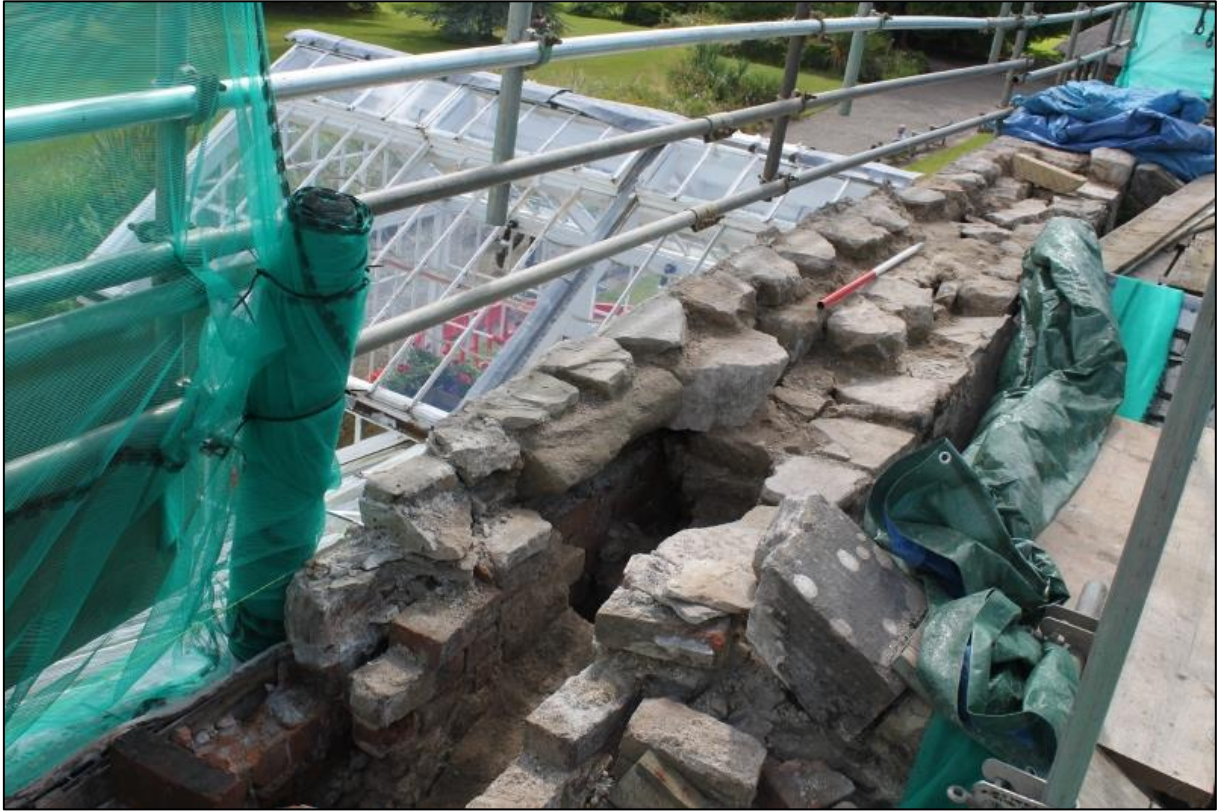
29. Along the length of this raised section [014], the wall face was flush with the external edge of the wall on both sides (giving it a total width of 0.8m), with no scarcement noted (Figure 8a & b). Since rooflines are evident on both sides, the presence of a raggle can be inferred, but this could not be confirmed by observation as both roofs remained *in situ* in this location. The masonry employed in the construction of [014] comprised large blocks of roughly squared or unworked sandstone rubble measuring up to 0.4 x 0.2m in extent. This elevated section of the wall had been bonded using a cement-based mortar, indication that it had been consolidated in recent times.

Figure 8a: Raised Centrepiece [014], General View with flues revealed

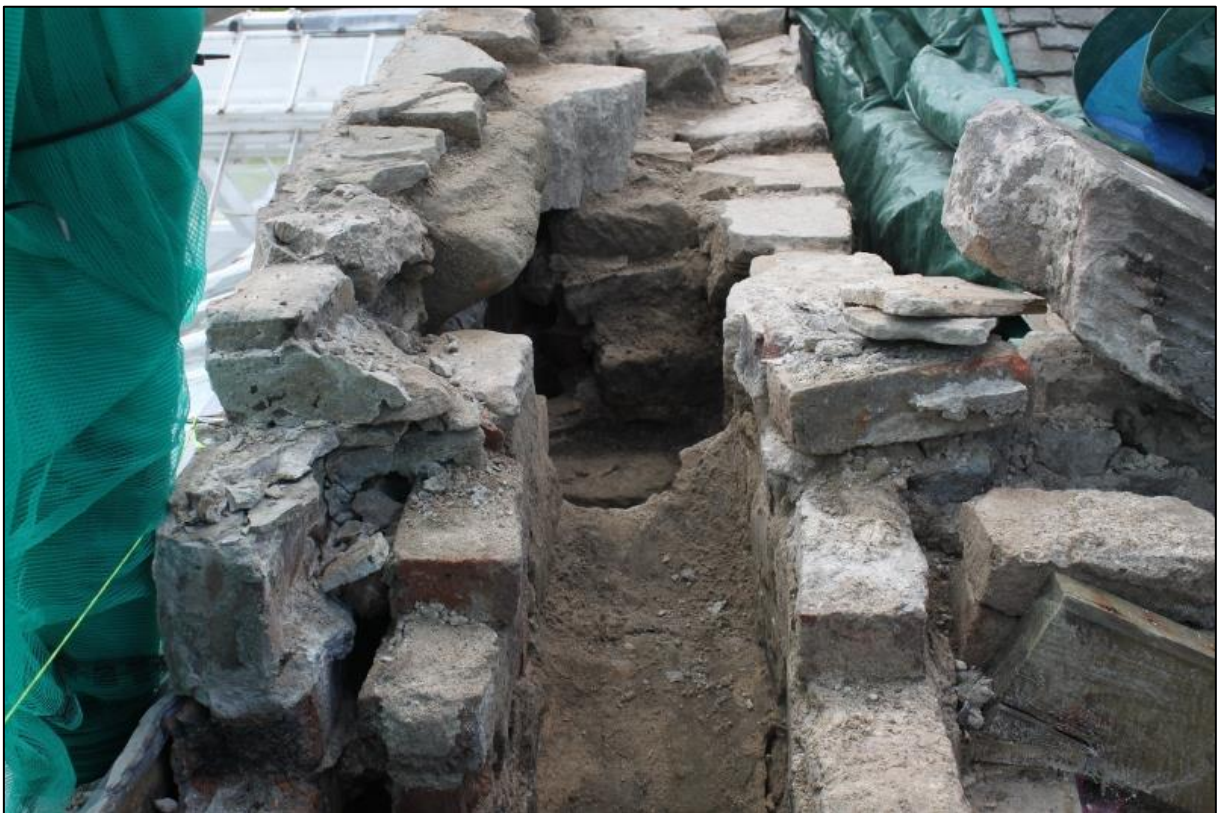
Figure 8b: Raised Centrepiece [014], seen in section, flue [017] in foreground
