Haddo House & Country Park Ice House, Tarves: Archaeological Mitigation

Data Structure Report

issued 31st May 2017

on behalf of Landscape Services, Aberdeenshire Council

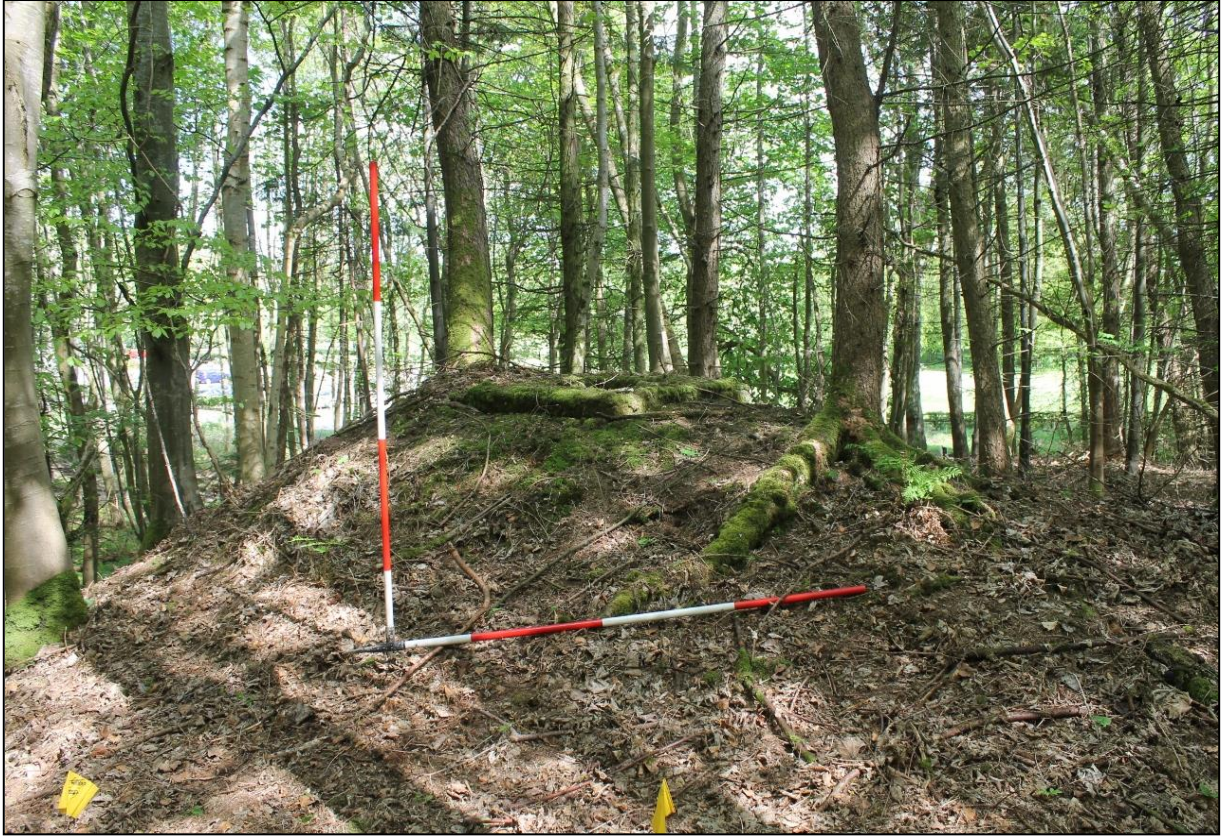
Figure 4a: Demonstrating the earth covered dome shape of the Ice House

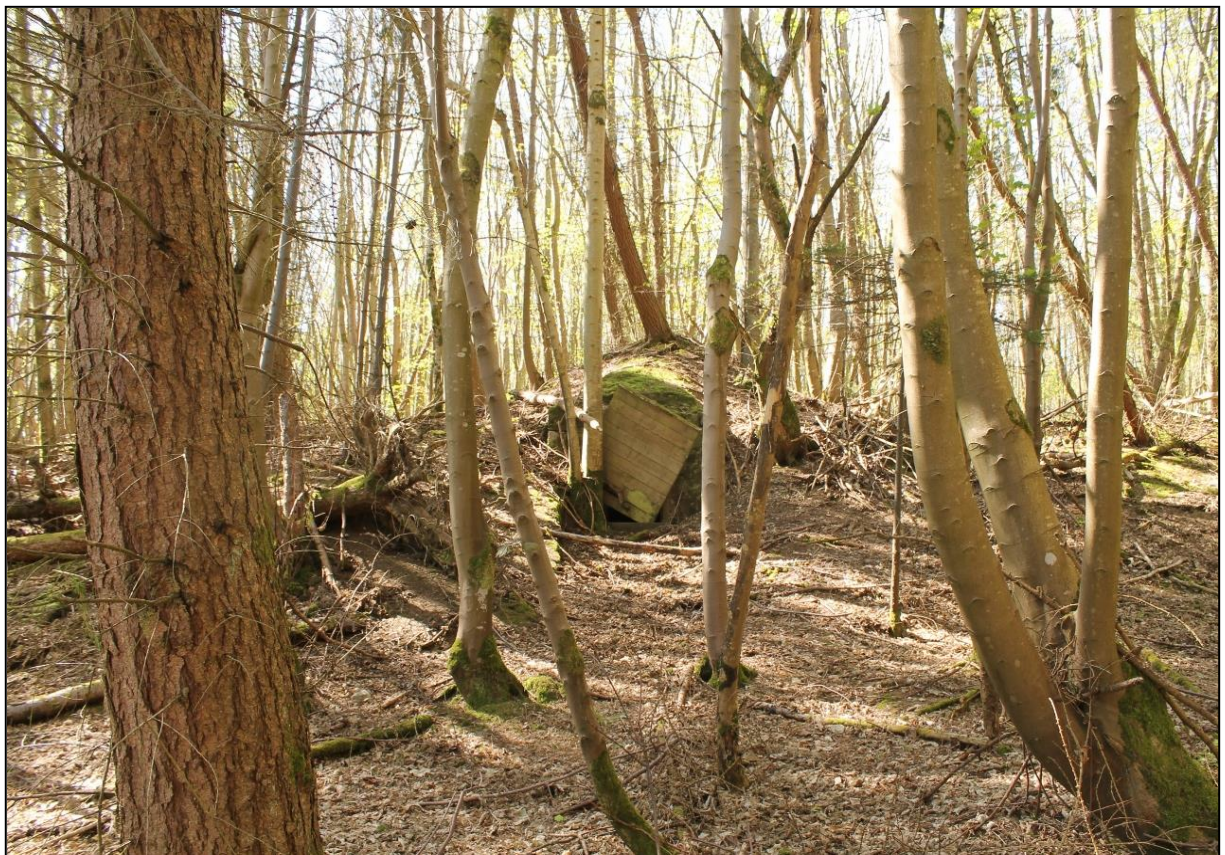
Figure 4b: Main northeast access to Ice House and currently sealed off using a wooden fence panel

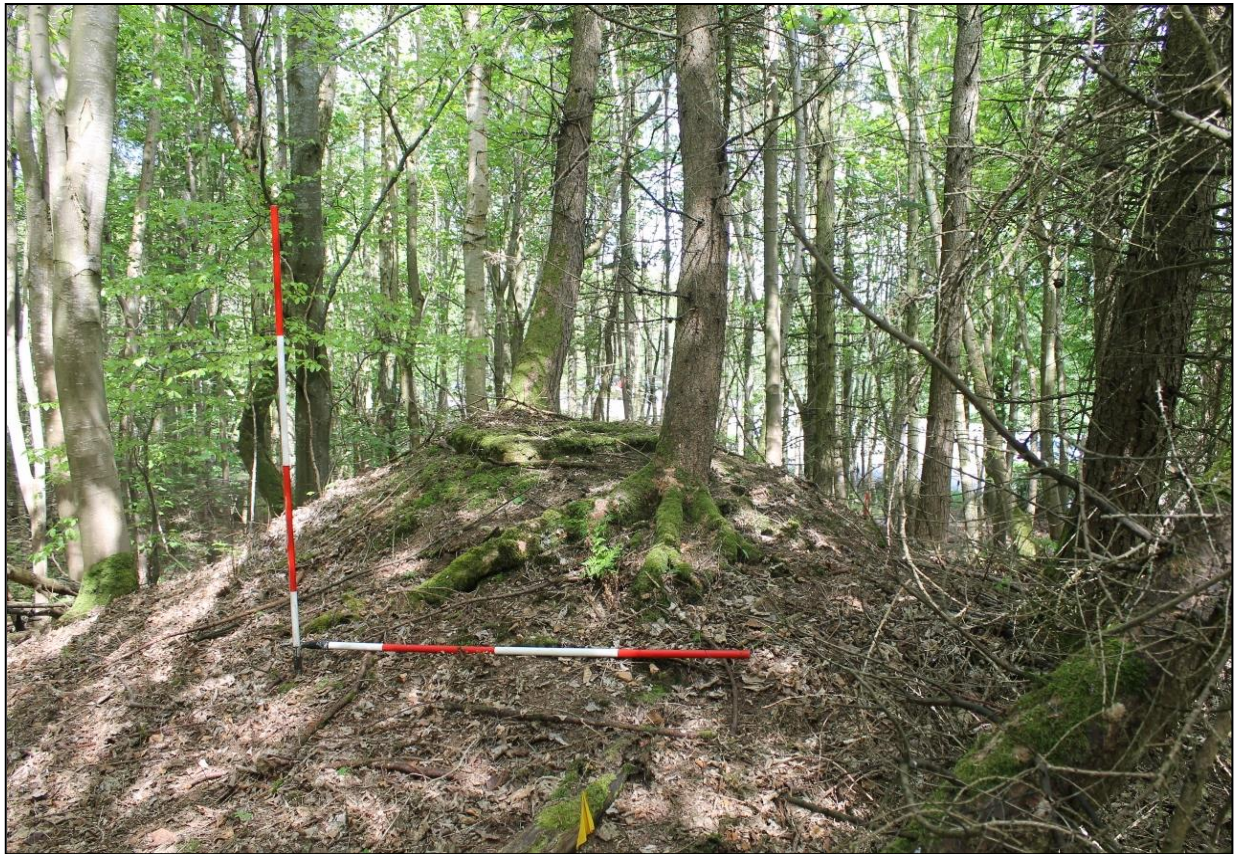
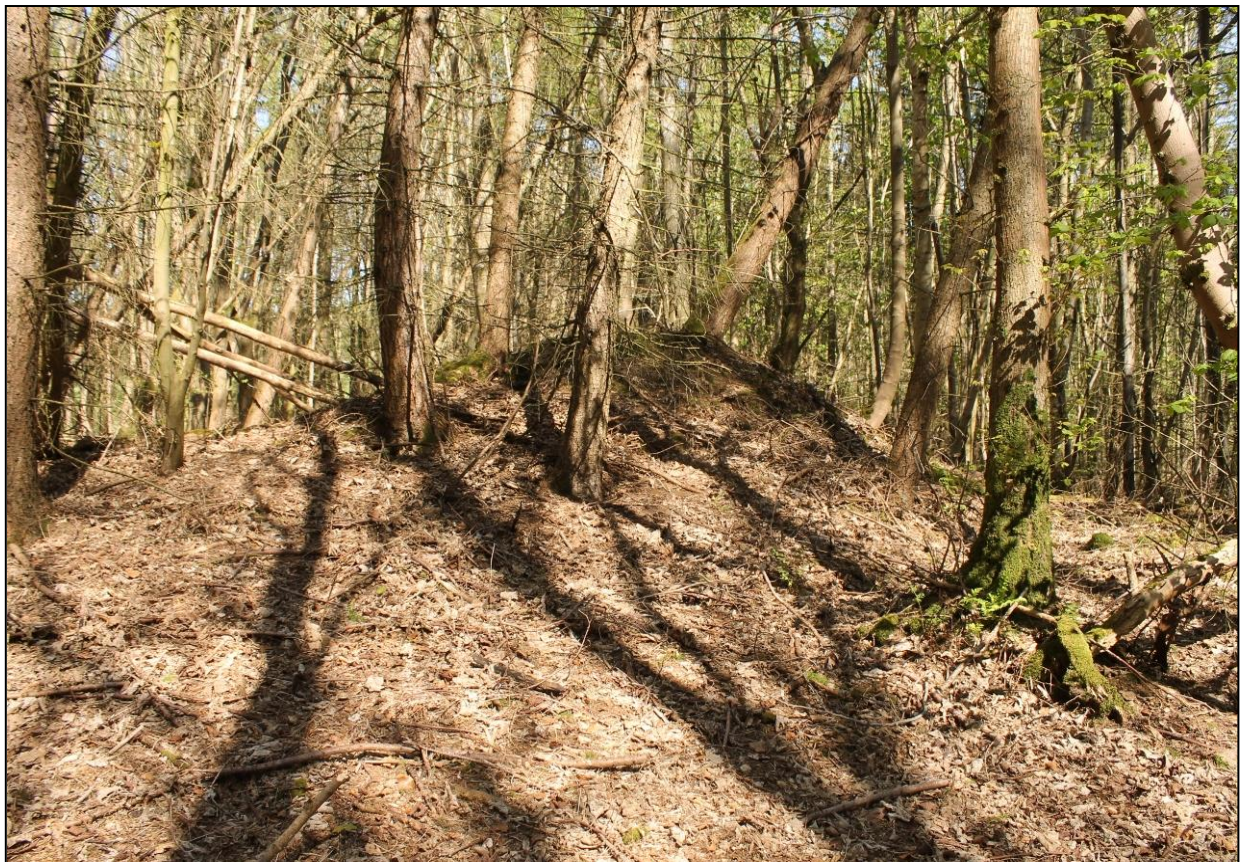
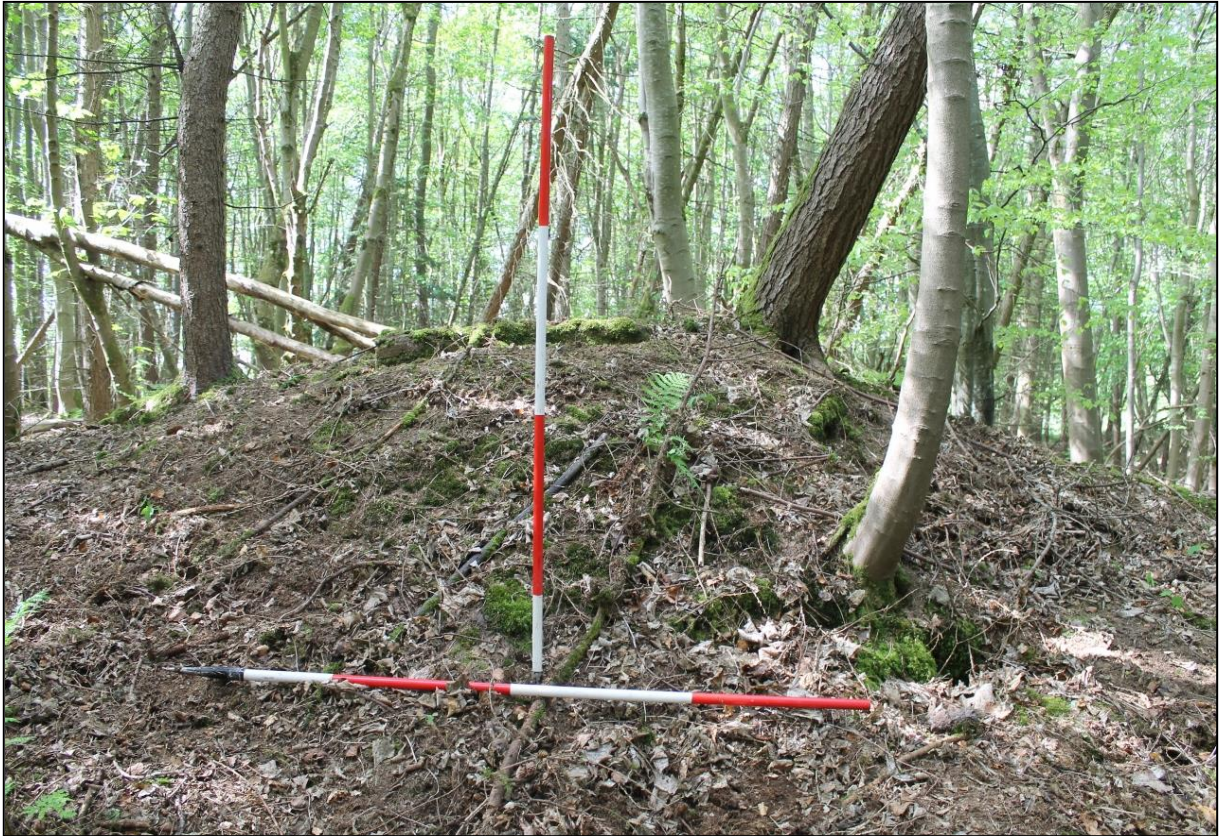
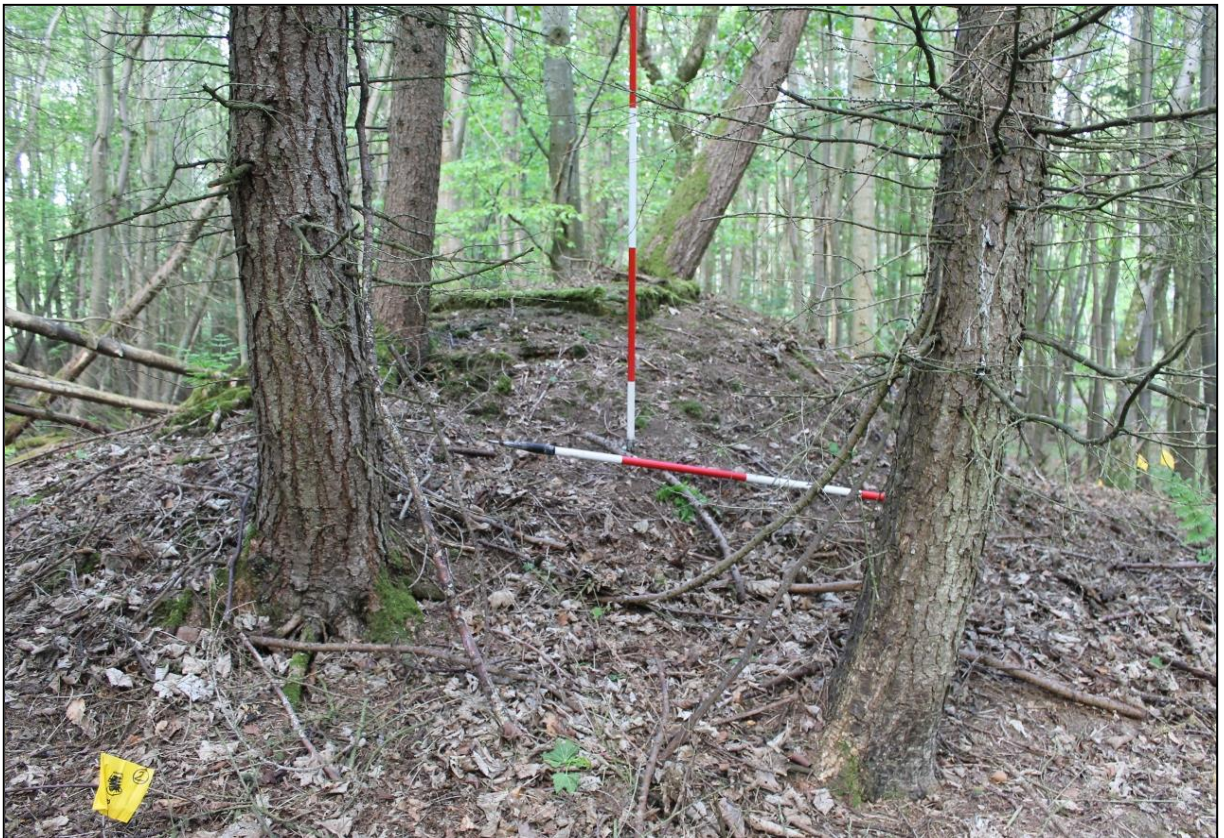
42. The structure appears predominately as an uneven dome shape, situated on the woodland floor and located partly below ground level. It is roughly oval in plan with a northeast-southwest axis (Figure 4a & Figure 5). Access to the interior is through an entrance on the northeast side of the structure which is currently sealed off by a wooden fence panel (Figure 4b & Figure 6). A number of trees have grown up both around and over the structure (Figures 7a, 7b, 8a & 8b).

Figure 7a: Demonstrating the tree cover and profile of the exterior earth dome

Figure 7b: Demonstrating the tree cover and profile of the exterior earth dome

Figure 8a: Demonstrating the tree cover and profile of the exterior earth dome

Figure 8b: Demonstrating the tree cover and profile of the exterior earth dome

65. The growth of trees and associated roots across the extent of the ice house may have helped to prevent the loss and erosion of the soil covering. It is recommended that any removal of the trees and roots must be undertaken by professionally qualified persons and that the advice of a qualified and registered structural engineer is sought to comment on any impacts the removal of trees and roots will have on the structural integrity of the ice house and to advise on any consolidation work required as a result of these changes in the structure's local environment.

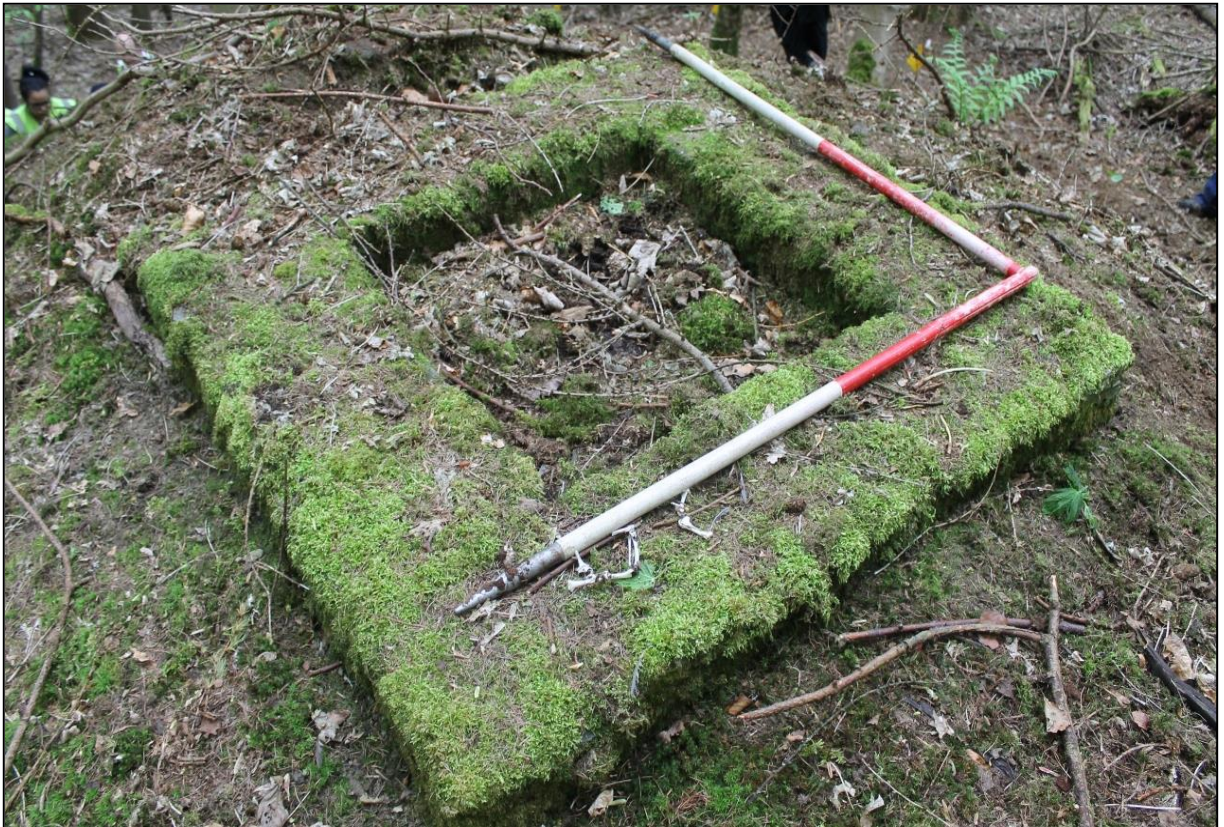
44. Centrally located on the top of the exterior of the ice house earth dome is a square red brick constructed square roof-light with a cement rendered exterior. The outside dimensions are 1.35m by 1.35m by 200mm with the dimensions of the square roof-light itself 700mm by 700mm (Figure 9a). The inside of the square roof-light has been sealed by what appears to be a stone block, although the covering soil and vegetation was not fully cleared so this is not conclusive.

Figure 9a: Centrally located exterior square roof-light

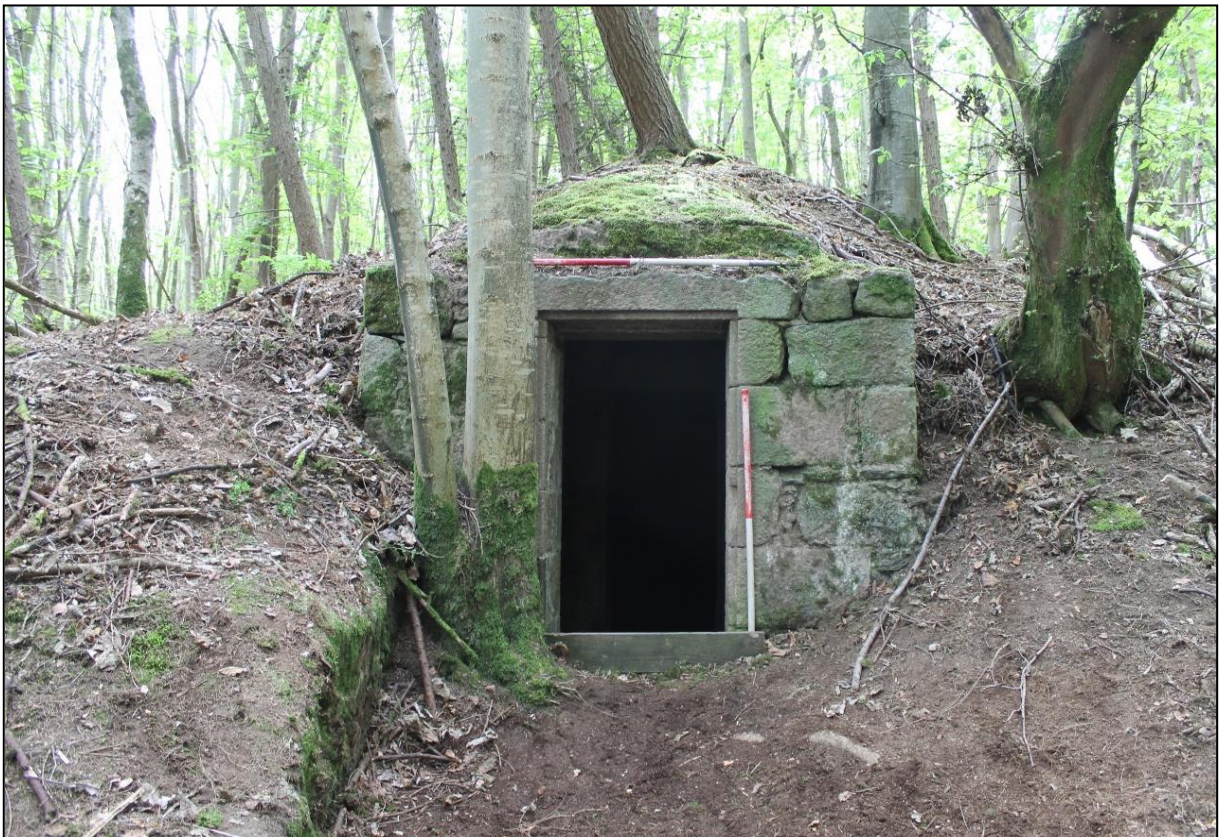
45. The main entrance to the ice house is on the northeast side of the building (Figure 6 & 9b) and is formed by roughly worked granite blocks with areas where smaller stones have been used to infill. The visible dimension of the northeast elevation have a maximum width of 2.25m and a height of 1.70m. The rectangular entrance/doorway has dimensions of 1.5m by 760mm in width and a depth of 617mm (Figure 6 & 9b). There is the presence of what would appear to be an original door hinge located on the upper east side of the entrance/doorway. This most likely was to hold an iron grille or gate.

Figure 9b: Main northeast facing entrance

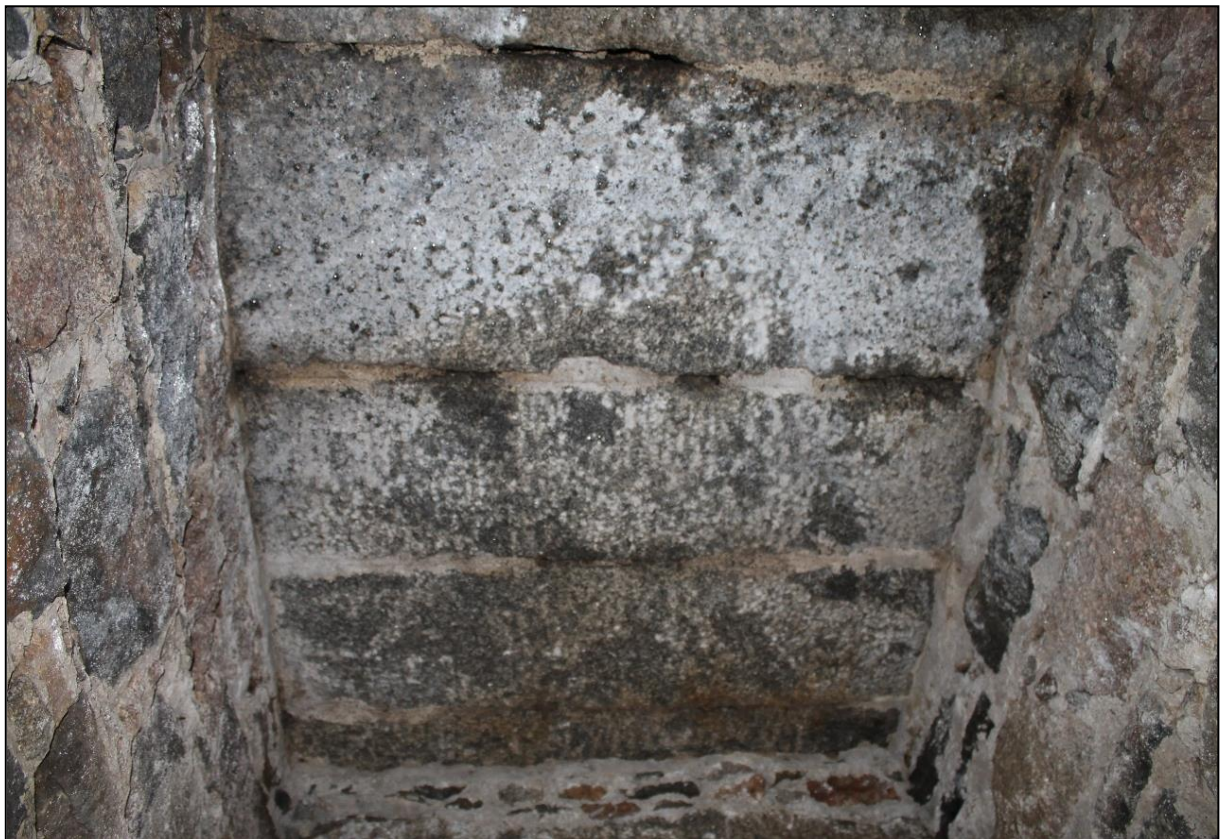
46. The entrance passageway leads from the exterior of the ice house to the main chamber with dimensions of 2.18m in length by 1.20m in width and 2.25m in high (Figure 13). Both side walls (Figures 10a) are coursed and constructed of roughly worked granite with the ceiling formed by six rectangular and roughly worked granite blocks (Figure 10b).

Figure 10b: Granite block entrance passageway ceiling

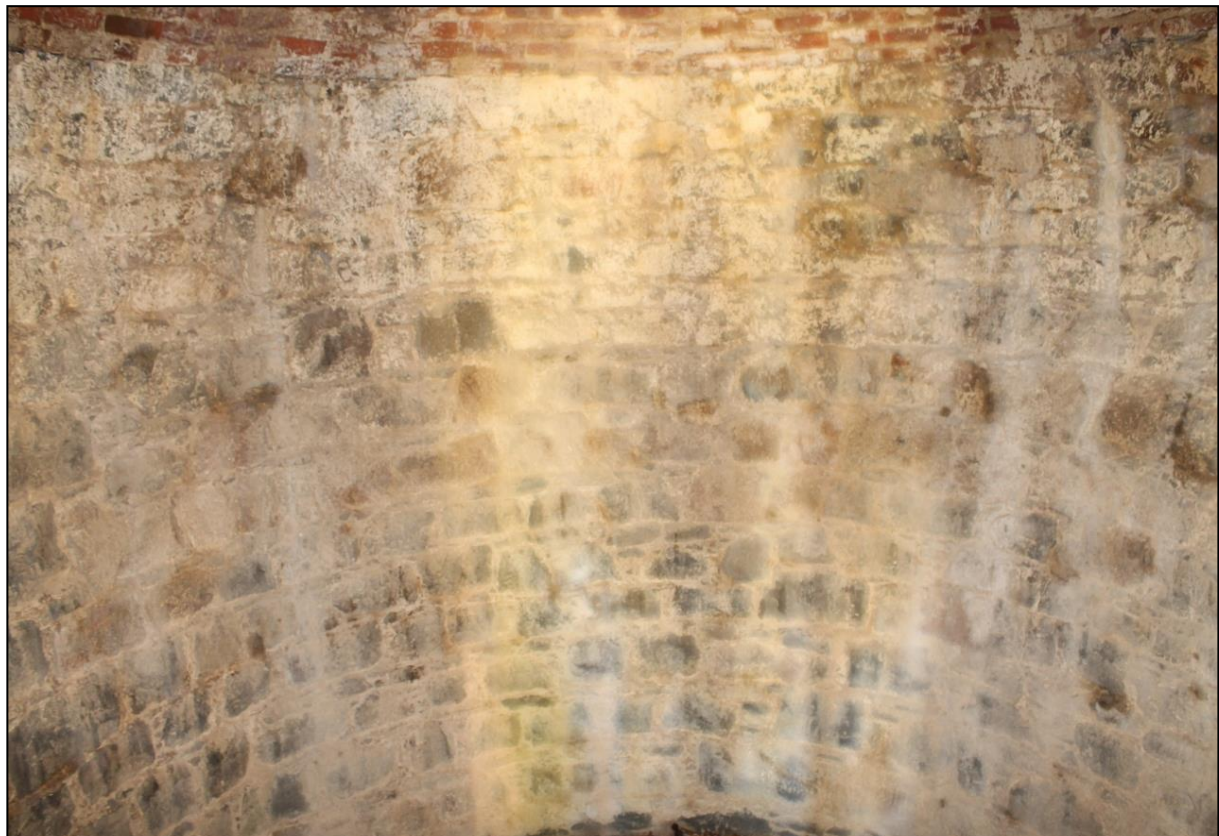
Figure 11b: Southwest (back) wall of the ice house main chamber

48. The main chamber is circular with a diameter of 4.38m and a height of 4.20m (Figures 11b, 12a & 13). The overall height may be more than that measured as there has been a build-up of rubbish and detritus on the floor of the chamber (Figure 12a) which may be relatively deep and which may also hide other features that could not be recorded. There is a drop of 1.50m from the doorway leading into the main chamber from the entrance passageway down to the current floor level.

49. The lower two thirds of the main chamber is constructed from worked and coursed granite (Figure 11b) with the upper one third of the main chamber comprising a red brick dome. The centrally located square roof-light is visible here, formed of worked rectangular granite blocks (Figure 12b).

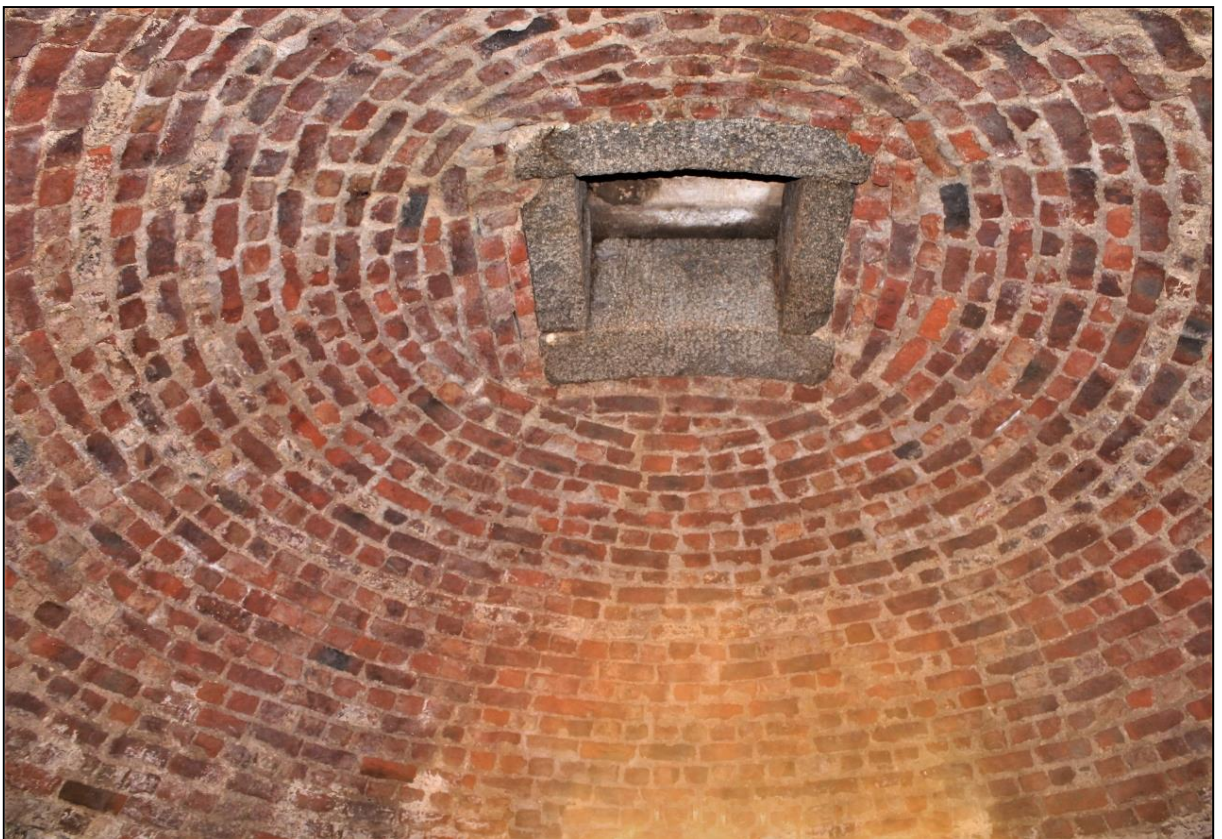
Figure 12b: Red brick dome roof with central square roof-light

50. Although there are a number of trees that are rooted into the exterior earth dome of the ice house, there are no visible signs of any cracking caused by the action of tree roots within the brick dome roof. There are also no visible signs of water having penetrated through any of the mortar between the bricks or the course of the granite blocks.

62. The building survey demonstrated that although a number of trees have taken root over the domed roof of the ice house, there has been no intrusion of roots into the internal brick dome roof/ceiling. No cracks were visible across the internal dome roof/ceiling and the bricks all appeared on visual inspection to be in very good condition.

64. Although on visual inspection the structure appears in very good condition it is strongly recommended that -should the restoration project proceed on the ice house- the advice of a suitably qualified and registered structural engineer should be sought to comment on the structural integrity of the ice-house.

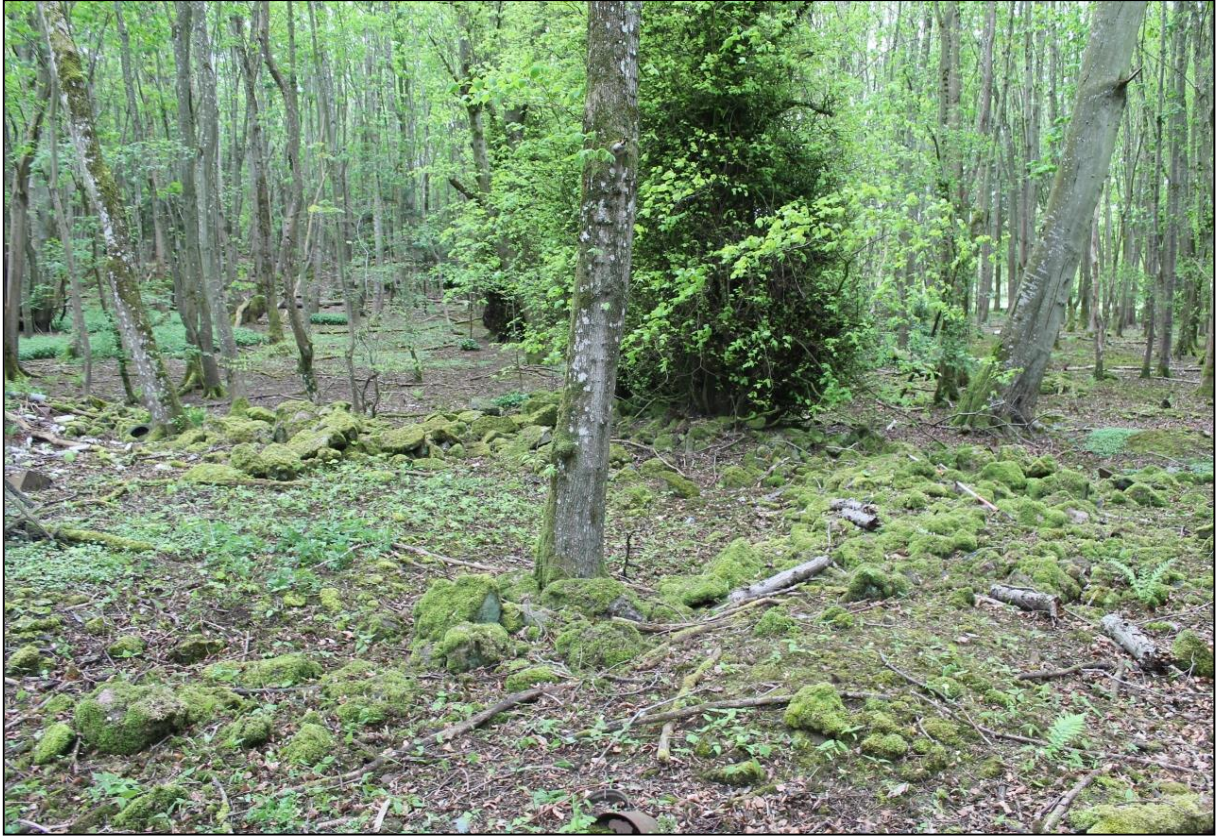
Figure 14a: Southeast end of the possible nursery located to the SW of the ice house

51. Located approximately 45m to the southwest of the ice house is a possible structural feature (Figures 14a & 14b). The area has been used as a small rubbish dump but there are signs of what appears to be a tumbled wall. The area is flat with a substantial amount of what appear to be roughly worked granite blocks.

52. There is a distinct area where the fallen stone suggests the outline of a wall (Figure 13a) measuring 5.5m north-south by 6m east-west. Where the two potential walls meet there would appear to be a return and forming a corner (Figure 14a). Due to vegetation cover across the area and the accumulation of rubbish it is difficult to get a proper understanding of the site as a whole. However, the way in which the stone is concentrated and the way it has tumbled would suggest the location of a wall. The area measures approximately 35-40m by 15m, although these are rough approximations.

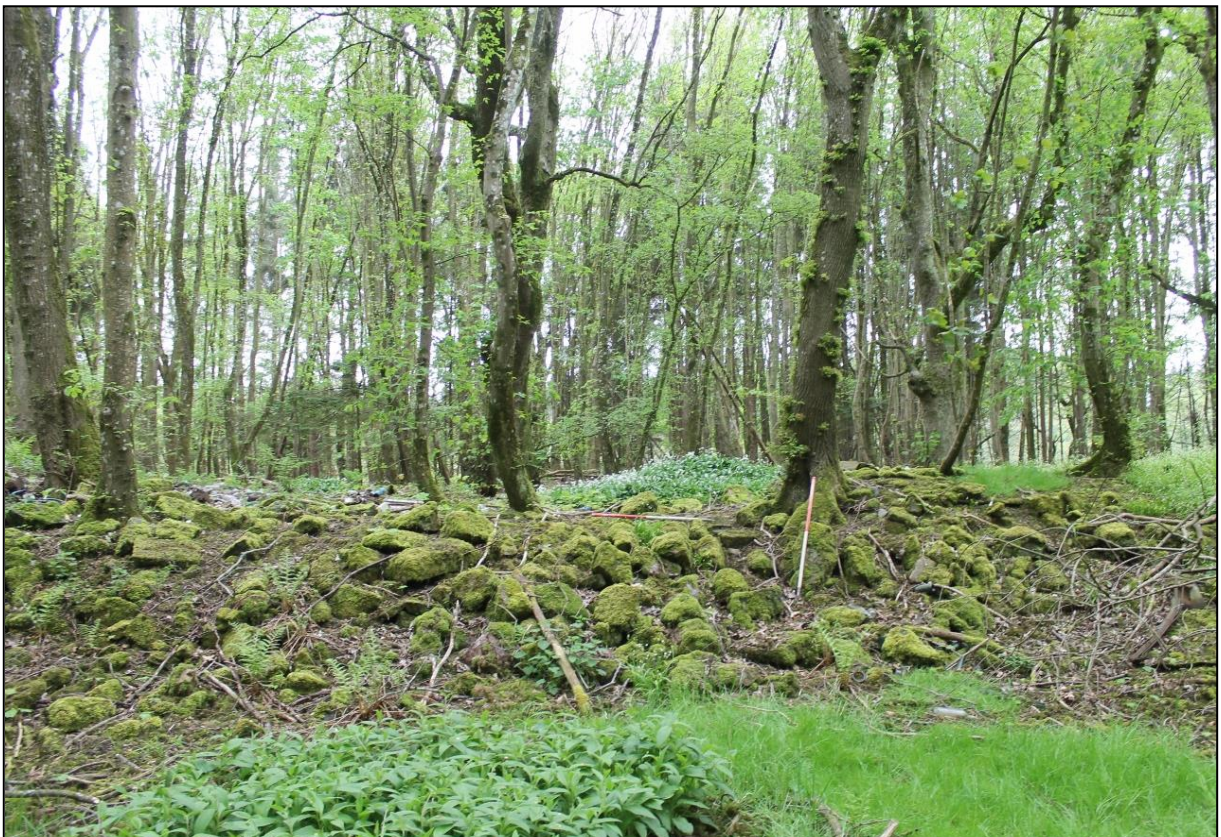
Figure 14b: East facing wall of the possible nursery located to the SW of the ice house

53. There is also an area along the east side of the site suggestive of a small section of wall approximately 6m in length (Figure 14b). There are also a number of ornate architectural stones within the surrounding area (Figures 15a & 15b). It is possible that the pieces of ornate stonework were coping stones along the top of a wall or derived from an entrance to the possible structural feature.
