**Goldenhill Park, Clydebank:
Archaeological Monitoring of
Access Improvement**

Data Structure Report

issued 2nd June 2017

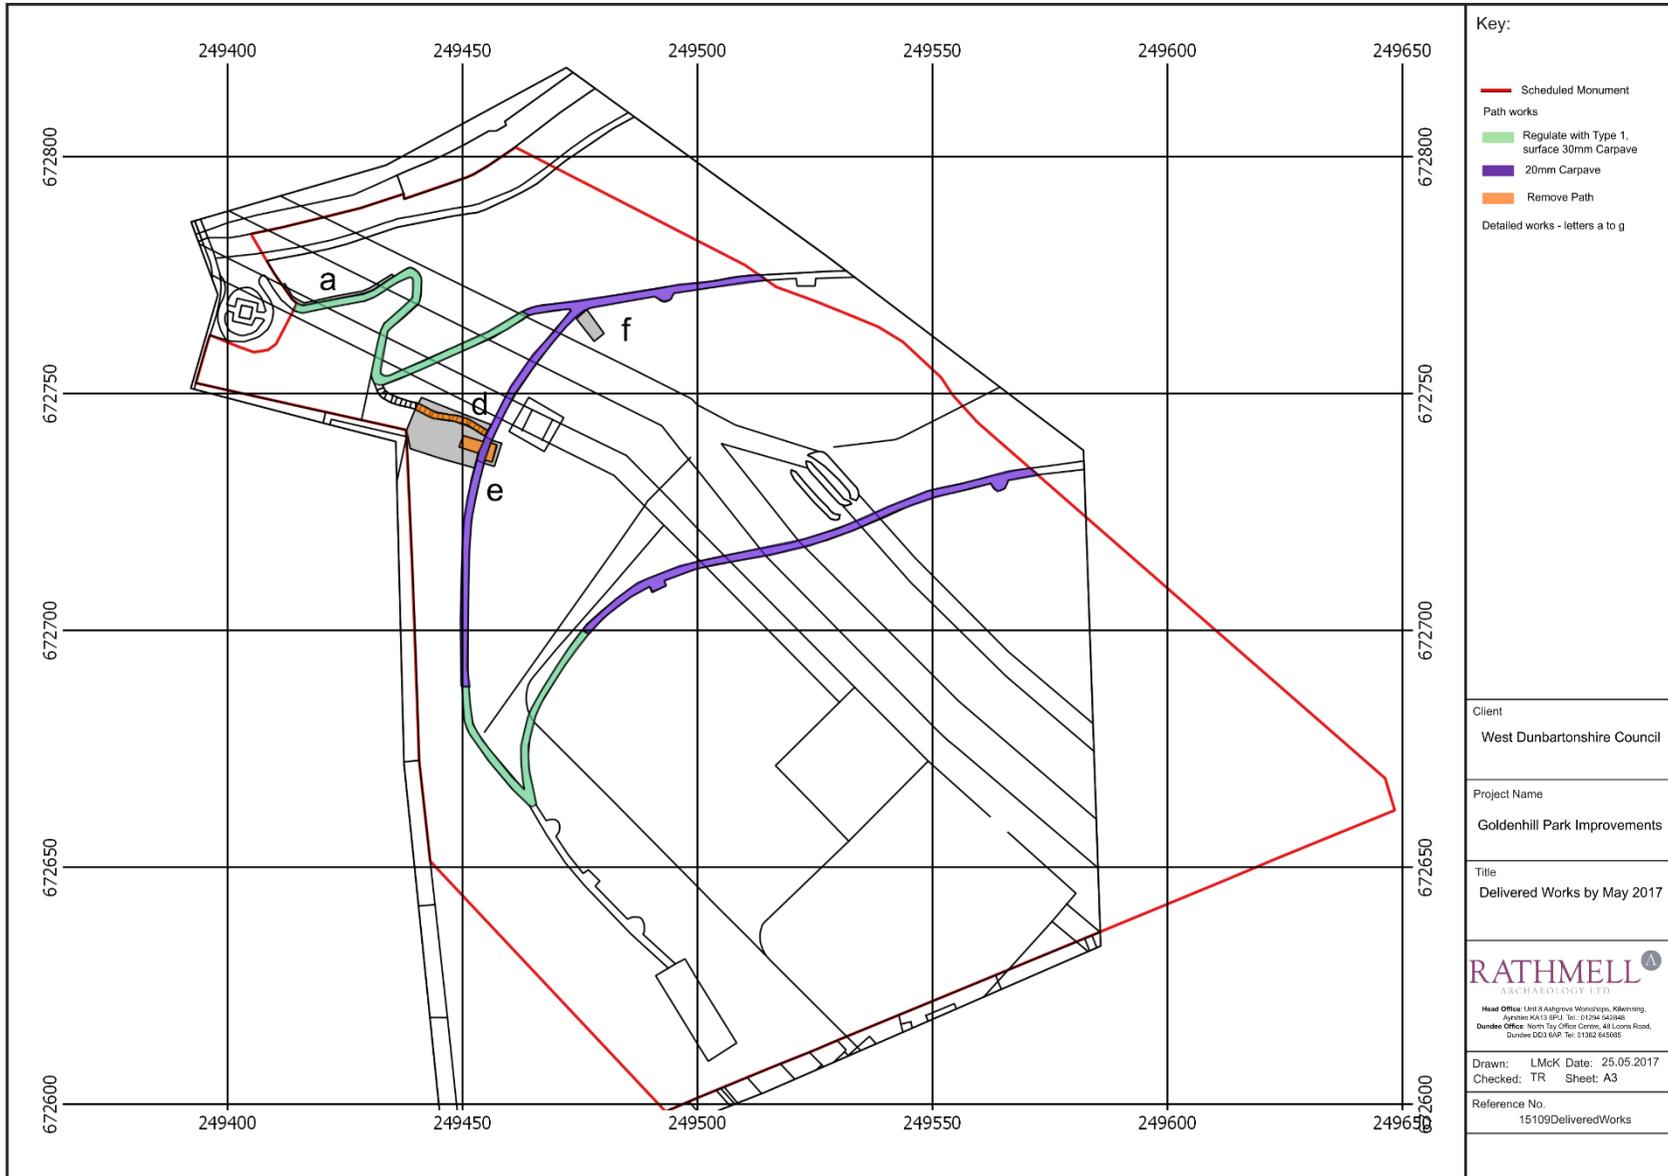
Figure 1: Site plan of delivered works

- ❖ Signage installation
 - ❖ Drainage repairs
 - ❖ Hedge removal
9. These works are being delivered in a staged programme by West Dunbartonshire Council and only those works depicted on Figure 1 were delivered in this phase. These were:

- ❖ Path surface renewal – not a monitorable activity
 - ❖ Steps and slide removal (d)
 - ❖ Regrading of former bench area (e)
 - ❖ Drainage repairs (f)
10. The area containing the former steps and slide (d) measured approximately 7m wide along the edge of the path by 18m stretching downslope away from the path. The steps were largely turf-covered, with timber risers still visible in places (Figure 2).

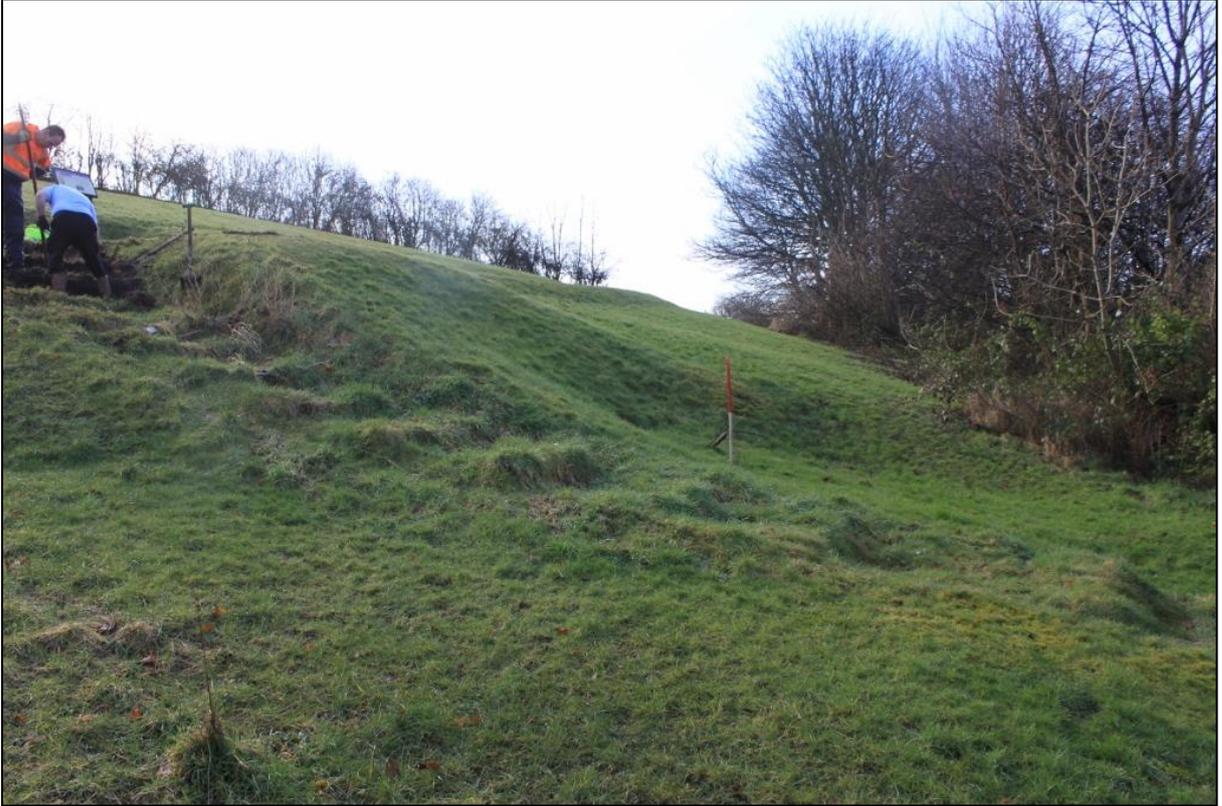
15. The topsoil, present in all areas exposed during the works, was a mid orangish-brown slightly sandy silt with occasional 19th/20th century ceramic fragments and small angular stone inclusions. This was excavated to a maximum depth of 500mm over the crest of the former slide base. No underlying deposits were exposed. As a result this deposit was interpreted as redeposited topsoil laid down during the construction works for the former slide.
16. Groundbreaking work on the steps was limited to the removal of their timber risers and stobs. The remaining flat depressions of the steps were filled in and smoothed over with topsoil removed from the slide area.

Figure 2: Slides and steps (Area D) prior to landscaping.

22. The material exposed in this area was characteristic of made ground deposits, probably relating to the construction of the earthen pad upon which the slide would have been mounted. The small angular stones, specific to the topsoil in this area, appeared to be of the same composition as the remaining gravel of the old path surface. These are therefore likely to be path material that has washed downslope over time.

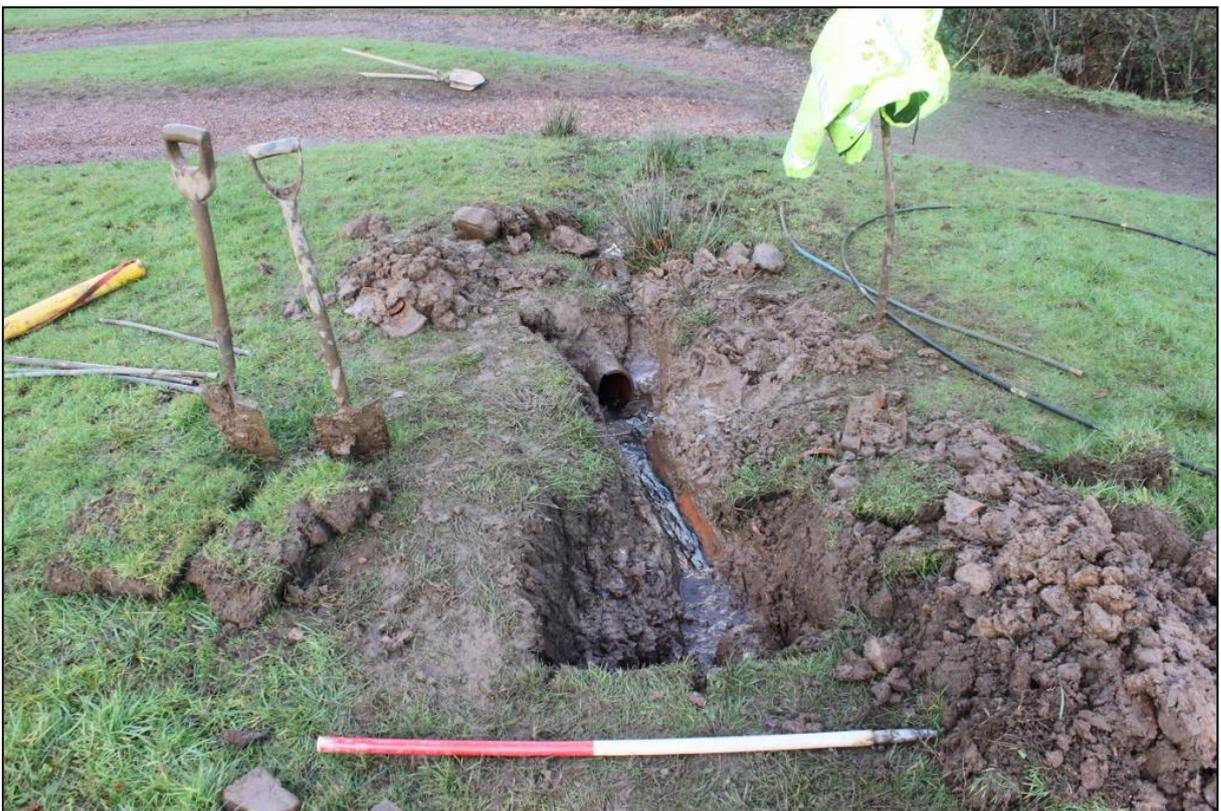
12. A leaking ceramic pipe drain (f), previously identified as a spring (McKinstry and Rees 2017), was discharging water approximately 3m upslope of the current path. This drain ran broadly parallel to the Antonine Wall and was positioned in the approximate location of the upcast part of the Wall. The length of drain which was excavated for repairs measured 0.6m wide by 2.5m long (Figure 3).

19. The drain was located at a depth of 250mm at the upslope end and 200mm at the downslope end. When fully exposed, the drain was revealed to be of a segmented oval design measuring 180mm in height and 140mm in diameter. One of the exposed segments had collapsed and silted up, causing the leaking 'spring' effect of the drain. The size of the drain, along with its depth as noted in the archaeological investigation phase, suggest that it does not relate to any former agricultural activity on the site, but rather drainage put in place during the earlier landscaping phase of the park.

Figure 3: Damaged length of drain exposed during initial repair work (Area F).

18. The initial phase of drainage repair was carried out on 6th March 2017. The ceramic drain discovered during the test pitting works (McKinstry and Rees 2017) was exposed to the immediate W of Test Pit 1 from that period of work.

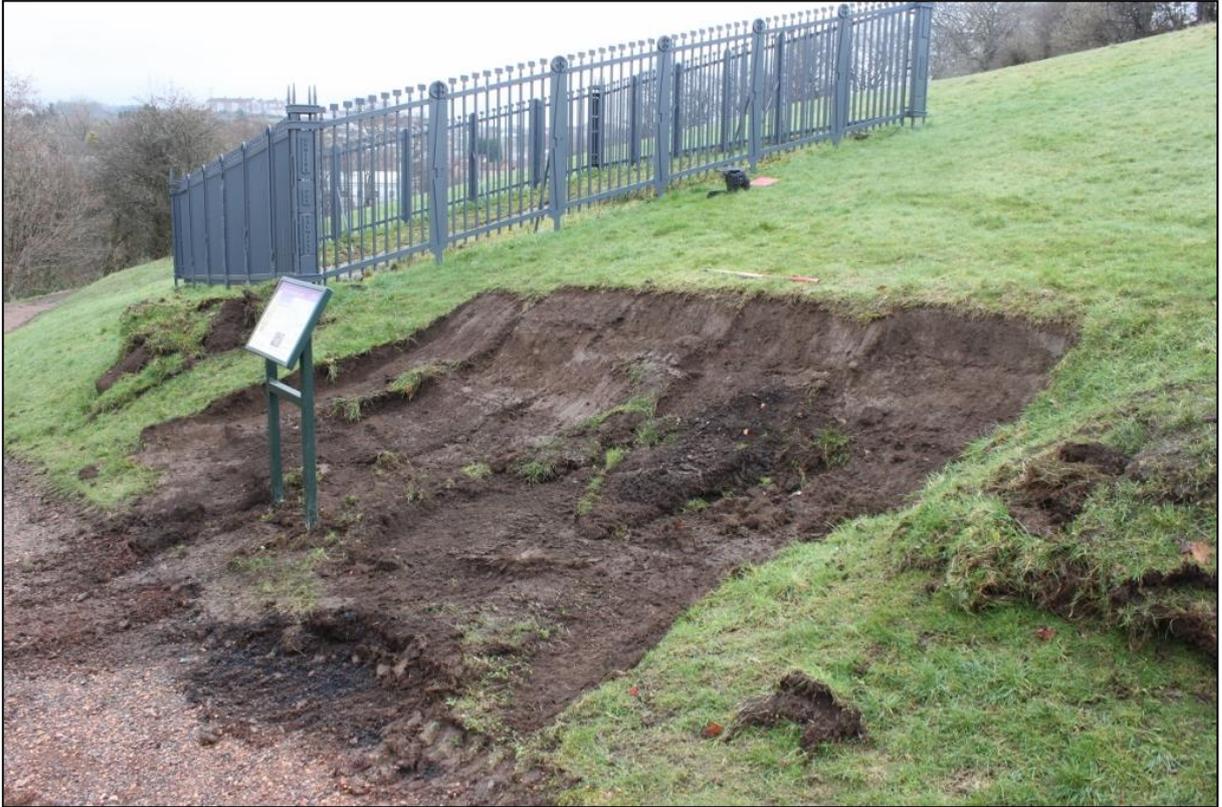
11. The bench area (e) appeared as a small hollow approximately 3m W of the exposed section of Wall base within the park. This feature measured 4m along the path edge and 3m wide. This area was stripped of turf and regraded with topsoil removed from the steps and slide area.

17. In the bench area, the topsoil was excavated to maximum depth of 100mm, being of the same composition as that in the steps and slide area on the opposite side of the path, but with considerably fewer small angular stones. As well as infrequent fragments of modern ceramic material, occasional fragments of modern glass and plastic were present.

Figure 4: Former bench (Area E) stripped of turves and necessary topsoil.

23. The topsoil here was of the same composition as that in the steps and slide area on the opposite side of the path, but with considerably fewer small angular stones. As well as infrequent fragments of modern ceramic material, occasional fragments of modern glass and plastic were present. These likely represent 20th century deposits relating to recreational use of the park.

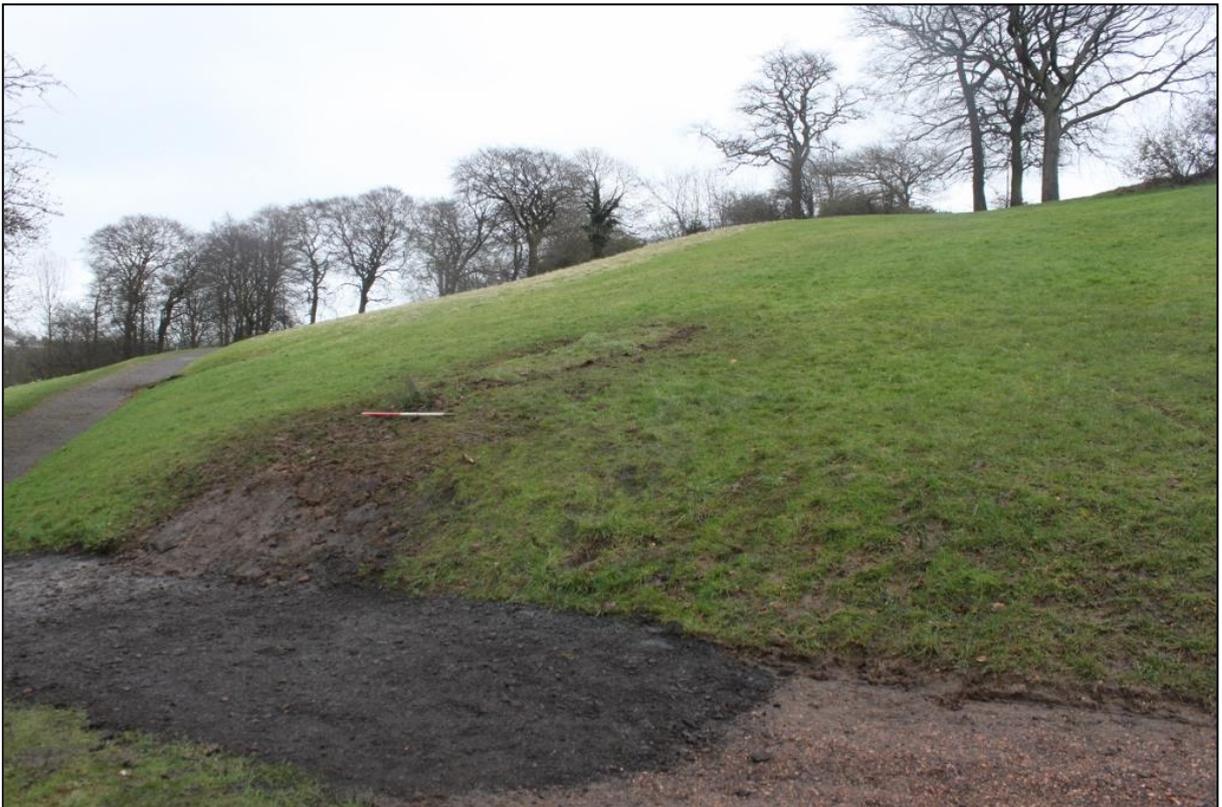
20. Further monitoring of drainage repairs in the same location was carried out on 15th March 2017 after it became apparent that the initial repair had not resolved the leak. A trench measuring approximately 1m long by 0.75m wide was opened immediately adjacent to the path on its SE side, where leaking water was flowing across the gravel surface. This revealed the same ceramic drain found during the repair previously carried out, located at a depth of 150mm.

Figure 5: Damaged length of drain (Area F) after both phases of repair, and reinstatement.
