St. Bride's Chapel, Lamlash - Consolidation: Archaeological Mitigation

Data Structure Report

by Louise Turner

on behalf of North Ayrshire Council

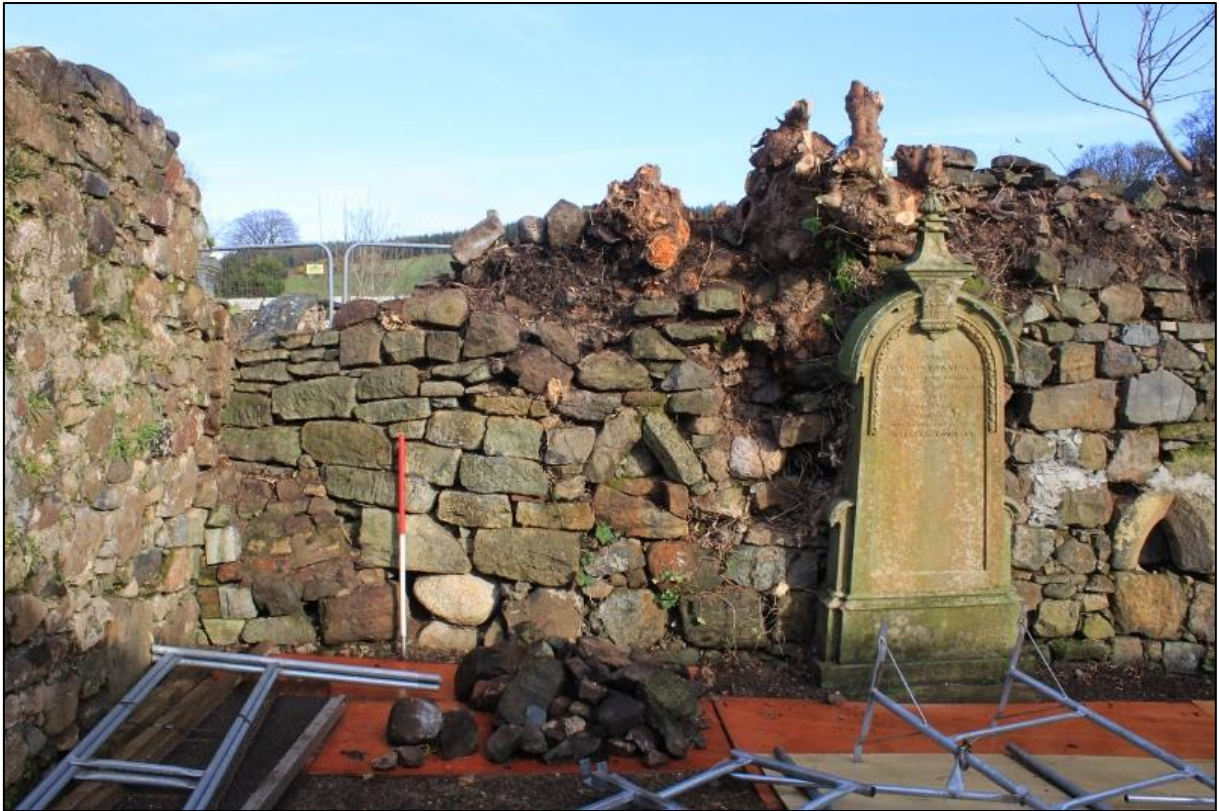
Figure 2a: North-west corner (internal elevation) prior to works commencing, with squared rubble repair pushed out of alignment and root masses clearly visible at wallhead

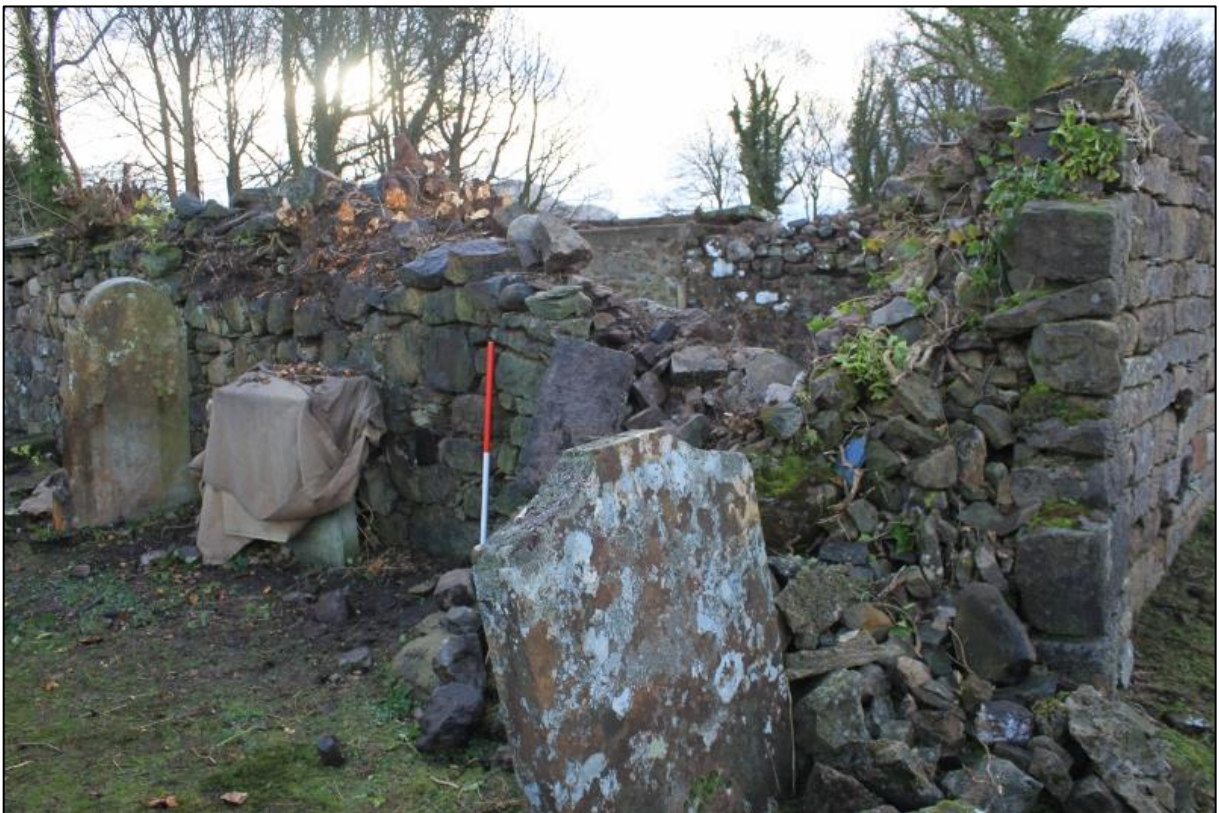
Figure 2b: North-west corner (external elevation) prior to works commencing, with tumbled masonry *in situ*

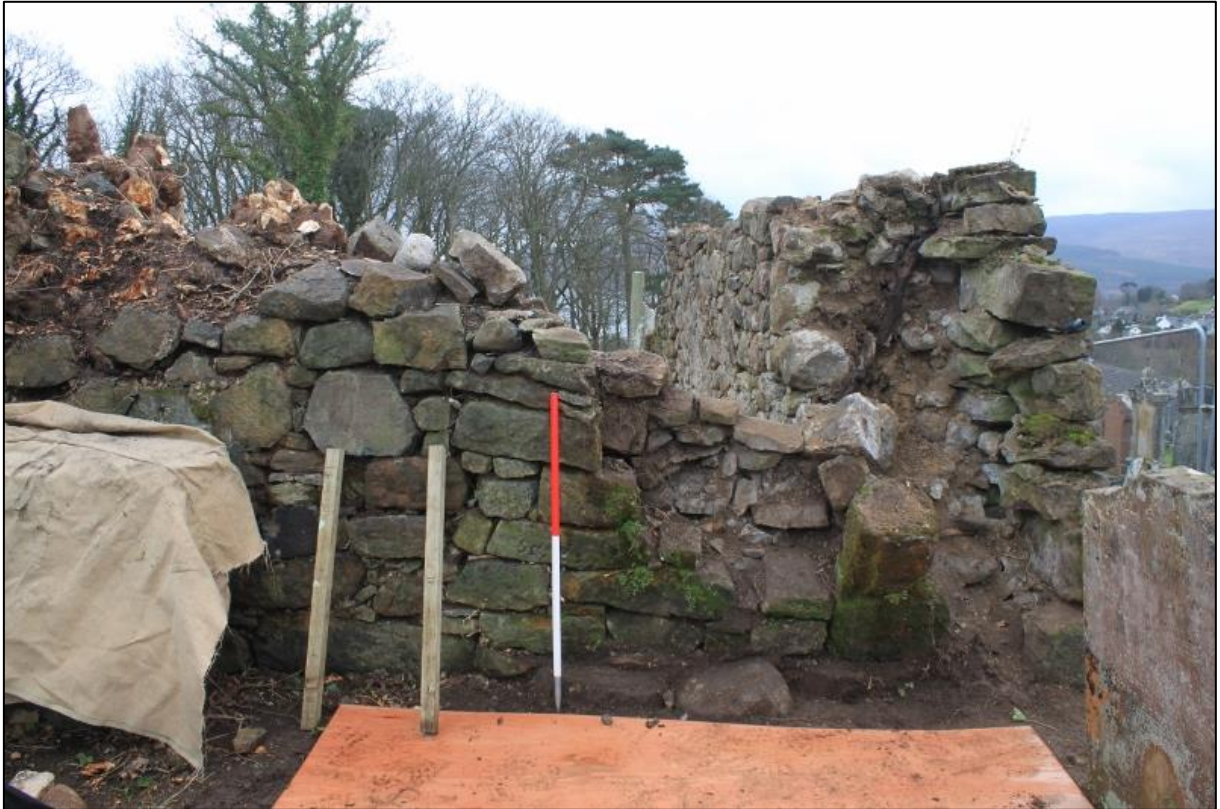
Figure 3a: North-west corner (external elevation): rubble cleared, threshold stone (broken) revealed in basal course with *in situ* rybat to west (two displaced rybats above)

52. We know that the earliest mention of the chapel dates to the mid-14th century, and so there is a potential for Fabric 1, in particular the basal course, threshold stone and rybat at the west end of the north elevation, to date back to this early phase of use. However, we are also informed by historical records that the church was damaged after 1406 by the English. We do not know the extent of this damage, nor do we know when the rebuilding work took place. It is unlikely that Fabric 2 represents this rebuilding work, as it is associated with features more in keeping with a post-medieval structure. So it may be the case instead that Fabric 1 represents the remnants of 15th century rebuilding work, with the site's earliest phase of use represented only by the fragmentary cross-slab and the two disc-headed stones (now missing) once recorded as being present on the site.

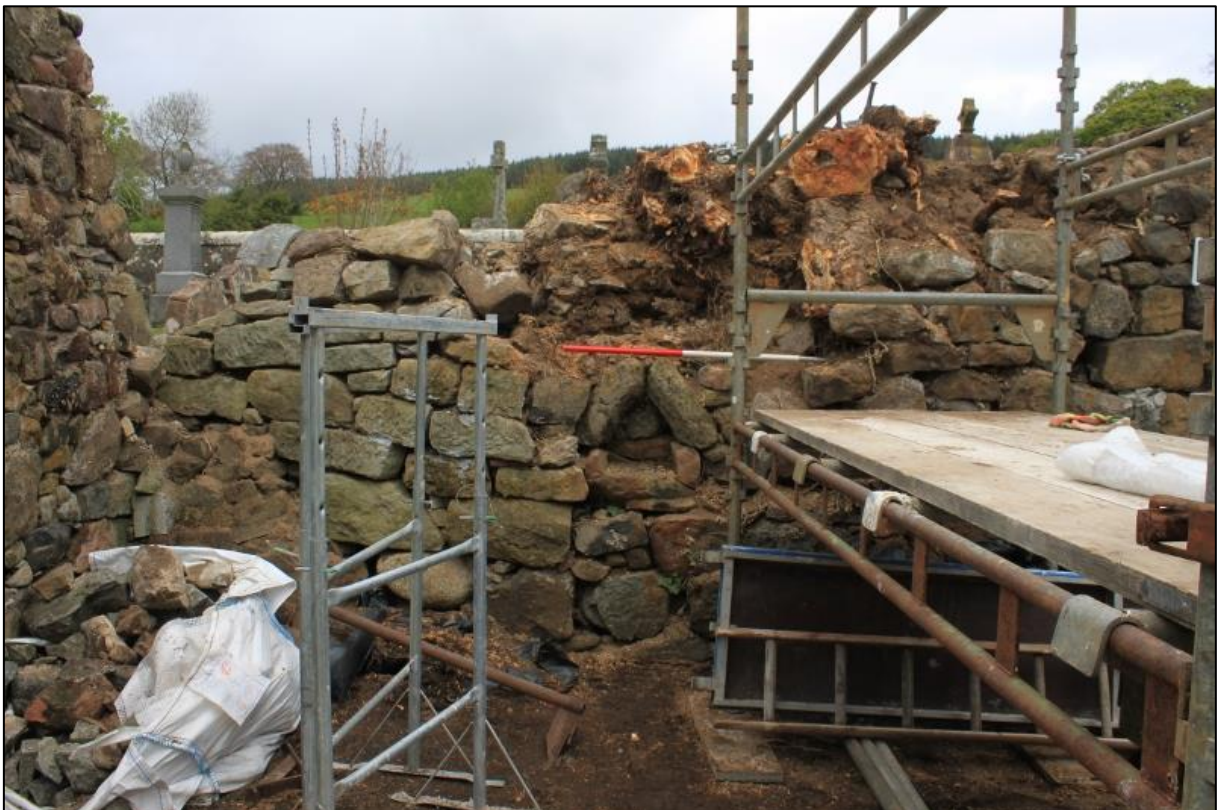
16. The dismantling of the inner wall face did not allow further insight into the construction of the medieval chapel. The wall core had been compromised through tree growth to such an extent that the root mass had expanded throughout the upper portion, with the small stone blocks of the rubble core incorporated into the root mass and the surrounding areas infilled with a matrix of mixed soil and degraded lime mortar or left as a void.

Figure 3b: North-west corner (internal elevation): works in progress, upper courses removed to reveal substantial portion of root mass

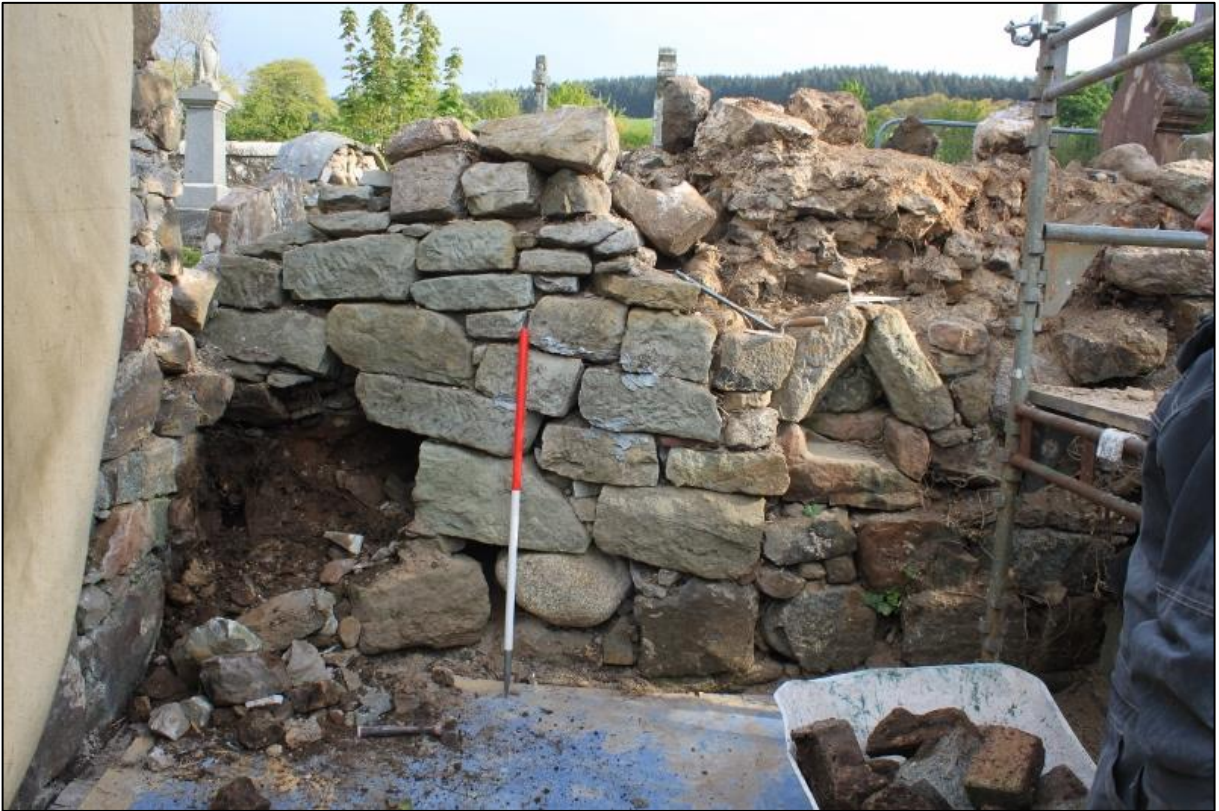
17. The dismantling of the coursed rubble wall at the west end was preceded by the removal of the buttress at its base. Composed of bricks and occasional marble blocks (re-used portions of memorial slabs) set within a mass of concrete 0.7m x 0.4m in extent, this feature had functioned partly as additional support to the walling but also as a means of infilling a large void of similar dimensions which sat in the north-west corner of the elevation at ground floor level (Figure 4a). Some thick roots survived *in situ*, indicating that there had once been a sizeable tree in this location, the growth of which may have played a significant contribution in the distortion of the inner wall face where it abutted the west elevation. The removal of the wall face revealed modern clear bottle glass deep within the wall core, supporting the earlier theory (Turner 2016) that this portion of the wall had been rebuilt in recent times.

Figure 4a: North-west corner (internal elevation): brick & cement buttress removed to reveal void to rear (former site of tree)

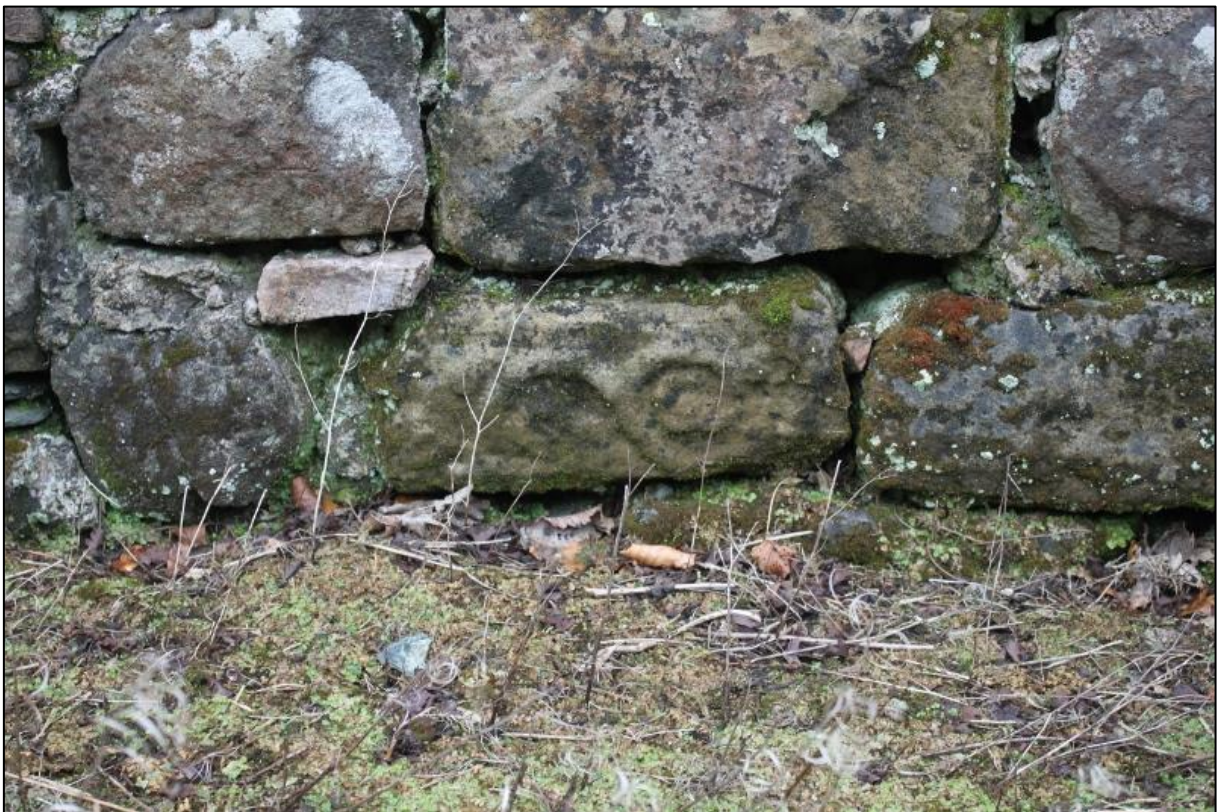
Figure 4b: Interior, South Elevation: Re-used carved stone (?fragmentary cross-slab) within Fabric 6 blocked doorway

21. The earliest evidence of ecclesiastical use upon the site comes from a fragment of carved stone, potentially derived from a free-standing cross which would, presumably, once have stood nearby (Figure 4b). This no longer has any coherent role in the structure: rather, it has been incorporated into a doorway which has been blocked at a much later date. Two further early carved stones – now missing – were recorded from the site: Cowley describes them as disc-headed stones, similar to an example from Cumbrae (Cowley 2011, 11)

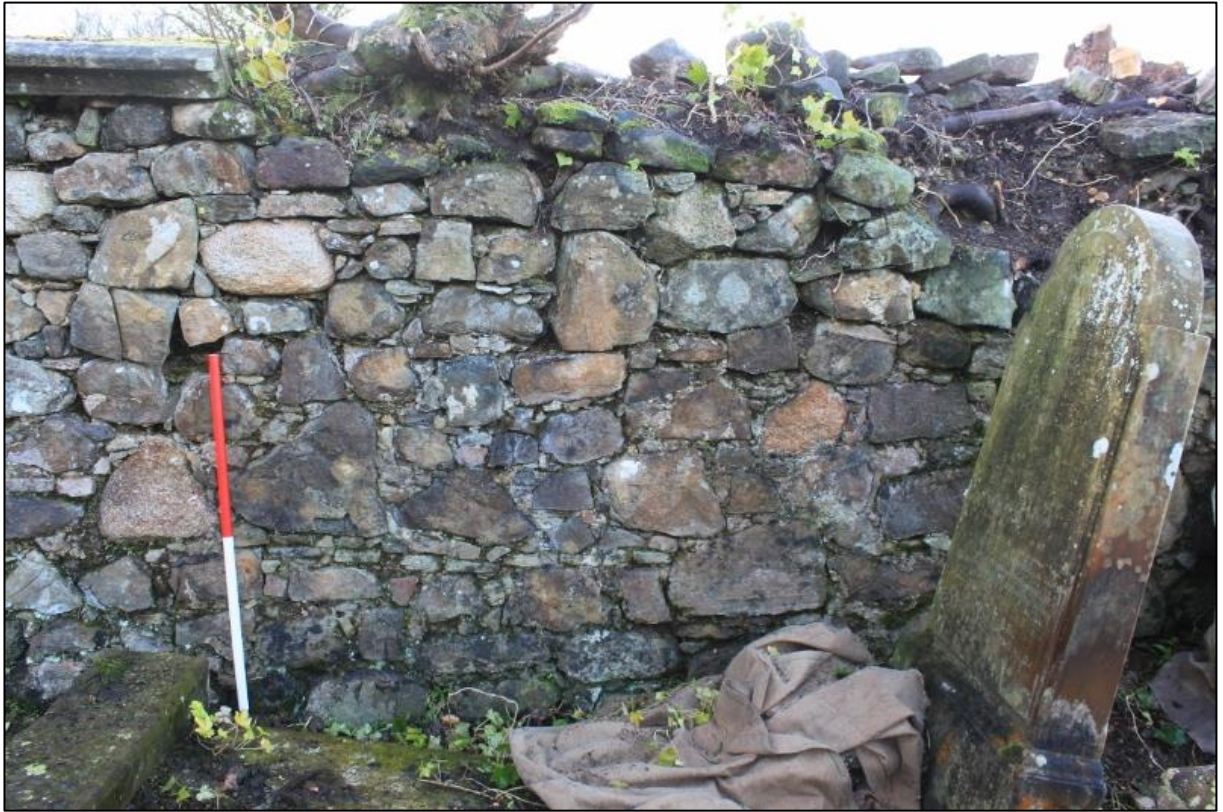
Figure 5a: North Elevation (external elevation, approx. 5-6m east of west end): Fabric 1 in lowermost six courses, showing thin line of snecking stones overlying irregular, unworked blocks

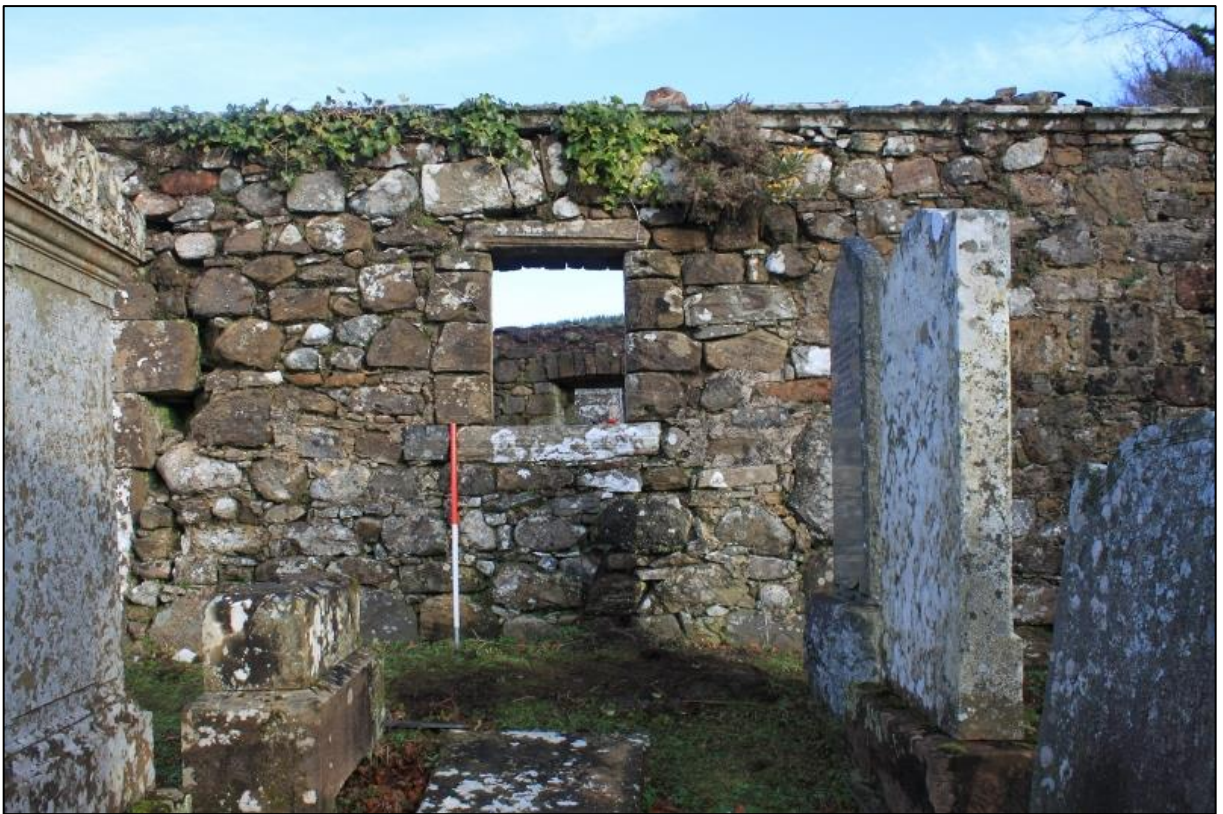
Figure 5b: South Elevation: Fabric 1 in lowermost 3 courses, with Fabric 2 above (excluding wallhead)

26. This particular fabric was one of the most difficult variants to identify and also to comprehend. It was similar in many respects to Fabric 1, making use of unworked rubble blocks of a variety of types and with small stones used as snecking in order to create fairly regular courses. It differed in that the snecking stones formed less coherent lines, with courses disrupted on an infrequent basis through the use of clustered pinnings which often formed a tapered, triangular shape within the masonry (Figure 5b).

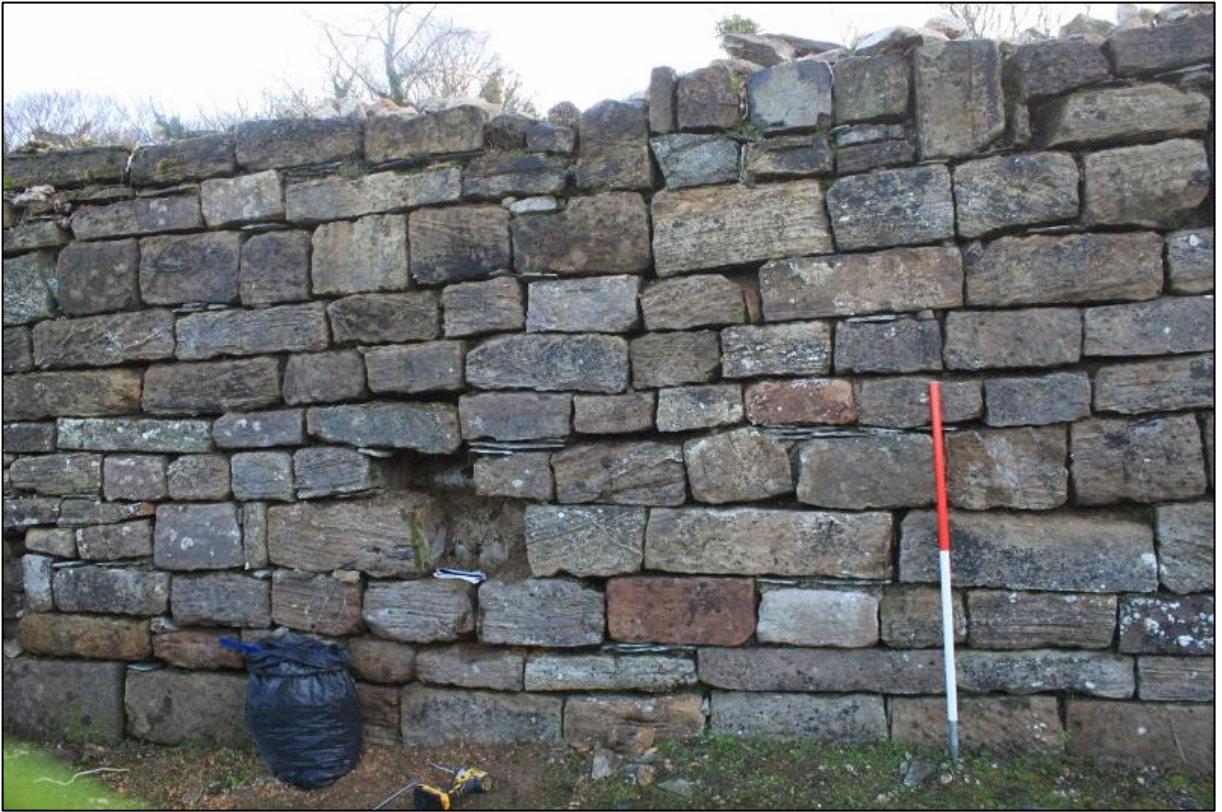
31. The outer face of the western elevation is entirely composed of Fabric 3 (Figure 6a), including the quoins which mark the wall return with both south and north elevations. The west end of the south elevation continues in this fabric (Figure 6b), with the doorway at this end incorporated within similar masonry and therefore likely to be contemporary. A carved skewputt still survives at the wallhead on the south side. Unfortunately, the northwest corner is too poorly preserved to allow any understanding of how Fabric 3 fitted into place alongside the earlier Fabric 1: however, the survival of an *in situ* threshold stone and adjacent Fabric 1 rybat to the west suggests that when the northwest corner was rebuilt at this time, elements of an earlier extant doorway were retained and incorporated. We have no way of knowing whether this doorway remained open and in use at this time.

Figure 6a: West Elevation: masonry in Fabric 3, with slate pinnings clearly visible

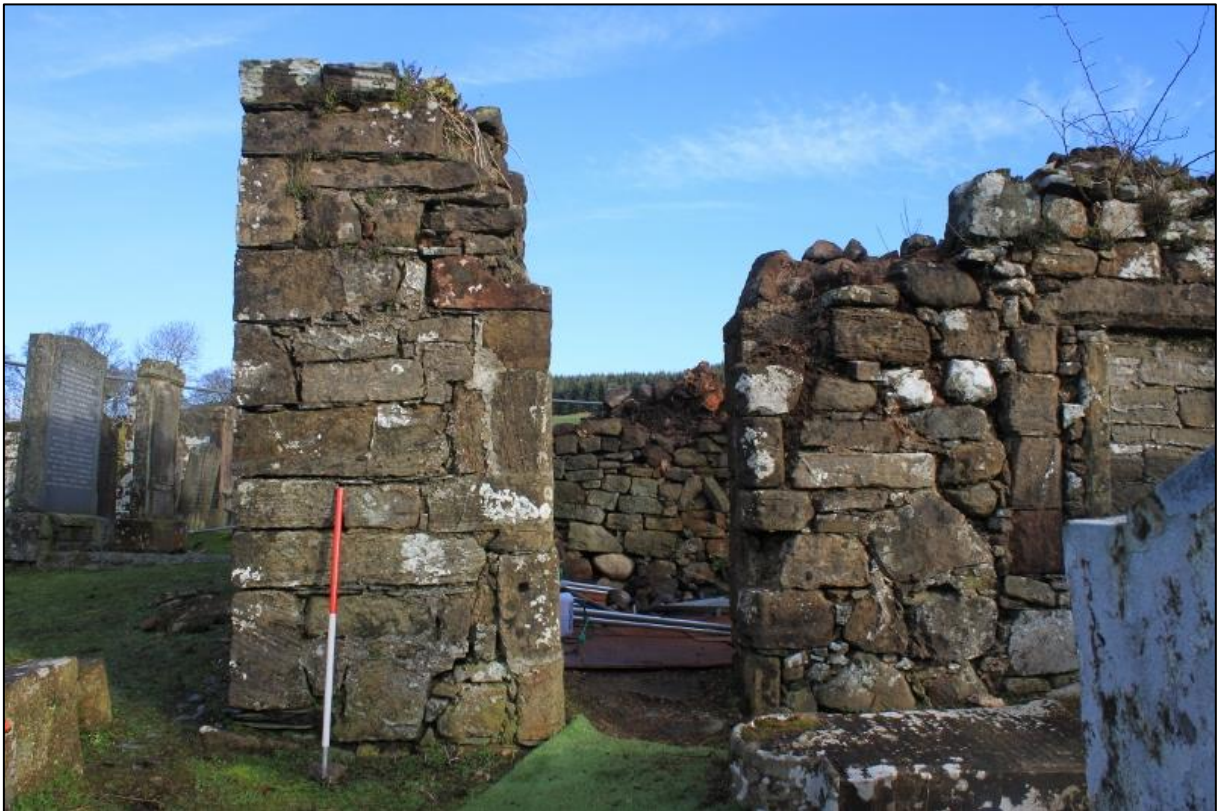
Figure 6b: South Elevation, W end: Fabric 3 in doorway

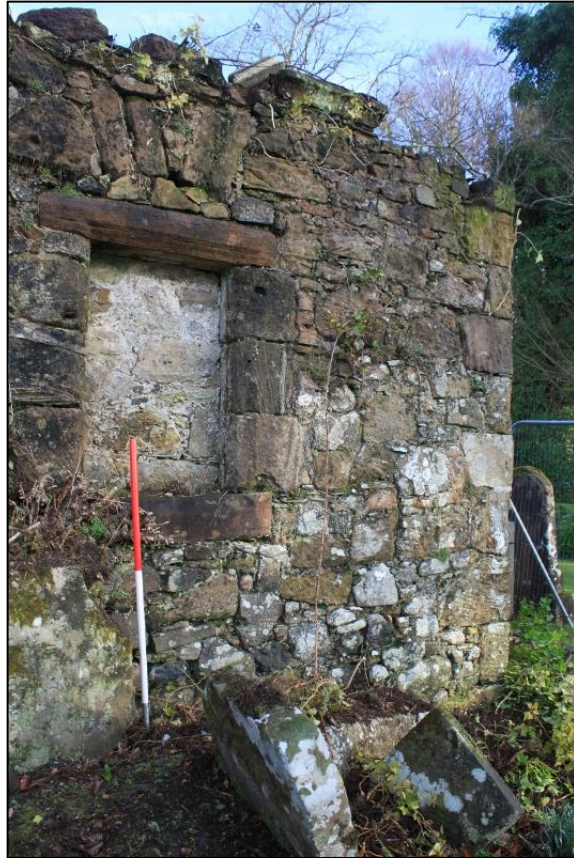
35. These clusters of pinning stones contrast markedly with the tapering clusters identified in associated with Fabric 2, and their localised presence in the external wall faces of the south and east elevations at the south-east and south-west corners might suggest a very limited episode of rebuilding work undertaken perhaps in response to some structural problem in this location (Figure 7a).

Figure 7a: Fabric 4, with re-used fabric (including quoins) combined with vertical pinning stones

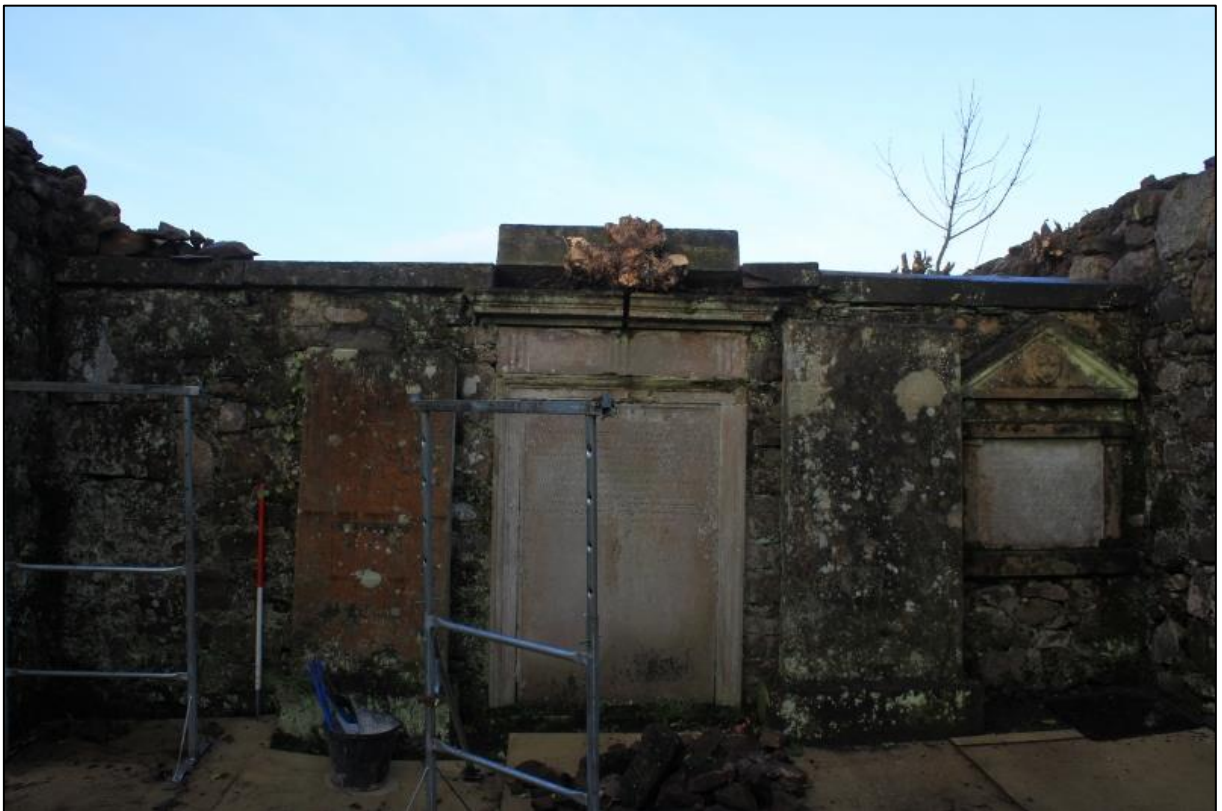
Figure 7b: Fabric 5, East Elevation of North-South Cross-Wall

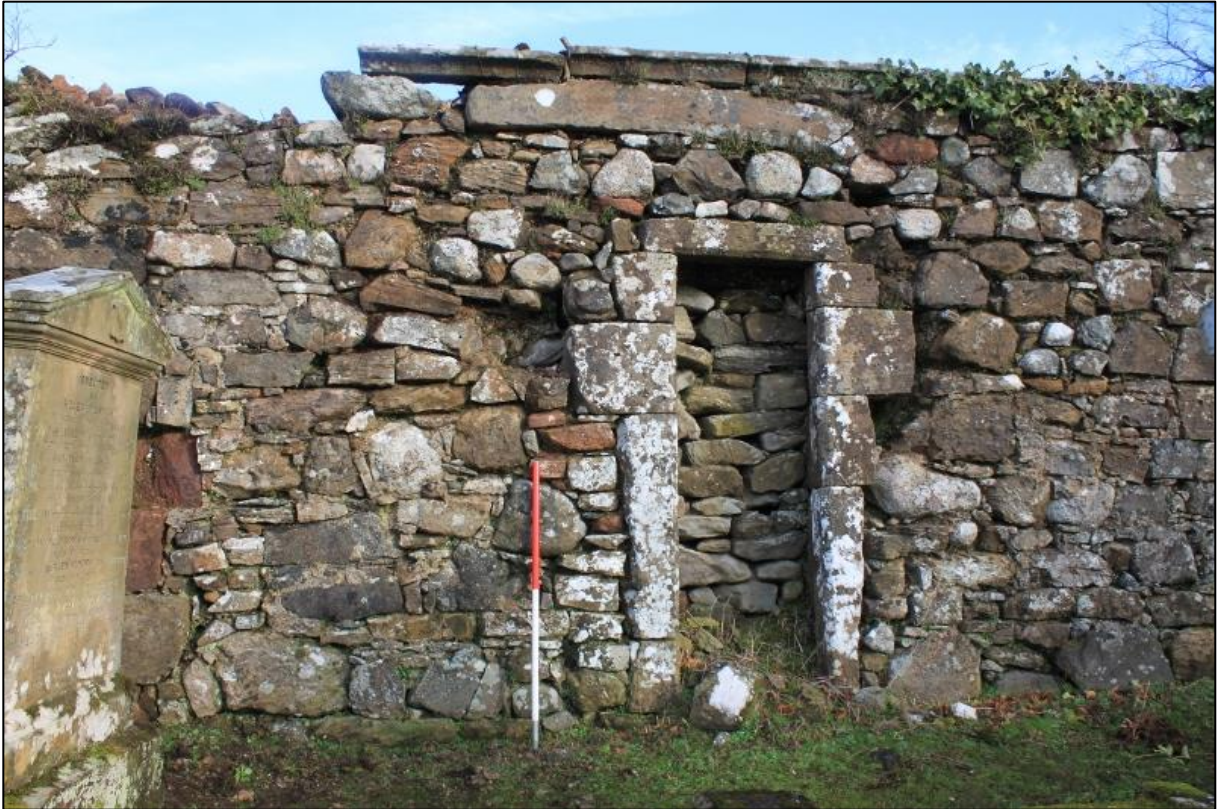
Figure 8a: Fabric 6, Blocked opening (?doorway) in South Elevation

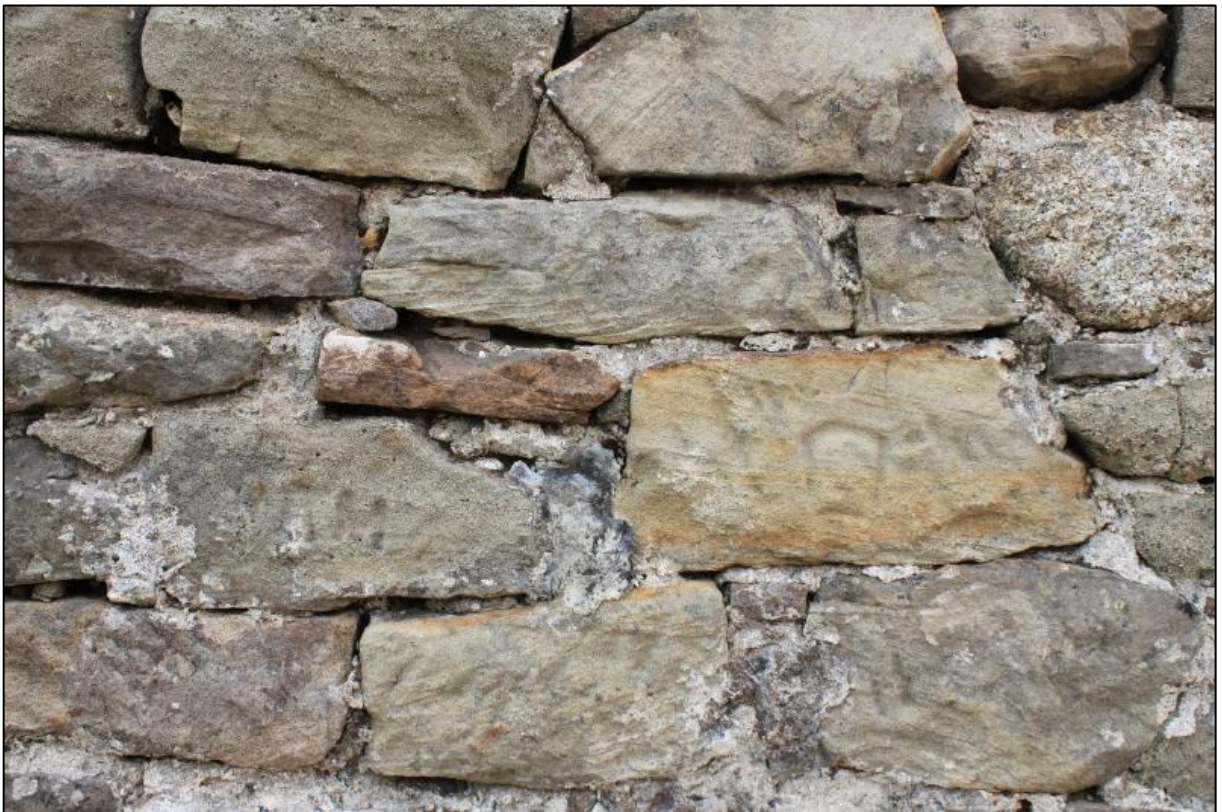
Figure 8b: Fabric 6, Carved stones incorporated into blocked doorway in South Elevation

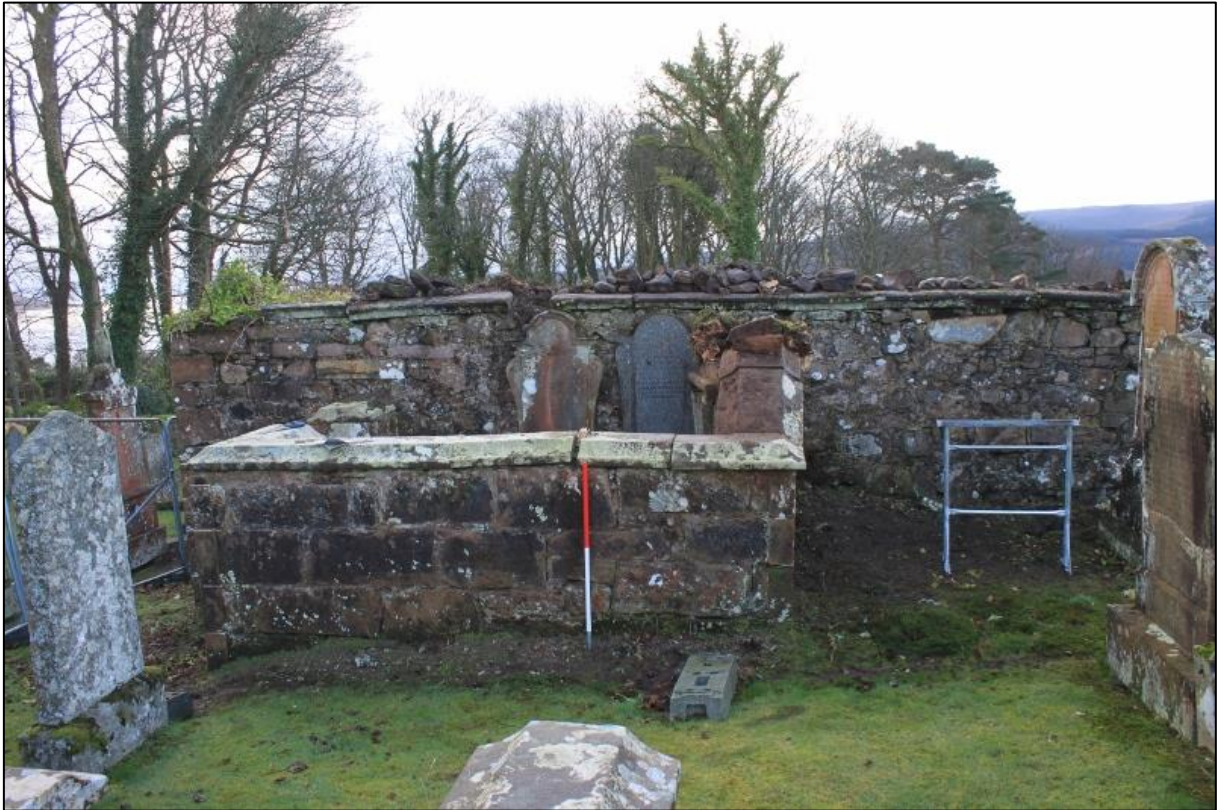
Figure 9a: Fabric 7, Low Enclosure With Stone Coping which Abuts North Elevation at East end

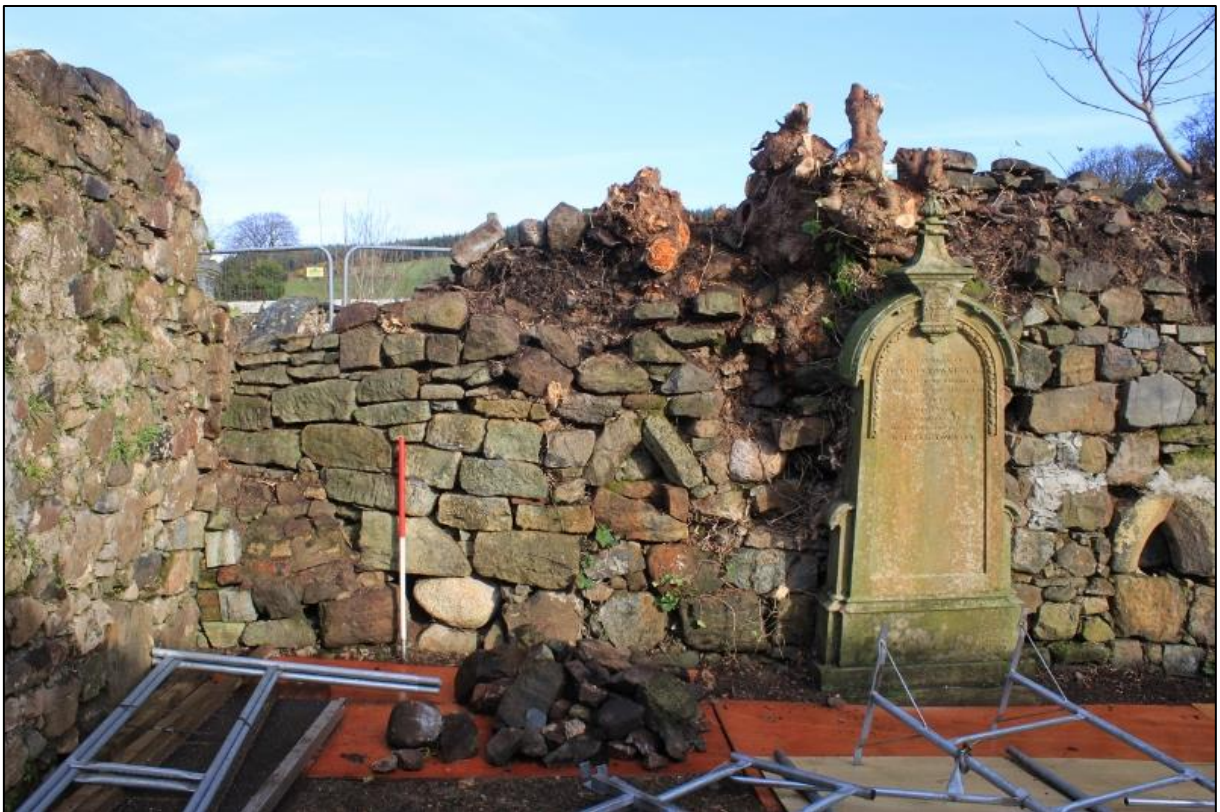
Figure 9b: Fabric 8, Brick/Concrete Buttress in North-West Corner (note also Portland cement to right of memorial stone.

64. The final phase of use is characterised by Fabric 8, which comprises the varied evidence for 20th century activities upon the site. This period included the construction of the brick gravediggers hut and the occasional use of Portland cement which in one instance has been inscribed with the date '1955,' as well as the addition of a crude concrete buttress, which incorporated bricks and broken pieces of memorial stones and was added to help shore up an area of the building in the northwest corner which was compromised as a result of tree growth.

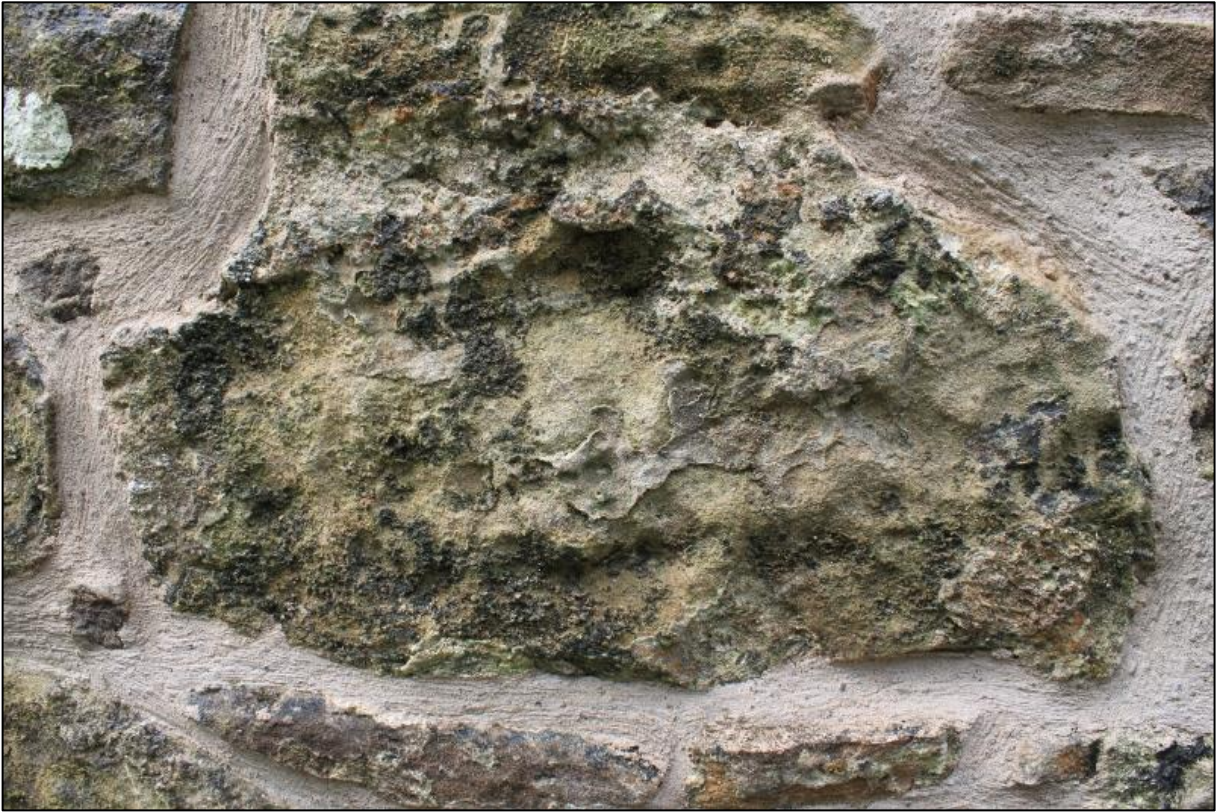
48. Traces of a grey external 'sneck' harling were evident at various locations around the external elevation of the church, and were particularly noticeable at the east elevation (Figure 10a). Once again, an early date could not be demonstrated, as the harling was found in association with Fabric 4, making it potentially modern (i.e. post-1770) in date. The same was true of the internal finishes, which were particularly noticeable over the west elevation, where traces of plaster, laid directly onto the masonry, were present. These earlier finishes were left undisturbed wherever possible during the works and can still be readily identified.

Figure 10a: East Elevation (External) – Relict Harling on Masonry (Joints Repointed during 2017 consolidation works)

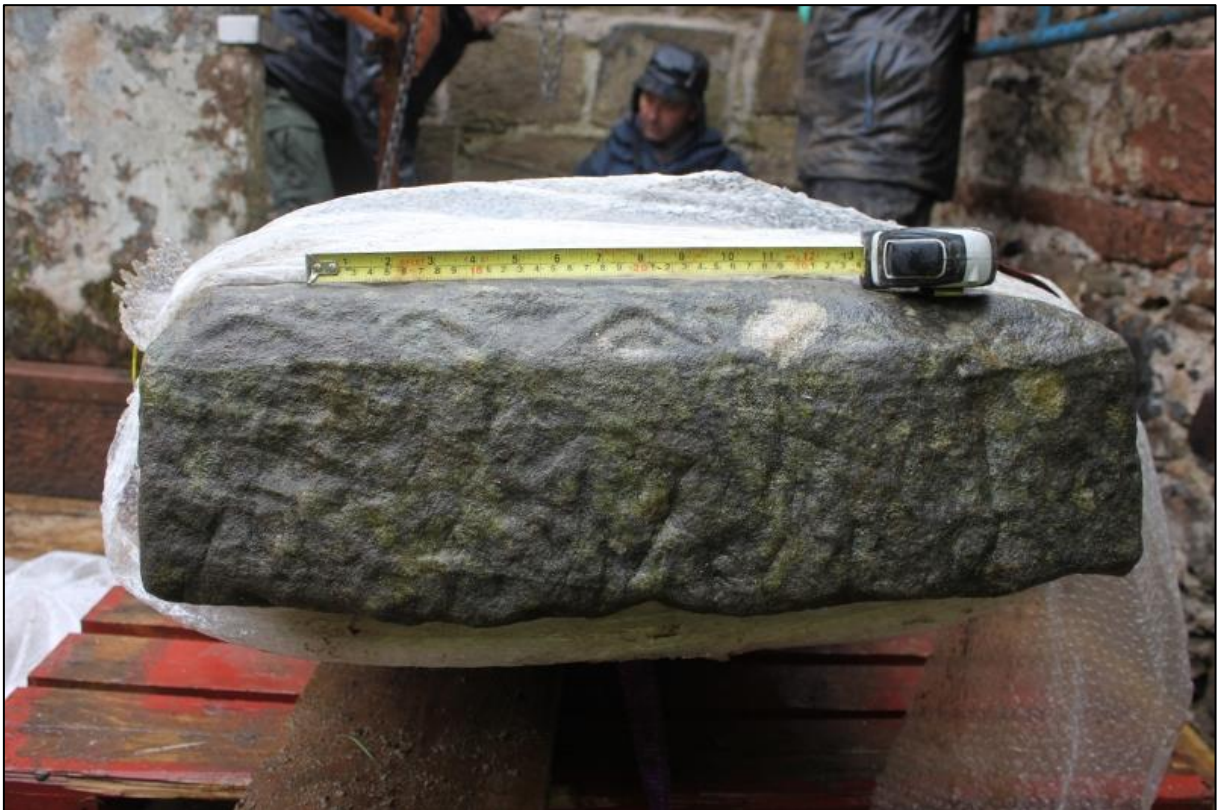
Figure 10b: Base of medieval grave slab, showing incised chevron decoration and rough tooling
