**Levensgrove Park, Dumbarton,
West Dunbartonshire:
Archaeological Mitigation**

Data Structure Report

on behalf of West Dunbartonshire Council

RATHMELL  
ARCHAEOLOGY LTD

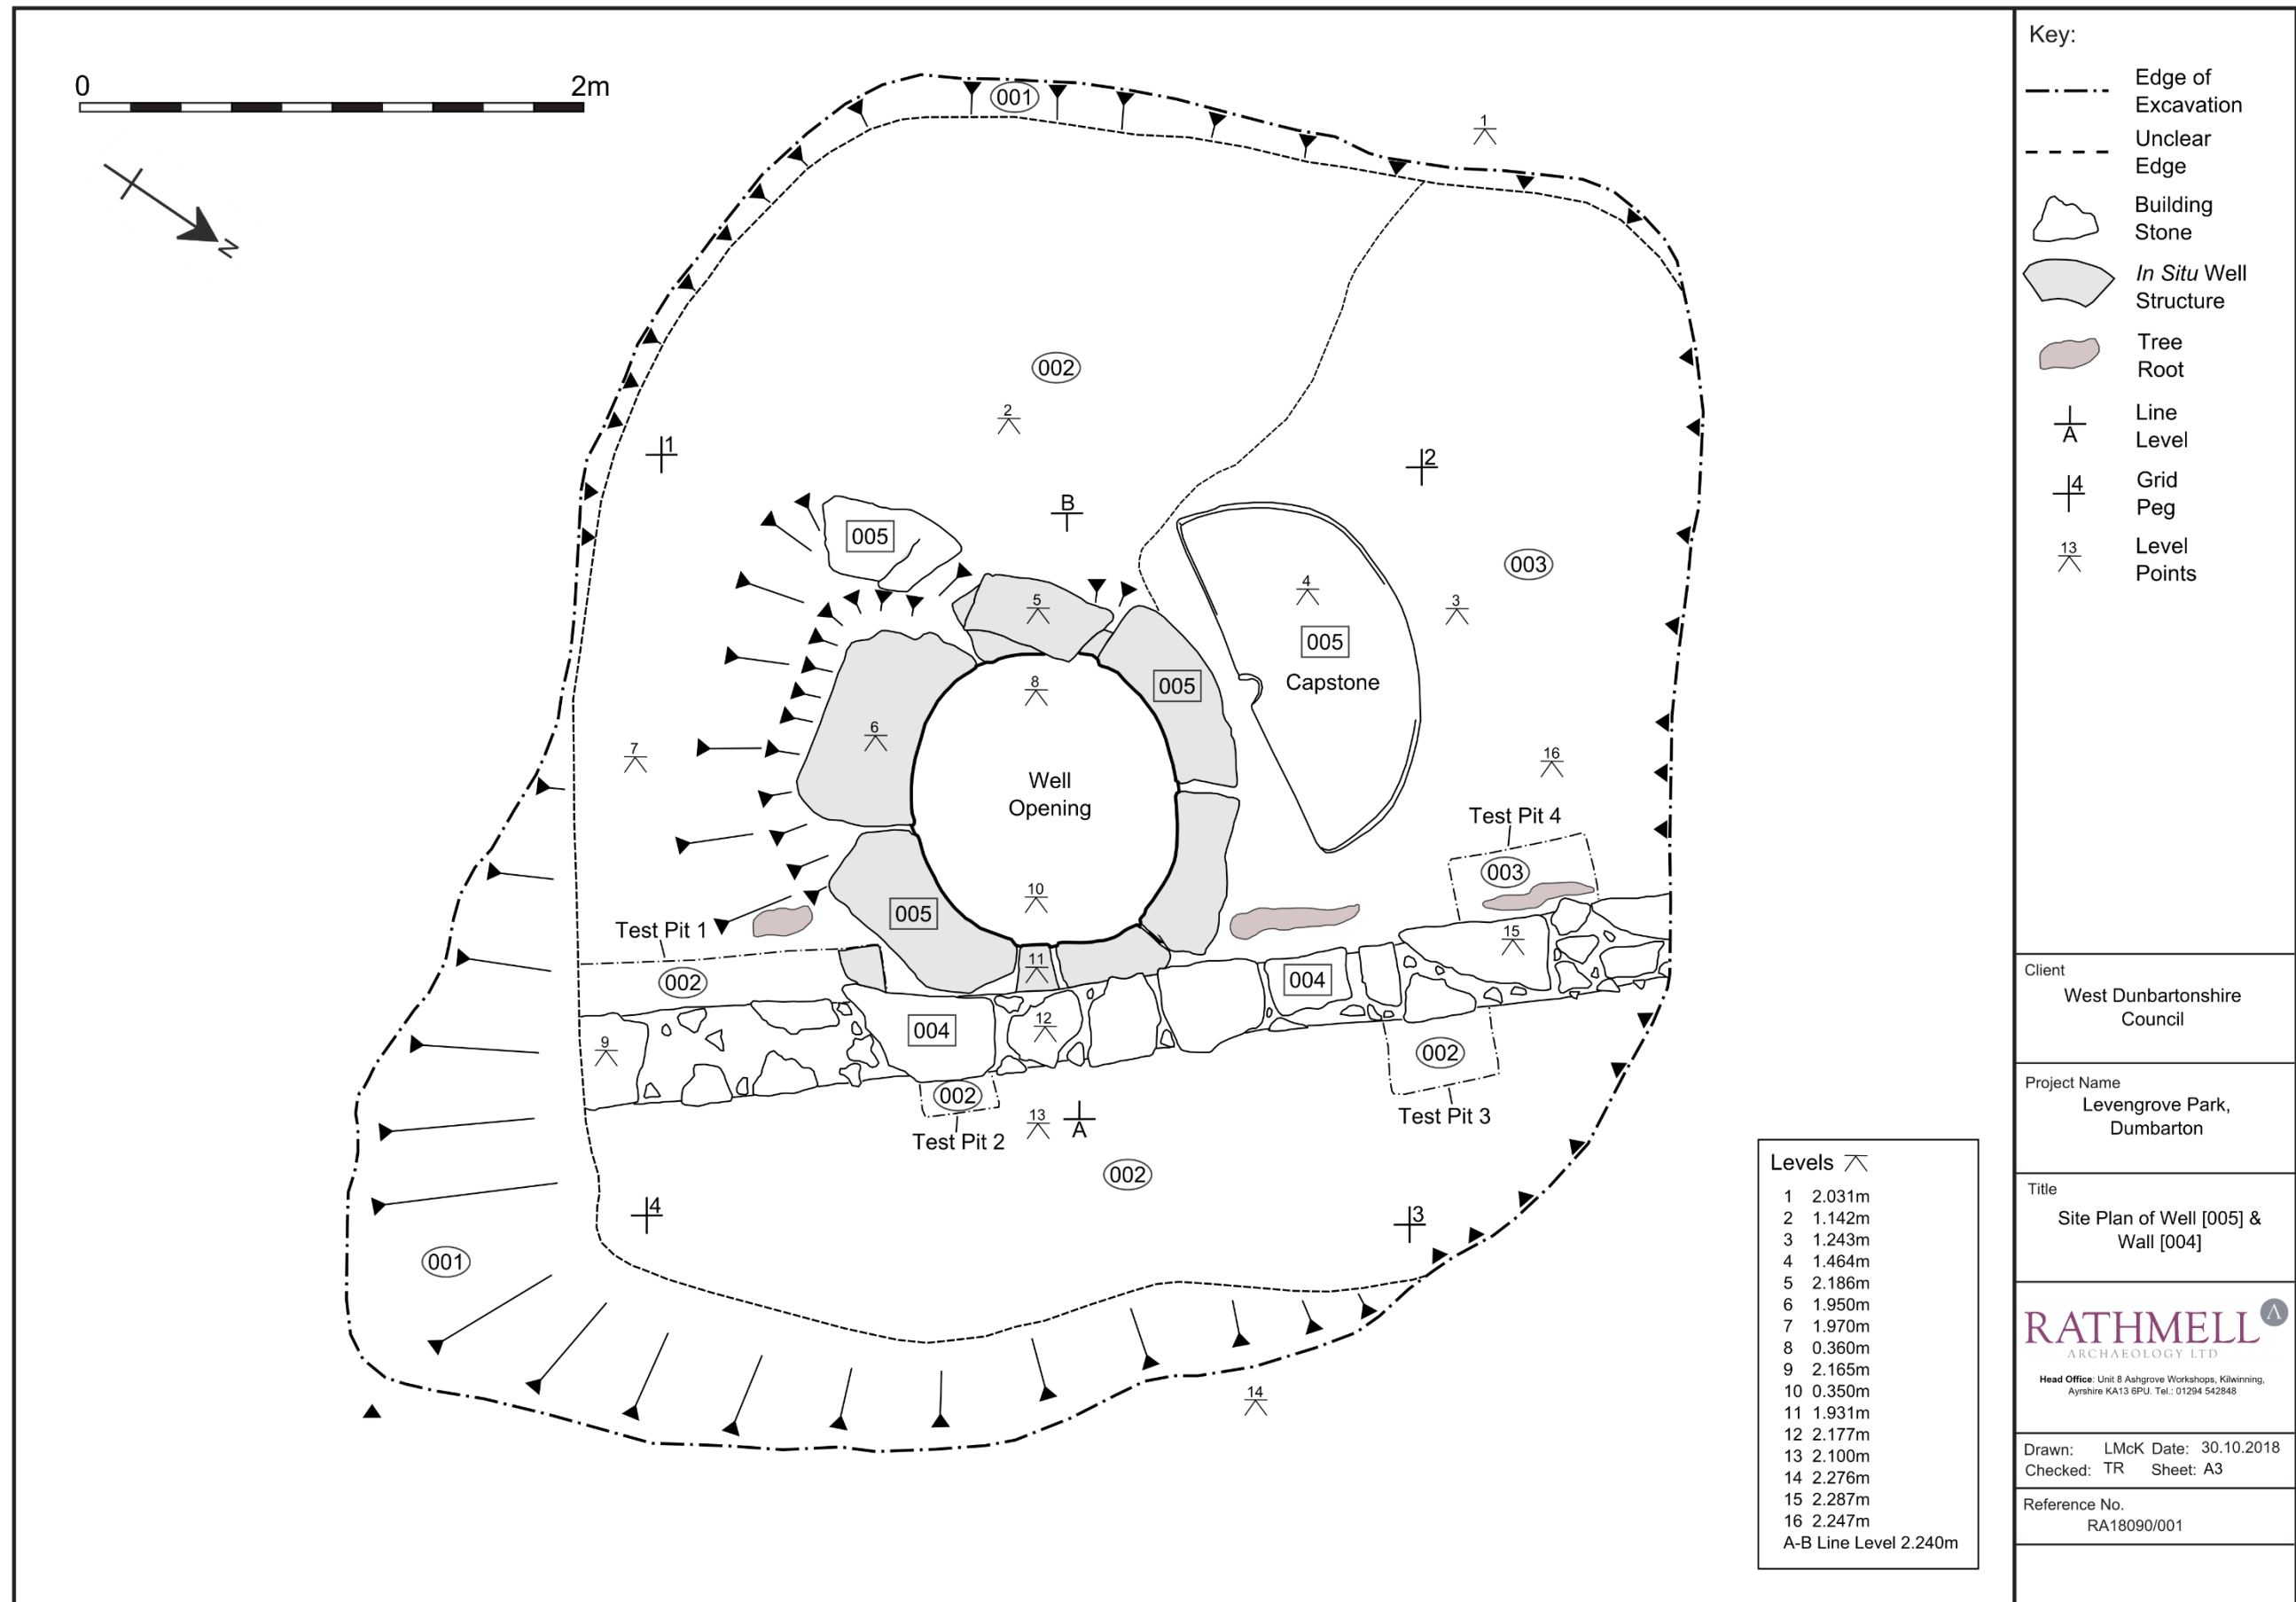
Figure 1: Plan showing Well [005] and Wall [004].

7. After the tree stump was removed a small subrectangular area, measuring 5.1m from northeast to southwest and 4.4m from northwest to southeast, was opened up using the tracked excavator. This revealed the partially-covered remains of a stone well [005] and the foundations of a wall [004] which partly overlay the well at its north-western edge (Figure 1).

10. The wall [004] (Figure 1) was orientated in a northwest to southeast direction. It measured 0.3m to 0.4m wide and 4.28m long within the excavated area, and had a maximum height of between 0.15m to 0.2m. The wall comprised a single line of sandstone rubble blocks, standing two courses high in immediate proximity to the well, but elsewhere surviving only as a single course. These blocks varied in size from 0.13m by 0.24m by 0.07m to 0.6m by 0.38m by 0.12m and had been roughly shaped and in some cases squared. They were bonded with a friable mid to light yellow coloured mortar. The wall underlay the topsoil on site (001) and overlay the disturbed subsoil layers, (002) and (003), within the excavation area. The wall also appeared to have been built directly over the north-easternmost edge of well [005].

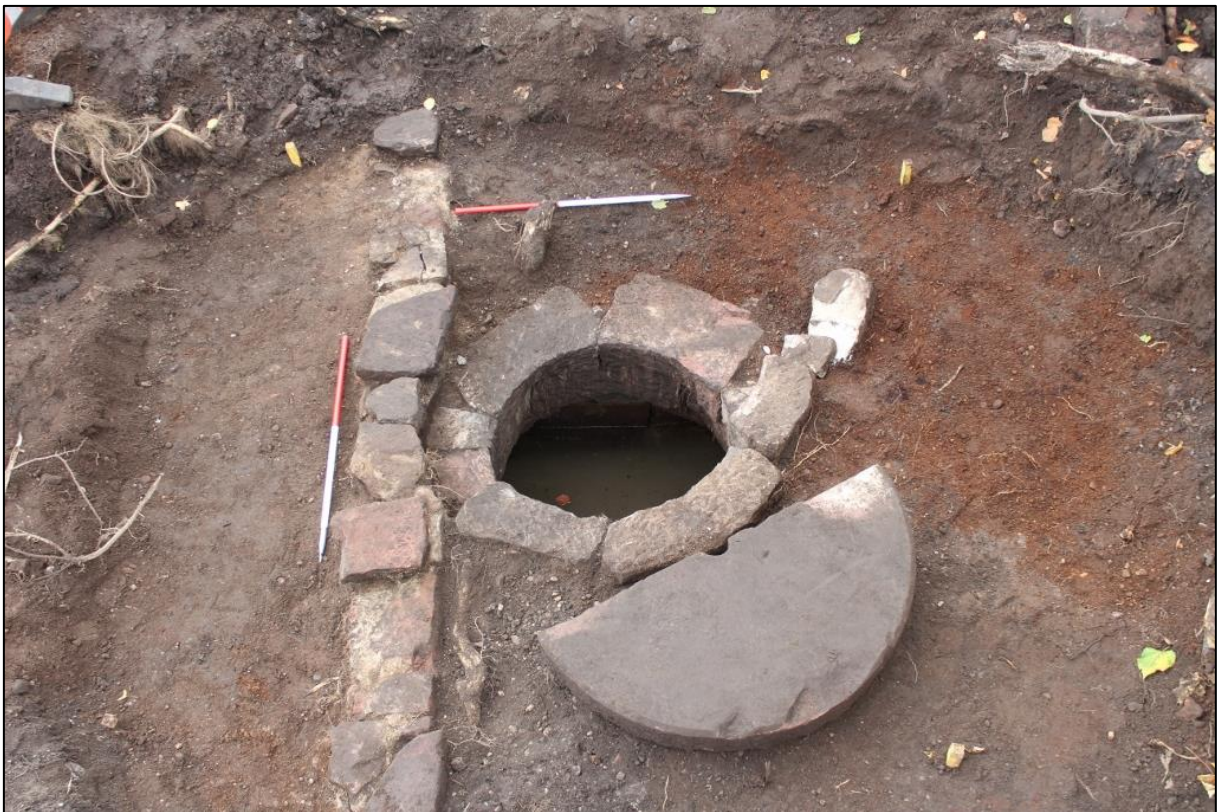
Figure 2b: View of well [005] and wall [004] after clean back had been completed. From the NW.

13. The structure of the partially covered well [005] (Figures 1 and 2b), identified beneath the tree throw, comprised three structural elements (Figures 3 and 4). The first of the structural elements consisted of a circular capstone which would have been placed over the well's opening. The capstone was made up of two pieces of similar size: it was flat in section, with upper and lower surfaces ground smooth, and the edges roughly broached to create a vertical face. A marked chamfer was visible around the circumference of the object where the faces joined the upper and lower faces; this had been damaged in places. A central hole, 0.1m in diameter, had also been drilled or carved into the capstone. With both stones placed together over the well opening, the capstone would have had a diameter of 1.44m and a thickness of 0.19m to 0.2m. One of the halves was broken, most likely though the action of the tree roots or through damage incurred when the tree blew over.

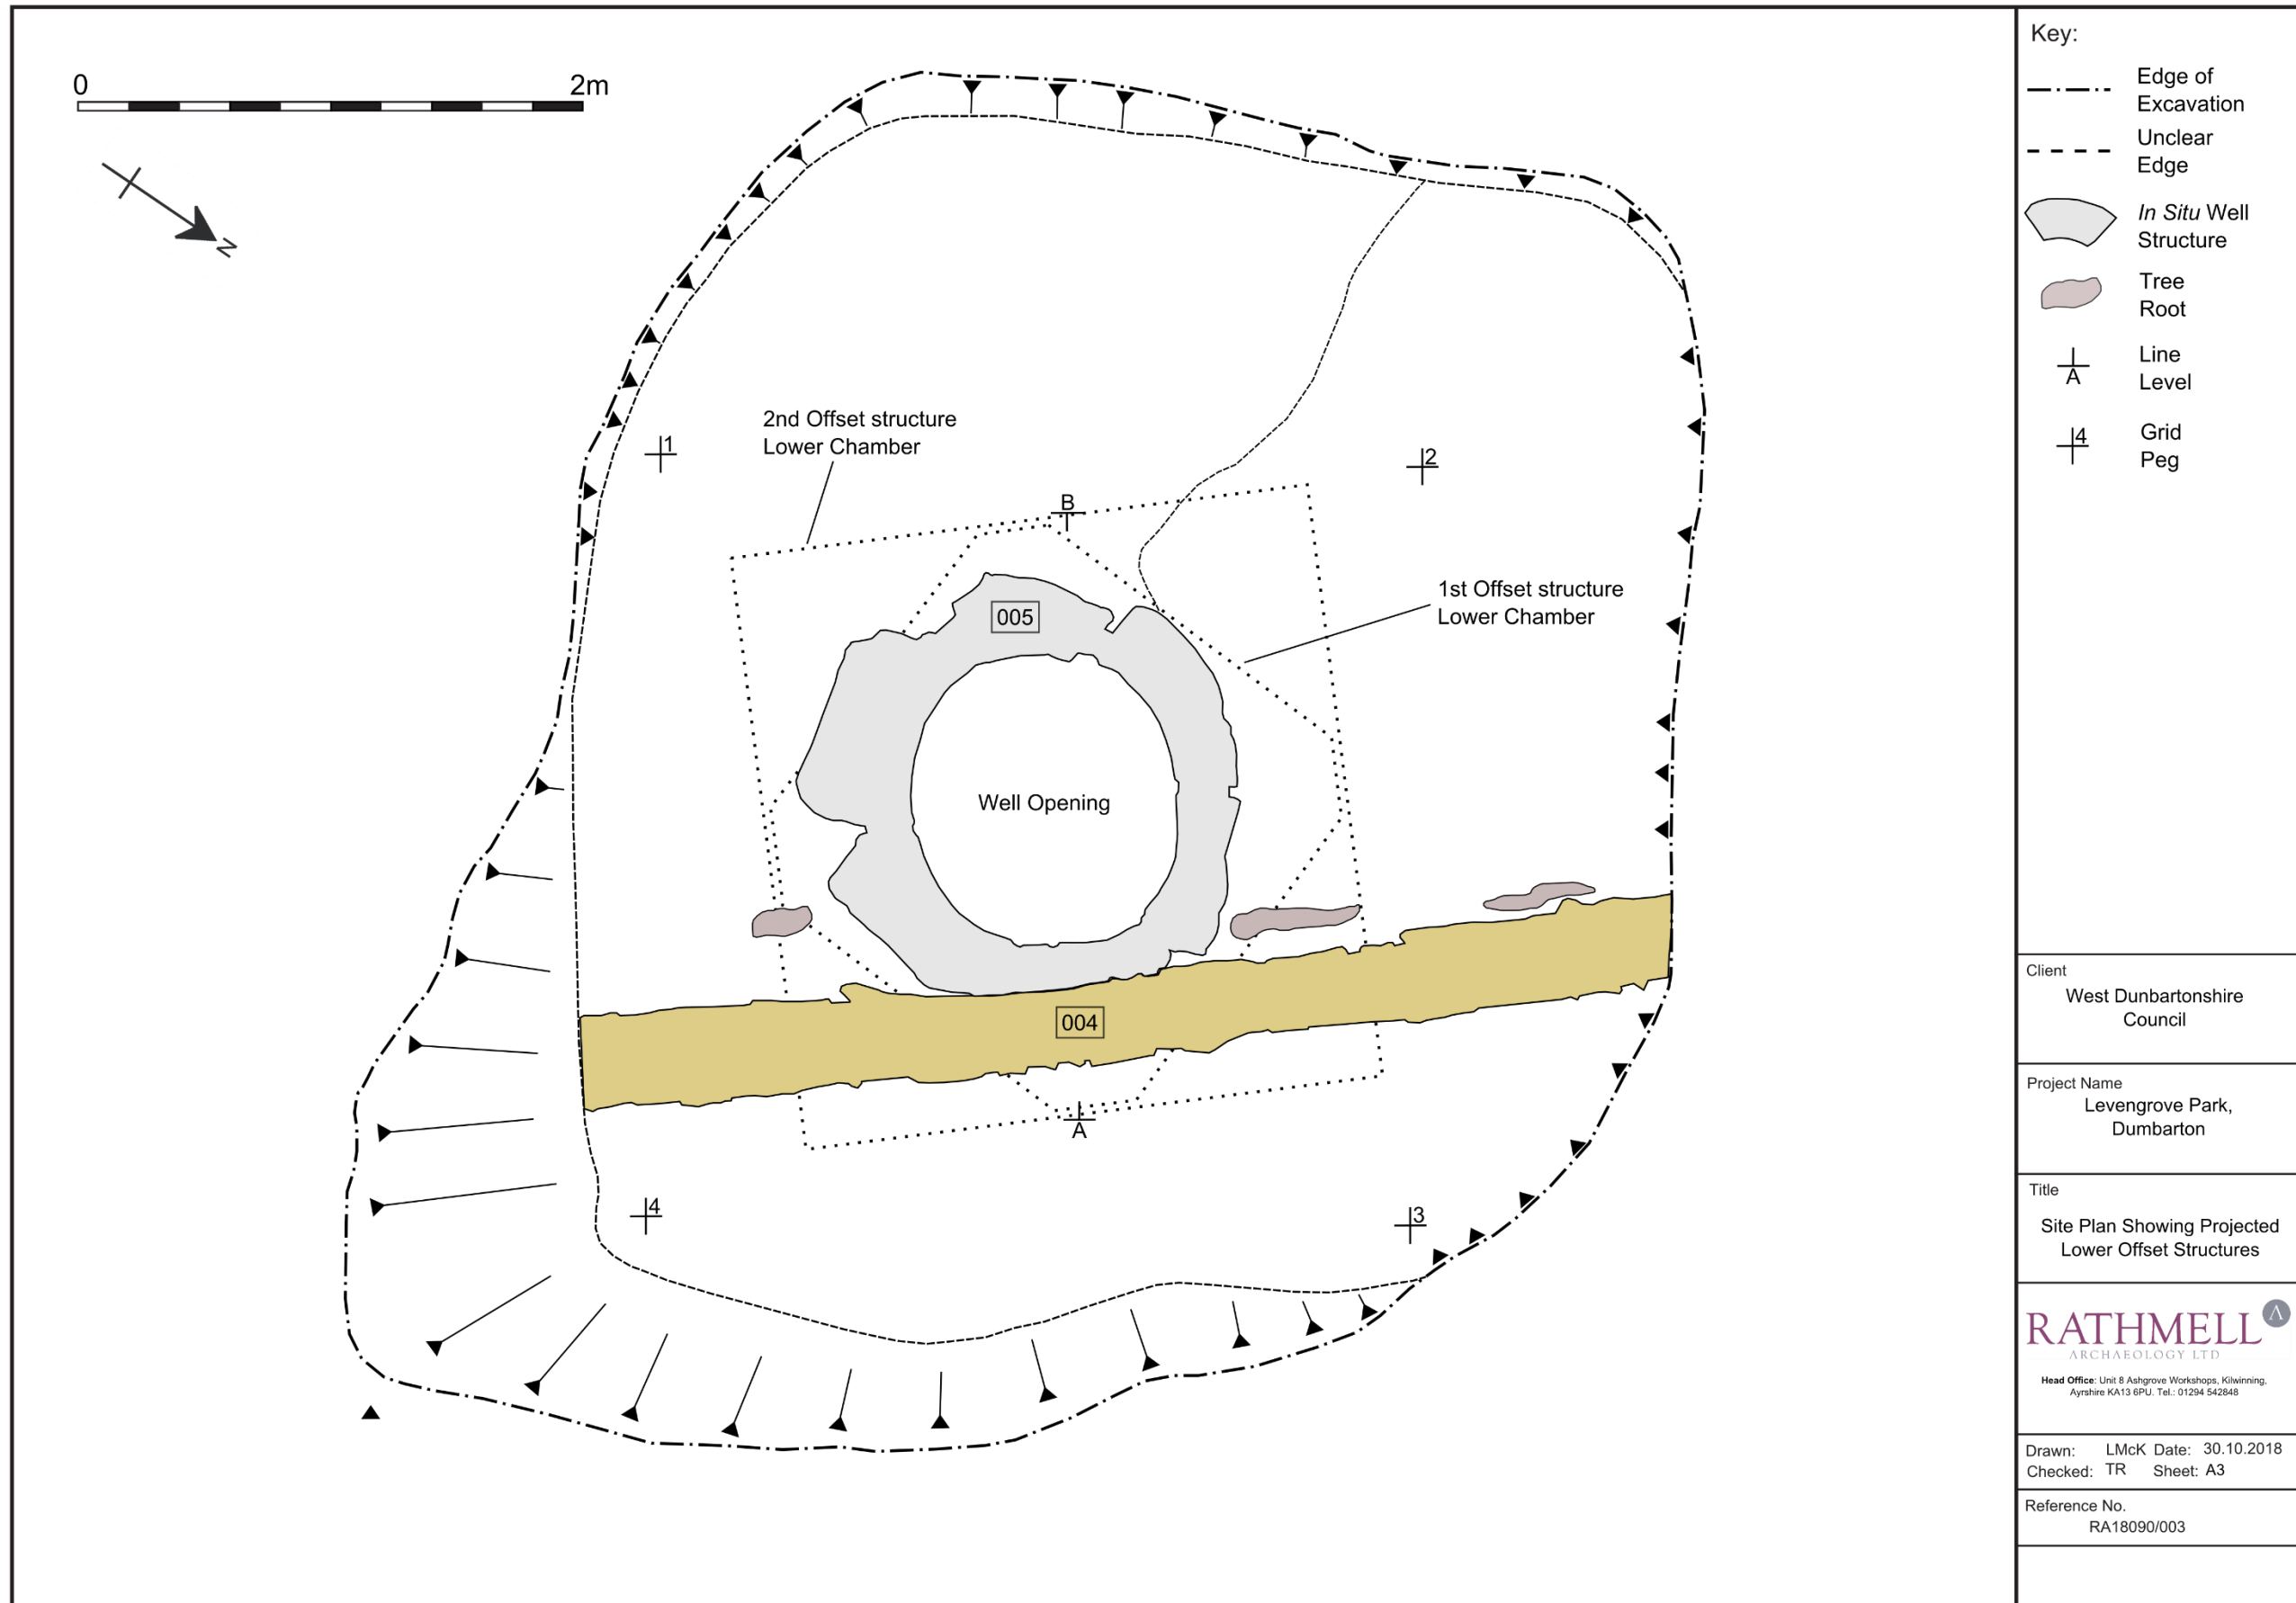
16. A 3D model of the well (Figures 5a and 5b) was constructed from photographs taken on site which allowed a better understanding of its internal construction and enabled the retrieval of the overall dimensions, which would have otherwise been impossible due to safety considerations. These dimensions were used to add to the site plan and profile of the well (Figures 1, 3 and 4). From this it was noted that the height from the well's opening to its base was 1.81m and that the circular upper part of the well was placed slightly off centre on its northeast to southwest axis (Figure 3). The inner part of the lower, square shaped, chamber measured 2.3m by 2.3m and had a height of 1.02m (Figures 3).

Figure 3: Plan showing projected structural elements of Well [005] partly obtained via 3D model data.

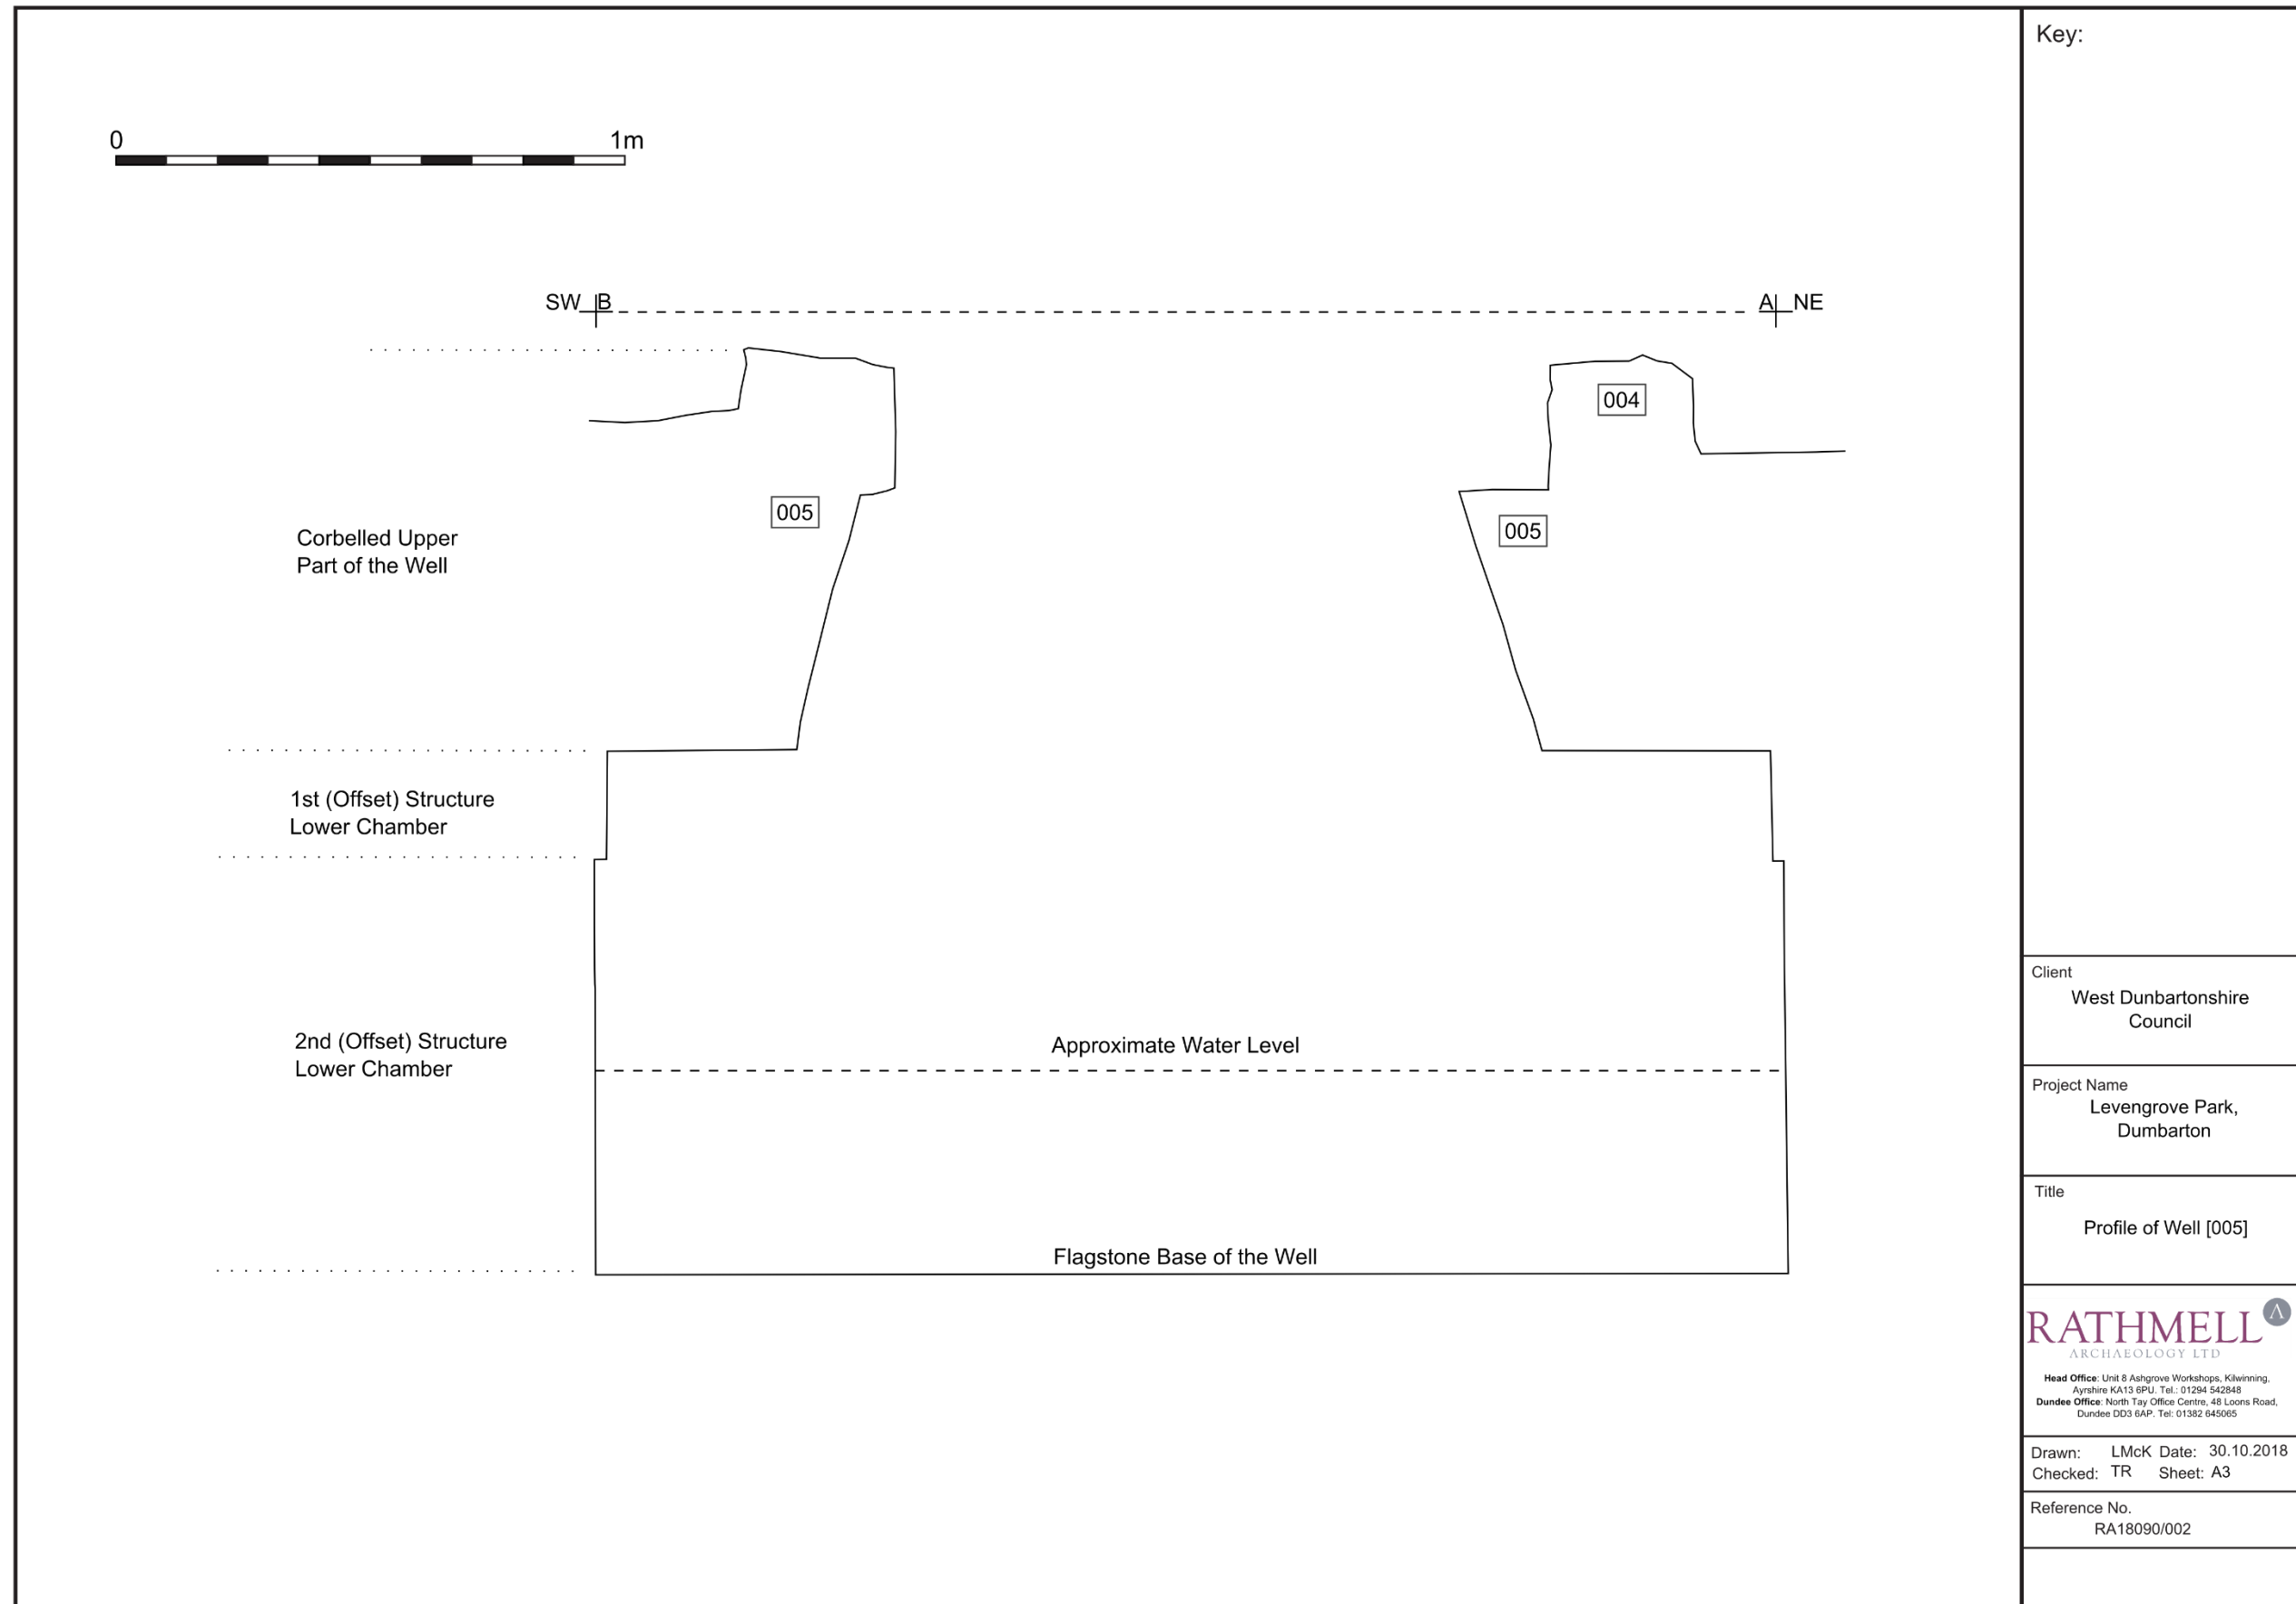
14. The second element of the well was the upper part of the structure which included the opening (Figures 1, 3 and 4). The upper opening had a diameter of 1.3m to 1.4m, with the outer edge of the well measuring 1.72m from northwest to southeast and 1.64m transversely. The outer height, as exposed, was 0.14m to 0.24m. The stones used for the upper part of the structure consisted of three courses (two visible on the surface) of squared, roughly broached, sandstone rubble blocks, which measured 0.18m to 0.8m long by 0.25m by 0.28m wide by 0.2m by 0.4m thick. The uppermost course (on which the capstone would have rested) was damaged, most likely when the tree growing over the well was blown over. The alignment of each of these three, uppermost, courses differed slightly, creating a corbelled structure which narrowed towards the opening. Throughout this corbelled section, the front faces of the rubble blocks appeared to have been worked in situ to create a smoother finish to the interior (pers. comm. Tam Boyd – Covanburn

Contracts) (Figures 4 and 5b).

Figure 4: Profile showing projected structural elements of Well [005] partly obtained via 3D model data.

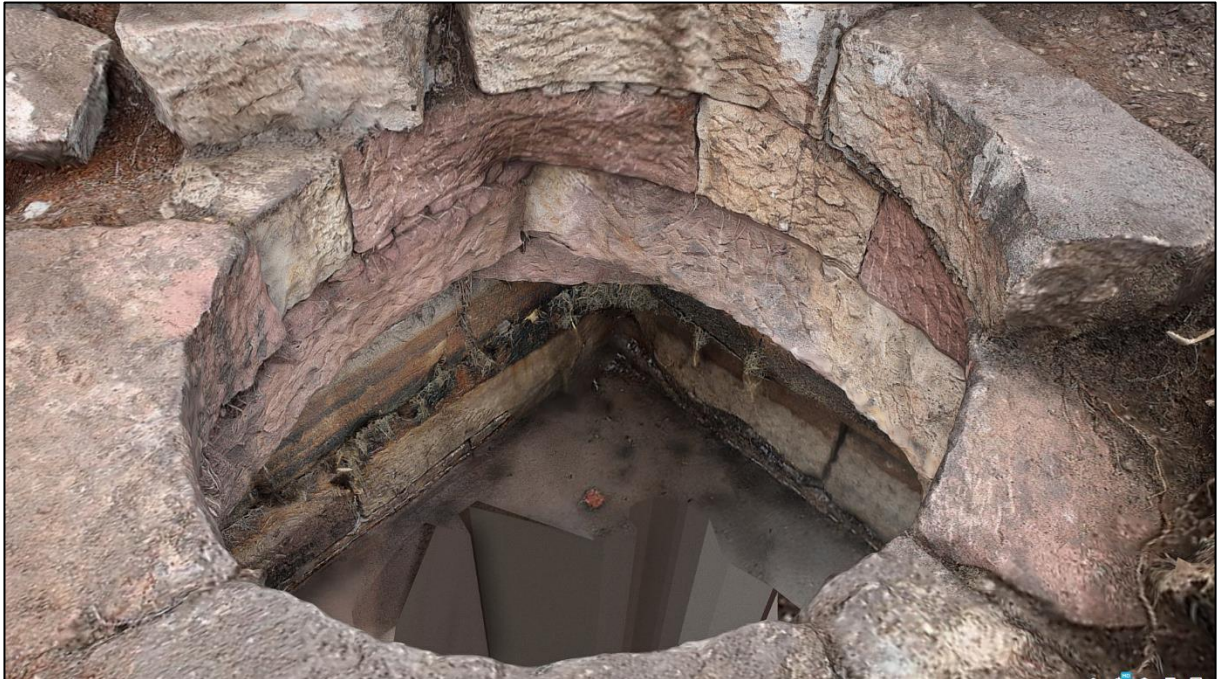
15. The corbelled and circular upper section sat upon a bridging section which comprised a single course of offset squared rubble blocks which in turn sat upon the lower chamber. The partly flooded lower chamber was initially found to be full of root, soil and displaced masonry which included most of the damaged stone work from the upper part of the well and part of the damaged capstone. All of this debris was removed, but a constant flow of ground water seeping through the southwestern inner wall of the now cleared lower chamber meant the base of the well remained obscured. What could be discerned was that the floor consisted of tightly fitting flagstones, with the masonry of the lower chamber itself comprising around three courses of dressed dry-jointed rectangular sandstone blocks which each measured 0.75m by 0.38m by 0.5m thick and which were packed very closely together. The lower structure itself was square on plan: no openings for pipes could be observed in the inner walls of the lower chamber though there may have been openings in the base obscured by the constant flow of water.

Figure 5b: Close up 3D model view of lower chamber of well [005] from E.

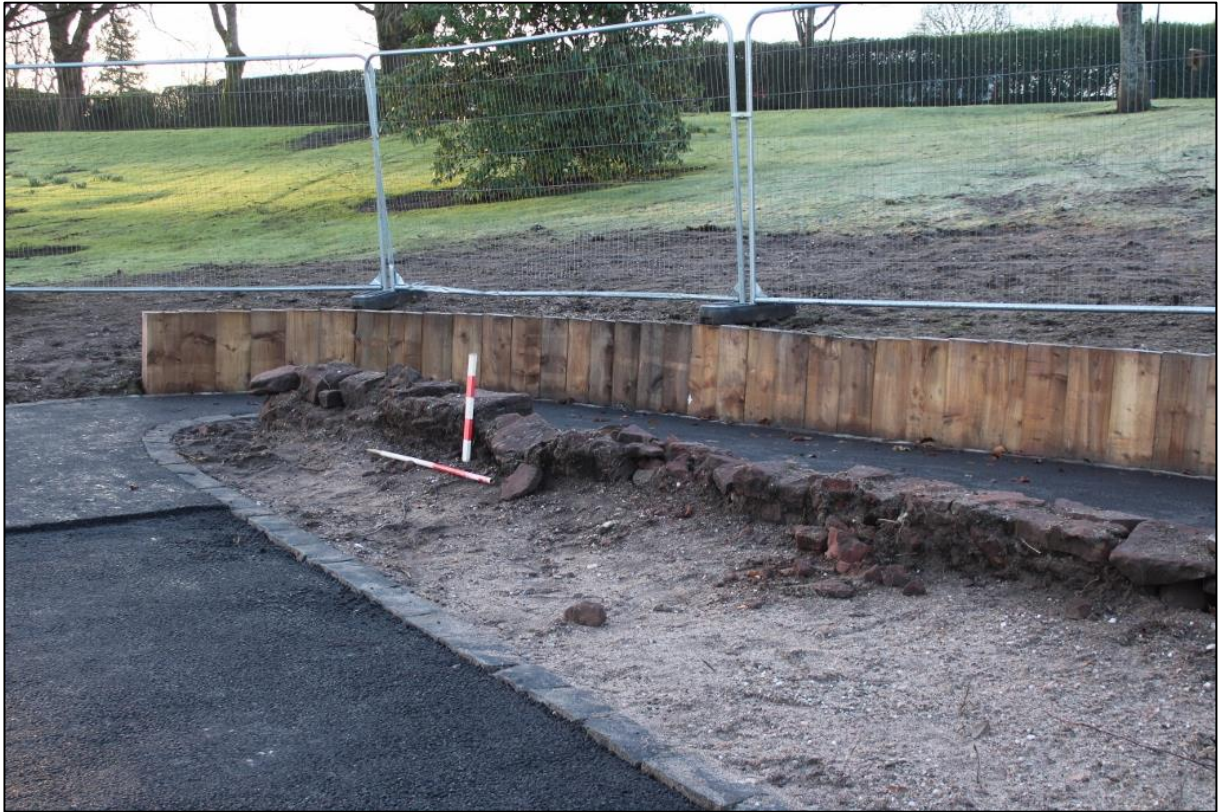
12. Further excavation of the wall took place in February 2019 which exposed another 10m stretch off its southeast end (Figures 6a, 6b and 7). After this no further trace of the wall could be located though fragmented stone inclusions similar to those used in the construction of the wall were identified possibly representing where the wall had been destroyed by one of the many full grown trees within the parks boundary suggesting that it had once ran further to the southeast.

Figure 6a: View of the extension of wall [004] from the N.

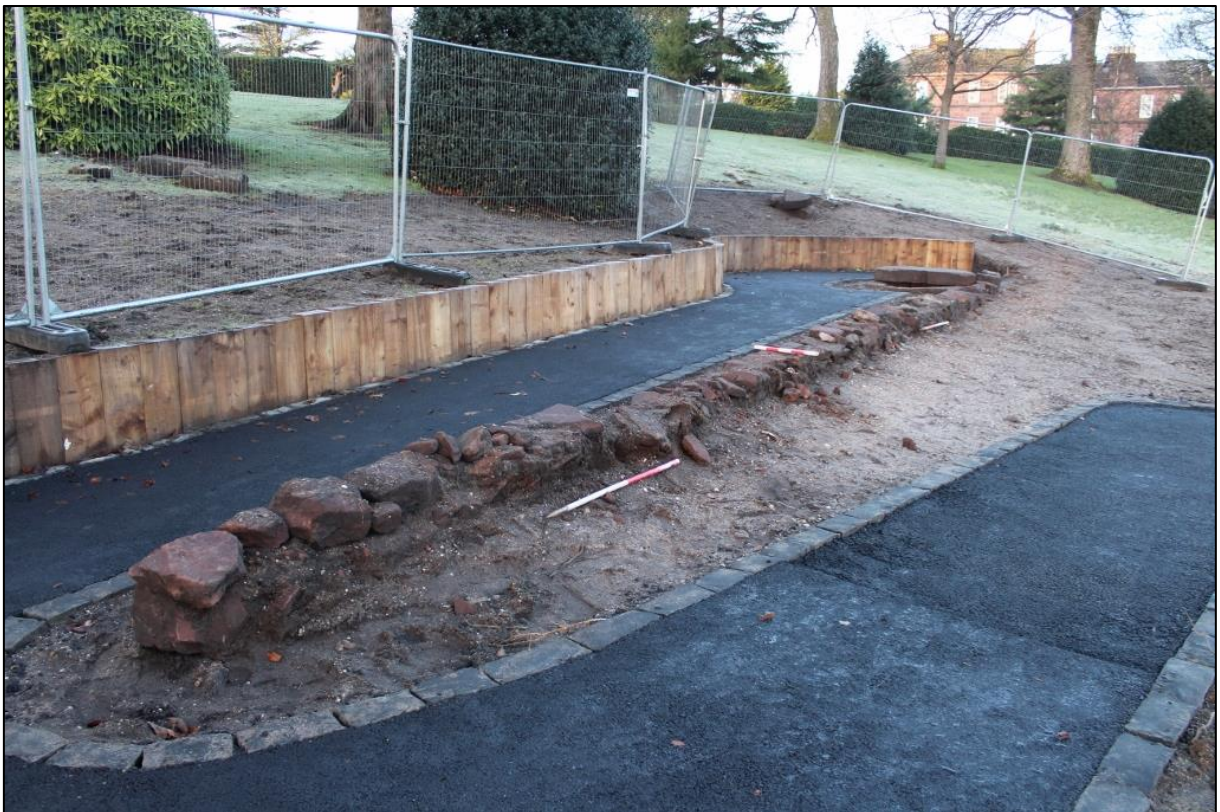
Figure 6b: General view of the public access works around well [005] and wall [004] from ESE.

5. Further works were carried out in February 2019 (Figures 6b and 7) including the well's repair which involved placing one of the capstones back in place and covering the rest of the opening with a Perspex surface so that the inside of the well chamber could still be observed. A further stretch of the wall was also exposed (Figures 6a and 7) to facilitate the construction of a new tarmac and kerb stone path which led from Woodyard road and around the wall and well. These works also included the general levelling off of the ground surrounding the well and wall and the construction of a retaining wall made from timber sleepers.

19. The upper course of the well was repaired in February 2019 (Figures 6a, 6b and 7) using the original stones which had been dislodged by tree growth. The stones were recovered from around the well and also from within the chamber. The unbroken capstone was placed over the opening but the broken half was not and is to be placed close by. The other half of the well opening is to be covered over with transparent Perspex to allow the viewing of the chamber below.
