Bridge Street, Stranraer: Historic Building Recording

Data Structure Report

by Louise Turner

issued 31st March 2020

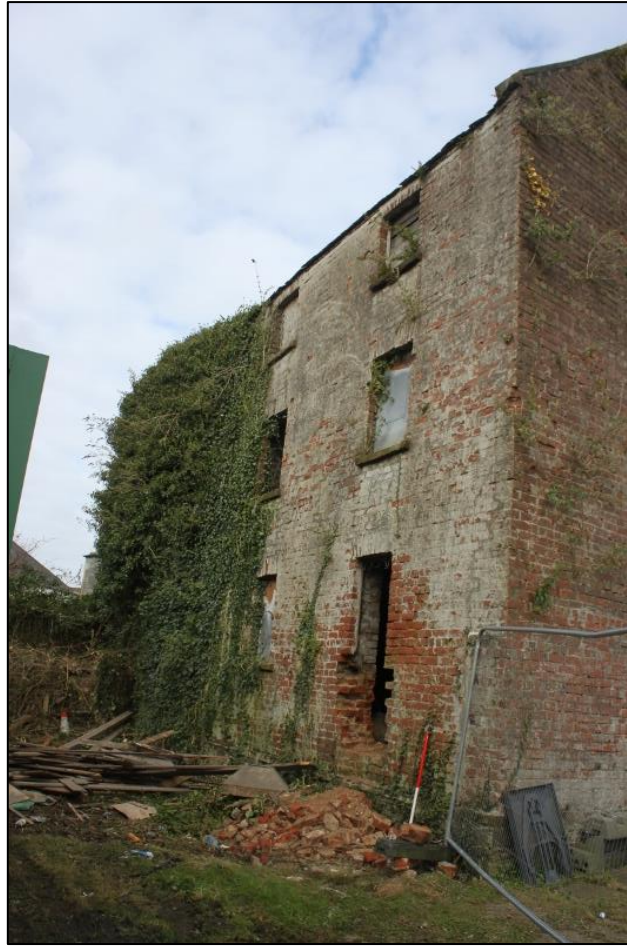
Figure 5a: Southern Portion of Grain Store ('Element 1'), S Elevation

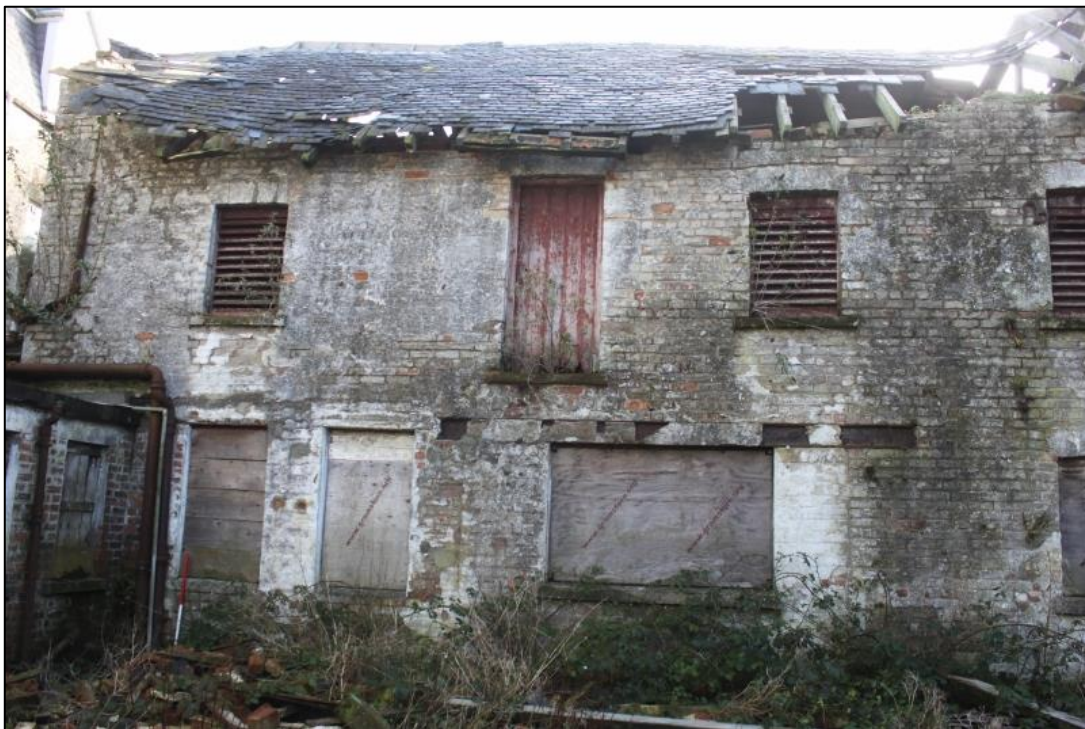
Figure 5b: N End of Grain Store, W Elevation, Showing Two-Storey section of Eastern Portion ('Element 2')

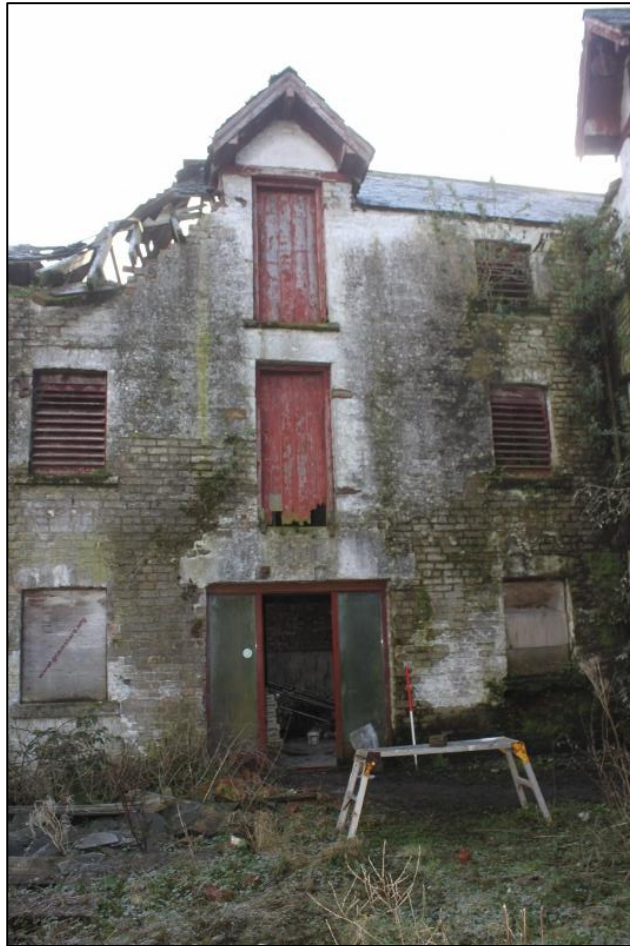
Figure 6a: S end of W Elevation, Element 2, Showing Transition from Two- to Three Storey Structure

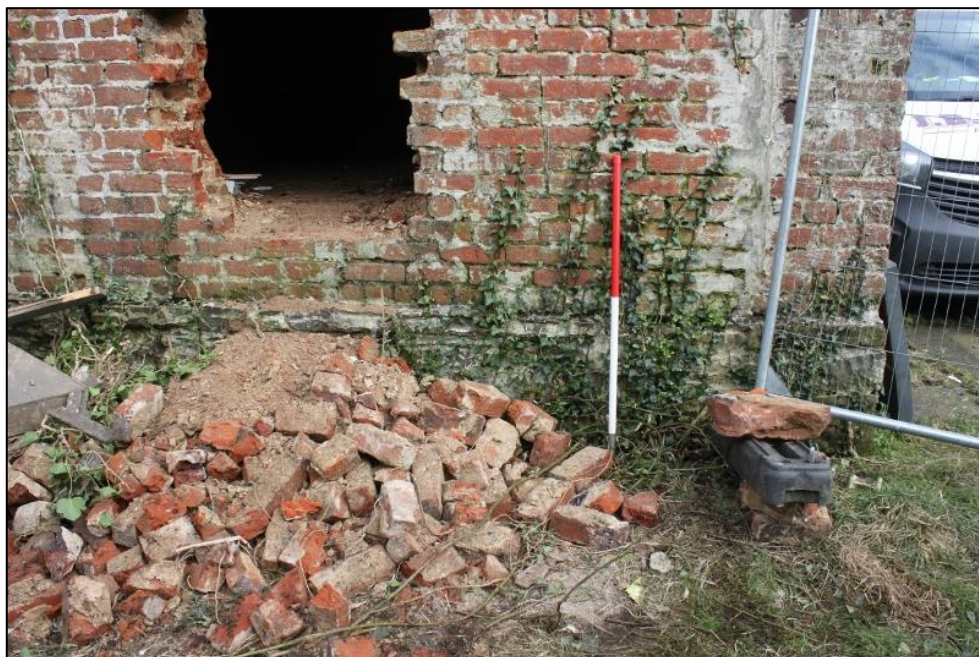
Figure 6b: S Elevation of Element 1, SE Corner, Showing Plinth Courses Composed of Mortared Rubble

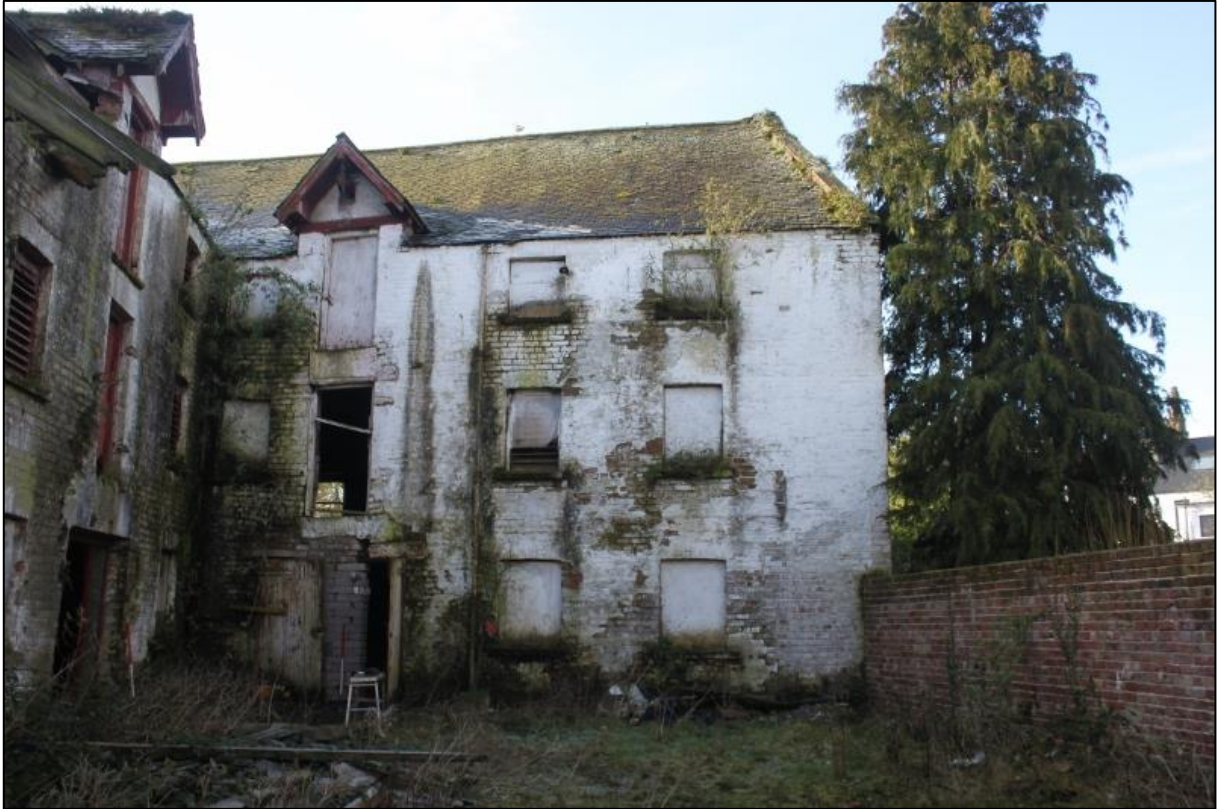
Figure 7a: N Elevation of Element 1, Showing Arrangement of Door/Hatch and Window Openings

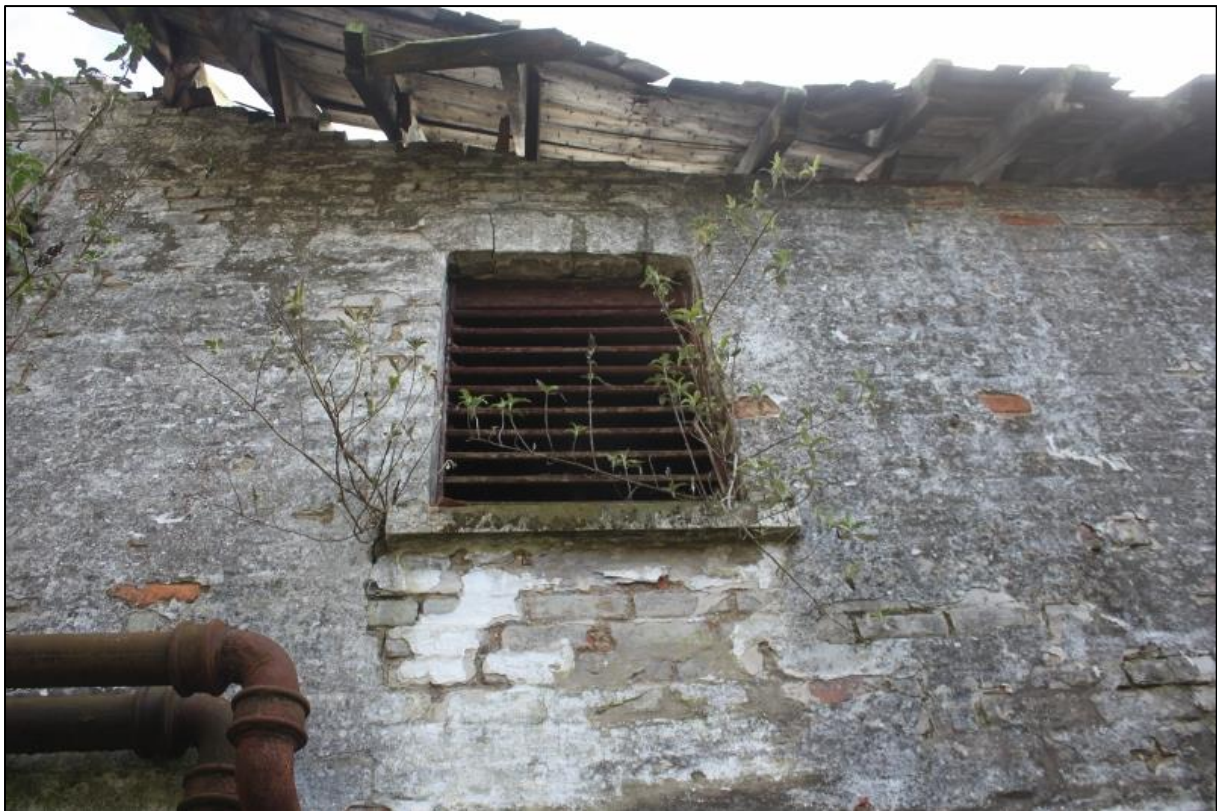
Figure 7b: Detail of Louvred Opening at 1st floor level, N end, Showing Original Timberwork, Broached Sandstone Sill and Segmental Arch

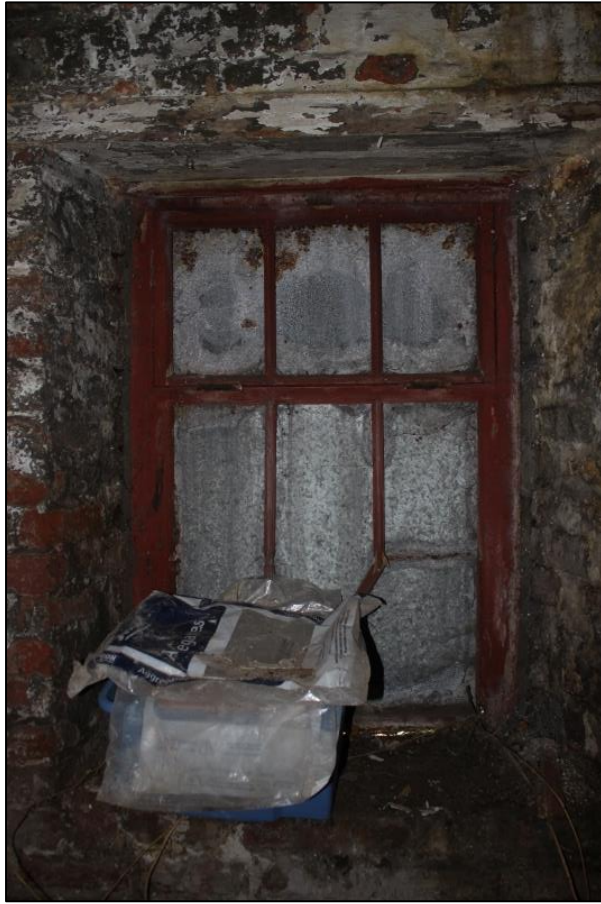
Figure 8a: Internal View of Ground Floor Window in N Wall (Corresponding to S External Elevation), Element 1

42. Unlike Room B, which had windows or ventilation openings along only one of its long elevations, Room B had similar openings along both. These were of identical form to the one surviving original opening in Room B, with splayed embrasures and timber lintels. They were, however, intended for use as glazed windows, rather than louvred ventilators, with most retaining window frames. Each contained nine rectangular lights, with an upper hinged three-light section that opened inwards (See Figure 8a). These appeared to be original fixtures.

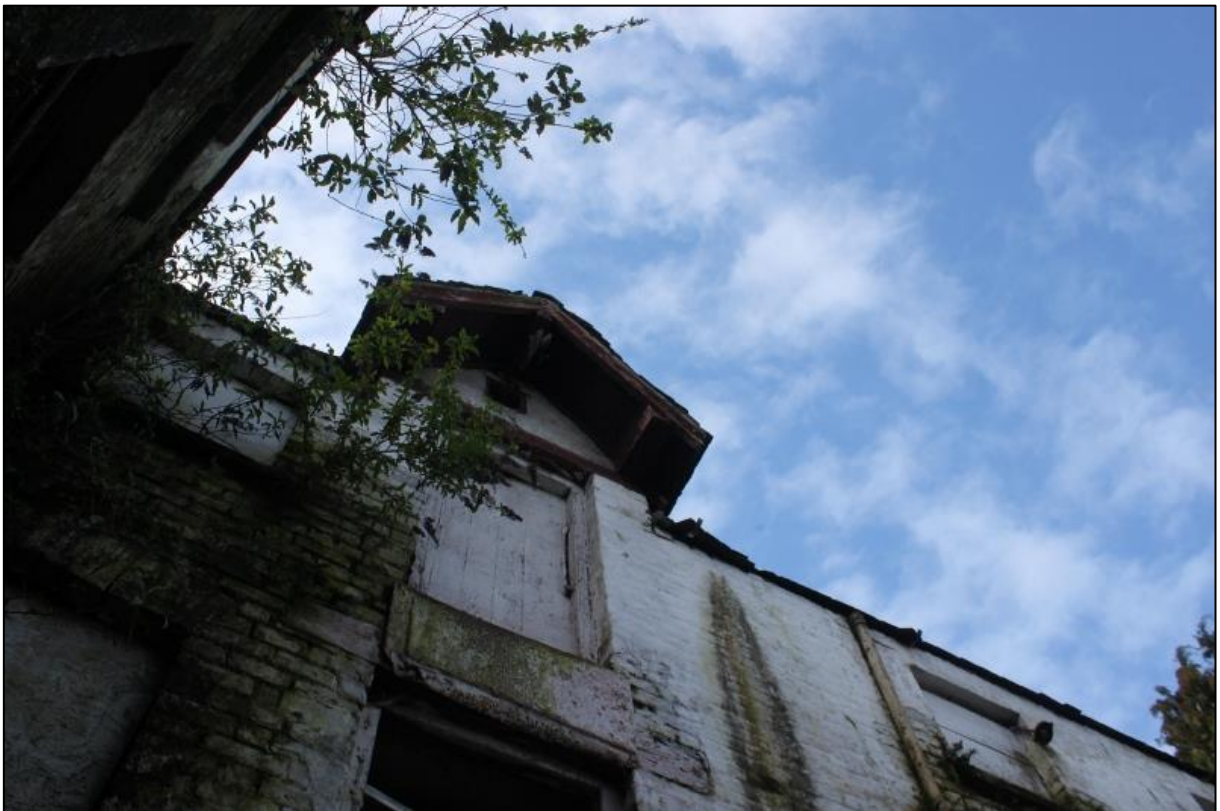
29. Only one confirmed original entrance was noted in the structure. This was a broad, two-leaf door at ground floor level in Bay 1 of the north elevation of Element 1 which would have allowed a cart to be backed up close to the building for loading or unloading: this corresponded to the location of the first and second-floor hatches/doorways and the pedimented gable which would have housed the hoist. Here, the pulley was still in place, mounted beneath the eaves of the gablet, with the projecting gablet providing some protection from the weather when the hatches/ doorways were open for loading and unloading (Figure 8b).

Figure 8b: View of Pedimented Gablet in N Elevation, Element 1 with *In Situ* Hoist Pulley

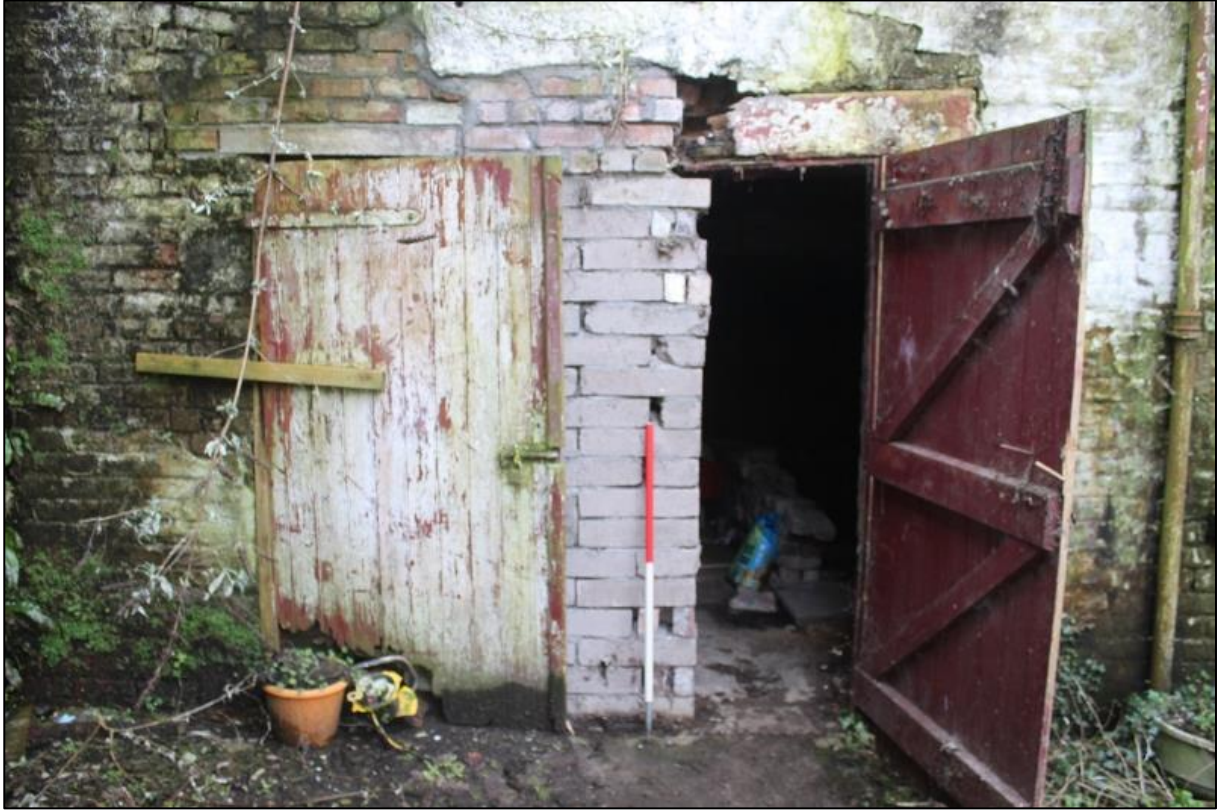
30. The ground floor double doorway still had both door panels *in situ*, with the fragmentary remains of a massive timber lintel still in place. This had snapped at some point, threatening the integrity of the entire facade, and evidence of a makeshift repair was evident, using a combination of brick and breeze-block to provide extra support, while at the same time, transforming the entrance from a broad vehicular doorway into narrow pedestrian access (Figure 9a).

Figure 9a: Element 1, Original Entrance in N Elevation with Broken Timber Lintel (to right) and Modern Repair

58. Viewed from the interior, most door and window openings retained original timber lintels, which in the case of the ground floor double doorway in the north elevation of Element 1 had snapped, resulting in a 'Heath Robinson' style repair which involved creating a breeze block pillar which reduced the broad opening into a more narrow pedestrian style entrance. The uncharacteristic window and door openings at ground floor level in the centre of the west elevation of Element 2 also differed from the originals in that they were instead coupled with cast concrete or even steel beams as lintels: this further emphasised the different character of these openings when compared with the originals. It was, however, impossible to fully comprehend the relationship between these new openings and the original features that they replaced, as close inspection of the interior was impossible due to safety concerns and the exterior entirely concealed beneath a layer of cement render.

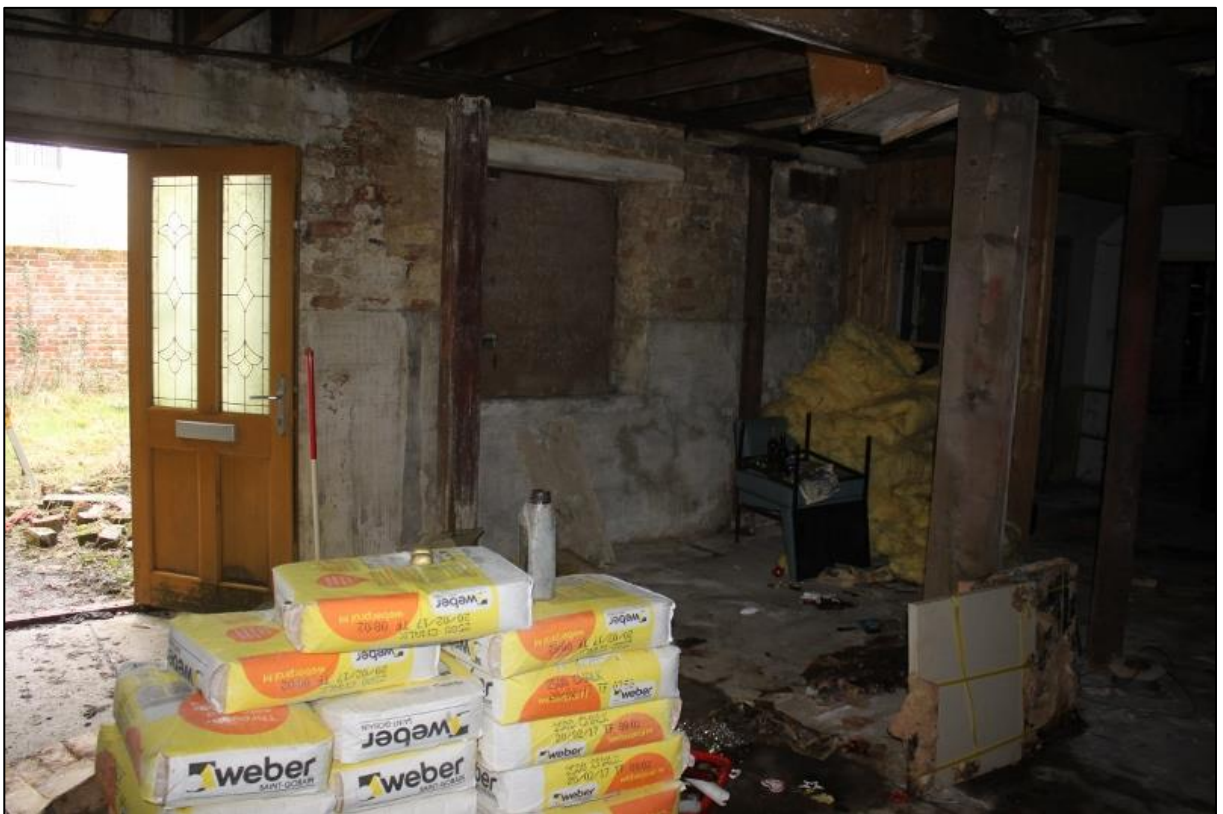
Figure 9b: Element 1, Modern Doorway and Window in W Wall (W Elevation), with concrete lintels

32. Located further to the north along the same elevation were three window openings, spaced irregularly along the wall throughout Bays 1 to 3. This placing was at odds with the regular spacing seen elsewhere on the north and south elevations of Element 1, and at first floor level on Element 2. Further evidence that they represented a phase of alteration was their large size: the two smaller windows, located at the north end of the building (see Figure 5b) measured 1.55 x 0.94m in extent, while the original windows/openings at ground floor and first-floor level measured a uniform 1.25 x 0.91m in extent. The final point of contrast was in their character, with the larger openings characterised by concrete lintels and sills.

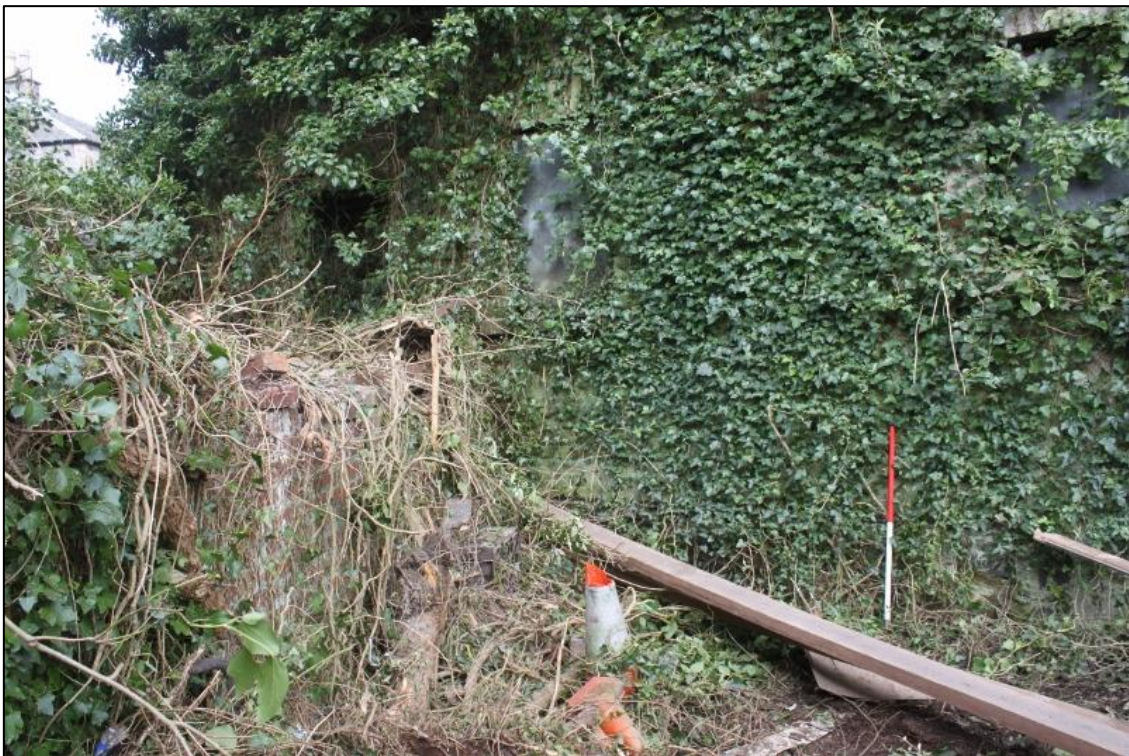
35. Before leaving this summary of the external character of the grain stores, mention should be made of a possible doorway which was identified at the west end of the south elevation during the field survey, in a part of the structure which was entirely obscured by a dense covering of ivy, inside and out. The internal wall had also been shored up in this location, which lay within Room C, further preventing understanding.

Figure 10b: S Elevation, W End, with Cross Wall and Possible Doorway

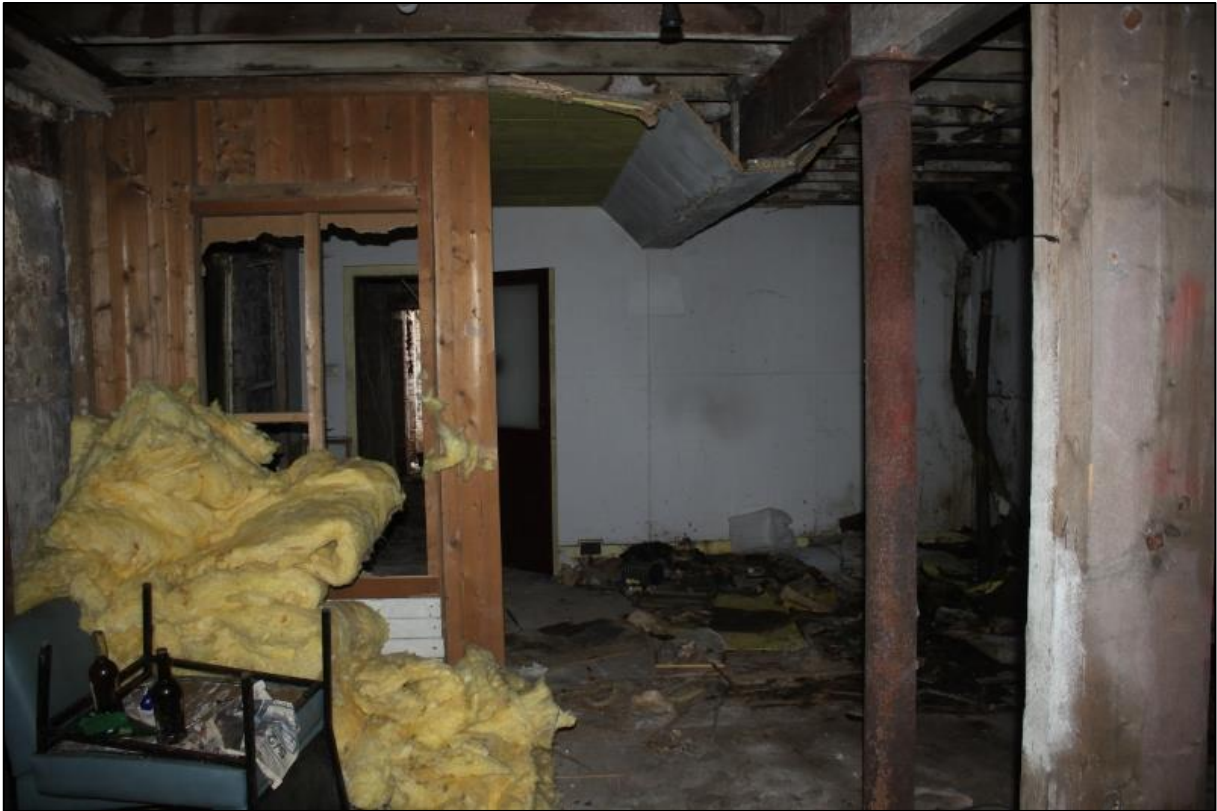
Figure 11a: Looking S Across Interior of Room B, Towards Inserted Stud Wall Subdividing Rooms A and B

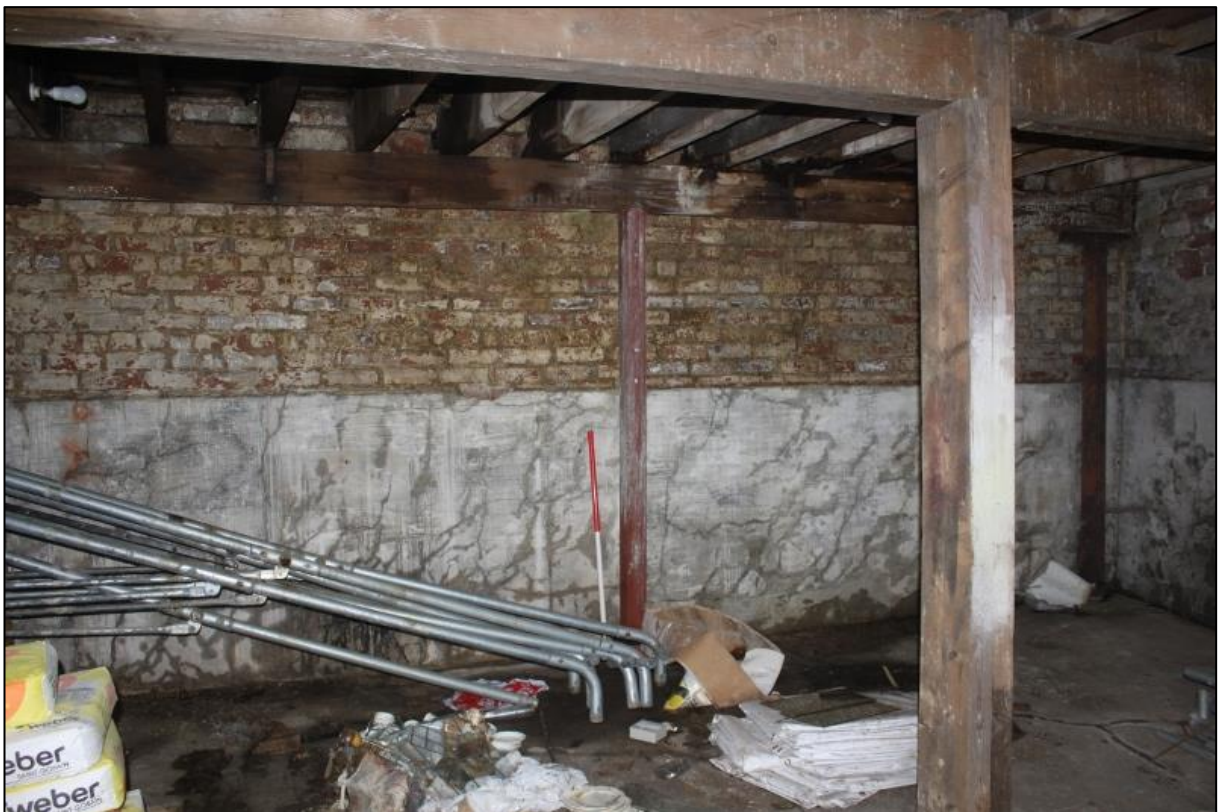
Figure 11b: Room B, SE Corner, Showing Top Plates and Supporting Columns/Posts and Plastered Wall to Dado Height

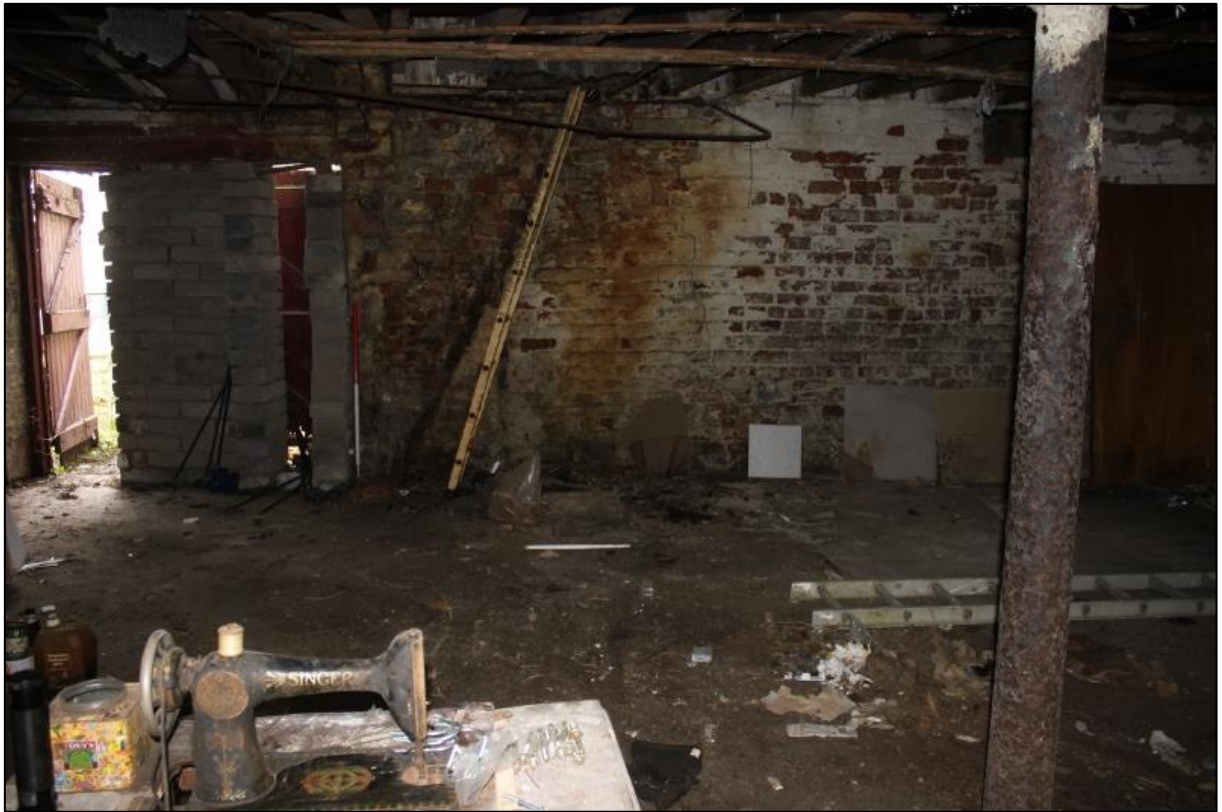
41. Room C occupied the entire ground floor of Element 1, and was rectangular on plan, measuring four by two bays in extent. It had originally been entered by a wide doorway located roughly in the centre of the north wall (Figure 12a - see Figures 7a and 9a for external images). This opened onto the central courtyard which occupied the angle between the north and west elevations of Elements 1 and 2 respectively. The failure of the original timber lintel had resulted in the modification of this doorway through the insertion of a breeze block column which narrowed the original opening to create a narrow-pedestrian entrance. The breeze block column did not immediately abut the existing wall to the east, leaving a narrow gap there. At the time of the survey, this doorway was used only to access the northwest courtyard area: access from the exterior was instead via a narrow pedestrian doorway created through the modification of a pre-existing window.

Figure 12a: Room C, E End of N Wall, with Modified Doorway to left

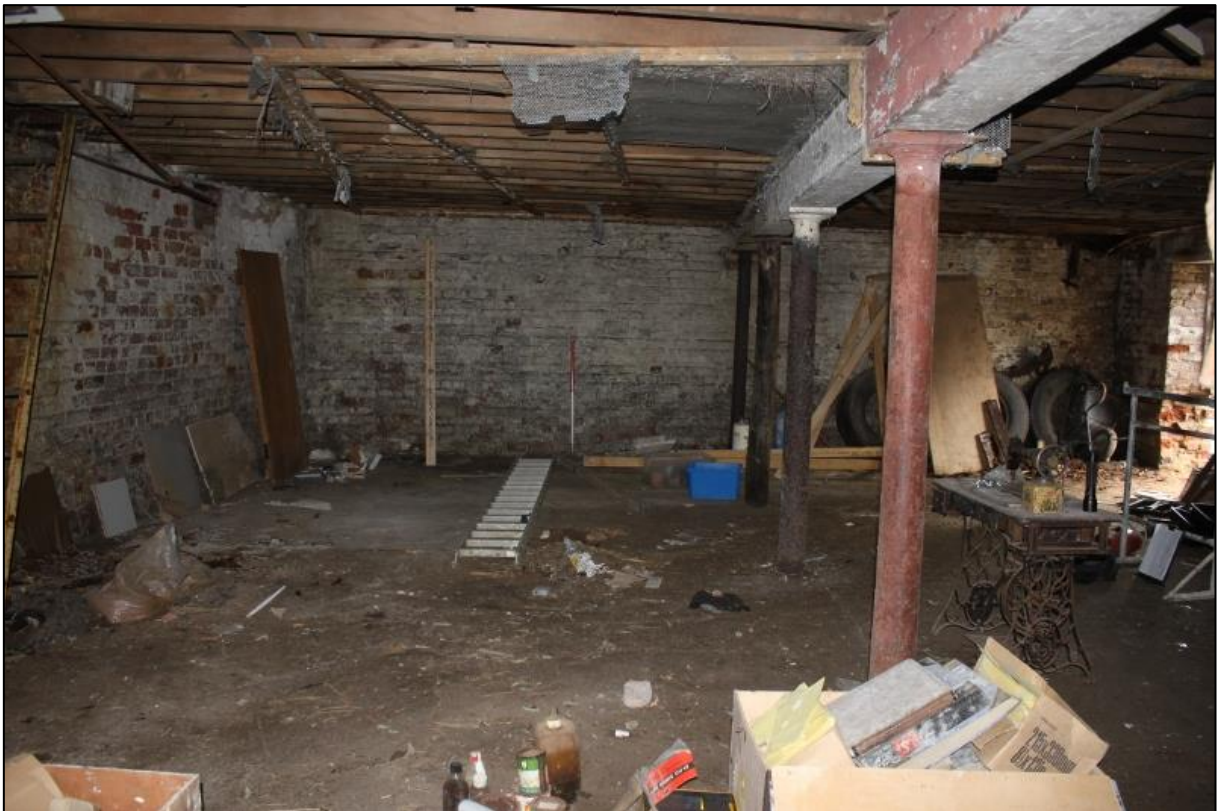
Figure 12b: Room C, Showing Central Timber Beam and Cast Iron Columns

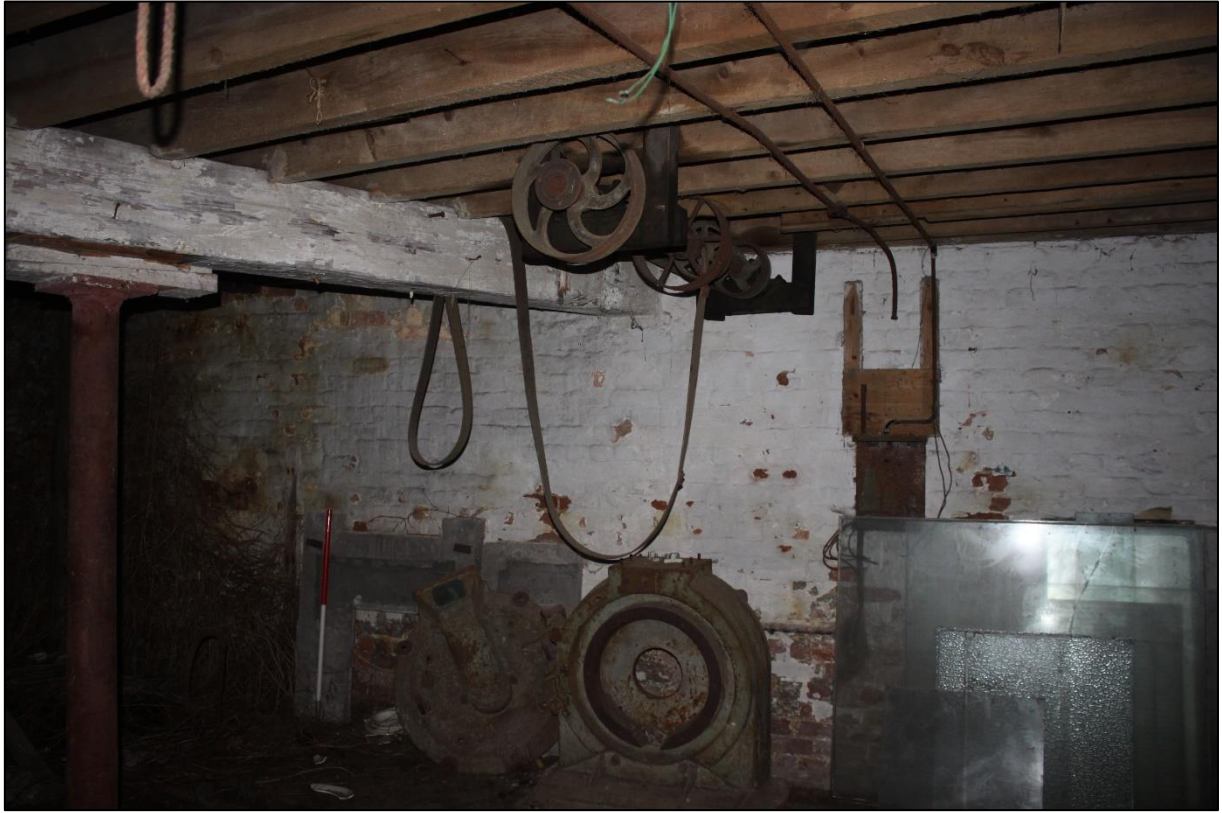
45. Two *in situ* items located in Room C were worthy of mention. The first was a substantial timber workbench, occupying the northwest corner of the room (not illustrated). The second was a ceiling-mounted drive-shaft, which survived intact with the drive belt still in place (Figure 14a). This appeared to derive from a grain bruiser, manufactured by Fisher, the dismantled drum of which lay propped against the wall in the vicinity of the drive-shaft (again, Figure 14a).

Figure 14a: Room C - Ceiling-mounted Drive Shaft and Dismantled Drum from Grain Bruiser

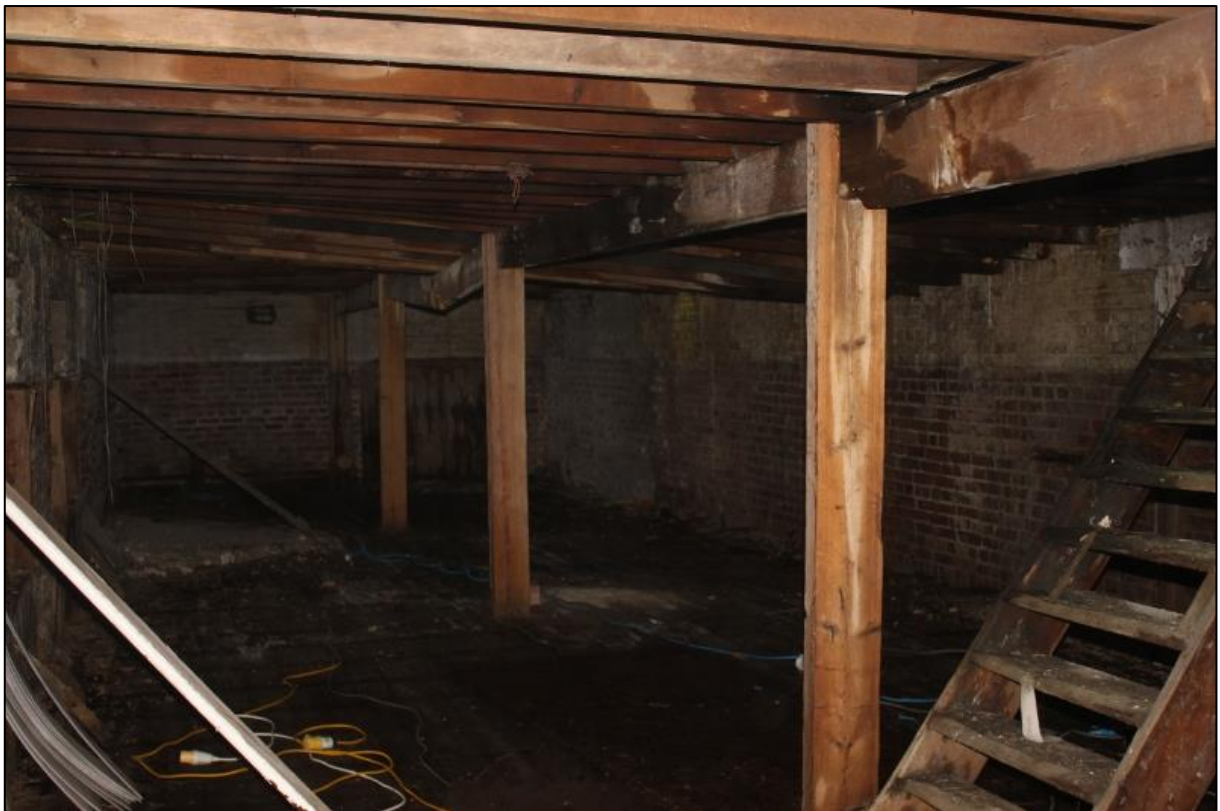
Figure 14b: General View of Room D, Showing Central Line of Timber Posts and Access Stair to Attic Level

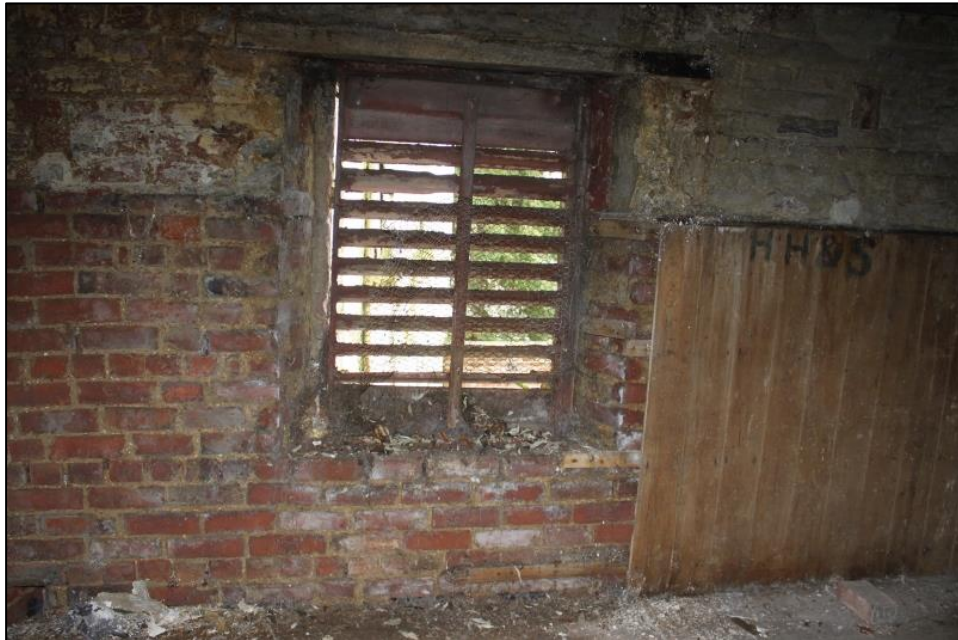
Figure 15a: Room D, W Wall, S End, Louvred Opening and *In Situ* Timber Panelling

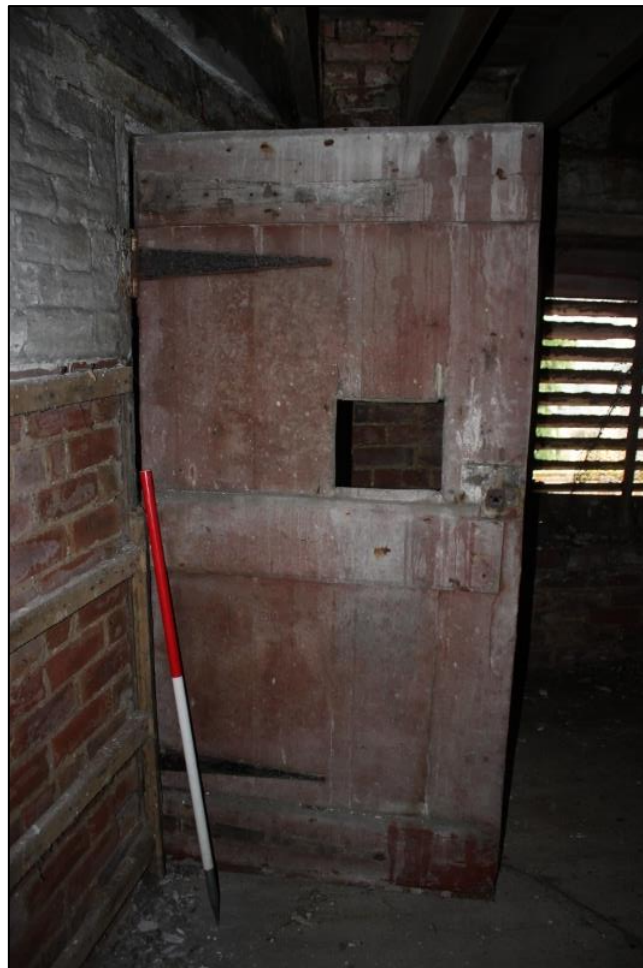
48. Like Room B at ground floor level, all external openings were located in the west wall, i.e. opening out onto the west external elevation. Here, it became apparent that the number of bays, as viewed externally, differed from the number of bays when viewed internally, with six openings (comprising, from north to south: window, hatch/door, window, window, hatch/door, window) distributed evenly across five bays. All of the original fixtures remained *in situ*, including louvred openings and doors (Figure 15a). The original door allowing access into the neighbouring Room E also remained *in situ*: this was constructed of timber planks and held in place by large, cast iron hinges (Figure 15b).

Figure 15b: Room D – Original Door with Cast Iron Hinges

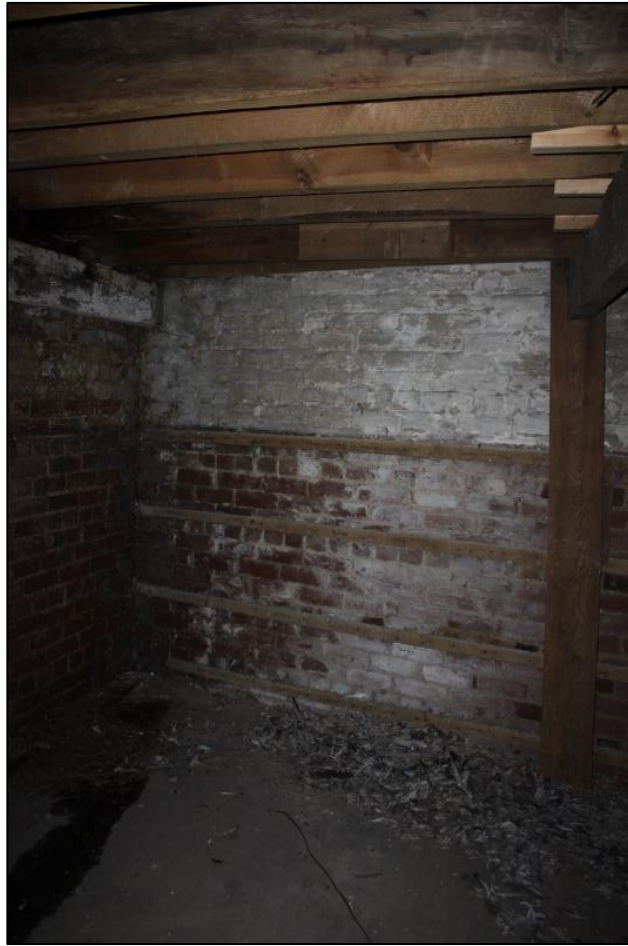
Figure 16a: Room D – *In Situ* Batons for Supporting Timber Panels

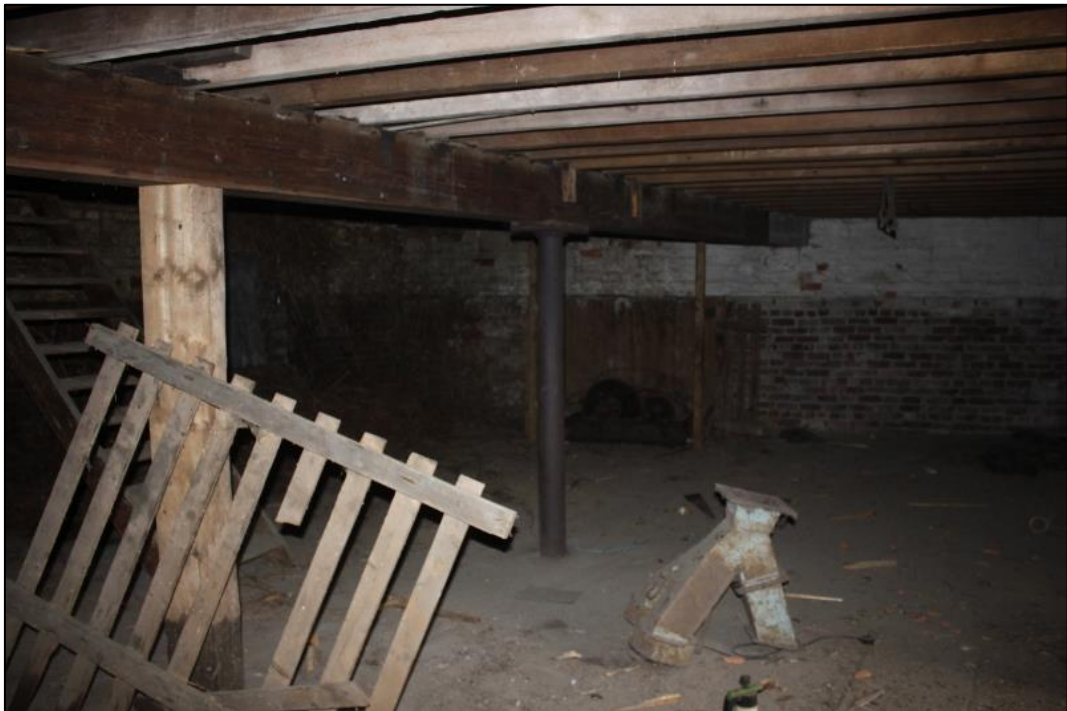
Figure 16b: Interior of Room E, Showing Central Beam and Supports

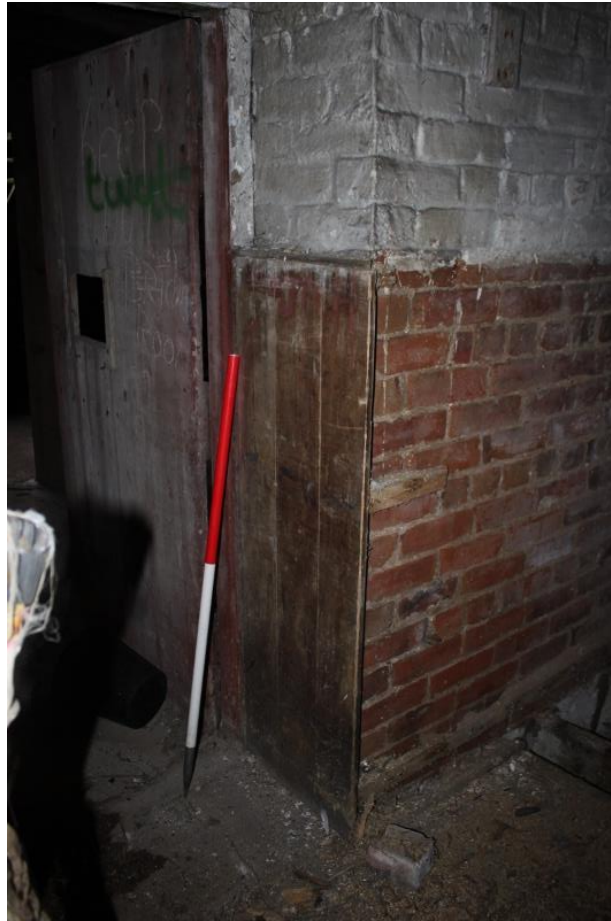
Figure 17a: Room E - *In Situ* Timber Panelling at Entrance to Room D

52. The decorative scheme in Room E was similar to that seen in Room D: the walls were unpainted to dado height and painted cream above. Panelling of identical character to that identified in Room D was present in one or two isolated places, namely over a short stretch along the centre of the west wall, to the rear of some *in situ* machinery, and in the ingo for the doorway leading into Room D (Figure 17a).

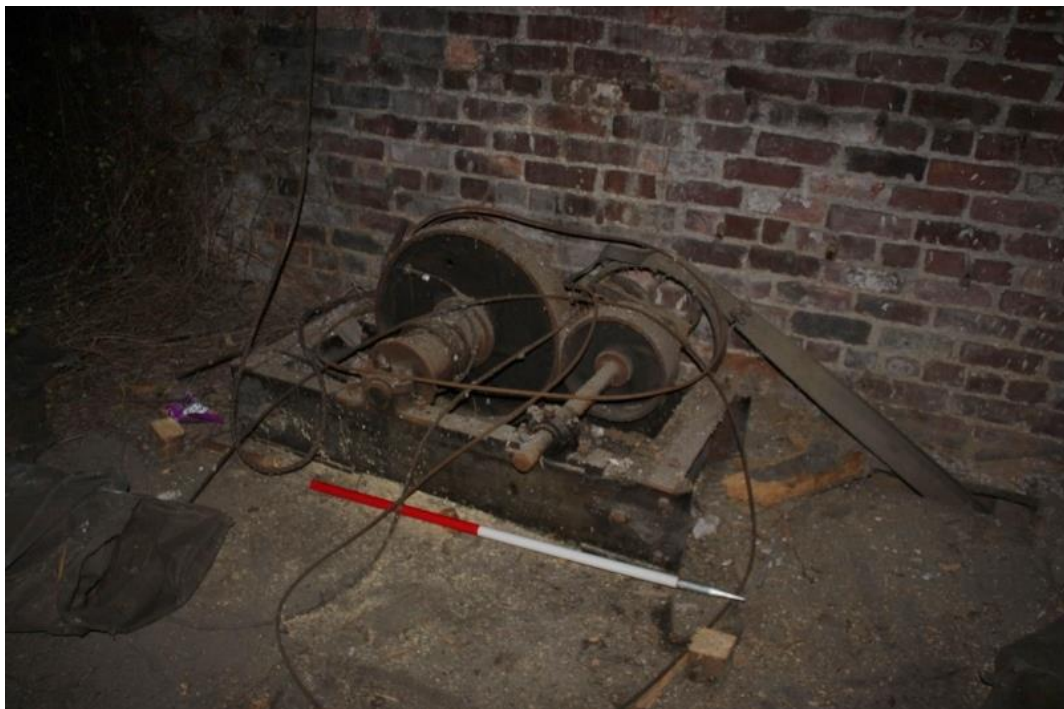
Figure 17b: Room E – *In Situ* Gearing for Grain Bruiser
